# Service Information Bulletins

# GRUNDIG

## Service Information

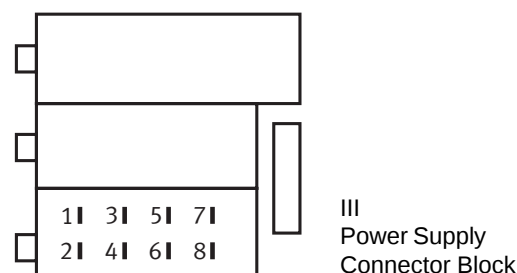
Car radio connector block

VW company have changed the pinning of the car's ISO power supply connector for the car radio. Contact 5 was previously provided for a positive voltage switched by the car radio (for antenna/booster). From 4/98 models onwards, an unswitched positive voltage may be applied to this contact.

Please ensure that no unswitched positive voltage is applied to contact 5 of the motor car otherwise remove the contact from the connector block and insulate it appropriately.

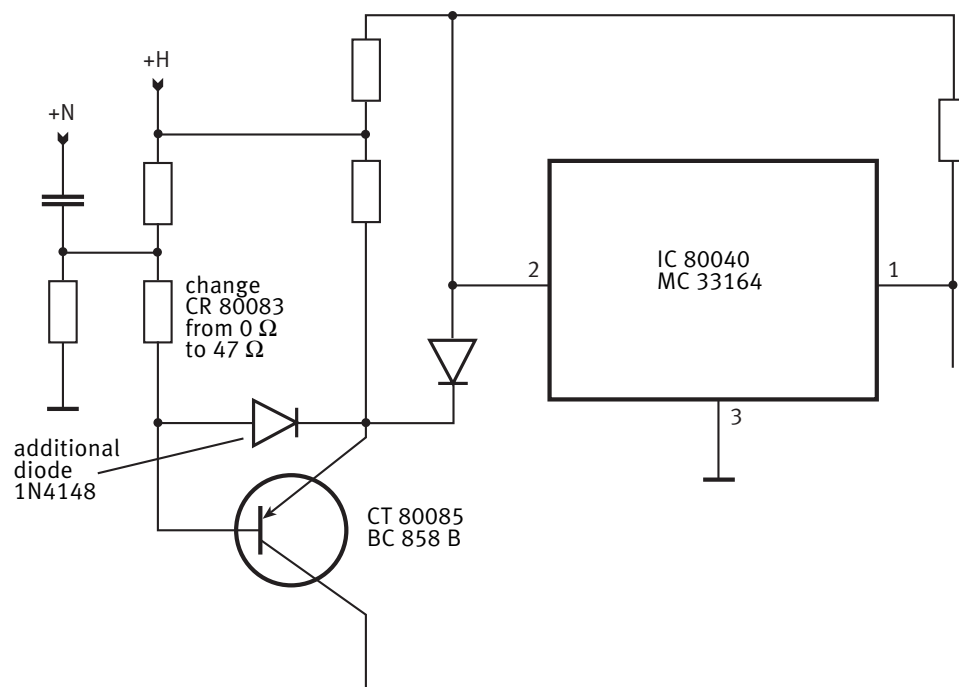
Failure of transistor CT 80085 BC 858B (position X=148, Y=18).

On replacement of the transistor, solder an additional diode 1N4148 from the base to the emitter (anode to base) of CT 80085 and change the resistor CR 80083 from 0  $\Omega$  to 47  $\Omega$  5% (structural shape 0805).

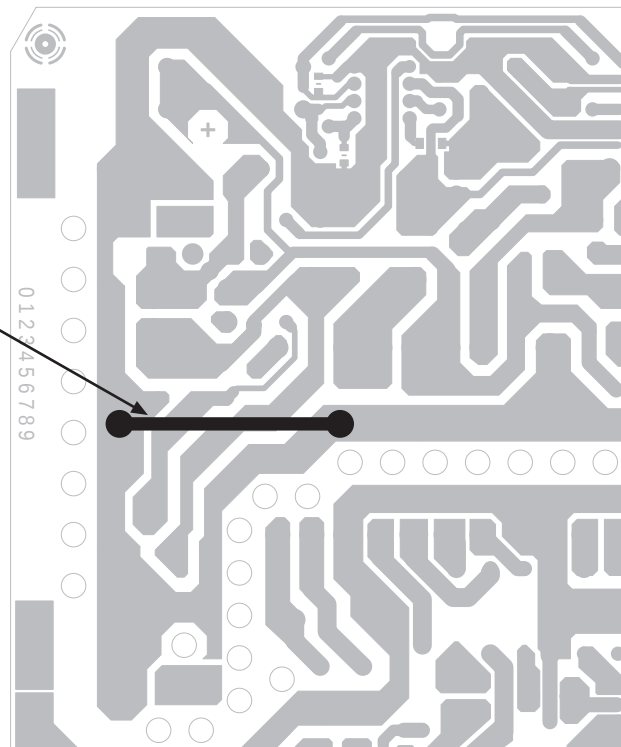
Solder an insulated wire of approx. 35mm (2.5mm<sup>2</sup>) in length on to the solder side of the mains supply section (between pos. R60007 and C60001) as shown below. This additional wire is used to short-circuit the ground loop which has been found to be the source of interference.

Solder in a bridge between these points and fix it with a heat-set adhesive

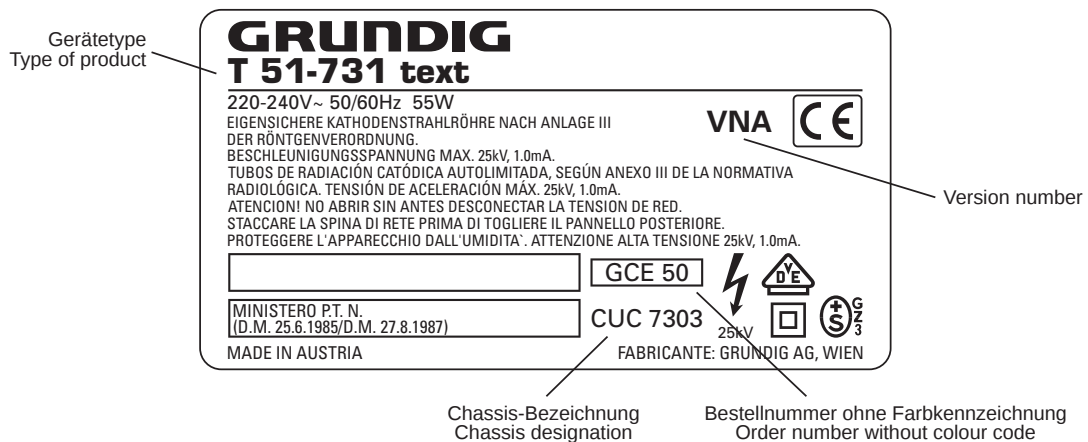
The television receivers with the reworked chassis are marked with a Version Number „VN...“ printed on the label on the back of the receiver (see figure).

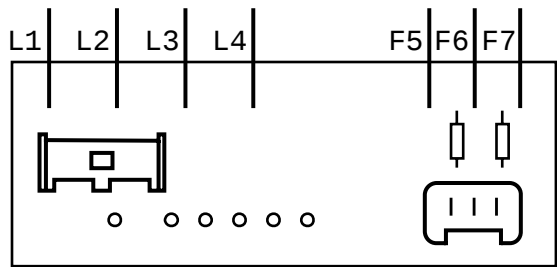
- changed yoke connections:  
The figure below shows the connections of the deflection unit for the new picture tubes A 68 ESF 002X143 part no. 8300 068 24300 and A 68 ESF 202X143 part no. 8300 068 20400.

- L1 - red yoke connecting lead (horizontal)
- L2 - black yoke connecting lead (horizontal)
- F5 - green yoke connecting lead (vertical)
- F7 - white yoke connecting lead (vertical)

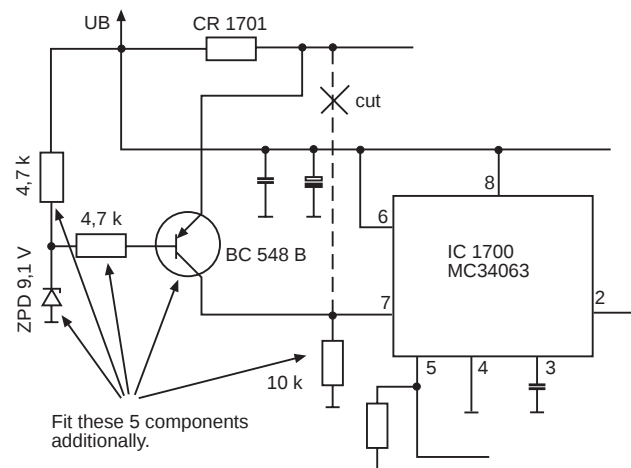
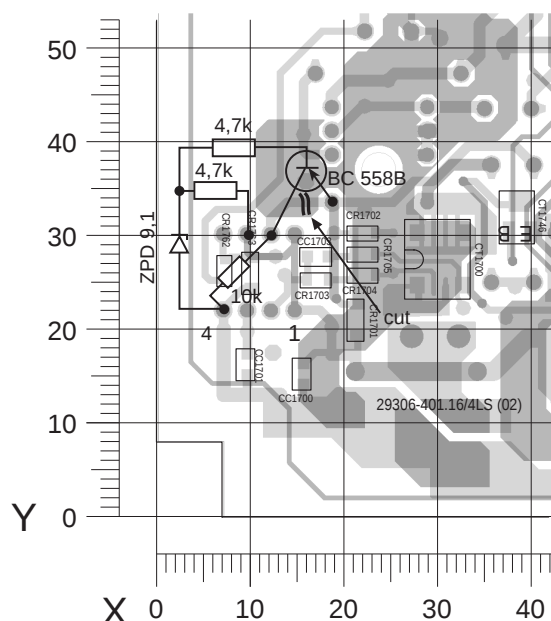
Failure of the transistor CT 1700 Si 9955 caused by a voltage supply (battery operation) below 9V.

When CT 1700 failed, fit the following additional components (see diagram):

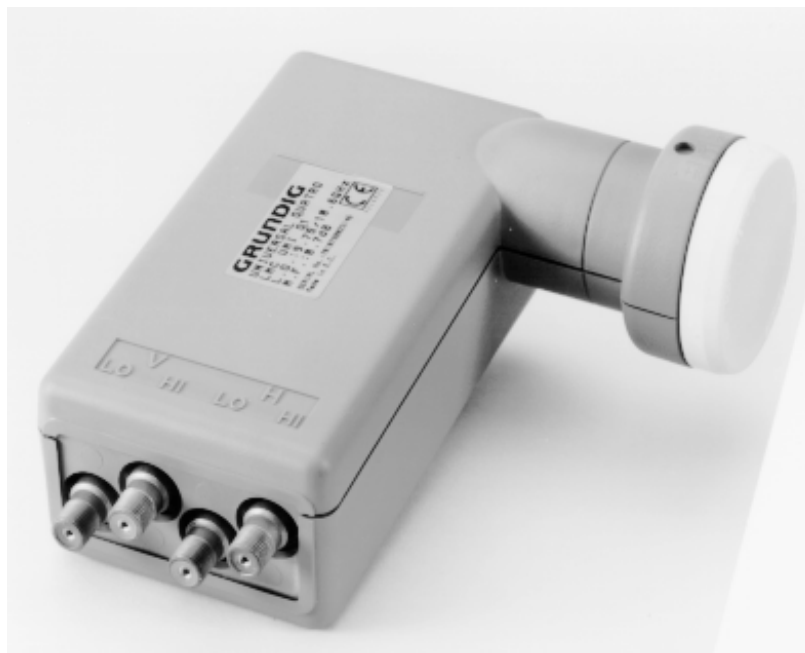
### Connections (position of LNC see figure above)

from left to right: vertical lower band  
vertical upper band  
horizontal lower band  
horizontal upper band

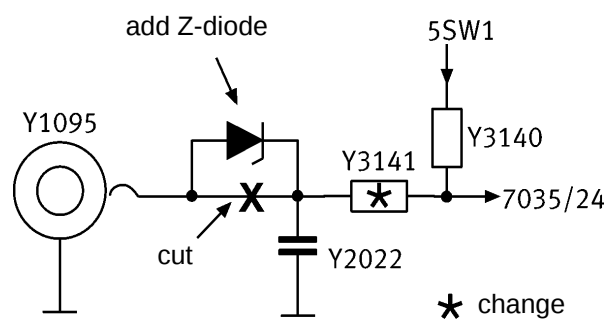
Extract from the circuit diagram in Service Manual  
72010-527.35, page 4-47

Add a 3.3V Z-diode (e.g. BZX 84 C 3V3), anode to Cinch socket.
