**GRUNDIG**

**SERVICE  
INFORMATION  
BULLETINS  
1999**

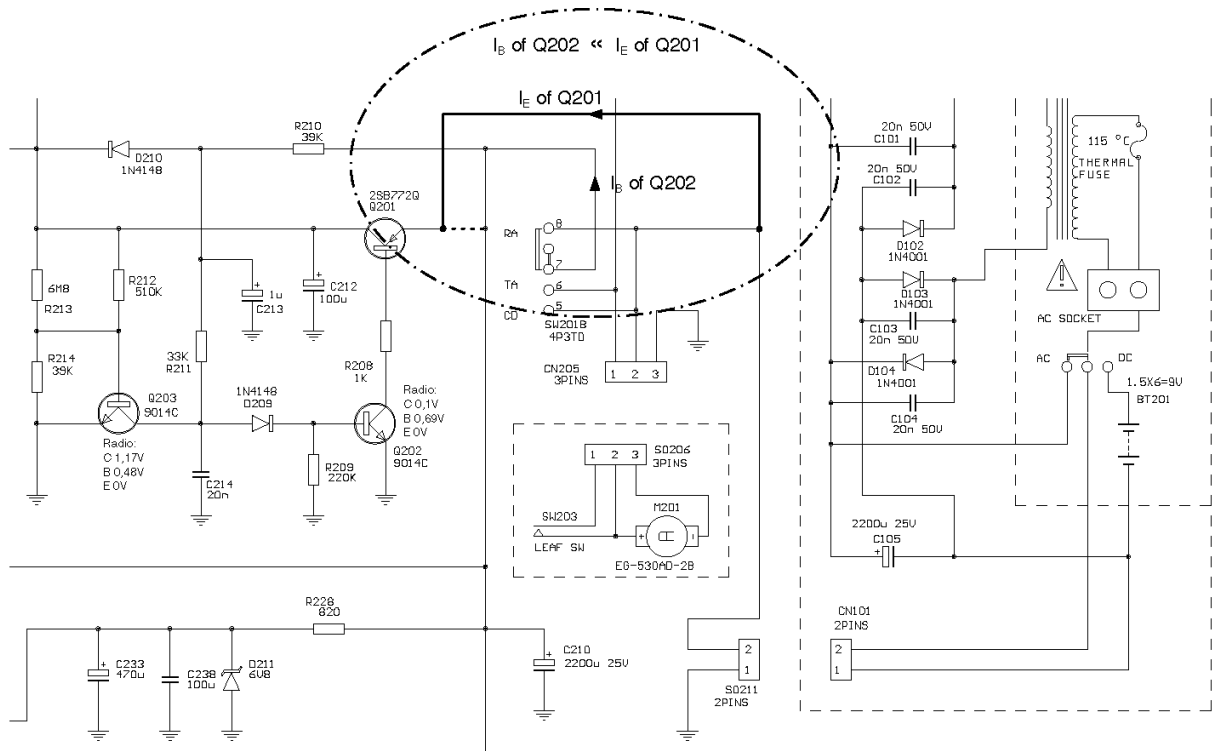
Figure 1

Connect the emitter of Q 201 directly to the voltage supply. The switch is only used for controlling the base current which is much lower than the emitter current. Fig. 1 (see page 2)

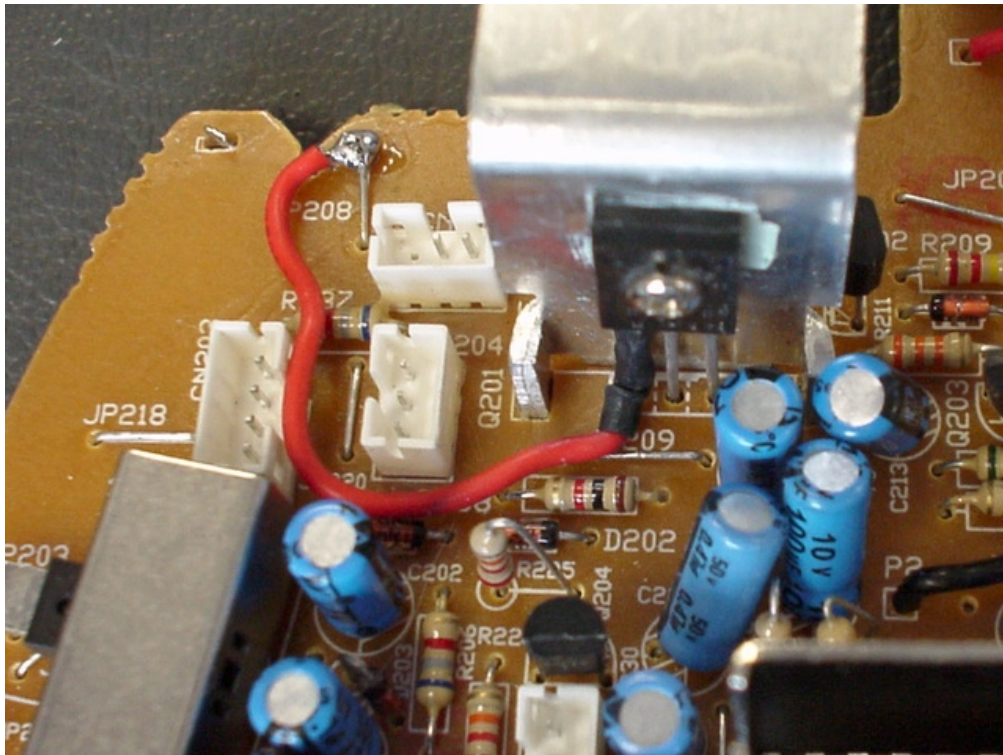
For repair: Fig. 2 (see page 2)

- Replace the slide switch.
- Disconnect the emitter of Q 201 from the circuit board using a wire cutter (or soldering iron).
- Solder a stranded wire (length=50 mm) to the emitter of Q 201 and insulate the solder joint with a piece of tube.
- Solder the other end to the jumper JP 208.
- Check the radio receiver and re-assemble it.

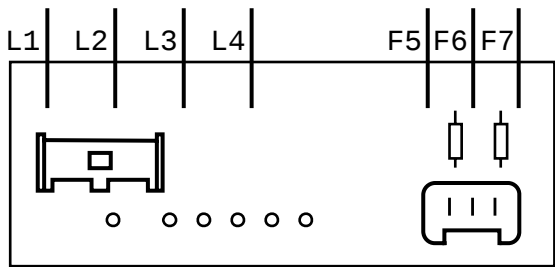
- changed yoke connections:  
The figure below shows the connections of the deflection unit for the new picture tubes A 68 ESF 002X111 and A 68 ESF 202X111.

L1 - red yoke connecting lead (horizontal)  
L2 - black yoke connecting lead (horizontal)  
F5 - green yoke connecting lead (vertical)  
F7 - white yoke connecting lead (vertical)

| <i>CRT fitted in the TV set</i> | <i>Changes when fitting the replacement tube</i> |
|---|---|
| A 68 ESF 002X11<br>A 68 ESF 202X11 | A 68 ESF 002X111<br>A 68 ESF 202X111<br>An existing seagull correction board is to be removed. The yoke connecting leads are soldered directly to the deflection unit (see figure). |
| A 68 ESF 002X011<br>A 68 ESF 202X011 | A 68 002X111<br>A 68 202X111<br>No change. Connect the picture tube as shown in the figure. |

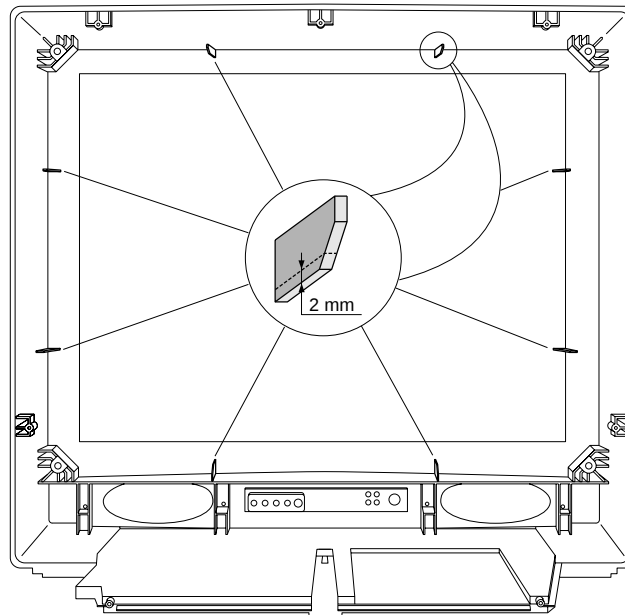
Due to the slightly larger overall dimension, the picture tube touches the fixing ribs within the cabinet. Consequently, when changing the tube, these ribs must be cut by about 2mm (see figure).
