Durability and Survivability of Piezoelectric Wafer Active Sensors on Metallic Structure

Bin Lin,^{*} Victor Giurgiutiu,[†] and Patrick Pollock[‡]

University of South Carolina, Columbia, South Carolina 29208

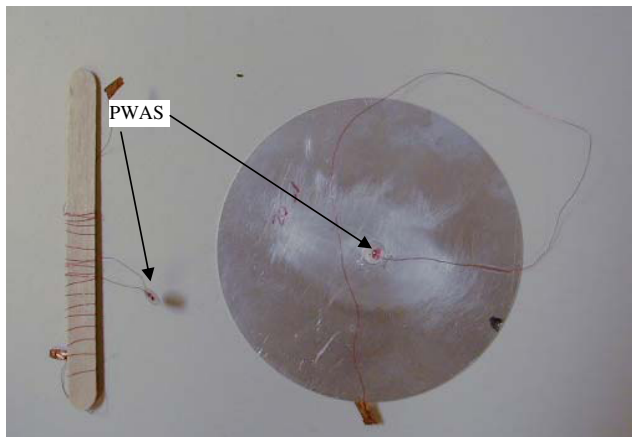
**Fig. 1** Free PWAS and attached PWAS.

Both free PWAS and bonded PWAS were studied (Fig. 1). Free PWAS were tested with two wires attached on both electrodes. The bonded PWAS specimens were made by attaching PWAS onto the center of a 100 m diameter 1 mm thick aluminum plate. The PWAS behavior was monitored using the electromechanical (EM) impedance method. Giurgiutiu [7] and others established a complete analytical model of free and bonded PWAS on circular plates as function of material properties of PWAS and structures. The analytical model results have been verified by experimental results and finite element simulation. For a free PWAS, the real part of the EM impedance reflects its free vibration spectrum. For a bonded PWAS, the real part of the EM impedance directly reflects the vibration spectrum of the tested specimen through the pointwise mechanical impedance at the point where PWAS is attached to the structure.

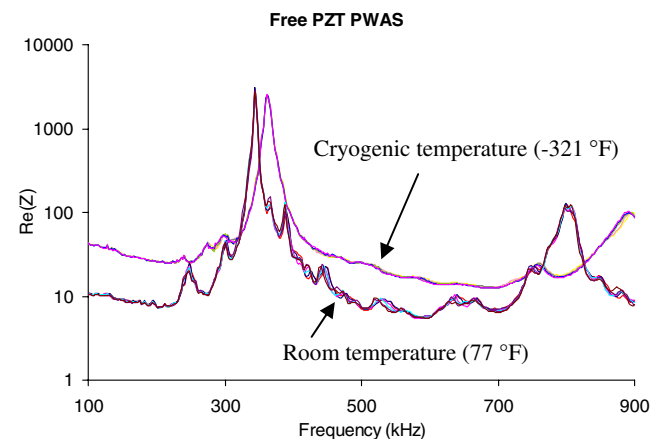
**Fig. 2** Indication of free PWAS operability while submersed in liquid nitrogen.

submerged into the liquid nitrogen and kept for 10 min before measurements to test the survivability. The impedance signatures were measured by a Hewlett Packard 4194A Impedance analyzer. The real part of impedance signature indicated that free PWAS, when subjected to liquid nitrogen at cryogenic temperatures, maintained their EM impedance (Fig. 2). The first resonance frequency increased from 344 to 362 kHz. Initial impedance signature of free PWAS was recovered when PWAS was warmed to room temperature.

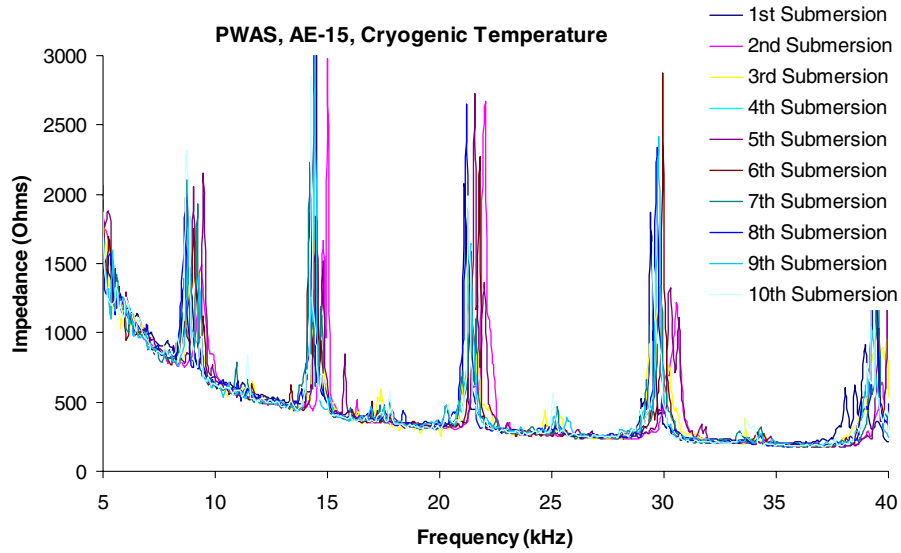
Fig. 3 The real part of impedance indication of operability through retention of resonant properties while submersed in liquid nitrogen.

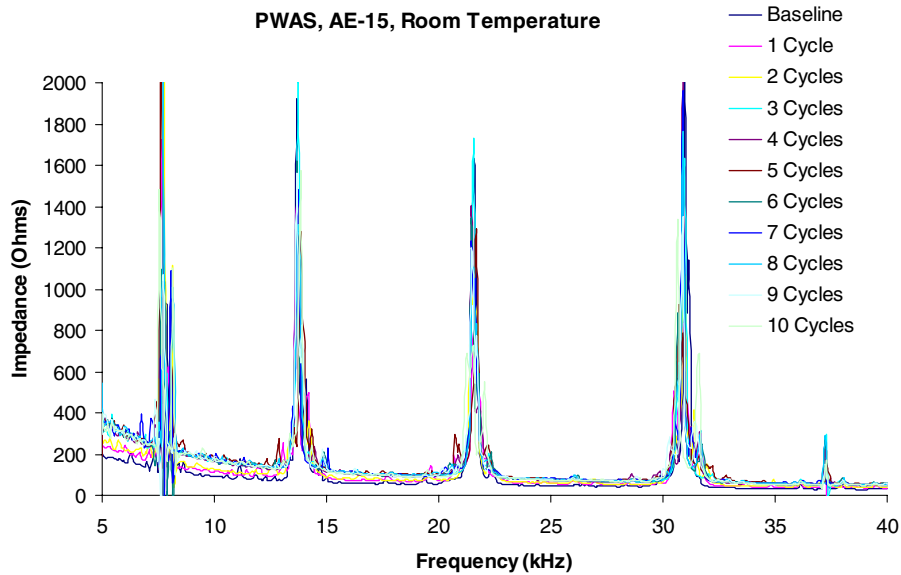
Fig. 4 The real part of impedance indication of survivability through resumption of resonant properties at room temperature after submersion in liquid nitrogen.

The short-term operation temperature of M-bond 200 is from -300 to $+200^{\circ}\text{F}$. Bonded PWAS with M-Bond 200 adhesive did not survive the cryogenic cycling. However, AE-15 maintained its ability during cryogenic cycling. Figure 3 shows the real part of impedance signatures taken from a bonded PWAS specimen with AE-15 adhesive that was submerged into liquid nitrogen for 10 times. The specimen was submerged in the liquid nitrogen for 10 min before each impedance measurement. Figure 4 shows the real part of impedance

signatures taken from the bonded PWAS specimen at room temperature after each submersion. The real part of the impedance retained its peaks and their relative frequency location. No major EM impedance changes were recorded for both free and bonded PWAS working at cryogenic temperature. The reverberated response is significantly higher under submersion than in air (e.g., approximately $1800\ \Omega$ at 5 kHz under submersion vs $400\ \Omega$ at 5 kHz in air), which indicates more damping when submerged, as expected. However, the damping of the resonance peaks is more elaborate to deduce and would need a separate study.

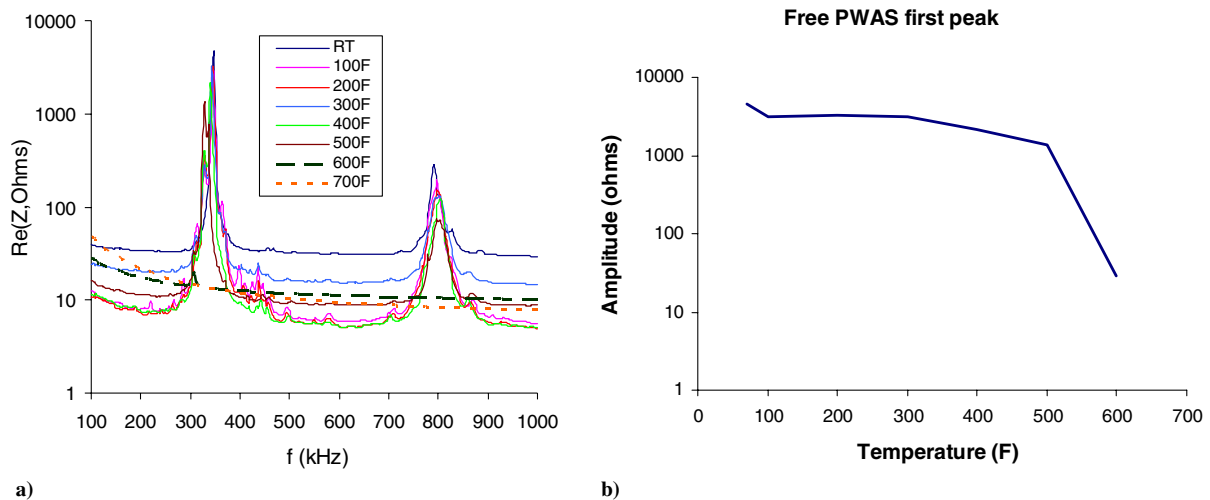
Fig. 5 Real part impedance spectrum of a free PWAS: a) impedance at room temperature after heating, and b) amplitude of impedance peak at room temperature after heating.

temperature. Figure 5a shows the real part impedance spectrum of a free PWAS measured in room temperature and the real part impedance spectrums of the PWAS after exposure to oven temperatures ranging from 100 to 700°F with 100°F increment. The Curie temperature for PZT PWAS is 625°F. As seen in the Fig. 5a, under 500°F, the real part impedance spectrums of PWAS possesses two strong antiresonant peaks due to the intrinsic electromechanical impedance of the free PWAS. With the further increment of oven temperature PWAS lost its piezoelectric effect, which is manifested by the loss of antiresonance peaks in real part impedance spectra. Figure 5b shows the free PWAS was able to maintain its antiresonance peak amplitude at the room temperature after the short-term heating up to 500°F. This suggested that free PWAS can survive after heating up to 500°F.

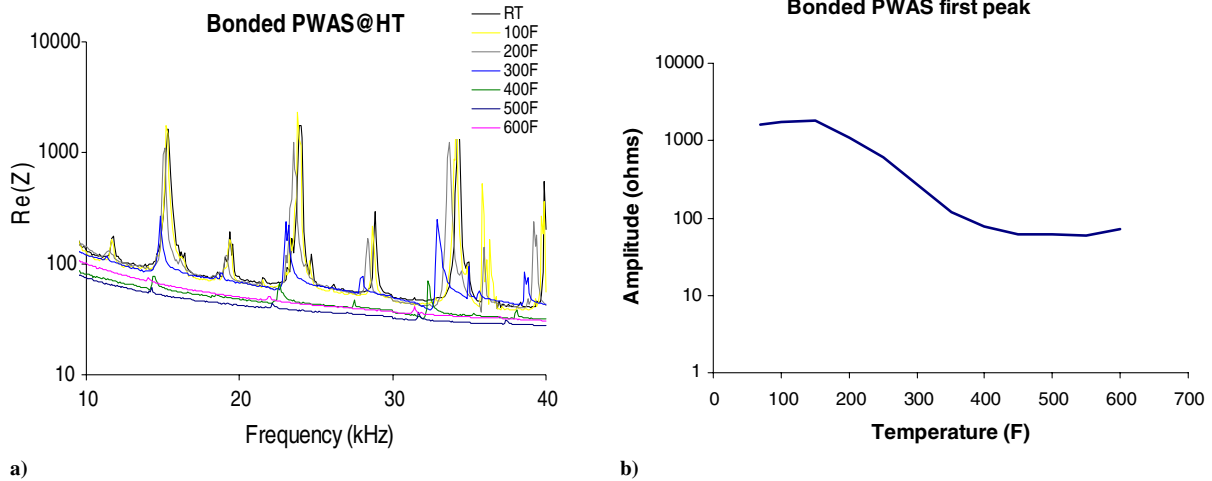
Fig. 6 Real part impedance spectrum of a bonded PWAS: a) impedance at the elevated temperature, and b) amplitude of impedance peak at the elevated temperature.

A bonded PWAS was subjected to high temperature in the oven with the similar setup as the free PWAS. Because of the high temperatures, extra care must be taken for the bonding of sensors. Vishay adhesive M-Bond 610 has a short-term operating temperature range from -452 to +700°F and a long-term operating temperature range from -452 to +500°F. The PWAS durability test for bonded PWAS at high temperature used M-Bond 610 adhesive. PWAS impedance spectrums were measured at the oven. Figure 6a shows the real part impedance spectrum of the bonded PWAS after exposure to oven temperatures ranging from 100 to 600°F with 100°F increment. As seen in the figure, the real part impedance spectrums of bonded PWAS antiresonant frequencies and amplitudes reduced after increasing the temperature. At temperature above 400°F, the real part of impedance spectrum becomes very small. After reaching

the Curie temperature, the bonded PWAS lost its piezoelectric effect. Figure 6b shows the first antiresonance peak amplitude remain the same when the environmental temperature was below 200°F. The amplitude started to drop above 200°F. However, this drop is not as abrupt as noticed for free PWAS above 500°F. This suggests that the performance of PWAS bonded to aluminum plate with M-Bond 610

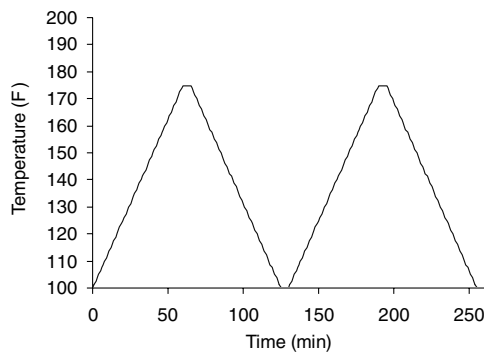
Fig. 7 Temperature cycling graph.

For temperature cyclic testing, free and attached PWAS were placed in an oven and exposed to a temperature variation between 100 and 175°F. The temperature cycle consisted of a slow rise from 100 to 175°F followed by a 5-min dwell at 175°F, then a slow descend from 175 to 100°F followed by a 5-min dwell at 100°F (Fig. 7). The peak of test environmental temperature is 25°F higher than the adhesive normal operating temperature. The data taken at the beginning of this experiment showed a settling in effect, that is, some amplitude reduction during the first few cycles, followed by a leveling off of the variations. The free PWAS survived the temperature cycling without any significant change in the EM impedance spectrum. In total, 1700 cycles have been performed (11 months of testing). The free PWAS survived 1700 oven cycles without significant changes in the EM impedance spectrum (Fig. 8a). Attached PWAS survived 1400 cycles in the oven without significant changes in the EM impedance spectrum. The spectrum taken after 1500 and 1600 cycles showed small changes. The spectrum taken after 1700 cycles showed marked changes shown in Fig. 8b, which were attributed to the failure of the attached PWAS.

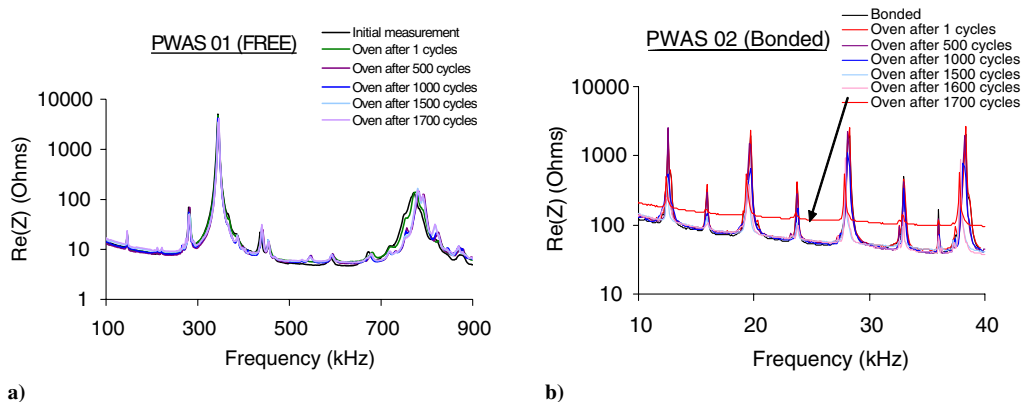
Fig. 8 EM impedance spectrum of PWAS after exposure to temperature cycling: a) free PWAS, and b) attached PWAS on a metallic plate.

AE-10 adhesive was used in this set. The operating temperature range is from cryogenic region to 200 F. M-Bond AE-10 is a 100%-solids epoxy system. For this set of temperature cyclic testing, free and attached PWAS were placed in an oven and exposed to the same temperature cycling previously described. The data taken at the beginning of this experiment showed a similar settling in effect. The free PWAS and attached PWAS survived the temperature cycling without any significant change in the EM impedance spectrum after 1000 cycles.

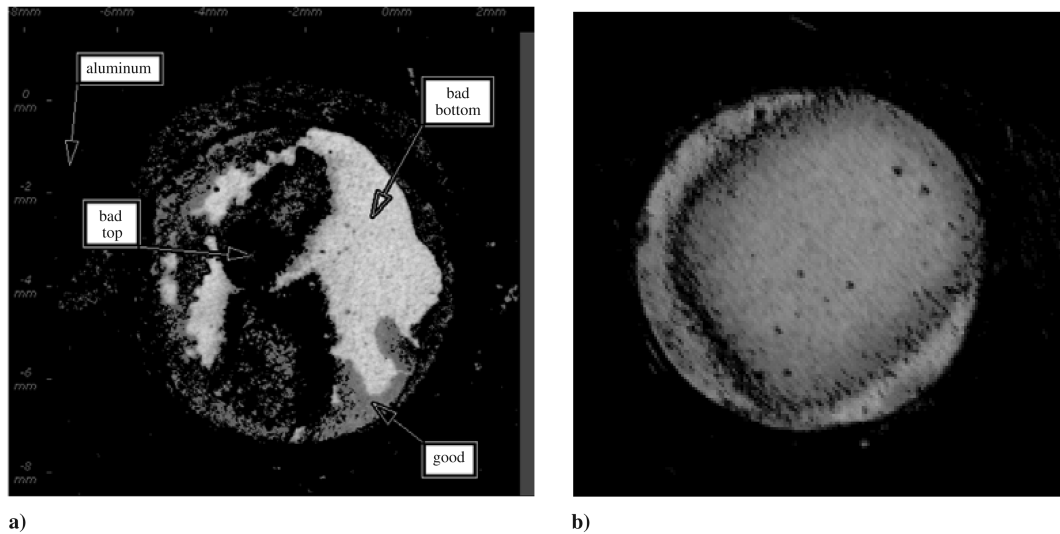
Fig. 9 C-Scan adhesive and PWAS interface images of a) bad bond specimen, and b) good bond specimen.

Further investigation with a Quantum 350 scanning acoustic microscope** indicated that disbond between PWAS and substrate took place. Figure 9a showed C-scan adhesive and PWAS interface images of the PWAS-02 specimen after 1700 cycles. We can easily identify some disbond areas. There are four distinct regions on the C-scan interface image, namely the black background (aluminum plate), white interface (probable disbond at the adhesive/PWAS interface), gray interface (good bond), and black interface (probable disbond at the aluminum/adhesive interface). In comparison, we put a C-scan image of good bond specimen in Fig. 9b. Hence, it was concluded that the failure was not due to the piezoelectric material failure, but due to the failure of the bonded interface between the PWAS and the substrate. The operating temperature is beyond the adhesive normal working range; this failure can be attributed to the repeated differential thermal expansion for the adhesive layer between the ceramic PWAS and the metallic substrate.

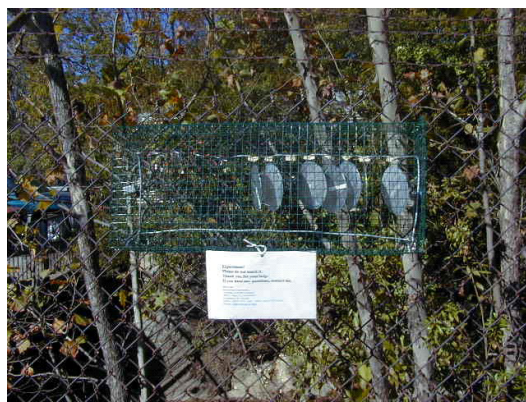
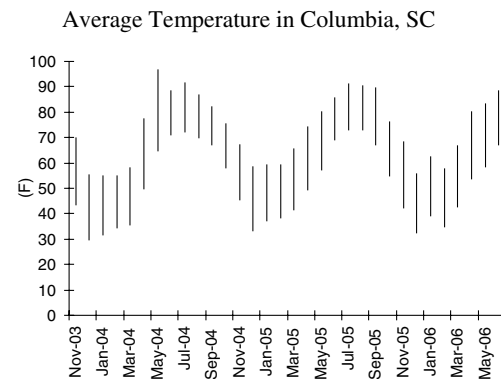
Fig. 10 a) Environmental testing of free and attached PWAS: a) outdoors test fixture, and b) temperature profile.

Free PWAS and attached PWAS were exposed to the outdoors environment (Fig. 10a) over a long time period. In this study, several adhesives and several protective coatings were examined (Table 3). The measured quantity was the EM impedance spectrum. The data taken at the beginning of these experiments showed a settling in effect, that is, some amplitude reduction during the first few cycles, followed by a leveling off of the variations. After this, the EM impedance data stayed rather constant for the duration of the test. This test has been conducted for 120 weeks and average temperature was shown in Fig. 10b. Minor repairs to the wire attachments were done. So far, significant changes of PWAS EM impedance spectrum have been noticed in the attached PWAS specimen. Free PWAS are still in good working condition. A brief description of all the PWAS conditions can be found in Table 3.

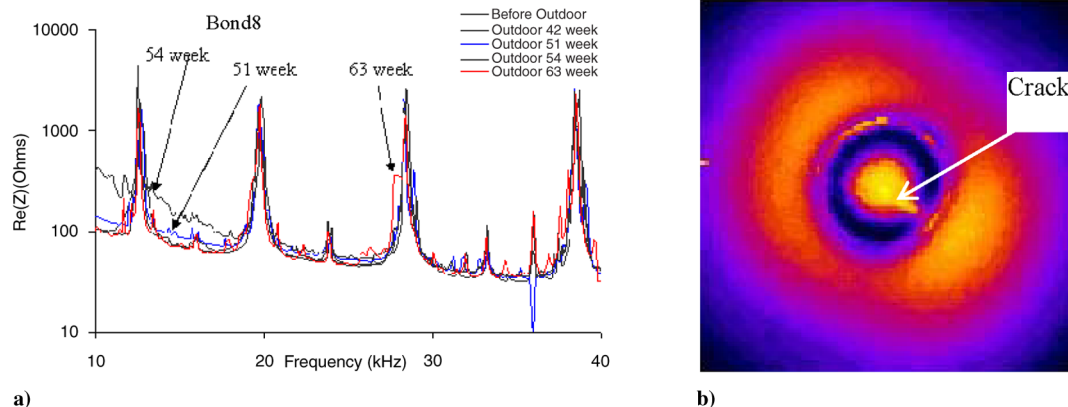
Fig. 11 a) EM impedance spectrum of specimen Bond8, and b) asymmetric displacement field [18].

For sample Bond8, this sample used the cyanoacrylate fast adhesive and had no protective coating. The historical evolution of the EM impedance spectrum for this sample is shown in Fig. 11a: up to 42 weeks, no significant changes were recorded; at 51 weeks, small changes were observed. The main peak dropped a little and more small peaks can be noticed. At 54 weeks, more changes were observed. At 63 weeks, significant changes were observed. The main peak dropped a lot and more small peaks appeared. At this stage, the sample was sent to Dr. Blackshire at Air Force Research Laboratory, where it was subjected to laser scanning interferometer investigation [18]. An asymmetry in the displacement field and large amplitude edge vibrations indicative of incipient disbonding were found (Fig. 11b). In addition, a crack was detected in the PWAS under optical microscope investigation [18]. The crack was located

diagonally in the right lower corner. These effects may explain the changes noted in the EM impedance spectrum. The Bond8 was received back and continued its outdoors test. The impedance spectrum was still recoded until final reading at 84 weeks. After that, the specimen completely was inactivated and impedance spectrum did not reflect the structure information anymore.

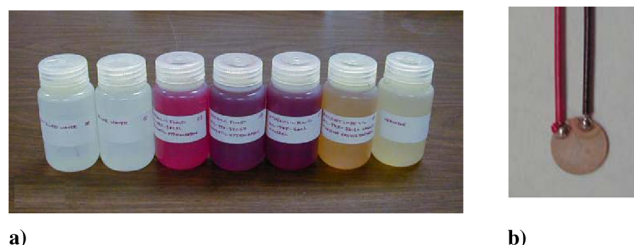
Fig. 12 PWAS submersion test: a) test containers, and b) 5-mm diameter free PWAS specimen.

The purpose of these tests was to determine how PWAS behaves when exposed to water and various maintenance fluids. The specimens used in this experiment were free 5-mm APC-850 PWAS with two connecting wires soldered by the manufacturer. The PWAS were submerged in plastic bottles containing the fluids (Fig. 12). The fluids used in the submersion test were distilled water (0), saline solution (1), hydraulic fluid MIL-PRF- 83282 synthetic hydrocarbon (2), ; hydraulic fluid MIL-PRF- 87257 synthetic hydrocarbon (3), hydraulic fluid MIL-PRF- 5606 mineral (4), aircraft cube oil MIL-PRF-7808L grade 3 turbine engine synthetic (5), and kerosene (6).

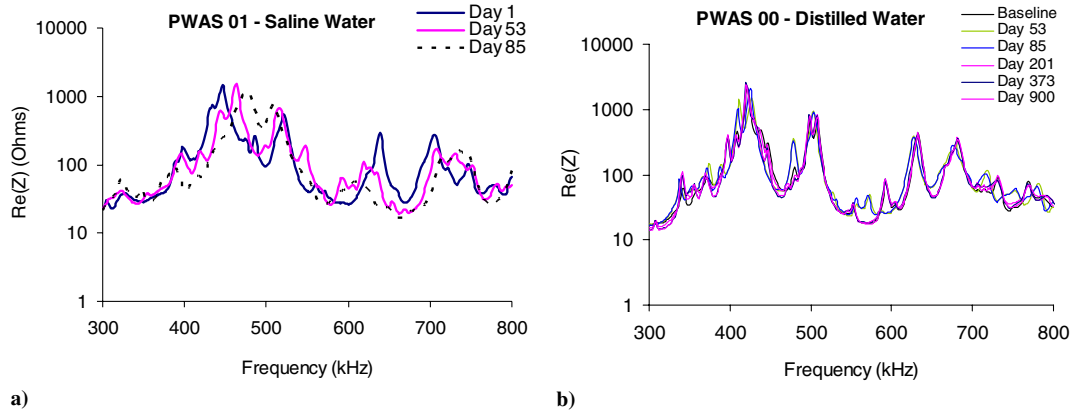
Fig. 13 EM impedance spectrum of PWAS after submersion exposure: a) PWAS in saline water, and b) PWAS in distilled water.

This test has been conducted for over 900 days (128 weeks). So far, no significant changes have been noticed in the PWAS EM impedance spectrum except for the PWAS submerged in saline solution (Fig. 13). The PWAS submerged in saline solution survived only a little over 85 days (15 weeks). The EM impedance reading taken at 85 days exposure showed marked differences from the previous readings. The failure of this PWAS was traced to the detachment of the soldered connection. This can be attributed to the corrosive effect of the saline solution.
