Cost-effective bridge girder strengthening using vacuum-assisted resin transfer molding (VARTM)

Abstract—The objective of this paper is to present the results of a demonstration project to apply externally bonded CFRP fabrics to retrofit a simple span prestressed concrete girder with improved repair and hardening techniques. The technique, Vacuum Assisted Resin Transfer Molding (VARTM), newly introduced to civil infrastructure was implemented in the field within two days without any traffic interruption. As an alternative to traditional hand lay up, VARTM has several processing advantages, like saving the processing time, uniform resin application, intimate contact between each layer of CFRP and concrete substrate ensuring good consolidation to remove void or dry spot, higher fiber volume fraction (about 70%) and greater wettability of the fiber, etc. The performance of the strengthened structures depends on the above potential factors to obtain high structural performance. VARTM uses single-sided molding technology to infuse resin over fabrics wrapping large structures such as bridge girders and saving tooling and processing time. Recently, the VARTM technique has been implemente

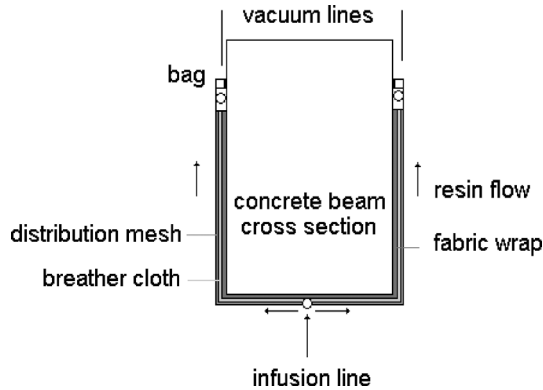
Figure 1. VARTM in rectangular concrete beam.

For this particular application, the surface of the concrete acts as the tool for the infusion process. After the surface of the concrete is prepared, a layer of primer is applied in the area to be infused. A vacuum seal is formed around the beam or column, using vacuum bag sealant tape to ensure an airtight seal. The dry fabric, initially cut to shape, is then placed on the concrete surface and held in place using adhesive tape on the edges. Then, the stretched fabric is covered using a porous medium, and a distribution mesh, to allow resin flow through the fabric. The infusion and vacuum lines are then placed, and finally covered by a bagging film. The lay-up is debulked and the resin/hardener mixture is infused with the aid of a vacuum. The feasibility of using VARTM was demonstrated on an 1828.8 mm (6 ft) RC beam, as illustrated in Figs 1 and 2. The resin flows across the fabric, and fills any surface flaw by the aid of the hydrostatic pressure that is applied by the atmosphere on the bag. The infusion parameters were optimized so that the infusion was symmetrical and even (Fig. 2), and resin rich areas were avoided. Curing took place under vacuum.

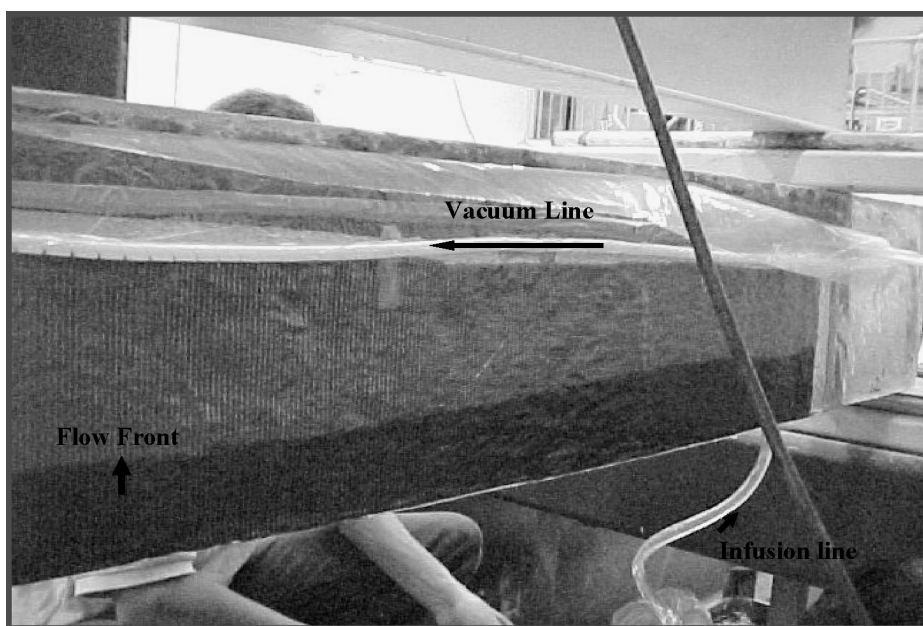
Figure 2. VARTM processing on 1828.8 mm (6 ft) RC beam.

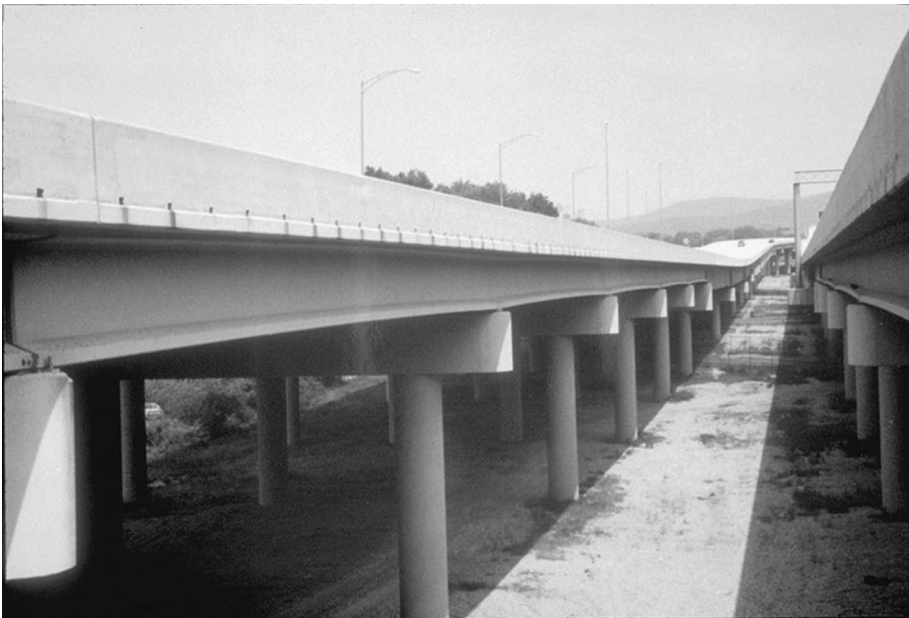
Figure 3 is the I-565 highway bridge in Huntsville. At the present condition it was seen that the open spaces in between some girders were sealed. As a result, cracks developed very close to the support due to bending caused by the temperature variation shown in Fig. 4 [6].

Figure 3. I-565 highway bridge in Huntsville.

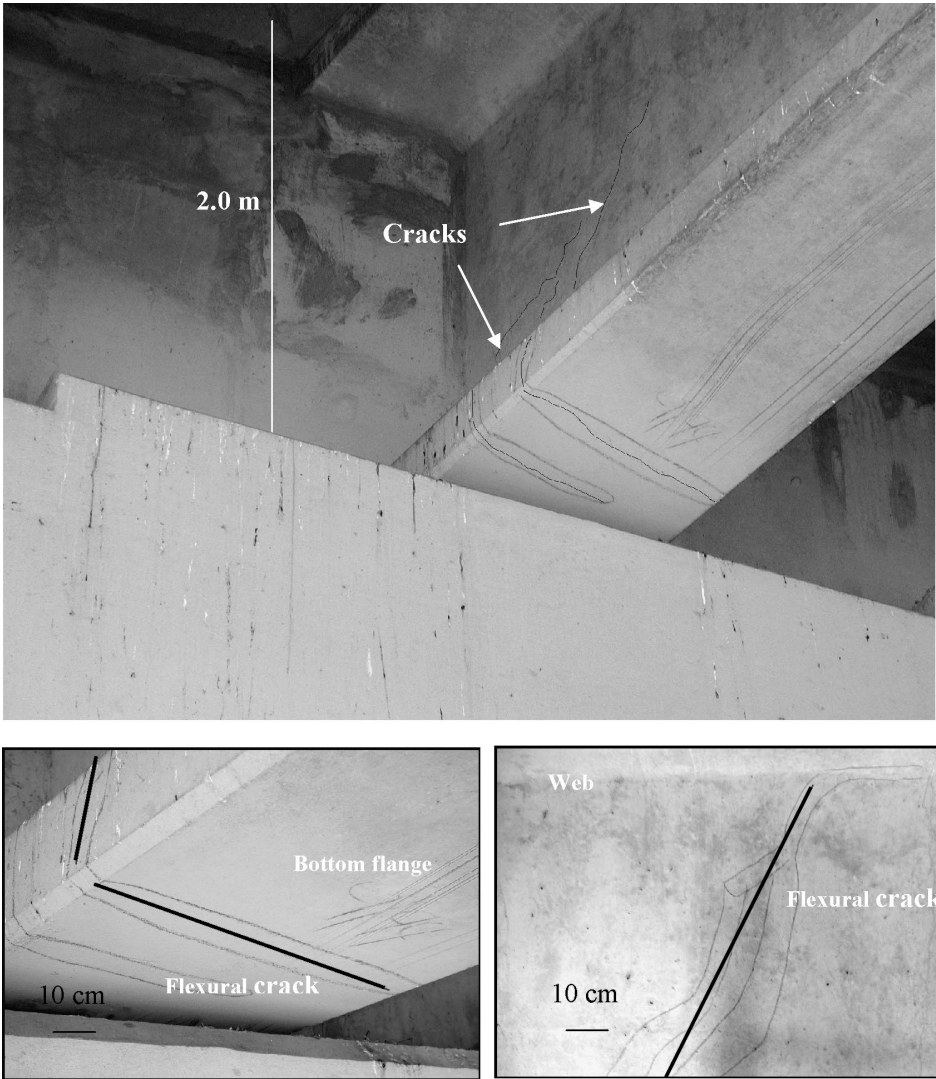
Figure 4. Initial cracks in analyzed girder, flexural cracks in flange and shear crack in the web (black lines illustrate crack direction).

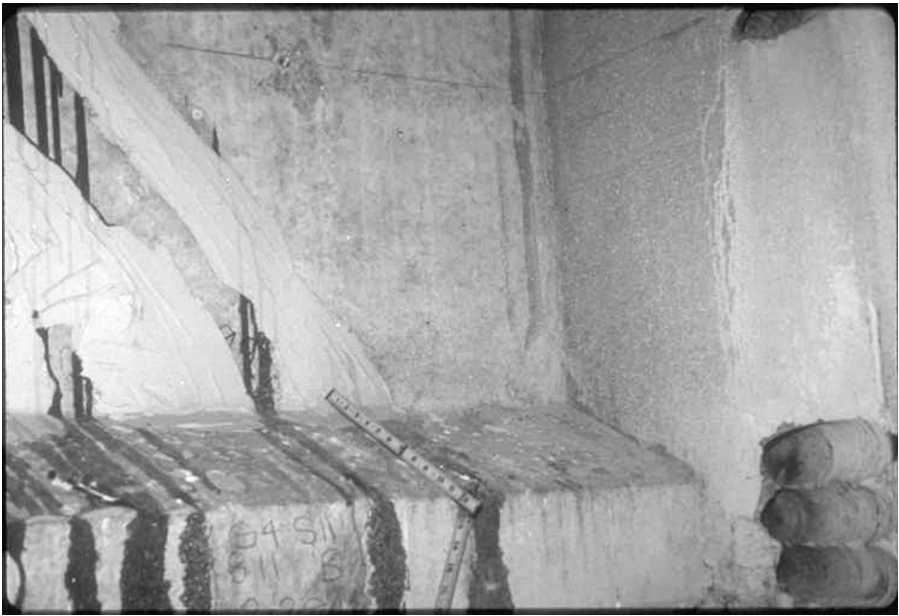
As shown in Fig. 5, some preliminary repair implemented by injecting polyurethane foam in the cracks is seen to be ineffective in containing the growth of stress- and environment-induced cracks. This technology only seals the crack. By sealing the cracks no infusion of resin can take place inside the cracks. No actual improvement is achieved in the structural integrity to carry the imposed load coming from the deck. Crack propagation is still in the micro phase. In order to improve this situation one must not only seal the cracks but also stop the crack propagation.

Figure 5. Some preliminary repair implemented by injecting polyurethane foam in the cracks is seen to be ineffective at I-565 highway bridge girder in Huntsville.

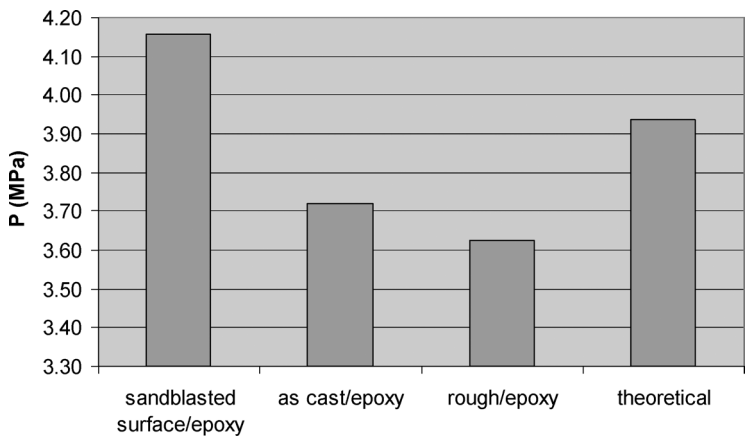
The surface strength of the concrete was studied by pull-off tests [7]. From Table 2, it was seen that sandblasting treatment was effective in transferring higher loads through the bond. Figure 6 shows a summary of the pull-off test results. So it was decided that the second phase of the test would only be conducted with the sand blasting surface treatment.

Figure 6. Results from pull-off test.

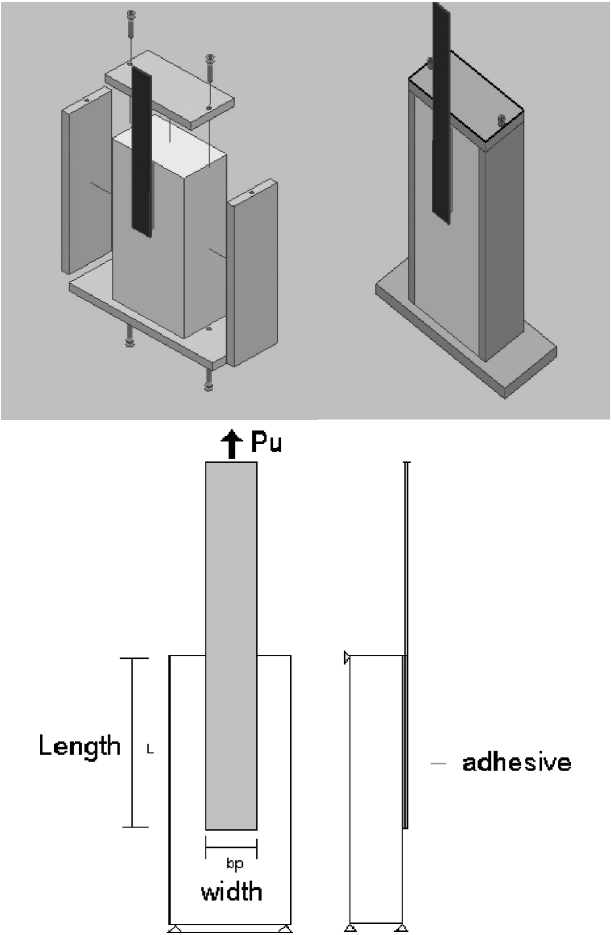
In this test a uni-axial tension is applied on the fabric bonded to the concrete, so that the interface is subjected to pure shear. It is known that the application of a laminate to a concrete beam introduces shear transfer to the concrete/epoxy interface. Figure 8 compares experimental VARTM results with the analytical model [7].

Figure 7. In-plane shear test schematic.

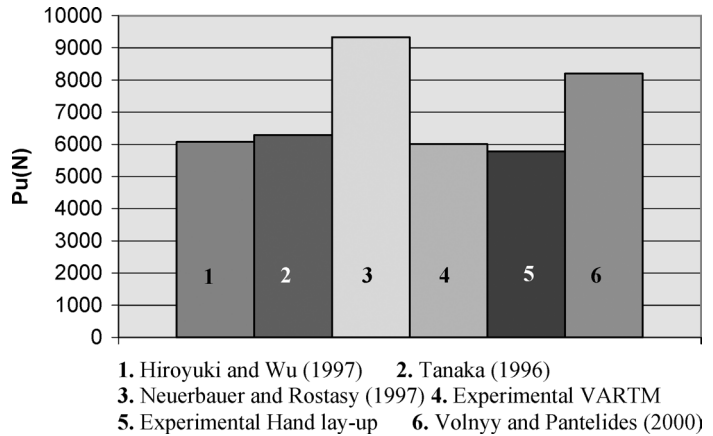
Figure 8. Experimental and theoretical results of in-plane shear test.

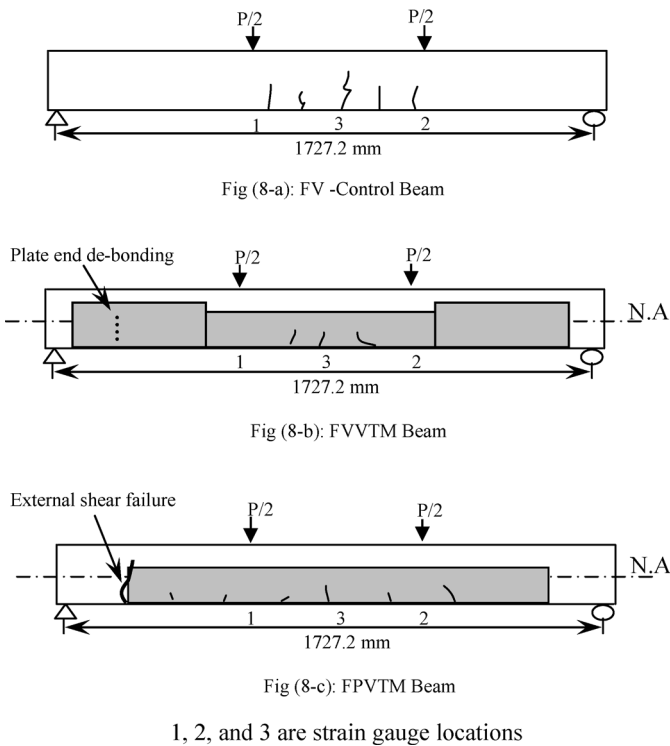
Figure 9. Strengthening scheme and failure modes.

Schematics of failure mode and FRP strengthening scheme for all three beams are shown in Fig. 9. A Linear Variable Displacement Transducer (LVDT) was placed under the mid span of the beam to measure the deflection, two strain gauges were

attached beneath the point load location and one was attached at the mid span of the beam, as shown in Fig. 9 (1, 2, and 3 are strain gage locations). All three strain gages were attached at the tension face of the beam. The strain gauges and the LVDT were connected to a data acquisition system (MEGADAC) which records data every one second. The load was applied through a load cell which was placed on the top of the set-up.

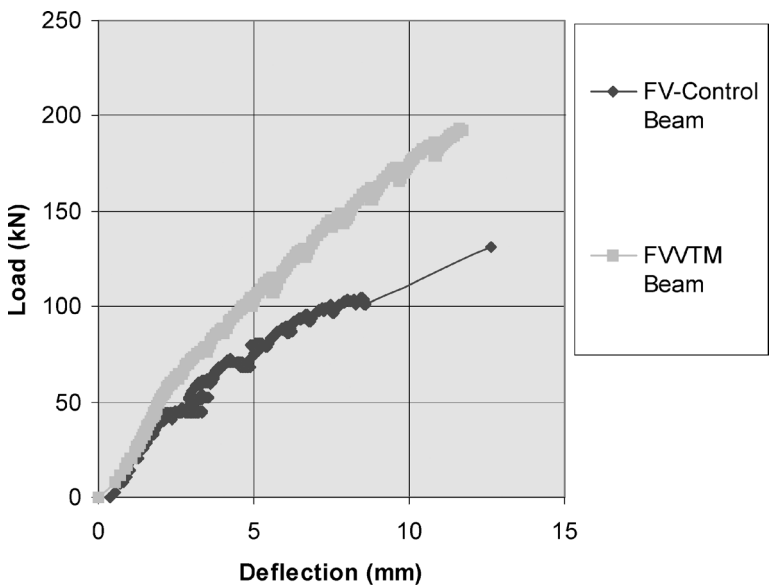
These tests were done to study the behavior of VARTM strengthening RC beam under flexural condition. Typical load *versus* deflection curves for three types of beam are shown in Figs 10 and 11. Table 5 shows the load, deflection and failure mode of the three tested beams. Figure 10 shows the load–deflection curve of FV-control and FVVTM beams. The FVVTM beam shows higher ultimate load before failure, compare to the unstrengthened beam (Fig. 10). Figure 11 shows the load–deflection curve of a pre-cracked beam. From the figure it is seen that the ultimate load was increased significantly after the VARTM strengthening. The tested RC beams were designed to balance failure so cracks at the bottom face and crushing in compression side in FV-Control beams confirms this. For the FVVTM beam, as both flexure and shear reinforcement were used, debonding occurred at the flexural CFRP plate cut-off point. For the FPVTM beam, no external reinforcement for shear had been done, so external shear failure was observed along with concrete crushing for this case.

Figure 10. Load vs mid-deflection curve of FVVTM and FV-control beam.

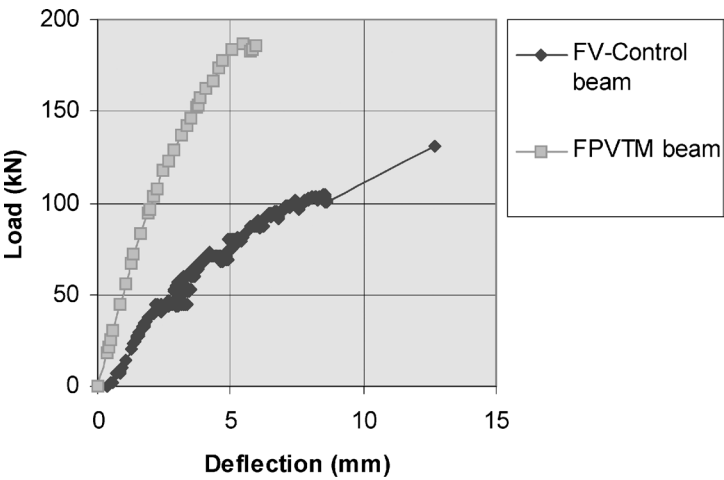
Figure 11. Load vs mid-deflection curve of FPVTM beam before and after VARTM strengthening.

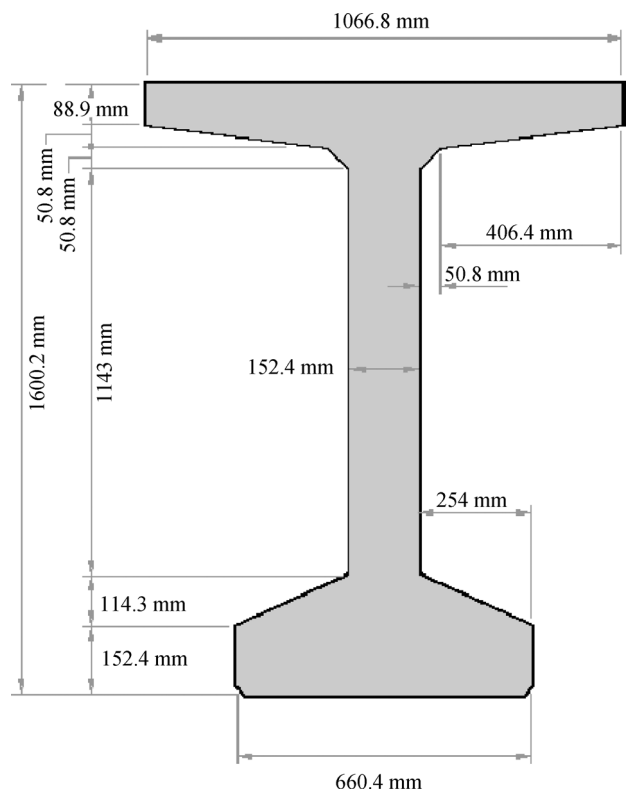
The cross-section of the 1600.2 mm (63") bulb-tee girder is shown in Fig. 12. Table 6 shows the sectional properties of the 1600.2 mm (63") bulb-tee girder. Table 7 shows the sectional properties of 1600.2 mm (63") bulb-tee girder and 203.2 mm (8") cast-*in-situ* slab. Here it was assumed that after developing flexural cracks, the concrete section is fully cracked and the concrete is no longer able to carry any tensile force. To retrofit such a section, it was assumed that the external reinforcement carries all of the nominal capacity of the section. The first critical section was calculated as h_c , centroid of the pre-stressing + 254 mm (10"), i.e. $h_c + 254$ mm ($h_c + 10"$) from the support. At this critical section both the pre-stressing force and temperature variation were considered in calculating the required number of CFRP layers. All the calculations for the required CFRP have been shown in Table 8 to Table 11. From Table 11, two layers of CFRP were required for flexural reinforcement. In order to avoid shear failure, shear reinforcement was calculated based on 292.6 kN (65.7 kips) shear force developed at the critical section from the load of an HS 20 truck. Based on the design guidelines ACI 440 [13], this gave two layers of CFRP for shear strengthening of that section. These shear

Figure 12. The cross-section of bulb T-girder.

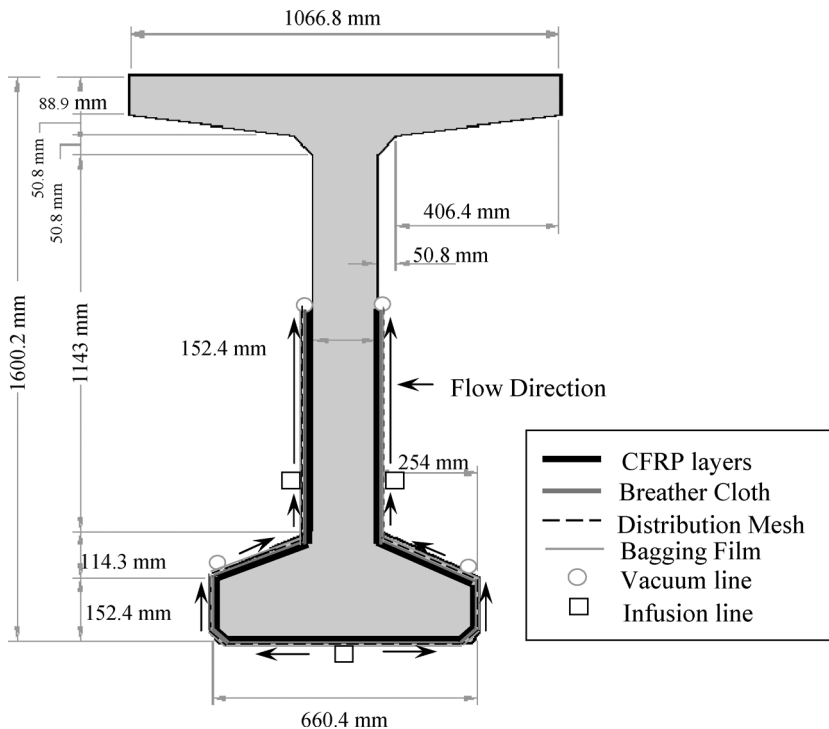
Figure 13. Schematic of bulb T-section with retrofitting strategy.

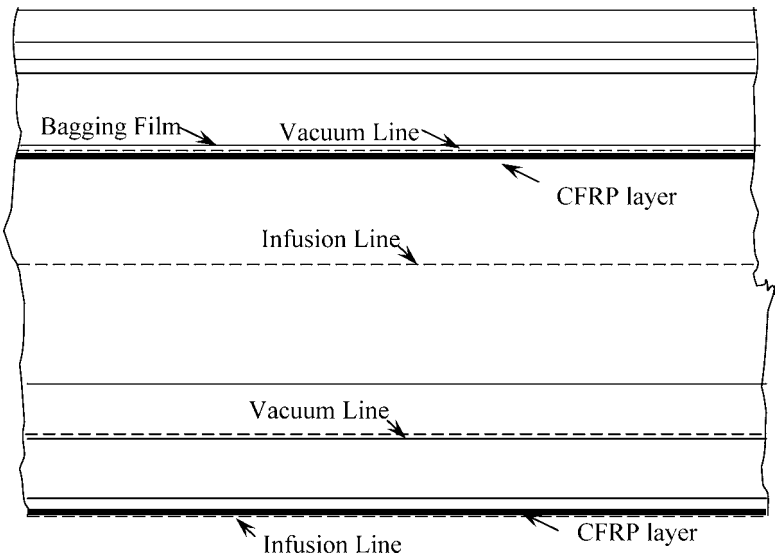
Figure 14. Longitudinal view of the 1600.2 mm (63'') bulb T-girder (not in scale).

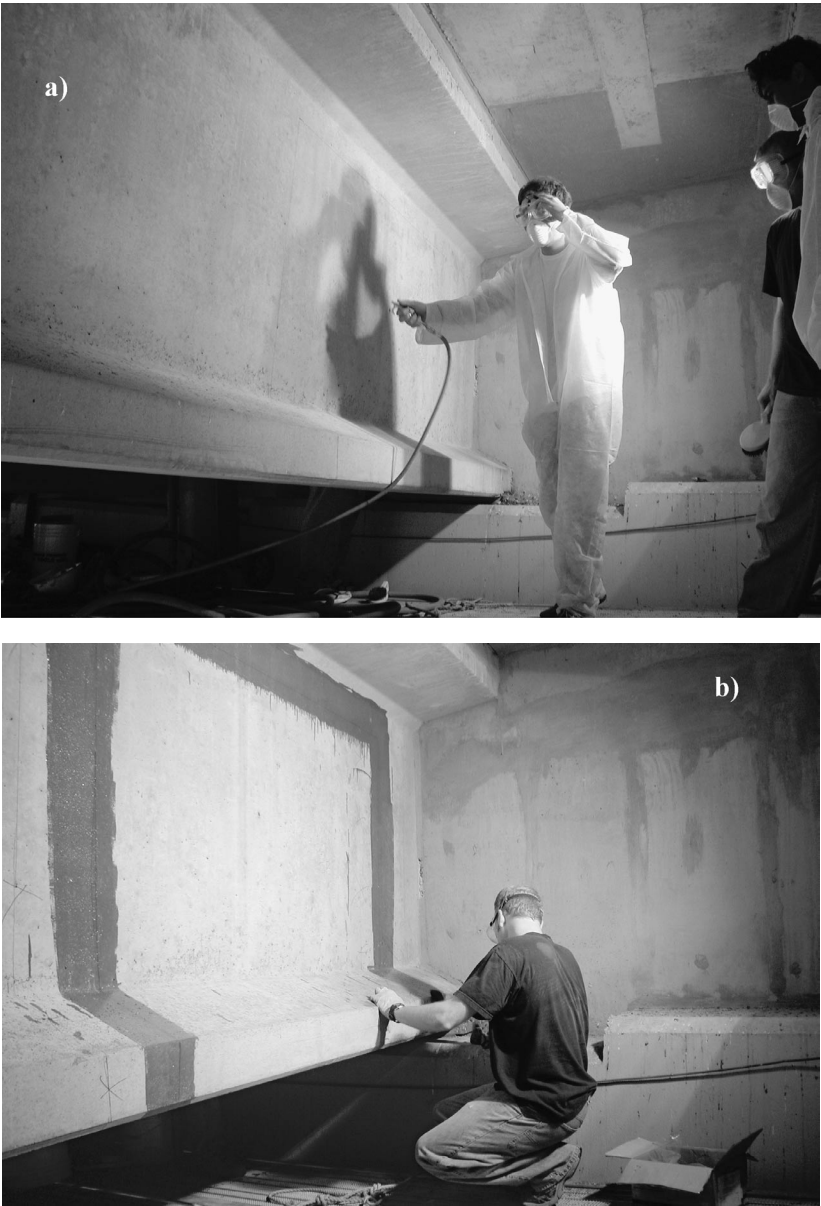
Figure 16. (a) Surface preparation and (b) pre-priming of vacuum bag sealant tape zone.

two days on a 1.52 m × 4 m area. The first step in the processing was the surface preparation of the girder using a sandblaster and compressed air; after the surface cleaning, a coat of resin was applied in the border of the part to ensure an adequate seal between the concrete and the vacuum sealant tape as shown in Fig. 16.

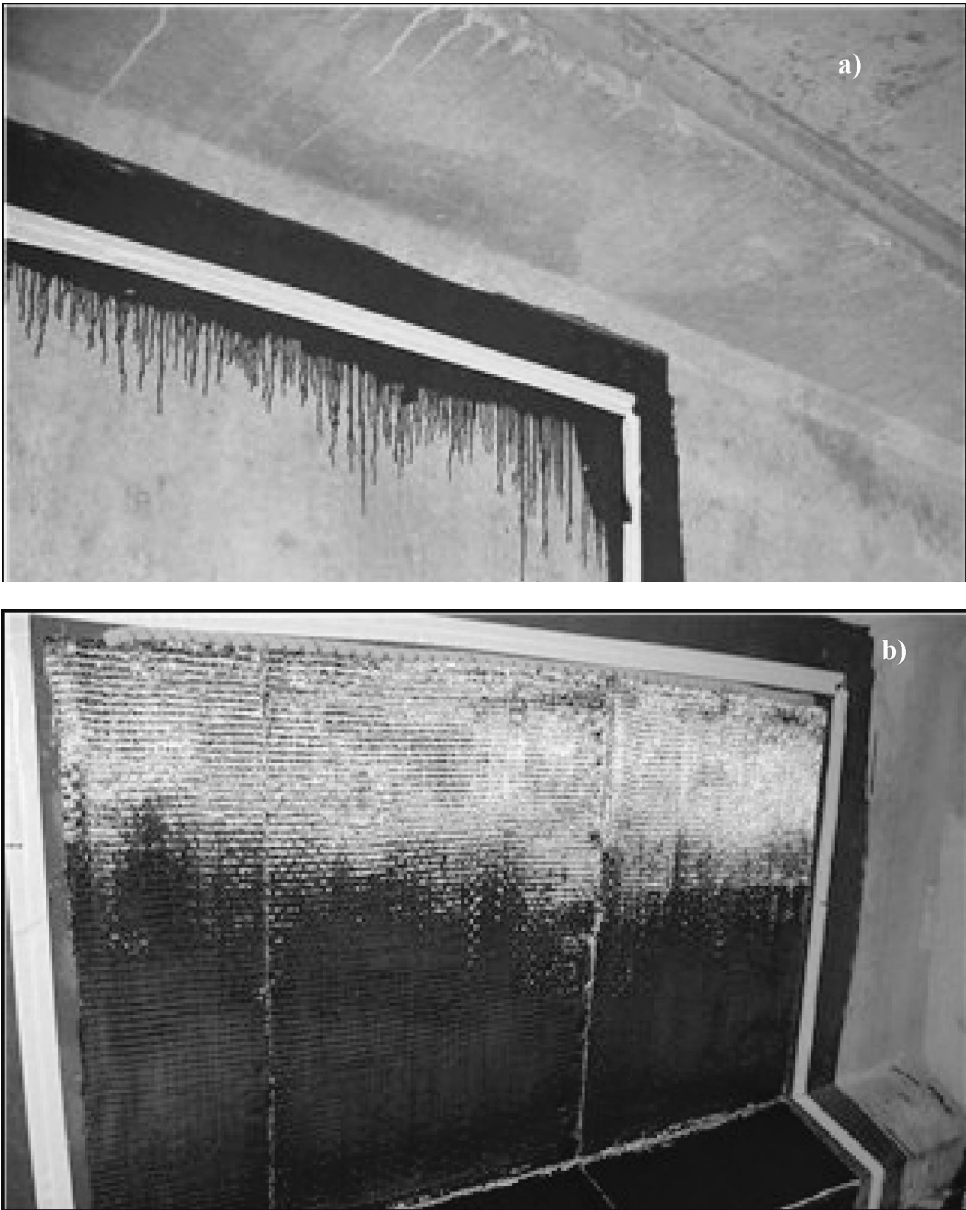
Figure 17. (a) Sealant tape lay out and (b) fabric placement with 3M spray adhesive.

After the layer of primer was cured, the vacuum sealant tape was placed onto the surface of the concrete following the pattern of the part to be bagged. The lay-up sequence of [0/90/0/90] was adopted and the flexure plies were laid first in order to have the shear plies (laid up to 0.2 m above the neutral axis to ensure anchoring effects) helping in containing the edge peel stresses that usually initiate debonding of the flexure plies. All plies were held in place against the concrete surface with the aid of 3M-spray adhesive as shown in Fig. 17. Once all the plies were in place, a porous bleeder release film made of tightly woven silicone coated polyester was placed on top of the lay up so that the distribution mesh would not bond to the fabric (Fig. 18).

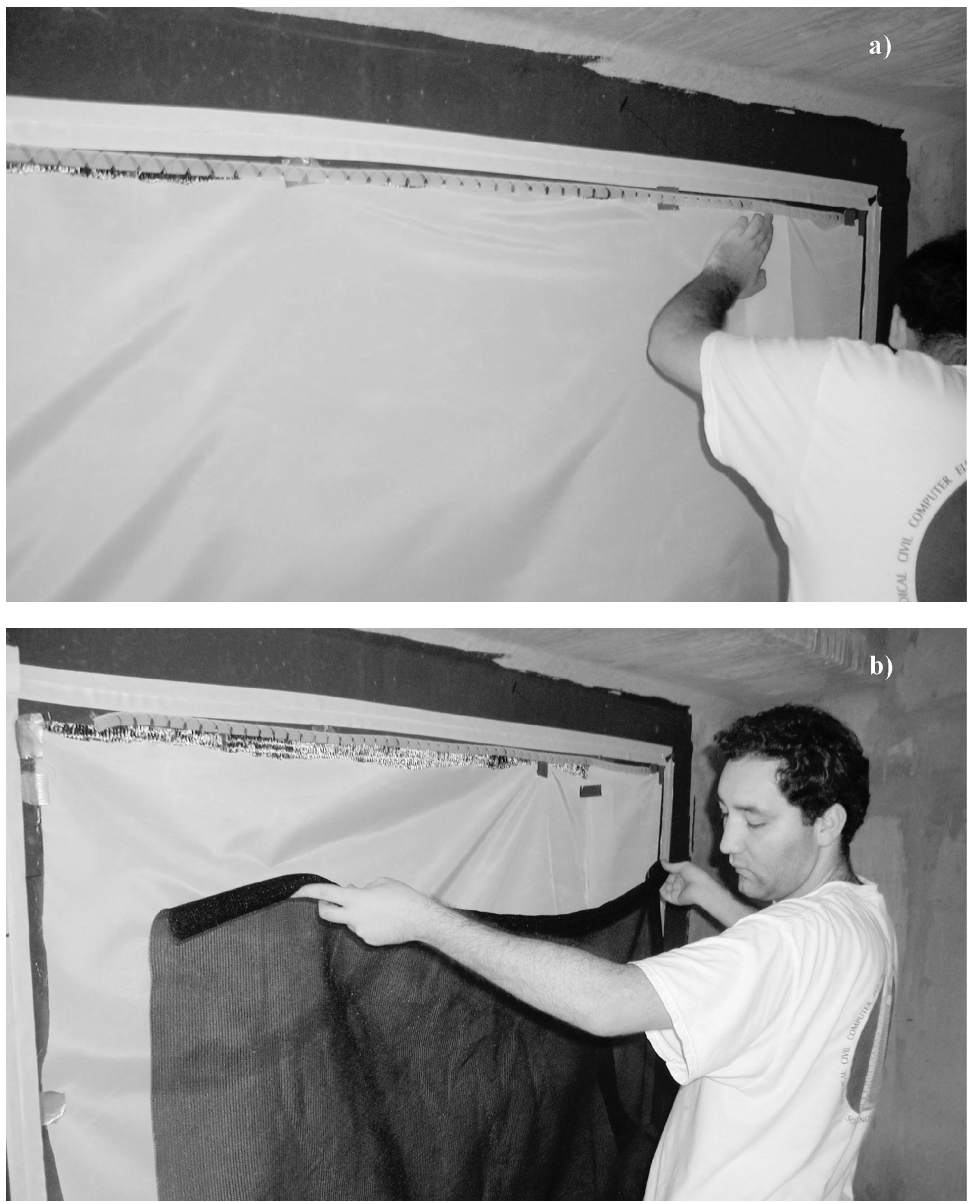
Figure 18. (a) Release film and (b) distribution mesh placement over placed fabric.

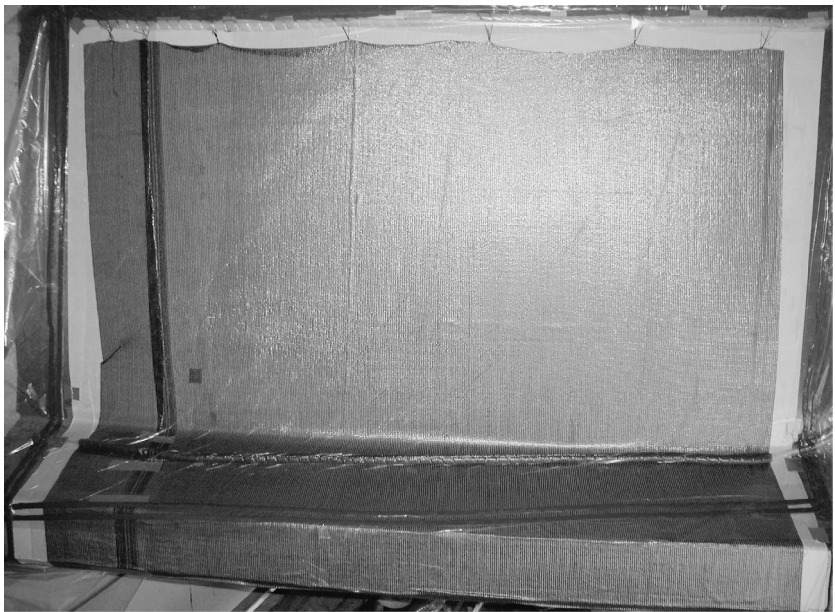
Figure 19. Bagging and debulking of lay-up.

as illustrated in Fig. 19. Debulking took place for 20 min under vacuum, and the bag was straightened and checked for leaks.

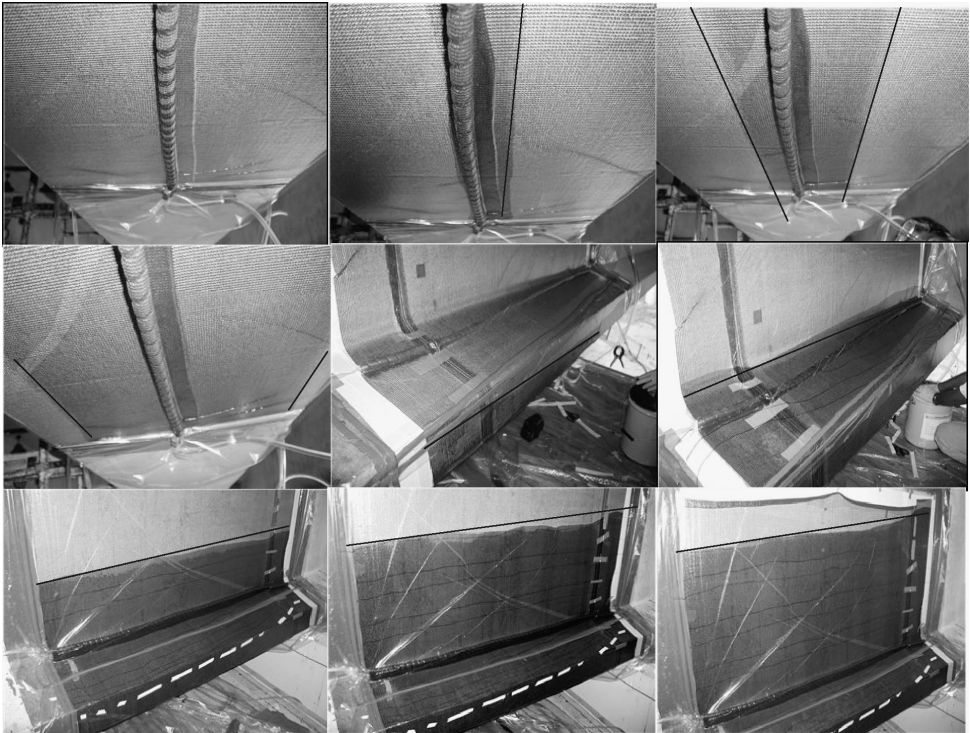
Figure 20. Infusion progression and flow front throughout flange and web. Straight line indicates flow front. Dark areas indicate wet area, light grey represents dry areas.

The infusion strategy proposed was placing an infusion channel at the middle of the bottom flange, two infusion/vacuum channels at the web and bottom flange and two final vacuum channels at the top of the part in the web as seen in Fig. 13. Finally, infusion was performed and monitored for 90 min; the flow front was very homogeneous and symmetrical to each side of the girder showing a linear pattern. The part was kept under vacuum for the following 12 h to ensure proper curing under 635 mmHg vacuum pressure (Fig. 20). The on-site filling time for the girder was approximately 60 min. After debagging, the part had conformed readily to the shape of the girder; details of the web and beam appearance at debagging are presented in Fig. 21. A coat of latex based paint was applied on the surface of the finished part to act as a seal against any environmental attack such as moisture, dust or particles (Fig. 22) and a final overall view is shown in Fig. 23.

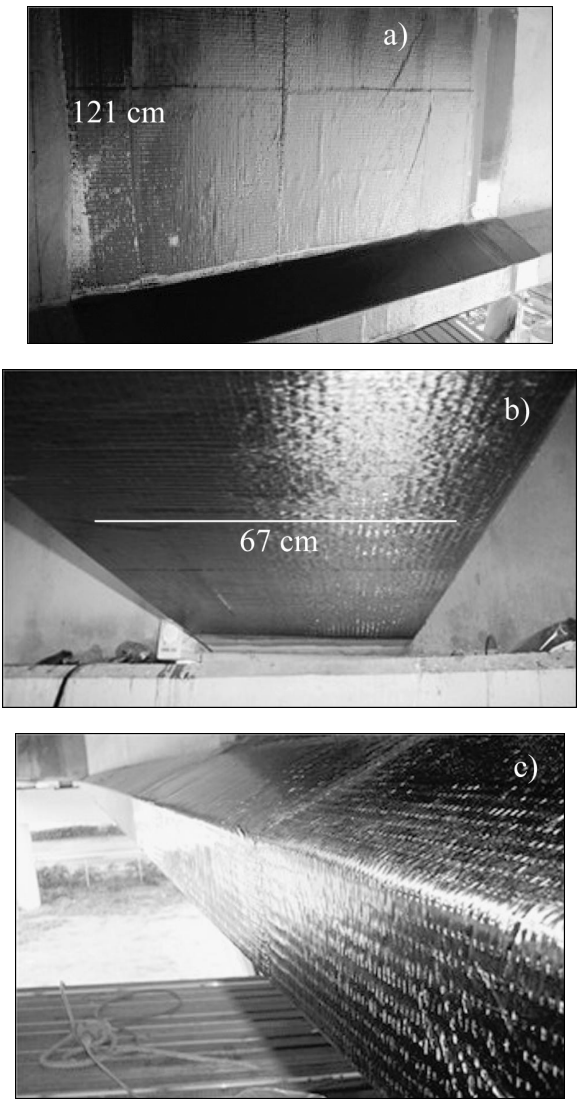
Figure 21. (a) Part after debagging; (b) bottom flange detail and (c) bottom flange side detail.

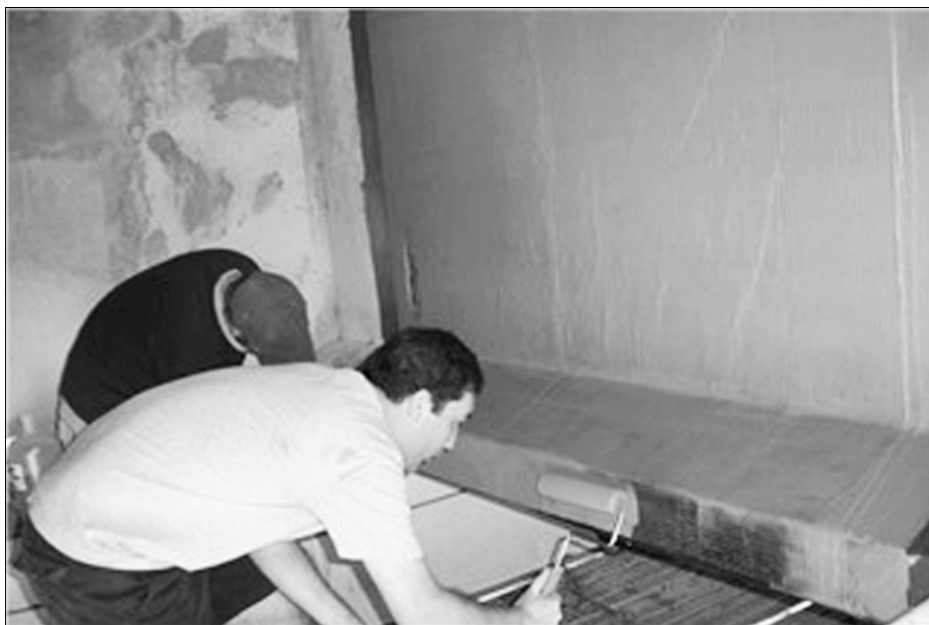
Figure 22. Latex based coating application.

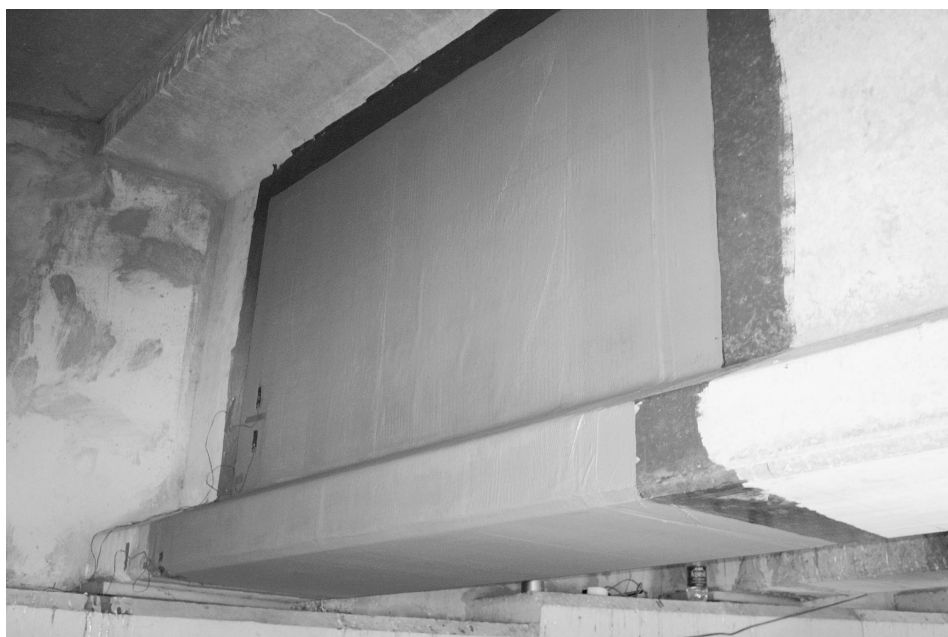
Figure 23. Final overall view of reinforced section.

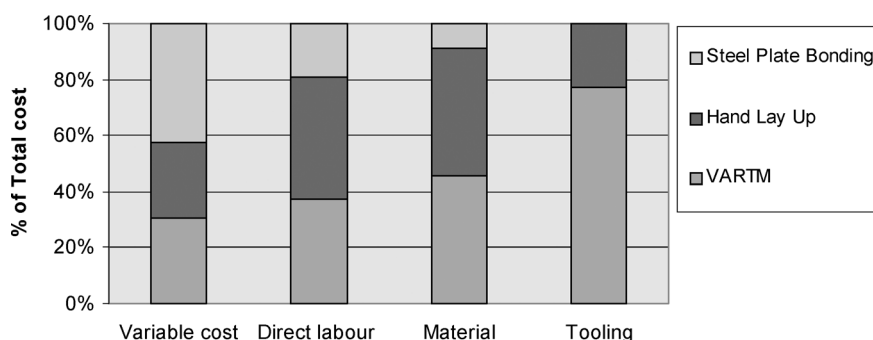
Figure 24. Initial project cost for repair of 6.4 m² of concrete girder using three different approaches.
