Identification by MRI

R. Amberg, B. Forster, and R. Fürmaier

Institut für Rechtsmedizin im Klinikum der Albert-Ludwig-Universität, Albertstrasse 9,
D-7800 Freiburg im Breisgau, Federal Republic of Germany

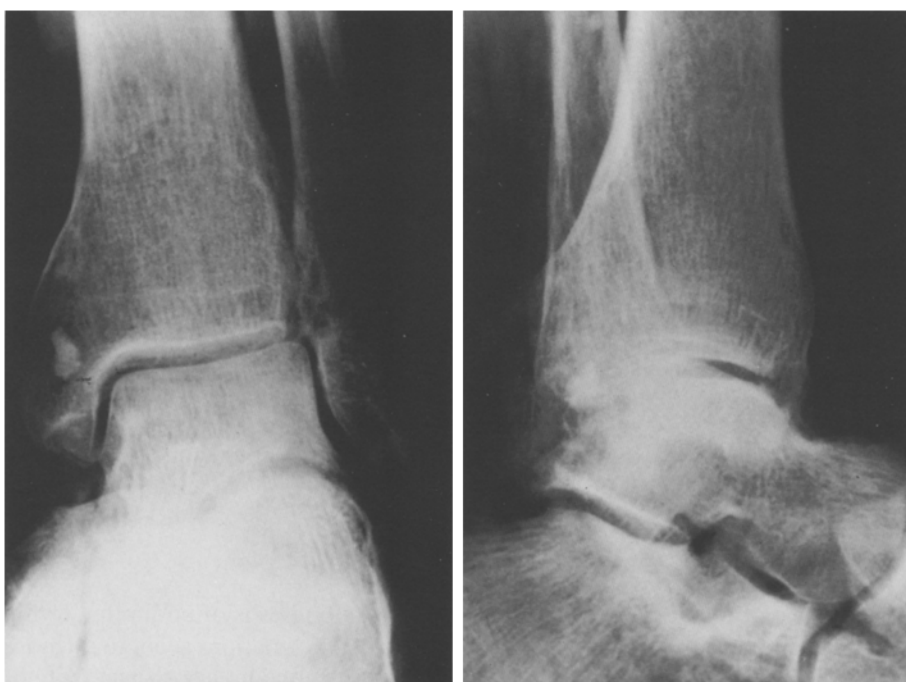
Fig. 2. Recent X-ray photograph (1988): no metallic remains, no identifiable marks as compared with Fig. 1

Advanced putrescence and the water-soaked skin of the left leg gave no hint as to a former operation. A comparison of recently taken conventional X-ray photograms with the former images did not show any identifiable marks. No metallic substances were detectable. Only a subcortical translucence with circular calcification could be regarded as a possible former position of a cerclage wire at the inner malleolus (Fig. 2). For this could not be judged as a mark of identification, an MRI was performed (Praxis Dr. Fürmaier, radiologist Freiburg/Brsg., FRG).

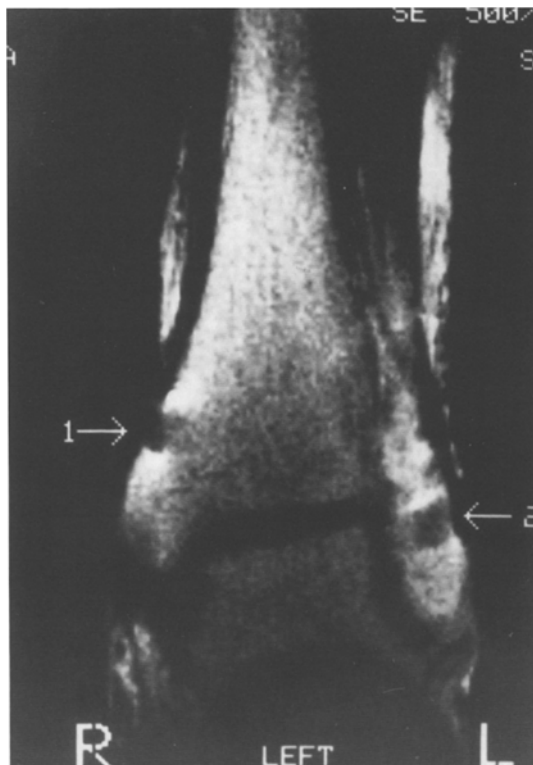
Fig. 3. MR-image, first examination -20°C . T-1 weighted coronal cutting: two metallic artifacts in this slice at the inner malleolus and fibula

The coronal slices of the T-1 weighted SE-sequence showed at the inner malleolus an intensive, irregularly shaped signal. Laterally, also intensive irregular shapes in the distal

fibula were observed (Fig. 3). Several slices showed five irregular signal intensities in the fibula and one at the medial malleolus. The irregular signal intensities were congruent with the position of the bone drills, chisels, and cerclage wire of the post-operative X-ray photographs. The fixing of the cerclage wire is at 35 mm distance from the tip of the inner malleolus in the post-operative X-rays (Fig. 1). Also the signal intensity at the medial malleolus is about 35 mm from the tip in the MR-images (Fig. 5).
