CASE REPORT

Unusual explanation for the death of a car passenger

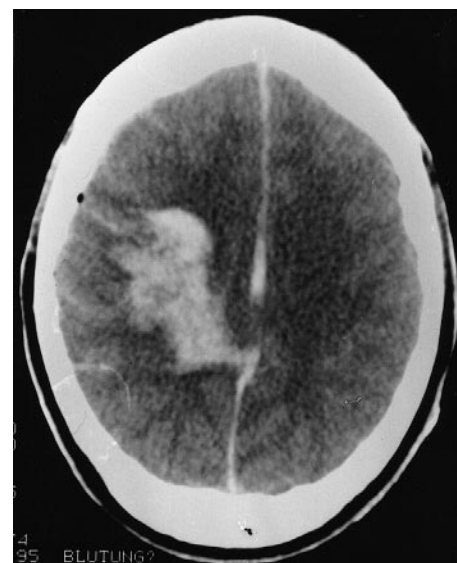
Fig. 1 CT imaging of an intracerebral haemorrhage temporo-parietal on the right

tion with the head injury the CT imaging showed a depression fracture parietal on the left and an intracerebral haemorrhage on the opposite side temporal-parietal on the right (Fig. 1). The volume of the haemorrhage was only about 25 ml. An operation was indicated to care for the large laceration with leaking brain pulp. The depressed bone fragments were removed. From the depth a coagulated haematoma issued which was also removed by suction. Peculiarly there was severe bleeding from the depth of the right hemisphere, which could not be related to the accident mechanism and the isolated depression fracture on the left. During the following hours the comatose state remained unchanged and brain death was diagnosed finally.

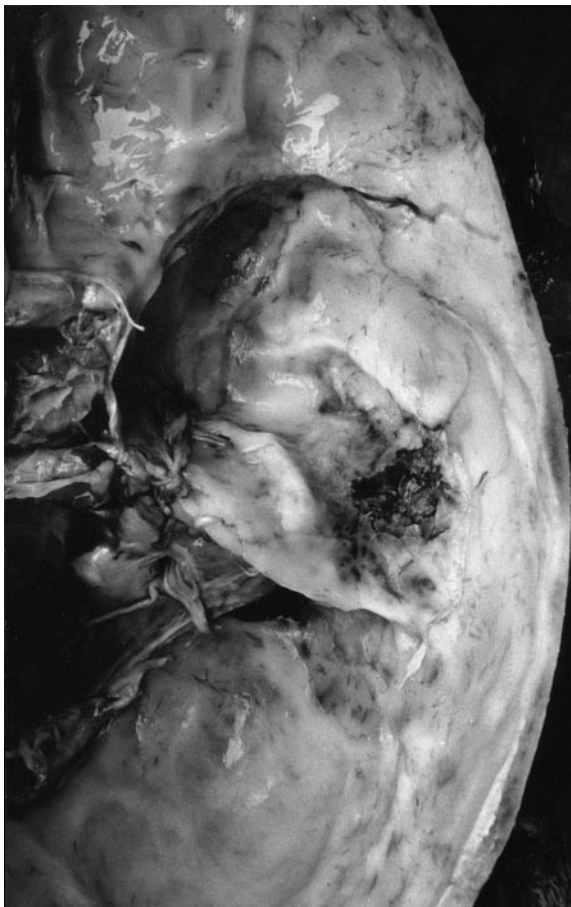
Fig. 2 Depression fracture at the base of the skull in the right temporal region

ameter of about 1.2 cm. Because of both the position and measurements inside the car the torn-off shock absorber was thus identified as the part which had caused the depression fracture and the injury to both brain halves and also another depression fracture to the base of the skull on the right-hand side.
