Survived ileocecal blowout from compressed air

Abstract Industrial accidents with compressed air entering the gastro-intestinal tract often run fatally. The pressures usually over-exceed those used by medical applications such as colonoscopy and lead to vast injuries of the intestines with high mortality. The case described in this report is of a 26-year-old man who was harmed by compressed air that entered through the anus. He survived because of fast emergency operation. This case underlines necessity of explicit instruction considering hazards handling compressed air devices to maintain safety at work. Further, our observations support the hypothesis that the mucosa is the most elastic layer of the intestine wall.

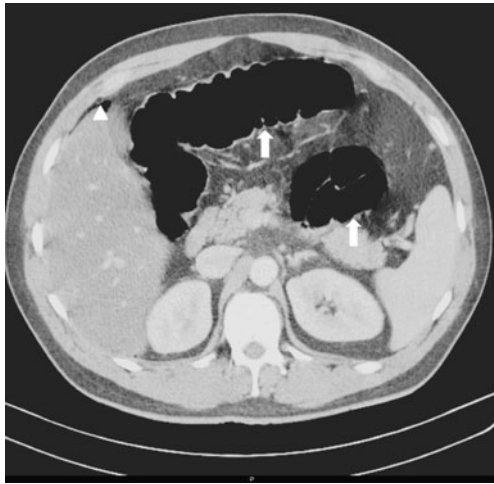
Fig. 1 Computed tomography (CT) scan taken on the day of hospitalisation about 1 h after the accident. Note the massive dilation of the colon (*arrows*) and subphrenic accumulation of air between liver and diaphragm (*arrowheads*). Contrast medium was administered prior CT scanning

A 26-year-old man was working in a foundry bent forward to check a casting mould for defects. A teammate approached from behind with a compressed air cleaner in his hand. He released the nozzle in a fraction of a second just near the anus of the unsuspecting man. Immediately, the victim felt the strongest pain in the belly and was delivered into the emergency department. Signs of an acute abdomen with peritoneal irritation, meteorism, difficulty in breathing and an abdominal compartment syndrome were ascertained. Computer tomography scanning showed free air in the peritoneal cavity and massively ballooned intestine (Fig. 1). The victim underwent emergency surgery.

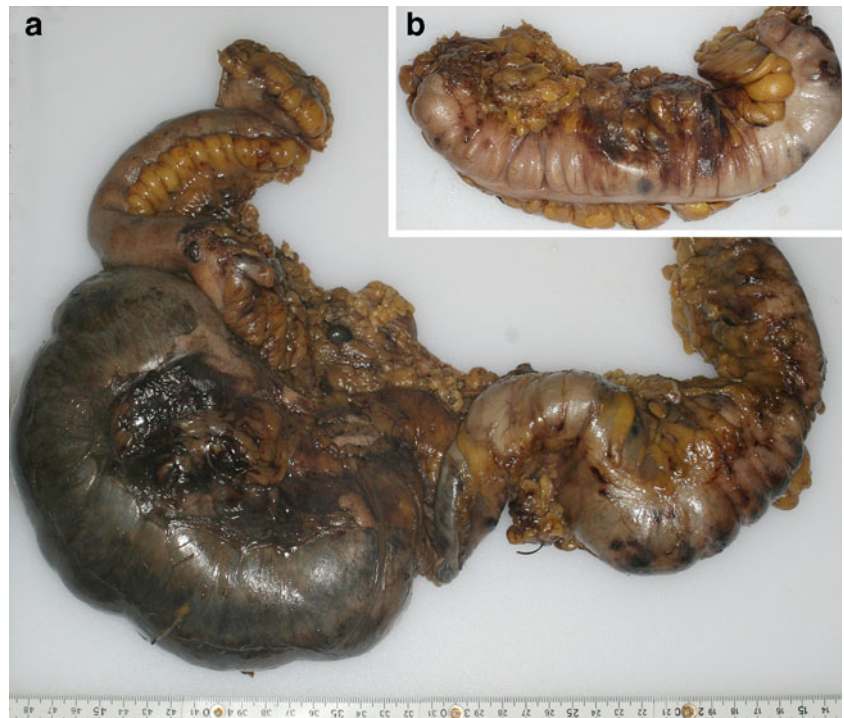
Fig. 2 The two resected colon parts after fixation in formaldehyde. **a** Terminal ileum, caecum and ascending colon. **b** Part of the transversal colon. The caecum is massively distended, and the wall is discoloured, whereas terminal ileum, ascending and transversal colon show haemorrhages to a lesser extent

The first specimen was 43 cm long and consisted of the proximal part of the colon (22 cm) including caecum, appendix and ascending colon, as well as the distal part of the ileum (21 cm). The appearance of the appendix was normal. The caecum and the distal part of the ascending colon were strongly distended with a circumference of 22 cm and were covered with haemorrhages (Fig. 2a). Apparently, the intestinal wall was thinned out, whereas a full penetration of the wall was not observed, but the serosa was disrupted and gaped until 10 cm in diameter. Furthermore, there were spotty haemorrhages in the mesenteries of the colon and the ileum. The terminal ileum was only slightly affected with few haemorrhages and little distension. The ileum was filled with normal content, whereas in the colon, the faeces were of pulpy consistency and mixed with blood.

The second specimen was identified as transversal colon measuring 27 cm in length (Fig. 2b). The intestine presented roundish haemorrhages into the intestinal wall. A 1.2-cm measuring serosa tear with surrounding haemorrhage was detected on the surface near the taenia libera. However, the intestinal wall was also not completely penetrated. In this specimen, normal but loosened faeces were found.

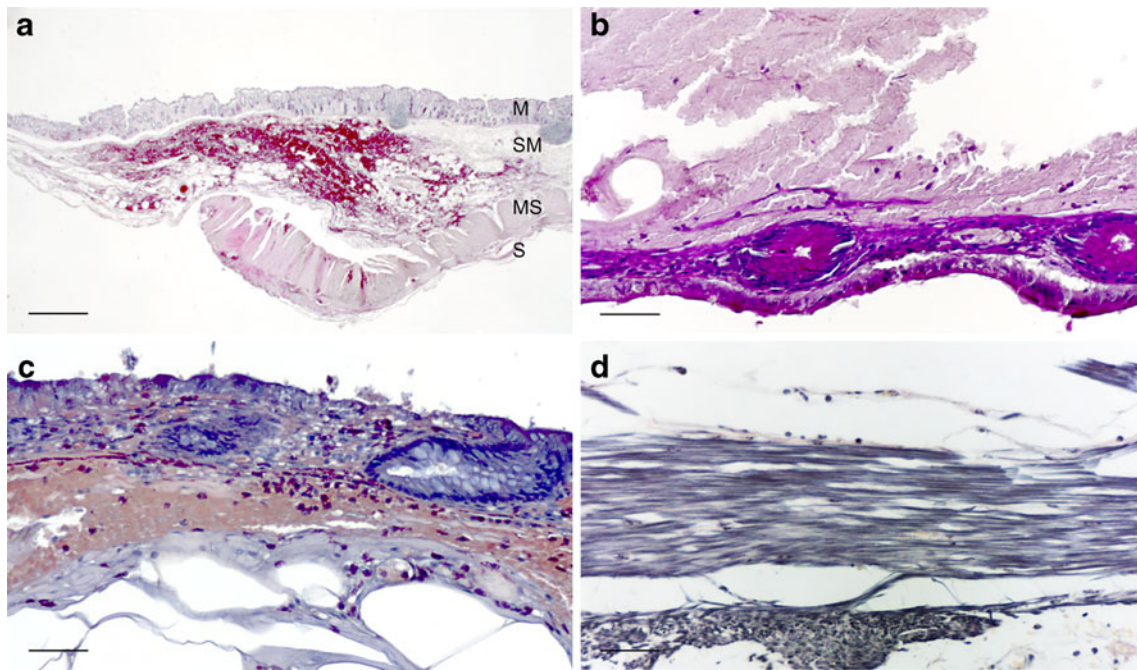
Fig. 3 Histological examination revealed no through-and-through penetration of the intestinal wall. **a** Haematoxylin and eosin staining. Stretched mucosa (*M*) and disrupted serosa (*S*) as well as muscularis (*MS*) in the caecum and widened submucosa (*SM*) with haemorrhage; scale bar 1 mm. **b** Periodic acid-Schiff staining. In another part of the caecum, flattened mucosa and remains of the basal lamina (*lower part*). The cloudy material up the basal lamina is blood; scale bar, 50 μ m. **c** Chloroacetate esterase staining. Note the granule cells

(*carmine colour*) within a small capillary and migrating into the injured zone in the submucosa and the mucosa; scale bar, 50 μ m. **d** Phosphotungstic acid-haematoxylin staining. The smooth muscle in the muscularis was found stretched and torn in the same intestine part (caecum) as in Fig. 2c; scale bar, 50 μ m. All micrographs were taken by means of a microscopic camera and Axiovision software (Zeiss, Jena, Germany)

The specimens were stained following [3] with haematoxylin and eosin, periodic acid-Schiff, naphthol AS-D chloroacetate esterase and phosphotungstic acid-haematoxylin. Some parts of the intestine were unaffected, whereas others showed massive haemorrhages into the intestinal wall. The serosa and muscularis were completely disrupted, whereas the mucosa was in a quite good condition (Fig. 3a, d). Interestingly, in the injured parts of the caecum, the mucosa appeared dramatically stretched and flattened (Fig. 3b, c). In some location, just the basal lamina and remains of the muscularis warranted integrity of the wall (Fig. 3b). Granule cells migrating from blood vessels towards the haemorrhage indicate the beginning inflammation (Fig. 3c). In the terminal ileum, the wall layers were not affected. Here, the wall was moderately stretched, and the veins were stuffed with blood (not shown). In all parts of the intestine, no signs of pre-existing pathology or trauma could be detected [4].

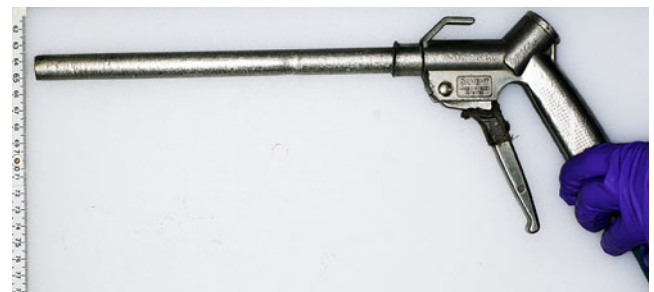
Fig. 4 The nozzle of the compressed air cleaner has a diameter of about 12 mm and is connected to a stationary air pressure system via flexible hose

The device that was used is a spray head driven by a compressed air motor. The spray head is made of aluminium with a barrel of 20 cm length and a bore of

12 mm (Silvent, Borås, Sweden, Fig. 4). The head is connected to a stationary air pressure system. The gas used was air. The operating pressure of the system is specified with 6 to 7 bar according to about 4,500 to 5,250 mmHg. This pressure is warranted by automatic control. The actual pressure at the end of the bore depends on the power when operating the trigger. If the trigger is not fully opened, the release pressure will be at a lower level as compared to the given operating pressure. All parts of the pressure system were checked for technical defects. The system was functioning properly. As proved by the documentation about maintenance of industrial health and safety standards,
