International Journal of Solids and Structures 38 (2001) 2025–2032

## Earthquake failures of welded building connections

Piotr D. Moncarz <sup>\*</sup>, Brian M. McDonald, Robert D. Caligiuri

*Exponent Failure Analysis Associates, 149 Commonwealth Drive, Menlo Park, CA 94025, USA*

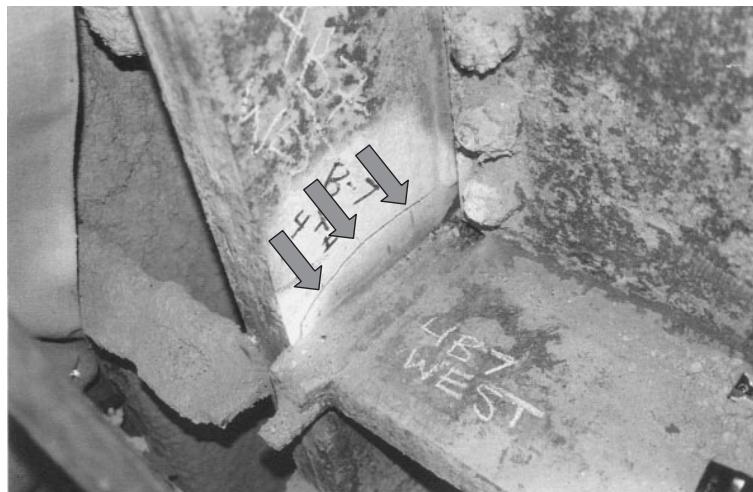
Fig. 1. Divot type connection crack in large section with no gross plastic deformation.

One reason for the lack of consensus on causes and remedies is the wide array of crack topologies observed in buildings and laboratory test failures. However, only a few patterns of crack initiation and trajectory are evident. For instance, the cracks tend to initiate near the center of the beam-to-column flange juncture, at or near the root of the weld. After initiation, there are many different observed trajectories including propagation along the fusion line, into the base metal of the column, through the weld material, and occasionally confined to the beam base metal. For instance, cracks have been observed that have similar initiation and paths, and subsequently bifurcate to two or more trajectories, of which one becomes the dominant fracture surface (FEMA, 1997). In addition, the authors and others have observed instances of ductile tearing at the crack origin, which triggers a cleavage crack that then propagates in an unstable manner.

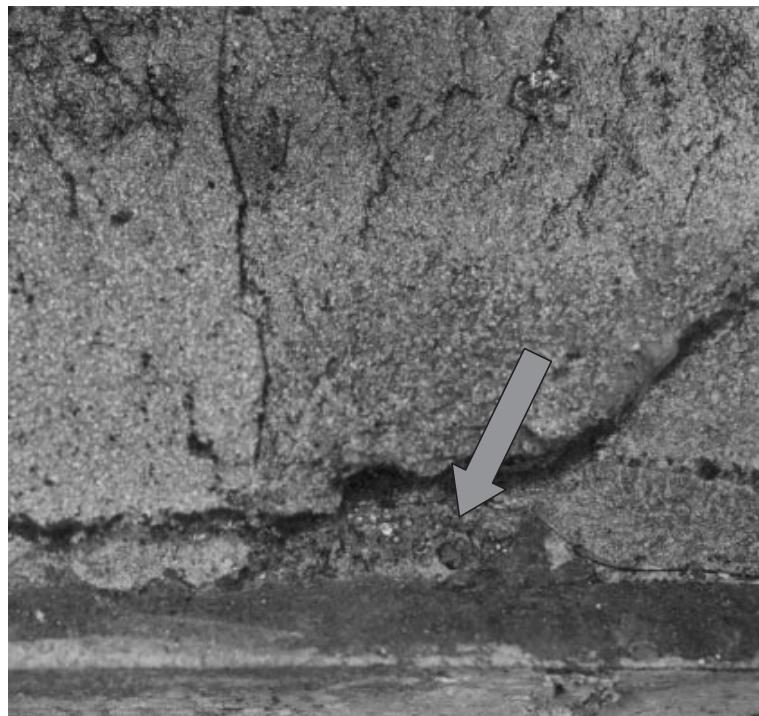
Fig. 4. Ductile tearing at root of predominantly cleavage fracture.

LEFM underpredicts measured connection strengths because it over-simplifies a more complex fracture process. Recent technical publications (Kuwamura, 1996, 1998; Ostertag, 1997) have described a failure mechanism that is consistent with both laboratory observations and stress analyses. Ductile tearing begins at a location of high cyclic plastic strain, and grows in a stable manner until conditions of stress and constraint a short distance ahead of the tear are sufficient to initiate an unstable cleavage fracture. This mechanism has been observed in tests conducted in Japan and confirmed by examination of structure steel connection failures that occurred during the 1995 Hyogoken–Nanbu earthquake (Kuwamura and Yamamoto, 1997). Using optical and scanning electron microscopy, the authors have observed instances of very localized ductile tearing at the crack origin of several SMRF crack samples removed from Northridge area buildings (Fig. 4), and believe that further research of this mechanism and how it relates to SMRF cracking is warranted.
