International Journal of Solids and Structures 41 (2004) 6699–6724

An experimental study of pre-notched clamped beams under impact loading

F.L. Chen^{a,b,*}, T.X. Yu^b

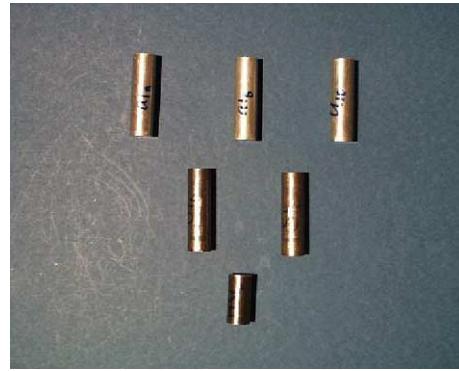
Fig. 3. Three types of projectiles.

Three types of cylindrical projectiles, shown in Fig. 3, were used in the tests. They were made of aluminium (labelled by A1a, A1b or A1c), steel (S1b, S1c) or high-density steel (HS1a), whose specifications are given in Table 1.

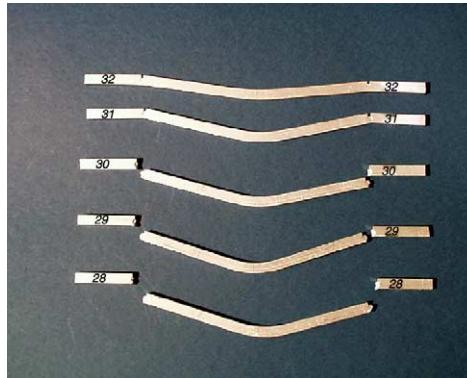
Fig. 13. Effect of increasing impact velocity: Set 7b (nos. 32, 31, 30, 29, 28).

The specimens in sets 7a and 7b were all machined with two pre-notches on the front surface at the beam ends. The width of the notches was 0.8 mm; the notch depth for of Sets 7a and 7b was $C = H/4 = 1.59$ mm and $C = H/3 = 2.12$ mm, respectively. Tables 6 and 7 give the test details of the two sets, while Figs. 12 and 13 display the final shapes of the beams of these two sets after impact. The beam in Set 7a broke at a critical impact velocity $V_c < 30.3$ m/s (test no. 23), while the beam in Set 7b broke at critical impact velocity $V_c < 31.6$ m/s (test no. 30). It seems that the critical impact velocity for breakage at the pre-notched sections is not very sensitive to the depth of the pre-notch.

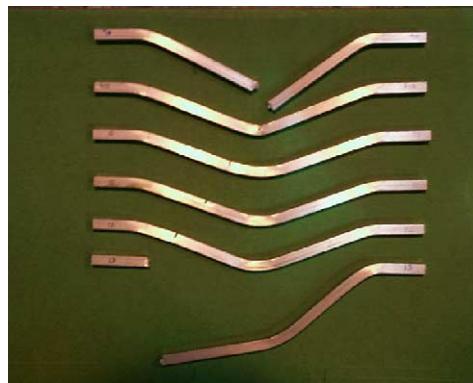
Fig. 15. Effect of notch location: Set 3 (nos. 10a, 10b, 10, 11, 12, 13).

Test sets 3, 5, 10, 6a and 6b were designated to demonstrate how a pre-notch (or pre-notches) influences the dynamic response and failure of a beam. In Sets 3, 5 and 10, each specimen was machined with a pre-notch at a distance of $0L$ (mid-section), $L/4$, $L/2$, $3L/4$ or L (one end) away from the mid-section of the beam. The test details of these three sets are given in Tables 9–11, for which a steel projectile (Slc), three aluminium projectiles (A1a, A1b, A1c) and a high density steel projectile (HS1a) were respectively used. The final shapes of the beams are compared in Figs. 15–17.

The results have verified that the effect of pre-notch is highly location-dependent and surface dependent. A notch located at the impact point (nos. 10a, 13) or at one end of the beam (nos. 34, 42) led the beam to break at the pre-notched section; while a pre-notch located at $L/4$ or $3L/4$ only had a minor effect on the final shape, and that located at $L/2$ had an even negligible effect. The impact point and the beam's ends (or more generally, the positions where plastic hinges appear in a modal response of the beam) were found to be the most dangerous positions in the case of a large mass ratio $\beta = G/(2\rho BHL)$.

Comparing test nos. 10a and 10b, it is found that a pre-notch located on the tensile surface of the beam has a much greater influence than that on the compressive surface. In the former case, the beam was utterly broken at the pre-notched section, while in the latter case, the pre-notch was only closed a little.

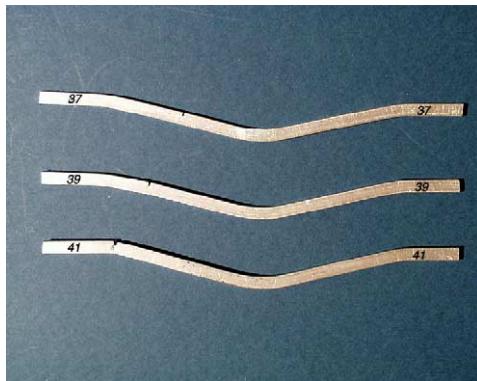
Fig. 16. Effect of notch location: Set 5 (nos. 37, 39, 41).

looking simultaneously at Figs. 14 and 16, we can see similar response patterns of the beam specimens in the different sets. The reason is that same moment of projectile will exert same impulse on the specimens, although the profile of the impulsive force is under the influence of many other factors.

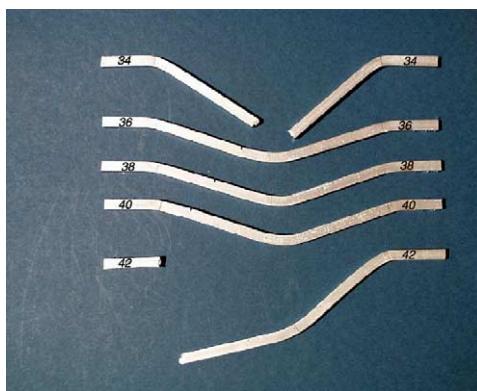
Fig. 17. Effect of notch location: Set 10 (nos. 34, 36, 38, 40, 42).
