Class Defects in Printwheel Typescript

REFERENCE: Behrendt, J. E., "Class Defects in Printwheel Typescript," *Journal of Forensic Sciences*, JFSCA, Vol. 33, No. 2, March 1988, pp. 328-335.

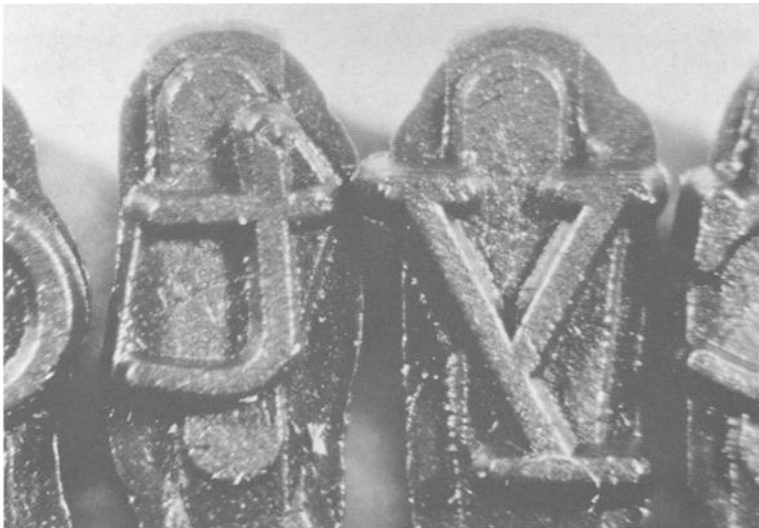
FIG. 1—The “t” and “y” spokes on this printwheel were molded together by excess plastic that escaped from the mold cavities as a result of warpage of the mold. This is a problem indicative of the use of soft molds.

At times, a manufacturer may elect to use a less expensive mold made of a brass alloy which is referred to as a soft mold. While a soft mold is much less expensive to make, they are less durable than a hardened steel mold and may cause production problems. Under the intense pressure of the thermoinjection process, a soft mold may warp slightly allowing excess plastic to flow between the spoke cavities. The excess plastic may join to the adjacent spoke thereby molding the two spokes together [3] (Fig. 1).

FIG. 7—The marks appearing to the left of the "t" and above the "c" are artifacts caused by the bonding of the two spokes illustrated in Fig. 1.

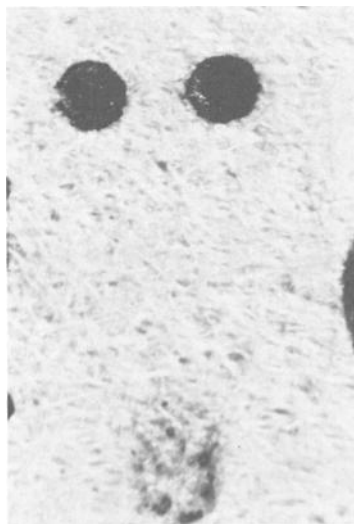
FIG. 6—*The mark appearing under the umlaut is due to extensive hammer pressure on the printer causing the lower portion of the backpad to bend forward and strike the ribbon.*

Figure 6 is an illustration of a printer produced typescript artifact. The small mark which appears directly below the “” is caused by the hammer hitting the typeface with sufficient force to bend the bottom of the backpad forward and strike the ribbon. This artifact is produced consistently throughout the samples obtained with this printer. When samples were taken from this printwheel on other printers, the artifact was not present.
