PAPER**CRIMINALISTICS**

High Resolution Imaging of Latent Fingerprints by Localized Corrosion on Brass Surfaces

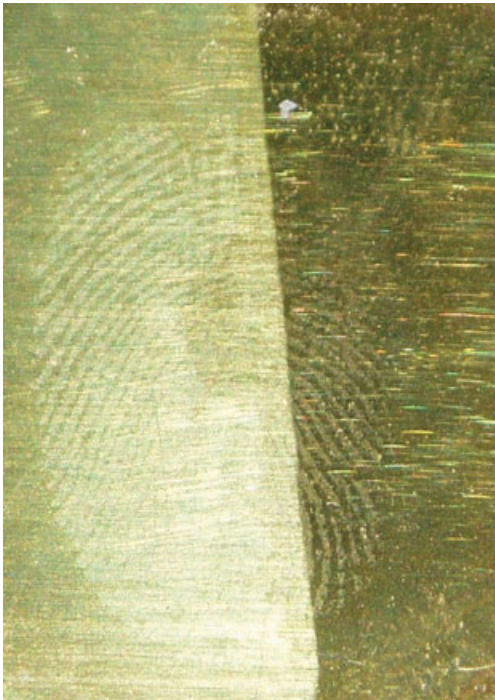
FIG. 1—Photograph of a typical fingerprint on a brass substrate. Prior to deposition of the fingerprint, the left hand side of the substrate was polished (see main text for details); the surface finish of the right hand side is as received.

In this section we define the problem and select the parameters for exploration. Figure 1 shows a photograph of a typical fingerprint deposited on a brass substrate. For visual comparison (to complement the AFM data shown below) of the influence of substrate surface finish, 50% of the surface was polished and 50% left as received (unpolished). Ridge features associated with the deposit of eccrine sweat transferred upon contact between the finger and sample are clearly visible, although fine detail is not at this resolution.

There are also clear differences in visibility of the ridges on the two surfaces, a distinction upon which we will focus. Simplistically, the experimental strategy is to use the AFM to obtain a high resolution image of (selected regions of) this surface. The high spatial resolution of the AFM makes it sensitive not only to the fine detail we wish to study but also to the imperfections (e.g., manufacturing and handling marks) on the metal surface. The problem is that the transferred material is not deposited on a perfectly smooth surface; consequently, any raised or depressed features (deposits or etched areas) will not be viewed as deviations from a perfectly smooth surface.

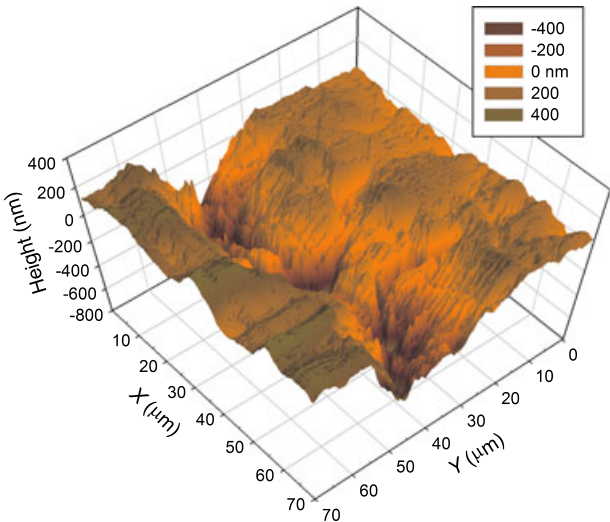
FIG. 2—AFM image from the unpolished (as received) brass substrate, sample 1 (prepared as in Table 1). Note different horizontal and vertical scales and false color vertical representation, as indicated.

The scope of the problem is demonstrated by Fig. 2, which shows an AFM image of what might (or might not, at this stage of the argument) be a feature resulting from a section of ridge detail deposited on one of the brass discs as received (sample 1, prior to polishing). The main feature is *c.* 30 μm wide and *c.* 600–800 nm deep (varying along its length). However, there are also a number of features on the order of 10 μm wide and 100–200 nm deep, which are present both on the unetched exterior surface and on the interior surfaces of the putative etch groove. From the perspective of a fundamental study of the scale and rate of formation of fingerprint-generated etched images, the latter complicate the situation considerably and make any assignment uncertain. In the context of unequivocal recognition of ridge features for identification purposes, the outcome would be ambiguous.

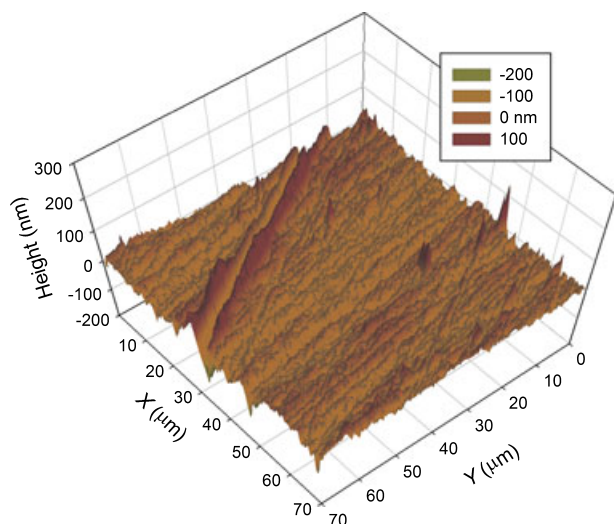
FIG. 3—AFM image from the brass substrate, sample 1, after polishing (see Table 1).

Materials and Methods section. While this is not realistic for the end application, it does allow unambiguous establishment of the methodology and definition of its capabilities and limitations. Figure 3 shows a typical AFM image of the same brass disc (sample 1) *after* polishing, from which two things are apparent. First, the mean surface roughness is decreased to features that are on the order of 1 μm wide and typically 20 nm deep. Second, where residual large machining features exist, they are obvious and unambiguously assignable. Specifically, the combination of characteristics exemplified by the linear scratch in Fig. 3 (approaching 5 μm wide and in excess of 100 nm deep) means that it could not be confused with the size or shape of the smaller polishing features or, as will be apparent later, fingerprint ridge detail.

mean that they cannot be confused with the substrate polishing marks or residual machining marks of the bare substrate in Fig. 3.

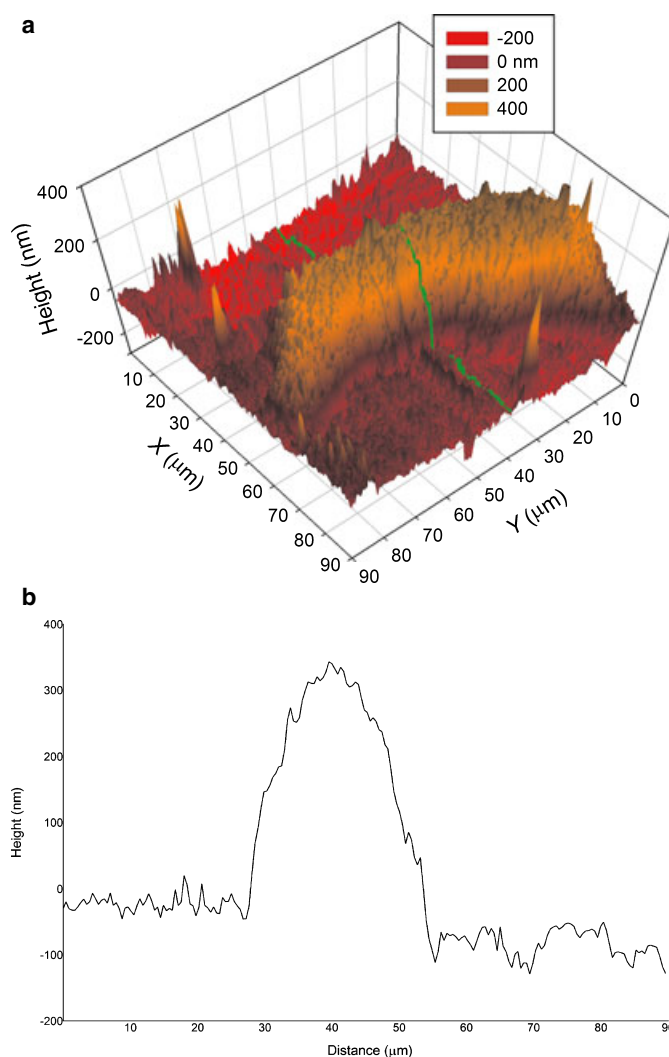
FIG. 4—AFM images from the polished and printed brass sample 2 (see Table 1). (a) 3D image showing (part of) ridge detail. (b) 1D linescan across ridge detail, as indicated by green line across center of (a).

In this section we consider the effect of elevated humidity but nonelevated (ambient) temperature. Figure 4 shows a representative example of ridge detail on a polished brass sample (sample 2) maintained at room temperature in a humid environment. Although the whole print image was somewhat patchy, exploration of the surface revealed a collection of similar ridges, along with ridge endings and other features typically associated with fingerprints. The eccrine sweat-derived deposit is clearly visible as a curved track c. 25 μm wide and 400 nm high. This feature is approximately a factor of 4–5 larger (in width and height) than the residual features on the polished substrate (see Fig. 3).

these were *raised* features. We did not observe the *depressions* (trenches or pits) that would result if corrosion and subsequent metal loss from the surface had taken place. One possible inference is that on the timescales employed (which are realistic for many crime scene investigations) the conditions of elevated humidity preserve the sweat deposit by preventing complete evaporation of the volatile components, but the ambient temperature does not drive the corrosion reaction sufficiently rapidly to generate an etched image in the metal.

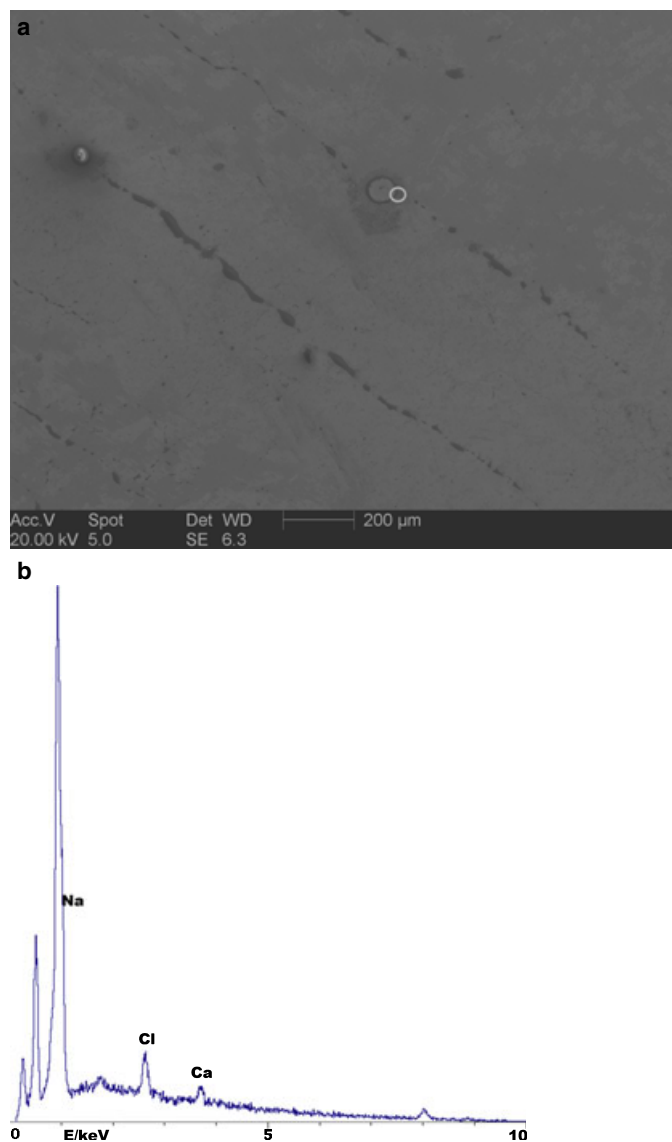
FIG. 5—(a) SEM image of sample 2, showing multiple ridges, one of which was imaged in part in Fig. 4. (b) EDAX elemental scan of the part of sample 2 represented by the circled region in (a). Beam energy set to 10 keV to remove contributions of copper and zinc (from the brass substrate). Annotations indicate elemental assignment of peaks.

Some pertinent information is provided by the supporting evidence of a lower resolution image showing multiple ridges. Figure 5a shows an SEM image of a larger part of the print of Fig. 4. Four ridges are clearly visible (running from top left to bottom right of the figure), as are two pores (one of which is circled in the image). Comparison of the images and differing lateral scales of Figs. 4 and 5a show that the feature in Fig. 4 assigned to a ridge is indeed of the correct size. This comparison also shows the dramatic enhancement in image quality and detail accessible with the AFM, an attribute that we will exploit further.

The observation that corrosion leading to pit/trench formation has not occurred demands an answer to the question as to whether this is because the required chemical agents were not present or whether the energetics of the system were inadequate. In chemical terms, the rate of a reaction is given by the product of concentration(s) and a temperature-dependent rate constant: the question is which of these is the limiting factor. This distinction is made by the EDAX spectrum of Fig. 5b, which relates to a spot located as

indicated by the white circle on the image of Fig. 5a. There is unequivocal evidence to indicate the presence of sodium and chloride ions, i.e., the constituents of salt, as well as lower levels of calcium secreted in the sweat. It is thus clear that all the required chemical species are present for corrosion. The conclusion is therefore that the reason for the lack of corrosion is insufficient energy to activate a kinetically rather slow reaction. We therefore now explore the effect of increased temperature as a source of energy.

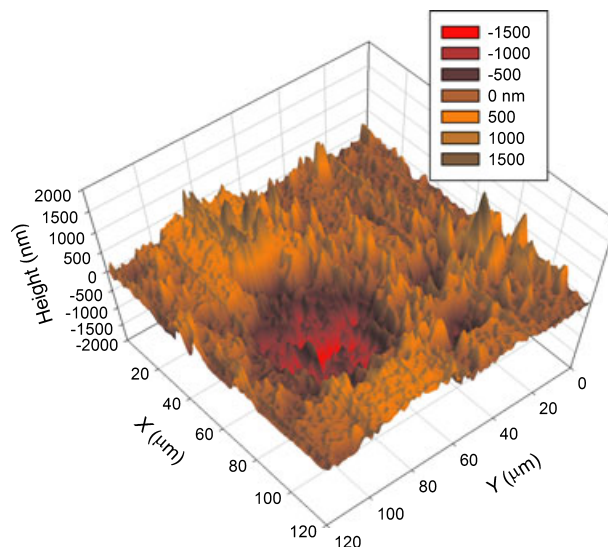
FIG. 6—AFM image from the polished and printed brass sample 3, after heat treatment in air at 100°C.

Since elevated humidity alone did not generate etched images in the metal substrate, the effect of additional enhancement by increased temperature was explored. Figure 6 shows an AFM image of a region of a polished brass sample (sample 3) subjected to moderate heat (100°C in air) after storage in a humid environment. On this sample, a number of trenches or pits were seen, with width varying from 50 to 80 μm and depth 2 μm, and there were significantly fewer deposits of the sort found in the nonheat-treated samples (see previous section, Figs. 4 and 5). A lower resolution photographic image of sample 5 (from the time lapse observations discussed in detail below) is shown in Fig. 7.

The scale of the features in Fig. 6 is clearly incompatible with fine polishing marks (see Fig. 3). Their shape and, to a lesser extent, their scale are also clearly incompatible with the few residual machining marks not removed by polishing (see the very regular linear scratch in Fig. 3). Finally, the fact that rather moderate heat treatment changes the surface features is incompatible with the brass substrate alone. We are therefore driven to the conclusion that the combination of elevated humidity and heat has generated the observed features derived from ridge deposits. However, the extent of image development is rather limited and by eye the print appears rather dotted. Pragmatically, the sample falls between two useful extremes: the heat treatment has driven off sufficient volatile material from the initial deposit to make conventional observation uncertain but it has not sufficiently developed the pits and trenches to make the corrosion-based image clear.

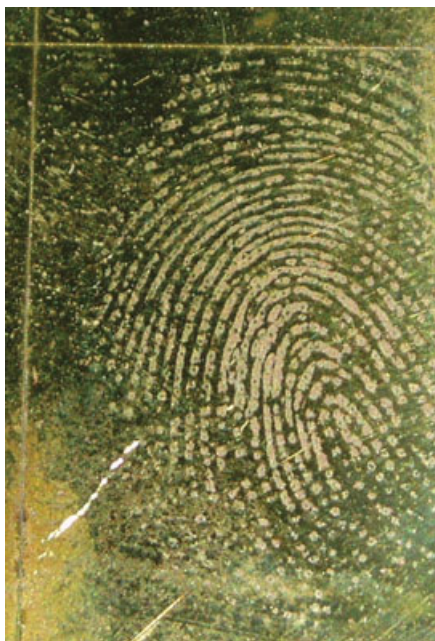
FIG. 7—Photograph of whole fingerprint for sample 5. The horizontal and vertical lines are registration marks used to locate the AFM tip for repetitive examination of the same area of the surface (as in Fig. 10).

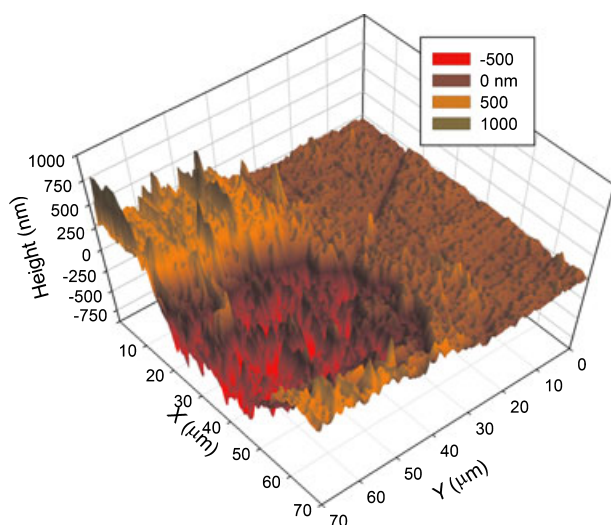
FIG. 8—AFM image from a part of the polished and printed brass sample 4 (after heat treatment in a Bunsen burner flame) showing a pit (at front corner of image) created by corrosion of the surface.

A more extreme form of heat treatment, exposure to an open Bunsen burner flame (c. 300°C for 75 sec; sample 4), generated images of the type illustrated in Fig. 8. This sample showed only

small residual amounts of deposited material and had pronounced pits. In the image shown, one can see a small raised area adjacent to the pit. The diameter of the pit is $50\ \mu\text{m}$ and the depth $c. 2\ \mu\text{m}$, as for the 100°C treated sample, but the pit definition is much sharper.

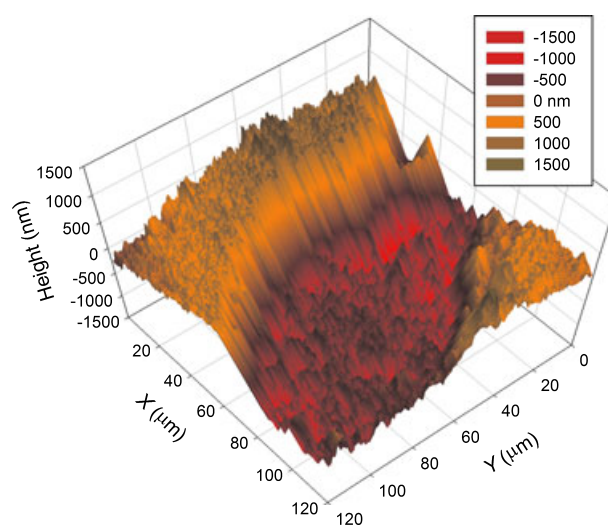
FIG. 9—AFM image from a part of the polished and printed brass sample 4 (after heat treatment in a Bunsen burner flame) showing a trench created by corrosion of the surface.

Another image from the same sample is shown in Fig. 9. This is a particularly well-defined example of a trench, which we propose is the result of local corrosion beneath a section of ridge deposit. The flat baseline, representing the pristine polished substrate, can be seen to either side of the trench. The characteristic dimensions associated with the trench of Fig. 9 and the pit of Fig. 8 (which are commensurate with the dimensions of fingerprint ridge detail)

The features seen in Figs. 4 and 9 (and replicate observations) essentially represent the start and end of the image development process. It is clear that enhancement by humidity *and* temperature elevation are required, but images of the sample of Fig. 9 give no indication of whether the forcing conditions employed are barely adequate or far in excess of what is required to generate the image. With a view to practical application of the method, there is considerable interest in understanding the temporal evolution of the etched image. For cases involving objects in a fire, this would be relevant to decisions about searching for items upon which images might be expected to be developed (1). For cases of objects not subject to heat but upon which there might be latent fingerprints that could be deliberately developed by application of humidity and heat, this would be critical to optimization of conditions for developing the image. Finally, it would be relevant for discarded objects at scenes not identified until some time after the crime.

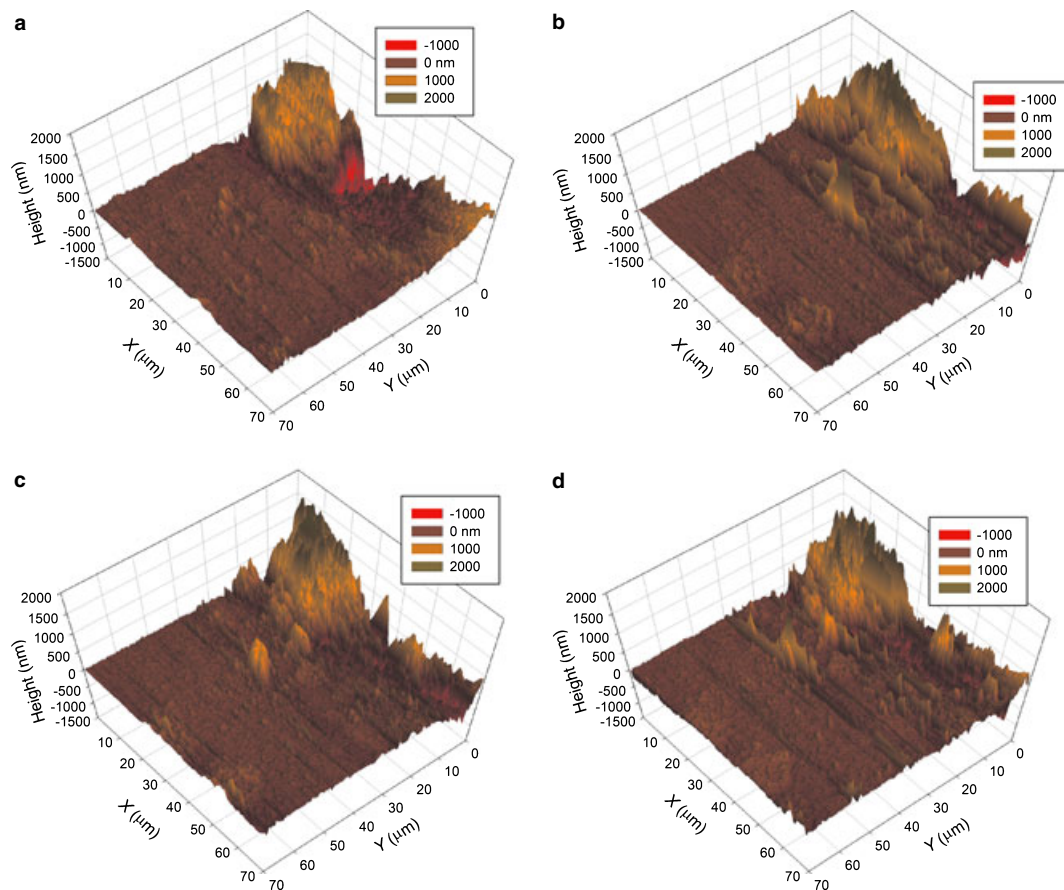
FIG. 10—AFM images from the polished and printed brass sample 5. The images are of the same region, identified by calibrated horizontal (x,y) translation of the AFM tip from registration lines of the type shown in Fig. 7. Time elapsed from fingerprint deposition and placement into a humid environment at 50°C (see Table 1): a: 4 days; b: 7 days; c: 8 days; d: 11 days.

We therefore attempted to observe the development of a section of ridge detail by time lapse imaging of the sample. Figure 10 shows a sequence of images of the same area of a brass surface (sample 5) on which one can see a section of a ridge deposit. This sample was exposed to a humid environment (saturated water vapor) at moderately elevated temperature (50°C , to give a convenient rate of change) and removed at periodic intervals for observation. Feature locations were reproducibly identified by the placement of a scratched cross-hair on the surface (as seen in the registration marks on the low resolution photograph in Fig. 7), some distance from the area investigated; the positioning system of the AFM allowed sample translation to repeatedly observe the same area. In the image shown in Fig. 10, the primary feature is a deposit (corresponding to a ridge) that progressively decreases in height and flattens on a timescale of days. One can also see the presence of a depression surrounding the deposit. While not at this stage proof, this and similar images suggest that the formation of etch trenches and pits does not initially take place *beneath* the ridge

deposits, but rather *around* them. A chemical explanation for this would be that corrosion requires water, salt, *and* oxygen to be available, and that all these agents are only present at the metal/deposit/air three-phase boundary. Beneath the deposit there is insufficient oxygen to drive corrosion and beyond the deposit the availability of water/salt is minimal. Pursuit of this hypothesis will be the subject of future study.

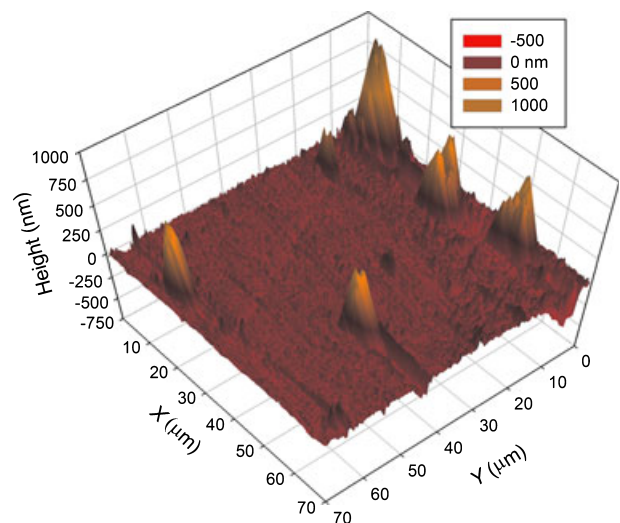
FIG. 11—AFM image from polished and printed brass sample 5 after 2 days in a humid environment at 50°C (see Table 1). The area shown is one not containing ridge detail, complementary to Fig. 10.

Given the unprecedented level of detail seen in the images above, it is interesting to ask how much of the exceptional spatial resolution of the AFM can be exploited in this context. Figure 11 shows an AFM image of a region not dominated by ridge detail. There are a number of small deposits, best described as depressed hemispheres typically 5–10 μm in diameter and 0.5–1 μm in height; note that the deliberately selected different lateral and vertical length scales in the AFM image alter the superficial visual perception. Comparison of the line scans (not shown) that in one case intercept and in another case avoid these features show that they can be clearly resolved on the comparatively flat polished brass surface. These features are not representative of generally acknowledged fingerprint features. However, their presence after—but absence before—placement of the fingerprint on the surface signals that they represent transfer of material from finger to metal. We attribute them to small-scale spatter associated with the delivery of the fingerprint onto the surface. One might reasonably anticipate that they would be capable of generating smaller scale corrosion pits on the surface, whose presence would complicate image analysis in much the same way that was true of surface roughness

present on the unpolished metal surfaces. Given their association with the formation of the fingerprint, there is no obvious way to avoid the presence of these small features; ultimately they may limit image interpretation.
