An Investigation of the Reduction in Tensile Strength and Fatigue Life of Pre-Corroded 7075-T6 Aluminum Alloy

B. Obert, K. Ngo, J. Hashemi, S. Ekwaro-Osire, and T.P. Sivam

(Submitted 14 September 1999; in revised form 8 March 2000)

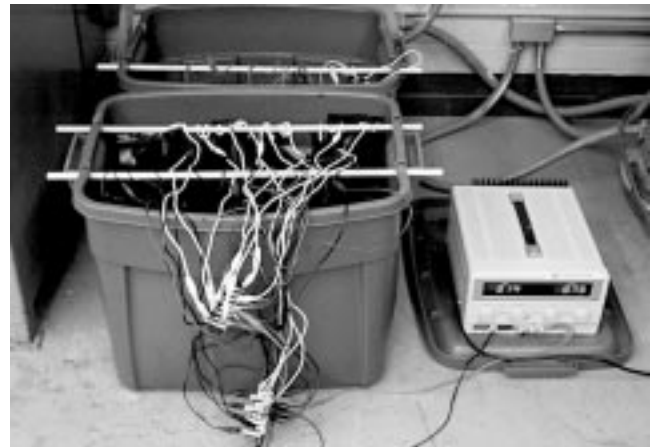
Corrosion of the samples was accomplished by the utilization of a corrosion cell. ASTM G 31-72^[2] was referenced. The corrosion cell consisted of 71.9 L (19 gallon) plastic containers, salt water, power supply, anode, and cathode. The corrosion cell is shown in Fig. 3. The aluminum samples were used as the anode, graphite rods as the cathode, and salt water as the electrolyte to complete the cell. The salt water was produced by mixing Instant Ocean (Canton, MA) aquarium salt with distilled water. Approximately 100 g (1/2 cup) of salt was added to each 3.8 L (1 gal) of water, which resulted in water that closely simulated seawater. The specific gravity of the salt water was measured for each experiment and was found to be between 1.023 and 1.026, which correlates closely with natural seawater. The masked specimens were submerged in the salt water vertically and connected to the positive lead of the power supply. Next, the graphite rods were submerged and connected to the negative lead. The power supply was used to provide an induced voltage to the cell varying from 750 to 850 mV. The samples were then allowed to corrode to the desired material loss level in the corrosion cell. Previously, several test samples were corroded over various time intervals and their material loss was recorded. Using the recorded data, the material loss rate was

Fig. 3 The corrosion cell: (a) top view and (b) front view

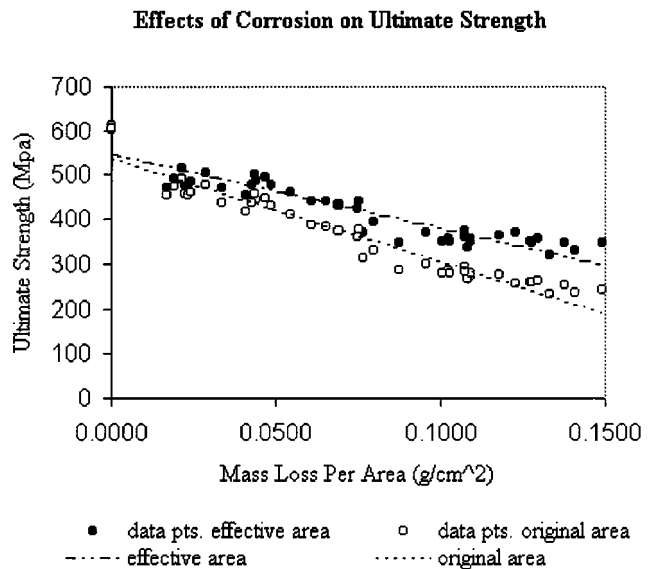
The tensile test results of samples tested at different mass loss per unit area levels due to corrosion are shown in Fig. 8. As seen in this figure, there is a large initial drop in strength from the undamaged specimens to the 0.0224 g/cm^2 mass loss samples. For example, the difference in mean strength between the non-corroded and 0.0224 g/cm^2 mass loss samples is approximately 138 MPa (20 Kpsi); and the difference between the 0.0224 and 0.0448 g/cm^2 mass loss samples is approximately 27.6 MPa (4 Kpsi). After the 0.0224 g/cm^2 mass loss, the strength of the aluminum tends to reduce linearly with increasing mass loss per unit area. The mean value for mass loss per unit area and ultimate strength at each level is presented in Table 1.

Fig. 8 Tensile strength vs mass loss per area

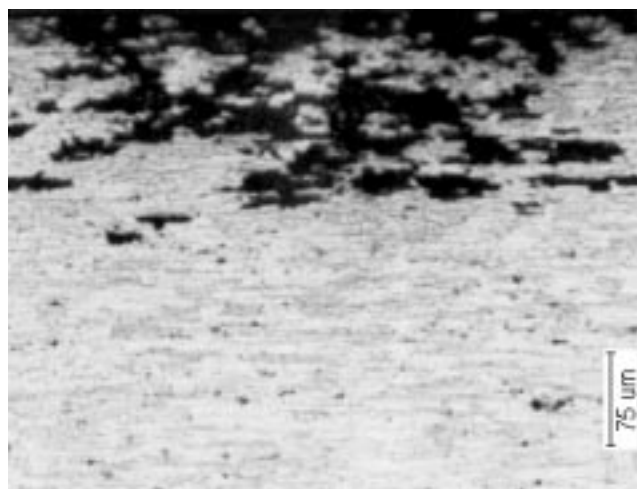
In order to investigate the subsurface damage, corroded specimens were prepared for metallurgical examination. Sections to be viewed were cut from the corroded area of untested samples. One section was cut along the X- (horizontal) axis

Fig. 10 Microstructure of corrosion samples: (a) cut along X- axis and (b) cut along Y-axis

and one along the Y- (vertical) axis, as indicated in Fig. 5 and 6. This was done to get a better picture of the pit topology. The samples were then mounted in a polymer resin such that the thickness could be viewed. Next, the samples were sanded and polished to a .1 μm finish. The samples were etched using Keller's reagent (2 mL 48% HF, 3 mL HCL, 5 mL HNO₃, 190 mL H₂O). The samples were then viewed using a metallograph, and photos were made of the samples for comparison and analysis. The resulting images are shown in Fig. 10 (a) and (b). These figures show that the corrosion penetrates into the thickness of the metal deeper than can be seen at the surface. It is due to the existence of this subsurface corrosion that the reduction in hardness occurs. The section cut from the Y- axis shows an internal crack believed to be induced by corrosion in combination with residual stresses present in the test material. A detailed examination of the crack shows that it is running along the grain boundaries and not across them. This observation indicates that this crack is corrosion induced. Next, a section was cut from a specimen that failed in fatigue. The sample was

cut so that the length of the fracture surface could be viewed. The sample was prepared in the same manner as described previously. The resulting image can be seen in Fig. 11. A fatigue induced crack such as the one in Fig. 11 runs across the grains and looks very different than the crack seen in Fig. 10 (b).

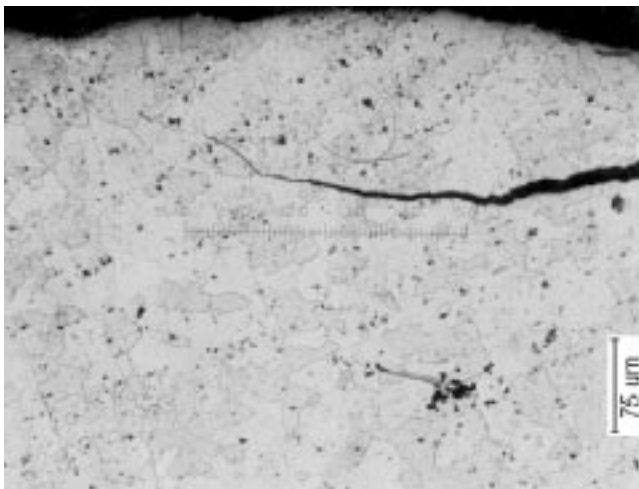
Fig. 11 Microstructure of fracture surface

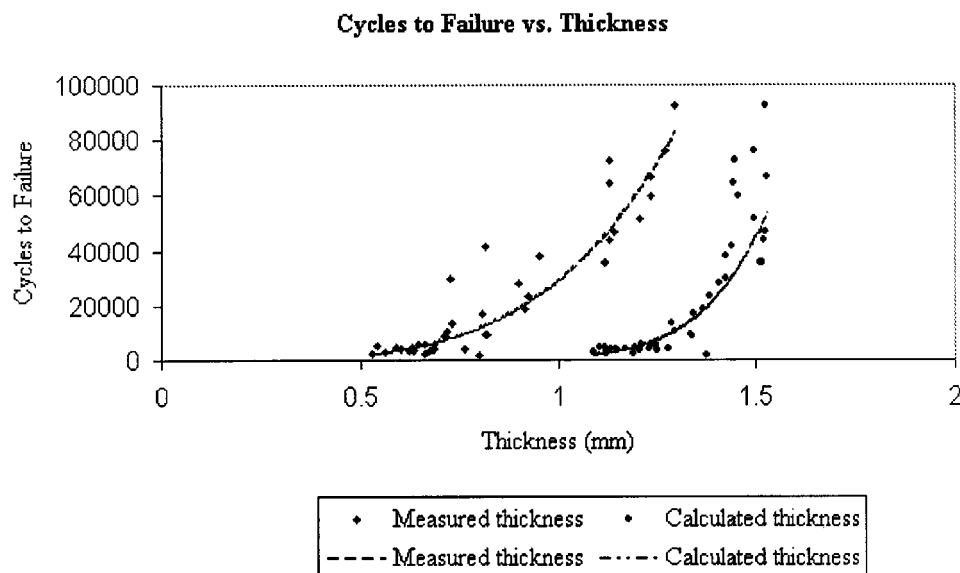
A plot was made of the cycles to failure versus measured thickness and versus calculated thickness; the results are shown in Fig. 12. Here it is assumed that the minimum thickness at the fracture surface represents the pit depth at which fracture started.

Fig. 12 Fatigue life vs minimum thickness curves
