Failure modes of fibre reinforced composites: The effects of strain rate and fibre content

This work set out to investigate the effect of strain rate and fibre content on the failure modes of fibre reinforced composite materials.

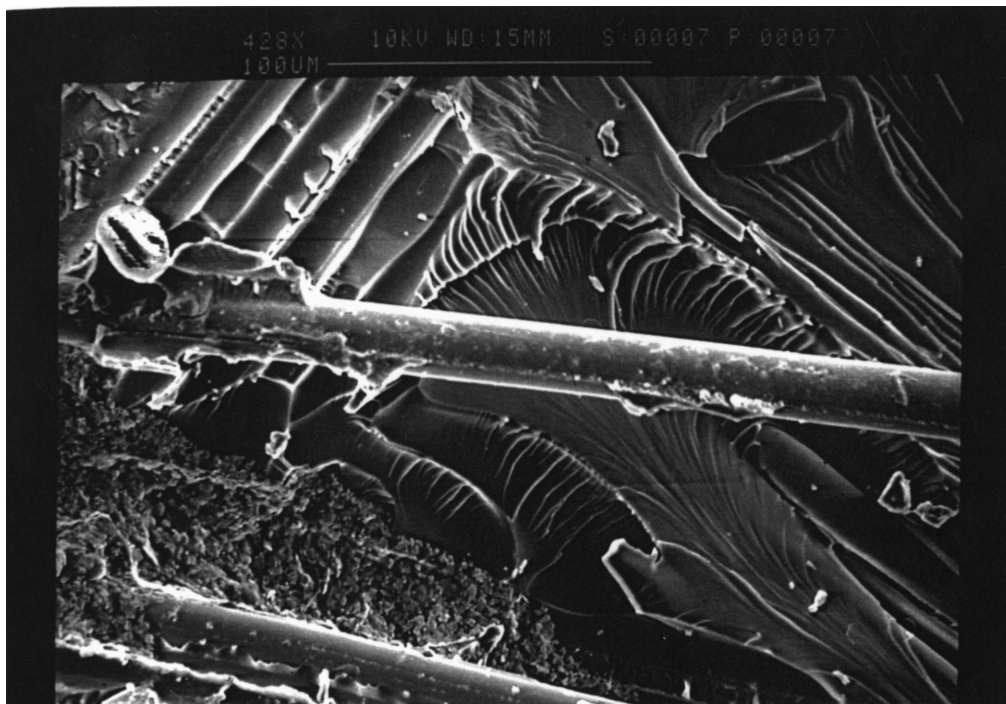
Figure 6 WMG Random Continuous Glass/Epoxy Laminates with 20.7% fibre volume fraction showing areas of fibre-matrix adhesion, fibre pull-out and fibre-matrix debonding ($\times 428$).

the same laminate shown in Fig. 5. The matrix shows river marks, indicating the direction of crack propagation. The matrix also shows areas of fibre-matrix adhesion, fibre pull-out and fibre-matrix debonding. The long fibre pull-out indicates composite toughness. The foregoing suggests that the laminate failed by fibre brittle failure and/or matrix failure.

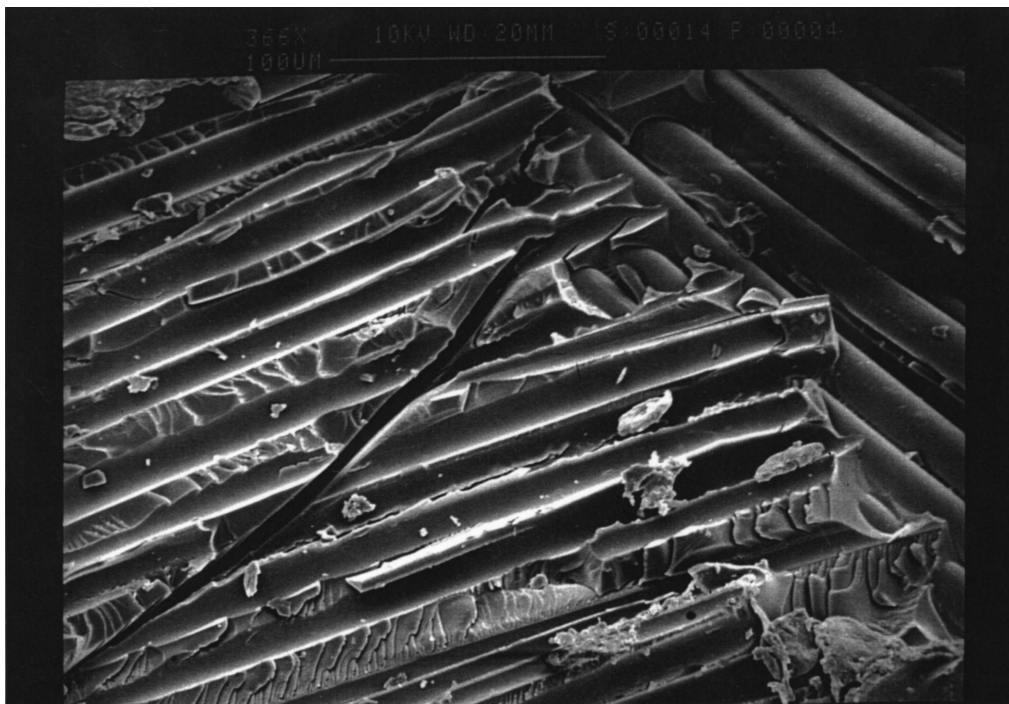
surface where matrix delamination and cracking can be observed with river marks, indicating the direction of crack propagation through the matrix. This suggests that the composite failed by fibre brittle failure with fibre pull-out and matrix failure.

Figure 12 WMG Random Continuous Glass/Epoxy Laminates with 41.2% fibre volume fraction showing crack running through debonded matrix ($\times 366$).
