The Fracture of Metals under Repeated Alternations of Stress

J. A. Ewing and J. C. W. Humfrey

Phil. Trans. R. Soc. Lond. A 1903 **200**, 241-250

VI. *The Fracture of Metals under Repeated Alternations of Stress.*

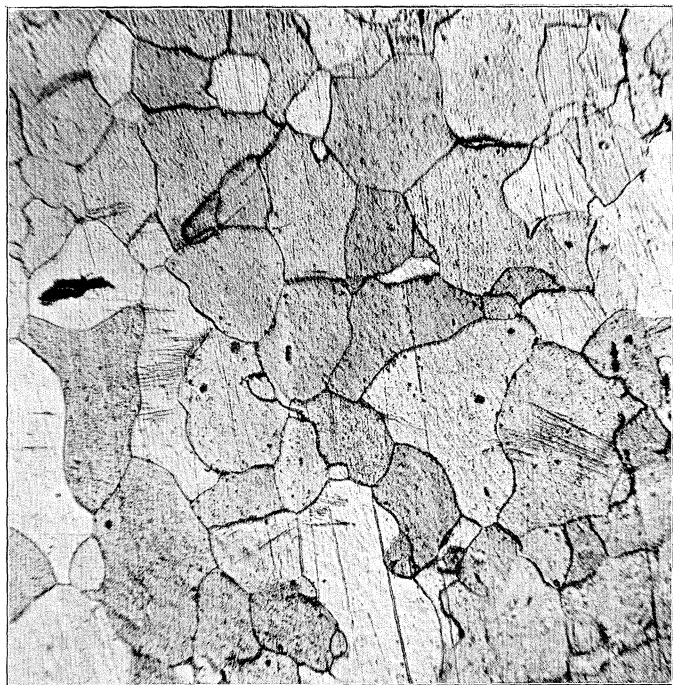
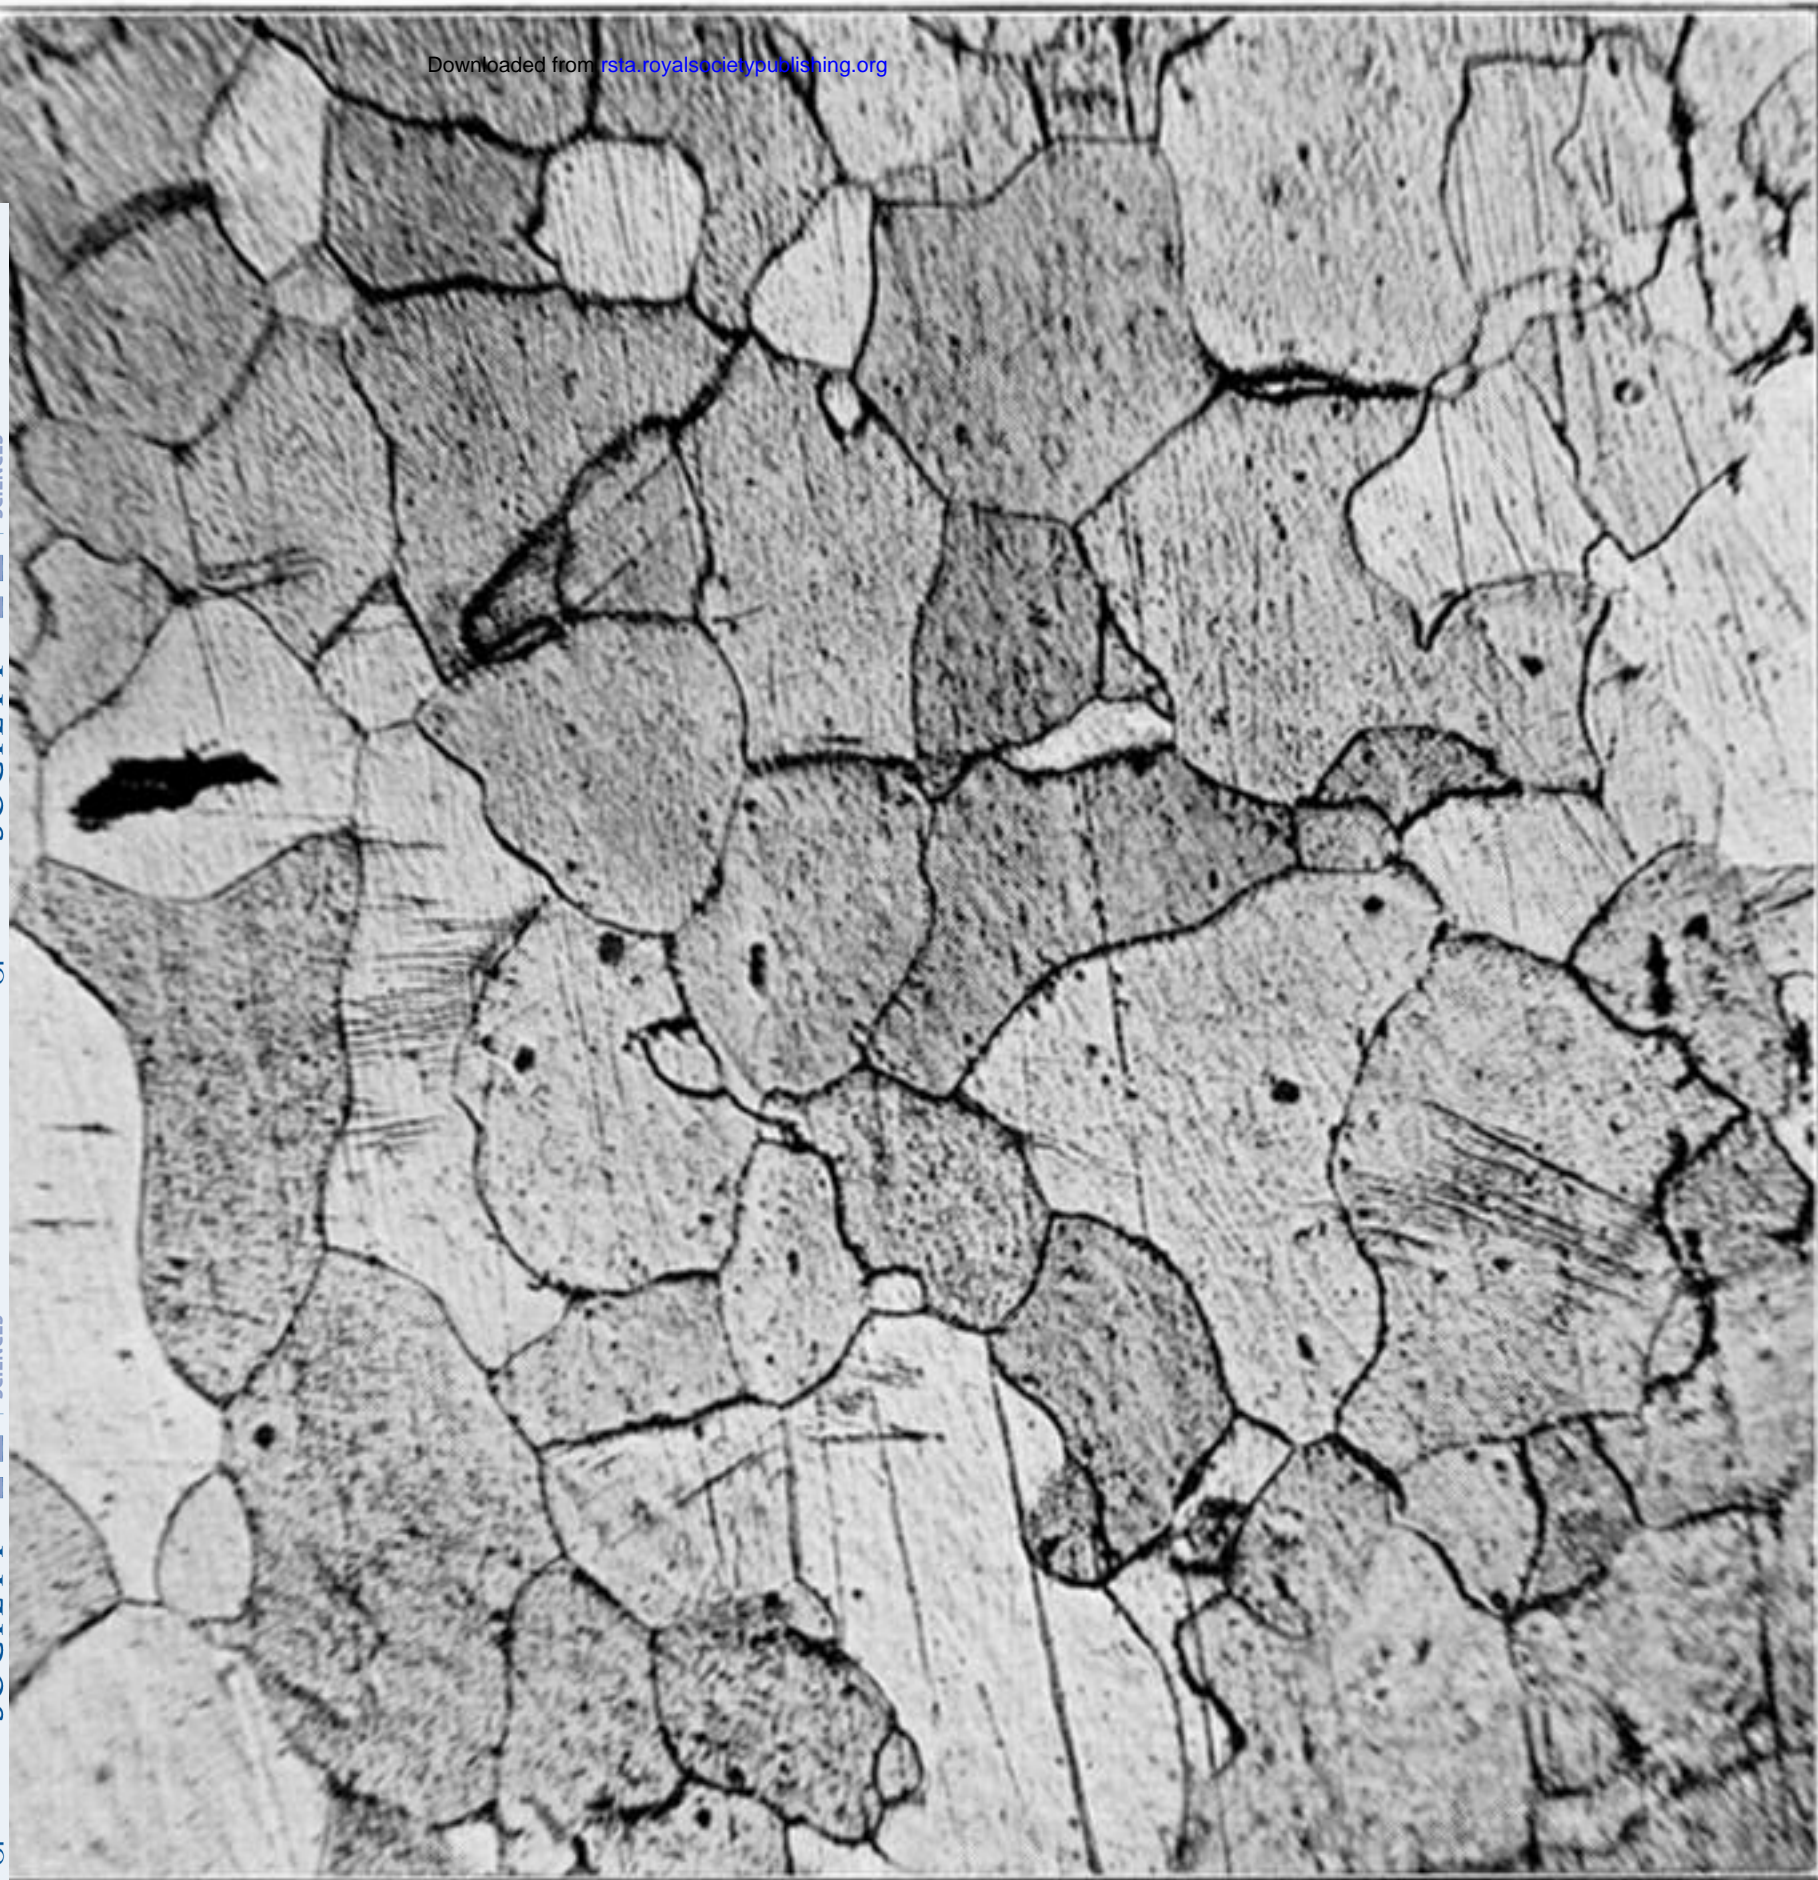
Fig. 3. Specimen of Swedish iron after 5000 reversals of a stress of 14.3 tons per sq. inch. $\times 150$.

Fig. 3. Specimen of Swedish iron after 5000 reversals of a stress of 14·3 tons per sq. inch. $\times 150$.

The first series show part of a specimen which had been subjected to a stress the maximum value of which, close to the grips, was 14·3 tons per sq. inch. In this series the magnification is 150 diameters. Fig. 3 was taken after 5000 reversals had been given. A few of the crystals exhibit signs of slip, the slip-lines being still fairly fine and sharp. Two crystals in the photograph are seen to have yielded more than the others. Figs. 4 and 5 show the same set of crystals after 40,000 and 60,000 reversals of stress respectively. In fig. 4 a good many more crystals show signs of slip, and the slip-lines which appeared in fig. 3 are far more strongly defined. In some cases it will be seen that the lines have so broadened out as to run together and form dark patches on the surface of the crystals. In fig. 5 a still further breaking up of the surface by slip has occurred. At this stage, and probably earlier, some of the slip-bands have developed into small cracks. Such a crack is seen near the top right-hand corner of the figure, first of all close to a crystalline boundary, and then in steps across the next crystal. On the latter crystal two systems of slip-bands had formed at right angles to one another and at about 45° to the direction of stress. Only one system is clearly visible in the photograph, but it will be seen that the crack runs in steps along both. Fig. 5 shows not only the development of this crack, but also a general increase in width, length, and number of the slip-bands. This was practically the final stage, so far as this portion of the surface was concerned, for the specimen broke after another 10,000 reversals along a crack outside the field of these photographs.

Fig. 3 after 5,000 reversals.

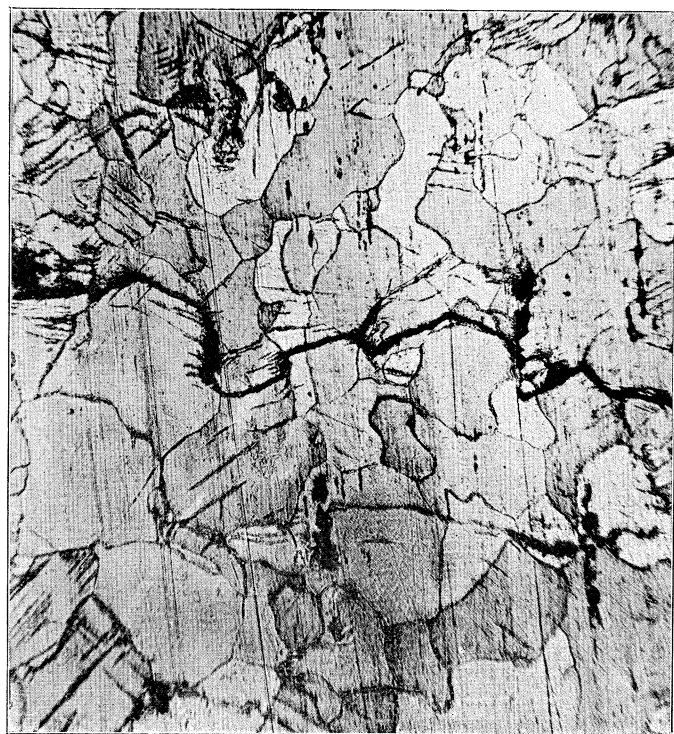
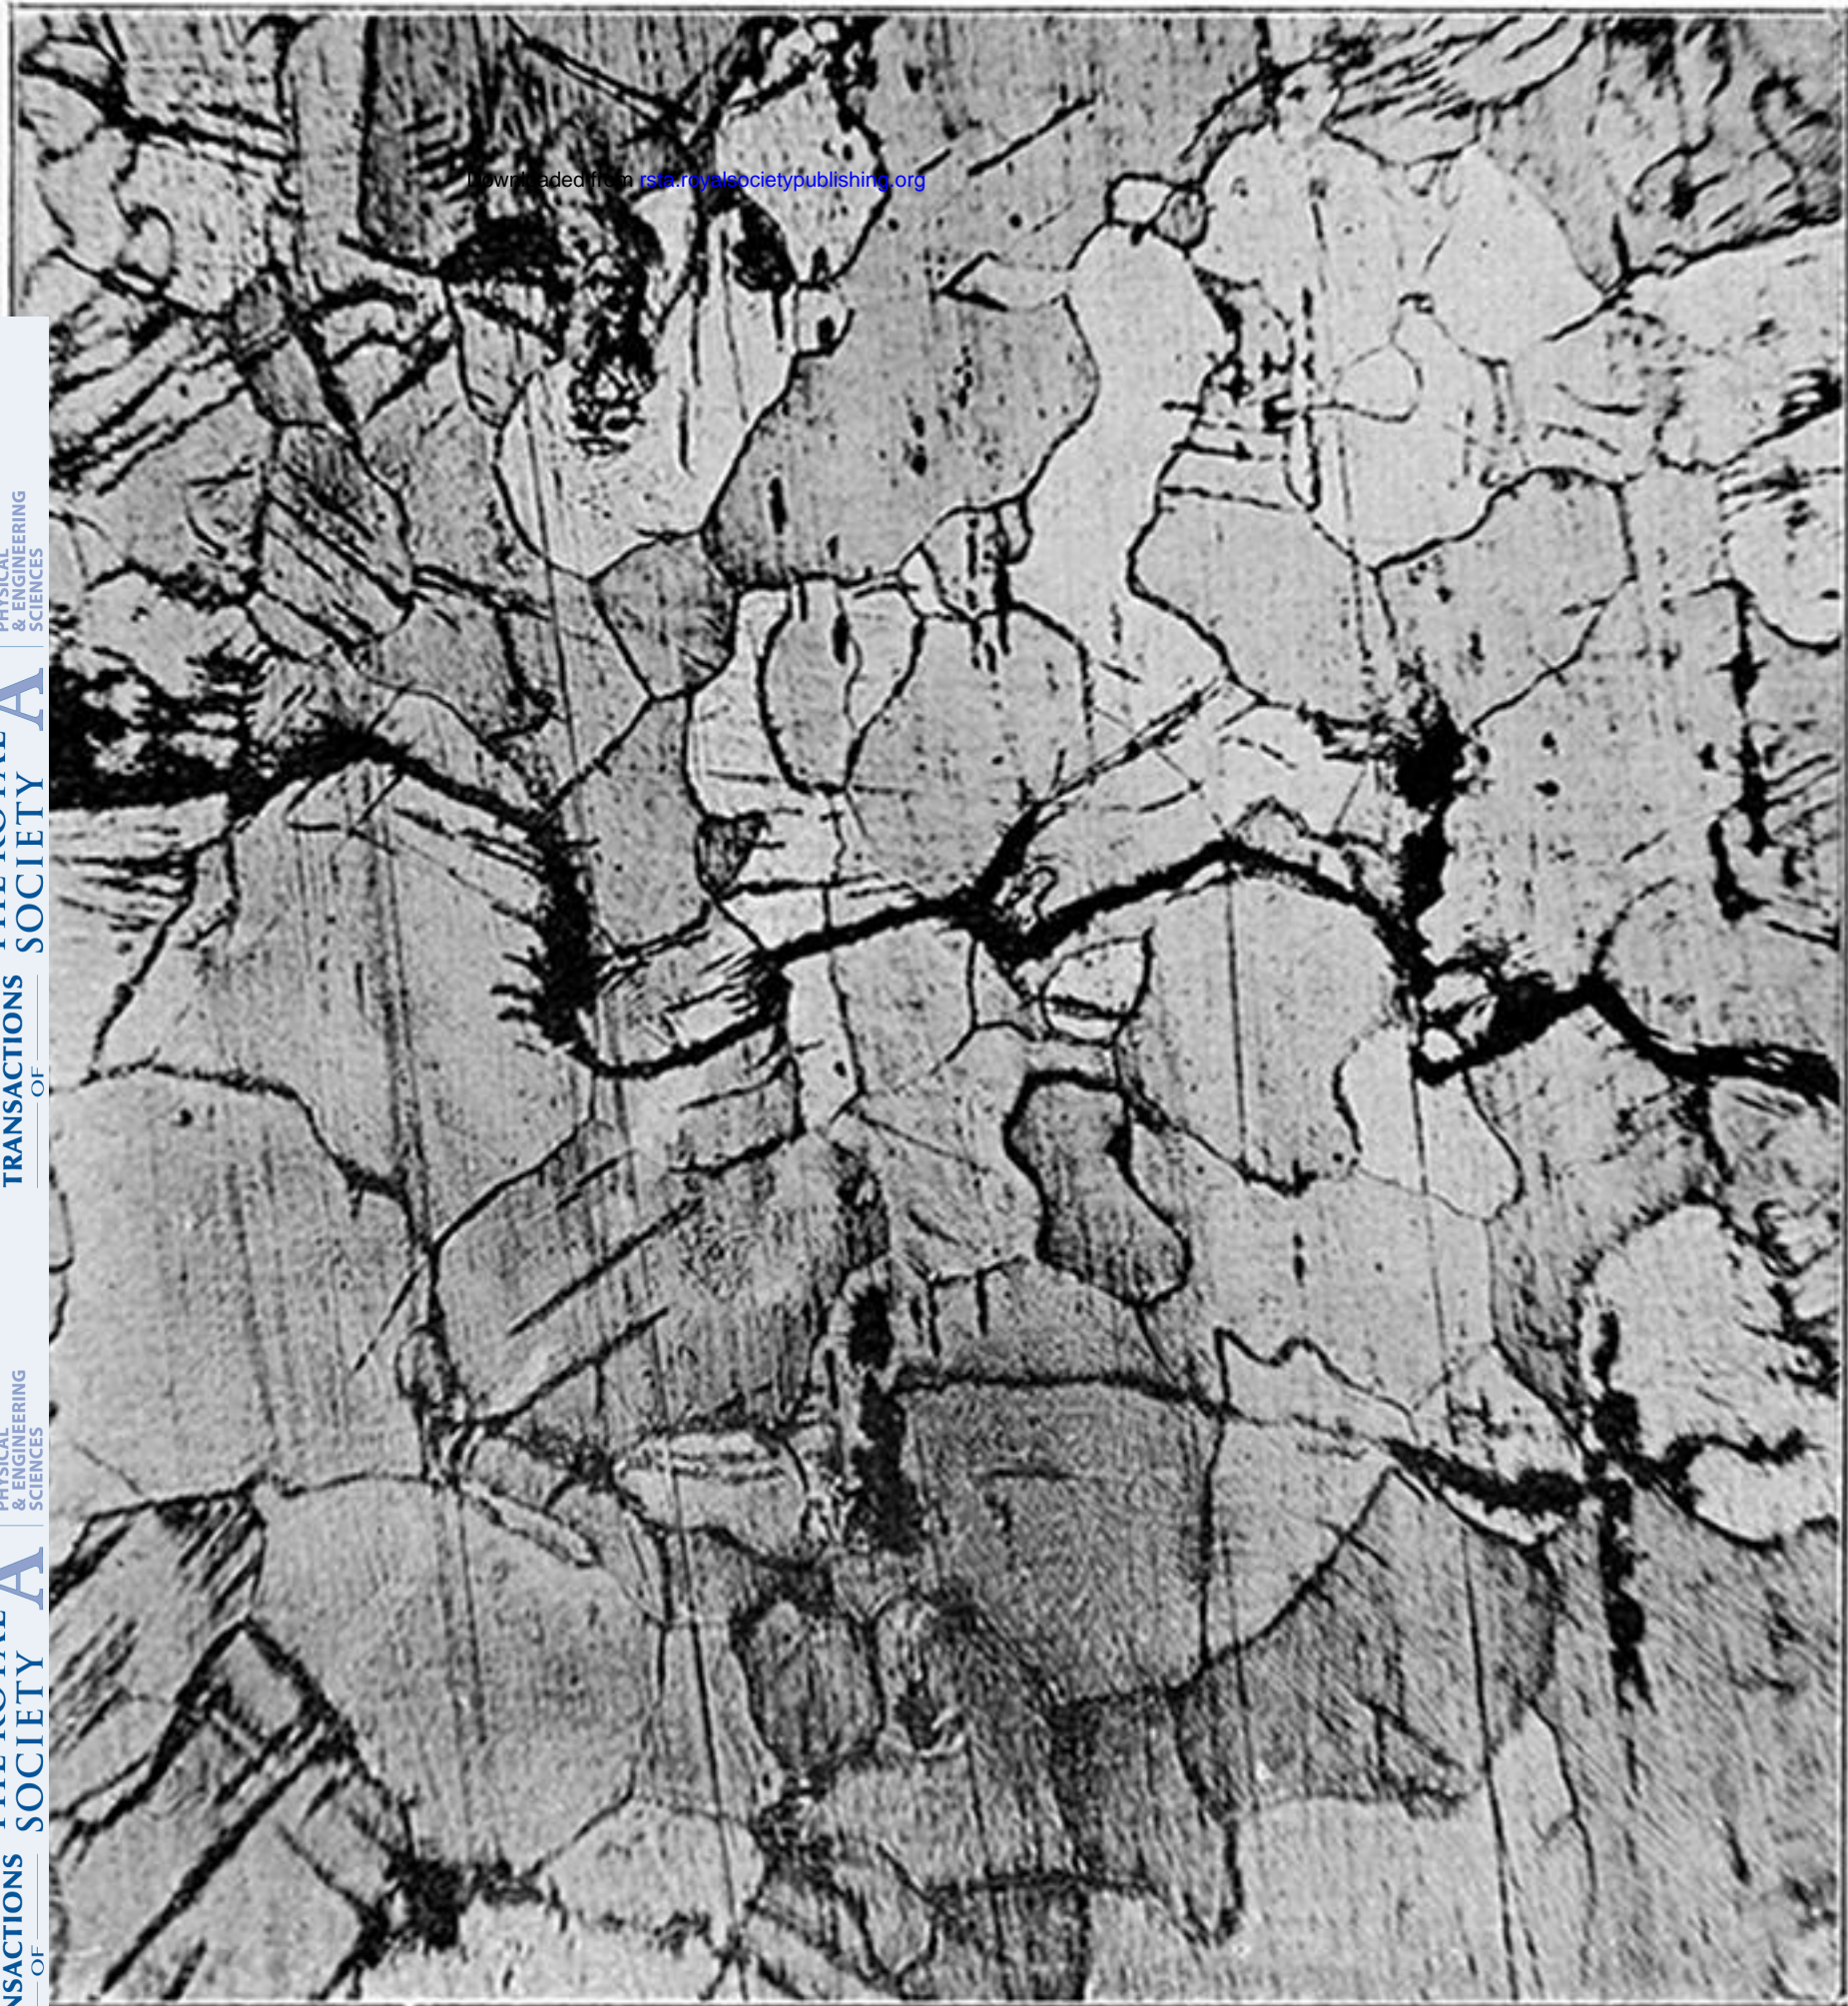
Fig. 7. Specimen after 170,000 reversals of a stress of 12.3 tons per sq. inch. $\times 150$.

The specimen illustrated in the next photograph, fig. 7, had been subjected to

170,000 reversals of a stress of 12·3 tons per sq. inch, at which it broke. The spot shown (magnified 150 diameters) is a little way further from the grips than the crack through which the specimen actually broke, but another severe crack is seen running across the centre of the figure. Comparing this with fig. 5, it will be at once seen that there are far fewer lines due to slip upon each individual crystal than in the former specimen. Fig. 8 shows the same spot after re-polishing and etching. Comparing this with fig. 6 it is seen that a greater proportion of the slip-lines appear in this instance as cracks after re-polishing. The maximum stress is less here than in the former example, and more than twice as many reversals were required to bring about fracture. This agrees with what has been found for all other specimens broken, viz., the lower the stress the fewer the slip-lines upon each crystal, but the greater proportion of these actually develop into cracks under the more numerous reversals to which the less severely stressed specimen is exposed.

Fig. 7 after 170,000 reversals.

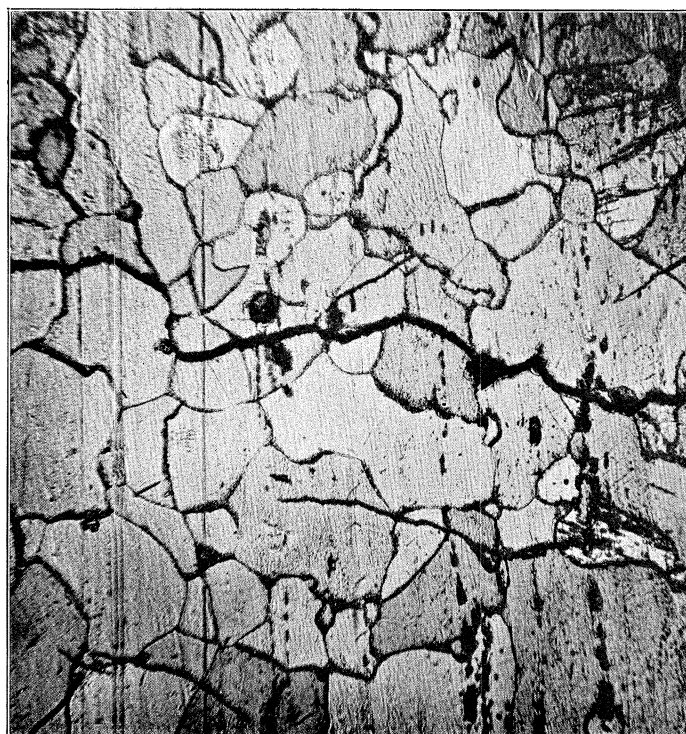
Fig. 8. Same after re-polishing and re-etching. $\times 150$.

Fig. 8 same after re-polishing and re-etching.

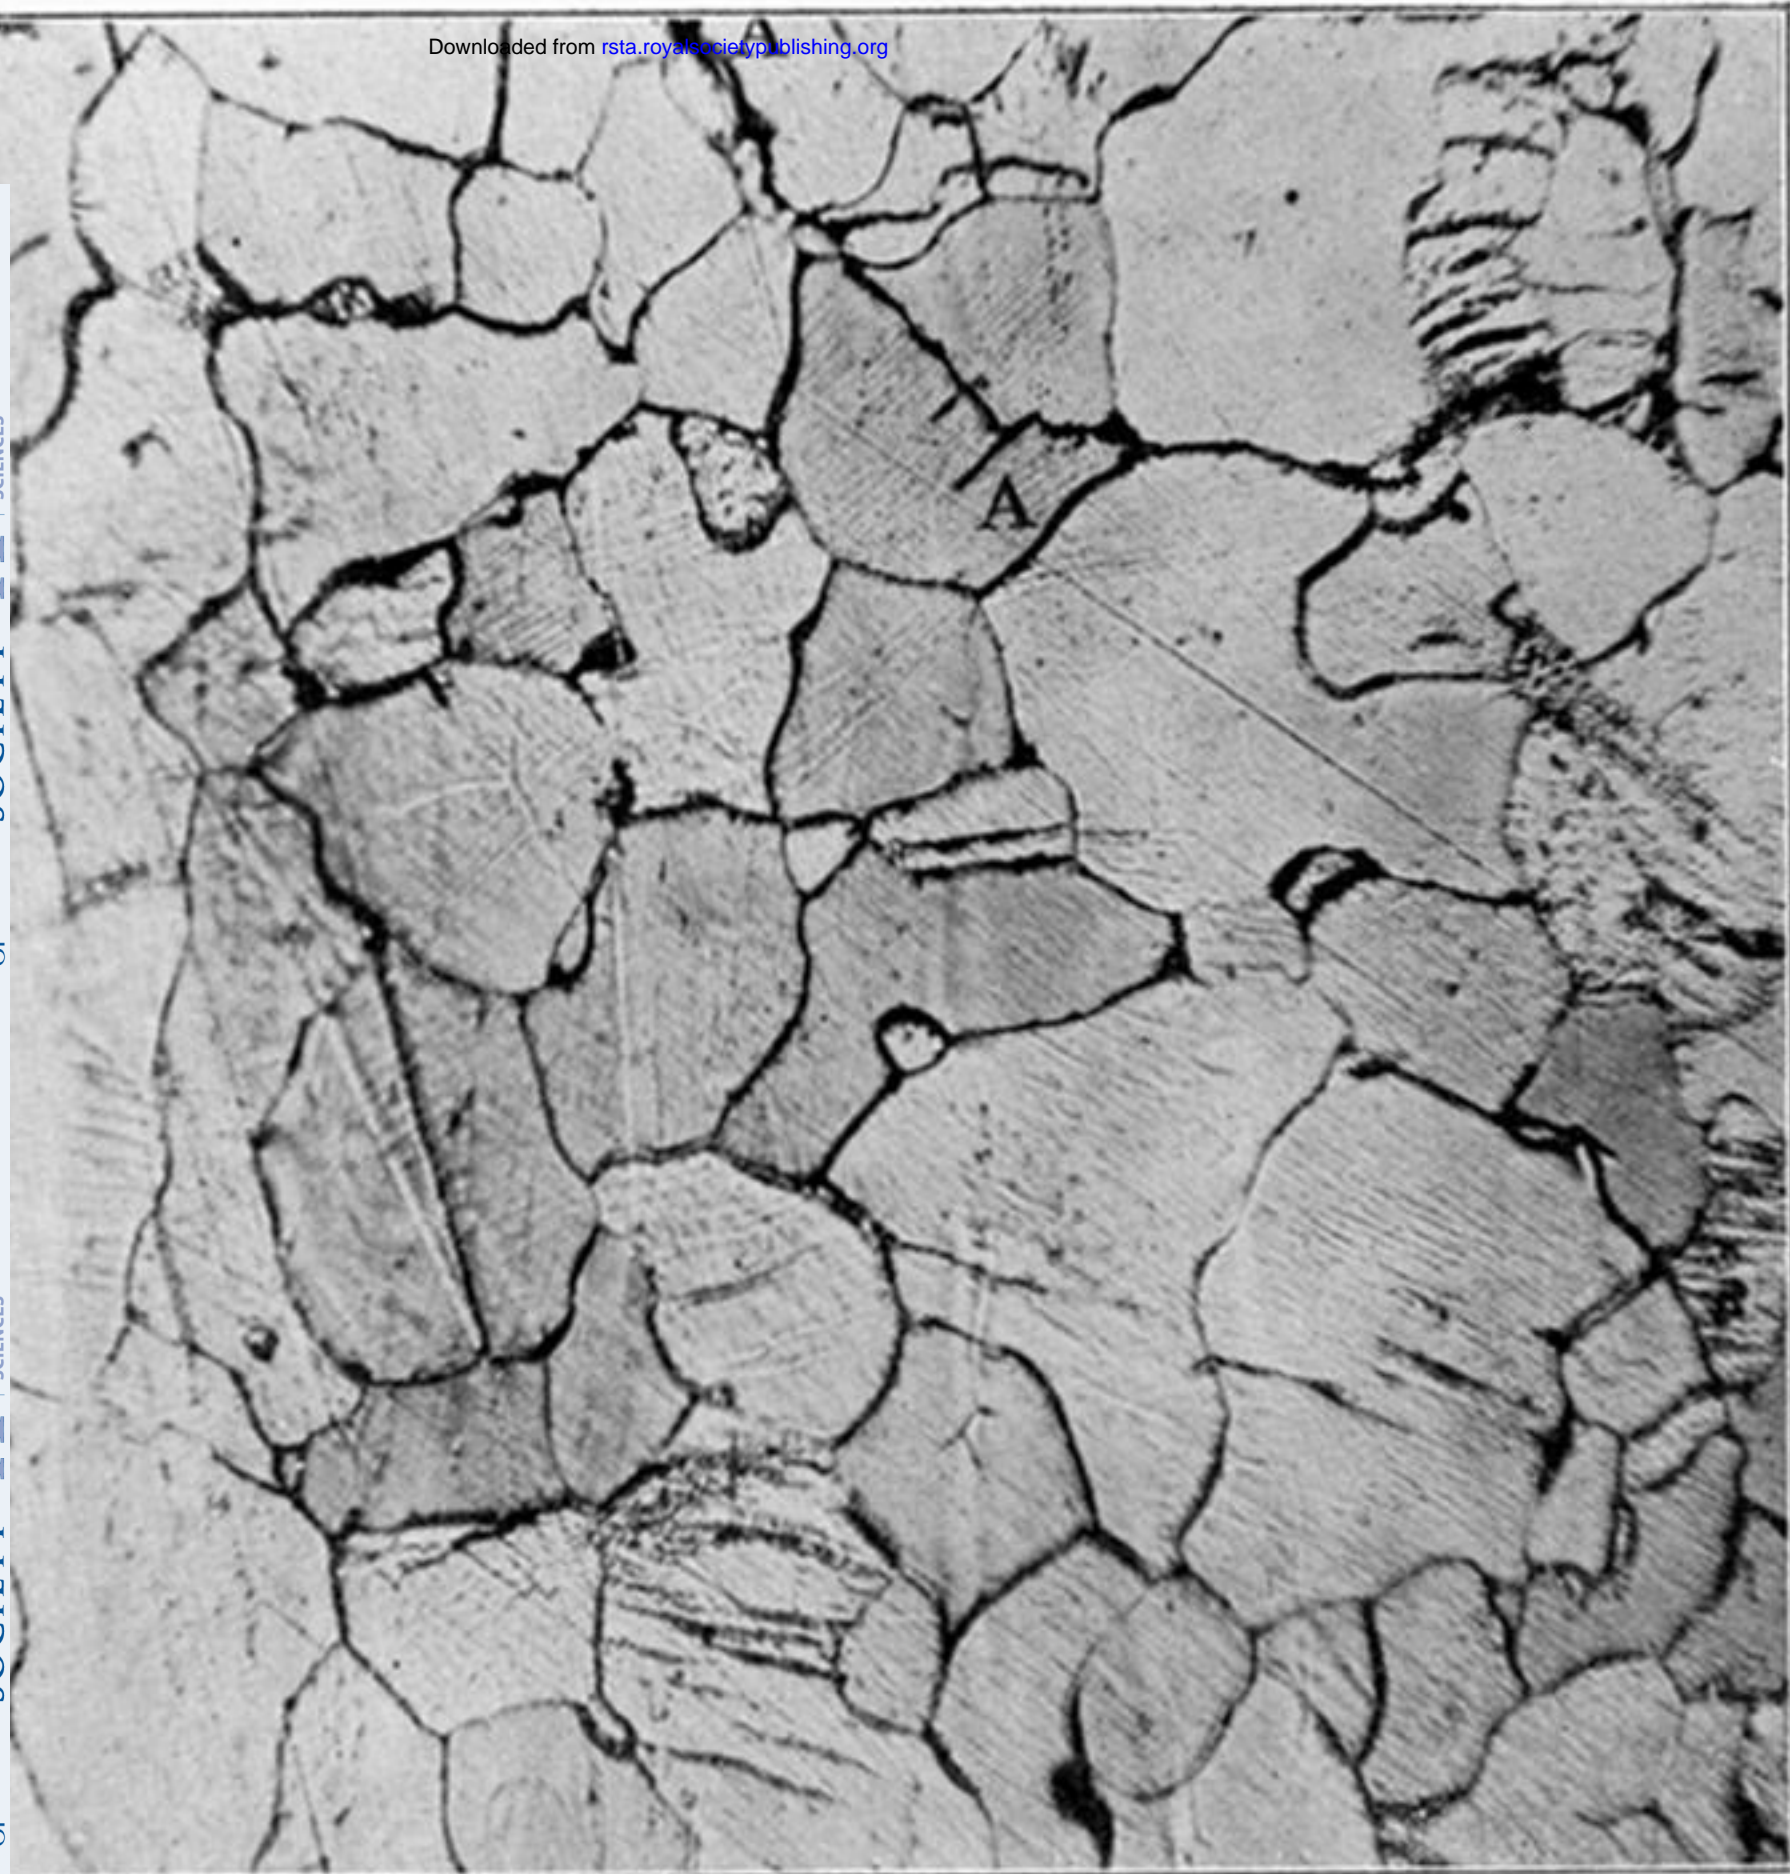
Fig. 6. Same after 70,000 reversals and re-polishing and re-etching. $\times 150$.

When viewed in this state it is not practicable to tell how many of the slip-bands have actually developed into cracks, but this is readily seen when the specimen is re-polished and re-etched. This treatment obliterates any ordinary slip-bands which are steps marking differences of surface level, but any cracks remain visible. The specimen which gave this series of photographs was accordingly re-polished sufficiently to clear away the slip-bands, and was re-etched. This left the cracks alone visible, rather accentuated indeed, for the sides of the cracks are to some extent eaten away by the acid, and hence the width of the crack is increased. Fig. 6 shows the same part of the specimen as figs. 3, 4, and 5, after re-polishing and re-etching. The slip-bands have disappeared, except where they have formed cracks. A careful comparison of this with fig. 3 will show where cracks have formed. The most conspicuous crack is at AA, and its zig-zag character as it follows the two directions of slip-bands across one of the crystals is specially noticeable.

Fig. 6 after 70,000 reversals, followed by re-polishing and re-etching.

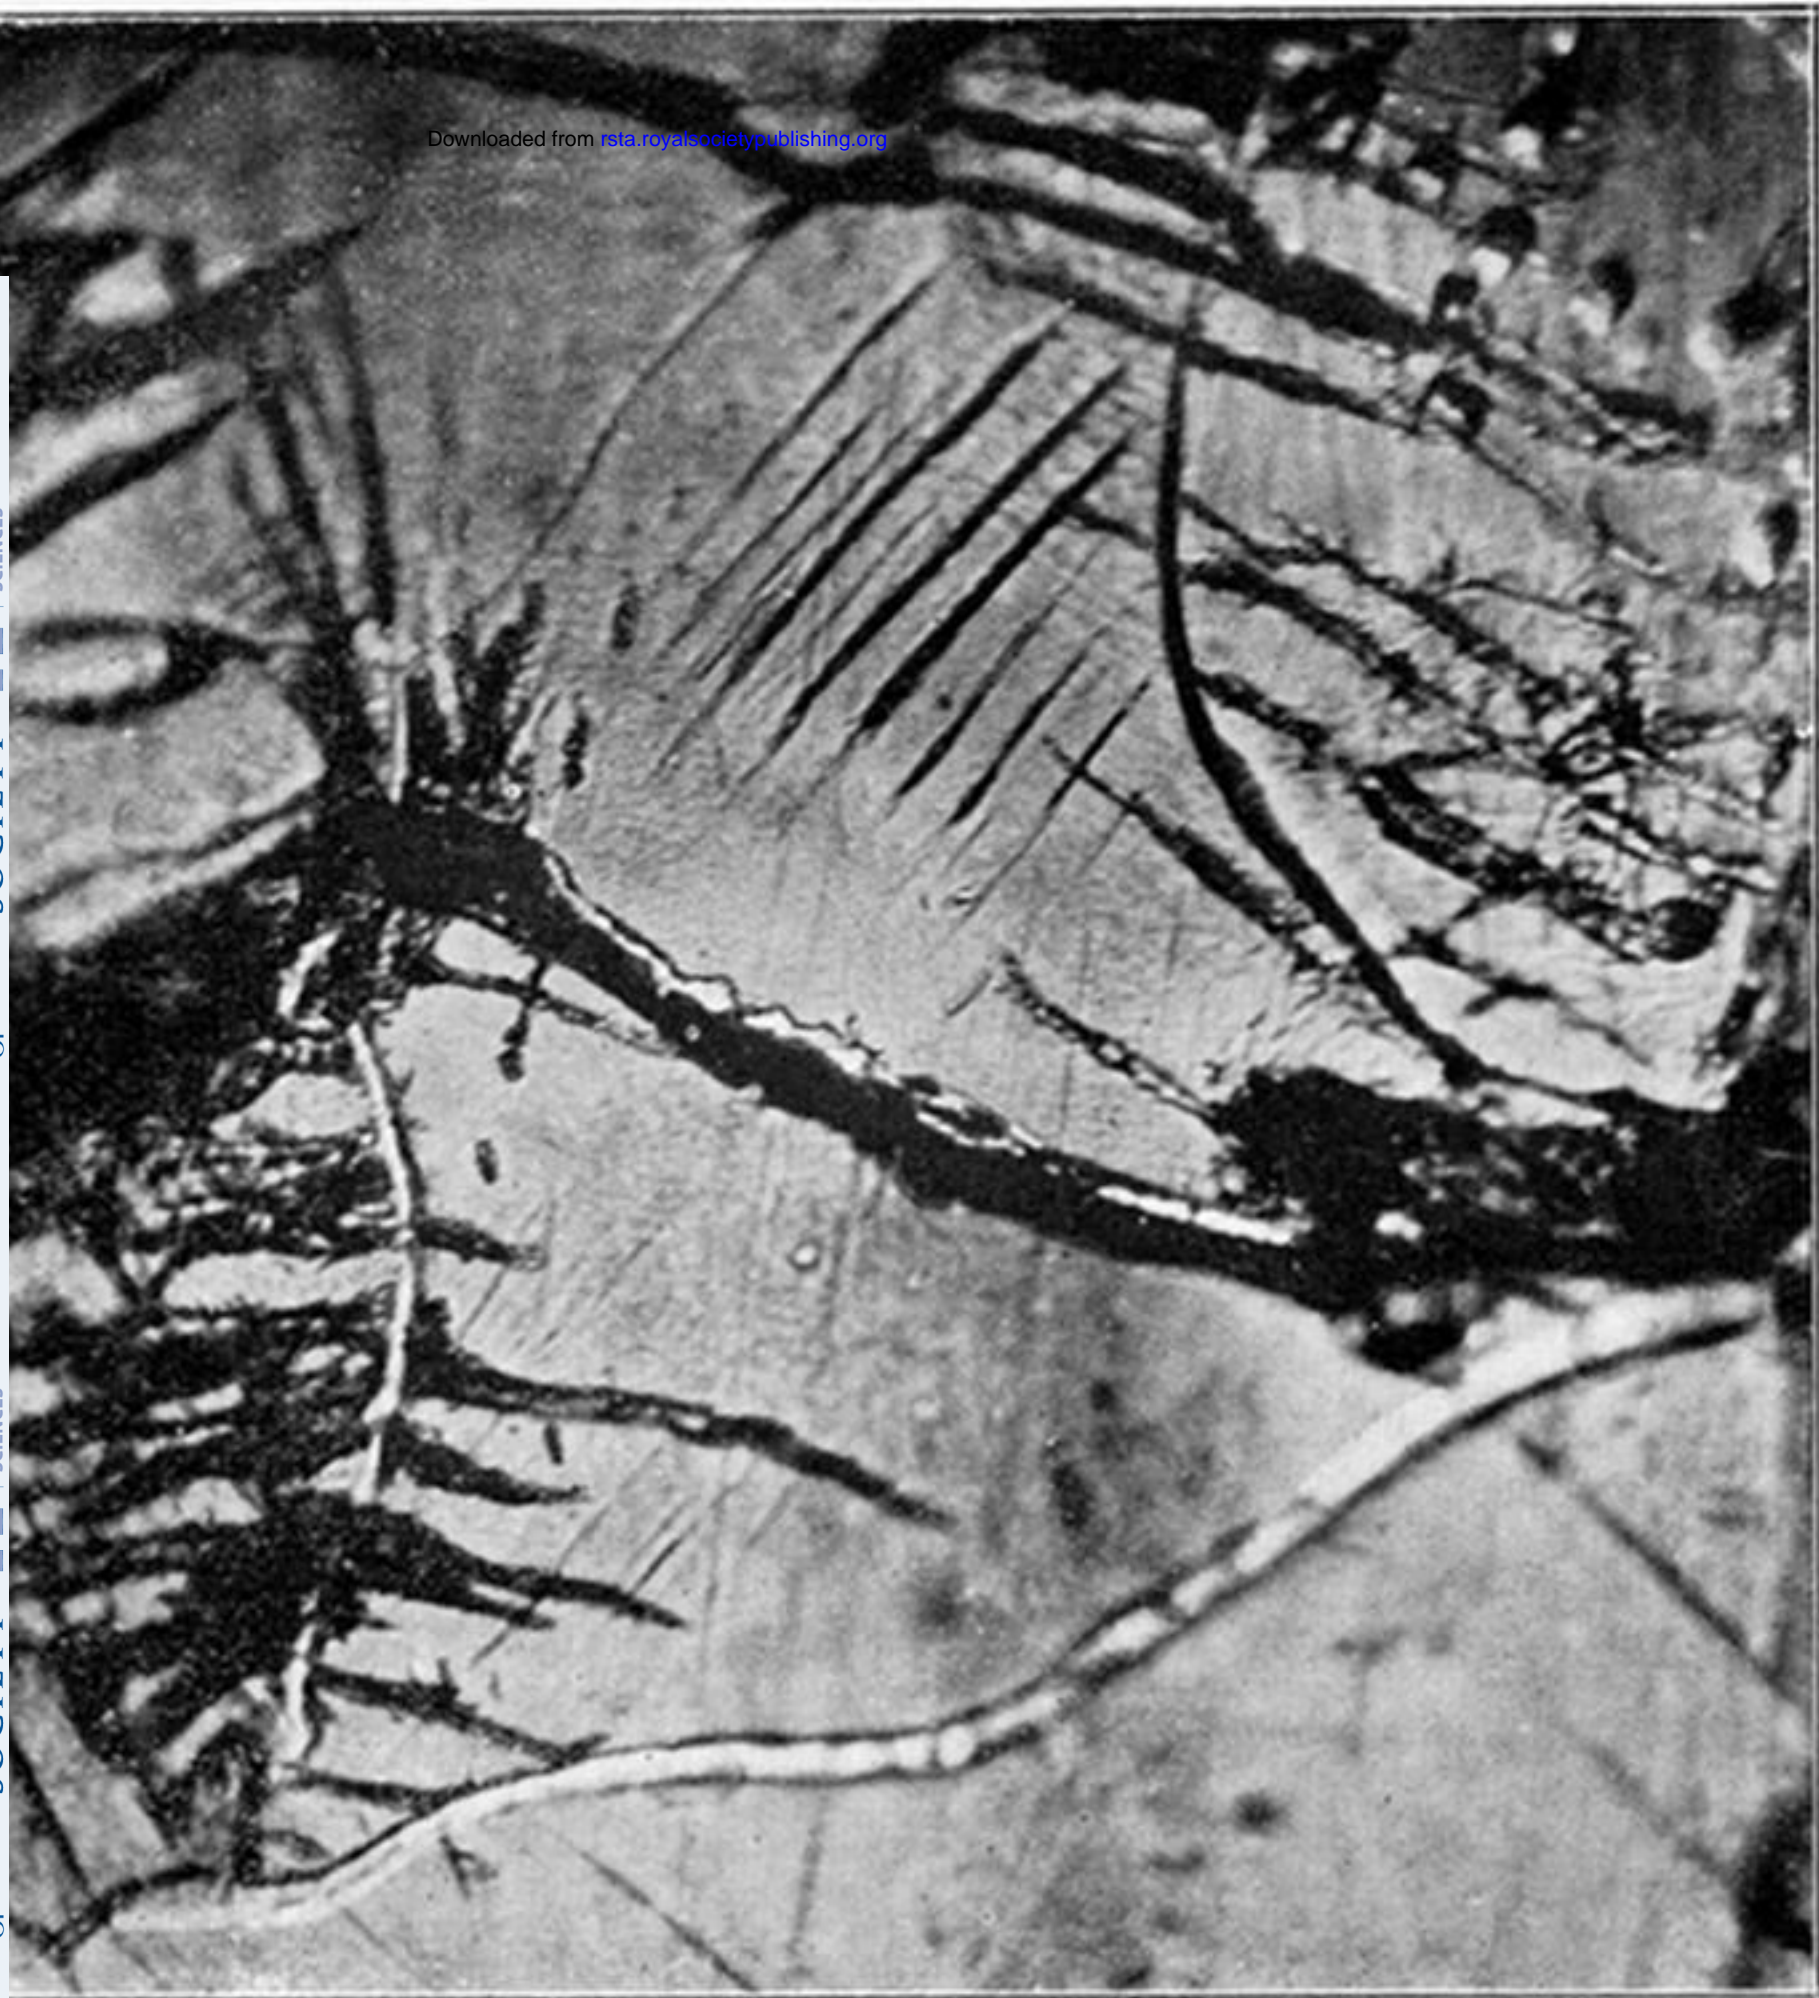
Fig. 14. Another part of the specimen of figs. 9–12, after 160,000 reversals. $\times 1000$.

Fig. 14 (Plate 8) shows a different part of the same specimen (after it had broken), also under a magnification of 1000 diameters. The broad band in the middle of the crystal is a crack which has developed along what was originally a line of slip. The heaving-up of the surface along the edges of the crack is well marked and may be compared with similar appearances at the edges of slip-bands in other parts of the photograph.

Fig. 14. Another part of the same specimen after 160,000 reversals.

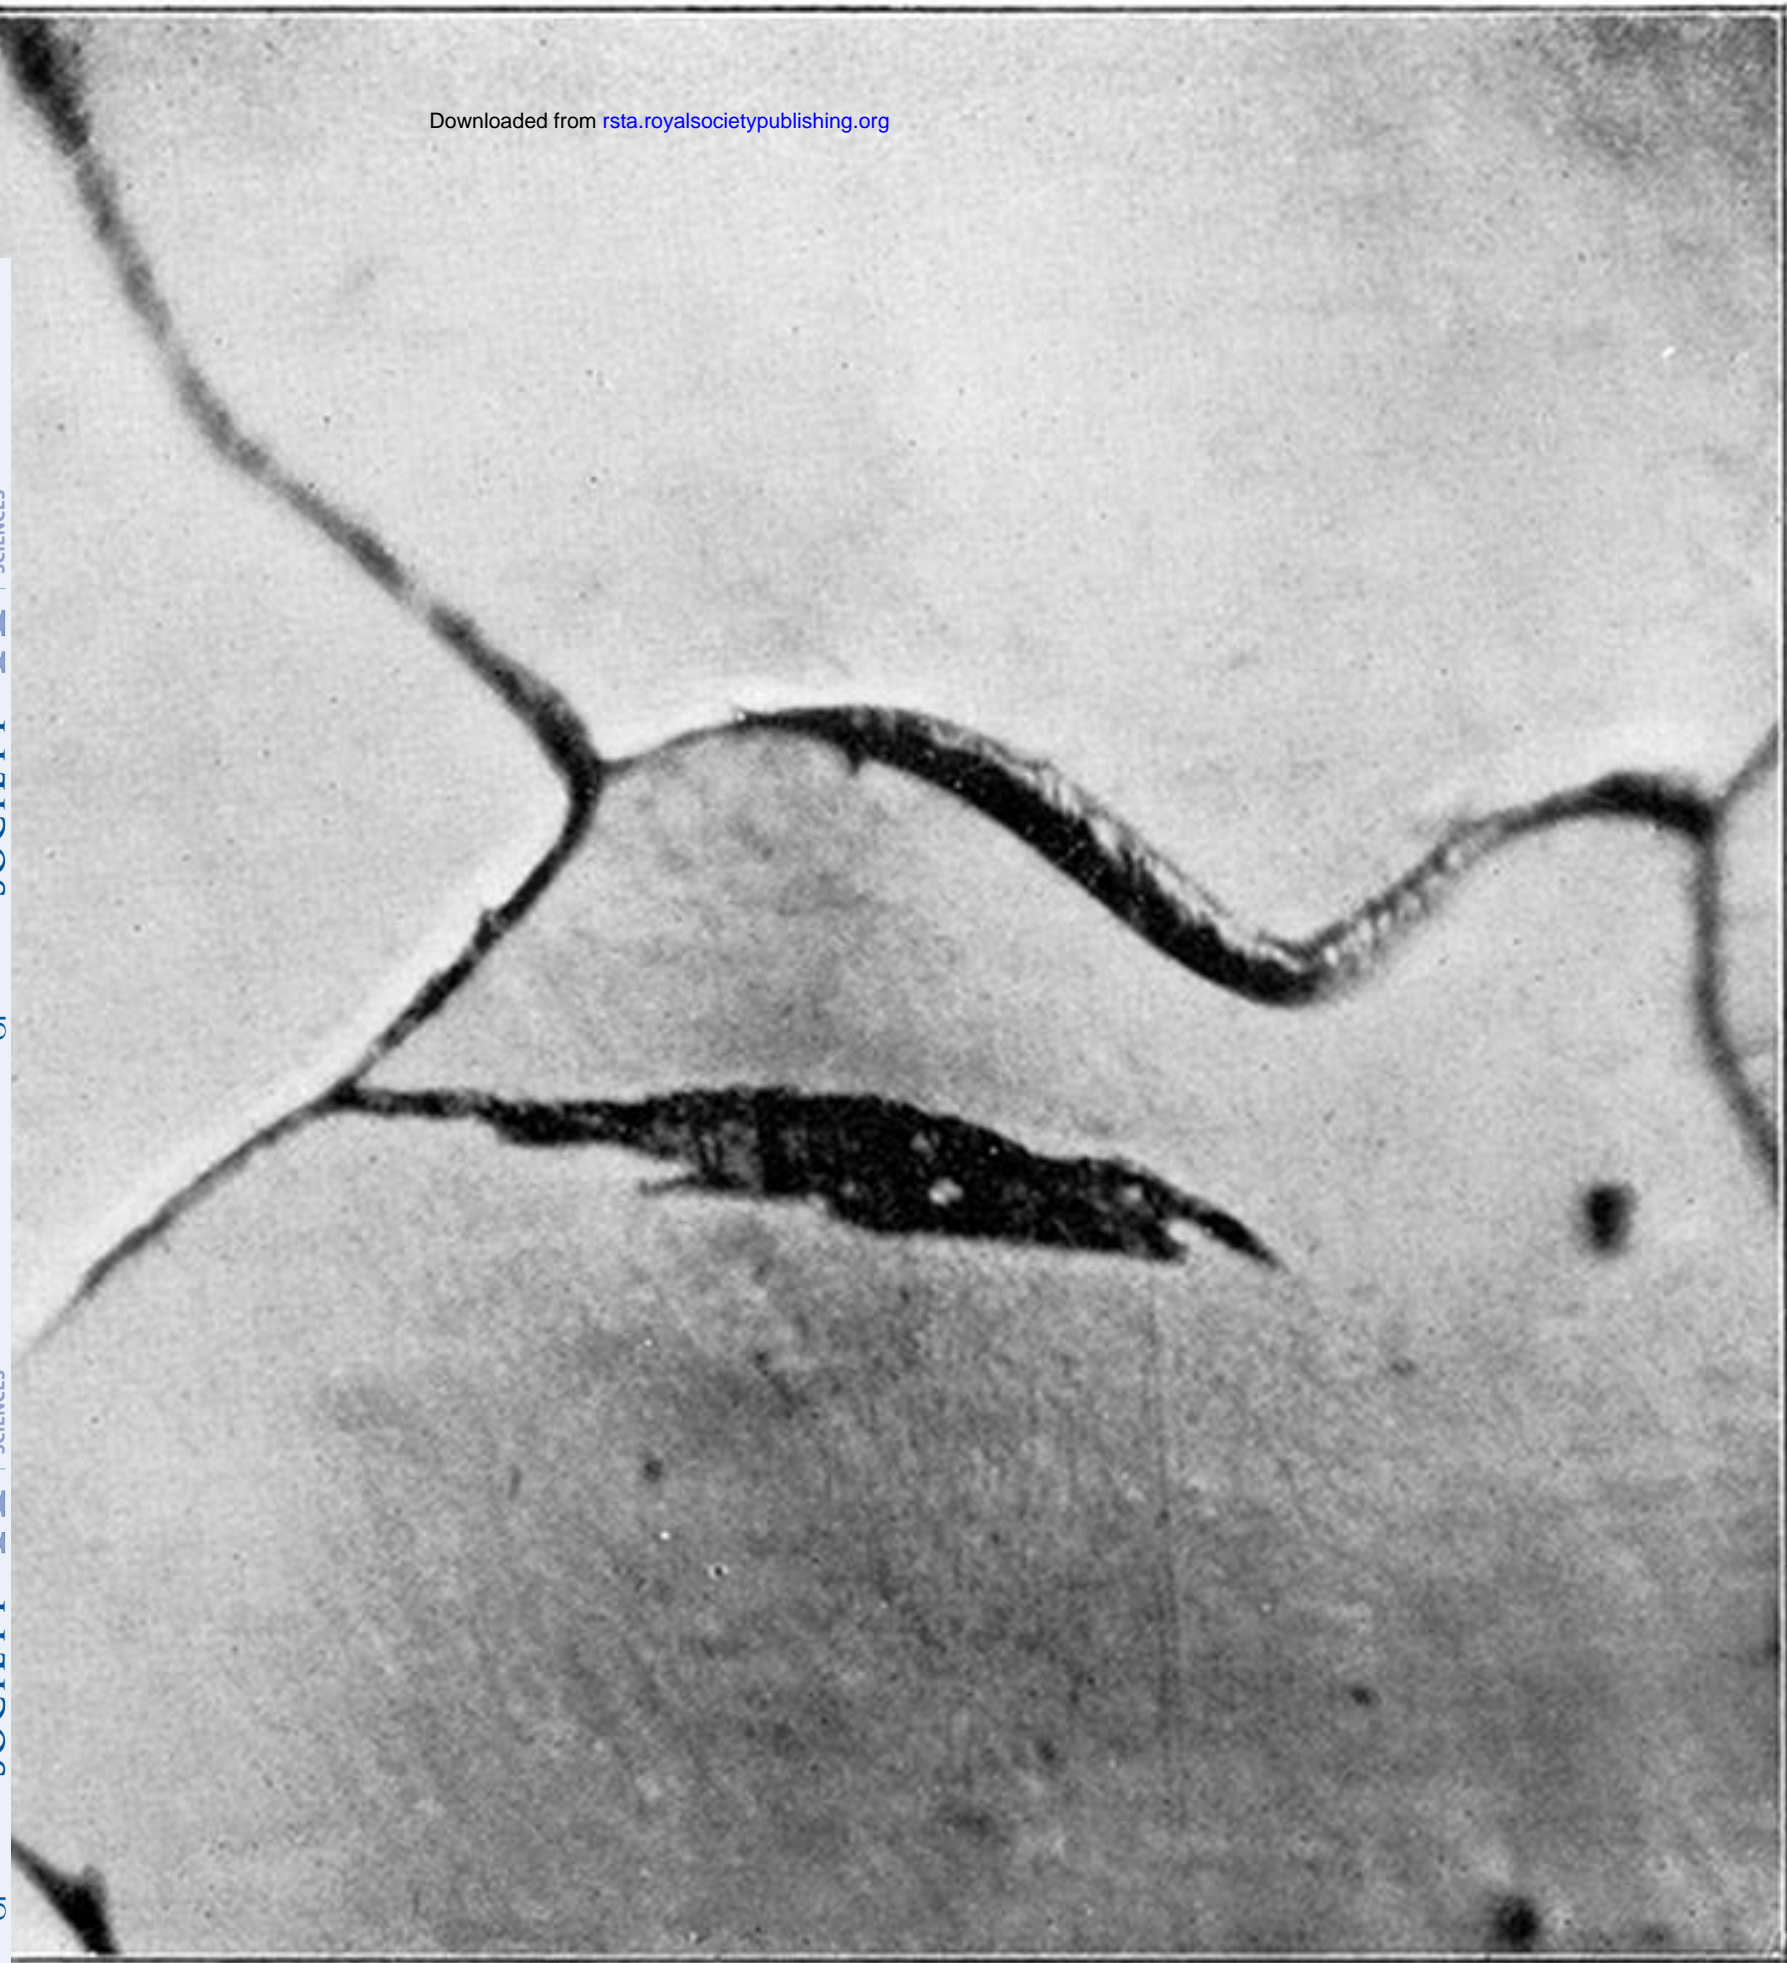
Fig. 15. Specimen after 3,000,000 reversals of a stress of 6.9 tons per sq. inch. $\times 1000$.

This was confirmed by another experiment in which the maximum stress, close to the clamp, was only 6·9 tons per sq. inch. After 3,000,000 reversals of this stress *one* slip-band was observed on a crystal a little way from the clamp. This is shown in fig. 15, where the slip-band is seen in the broadened condition which resulted from 3,000,000 reversals of stress. Prior to this, the same specimen had suffered 1,000,000 reversals of a stress of 5·3 tons per sq. inch, without showing the smallest sign of damage. It was only after increasing the stress to 6·9 tons per sq. inch that any action became apparent. It is an open question whether an isolated slip-band such as this would have led to fracture, if the process of reversal had been continued. At the conclusion of the experiment it was still confined to one crystal and it did not even extend all the way across that.

Fig. 15. Development of a slip-band by 3,000,000 reversals of a stress of 6·9 tons per sq. inch.
