The Fracture of Metals under Repeated Alternations of Stress

J. A. Ewing and J. C. W. Humfrey

Phil. Trans. R. Soc. Lond. A 1903 **200**, 241-250

VI. *The Fracture of Metals under Repeated Alternations of Stress.*

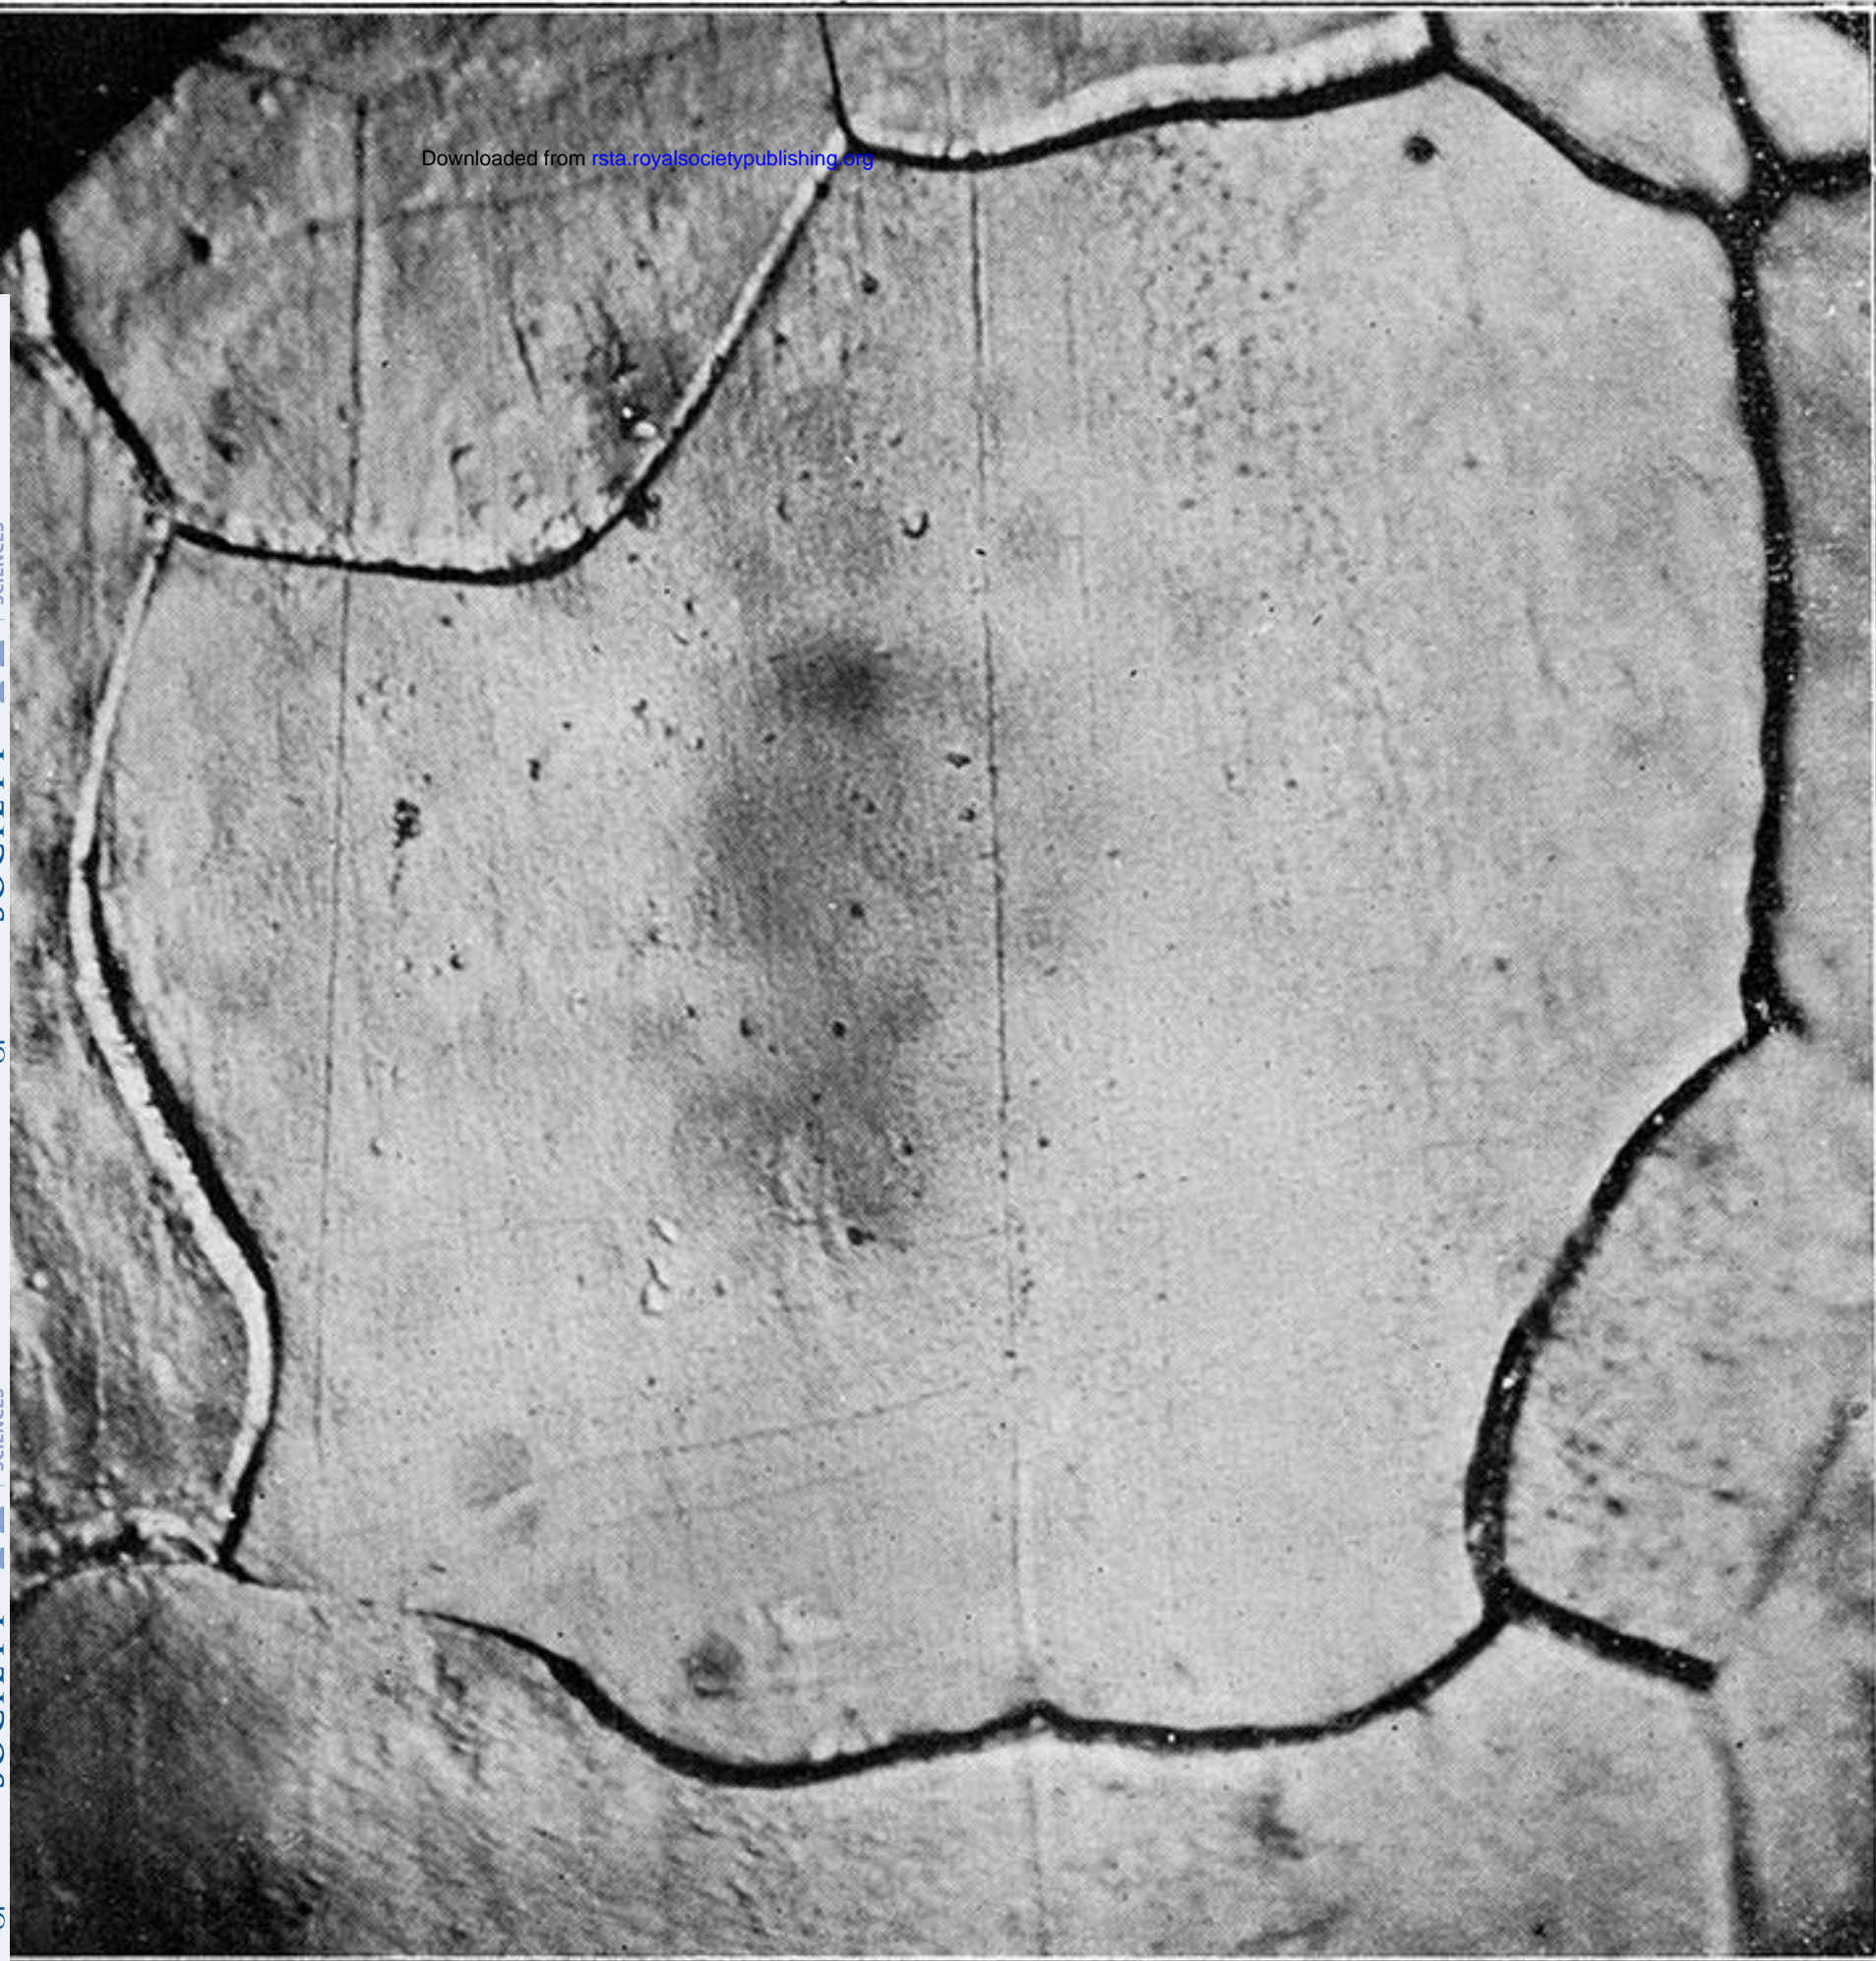
Fig. 9. Specimen after 1000 reversals of a stress of 12.4 tons per sq. inch. $\times 1000$.

The photographs described above are on rather too small a scale for the actual changes in the slip-lines themselves to be clearly seen, and these are better illustrated by the next series, figs. 9–12. These show with a magnification of 1000 diameters a small part of the surface of another specimen of the same iron which was subjected to reversals of 12·4 tons per sq. inch. Fig. 9 is taken after 1000 reversals. The slip-bands which have formed are very faintly visible as fine lines upon the surface of the crystal. Fig. 10 is after 2000 reversals; the slip-bands seen in fig. 9 are now more distinct, and some new ones on the right of the crystal are fairly strongly defined. Fig. 11 is after 10,000 reversals; some of the slip-bands now show a decided tendency to broaden out and those upon the right have extended further across the crystal. Fig. 12, taken after 40,000 reversals of stress, shows further broadening out and spreading of the

Fig. 9 after 1,000 reversals.

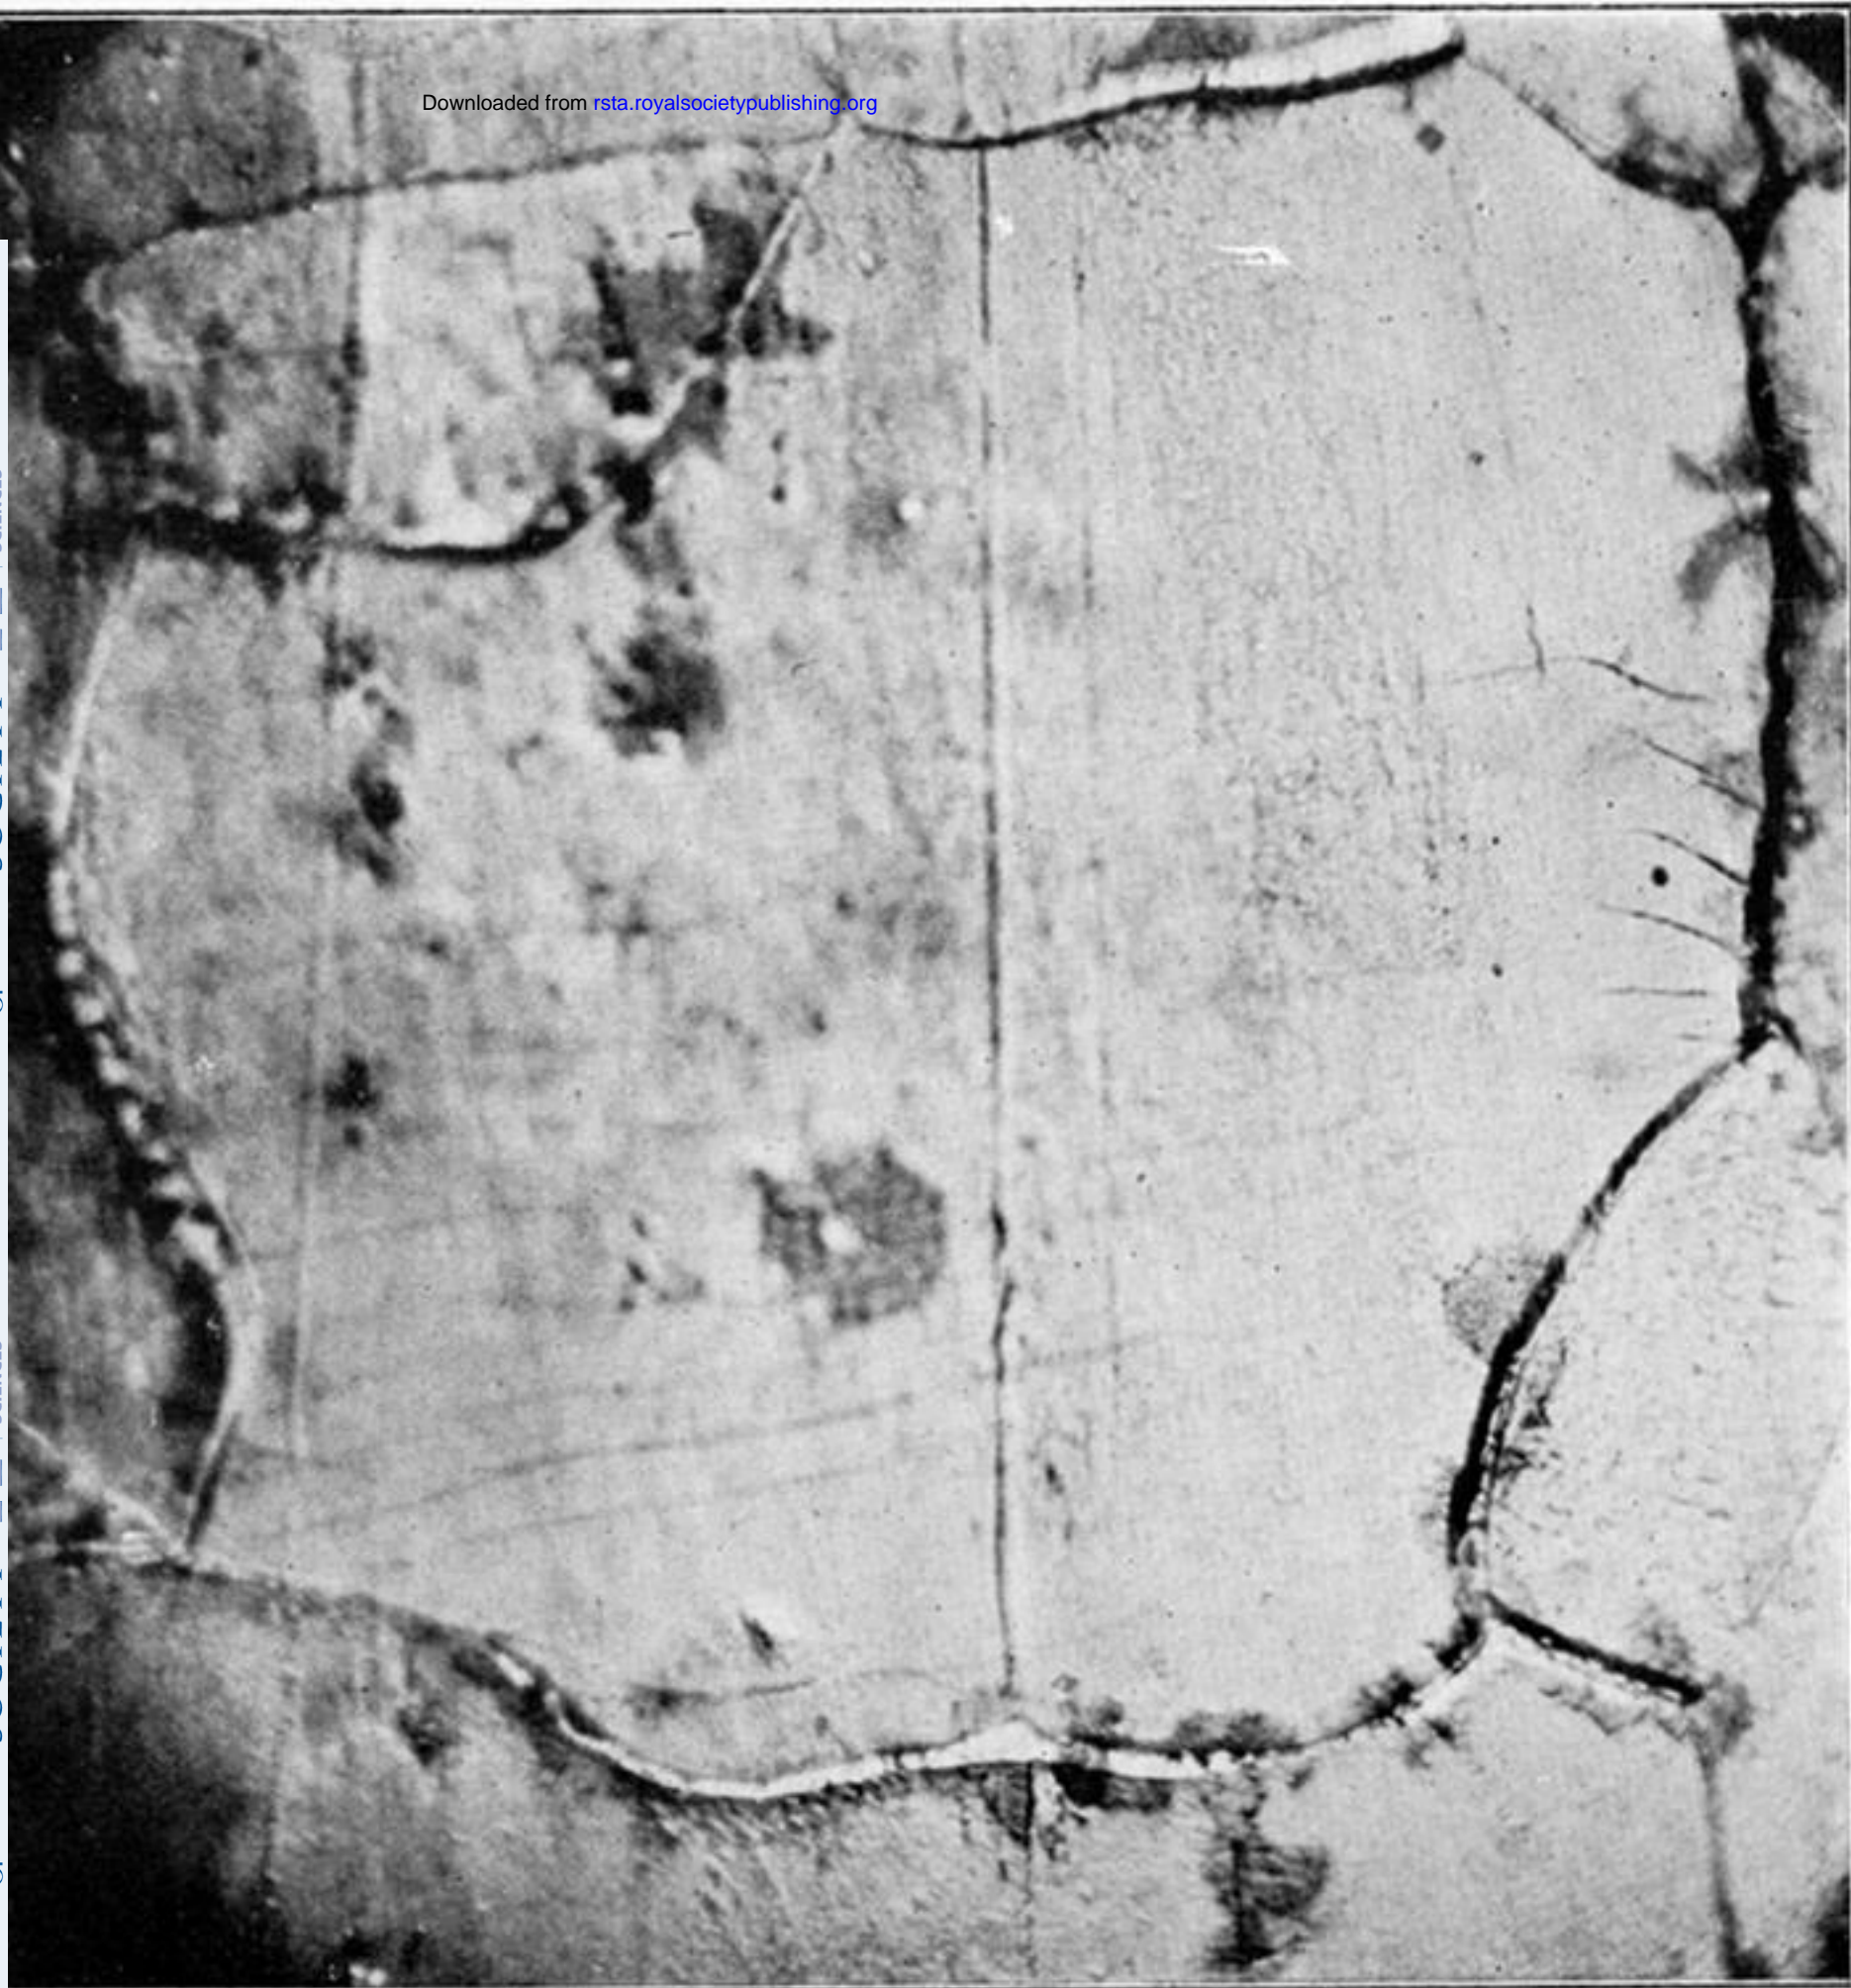
Fig. 10. Same after 2000 reversals. $\times 1000$.

Fig. 10 after 2,000 reversals.
