Power Station CVG B 7FA Generator EHS Incident Report

Line of Business: EPC ProEnergy Services

Power Station CVG B

Puerto Ordaz, Venezuela

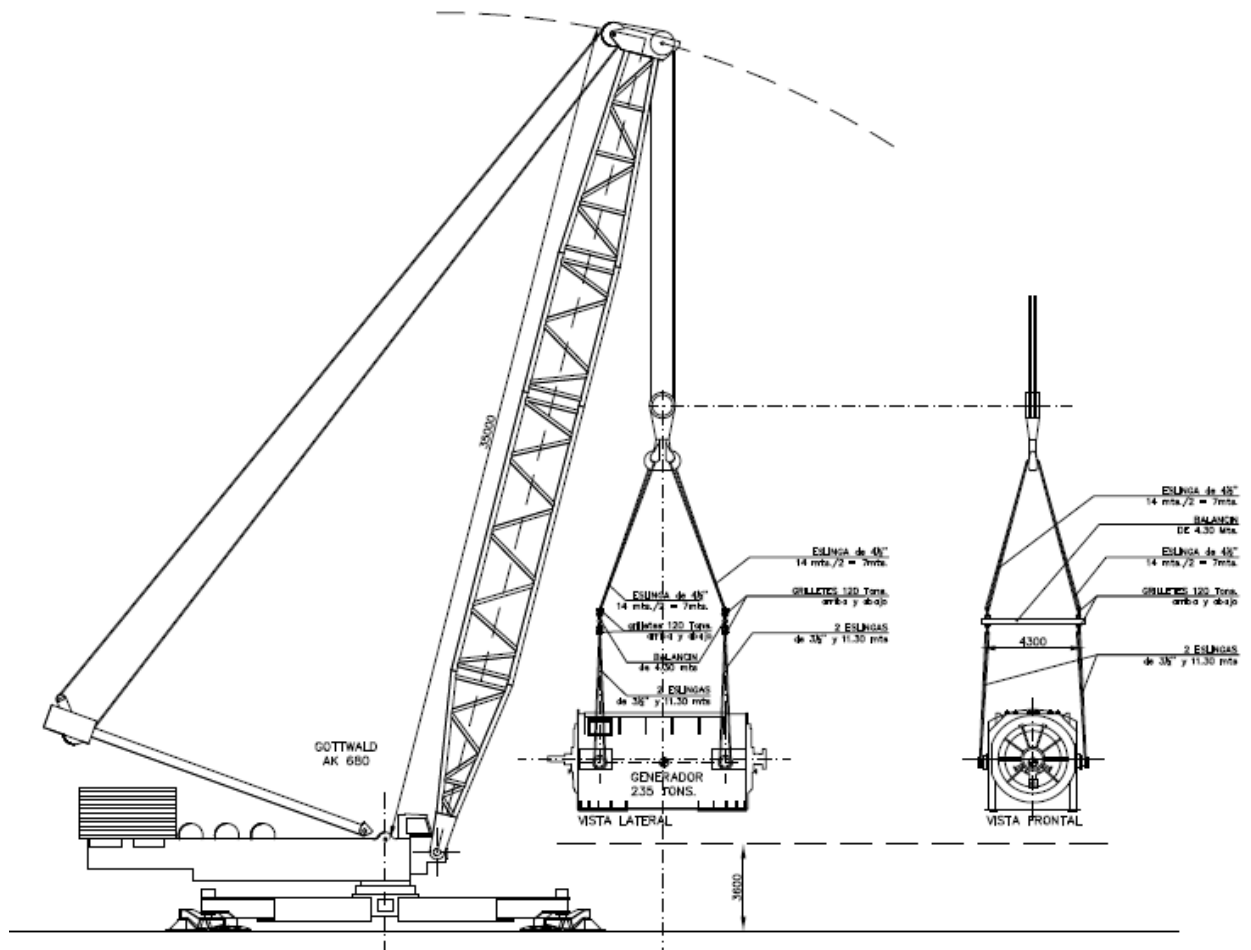
Generator Erection – Figure 1

ProEnergy is in the process of constructing a power station, named CVG B, within SIDOR's industrial area. PES is in the process of working on foundations and erecting mechanical equipment. The GE 7FA Turbine and associated Generator were already on their respective foundations when the incident occurred. Both of these units were erected and located on their foundation using an 850 ton crane (Gottwald AK 680). The crane is owned by a company called Tecnosur (Heavy Cranes) subcontracted by SIDOR. The same crane that was later involved in the incident.

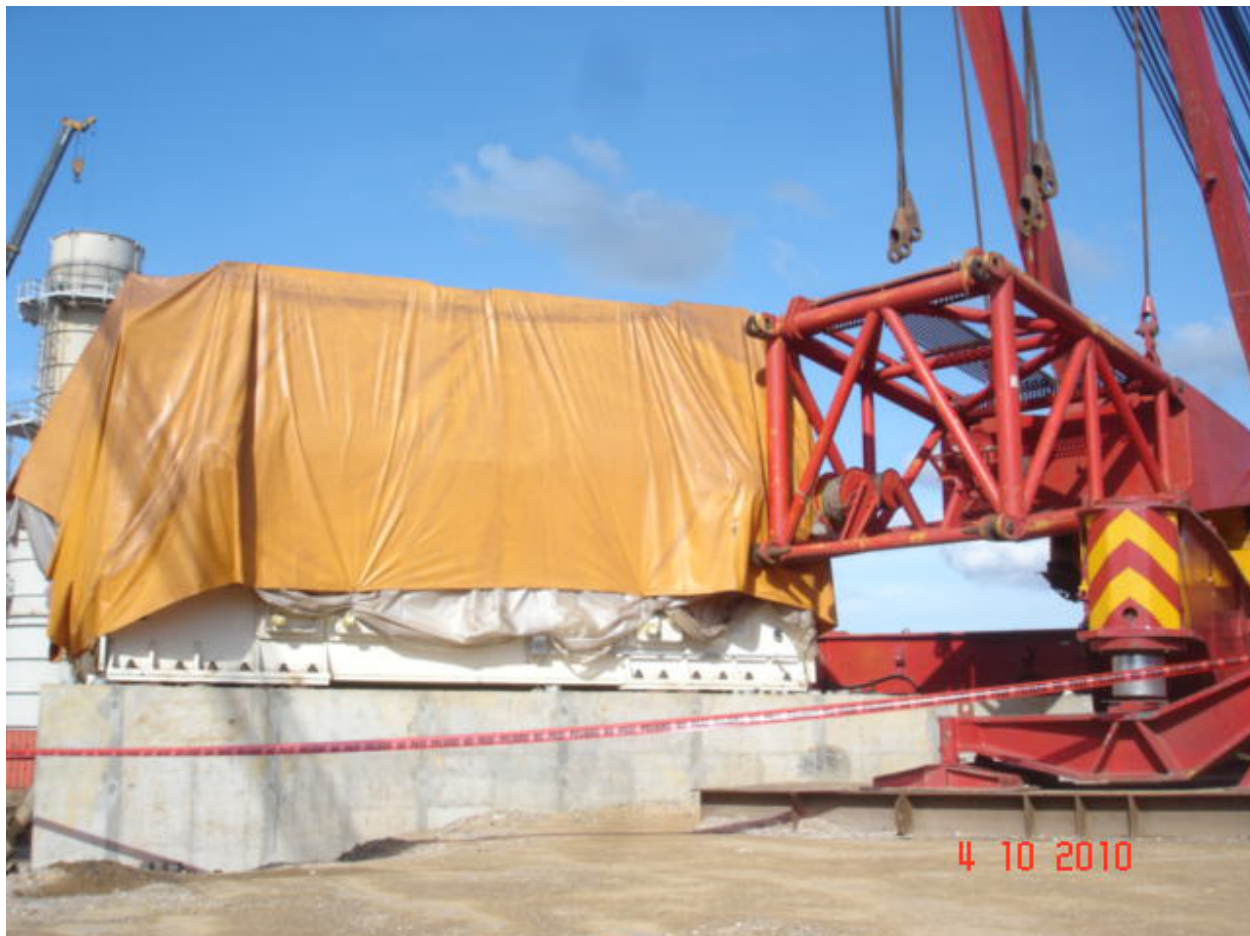
Picture 2 – Crane and Generator after the Incident

On Monday, October 4th, 2010 at approximately 10:05 AM, the crane operator, supposedly, miss operated the crane and, during such a miss operation, the crane hit the generator of the GE 7FA Turbine, see sketch in Appendix A. The impact moved the generator to the East putting all the anchor bolts in a bind (see Appendix B & C for anchor bolt bending position). At the point of contact the outer case of the Generator was bent and separated at 2 different locations, see pictures included in Appendix D & F for more details.

The generator involved in the incident is owned by CVG, and the crane company as well as the crane involved in the incident was subcontracted by SIDOR. This incident occurred during the disassembly of the crane, needed to allow the removal of it from SIDOR facilities. There were no construction activities in the area of the crane at the time of the incident and only SIDOR staff and its subcontractor equipment and staff was involved in the operation.

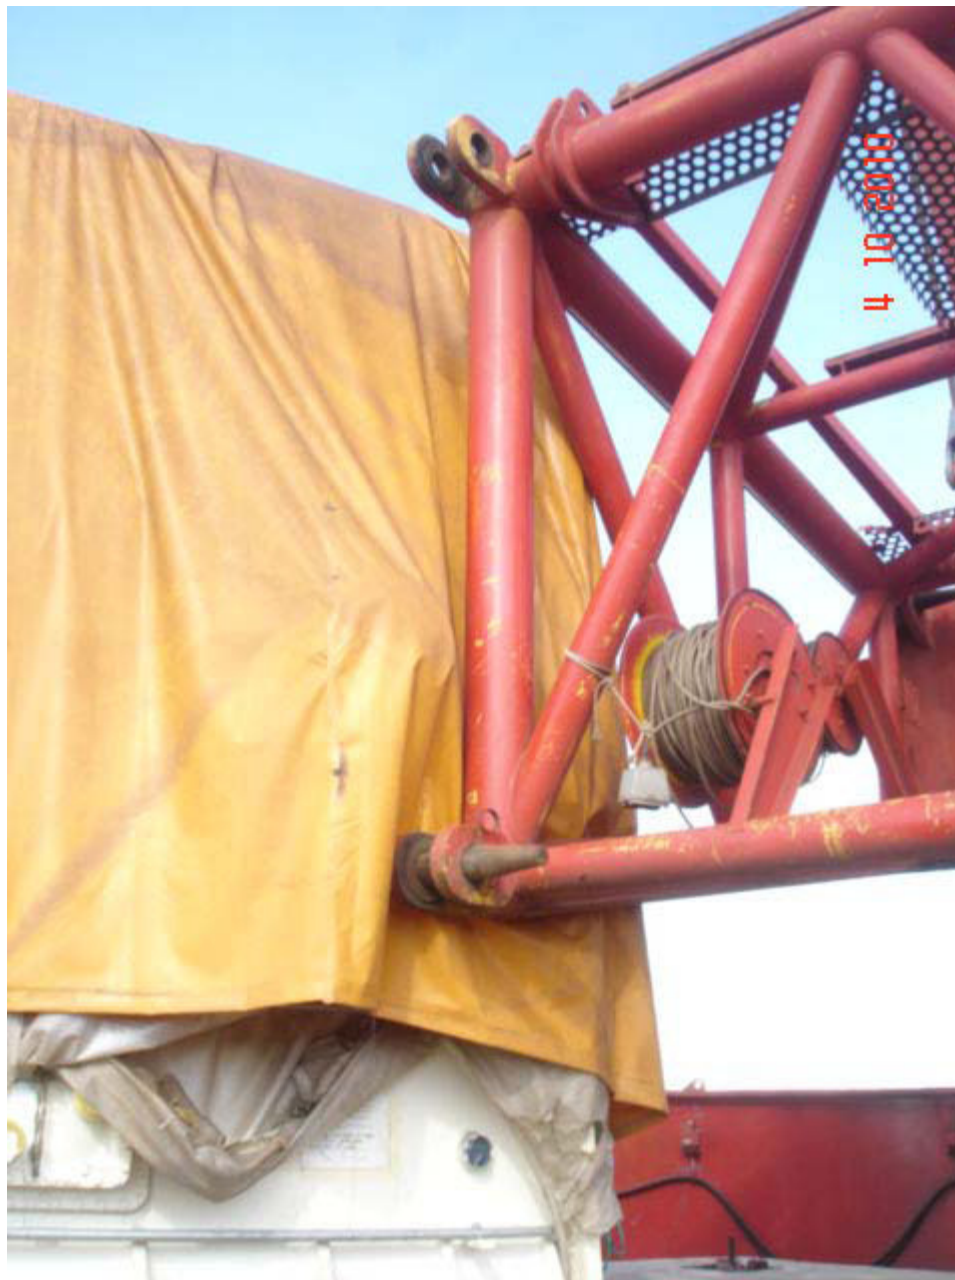
Picture 3 – Points of Contact

- k. **Thursday Oct 7th, 2010 – 2:30 PM.** SIDOR & Tecnosur (Heavy Cranes) proceed to move the crane boom away from the generator, see pictures in Appendix F. PES' contractor personnel proceed to remove the tarp from the generator to allow for a visual inspection of the hit area. GE TA as well as PES technical personal proceeded to inspect the generator damage as well as other areas such as generator anchor bolts, see pictures included in Appendix F for more information.

Waiting for formal GE response from their initial assessment of the incident to inform Derwick, SIDOR and CVG of correcting actions required to repair the generator damage. Also, we have PES engineering reviewing the amount of anchor bolt deflection to see what corrective actions are needed.
