## PROPERTY INSPECTION REPORT

**Report #:** MEC20090114-01

**Concerning:** 11727 WICKHOLLOW, HOUSTON, TX 77043  
(Address of Inspected Property)

**By:** Michael E Cummins, #Texas 4583 01/14/2009  
(Name and License Number of Inspector) (Date)

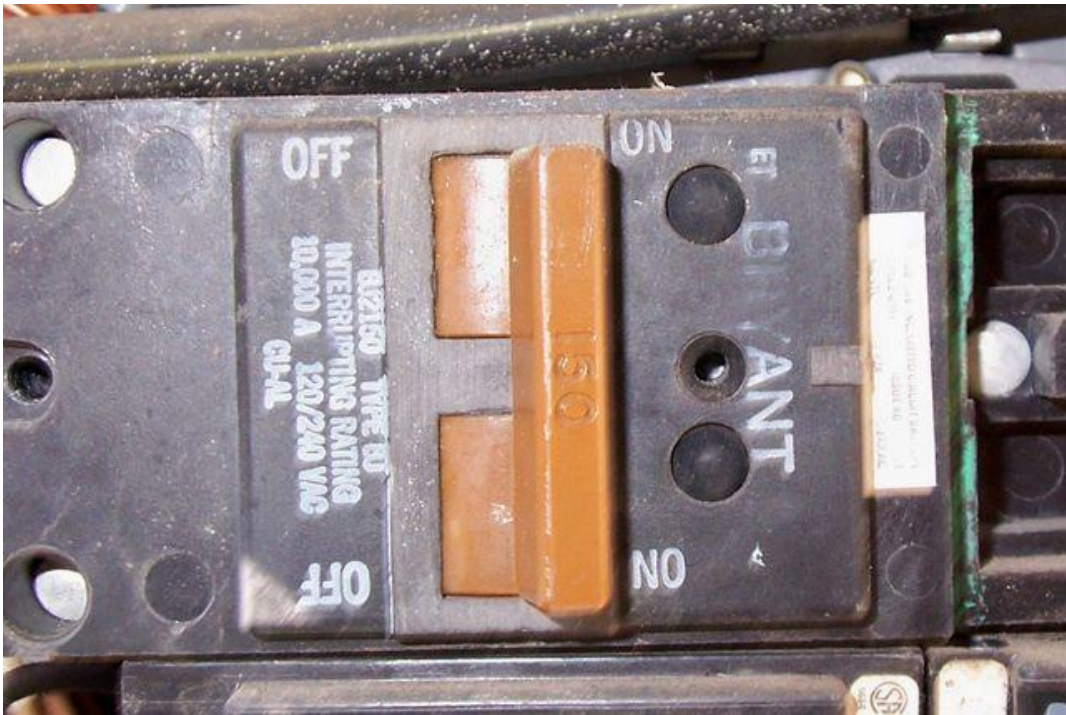
There is a 150 amp main breaker in a Bryant electrical service panel box. The house is wired with copper wire. The house has no "Knob and Tube" wiring or screw-in type fuses.

The service is underground. The electrical meter and the conduit appear to be secure together.

The breakers are not labeled.

There is not any anti-oxidant on the connections. This substance will prevent any corrosion on the connections. There was not any visible corrosion.

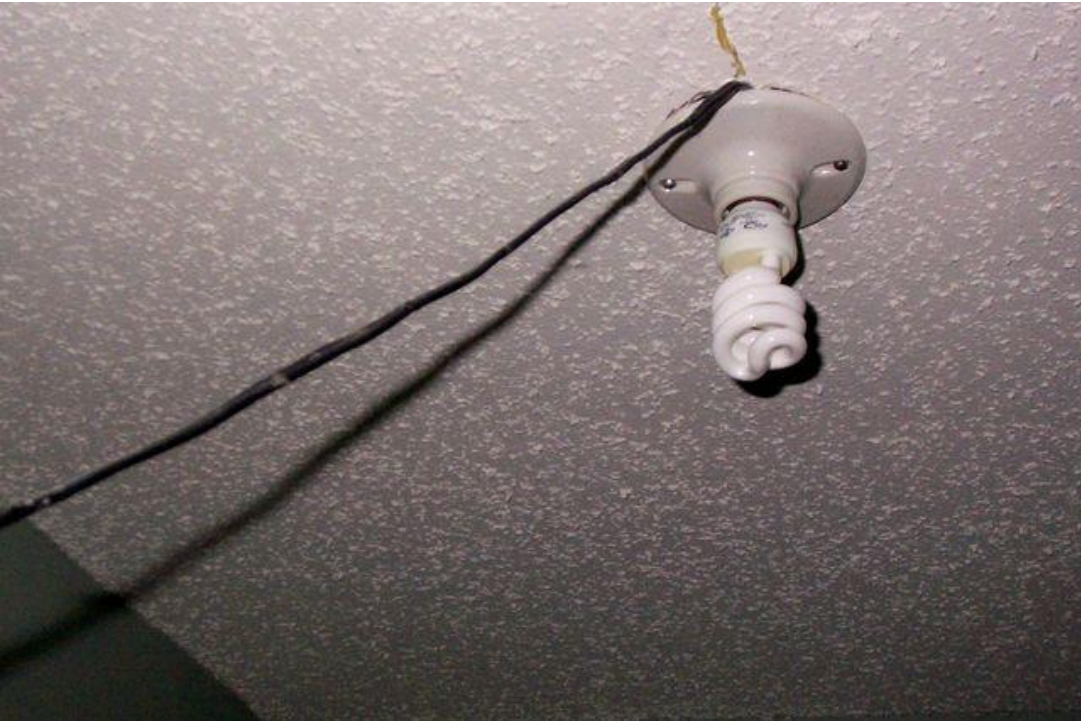
The wiring in the upstairs front west bedroom should be removed.

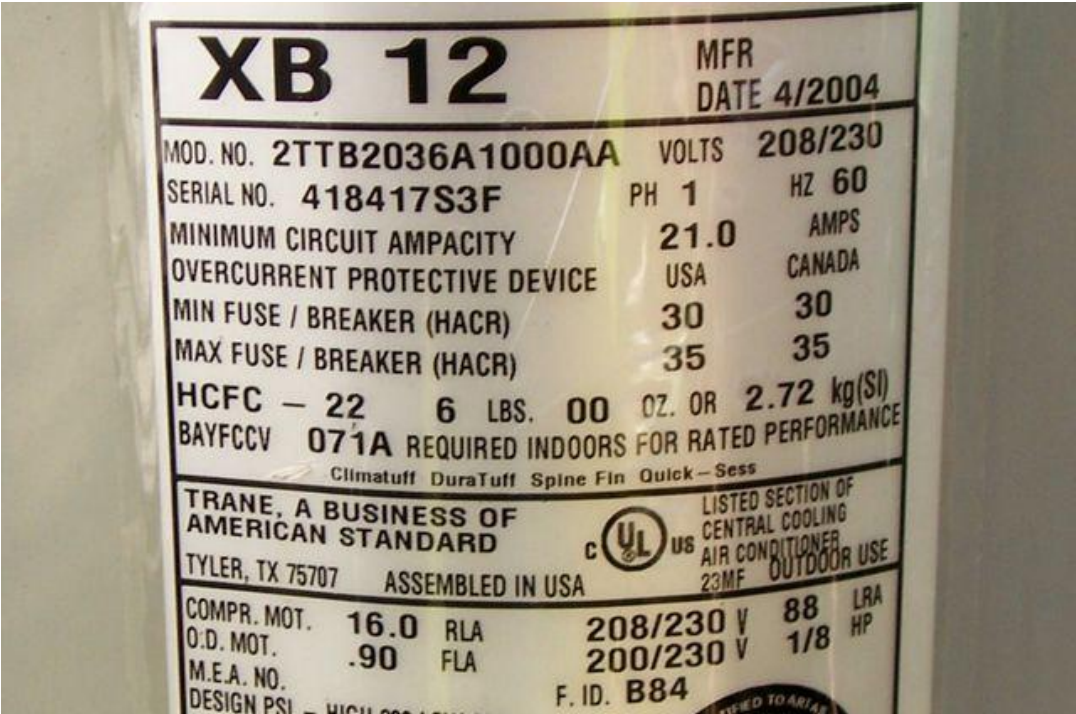
There are two Trane A/C compressors: a 3 ton, manufactured in 2004; a 5 ton, manufactured in 2000.

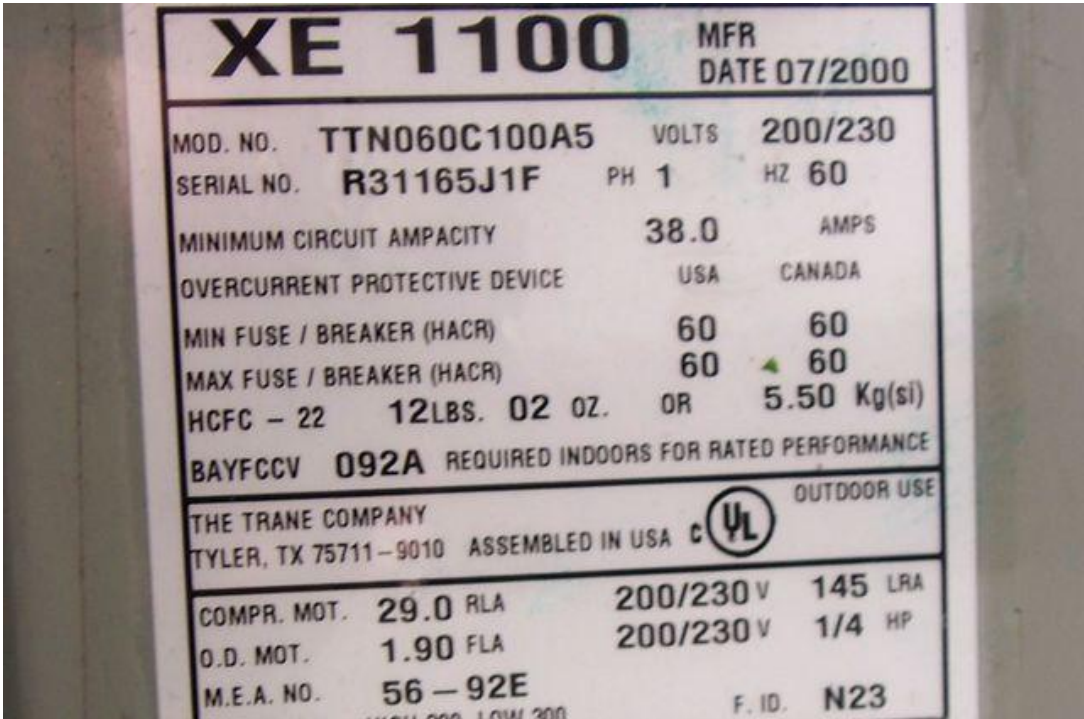
The specification plate calls for certain size breakers. The breakers are not labeled in the panel box; the size of the A/C breakers cannot be determined. An oversized breaker can allow too much heat in the compressor before it will trip the larger breaker. This can damage the compressor or void any warranties.

We recommend further investigation and evaluation by a qualified/licensed HVAC company on the A/C system.

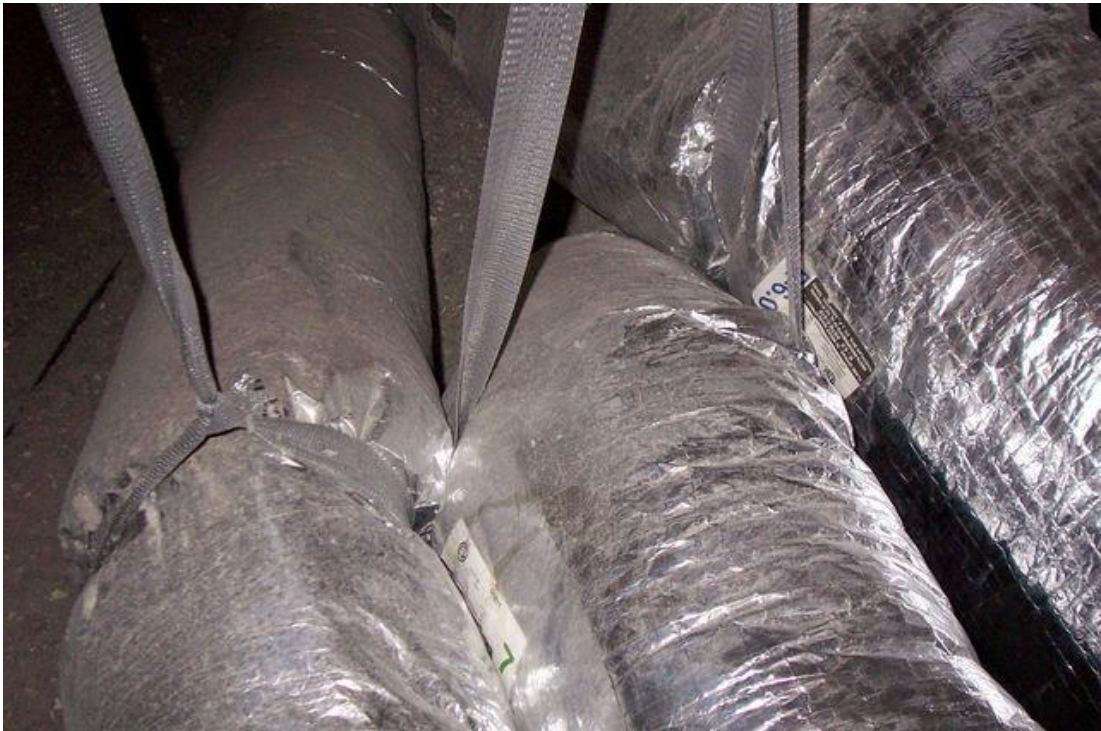
The returns have electric wiring and sewer vent pipe inside. If there is a short in the electrical wires, the A/C blower can fan any flames or spread smoke throughout the house, and if the vent pipe should break, sewer odor can be spread.

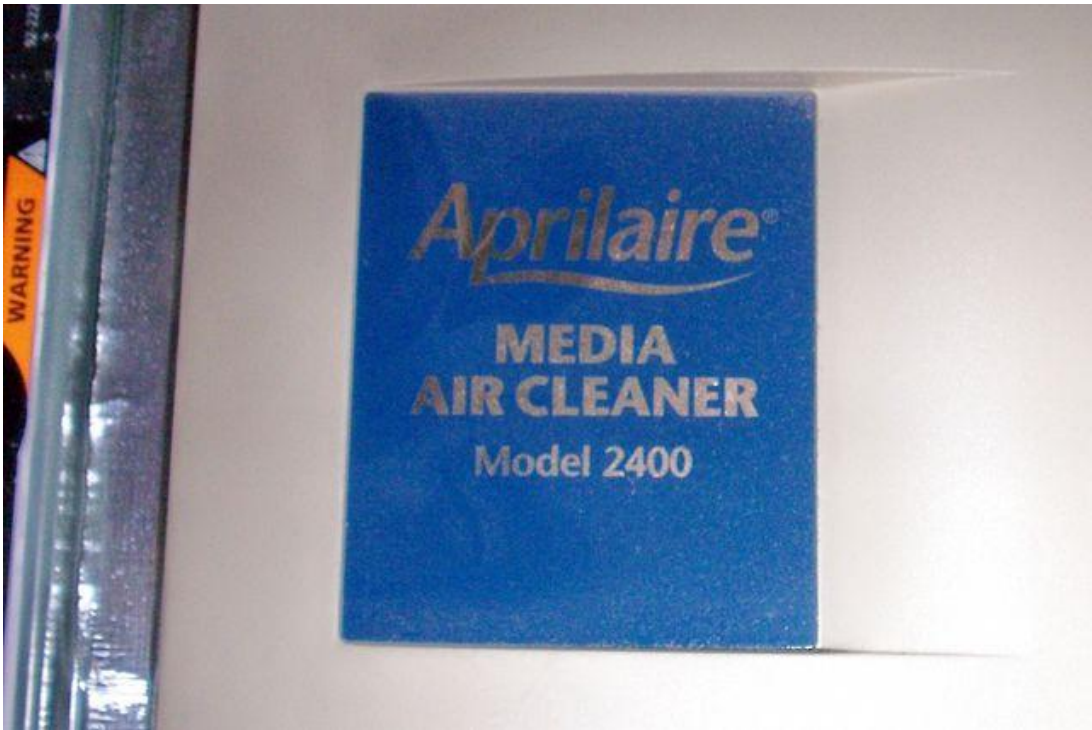
Media filters appear to have been installed at the evaporator coils. The filters in the returns should be removed. Too much filtering can damage the blower motor. We recommend further investigation and evaluation by a qualified/licensed HVAC

company.

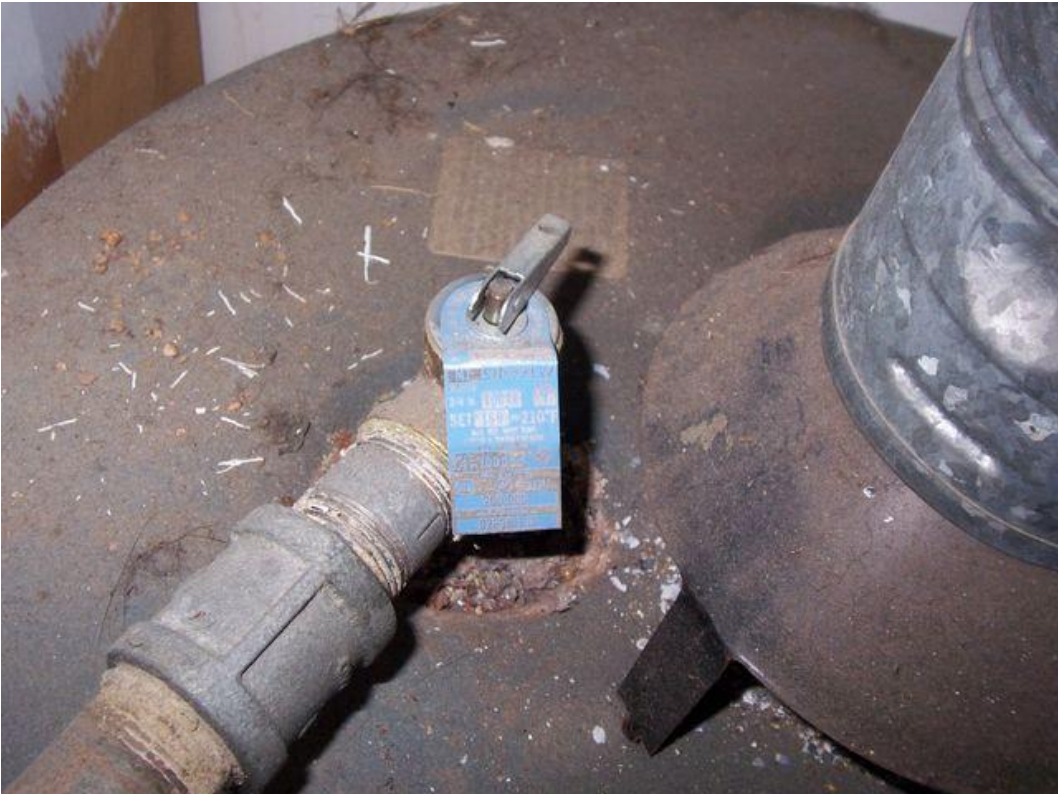
The specification plate on the water heater is not visible, the age and size cannot be determined.

The T&P valve (Temperature and Pressure Relief Valve), the safety valve, should be replaced every three years as regular maintenance.

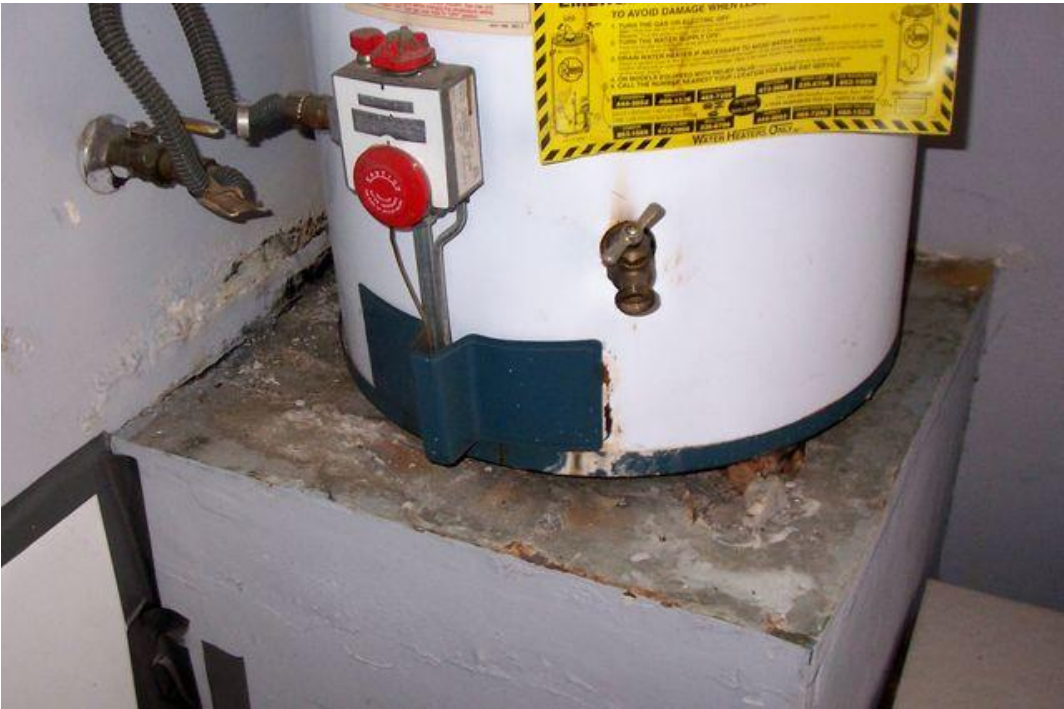
The raised platform is beginning to deteriorate.

Although the age cannot be determined, this water heater is probably nearing the end of its effective life and should be replaced.

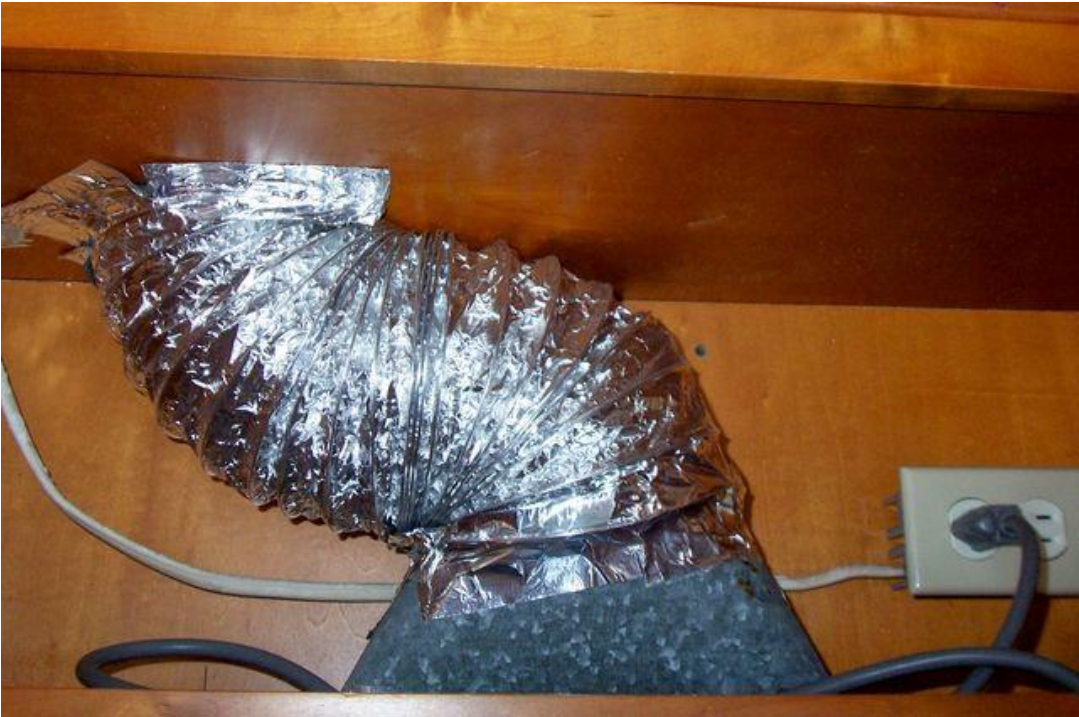
Comments:  
The electrical Romex wire is not in a metal clad conduit.

The duct in the cabinet is aluminum. This duct should be stainless steel, copper or in this case galvanized metal. The solid metal can withstand heat better.

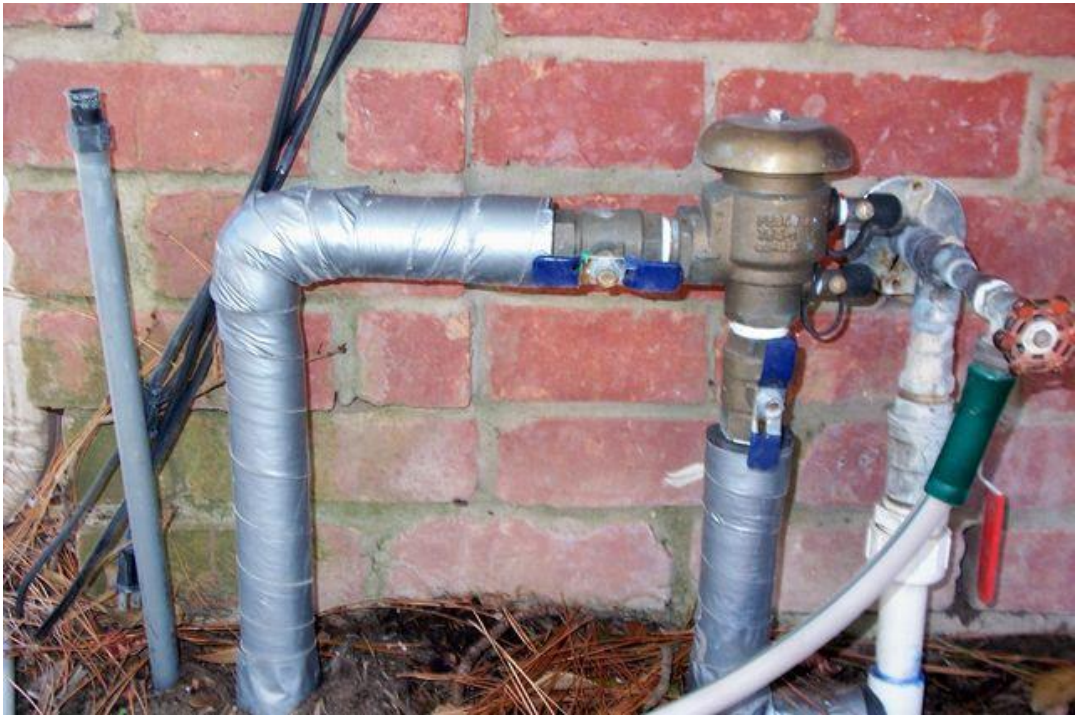
VI. OPTIONAL SYSTEMS  
A. Lawn Sprinklers  
Comments:  
The sprinkler system has a vacuum breaker. This is an anti-siphon device for the system. It will prevent any outside ground water from entering the water lines if there is a water main break in the area and water flows in reverse.
