Field Service Report For

LM 2500 Repair

**Facility: WG-Pratt & Whitney
Unit: 481-642**

REPAIR SUMMARY LM2500 481-642

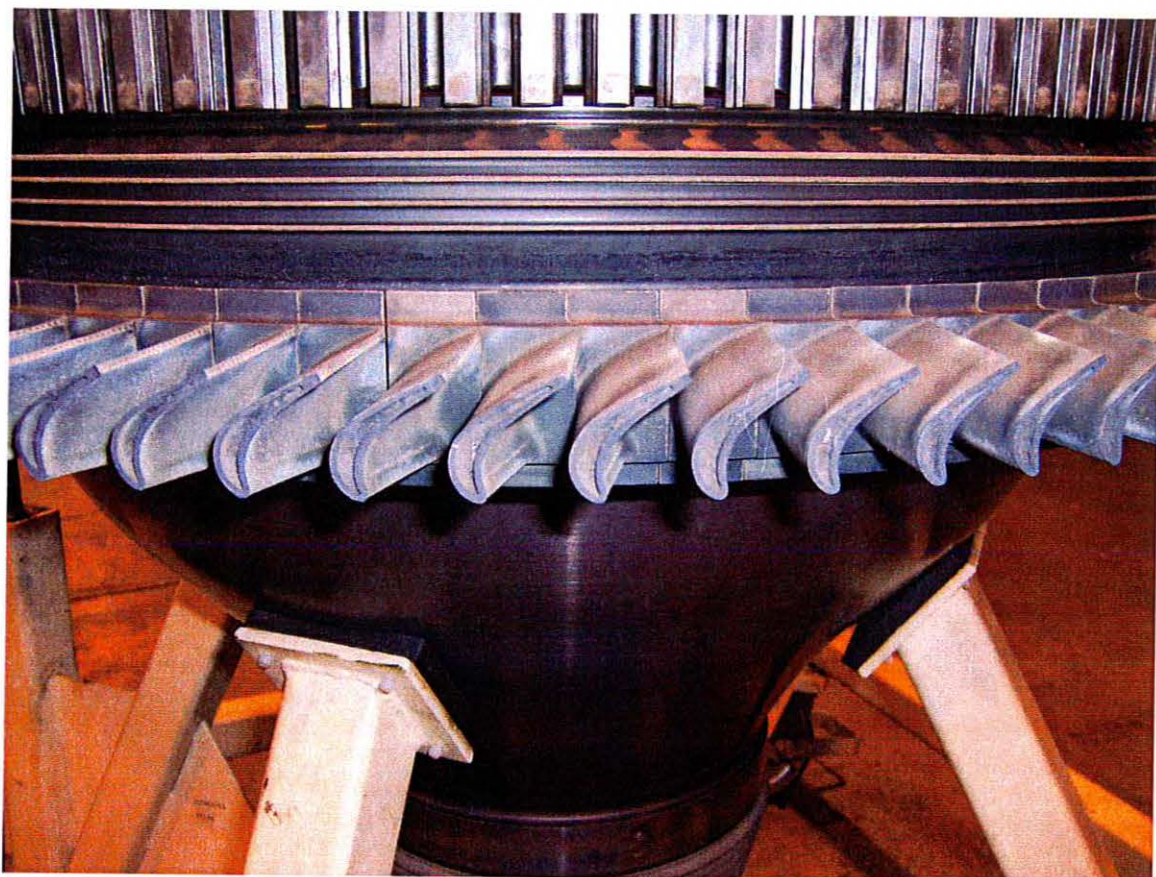
HPT ROTOR STAGE 1 BLADES

481-642: HPT blades and stage 2 nozzle has been sent of to Chromalloy. They will recoat the blades and inspect the stage 1 blade shrouds which according to GEK 93710 chapter 5 gives you the limit and as inspected are in serviceable condition. To make the shroud look better there is a possibility of recoating which will be determined upon price and time. HPC is being hand cleaned since the top case removal. Minor dents will be blended if necessary. The stage 1 HPC blade dampers show wear and missing material. This is not uncommon on units that operate at low and fluctuating loads. The condition was not mentioned in the second party inspection. Will determine the outcome after reviewing the BSI report. JTS has blades if necessary. FYI they will give us a quote for overhauled and one set that is serviceable. If the blades were not mentioned in the inspection report I would not replace them. Attached are some of the pictures from the JTS shop with recommendations. As we all know these are their recommendations and to benefit their profit. This unit will only need minor work since the inspection after tear down.

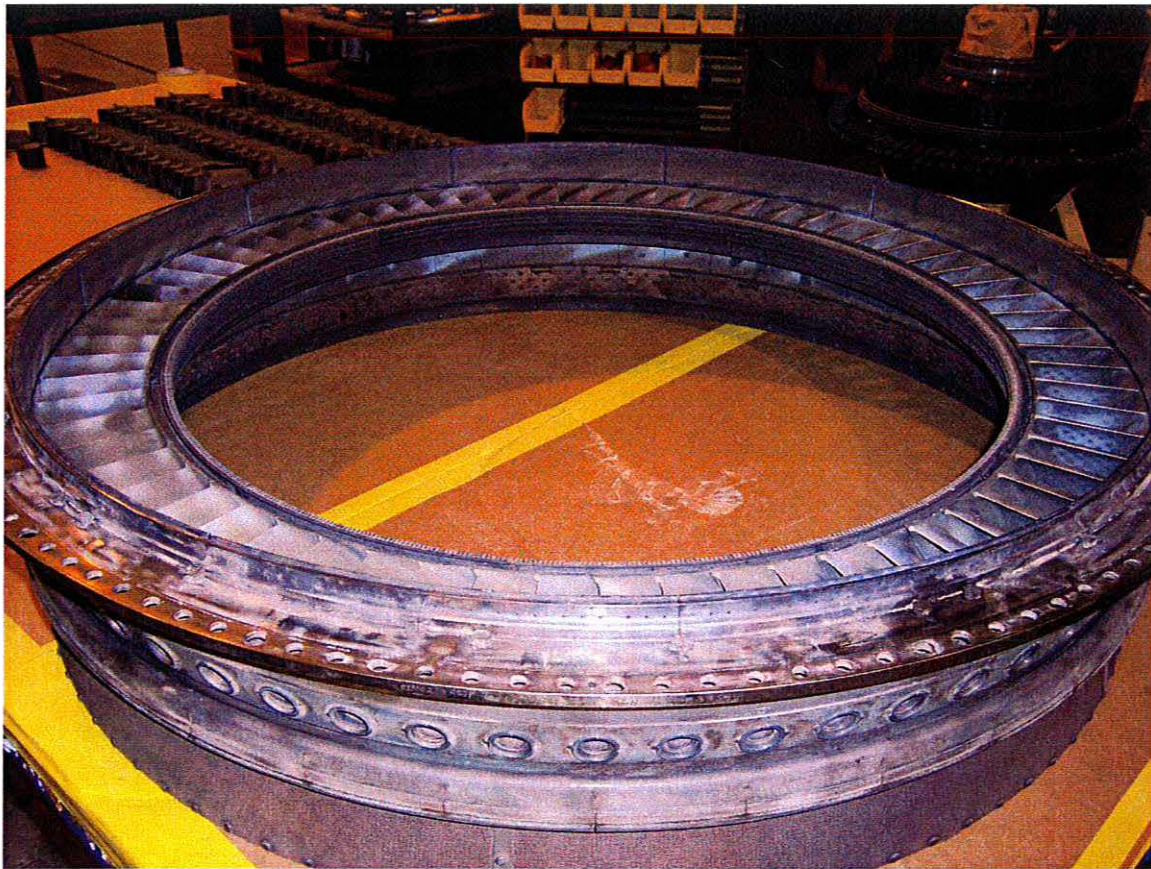
STAGE 2 NOZZLE ASSEMBLY PRIOR TO CLEAN UP AND REPAIR

2. The stage 2 nozzle assembly is being disassembled today since it arrived from Chromalloy. It was shipped back due to no facility in the US. The damaged shrouds will be removed and replaced. This will take a few days. When finished the nozzle will need to ship out for grind. I forwarded Cost for this earlier but will attach it again. We have a few options on what shrouds to use and we should try and keep the cost down by using their Pratt parts. When the nozzle returns it will be reassembled and installed.

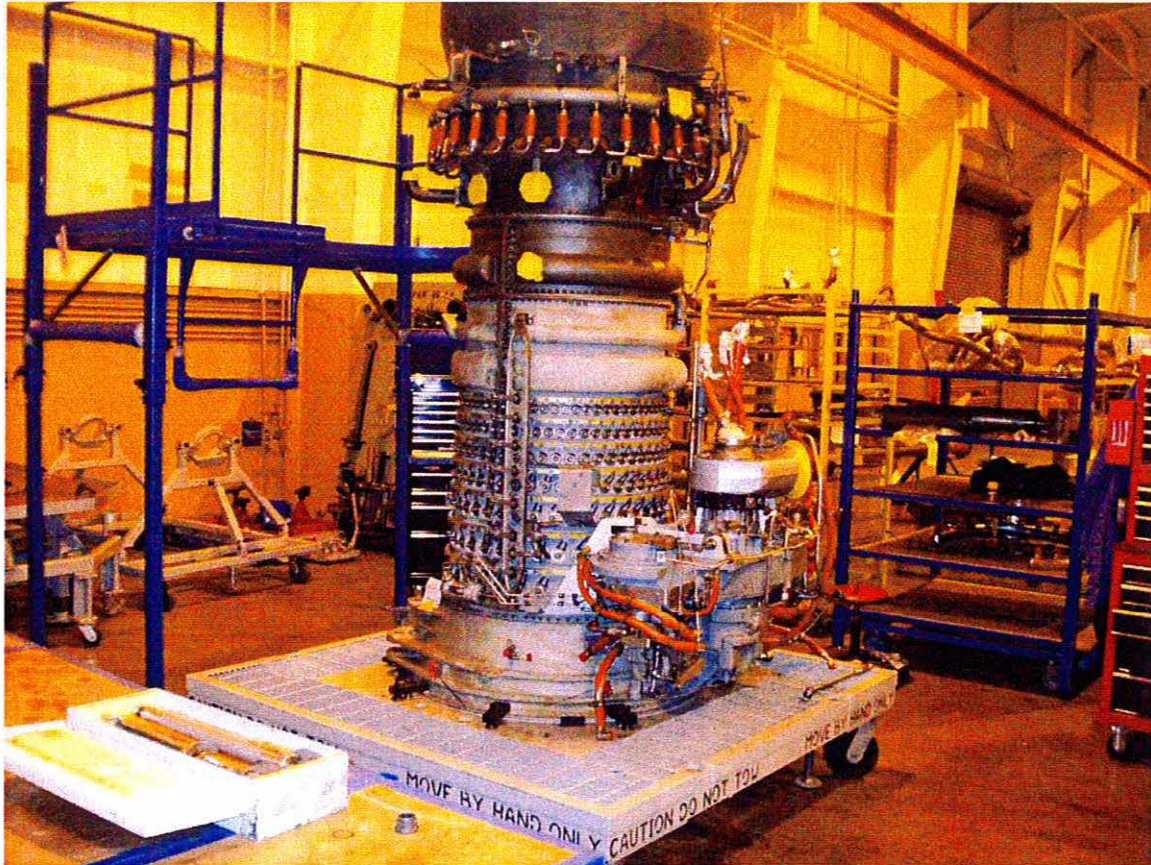
**UNIT VERTICAL READY FOR GEARBOX REMOVAL
AND STATOR CASES**

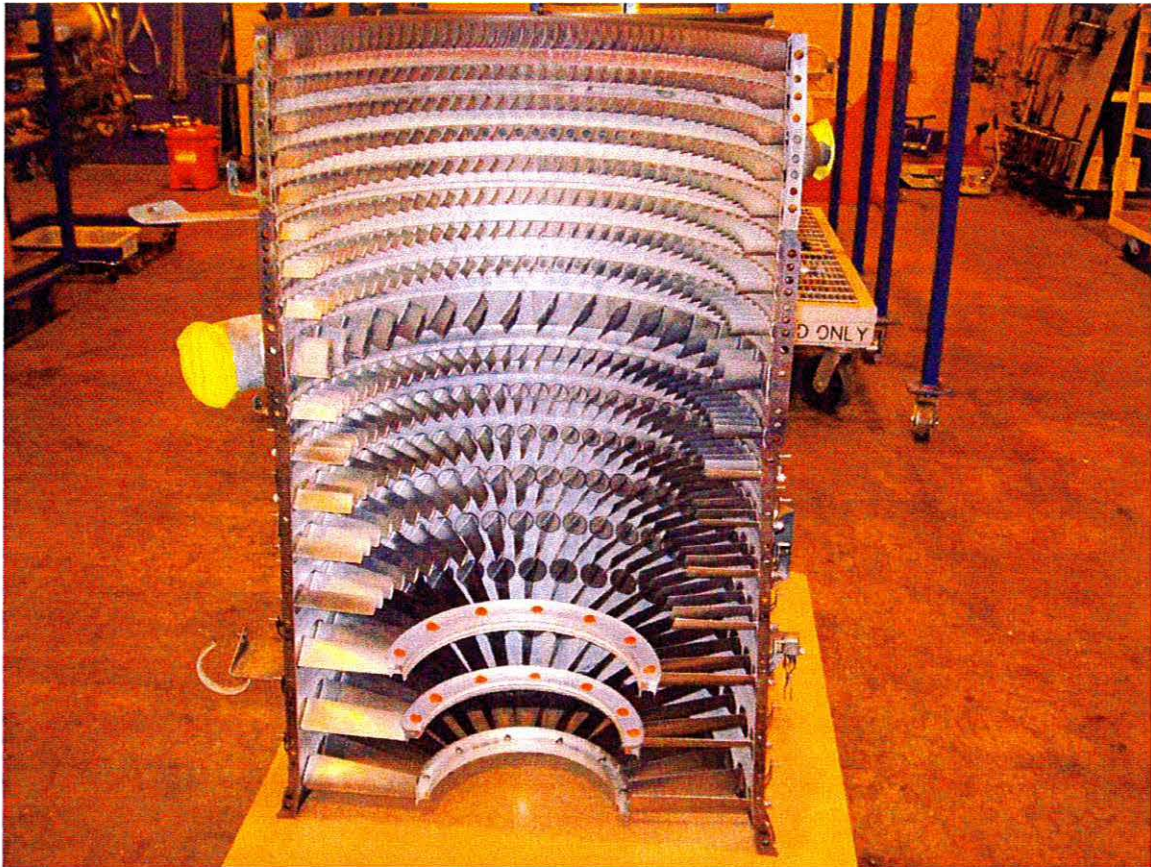
UPPER COMPRESSOR CASE AFTER REMOVAL

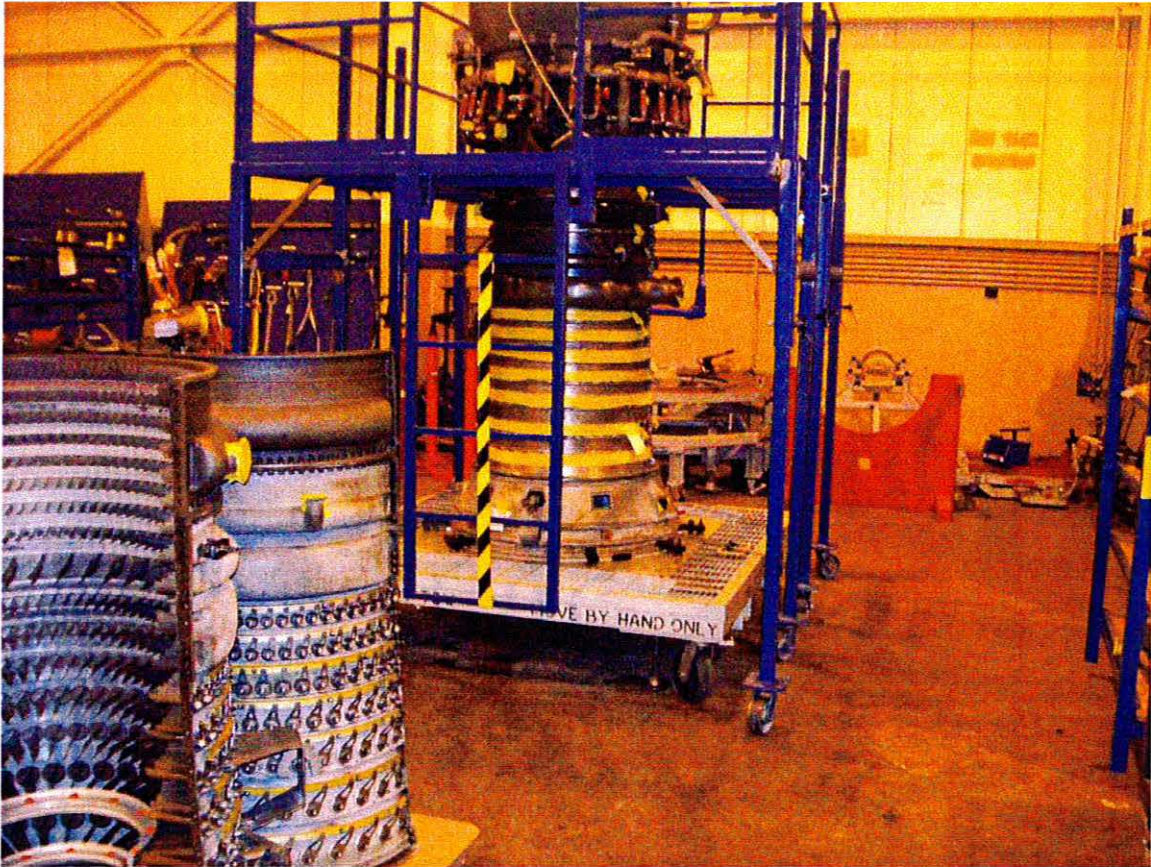
ENGINE VERTICAL WITH STABILIZER CASES FOR PROTECTION

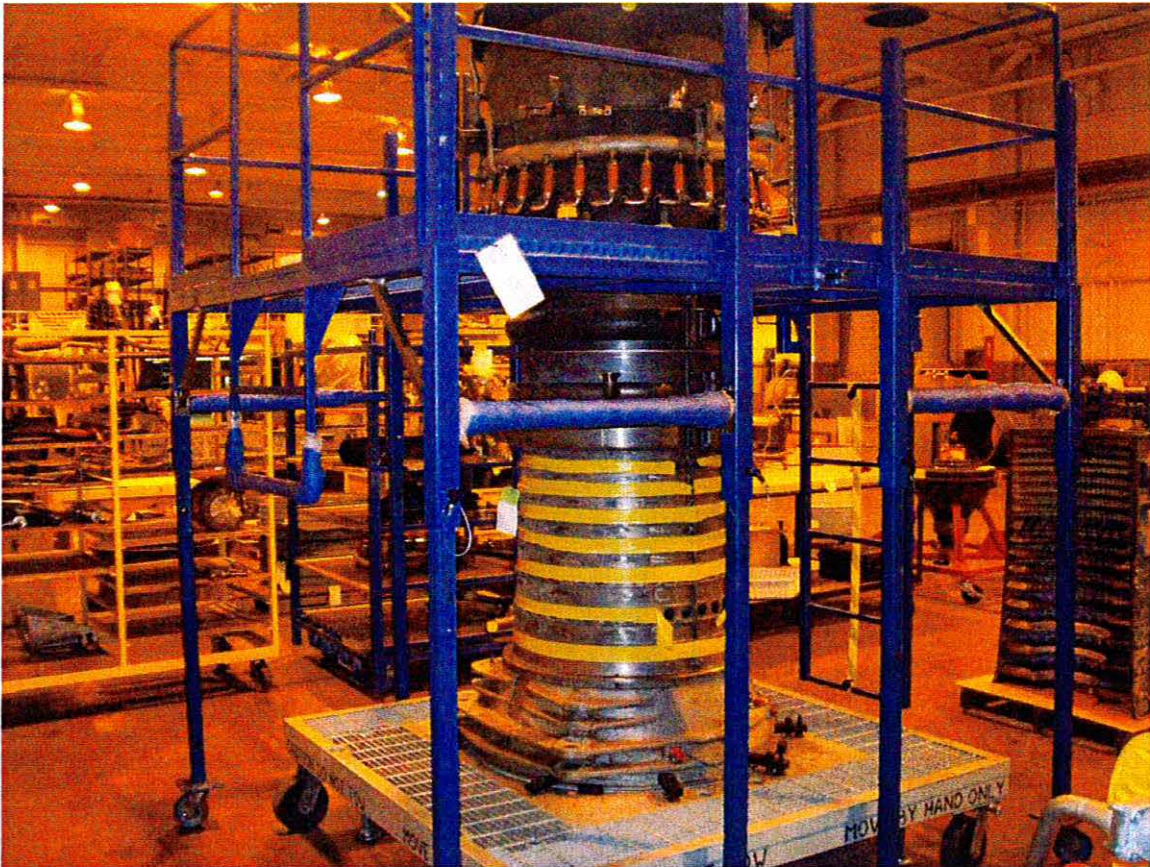
ENGINE VERTICAL

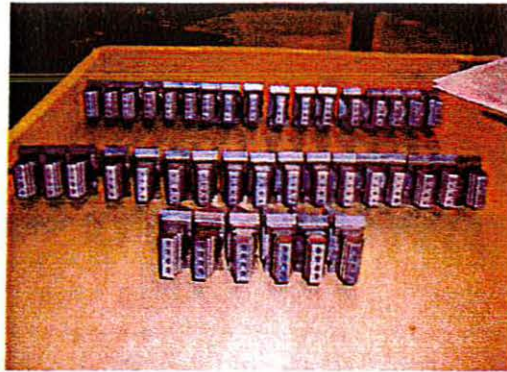
Stage 1 Blades

Picture in Folder			
Corrective Action: Replaced stg 1 blades with 48 ea. From WGPW stock and 40 ea. CFM			
		Completed By: RM	Date:
