Re: Geotechnical Data Report
Manhattan West SW Tower
New York, New York
MRCE File No. 9560E

At your request, we have conducted a subsurface investigation for the proposed southwest tower of the Manhattan West project. The site in Manhattan is located immediately east of Dyer Avenue between 31st Street and the Amtrak Rail cut.

This data report summarizes previous and current investigations and describes subsurface conditions on site and our foundation recommendations.

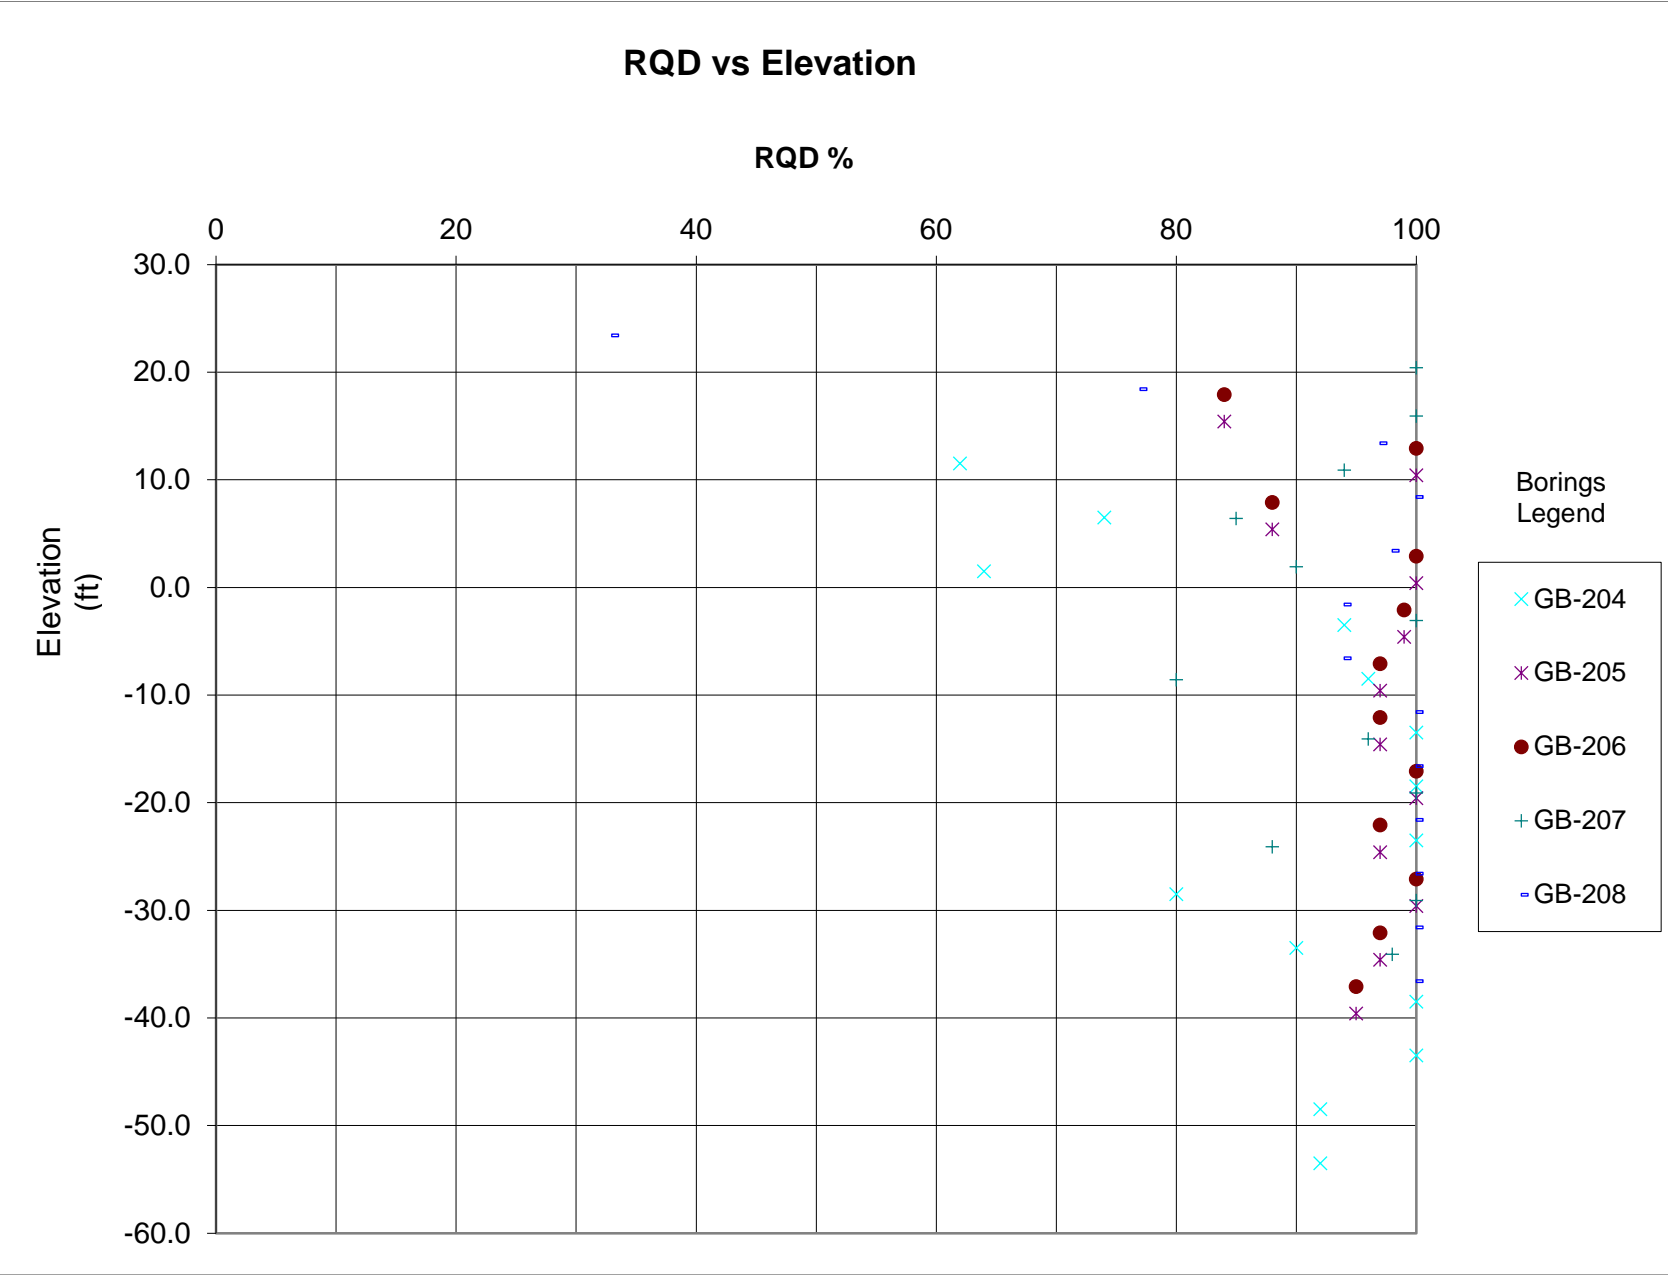
MANHATTAN WEST SOUTHWEST TOWER		
BROOKFIELD PROPERTIES		
NEW YORK		NEW YORK
MUESER RUTLEDGE CONSULTING ENGINEERS		
225 W. 34 th Street • New York, NY 10122		
	MADE BY: IAB CH'KD BY: DRG	DATE: 01/02/2014 DATE: 01/02/2014
		FILE NO. 9560E
ROCK QUALITY DESIGNATION (RQD) vs ELEVATION		PLATE NO. 5

Descriptions of recovered rock cores, core recoveries and Rock Quality Designations (RQDs) are provided on the boring logs. Rock recovery is the length of core recovered divided by the length of the core run expressed as a percentage. RQD is the sum of the length of core fragments recovered four inches or greater between natural breaks divided by the length of the core run expressed as a percentage. RQD is a measure of the relative frequency of jointing or natural fracturing of the bedrock. Selected samples of rock core from the gneissic schist and hornblende schist formations were sent out for strength testing, as described later herein.

RQD vs elevation

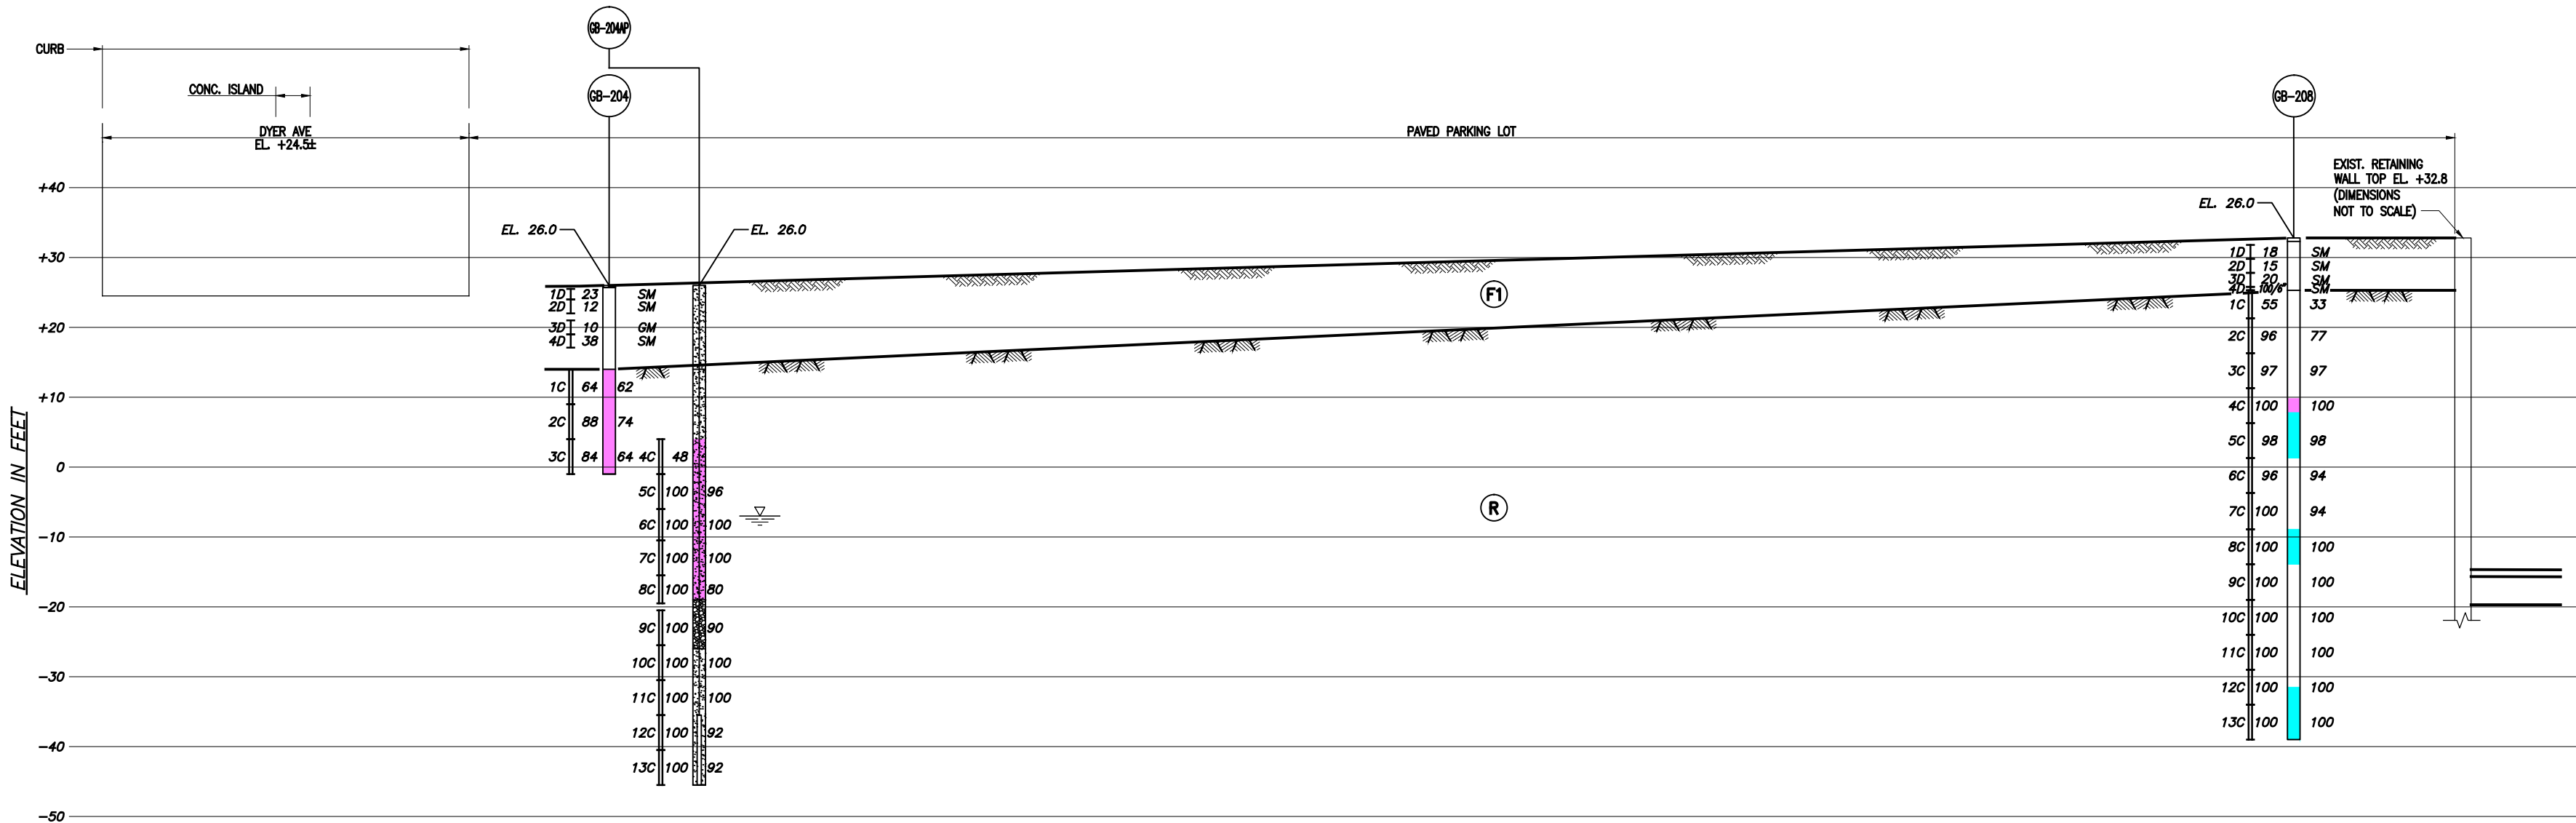
GEOLOGIC SECTION A-A
SCALE: 1"=10'-0"

- (F1)** **FILL** - LOOSE TO COMPACT BLACK AND GRAY, OCCASIONALLY RED FINE TO COARSE SAND WITH SOME TO TRACE OF SILT, CLAY, MICA, GRAVEL AND ROCK FRAGMENTS, BRICK.
- (R)** **ROCK** - MEDIUM HARD TO HARD, SLIGHTLY WEATHERED TO UN-WEATHERED, GRAY GNEISS, GNEISSIC SCHIST AND HORNBLENDE SCHIST, TRACE PEGMATITE, MODERATELY JOINTED TO JOINTED WITH SOME IRON STAINED JOINTS AND MINERAL COATED JOINTS.
- (DR)** **DECOMPOSED ROCK** - GRAY MICACEOUS FINE TO MEDIUM SAND, SOME SILT AND ROCK FRAGMENTS.

General soil conditions consist of an approximately ten foot thick granular fill layer underlain by bedrock. Occasionally a discontinuous layer of decomposed rock was encountered above the bedrock. Our interpretation of the subsurface strata is shown on individual boring logs. The subsurface material stratification at the site is illustrated on Geologic Sections A-A, B-B and C-C on drawings GS-1, GS-2 and GS-3. Geologic section marks are shown in plan on Drawing B-1.

Stratum F1 - Fill (NYC Class 7) A granular fill layer that ranges from seven to 15 feet in thickness was encountered. Stratum F1 consists of loose to compact black, gray and red fine to coarse sand, some to trace silt, clay, mica, gravel rock fragment, trace of brick fragments. Remnant foundations and slabs can be anticipated to be found in this Stratum.

Stratum R - Bedrock (NYC Class 1a to 1c) The dominant rock type at the site, is gneissic schist. Roughly half the cored rock at the site was gneissic schist. The gneissic schist rock is typically a hard to medium hard, unweathered to slightly weathered gray gneissic schist, trace pegmatite, schistose gneiss, mica schist, jointed to massive, with iron stained and occasionally weathered joints. Isolated bones of more highly weathered rock have been encountered, requiring remedial concrete facing to presence and weather project exposed forces.
