**INSPECTION OF BORINGS FOR
MANHATTAN WEST NORTH EAST TOWER
375 9TH AVENUE
NEW YORK, NEW YORK**

**GEOTECHNICAL DATA REPORT
MANHATTAN WEST
NE TOWER**

**Brookfield Properties
250 Vesey Street
New York, NY 10281**

This data report summarizes previous and current investigations and describes subsurface conditions on site.

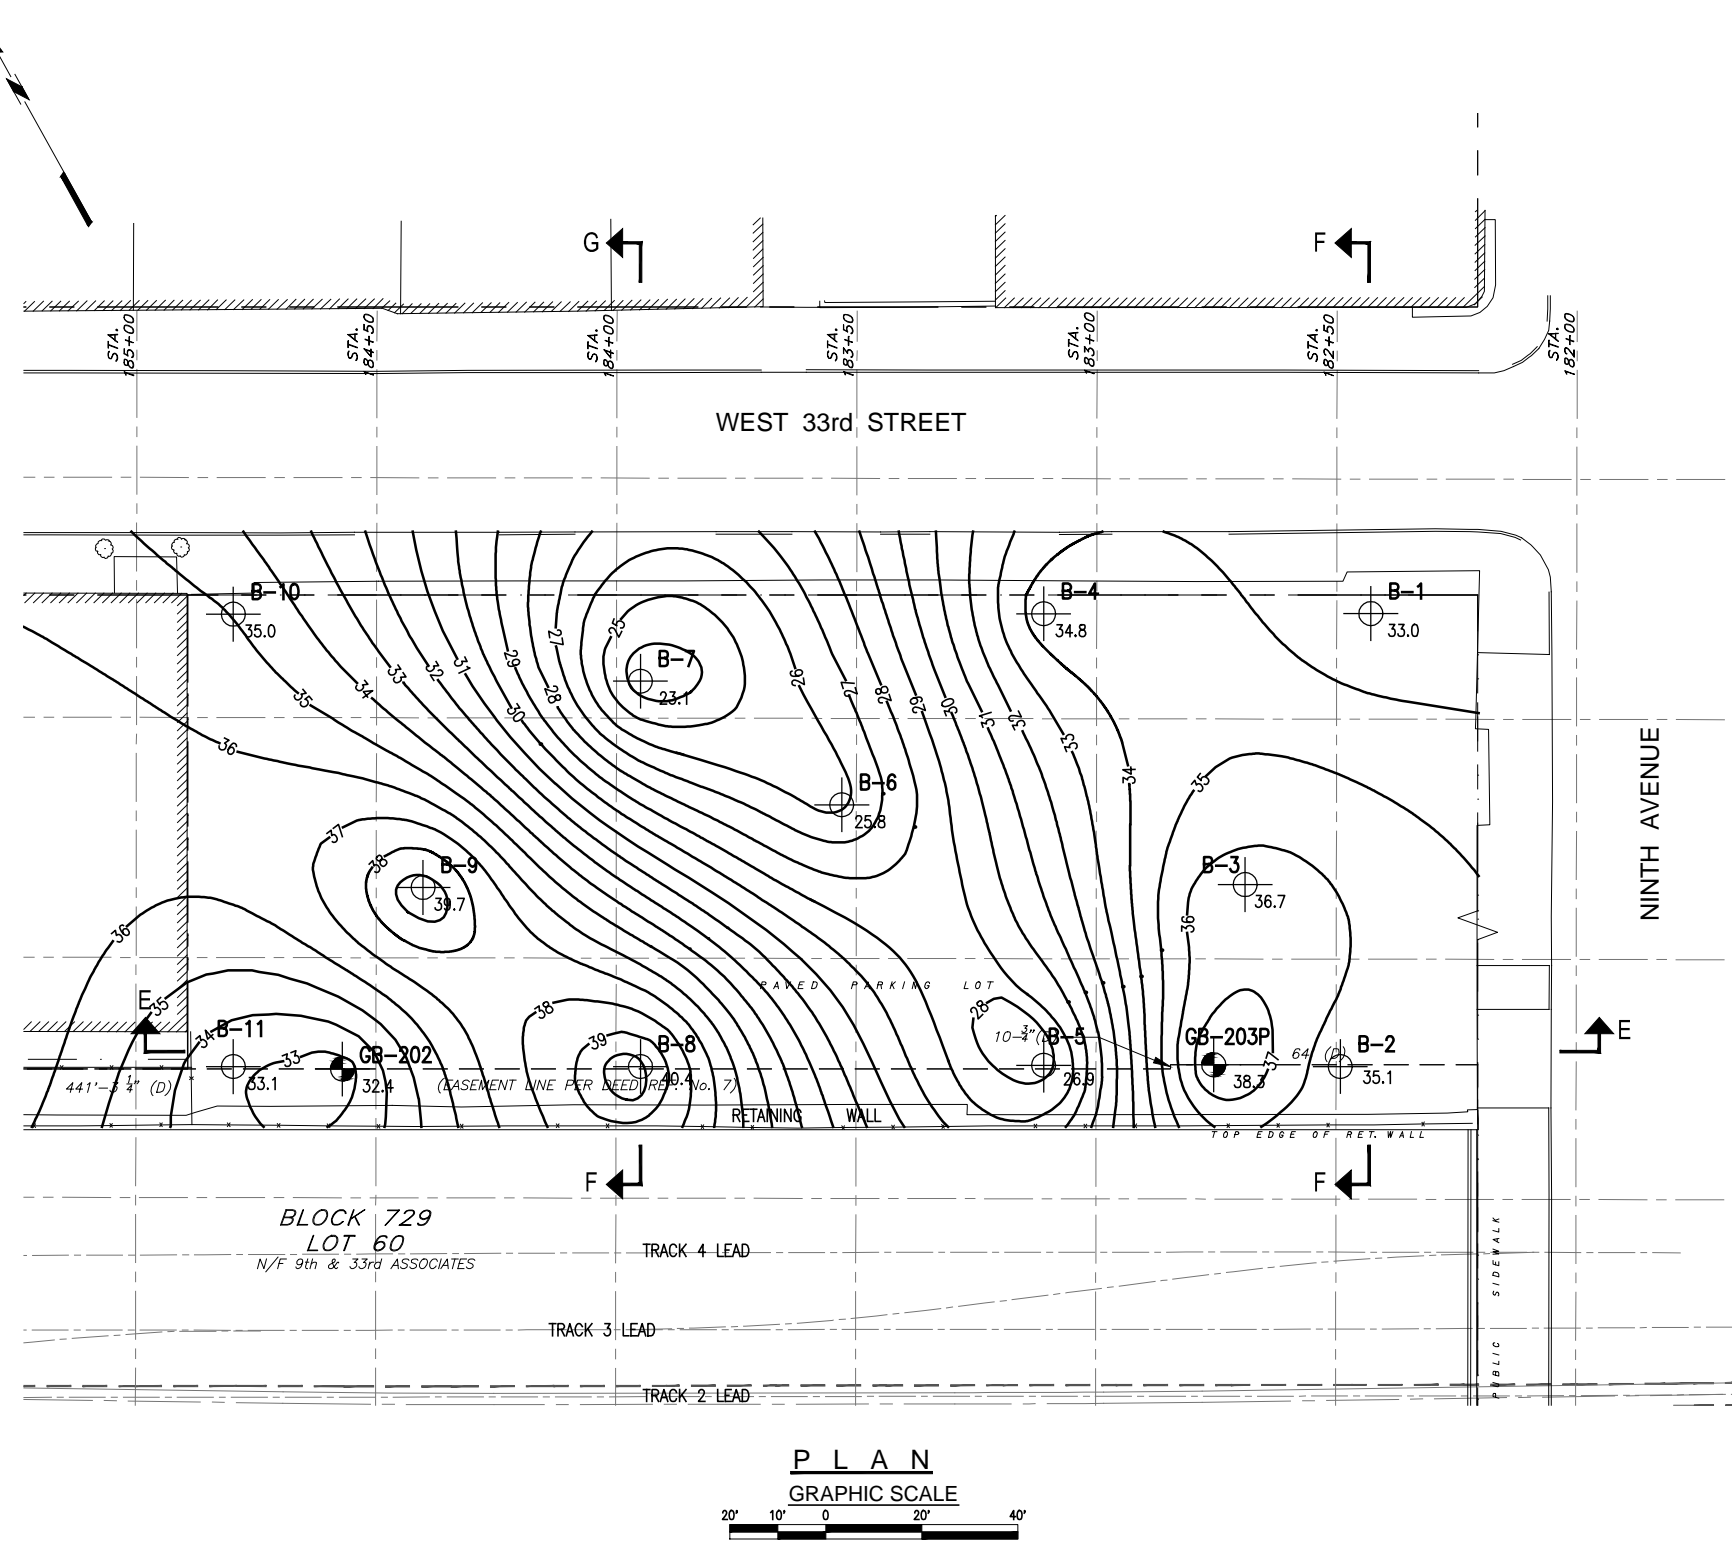
1. FOR PLAN NOTES, SEE DRAWING B-1.
2. ELEVATIONS OF TOP OF ROCK (STRATUM R) ARE SHOWN AT THE BORING LOCATIONS. SURFACE ELEVATION OF ROCK BETWEEN BORINGS WILL VARY.
3. ELEVATIONS REFERENCE BOROUGH PRESIDENT OF MANHATTAN (BPM) DATUM. TO CONVERT TO NAVD88, ADD APPROXIMATELY 1.7 FEET.
4. CONTOURS ARE BASED ON INFORMATION FROM BORINGS ONLY.

REV.	DATE	BY	DESCRIPTION
MANHATTAN WEST—NORTH EAST TOWER			
NEW YORK			NEW YORK
BROOKFIELD PROPERTIES			
NEW YORK			NEW YORK
MUESER RUTLEDGE CONSULTING ENGINEERS			
14 PENN PLAZA — 225 W. 34TH STREET, NY, NY 10122			
SCALE GRAPHIC	MADE BY: E.C. CH'KD BY: A.E.P.	DATE: 10—30—2014 DATE: 10—30—2014	FILE NUMBER 9560
CONTOUR PLAN — TOP OF STRATUM R AT TERRA FIRMA			DRAWING NUMBER C—2

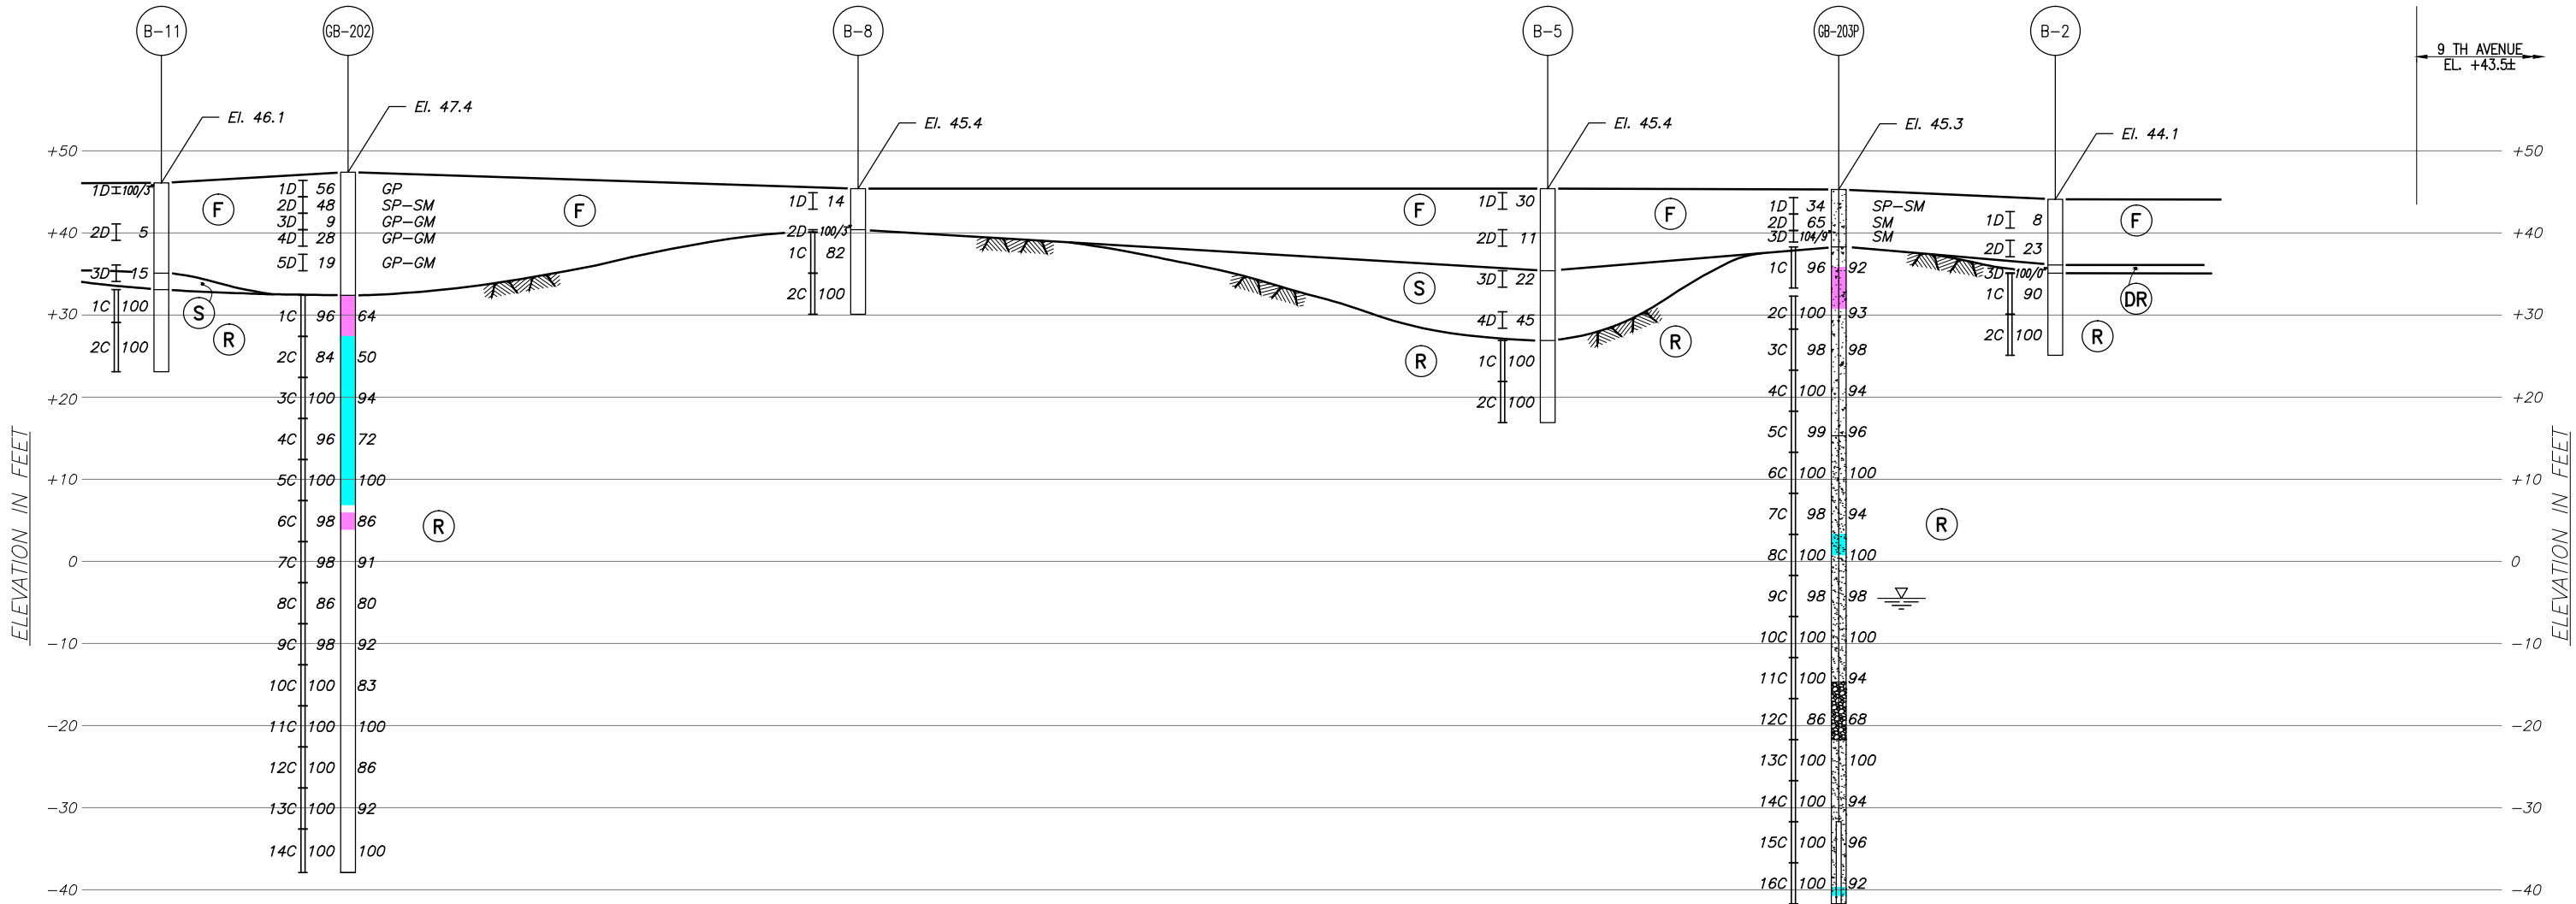
SECTION E-E
GRAPHIC SCALE
10' 5' 0 10' 20'

- (F) - **FILL** LOOSE TO COMPACT BLACK AND GRAY, OCCASIONALLY RED FINE TO COARSE SAND WITH SOME TRACE OF SILT, CLAY, MICA, GRAVEL AND ROCK FRAGMENTS, BRICK.
- (S) - **SAND** MEDIUM COMPACT TO COMPACT, MEDIUM TO FINE SILTY SAND WITH SOME COARSE TO FINE RED-BROWN GRAVEL .
- (DR) - **DECOMPOSED ROCK** GRAY MICACEOUS FINE TO MEDIUM SAND, SOME SILT AND ROCK FRAGMENTS.
- (R) - **ROCK** MEDIUM HARD TO HARD, SLIGHTLY WEATHERED TO UN-WEATHERED, GRAY GNEISS, GNEISSIC SCHIST AND HORNBLENDE SCHIST, TRACE PEGMATITE, MODERATELY JOINTED TO JOINTED WITH SOME IRON STAINED JOINTS AND MINERAL COATED JOINTS.

REV.	DATE	BY	DESCRIPTION
MANHATTAN WEST-NORTH EAST TOWER			
NEW YORK			NEW YORK
BROOKFIELD PROPERTIES			
NEW YORK			NEW YORK
MUESER RUTLEDGE CONSULTING ENGINEERS			
14 PENN PLAZA - 225 W. 34TH STREET, NY, NY 10122			
SCALE GRAPHIC	MADE BY: E.C. CH'KD BY: A.E.P.	DATE: 10-30-2014 DATE: 10-30-2014	FILE NUMBER 9560
GEOLOGIC SECTION E-E			DRAWING NUMBER GS-5

General site subsurface conditions consist of a granular fill layer typically overlying a natural sand layer, underlain by bedrock. Occasionally a discontinuous layer of decomposed rock was encountered above the bedrock. Our interpretation of the subsurface strata is shown on individual boring logs. The subsurface material stratification at the site is illustrated on Geologic Sections E-E to G-G presented on Drawings No. GS-5 to GS-7. Geologic section orientation is shown in plan on Drawing B-1.

Stratum F1 - Fill (NYC Class 7) A granular fill layer that ranges from seven to 15 feet in thickness was encountered. Stratum F1 consists of loose to compact black, gray and red fine to coarse sand, some to trace silt, clay, mica, gravel rock fragment, trace of brick fragments. Remnant foundations and slabs can be anticipated to be found in this Stratum.

Stratum DR - Decomposed Rock (NYC Class 1d) A thin layer of decomposed rock overlies the bedrock in locations. The decomposed rock ranged from 0.2 to 1 foot thick in the borings, but a deeper trough was noted during excavation for the deck foundations.

Stratum R - Bedrock (NYC Class 1a to 1c) Gneissic schist and hornblende schist are the two dominant rock types at the site. The gneissic schist is typically a medium hard to hard slightly weathered to unweathered gray gneissic schist, trace pegmatite, schistose gneiss, mica schist, jointed to moderately jointed, with iron stained and occasionally weathered joints. The hornblende schist is generally a hard to medium hard unweathered to slightly weathered gray to black hornblende schist, jointed to moderately jointed, with mineral coated, iron stained and occasionally weathered joints.

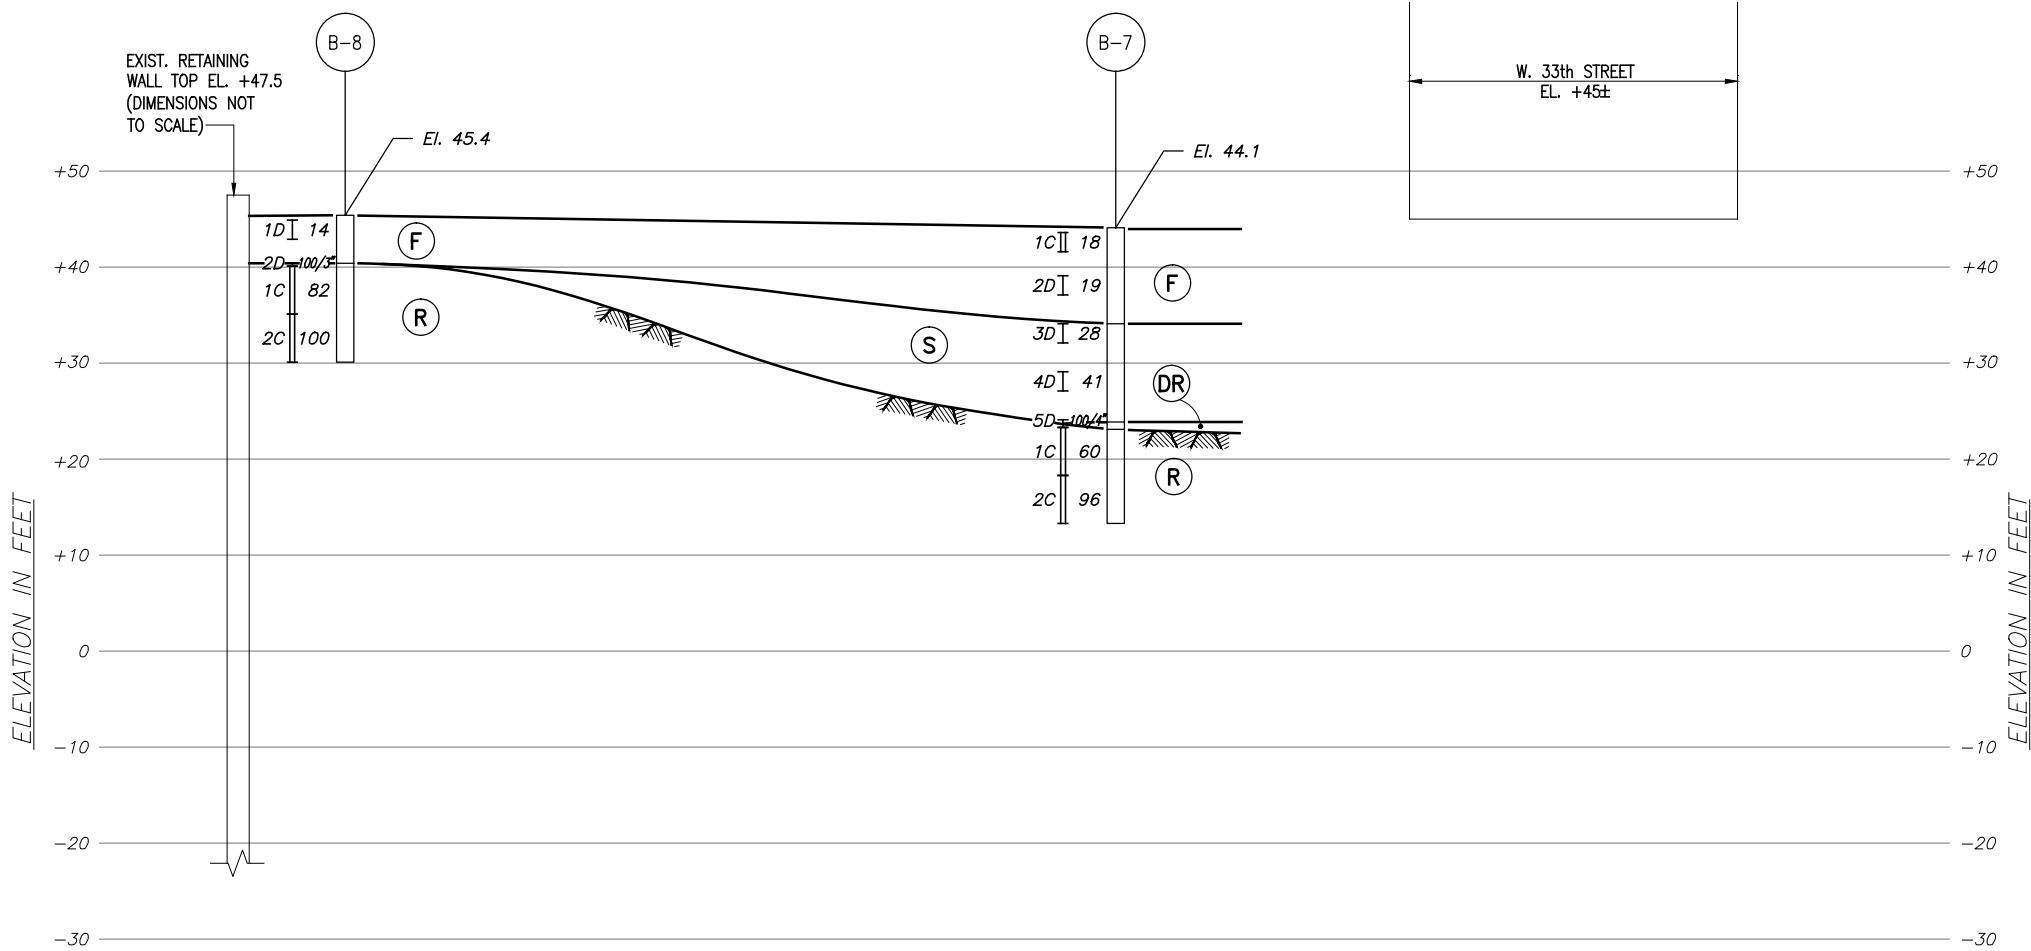
- (F) - **FILL** LOOSE TO COMPACT BLACK AND GRAY, OCCASIONALLY RED FINE TO COARSE SAND WITH SOME TRACE OF SILT, CLAY, MICA, GRAVEL AND ROCK FRAGMENTS, BRICK.
- (DR) - **DECOMPOSED ROCK** GRAY MICACEOUS FINE TO MEDIUM SAND, SOME SILT AND ROCK FRAGMENTS.
- (R) - **ROCK** MEDIUM HARD TO HARD, SLIGHTLY WEATHERED TO UN-WEATHERED, GRAY GNEISS, GNEISSIC SCHIST AND HORNBLENDE SCHIST, TRACE PEGMATITE, MODERATELY JOINTED TO JOINTED WITH SOME IRON STAINED JOINTS AND MINERAL COATED JOINTS.

REV.	DATE	BY	DESCRIPTION	
9th AVENUE DEVELOPMENT				
NEW YORK			NEW YORK	
BROOKFIELD PROPERTIES				
NEW YORK			NEW YORK	
MUESER RUTLEDGE CONSULTING ENGINEERS				
14 PENN PLAZA – 225 W. 34TH STREET, NY, NY 10122				
SCALE GRAPHIC	MADE BY: E.C. CH'KD BY: A.E.P.		DATE: 10–30–2014 DATE: 10–30–2014	FILE NUMBER 9560
GEOLOGIC SECTION G–G				DRAWING NUMBER GS–7

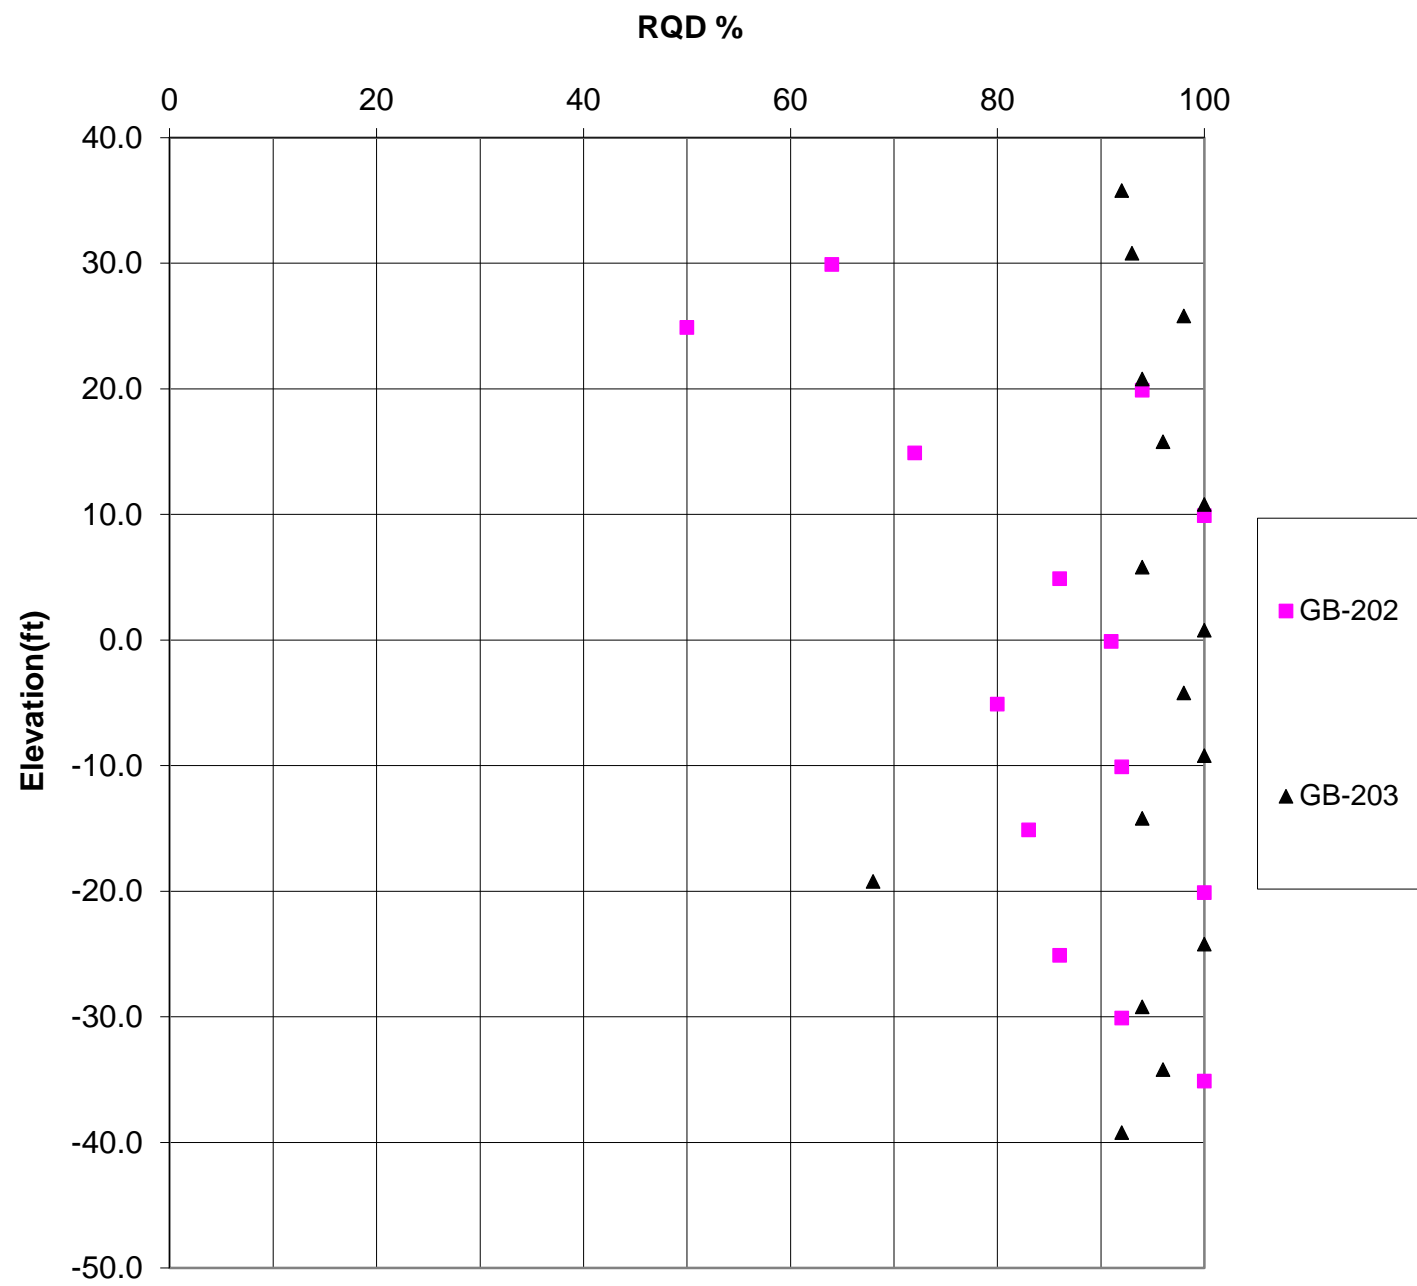
RQD vs Elevation

1. ELEVATIONS REFER TO BOROUGH PRESIDENT OF MANHATTAN (BPM) DATUM. TO CONVERT TO NAVD88, ADD APPROXIMATELY 1.7 FEET.

percentage. RQD is a measure of the relative frequency of jointing or natural fracturing of the bedrock. Selected samples of rock core from the gneissic schist and hornblende schist formations were sent out for strength testing, as described later herein.

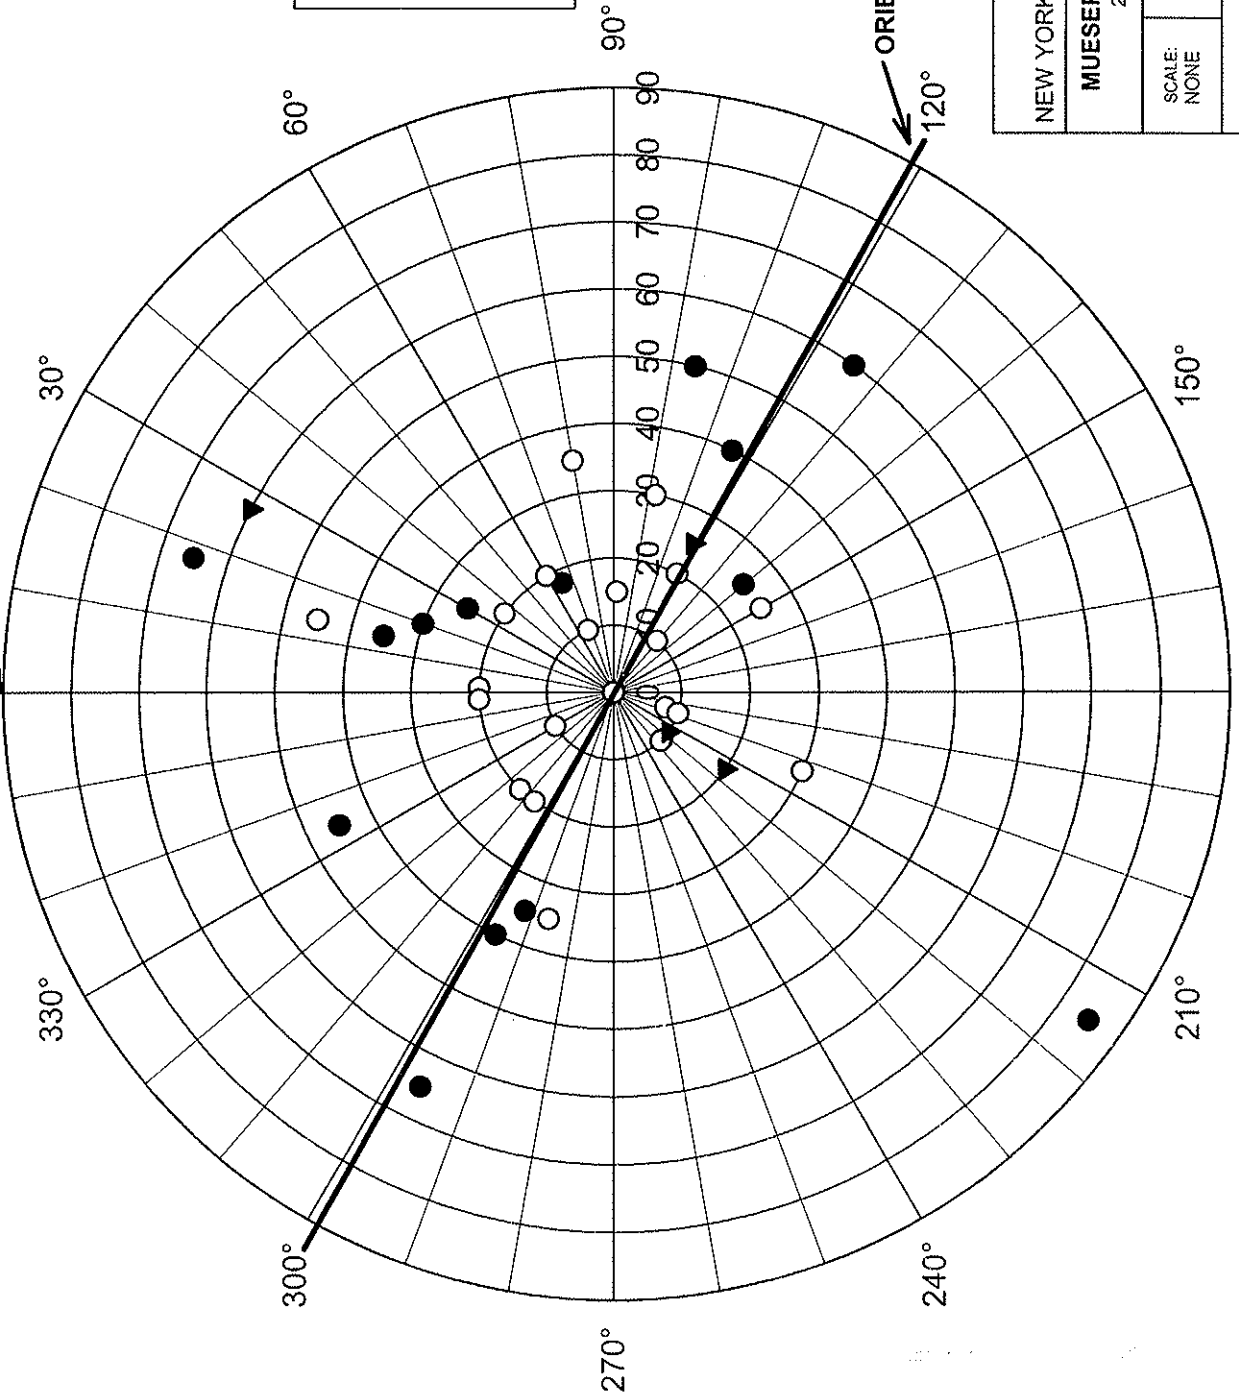
- JOINT PLANES
CROSSING FOLIATION
- JOINT PLANES
PARALLEL TO FOLIATION
- ▼ JOINT PLANES IN
UNFOLIATED ROCK

NEW YORK		9TH AVENUE DEVELOPMENT		NEW YORK	
MUESER RUTLEDGE CONSULTING ENGINEERS					
225 WEST 34TH ST., NEW YORK, NY 10122					
SCALE: NONE	MADE BY: CJM CHKD BY: JMT	DATE: 4/21/08 DATE: 4/22/08	FILE NO. 9560	POLAR PLOT OF PLANAR JOINT DISCONTINUITIES BORING GB-202	
				PLATE NO. P-7

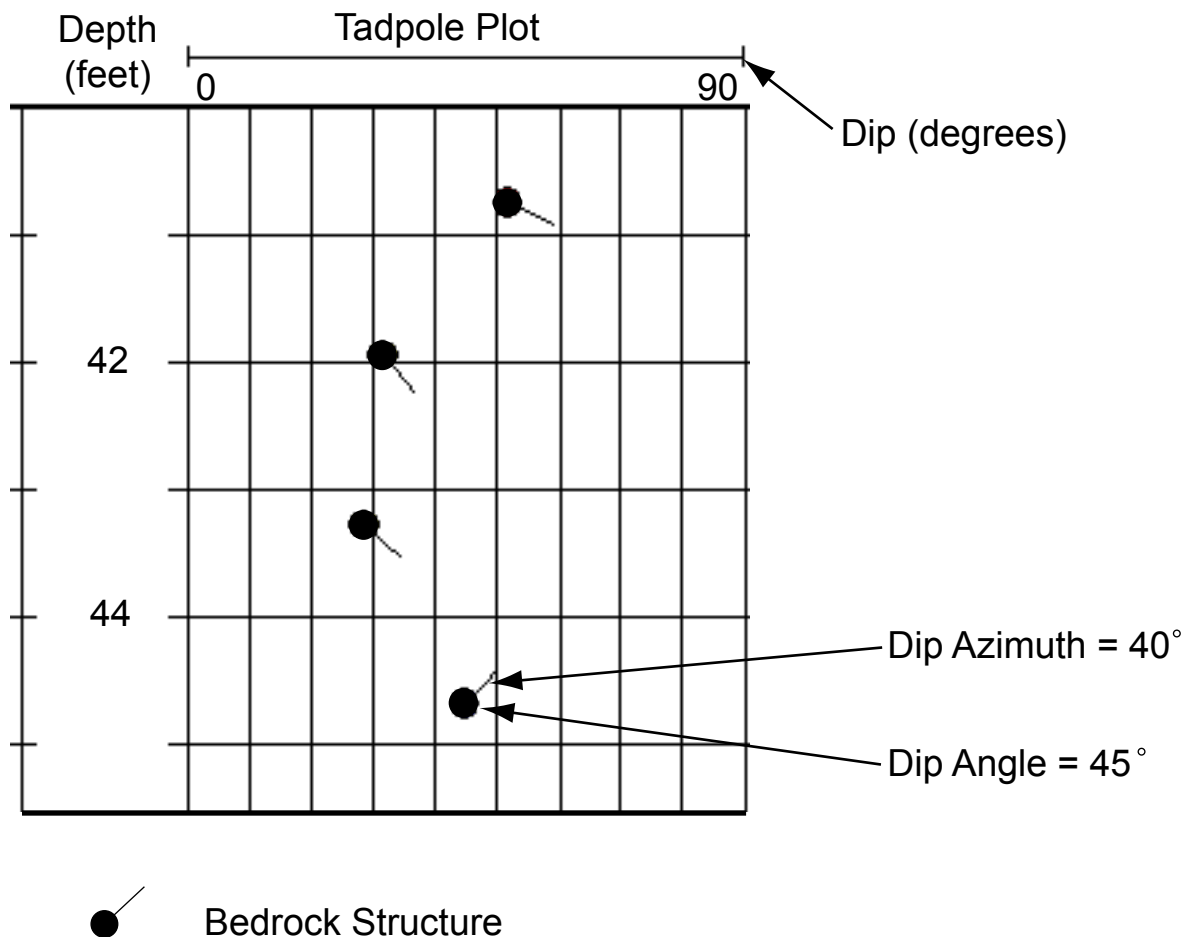
Figure 2. Tadpole plot explanation. The orientation of the bedrock structures is graphically displayed by a tadpole consisting of a circle, the head, and a line, the tail. The position of the head, left to right on the tadpole plot, gives the dip angle of the structure. The left side of the track indicates a dip angle of 0°, and the right side of the track indicates a dip angle of 90° from horizontal. The orientation of the tail gives the dip azimuth of the structure and can be read like a compass. The tail pointing directly up is 0°, north.

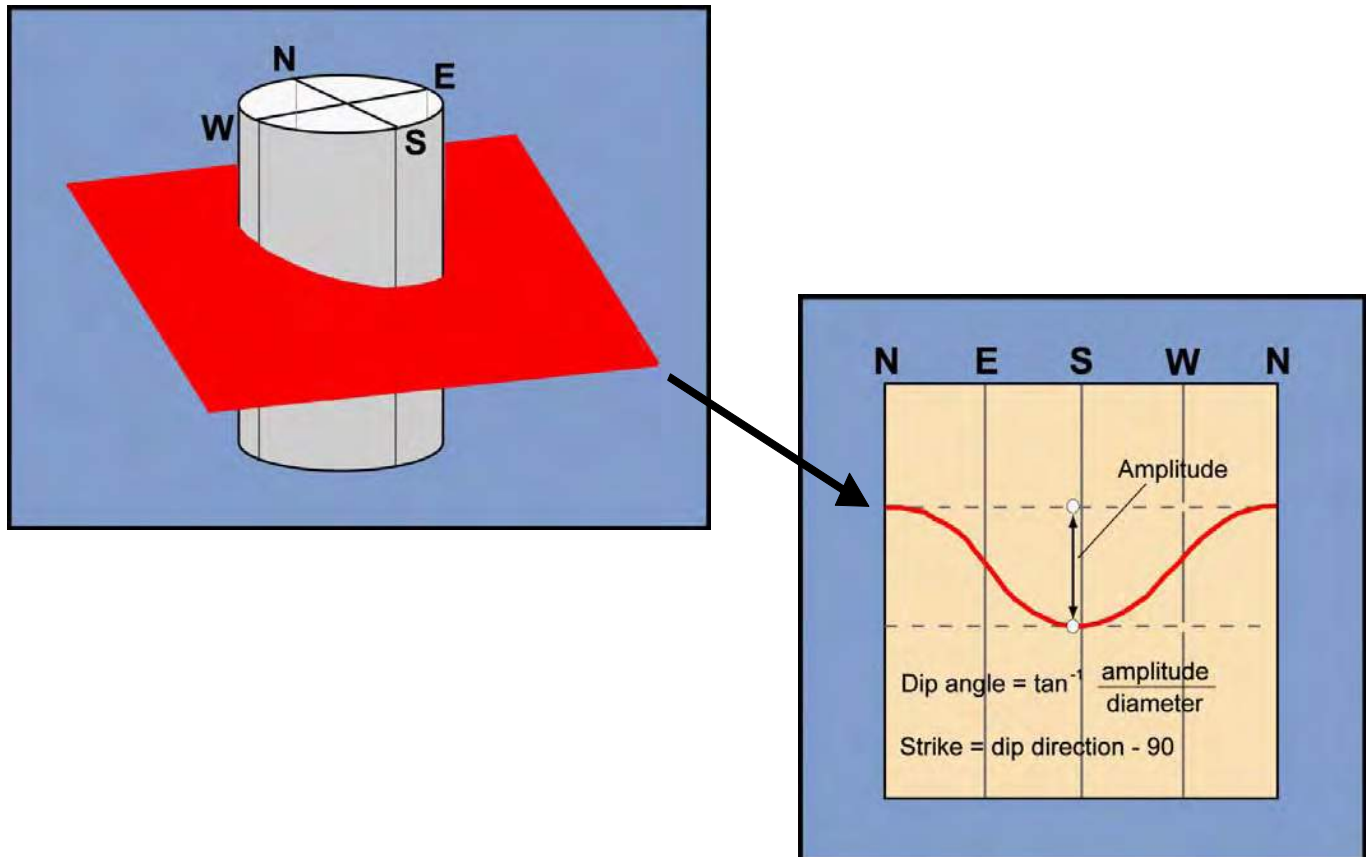
Figure 3. Televiewer Explanation Figure. The image on the left depicts a planar structure in red, such as a fracture or bedding plane, intersected by a borehole. The image on the right depicts the same structure unwrapped as it would be displayed in an optical televiewer (OTV) or acoustic televiewer (ATV) log.

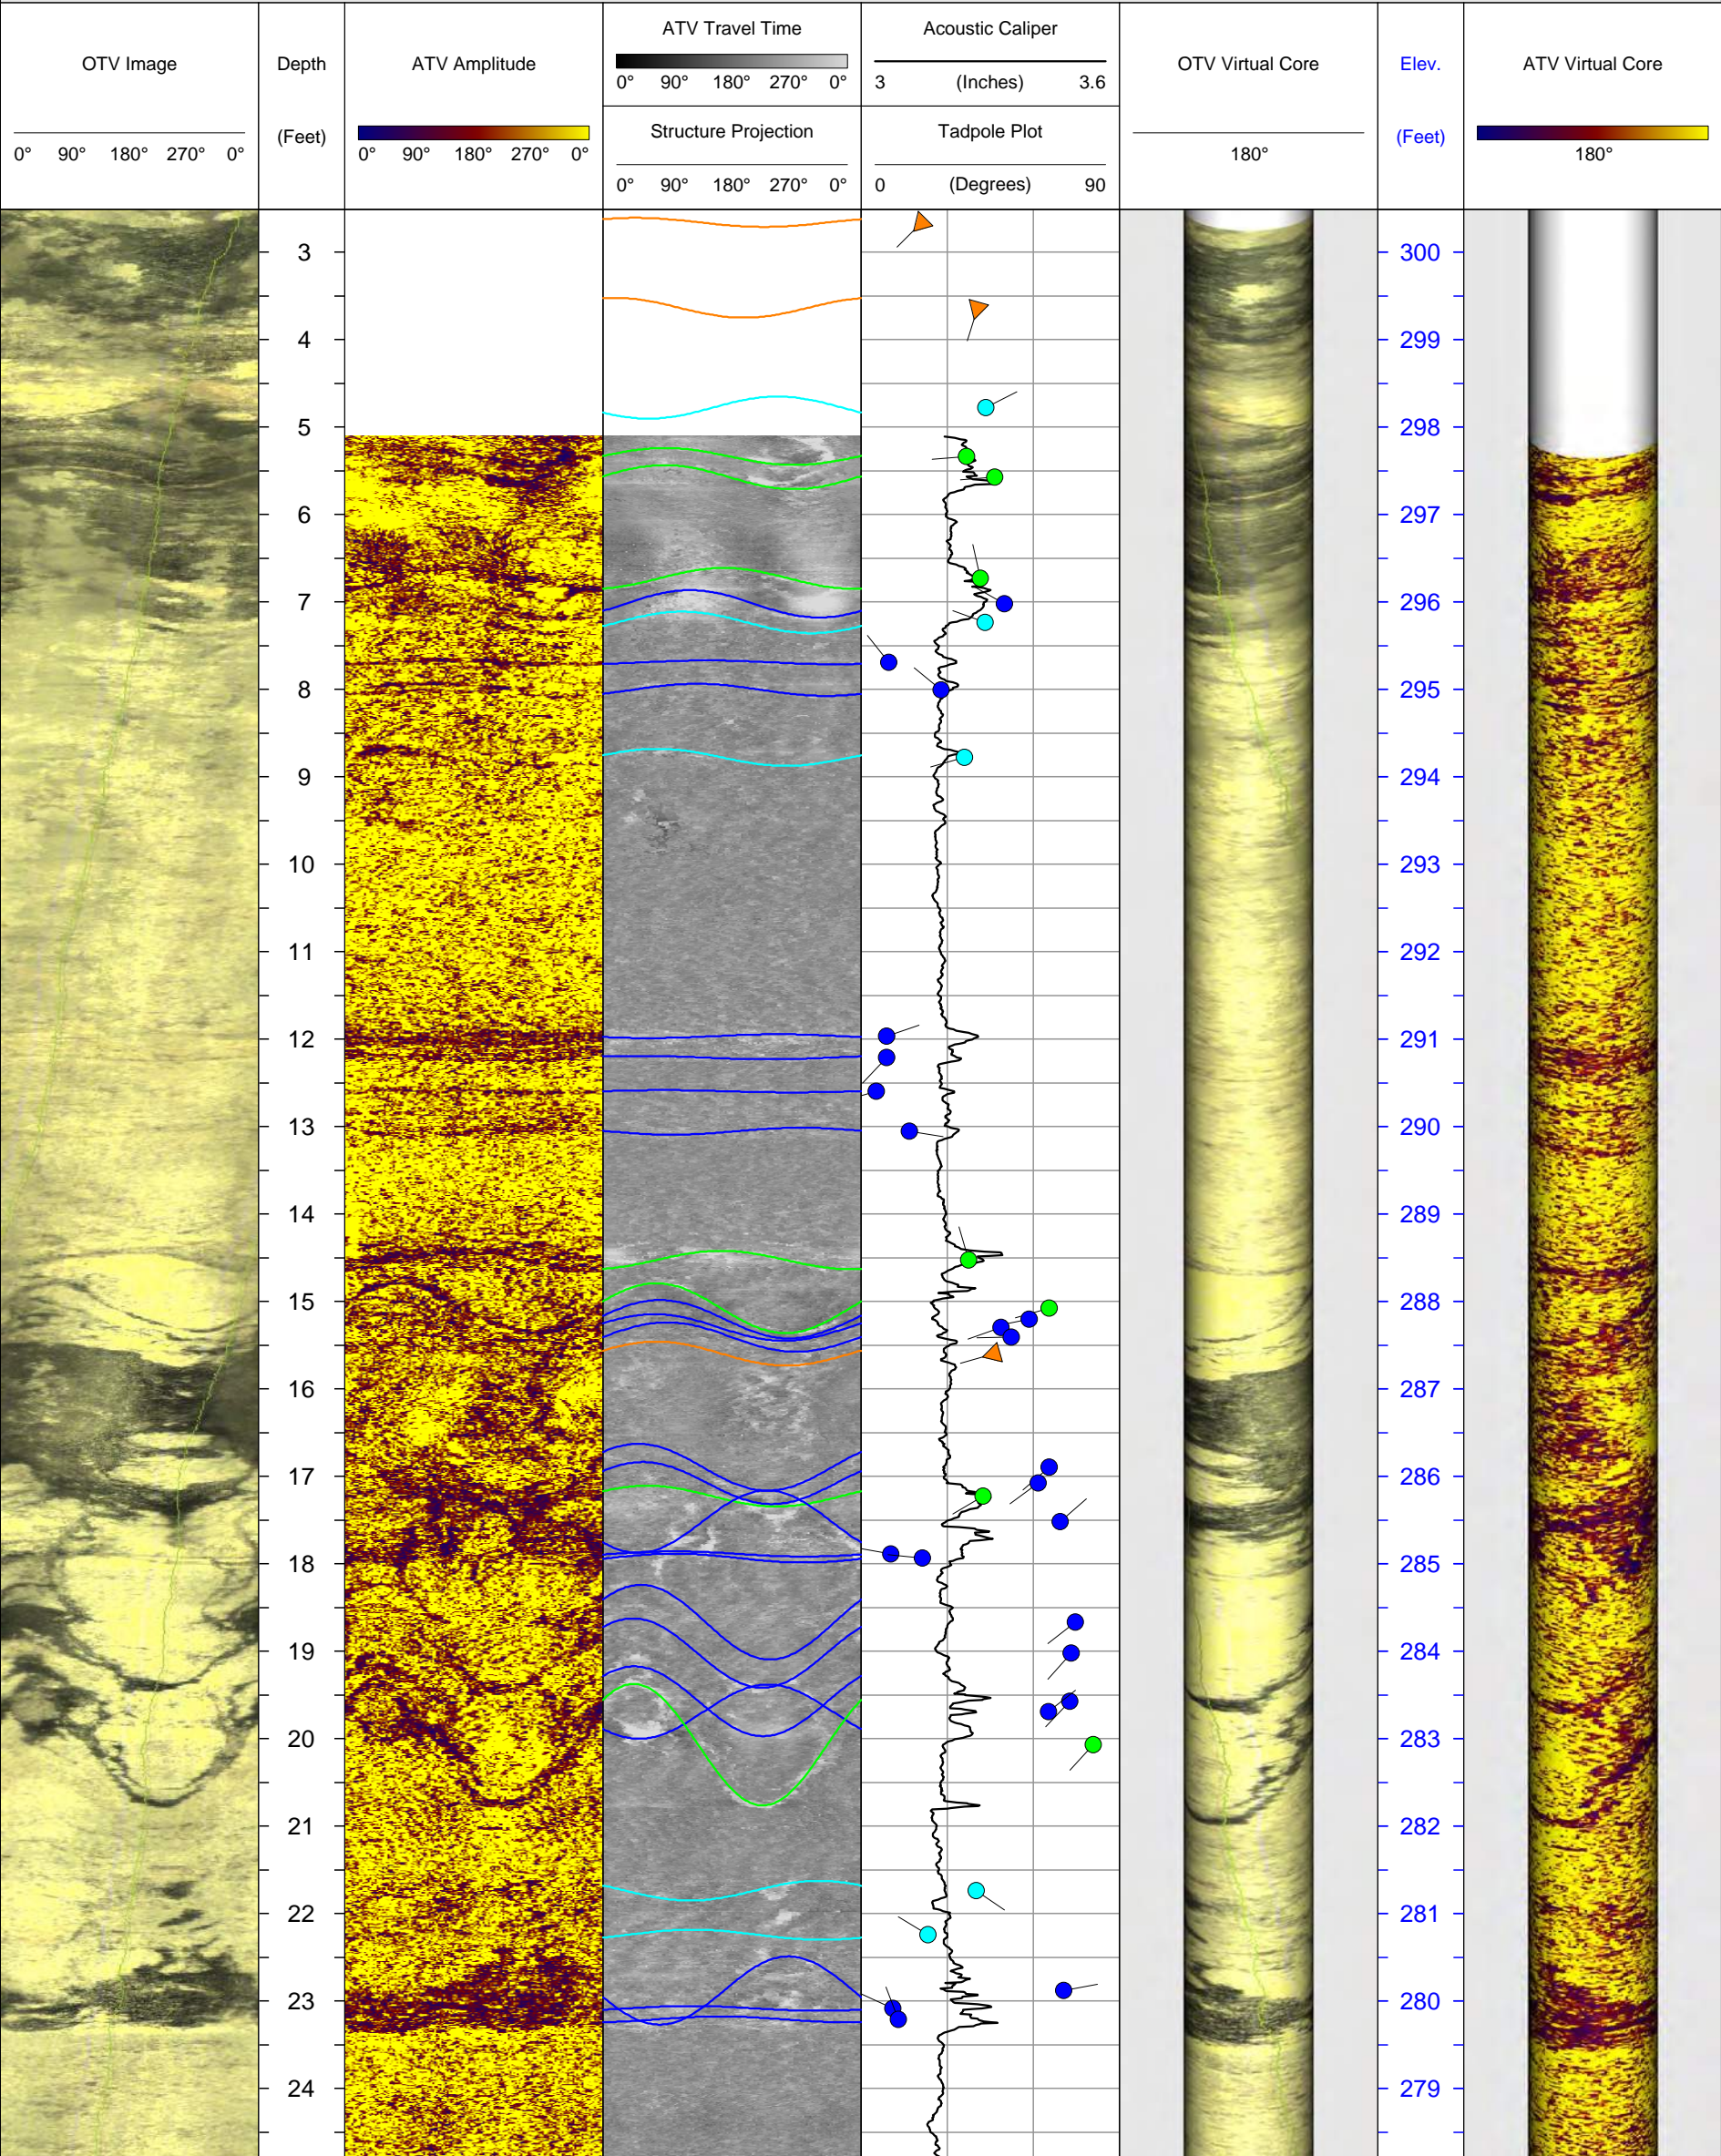
DH-1 - Borehole Geophysical Logs

Fracture Rank 1
 Fracture Rank 2
 Fracture Rank 3
 Fracture Rank 4
 Foliation / Vein

Three holes were also drilled by airtrack in September 2013 for logging by Televiwer at the request of MRCE. Televiwer logging was performed by Hager-Richter Geoscience, Inc. The televiwer holes were drilled from about the elevation of the bottom of the cap beam to depths ranging from 40 to 51 feet. The televiwer holes were drilled fully in bedrock, performed to characterize the quality of bedrock to depths below the deepest intended footing foundation. The Televiwer report is attached as Appendix H.

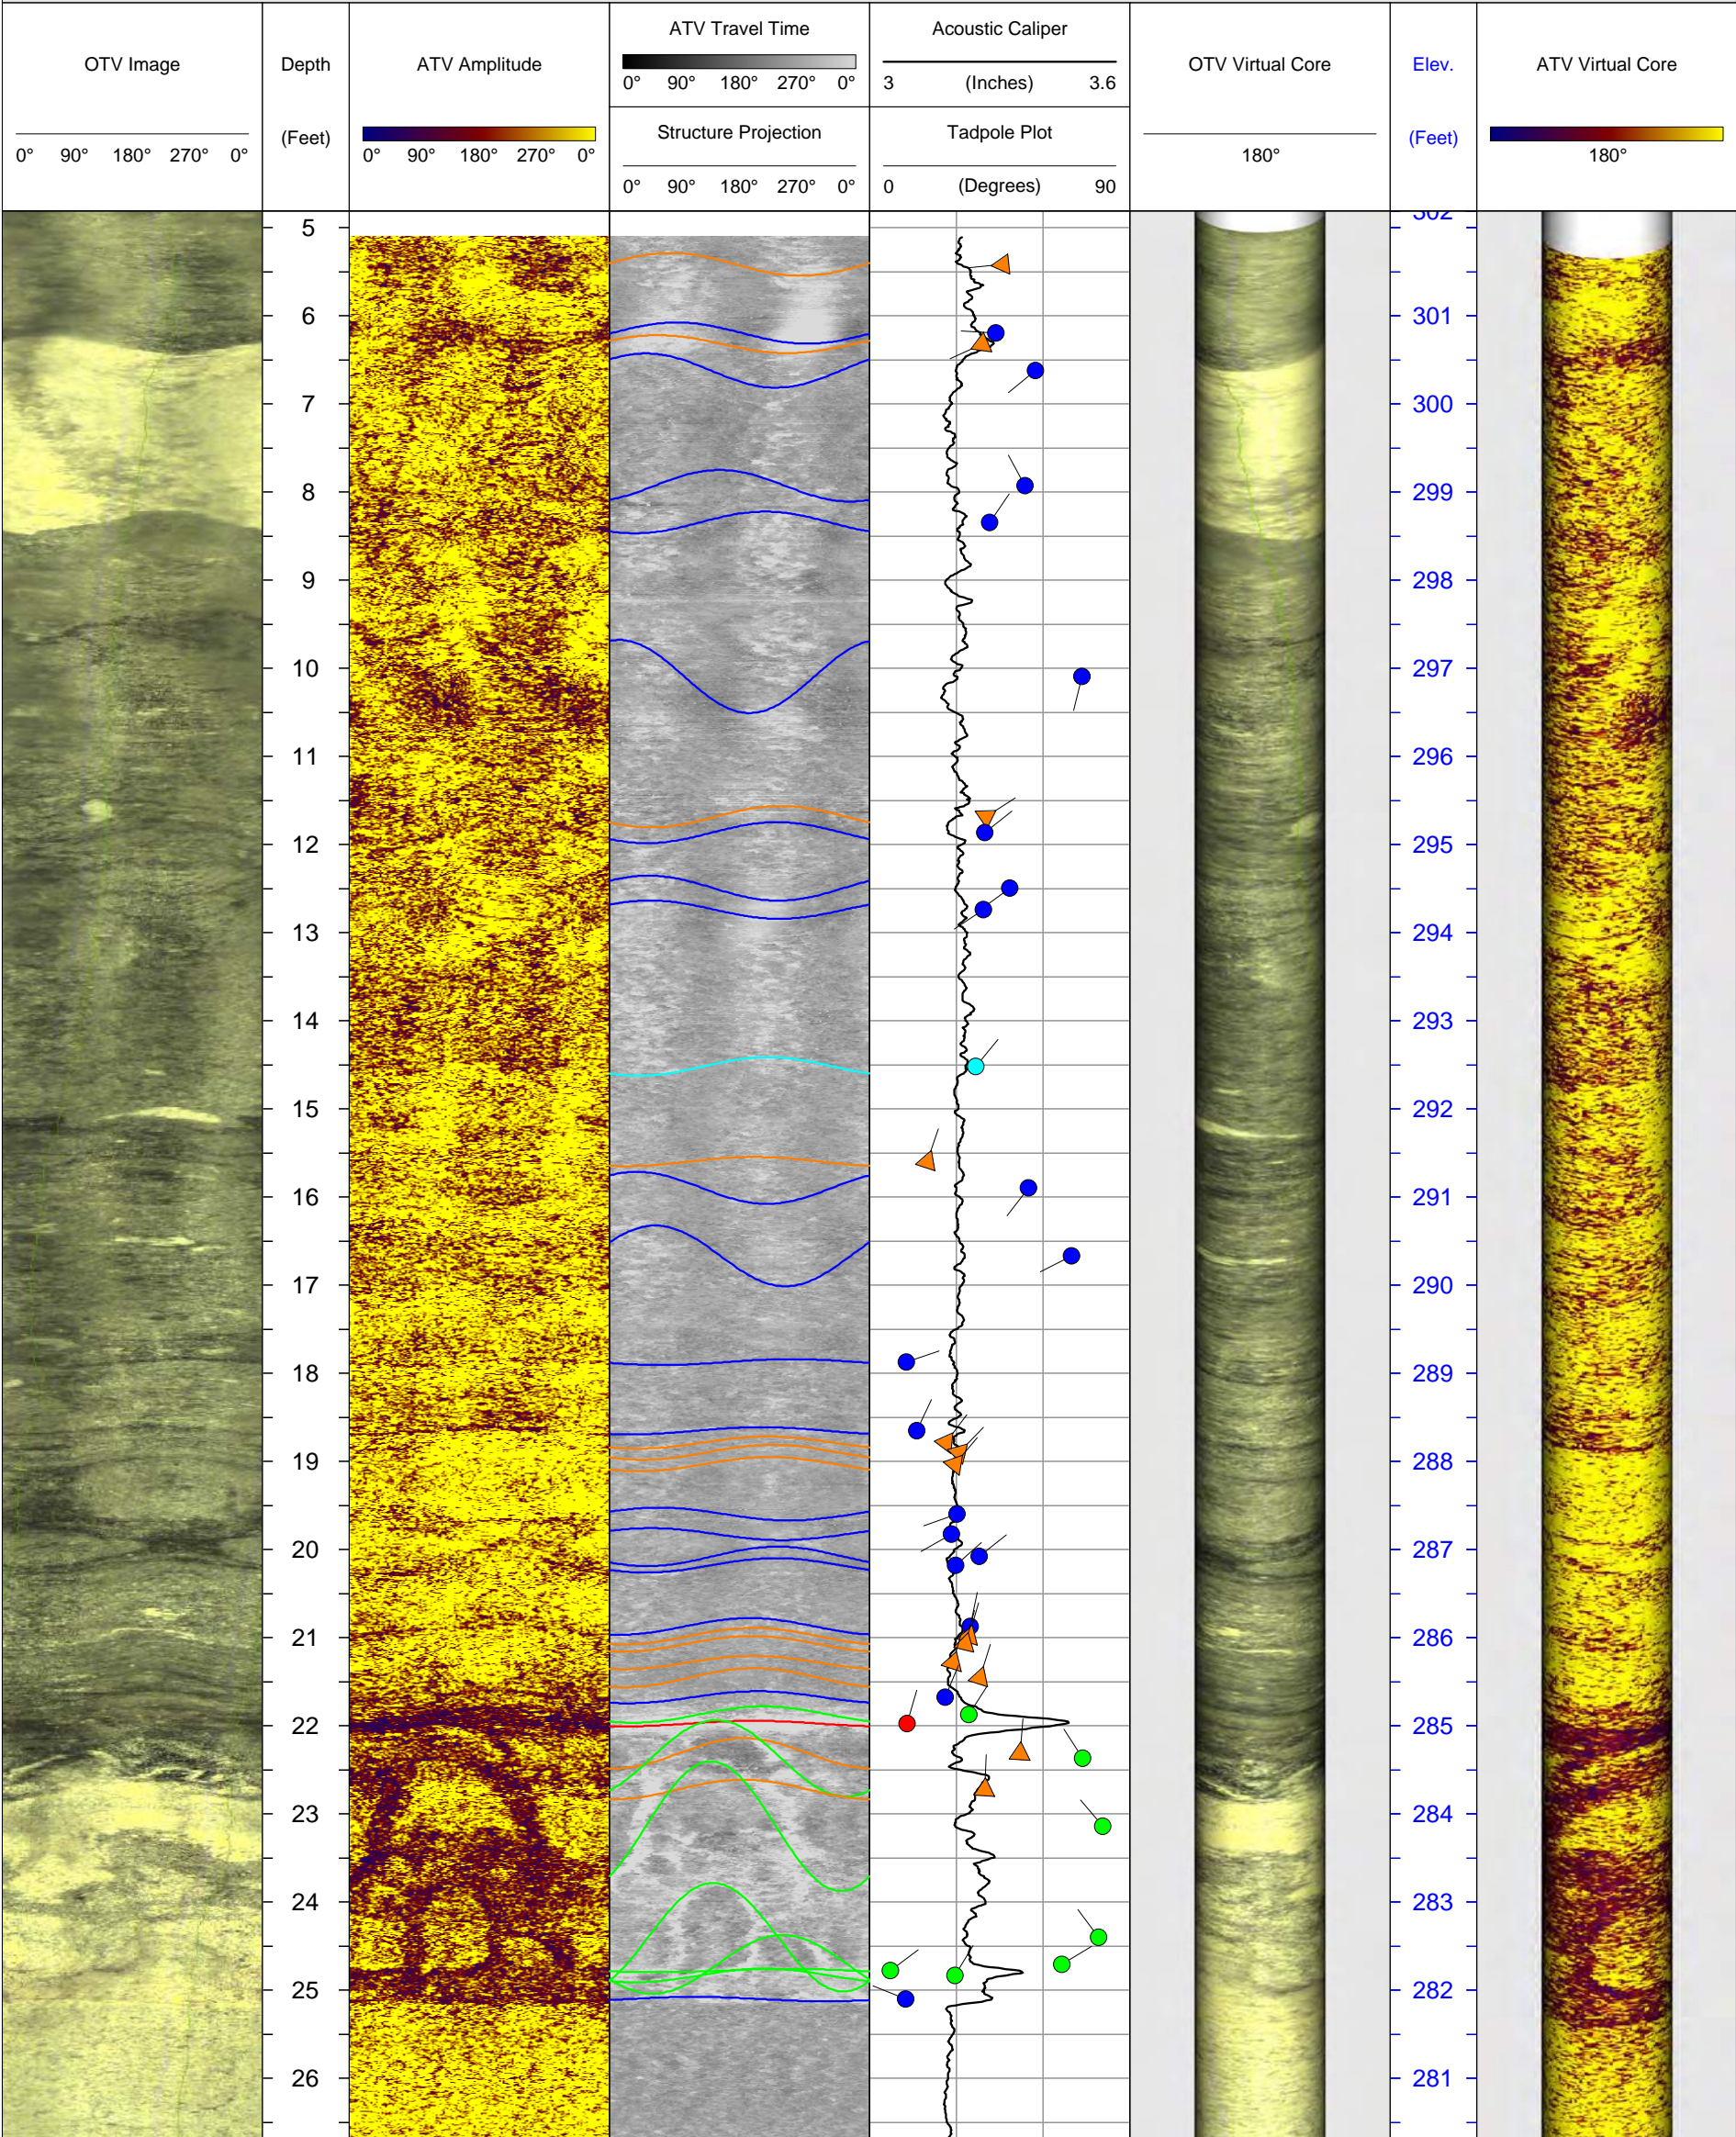
DH-2 - Borehole Geophysical Logs

Fracture Rank 1
 Fracture Rank 2
 Fracture Rank 3
 Fracture Rank 4
 Foliation / Vein
