**INSPECTION OF BORINGS FOR
MANHATTAN WEST NORTH EAST TOWER
375 9TH AVENUE
NEW YORK, NEW YORK**

**GEOTECHNICAL DATA REPORT
MANHATTAN WEST
NE TOWER**

**Brookfield Properties
250 Vesey Street
New York, NY 10281**

This data report summarizes previous and current investigations and describes subsurface conditions on site.

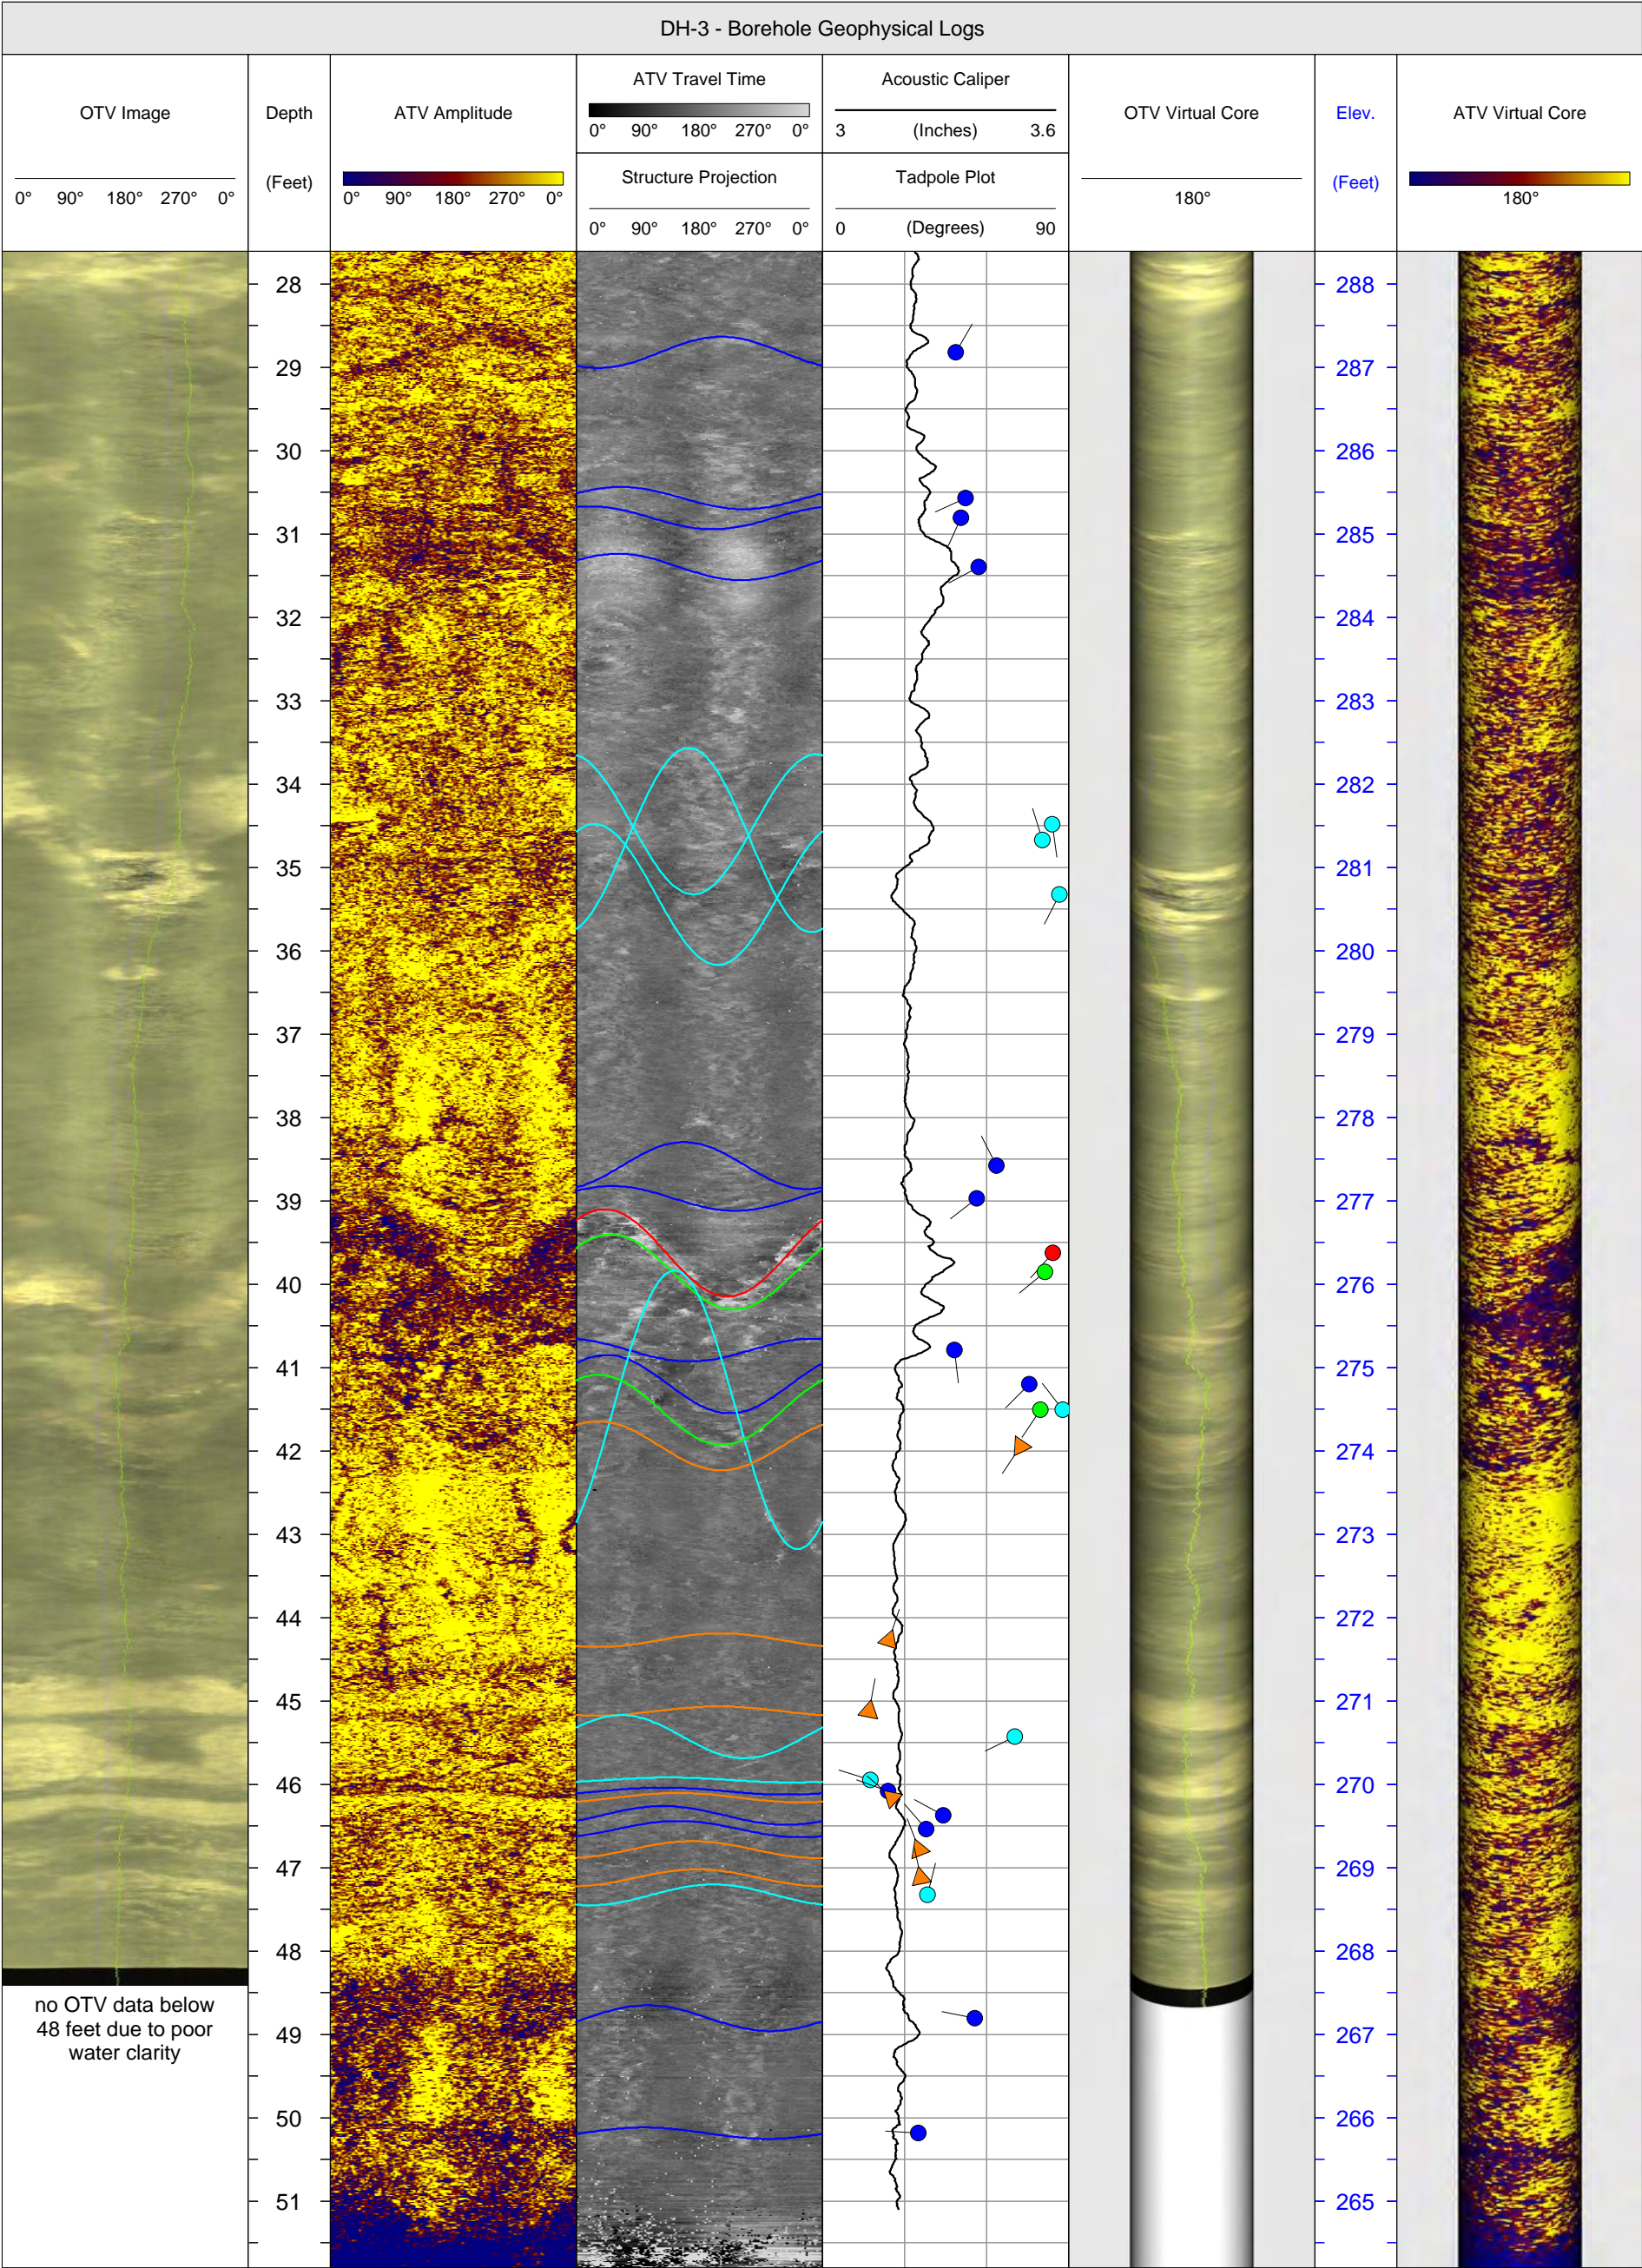
DH-3 - Borehole Geophysical Logs

DATE(S) LOGGED: August 26, 2013

Three holes were also drilled by airtrack in September 2013 for logging by Televiwer at the request of MRCE. Televiwer logging was performed by Hager-Richter Geoscience, Inc. The televiwer holes were drilled from about the elevation of the bottom of the cap beam to depths ranging from 40 to 51 feet. The televiwer holes were drilled fully in bedrock, performed to characterize the quality of bedrock to depths below the deepest intended footing foundation. The Televiwer report is attached as Appendix H.
