Allied-Axis

THE PHOTO JOURNAL OF THE SECOND WORLD WAR

Contents

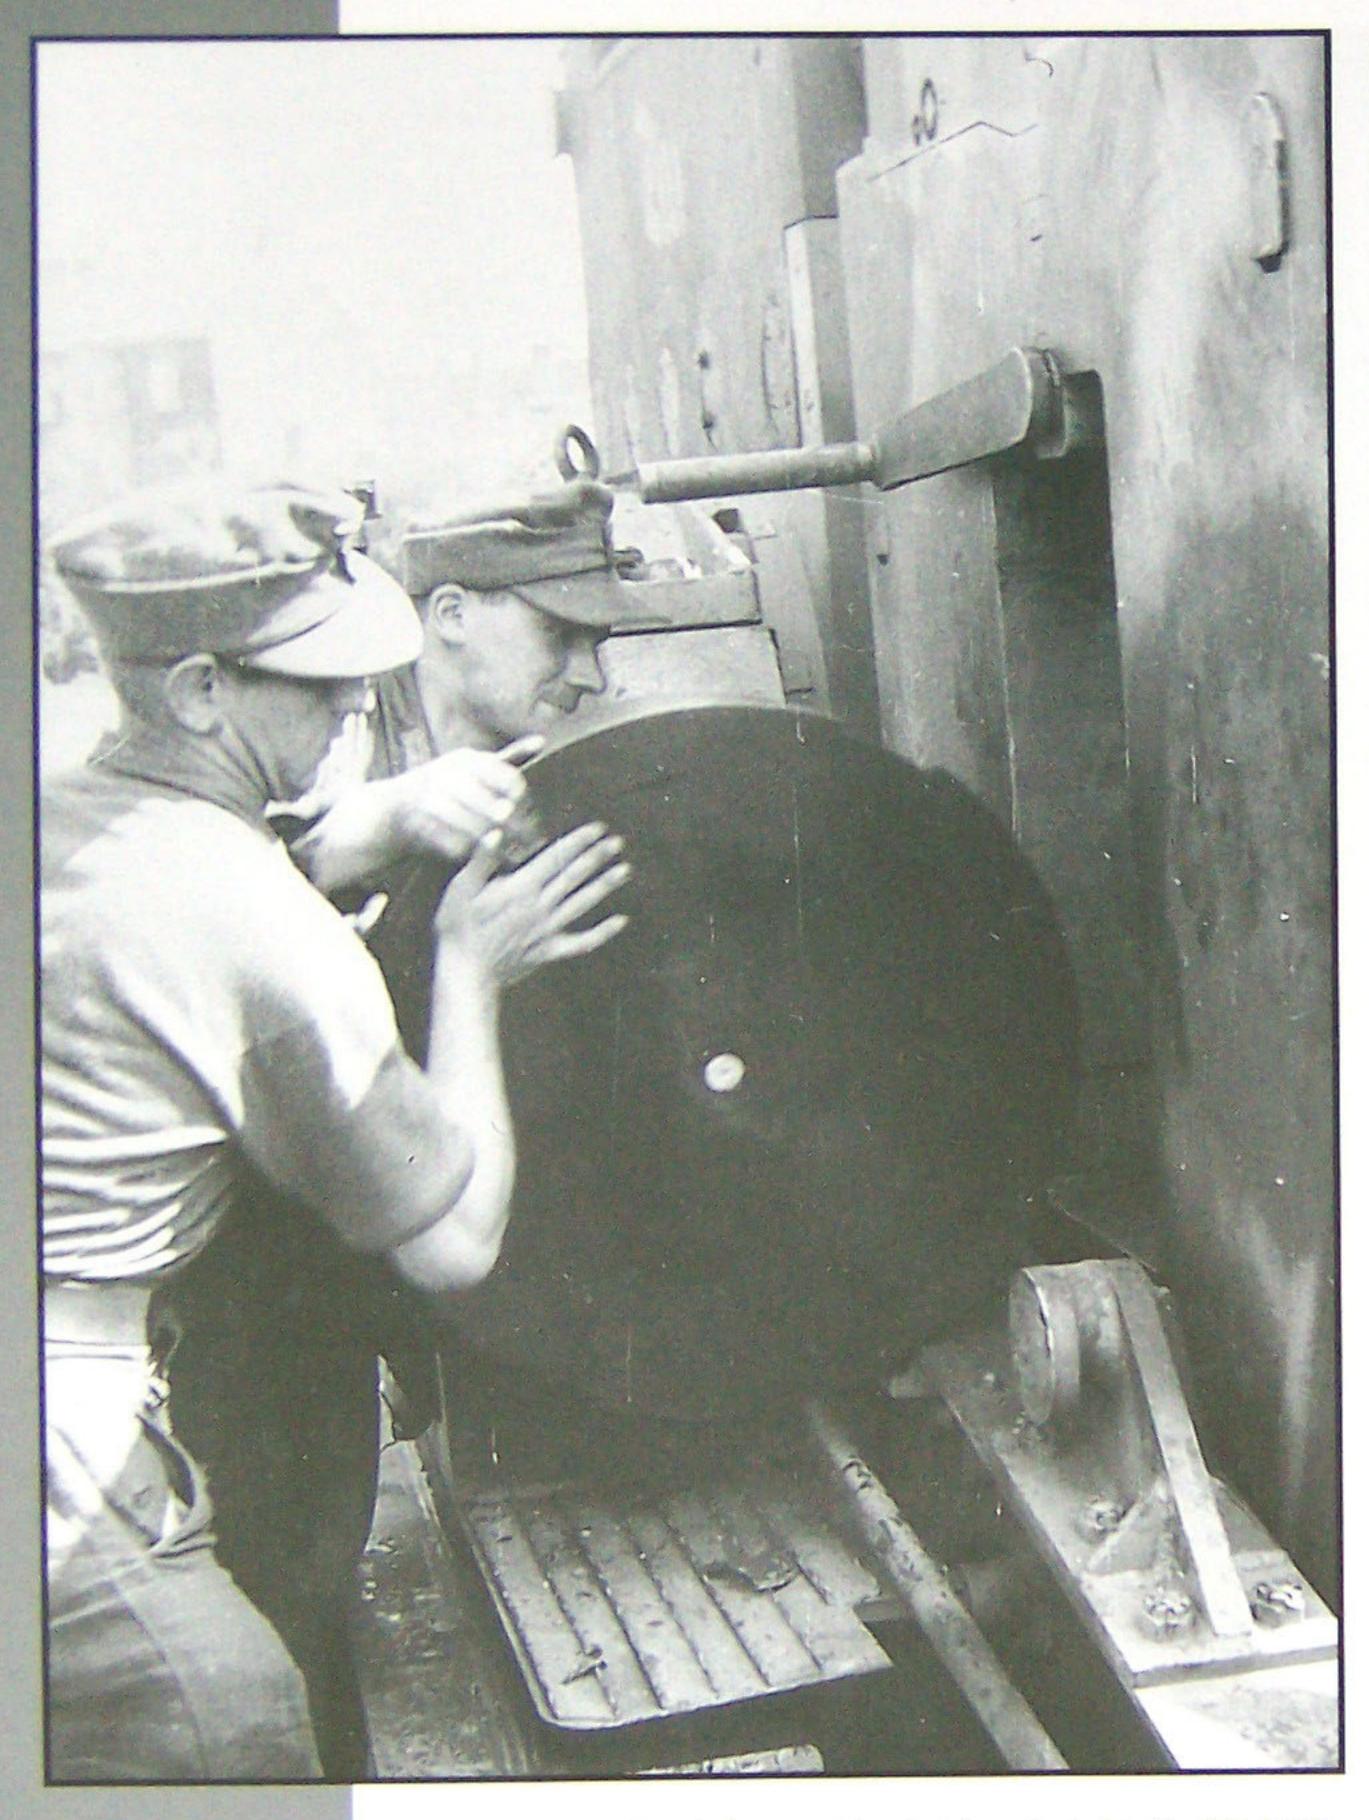
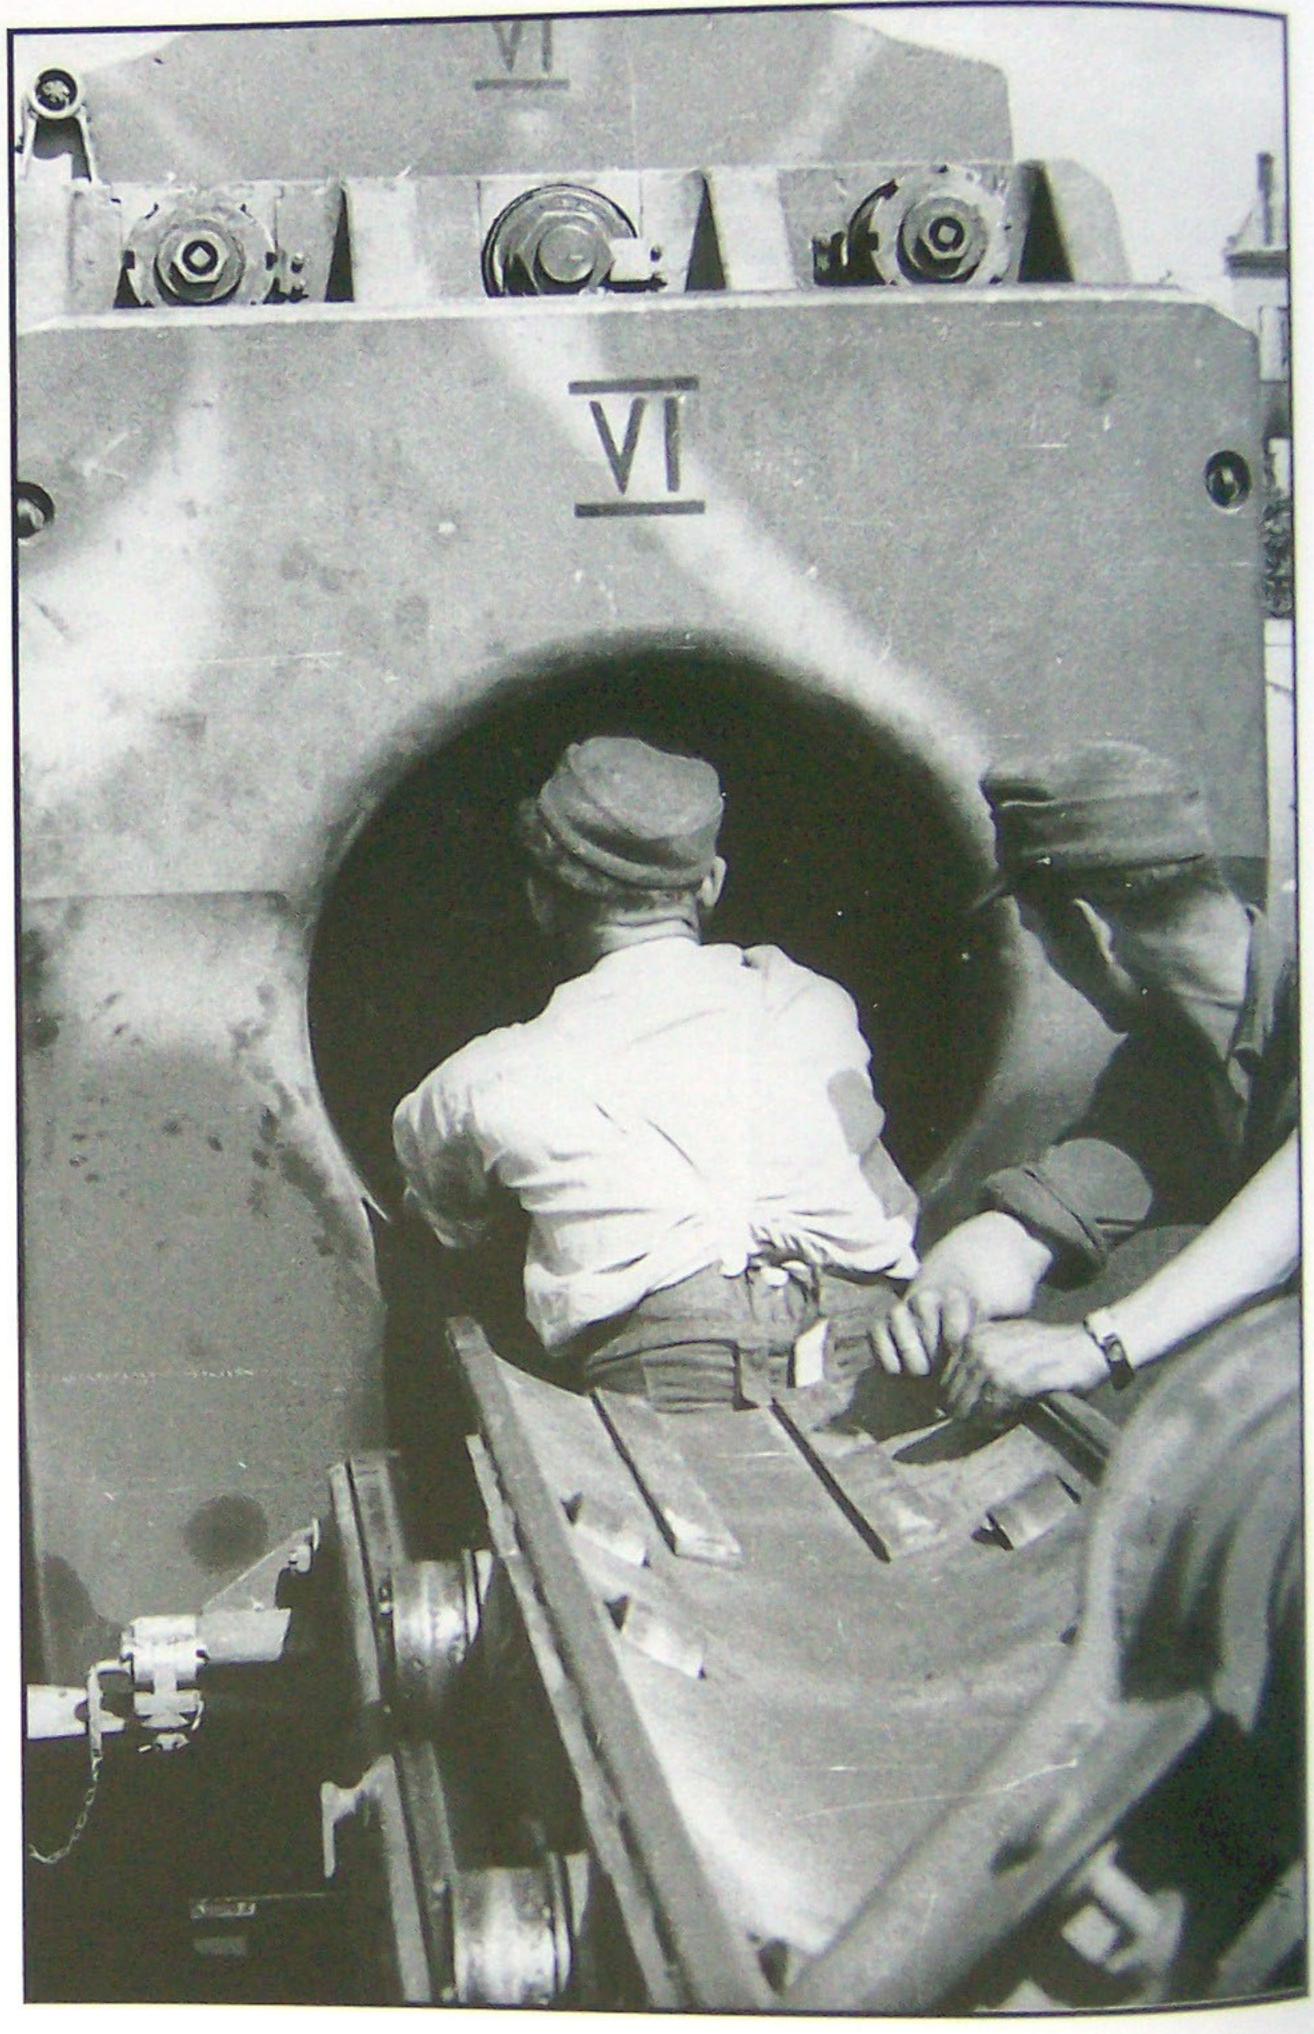
Interestingly, the Karl-Gerät had a separately actuated opening in the side of the breech to receive the charge for the shell. In the left shot, the charge is being added, while in the right shot the crew is checking the seat of the charge against the breech and the shell. Nine different charges were available for either shell type and for example, with charge four in place the concrete piercing shell could achieve a muzzle velocity of 220 meters per second. (BA)

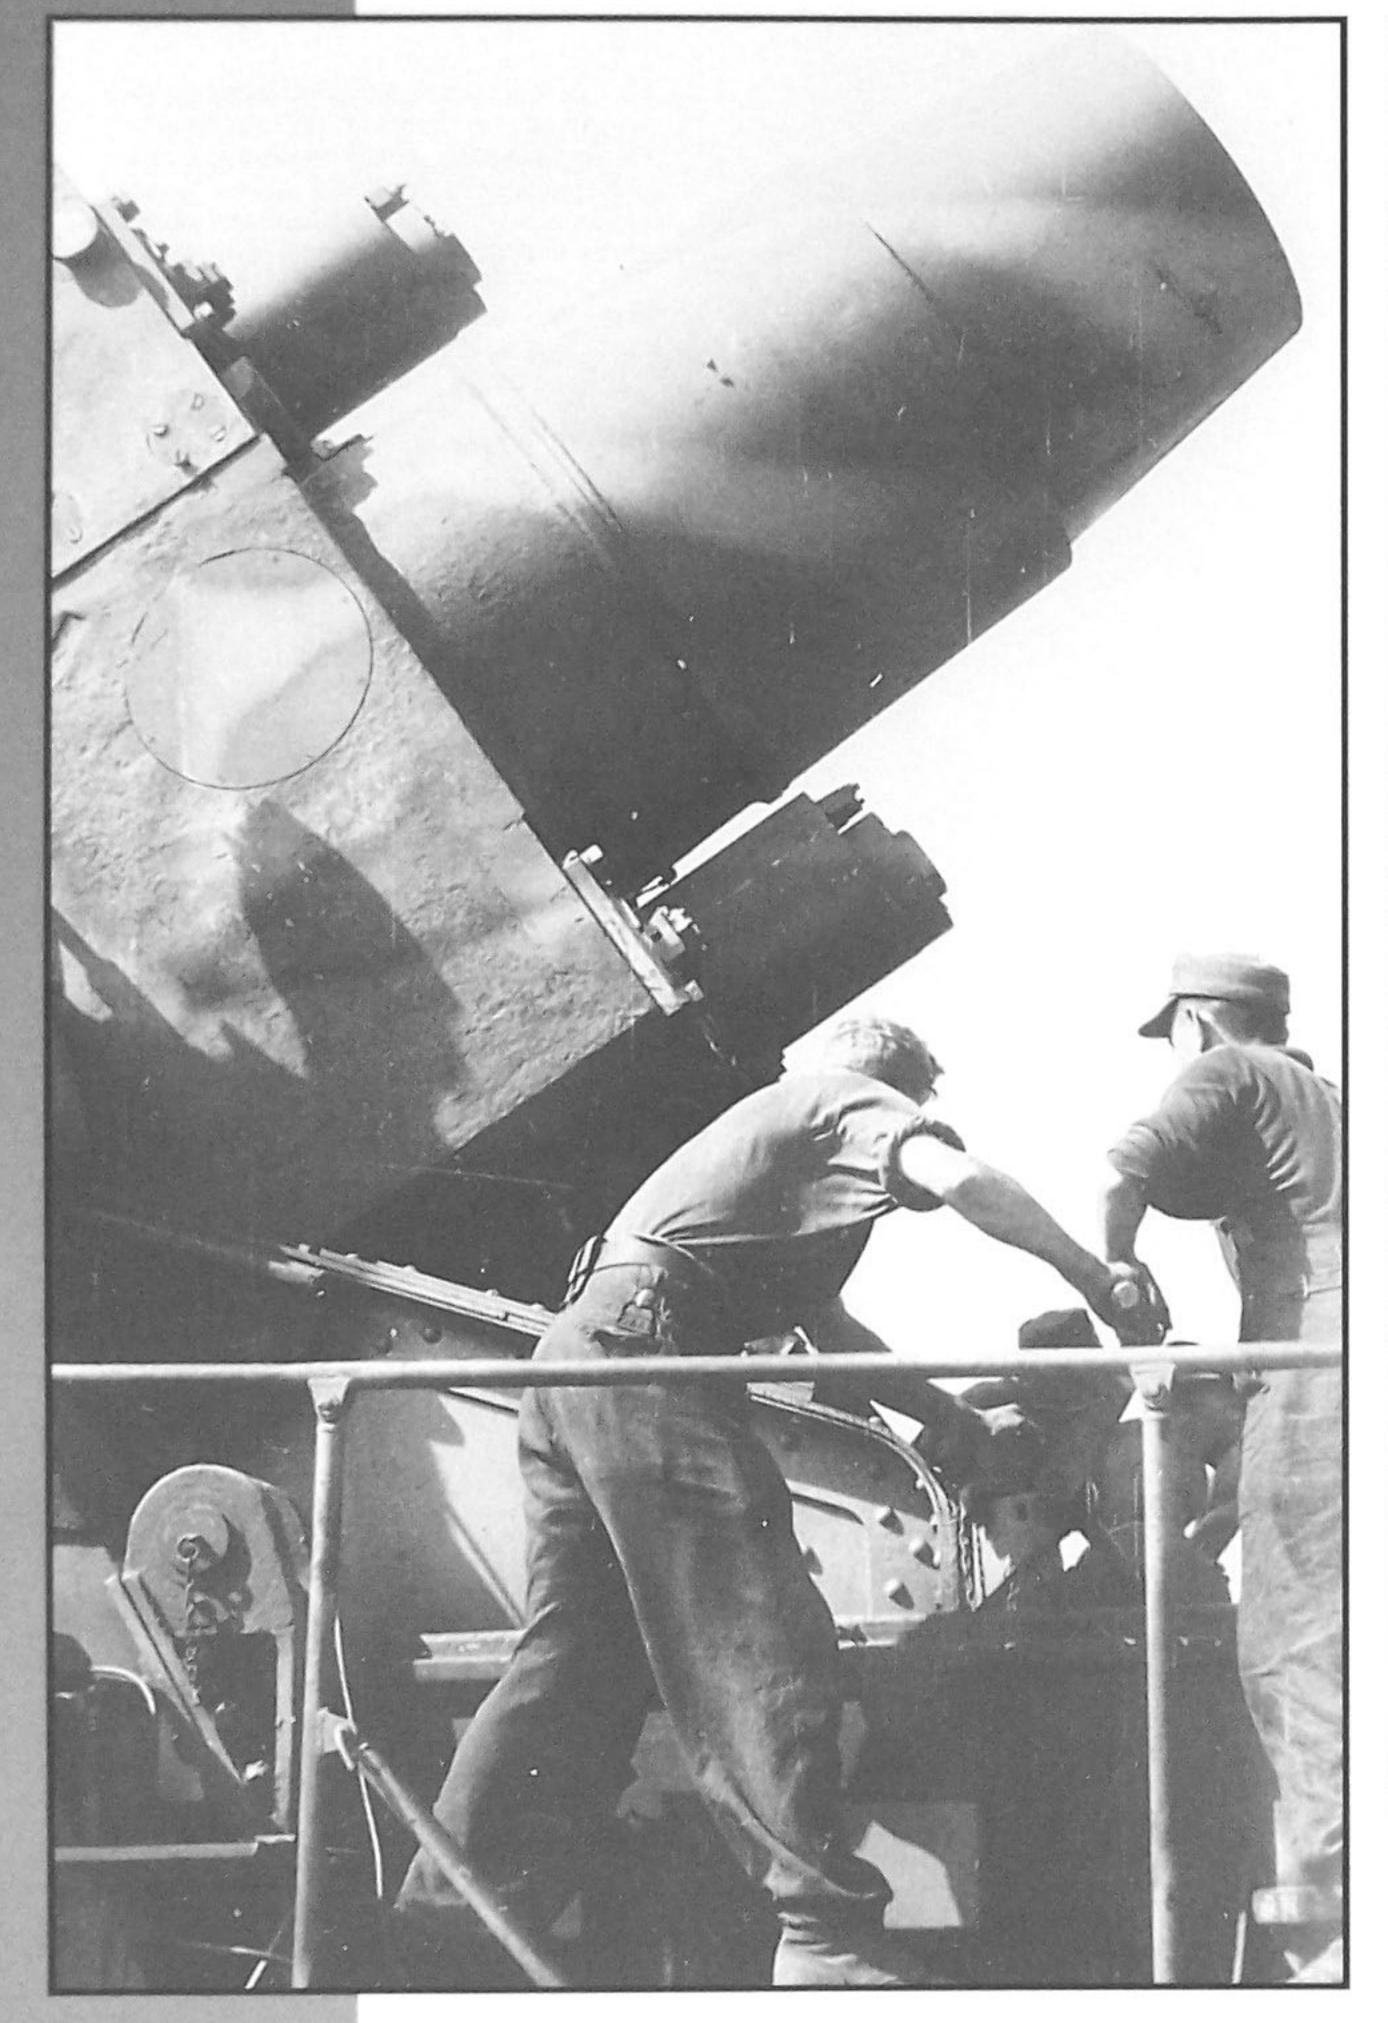
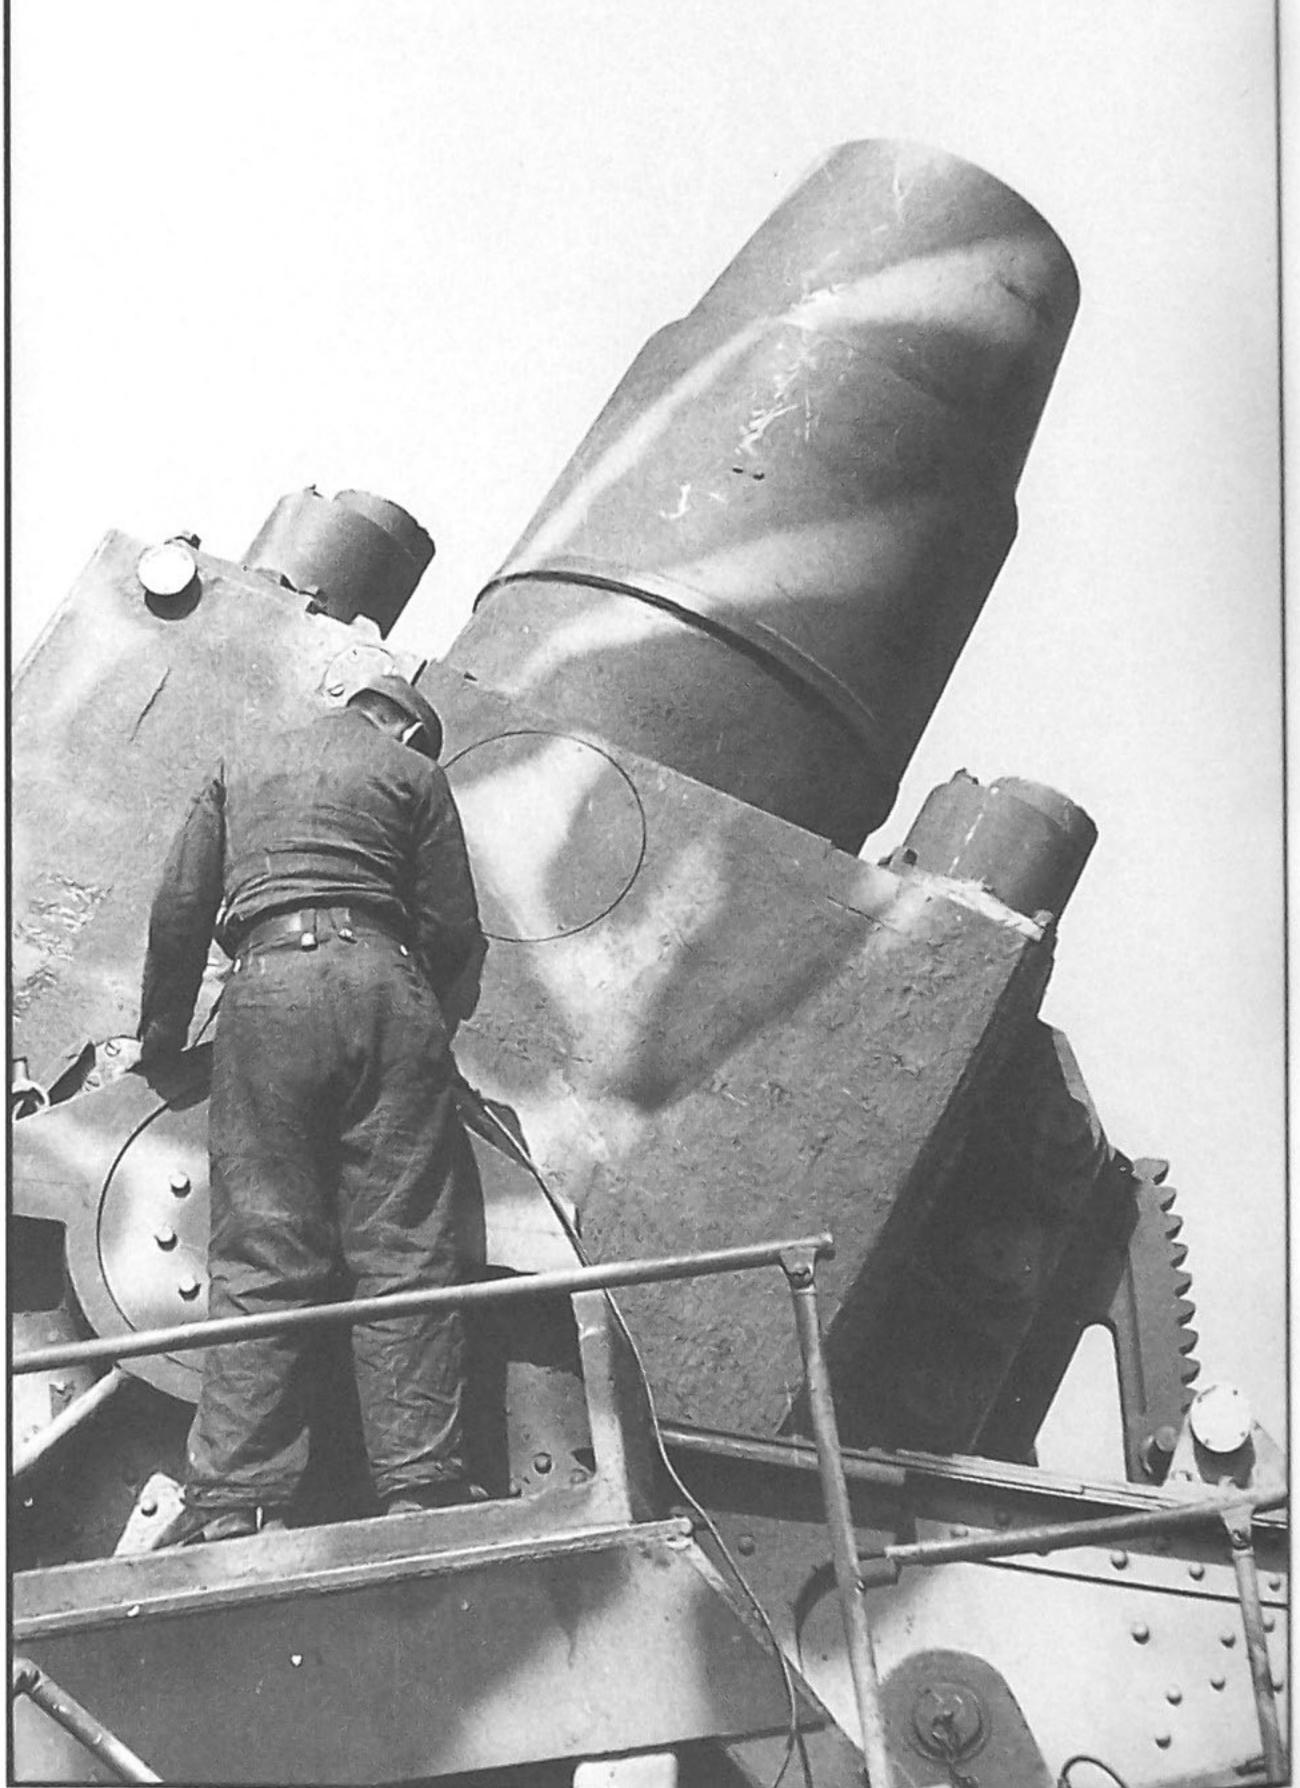
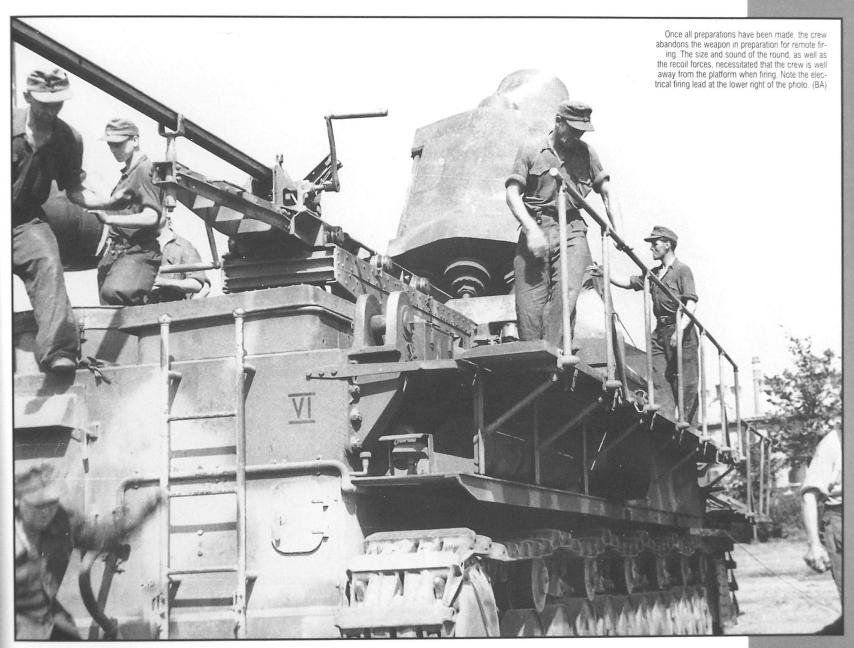
The gun tube length of the Karl-Gerät was just over five meters. The gun could elevate between 55 and 70 degrees, but could only be traversed four degrees. Larger adjustments meant moving the entire vehicle. However, using the main engine, the firing platform could be raised and lowered in only 30 seconds. A very careful and precise camouflage pattern has been applied to this gun. (BA)

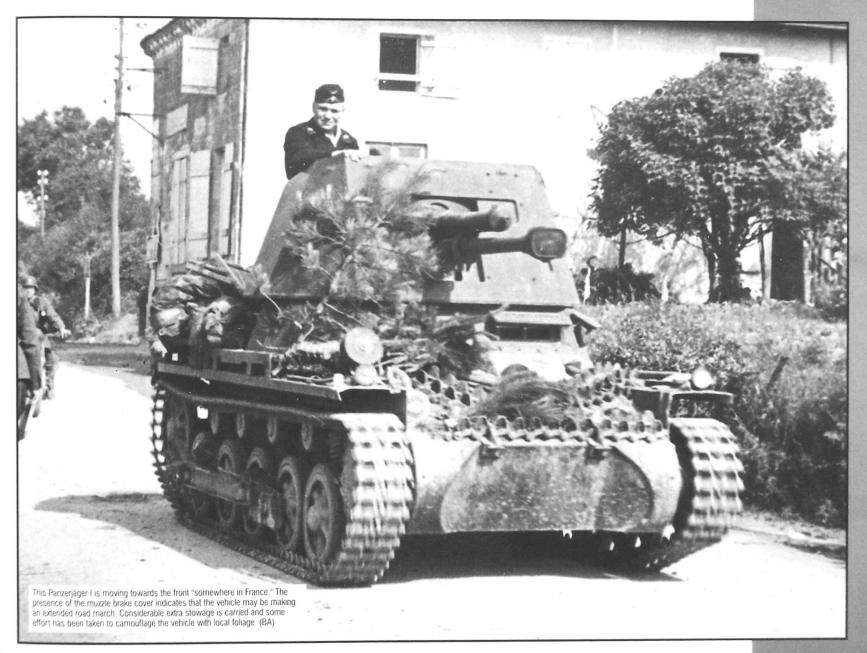
A vehicle of the 670 Panzerjäger Abteilung. This picture may have been taken near the Belgian village of Pommeroeul in late May of 1940. (BA)

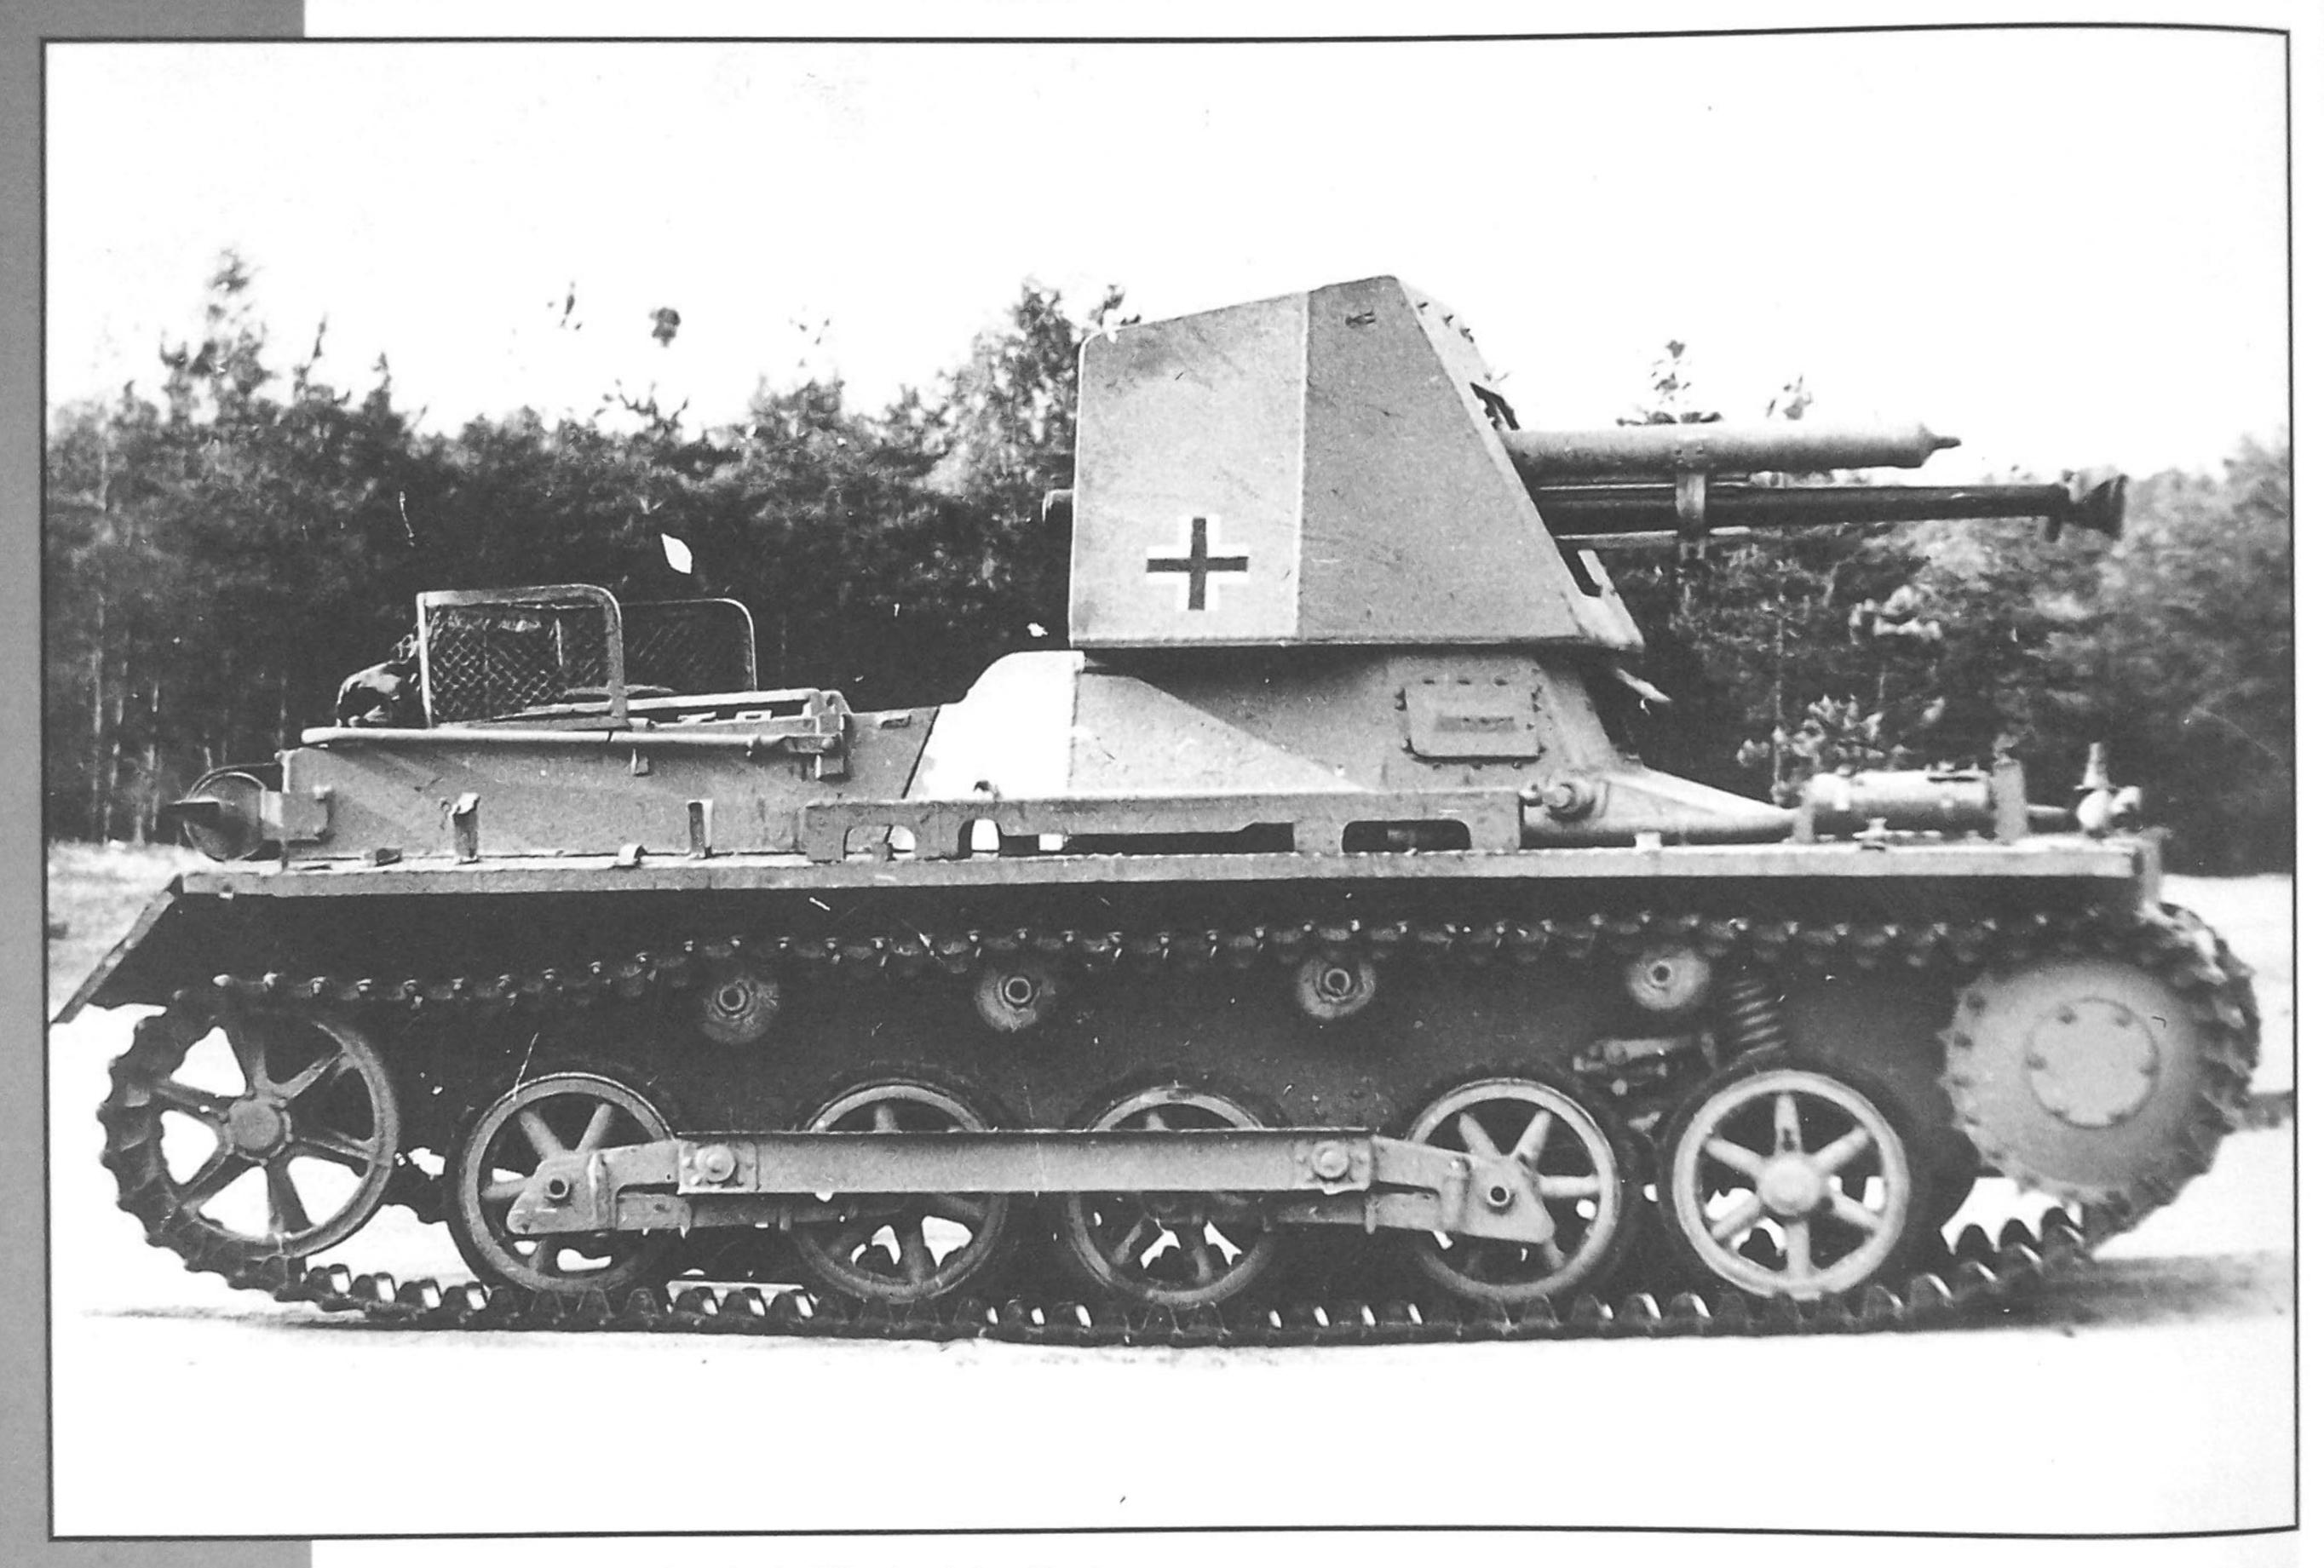
The British captured at least three Panzerjäger I at El Alamein and returned them to England for evaluation, where this photo was taken. They all had been assigned to the 605 Panzerjäger Abteilung. One of these vehicles was later sent to Aberdeen Proving Ground in the USA, where it remained on outdoor display for many years. (IWM)

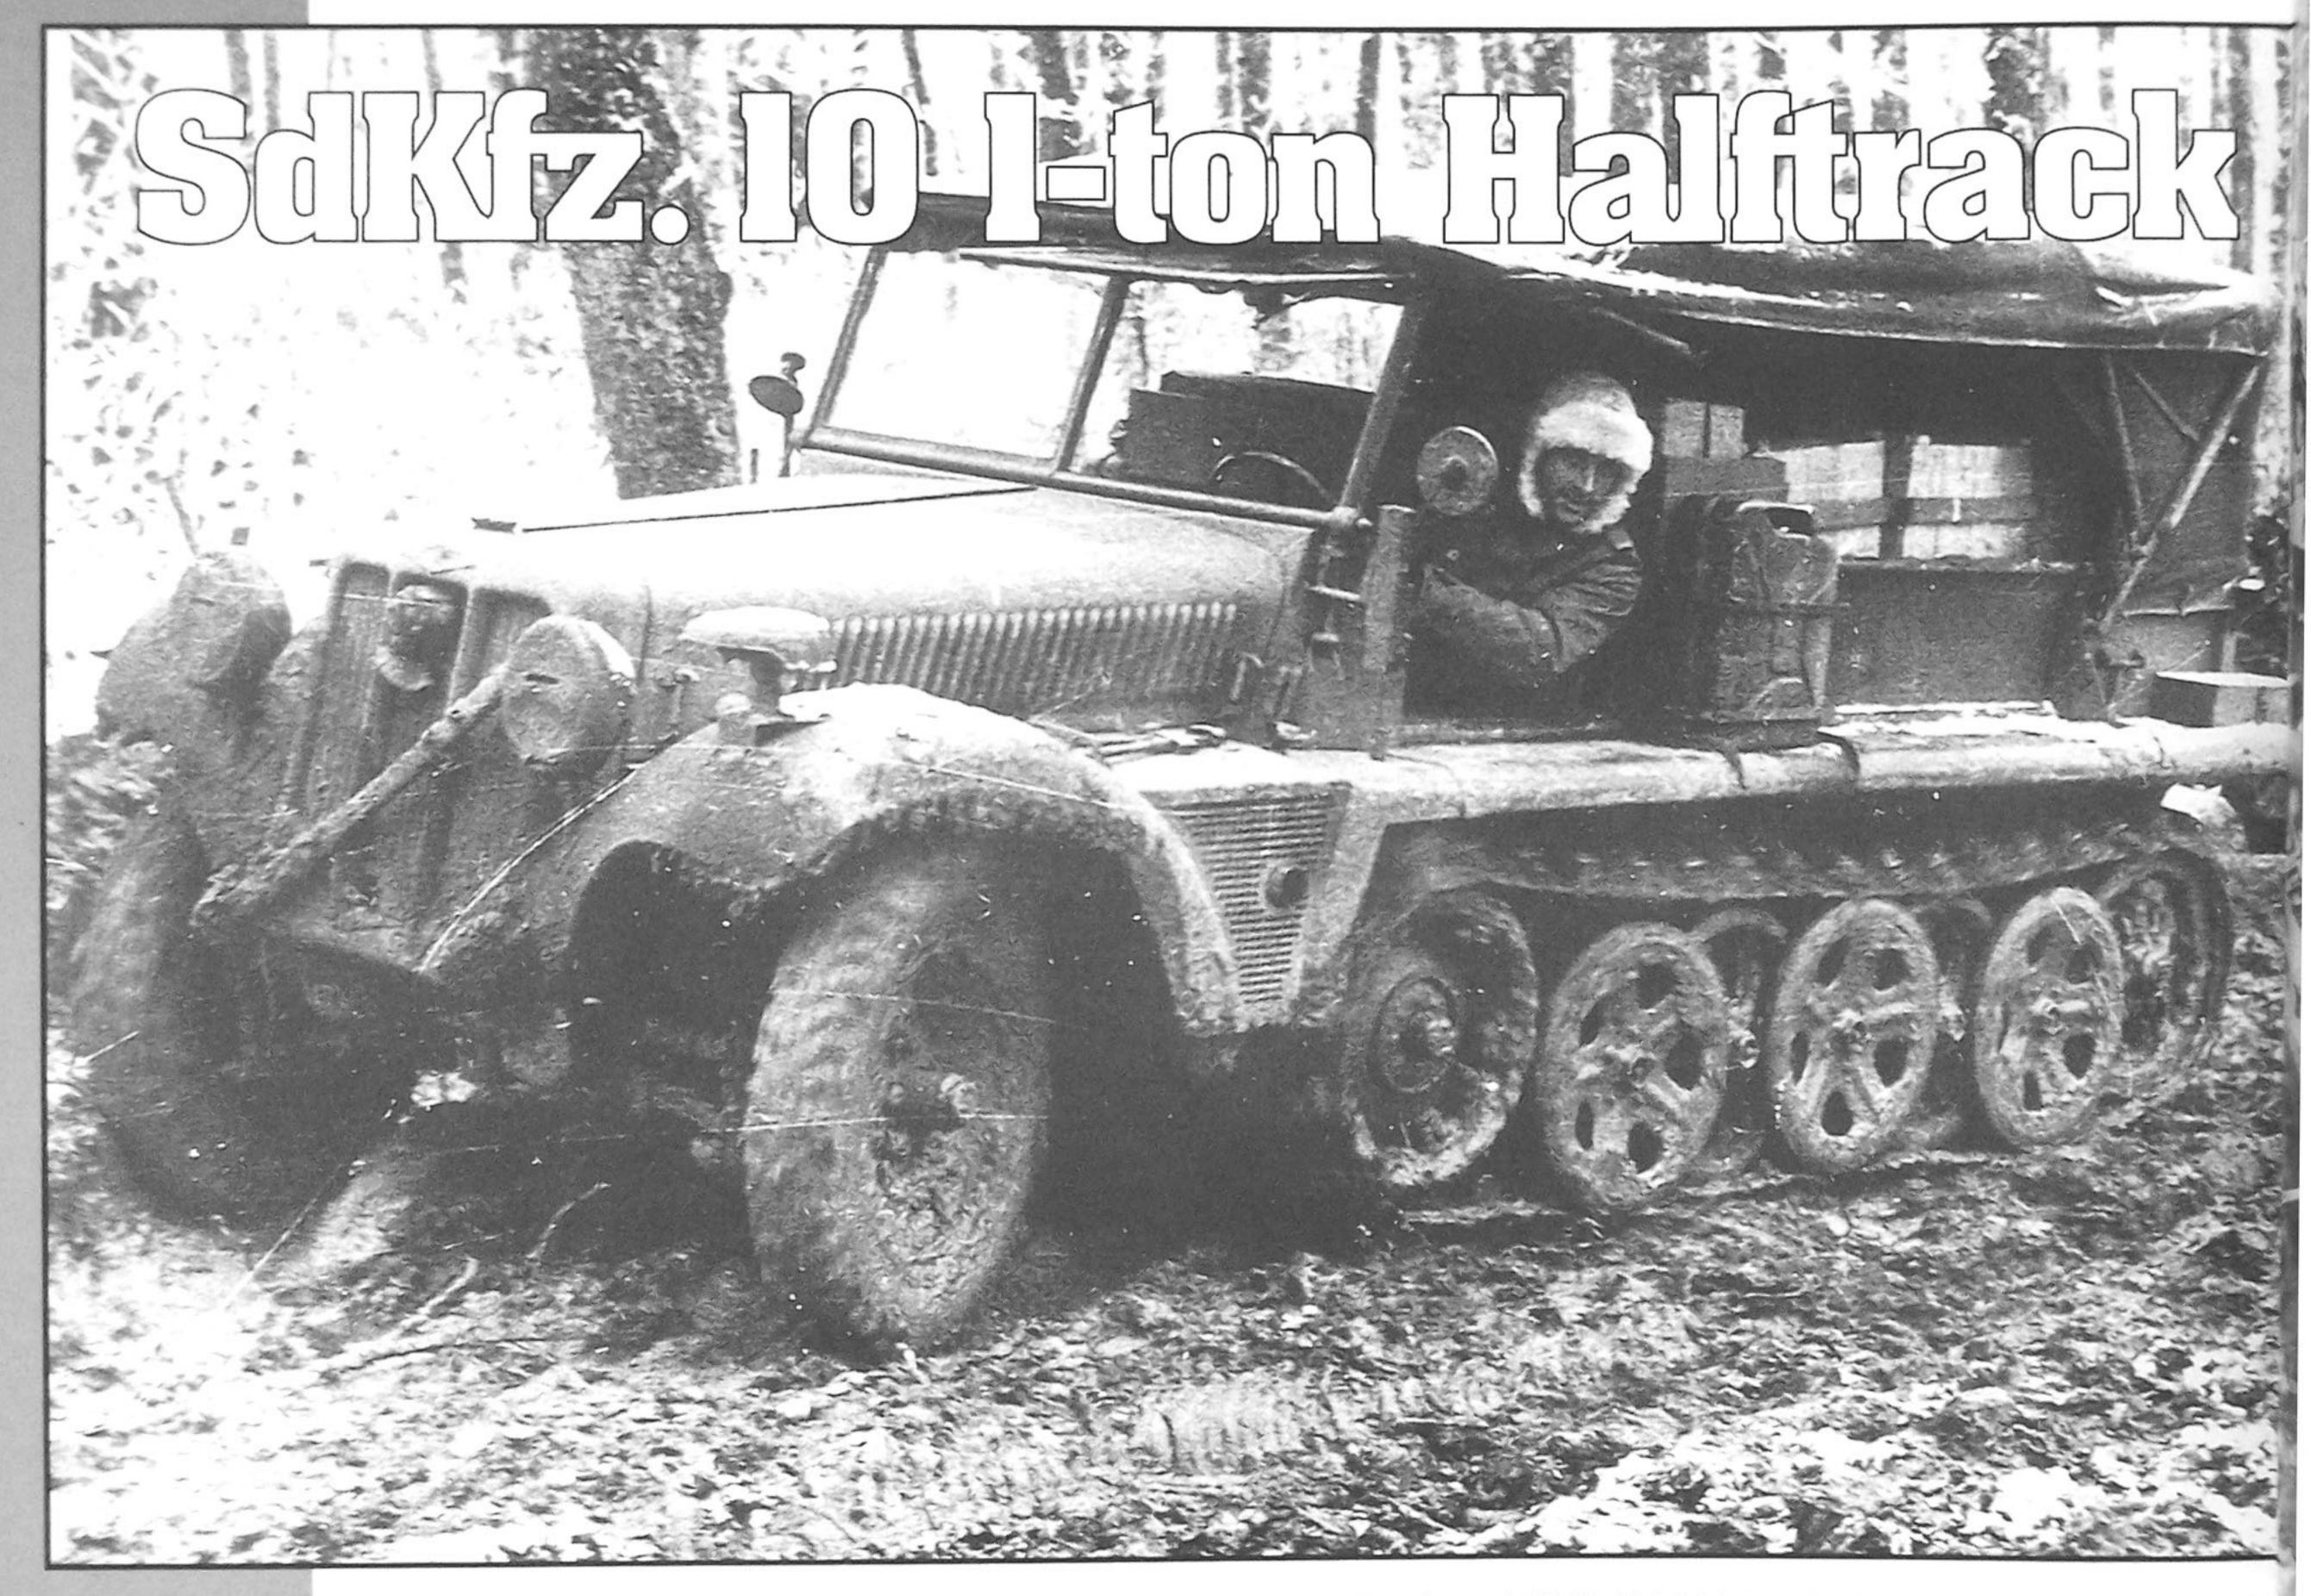
The SdKfz. 10 1-ton Halftrack was one of a number of specialized semi-tracked vehicles developed before and during the Second World War. Design of the SdKfz. 10 began as early as 1934, with several prototypes being tested. The vehicle utilized an unpowered front axle combined with a tracked rear drive composed of interleaving roadwheels and lubricated, padded tracks. The final production version of the vehicle was powered with a Maybach "NL 38" six-cylinder engine and was designated leichter

Zugkraftwagen 1t (Sd. Kfz. 10). Initial design and production was done by Demag AG of Wetter/Rubut later Alder, Bussing-NAG. Mechanisehe Werke-Cottbus and Saurerwerke also joined production French firms, such as Lorraine, Panhard, Peugeot, Renault, and Simca, also produced parts for the vehicle. This vehicle is seen in service on the eastern front during the winter of 1943/44. If properly maintained, the automotive performance of SdKfz. 10 was considered excellent. (BA)

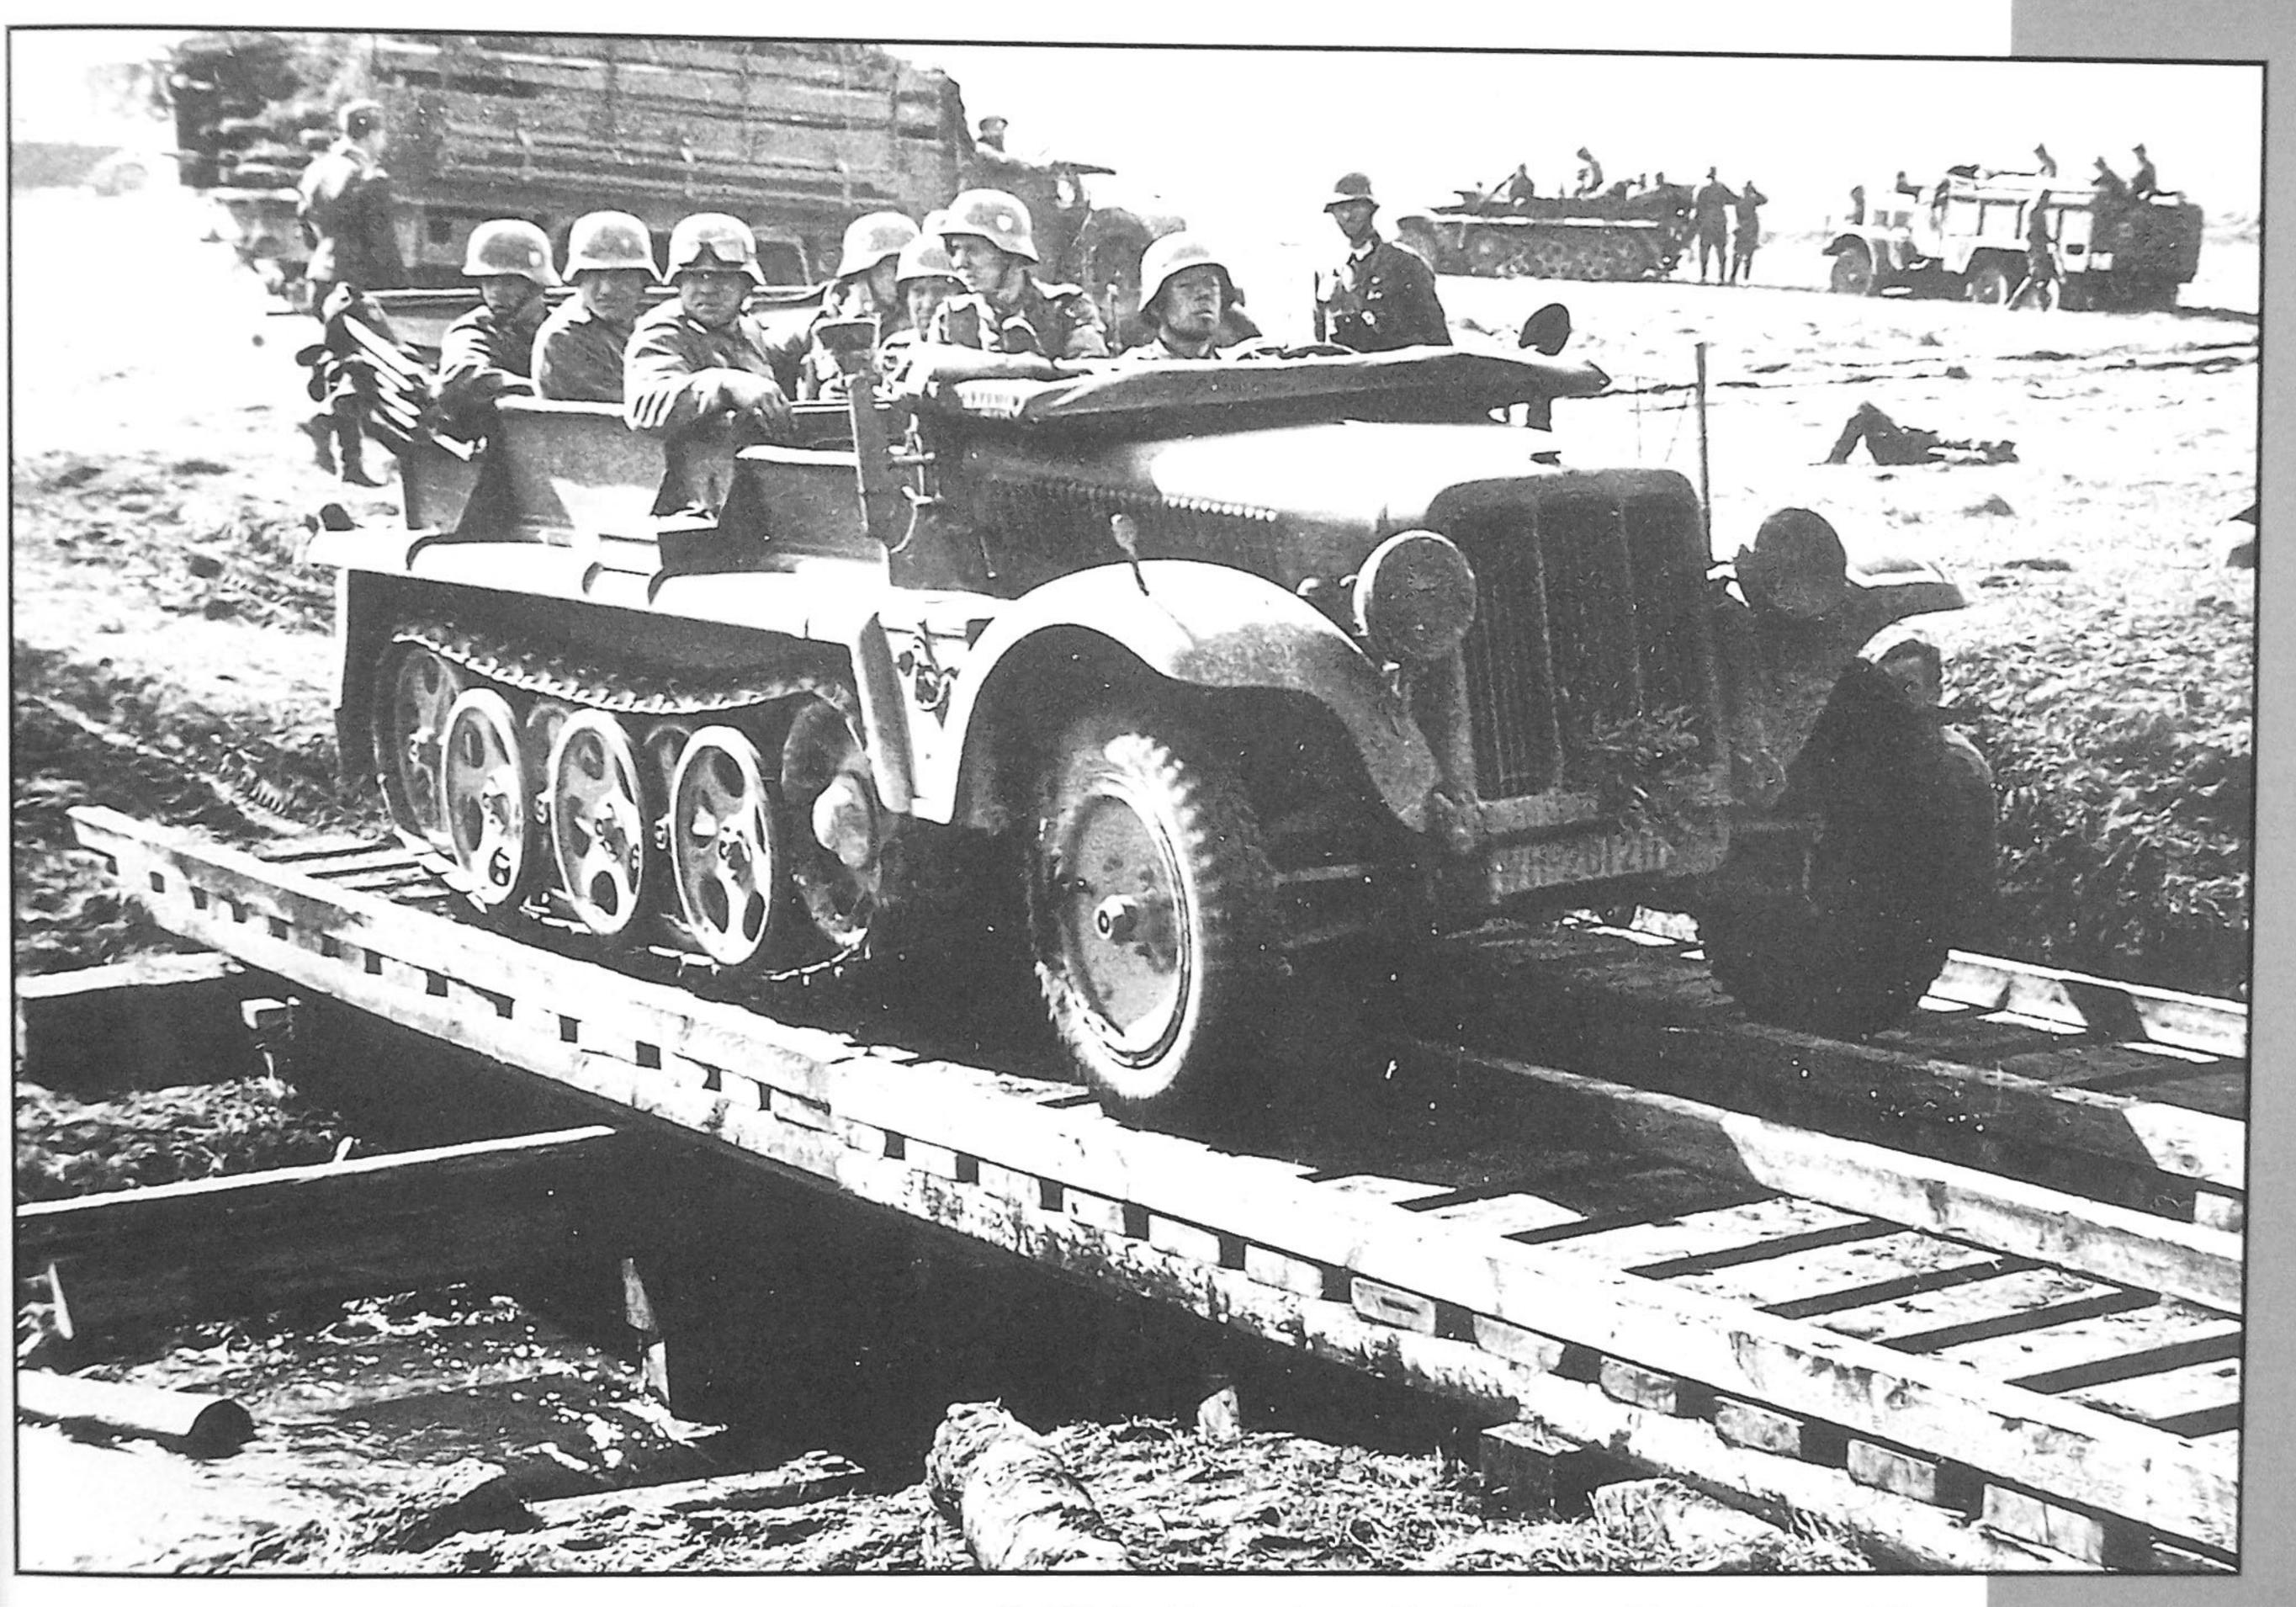
The SdKfz. 10 could accommodate up to eight soldiers under cover. This and its cross-county abilities made it a popular choice for HQ companies. This vehicle is seen crossing a wooden bridge in Poland on September 12th 1939. A full canvas cover is provided to protect the wind screen glass while it is in the lowered position. (BA)
