Allied-Axis

THE PHOTO JOURNAL OF THE SECOND WORLD WAR

Contents

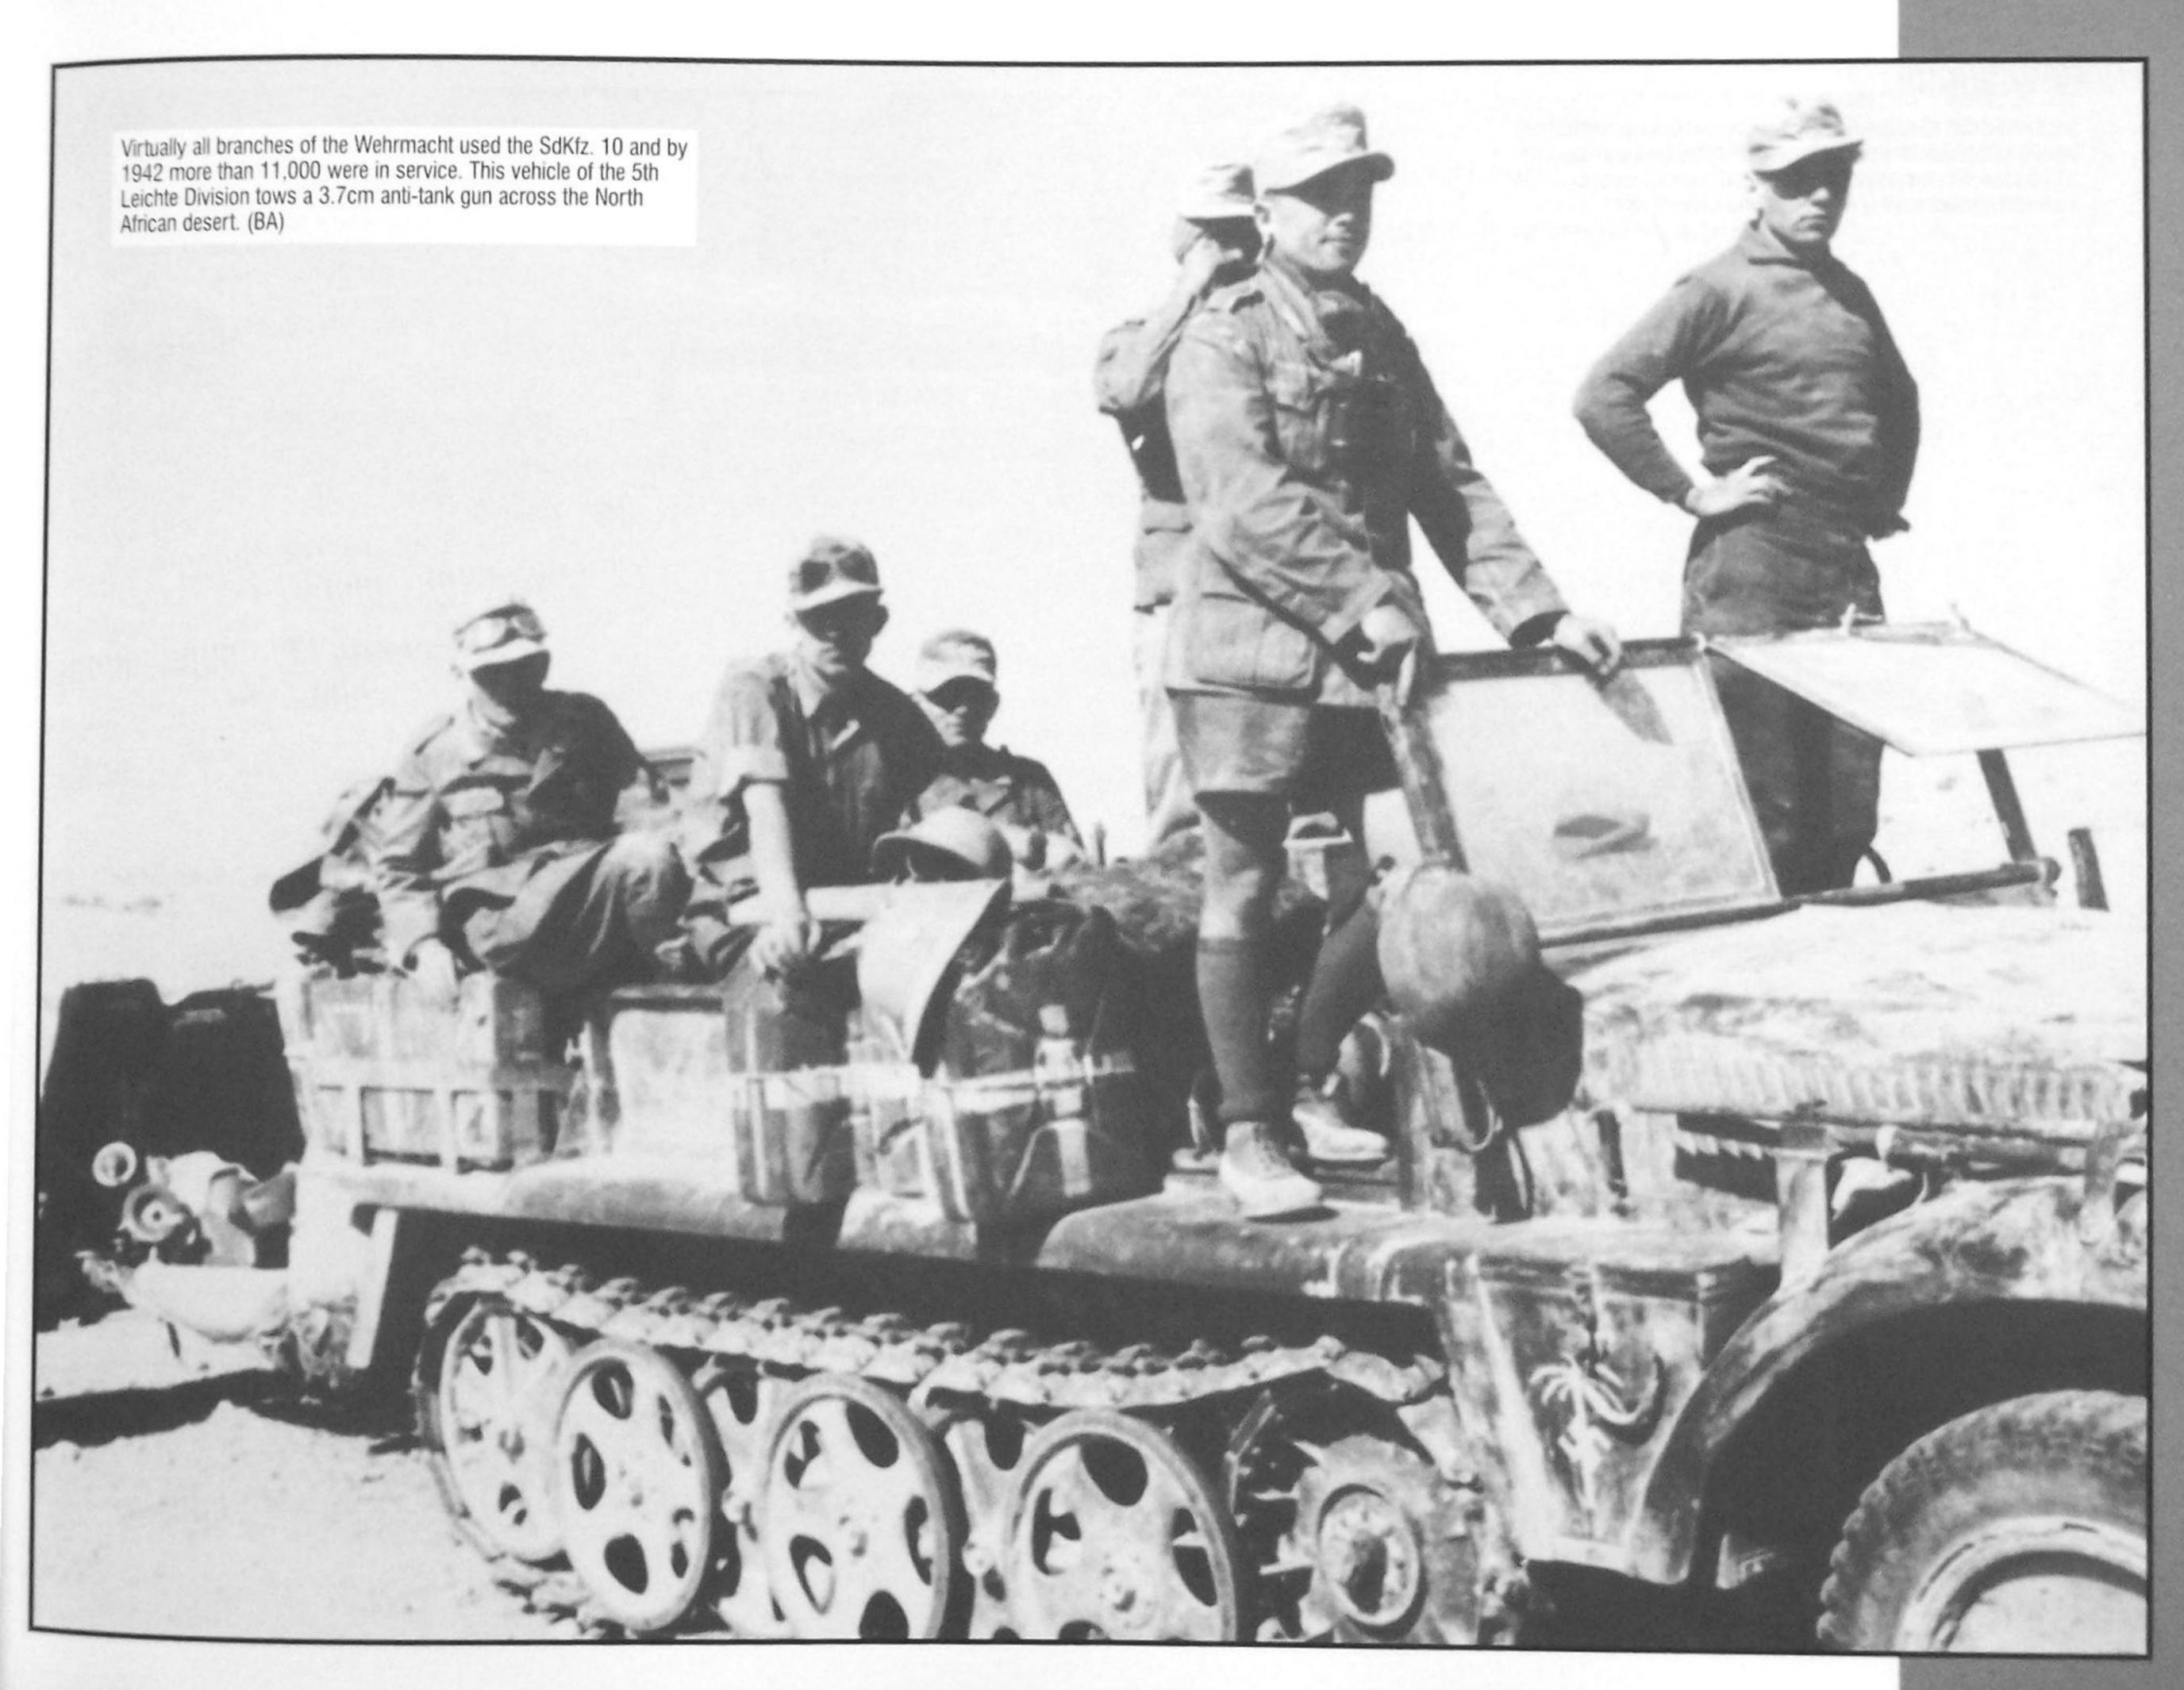
Another SdKfz. 10 of the 5th Leichte Division is seen here towing a 5cm PaK38 L60 anti-tank gun. Although the PaK 38 was not in service when the SdKfz. 10 was developed, it was the perfect towing vehicle for that weapon. (BA)

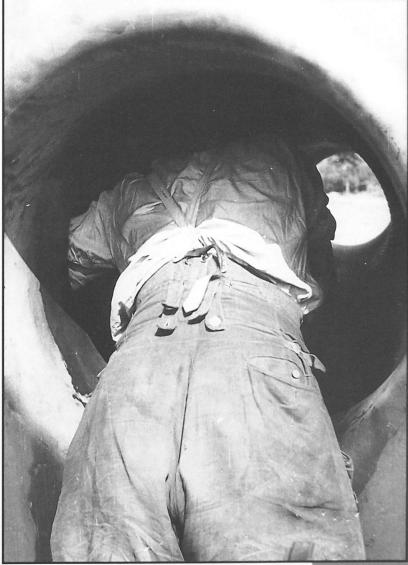
Above left: Prior to firing or loading a careful inspection of the barrel rifling was conducted. Any defects in the bore could effect the round's ability to land accurately, or even fire at all. (BA) Above right: The immense size of the bore is illustrated clearly here. (BA)

Because of the small number of guns produced, it is possible to trace the combat action of individual guns. The following series of photos depicts Karl-Gerät Number VI "Ziu," firing on Warsaw during the late summer of 1944. Karl-Gerät Number VI was part of Heeres Artillerie Batterie (bo) 638 at that time.

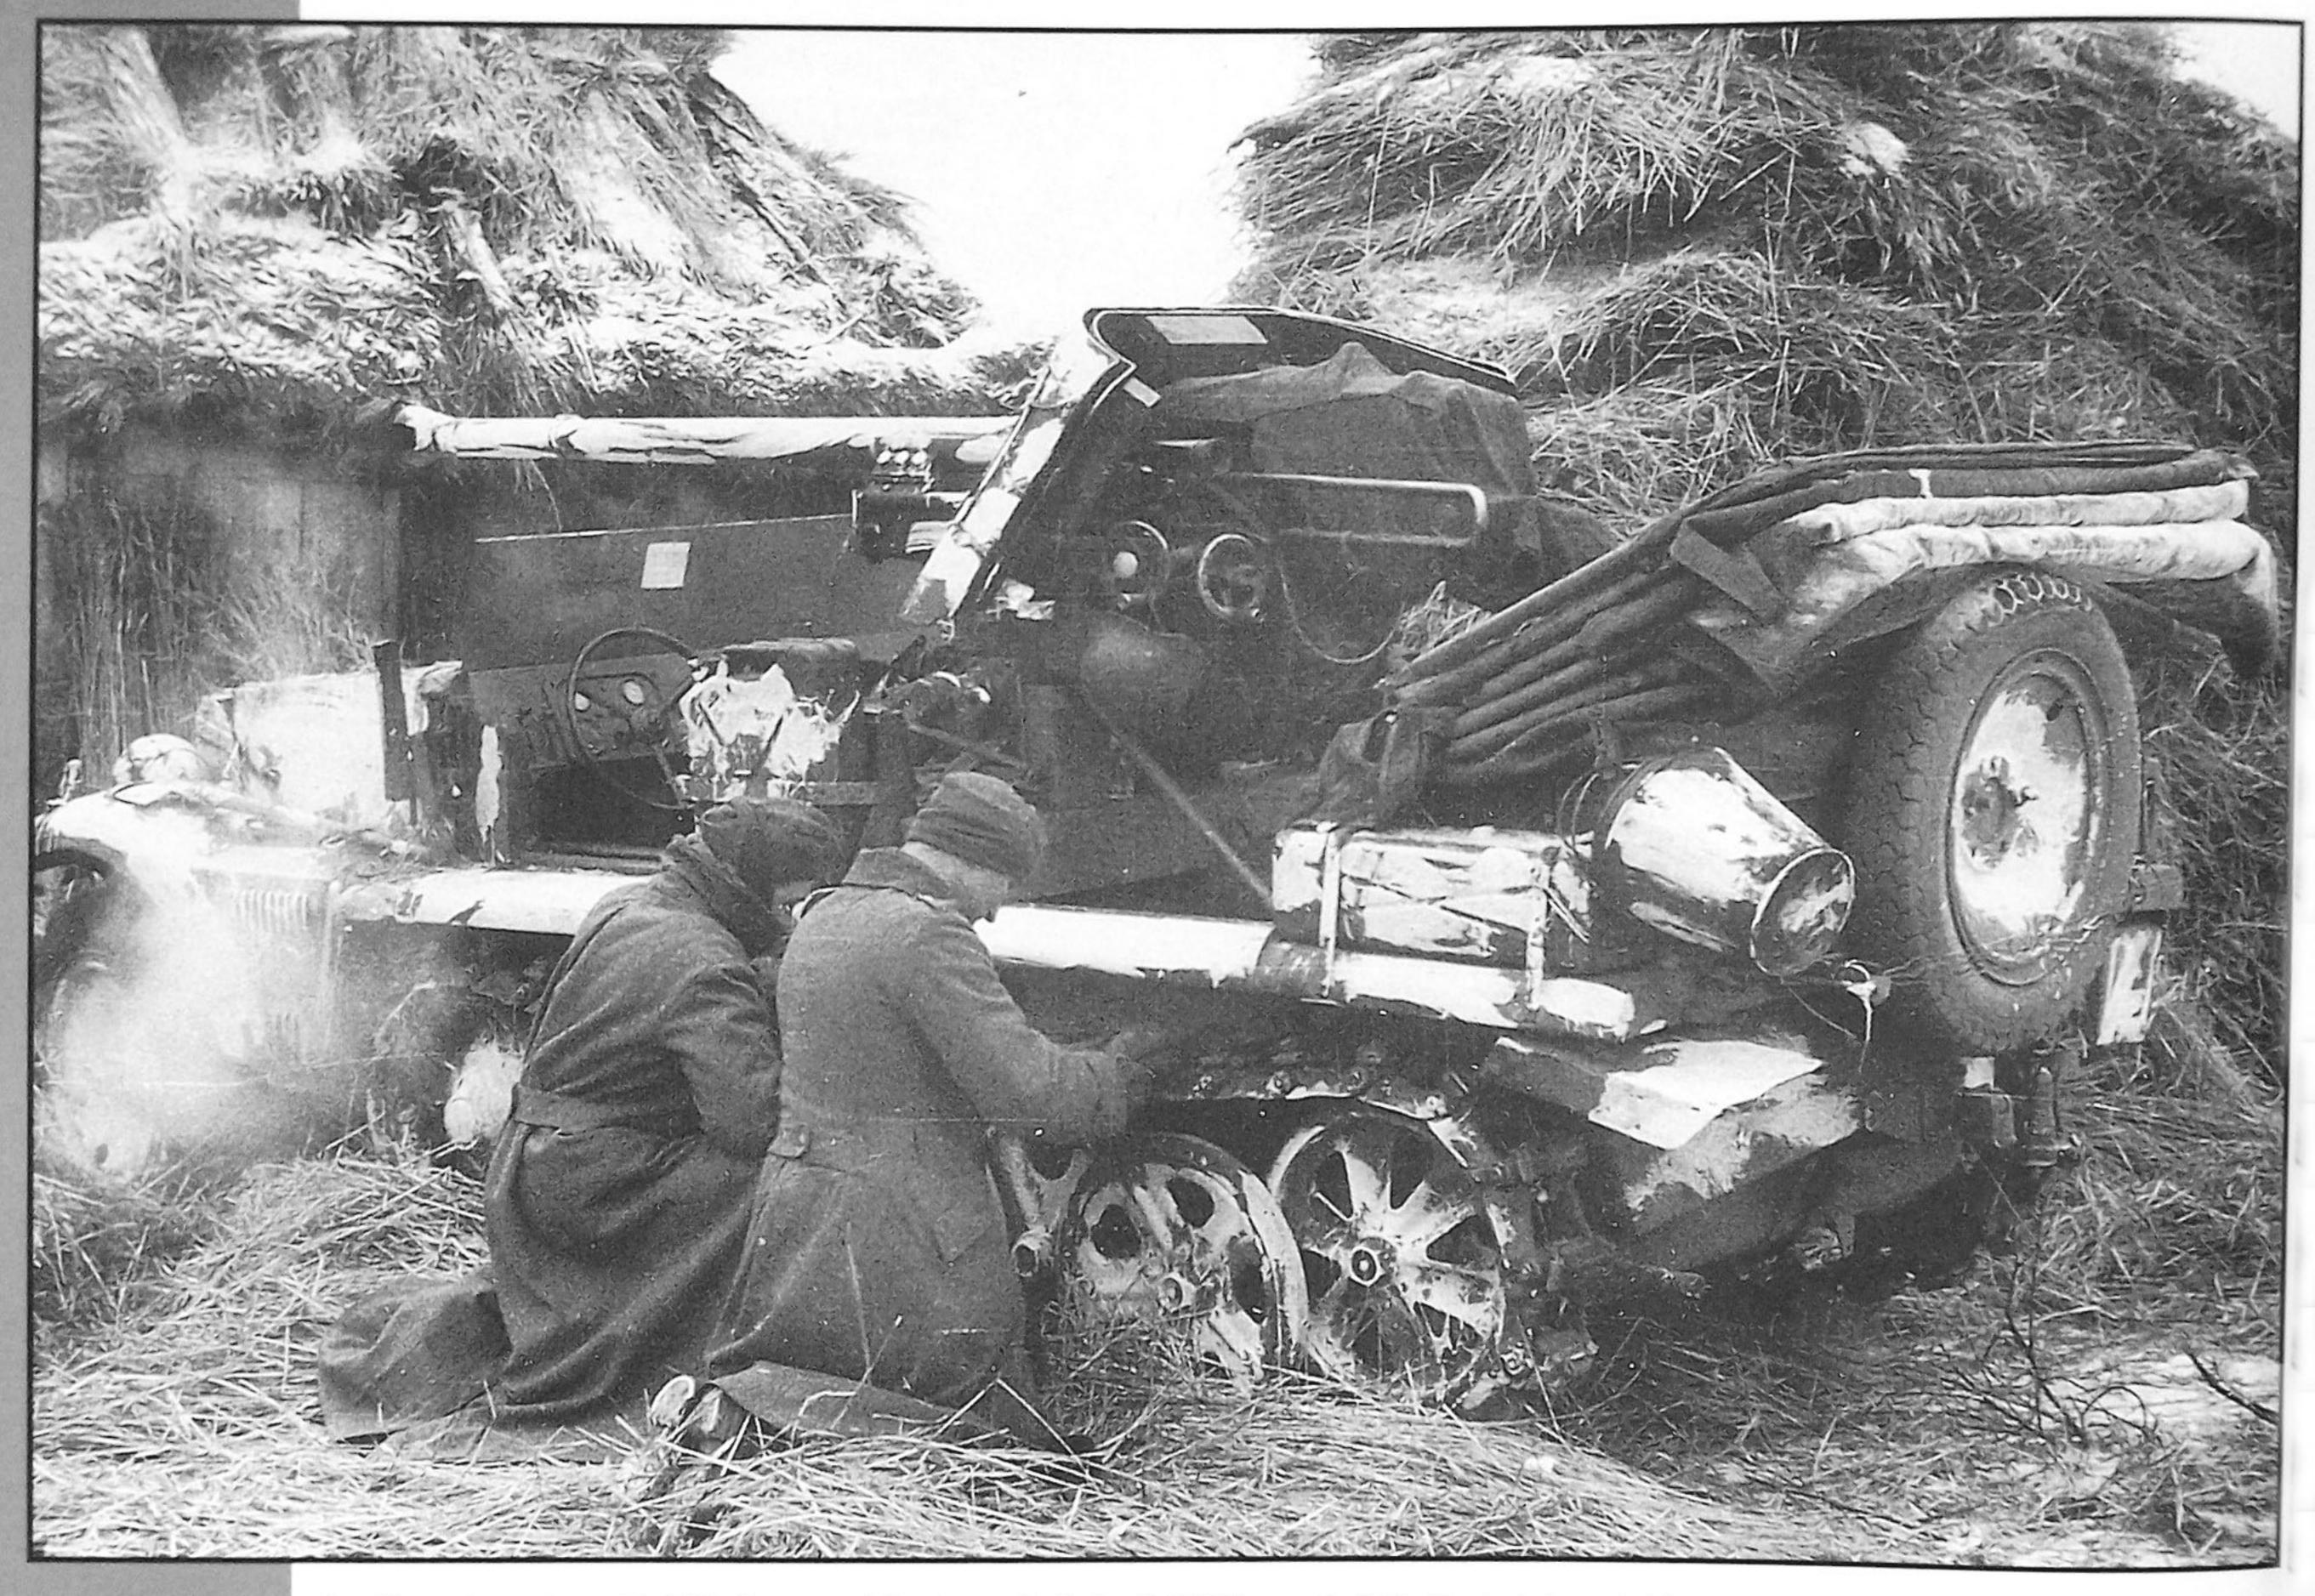
One of the most unusual uses of the SdKfz. 10 was as a platform for mounting the 5cm PaK38 L60 anti-tank gun. The gun was placed on a steel crossbeam that was laid across the rear crew compartment. The gun was used complete, minus its wheels and trails. Armored plate was added to the radiator housing and the windshield in a manner similar to the SdKfz. 10/5. This was a unit made conversion of

the SdKfz. 10 and not a true variant. It appears to have been limited to use within Waffen SS units. It is interesting to note that in this photo and others the entire soft-top has been retained to give both the gun and the crew some protection from the elements. (BA)

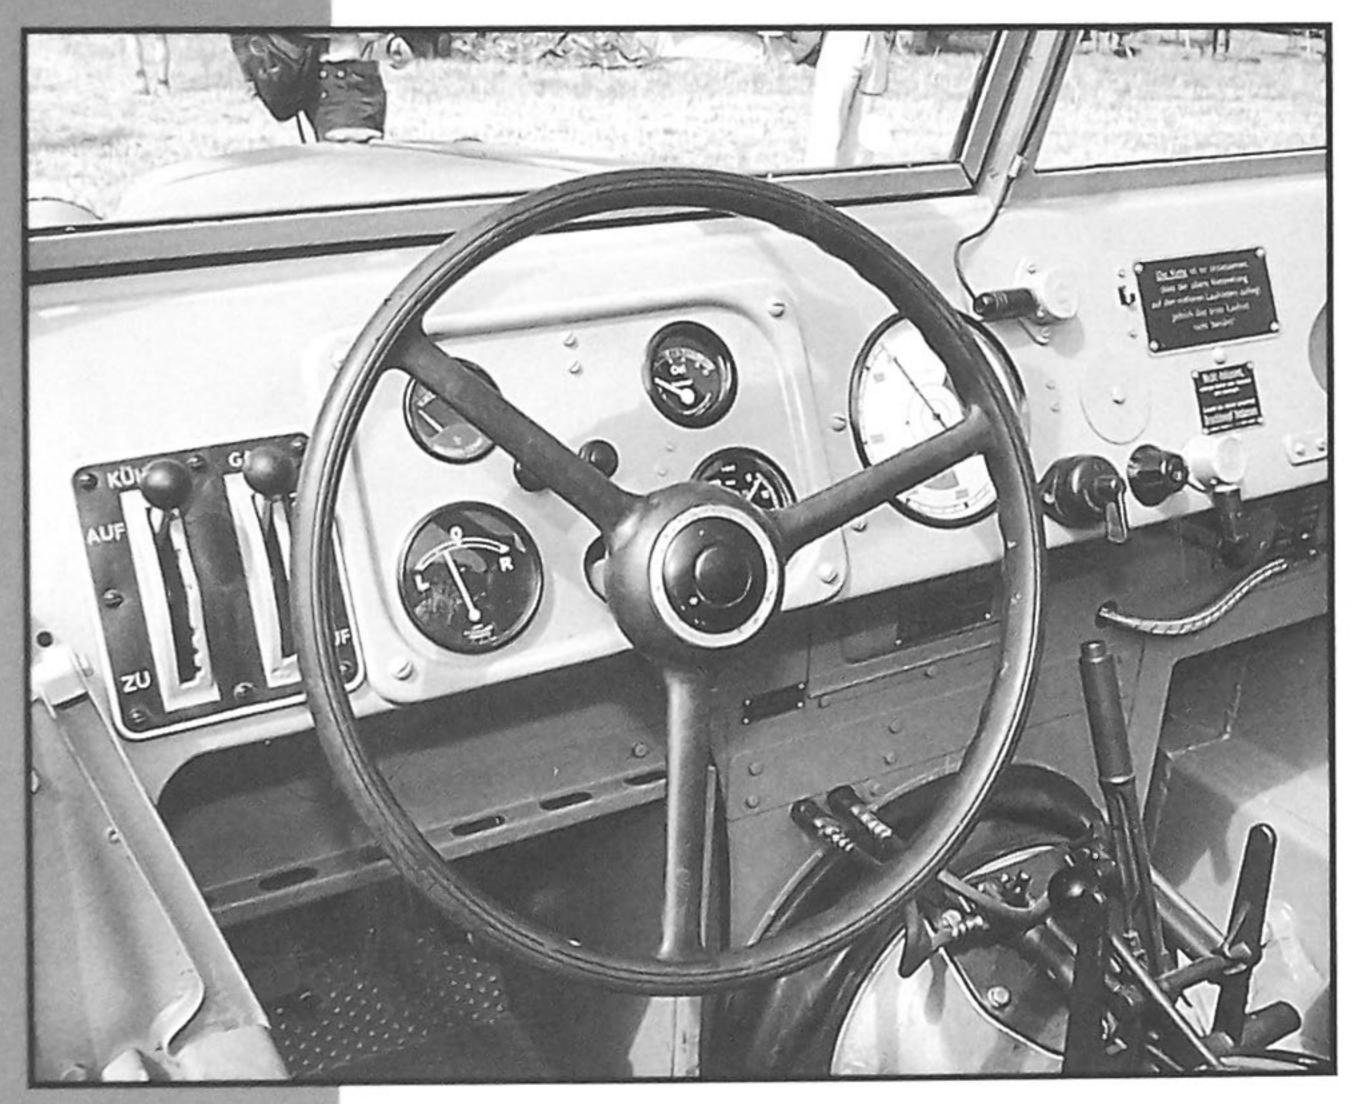
Top left and right: Two views of the front crew compartment showing the overall layout of the dashboard. Left: A close-up of the steering wheel and instrument panel. Above: A close-up of the central portion of the dashboard. The central placard reads "The track is not to be engaged while the top run is on the roadwheels, only the first roadwheel can be affected." The smaller placard reads "Do not start as long as the engine or starter is moving" and "As soon as engine starts, release starter button."

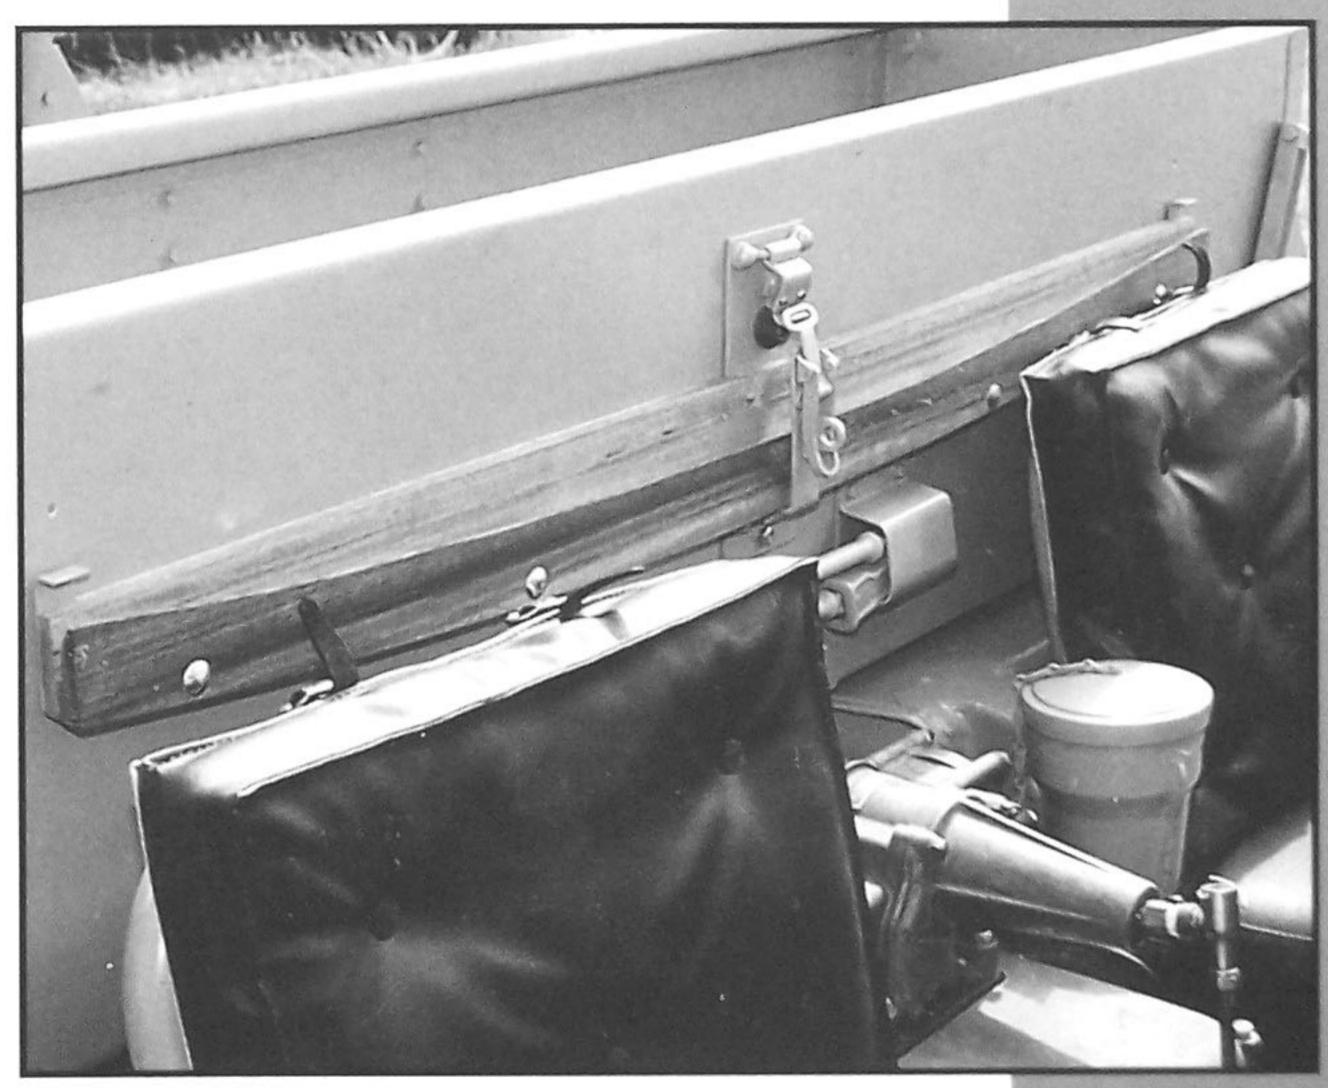
Top left: The cockpit and the crew area were divide by a large stowage box and this shows the layout of the items attached to the back. The racks on either side for securing rifles (note the butt-rack on the floor of the vehicle) and the object in the center is the jack and its handle. **Top right:** A close-up view of the left-hand rack. **Left:** A close-up of the jack and its mount. **Above:** The crew area was fairly spacious and could easily accommodate six individuals and their personal gear.

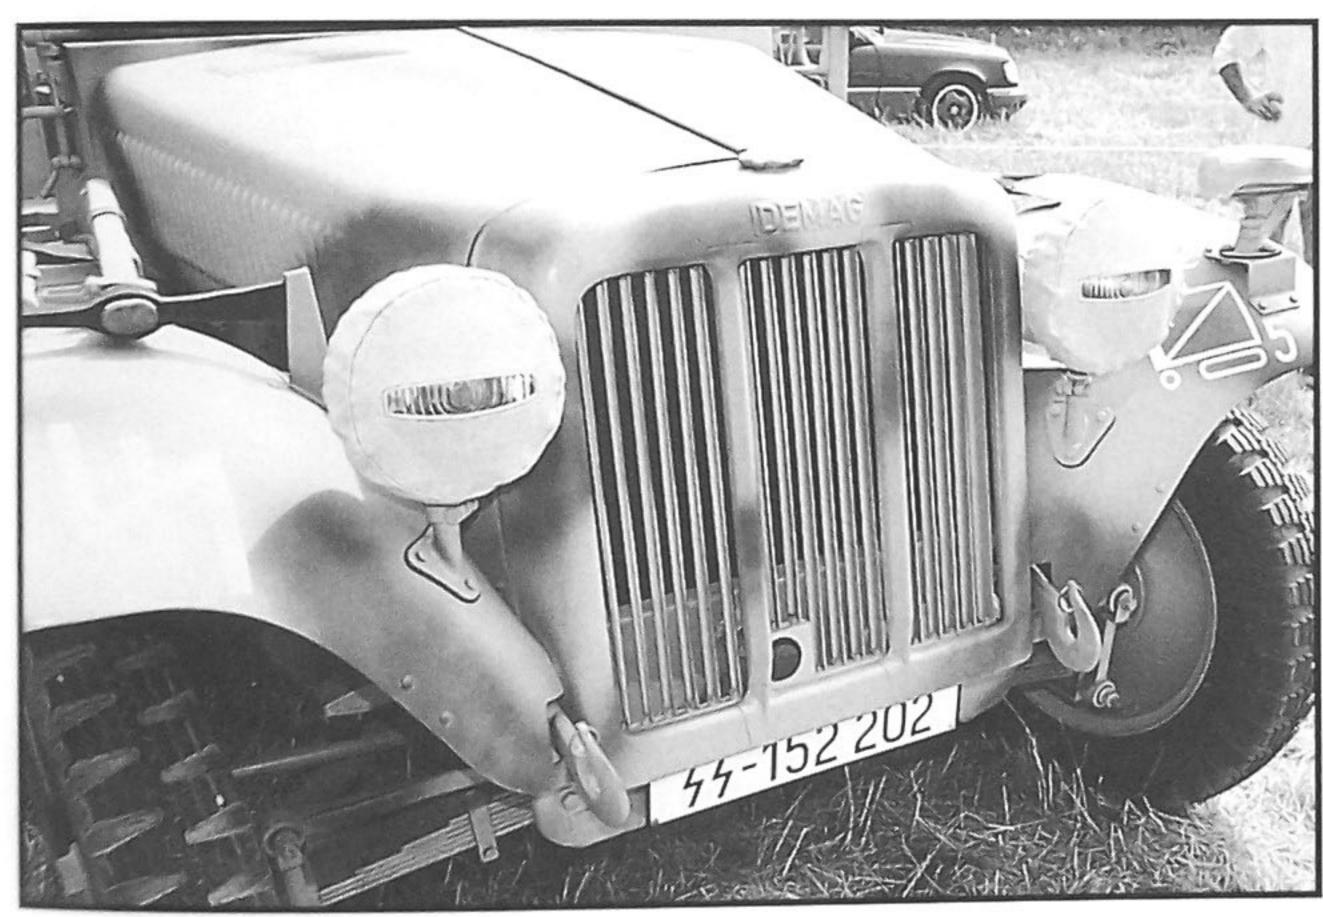
Top left: The DEMAG stamp on the radiator housing. Note the shape of the cap. Right: A close-up of the front right headlight. Note the design of the canvas cover and the amount of glass that shows though the cover. Above: An overall view of the front of the vehicle.

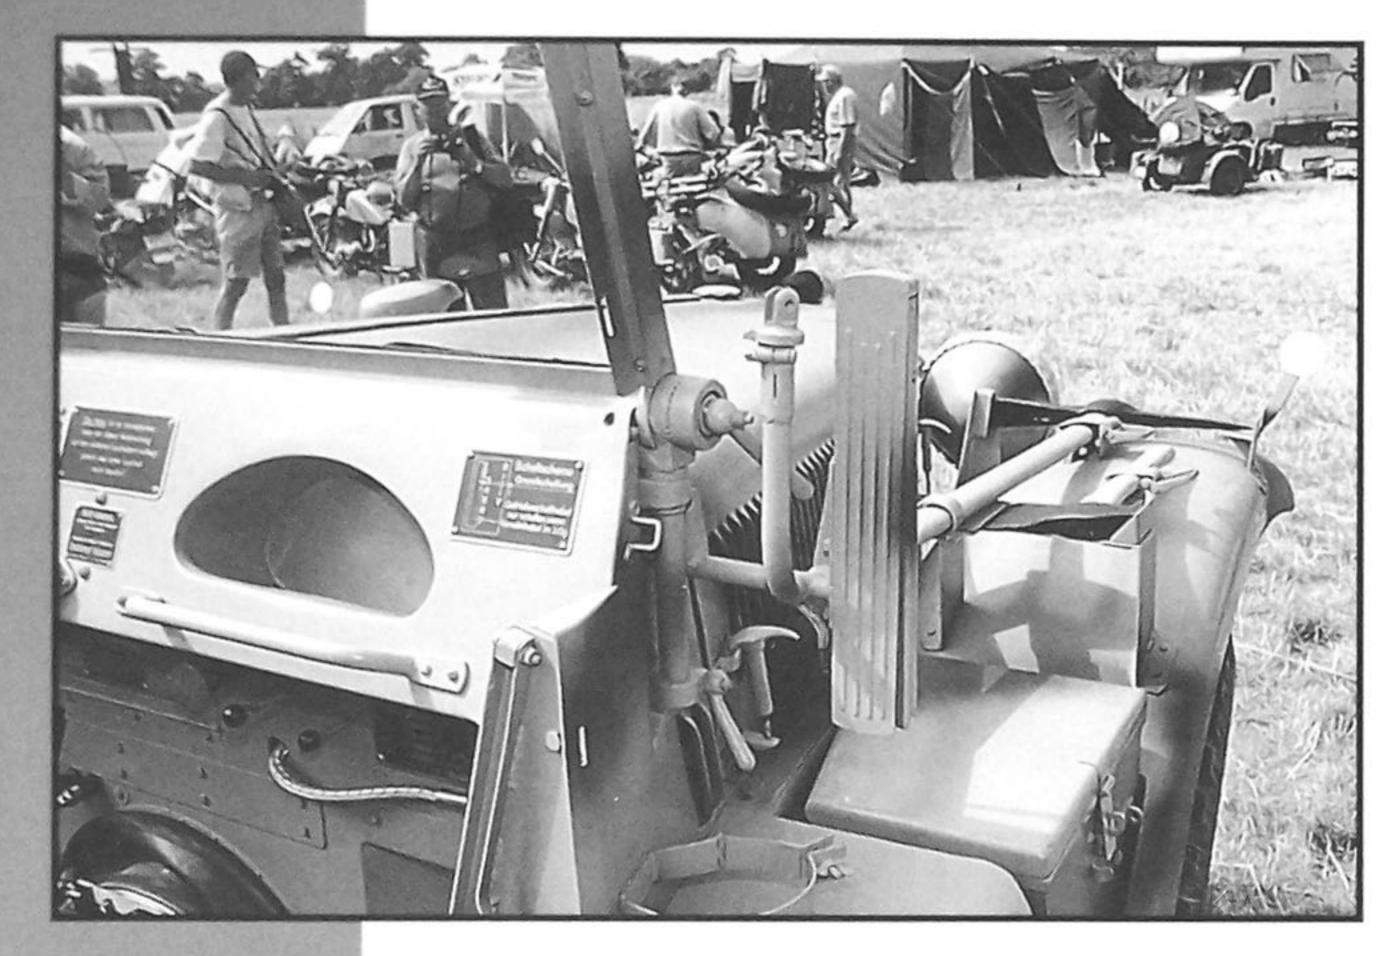
Top left: The right hand turn signal. A lever next to the steering wheel actuated it. The signal itself is actually a brightly colored wooden band housed inside. Top right: The front left tow hook. The small ring was used to secure tow cable to keep it from popping off when slack. Left: The tool suite (pick and ax) and stowage box on the right front fender. Above: A view from the front. Note the tire pressure marking on the fender.

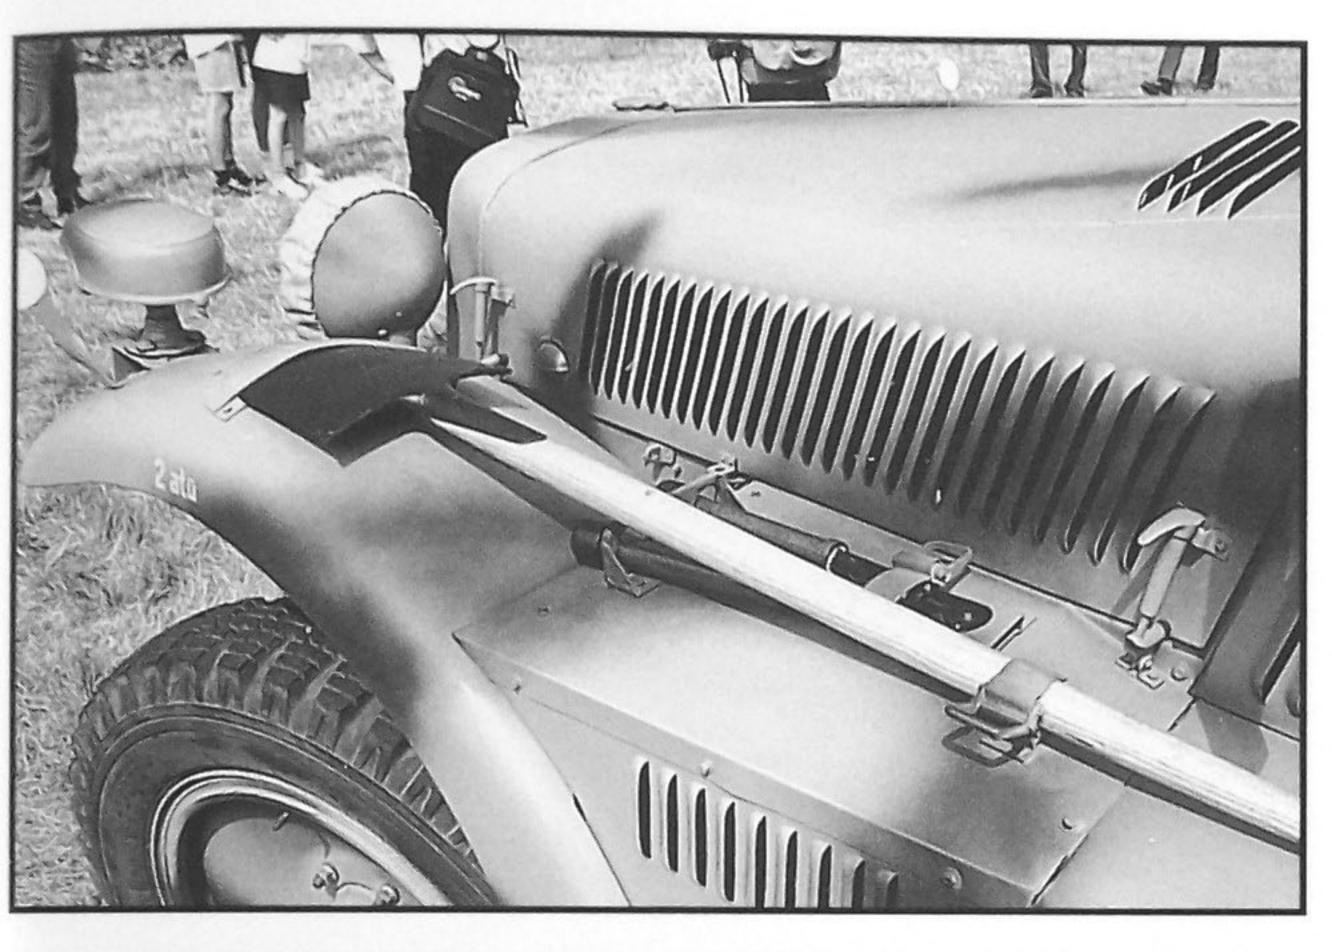
Top left: The spade and wire cutter stowed on the front left fender. Top right: Sheet metal distance markers were found on the front of both fenders. Above and right: Separate views of the spring clamps securing the engine cover, front on the left, rear on the right. A total of four were used. Both shots also illustrate the precisely stamped venting seen on the SdKfz. 10.

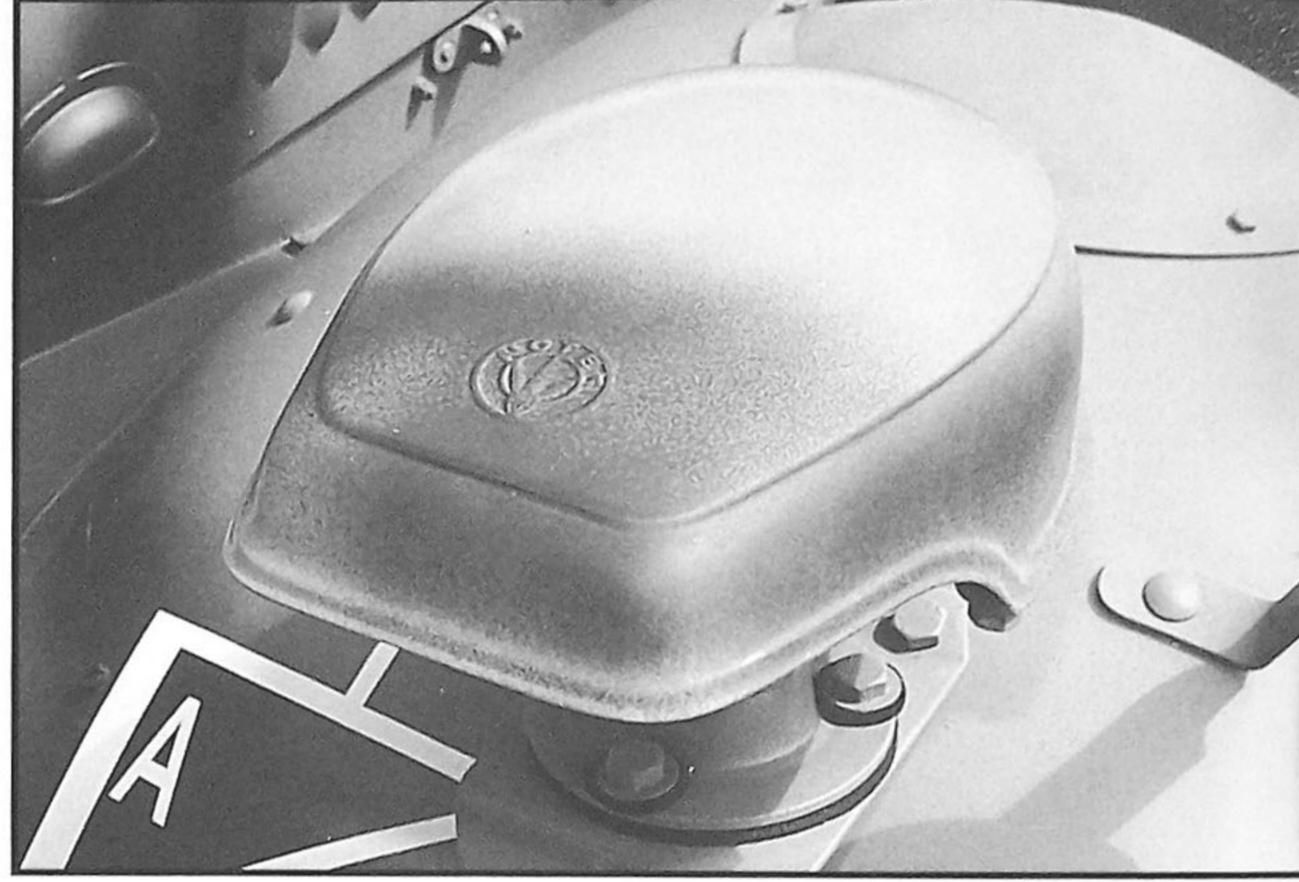
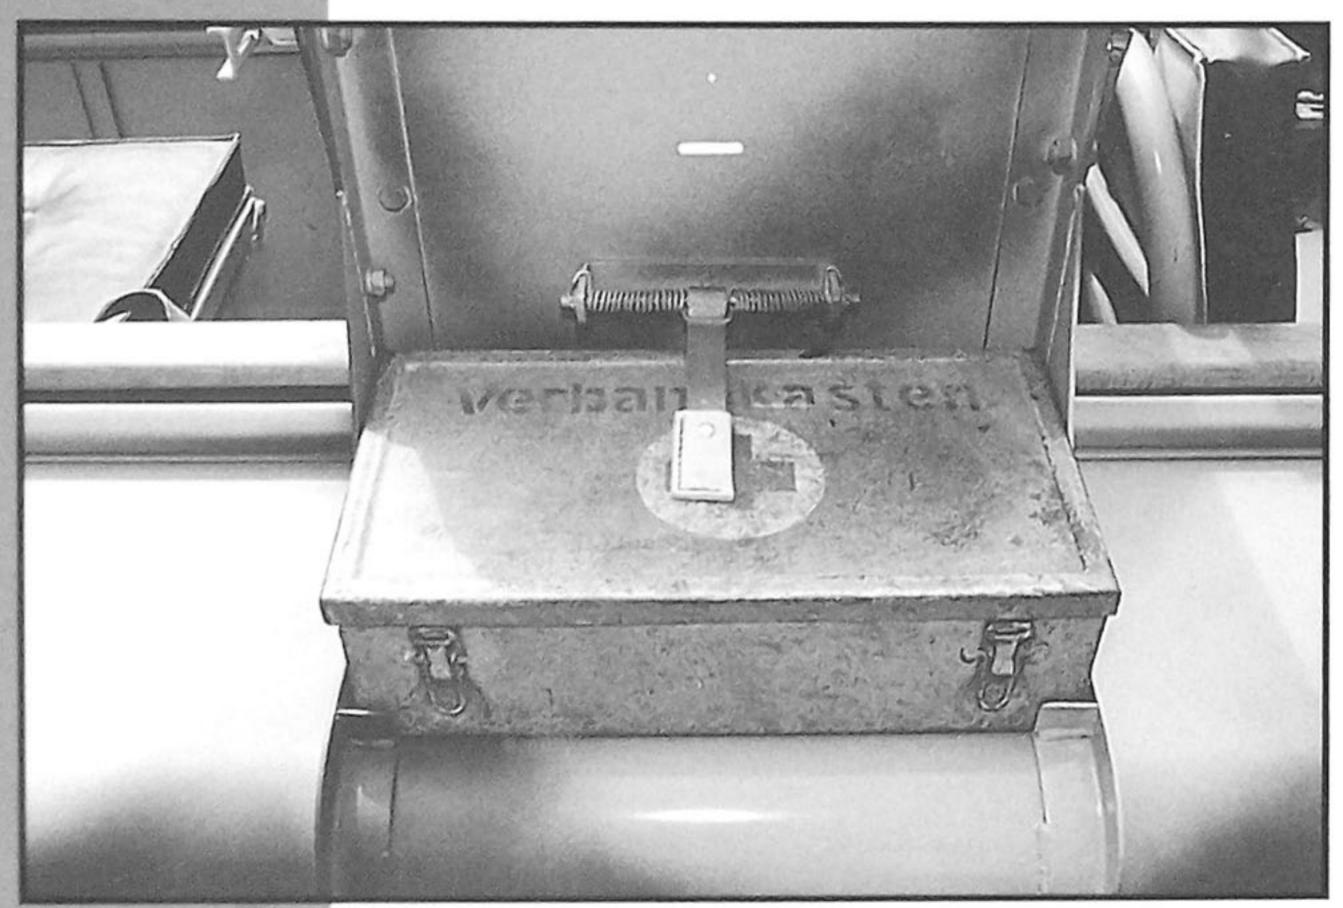
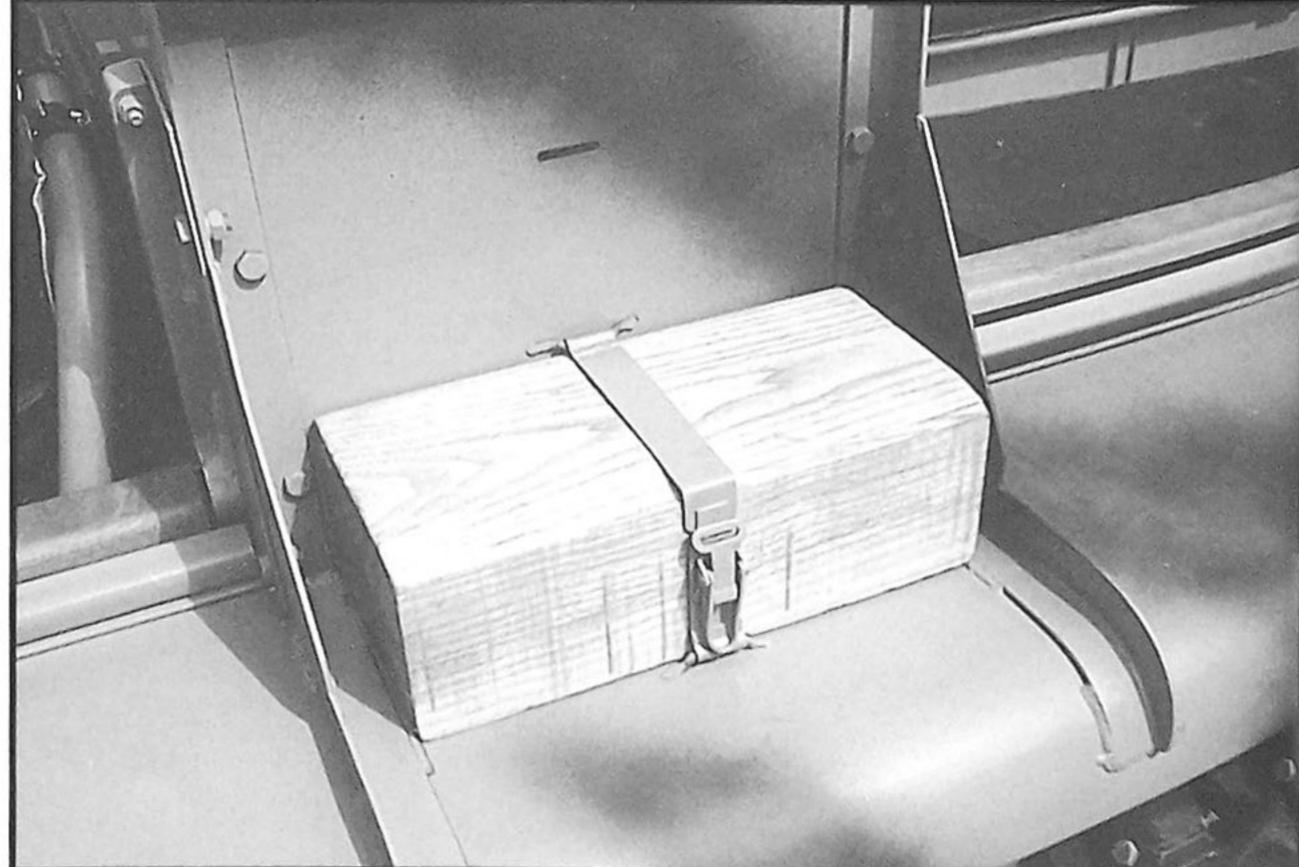
Top left: Details of the clamps securing the pick and ax. Top right: The Notek light mount on the front left fender. Note the Notek stamp on the top. Left: The first aid box mounted on the right side fender above the tracks. Above: The large wooden jack block on the left side fender above the tracks.

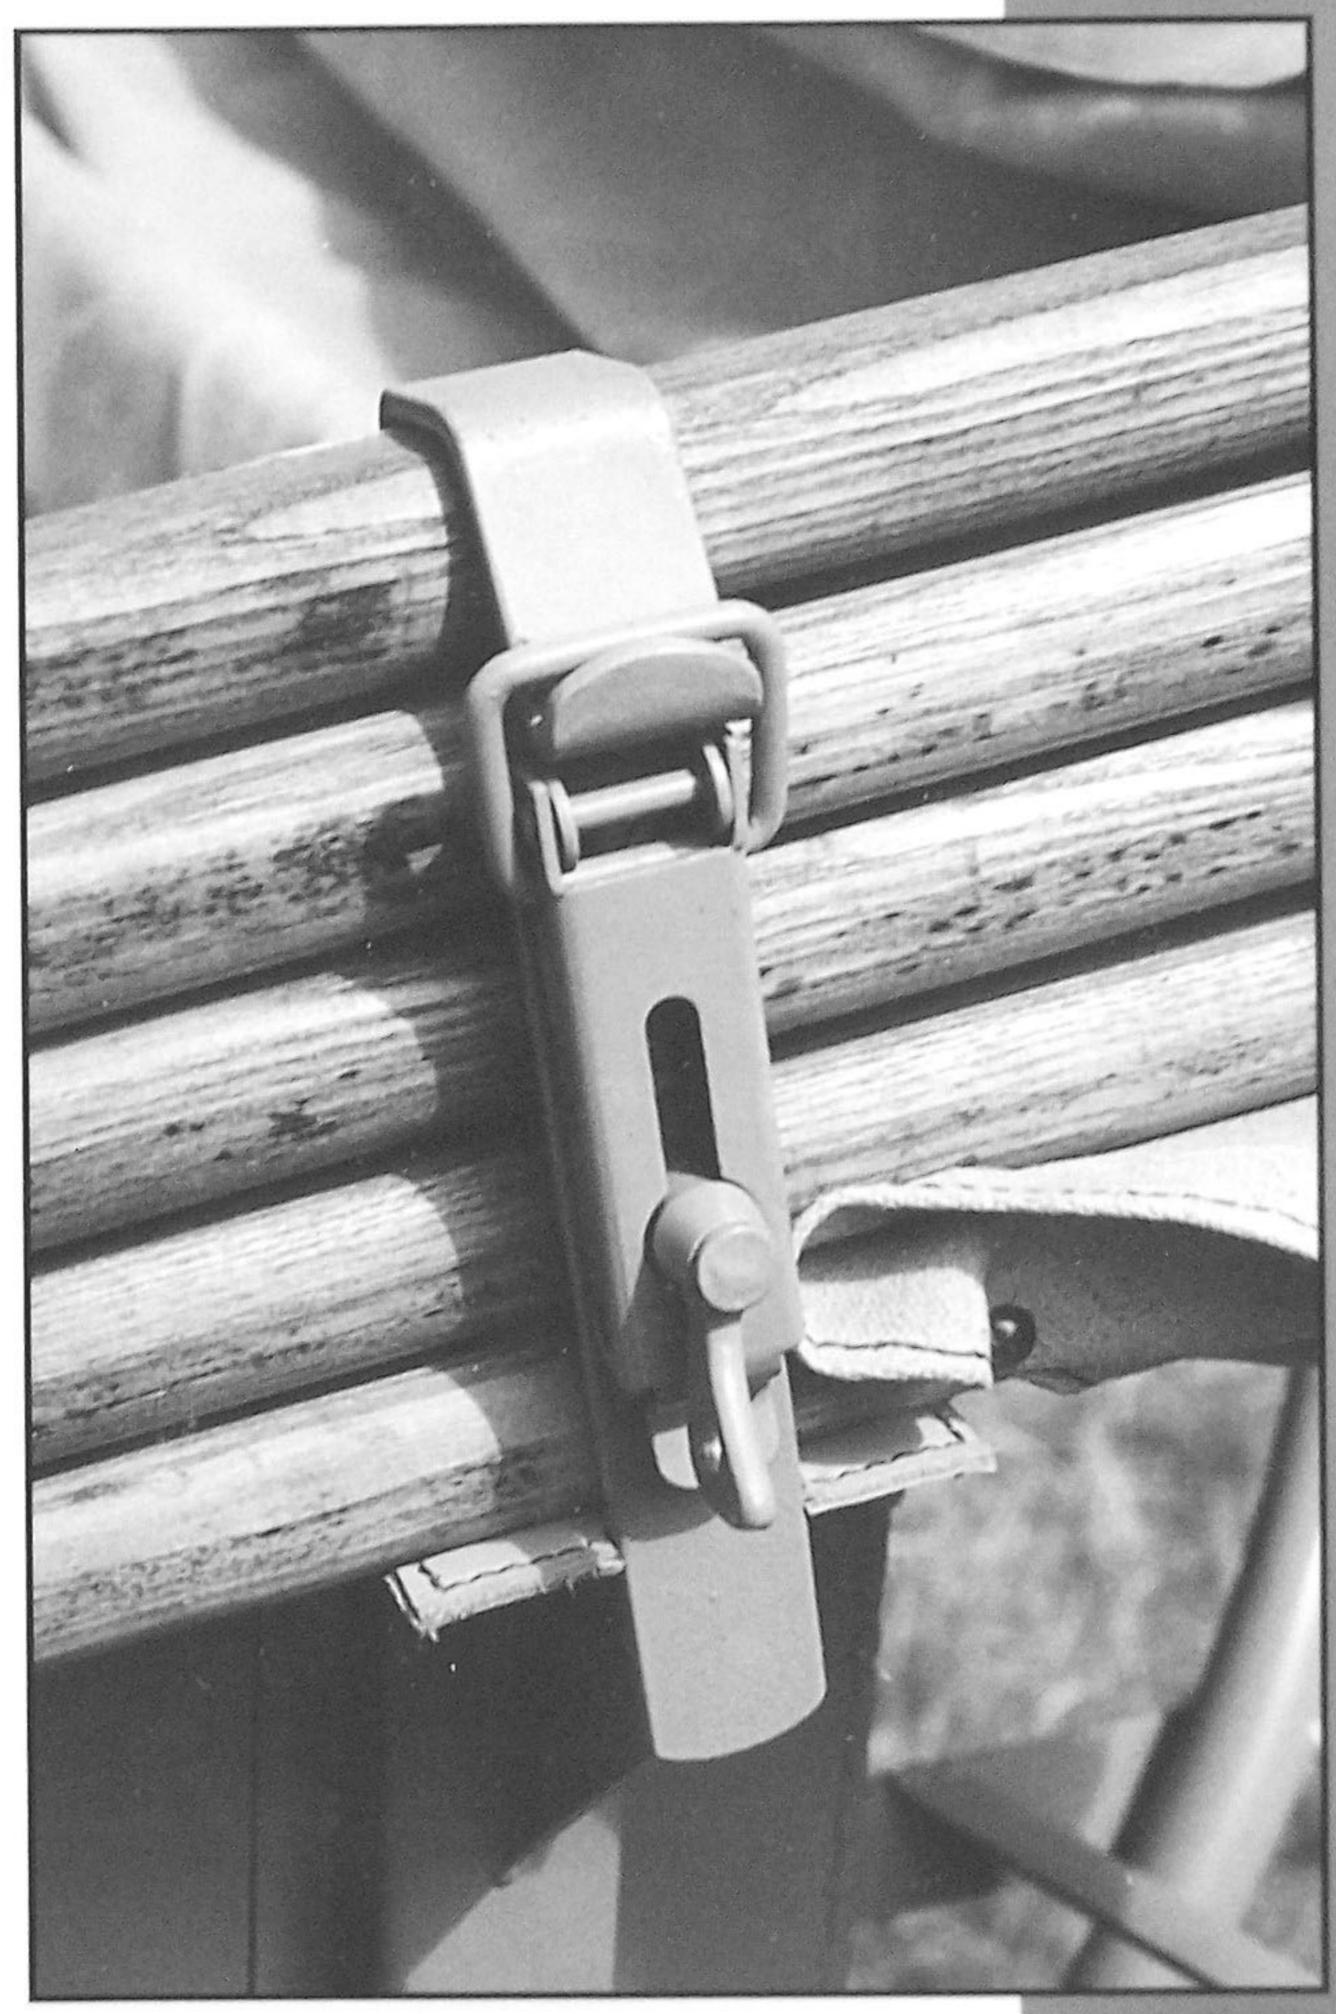
Top left: The complex system of wooden stays for the canvas top. Above: Front and rear views of the rear blackout driving light Right: A good close-up of the clasp used to secure the soft-top stays.
