Allied-Axis

THE PHOTO JOURNAL OF THE SECOND WORLD WAR

Contents

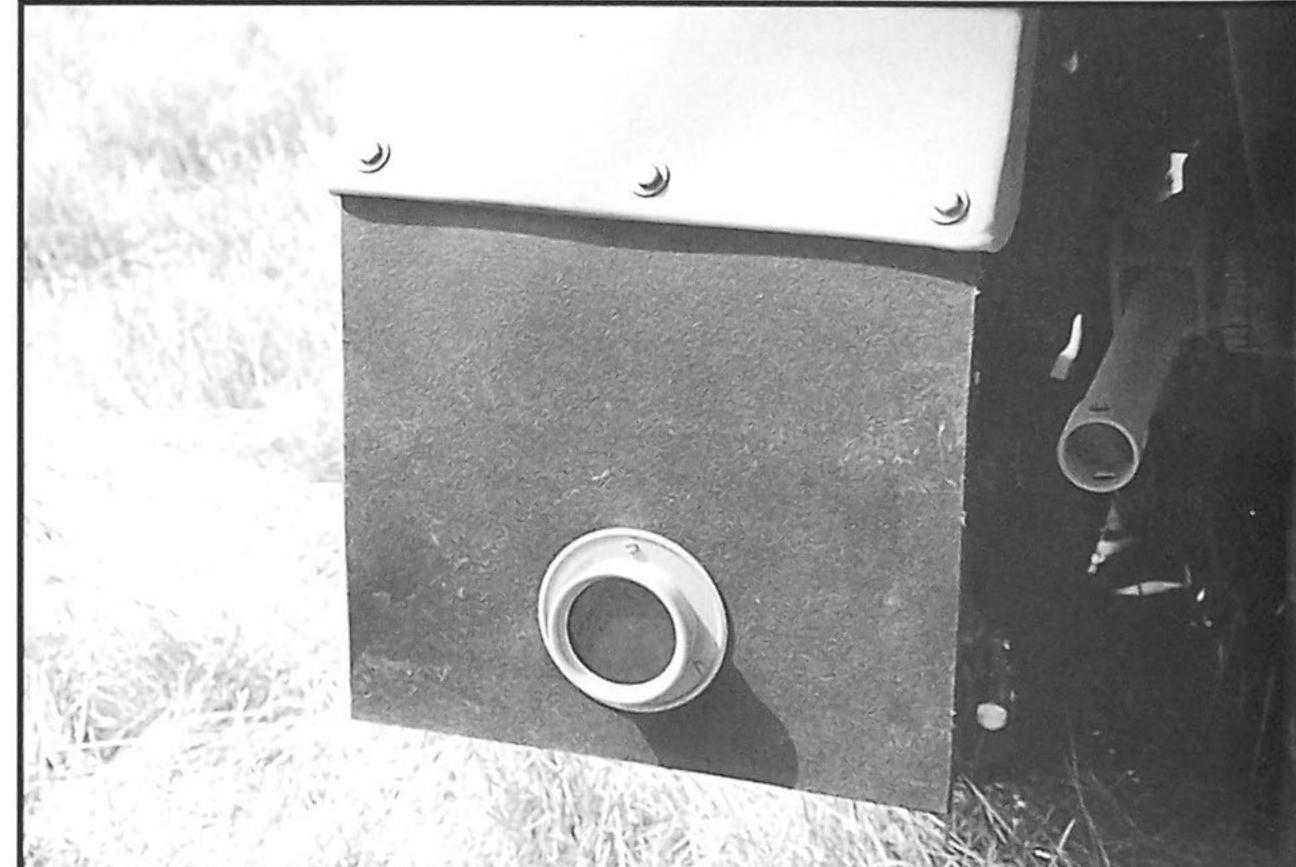
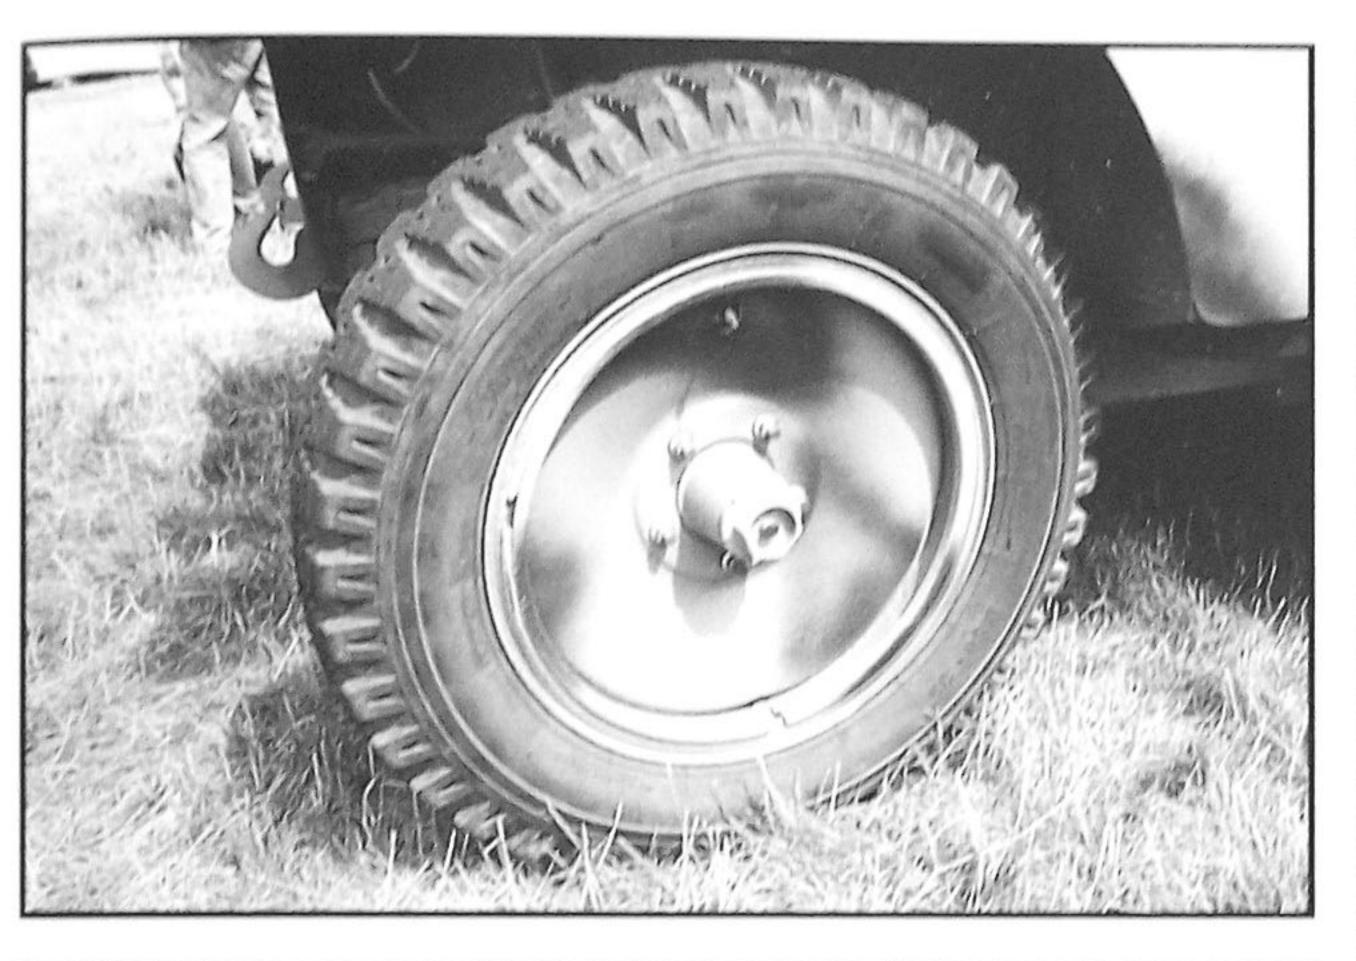
Top left: This rack was used to stow a tow cable or rope. It was sometimes modified in the field to mount a spare from tire. **Top right and left:** The left and right rear track adjusters. A special tool could be inserted in the opening around the edge to turn the adjuster, which would either tighten or loosen the tracks by moving the rear idler. **Above:** The left rear mud flap and its reflector.

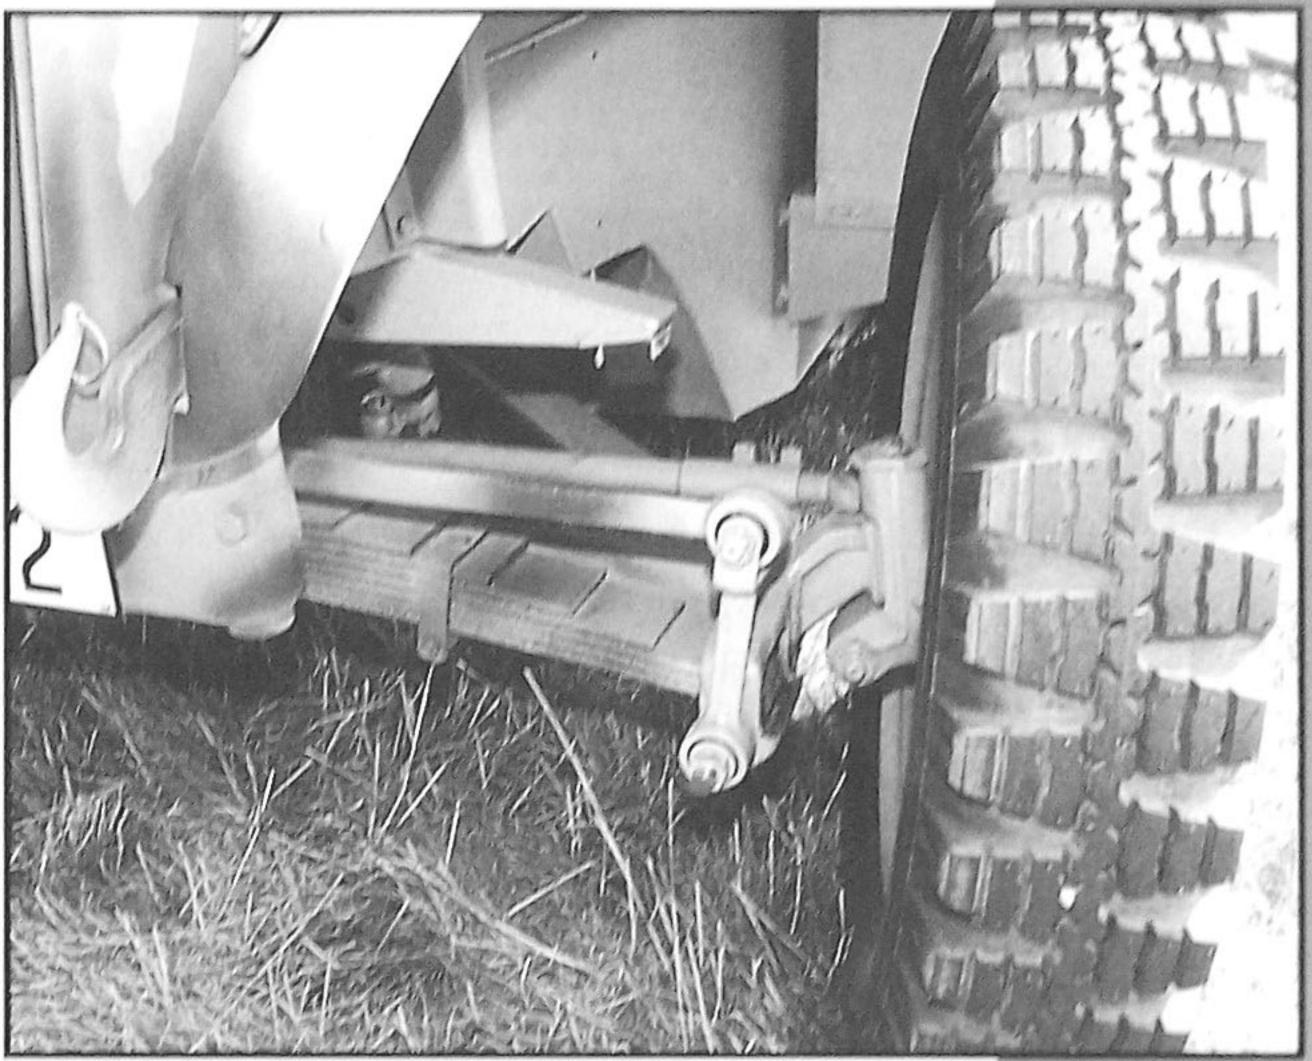
Top left: The front wheels were a solid dish split rim type. The tires are pneumatic, but early prototypes had bulletproof tires. Top right: The front steering link and leaf spring. The front axle was not powered. Above: The drive sprocket could differ in design, depending on the manufacturer. Like the tracks, the sprocket was also padded with rubber to reduce track wear and noise. Right: The suspension was quite complex and it required constant cleaning and maintenance. It could be susceptible to rocks or other debris becoming jammed between the closely spaced roadwheels.

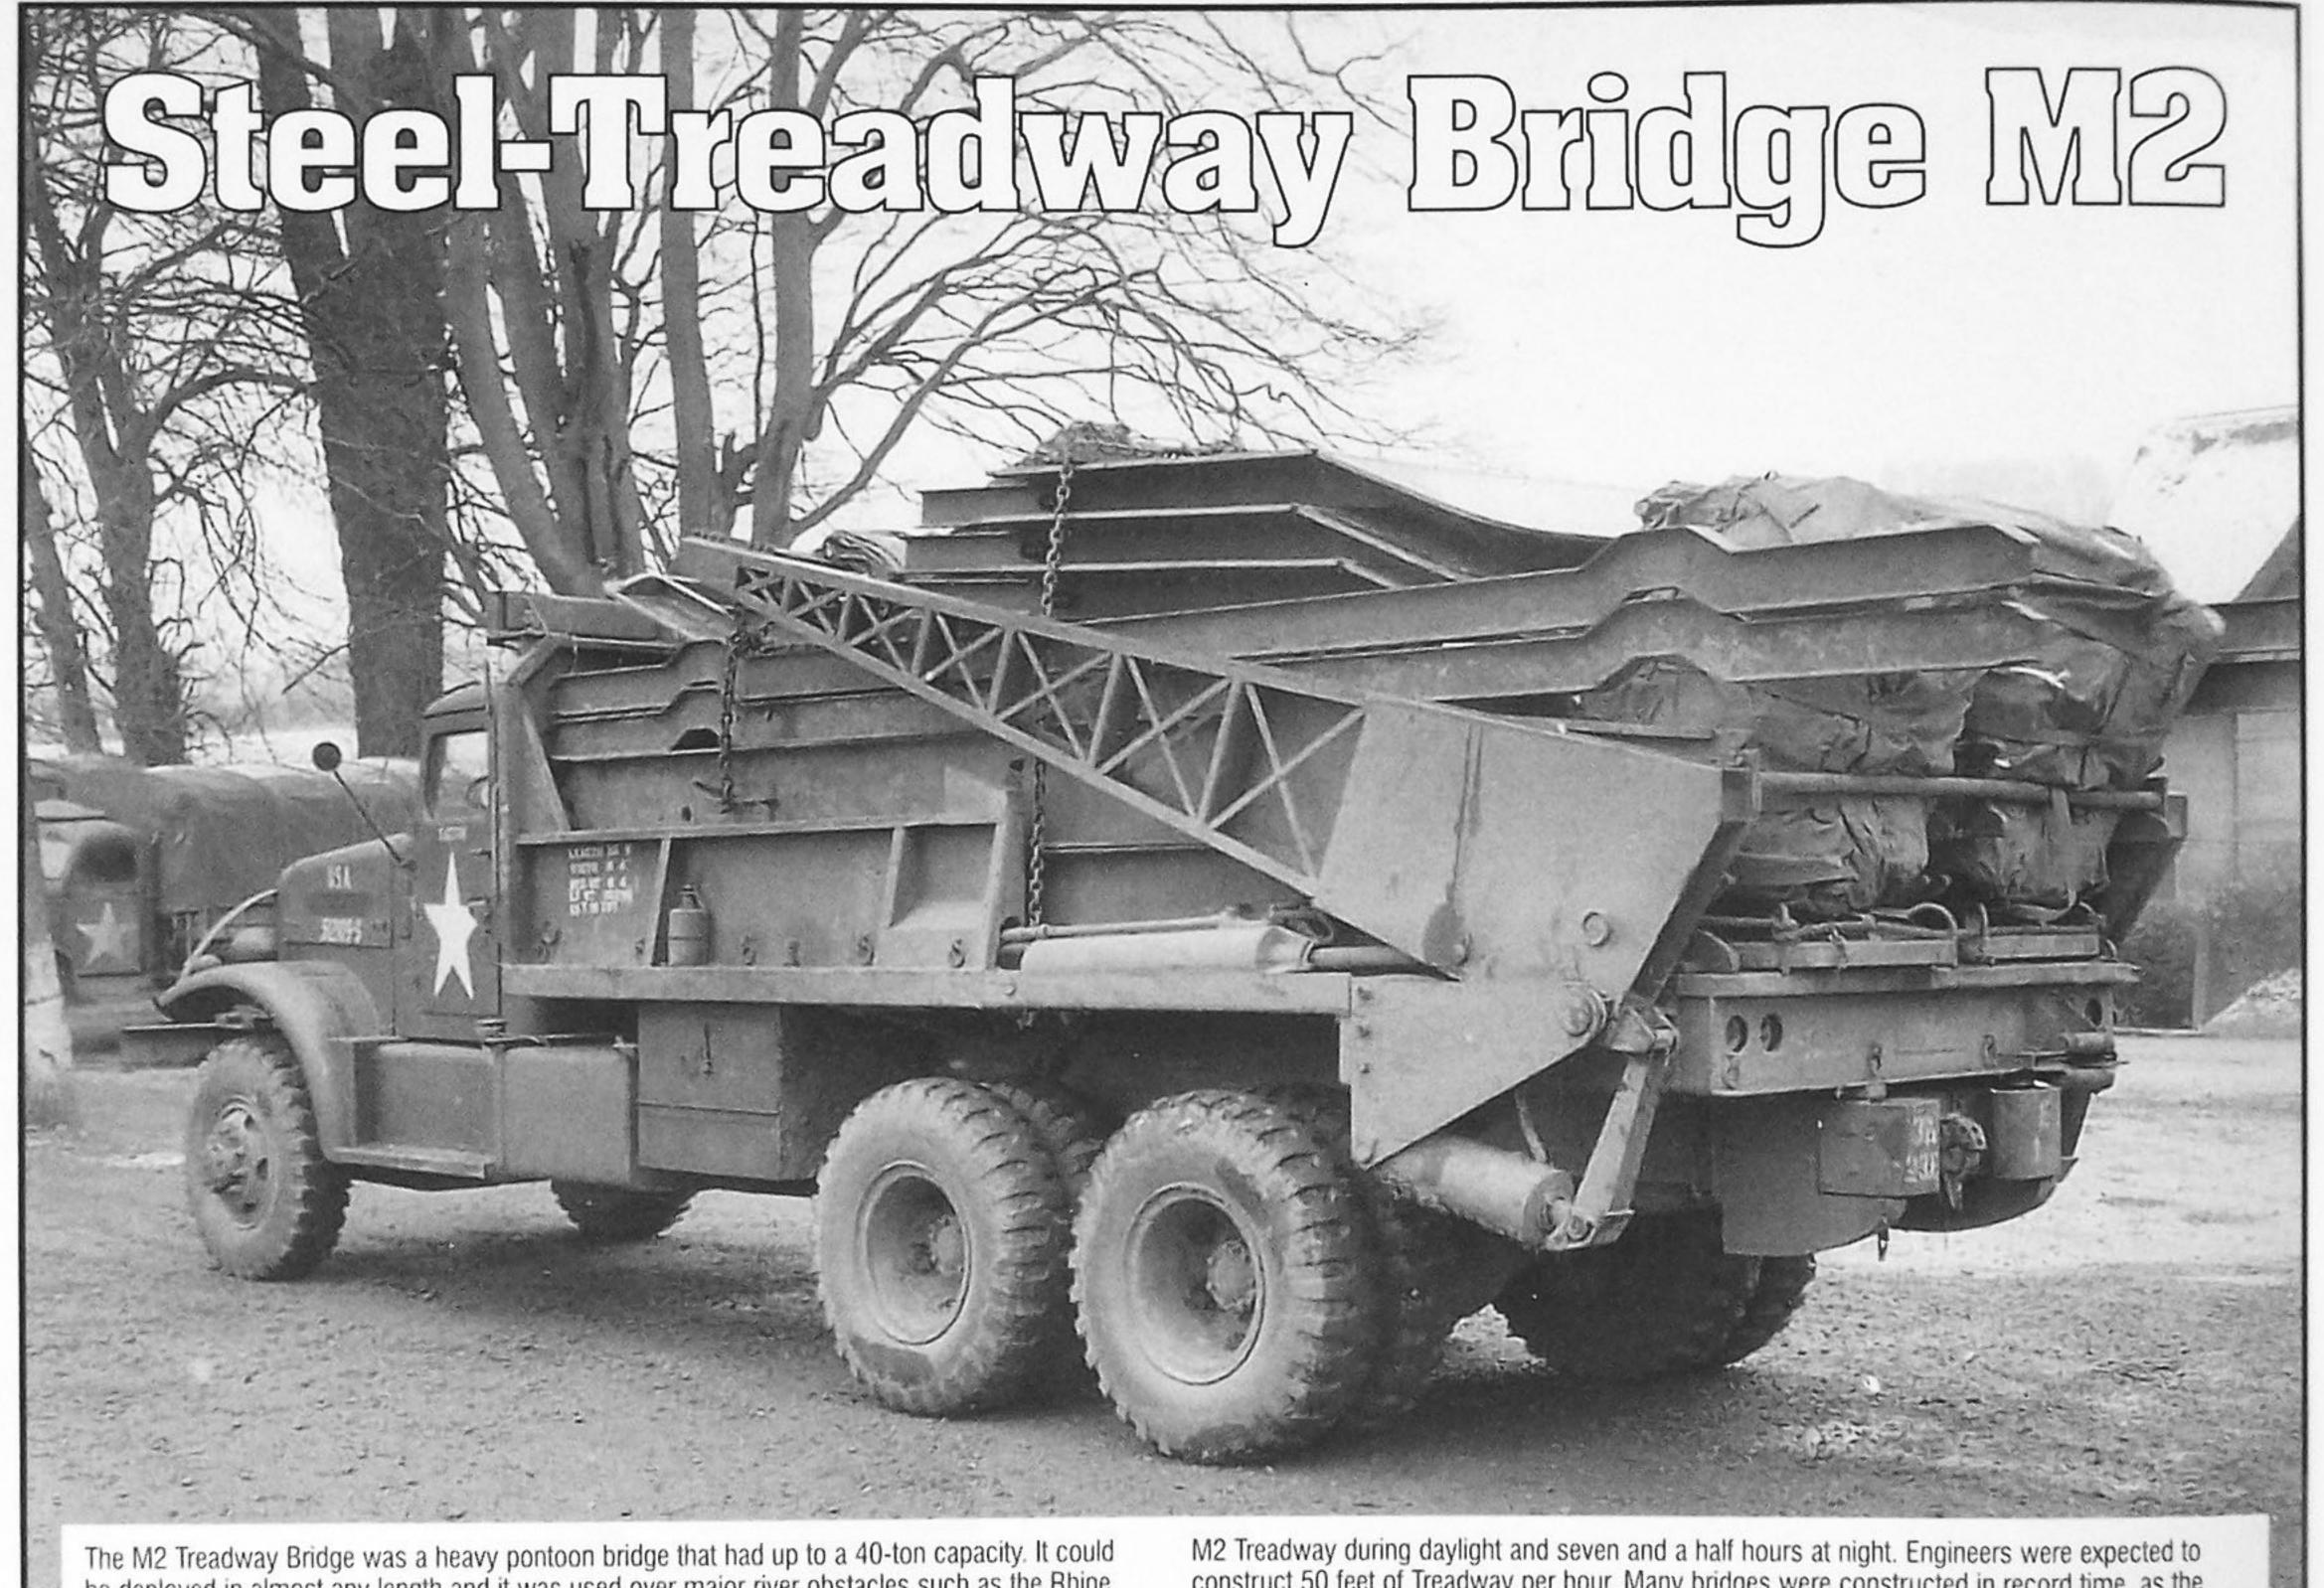
The M2 Treadway Bridge was a heavy pontoon bridge that had up to a 40-ton capacity. It could be deployed in almost any length and it was used over major river obstacles such as the Rhine and Moselle. The bridge was built using several purpose-built components, including the U.S. M2 Pneumatic Pontoon, M2 Treadway Bridge sections (composed of two parallel girders with reinforced steel grating), M2 Treadway truss support (to support the sections over gaps) and access ramps for approaches. Generally, it would take five and a half hours to place a 362-foot section of

M2 Treadway during daylight and seven and a half hours at night. Engineers were expected to construct 50 feet of Treadway per hour. Many bridges were constructed in record time, as the following examples illustrate. To free the captured Ludendorff Bridge for repairs, the 291st Engineer Combat Battalion, assisted by the 988th and 998th Engineer Treadway Bridge Companies, began erecting a 1,032-foot, Class-40 steel Treadway bridge just south of the Ludendorff Bridge on March 10, 1945. It opened to traffic on March 11 and was the first

American floating bridge over the Rhine. **Above:** Brockway, White, Ward LaFrance and FWD all produced "bridge erector trucks," which were used for transporting bridging components and for the erection of bridges, both pneumatic and fixed. Approximately 3,075 were produced and were all very similar. This photograph shows a Brockway Model B666 Treadway truck with hardtop. It was a 6-Ton, 6x6-cargo

truck with a double-jib gantry operated by four hydraulic cylinders powered by the truck's engine. The 4-ton gantry was controlled from a platform at the front of the cargo body. A double drum front winch, snatch block and rear fairlead allowed for extended lifting and lowering of Treadways and equipment from the rear. (NARA)

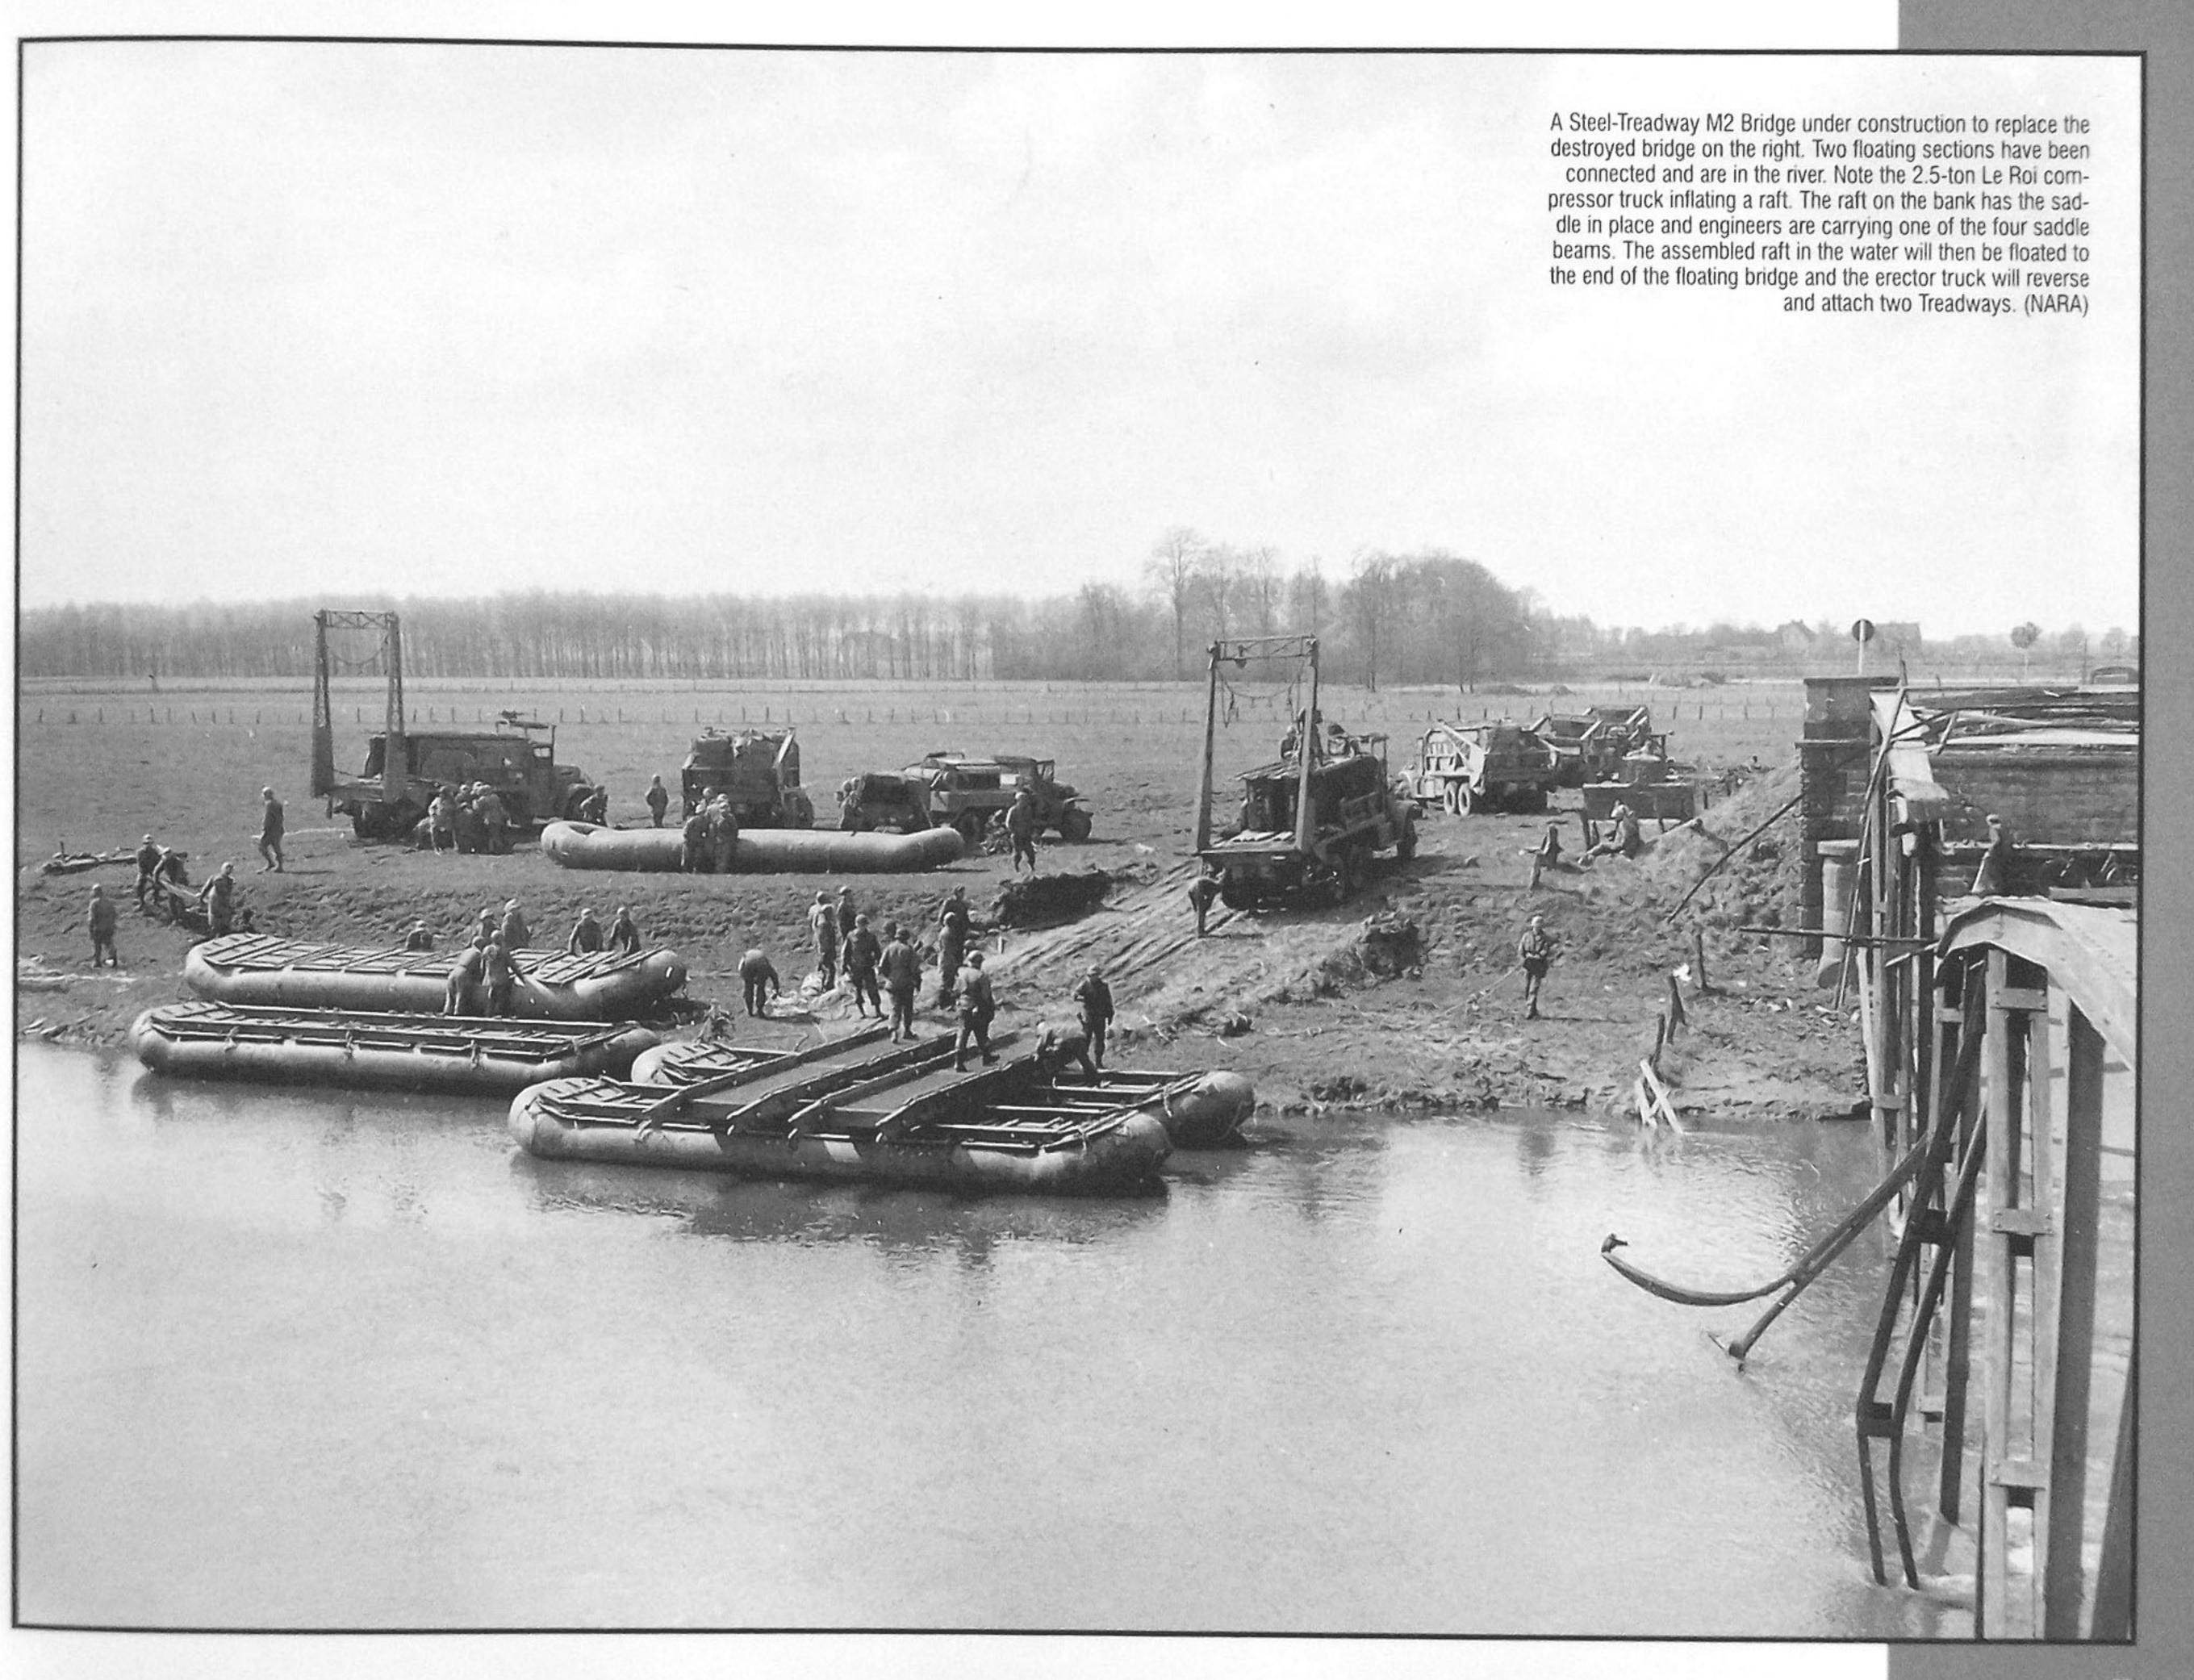
A follow-up photo with six pontoon sections assembled and in position. Engineers are manhandling the raft with saddle into the river while the truck brings out the Treadway flooring. The steel Treadway section weighs 2,350 pounds and has an effective length of 12 feet and a clear track width of 45.5 inches. The M2 Bridge was designed to support medium tanks and other heavy vehicles. (NARA)

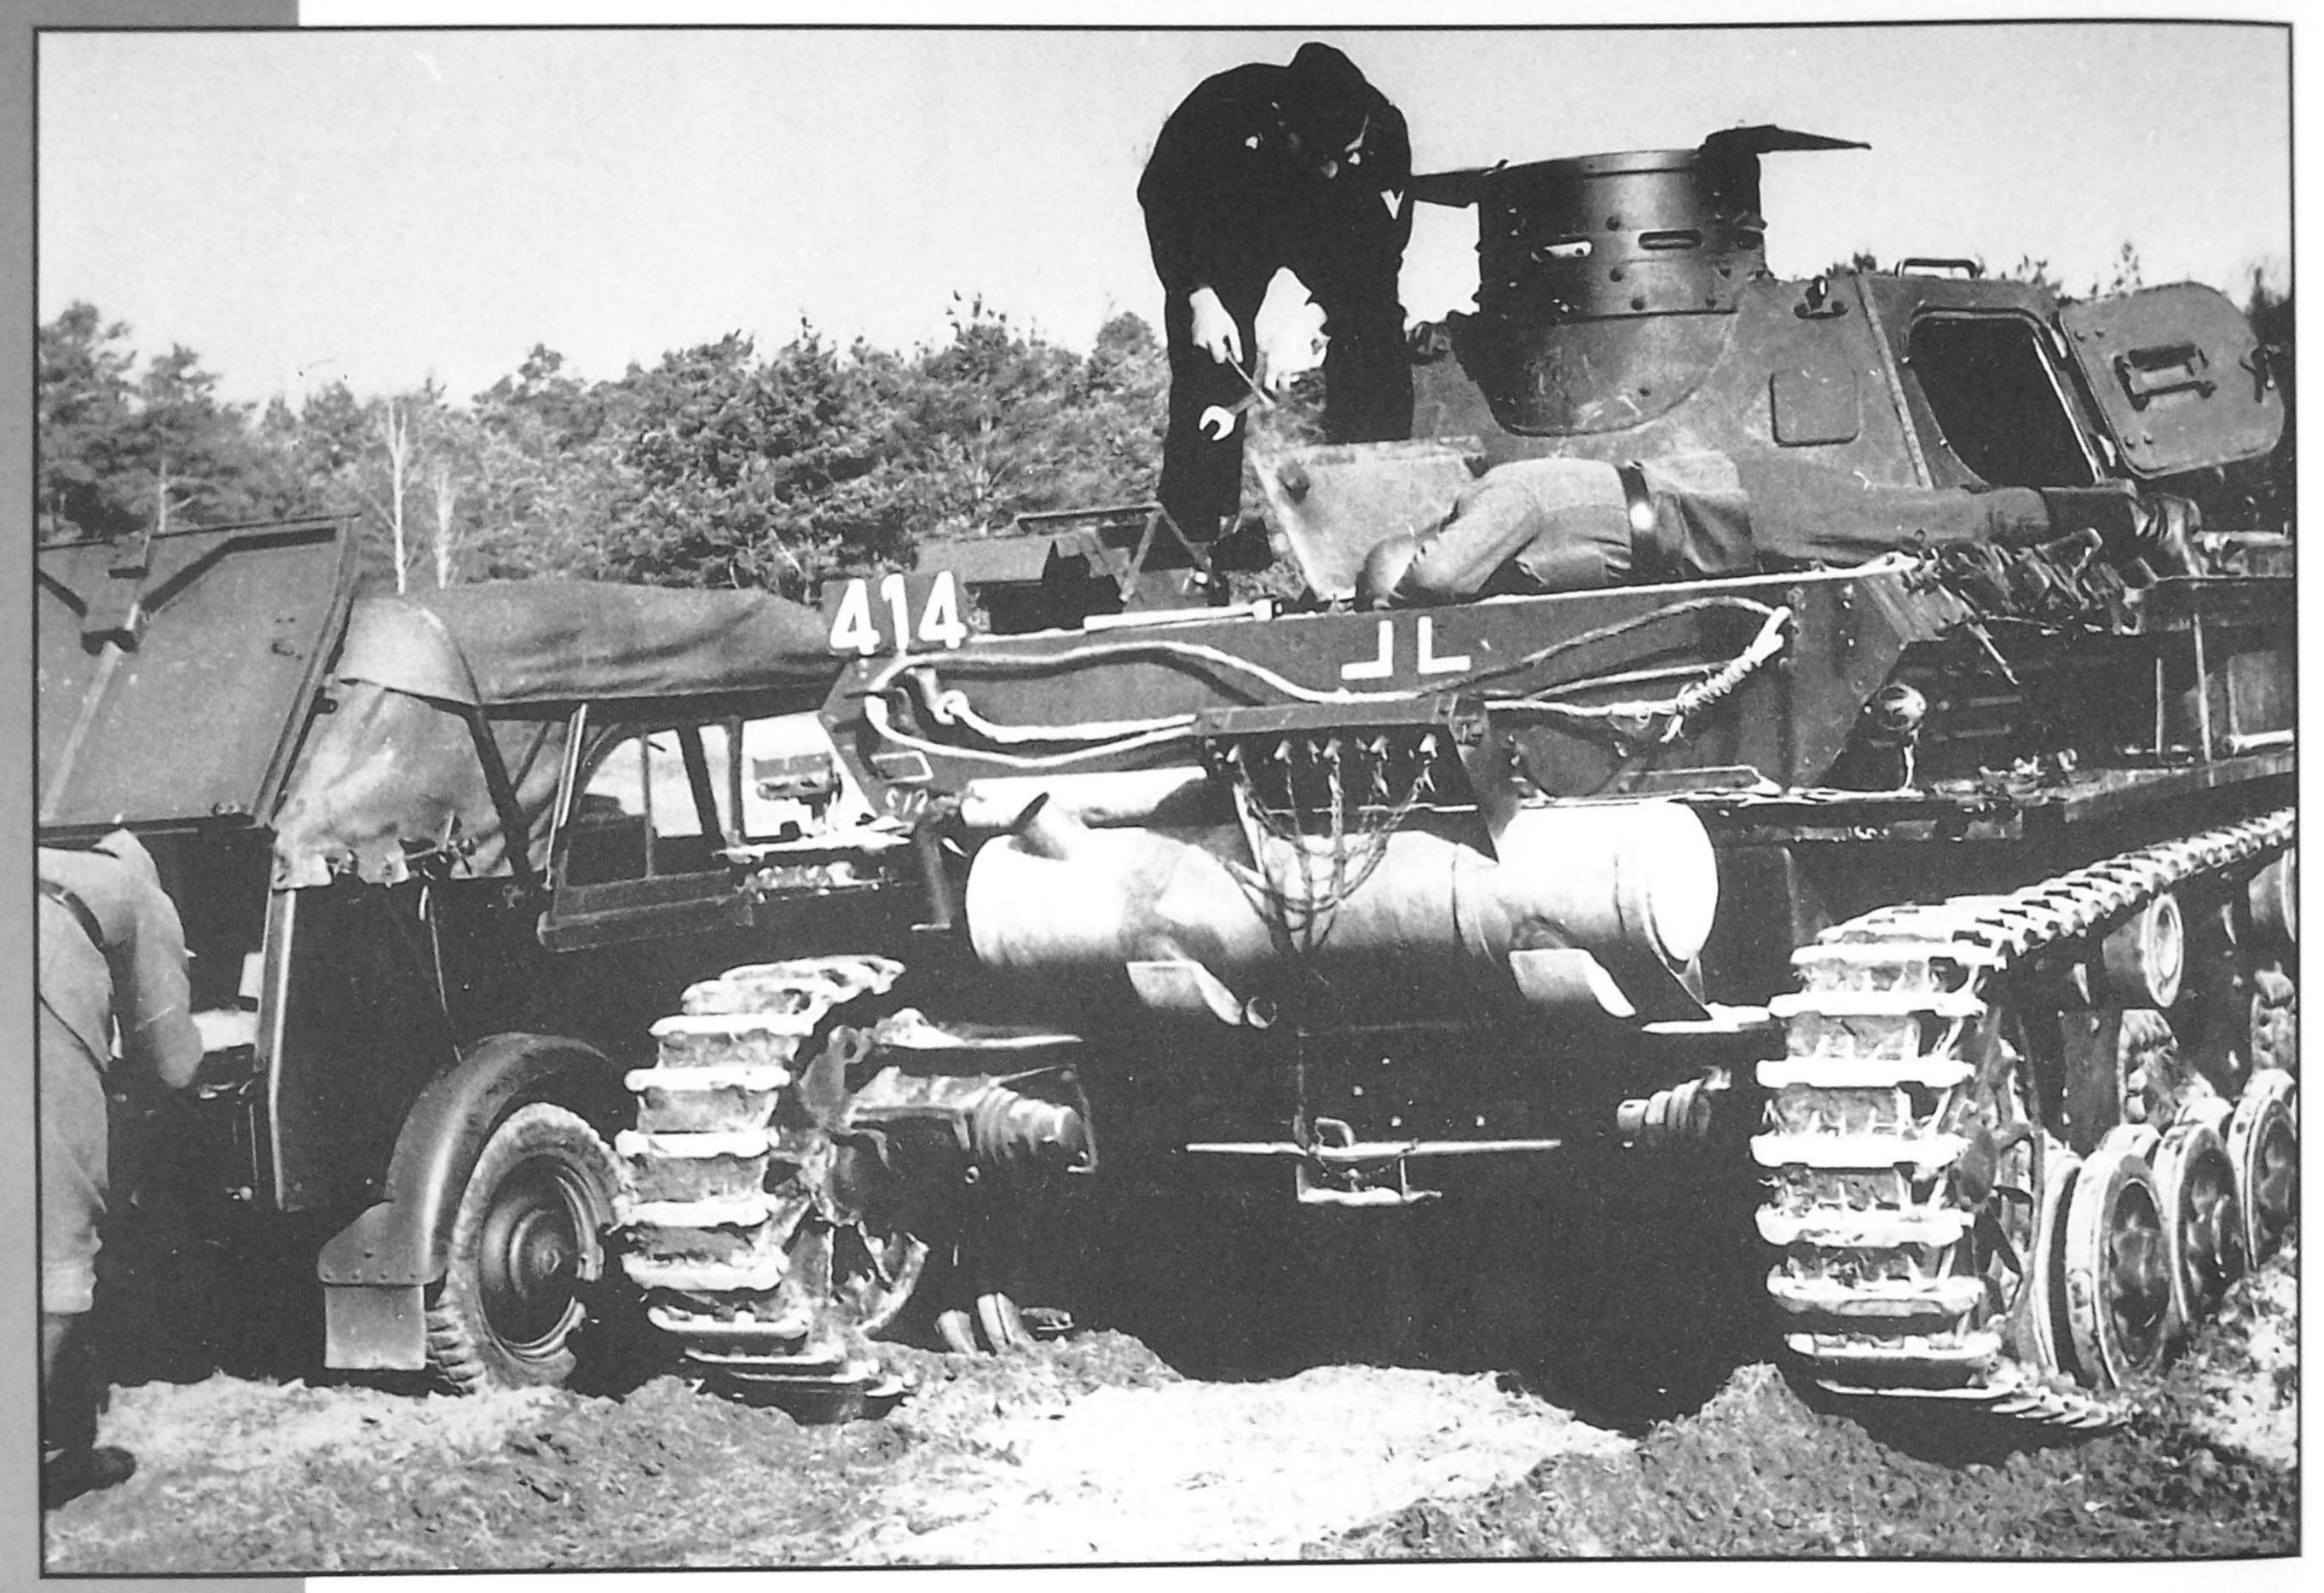
This initial version of the Pz.Kpfw. IV had 14.5mm thick plates on all vertical surfaces, which provided complete protection against steel-cored armor-piercing bullets fired by machineguns and rifles. This was sufficient to regain mobility that had been lost due to massed machine gun fire in World War I. Germany learned that the French were working on the development of a 25mm automatic cannon. They

were concerned that Panzers only protected against machine gun fire would be mowed down by these automatic weapons just like the cavalry had been decimated in World War I. Therefore, frontal armor on the next model of the Pz.Kpfw. IV, the Ausf. B, was increased to 30mm thickness. (BA)

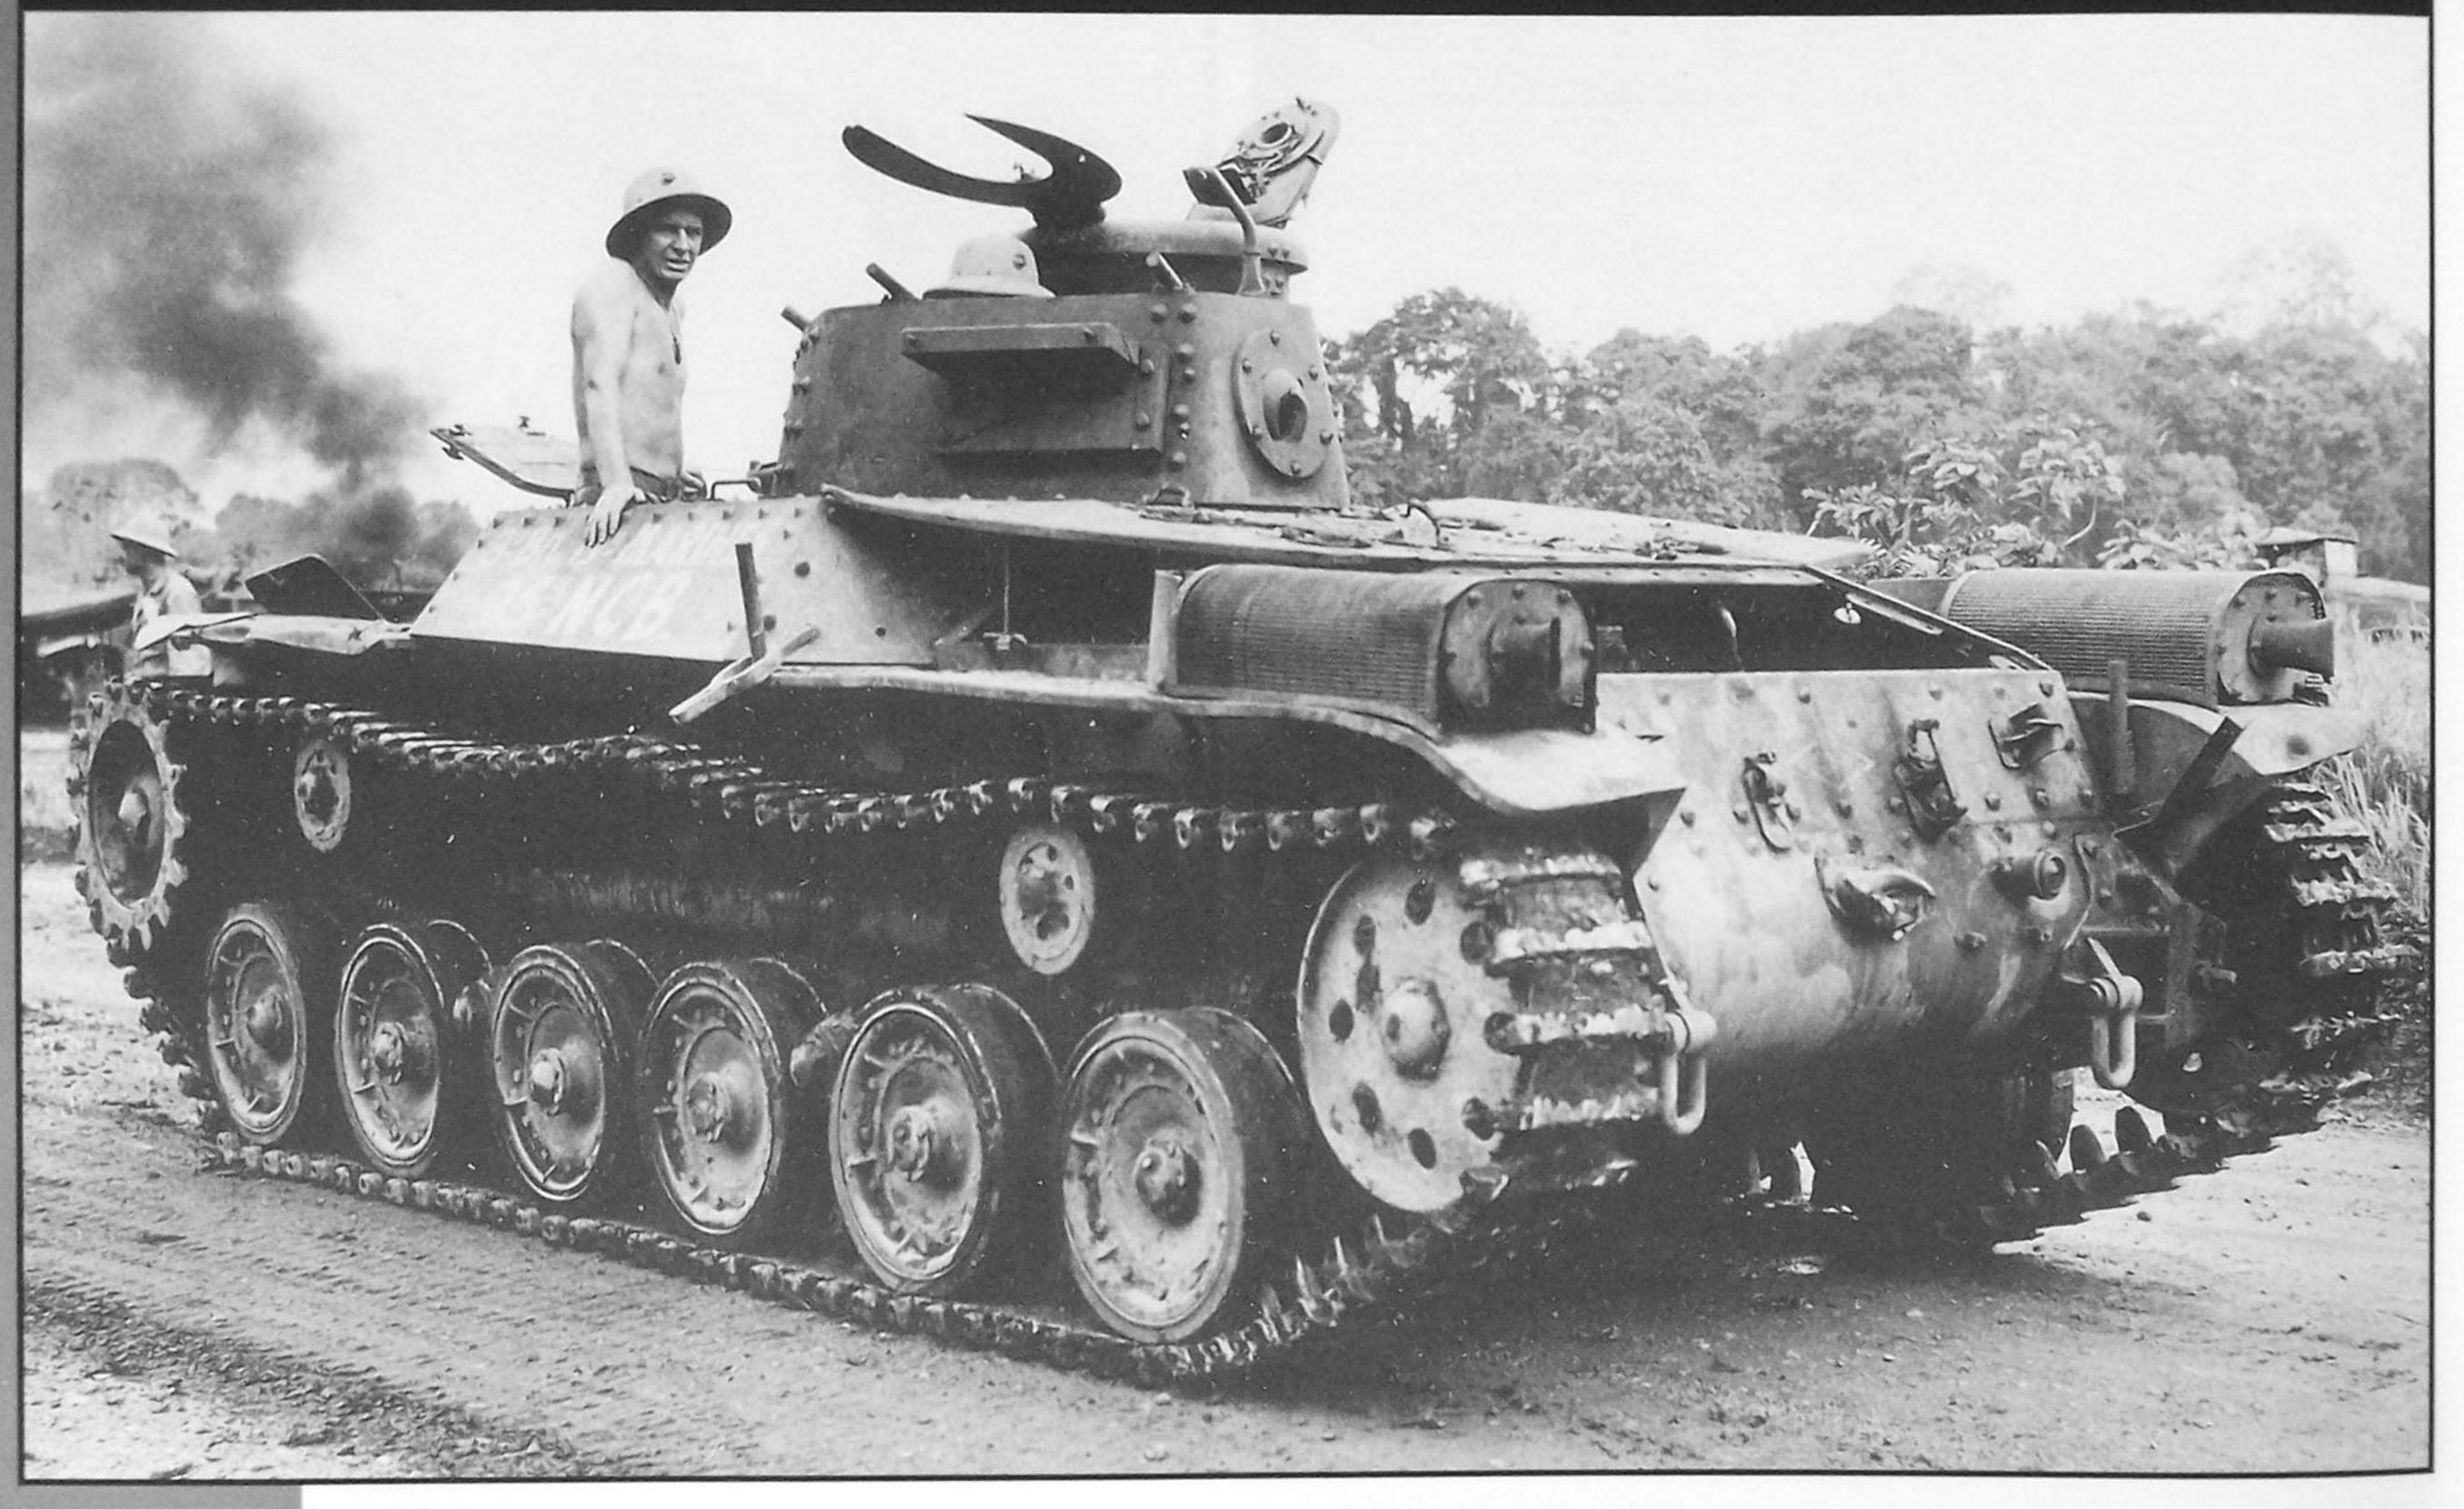
The first medium tank the Japanese developed and produced was the Type 89. Even as it was being deployed it was recognized that a more capable successor was needed. Two different designs were considered as replacements. One was the 'Chi-Ni,' which was lighter and cheaper than the second candidate 'Chi-Ha.' At first the 'Chi-Ni' was the favorite, but when full-scale war broke out in 1937 it was

decided that the 'Chi-Ha' was the better choice. The 'Chi-Ha' was standardized as the main medium tank for the Japanese during WWII and was designated the Type 97. **Above**: Under new management. This Type 97 also has the smoke canister mount on the turret side. There is also an empty anti-aircraft machine gun mount on the turret roof. (NARA)
