Allied-Axis

THE PHOTO JOURNAL OF THE SECOND WORLD WAR

Contents

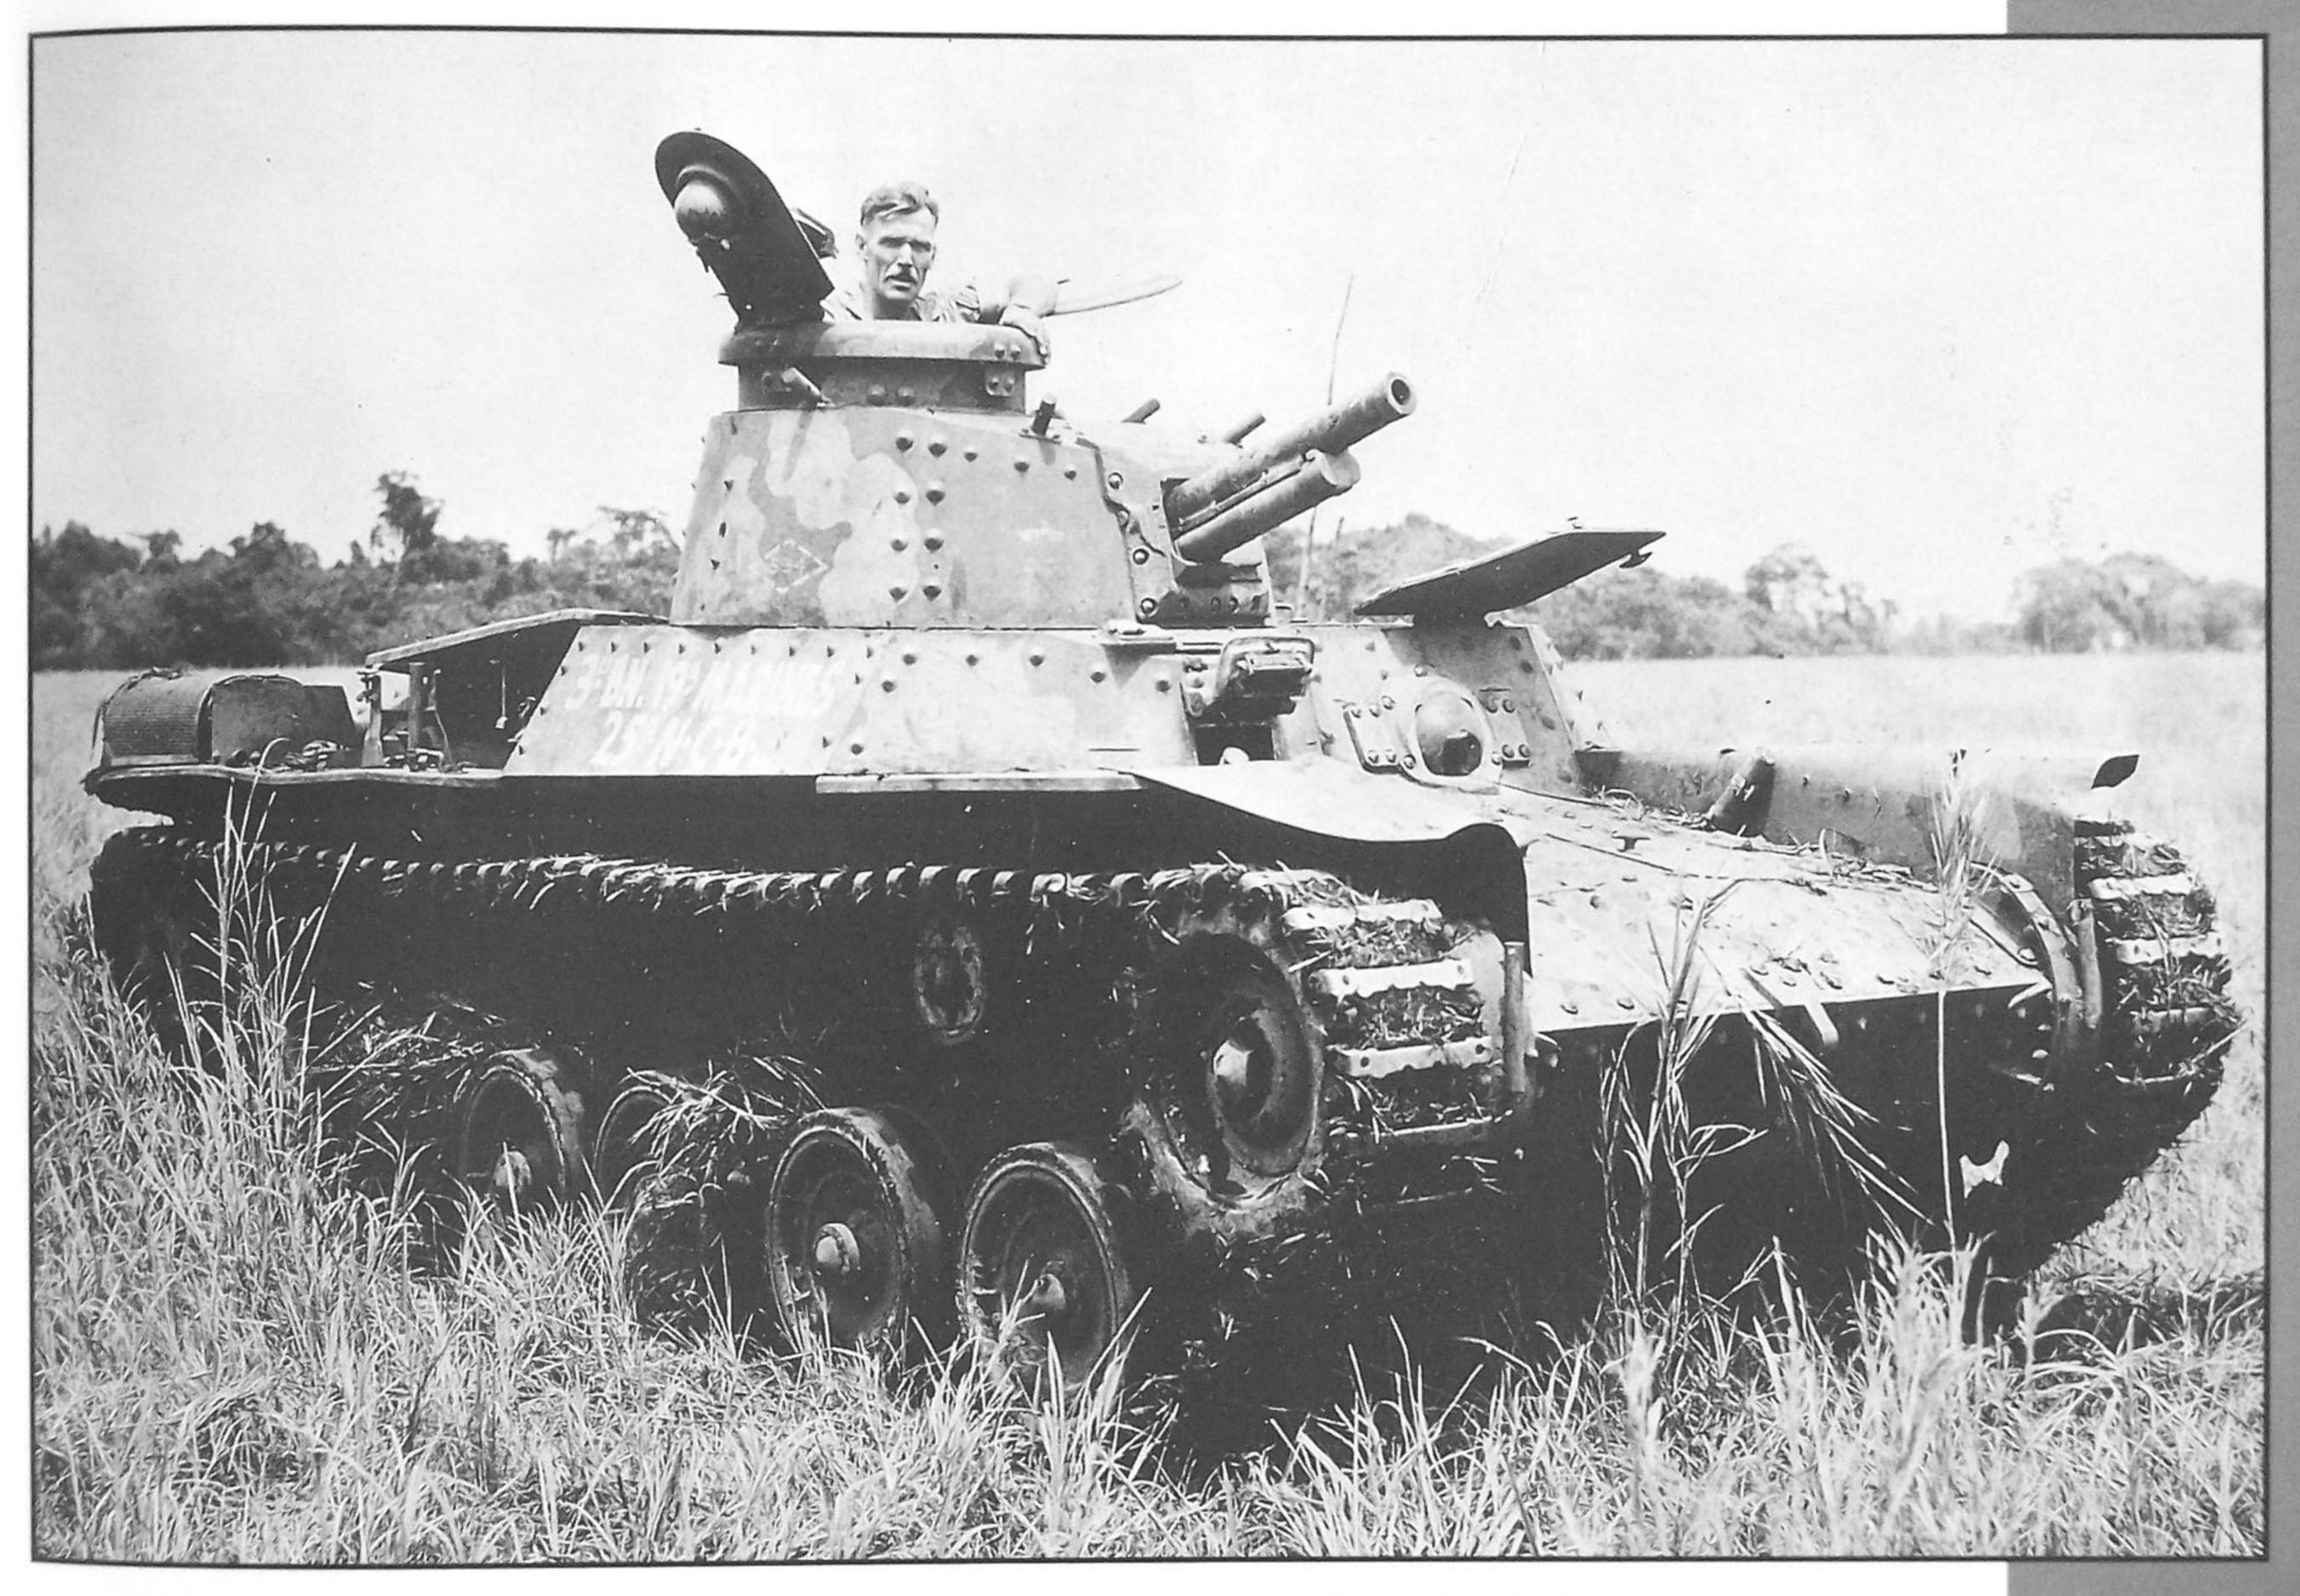
Although considered obsolete by the time war started with the United States, it served throughout the war. The Type 97 was the most powerful and heavily armed Japanese tank at the beginning of WWII, but it was never a serious challenge to the USMC and Army Shermans. Its armor was very thin at around 25mm and was riveted on. The main armament was the Type 97 57mm gun, plus two 7.7

machine guns and it had a crew of 4. **Above**: On this Type 97 the antenna has been removed but plugs of some sort have been fitted to close the mount tubes. Notice the short rod on the left fender lying down. This is part of the auxiliary antenna that was sometimes mounted. (NARA)

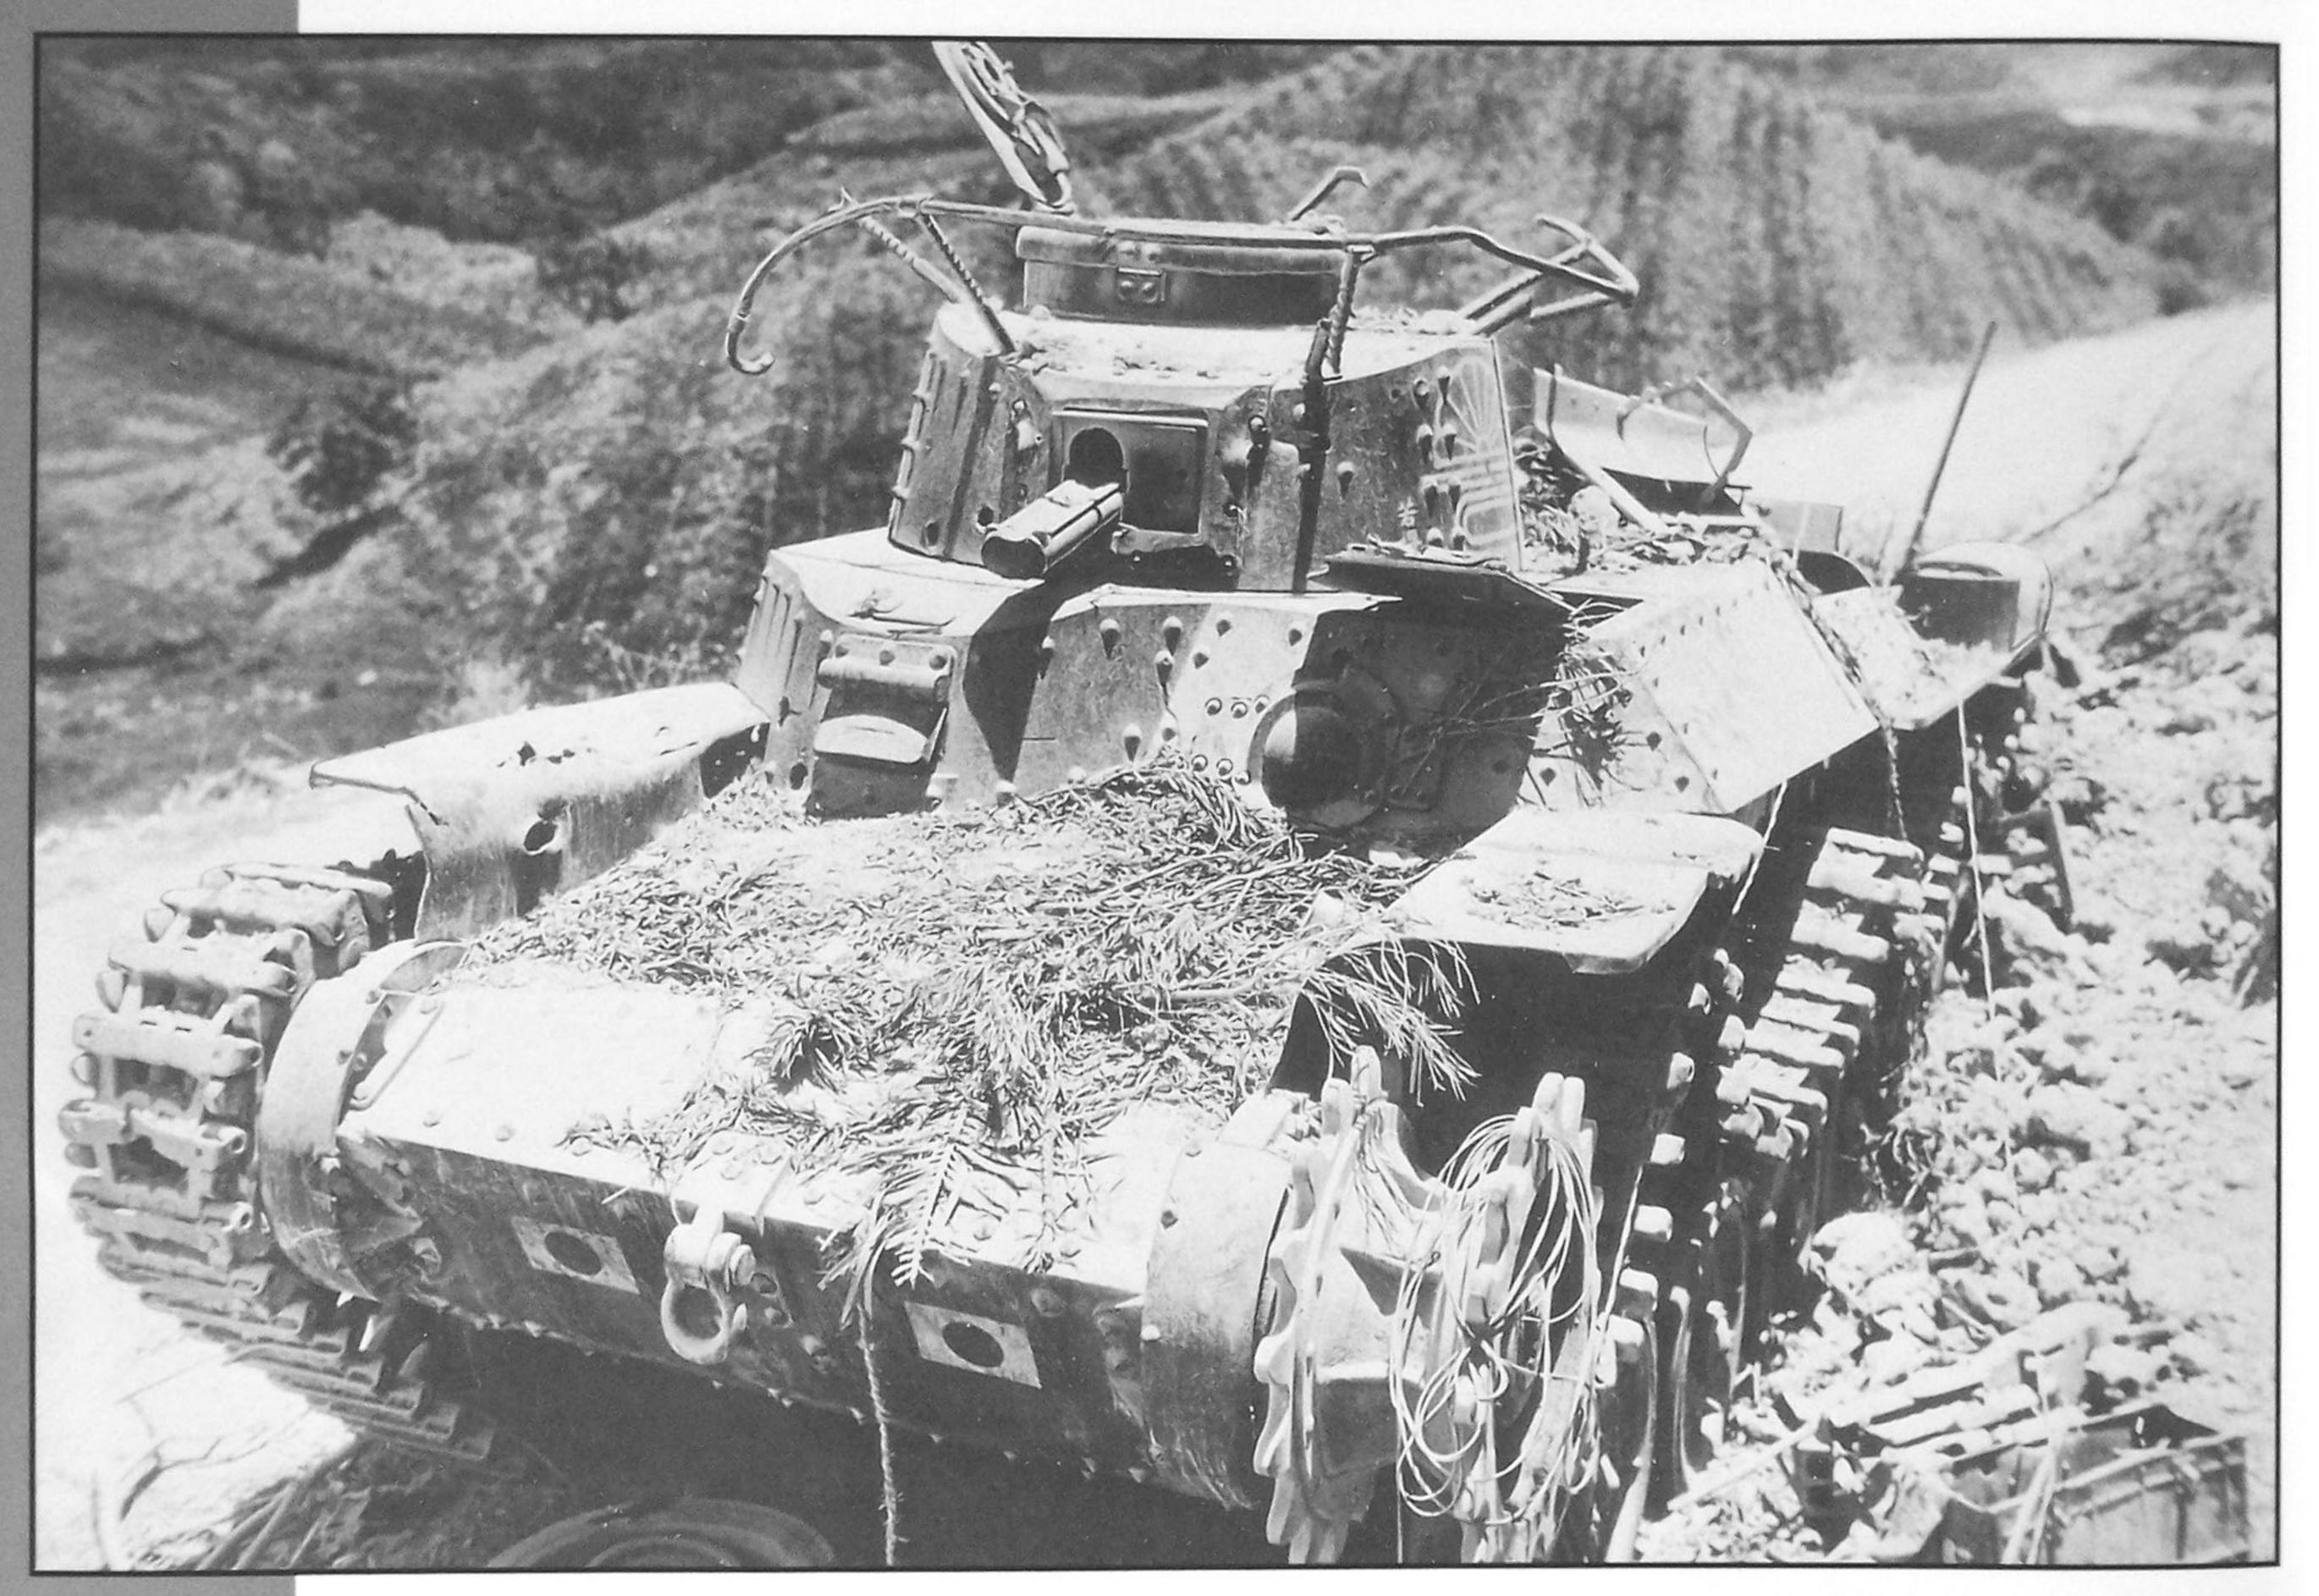
The suspension is the most interesting feature of the Type 97. There are two sets of bogies sprung horizontally, while the two outside wheels were sprung diagonally outwards. It weighed in around 14.3 tons and the engine was an AV-12 air-cooled diesel with 170 hp and a top speed of 23.5 mph. The Japanese never put any emphasis on tank production because of the priority given to ships and planes.

Above: Although missing its main gun, this Type 97 somehow kept its antenna on. Also notice the marking on the turret, which is a floating chrysanthemum and the two Japanese flags on the bow. This tank is one of the tanks from the 9th Tank Regiment, 5th Company on Saipan, which was probably knocked out by M5A1 light tanks from the 762nd Tank Battalion in June 1944. (NARA)
