# Armor Battles on the Eastern Front

(2) Downfall of the Reich 1943-1945

Robert Michulec

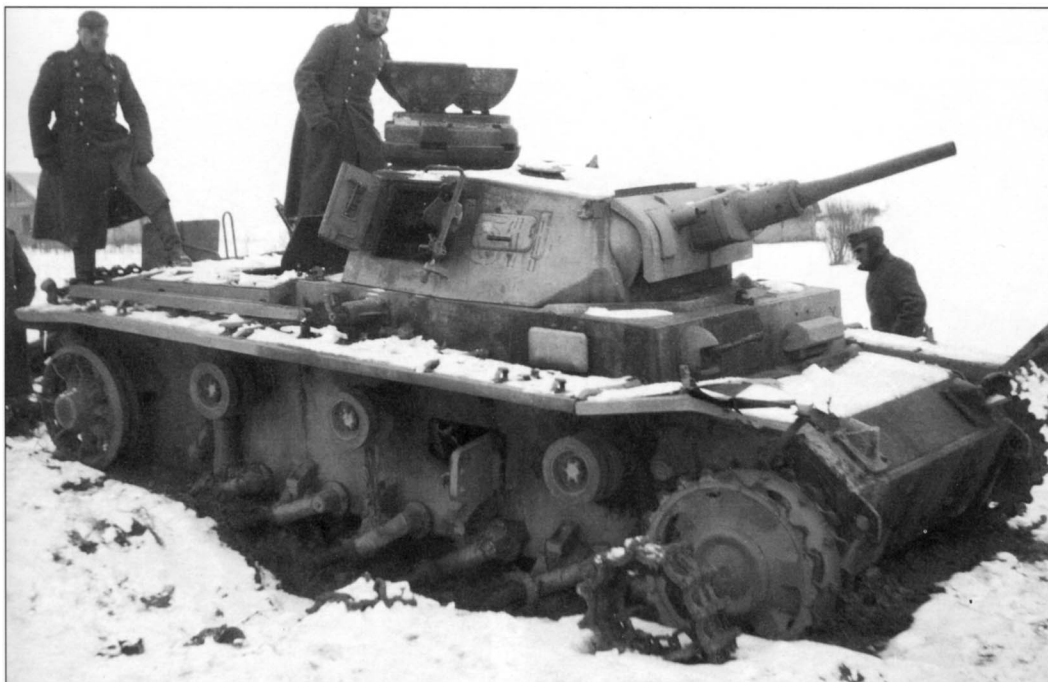
This wreck of a Pz.Kpfw. III Ausf. J from 9.Panzer-Division was photographed in January 1943 at the central part of the Eastern Front. The tank is painted dark yellow and the unit emblem is visible on the right part of the frontal superstructure plate. The road wheels and tracks were "borrowed" by other crews to improve the protection of their tanks against anti-tank rounds.

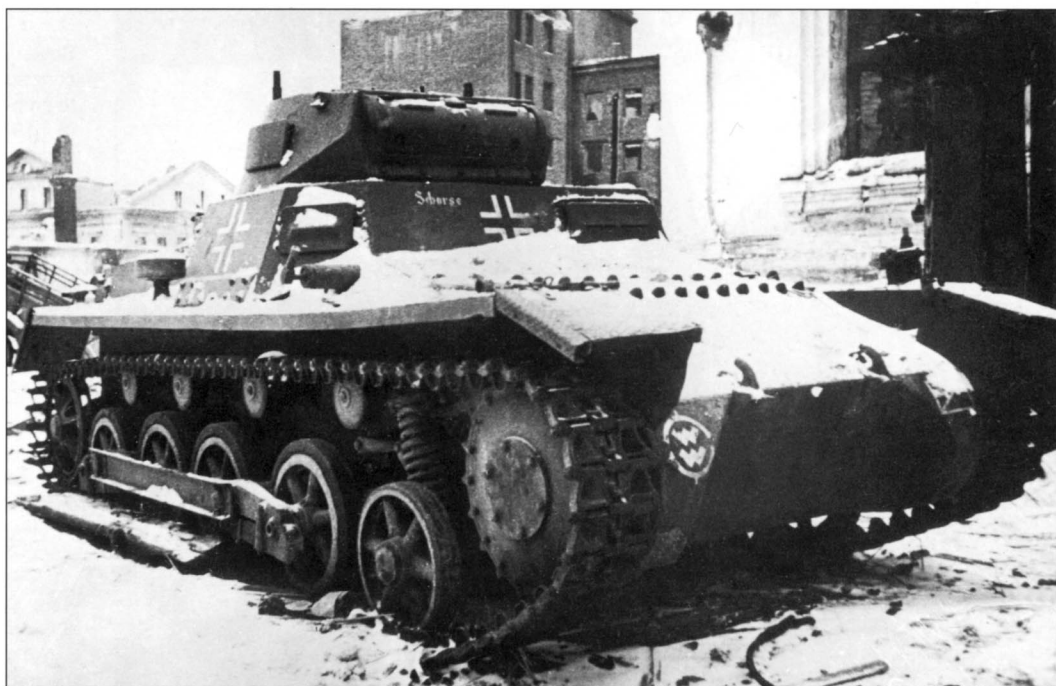
A Pz.Kpfw. I Ausf. B abandoned by its crew during the January fighting for Velikiye Luki on the Kalinin Front. It is unarmed, which could indicate that it was used as the armored personnel vehicle for a staff sub-unit. Note the markings on this vehicle. The unit emblem is clearly visible on the hull, and on the opposite side of the hull is a tactical sign. Beneath the turret is the name of the tank – "Schorse".

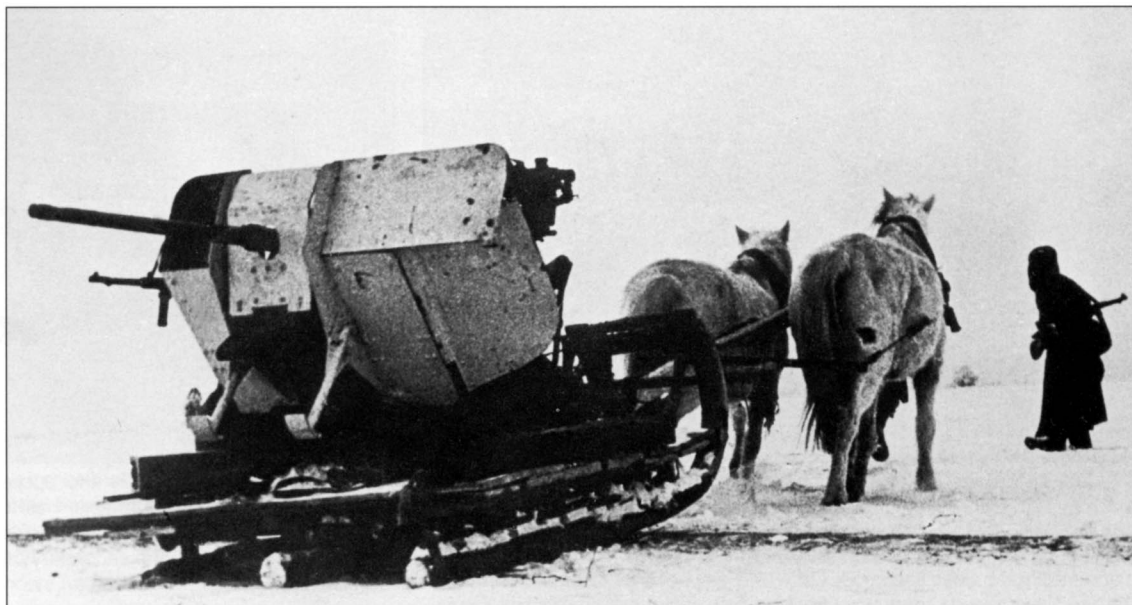
This is entirely different sort of mobile anti-aircraft artillery — a 2cm gun with a heavy armored shield installed on a sled commonly used in Soviet villages. Improvised use of such vehicles by various units that had lost all of their trucks led to the later organization of entire batteries with specially fabricated sleds.

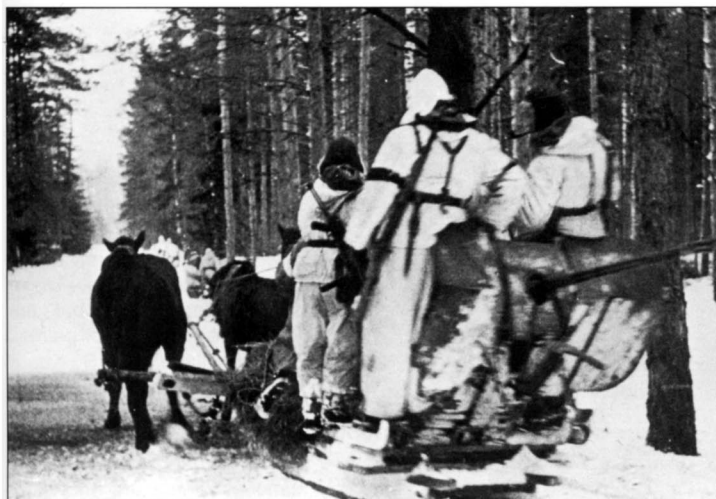
The same type of 2cm gun but the sled is different. It looks like a civilian one that was altered for the installation of a gun. The horses hauling such carts led a hard life, and the losses among these charming animals must have been very high.

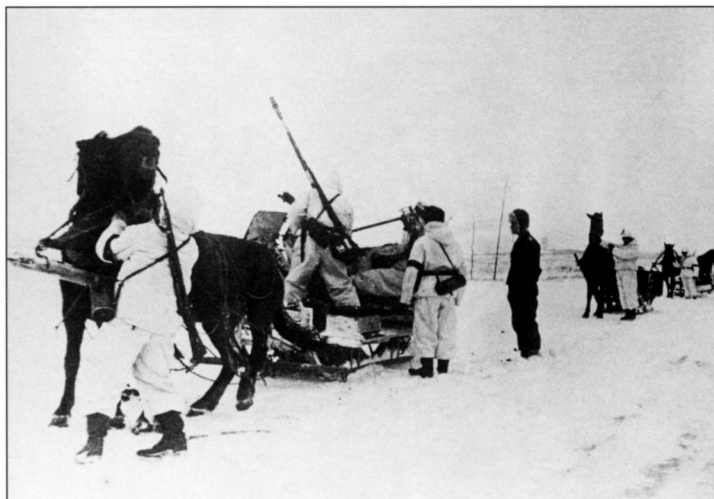
An entire battery of 2cm guns is visible in this scene, including the "support vehicles" — one for each gun — that carry the ammunition. This was probably the most amazing sort of "self-propelled artillery" seen in Russia since the Soviet "Tachankas" armed with Maxim 76.2mm heavy machine guns, who won the Bolshevik revolution and then the civil war in Soviet motion pictures.

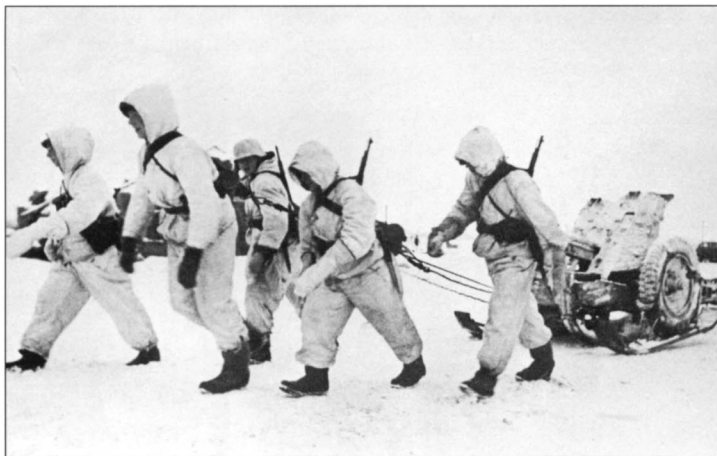
The final stage in the evolution of the Panzerwaffe motorization. Here a 3.7cm PAK 36/37 gun is towed by soldiers during the winter of 1942/43. The specially prepared skis for these guns were quite common among the German units during this winter season.

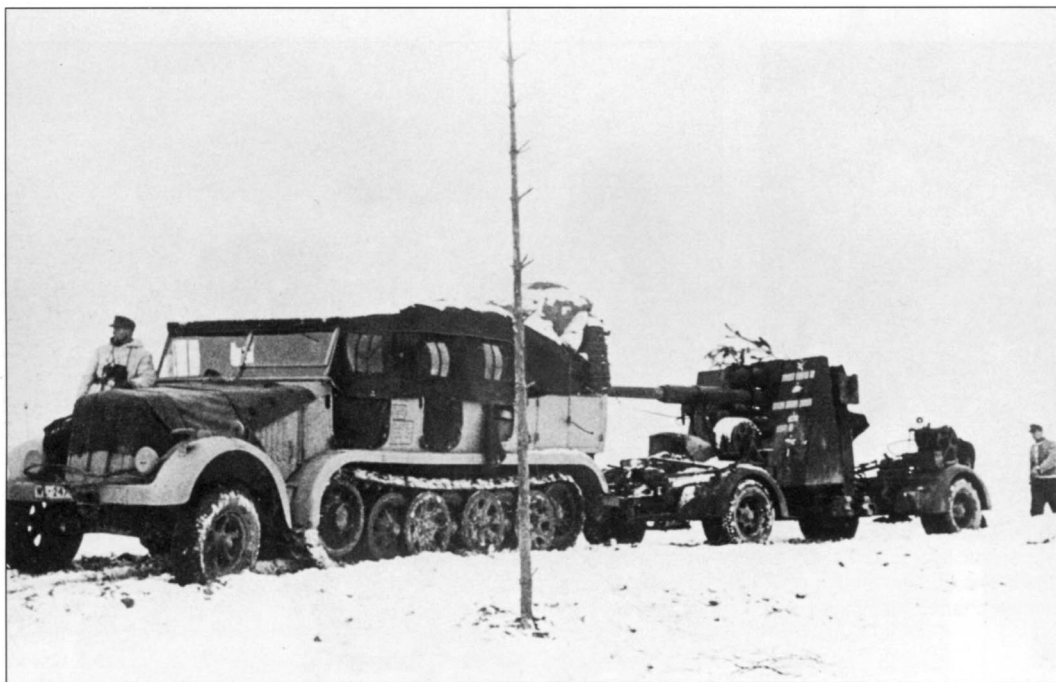
Within the Panzerwaffe the opposite of the makeshift horse-drawn vehicles were the strong, mobile half-tracked tractors used to transport a variety of artillery. Unfortunately, they were produced in too small a quantity throughout the war, so the secondary units had to use horses. This is a 12-ton Sd.Kfz. 8 prime mover with an incomplete 15cm sIG 33 gun.

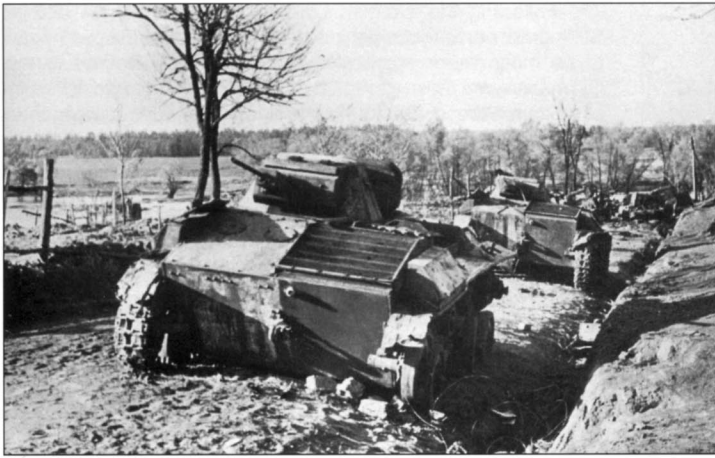
A column of Soviet mechanized troops that were surprised by Germans from the rear and exterminated. In the foreground are two T-60 light tanks with white camouflage. Note that only half of the hull rear plate was painted with white removable paint on both vehicles.

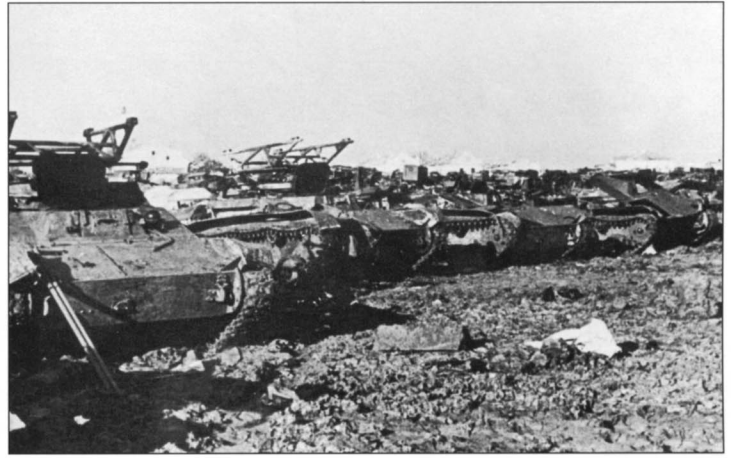
A dumping ground for Soviet armor destroyed in battle and then gathered from the killing fields. All vehicles seen in the first row are T-60 tanks rebuilt into the BM-8-24 vehicle, the so-called "Stalin organ". These "combat machines" (from BM - Boyevaya Mashina) were first produced in the late autumn of 1941 on the T-40 and T-60 chassis following the removal of the turrets and the installation on their mounts of special scaffolding for M-8 missile launchers.

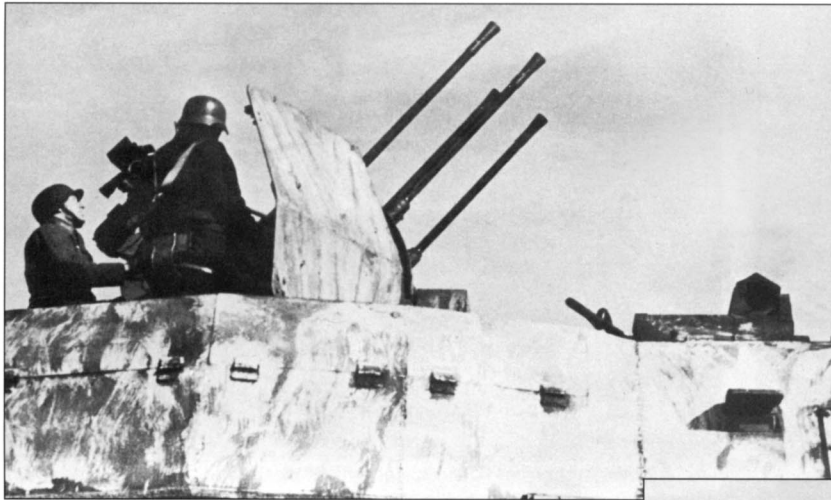
Following the German collapses in North Africa and at Stalingrad, partisan activity in almost the whole of Europe began to be much more aggressive. The most troublesome to the Germans were those groups that had fought in the vast forests of eastern Europe. One of their main targets was railways used by "Panzerzug" armored trains for anti-partisan actions and for defending main railway junctions against Soviet air attacks. Here is a close-up of one of the Panzerzug wagons fitted with a 2cm Flakvierling 38 anti-aircraft gun. The 2cm gun was intended as defense against aircraft, but it could also be used against ground targets. Note the style of applying the removable white camouflage.

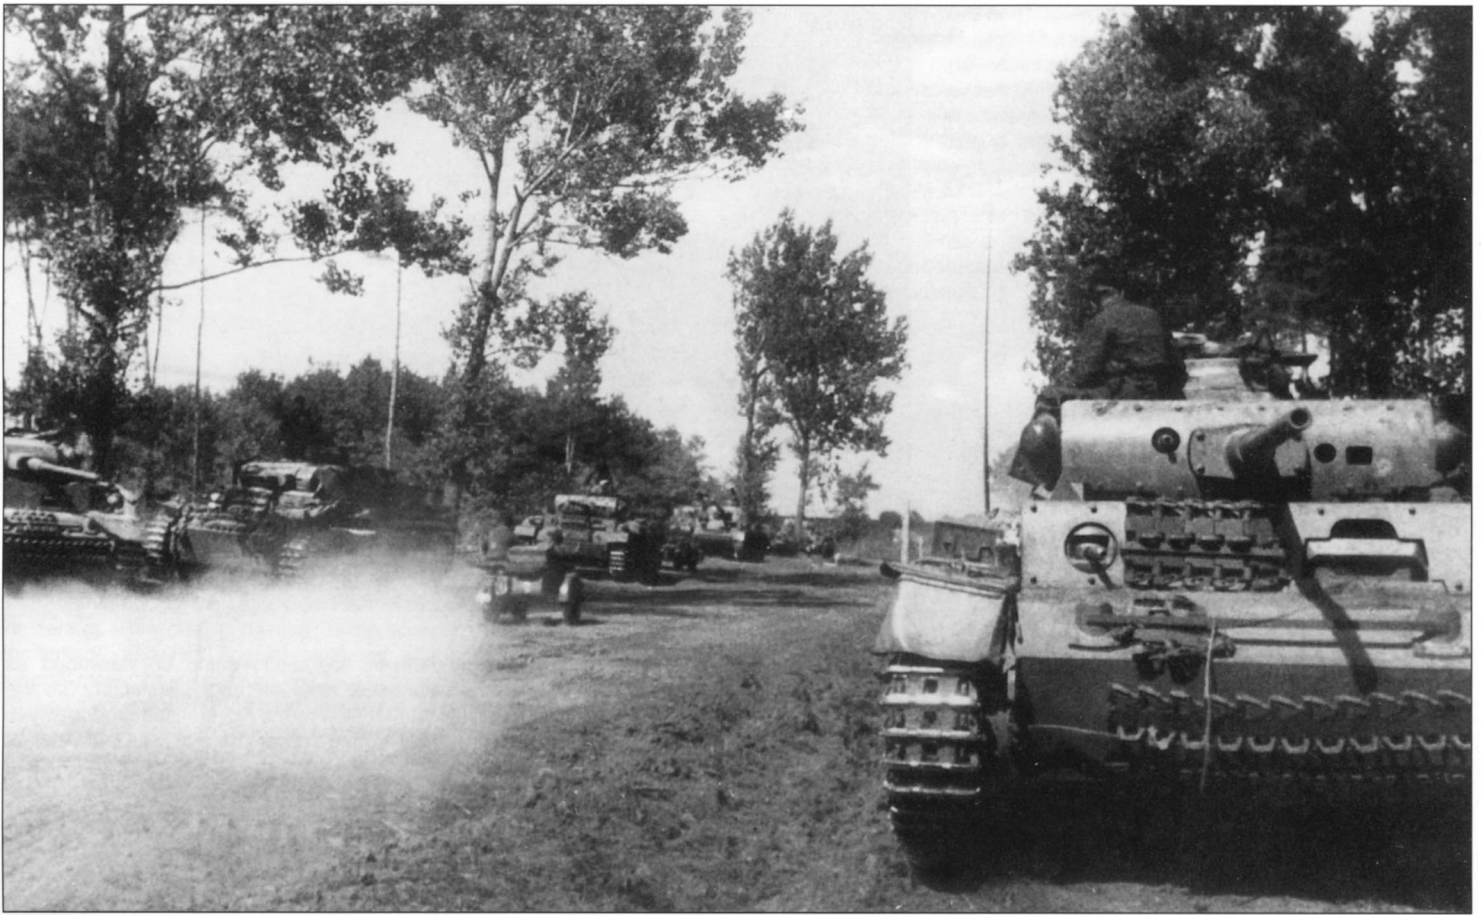
A column of Pz.Kpfw. IIIs from an unidentified division. The tank at the right is the standard version, but the one at the left lacks additional mantlet armor. It also features a very strange, square-shaped hatch in the superstructure frontal plate where the machine gun position should be. Behind this tank is a Pz.Bef.Wg. III Ausf. H fitted with a dummy 3.7cm gun. Note that none of the tanks seen in this photo have side skirts.

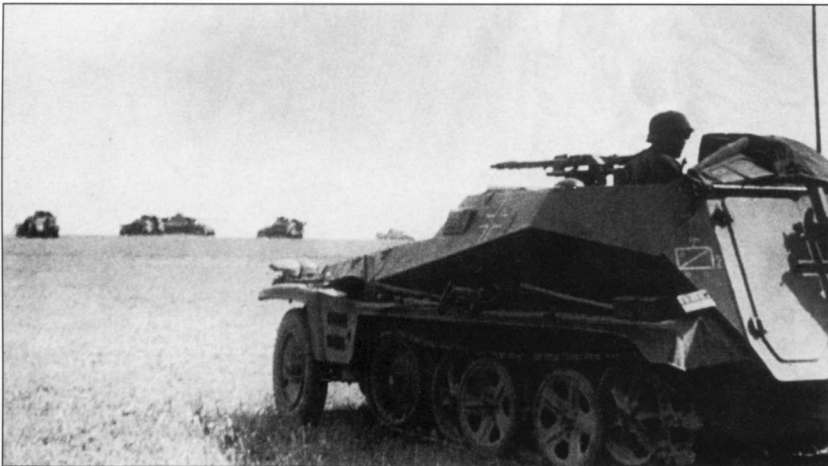
SS armored troops close in on an enemy position across the steppes from the Kursk area in preparation for Operation "Zitadelle". Note the tactical sign painted near the door of this Sd.Kfz. 250/1; it indicates the 2nd company of a reconnaissance battalion of a Panzer-Grenadier division. In the background are three other Sd.Kfz. 250s, and behind them are two Pz.Kpfw. Vs. The II.SS-Panzer-Korps played a major role during the July fighting in the southern part of the Kursk bulge.

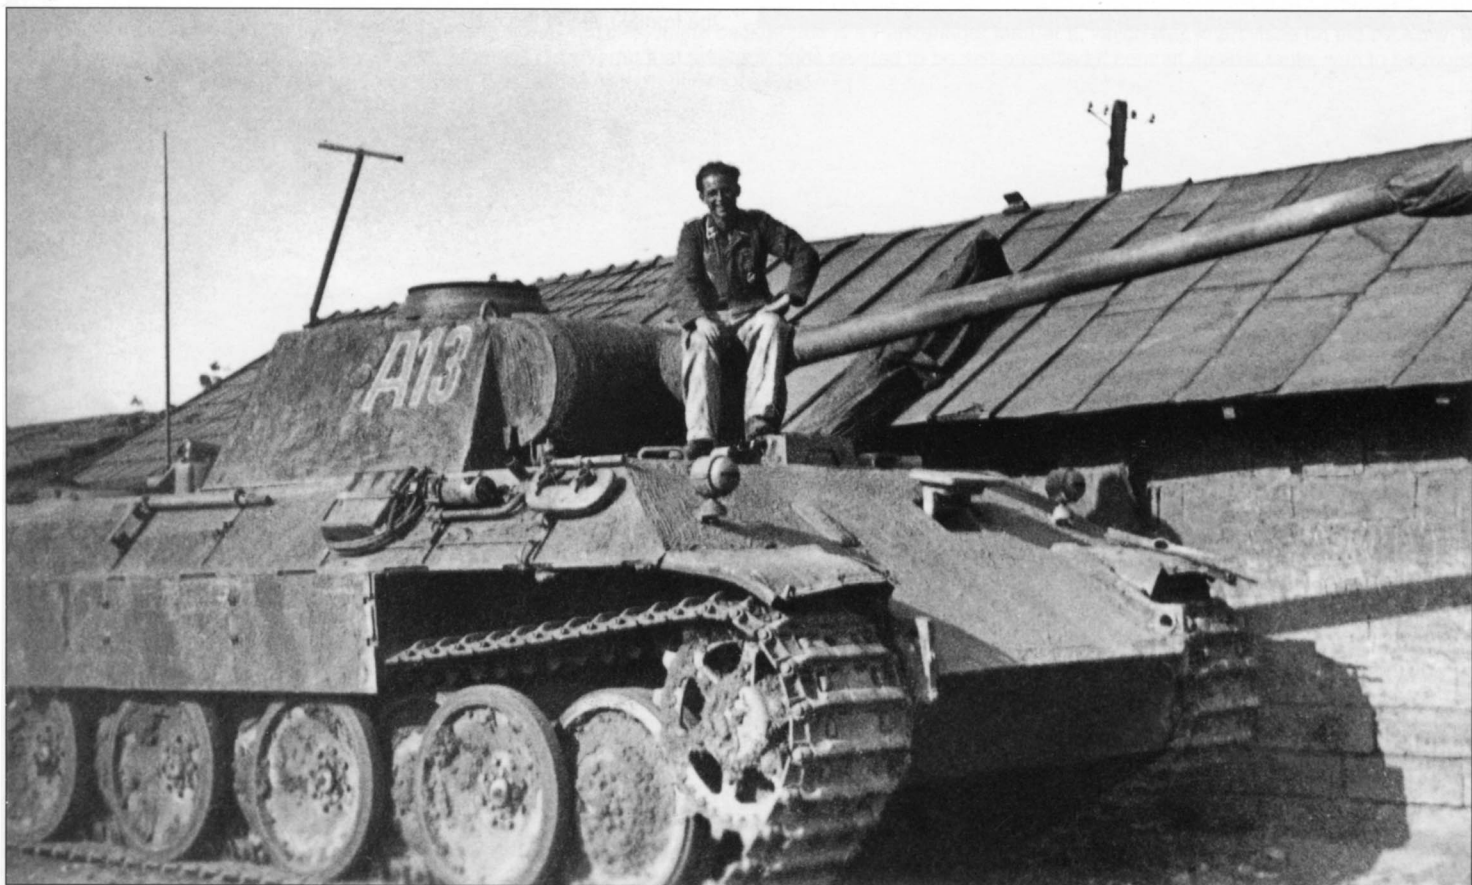
The best medium tank of the second part of WWII — the Pz.Kpfw. V Panther — suffered from some technical problems in the middle of 1943. Nevertheless, it was a very dangerous weapon to the Soviet tank crews, who appreciated the tank very much. Here a soldier poses with a Pz.Kpfw. V Ausf. D belonging to the staff of an Abteilung. The tank is marked with the two-color (red outlined with white) tactical marking "A13". Note the camouflage of the tank; it is covered with solid coat of brown and green spots, so the dark yellow color is only occasionally visible. The Ausf. D had no machine gun in the glacis plate, this being the standard for the tanks and self-propelled guns of the Panzerwaffe during this period of the war.

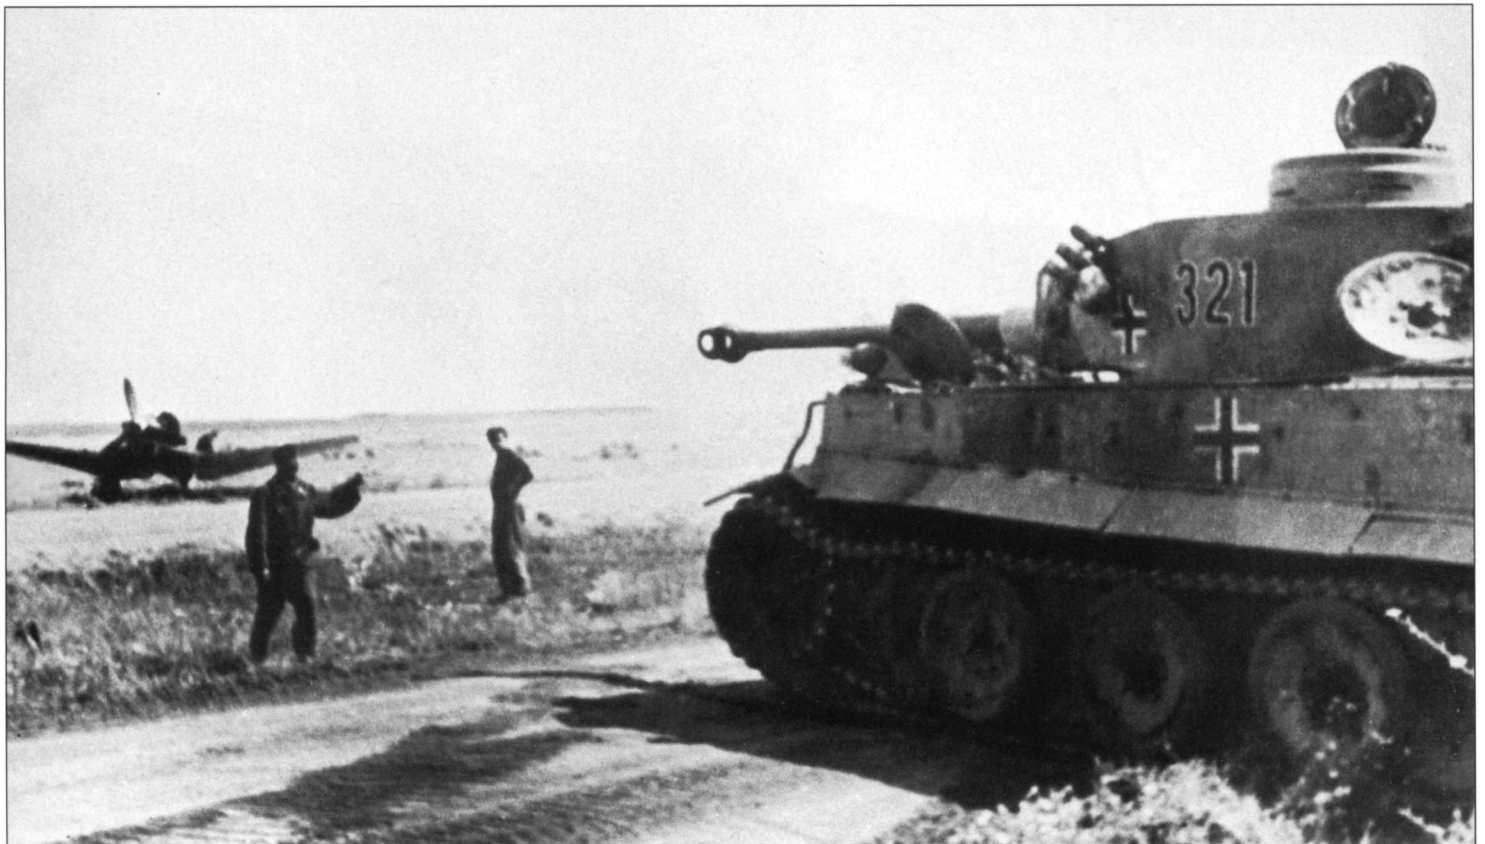
Tank units used Tigers during the fighting on the Kursk bulge — two battalions and four companies with 146 Pz.Kpfw. VIs. They lost 33 tanks, but destroyed about 30 times more Soviet tanks, many other weapons, as well as field installations. They lead almost every assault and gave immediate destructive support for attacking infantry. This photo shows one of these Tigers, which carries the tactical number "321" and is painted in a two-color camouflage scheme.

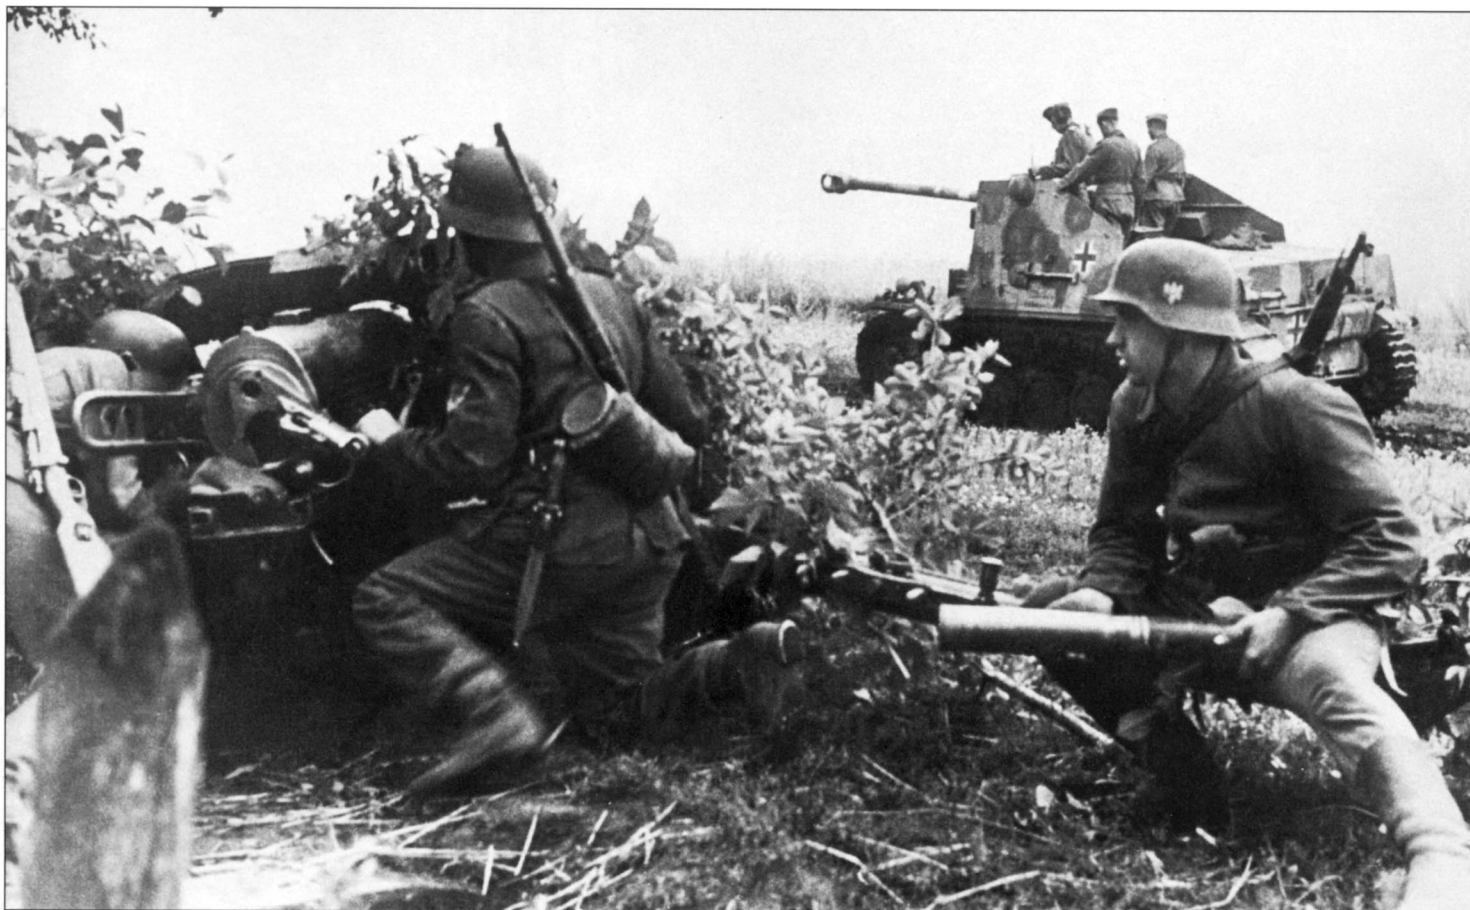
Two different sorts of anti-tank artillery are visible here, though they do have something in common — improvisation. In the foreground is a 7.5cm PAK 97/38 gun, which was improvised based on German and French elements after the Germans learned during the first two years of the 1940s that they did not have enough powerful guns to fight against heavy armored vehicles. In the background is a Panzerjäger Marder II, which was improvised on the Pz.Kpfw. II chassis with a 7.5cm PAK 40/2 gun when the Germans discovered that anti-tank guns needed to be self-propelled if combat against tanks was to be more fruitful and with fewer losses. Note the interesting camouflage pattern on this vehicle.

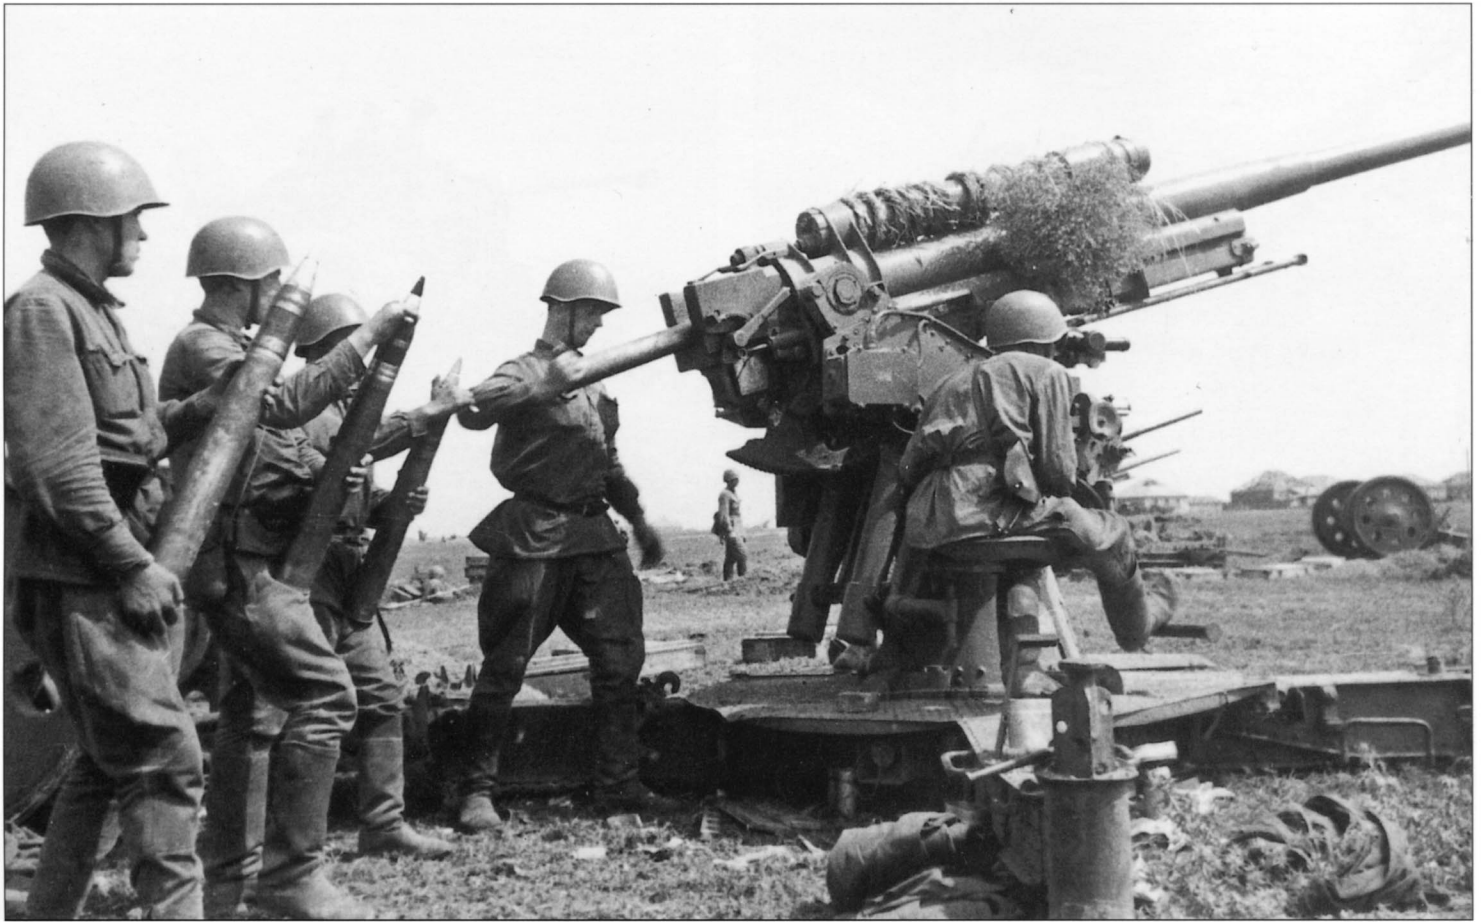
The crew members of a Soviet 85mm Model 39 anti-tank gun get ready for action. This gun was almost the equivalent of the German "88", being just a bit less powerful. An anti-tank round from this gun could penetrate 100mm vertical armored plate at a range of 1,000 meters (about 1,100 yards), while the "88" could penetrate almost 140mm of armor at a 30 degree angle.

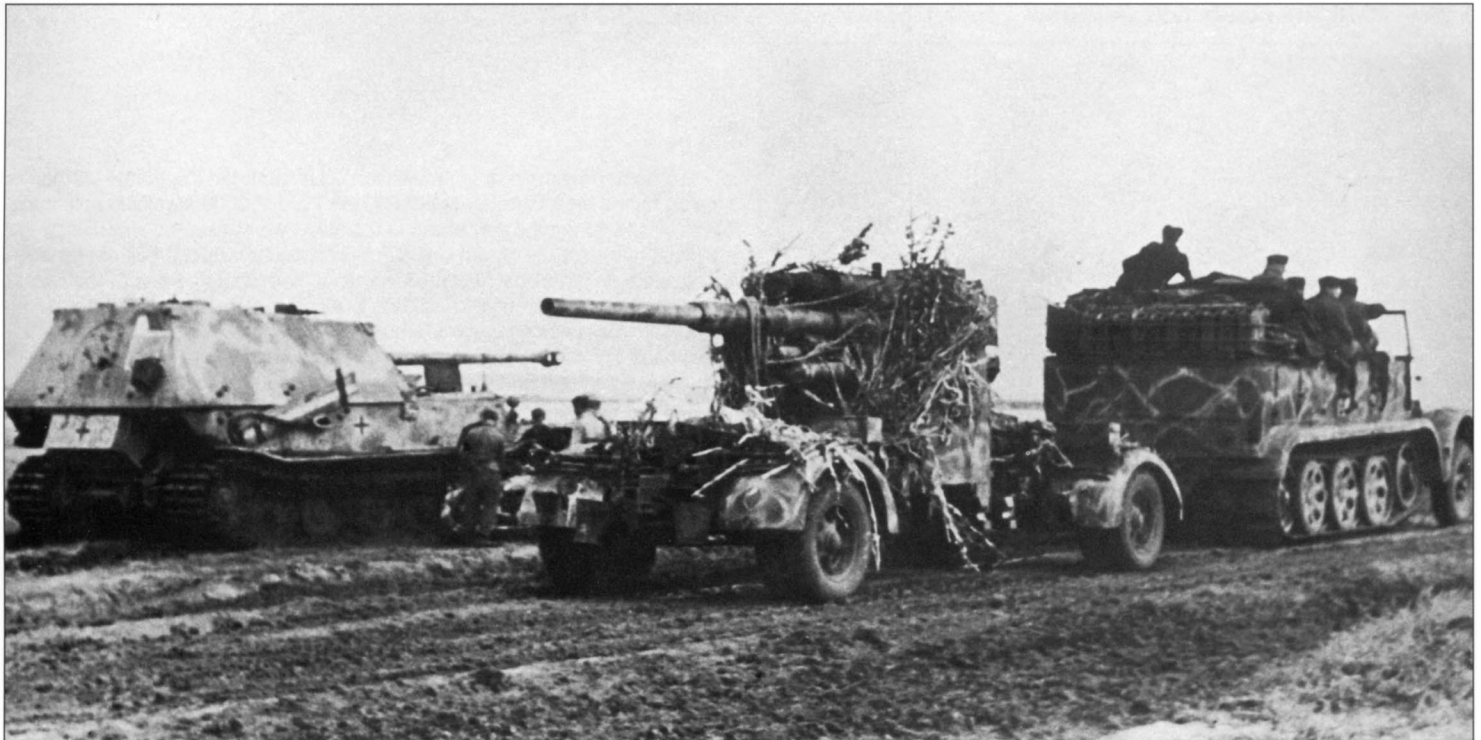
Both the 12-ton Sd.Kfz. 8 half-track (at right) and the 8.8cm Flak 36 it is towing are camouflaged with a dark yellow pattern over dark gray. They are passing by the weapon that turned out to be the hit of the summer of 1943 — the Elephant. During the fighting on the Kursk bulge, the Elephant won immortal fame as the heaviest AFV of this period. In the following decades this vehicle was described almost solely as unsuccessful and basically inefficient in combat. This description is based mainly on one statistic — the number of Elephants that were lost, which was 39 pieces. The losses were, in fact, heavy, but they were only about 50% of the strength of Jagdpanzer Regiment 656 (comprising Pz.Jäg.Abt.653 and Pz.Jäg.Abt.654). It should be noted that the same percentage of losses was experienced in some Tiger units. The German Elephant crews forced the Soviets to pay a very high price for their victories. As of 27 July 1943, during only 22 days of battle, the Elephants destroyed 502 tanks and many other weapons. The camouflage of the Elephant seen in this photo consists of large green spots on a dark yellow background. Note that there is no tactical number.

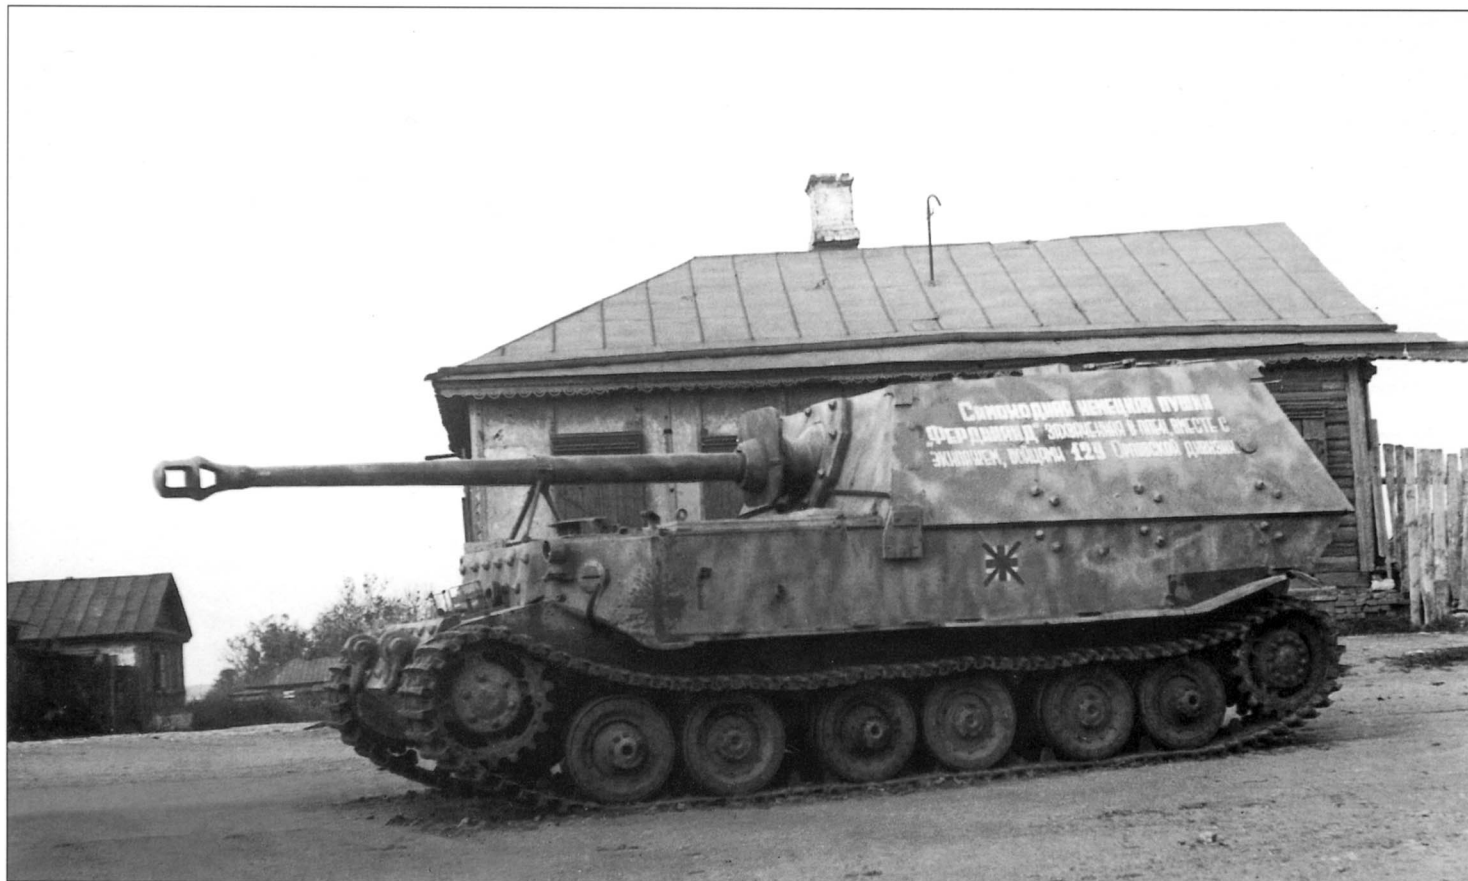
One of the 39 Elefants lost was captured in almost perfect condition by the Soviets. The vehicle showed only minor damages (the frontal parts of mudguards are shot off, for example). Note the camouflage pattern that was not typical of these self-propelled guns. The inscription on the superstructure reads: "Self propelled German gun 'Ferdinand' taken into captivity, together with the crew, by soldiers of 129th Orel Division". The division, commanded by Col. I.V. Panchjuk, took part in the capture of Orel city (with 4 other divisions and 3 tank units), and it was honored with the name of the city. For many years it was thought that most of the Elefants were lost because they had no machine guns, but this is not true. Many of them were lost due to damage or a lack of fuel, not because of deadly shooting from enemy guns or infantry. The Elephant was an offensive weapon, so during retreating combat it had less chance of fighting successfully (especially in cities!), and many of them had to be abandoned on battlefields with only minor damage, like the one seen here.

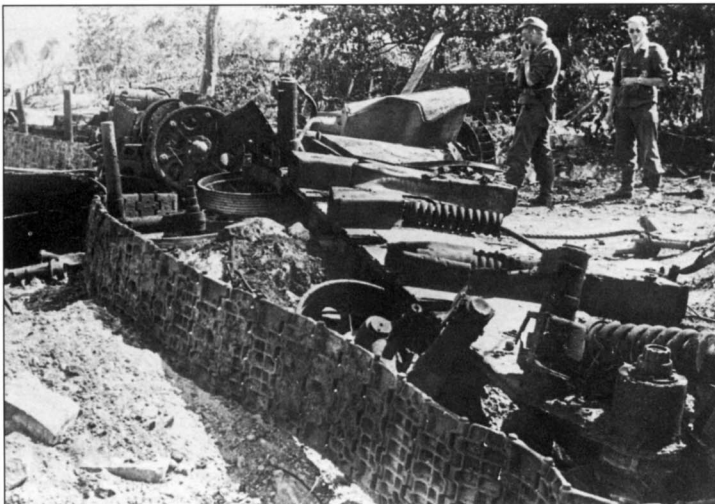
What we see in this photo are the few remains of a T-34 that exploded after receiving a direct hit from an 8.8cm round. The armor-piercing rounds of 8.8cm KwK36 L/56 and 7.5cm KwK42 L/70 guns had tremendous power and easily penetrated the low-quality steel armor of the Soviet tanks produced in 1942 and early 1943.

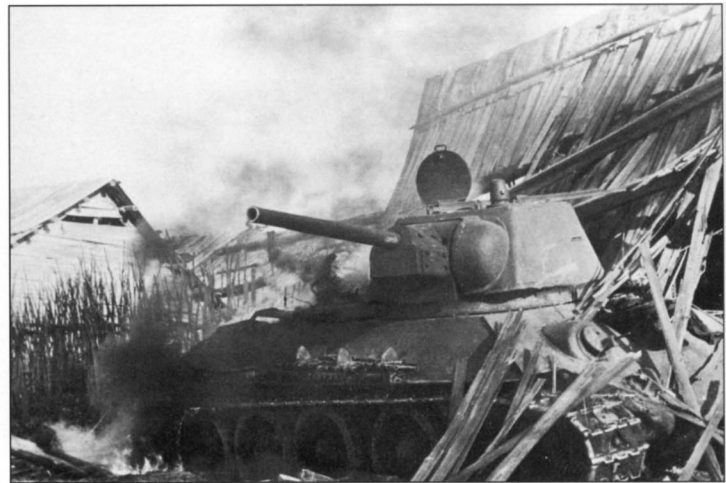
Another T-34 destroyed by the Germans. A well-aimed round hit the tank in the engine compartment, which burst into flames. During "Zitadelle" German tank crews enjoyed complete superiority over the enemy armor. Nevertheless, the Soviets did manage to win many armored duels. For each of their own tanks or SPGs lost in the tank clashes, the Germans destroyed 4-5 enemy tanks.

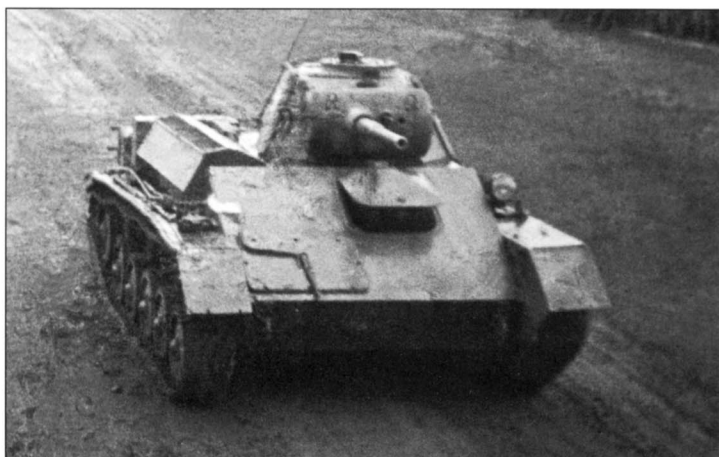
One of three main tanks used by the Red Army during the fighting in the Kursk bulge was the T-70. History has judged it to be a weak tank, but it was actually the best light tank of its time. After the modification of its chassis at the end of 1942 it was quite easy to drive, well armored (the same armor was used on T-34 tanks), and not badly armed. Anti-tank rounds from its 45mm gun could penetrate almost 50mm of vertical armor at a range of 500 meters, so it was almost as powerful as the 37mm gun on the M3/M5 "Stuart" tank. However, these tanks were very rarely equipped with radio equipment.

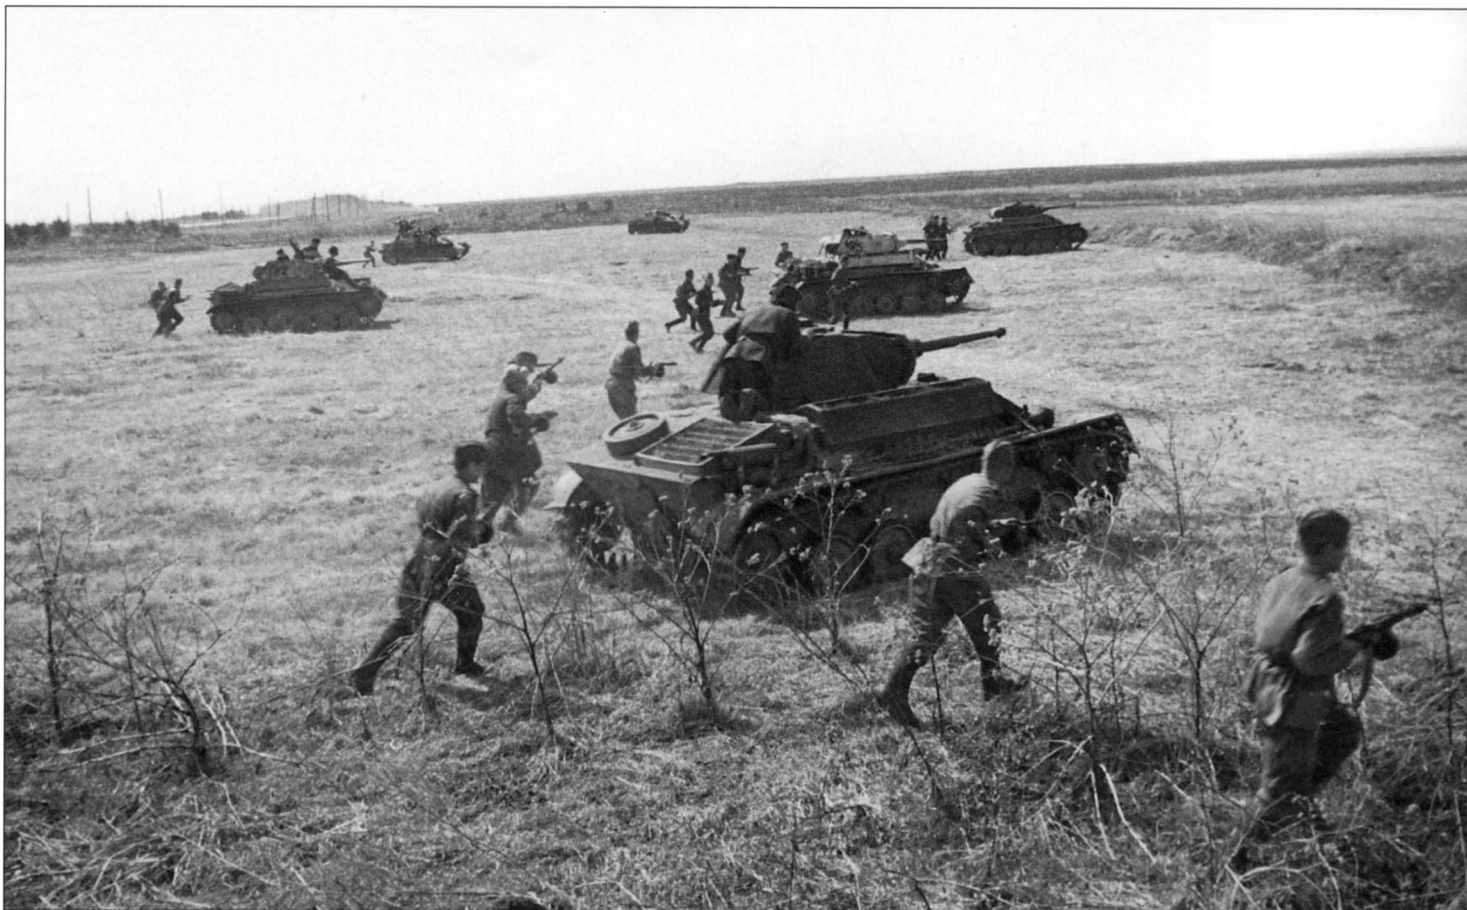
This sub-unit equipped with T-70s was photographed during exercises. Note that a few tanks in the background are still camouflaged with white winter camouflage. The tank at left has white only on its turret, while the one in the center of the photo is entirely covered with whitewash. The standard tank brigade was equipped with 32 T-34s and 21 T-70s at the time of "Zitadelle", but there were also units equipped only, or almost only, with T-34s.

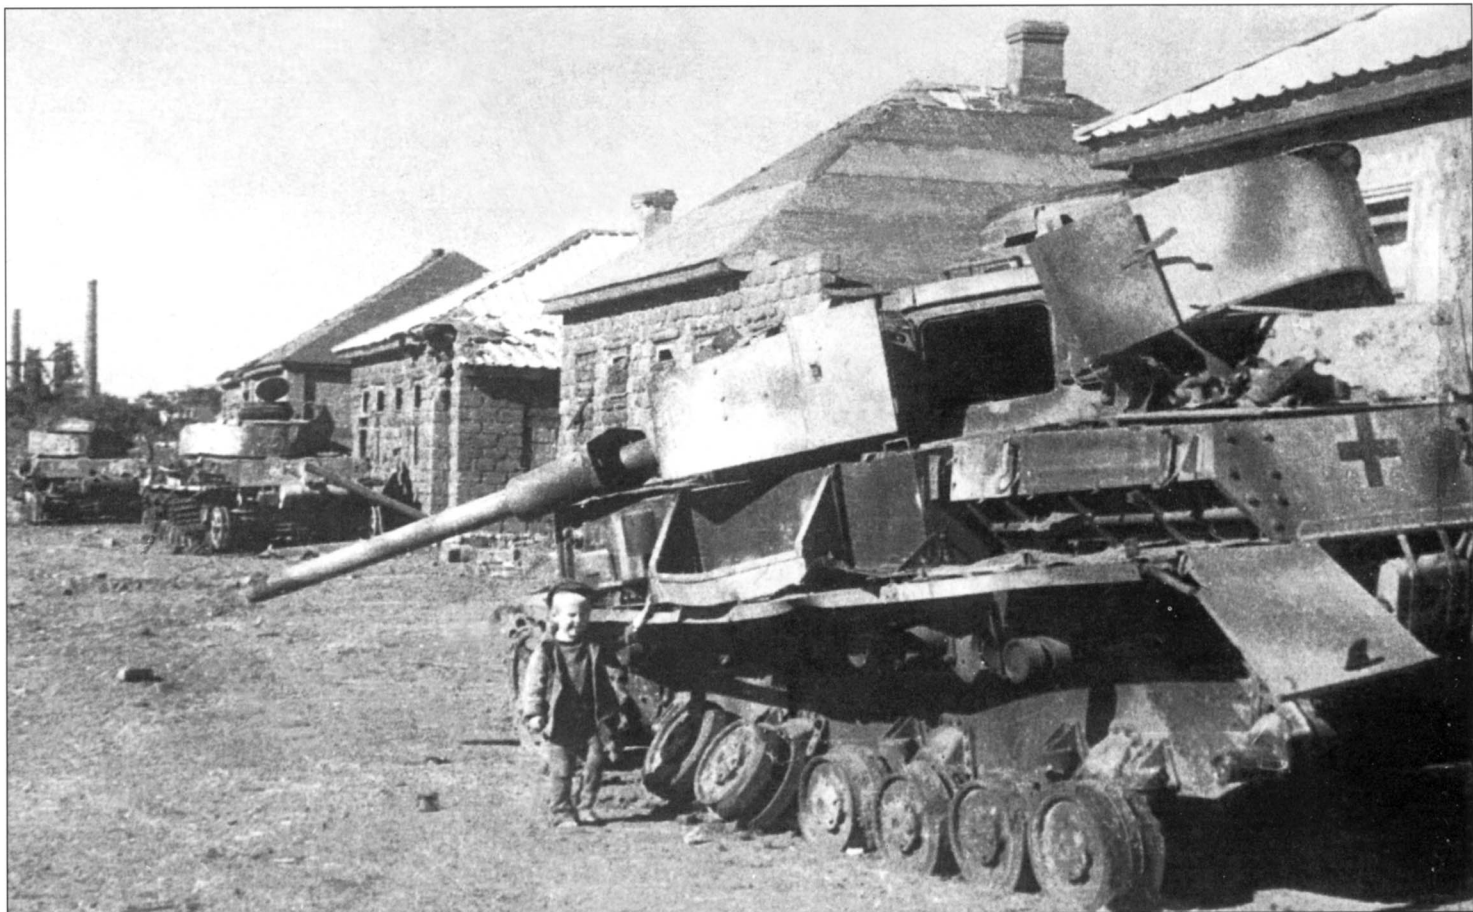
This photo shows the remains of three Pz.Kpfw. IV Ausf. Hs that were shot to pieces by the Soviets after stopping near some houses in the town of Makeyevka in the autumn of 1943.

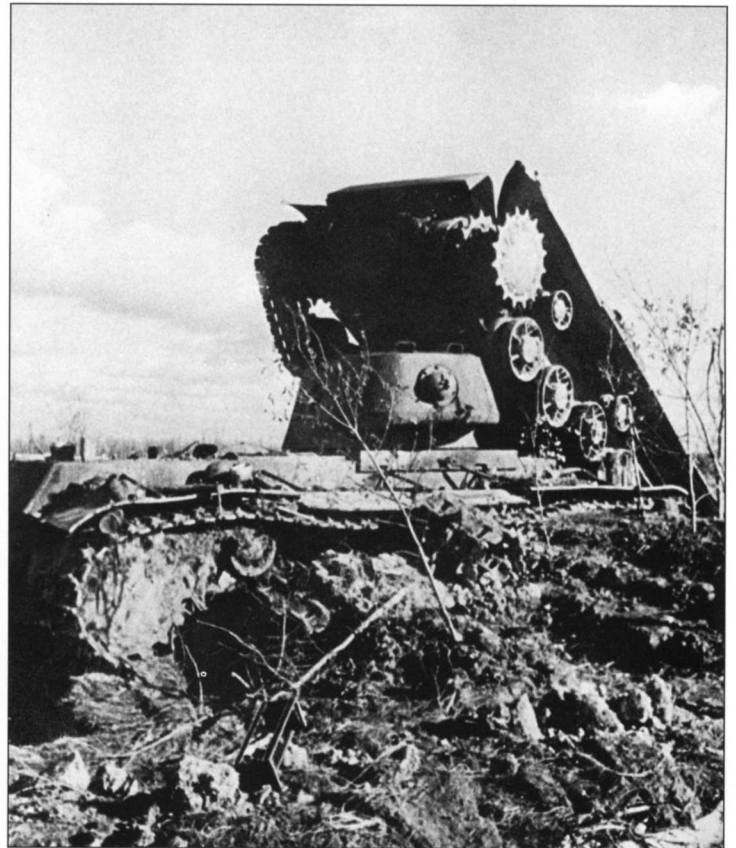
Here is a similar, but even more amazing situation. A KV-1 tank, which had become stuck in an enemy entrenchment, was run over by another one, which lost its right track during the accident. It vividly illustrates what soldiers could expect to see in the chaos of battle on the Eastern Front.
