# Armor Battles on the Eastern Front

(2) Downfall of the Reich 1943-1945

Robert Michulec

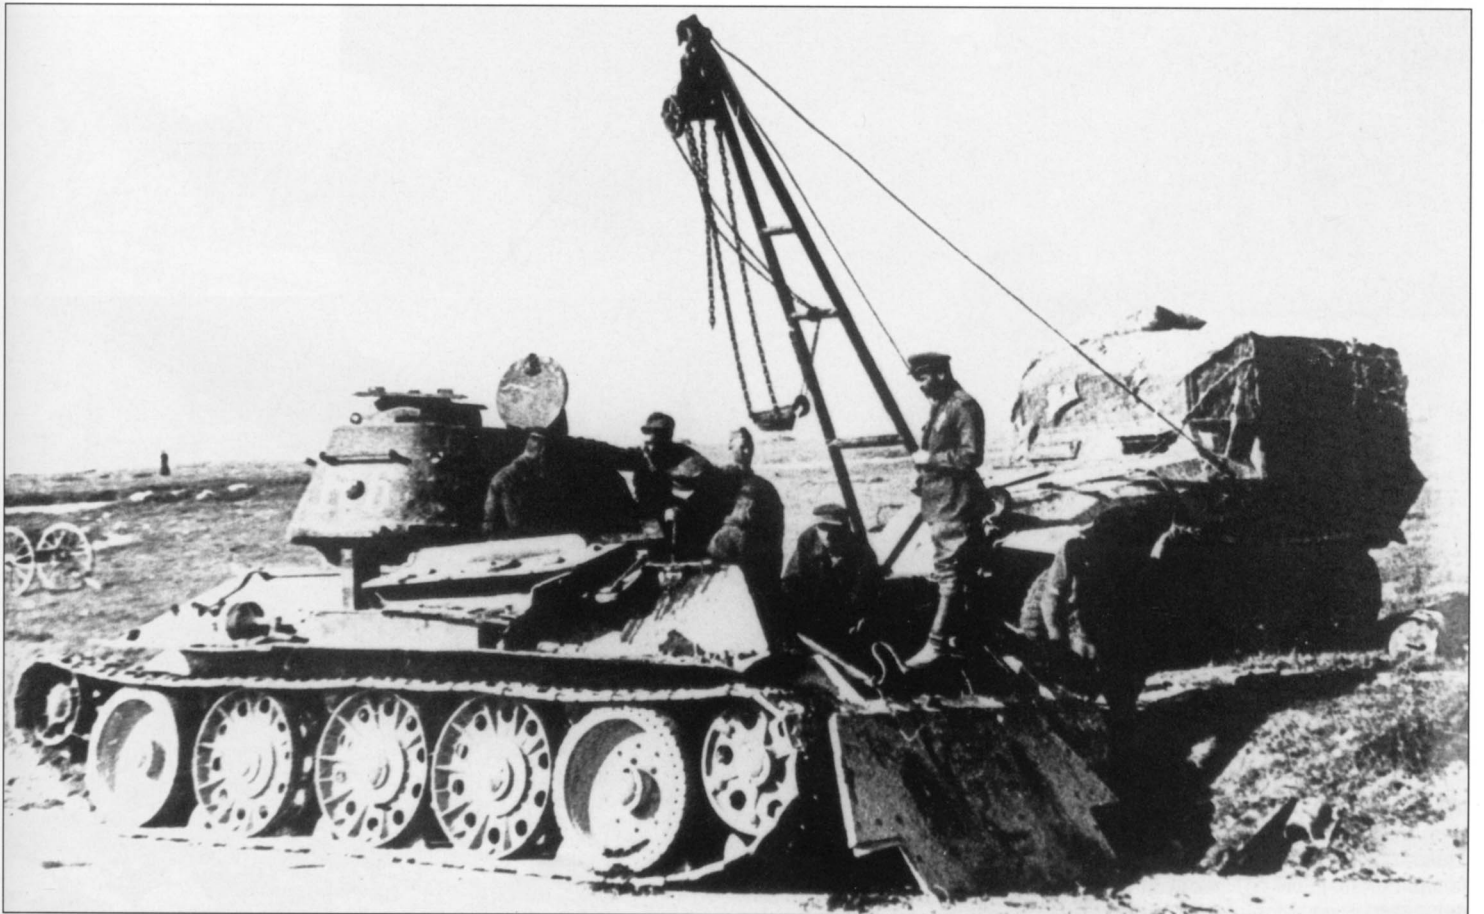
Russian mechanics overhaul the engine of a T-34 tank. The V-2-34 engine was a simple machine that weighed 750 kg and could produce 500 HP, but it had quite a short operating time between overhauls. Of special interest is the vehicle in the background, a German Sd.Kfz. 251 half-track APC captured by the Soviets and adapted to recovery duties.

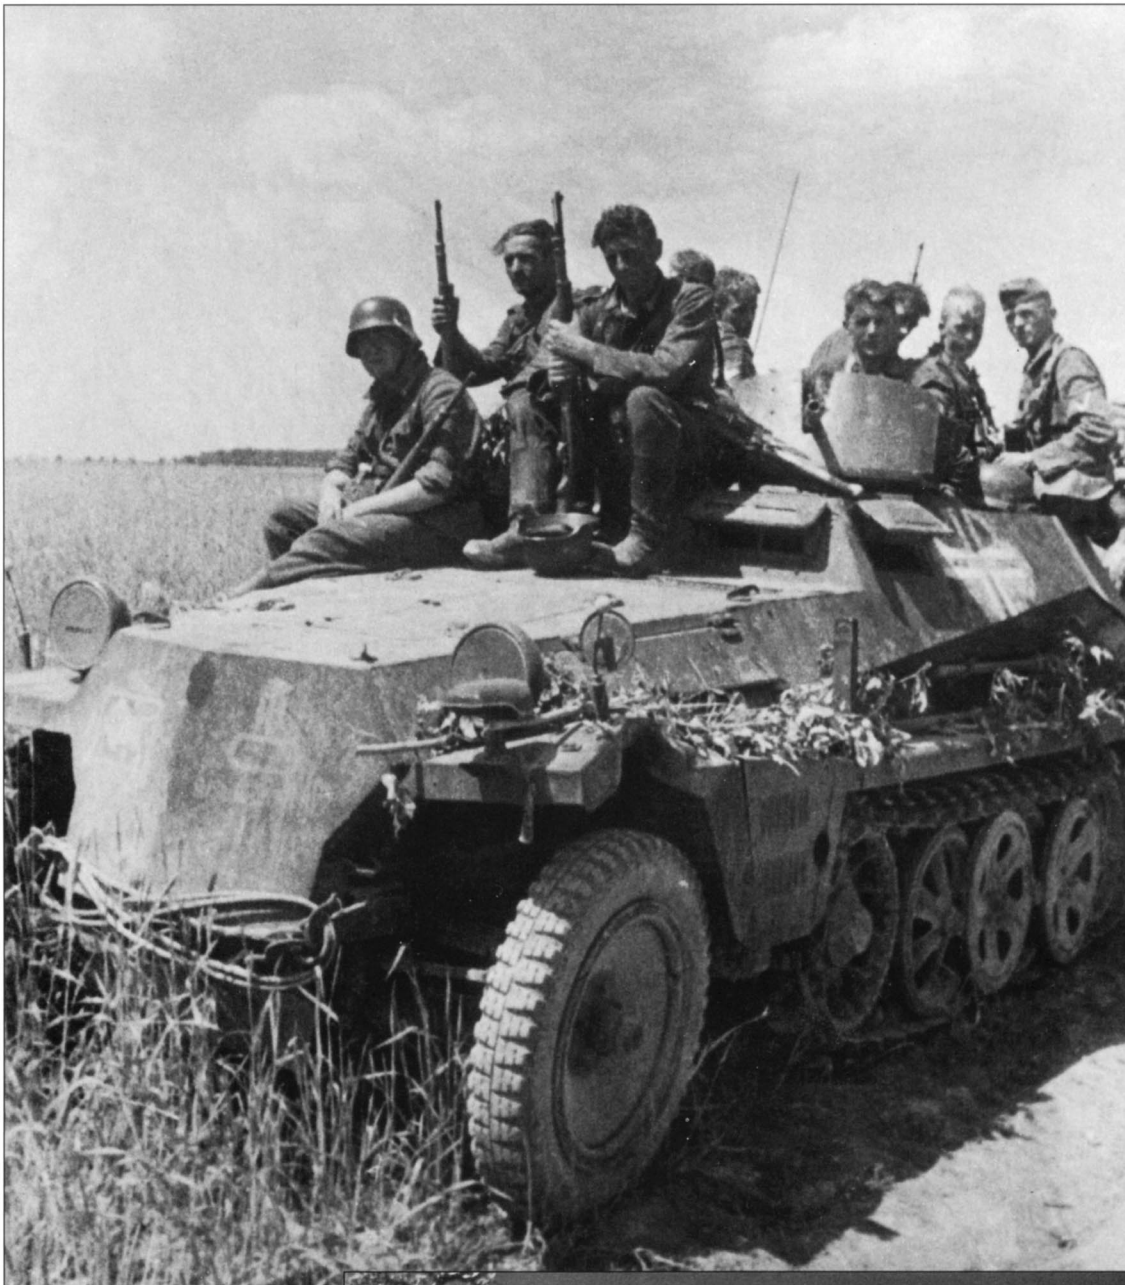
A Sd.Kfz. 250/1 sits at the side of a road loaded down with a squad of stormtroops. This half-track belonged to a StuG battery from StuG.Abt.191, which was employed by Herresgruppe Sud throughout most of 1943, mainly on the Kuban bridgehead. Note that the front plate of the engine armor features a number of markings but lacks a license plate. The unit emblem is visible at left and on the right is the tactical sign.

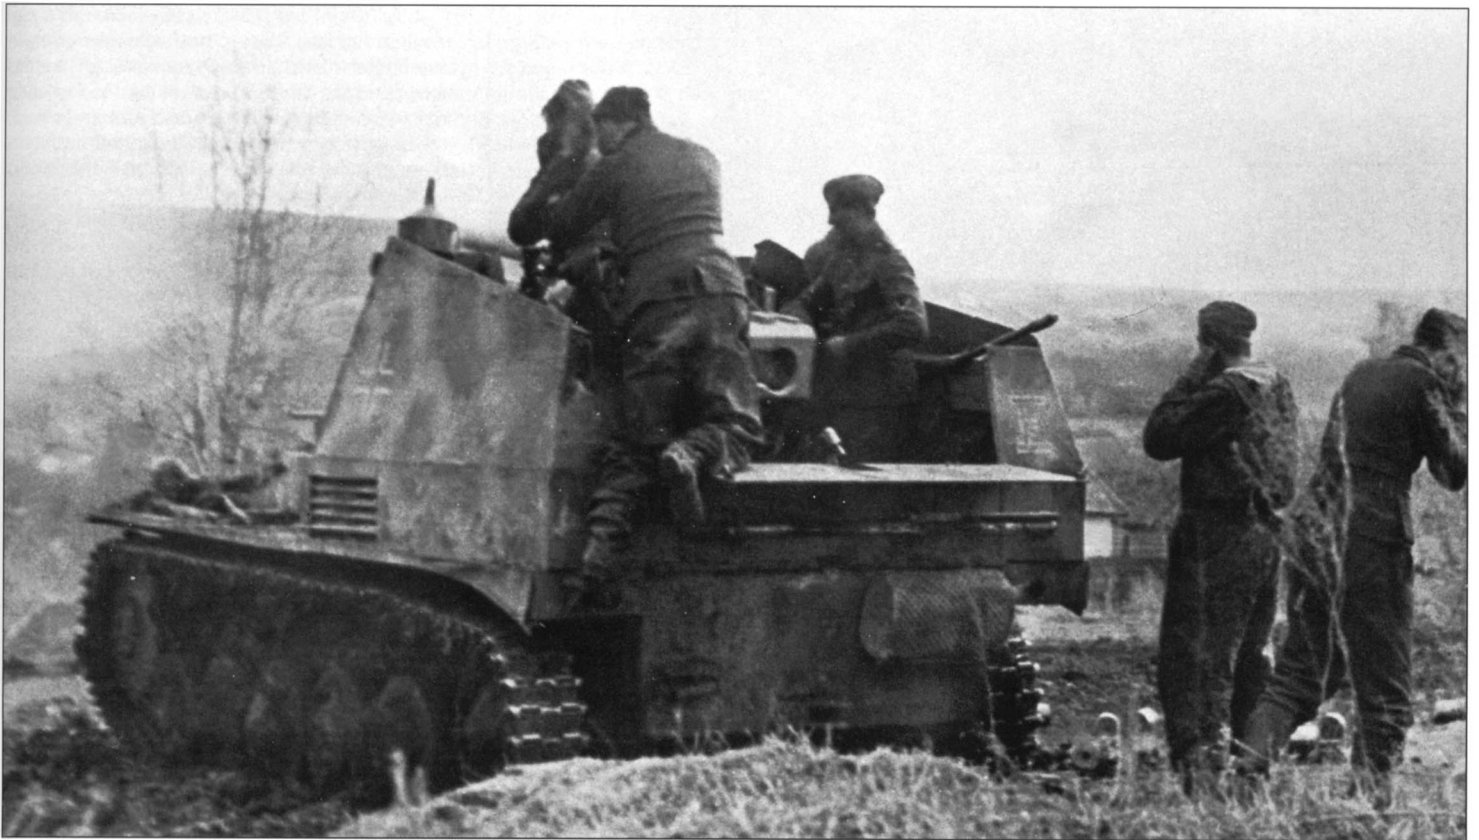
Crew members of a light self-propelled howitzer protect their ears from noise as their gun goes to work. The Wespe was the only vehicle of the Panzerwaffe in which the 10.5cm howitzers were installed. The conception of this vehicle was the same as all the other self-propelled guns of the Panzerwaffe. An obsolete tank chassis was adapted for the leFH 18 howitzer, so the Wespe gun crew had little space for comfortable work. Therefore, only two soldiers were stationed in the combat compartment, while three others, as well as the ammunition, remained outside of it. This Wespe is camouflaged with green or brown spots and marked with the letter "E", which indicates that it is from an independent artillery unit used by the staff of an army corps.

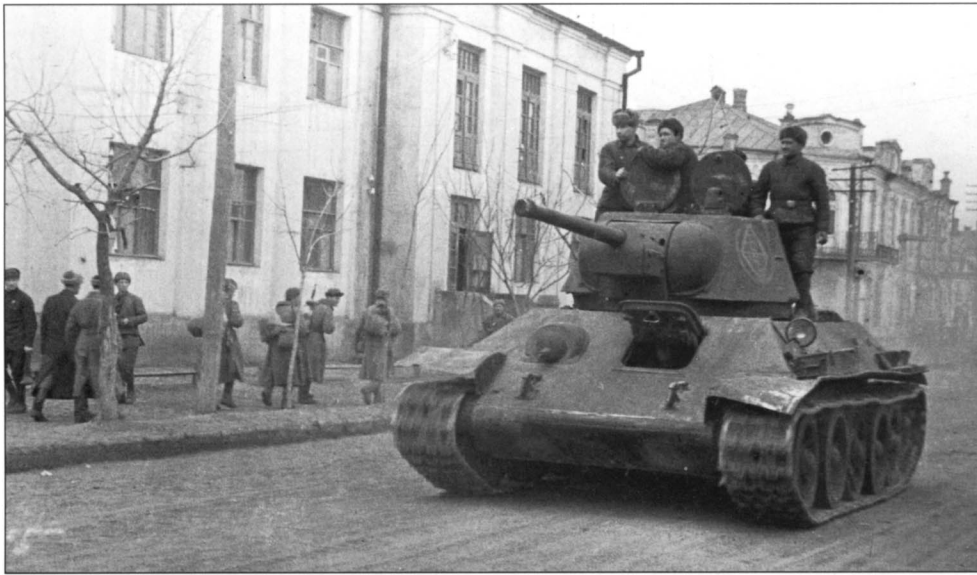
A T-34 Model 1942 passes through a city as it advances toward the Dnieper river in September 1943. Note the markings on the turret and the different width of the road wheels: the first and the last are pierced rubber-rimmed, the second and fourth are the standard rubber-rimmed style, while the road wheel in the middle is the all-steel version.

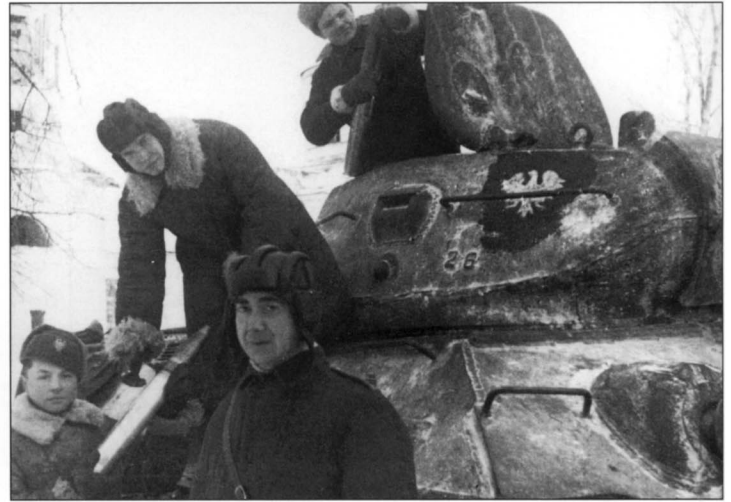
A close-up of a T-34 Model 1942 from the Polish 1st Polk Czolgow photographed during the loading of ammunition during the winter season. Note the many details of the construction of the tank produced by Factory No. 112, such as the raised casting of the number “26” on the side of the turret, which may indicate the production series. This white residue on the armor is the remains of the removable white paint used for winter camouflage. The white eagle, the national insignia of the Polish People’s Army, was painted with the help of a stencil in a dark color (maybe black) over the tank’s base color. The shells passing through the hands of the crew are high explosive rounds.

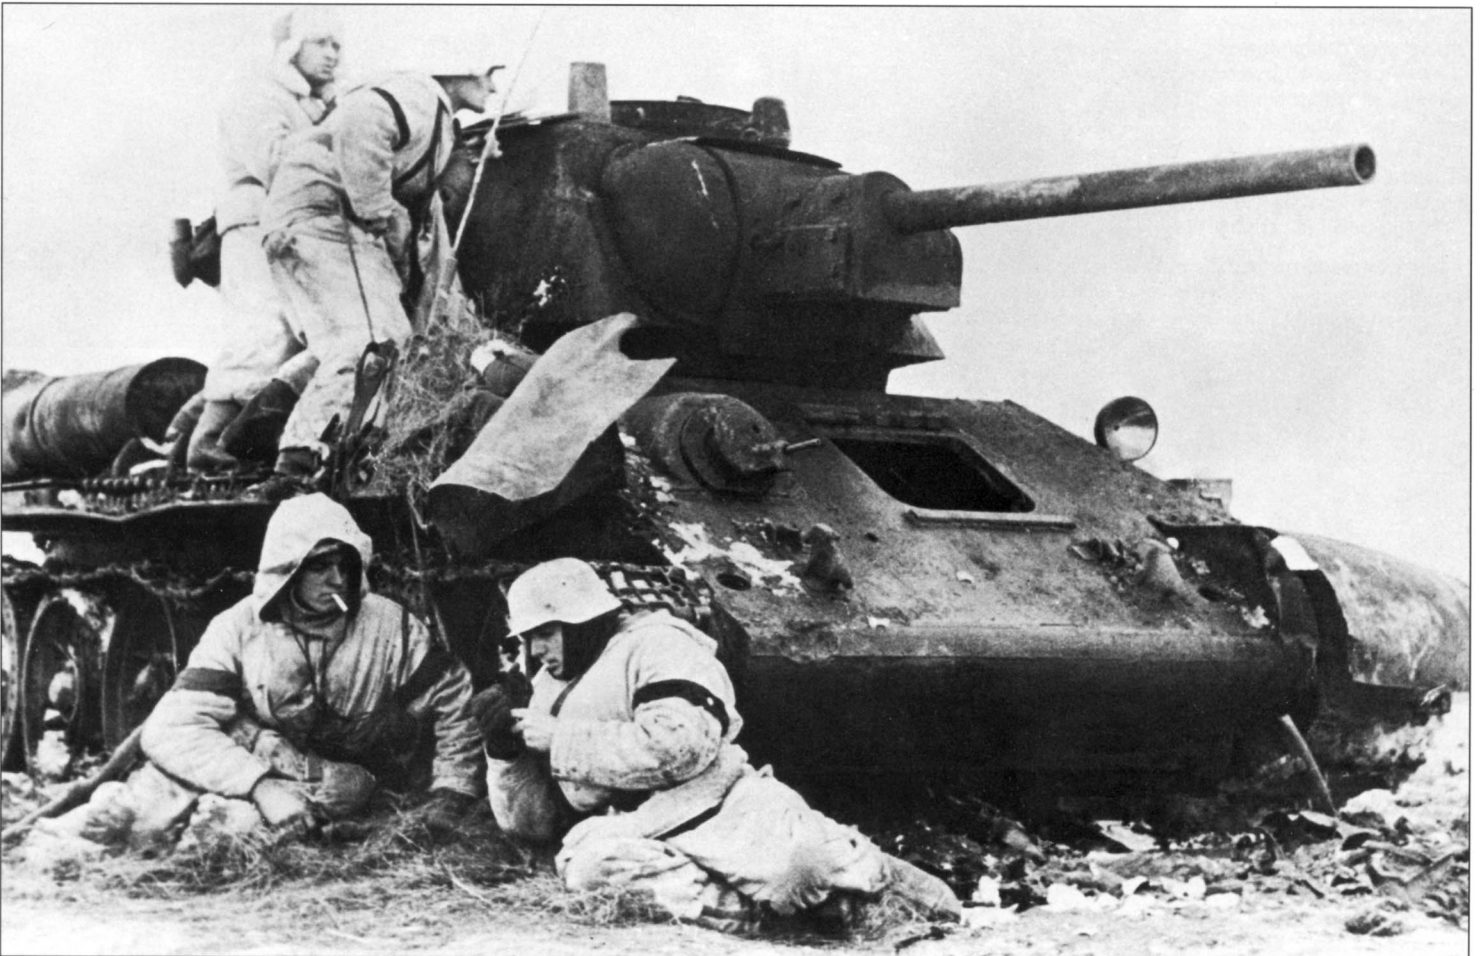
An interesting scene of German soldiers resting alongside a T-34. This T-34 is from the series in the second half of 1943 and exhibits all of the details typical of this model — fuel drums, a commander cupola on the turret and only rubber-rimmed road wheels. After the tank received a direct hit and was burned out, it was used by advanced enemy troops as an observation post.

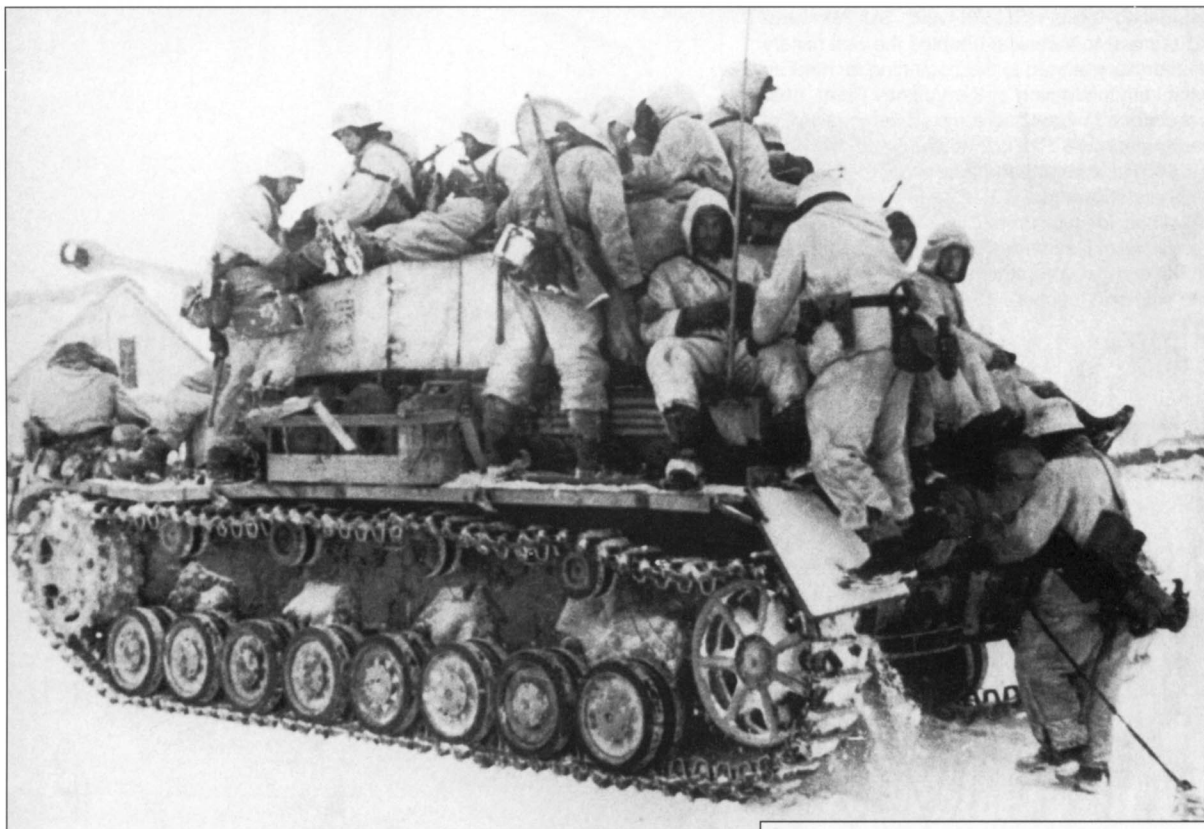
This was a typical sight during the winter fighting of 1943/1944, when infantry troops had to be transported on tanks and similar vehicles because soft-skinned vehicles were rendered useless by deep or wet snow and the lack of fuel. Note the way the soldiers transport the machine gun ammunition — they were so lazy (or creative?) that they attached the ammo box to the tank and towed it on a “leash”!

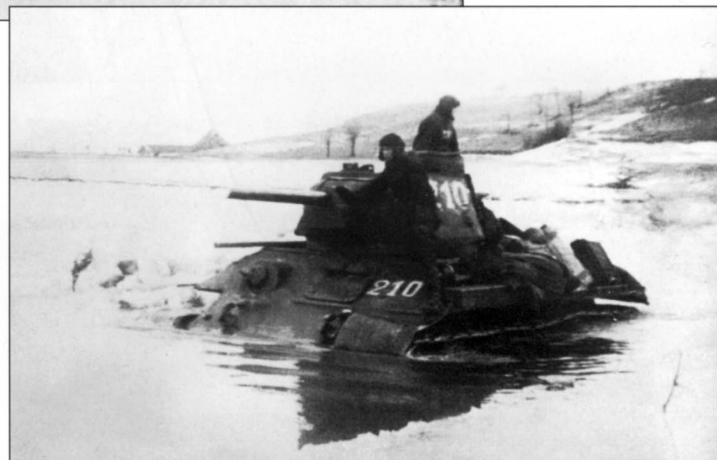
A T-34 performs a chilly river crossing in the dead of winter. Note the tactical number “210” painted in white on the glacis plate. This was very rare in 1944 since by that time Soviet crews had begun to paint red stars on the glacis.

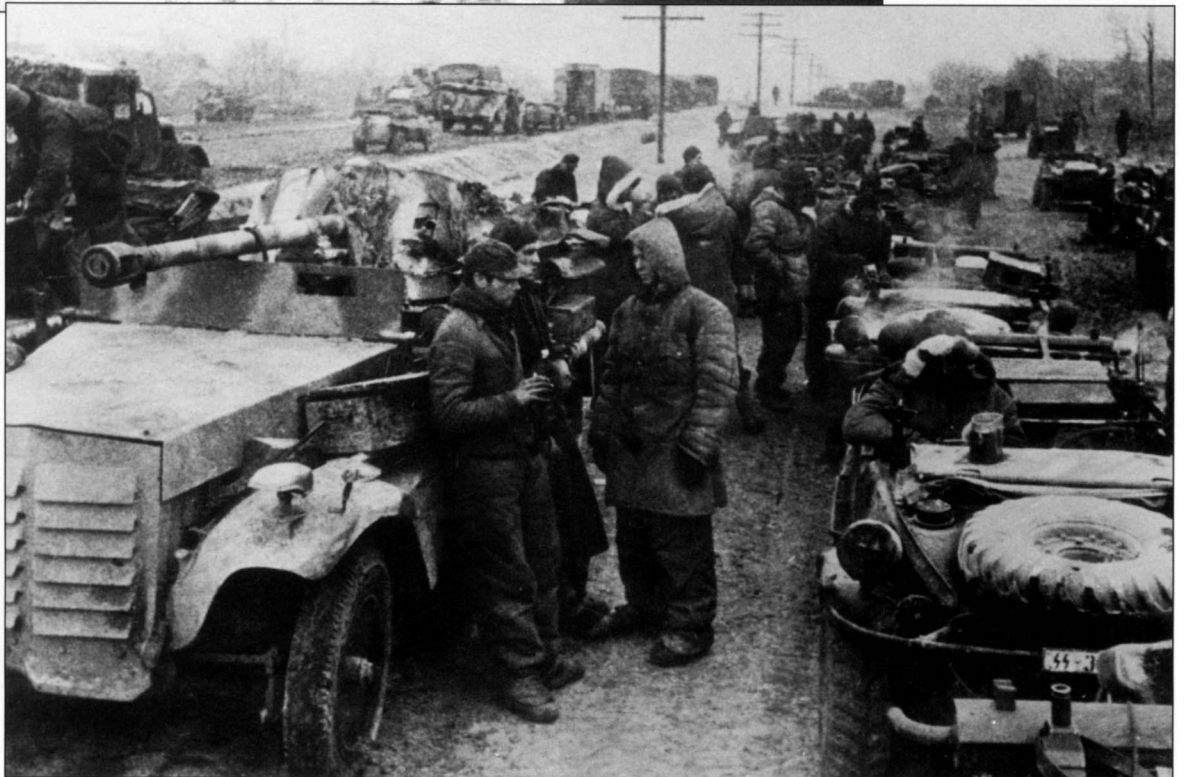
Sitting at a rail station at Kovel in late March 1944 is a wagon (No. 2 or 3) from Panzerzug 10. The armored train was badly bombed by the Soviet Air Force, and due to resulting damage this wagon is being towed by a standard locomotive (at the extreme right in clouds of steam). This Panzerzug had a very interesting history. It was originally built by the Poles as armored train No. 53 "Smialy" ("Brave"). Then, in the middle of September 1939, it was captured by the Soviets at Kovel and used as BEPO 75. Later, in the beginning of July 1941, it was captured again by the Germans and named "Panzerzug 10". Note the interesting camouflage on this wagon and the cupola from a Pz.Kpfw. III/IV, which is visible on the central part of the wagon. The curious feature visible above the closest door is a chimney from a stove used by the crew.

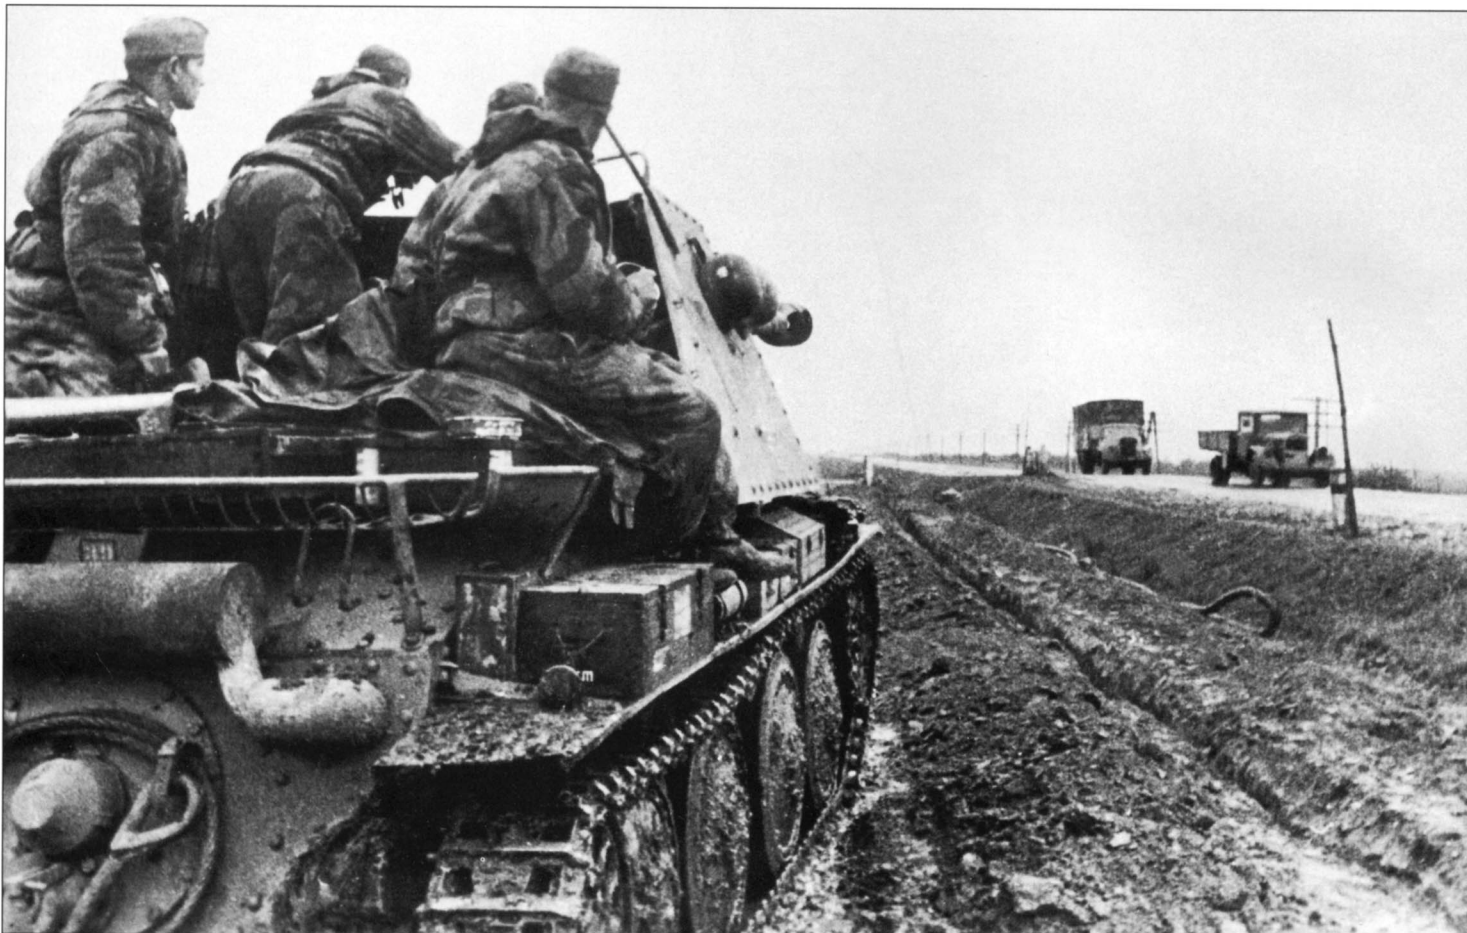
A Marder III guards one of the roads used by retreating German troops. Such a lone self-propelled gun was very often deployed in the rear guard against attacking Soviet armor. If successfully employed in combat, the gun could win some precious hours for the German troops, separating the last German vehicles of the long retreating columns from the first Soviet advanced units.

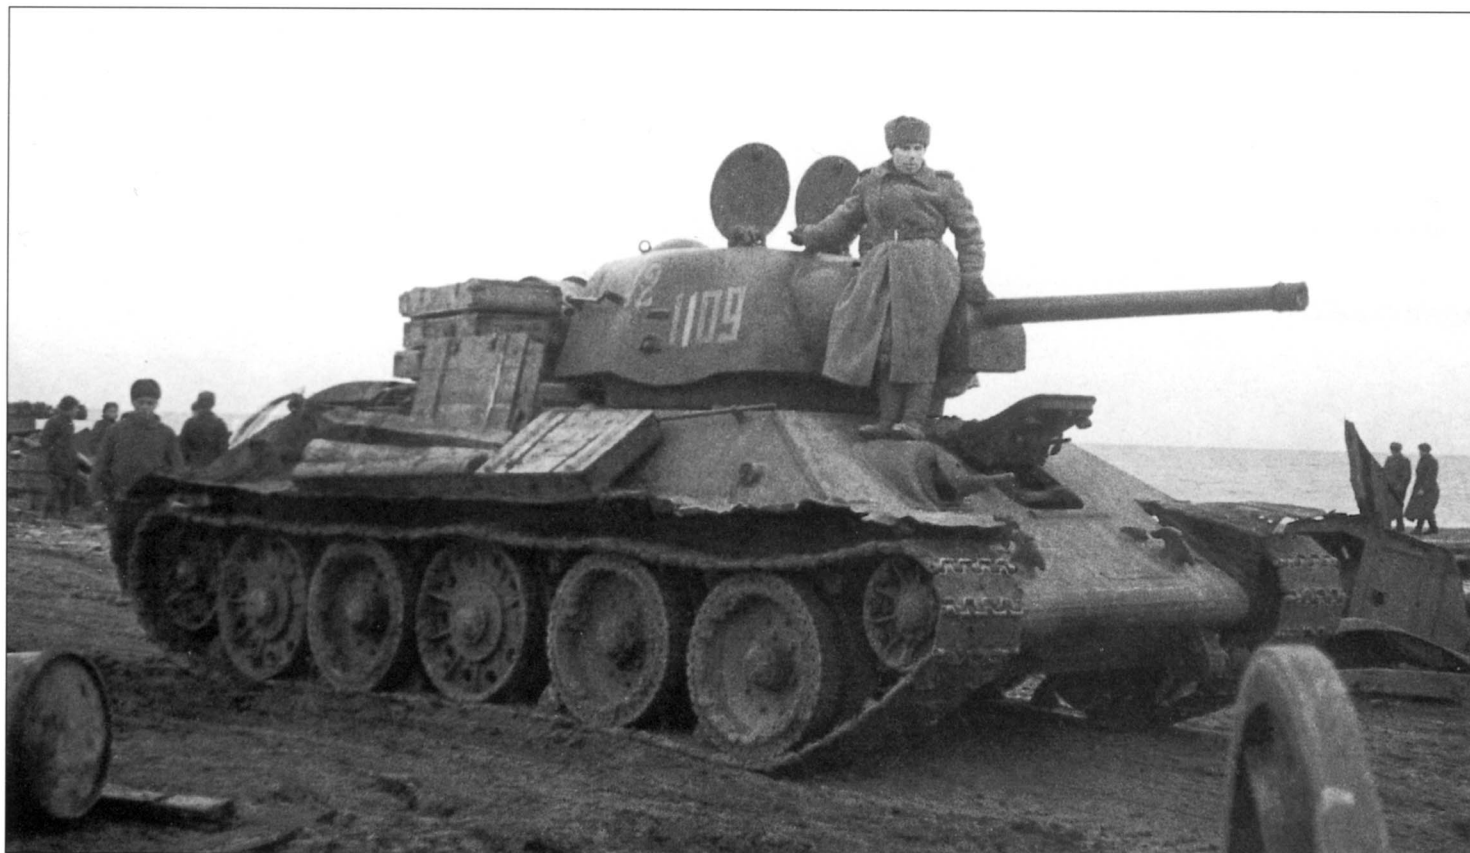
This T-34 Model 1942 with the Uralmash turret typical of the Chelyabinsk Tractor Works factory was photographed in the Crimea in the spring of 1944. The turret is marked with two different numbers: 12 (probably in yellow) and 1109 (in white), and the tank is equipped with a lot of combat equipment — boxes with gun ammunition and a fuel drum behind the turret. Note that the tank has no radio antenna, so it may not be fitted with radio equipment.

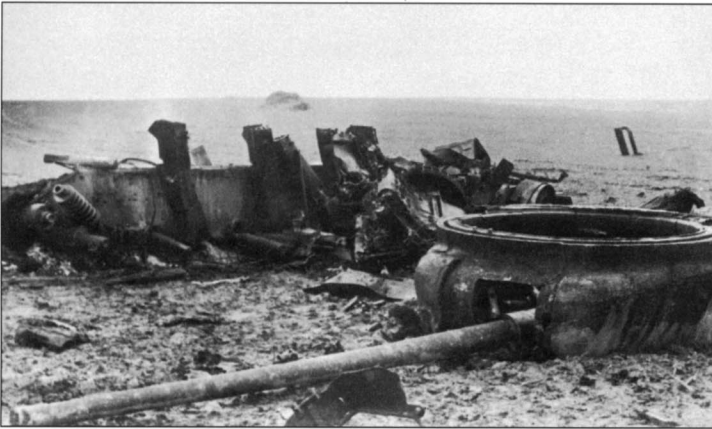
The remains of a Soviet KV-85 heavy tank destroyed somewhere on the flat landscape of western Ukraine. This was one of the rarest series of Soviet tanks. Nevertheless, one of them was captured by the Germans and tested at the Kumersdorf testing ground. There is no doubt that the tank was hit hard at short range by an 8.8cm anti-tank round, or maybe even by a Panzerfaust warhead, which caused the internal explosion of the ammunition.

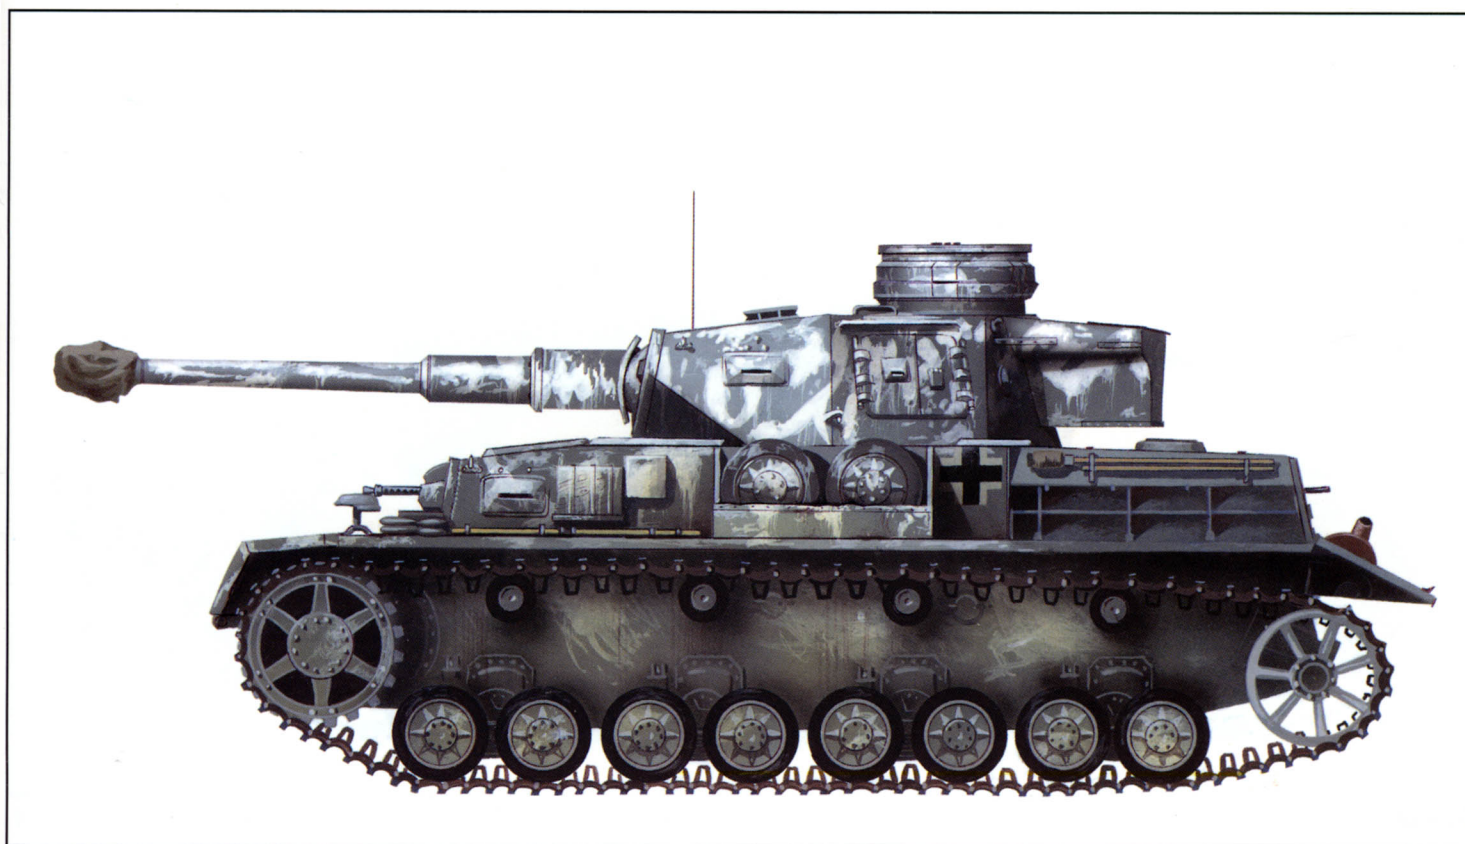
**Pz.Kpfw. IV Ausf. G, Pz.Gren.Div. "Großdeutschland", Borissovka, early 1943**

A very new tank, this Pz.Kpfw. IV was issued to the tank regiment of Panzer-Grenadier-Division "Großdeutschland" as February turned to March in 1943, prior to the offensive at Kharkov. Borissovka was located west of Belgorod in the southern sector of the Eastern Front. The tank was painted in standard dark gray camouflage covered with an irregular pattern of white winter camouflage, which was applied with a brush.

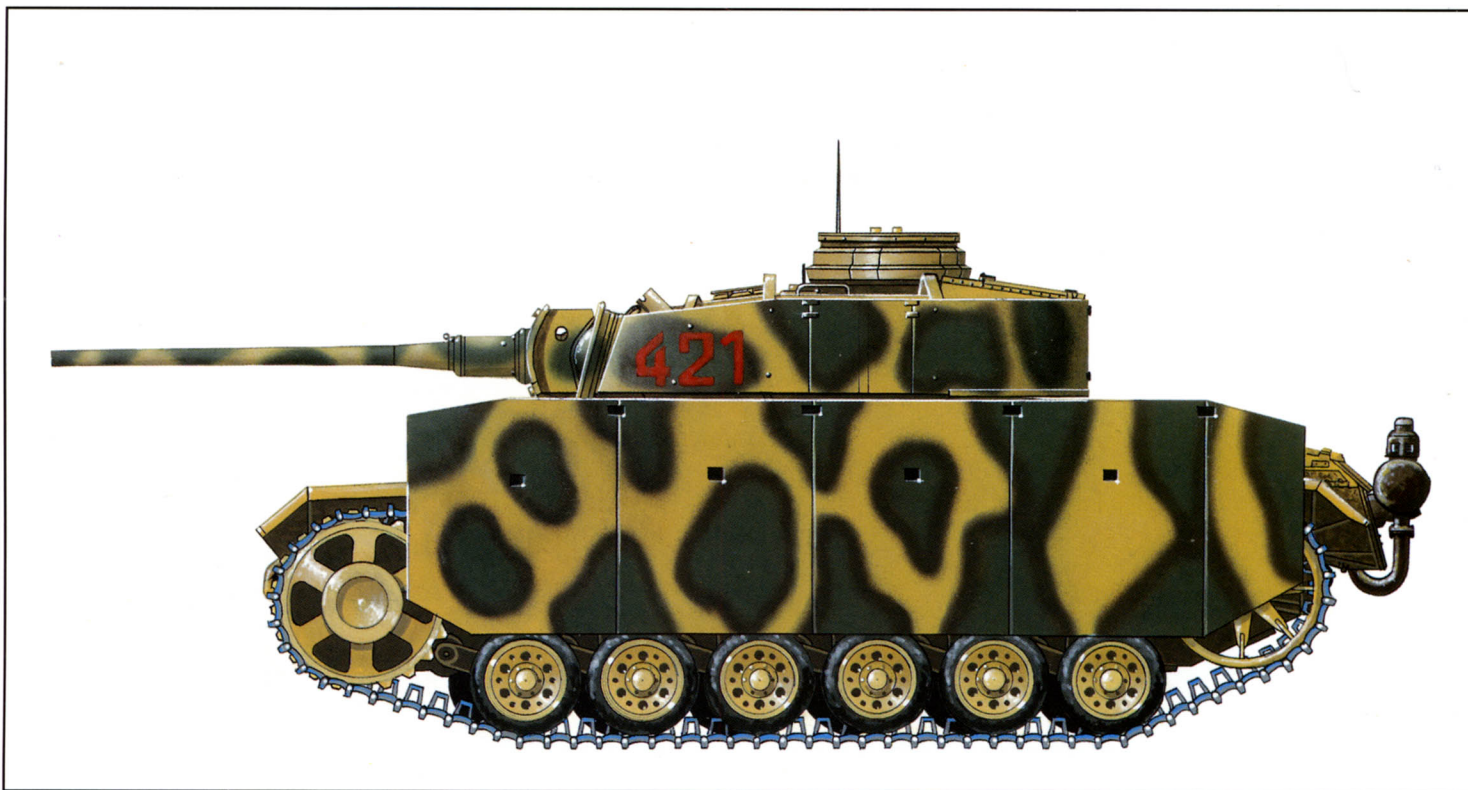
**Pz.Kpfw. III Ausf. M, Pz.Rgt.15, 11.Panzer-Division, Kursk bulge, July 1943**

This vehicle was used by the 2nd platoon commander of 4th Company, Panzer-Regiment 15, 11.Panzer-Division (XXXXVIII Pz.Kp., Pz.Ar.4), and saw action in the southern sector of the Kursk bulge in July 1943. The tank wears the typical camouflage of this period. Clearly visible are the exhaust valve for deep wading at the rear of the tank and the Schürzen (armor skirts) fastened to the sides of the tank and around its turret.

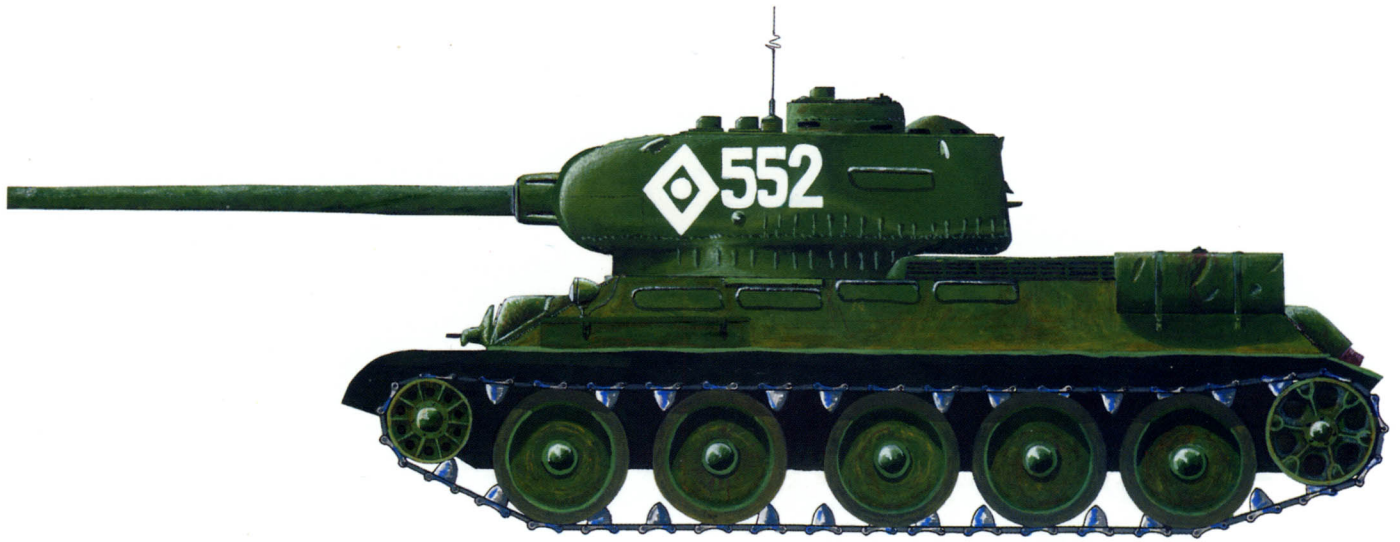
**T-34-85, 8th Guards Tank Corps, 2nd Tank Army, Lublin, Poland, July 1944**

This corps was composed of three tank brigades — 58th, 59th and 60th, all of which were Guard units. The tank wears standard dark olive-green camouflage with white corps markings. The three-digit tactical number next to the corps marking indicates the regiment within the brigade (first number), the company (second number) and the vehicle number (last number).

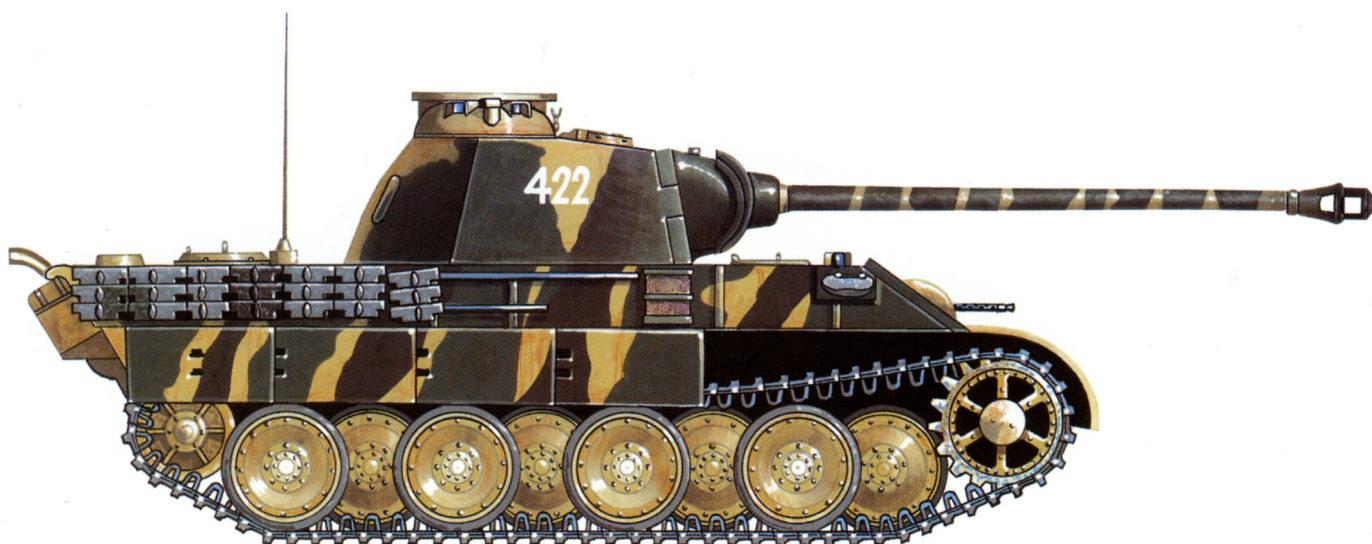
**Pz.Kpfw. V Ausf. A Panther, unknown unit, Poland/East Prussia, autumn 1944**

This Panther belonged to the 2nd platoon of the 4th company of an unknown Panzer division that was fighting a retreating action in the central Poland/western East Prussia region in the autumn of 1944. It is camouflaged with a two-color pattern of green and brown patches over a dark yellow background. The tactical number "422" is in white. The gun barrel also wears the distinctive camouflage.

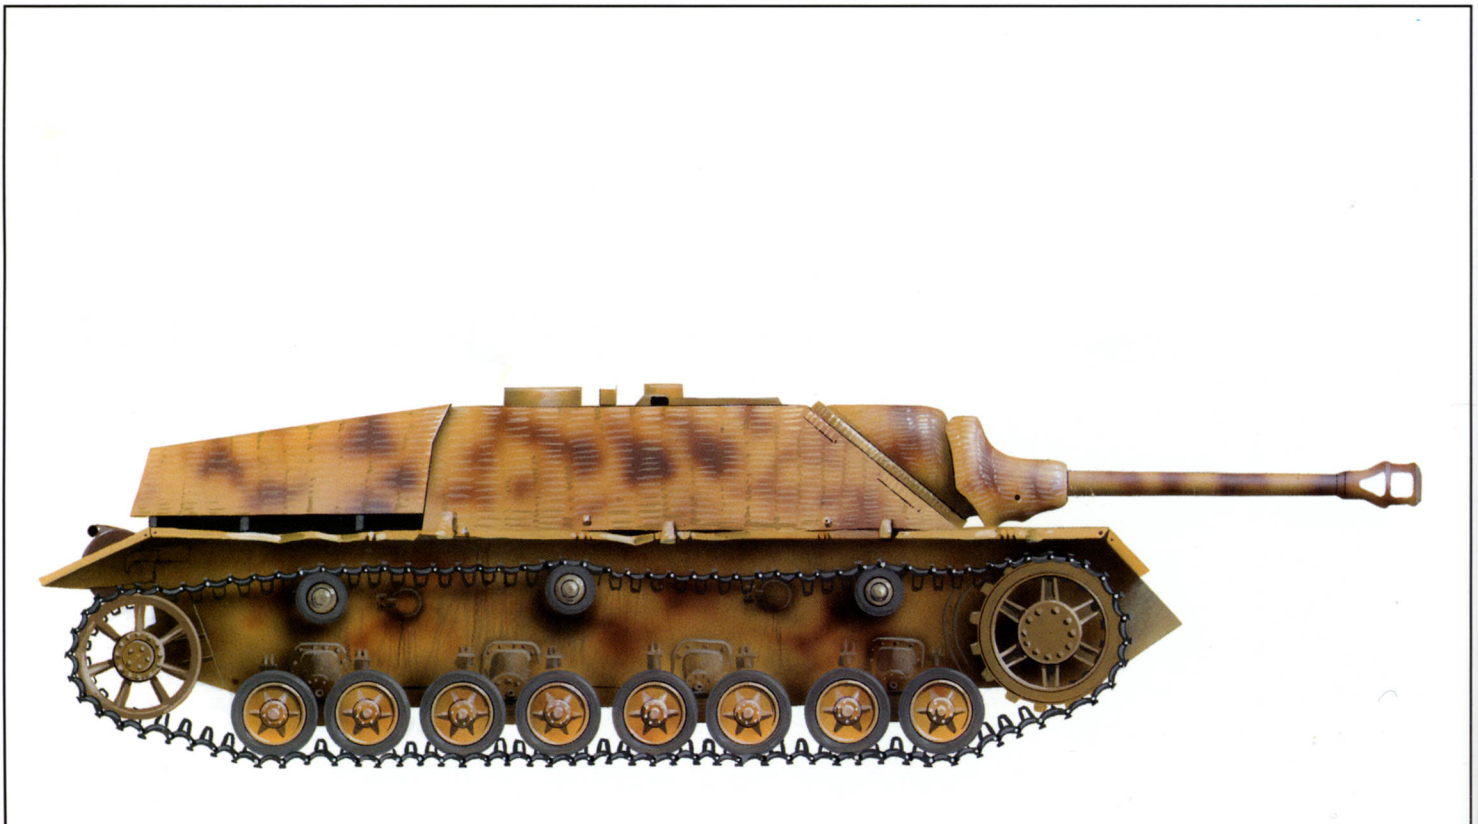
**Jagdpanzer IV, unknown Pz.Jäg.Abt., Balaton lake area, early 1945**

This Jagdpanzer IV was employed in the counter-offensive in the Balaton lake area in early 1945. The vehicle has no markings, and even the national cross is missing. An autumn/spring camouflage pattern has been applied to the tank in the form of irregular spots of brown over dark yellow on all side surfaces and the gun barrel. The last winter of the war was quite warm so white camouflage was not in use in most areas of Europe.

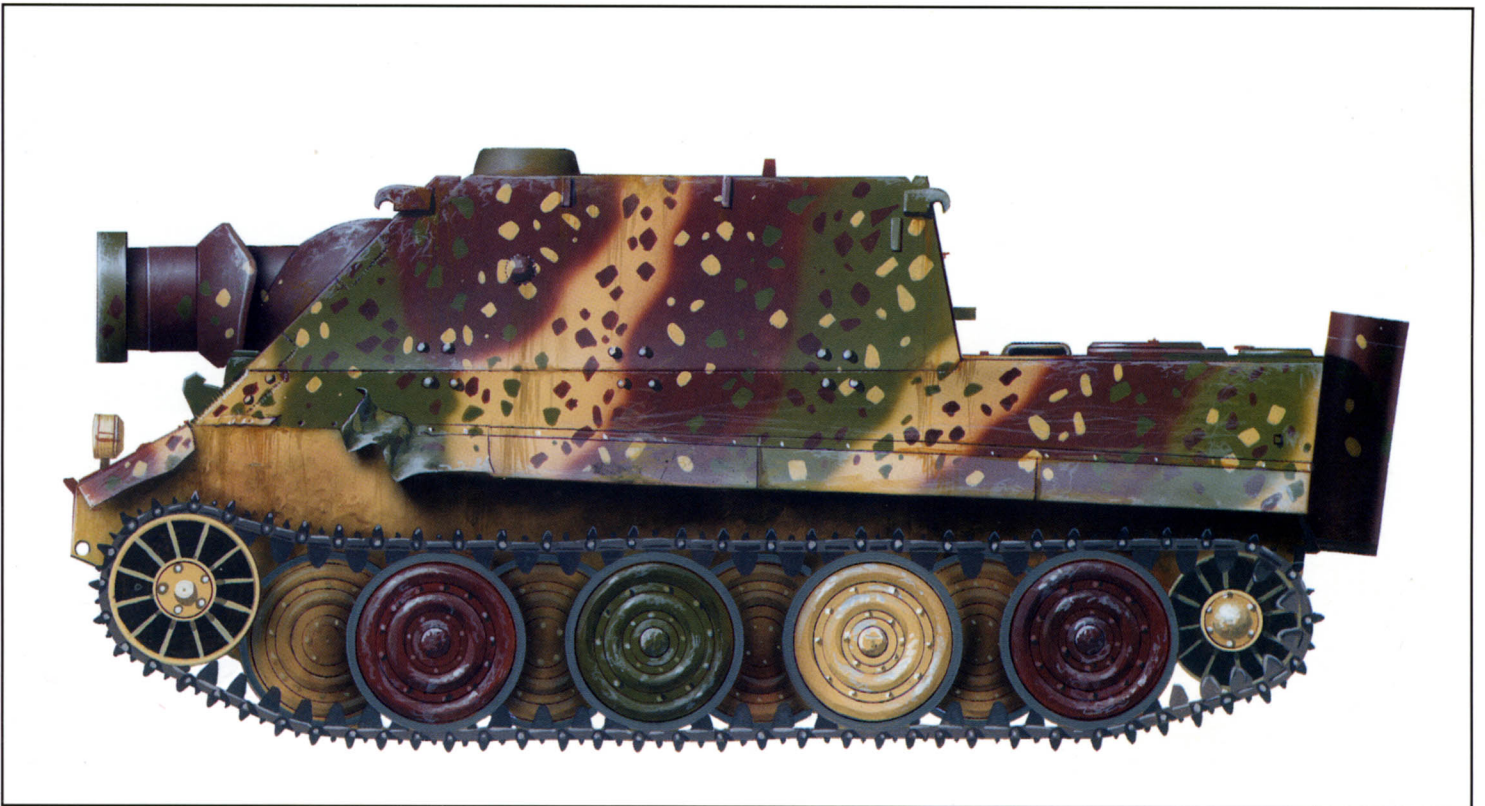
**Sturmgeschütz Tiger, unknown unit, suburbs of Berlin, April 1945**

This tank was abandoned by its crew and captured by the Soviets, who tested it along with other of the latest pieces of German armor throughout the first year after the war. The tank was camouflaged in the three-colored "Ambush" pattern used in the latter part of the war. Some sections of the tank are missing, which could identify it as one of the last five vehicles of this type, which were built in late 1944 but were not completely finished. There were 18 "Sturmtiger" tanks built in 1944, and 13 of them were incorporated into four companies of platoon-size: Sturmgeschütz Companies 1000, 1001, 1002, and 1003. The first one saw combat when it was put into action in Warsaw in early August 1944.

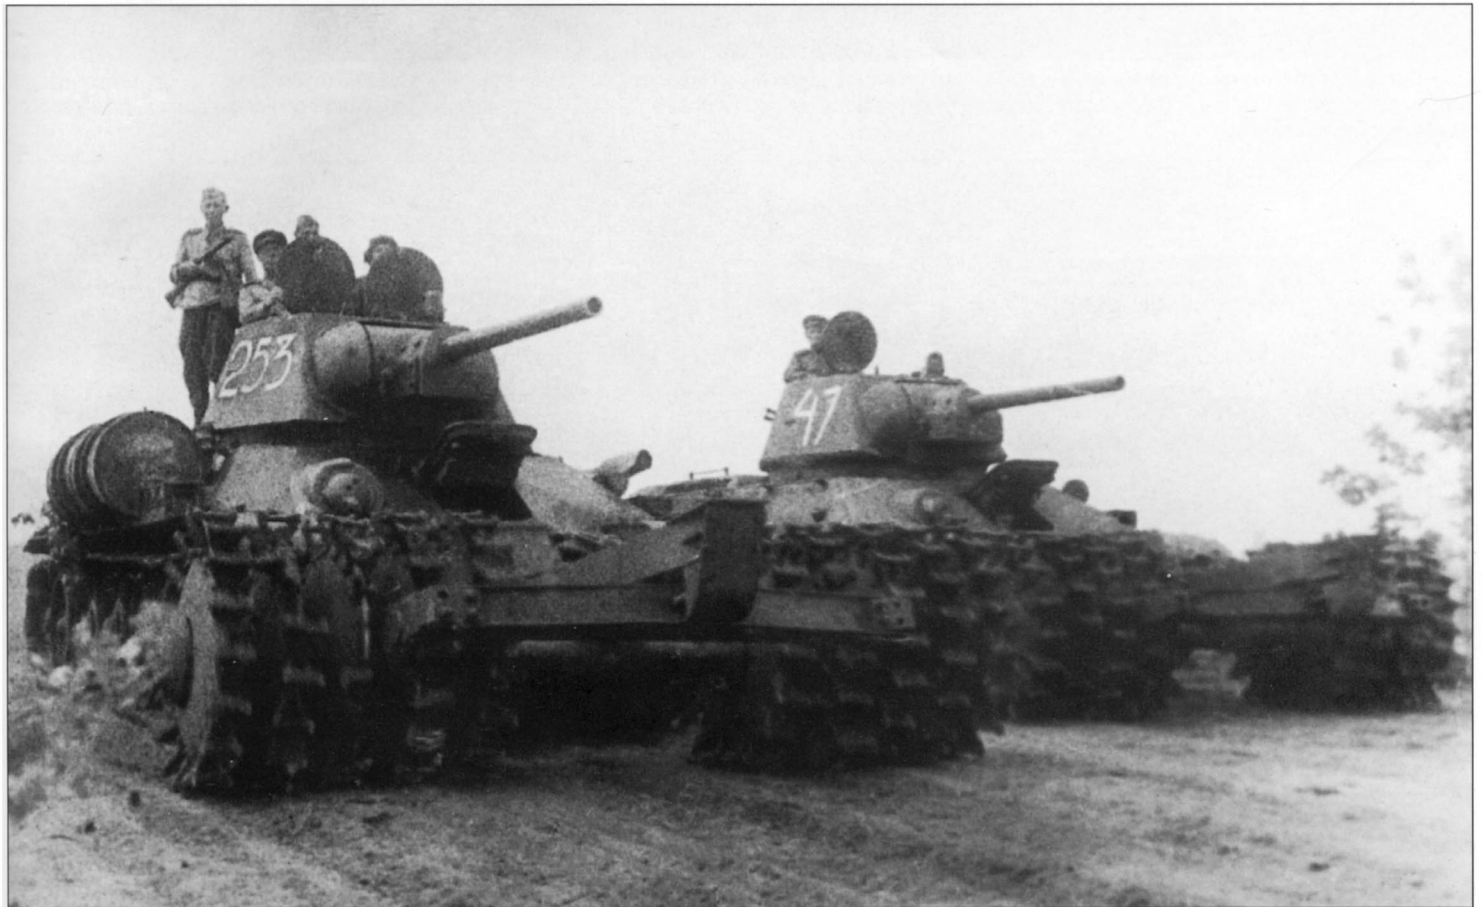
Two T-34 tanks with PT-34 mine rollers clear the way for the rest of an armored unit in Byelorussia. These tanks were used in different brigades while breaking through front lines, but usually they were organized into independent tank-engineer regiments. Note the cover on the light on tank number "253", as well as the two drums secured to its right side. T-34s normally carried only one such drum on each side.

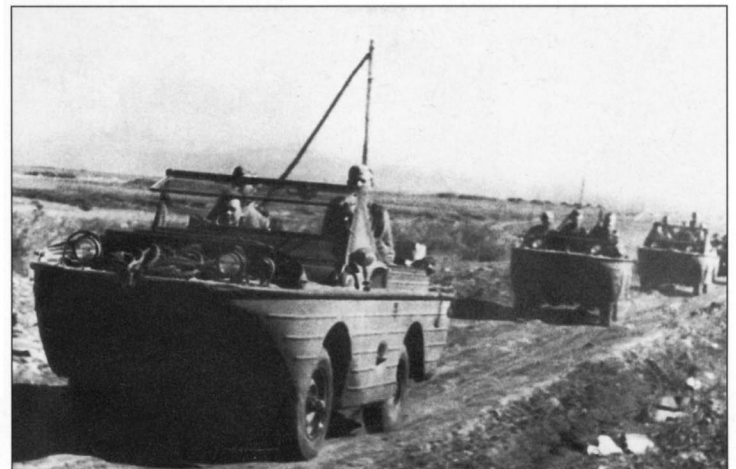
A column of M38 amphibious vehicles travels down a road somewhere on the Polish-Soviet border. The M38 was built on the base of the famous GPA amphibious jeep and was later copied by the Soviets.

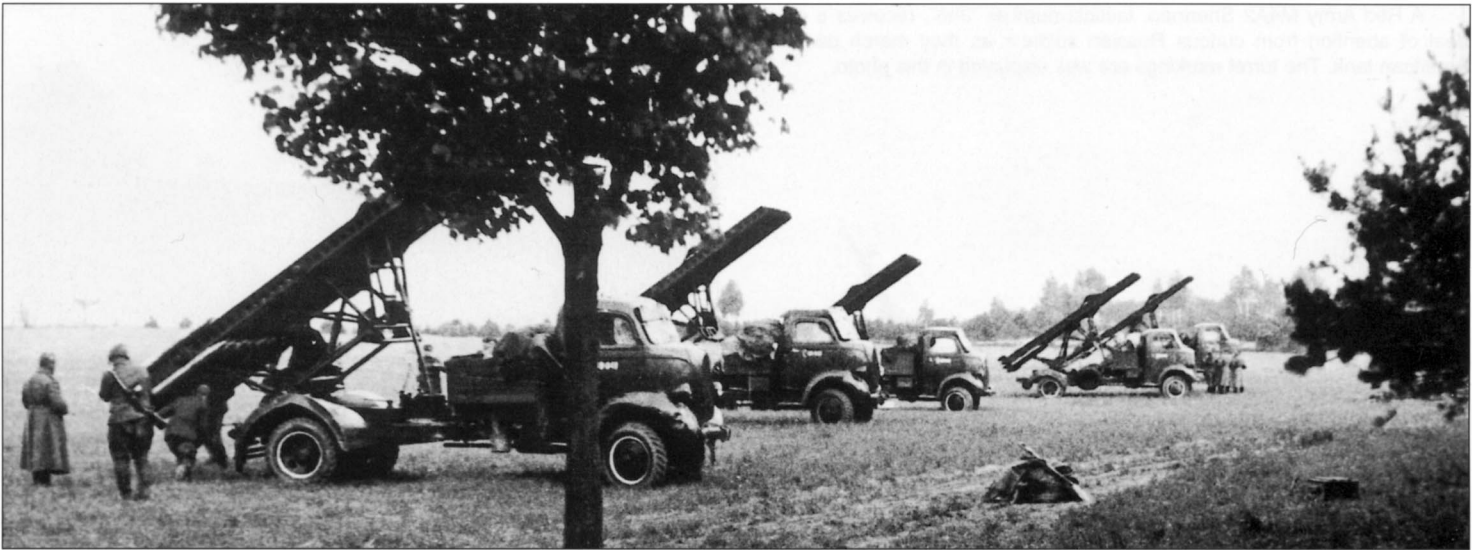
These M-13-16 rocket launchers are each mounted on an American truck, the General Motors COE. Here a battery is ready to fire a salvo. Note the unit markings painted on the cab doors and, particularly, the white circle on the wheels — the Red Army, along with other communist armies, had a special affection for such markings.
