# Armor Battles on the Eastern Front

(2) Downfall of the Reich 1943-1945

Robert Michulec

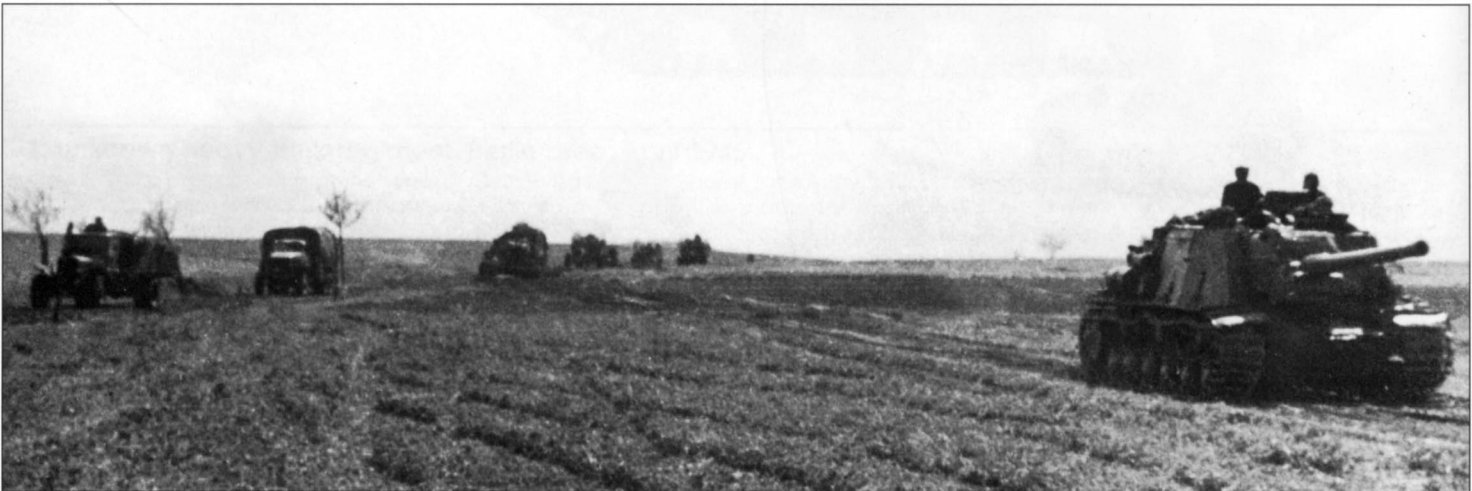
An ISU-122 heavy self-propelled gun and a column of trucks (in the background) are shown on the march toward an assembly area. The ISU-122, designed just after the ISU-152, was a powerful vehicle armed with a 122mm A-19 gun, but it was also slow, not maneuverable and had a short range. Like the ISU-152 it was very similar to the German Elephant, so it had to be used properly and thoughtfully if success was to be achieved. However, the actual performance of the ISU-152 on the Ukrainian battlefields in the winter of 1944 was a disaster: two regiments of these vehicles were wiped out in one action. These losses were so heavy that a special commission had to visit the front to find out the reason for this collapse.

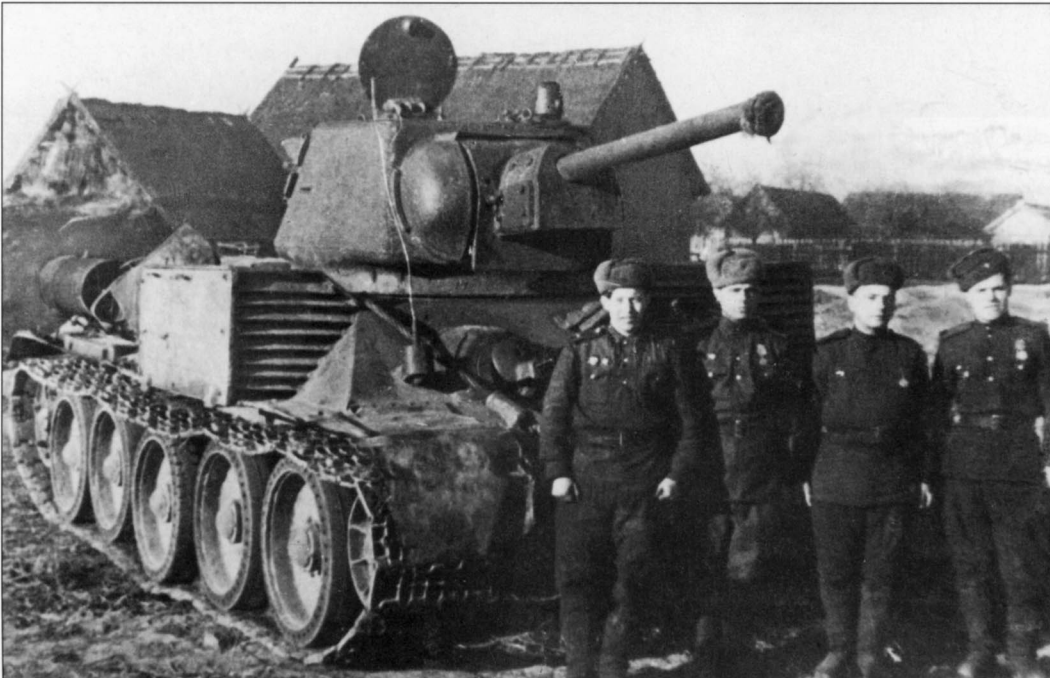
This is a special version of the T-34 Model 1943 converted to a propaganda vehicle and equipped for psychological warfare with loudspeakers in armored casings on the fender. These propaganda vehicles were quite successful in 1944 when the Wehrmacht losses led to many desertions. Note the new type of additional fuel tanks affixed to the side of the superstructure and not to the rear plate. Originally there were two such tanks used, but later their number was increased to three, and sometimes the addition of big drums hiked the total to four and five.

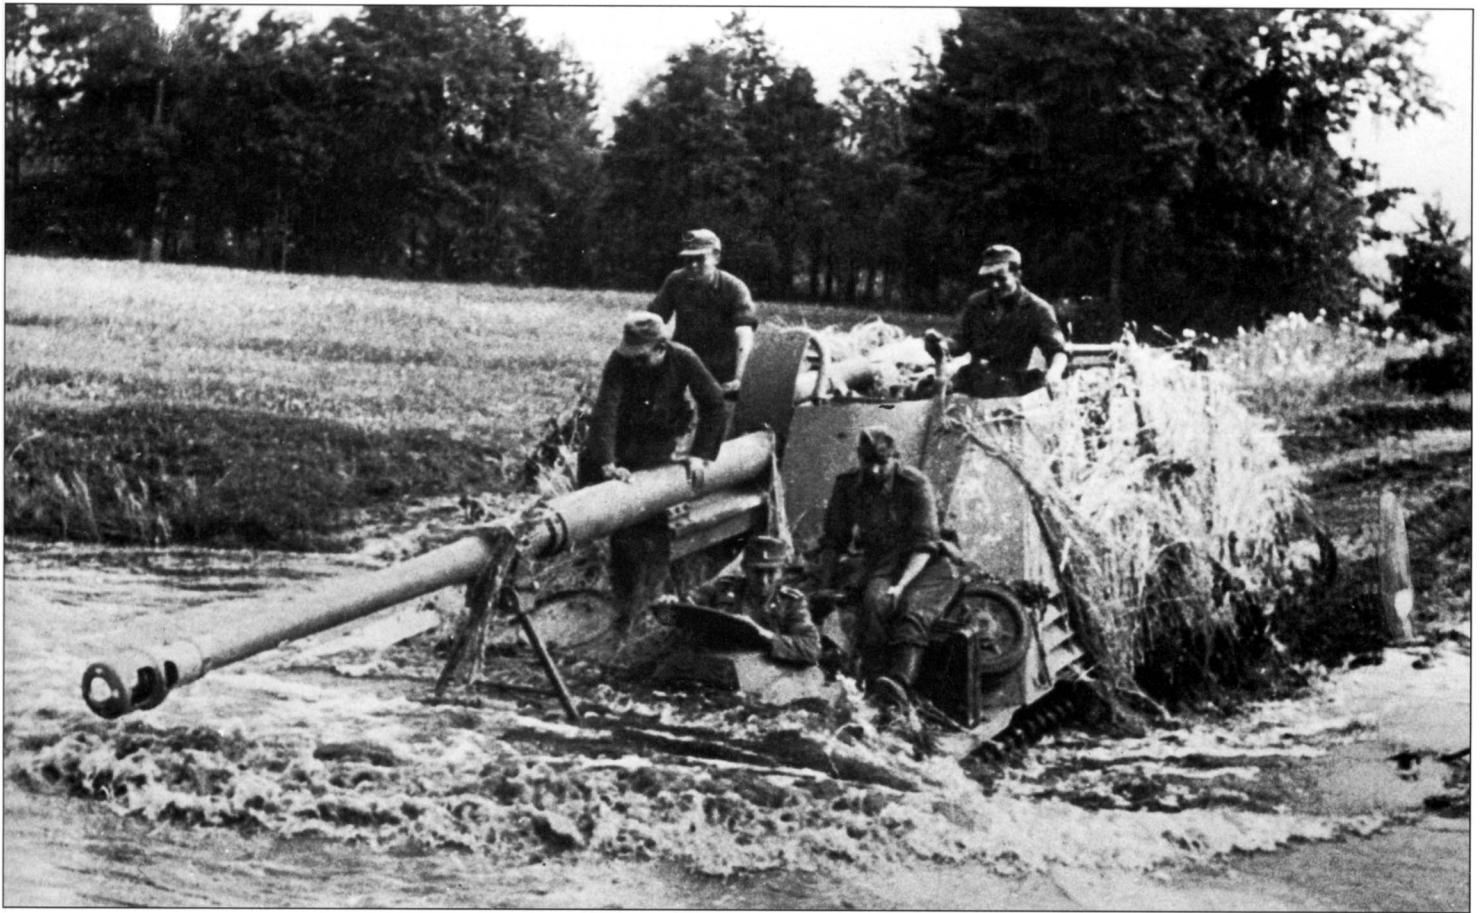
The Panzer IV chassis of this Nashorn is submerged as the tank killer fords a river. This vehicle was the best tank destroyer used by either side on the Eastern Front. No tank or self-propelled gun was safe when the Nashorn went into action.

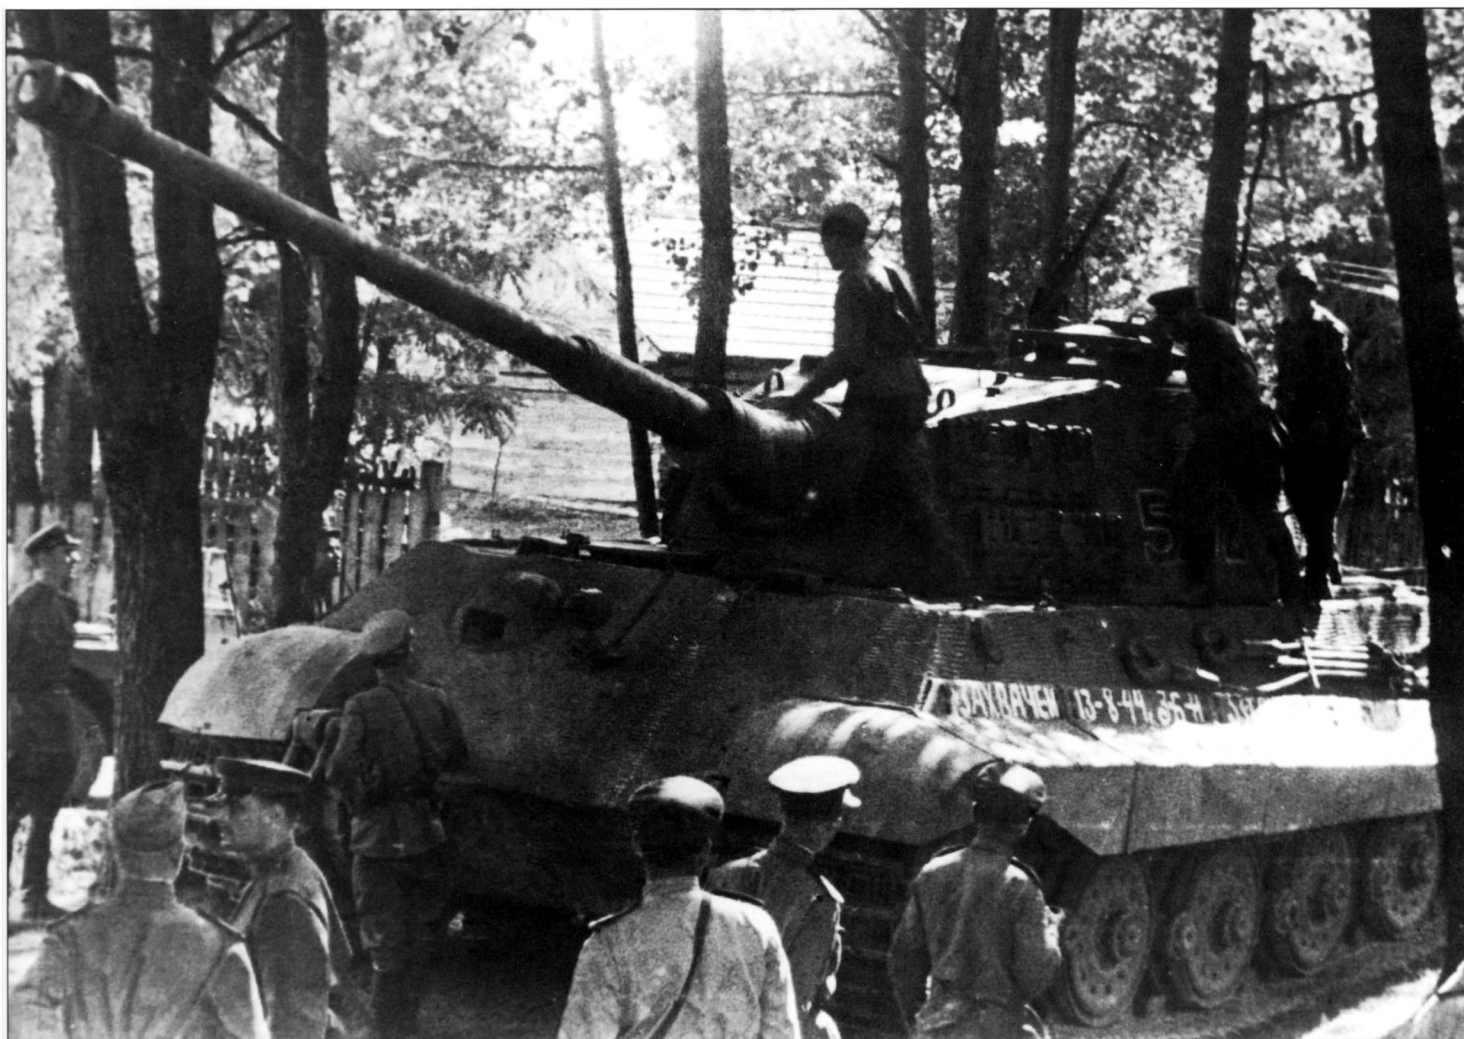
The heaviest tank on the Eastern Front in 1944 was the Pz.Kpfw. VI Ausf. B "Tiger II". They were used for the first time by sPz.Abt. 501 in August 1944 during the battle for the bridgehead at the Vistula river in the Sandomierz area. The first clash was won by the Soviets, when ml.Lt. (2nd Lieutenant) A. Oskin from 53rd Guards Tank Brigade surprised three Tigers that were not ready for combat, destroying all of them. It is important to note that the Soviet tank commander used BR-365P APDS rounds, which theoretically could penetrate 138mm vertical armored plate at a range of 500 meters (546 yards). They were useless in this situation, however, even though they were fired at a range of 200 meters (219 yards) against the Tigers' side armor! During the next few days the same Soviet unit again met the German Abteilung and knocked out another five Tigers. On 13 August 53rd Guards Tank Brigade captured three others in perfect condition, including one used by a company or unit commander. All Tigers IIs found by the Soviets on the battlefield or captured by them during combat were sent to Moscow for testing. Here is one of them, the Pz.Bef.Wg. VI Ausf. B with tactical number "502", being inspected by Soviet officers of the 1st Ukrainian Front. Written in Russian on the tank are: "Captured 13-8-44 Z-B-N" and (further toward the rear) "53-Tankovaya Brigada" (probably).

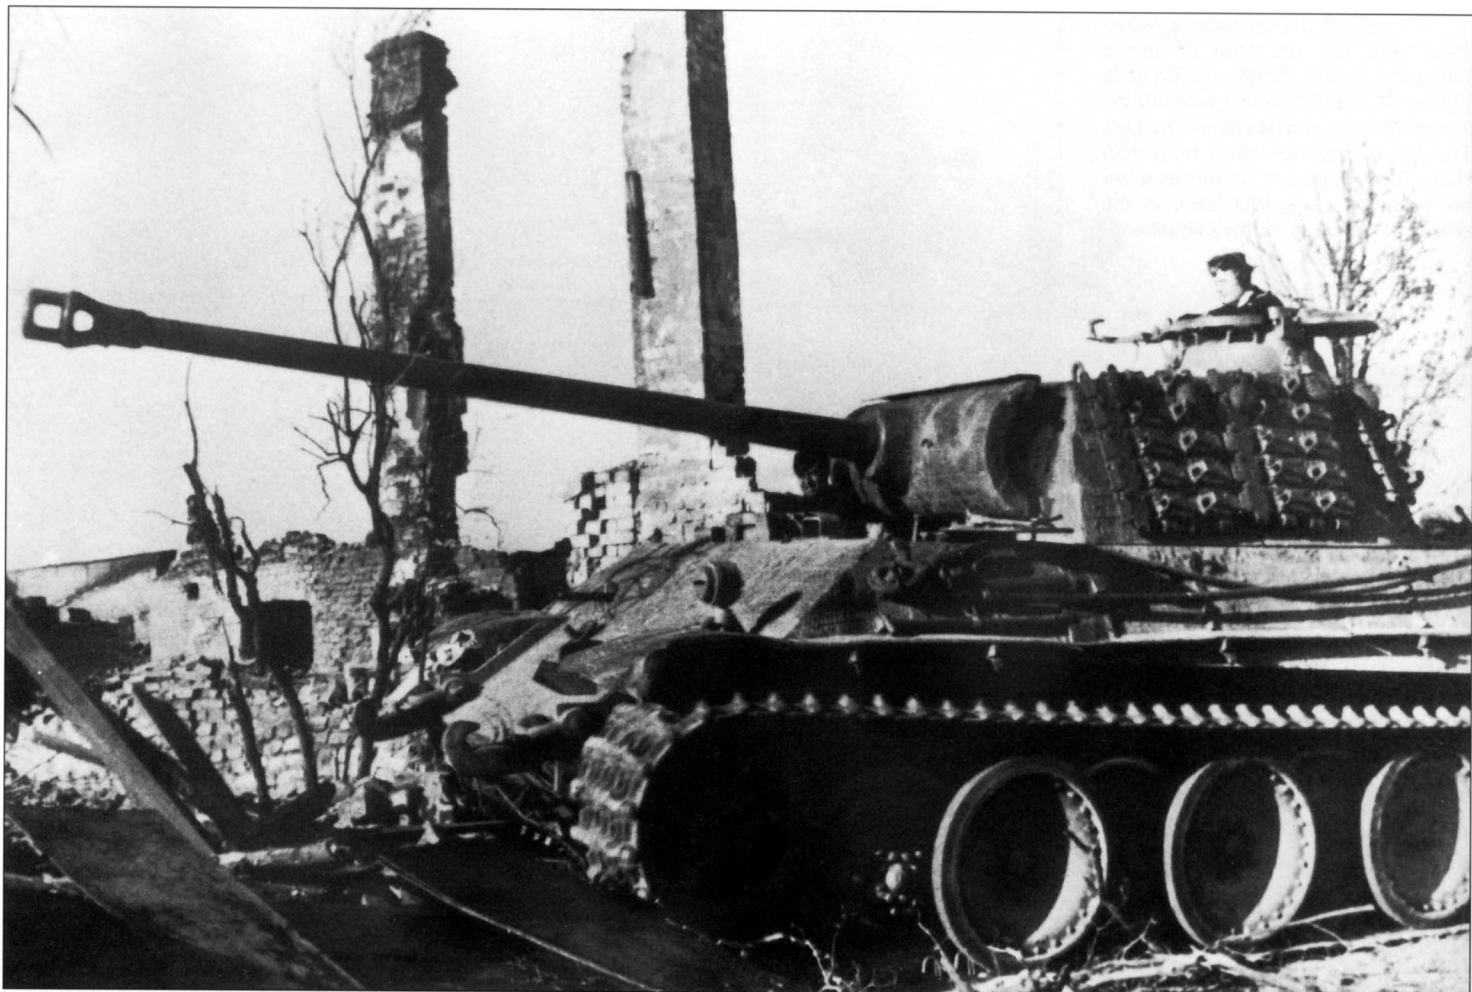
A Pz.Kpfw. V Ausf. G in action in a destroyed village. This vehicle is from the early series, without reinforced armor on the mantlet below the gun. The towing hooks are fixed in working position. Note that the black national cross at the very front on the side of the superstructure appears to be composed of just a couple of brush strokes. There are no other markings. The anti-tank rounds fired from a Panther tank could penetrate armor plating of about 150mm at a 30 degree angle at 1,000 meters, so its ballistic capabilities were much better than Soviet 85mm guns on the T-34 or SU-85 vehicles, and very similar to those of the IS-2's gun.

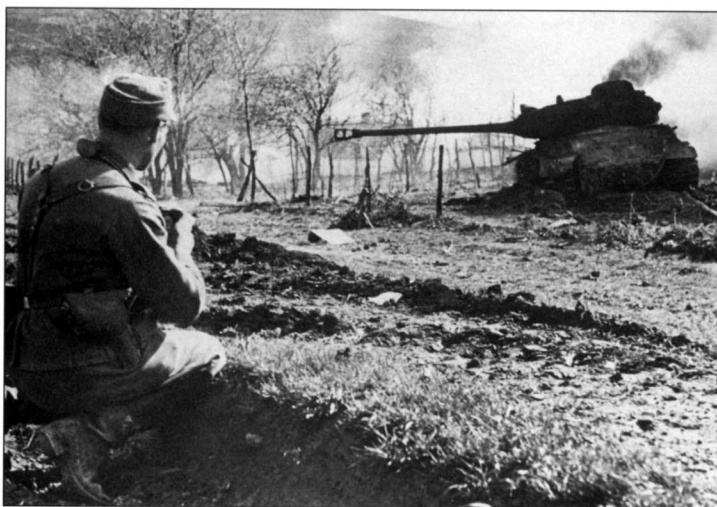
German rounds struck this SU-76M on the outskirts of a village. Note the dark color of the vehicle's interior. It was painted with a dark green camouflage paint, but in 1944 the Soviets introduced white interiors to all their armored fighting vehicles.

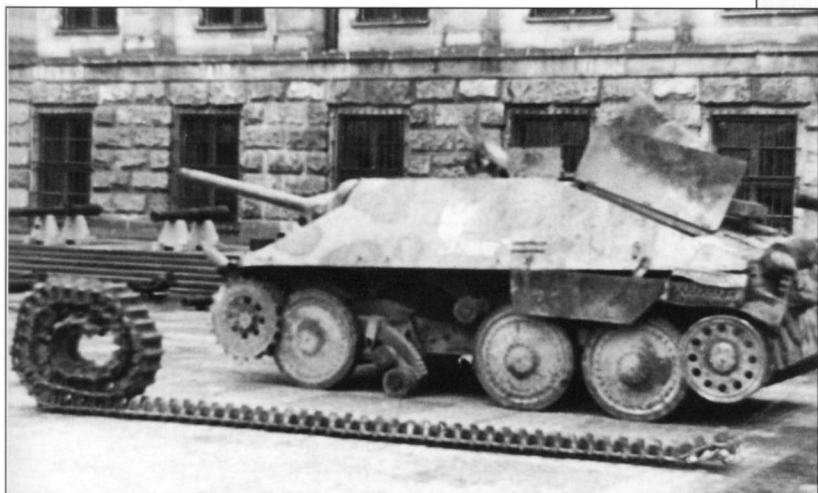
In the two months of fighting during the Warsaw uprising — 1 August 1944 to 2 October 1944 — three Hetzer self-propelled guns were captured, among them this one, which the Poles used in combat after it was repaired. The vehicle was painted in a three-tone camouflage scheme and marked with the national insignia of the Polish People's Army, the white Piast eagle. The eagle was painted on a dark spot of an unknown color.

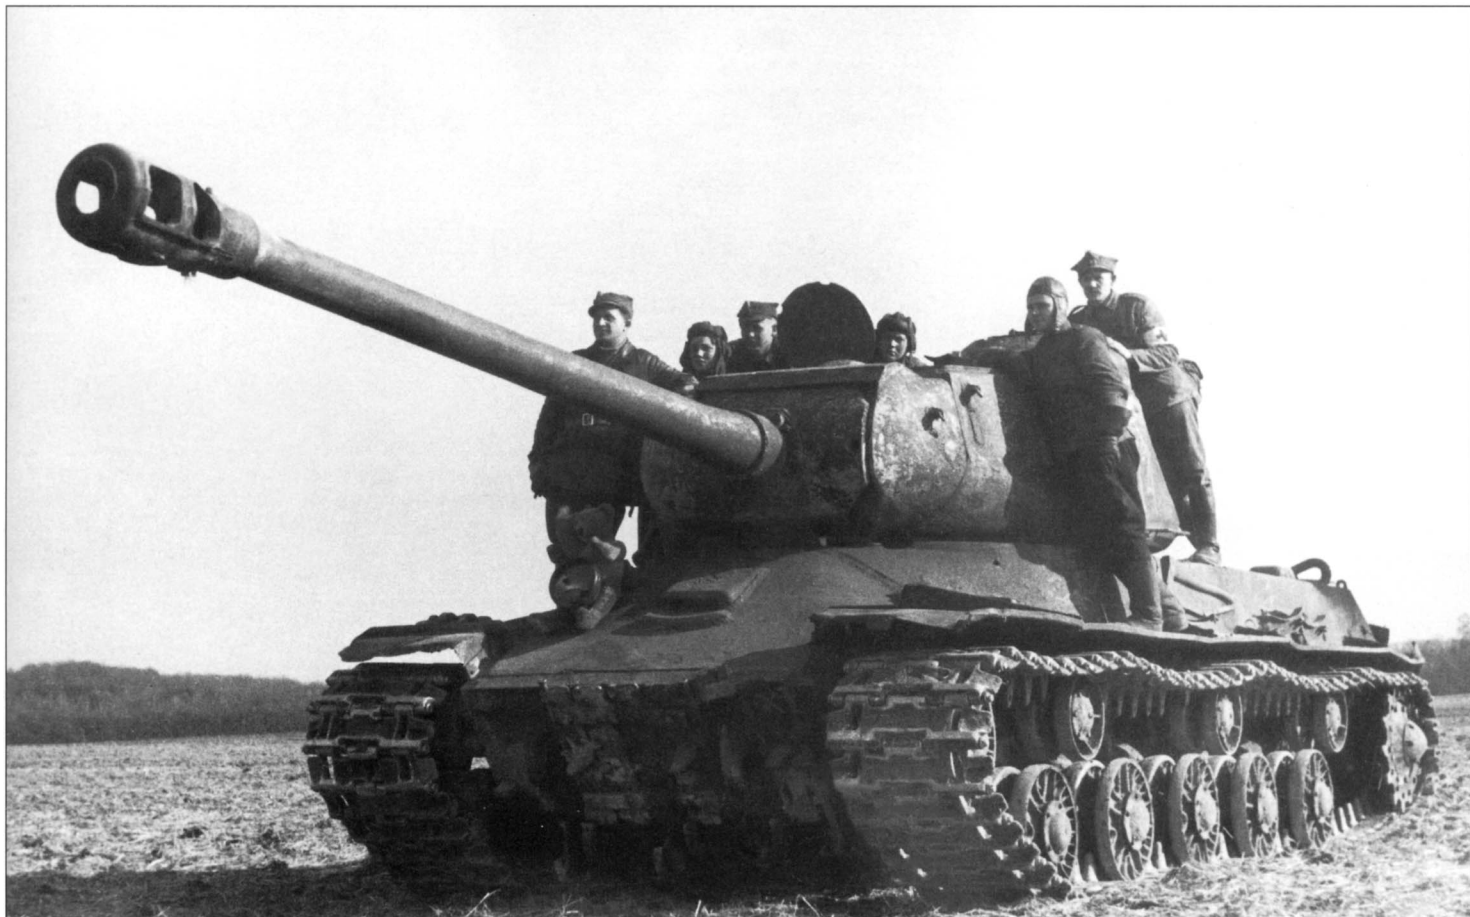
This is an excellent portrait of an IS-2 heavy tank from the Polish 4th SPCzC. It is the later model with a rebuilt frontal part of the superstructure. Note the many details on this tank, including the crew's mascot (a teddy bear) seated behind the front light. The lack of the rear road wheel was quite a common sight in units equipped with these tanks. The Soviets did not care for spare wheels, and when the chassis was damaged by a mine, they simply replaced the damaged road wheel with one from the rear. Remnants of white paint, which was removed soon after December 1944, may be seen on the turret and gun barrel. The clothes worn by the soldiers show just how warm this winter was. This photo was taken in the first half of February 1945!

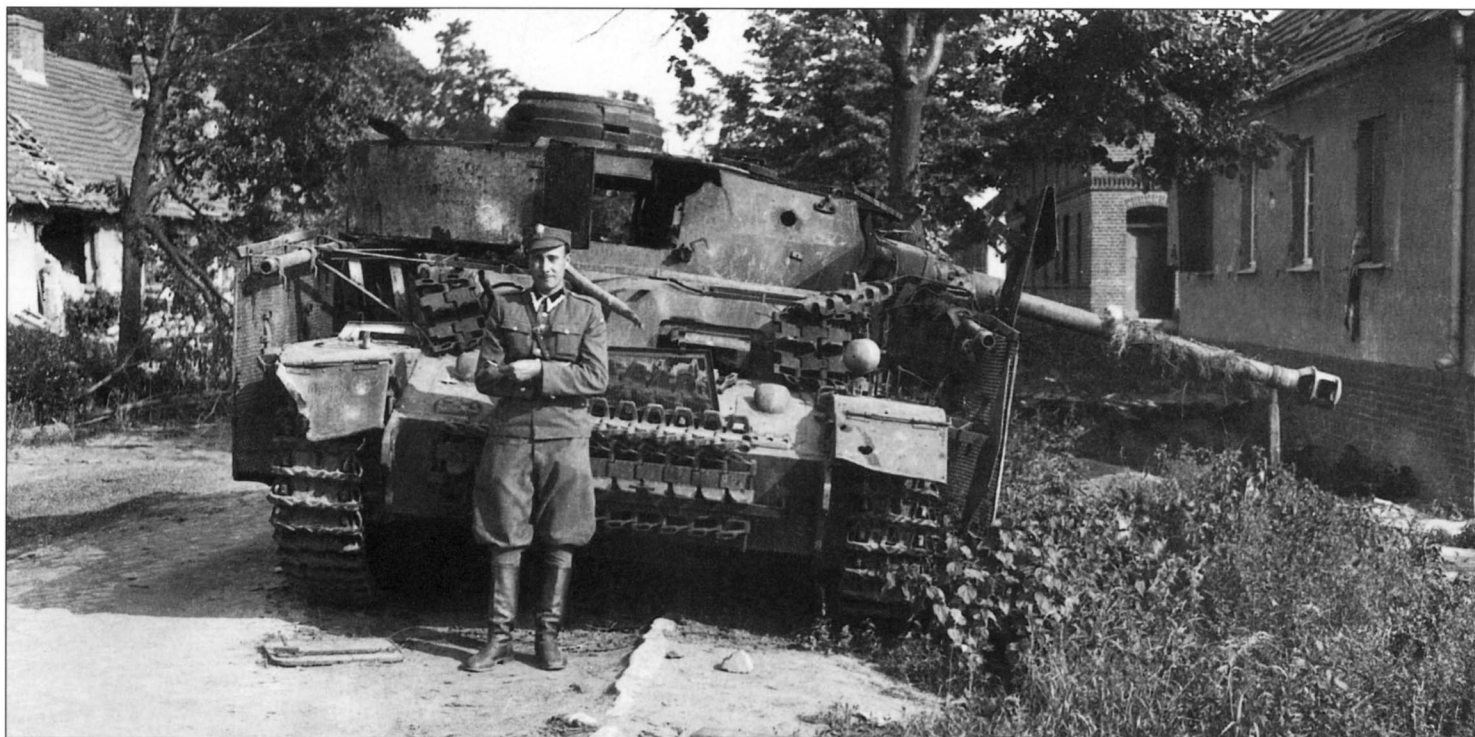
Another German vehicle abandoned on a Pomeranian road — a Pz.Kpfw. IV Ausf. J with wire mesh side skirts and standard armored skirting on the turret. Note the additional armored plate bolted onto the frontal wall of the superstructure and the two entry holes where rounds hit the turret. One of them blew off the doors and a piece of turret in the area at the upper right corner of the hatch.

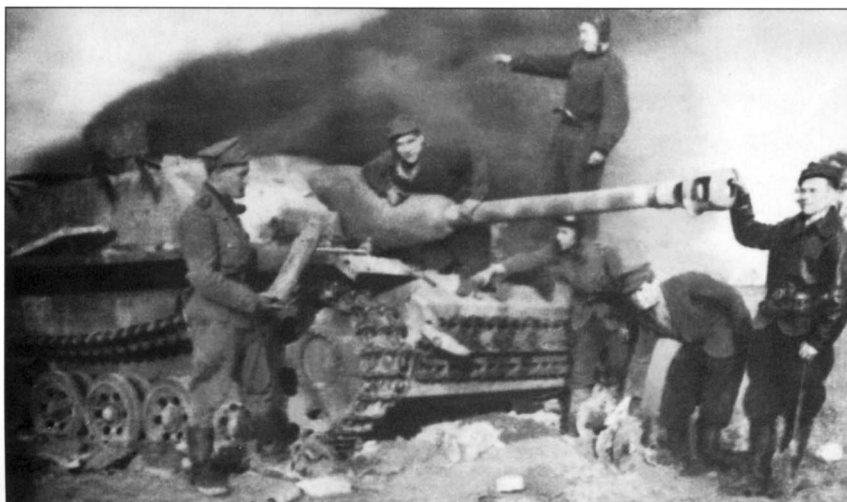
A German assault gun destroyed during the fight for Pomerania in early spring of 1945. This is a late production StuG III Ausf. G with the "Saukopf" gun mantlet and the small, remote control MG42 mount. The entire surface of the vehicle is covered with a camouflage pattern. Polish troops examine the vehicle even as it burns after receiving several hits.

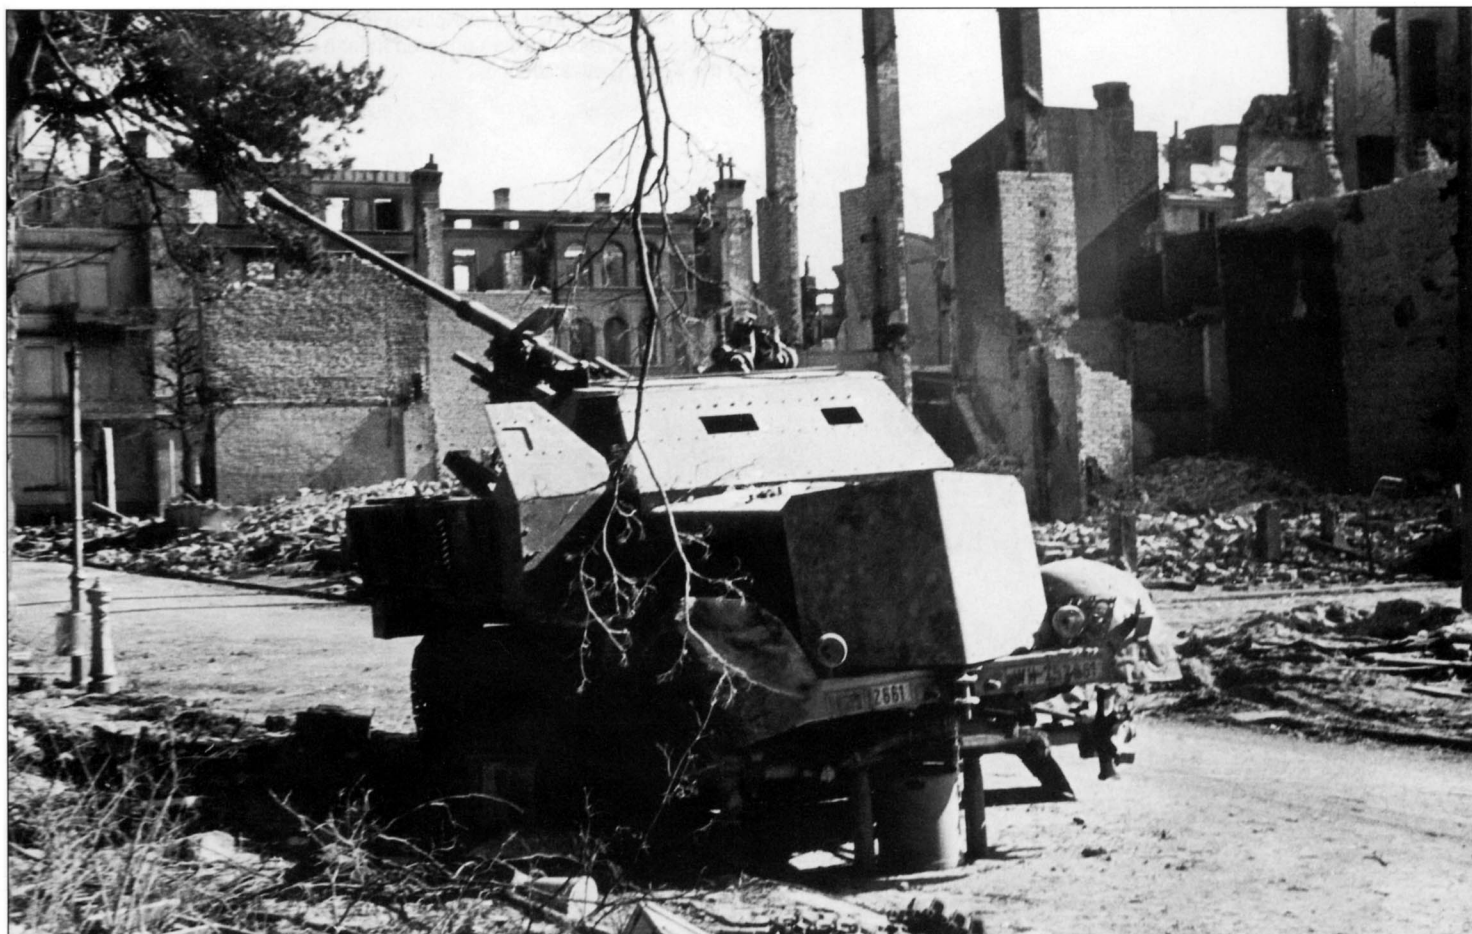
Wreckage of the Panzerwaffe found by victorious Polish and Soviet units in captured Kolberg (Kolobrzeg) in March 1945. This photo shows the remains of a Sd.Kfz. 7/2 armed with a 3.7cm Flak 36 anti-aircraft gun and equipped with an armored cab. Like many of the Panzerwaffe's other wheeled or half-tracked vehicles, this half-track had its wheels plundered for the benefit of a needy Soviet vehicle that suffered from the general lack of spare wheels. The Sd.Kfz. 7/2, license plate number "WH-152661", is painted in a three-tone camouflage (small green and brown spots on a dark yellow background).

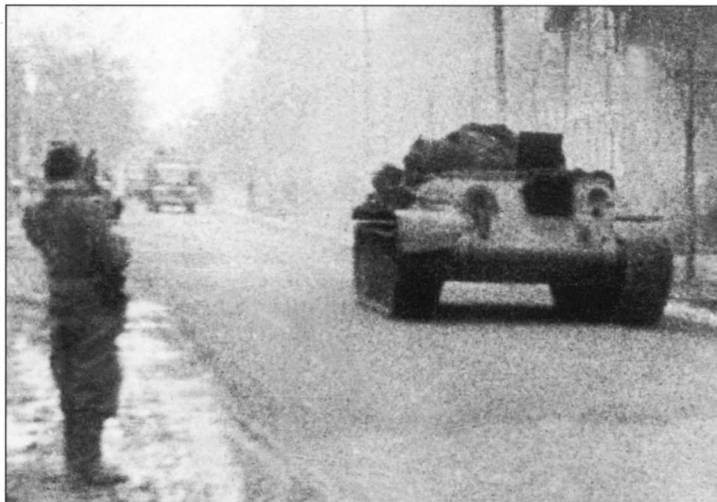
A recovery vehicle built on the chassis of a T-34 tank travels down a main street in Zoppot (now Sopot) in March 1945. Vehicles of this type were usually built by rear echelon recovery depots by converting damaged tanks that had lost their turrets in combat.

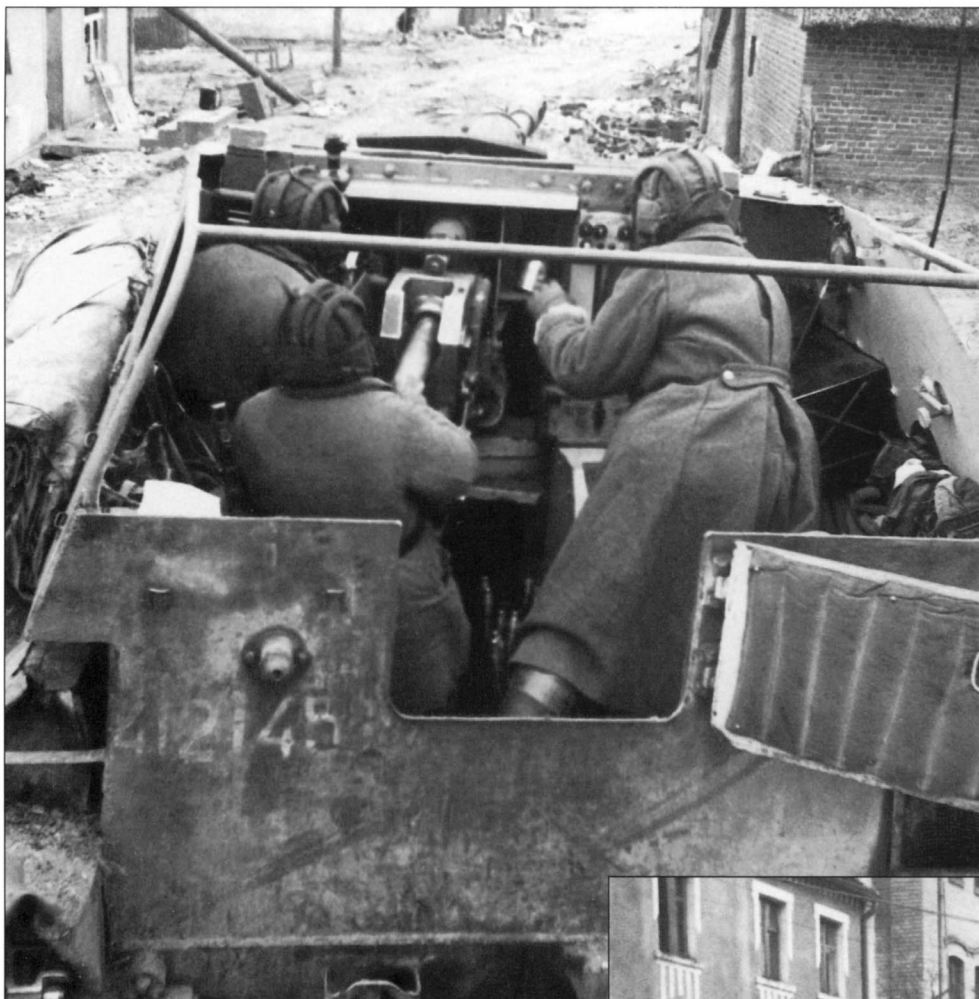
A SU-76M (serial number "412145") is involved in a street fight in a small German town. The self-propelled gun was commanded by Lt. A.L. Lalak. Note that the interior of the "bitch" (as the gun was nicknamed) is painted in white.

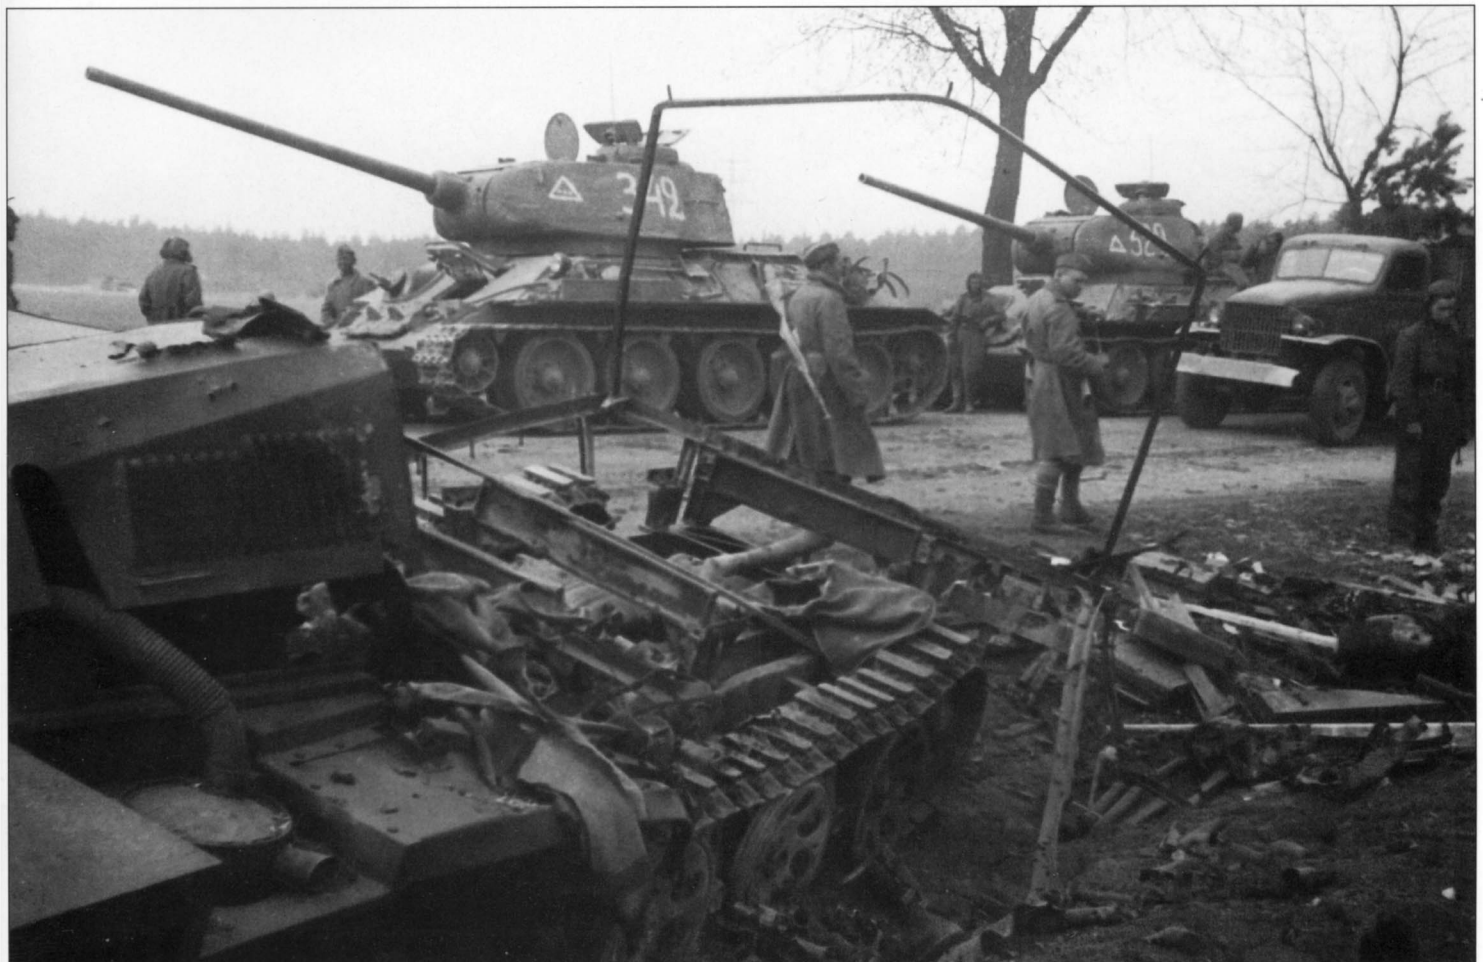
What remains of a T-34-85 column sits silently on the road to Brandenburg. Note the tactical markings and the tactical numbers on each of the tank's turrets — they look like markings of an independent brigade. In the foreground are the remnants of a Sd.Kfz. 10 half-track.

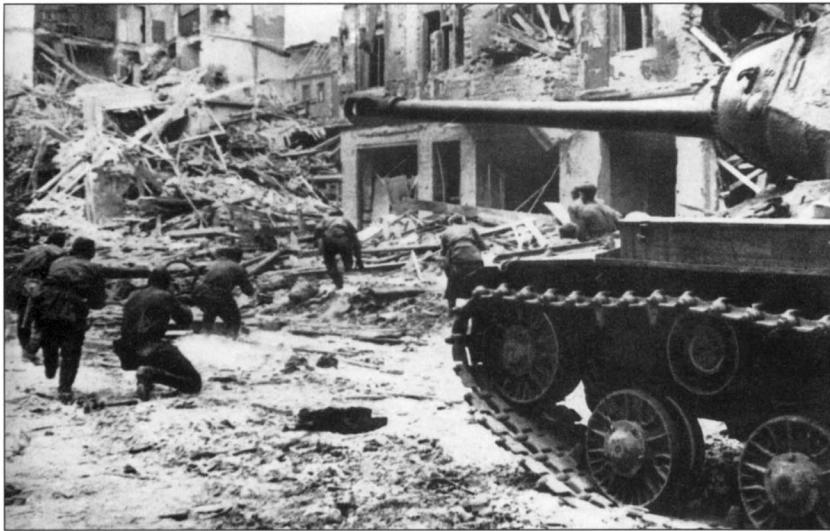
Soviet troops supported by an IS-2 storm a city in Germany. The IS-2 was armed with the 122mm D-25T Model 43 gun, which was capable of accurate shooting at a range of 1,100 meters (1,202 yards) with a muzzle velocity of 800 m/s. The anti-tank rounds could penetrate vertical plates 150mm thick at a range of 1,000 meters (1,093 yards). It was a powerful gun, but because of its size and weight it proved difficult in actual operation. Compare this gun to the 8.8cm German KwK43 L/71, which was introduced at the same time. This smaller gun was accurate at a range of 1,500 meters (1,640 yards) with a muzzle velocity of 1,130 m/s. Anti-tank rounds from an "88" could penetrate 193mm armor plate slanting at a 30 degree angle at a range of 1,000 meters.

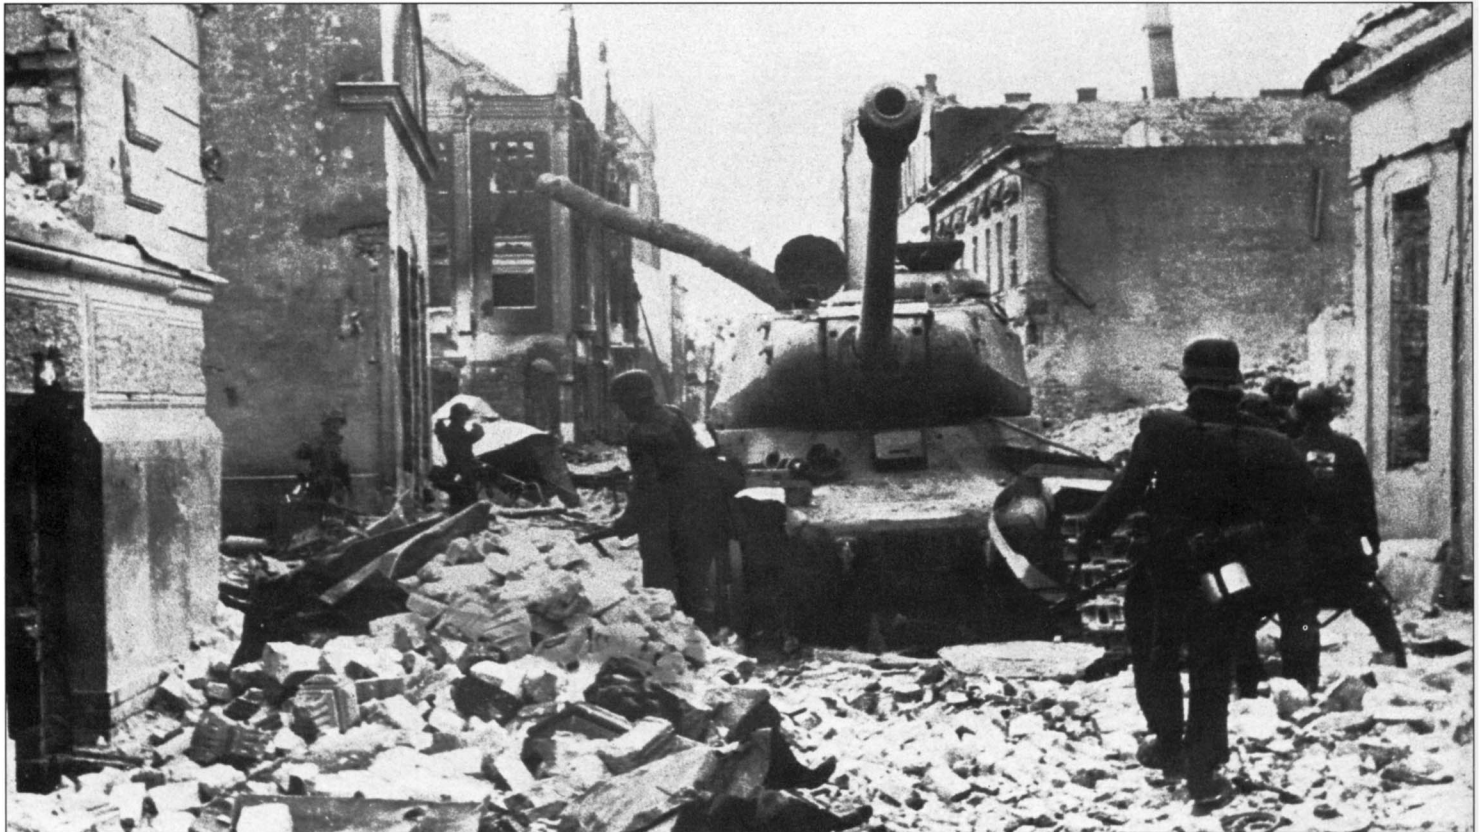
This photograph of more street fighting shows German troops after their successful repulse of a Soviet attack. Unlike the above photo, this one shows an IS-2 of the early series, with the front part of the superstructure similar in concept to the KV-1. It is important to note that the side armor plates of the IS-2 were 90mm thick, which is the same thickness as the frontal plates! This mistake was constantly repeated on all main Soviet tanks (the T-34 and KV-1).

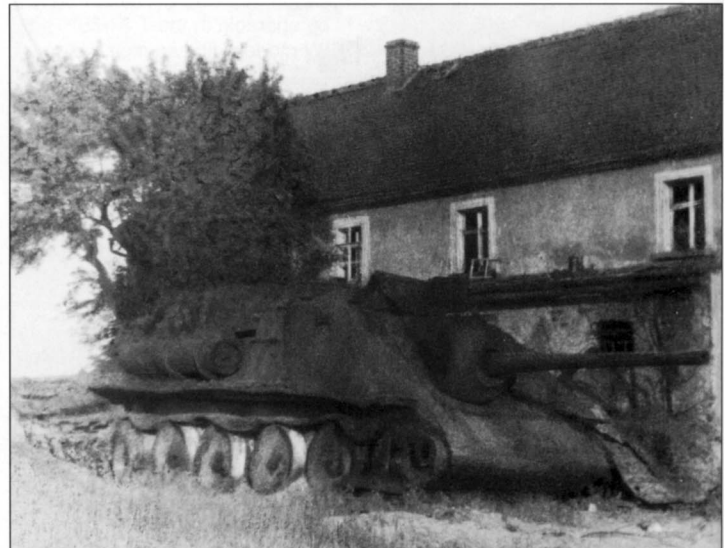
This Polish SU-85 was completely burned out during the heavy fighting on the way to Dresden. This later model, which features a commander's cupola, belonged to 24th PAS. Out of 431 tanks and self-propelled guns used by the Polish 2nd Army during these fights, a little over 200 of them were destroyed in almost two weeks of fighting.

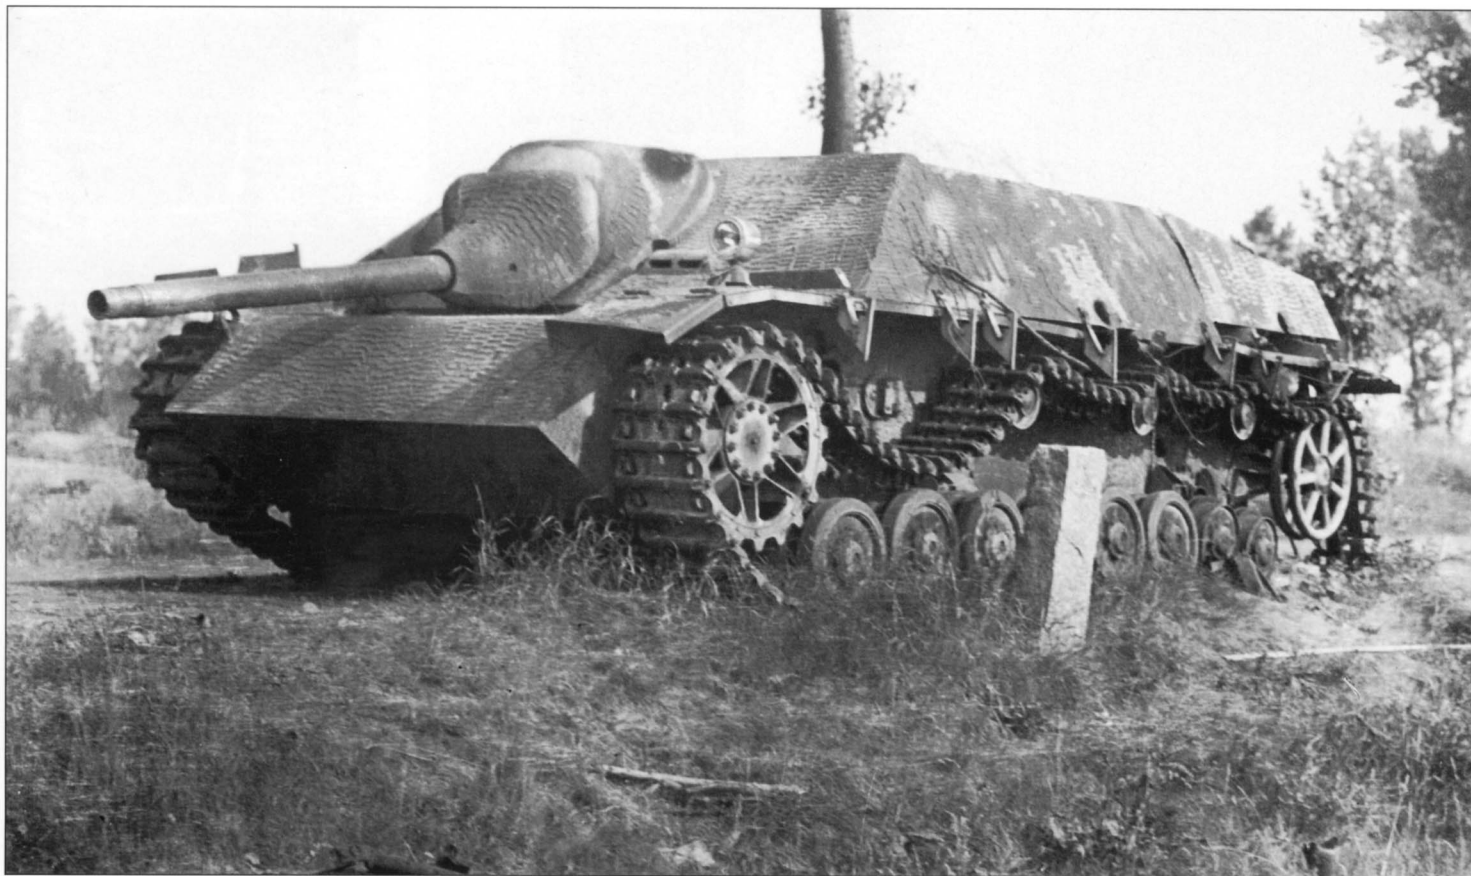
A Jagdpanzer IV with a 7.5cm gun (minus its muzzle break) that was knocked out in the Dresden area. This self-propelled gun received no fewer than three hits in the left side — one in the superstructure, another in the engine compartment and the third in the hull near the middle return roller. Note the tactical number "300" painted on the front part of the side plate. The vehicle has a coating of Zimmerit anti-mine paste on its armor, but it has lost its side skirts.

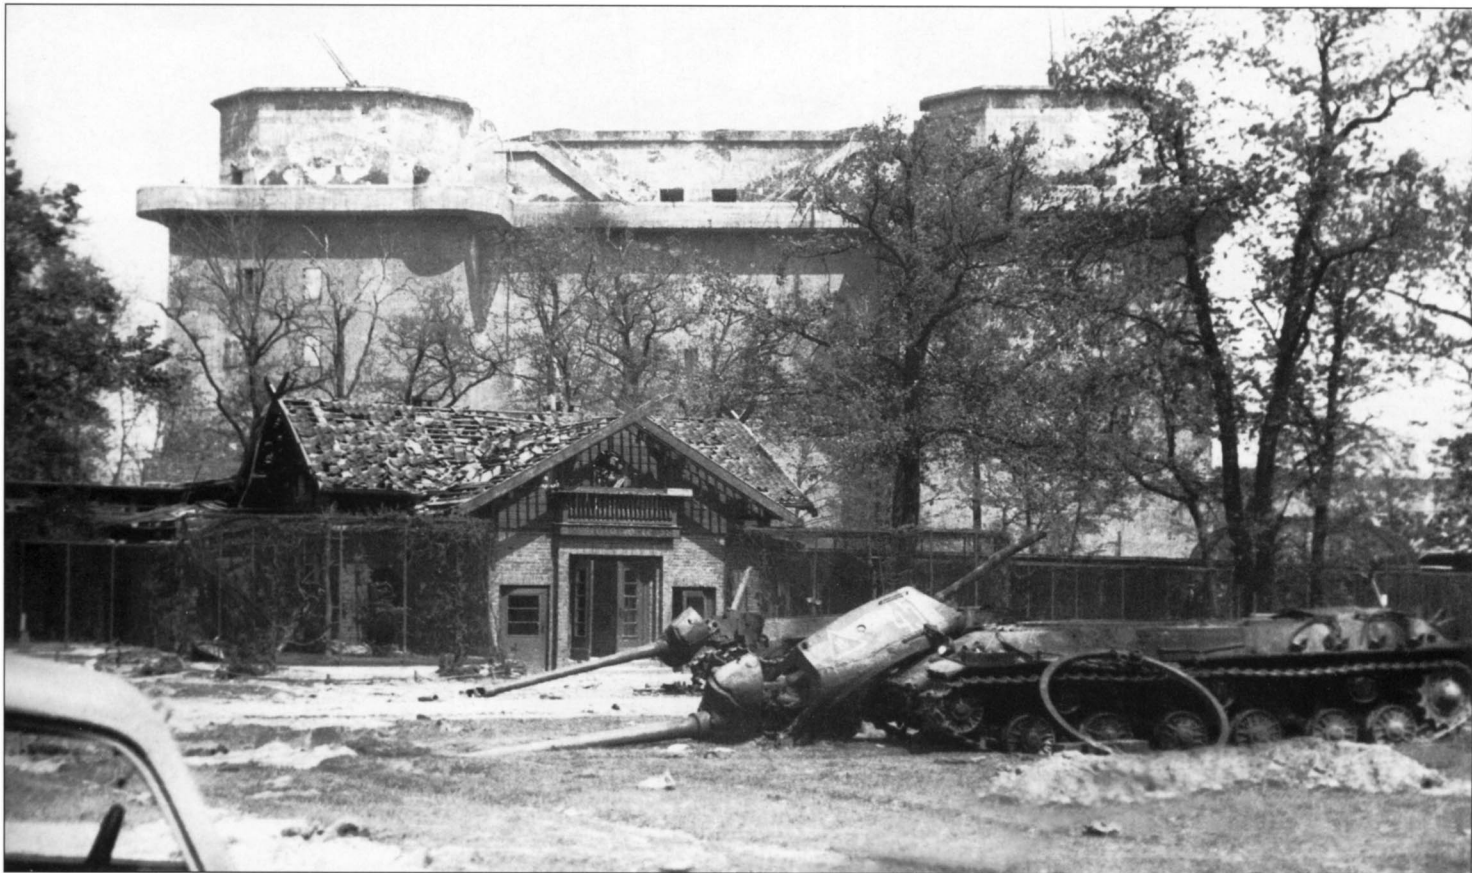
Two IS-2 heavy tanks demolished by German defenders. This photo is a good commentary on the quality of Soviet tank production. Both tanks lost their turrets after receiving hits, and both of them were blown to pieces from explosions or the shock of the collision with the ground. Note the interesting markings on the nearest turret. There is a white band around the turret that is interrupted by unit markings (white triangle with the Russian letter "N"), the number "45" (tactical markings) in white and a vertical band from the white cross painted on the top plate of the turret.

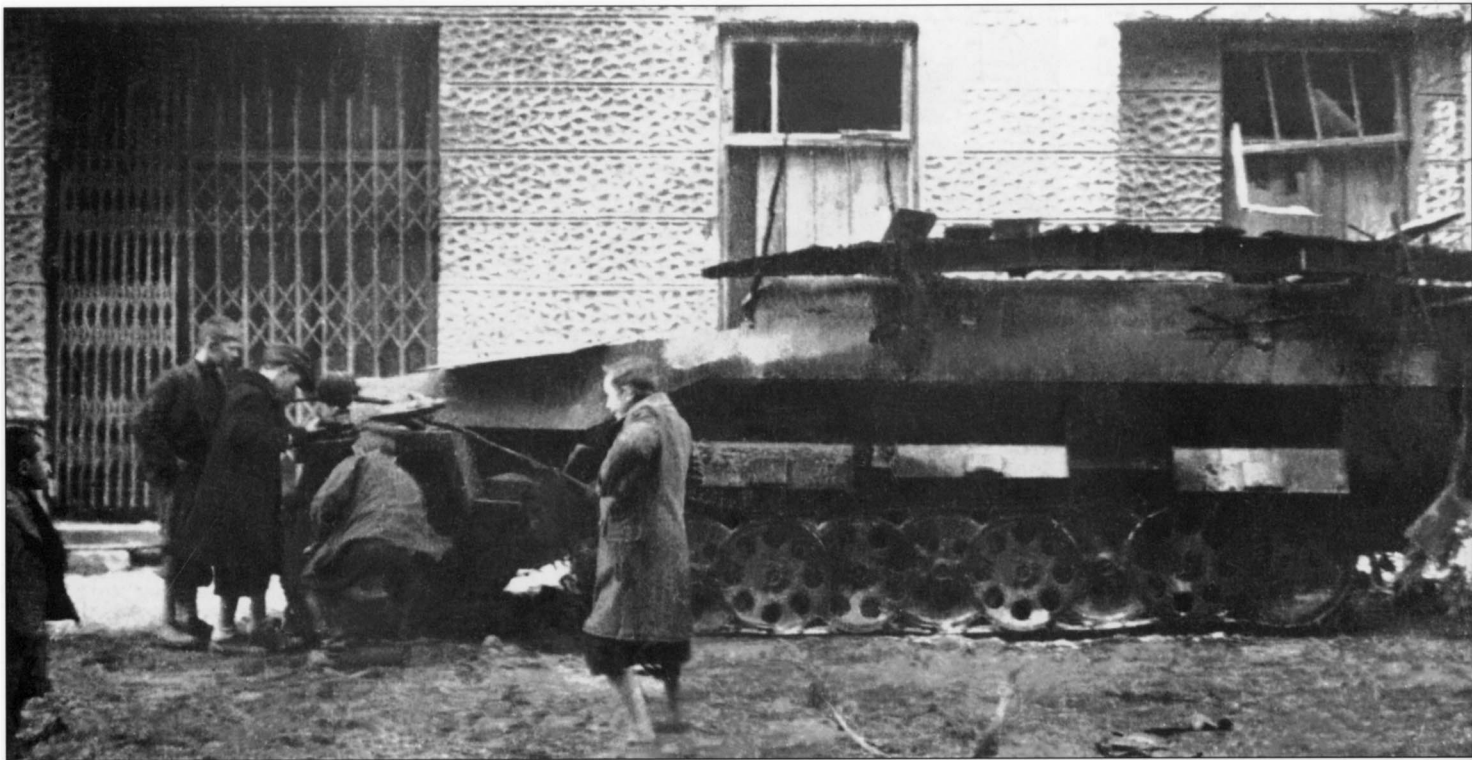
This Sd.Kfz. 251/7 Ausf. D Pionierpanzerwagen was left abandoned on a German street. Note the remains of the standard German camouflage seen in the final period of the war. It was composed of three colors — dark yellow, brown and green, which were painted in equal proportions.
