# Armor Battles on the Eastern Front

(2) Downfall of the Reich 1943-1945

Robert Michulec

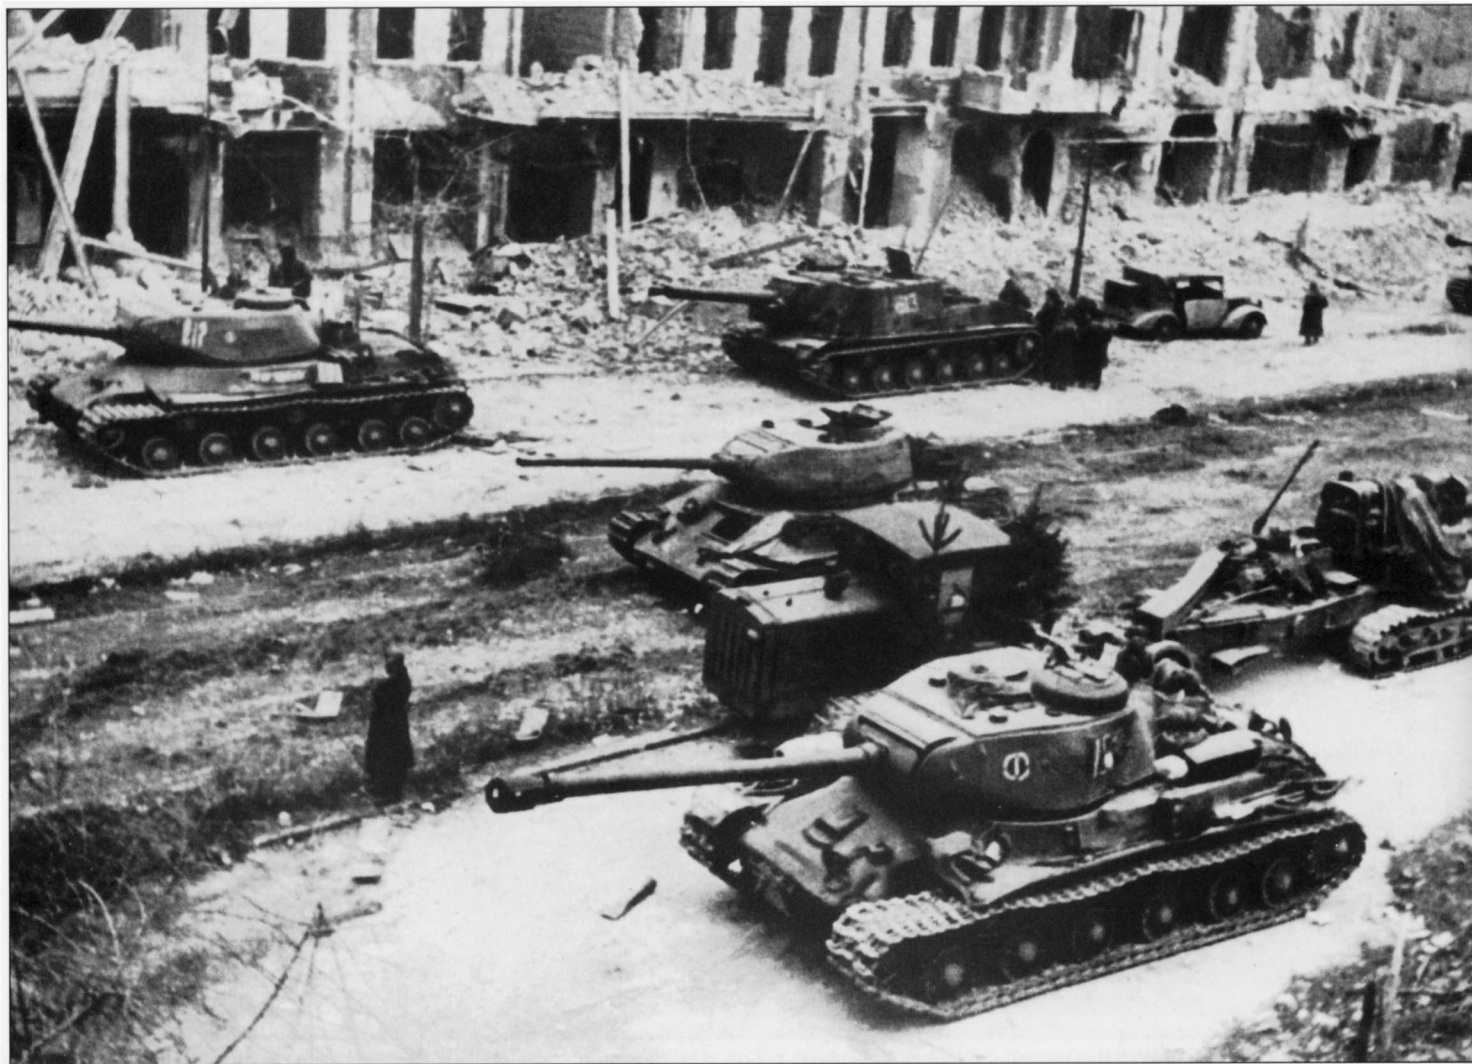
Soviet armored troops advance past the demolished remains of a German town on their way to Berlin in April 1945. Both IS-2 tanks are from a late production series and probably belong to the same unit since they carry the same emblem painted in different places on their turrets. Note that most of the armored vehicles in this photo are missing their front mudguards. This was typical of Soviet tanks throughout the war.

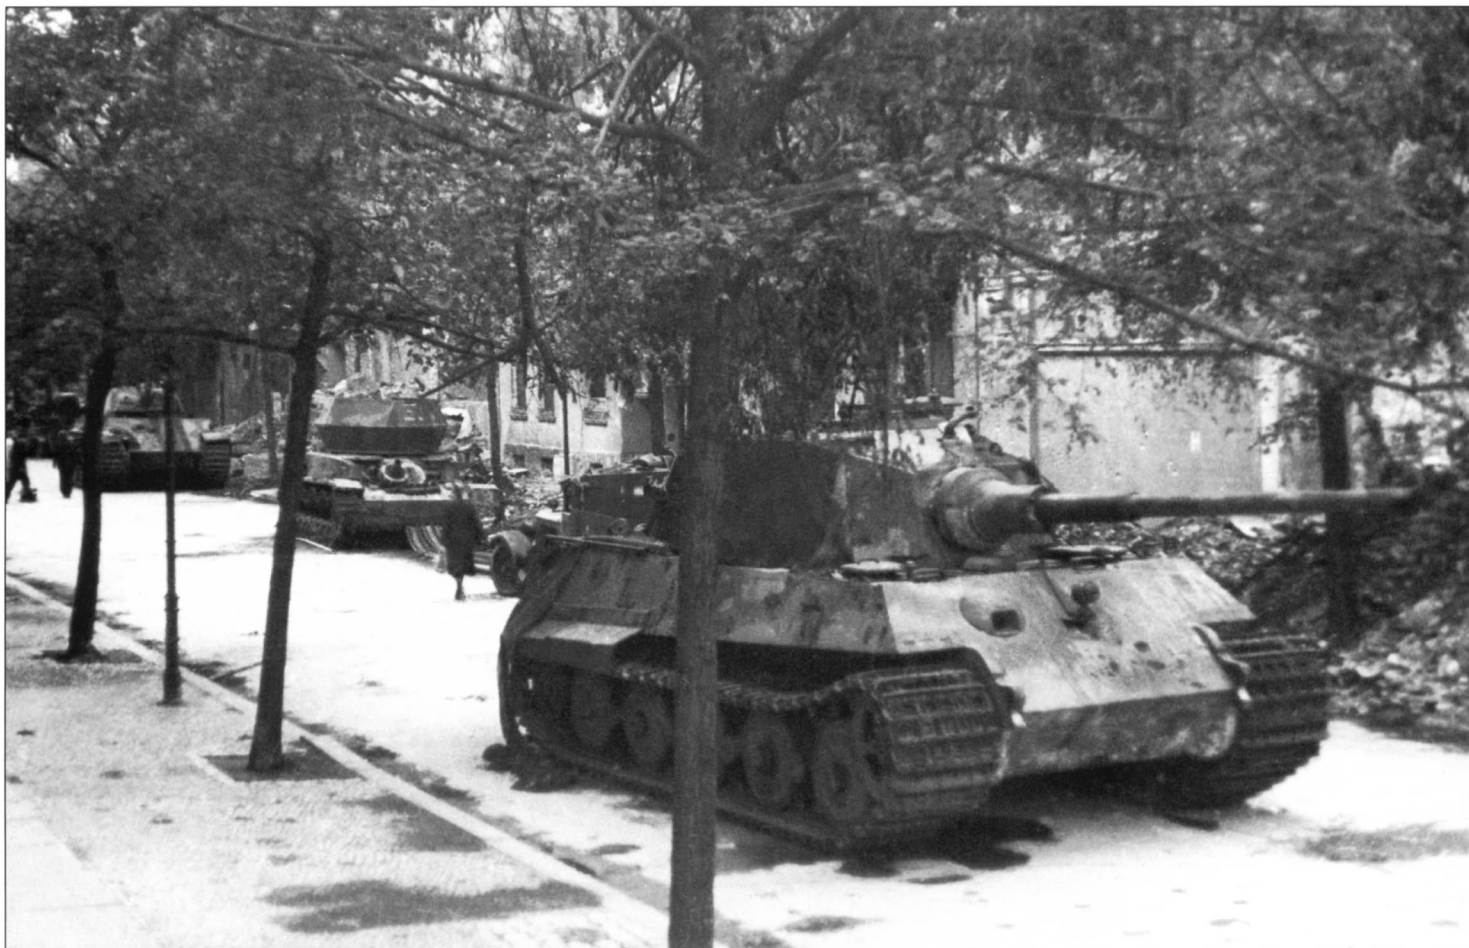
Another Tiger II (in the foreground) abandoned on a street in an unknown German city somewhere in the Berlin area. Note that the tank's muzzle break and machine gun are missing. Behind the Tiger II is a Flakpanzer "Wirbelwind" and a Panther.

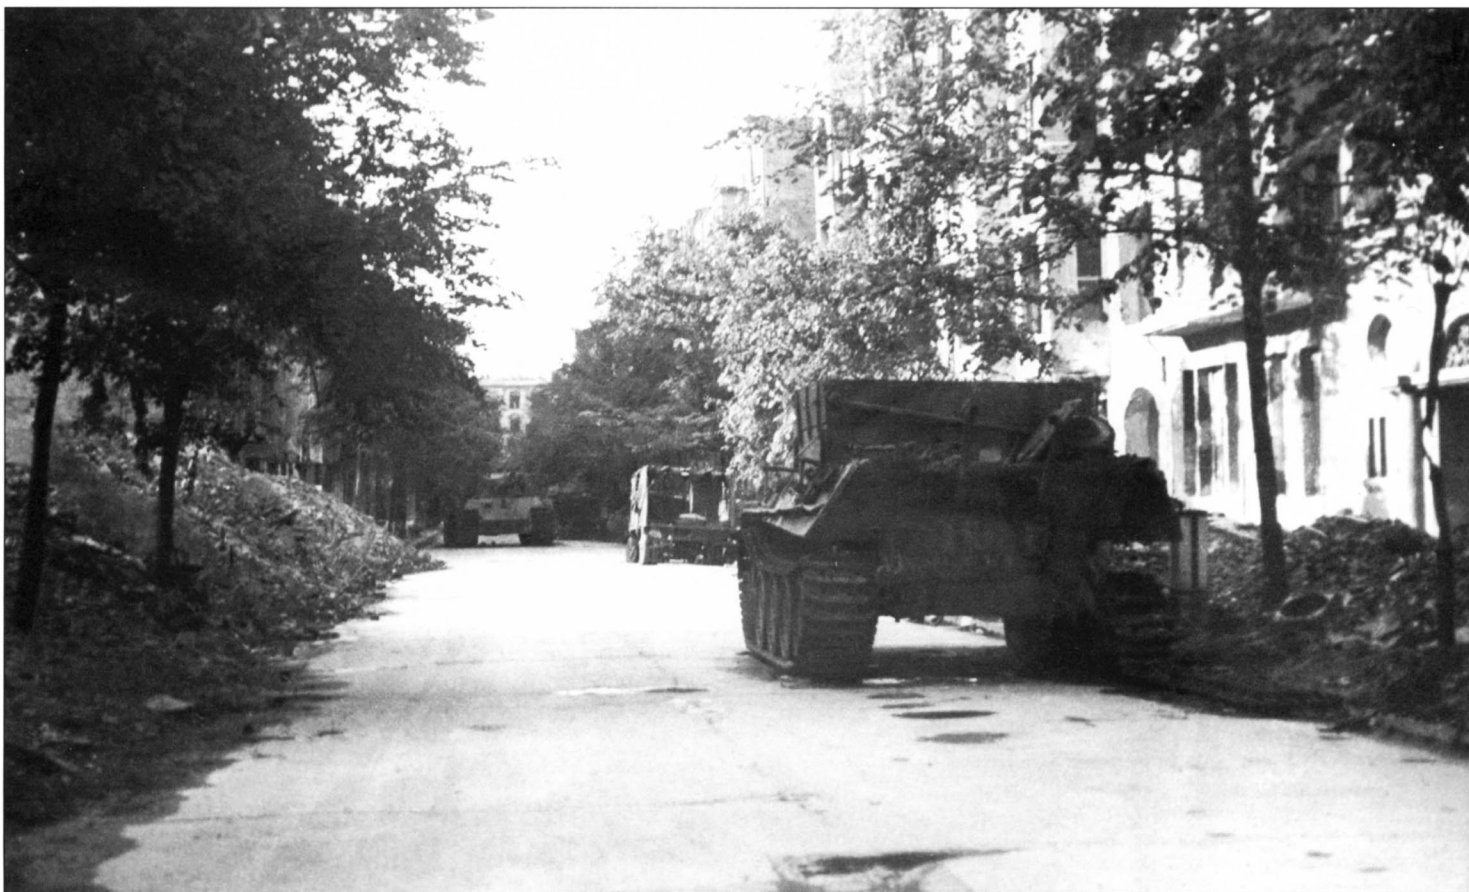
The same street as just seen but photographed from another position. In the foreground is a Bergepanther armored recovery vehicle, while in the background is the Tiger II seen in the above photo.

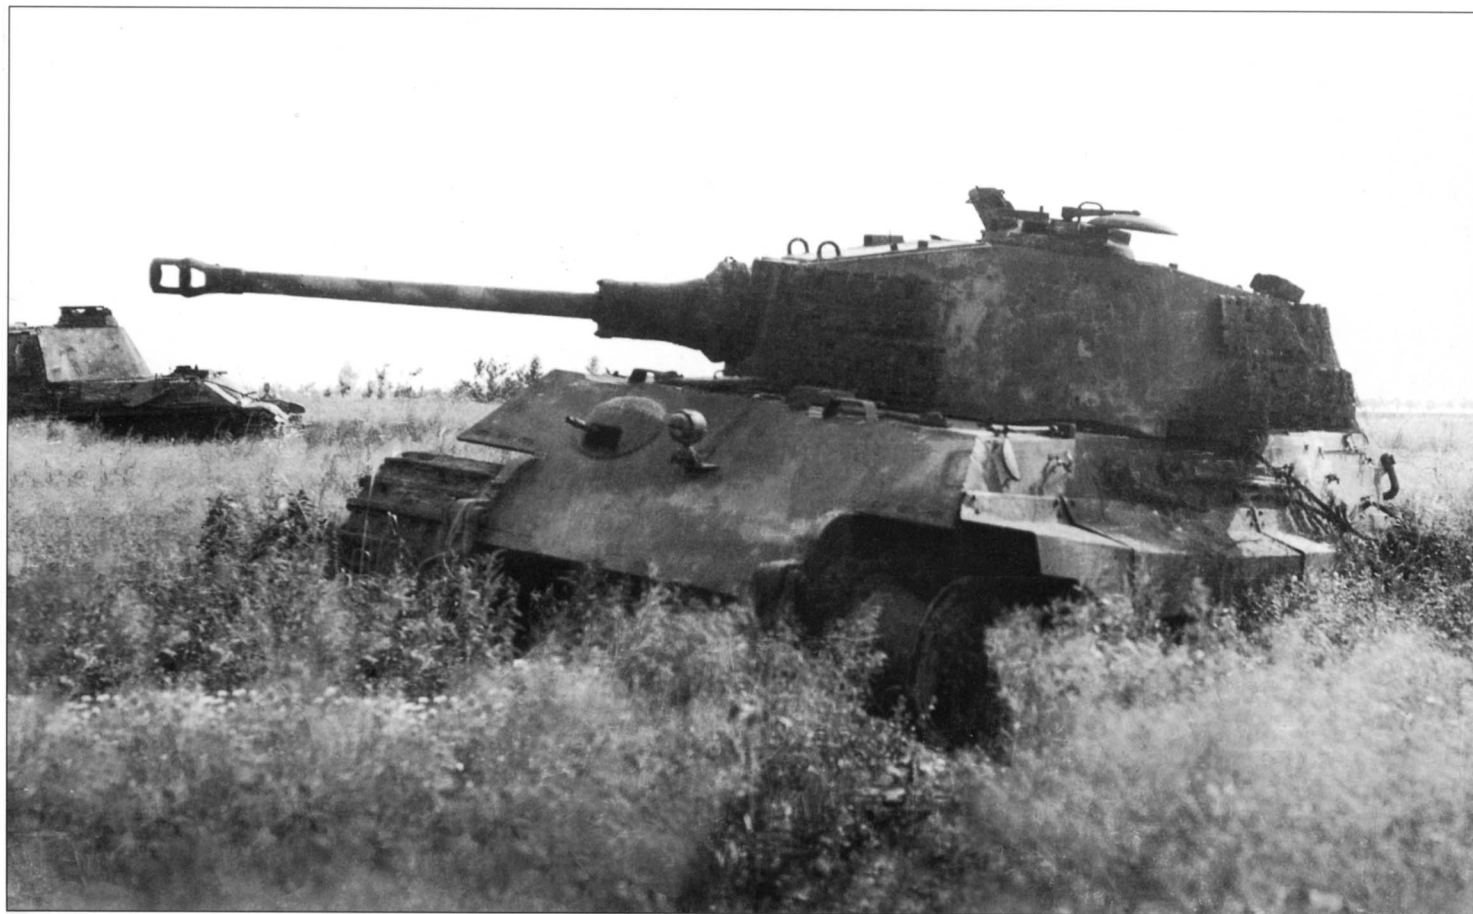
And here is a small surprise — a Pz.Kpfw. VI Ausf. B armed with the 7.5cm KwK42 L/70 from a Panther tank. The standard model of Tiger II was armed with the 8.8cm KwK43 L/71 gun. The reason for rearming this tank is not known. However, it is possible that the original gun was damaged and then replaced with the only one available at the time. This tank was probably from sSS-Pz.Abt.502, which was assigned to defend Berlin.

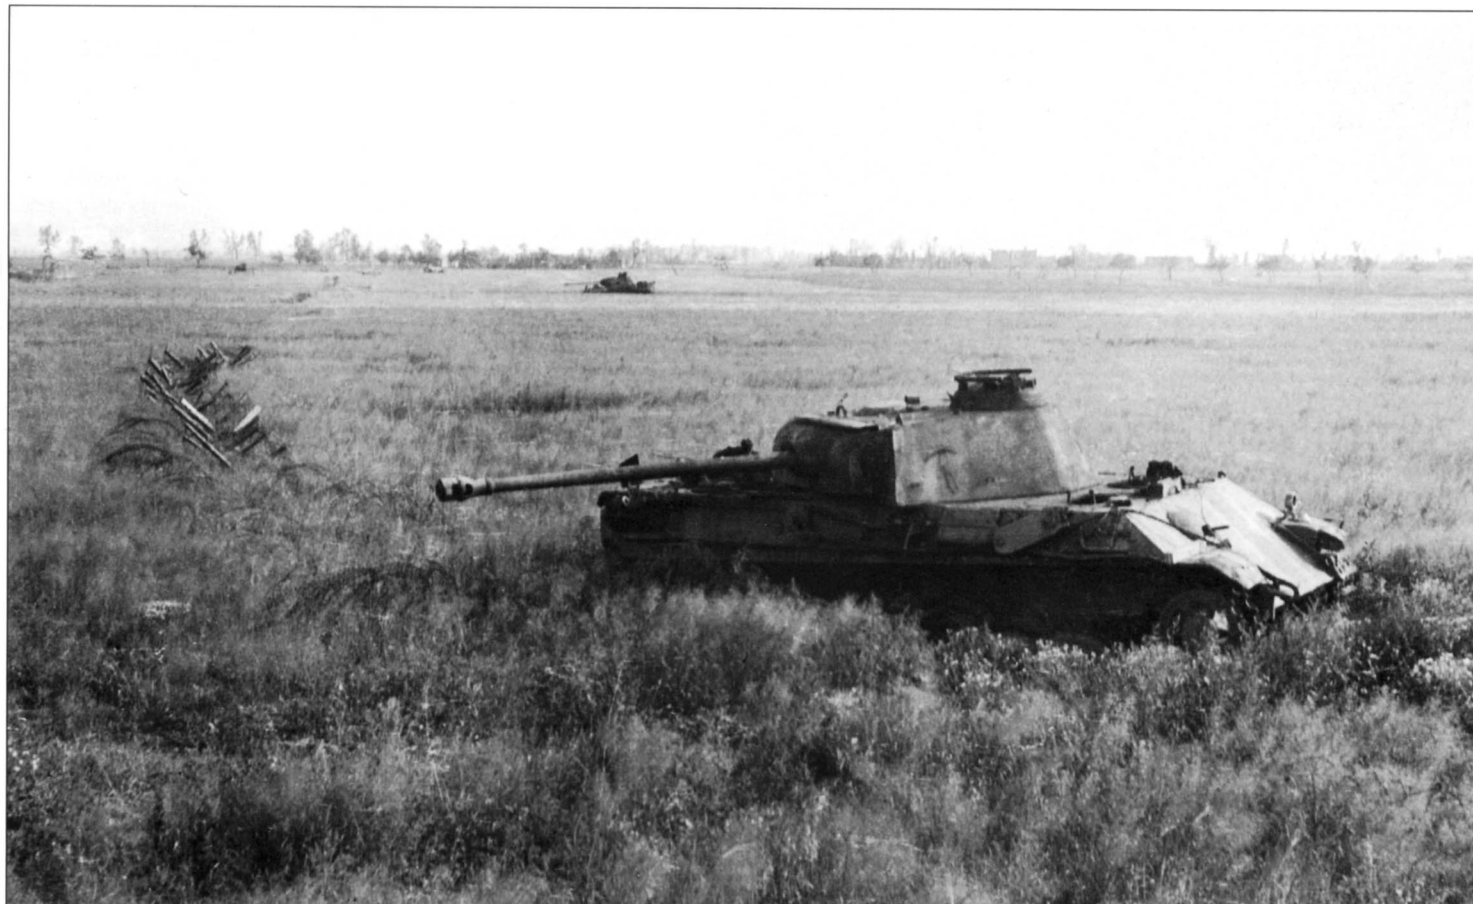
This photograph of the same scene was taken from a different angle. It shows a final series Pz.Kpfw. V Ausf. G Panther with a chin-type gun mantlet used to prevent shells from deflecting onto the thin roof. Note the three-color camouflage pattern seen on the glacis.

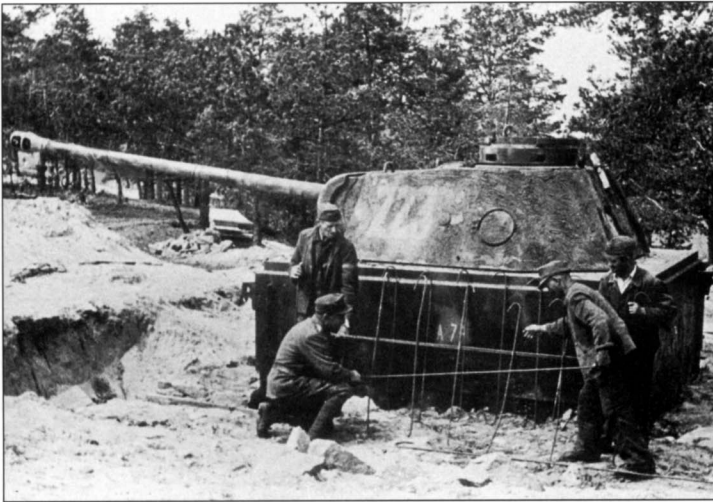
One noteworthy invention in the Panzerwaffe's arsenal in the last year of the war was the "Panther pillbox", i.e., a Pz.Kpfw. V turret converted into a fortification or pillbox. This photo shows preparations being made to build a concrete fortification beneath a Panther's turret. These turrets were often taken from damaged or destroyed tanks, especially older ones.

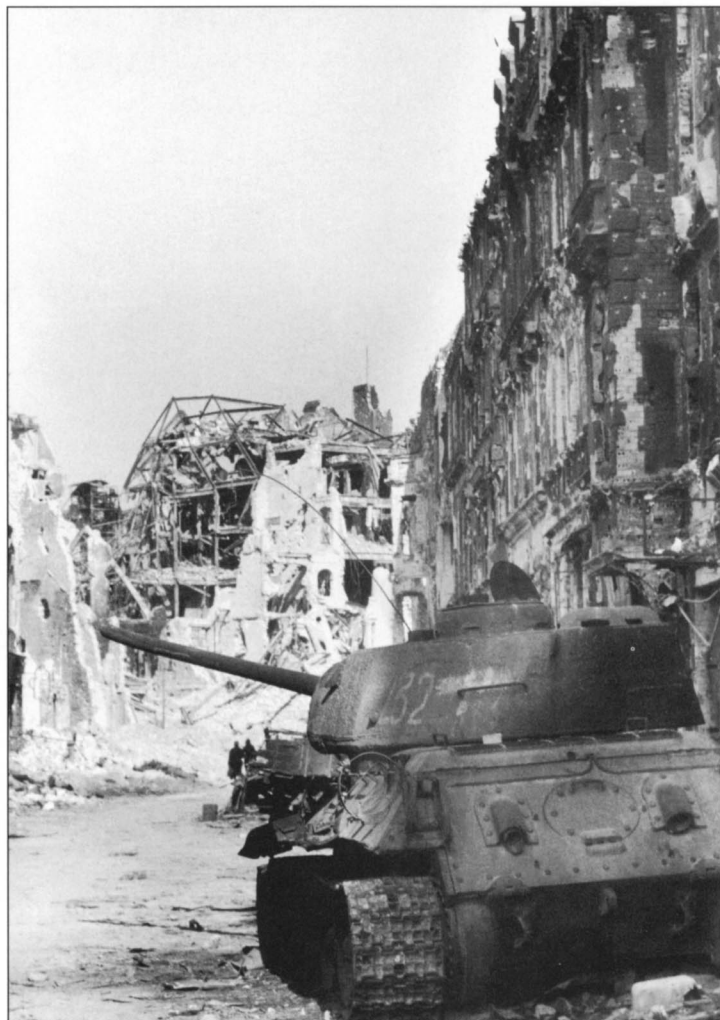
A T-34-85 hit and burned out on a street in the completely demolished city of Berlin, May 1945. Despite the smoke stains that cover the entire vehicle, the tactical number "232" is still visible, as is the white band around the turret. Note that the first number "2" is painted in different style than the second. The Red Army lost 800 tanks while reducing the size of the German pocket in central Berlin.

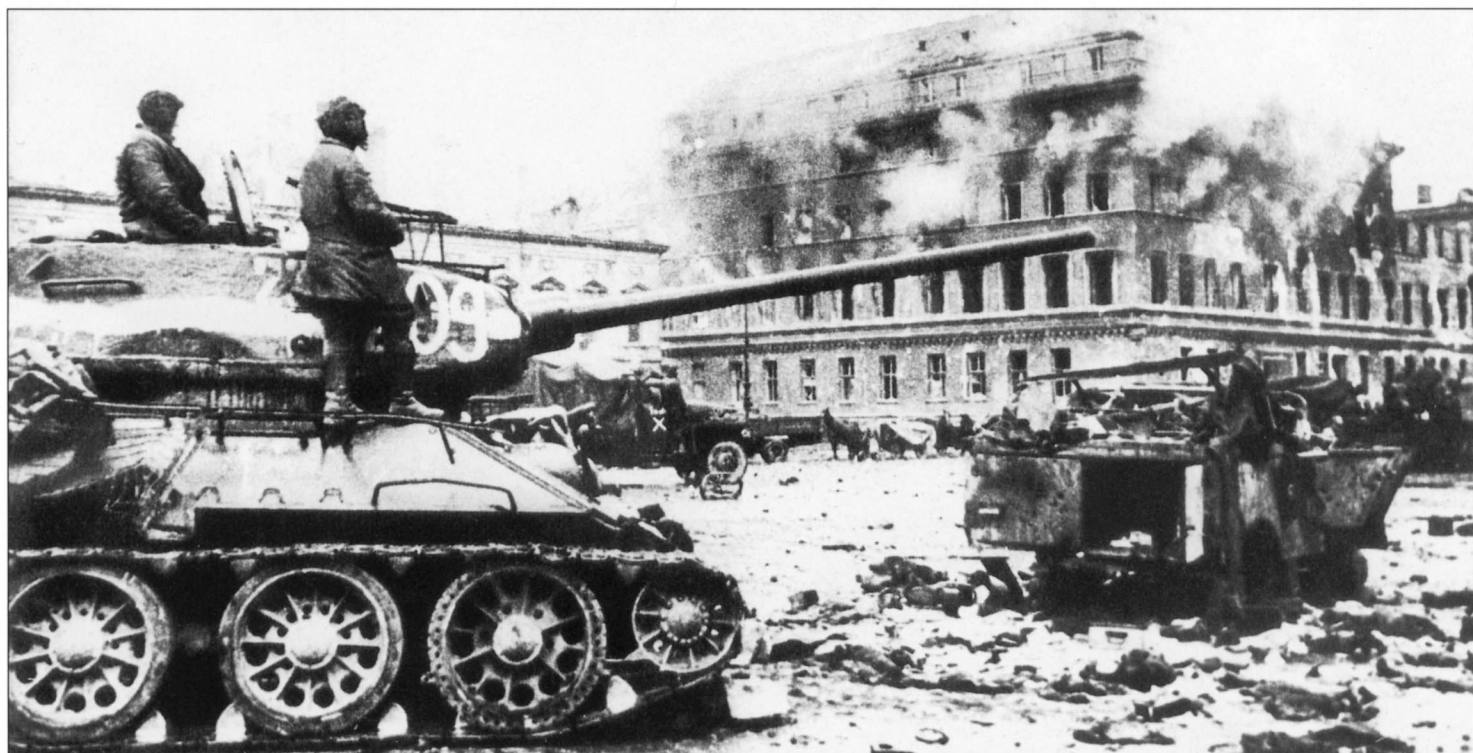
This is a view of the final minutes of the war in the slaughter pen of Berlin. The T-34-85 at the left is marked with a white band around the turret (an Allied recognition sign) and is equipped with wire mesh skirts to protect the tank against Panzerfaust anti-tank weapons. One of them is affixed to the turret in front of the crew hatches. Note that the skirts that were attached to the frontal parts of the turret and superstructure were shot off. Note also the tactical numbers on the turret. One of them is small and painted above the white bar, while another larger one was painted at the same time and with the same paint as the bar. The existence of the unit markings just visible under the number "09" could be explained if the tank carries the markings of two units that used the tank within a few days.

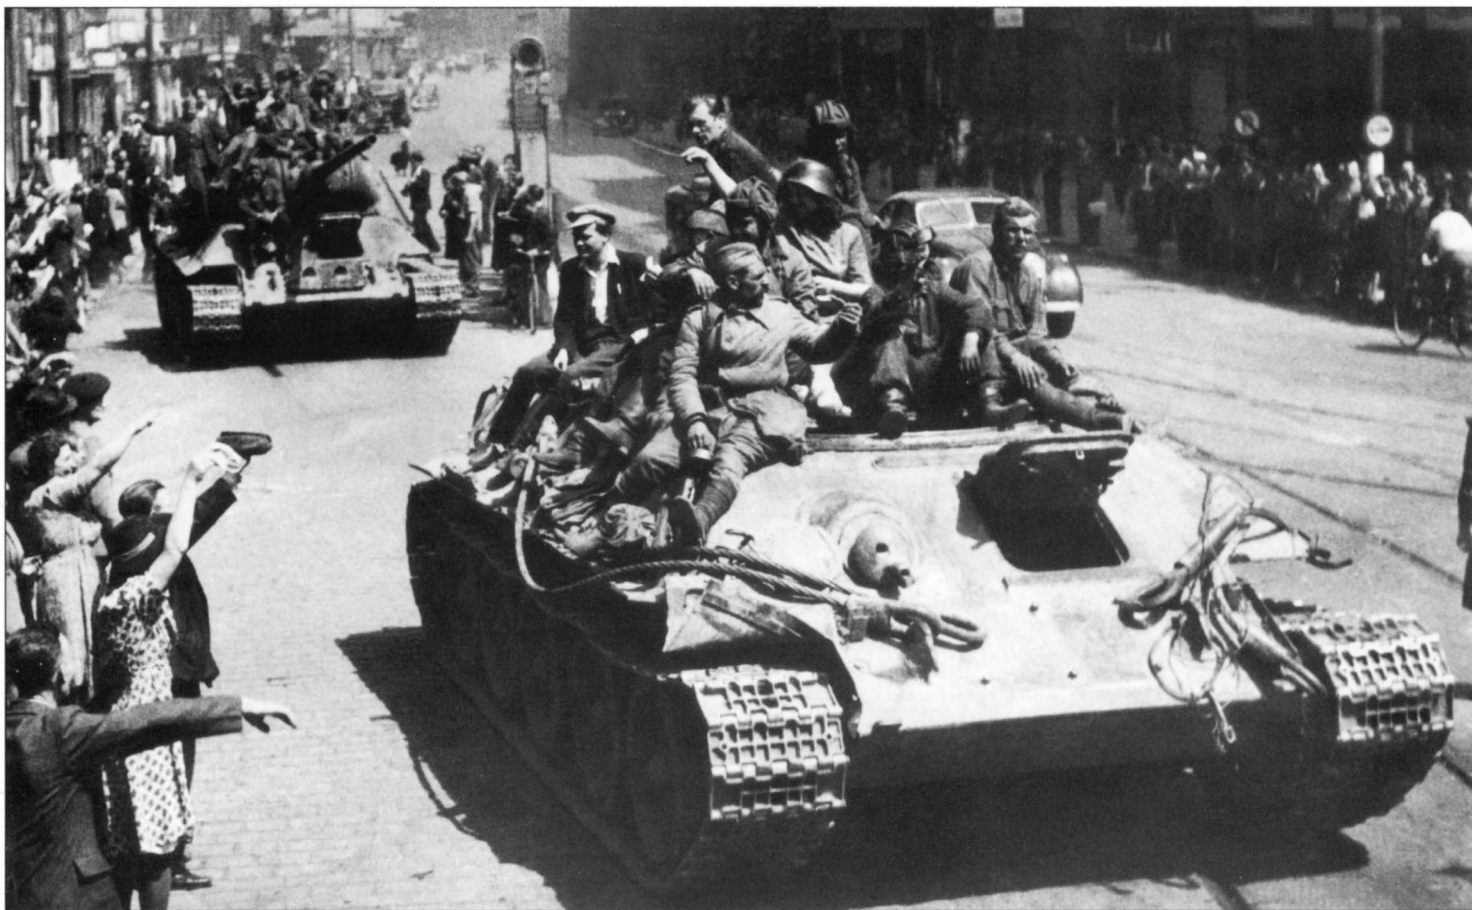
A T-34 recovery tank travels down a street in Prague during a victory parade in May 1945 just after the liberation of the city. The T-34 recovery tank was built in front-line workshops utilizing damaged tanks with turrets that were beyond repair. The 1st Ukrainian Front under Marshal Ivan Konev was the main force assigned the task of liberating Prague. Feldmarschall Ferdinand Schoerner, who was defending Prague, finally surrendered on 11 May.

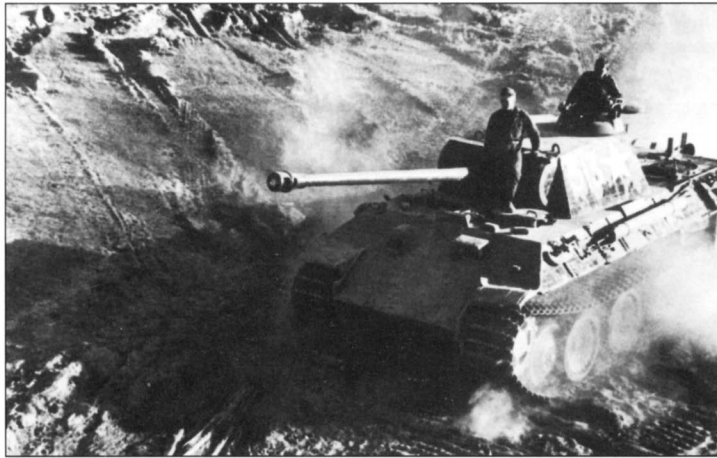
This shot of a Pz.Kpfw. V Ausf. A Panther manned by a Soviet crew from the Guards company commanded by Lt. Sotnikov was taken in Praha in May 1945. This was one of three such Panthers used by this sub-unit, all of which were painted with standard dark yellow camouflage and marked with white, three-digit tactical numbers ("503", "513" and "518") and stars.

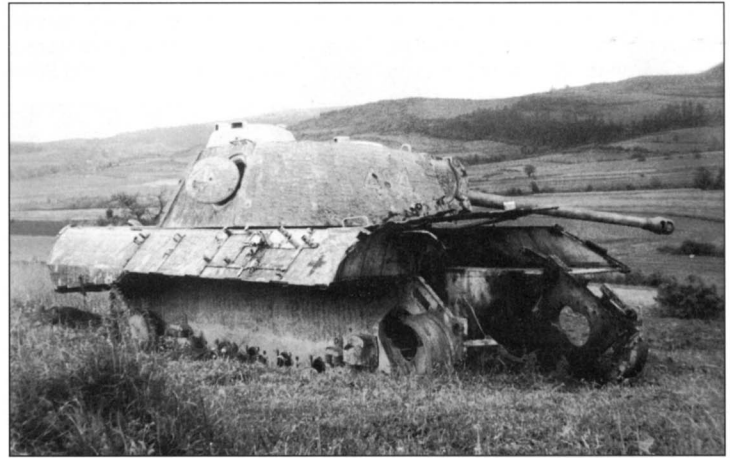
Hundreds of other Panthers that were left behind the front lines could be seen on killing fields all over Poland up to the 1950s. One of them is seen here — an Ausf. A model with the front part of its hull demolished. A military commission discovered it somewhere in southern Poland in the late 1940s. Note the yellow tactical number "414" outlined in black painted on all three sides of the turret.
