# Armor Battles on the Eastern Front

(1) The German High Tide 1941-1942

# **Armor Battles on the Eastern Front**

## **(1) The German High Tide 1941-1942**

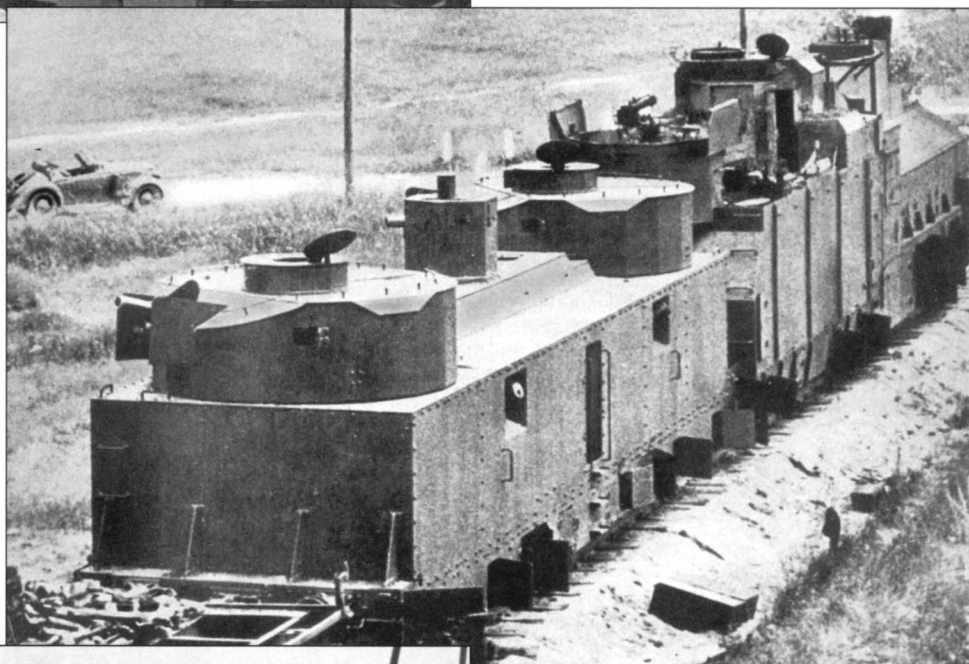
The Soviets fielded many armored trains. About 75 of them were in service at the beginning of the war, 25 of them being put to use by the NKVD. This BP-35 armored train was both damaged and captured by the Germans.

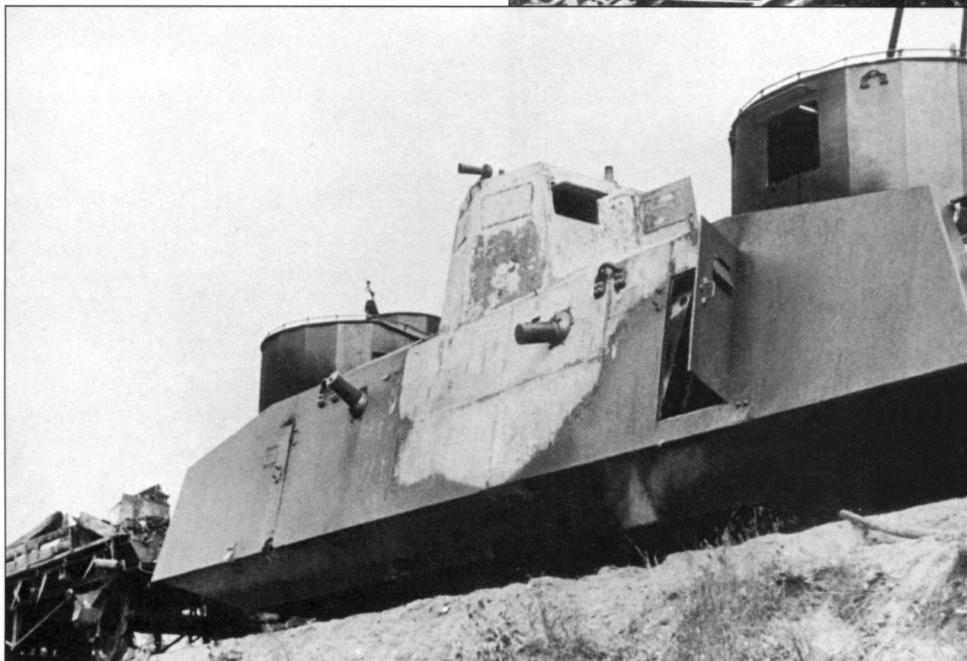
An overhead view of the same BP-35 armored train. Most armored trains were either destroyed by the Luftwaffe or captured intact with only minor damage, though the Soviet crews would write in their reports that they blew them up.

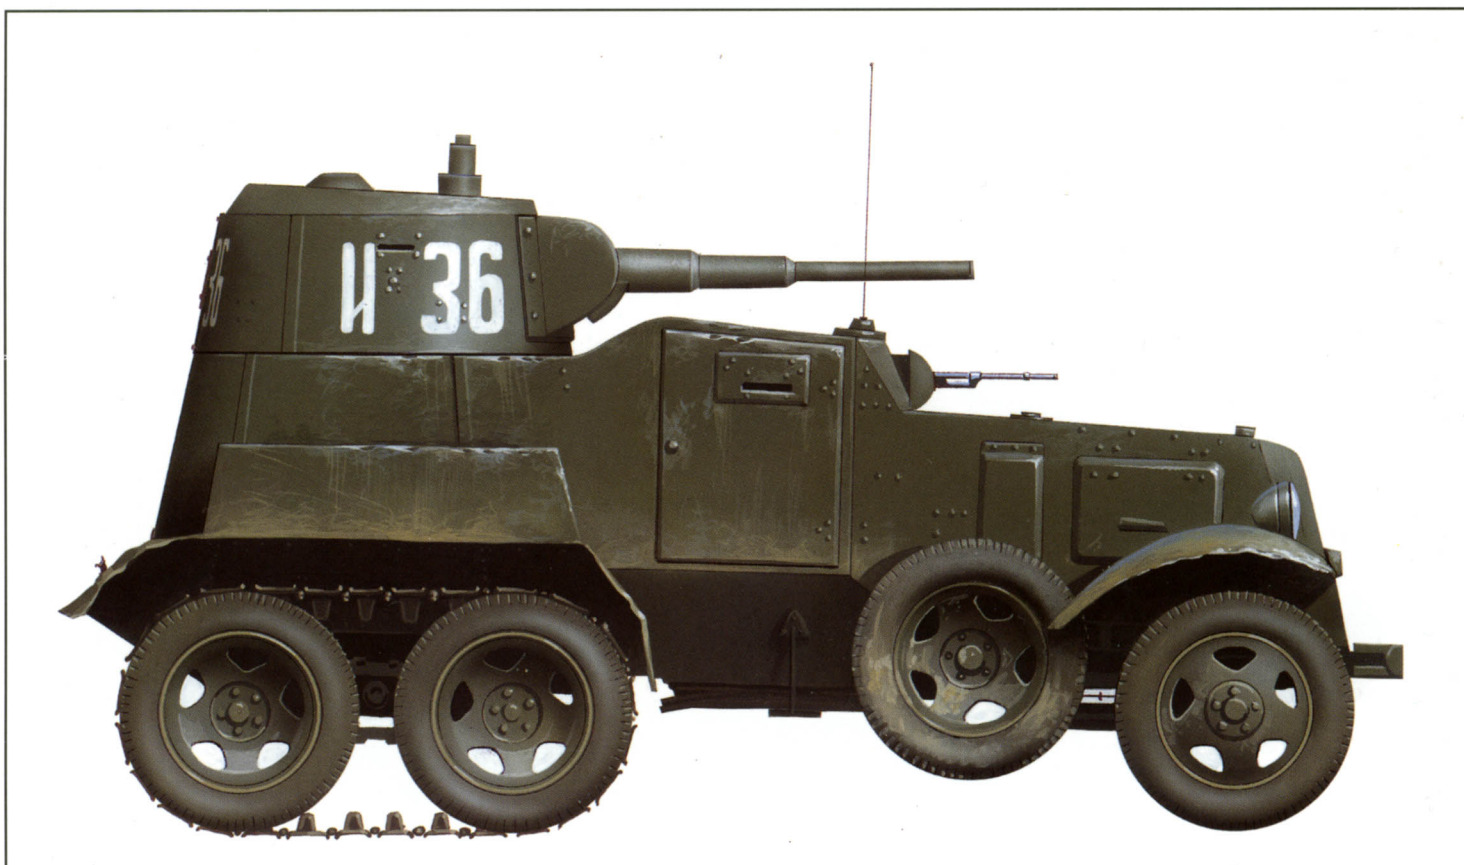
**BA-10 heavy armored car, Leningrad Front, spring 1942**

The BA-10 was the standard Soviet armored car, though the BA-6 and BA-20 were also used. Many BA-10s were transferred from the Far East to western Russia in the summer of 1941 to replace destroyed ones. This vehicle wears the standard camouflage of Soviet vehicles, with the code "I-36" painted in white. The meaning of this code is unknown, but it could be the unit code.

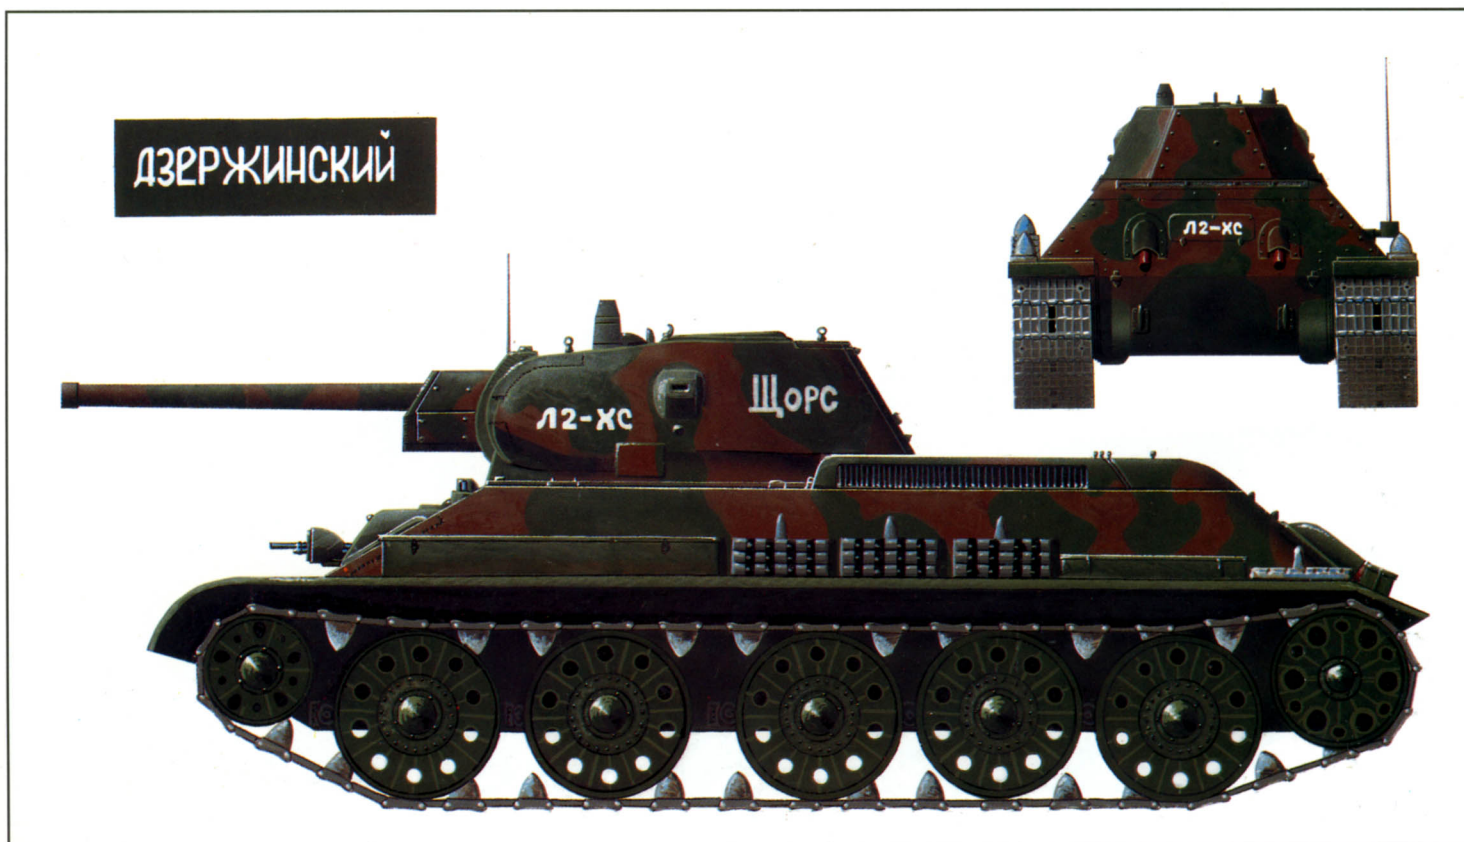
**T-34 Model 1941, 4th Guards Tank Corps, South-West Front, May 1942**

The unit code "L2-KhS" was painted in white on the glacis, rear plate and on both sides of the turret. The early cast turret is evident. The running gear uses the all-steel spoked wheels introduced in the spring of 1942. Each tank in this unit was named after a hero of the 1917 Bolshevik revolution (for example, Shchors or Dzerzhinski) and wears a two-color camouflage of brown or dark earth over a dark olive-green background.
