# Battle on Two Fronts

## 1944-45

Tom Cockle

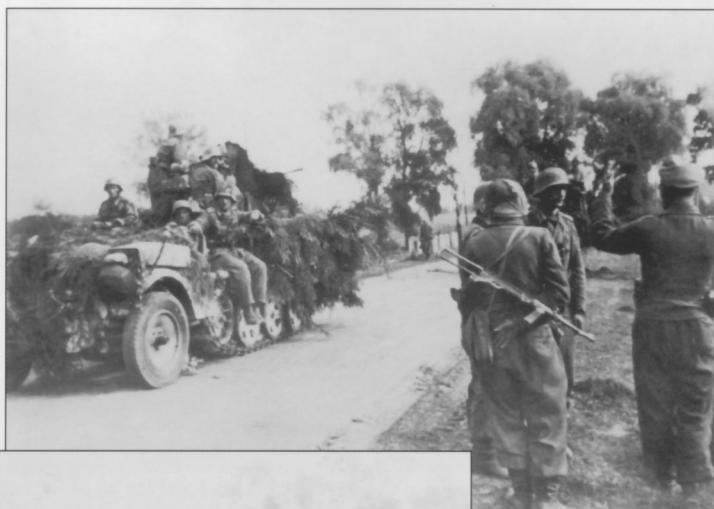
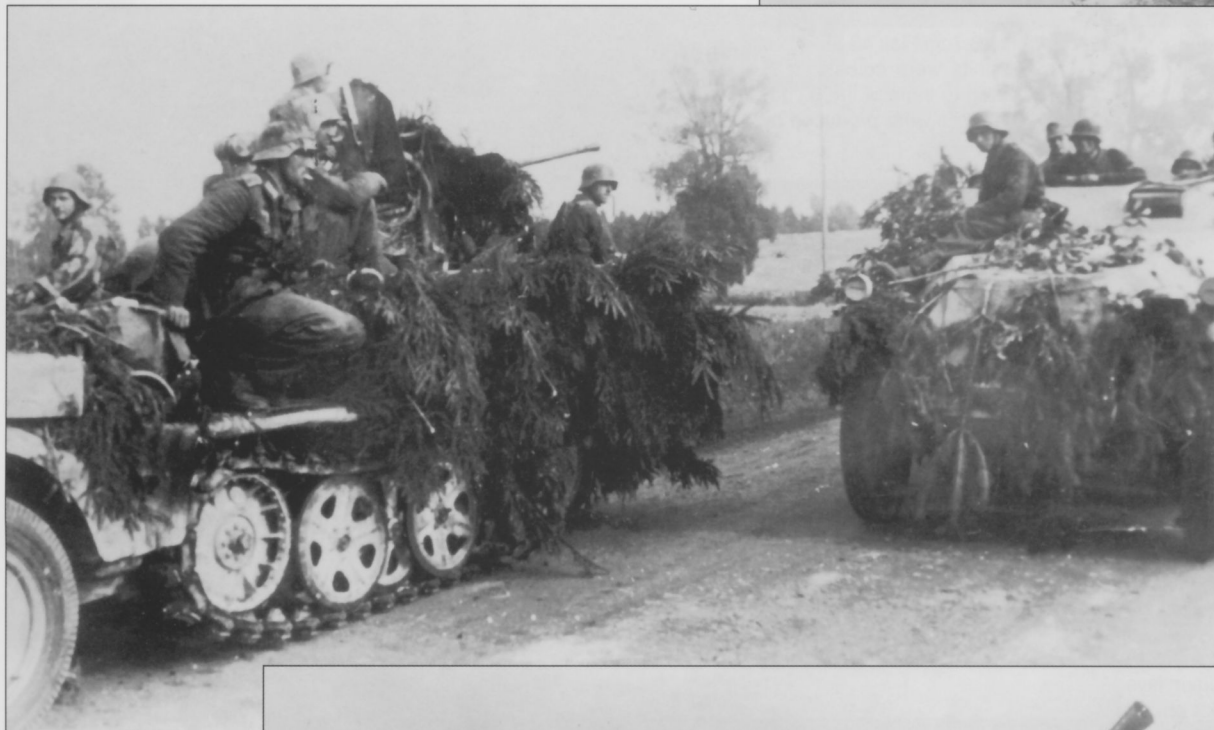
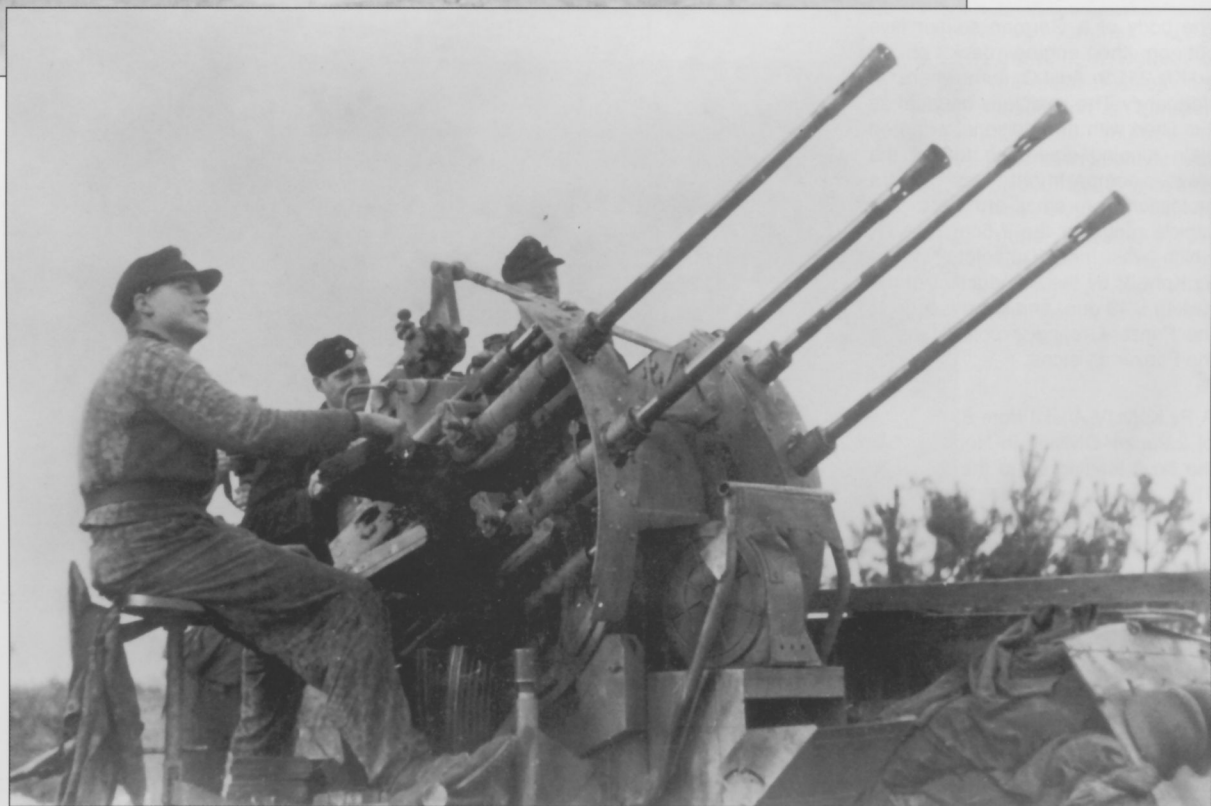
Two photos of an Sd.Kfz.10/5 from an unknown unit parked on a Norman roadside in the early days of the invasion. This is the unarmored version mounting the 2cm Flak 38, although the identifying feature was not the gun, but the width of the gun platform and on this example, the fender can be seen to flare out over the drive sprocket. Initially, they were issued to independent anti-aircraft battalions in the both the Heer and Luftwaffe but in 1942, they were authorized as part of a Panzer-Regiment or Abteilung. In the second photo, a rarely photographed 2cm Flak 38 auf Selbstfahrlafette Zgkw.3t (Sd.Kfz.11) is coming into view. The gun is missing but the shape of the armored front, similar to the Sd.Kfz.251, is unmistakable.

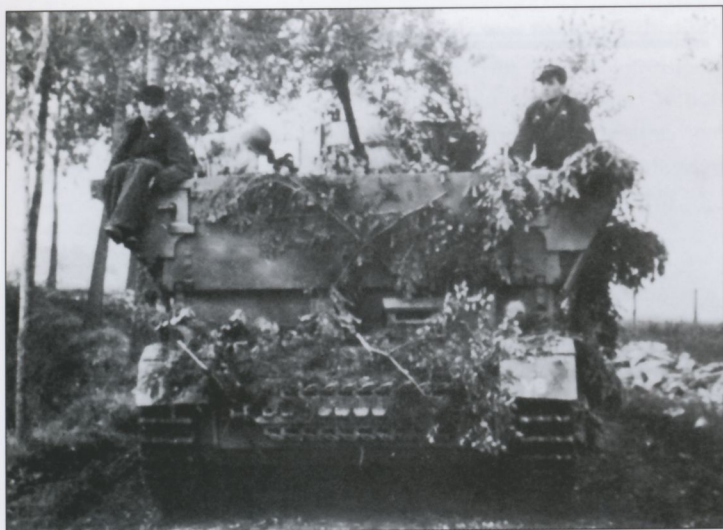
An Sd.Kfz.7/1, mounting the formidable 2cm Flakvierling 38, from an unknown SS unit sits manned and ready for action. This particular vehicle is fitted with the armored cab, part of which can be seen on the lower right of the photo. In practice, the gun could fire up to 800 rounds per minute, which increased the chances of hitting high-speed fighter aircraft. Almost 800 units were completed from April 1940 to December 1944.

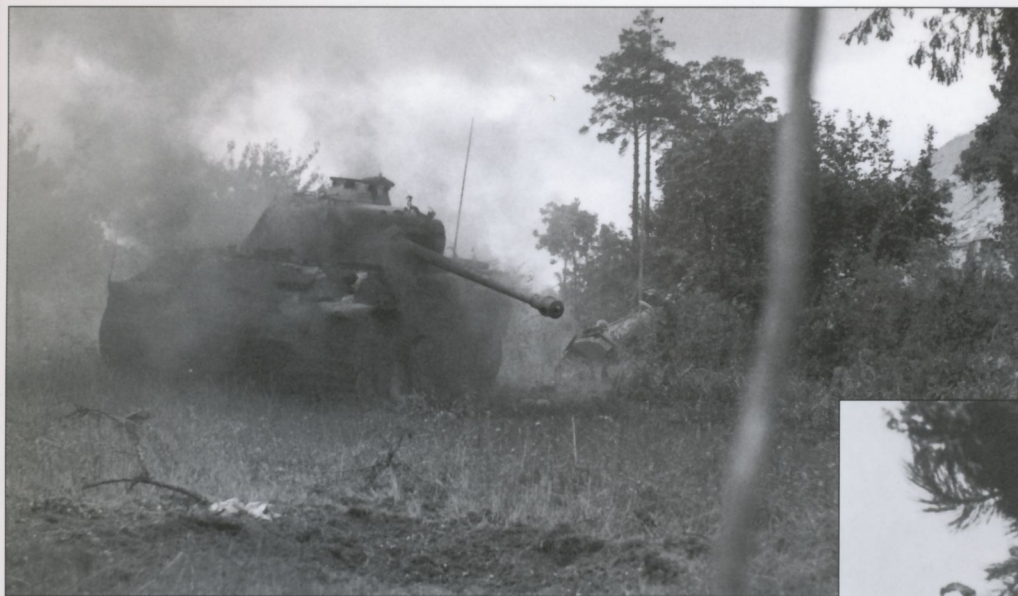
A Panther Ausf.A from I./Pz.Rgt.3 of 2.Panzer-Division burns south of Cheux on 27 June 1944 while another one lies abandoned in the background. The division lost seven Panthers in an assault on the town to relieve 8./SS-Pz.Rgt.12.

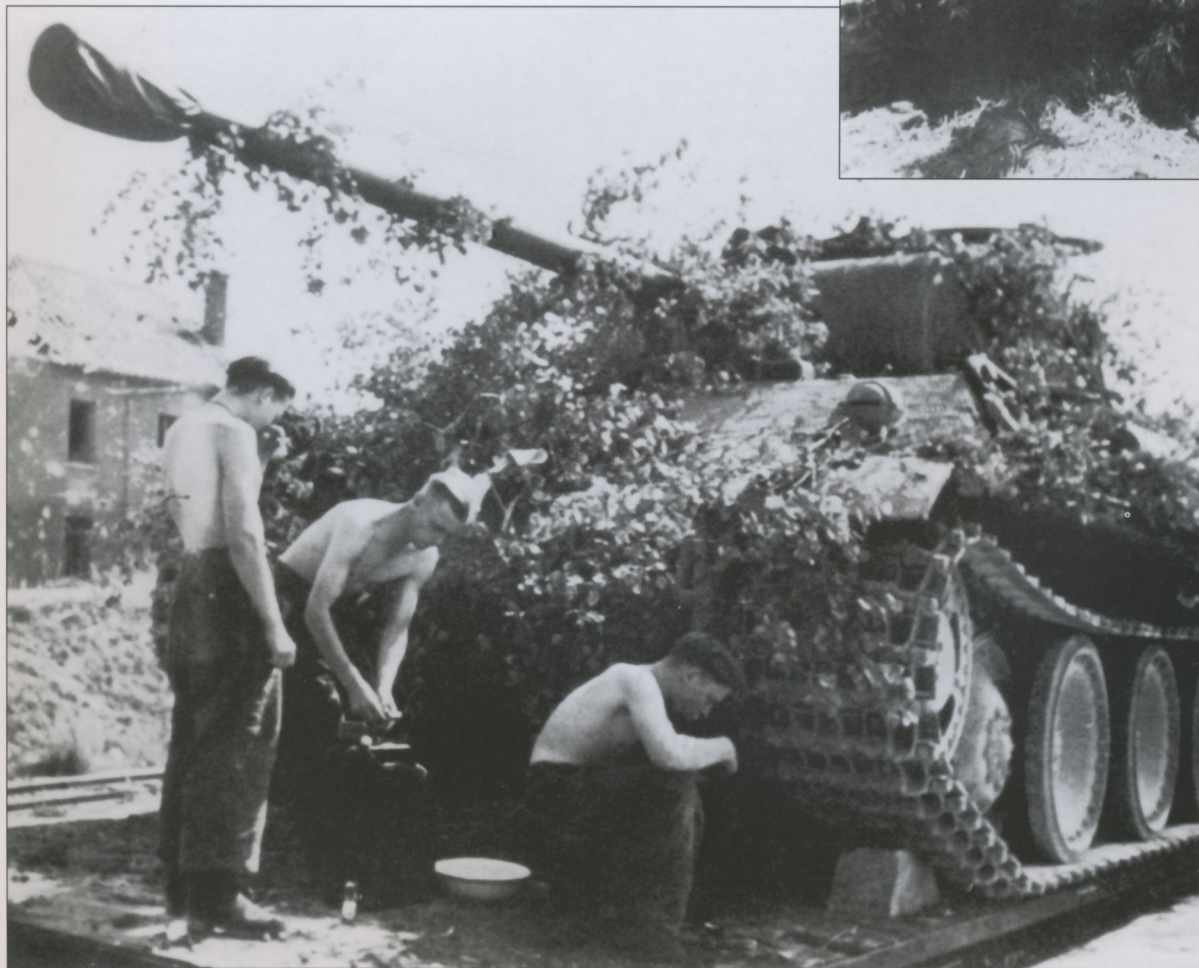
Two Panther Ausf.G from II./Pz.Rgt.33 of 9.Panzer-Division are loaded on rail transport for the journey to Normandy from its base in southern France after the invasion. On 10 June 1944, the divisions reported strength was 78 Pz.Kpfw.IV and 40 Panthers.

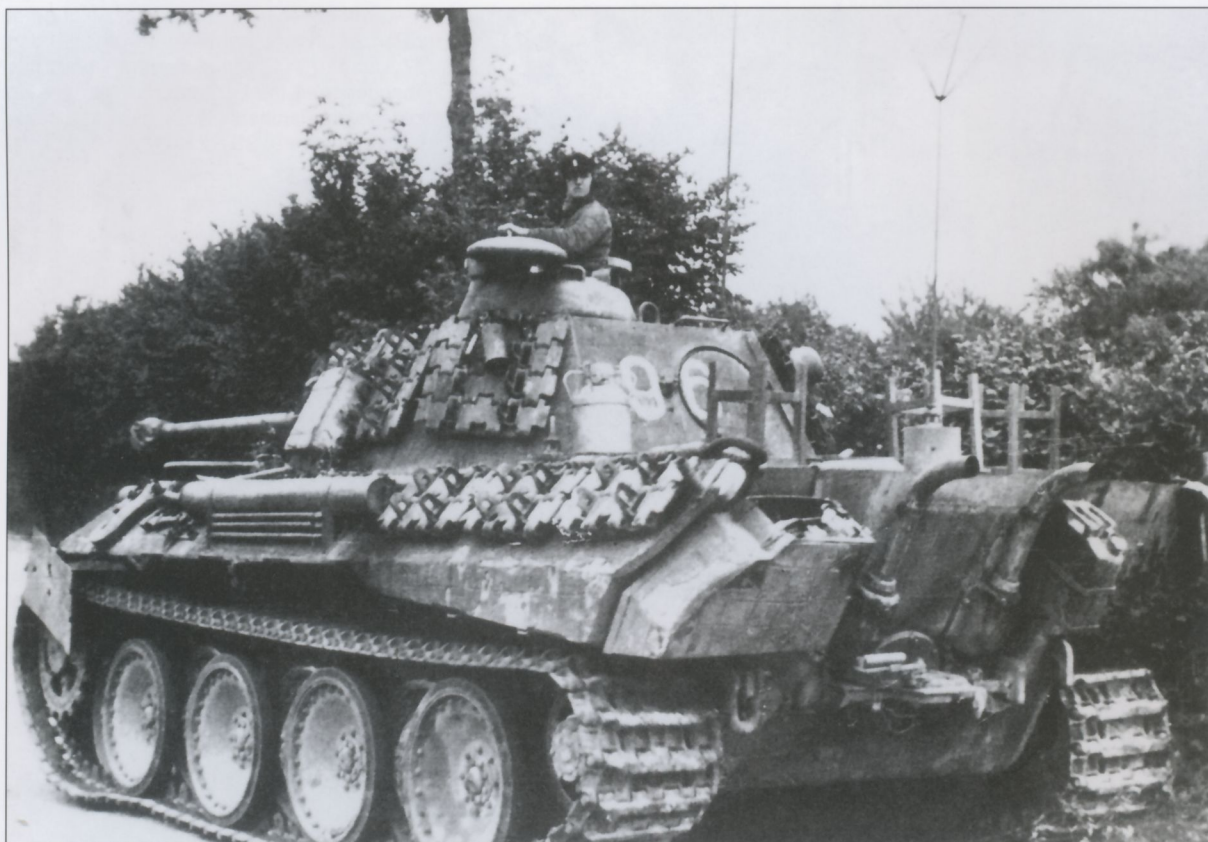
A Panzerbefehlswagen V Panther Ausf.A from II./Pz.Rgt.33 of 9.Panzer-Division in Normandy. The division suffered heavy losses on its journey to the invasion front and served for only about two weeks at the beginning of August. Judging from the battle scarred condition of this vehicle, it was involved in some intense fighting. This is an early production Ausf.A as indicated by the horizontal jack mount.

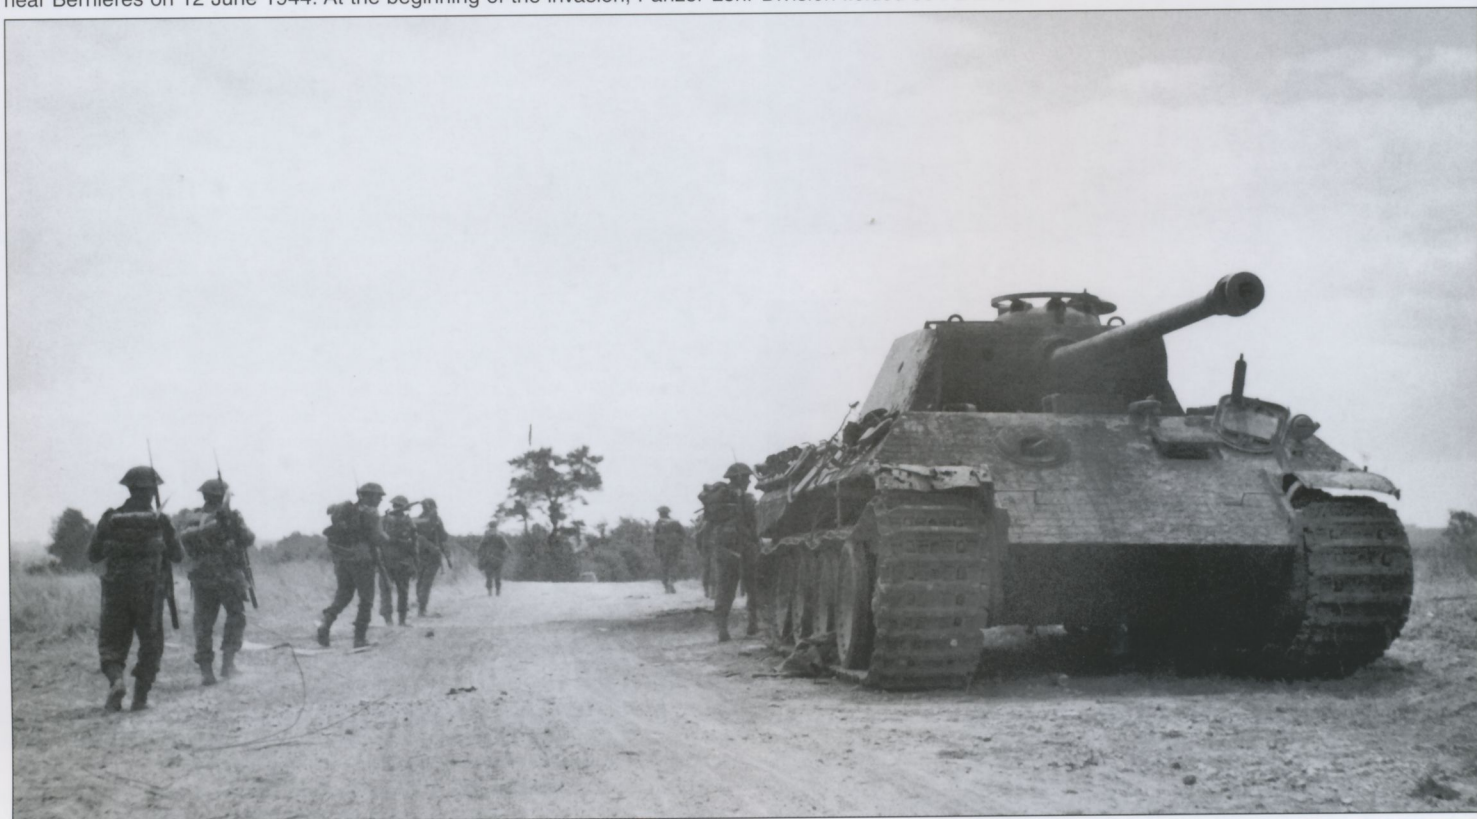
Two photos of a Panther Ausf.A from I./Pz.Rgt.6 of Panzer-Lehr-Division knocked out by the British 50th Division along the road northwest of Tilley-sur-Seulles near Bernières on 12 June 1944. At the beginning of the invasion, Panzer-Lehr-Division fielded 88 Panthers.

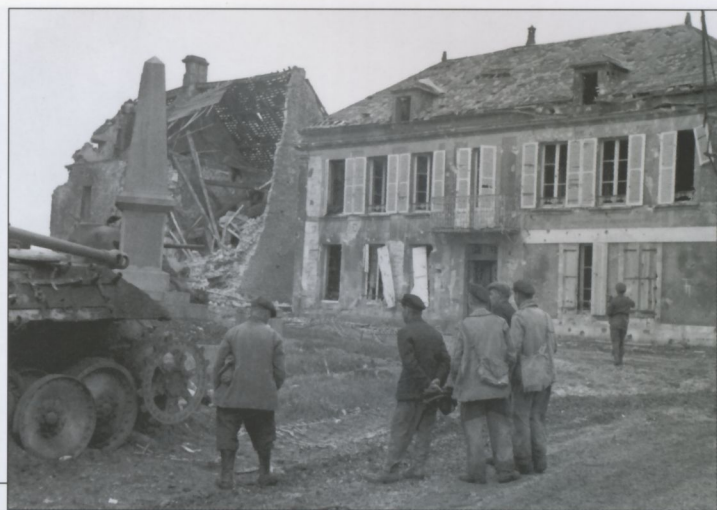
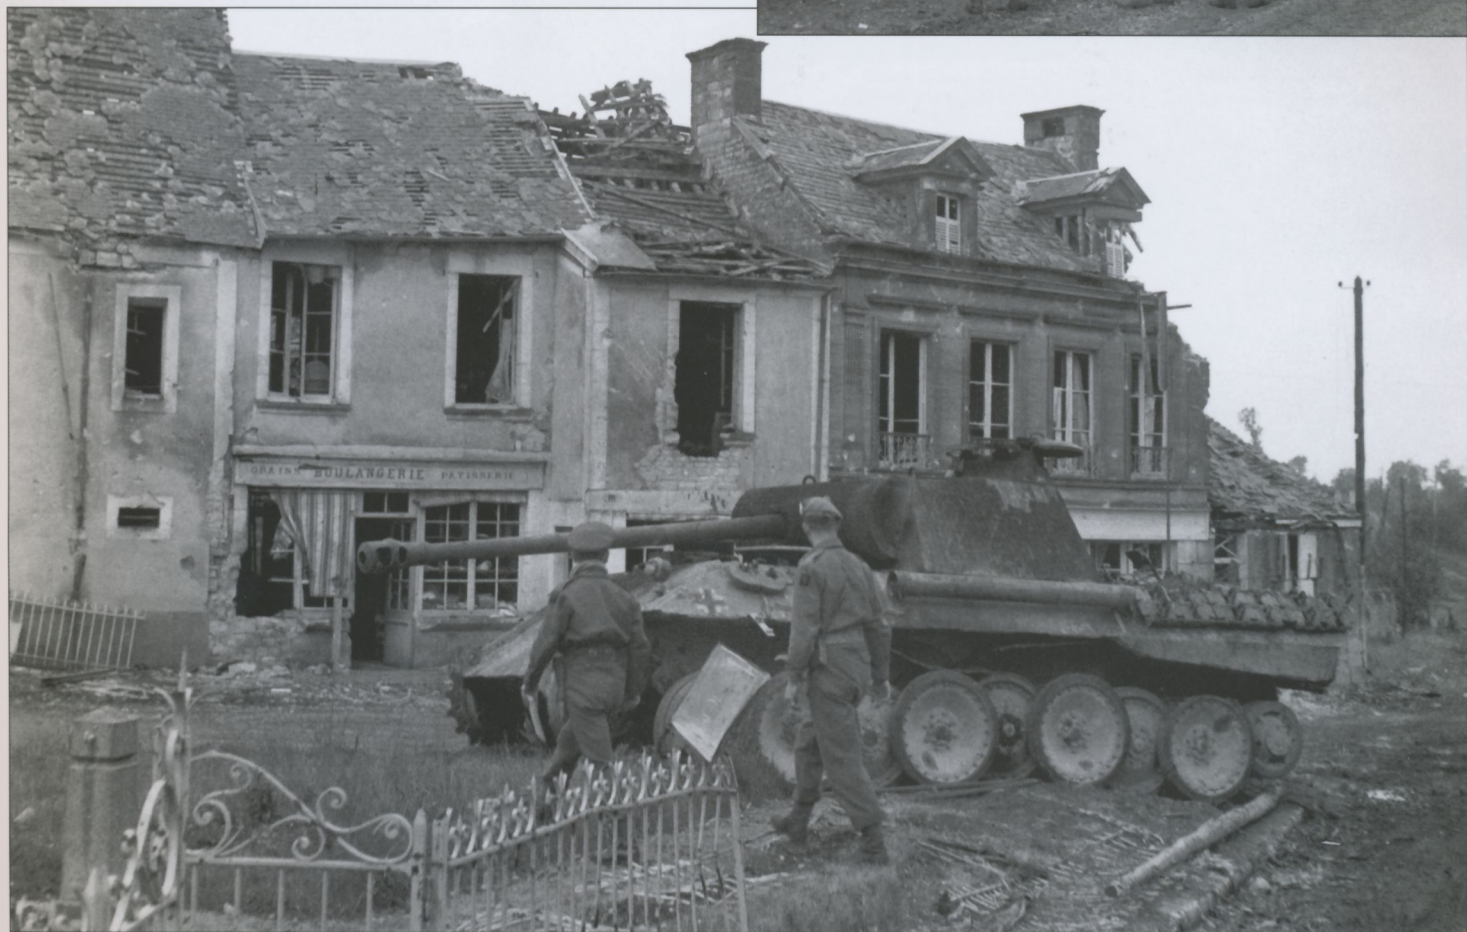
On 14 June 1944, this Panther Ausf.A was one of six Panthers lost to I./Pz.Rgt.6 of Panzer-Lehr-Division at Lingèvres, 3.5 kilometers west of Tilley-sur-Seulles. Barely recognizable under the soot blackened side of the turret is the tactical number '225', painted in red with a white outline.

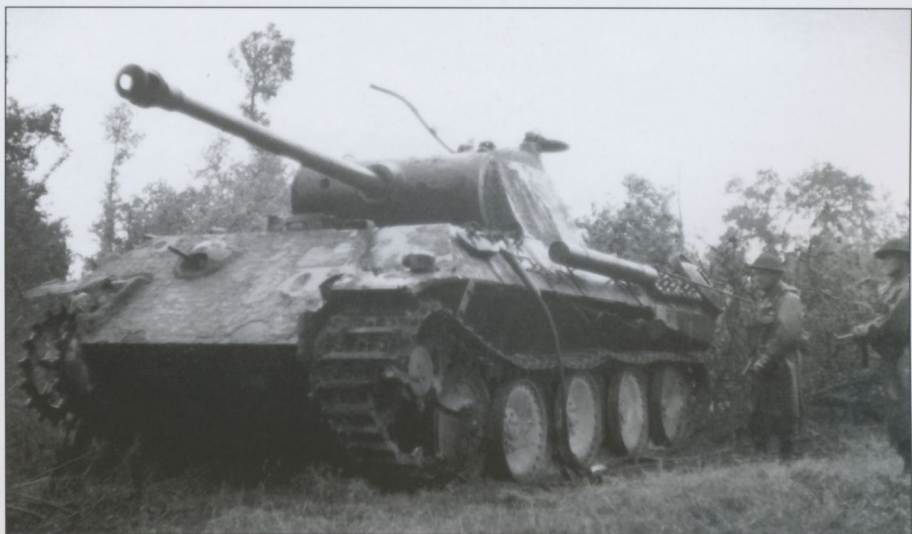
This Panther Ausf.A from I./Pz.Rgt.6 of Panzer-Lehr-Division, was knocked out near Hottot-les-Bagues, southwest of Tilley-sur-Seulles on the night of 15/16 June 1944 during an attack to retake the village. The regimental commander's Panther was also lost that night.

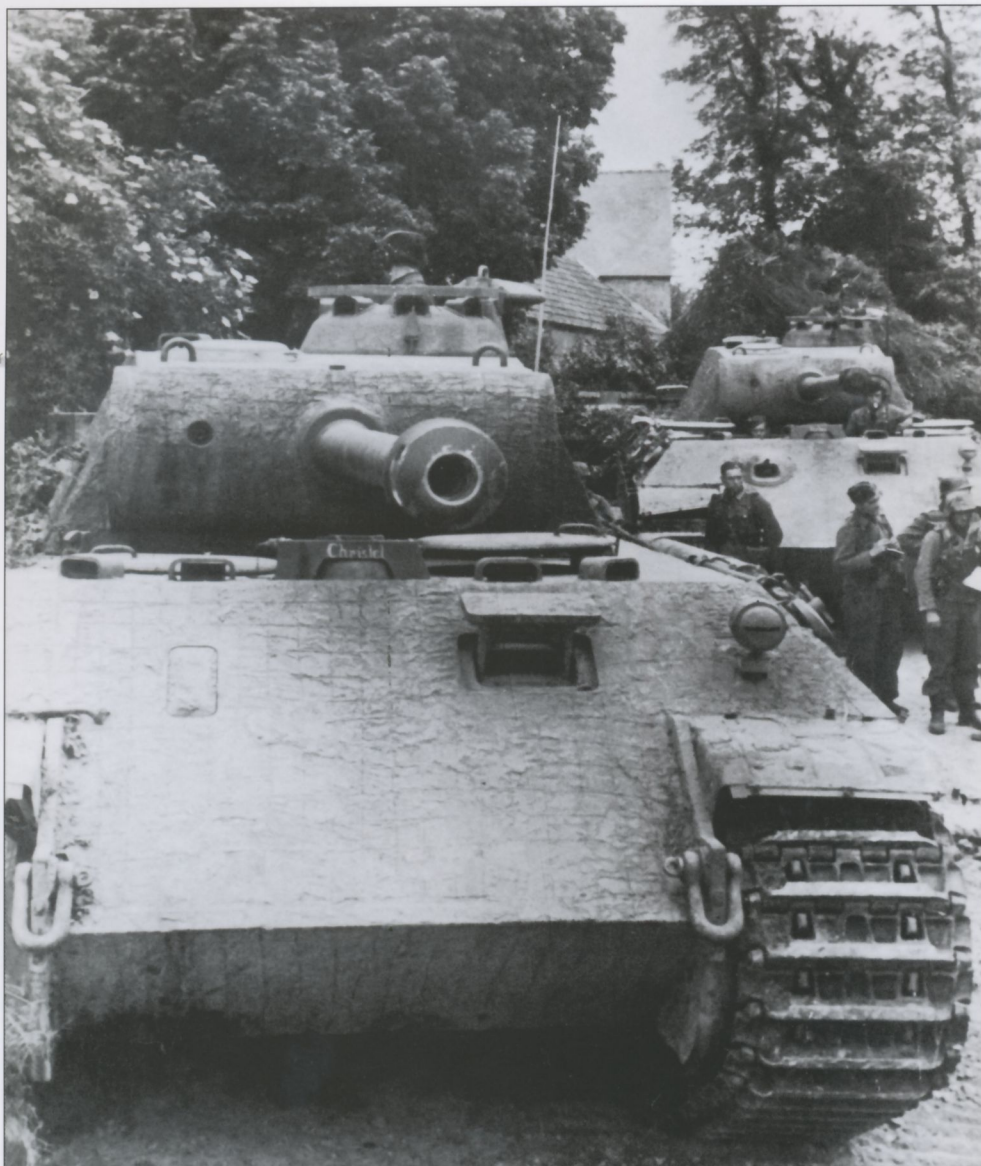
An armored column with Panthers and SPW waits along a French country lane while a commander's conference is held to plan the next attack. This is an early Panther Ausf.A with the 'letter box' machine gun port on the glacis, which was later replaced by a ball mount. It was common for the Panther crews from I./Pz.Rgt.6 of Panzer-Lehr-Division to paint the name of a girl on the bottom of the gun travel lock and here we see the name 'Christel'.

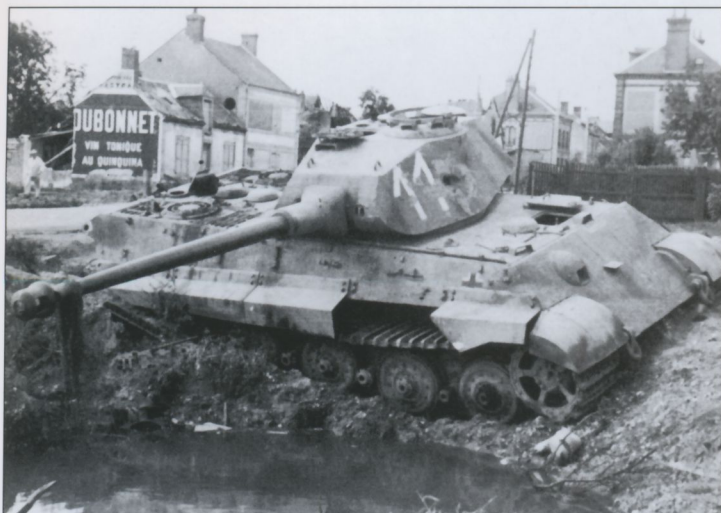
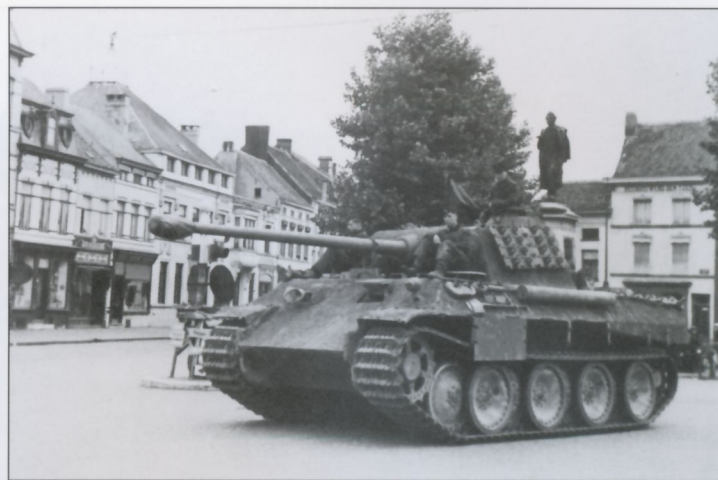
A Panther Ausf.A from I./SS-Pz.Rgt.1 from 1.SS-Panzer-Division 'LSSAH' seen in a Belgian town during the spring of 1944, where it was resting and refitting after the devastating losses on the Russian Front the year before. At this time their reported strength was 98 Pz.Kpfw.IV and 79 Panthers.

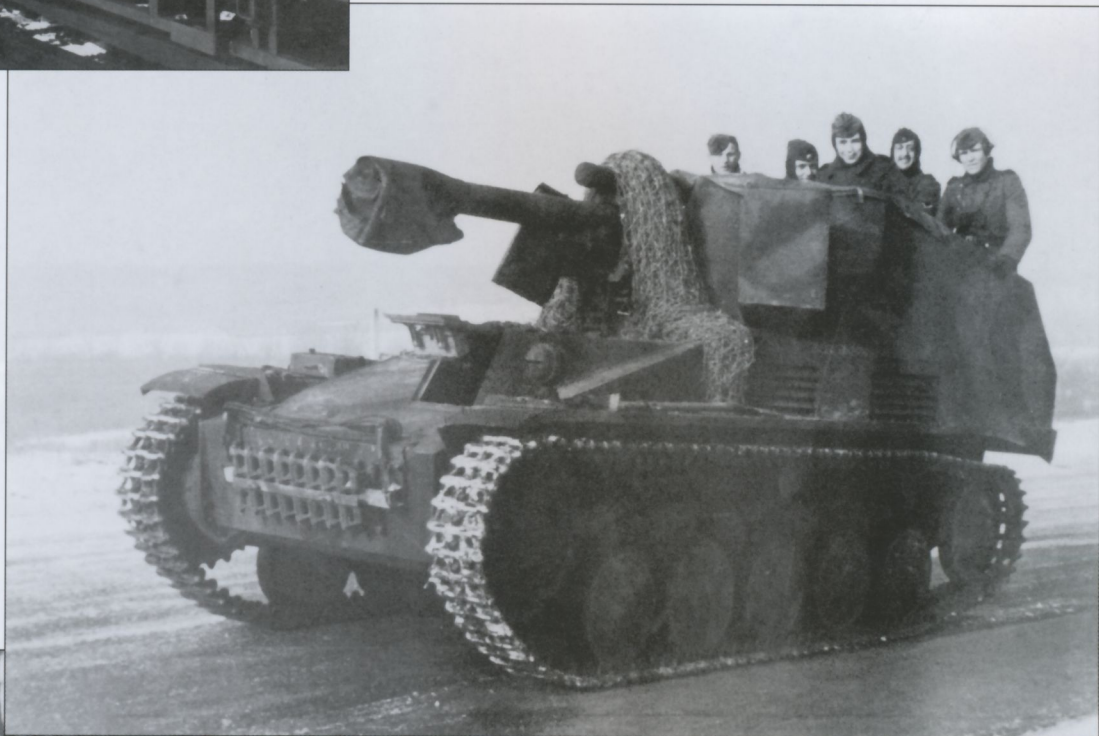
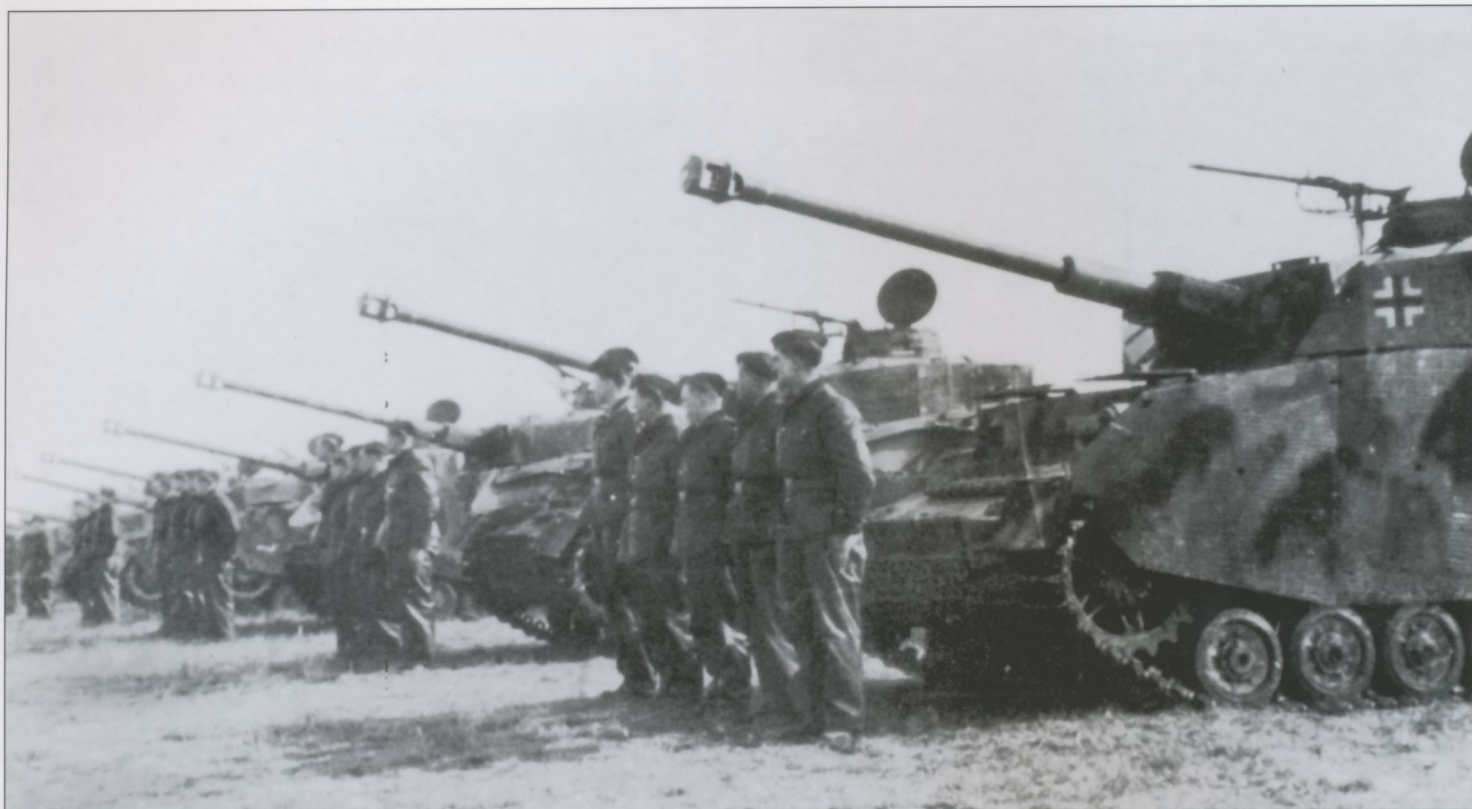
Three photos of 'Wespe' self-propelled light field howitzers of SS-Pz.Art.Rgt.10 from 10.SS-Panzer-Division 'Fruindsberg' while they were stationed in France during the winter of 1943-44. Built on the modified chassis of the Pz.Kpfw.II, the 'Wespe' mounted the 10.5cm leFH18/2 and were issued to the Panzer-Artillerie-Regiments of the Panzer and Panzer-Grenadier divisions.

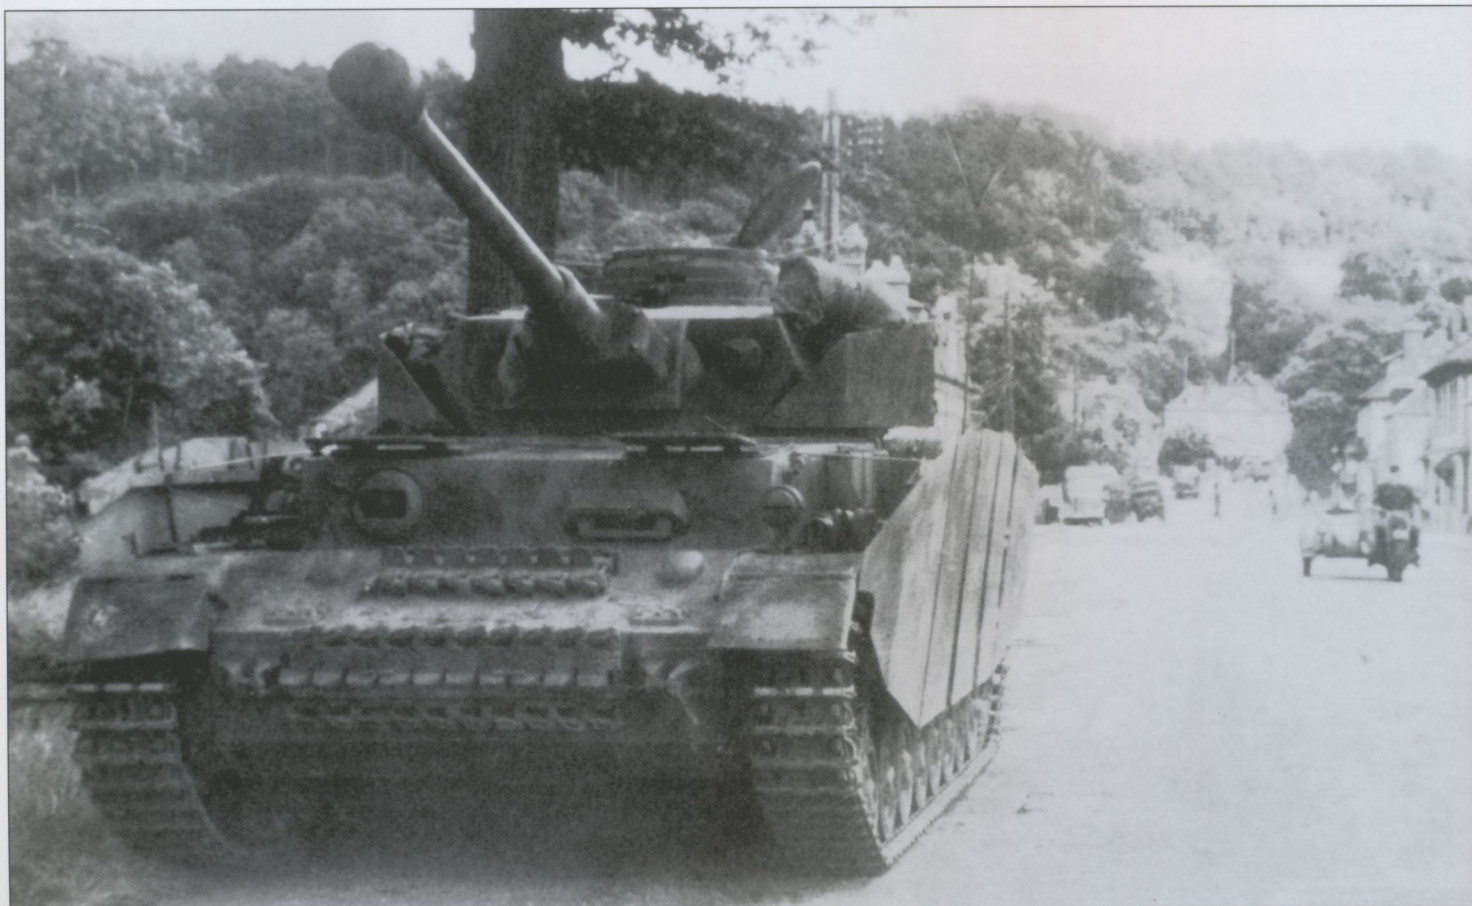
A new Pz.Bef.Wg.IV Ausf.H parked alongside a road on the way to the invasion front. A 2m 'Sternantenne D' (star antenna) for the Fu 8 radio set can be seen mounted where the normal antenna was mounted which, along with the lack of a tactical number on the turret skirt, would indicate this is probably a II.Bataillon command vehicle. Production of the Pz.Bef.Wg.IV. started in March 1944 with 88 units being converted from rebuilt Panzer IV's. Records indicate that the division was issued with 5 on 30 April 1944. The divisional emblem of the 12.SS-Panzer-Division can be seen painted in white on the right mudguard.

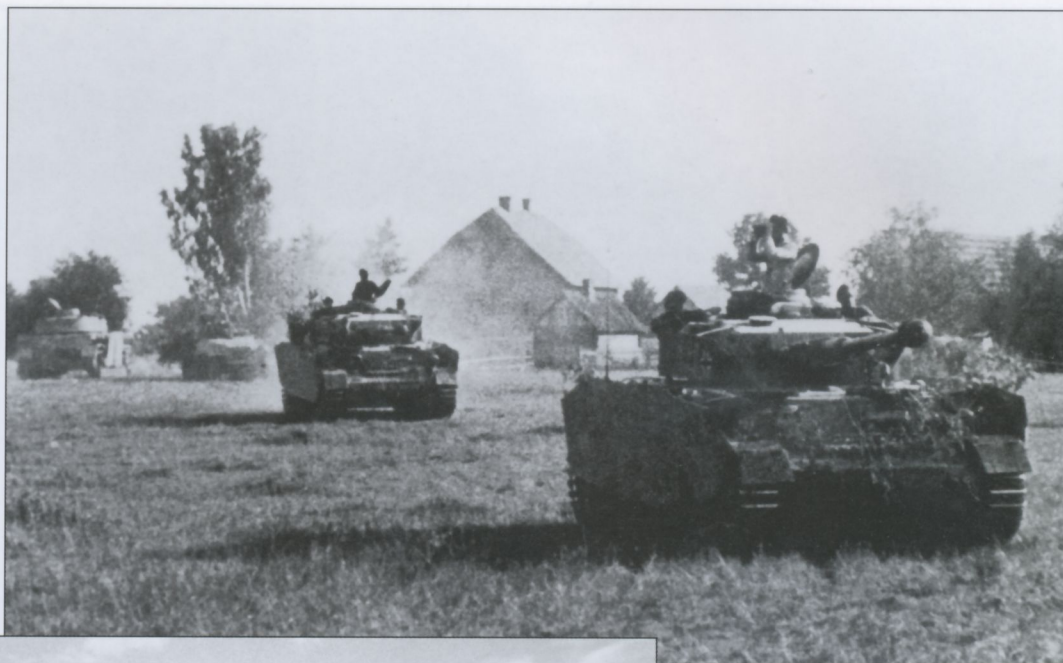
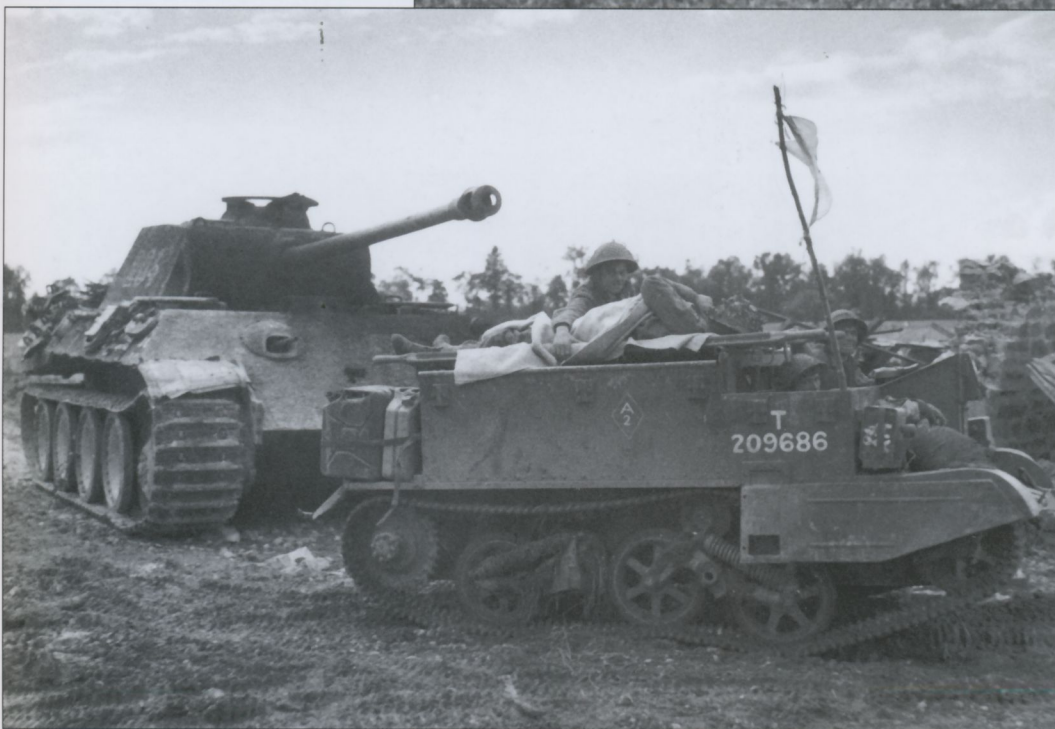
Two Pz.Kpfw.IV Ausf.H roll across an open field followed by an Sd.Kfz.251 Ausf.C. The vehicle on the right is also a Pz.Bef.Wg.IV but with the star antenna, barely visible on the original photograph, mounted to a special armored housing welded on the upper right rear of the hull. Another Pz.Kpfw.IV can be seen parked in the background.

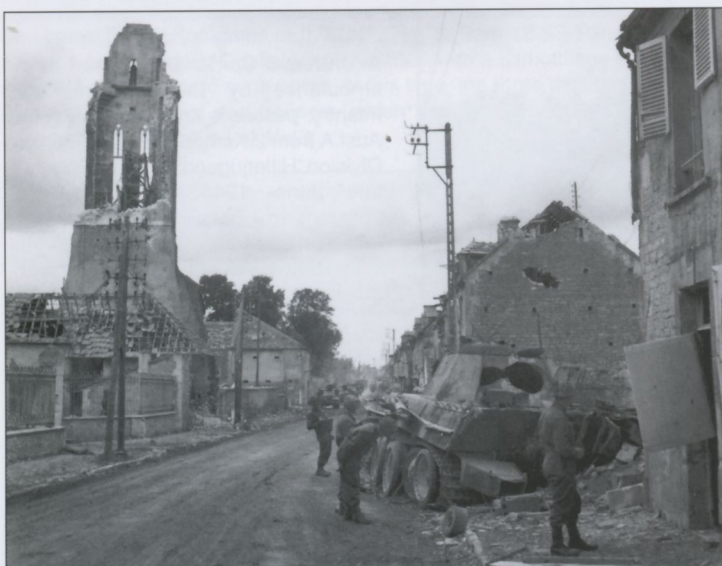
A Panther Ausf.A from 1./SS-Pz.Rgt.12 lies upside down beside the road between Norrey-en-Bessin and Bretteville-l'Orgueilleuse where it was overturned by Allied engineers to clear the road. An anti-tank gun knocked it out on 8 June 1944 but most of the damage was caused when explosive trials were conducted on the hulk at a later date.

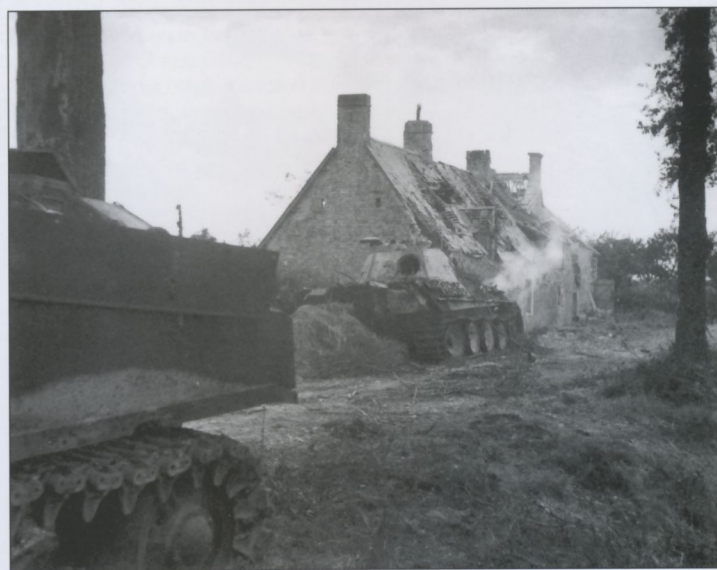
Canadian troops examine the wreckage of a Panther Ausf.G from 4./SS-Pz.Rgt.12 destroyed by a PIAT bomb in Bretteville-l'Orgueilleuse during a night attack on 8 June 1944. The damage to the rear of the turret was caused when another Panther following fired into it in the confusion of battle. This photo was taken around 20 June 1944.

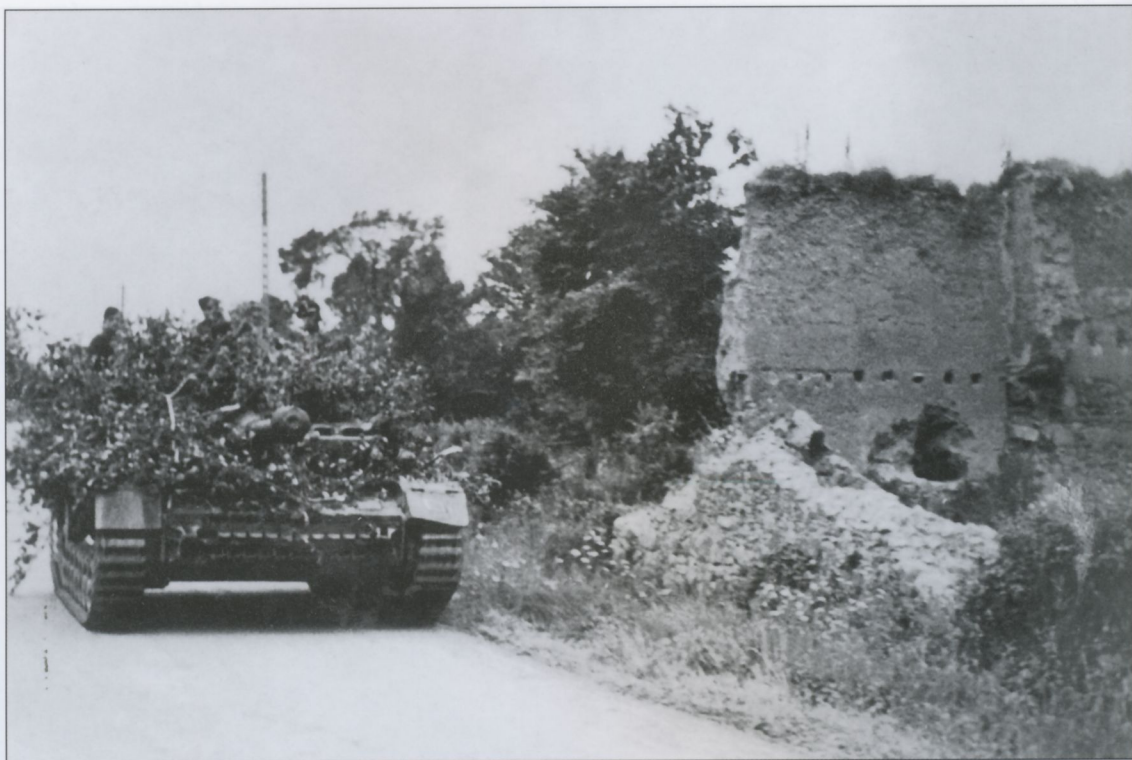
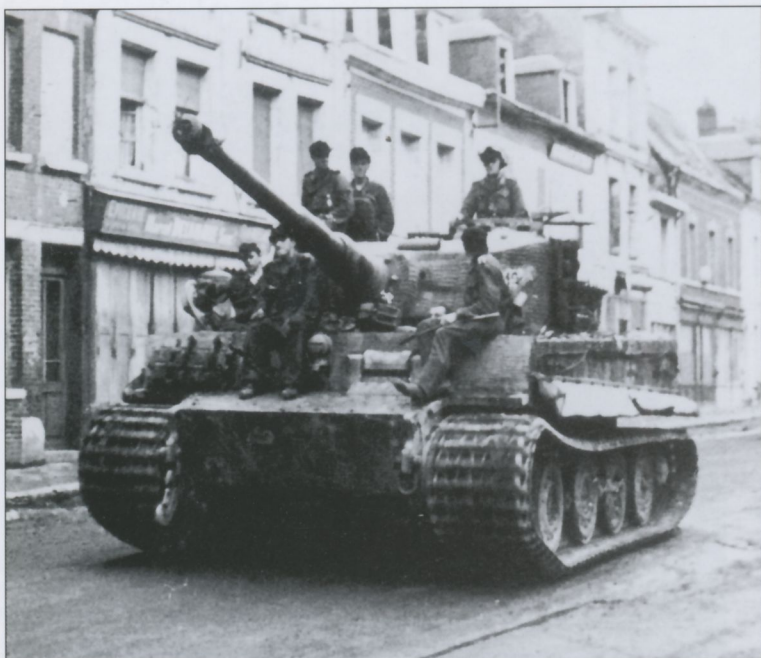
Two photos of Tiger '213' from 2./s.Pz.Abt.503 as it rolls through Bourghéroulde towards the Seine River after escaping destruction in the Falaise Pocket, 12 August 1944. The battalion was in training at Ohrdruf when it was ordered to Normandy, arriving east of Caen on 6 July 1944 with two companies equipped with Tiger Is and one company of the new Tiger II. Most of the vehicles that made it to Rouen during the retreat would be unable to cross the river and were abandoned.

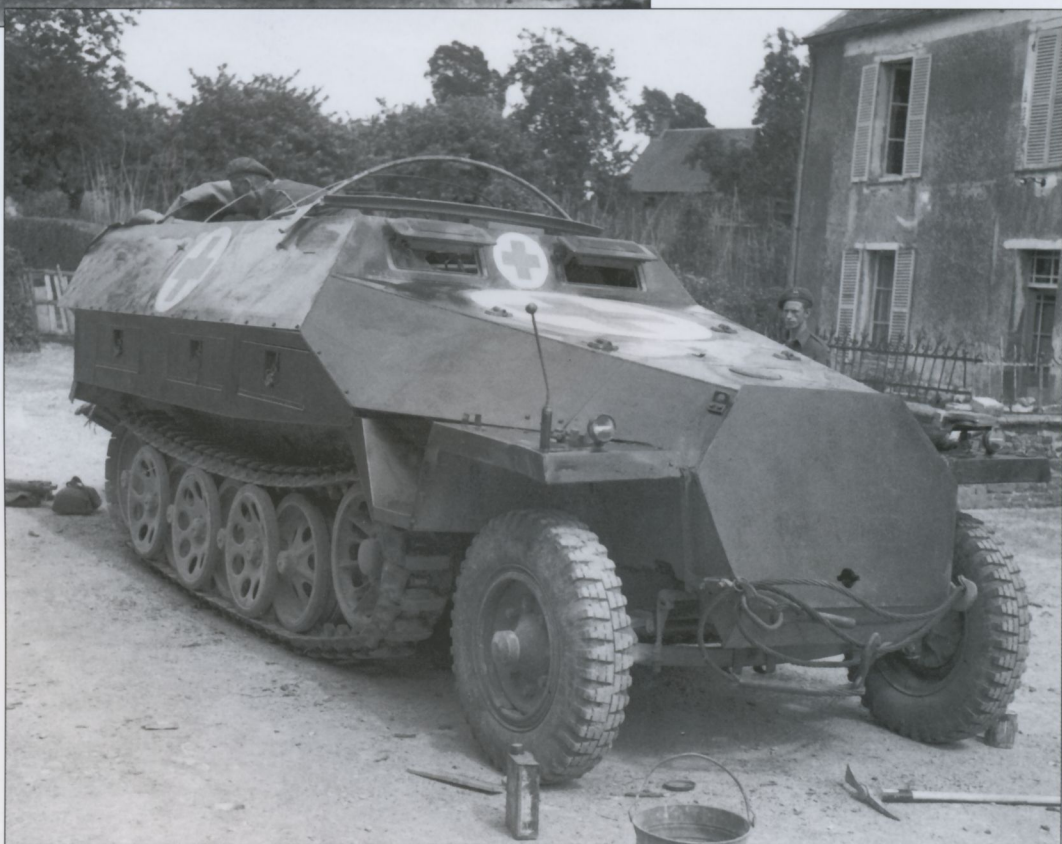
Another Sd.Kfz.251/8 Ausf.D, captured intact by British forces is cleaned up and has received a fresh coat of olive drab paint, leaving the Red Cross markings intact. It was a common practice for both sides to impress captured vehicles in good working order into service.

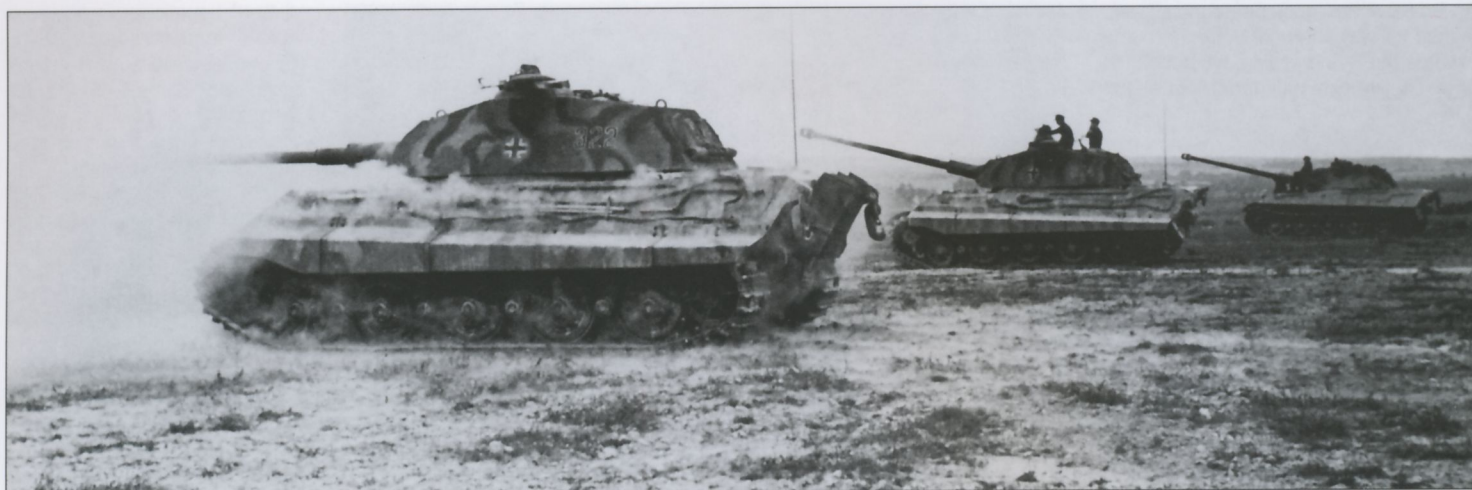
Two photos of new Tiger IIs from 3./s.Pz.Abt.503 conducting firing trials at Mailley-le-Camp, east of Paris. The company had been withdrawn in late July and sent there to be re-equipped. On 11 August 1944, the company was entrained for the journey back to Normandy, however, their train was attacked by Allied fighter-bombers with the loss of several men and one Tiger. By this time the German Army was in full retreat and the unit never made it back to Normandy.

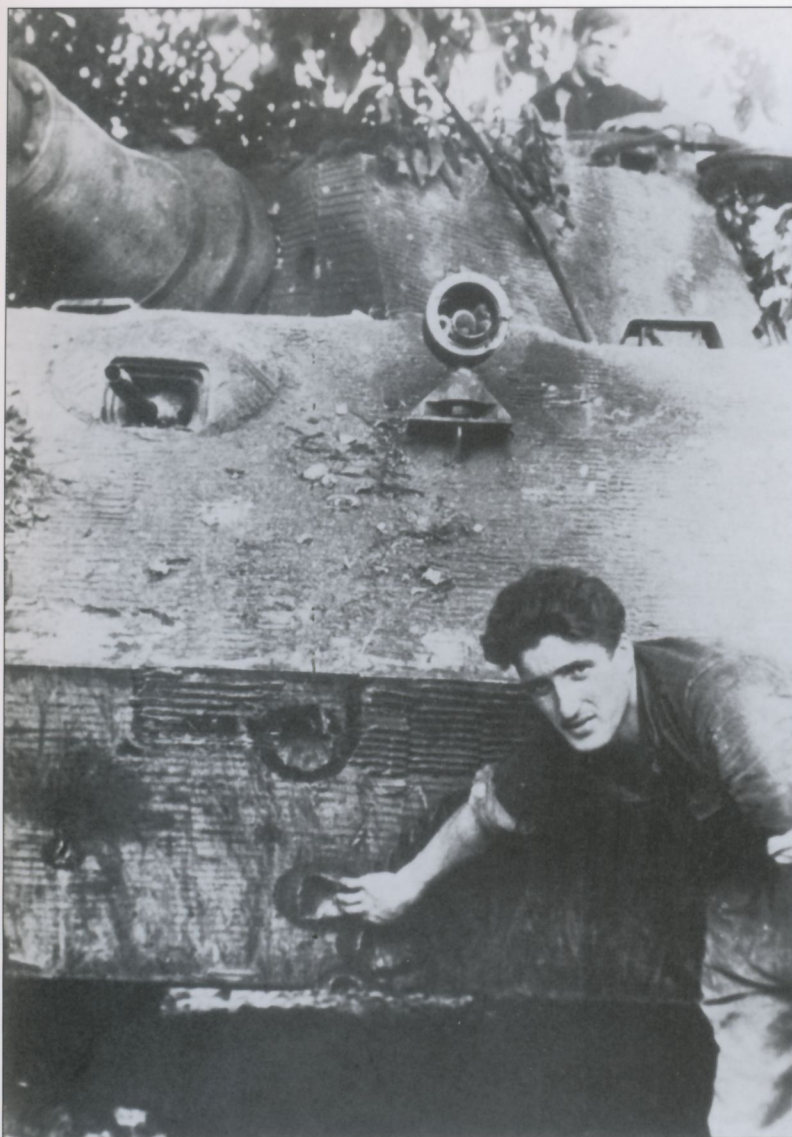
A crewman from s.Pz.Abt.503 points out the punishment absorbed by the 100mm thick, sloped armor plates of the Tiger II that resulted only in deep gouges and chipped Zimmerit coating, but did not otherwise cause any damage.

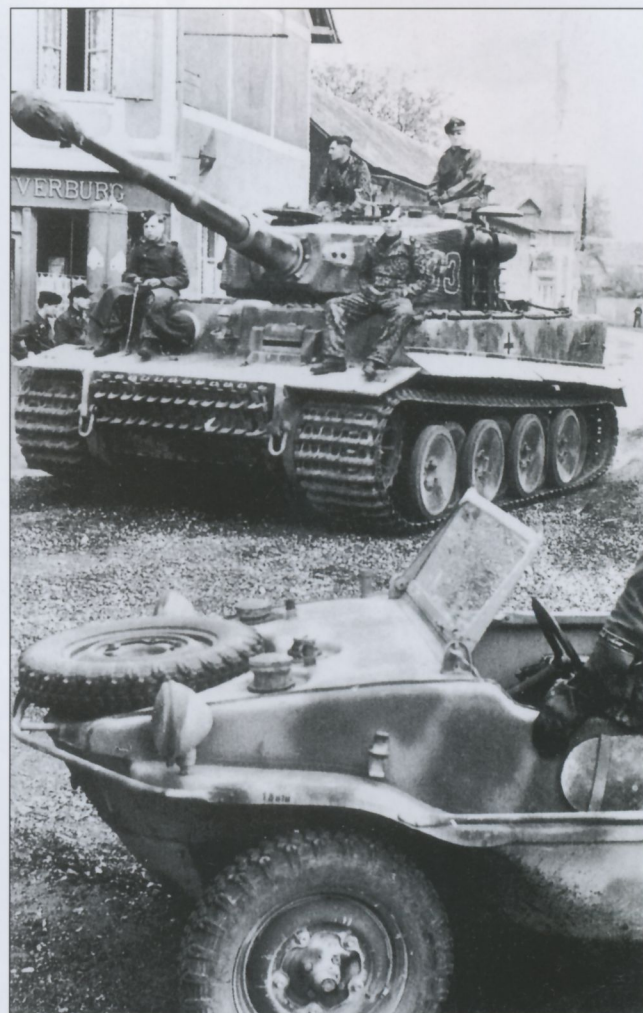
Tiger '133' from 1./s.SS-Pz.Abt.101, rolls through Morgny on the morning of 7 June 1944. The Tigers from this unit all displayed carefully applied, textbook camouflage paint schemes of Rotbraun RAL 8017 and Olivgrün RAL 6003 patches over the Dunkelgelb RAL 7028 base and neatly applied three digit tactical numbers.
