# Battle on Two Fronts

## 1944-45

Tom Cockle

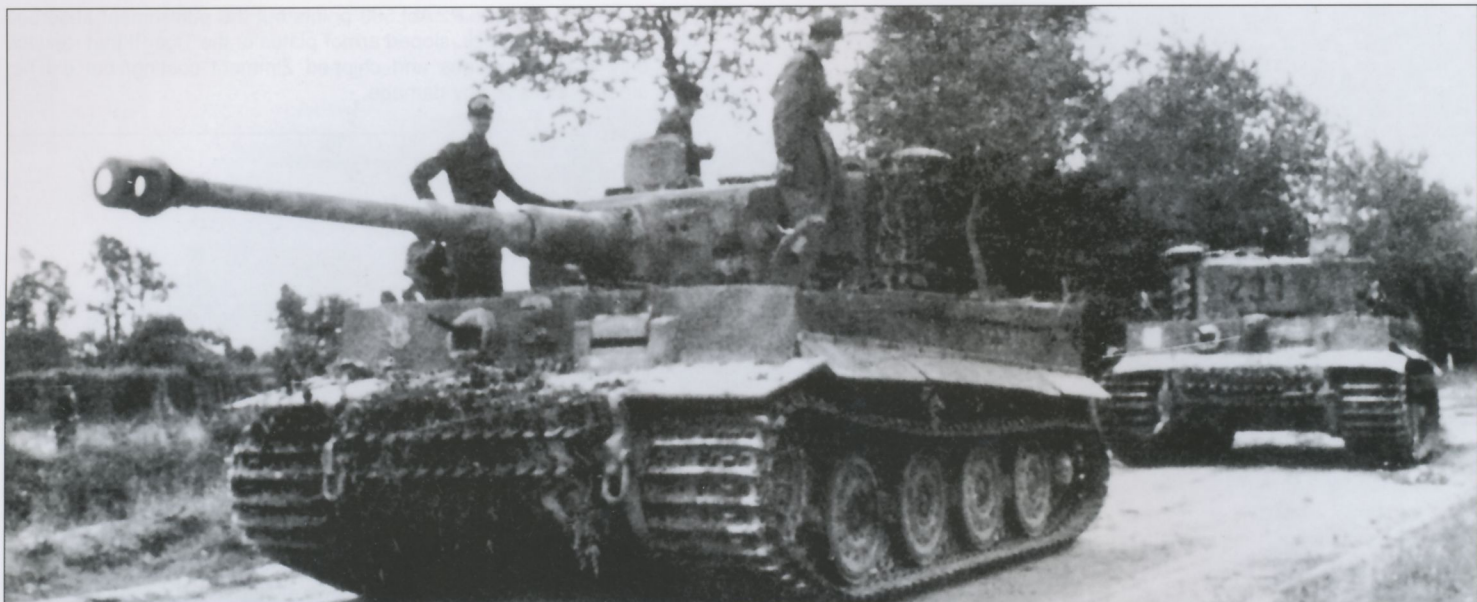
Tiger '222' is seen here towing disabled Tiger '231' away from Villers-Bocage on 14 June 1944, the day after SS-Obersturmführer Michael Wittmann's spectacular victory against a tank battalion from the 4th County of London Yeomanry. The towing Tiger has often been misidentified as '211' or '232' but in the original photo, the last digit can be seen to be a '2', thereby eliminating the possibility of it being '211' and in another photo of '232', the unit insignia can be clearly seen to be painted on a patch of the bare hull from which the Zimmerit has been removed and this Tiger has it painted onto the Zimmerit.

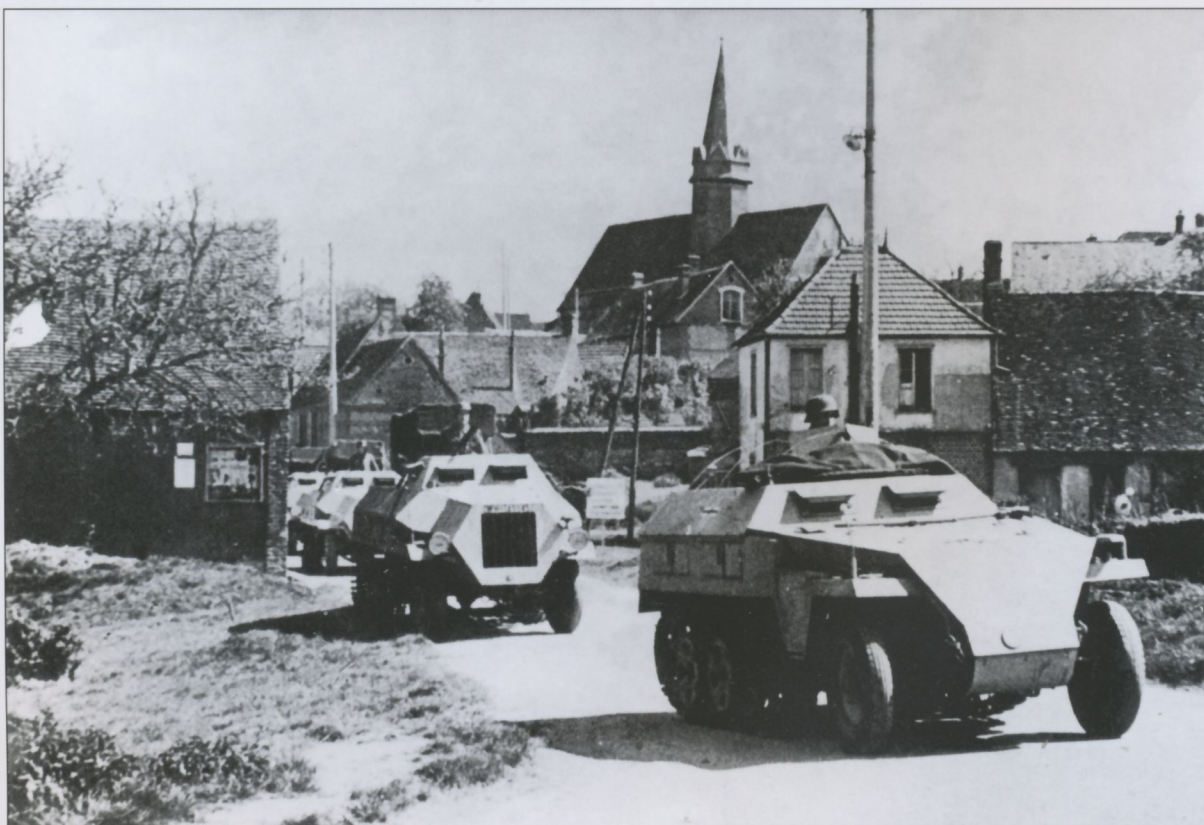
A battery of 15cm Panzerwerfer 42 auf Sfl (Sd.Kfz.4/1) led by an Sd.Kfz.250/3 (Neu) passes through a French village on its way to the front in July 1944. The Panzerwerfer 42 was fitted with a ten-barrel rocket launcher, the 15cm Nebelwerfer 42. Due to the conspicuous smoke trails left by the projectiles it was necessary to move the weapon immediately after firing to avoid enemy counter fire.

The 15cm Nebelwerfer 42 projectiles weighed 34 kilograms and had a range of 6,900 meters. The rockets were not very accurate and the Germans relied on blanketing the area with a heavy concentration of fire. Armored vehicles were practically immune to all but a direct hit but unprotected infantry were more susceptible to the explosive force of the blast, the thin casings providing little in the way of fragmentation.

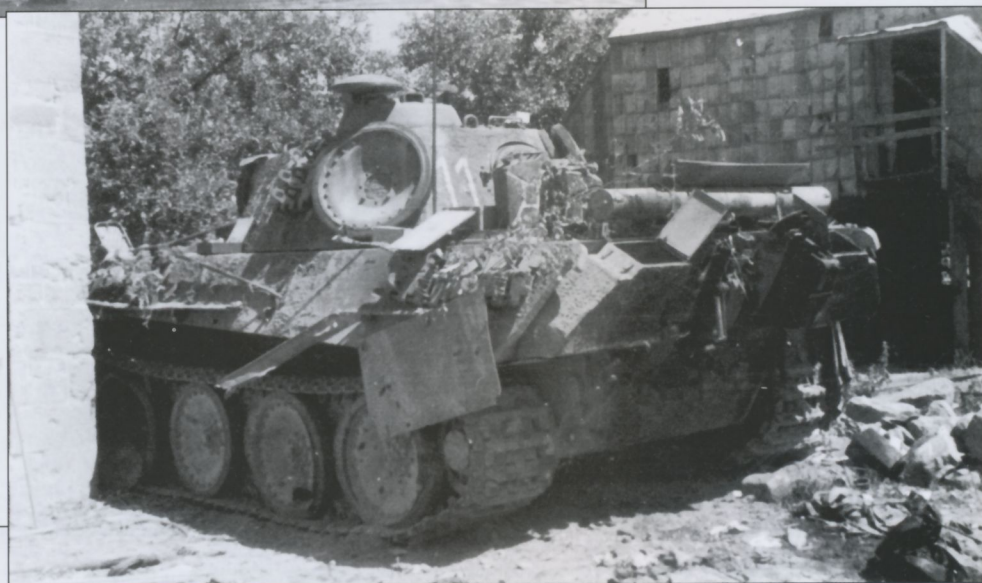
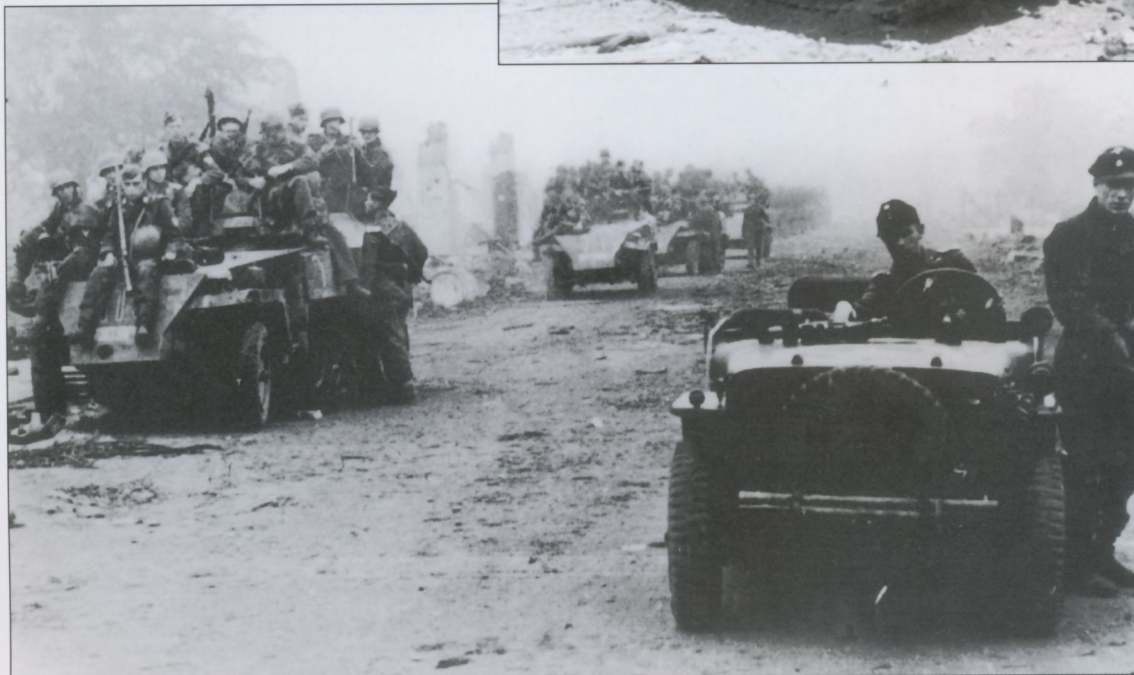
A battle scarred Panther Ausf.G from I./Pz.Rgt.24 of 116.Panzer-Division sits abandoned beside a French café during the late summer of 1944. The Panthers from this unit are noted for carrying spare road wheels bolted to the back of the turret and relocating the gun cleaning rod tube onto the back of the engine deck. Another unique trait is the Jerrycan racks attached to the rear of the hull inside of the rear stowage bins.

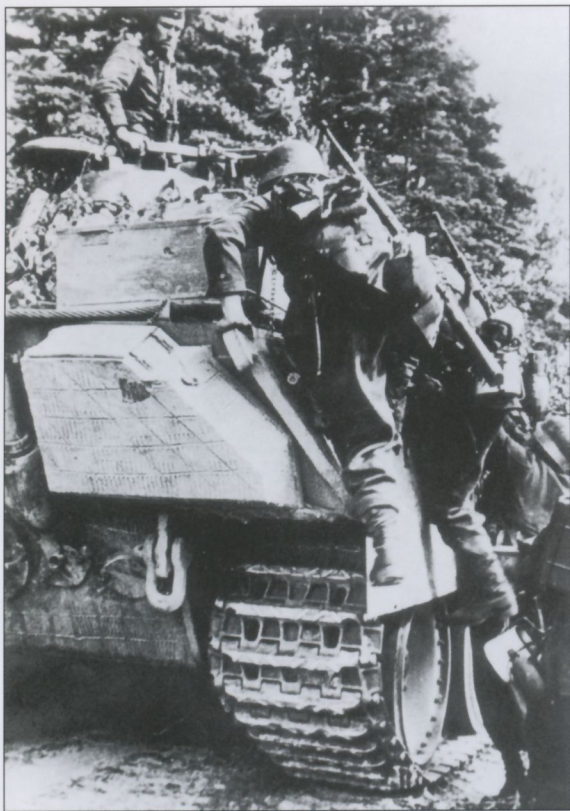
Grenadiers climb aboard a Panther Ausf. G from I./Pz.Rgt. 24 of Panzer-Brigade 111. The device being held by one of them is a mine detector and the operator with the battery pack on his back can be seen climbing up on the right. At the end of the battle, Panzer-Brigade 111 was left with seven tanks and 80 men out of 90 tanks and 2,500 men that they started with.

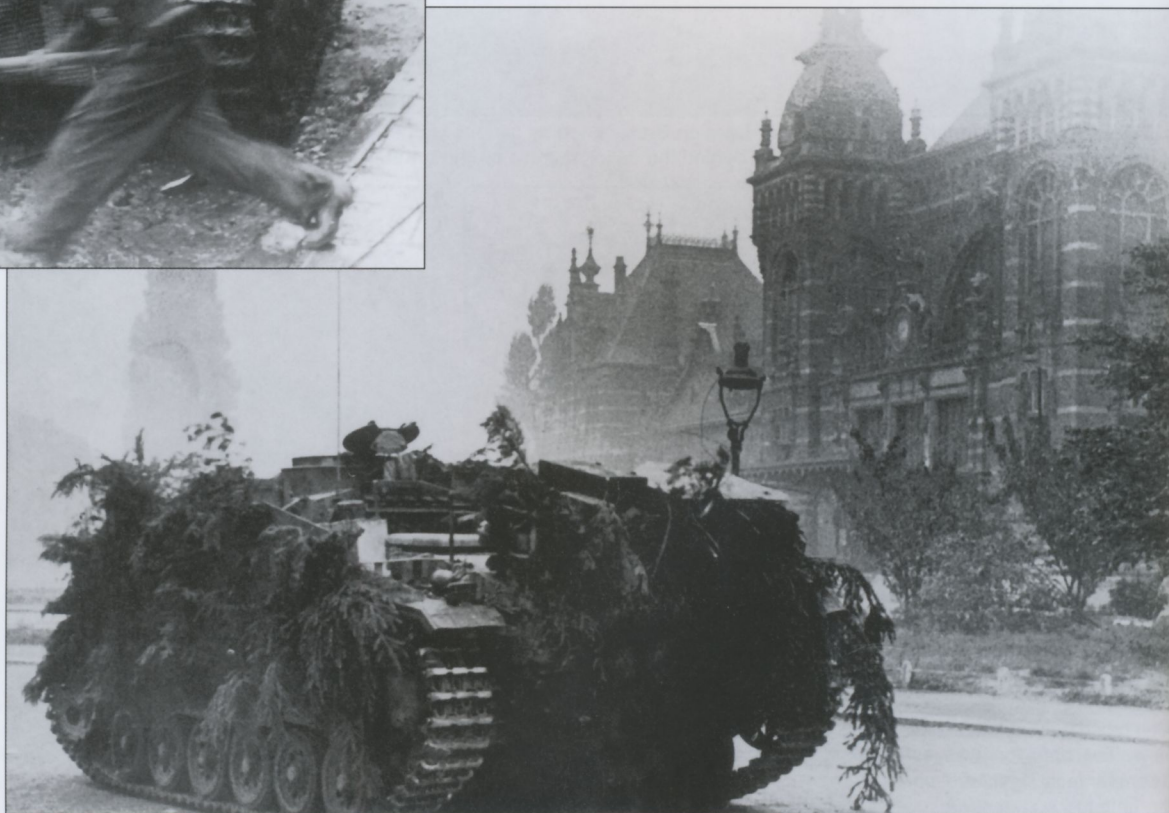
**Flakpanzer 38(t) Ausf.L, SS-Flak-Abteilung 12, 12.SS-Panzer-Division 'Hitlerjugend', Normandy, June 1944**

In February 1944, twelve Flakpanzer 38(t) were issued to this unit and were still painted in their factory coat of Dunkelgelb RAL 7028. The only visible markings were the standard Balkenkreuz painted on the sides of the superstructure.

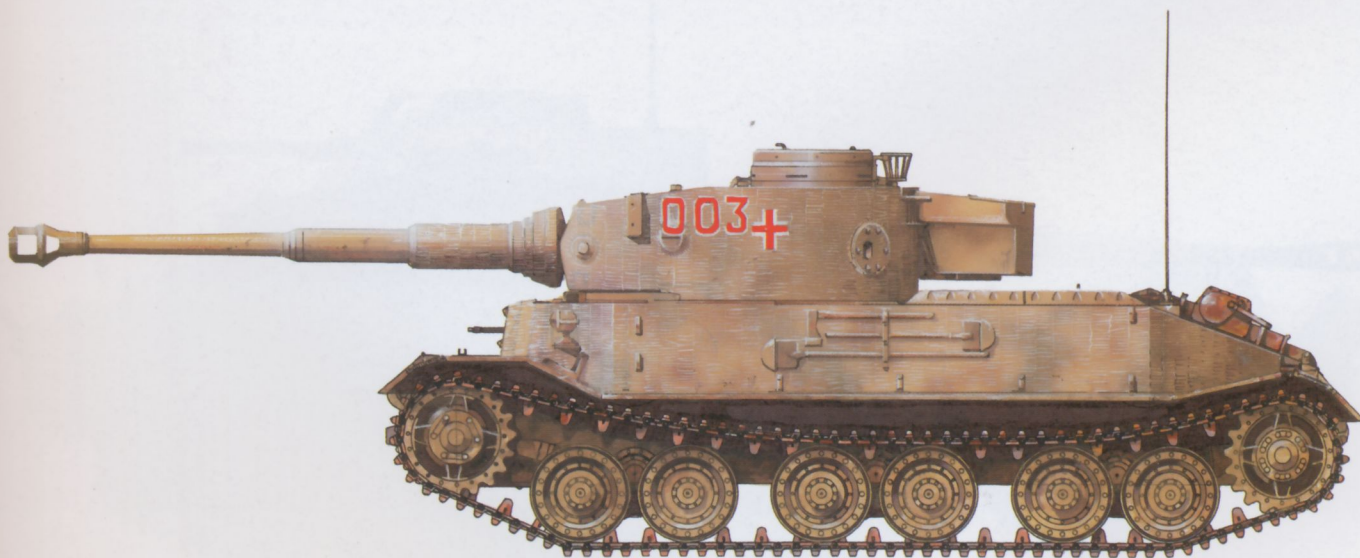
**VK 45.01 (P), Stabs-Kompanie, s.H.Pz.Jg.Abt.653, Galicia, July 1944**

This is the only Panzerkampfwagen VI P to be used in combat. It is painted in Dunkelgelb RAL 7028 with a camouflage scheme of Rotbraun RAL 8017 and Olivgrün RAL 6003 patches. The three digit tactical number is painted in red with a white outline on the sides of the turret and also appeared on the top right of the rear plate. The unit insignia was also painted on the front and rear hull plate.

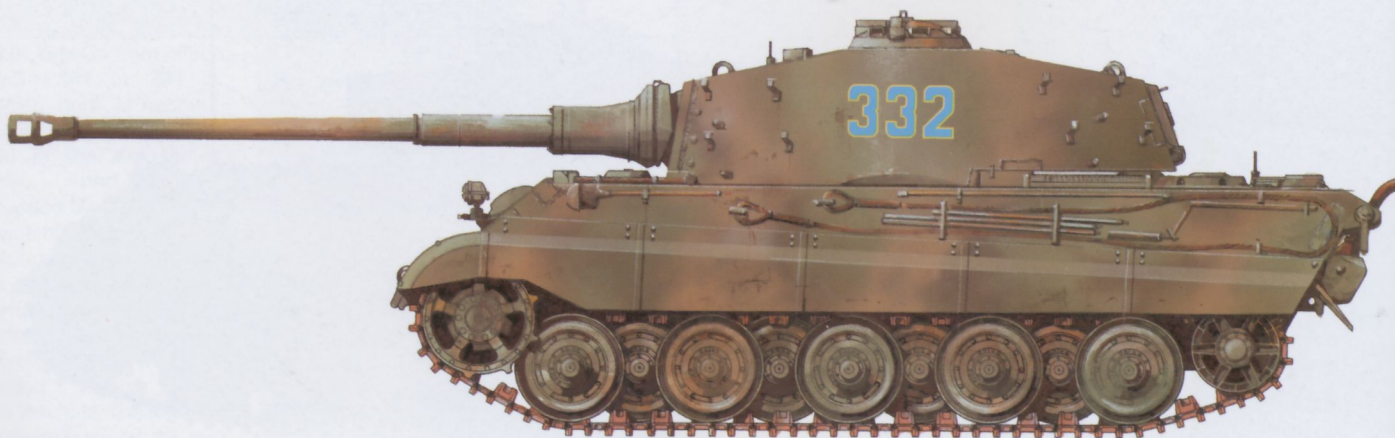
#### **Tiger II, 3./s.SS.Pz.Abt.501, Ardennes, December 1944**

This Tiger II was painted in Dunkelgelb RAL 7028 with a camouflage scheme of Rotbraun RAL 8017 and Olivgrün RAL 6003 patches. The large three-digit tactical numbers for 3.Kompanie were light blue with a yellow outline.

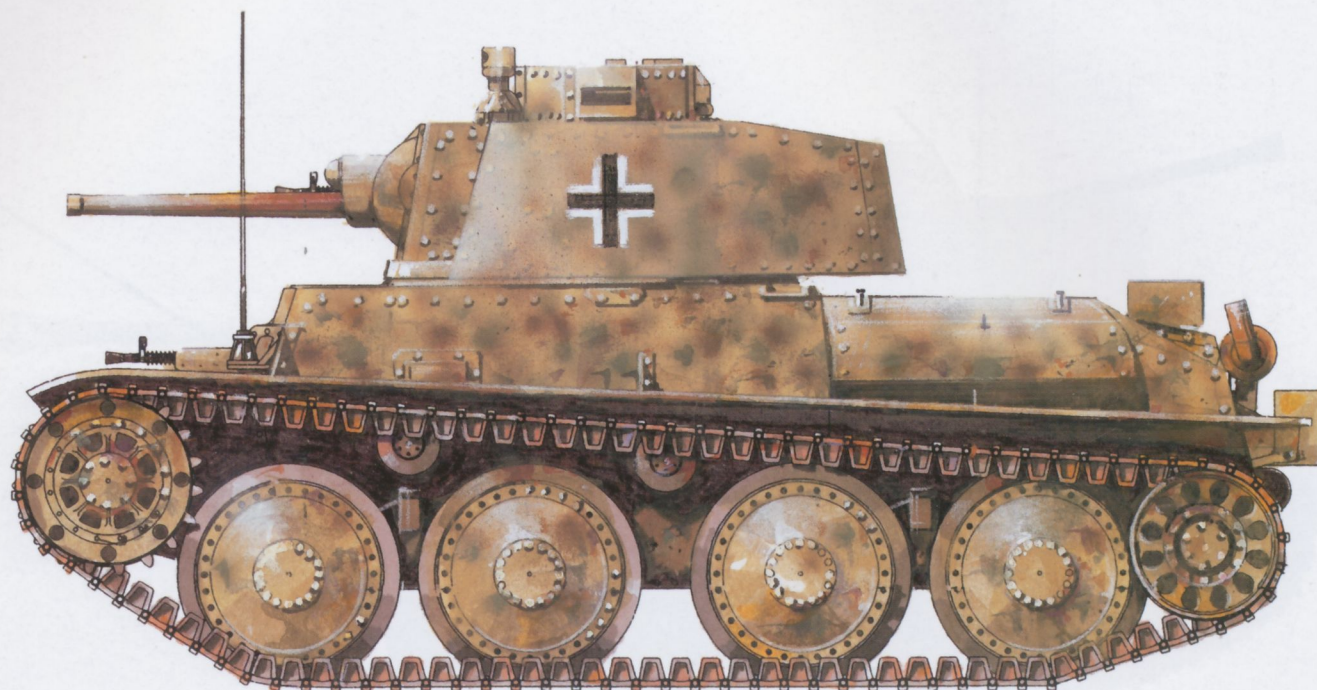
**Pz.Kpfw.38(t), unknown unit, Poliāka, Bohemia, May 1945**

It was very unusual to see an early vehicle of this type in use by the end of the war. This one is painted Dunkelgelb RAL 7028 with a camouflage scheme of Rotbraun RAL 8017 and Olivgrün RAL 6003 spots. The only visible markings are a standard Balkenkreuz painted on the side of the turret.

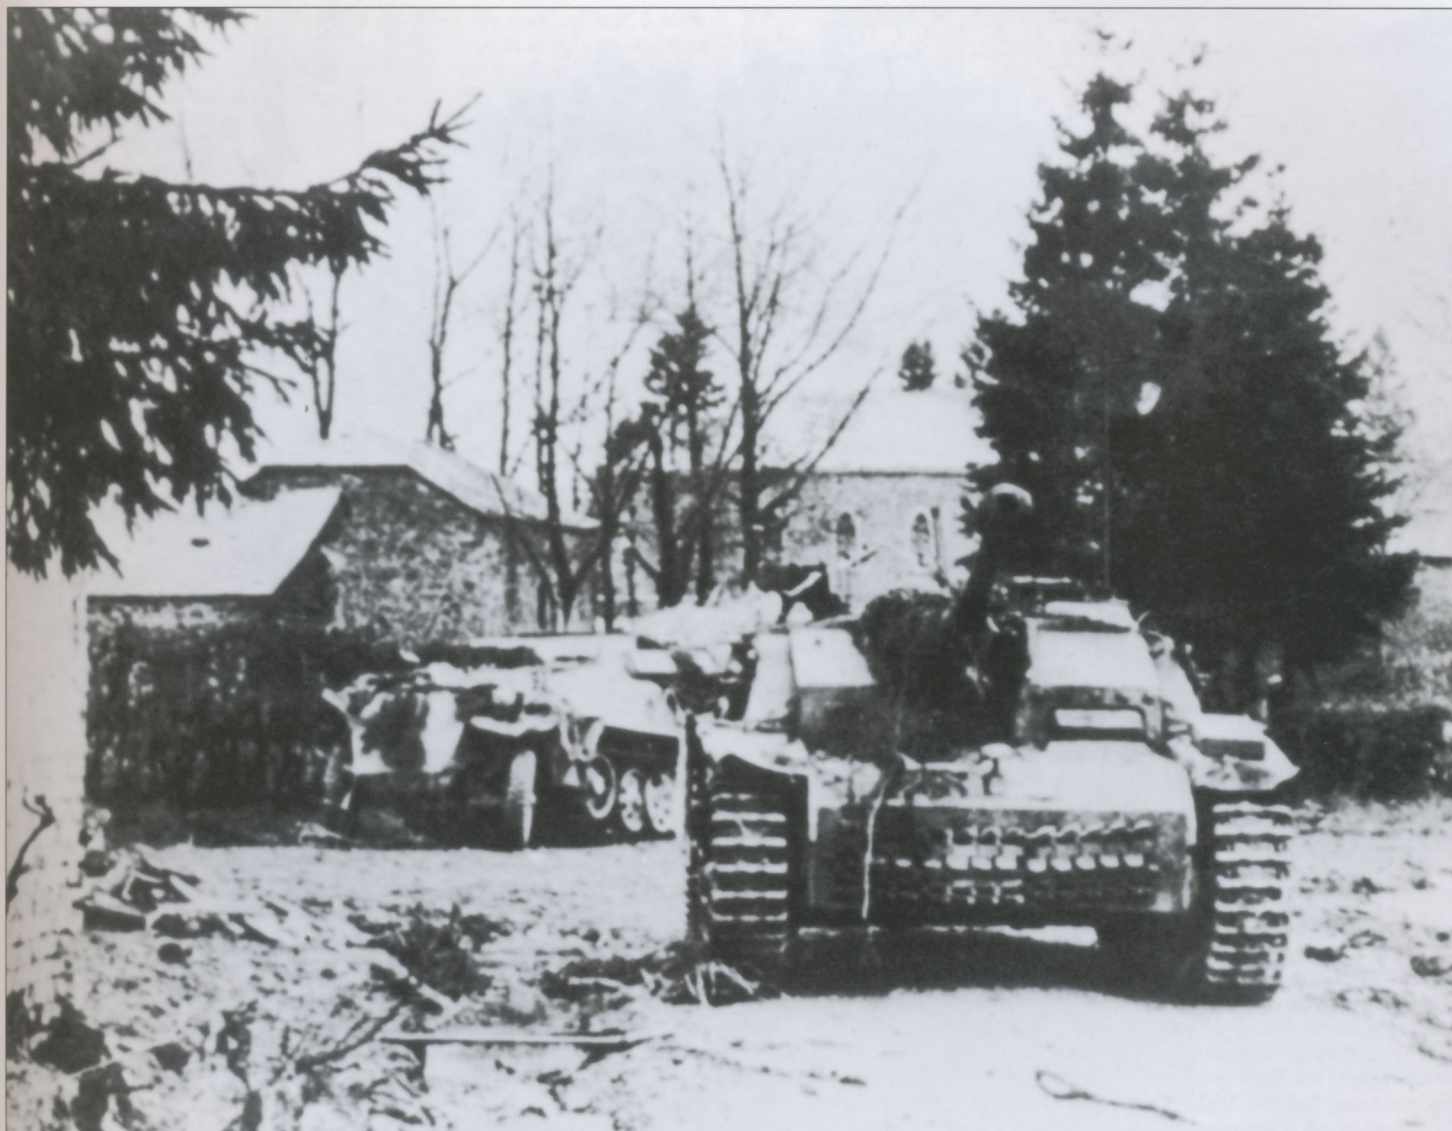
A StuG.III Ausf.G and an Sd.Kfz.251/1 Ausf.D sit abandoned near Manhay, Belgium in late December 1944. This is a late production StuG.III without Zimmerit and equipped with the remote control machine gun mount on the fighting compartment roof, 80mm front plate on the right side of the superstructure, barrel travel support and deflector in front of the commander's cupola.

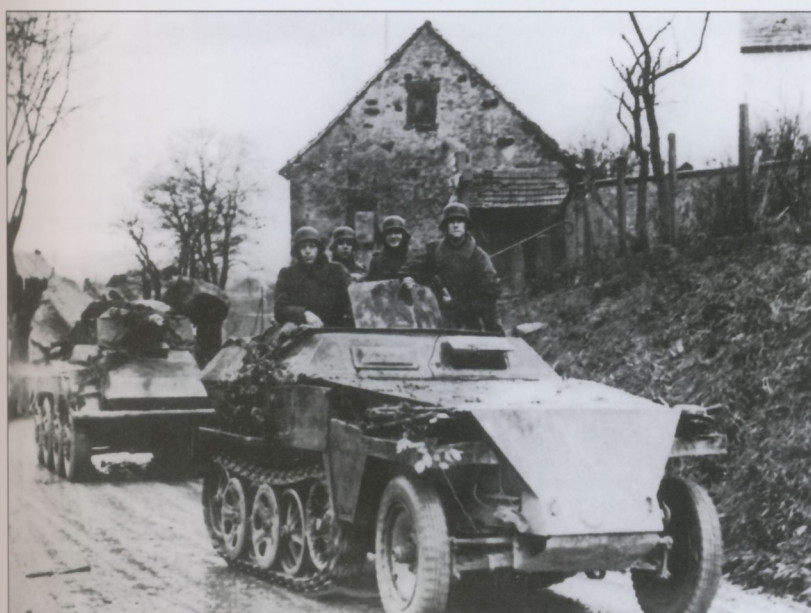
An Sd.Kfz.250/1 (Neu) followed by an Sd.Kfz.234/3 from 116.Panzer-Division pass through a German village near Aachen in the fall of 1944. The Sd.Kfz.234/3 mounted the 7.5cm KwK51 L/24 and were issued to the reconnaissance companies of the Panzer divisions to provide anti-tank support. A total of 88 were produced from June to December 1944.

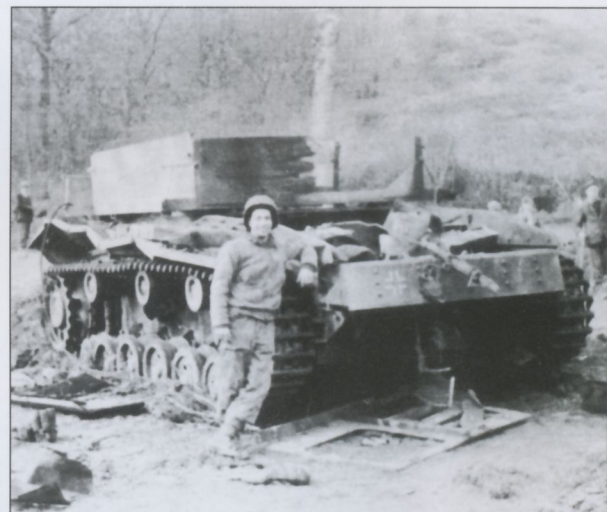
A U.S. soldier poses for a picture with a Bergepanzer III knocked out in Belgium in the fall of 1944. In January 1944, all Panzer III returned for overhaul, were ordered converted to Bergepanzer and a total of 150 were completed from March to December 1944. Although this one has been converted from an Panzer III Ausf.J, it is fitted with the early style eight-hole drive sprocket with the spacer ring to accommodate the 40cm tracks.

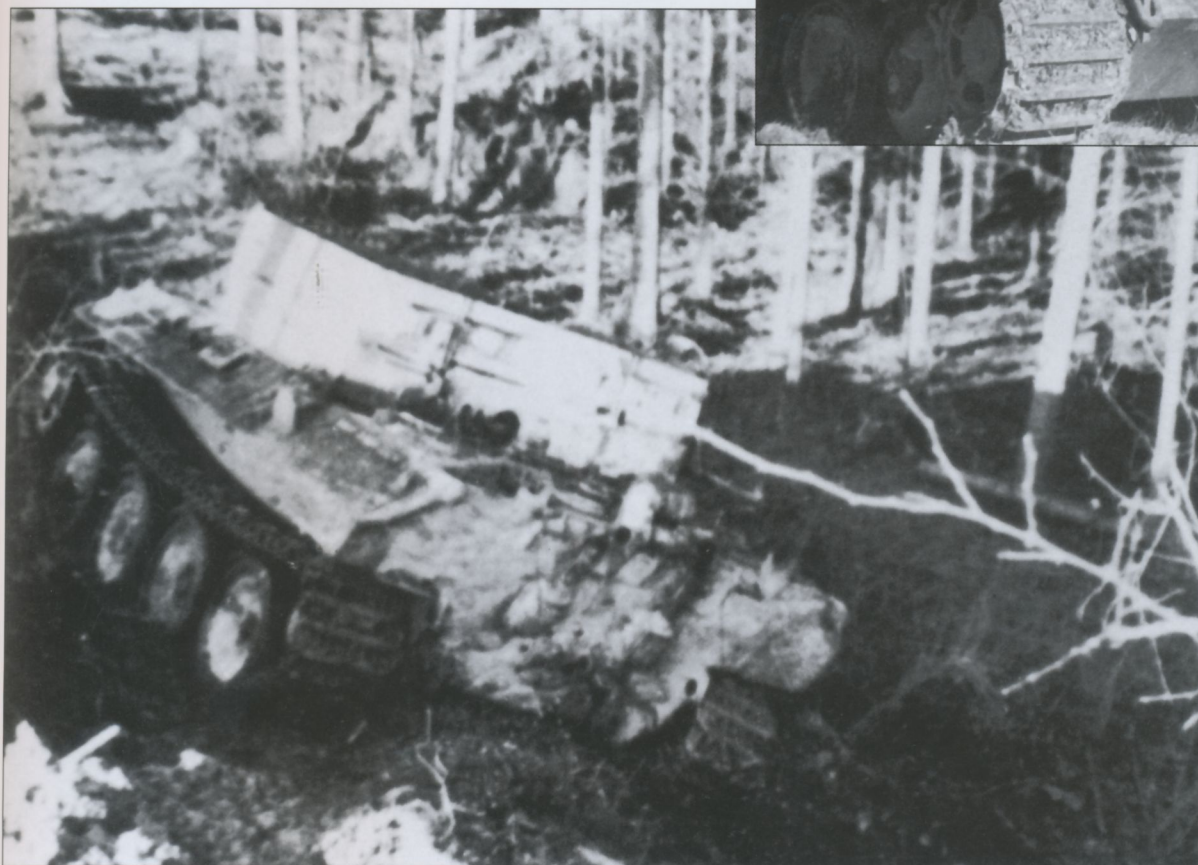
Two Bergepanther armored recovery vehicles abandoned somewhere on the Western Front. The one without the earth spade mounted on the rear is likely based on an Ausf.D chassis and does not appear to have Zimmerit while the one with the spade and Zimmerit is based on an early Ausf.A chassis. There were 240 Bergepanther produced on the Ausf.D and Ausf.A chassis from June 1943 to September 1944 with an additional 107 produced on Ausf.G chassis from September 1944 to March 1945.

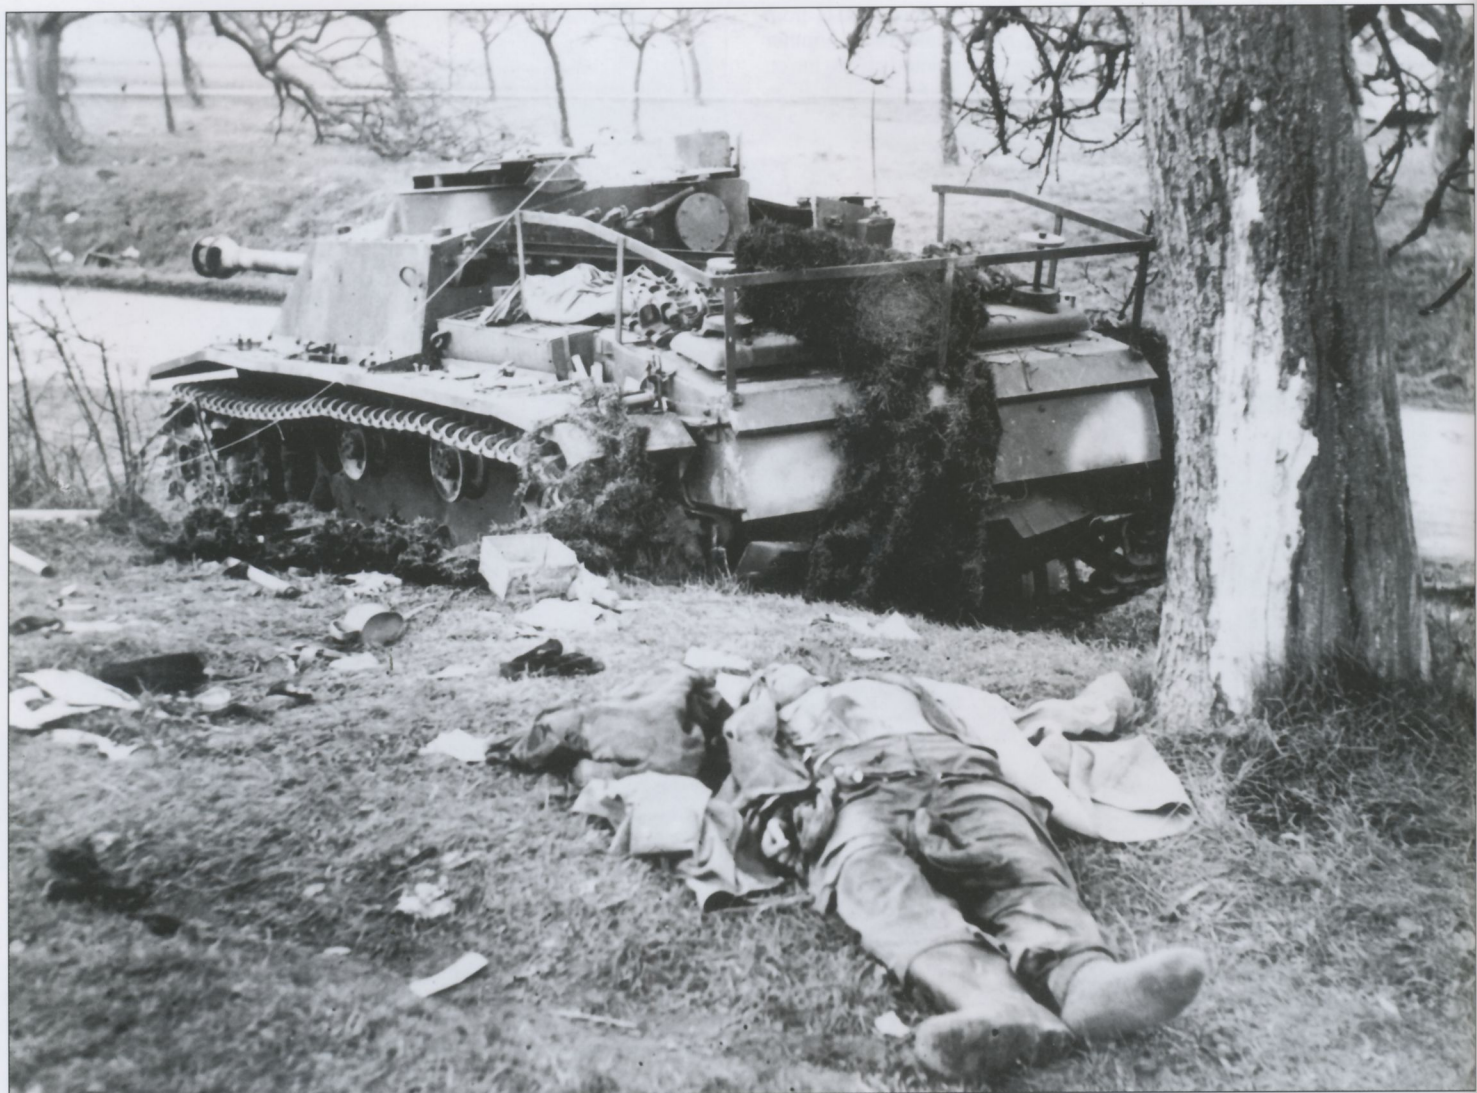
A knocked out late StuG.III Ausf.G somewhere in Western Europe in the late fall of 1944 or early spring of 1945. The vehicle has taken a hit, low in the left side, which has blown off the first return roller and damaged the drive sprocket. It appears that part of the rear plate of the fighting compartment behind the loader, has been neatly cut out for some unknown reason.

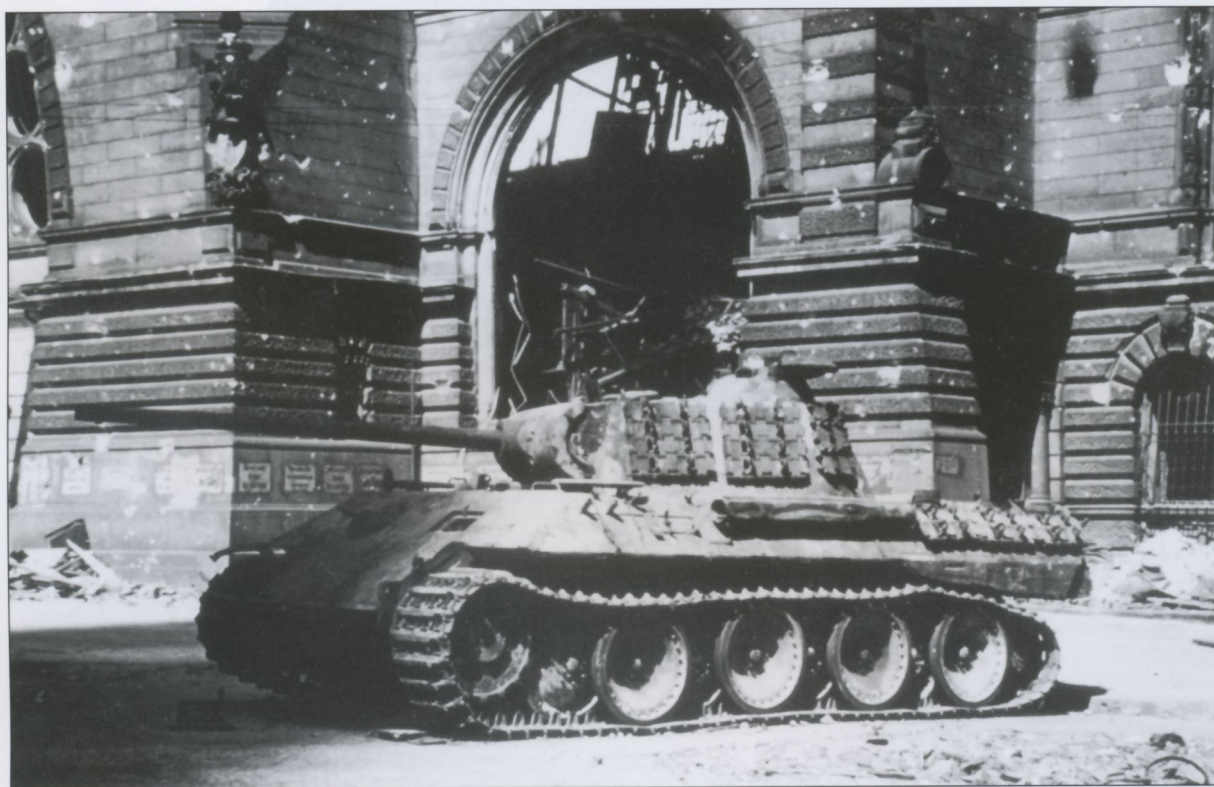
This is the famous Panther Ausf.A from II./Pz.Rgt.33 of 9.Panzer-Division that was knocked out in front of the Cologne cathedral in March 1945. The Panther had knocked out two approaching Sherman tanks when it was successfully taken in the flank by a T26E3 Pershing tank from the 32nd Armored Regiment of the 3rd Armored Division. It is pictured here sometime later after it had been towed around the side of the cathedral and left in front of the train station.

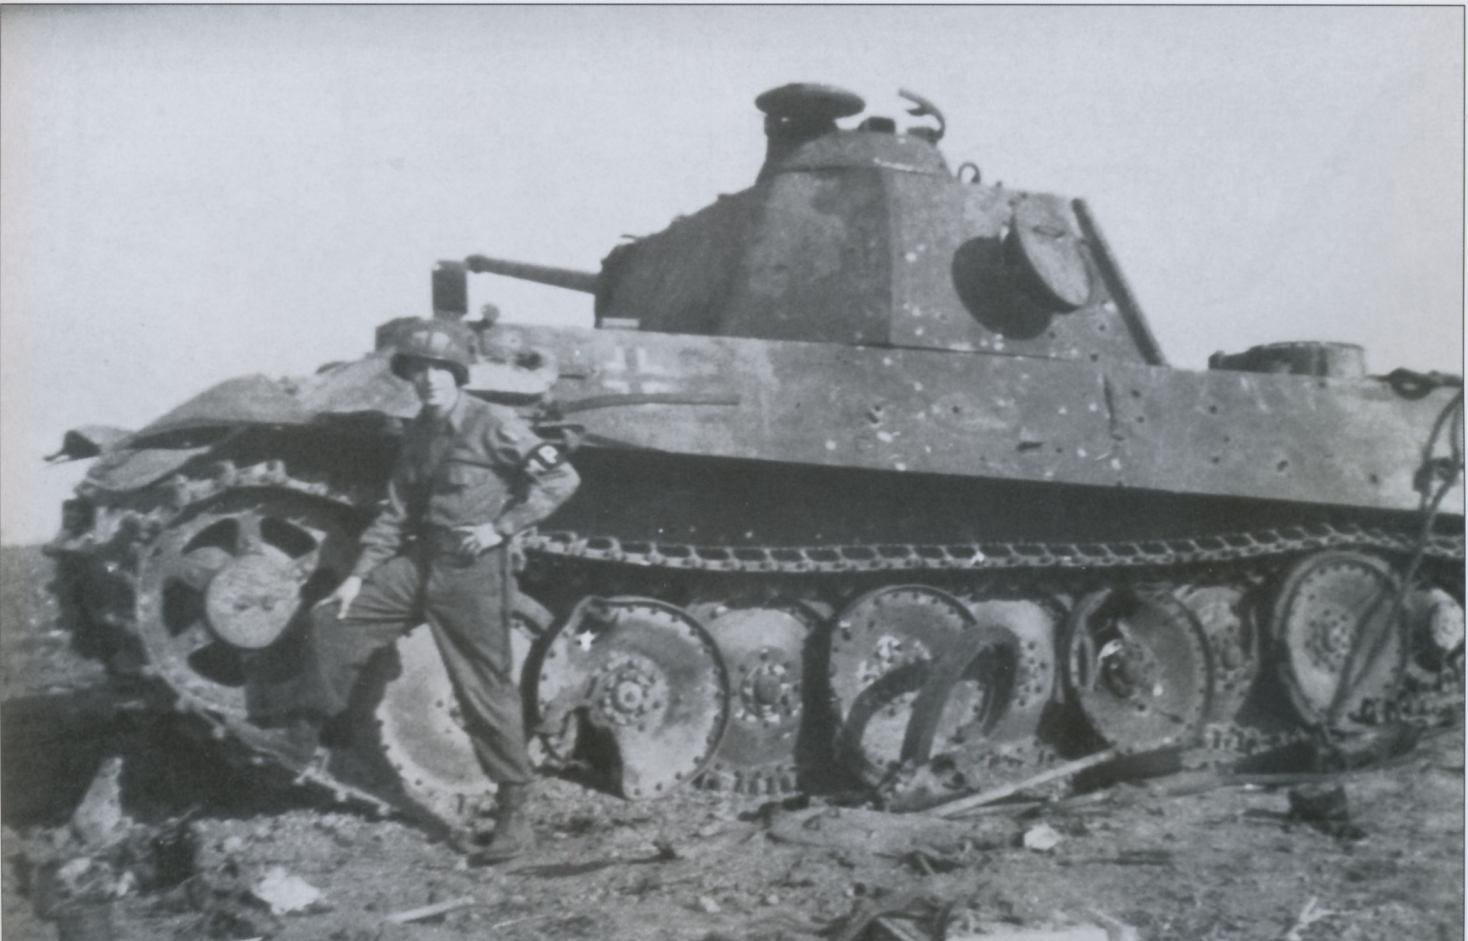
An MP poses beside a badly shot up Panther Ausf.G somewhere in Germany in early 1945. The raised fan tower on the engine deck indicates that this vehicle was fitted with the crew compartment heater introduced in October 1944.

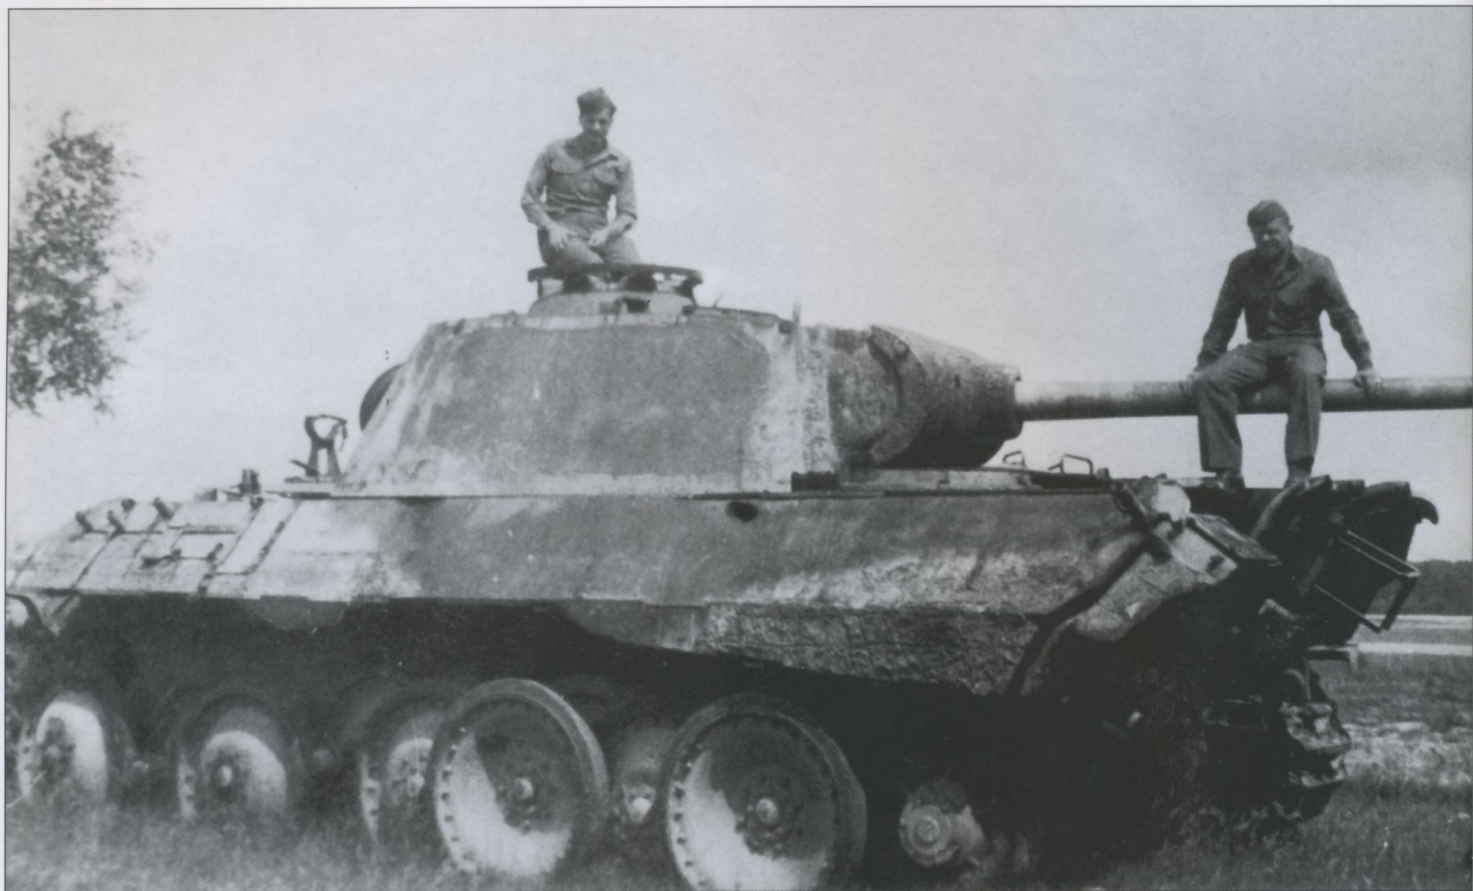
Two U.S. servicemen pose with a Panther Ausf.A near Braunschweig, Germany in early 1945. The penetration hole from the shot that knocked it out can be seen just below the top of the engine deck. The resulting fire has burned away the Zimmerit coating on part of the hull and side of the turret.

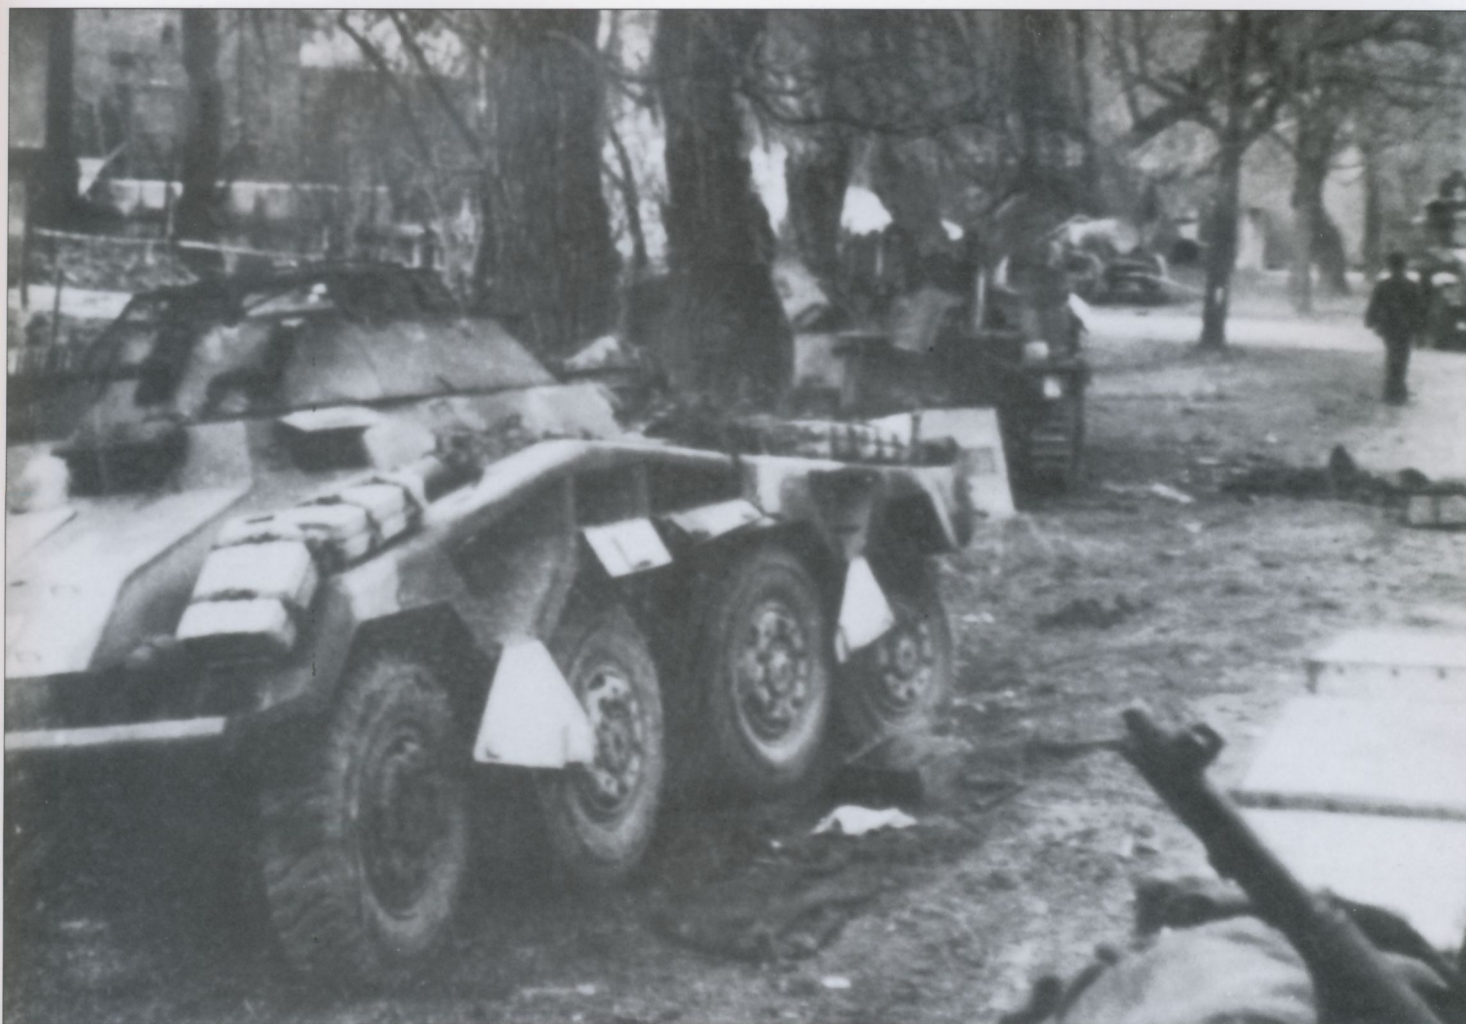
This schwere Panzerpähwagen (2cm) Sd.Kfz.234/1 sits abandoned in a German town in 1945. These heavy armored cars were issued to the Panzer-Aufklärungs-Abteilung of the Panzer and Panzer-Grenadier divisions starting in July 1944. A total of 200 were produced from June 1944 to January 1945.

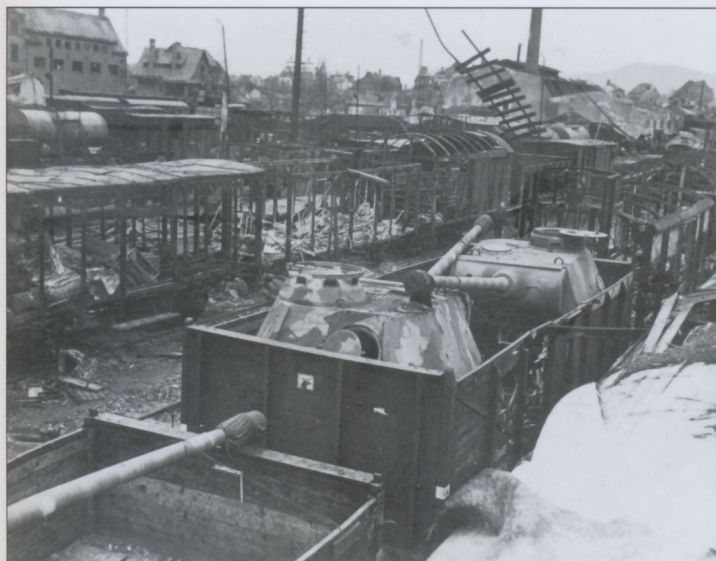
These Panther turrets were photographed in the bombed out railway station in Aschaffenburg in 1945. The turret with the colorful camouflage paint scheme is probably an Ausf.A production as it has the Nahverteidigungswaffe on the right rear of the turret roof but is lacking the Pilze socket. The other turret is obviously from an Ausf.D.

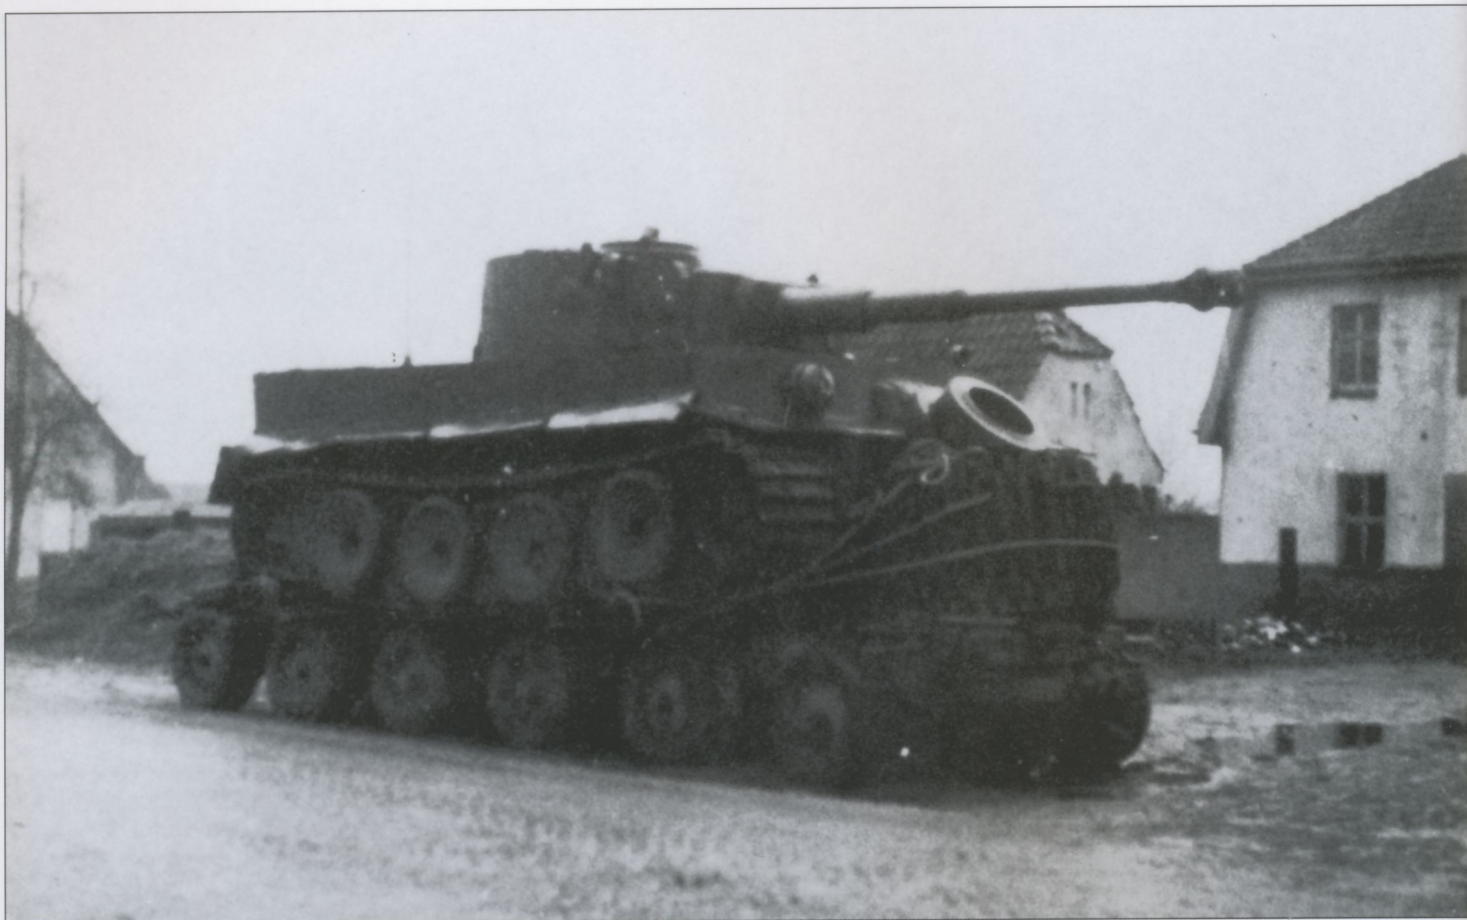
This early Tiger I was captured in Germany by the British Army and shipped to England for evaluation after the war. It has been fitted with the narrow transport tracks and is seen loaded on a Gotha 80 ton transporter with the wide battle tracks coiled up on the front of the trailer.

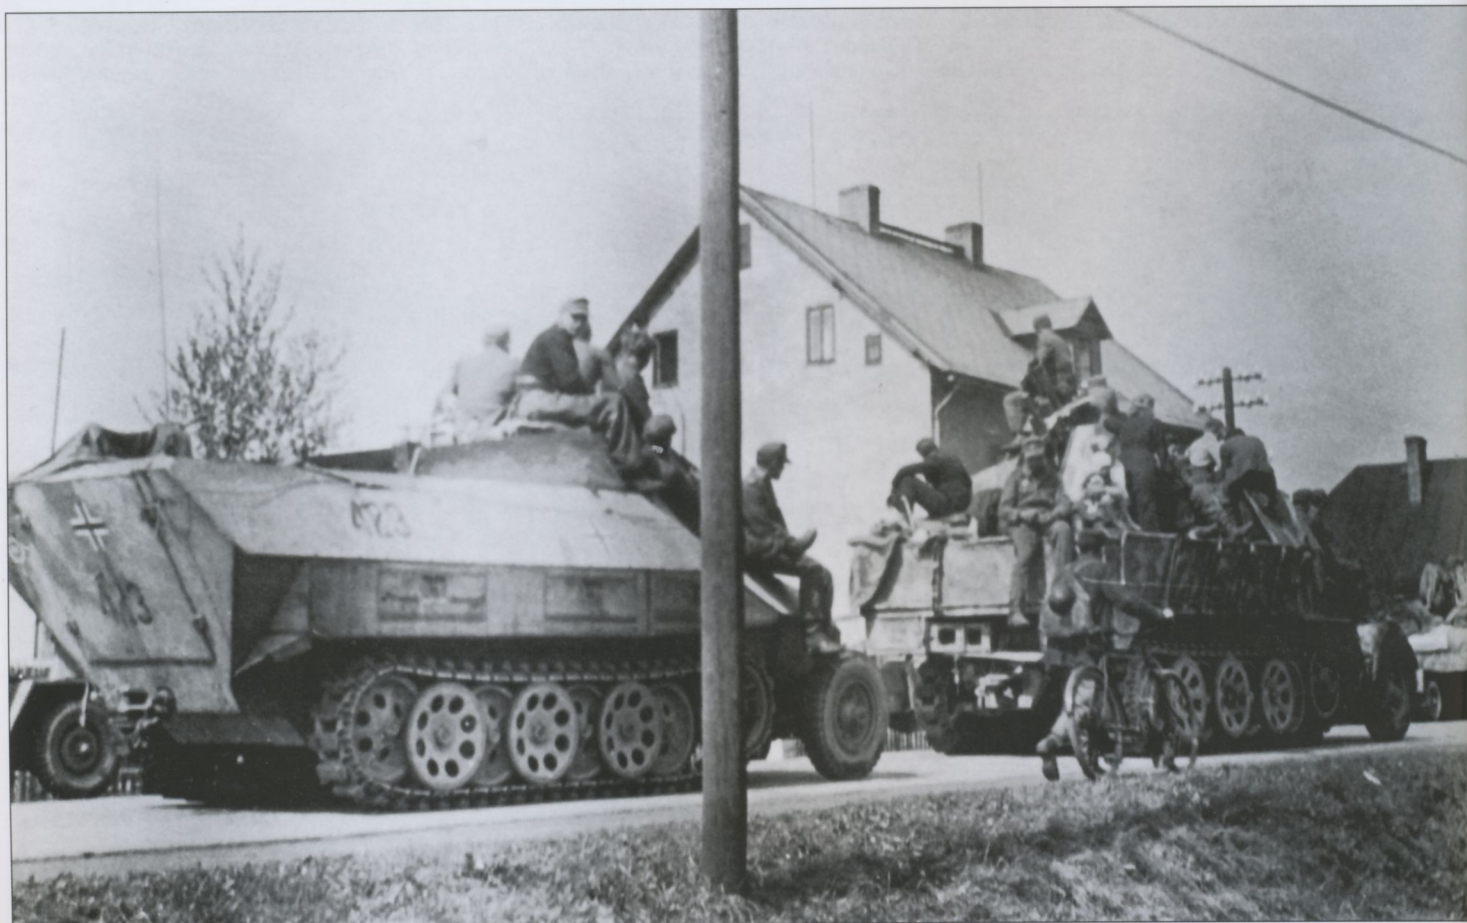
An Sd.Kfz. 251/9 Ausf. D follows an Sd.Kfz. 7/2 into captivity after the cessation of hostilities in 1945. The marking on the left rear of the Sd.Kfz. 251/9 looks like it may be the 'Windhund' emblem of 116. Panzer-Division. The gun barrel of the 3.7cm Flak 43 has been removed, probably to render the weapon inoperable.
