# Battle on Two Fronts

## 1944-45

Tom Cockle

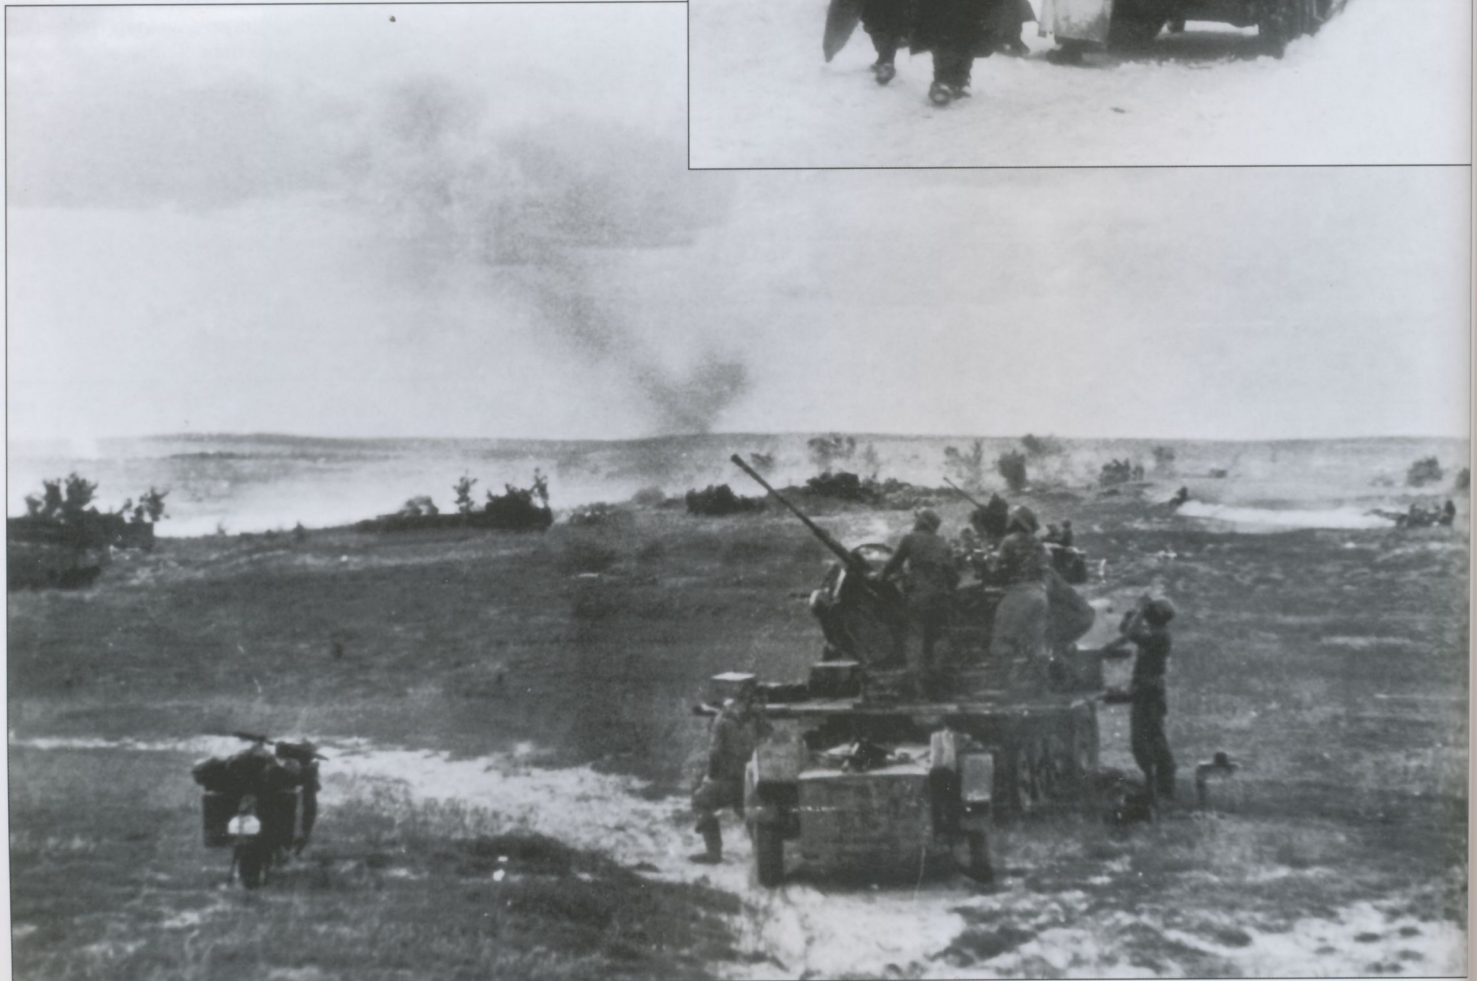
A pair of Sd.Kfz.10/4, also mounting the 2cm Flak 38, fire at Russian aircraft flying over the German positions. A crew of seven manned the vehicle. There were 220 rounds of ammunition stowed in 20 round magazines in boxes mounted on the sides of the fold-down platform and on the gun itself. An additional 640 rounds was carried in a special two-wheel trailer, the Sd.Ah.51.

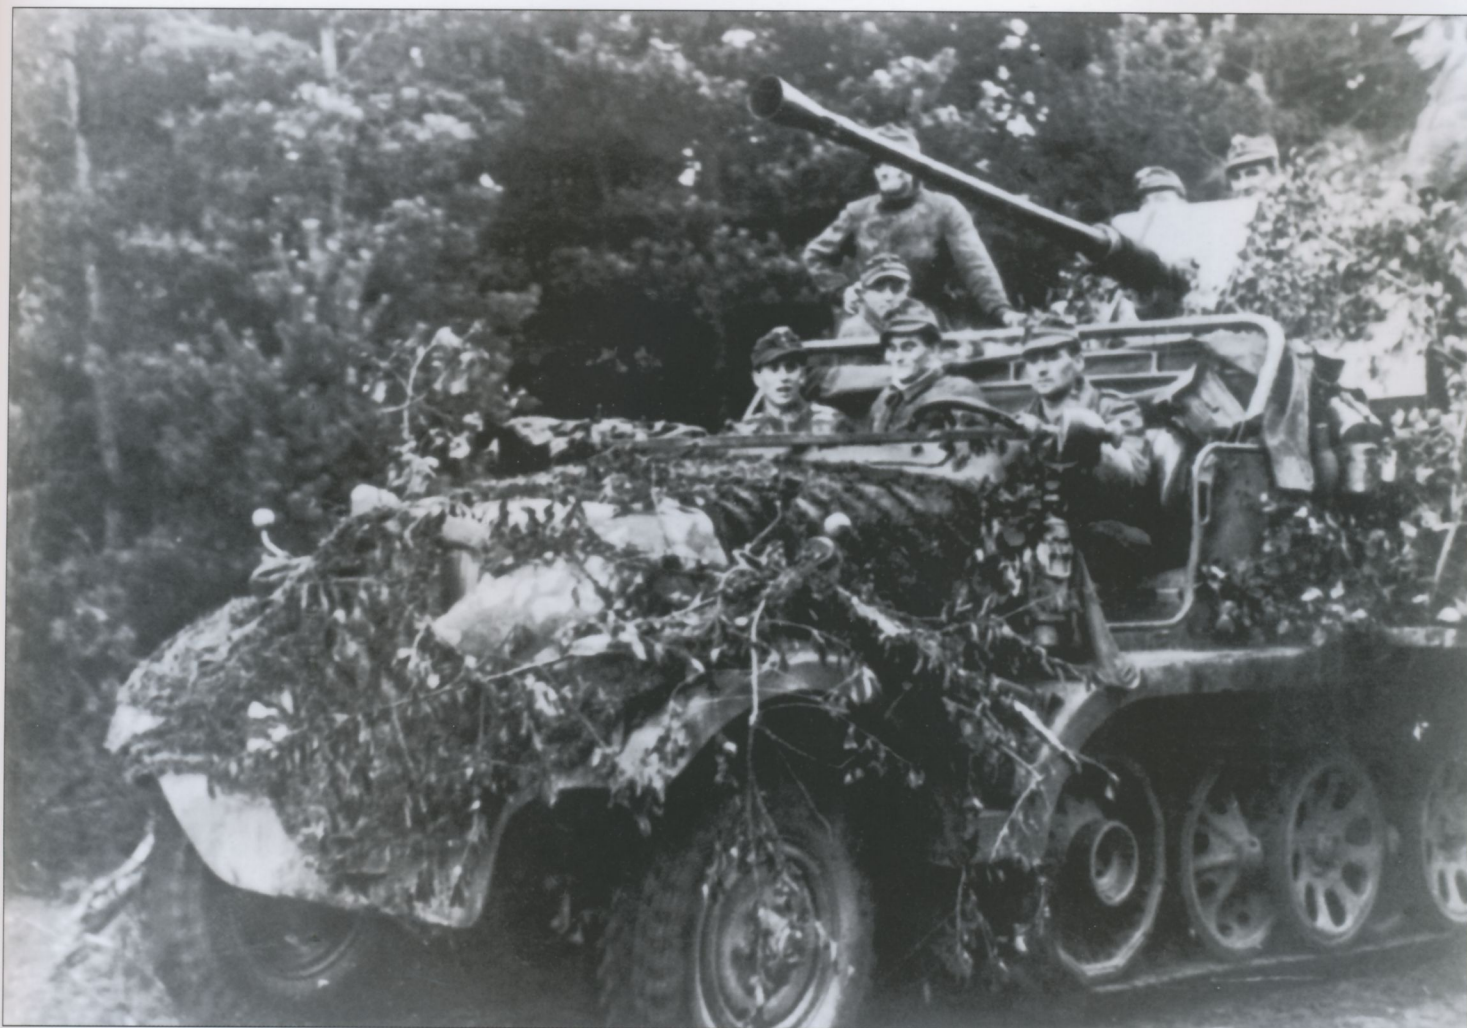
The Sd.Kfz.6/2 carried the 3.7cm Flak 36, which had a practical rate of fire of 80-100 rounds per minute. Although this was slower than the 2cm Flak, it had a horizontal range of 6600 meters and a ceiling of 4800 meters. The Sd.Kfz.6/2 were issued almost exclusively to Luftwaffe Flak Regiments, the exception being 18 issued to Regiment 'Großdeutschland'.

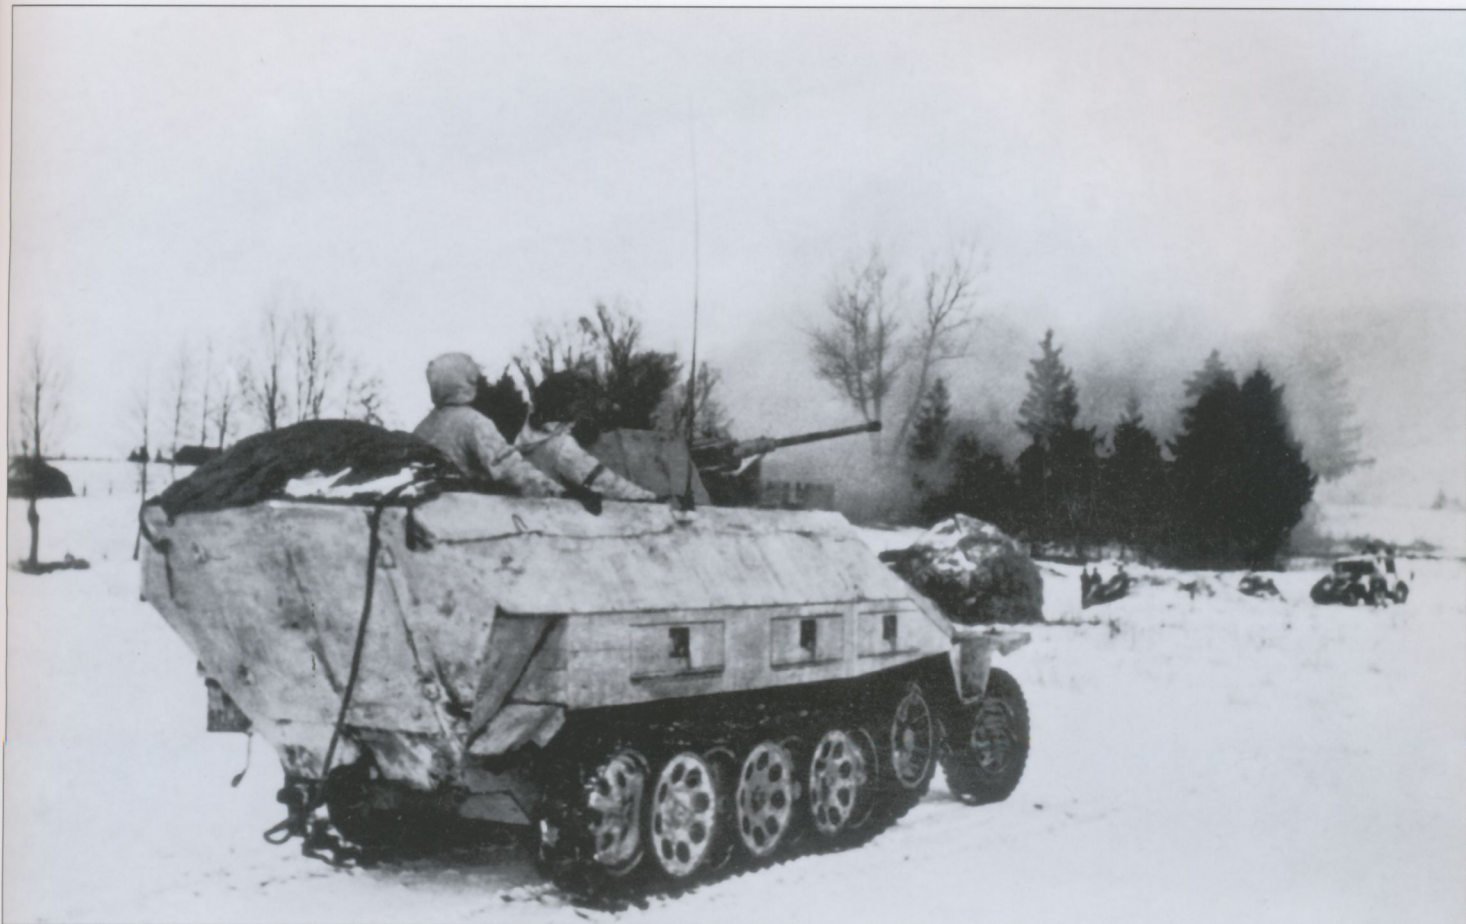
The Sd.Kfz.251/17 Ausf.D armed with a 2cm KwK38 autocannon, is rarely seen in photographs. The gun was mounted on a pedestal and a small armored, open top turret that protected the operator surrounded the upper part.

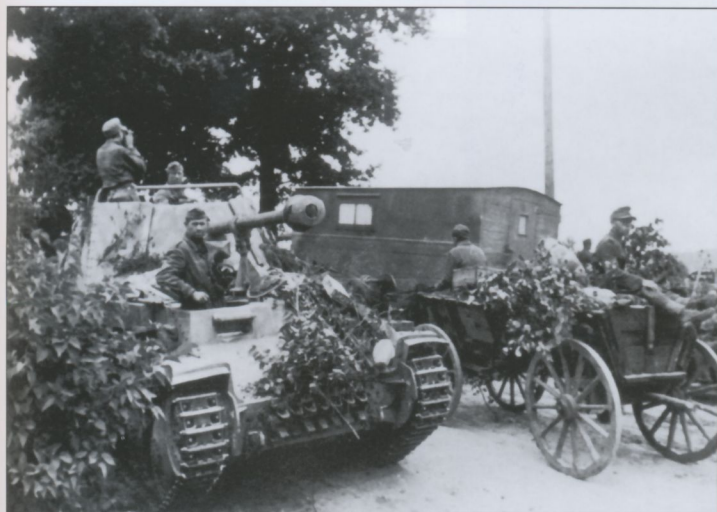
A late production Marder III Ausf.M (Sd.Kfz.138) in Latvia during the summer of 1944. The early production vehicles featured a cast hood over the driver's position while later ones were made up of flat plates welded together like this one. The Marder III Ausf.M mounted the 7.5cm Pak40/3 on the modified chassis of the obsolete Pz.Kpfw.38(t) and was crewed by 4 men.

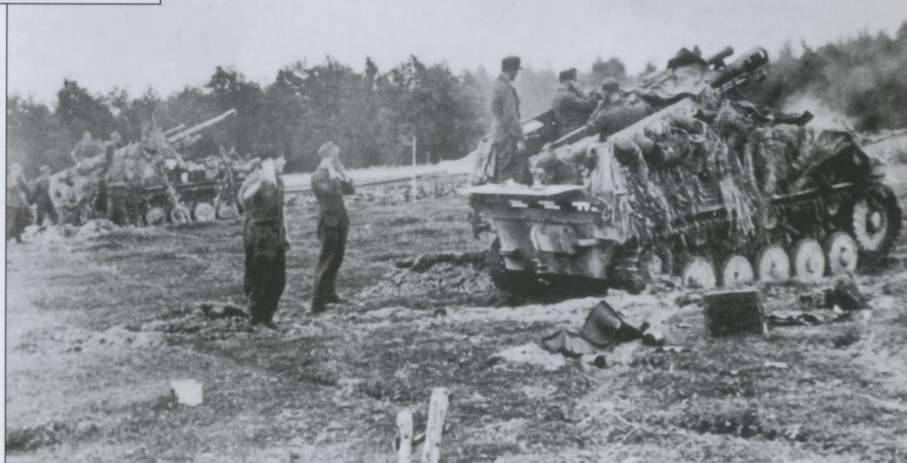
A battery of Wespe self-propelled howitzers fires on enemy positions in the Soviet Union in August 1944. The Wespe carried the 10.5cm leFH18M gun mounted on a modified Pz.Kpfw.II chassis and had a crew of 5 men. They were issued to the Panzer-Artillerie-Regiments of the Panzer and Panzer-Grenadier-Divisions and first saw action at Kursk in July 1943.

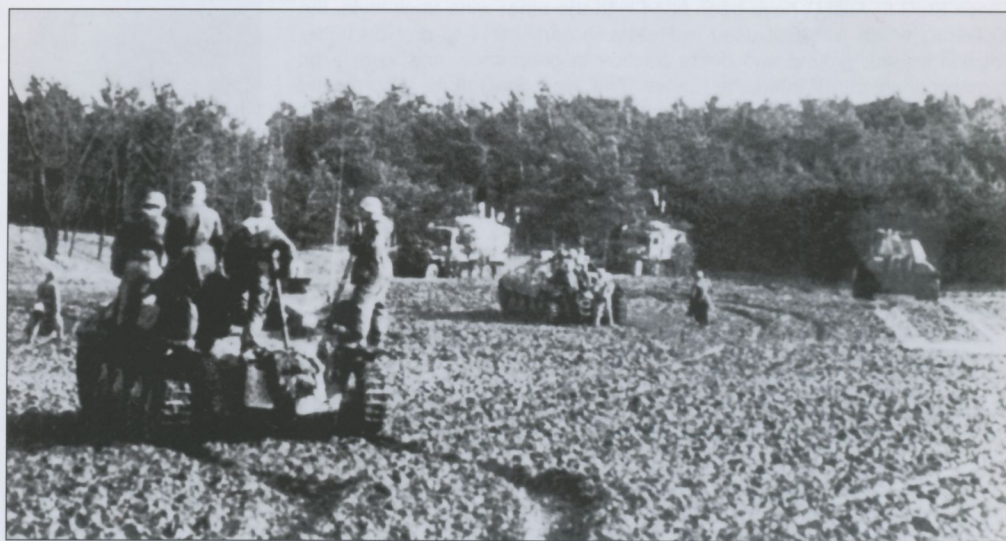
Two late model Jagdpanzer 38(t)s carry infantry across a muddy field in early 1945. The nearest vehicle is fitted with the later Flammenvernichter flame dampening exhaust system. In the background, a late Panther Ausf.G can be seen with its own version of the Flammenvernichter exhaust.

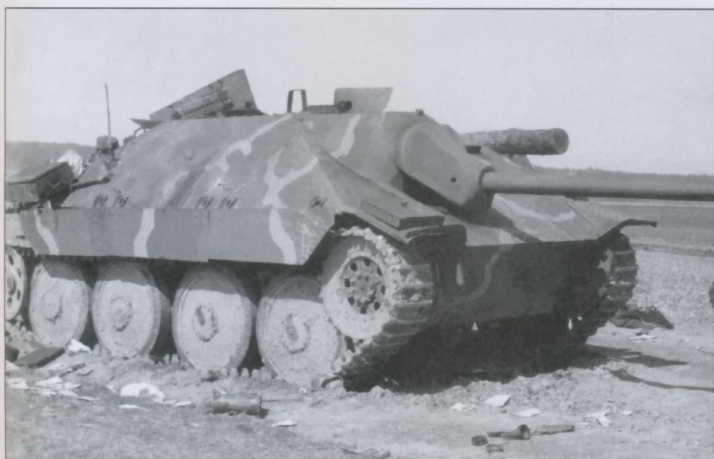
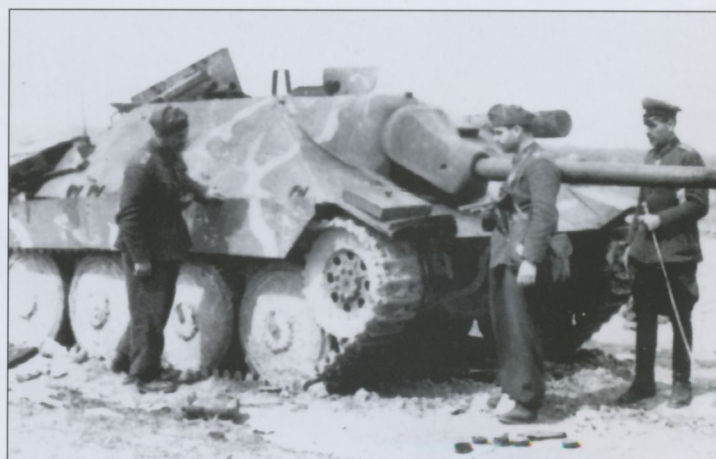
Two photos of the same Jagdpanzer 38(t), likely taken at the same time but in the second one, some Hungarian soldiers can be seen inspecting the abandoned vehicle. This Jagdpanzer is painted in a slightly different camouflage pattern than the previous photo but was also very common. A total of 2,584 of these vehicles were built from April 1944 to May 1945.

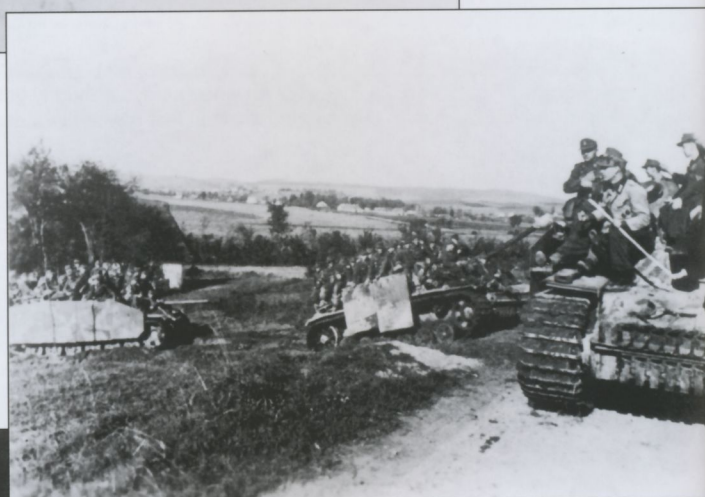
This StuG.III Ausf.G is fitted with the wider 'Winterkette' tracks that were introduced in the winter of 1942-43 to provide increased traction in deep snow. They were issued to units equipped with the StuG.III, Panzer III and some Panzer IV in the fall and were to be returned in the spring. This StuG.III Ausf.G has the waffle pattern Zimmerit coating that was applied only by the Alkett plant in Berlin.

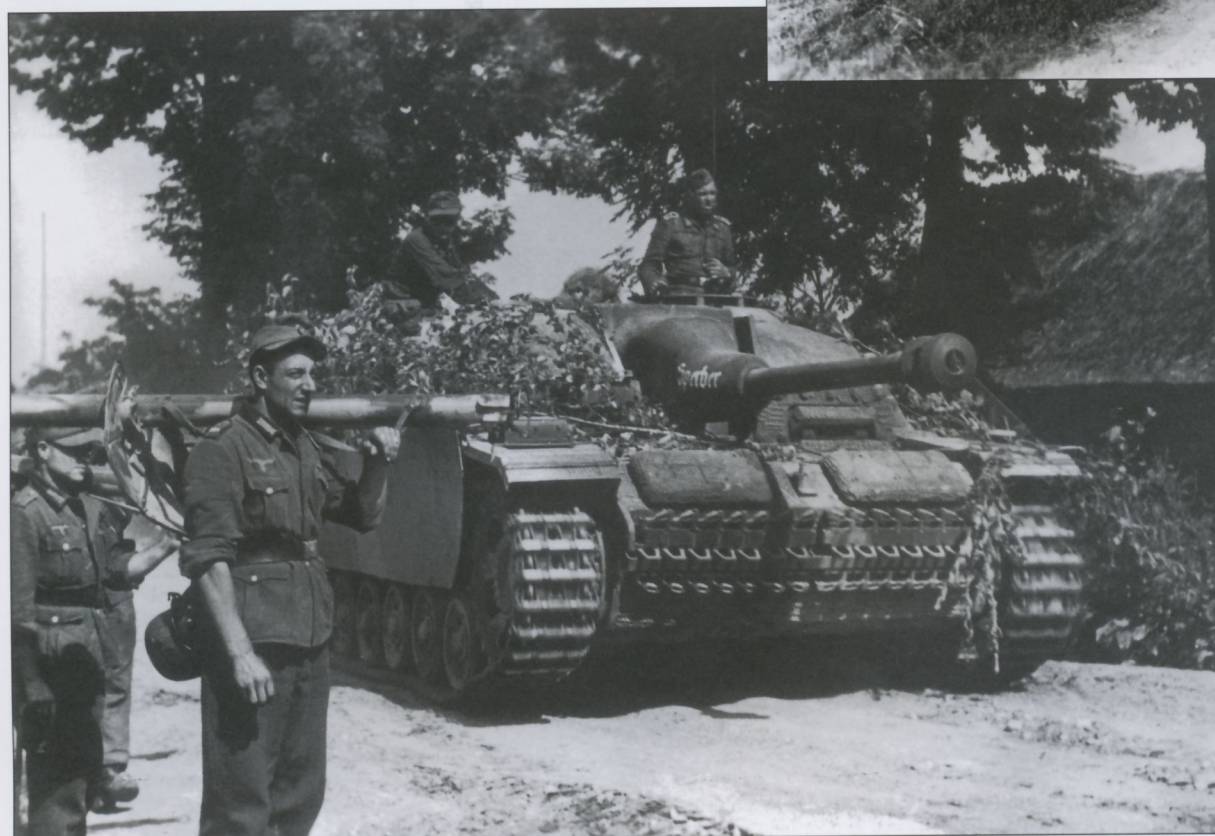
The crew of this StuG.III Ausf.G has added improvised spaced armor to the glacis of their vehicle using two armored covers from another StuG.III that had probably been knocked out. The cast 'topfblende' mantlet was introduced in November 1943 but never totally replaced the welded mantlet, which continued to be used up to the end of the war. The name 'Sperber' has been painted on the side of the mantlet, the meaning of which is unknown. Concrete reinforcement has been added to the sloping roof over the driver and on the right side. The photo was taken in September 1944.

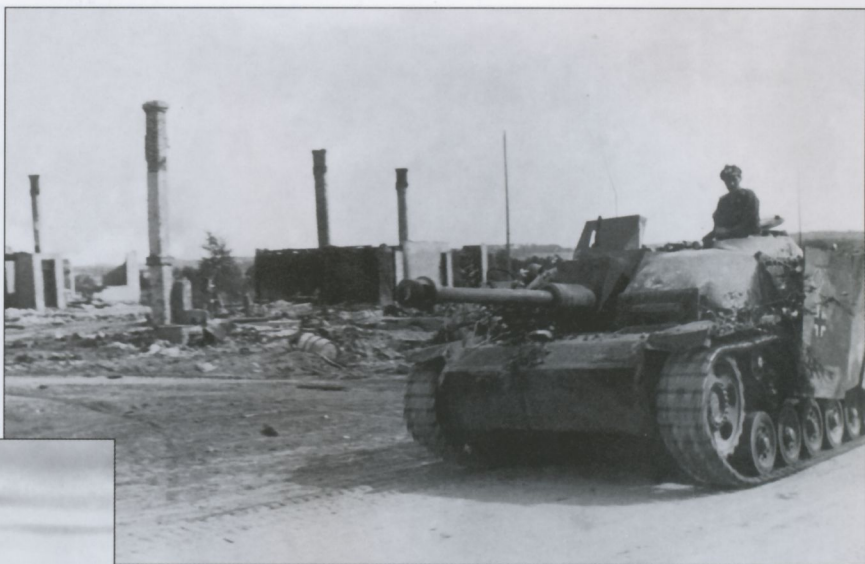
Concrete reinforcement has been added to the sloping roof of the superstructure on this StuG.III Ausf.G seen in Latvia in September 1944. Also visible in this photo is the shot deflector welded in front of the cupola that was introduced in October 1943. The opening in the MG shield was changed to a rectangular shape to accommodate the larger sleeve on the MG 42 but this vehicle is still equipped with the MG 34.

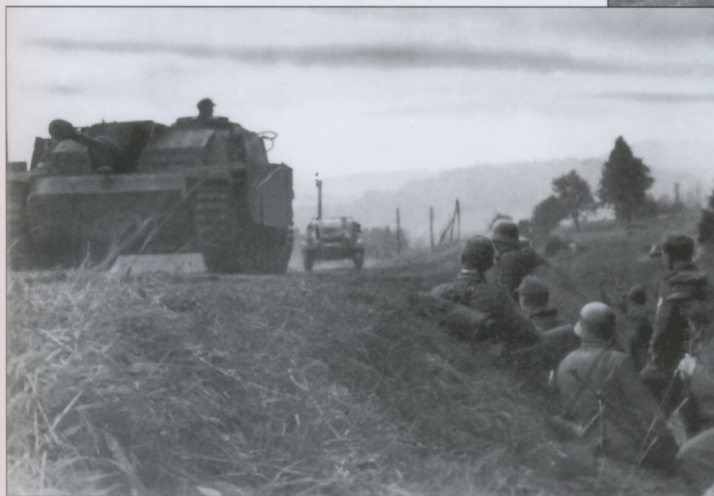
A StuG.III Ausf.G passes an infantry squad huddled in a ditch in Rumania in late October 1944. The Schürzen have been field modified to hang on short pieces of pipe welded to the fenders. The plates were held in place with a cotter pin that allowed them to rotate freely when traveling through dense brush and which prevented them from being torn off and lost. A single or sometimes double plate was fixed on the side of the fighting compartment to protect the upper sides.

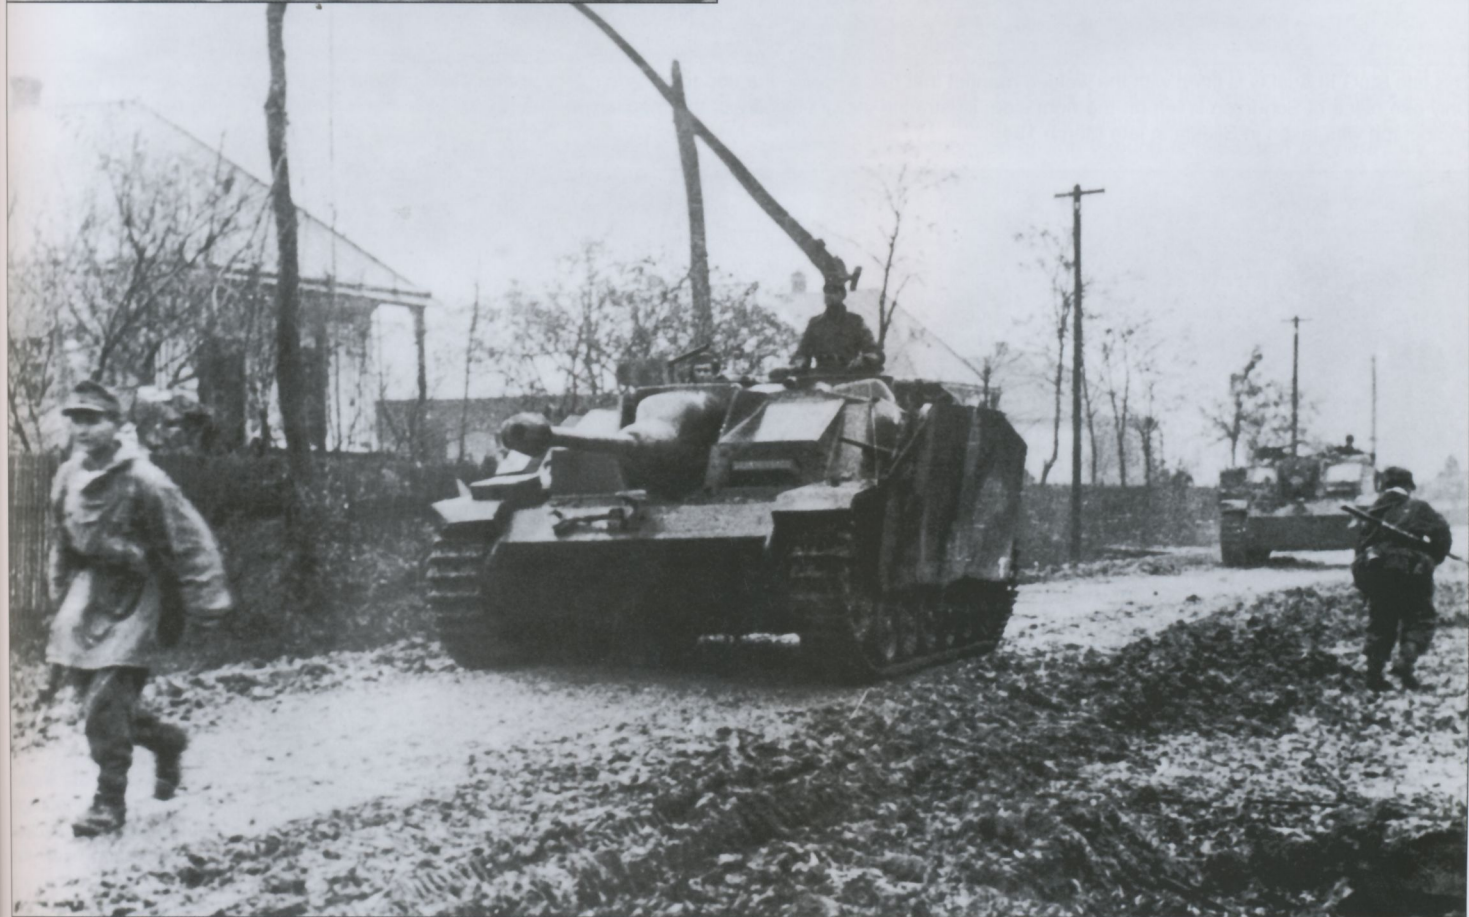
This late production StuG.III Ausf.G was manufactured after September 1944 when the application of Zimmerit was discontinued. It is also fitted with the folding gun travel lock on the glacis and single 80mm thick plate on the right side of the superstructure, which were introduced in July 1944. The remote MG mount, or Rundumfeuer, was introduced in April 1944 but shortages of the weapon meant that there were many vehicles issued without them. The loader's hatches were redesigned to open to the sides to accommodate the device, which could be operated with safety from inside the vehicle using a periscopic sight.

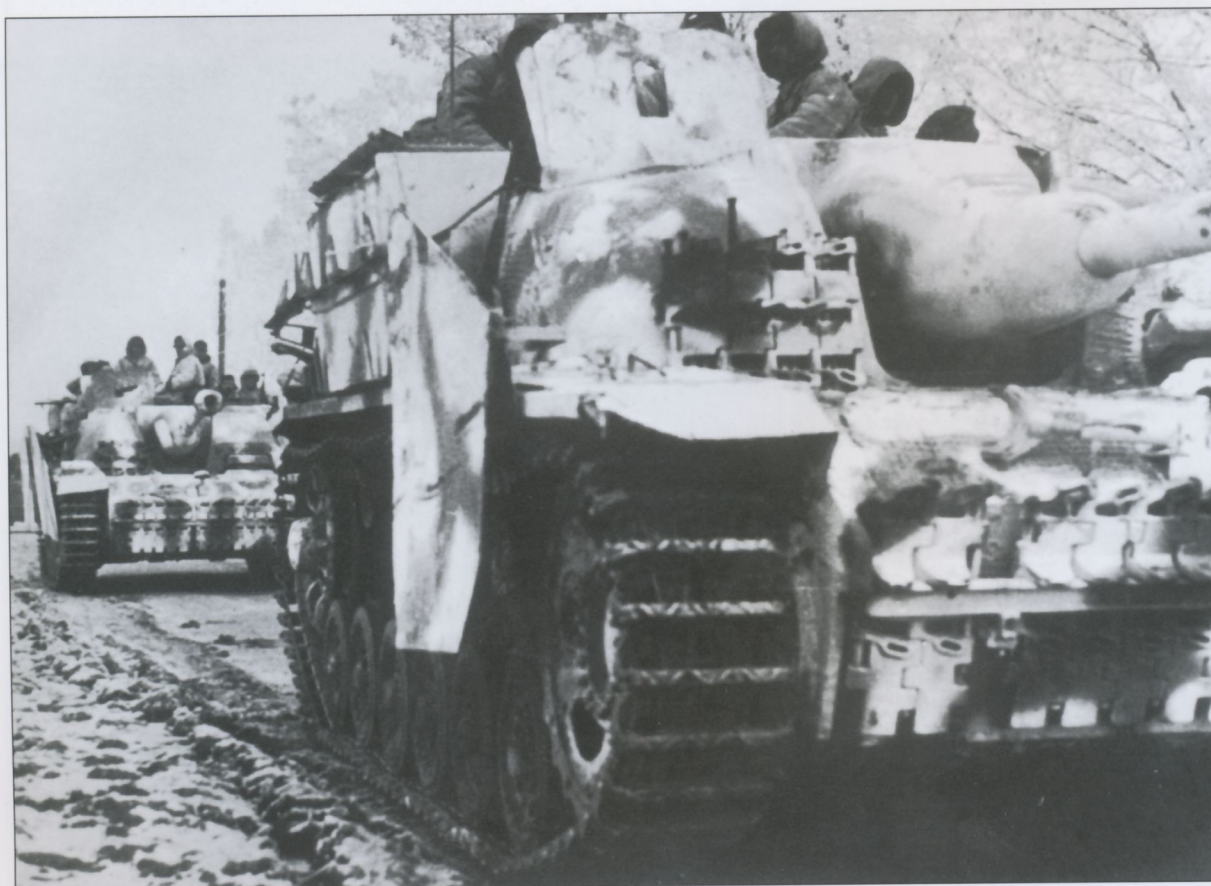
A column of StuG.III Ausf.G, possibly from 3.SS-Panzer-Division 'Totenkopf', in Hungary in January 1945. Unusually, the vehicles are carrying 'Oskette' spare tracks but are still fitted with the standard tracks with the ice chevrons. Both have new coats of winter whitewash camouflage paint applied in patches leaving some of the original paint showing through. The gun travel lock and waffle pattern Zimmerit place the time of manufacture at sometime between July and September 1944.

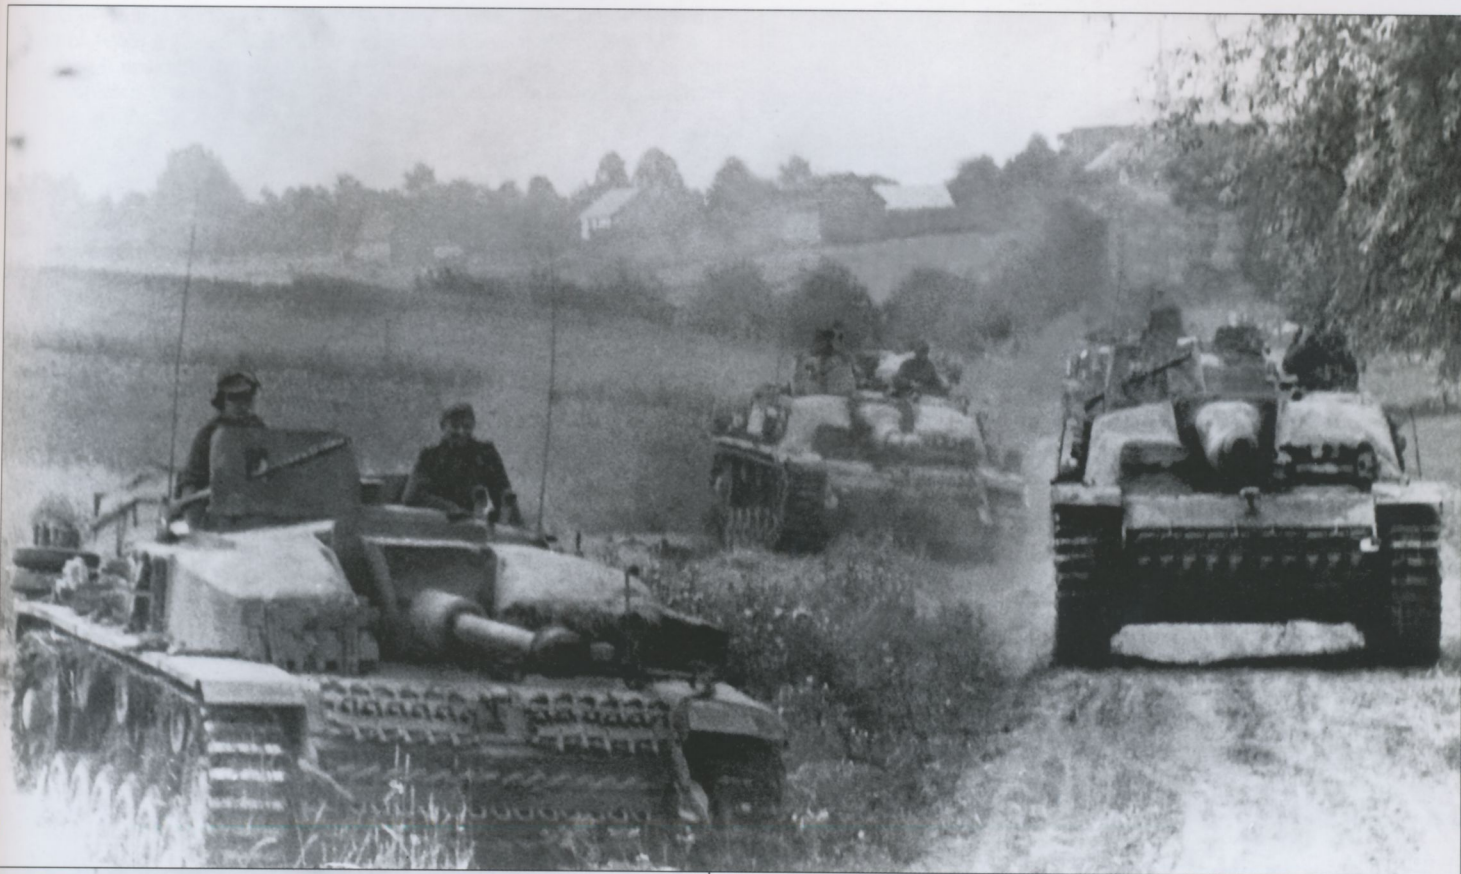
Three photos of a column of StuG.III Ausf.G somewhere on the Eastern Front in the late summer of 1944. The concrete reinforcement has been applied with an artistic flair and projects out around the driver's visor. Salvaged T-34 tracks have been hung on the spare track bracket on the front of one of the vehicles, probably because the wider track provides better protection. Usually, the Schürzen plates lapped front over back to prevent them from being snagged driving through dense brush but here they have been installed backwards.

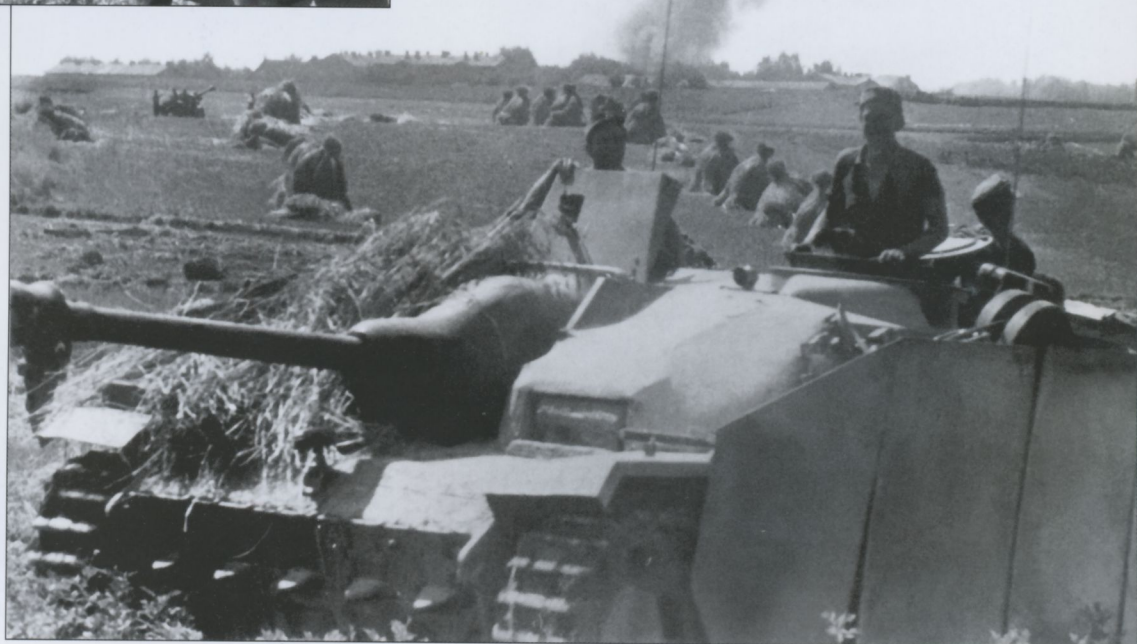
This column of July-September 1944 production StuG.III Ausf.G have had a unique set of spaced armor plates added to the sides of the superstructure in place of the standard Schürzen. The gunner's seat can be seen laying on the forward edge of the roof. They are otherwise unremarkable except for the standard Bosch headlight fitted to the Notek light base on the glacis.

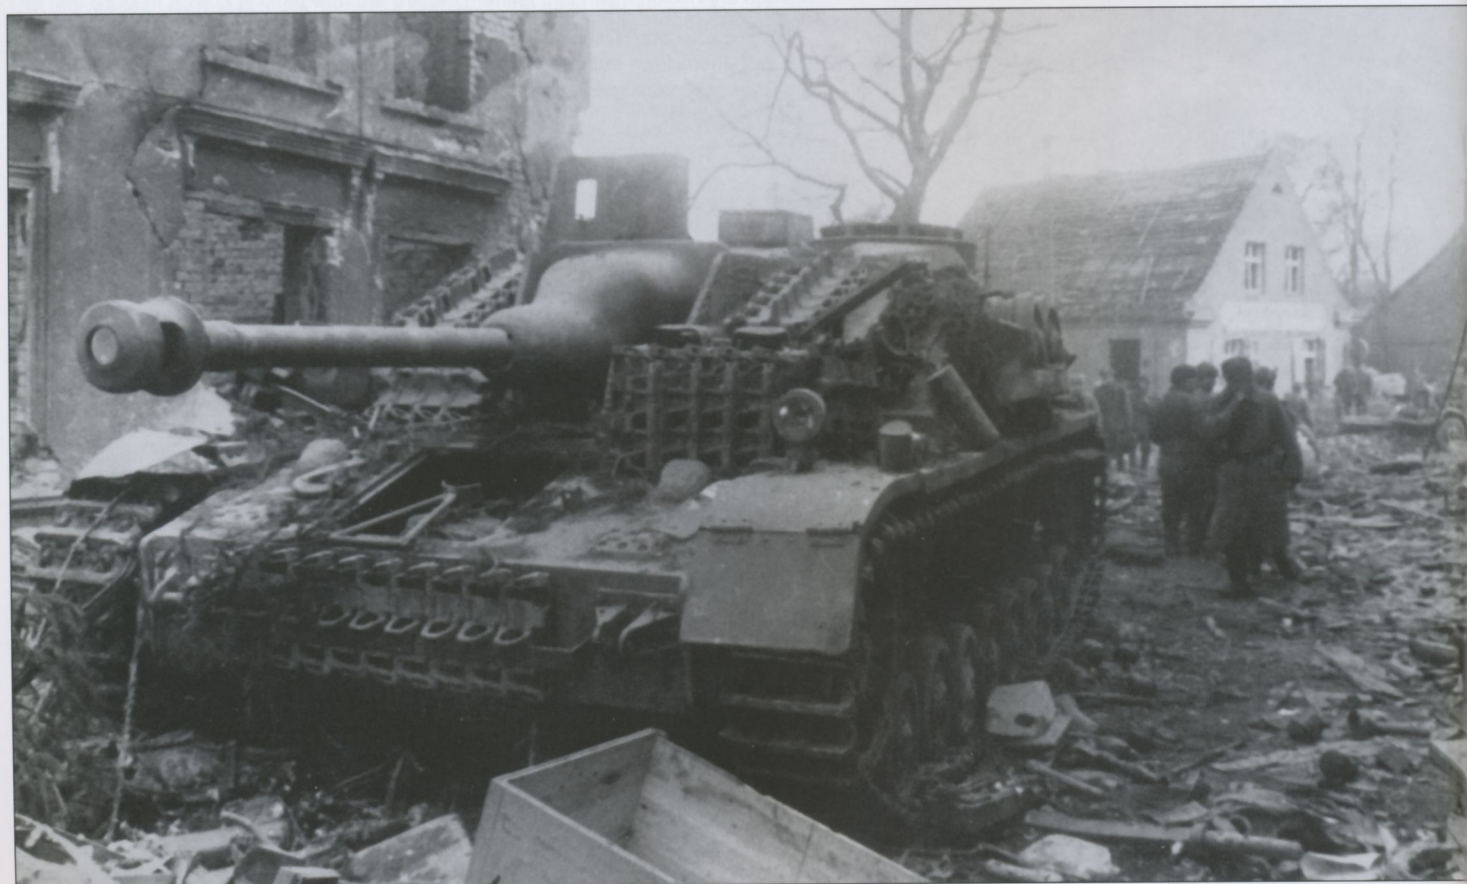
A StuG.IV from 277.StuG.Bde., photographed in East Prussia in February 1945 while Soviet troops mill around in the background. The StuG.IV was ordered into production in December 1943 to replace lost StuG.III production after the Alkett plant in Berlin was bombed. A total of 1,139 were produced from December 1943 to March 1945.

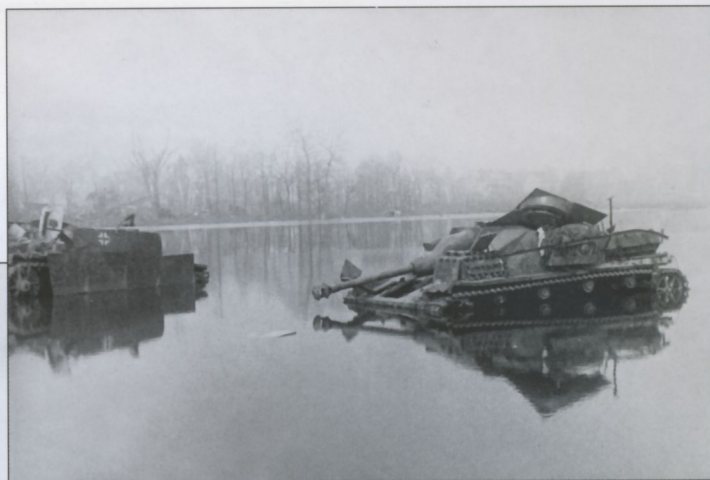
A StuG.III Ausf.G and a StuG.IV lay in a low flooded area, probably in the spring of 1945. An internal explosion has lifted the roof off the StuG.IV and deposited it upside down back on top of the vehicle. The StuG.III is one of those vehicles that received the modified Schürzen arrangement seen in previous photos.

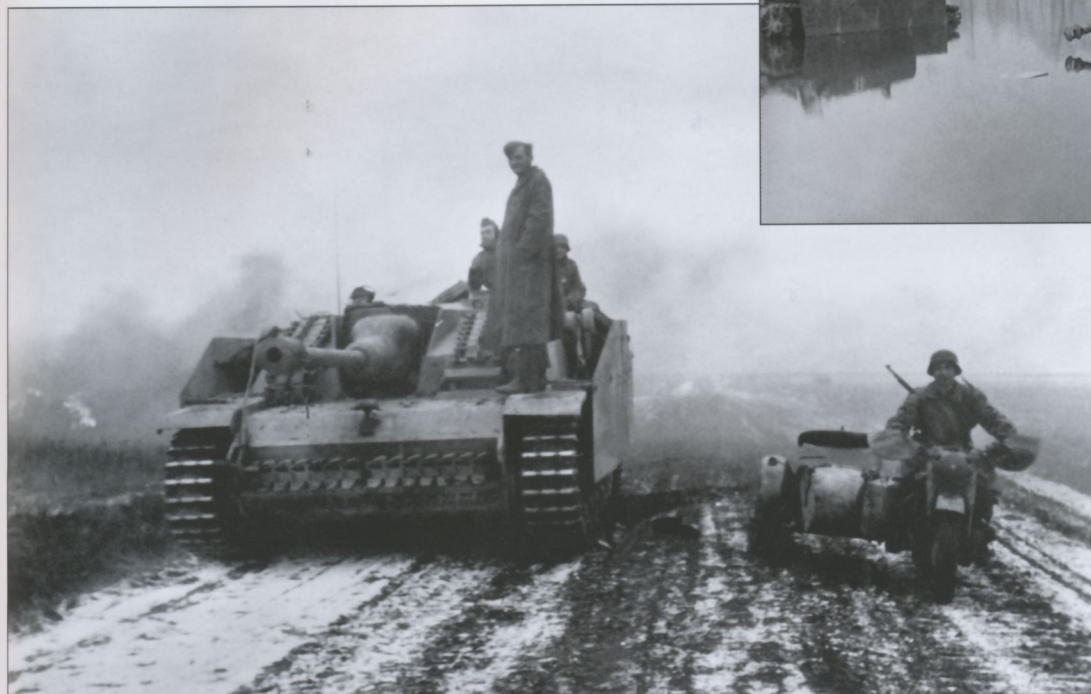
A damaged StuG.IV waits for recovery or repair somewhere on the Eastern Front in the winter of 1944-45. The left drive sprocket can be seen laying on the glacis. The absence of Zimmerit places the date of manufacture sometime after September 1944. —

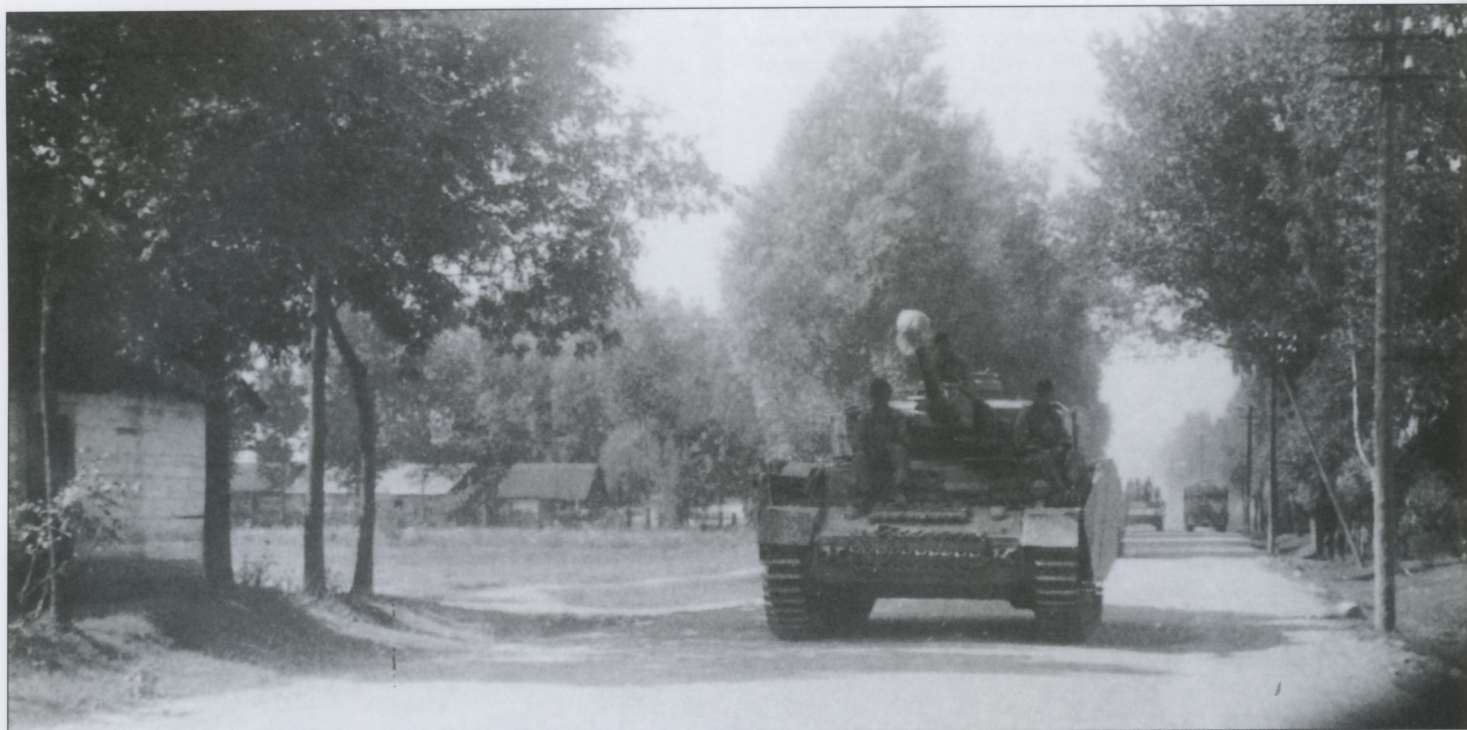
A column of Pz.Kpfw.IV Ausf.H or Ausf.J on the outskirts of an East Prussian town in the summer of 1944. They are probably new issue as there does not appear to be any battle damage and they carry a full set of Schürzen. The single Bosch headlight on the left fender is an identifying feature of the Panzer IV Ausf.H or J, as there were two headlights on the Panzer IV Ausf.G.

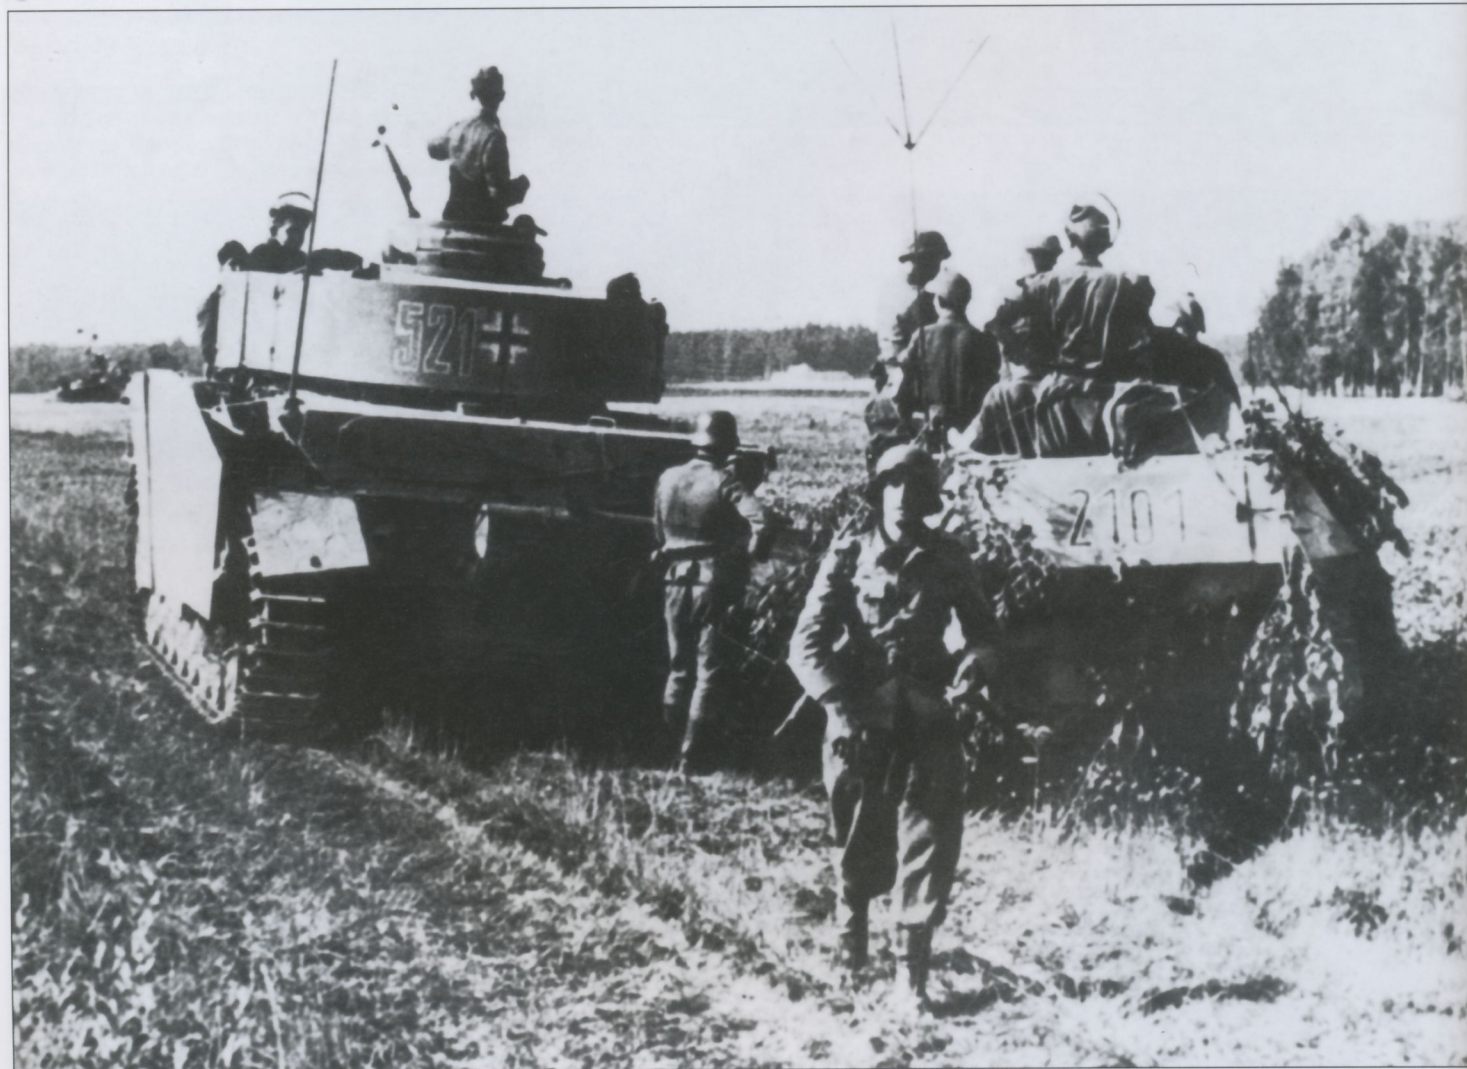
A Pz.Kpfw.IV Ausf.J with an Sd.Kfz.251/3 Ausf.C on the Eastern Front during the summer of 1944. The tactical numbers on the turret Schürzen are probably red with a white outline compared to the black center of the national cross. The Sd.Kfz.251/3 mittlere Funkpanzerwagen has a 2m Sternantenne attached to a mount on the rear plate and was used for the FuG8 radio set.

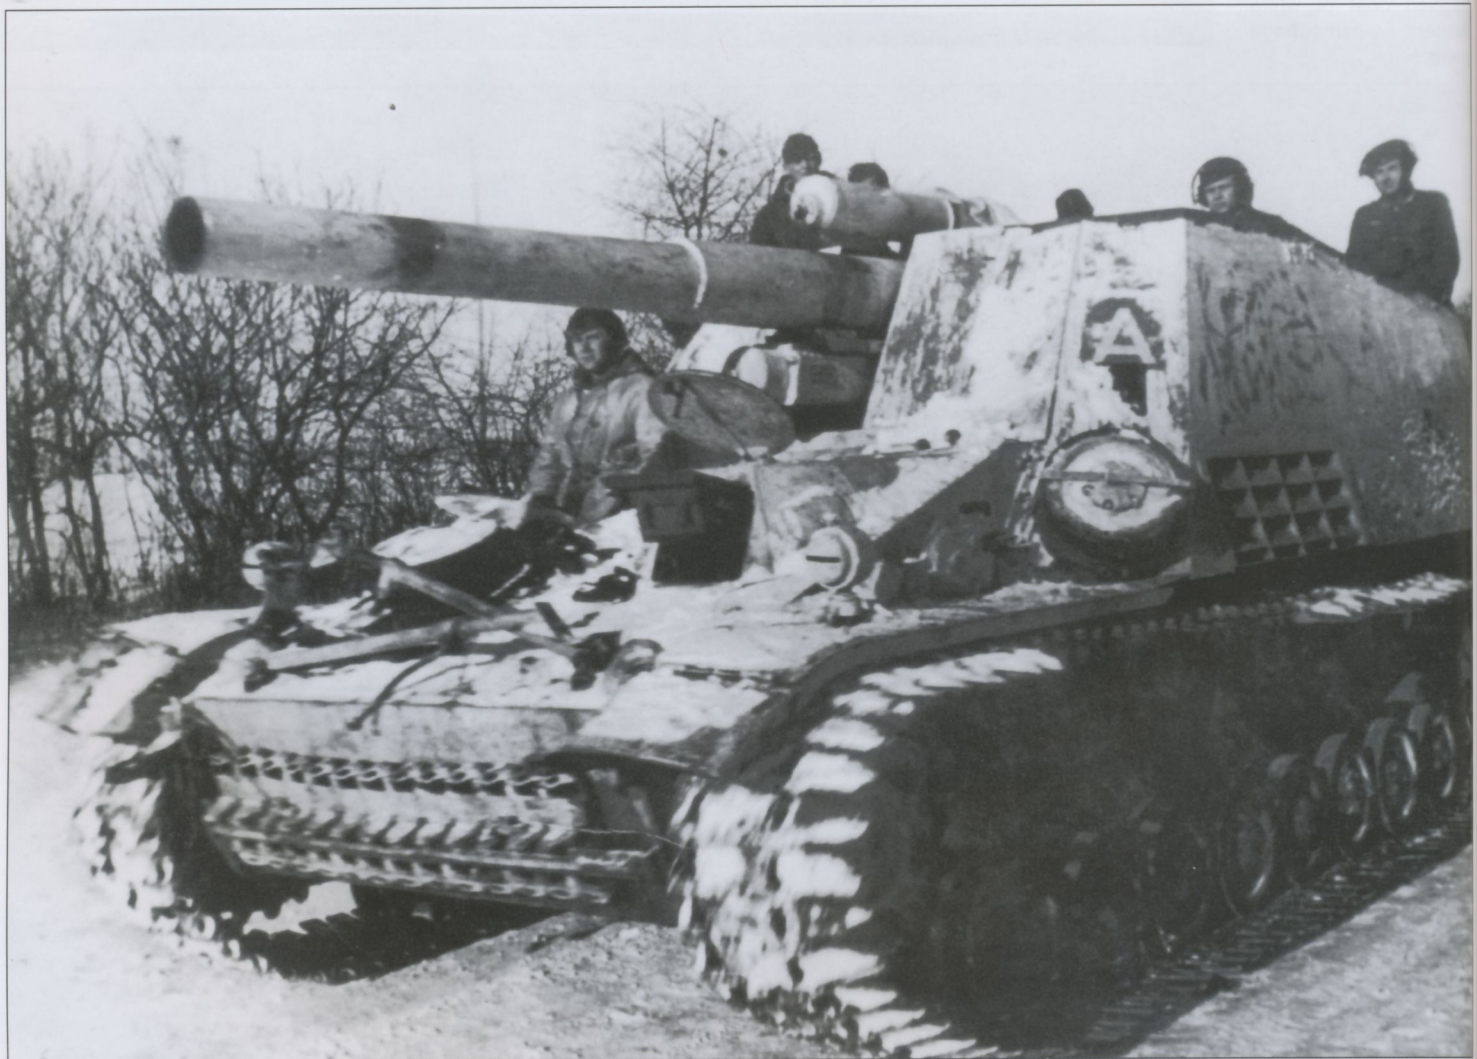
This early Hummel has been fitted with the wide 'Winterkette' tracks used exclusively on the Eastern Front. In early 1944, the extended housing for the driver was extended across the full width of the hull to provide additional space for the radio operator. There were six guns in a battery and it was common to see the position of each gun identified by a painted letter, in this case, an 'A', indicating that this was the first gun in the battery.
