# Battle on Two Fronts

## 1944-45

Tom Cockle

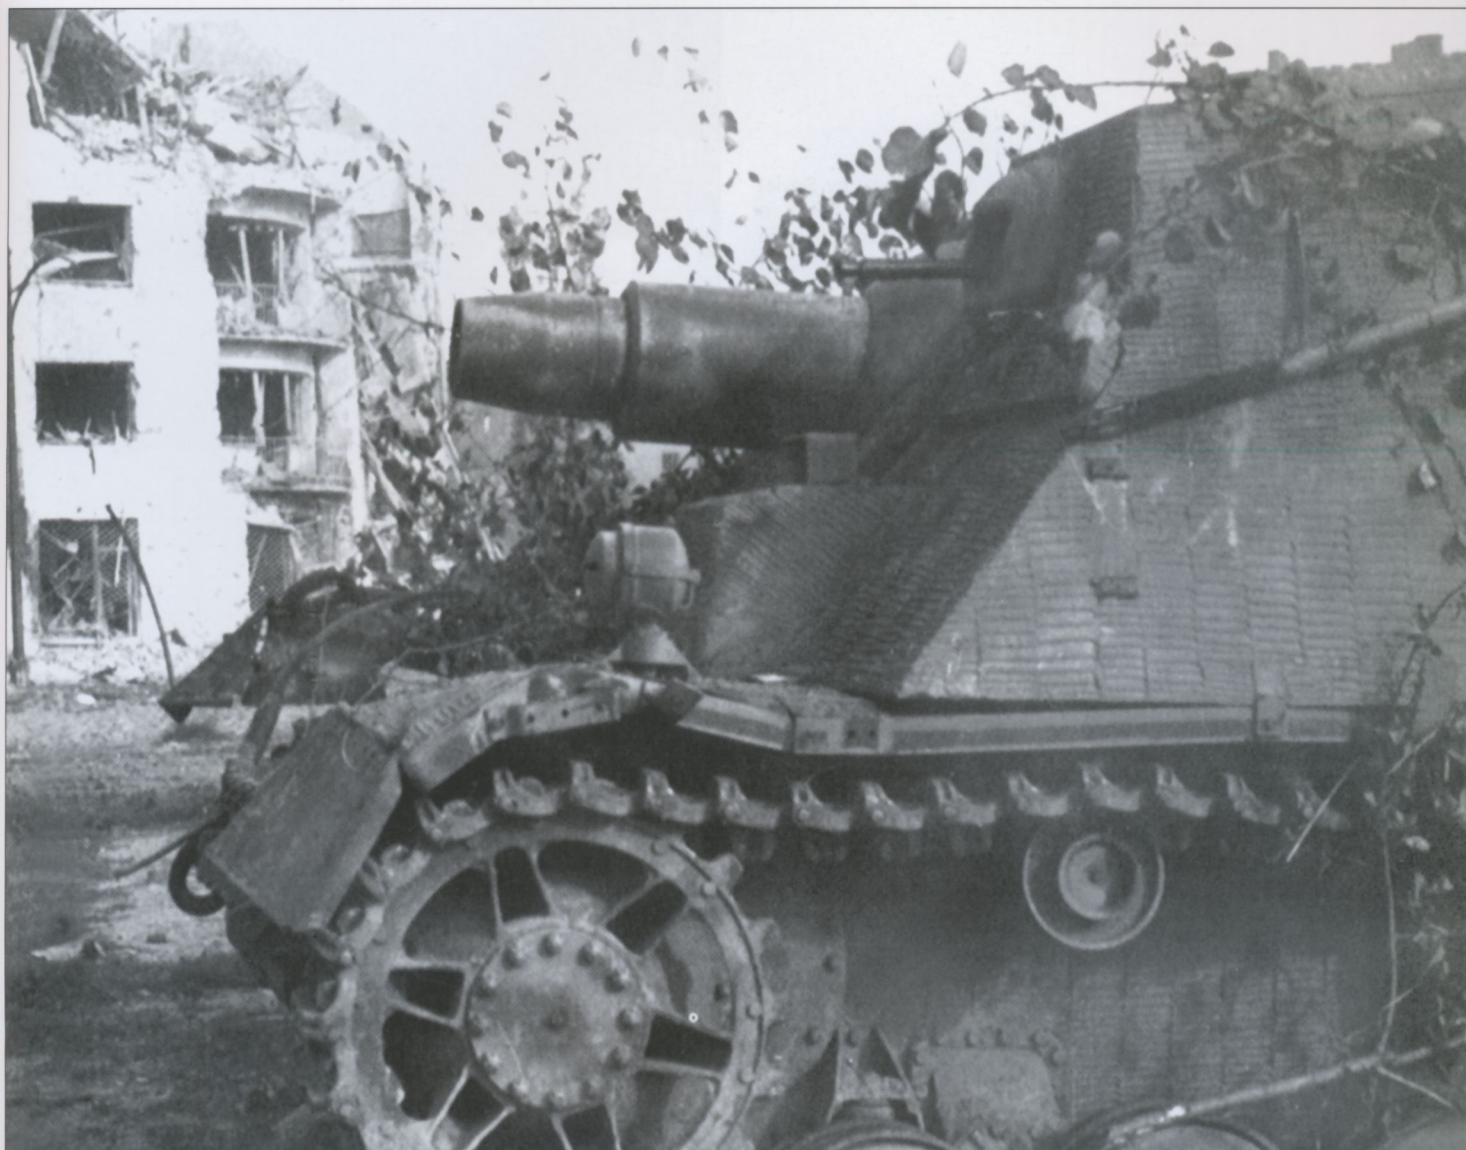
A late production Sturmpanzer IV (Sd.Kfz.166) 'Brummbär' from Stu.Pz.Kp.z.b.V.218 photographed in Warsaw, Poland during the summer of 1944. This unit was formed in early August 1944 and transferred to Army Group Center with 10 Sturmpanzer IV to assist against the uprising. The unit was destroyed in January 1945 before it could be fully organized as Stu.Pz.Abt.218.

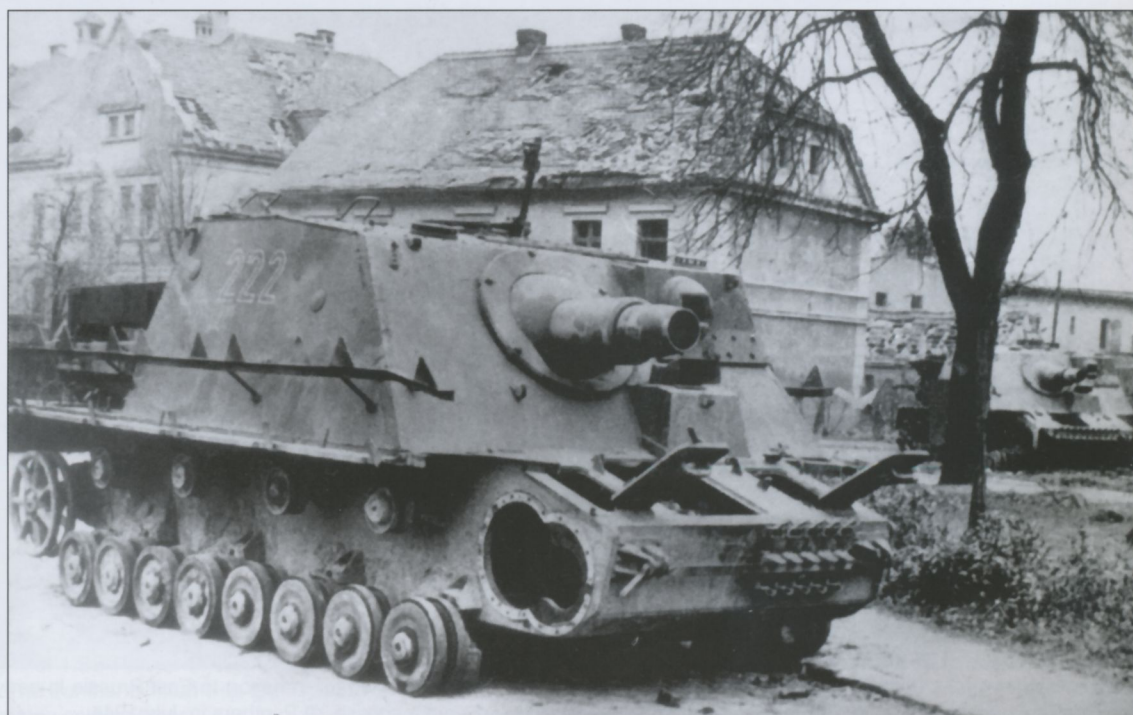
A pair of late production Sturmpanzer IV 'Brummbär' knocked out somewhere on the Eastern Front in the spring of 1945. These vehicles were manufactured sometime after September 1944 when the application of Zimmerit was discontinued. Of particular interest is the unusual return roller mounts on the nearest 'Brummbär'. Instead of the standard cast mount, they have been manufactured out of welded plates. This type of mount has been observed on other late Panzer IVs, including a Panzer IV preserved at a Czech museum, and is believed to have been a stopgap solution necessitated by a shortage of cast mounts.

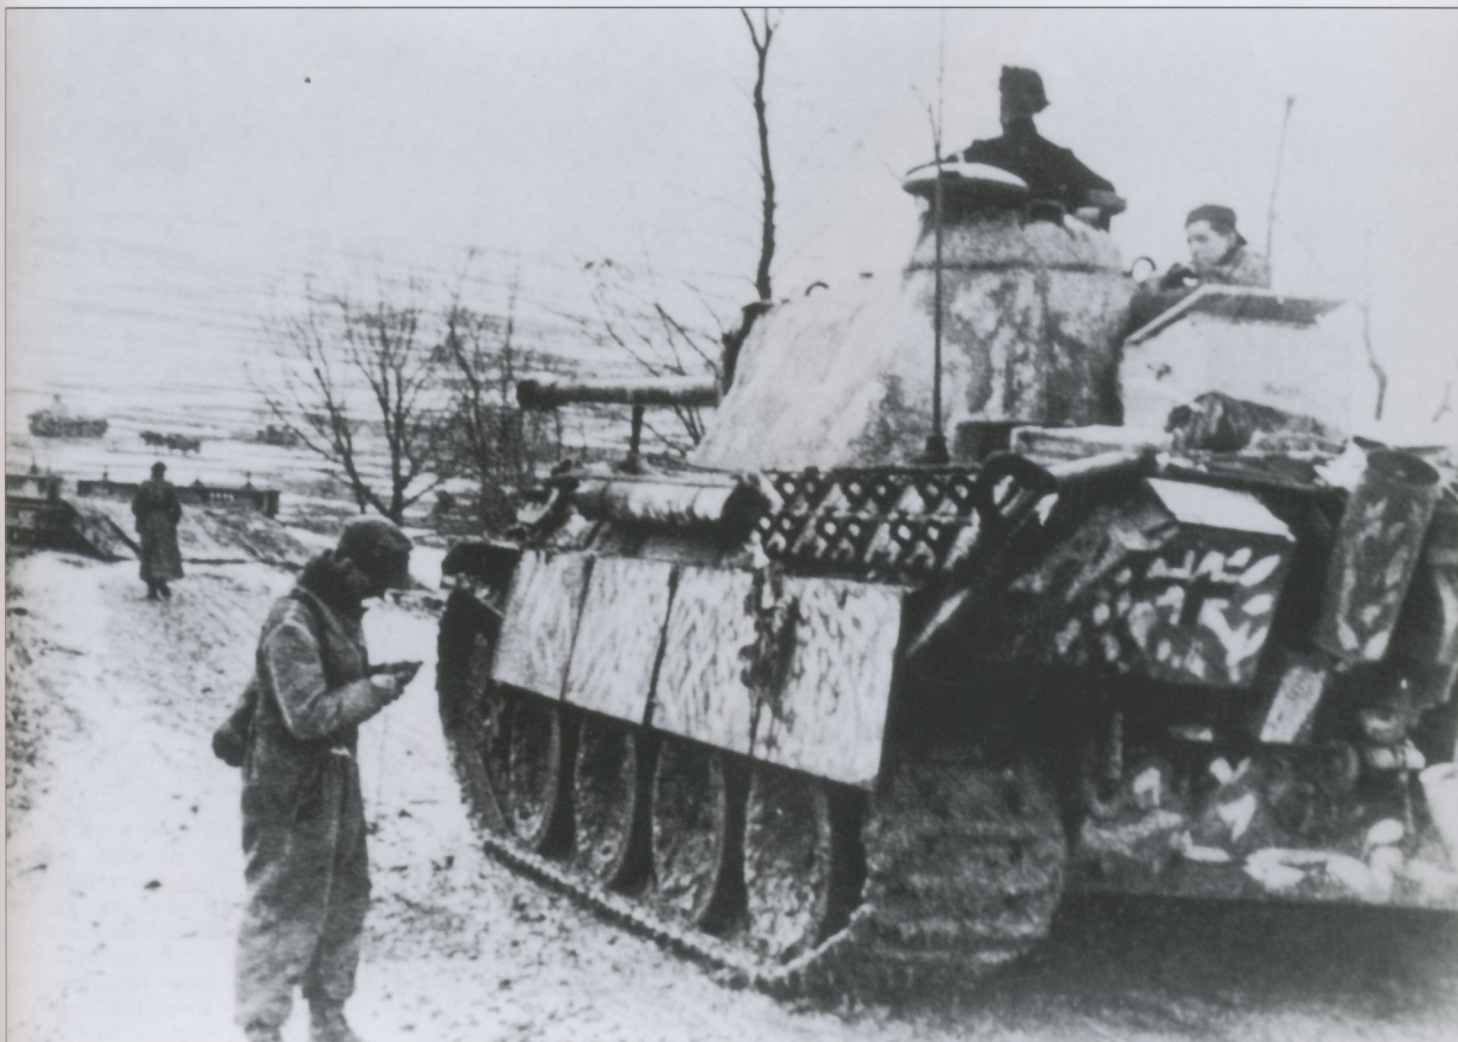
A Panther Ausf.G from I./SS-Pz.Rgt.1 of 1.SS-Panzer-Division 'LSSAH' photographed in the Gran bridgehead area of Hungary during Operation Südwind in late February or early March 1945. The Panther is fitted with the vertical 'Flammenvernichter' flame dampening exhaust and raised cooling fan tower used to provide heat to the crew compartment in cold weather.

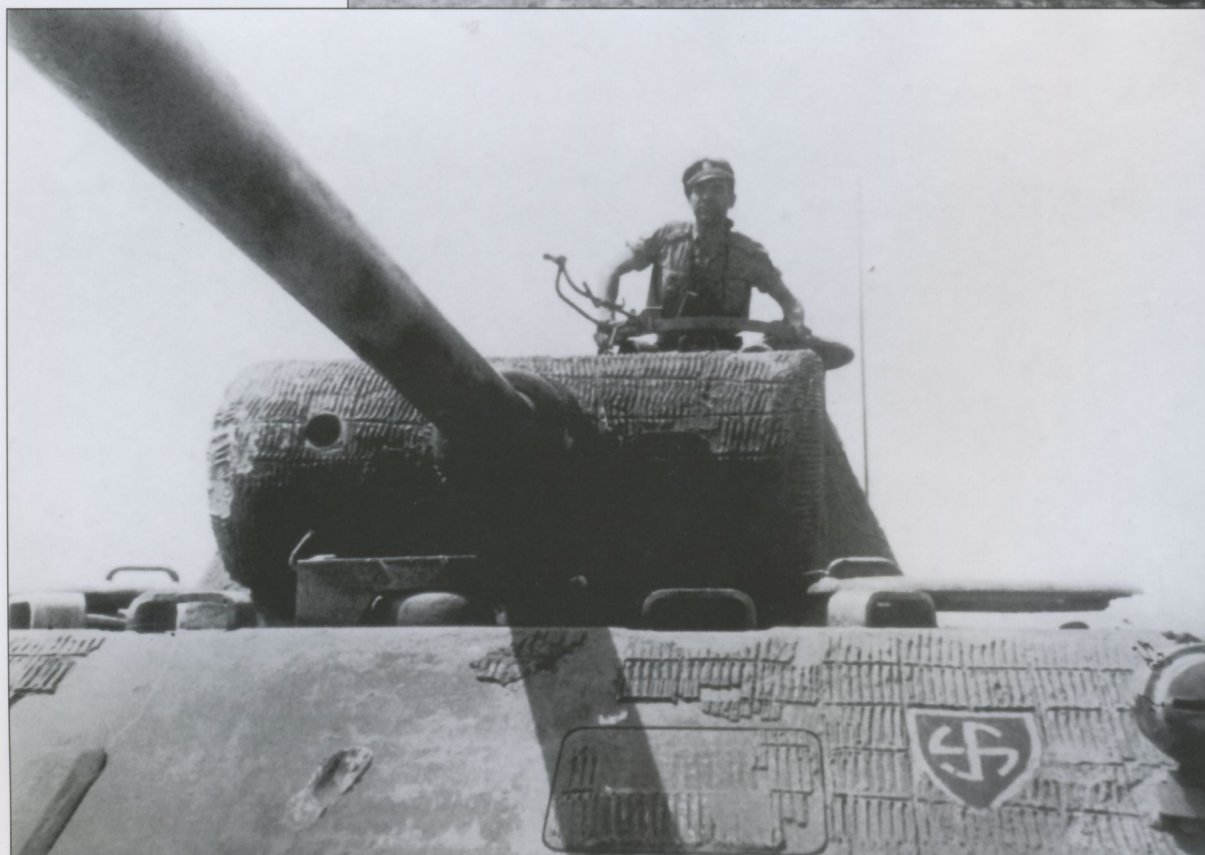
This early Panther Ausf.A from I.SS-Pz.Rgt.5 of 5.SS-Panzer-Division 'Wiking' was photographed in the summer of 1944. The divisional emblem, a rounded swastika, has been painted in white in a white outlined black shield on a bare patch of the glacis plate. Note how small arms fire and shell splinters have chipped off the Zimmerit coating leaving areas of bare steel and red primer.

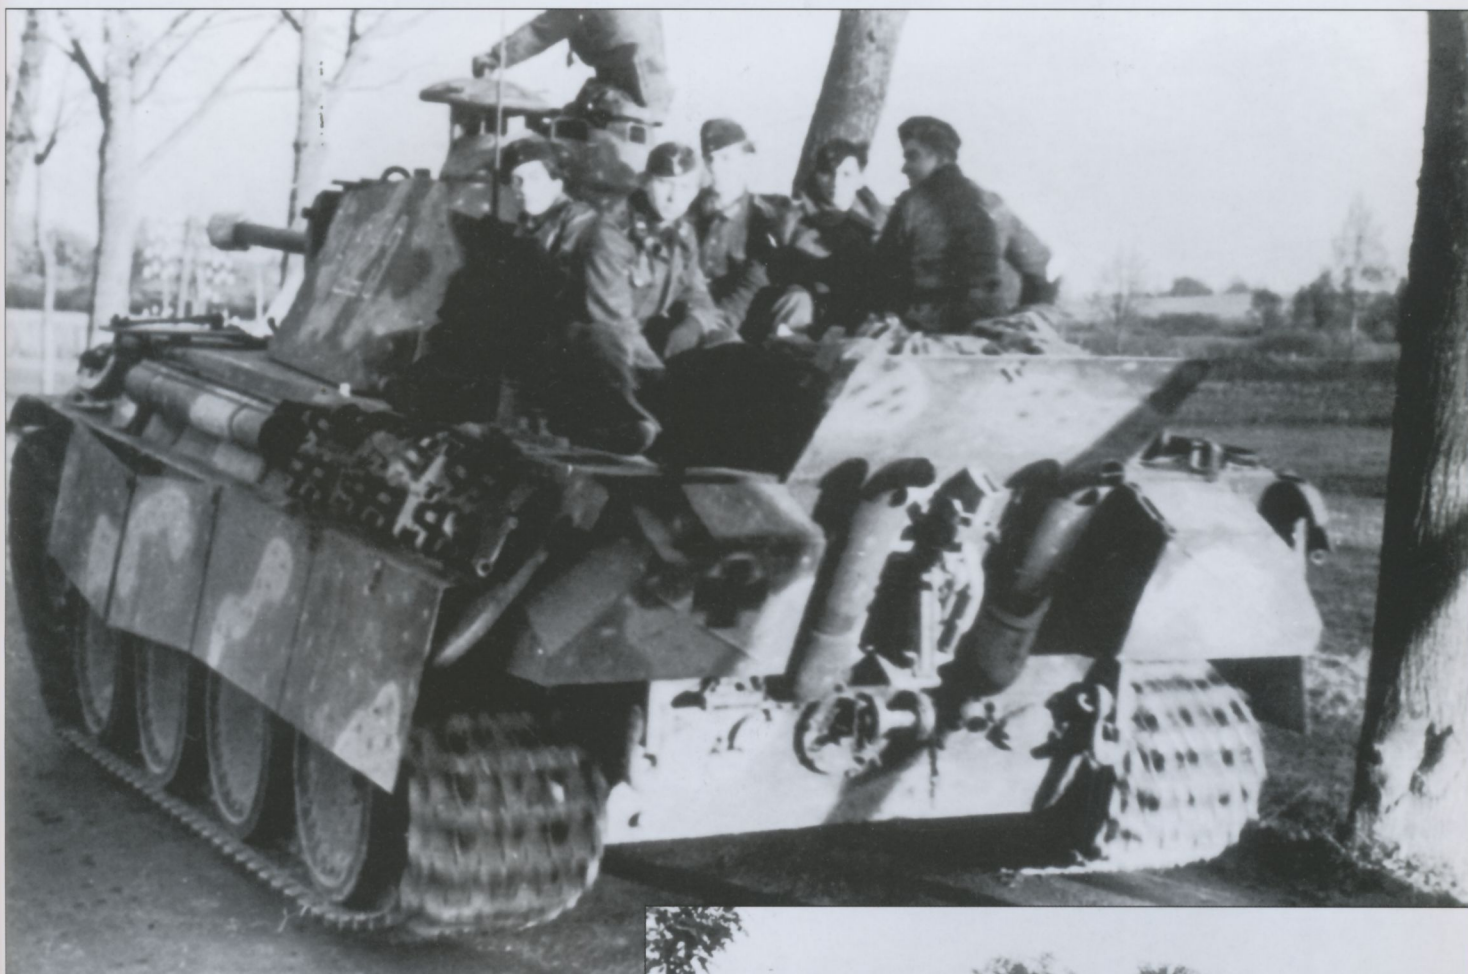
Another Panther Ausf.G from I./Pz.Rgt.31 of 5.Panzer-Division. In this photo, the white outlined red numbers on the turret are more apparent. Also of note is the red outline painted around the national cross on the rear stowage bin. This is a peculiarity seen on many Panzer IVs and Panthers of this division.

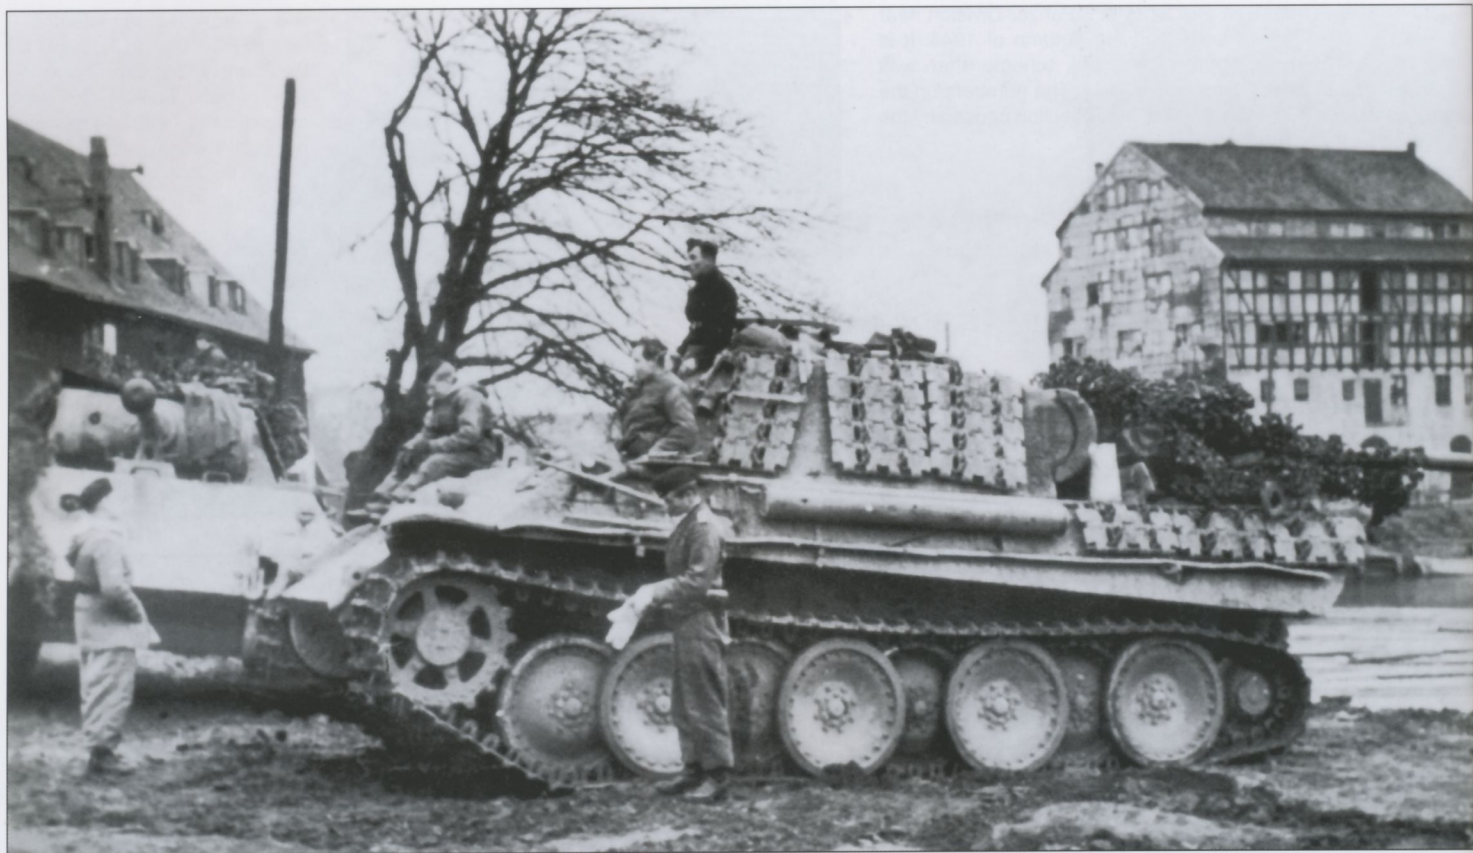
A Panther Ausf.G from an unknown Army unit, photographed after arriving at the Baltic port of Memel, Lithuania in early December 1944. Telltale signs of previous battles can be seen in the form of shrapnel holes in the gun cleaning rod storage tube mounted on the side of the tank. Russian forces surrounded the port in October 1944 and strong German resistance prevented them from taking the city until 27 January 1945.

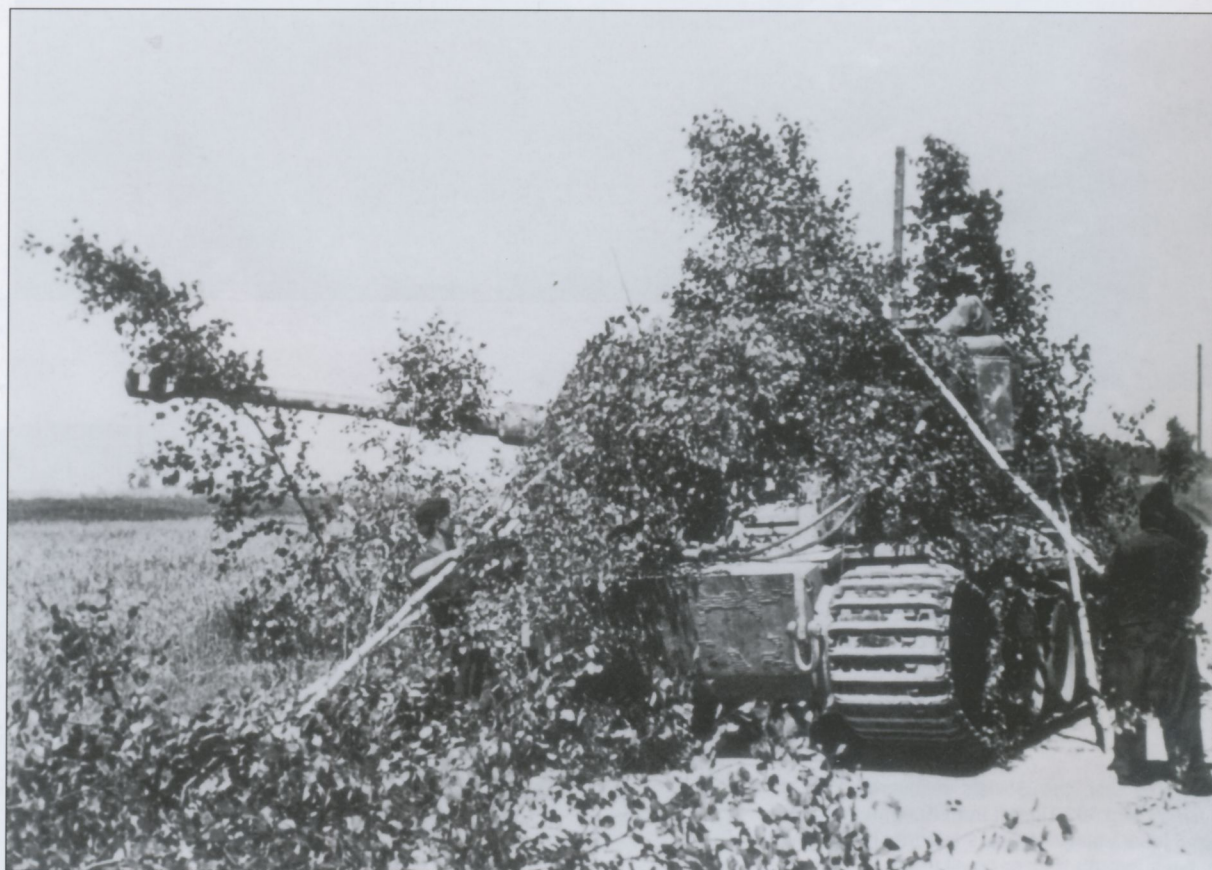
The crew of this mid-production Tiger I from an unknown unit, work to cover their vehicle with cut foliage to help camouflage it from air attack. The rubber tired road wheels and the shape of the front towing point identify this Tiger I as being manufactured before January 1944.

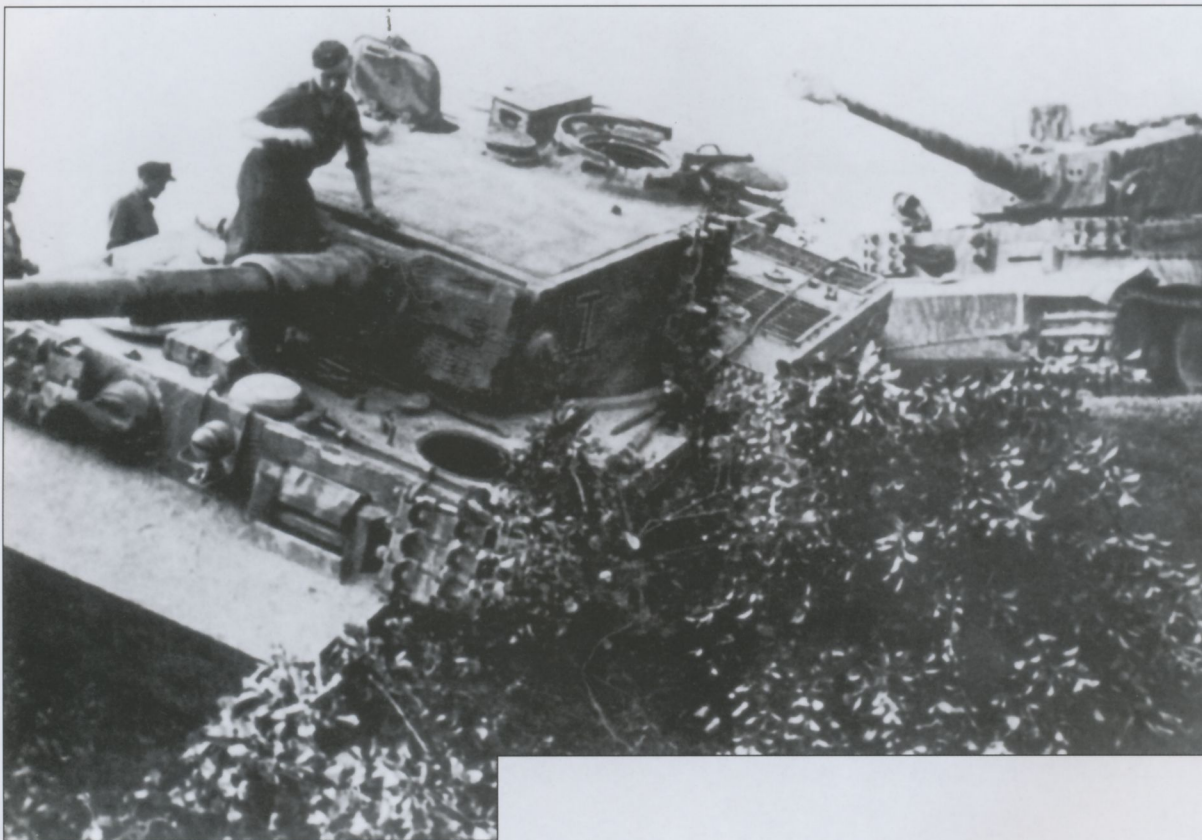
This Tiger II from 3./s.Pz.Abt.501, is pictured here abandoned after the fighting in the Weichsel bend on 2 October 1944. At the beginning of October, the unit received some Tigers transferred from s/Pz.Abt.509, which brought their complement up to 36 combat ready tanks.
