# **German Armored Trains** in World War II Eisb.Panzerzug 2

Vol.II

Wolfgang Sawodny

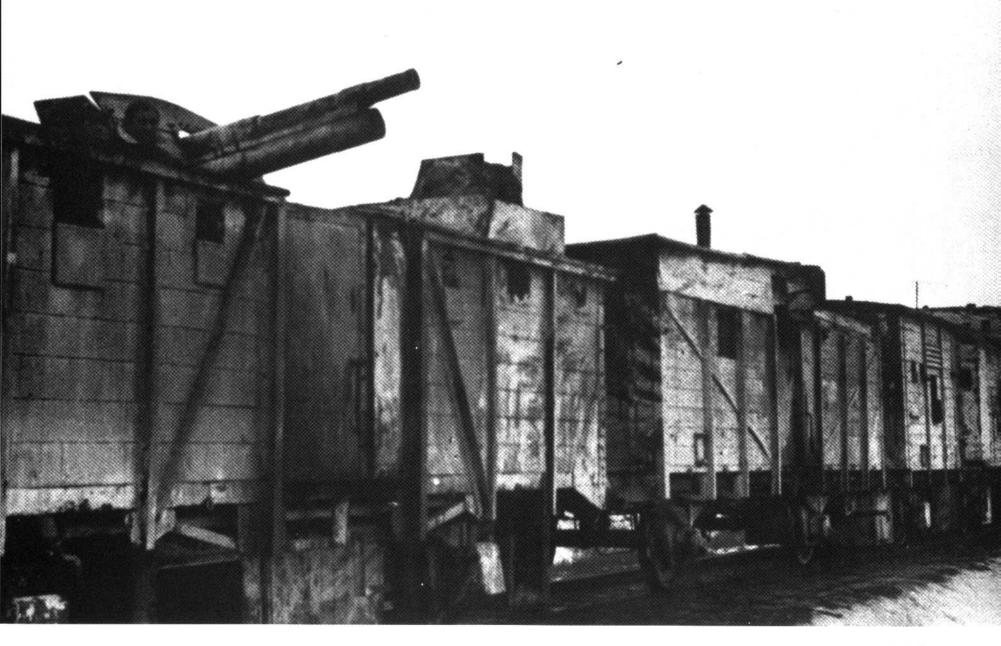
Armored Train No. 7 (see also Vol. I, p. 23, below) retained its "freight-train look" from its railway protection days to the beginning of 1944. The 7.5-cm 02/26(p) cannon was mounted on top.(BA)

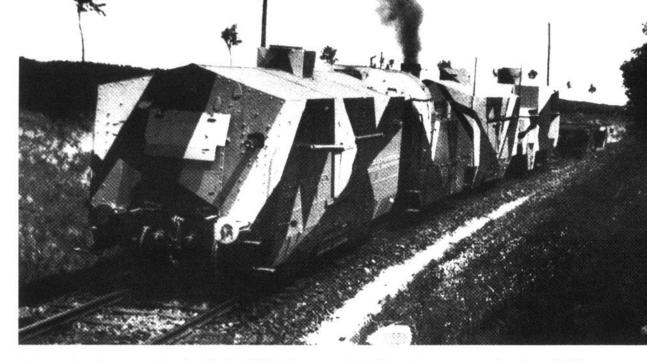
Above: Czech armored train (built 1919): the material of the three armored trains of this type was utilized as of 1940 in German armored trains 23 to 25.

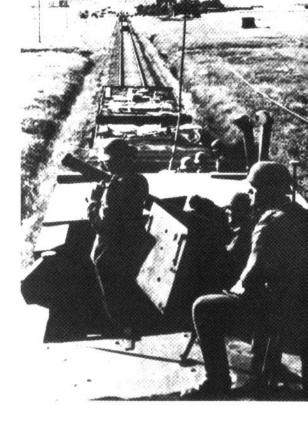
Pictures at right: Armored Train No. 6 (formerly Insterburg Railway Protection Train, see also Vol. I, pages 5 and 23, above).(BA)

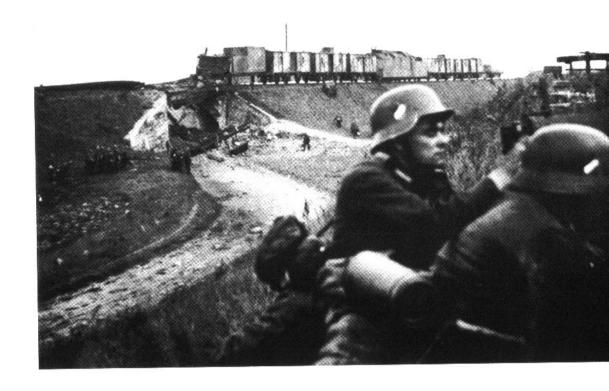
Armored Train No. 3 after the battle at Konitz on September 1, 1939. The train went from the station to a blown-up bridge, where the pusher car fell off and the gun car was derailed. The train, thus immobilized, was exposed to heavy Polish fire, traces of which can be seen clearly in the lower picture. The almost undamaged armor plates behind the shattered woden freight-car walls are also easy to see.

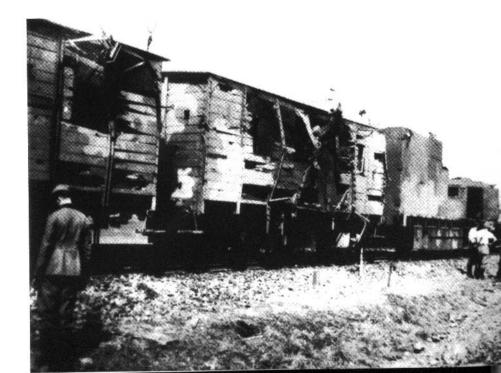
Above: Two more pictures of Armored Train No. 3 at Konitz. After being hit by artillery fire, the ammunition in one of the gun turrets blew up.(SA)

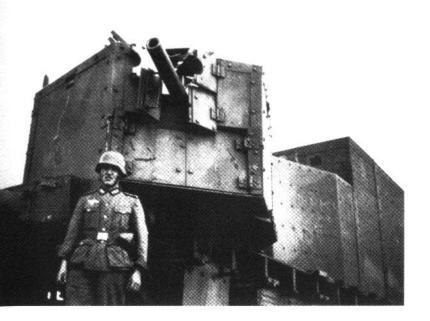
Below: The Commander of Armored Train No. 3, Oberleutnant Euen, was killed by this direct hit of an antitank shell on the observation turret on September 1, 1939.(SA)

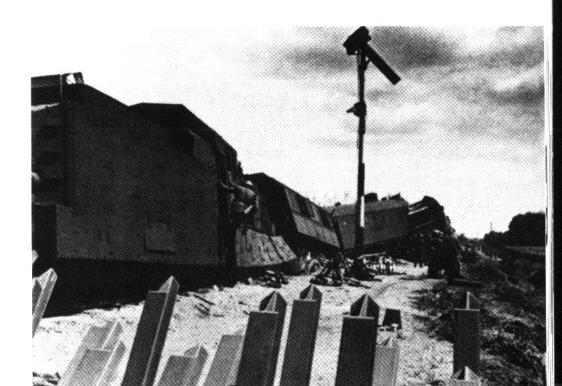
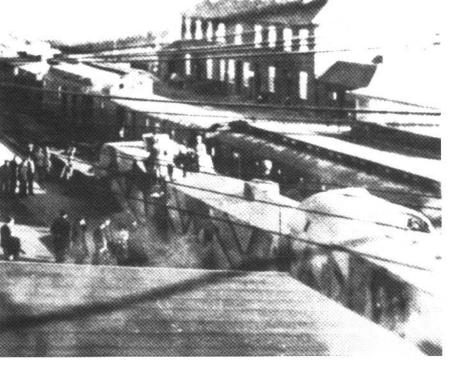
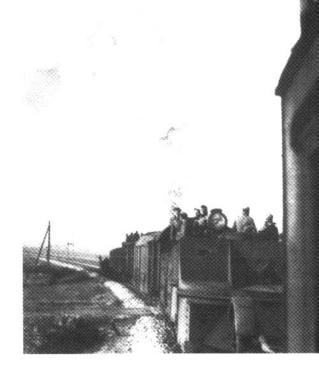
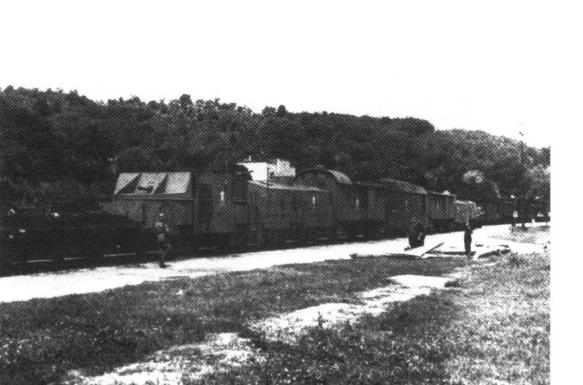
Pictures of Armored Train No. 23, assembled from captured Czech rolling stock. Upper left: The train in Denmark in April of 1940, still in Czech camouflage paint. The other pictures show the train later in the Balkan area. Along with the Czech armored cars, two internally armored freight cars (as in the railway protection trains) were added. The locomotive is German, of Series 93 (No. 220). For other pictures see Vol. I, page 9.(1 x ML, 3 x SA)

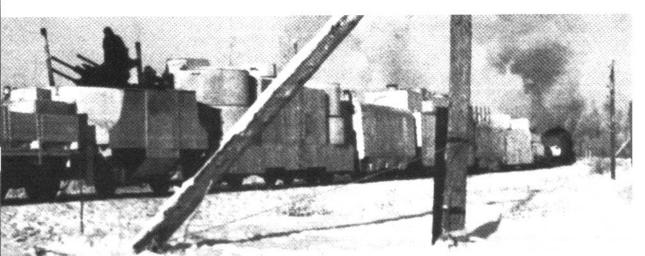
Armored Train No. 21 consisted of rolling stock from four Polish armored trains. The pictures show it in three cities. Above: Shortly after it was established, in the summer of 1940; the small gun car is still missing. Center: In France in 1941-42, still with a Polish locomotive; 2-cm anti-aircraft guns on low-side cars in front of a small gun car. Below: In Russia, 1943, a German Series 93 armored locomotive, small gun car: quadruple anti-aircraft guns instead of a gun turret.(SA)

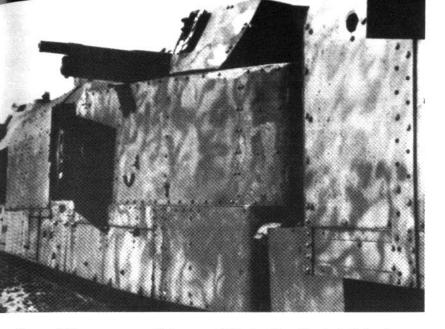
Above: The gun cars of Armored Train No. 21. At left is the streamlined car from the Twenties. In front is the 7.5-cm F.K. 02/26(p), in back the 10-cm light F.H. 14/19(p). At right are the one- and two-turret old-type cars (1918-19). Armored Train No. 22, also consisted of captured Polish equipment, also had such cars (see Vol. I, pp. 7 & 8).(SA)

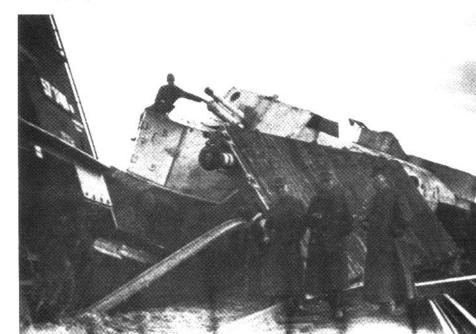
Lower left: On October 7, 1943 Armored Train No. 21 ran onto a mine between Rechiza and Vassilievici, which caused the front half of the train to be derailed. Lower right: On June 23, 1944 a similar accident occurred to Armored Train No. 21 near Kola (southeast of Minsk).(SA)

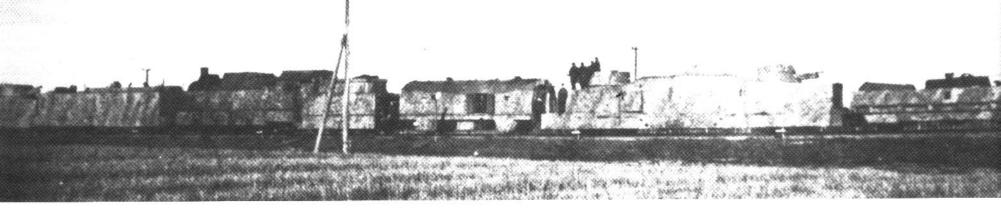
Above: From the same Polish rolling stock, which in this case fell into Russian hands in September of 1939 and then was captured by the Germans at Lemberg in June of 1941, Armored Train No. 10 was made; this is Train 10a (see also Vol. I, page 11).(SA)

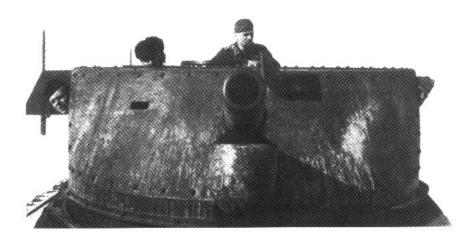
Left: Front view of the gun turret with the 10-cm light F.H. 14/19(p) of this train.(SA)

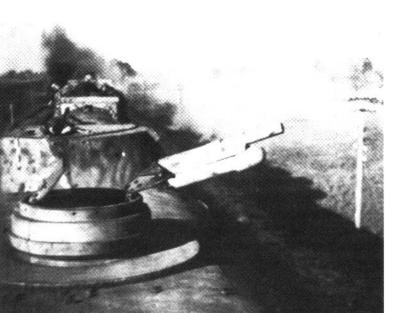
Train 10a in action. Left: The Polish-type light field howitzer can be recognized here too. The original observation turrets have been replaced by German tank cupolas, such as were used on Panzer III and IV tanks. On March 16, 1944 this train (meanwhile Armored Train No. 10) was surrounded in Kovel. The picture shows it firing (here the 7.5-cmF.K. 02/26(p)) on the railway station there, where it was badly damaged by bombs on March 21.(1 x SA, 1 x BA)

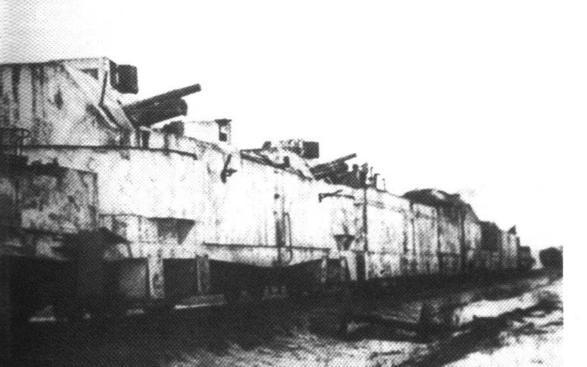
Armored Train No. 10 at first included a second battle train (10b). Its early history was the same as that of Train 10a but went back even farther, for the Poles had captured the gun cars of this train from the Soviets in 1920. Later this train, 10b, became the independent Armored Train No. 11 (see also Vol. I, p. 12, above).(1 x SA, 1 x BA)

Below: These two photos from the "Deutsche Wochenschau" of January 1943 show the 7.5-c, F.K. 02/26(p) of Armored Train No. 10b at the times of firing (above) and maximum recoil (below).(BA)

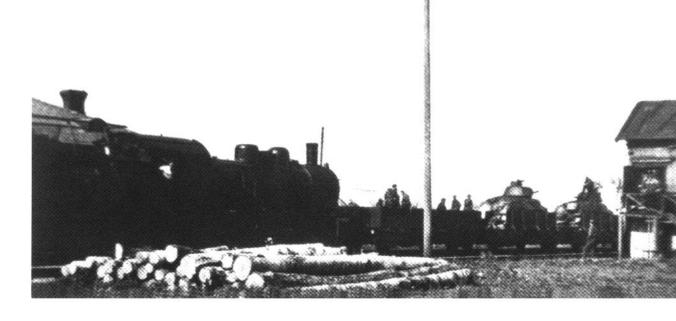
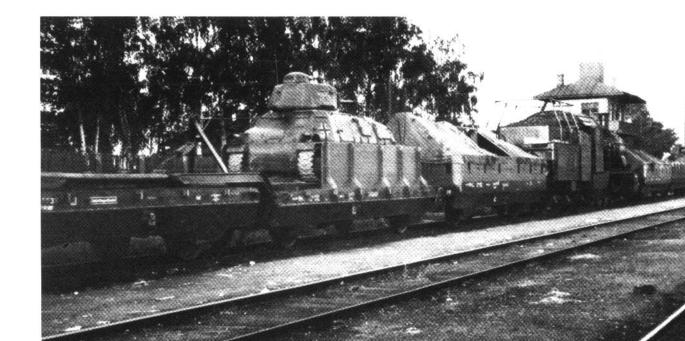
The auxiliary broad-gauge armored trains prepared for the Russian campaign, that consisted only of tank-carrying cars with removable captured French Somua S 35 tanks, infantry cars open at the top, and a Series 57 locomotive with only its cab armored. Above is Armored Train No. 28 (Army Group Center).(1 x SA, 1 x BA)

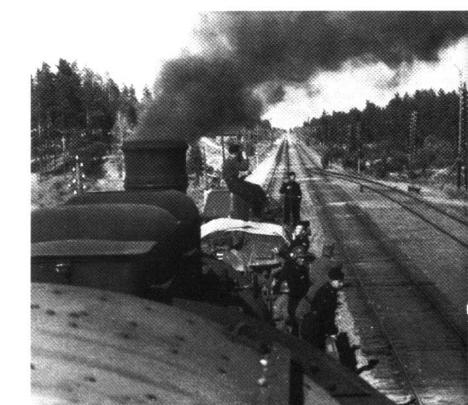
A view from the tender of broad-gauge Armored Train No. 30 on a line leading through the endless forests of northern Russia.(BA)

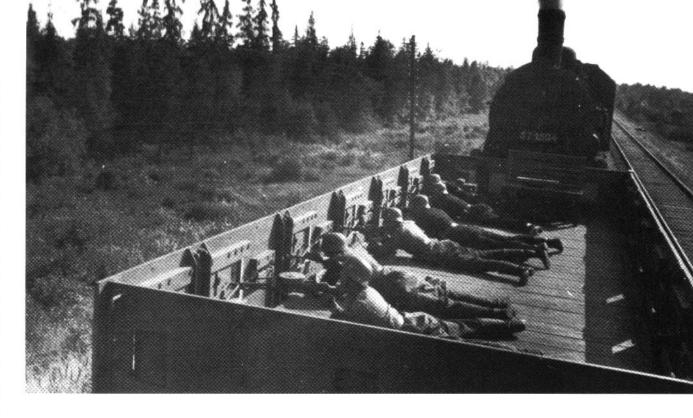
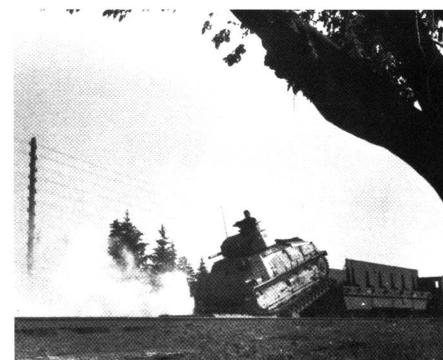
Two more pictures of Armored Train No. 30. The picture above gives an excellent view into an infantry car, whose armored walls offered protection only to men lying down. The lower picture shows the unloading of a Somua tank on an automatically lowering ramp.(BA)

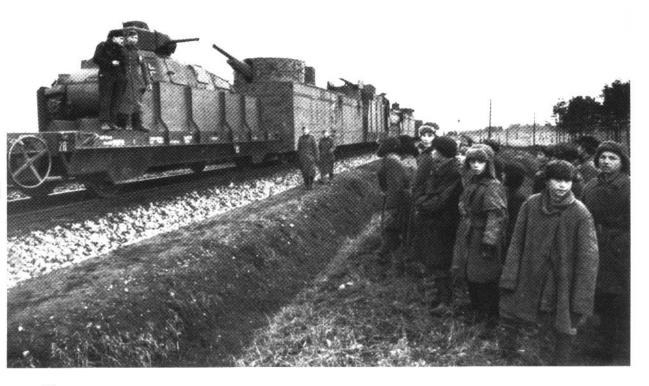
These auxiliary broad-gauge armored trains with their open infantry cars were naturally very unsuitable for the Russian winters. Thus attempts were made to improve the situation through the use of captured Russian rolling stock. The most successful of them was Armored Train No. 28, which by the autumn of 1941 had added a complete heavy Russian armored train (two gun cars, each with a 10.7-cm field gun and an armored O Series locomotive). Of the original stock, only the tank-carrier cars with the Somua tanks were retained; the infantry cars and the German locomotive were turned over to the supply train.(BA)

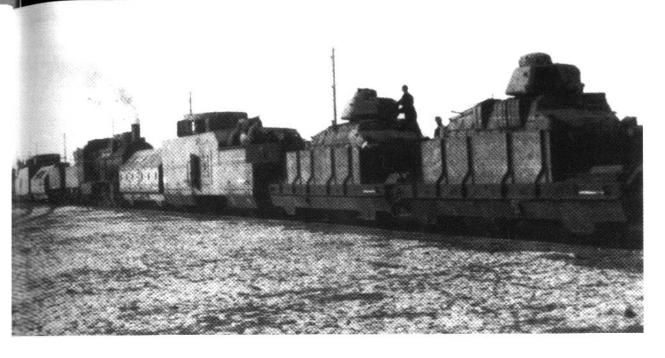
Left: With the conversion to standard gauge in the early summer of 1942, this captured Russian rolling stock was called in by the OKH. Armored Train No. 28 now ran again with its old locomotive, still only partly armored, and the old infantry cars, now at least closed in by slanted roofs, were put back into service. Two ex-Russian gun cars of a different type were added.(SA)

Below: In these gun cars, which originally had two turrets, one of the turrets was replaced by an anti-aircraft position (quadruple 2-cm guns). In the remaining gun turret there is not the usual 7.62-cm F.K. 295/1(r) cannon, but a 4.5-cm Pak 37(r) antitank gun. Behind it is one of the old

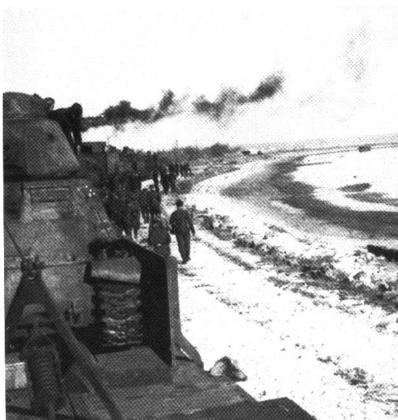
Right: Armored Train No. 27 had been surrounded at Suchinitski in January of 1942 and lost its cars. After being liberated, it was supplied with twin-turret captured Russian cars at Roslavl and, along with Armored Train No. 3, was sent to the Nevel-Velikiye Luki line to protect the supplying of the 83rd Infantry Division there (not Armored Train No. 28, as has often been stated in the literature!) On May 30, 1942 it was badly damaged by exploding mines there. The explosion of the forward gun car cost four crewmen, including the commander, their lives.(SA)

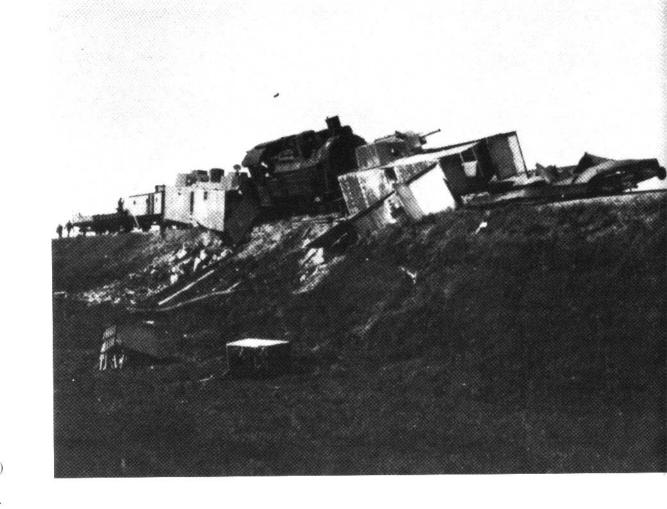
Below: Only single captured Russian cars were used in some of the other broad-gauge armored trains. Armored Train No. 26 (left) used a former gun car, one of whose turrets had been rebuilt into an anti-aircraft position, and the gun was removed from the other. In Armored Train No. 31 (right) a large four-axle infantry car was already in use in the winter of 1941-42.

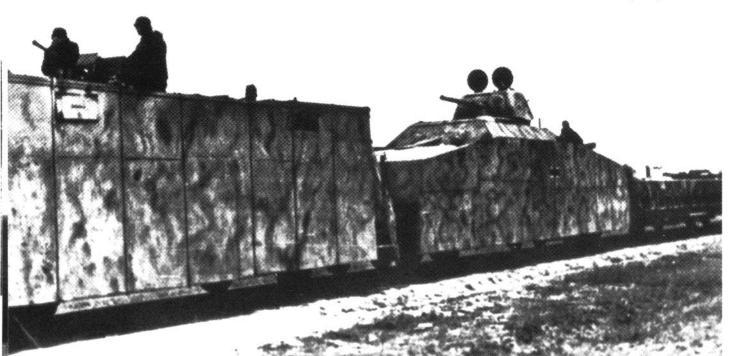
Left: The track protection train "Michael", which saw service in Crimea from November 1943 until its destruction in May of 1944, appears to have had complete T-34/76F tanks with cast iron turrets set on flatcars and surrounded by armor plate. In front is an anti-aircraft gun car armored with sheet steel.(MG)

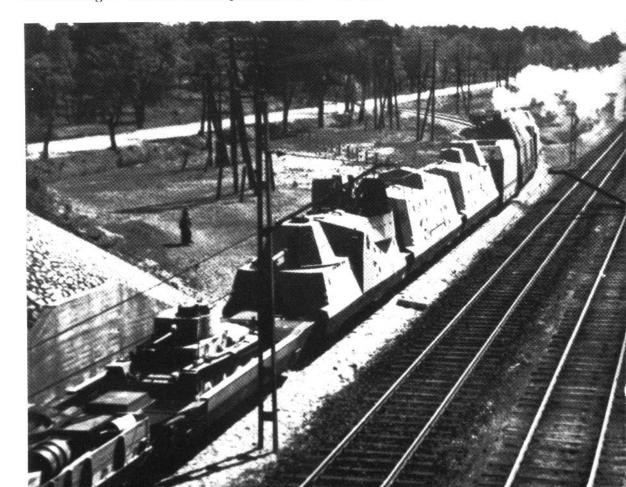
The uniform Type BP 42 armored train developed in 1942, shown at left on a siding built for test firing at the Rembertow drill facility (near Warsaw, where the armored train replacement unit was located). At right is a similar train in Russia during the winter of 1943-44.(SA)

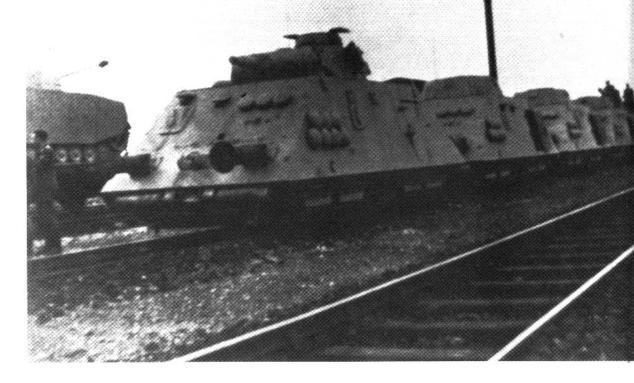
The front half of a heavy scout train (as delivered as of November 1944). Originally it was to consist of twelve cars with individual powerplants, but it actually was made up of only eight cars, of which the two gun cars were equipped with Panzer III N turrets (with 7.5-cm KwK short).(SA)

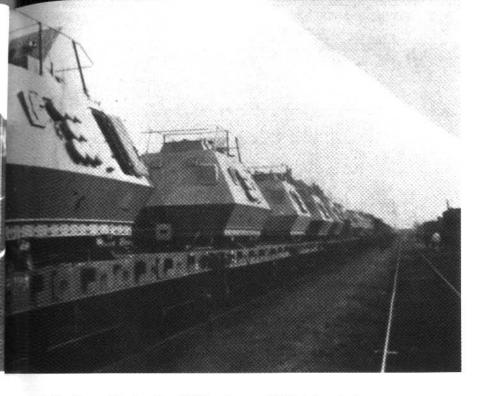
Light Scout Train No. 303 in June of 1944, loaded on flatcars for delivery to the Balkan area.(SA)

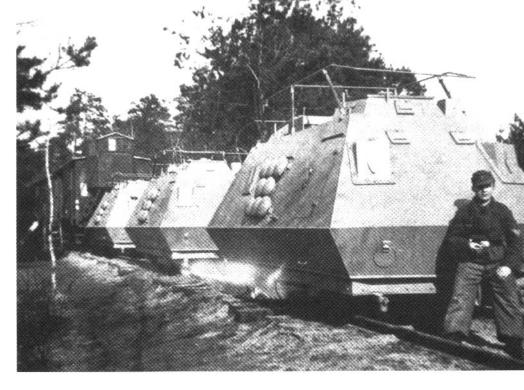
Three cars of Light Scout Train No. 303. The complete train consisted of ten cars of this type, usually used singly or in pairs (for mutual assistance).(SA)

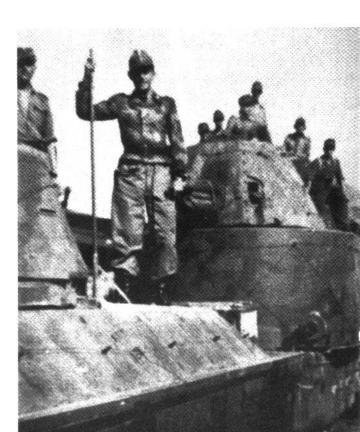
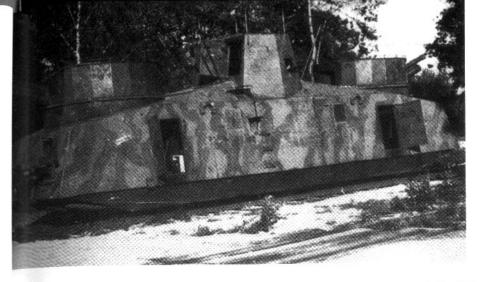
At left is the former Track Protection Railcar No. 15. From August 1943 to February 1944 it was used in Greece as a separate entity, with six Panhard scout cars.

At right is Armored Railcar No. 16. This was originally planned as a Diesel locomotive for an armored train. With its 550 horsepower and 100-mm side armor plate, it was the most heavily armored railway vehicle of the German Wehrmacht.(SA)

continued, the anti-aircraft guns were replaced by uniform rotating turrets (as on BP 42) with 7.62-cm 295/l(r) cannons, and the vehicle was put into service at the beginning of 1944 as Armored Railcar No. 16. It was captured by Polish units near Neu-Ruppin early in May of 1945 and is in the Warsaw Railroad Museum today, one of the few formerly German rail vehicles to be preserved. Even before - in December of 1943 — a captured Russian train, likewise with two 7.62-cm guns in rotating turrets, was taken over as Armored Railcar No. 17. It was followed by six more vehicles of the same kind (No. 18 to 23, established between November 1943 and January 1944, but only reaching the troops in the latter half of 1944).

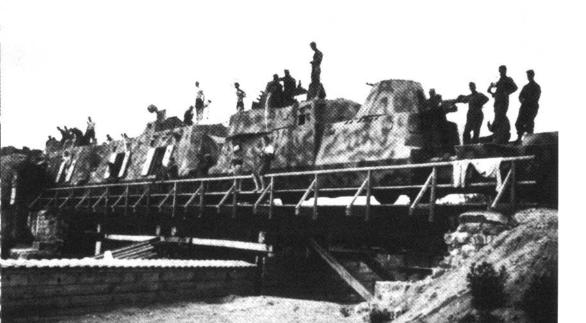
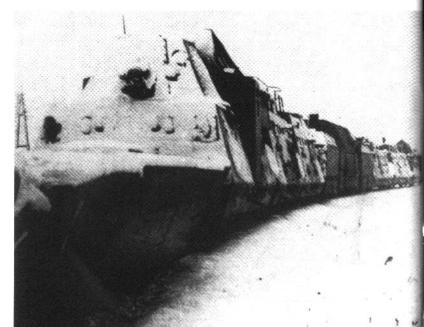
The first four armored trains of the BP 42 standard type. Above: Armored Train No. 61 in December of 1942, during testing at Rembertow. Right: Armored Train No. 62 in action near Stanislau (March 1944). Below: Armored Train No. 63 stopped on a bridge in the Volkov area in the summer of 1943. Lower right: Armored Train No. 64 in Croatia during the winter of 1943-44.(SA)

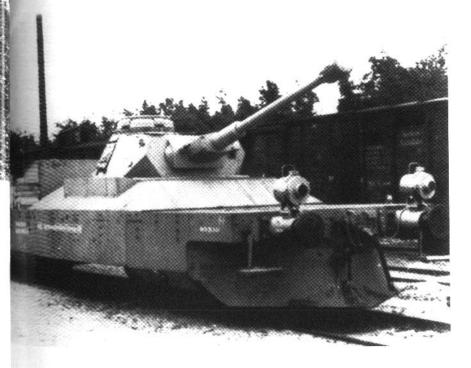
Right: The transition to the improved Type BP 44 was supposed to begin with Armored Train No. 73 (June 1944). But the intended 10.5-cm Light Field Howitzer 18M was not yet ready at first, and the earlier captured guns were used further. When Armored Train No. 74 (shown here) had to be pressed into service hastily in July of 1944 after the Russian breakthrough between the Bug and the Vistula, even the Panzerjäger cars were still lacking.(SA)

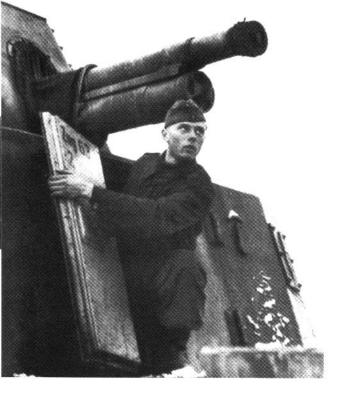
The guns of the BP 42 armored train. At left is the 7.62-cm 295/l(r) field cannon, the Russian M 02/30 with the shorter L/30 barrel (Vo 635 m/sec, maximum range 12 km); at right the Skoda 14/19 10-cm light field howitzer, from captured Polish and probably also from Czech material (Vo 395 m/sec, maximum range 9.8 km).(BA)

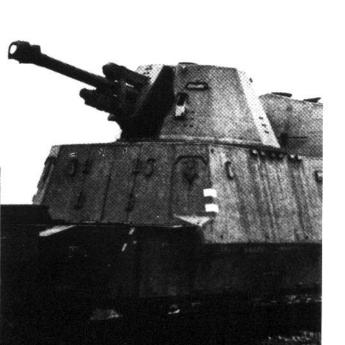
Left: For the BP 44 armored train, they were intended to be replaced by the 10.5cm M 18M light field howitzer (Vo 540 m/sec, maximum range 12.3 km). Right: The actual upgrading, though, was in the form of the added Panzerjäger cars with their 7.5-cm KwK L/48 (Vo 790 m/sec).(1 x BA, 1 x SA)

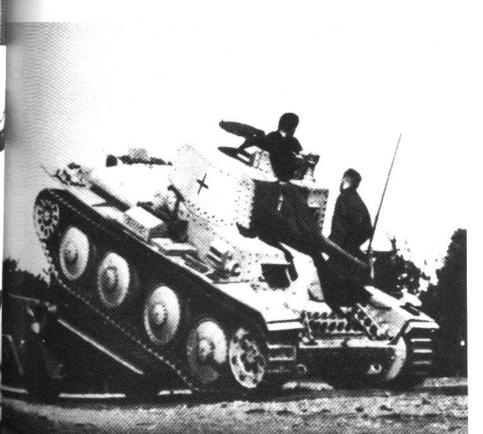
After good experiences with them in the broad-gauge armored trains, the standard BP 42 (as was the later BP 44) was also equipped with two tank-carrier cars with removable Prage 38(T) tanks. The tub-shaped cars plus a folding armored shield protected the running gear. To remove the tank, the pusher car ahead had to be uncoupled; an automatic Scharfenberg coupling was provided. The pictures above and at left show three stages of unloading. At right is the "face" of the 38(t) tank. With its 3.7-cm KwK and thin armor, it was not the equal of an enemy tank as of 1942, but was well suited to use against partisans because of its good cross-country performance.(3 x SA, 1 x BA)

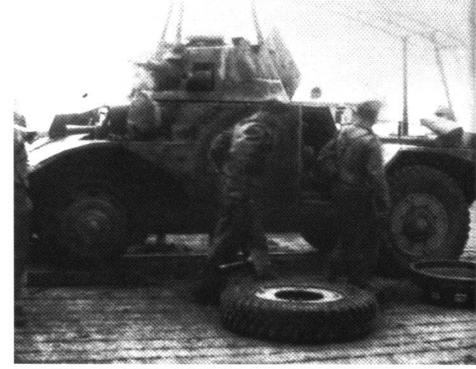
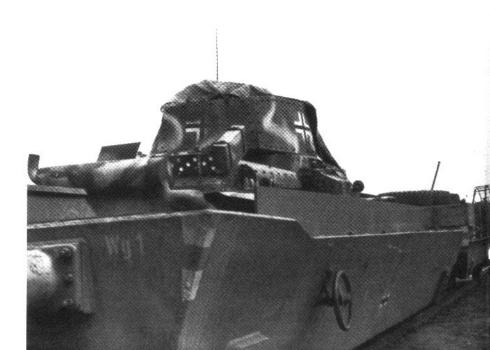
As a reconnaissance vehicle, as of the end of 1942 the armored trains used only the Panhard 38(f) scout cars captured in France in 1940; they had 105-HP rotary engines and 2.5-cm KwK guns. They could be changed from rail to road wheels or back in about 15 minutes. The pictures above and at the left show them in roadgoing form, being altered and running on rails. At right the road wheels, which the scout cars could not carry with them, loaded on the pusher car of the armored train.(3 x SA, 1 x BA)

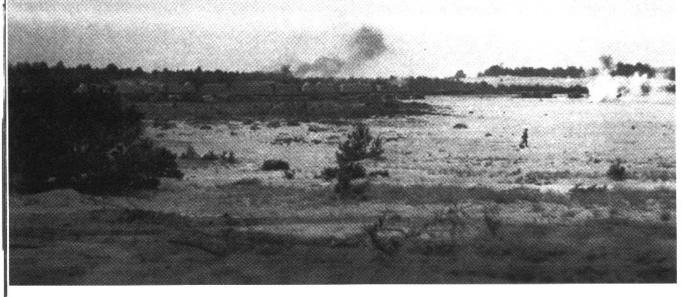
An armored train of Standard Type BY 42 at firing drill on the shooting track of the Armored Train Replacement Unit at Rembertow.(SA)

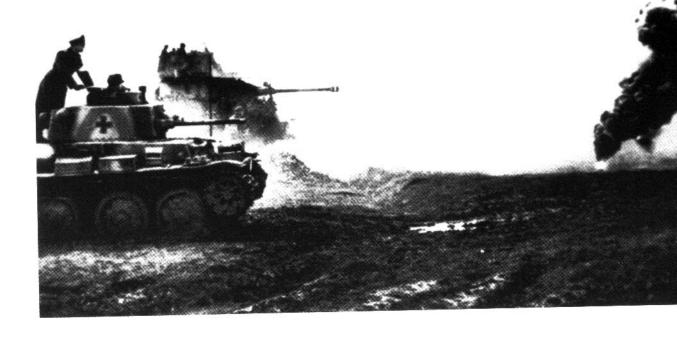
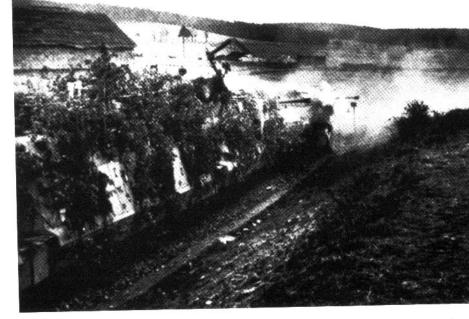
Photos of armored trains in action are very rare. The two on this page were taken during a display of Armored Train No. 76 for officers of the OKH at the Milowitz drill facility in October of 1944.(SA)

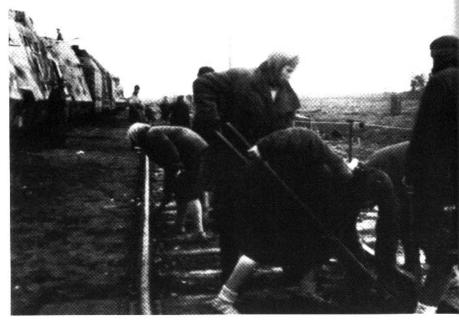
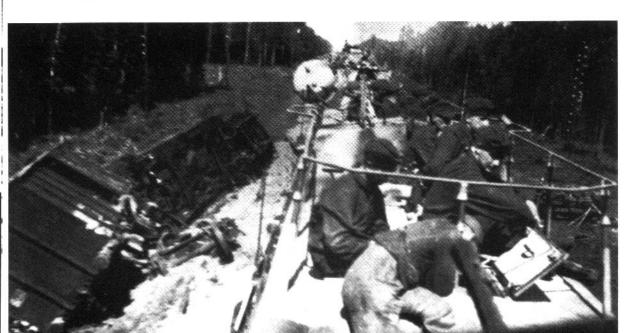
Above: Russian women were also called in for repair work, under the protection of a standard-type armored train. Below: In November of 1943 Armored Train No. 68 was able to rescue and bring back a battalion enclosed south of the Berezina Pass near Shazilki.(SA)

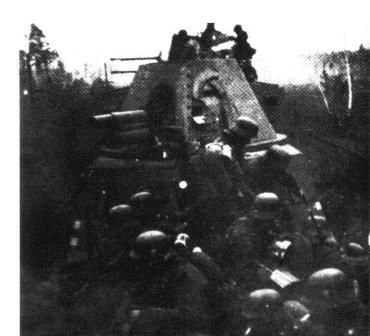
Above: A heavy shell not only shattered the barrel of this 7.62-cm Field Cannon 295/l(r) on Armored Train No. 67, but also blew up the turret. Below: After Armored Train No. 1 had already been damaged in action, another bomb hit it in Vyasma on December 10, 1942. Afterward it was built up anew at the RAW facilities in Königsberg.(SA)

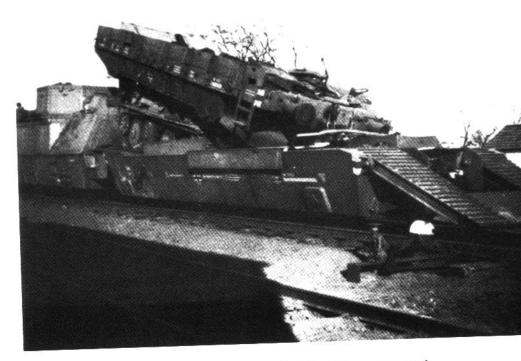
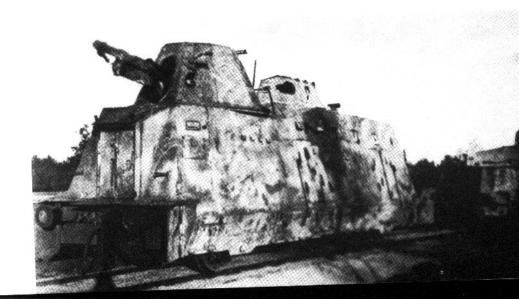
Above: On March 11, 1944 Armored Train No. 30 was rammed by an ammunition train at Lozinko (north of Nikolaiev). The pusher car was pushed up onto the tank-carrier car. Below: What remained of an armored train damaged in a fight with Russian tanks.(1 x SA, 1 x KR)

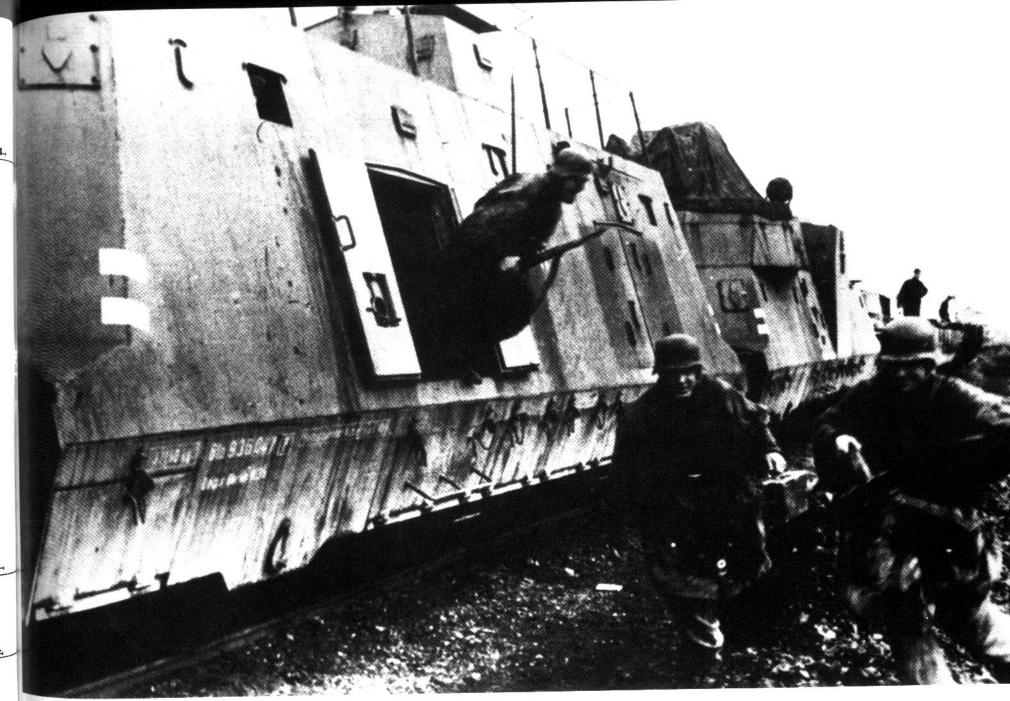
Winter 1943-44 in Croatia. The infantry group of Armored Train No. 64 disembarks for action.(BA)

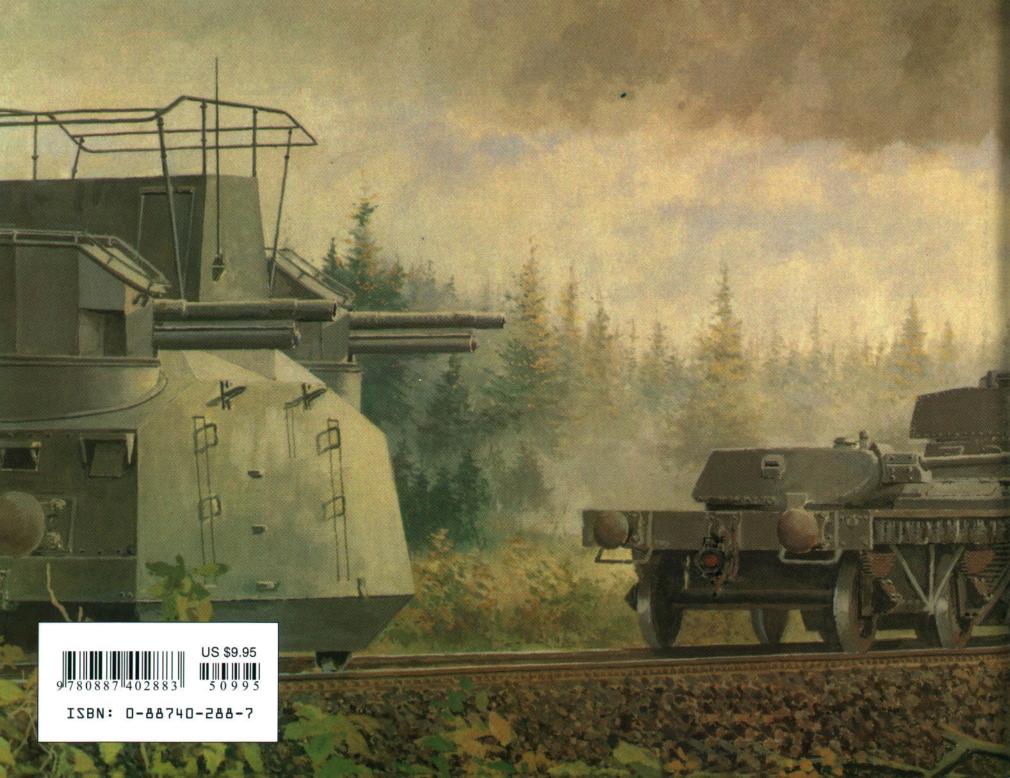
Composition of German Armored Trains from 1941 to 1945
