German Armored Units at **Arnhem**

September 1944

Marcel Zwarts

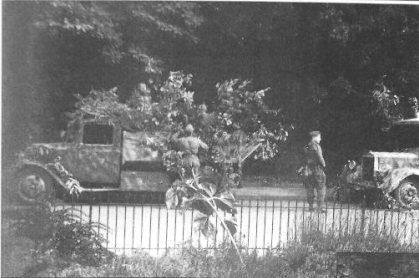
The third lorry to be photographed is this Lkw. 31, Opel Blitz (4x4). This also belonged to SS-Btl. Krafft. The truck has no rear mudguards and is painted dark yellow overall, with no camouflage. A huge camouflage net is thrown over the lorry to provide some much-needed cover. (Mrs A.L.A. Kremer-Kingma, Municipal Archives Renkum)

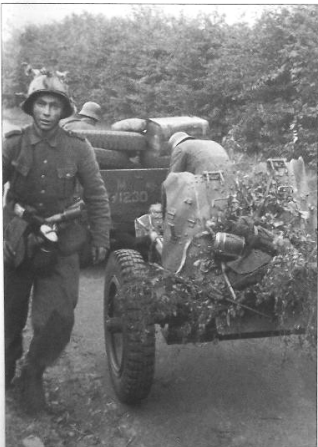
SS-Btl. Krafft's Stabs-Kompanie possessed the unit's heavy weapons. This obsolete 3.7cm Pak 35/36 anti-tank gun, of which there were two, belonged to this unit. They also had a few Werfer Rahmen and two 2cm Flak guns, which were mounted on a lorry or half-track. These two photos were taken on Wednesday the 20th in the Dreyenseweg area in north Oosterbeek. The gun is painted in the usual three-color camouflage scheme. (BA 2K BK771/26+27)

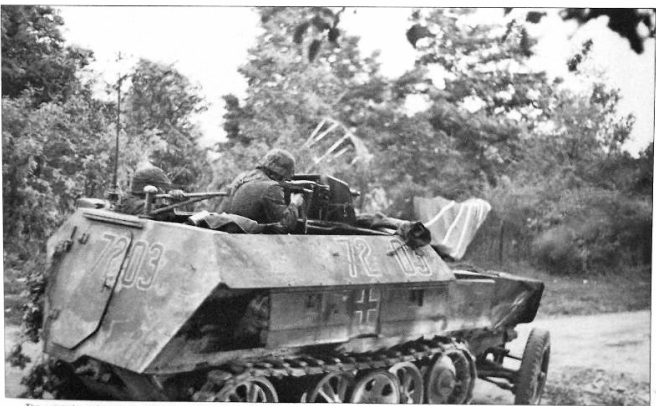
The painted number on the SPW is probably black with white edging. It was obviously painted in a rush because it is not so neatly finished. The camouflage pattern consists of a dark yellow base with red-brown and green flecks. The camouflage is further reinforced by the many grease and oil stains. Despite its worn condition, this Sd.Kfz 250 could still provide formidable opposition to the lightly armed parachutists. (BA 2KKB771/30)

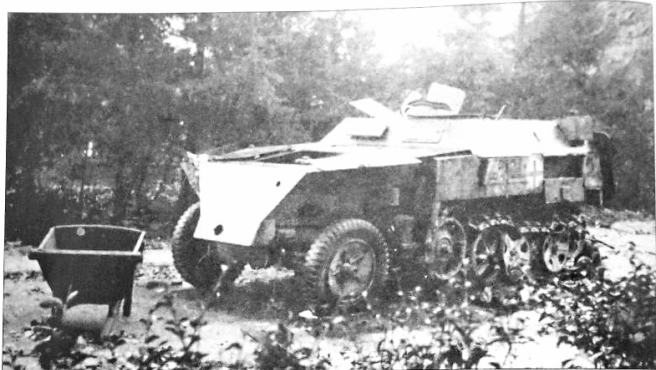
This Sd Kfz 250/3 'neu' of SS-Pz.AA.9, put out of action on 20 September, was photographed in October 1944. This was the only armored vehicle which we are certain was lost by the unit in the battle around Oosterbeek. It was in Graaf van Rechterenweg in north Oosterbeek and remained there till after the war. It is quite possible that the Hohenstaufen's reconnaissance unit lost more vehicles at Oosterbeek, but they were all probably recovered by the Germans. The Sd Kfz 250 is fitted with a rather unusual front wheel, which was provided with five reinforcing strips. Apart from the national cross, the other markings and color are indiscernible. However, it can be seen that the basic color had been dark yellow. (G. R. Castendijk, Municipal Archives Renkum)

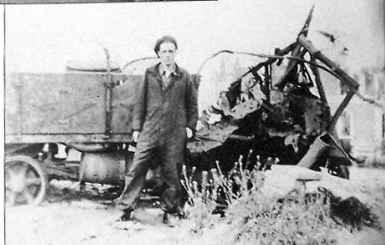
Lorries were also used in Gräbner's attack on the bridge. These oil-drum laden lorries (the oil drums serving as cover for the heavily-armed SS grenadiers) attempted in this way to reach the center of Arnhem. The photo shows that they were unsuccessful. A shell from an anti-tank weapon hit the cab and brought the Lkw. 3t, Renault Typ AHN (16) to a halt, after which it was riddled with bullets from the parachutists' hand weapons. Here, the lorry is shown next to the ramp, but during the battle it was destroyed much closer to the bridge. (Municipal Archives Arnhem B9048/2)

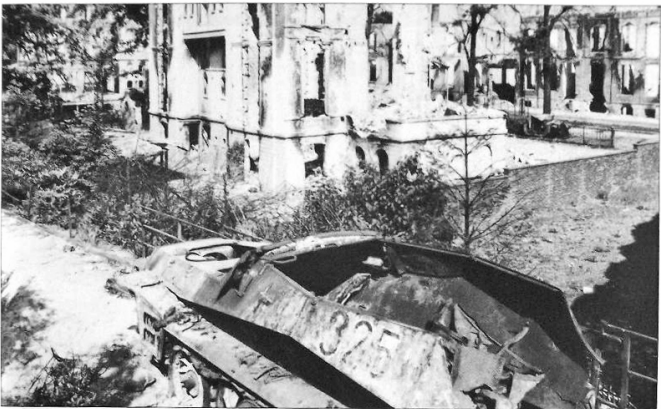
Another couple of totally destroyed trucks (07) (08). It is not even possible to identify the type of lorries involved. They did not belong to SS-Pz AA.9 but were knocked out during the night of 17/18 September by Lieutenant-Colonel Frost's recently arrived parachutists. Here they are shown on the east side of the northern ramp to the bridge. (P.J. de Booy, Municipal Archives Arnhem B1620-30-6A)

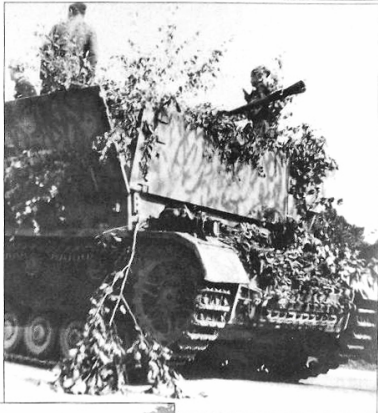
Two Möbelwagen, the one on the left has an early chassis unit, the one on the right is a later version. This can be seen by the different exhausts. The later version is probably the same vehicle that was photographed in Zutphen. Both vehicles are on Dreyenseweg and the photo was taken on Wednesday, 20 September. (BA 2KBK771/35)

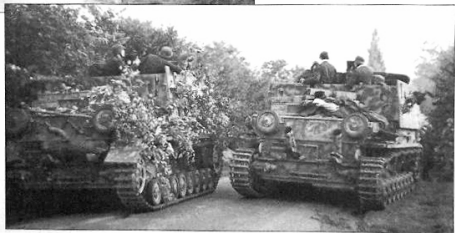
The Möbelwagen were armed with 3.7cm Flak 43 guns. This quick-firing gun was developed as an ack-ack weapon, but like many German Flak guns it was also used against ground targets. There was a third Möbelwagen operating in Oosterbeek and it was filmed by the same civilian who filmed the retreating SS-Pz AA 9. (BA 2KBK771/34)

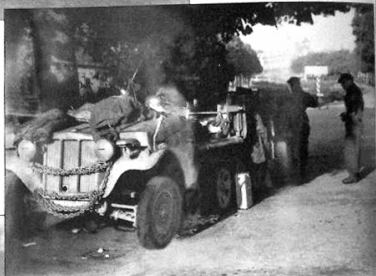
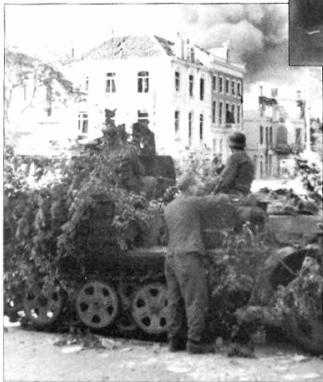
The 2cm Flak guns that belonged organically to the Abteilung were probably motorized. The Sd.Kfz.10/4 in these two photos is more than likely the only survivor of the unit's 'organic' 2cm Flak guns. The vehicle is wearing just its dark yellow livery and is fitted with a number plate. It is shown here on Jansbuitensingel at Arnhem, which crosses Apeldoornseweg at this point. This is in the neighborhood of the Muis Sacrum theatre to the north of the bridge. These photos were taken on Tuesday, 19 September. (BA 497/3526/3)

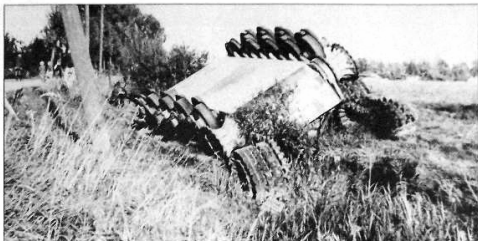
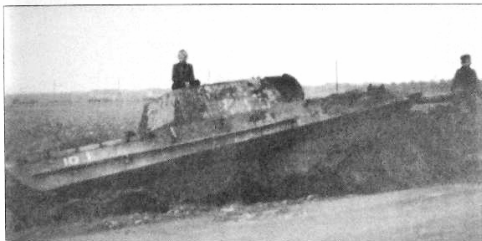
At about 18.30 in the evening of Friday, 22 September, a number of tanks were ambushed by soldiers from the British 214th Infantry Brigade, the 43rd (Wessex) Infantry Division, at the Valburgseweg/Hollanderbroekstraat crossing. This was west of Elst. Five tanks were lost during this action, including a number of I./SS Pz.Rgt.10's Panthers. The tank on its back in the ditch is one of these. It toppled over here on the Valburgseweg when it tried to reverse out of danger. As the tank lay there helpless it was set on fire so that it would be of no further use. (Herberts Archives)

This photo shows the second tank that failed to escape from the ambush. Sunk into the ditch it has become totally unusable due to its great weight. Because both vehicles have been on fire, one can no longer distinguish the original camouflage scheme. Neither are any recognition markings visible. (Herberts Archives)

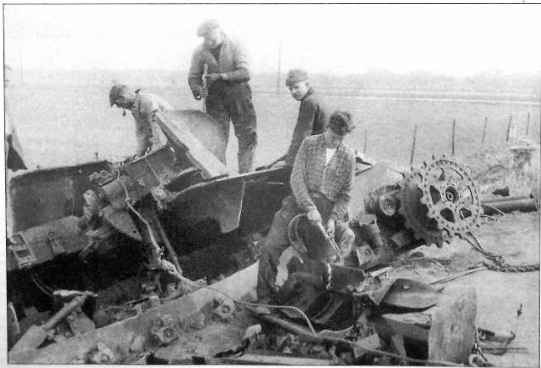
After the war a huge clear-up operation took place. All the tanks spread throughout the Netherlands were broken up. The scrap was taken to the Hoogovens in IJmuiden (a huge steel plant) and re-processed. Here, on 17 April 1947, the Panther in the photo above is being scrapped.

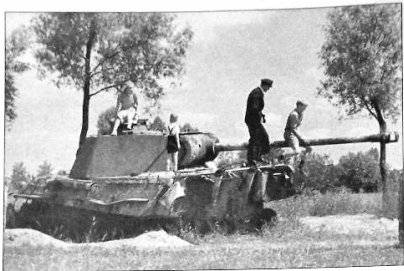
Two Panthers and one Tiger tank were knocked out during an attack west of Elst on Saturday, 28 September. The action took place around Vaiburgseweg. The Panthers were from I./SS-Pz Rgt 10. On the same day, British armor on the way from Driel to Nijmegen was fired on by a Panther which came from the Elst direction. By the time Elst was liberated I./SS-Pz Rgt 10 had lost six Panthers. More than likely this is one of these tanks, completely burnt out and therefore devoid of all zimmerit, camouflage and recognition markings. (A. Hustinx)

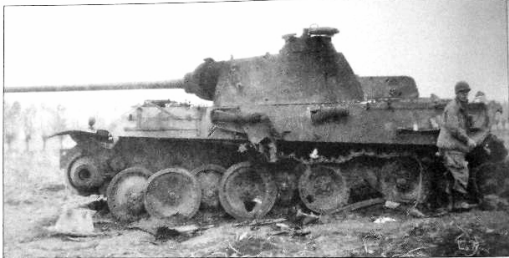
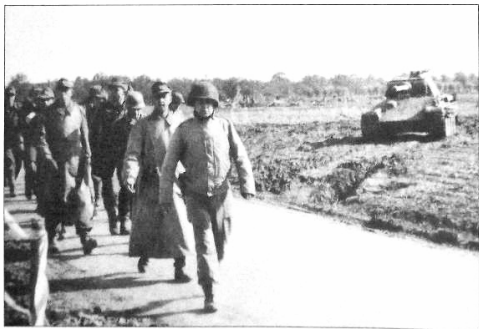
A period of rest followed the British Wessex Division's capture of Elst. During this time, 9 SS-Pz Div. was sent back to Germany and 10 SS-Pz Div. received reinforcements in the form of 9. Panzer-Division and 116 Pz Div. Both came from the front at Aachen and were now deployed for the great counter-attack to capture the Nijmegen road bridge. Up to now it has not been possible to establish what material these armored divisions possessed, but 116 Pz Div. had I./Pz Rgt 24 of 24 Panzer-Division at its disposal. This unit was equipped with 26 Panther tanks. When these arrived in Oosterbeek they were sent to Heveadorp where they were set up along the bank of the river Rhine. Here, from 1 October on they operated as artillery in support of the great German counter-attack. This relatively undamaged Panther from I./SS-Pz Rgt 10 was next to Schoondonk west of Elst. (Herberts Archives)

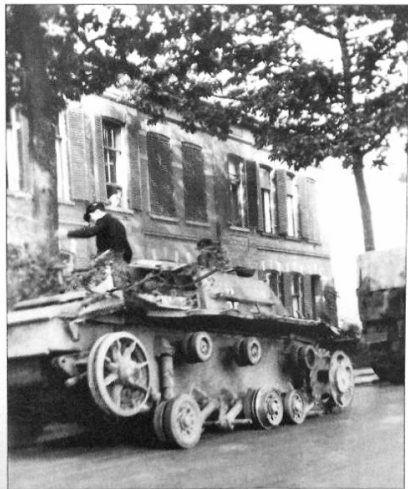
The Sturmgeschütz III Ausf. G shown being towed in these two photos is one and the same vehicle. In the top photo, the StuG. is seen being towed along Arnhemsestraat, in the municipality of Brummen, on the way to Zutphen. The towing vehicle is a heavy Zugkraftwagen 18t (Sd Kfz 9/1). This was the heaviest half-track in the German army, and this second type was equipped with a six-ton crane. The lower photo shows the StuG. being towed through Zutphen by an Sd Kfz 9. The towing vehicle was manufactured by the FAMO company. The SP is an early G version with just dark yellow livery, barred crosses on the sides and rear, and an old number 102 in red with white edging on the rear. The Sd Kfz 9 half-tracks, both very late versions, were painted in three-color camouflage. (A.R. Schokker)

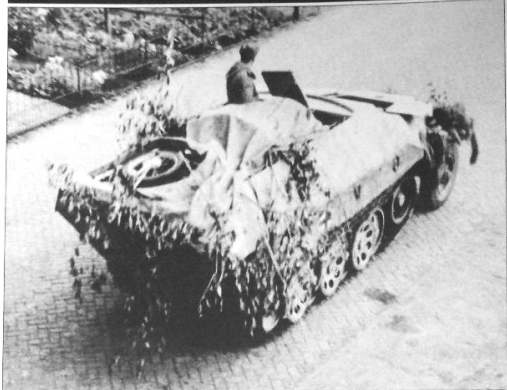
This Sd Kfz 251 Ausf. D drives through Brummen along Arnhemsestraat in the direction of Zutphen. Camouflaged with small branches and three-color camouflage, it is being driven with its engine hatches open and is loaded with spare parts including the front forks of a motor-cycle. Almost invisible but nevertheless there, hidden by the branches, is the number on the side of the hull. (Photo Brouwer-Brummen)

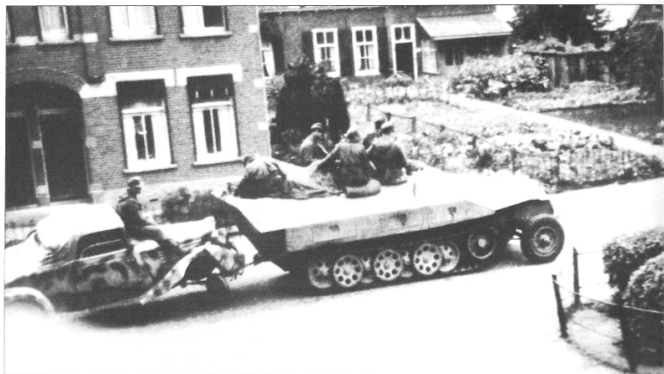
Another Sd Kfz 251 Ausf. D of SS Pz Gren Rgt 22, also driving along Arnhemsestraat and towing a Personenkraftwagen 'Pkw' Ford Type 48 1935-36 convertible. The Sd Kfz 251 is yellow overall, with no extra colors and no front mudguards. When the complete 10 SS Pz Div. had arrived in the Netherlands it was decided that all the division's armored half-tracks had to be handed over to the Recce Unit. This regiment also managed to bypass these orders because there are reports of SPWs being used by SS grenadiers of 10 SS Pz Div. These photos were taken by Mr C. Brouwer from Brummen. As a professional photographer he could not let the opportunity go by of photographing what he thought to be the permanent withdrawal of German troops. He took about 27 photos from two locations and at various times between 5 and 7 September. (Photo Brouwer-Brummen)

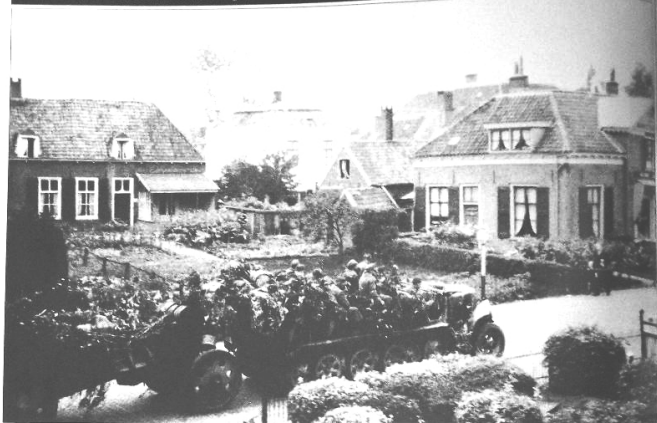
The middle Zugkraftwagen (m Zgkw) 8t, Typ KM m. 11 (Sd.Kfz.7) seen here driving along Anhemsestraat in Brummen, is towing a 15cm schwere Feldhaubitze (howitzer). The entire gun crew is in the half-track. Further camouflaged with branches and packed full with extra equipment, the combination heads for the 10 SS Pz Div's assembly point, slightly to the north-east of Zutphen. The Sd.Kfz.7 is camouflaged with large green and brown flecks, so large in fact that the basic dark yellow color is barely visible. (Photo Brouwer Brummen)

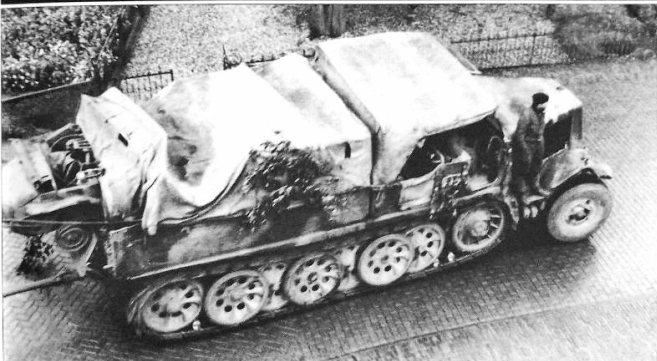
The Werkstatt-Kompanie also managed to escape from France. Here is a wonderful example of taking as much with you as you could. In the back of the 6.Zgkw. 18 ton (Sd.Kfz.9) Typ F3 (FAMO, very late version) is a Pkw. K2s Schwimmwagen Typ 165 without tyres. The towing vehicle has another vehicle in tow but it is not possible to say what it is. Both vehicles have three-color camouflage, but the FAMO wheels were left in dark yellow. (Photo Brouwer-Brummen)

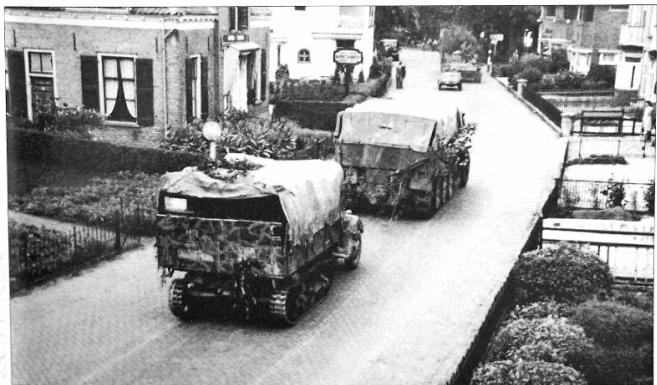
Another FAMO of SS-Panzer-Werkstatt-Kompanie10, but this time with a Gleitsketten-Lkw. 2t. Maultier Ford V 3000 S-SSM (Sd.Kfz.3) in tow. Both are camouflaged in the familiar three colors, and have hardly any markings. The Maultier carries the sign 'Distance 100 meters' at the back, with some other unclear markings. In the background one can just see the combination shown in a previous photo. That was the FAMO towing a StuG. III of II.-SS-Pz Rgt 10. (Photo Brouwer-Brummen)

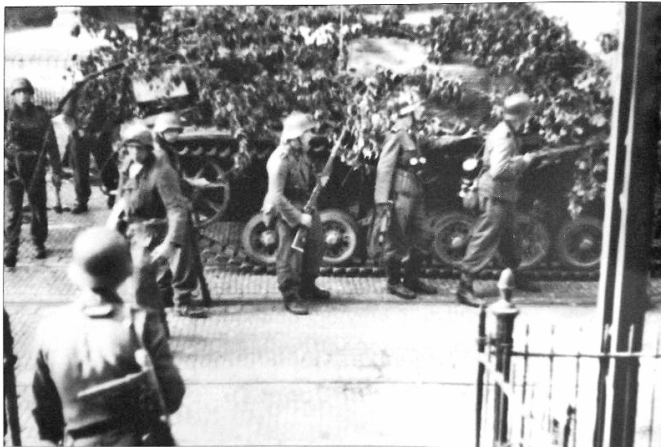
From this photo one can determine the type of StuG involved. On the roof it can be seen that the loader hatches open sideways, and this indicates that it is a later G version. The remotely operated MG that should have been on the roof is missing. (BA 497/3530/34)

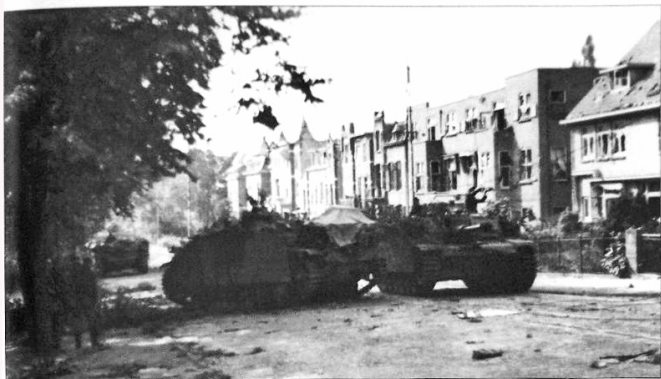
In order to avoid injury to the approaching crews, the commander is cutting through the overhead tram cables. This photo shows that there were StuG's present with a black gun mantle, but that does not mean it is an early G version. The gun support at the front of the hull shows that it is a later G type. (BA 497/3528/11)

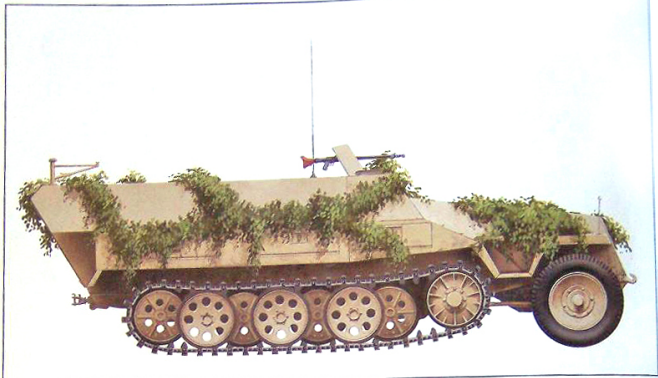
Sd.Kfz.251 Ausf. D, SS-Panzer-Aufklärungs-Abteilung 9, Amsterdamseweg, Arnhem/Oosterbeek, 20-9-1944

This unit probably had more Sd.Kfz.251s, but there are not many shown in photographs. This specific example was painted dark yellow overall with no camouflage colors.

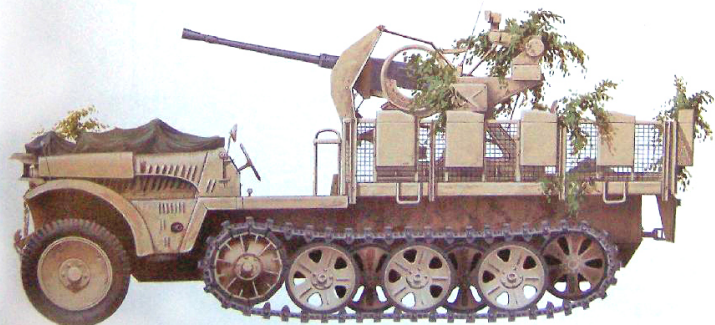
Sd.Kfz.10/2 '2cm Flak 38, SS-Panzer-Flak-Abteilung 9, Arnhem and Oosterbeek

Apart from the number plate, small anti-aircraft vehicles such as these carried no recognition markings. They had either a complicated camouflage scheme or were just painted in the basic dark yellow color. Of course they were all decked with small branches taken from trees in the area.

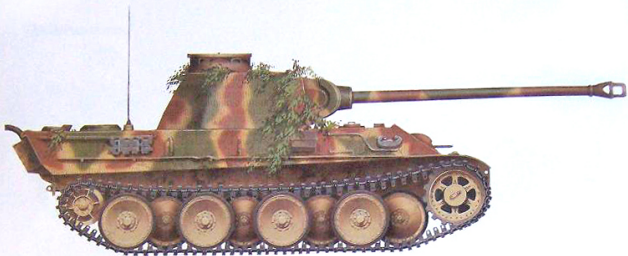
Sd.Kfz.171 Pz.Kpfw.V Panther Ausf. G 'early version', I./SS-Panzer-Regiment 10, Elst

Again, a tank painted in the three-color scheme, and once more a dark yellow base color with green and brown flecks. Unit markings were non-existent, and nothing is known of the numbers. The barred cross was on the front of the hull, and the whole tank was covered with zimmerit.

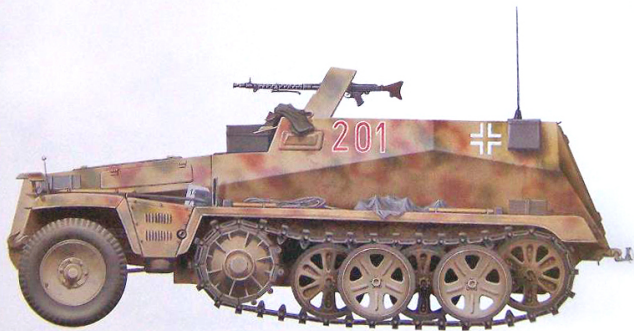
Sd.Kfz.250/3 'all', SS-Panzer-Aufklärungs-Abteilung 10, Arnhem road bridge to Elst

A nice example of an old command vehicle still doing service. The large numbers in red with white edging were on the vehicle side, probably with the national cross behind. A number plate bearing the old Wehrmacht number was painted over with SS symbols. The vehicle was filthy, and painted in the familiar three-color scheme.

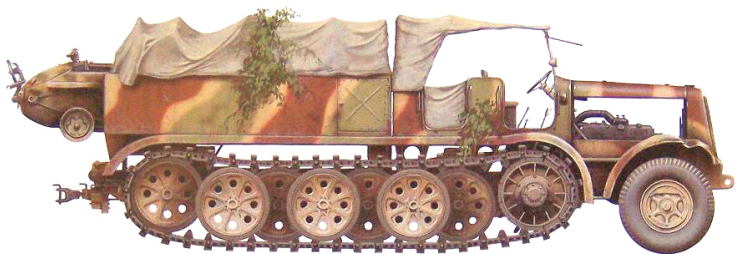
Sd.Kfz.9 18t FAMO 'very late version', SS-Panzer-Werkstatt-Kompanie 10, Brummen

FAMOs were used for the recovery of armored vehicles, and the towing of heavy equipment. At the beginning of September this vehicle passed through Brummen on the way to Zutphen. It was painted in three-color camouflage and, apart from a number plate, had no recognition signs.

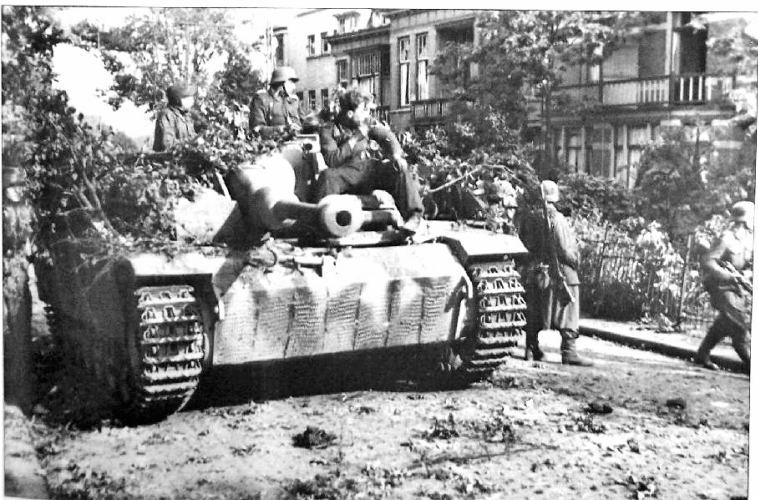
Next Day, Wednesday, 20 September, the brigade commander, Major Kurt Kühme, drives towards Oosterbeek in his Sturmgeschütz. Reporter Jacobsen goes with him, and takes pictures when the StuG stops somewhere. Here, they are at the junction of Bovencroet and Onderlangs. In the previous day's fighting, Kühme's StuG had received a direct hit on the armor plating (left in the photo) on the right hand side by the gun. A large dent and the disappearance of the Zimmer show this. (BA 497/3529/3)

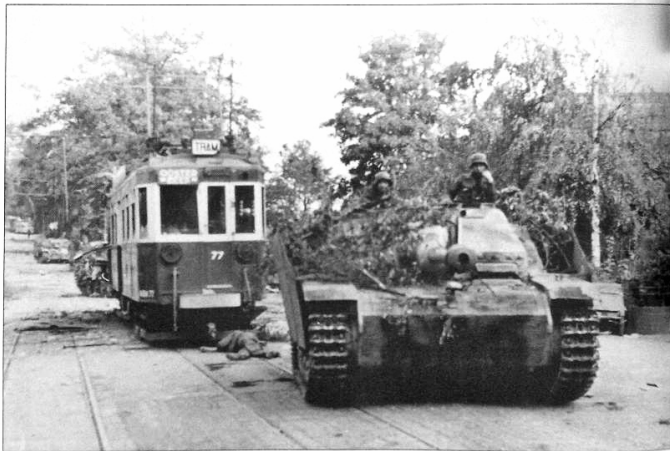
Another photo taken in the opposite direction. Here we see the remaining Sturmggeschütze plus a Sturmhaubitze just visible behind the tram, heading for Oosterbeek. There, after heavy fighting, the parachutists were driven back halfway into the village. By using their anti-tank guns the British were able to avoid being completely overrun by the German troops. (BA 497/3529:6)

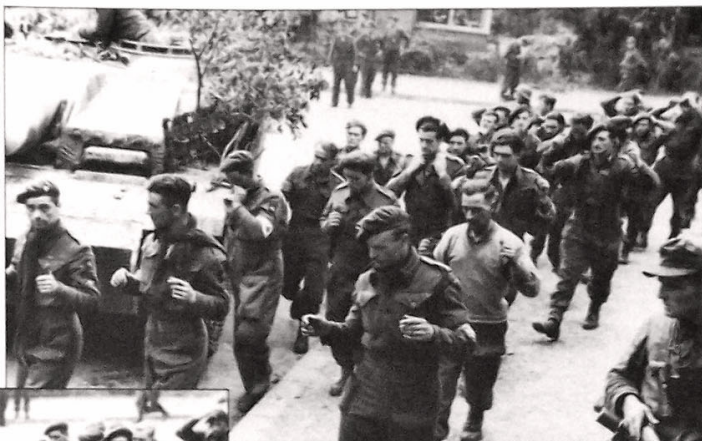
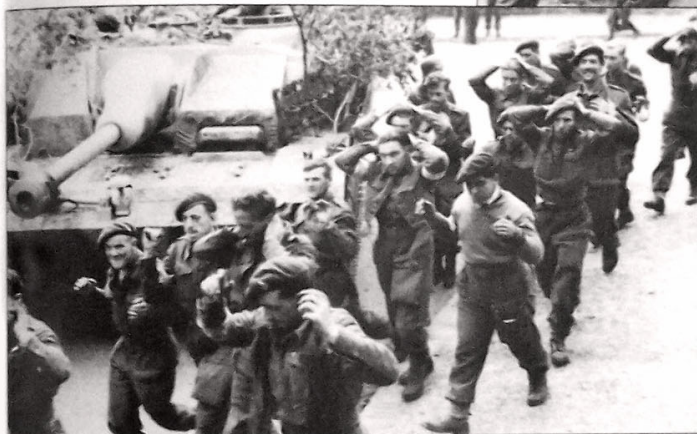
The section of track links fixed to the driver's armor is intended as alternative additional armor, not as spare track. They are actually old model track links, used from 1941 up until 1944, and the StuG's of StuG BrG 280 were fitted with the newer model, which was manufactured from the end of 1943. The main difference in these links was that the old type had an open horn while on the new type it was closed. (BA 497/3527/21)

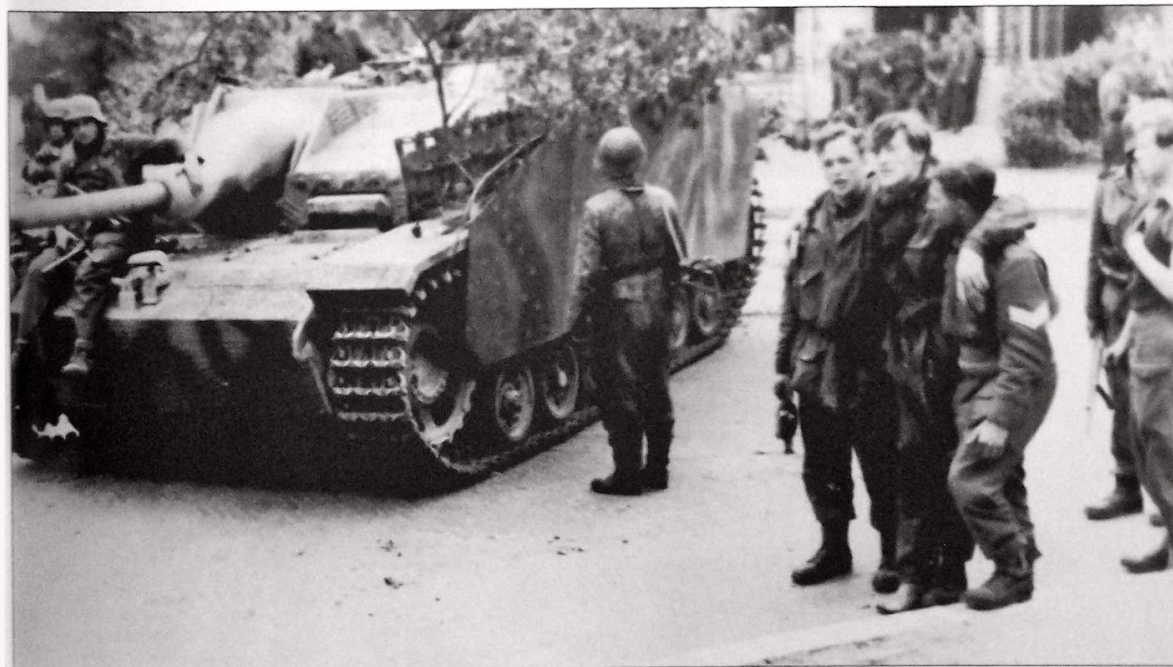
The Sturmgeschütze manufactured by the Altkett company are recognizable by the waffle pattern zimmerit. It can be recognized as a later version by the gun support, which moved automatically to the right when the gun was raised. It is interesting to see that the skirts on this StuG, differ from that on the others. The first is in the ambush pattern while the rest is in totally varied schemes. (BA 497/3527/19)

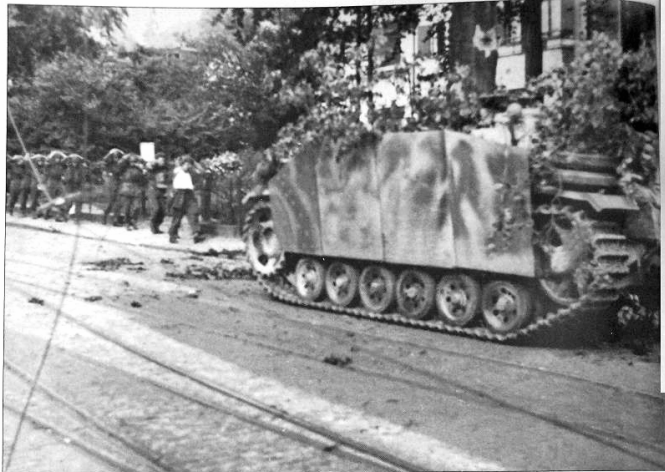
Major Kühme's Sturmgeschütz is shown here on Wednesday the 20th driving on Utrechtseweg near the crossing with Stationsweg. It is odd that on this date this SP could approach so close to the British positions, which were mainly on the west side of the crossroads. The reserve roadwheels, usually located on the engine deck, were fitted on the rear part of the mudguard. The wheels were also painted green and brown. (BA 497/3529/8)

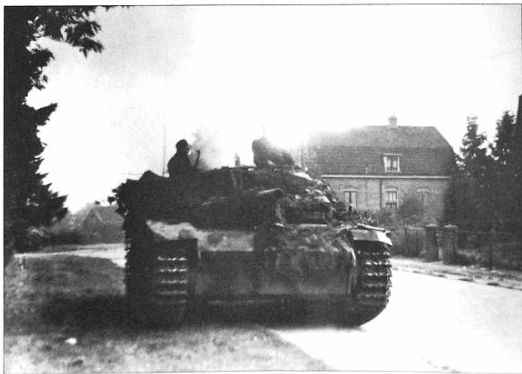
This is a Sturmhaubitze 42G 'late version' belonging to 2./StuG BriG.280. Here it is shown driving north on Jhr. Nedermeyer van Rosenthalweg towards Utrechtseweg. P.K. War Reporter Kutzner took this photo, probably on Tuesday, 26 September. Many photographs were taken by the various German war reporters on that and subsequent days. One of two P.K. members were probably carried onboard this StuH. III because it appears in a number of photos. (BA J27 757)

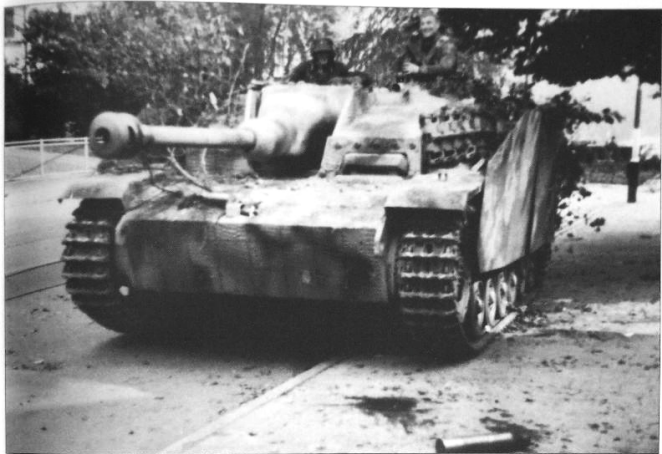
Here again is a remarkable series of photographs. This Sturmgeschütz III Ausf. G is on Utrechtseweg, just to the east of Stationsweg. This series of photos was also taken on Wednesday the 20th, therefore close to the British lines. It can be seen in other pictures of this area that heavy fighting was still taking place at this part of Utrechtseweg. (BA 497/3529/28)

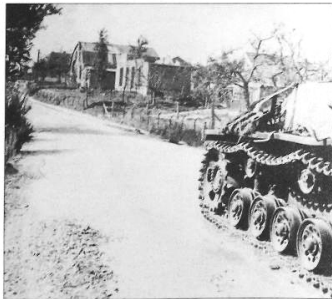
This Sturmgeschütz was successfully brought to a halt after at least eight direct hits. One completely removed the right differential gear housing. The hits also saw to it that the SP was entirely destroyed by fire. Despite the doubts about the number of tanks he put out of action, Baskeyfield made sure that, for a time, the Germans did not dare to advance any further. Fearful for the loss of more valuable armored vehicles, they preferred to keep their distance. (H.J. Wilink, Municipal Archives Renkum)

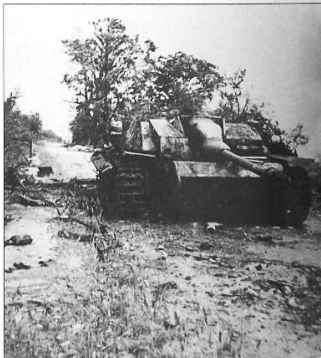
The StuG. was facing west. The Lower Rhine is just out of the picture to the left. (D. Renes, Municipal Archives Renkum)

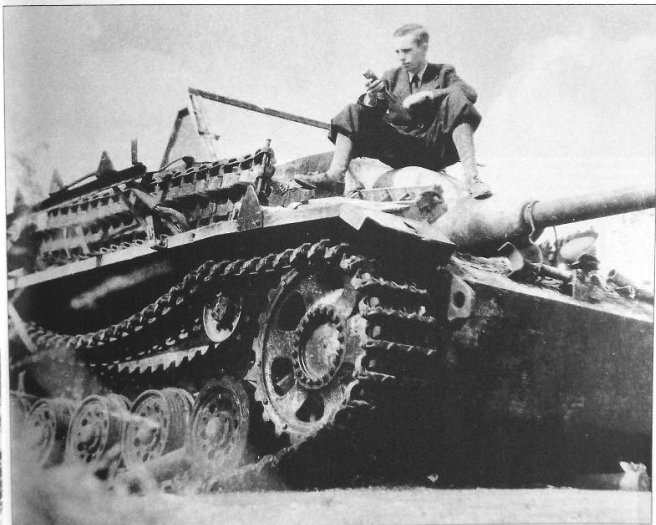
Here is a fine photo of the side of the StuG. Actually, the overall damage is not so great, but a direct hit between the wheels on the right hand side set the SP on fire. And burnt-out means that an armored vehicle can be used no more. (D. Teunissen, Municipal Archives Renkum)

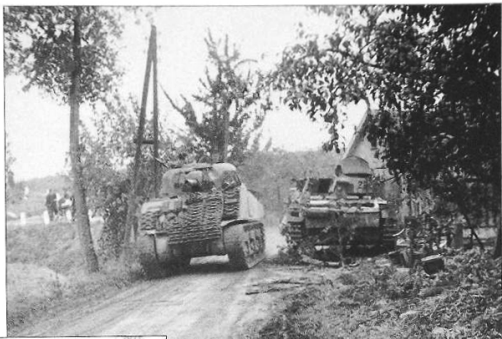
A little further back was this Panzerkampfwagen III Ausf. G. This was the second tank to be knocked out. This rare old type had received two direct hits in the front, one by the driver's vision slit and one on the front armor. (IWM B10376)

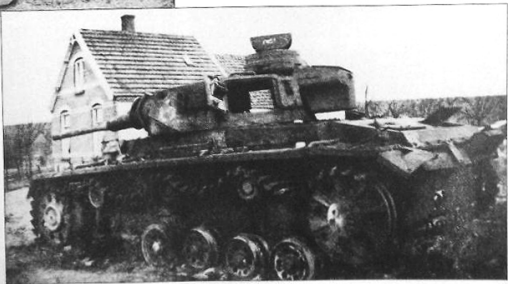
Here is the same tank, but photographed in 1945. From this picture it is clear to see that it is an old type by the old drive and tension wheel. This Panzer III Ausf. G is also shown in the photo on the Nieuwe Kade in Arnhem. This can be seen from the camouflage pattern on the front of the tank.

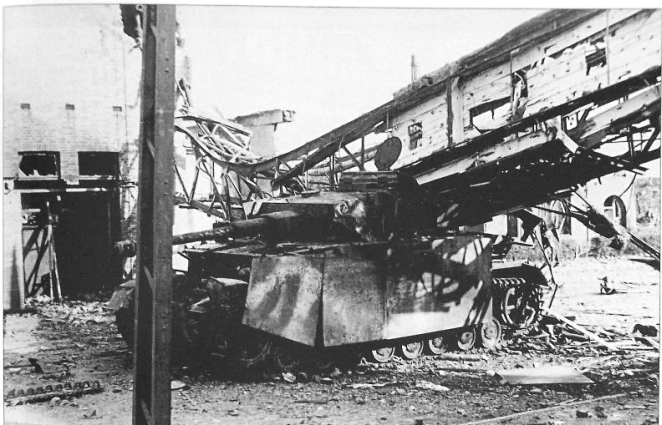
It can be assumed that the second Pz.Kpfw.IV Ausf. H under the collapsed pipe bridge in Westervoortseijk was lost by Pz.Kp. Mielke in the fighting on Tuesday 19 or Wednesday, 20 September. Three hits on the front set the tank on fire. However, it is possible that the two Pz.Kpfw.IV's belonged to II./SS-Pz. Rgt.10, but in this case Pz.Kp. Mielke is the most likely. (P.J. de Booy, Municipal Archives Arnhem B1620-13/13A)

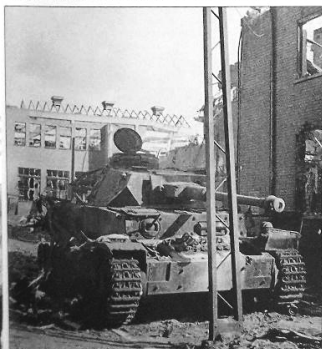
The two Pz.Kpfw.IV's that were photographed were already obsolete by September 1944, even though they had been modified. Both had been fitted with the new skirt attachment system but neither had zimmerit. The Pz.Kpfw.IV that came to its end under the pipe bridge had a new type tank commander's hatch. (IWM HU46265)

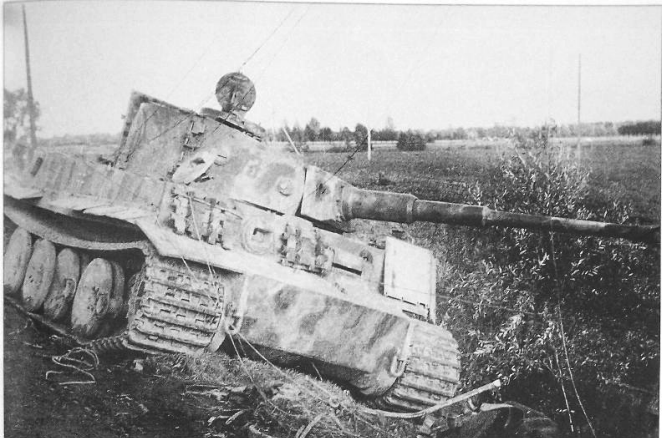
This Panzerkampfwagen VI Ausf. E Tiger I had a dark yellow base color and was camouflaged with small green and brown flecks. It had a registration number in red or blue. Many extras had been removed from the tank, such as the smoke grenade launchers on the turret and the mine launchers on the hull of the tank. One point identifies the Tigers of s.Pz Kp. Hummel. A piece of transport track was fitted to the front armor. Three links were fitted between the driver's vision slit and the front machine gun and three standard links were sometimes placed on the sides of the armor plate. Photos from Belgium and Germany also show that the unit possessed later Tiger I versions. The hull with steel wheels was sometimes combined with the old turret and some of these combinations had zimmerit, the majority not. (M. Bando)

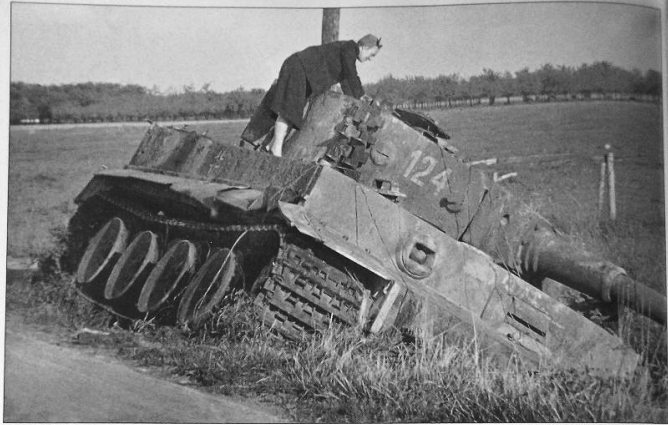
This is one of the tanks ambushed by 214th Brigade. The Tiger I lies helpless in the ditch. The chassis has been on fire but the rest of the tank has not been completely burned. This is at the Valburgseweg. The white number is clearly visible, as is the barred cross on the rear. (Herberts Archives)

It is also clear to see that the unit possessed the older Tiger I tanks fitted with an interim type turret. This means that the commander's hatch was modified. That the chassis came from an older type Tiger can be seen from what remains of the filter system and the mine launchers on the rear deck. (Herberts Archives)

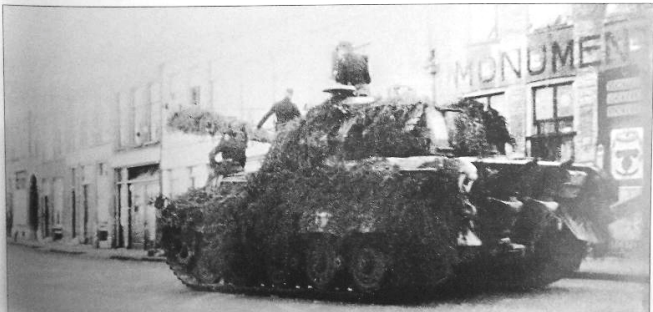
The Tiger II's were 'trained' to Aachen between 10 and 13 October. The Königstigers of 2. and 3./s Pz Kp.506 were loaded on various trains in Apeldoorn, Zutphen and Bocholt. Here one of the Tigers is being driven along Warnsveldseweg near Zutphen station. This Tiger was built before June 1944 which can be seen from the lack of armor on the hinge of the turret's rear hatch. (A.R. Schokker)

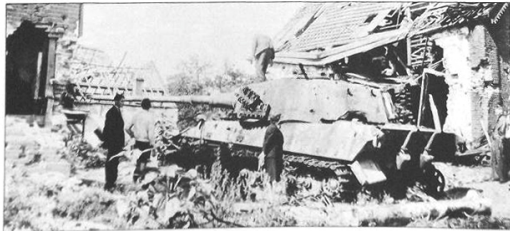
Of all the photos taken of this wreck, about half were taken from this position. Despite British shelling, this is the only Tiger to be lost in the fighting around Oosterbeek. Perhaps more were brought to a halt due to damaged tracks, but this is the only one to be totally destroyed. (Municipal Archives Renkum)

This photo clearly shows that the right track is off. One can also see that the vehicle was hit more than once. Most of the Zimmerit has been burned off, only small pieces remaining at the front and on the right side. The Königstiger belonged to 3./s.Pz Abt.506, and was knocked out on Monday, 25 September. The 14 tanks from the third company carried a black number with yellow edges. The barred crosses were painted in the center of the turret sides. To the left of the cross was the number 3, and to the right the vehicle number (01 to 14). This Königstiger was also manufactured before June 1944. (F. de Soet, Municipal Archives Renkum)

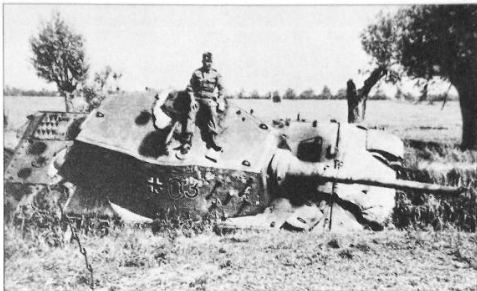
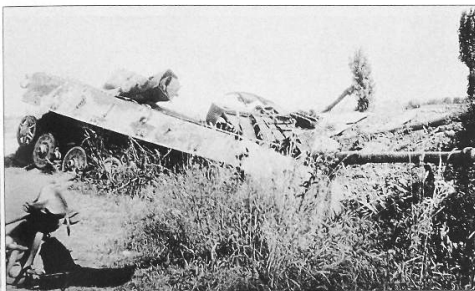
The first Tiger II was destroyed by five PIAT hits. Around 10:30 on 1 October, a soldier from the 11th Platoon disabled it with a PIAT. This occurred about 70 meters north of Den Heuvel farm and close to number 03, shown in the top photo. It would seem that after being hit, the tank, which was fitted with a Henschel turret, was blown up because little of it remains intact. This Tiger belonged to 2./s.Pz.Abt.506 and had red numbers with white edging. (NIOD)

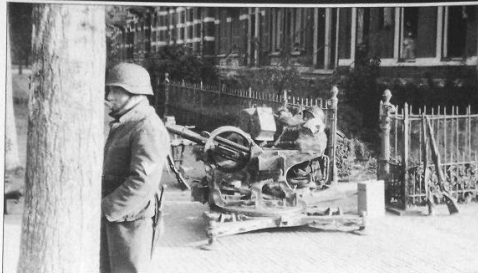
The 2cm Flak 38 gun seen here with its Sd.Ah.51 trailer was photographed by P.K. War Reporter Jacobsen. It is at Kastanjelaan at the point where it crosses Boulevard Heuvelink and Johan de Wittlaan. Together with a similar combination, seen in the background, it had to prevent the parachutists occupying the northern ramp of the Arnhem bridge from breaking out to the east. The officer holding a bottle of wine is Jacobsen's colleague, Wenzel. These two photographs were taken on the morning of 19 September when the two photographers happened to wander into the battle area. The trailer's unusual camouflage scheme is quite remarkable, looking somewhat like a Picasso painting. (BA 497/3530/3)

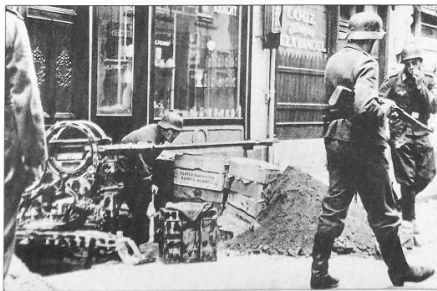
Another 2 cm Flak 38, this time in Walstraat, behind the theater in the town center. This gun had a similar color scheme to those shown in the above two photos; small brown and green flecks on a dull yellow base color. The gun was also deployed at the above-mentioned blockade. (R.P.G.A. Voskuil Collection)

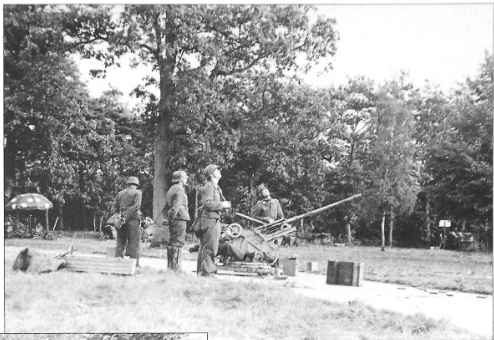
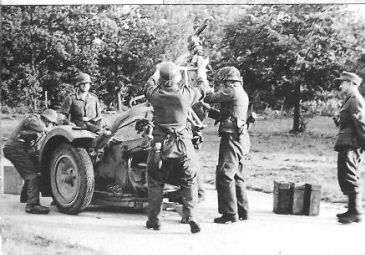
To prepare the gun for moving, the rear of the trailer had first to be hooked up to the mounting. Although this was only a small gun, this operation required four men. (BA 2K BK772/30)

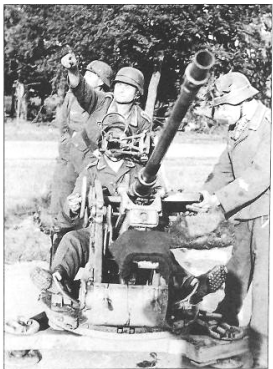
At the moment that the P.K. man arrives at the gun position it is still relatively peaceful. At a leisurely pace he takes some excellent pictures of the gun crew, so-called in action. These pictures show clearly that the entire gun mounting was painted in the standard German color of dark yellow. The long case on the ground contained spare gun barrels, with extra ammunition magazines in the smaller boxes. (BA 2K BK772/26)

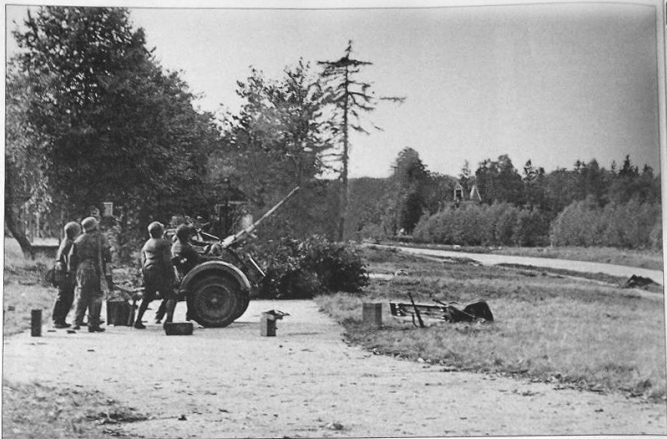
Once on its trailer the 2cm Flak 30 + Sd.Ah.51 is ready for action. Allied aircraft are fired on. Amsterdamseweg is in the right background, seen from the east. Operating the gun in this way it was extremely easy for the crew to seek cover if threatened, for example by simply driving under a tree. (BA2KKB772/32)

When this had been done the whole unit could be tipped, and the front coupling connected. This old type 2cm Flak gun probably originated from Deelen airfield air defense. The airfield was a few kilometers north of Arnhem. (BA 2K BK772/31)

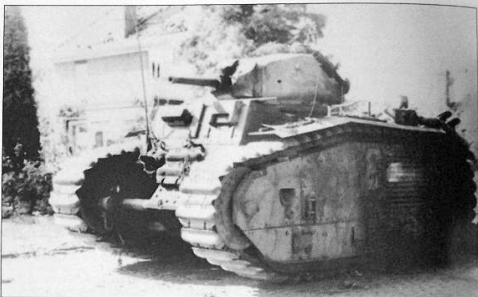
The first allied reports of flame-throwing tanks were received from the 1st Battalion, the Border Regiment on 20 September. The Kompanie is also mentioned in Von Tettau's (commander of the west blocking forces) report of 19 September. At 4.30 pm that day three tanks were assigned to the Lippert and Knoche Regiment, and these advanced along Utrechtseweg. During the battle Lippert was commander of the 'SS-Unterrührer-Schule "Arnhem"', and Von Tettau placed a number of units under his command. One of these was Pz.Kp.224, of which Lippert said, 'While advancing towards Willehe via Wageningen, Renkum and Heeslum, I encountered enemy opposition just to the north of these towns. Here, the five Renault tanks I had been given were quickly set on fire by the enemy'. He also mentions the unit with the R35 tanks which, because of the early destruction of the Char B2s, were not deployed. (BA 590/2331/5)

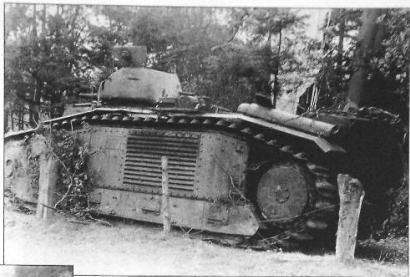
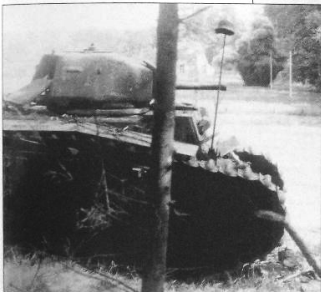
The Flammpanzer B2 (f) on Van Borsselenweg was destroyed on 21 September by an anti-tank gun crew of 26th Anti-tank Platoon, the Border Regiment, and just at the moment when it was only 20 meters from the positions of 22 Platoon, D Company, of the same Regiment. Just before the tank was hit a Corporal from D Company was killed. The rest of the gun crew were so infuriated that, even though the tank had been disabled with the first shot and set on fire, five more shells were fired at it. Others had to drag the crew away from the gun. The tank crew were killed here, but their names are not known. (Municipal Archives Renkum)

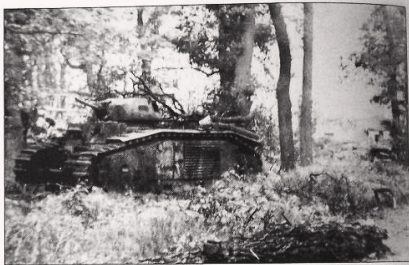
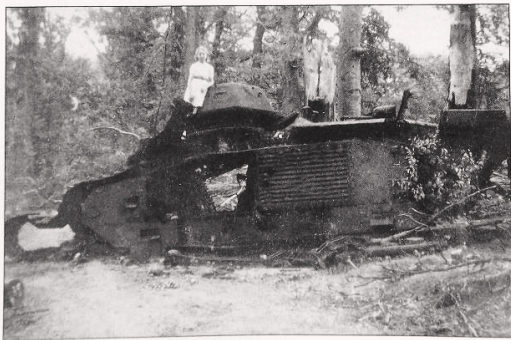
Two pictures were taken of this tank in 1945. A girl is sitting on top of the tank, and the shell impact is clear to see on the right hand side of the tank. Contrary to the right side, the left side had no door because this is where the engine was located. This Flammpanzer B2 (f) was knocked out on 20 September in Sonnenberglaan by a 17 pounder AT gun of X Troop, 2nd Oban Anti-Tank Battery. The tank crew were killed. (A.J. Nijholt, Municipal Archives Renkum)

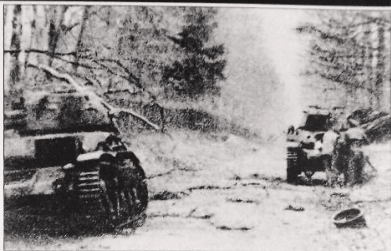
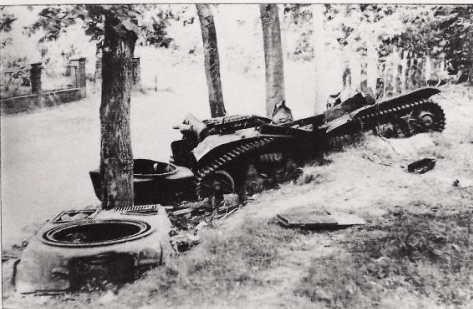
During the liberation of Arnhem on 14 April 1945 the defense of the town was mainly in the hands of German infantry units from 346 Volksgrenadier-Division. During these actions a minor counter attack was carried out with German tanks. Shortly before darkness fell, around 8 pm, three Pz Kpfw.35R (f) tanks tried to force a breakthrough at the Apeidoornseweg/Schelmseweg crossroads. On this Saturday the three German Renault tanks drove along Stroolaaen through the nearby village of Schaarsbergen. They were accompanied by Dutch SS, who had come from Harskamp. The small tanks were attacked by a Canadian Sherman. Their attack along Kemperbergerweg failed, and the three tanks were destroyed. Three photographs exist of this situation, and all three wrecks can be seen here on this rather unclear photo. (P. Voemen Collection)

There are two pictures of this wreck, which is shown far right in the above photo. It seems that they were still painted Panzer grey and had numbers and barred crosses. The white, three-digit numbers were painted on the sides of the turret, and behind the number came the barred cross. The bottoms of the rear mudguards had white edges to make the vehicle better visible at dusk. An internal explosion blew the Panzerkampfwagen R35 (f) to pieces. The three tanks belonged to Pz Jg Abt.657 which, at this stage of the war, was known as Pz Jg Abt.684. This unit was commanded by Hauptmann Pułkowski and possessed six 4.7cm Pak (f) auf 35R (f), twelve Chenillette RUE 630 (f), eight 7.5cm Pak 40 guns and seventeen Pz Kpfw.35R (f) tanks including a few Pz Kpfw.35H (f). (P. Voemen Collection)

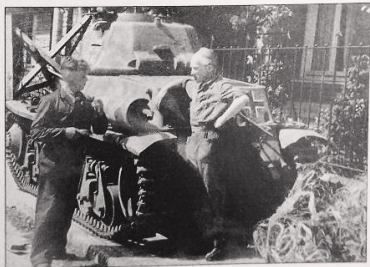
Where this unit actually fought is not known. Presumably it saw action on the west side of the corridor which ran from Lommel in Belgium to Elst near Arnhem. There are actually a few known photos of Renault and Hotchkiss tanks and Panzer hunters in this area. This Pz Kpfw.35H (f), standing beside the Du Soleil Grand Hotel by the Oude Haven, belonged to Pz Jg Abt.657 as well. The hotel stood on the bank of the Lower Rhine in the center of Arnhem. (P. Voemen Collection)

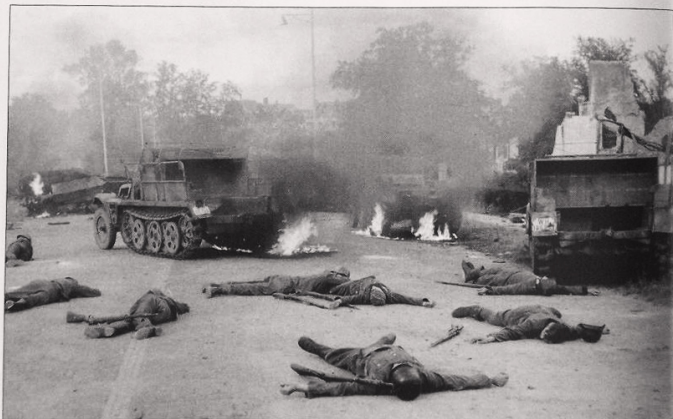
Three Sd.Kfz.10's plus a very odd vehicle were used in the reconstruction of Gräbner's attack on the Arnhem road bridge. Extreme left on the photo is something that looks like an Sd.Kfz.10 chassis with a built-on wooden cab and load platform. The three Sd.Kfz.10's were fitted and remodeled into transport for the crew of a 15cm Nebelwerfer. Where the vehicles came from is not known. They all carried Wehrmacht number plates. The object burning in the background is the hull of an Sd.Kfz.250 'neu' that remained behind after the original attack. (P.J. de Booy, Municipal Archives Arnhem B1620-56/9)

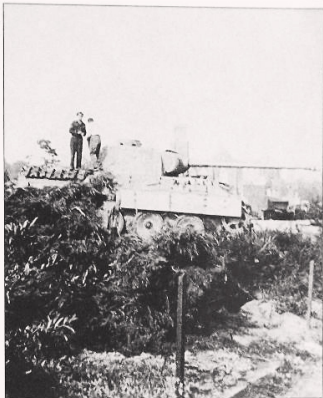
A real Panther tank in a war film. This is many enthusiasts' dream that finally ever comes true. In 'Theirs is the Glory' there are several scenes of Panzerkampfwagen V Panther Ausf. D tanks in action. The scenes were shot at the ramp of Arnhem bridge and in Oosterbeek. In this photo one of the two Panthers used in the film is shown driving into Arnhem. This still driveable tank was probably brought from Germany to the Arnhem bridge ramp on an allied transporter. (NIOD)

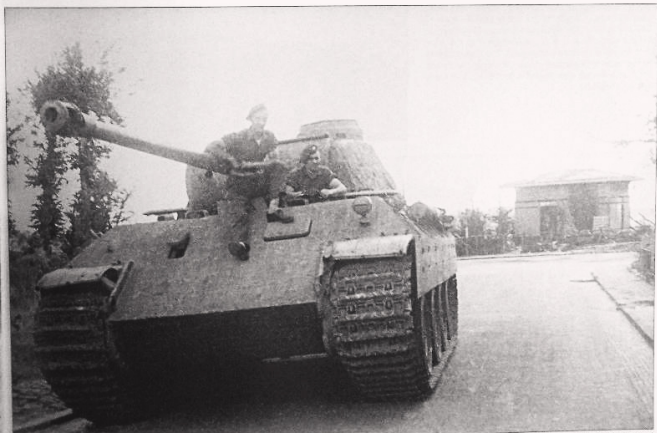
Here, on the ramp close to the ruins of the bridge, an entirely dark yellow Panther drives back and forth, together with a second example simulating the attack made by s.Pz.Kp. Hummel on 19 September. This action is also included in the 1970s film 'A Bridge too Far'. There, two remodeled Leopard tanks drive from the southern ramp towards Arnhem. (Municipal Archives Arnhem B7061/9)

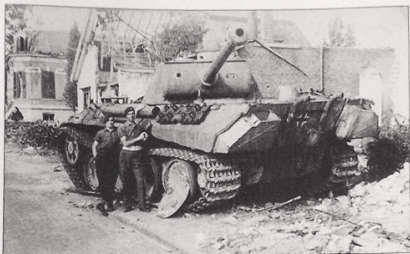
This photo shows clearly that we have an excellent example here. All the skirts are in place, the tracks are as new, and all the small details, such as the head lamp and tool rack, are there. It looks as if this Panther, without numbers and tactical markings, has just been brought from the factory. In this picture the tank is in Weverstraat Oosterbeek, with the junction with Benedendorpsweg in the background. (W.K. Kirkham, J. Kardol)

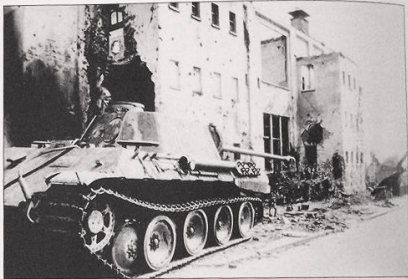
Here is the second Panther, also an old D version. This tank was no longer independently mobile and was used in Beneden-Weverstraat, where it remained after filming, for a scene in which it was fired on by a PzAT anti-tank weapon. This Panther carried the tactical number 102 in red with white edging. It was painted on the side and rear of the turret. The national crosses were on the front part of the hull and, as can be seen here, on the rear between the tank exhausts. (W.K. Kirkham, J. Kardol)

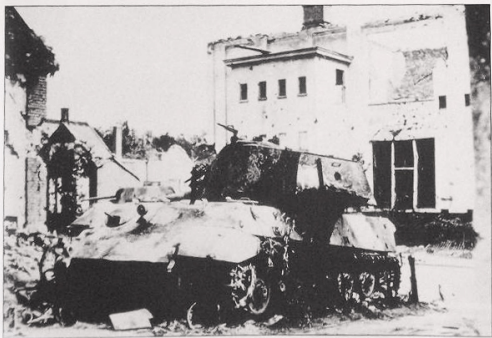
This Panther in three-color camouflage remained for months in front of the Klompenschool in Oosterbeek. This and the other, driveable, Panther probably came from Germany and did not take part in the battle in Oosterbeek. The reason for saying this is as follows. In Breda, a town in the south of the Netherlands, a Panther Ausf. D forms a peace monument. This was presented to the town after the war by its Polish liberators. This Panther, which was initially believed to have been used in the film, was brought by the Poles from Bremen in Germany. Seeing that these events occurred at more or less the same time, it is not impossible that the 'film' Panthers came from the same place. The Breda tank is not the same one because it has old tracks, while the film Panthers had new tracks. (D. Renes, Municipal Archives Renkum)
