# German Battleships 1939–45

Gordon Williamson • Illustrated by Ian Palmer

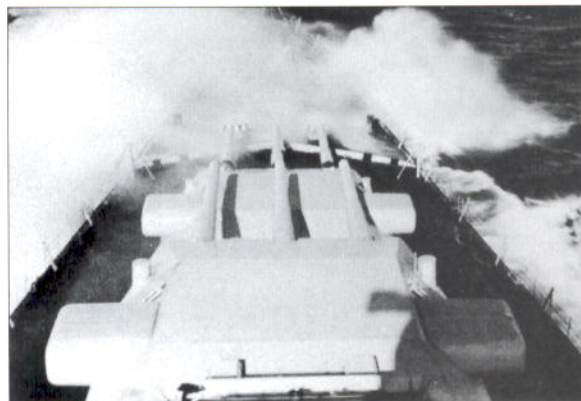
A view down towards the bow from *Scharnhorst*'s bridge area gives a good impression of just how 'wet' a ship she was. The constant flooding of waves over her fo'c'sle caused regular problems with the electrics of her forward turrets.

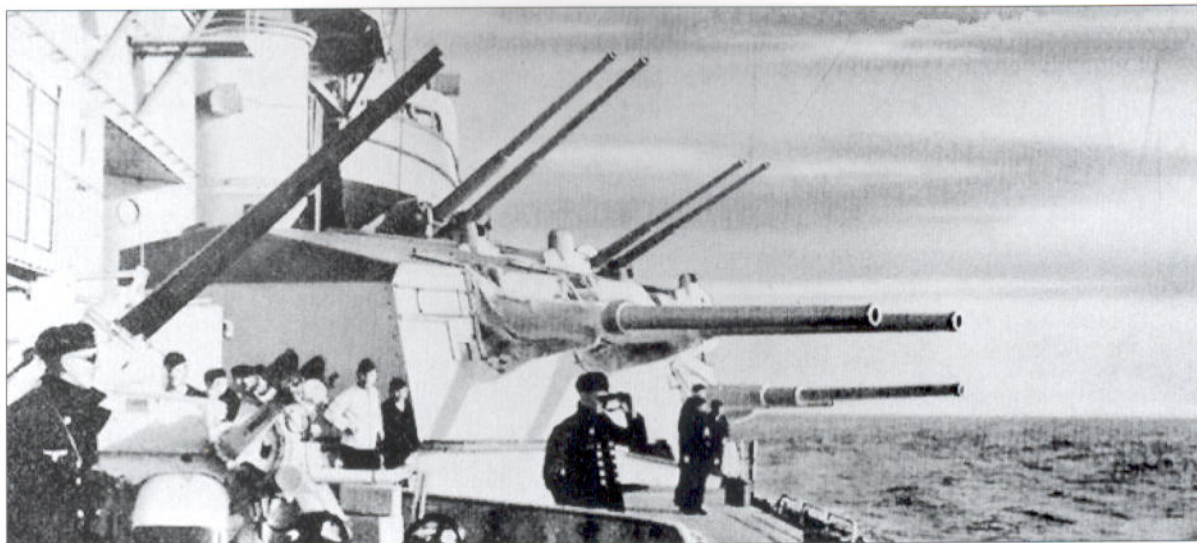
An excellent view of one of *Scharnhorst*'s secondary turrets, mounting 15cm guns. The guns shown at high elevation behind this turret are those of her main 10.5cm flak batteries. One of the ship's boats can be seen just above these flak guns.

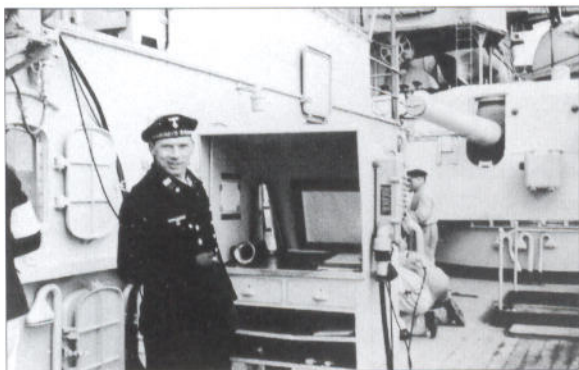
Another detail view taken on *Scharnhorst*'s starboard side main deck looking forward towards one of her secondary armament turrets.

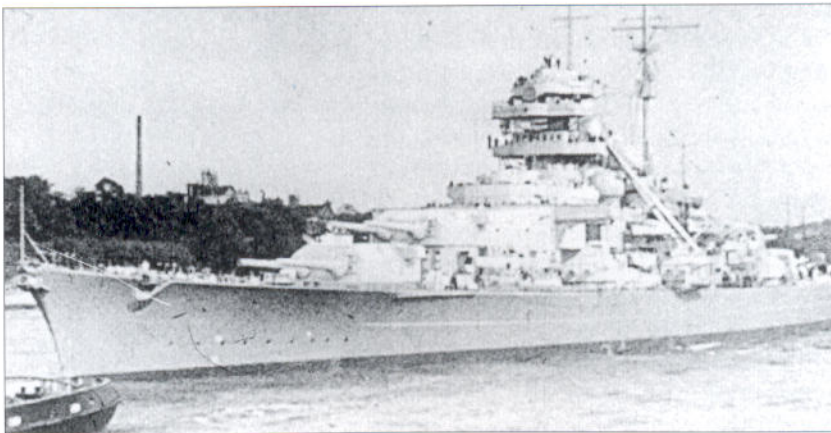
The *Bismarck* shortly after her completion and commissioning, immaculate in her fresh light grey paintwork. Note that the main fire control rangefinder on her foretop has not yet been fitted.

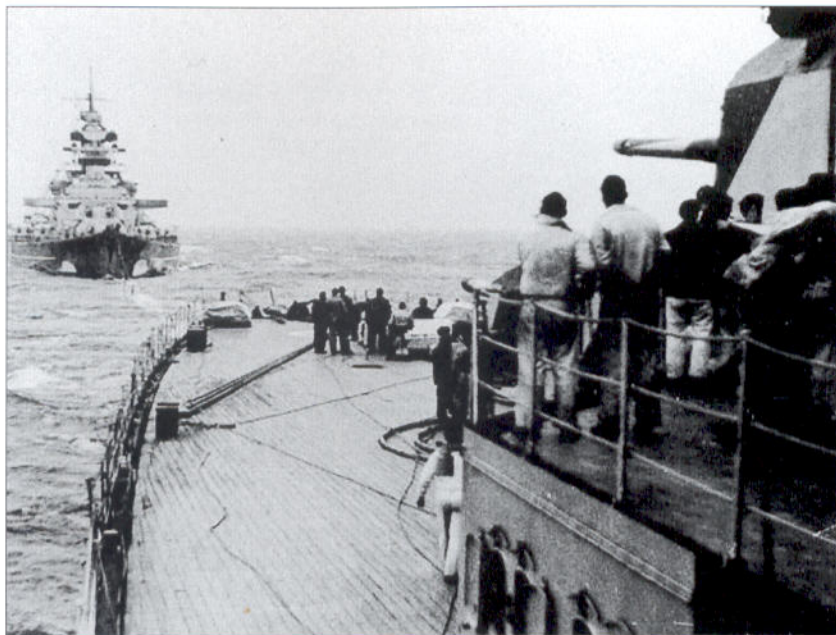
*Bismarck* carrying out refuelling from *Prinz Eugen* during training exercises. The massive beam of this huge warship can be seen to good effect here. The dark grey forward part of the hull and false bow waves can also be seen clearly.

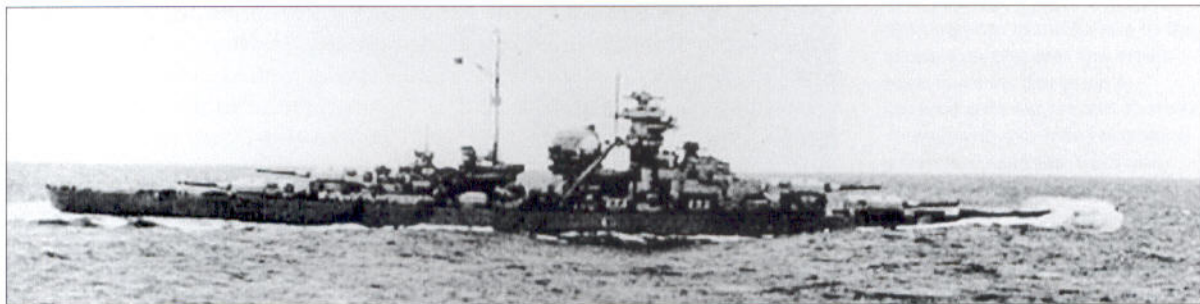
One of the last photographs taken of *Bismarck*. Shot from *Prinz Eugen*, she can be seen to be down by the bows having shipped a considerable amount of water through the hole caused by a direct hit from *Prince of Wales*.
