No.3 GERMAN

EASTERN FRONT

FOCUS ON
ARMOUR
CAMOUFLAGE
& MARKINGS

Kenneth M Jones

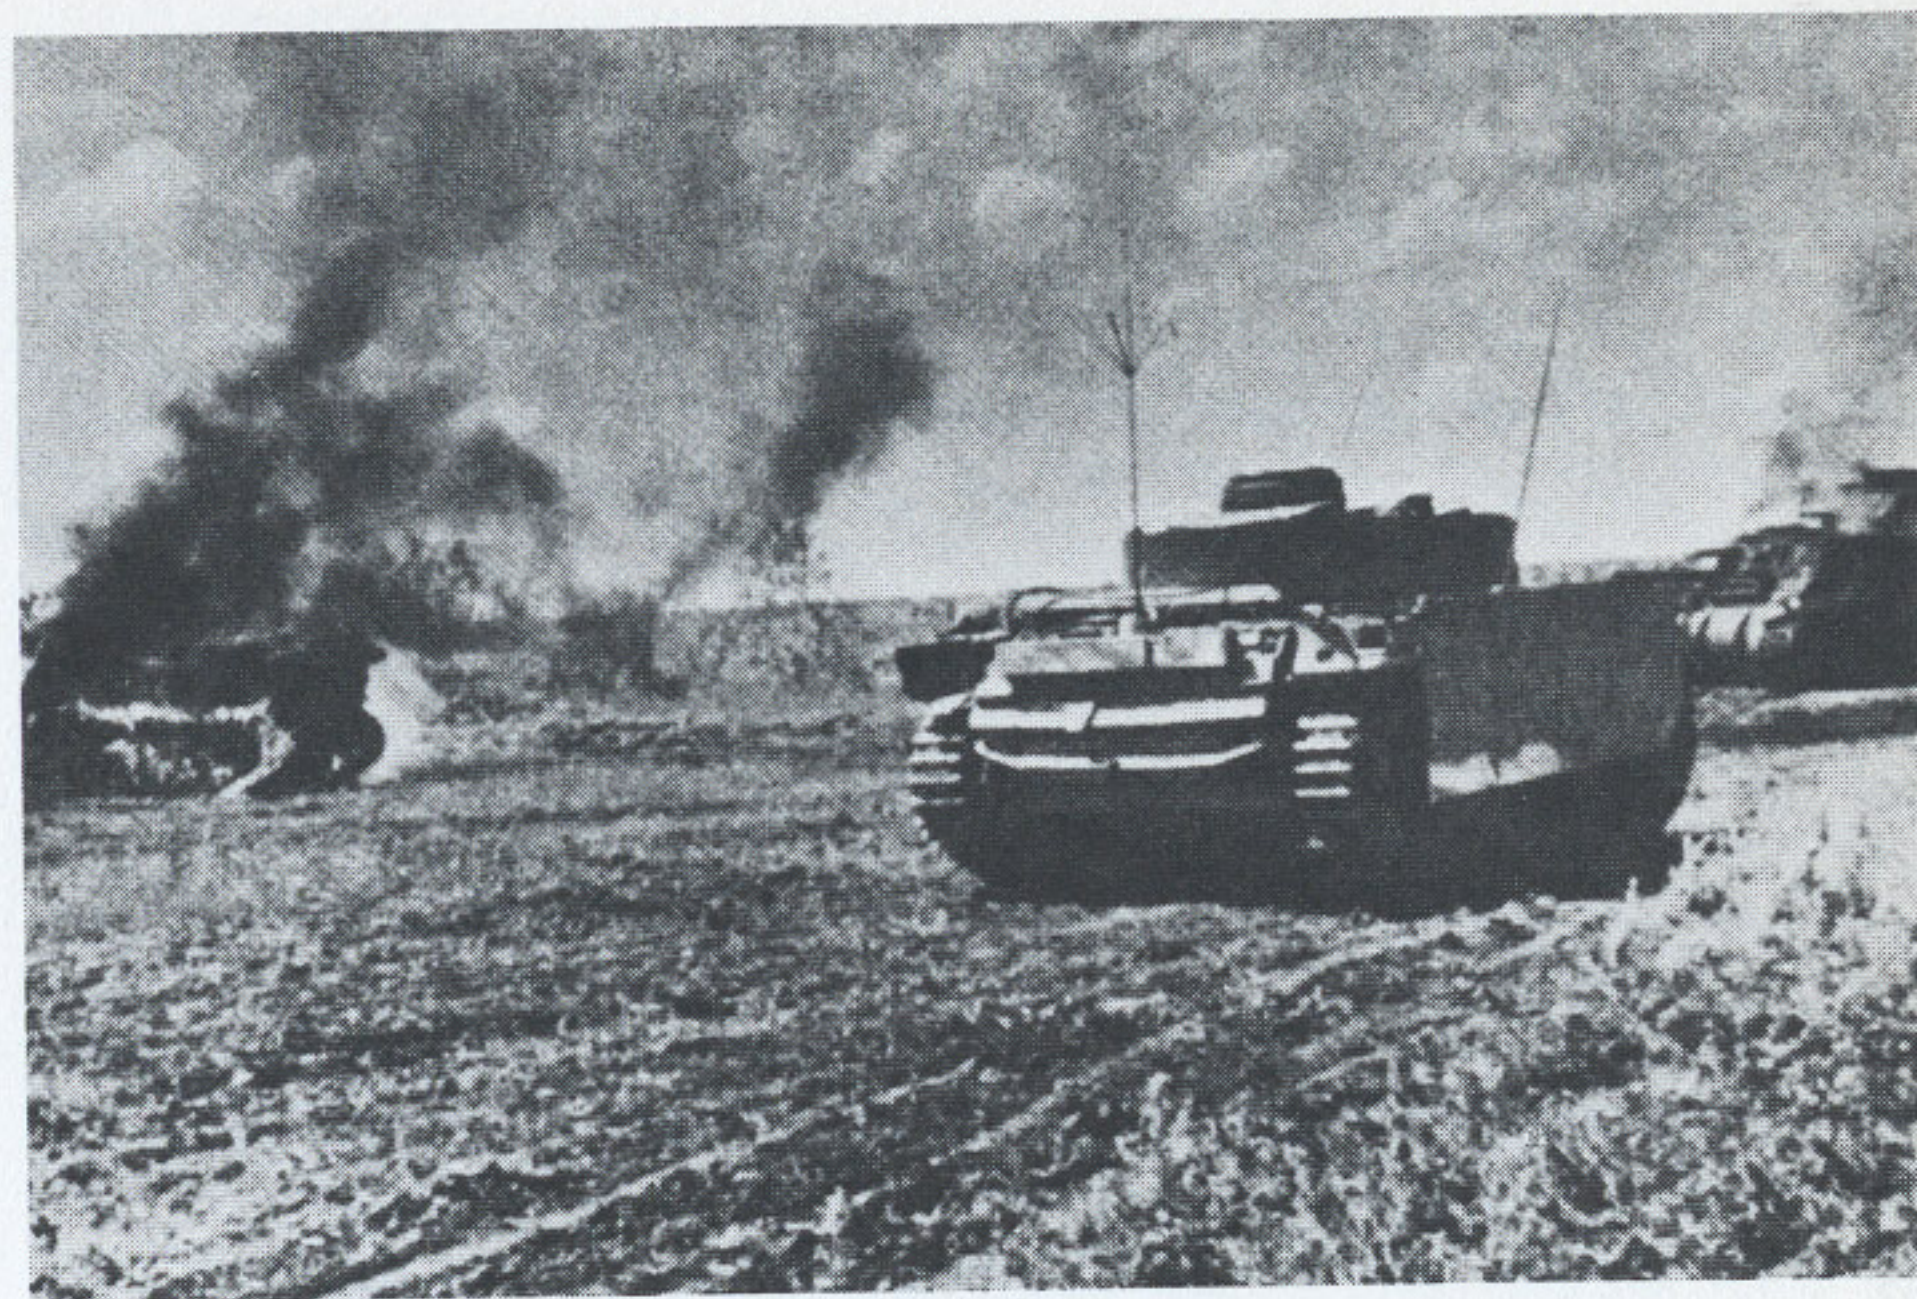
A PzKw III command vehicle passes burning Soviet armour. Barely visible on the tanks rear is the 'Kursk' marking for the 2nd SS Panzer Division 'Das Reich'. The tank in right background is a lease-lend M3 Lee in Soviet service.

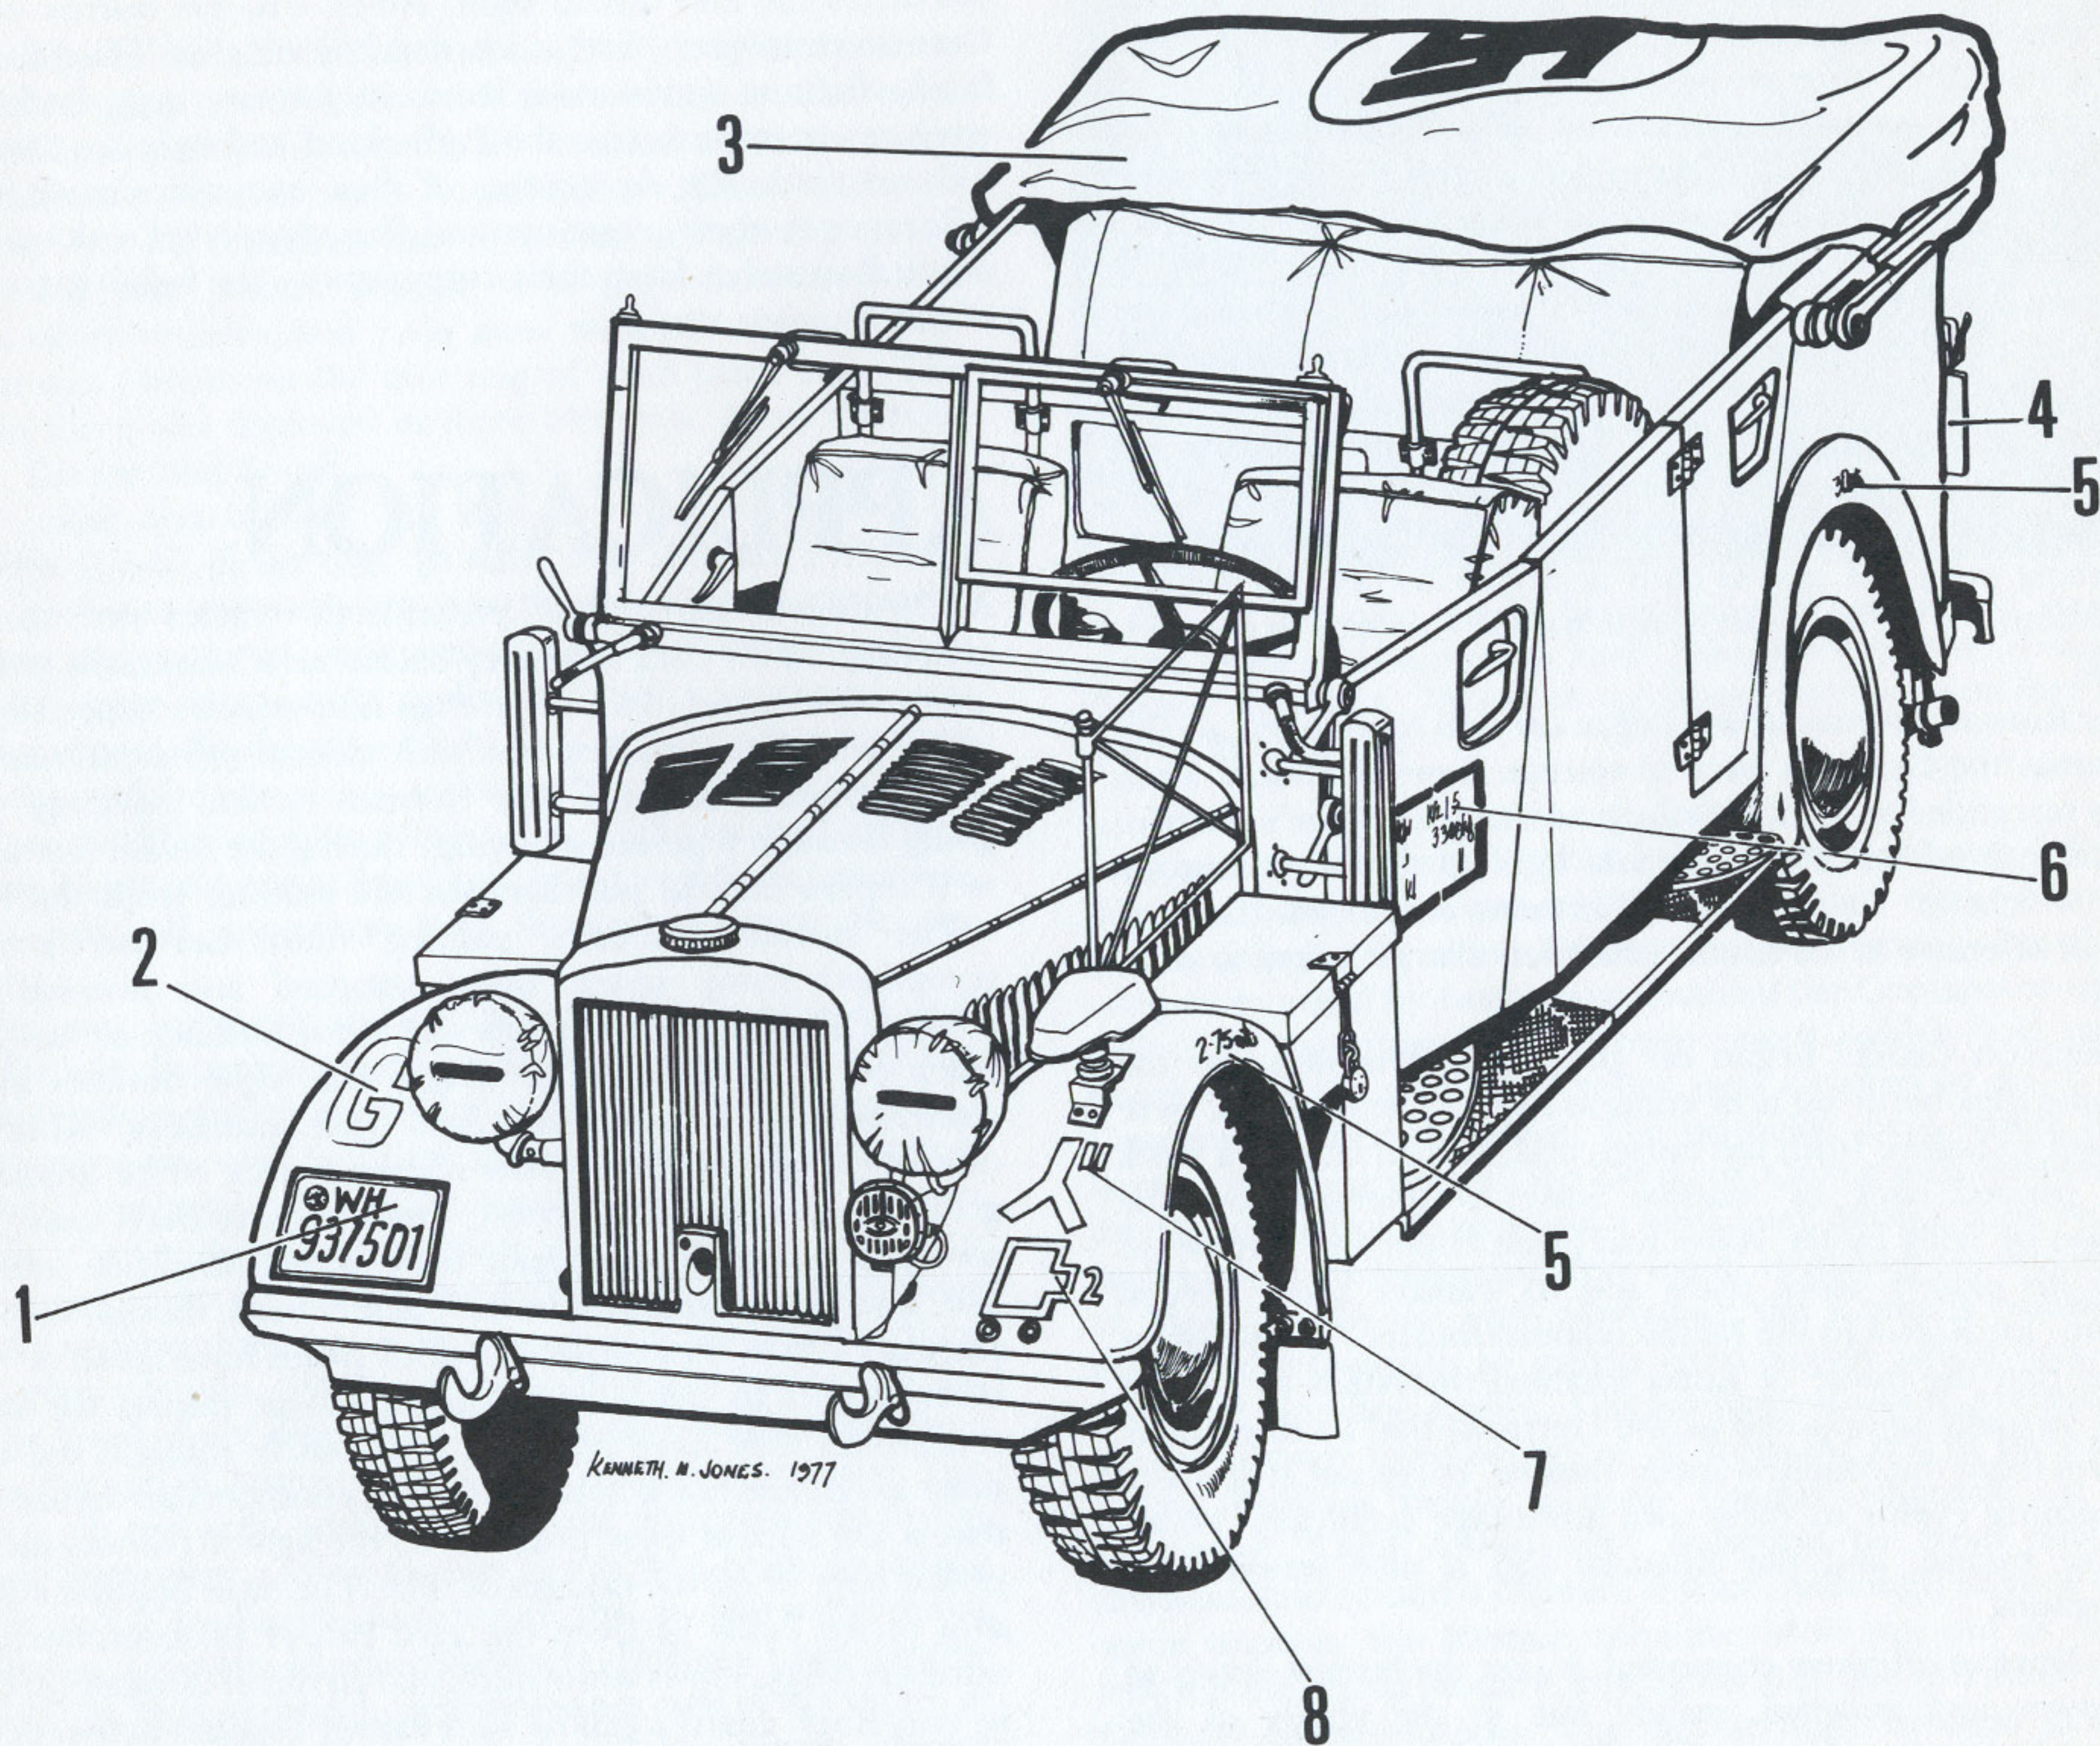
TYPICAL POSITIONS OF MARKINGS ON WEHRMACHT VEHICLES

Kfz 15

1. Number plate.
2. 'G', signifies that the vehicle belonged to Guderian's Group.
3. National flag as an aerial recognition signal – alternatively displayed on the vehicle bonnet.
4. Rear number plate.
5. Tyre pressures in atmospheric units.
6. Weight data shipping panel.
7. Divisional markings.
8. Tactical marking.

Tiger I

1. Divisional insignia.
2. Chassis number, often painted over in service.
3. Kill tally usually painted as rings on gun barrels.
4. Tactical numbers.
5. Tactical marking.
6. National marking.

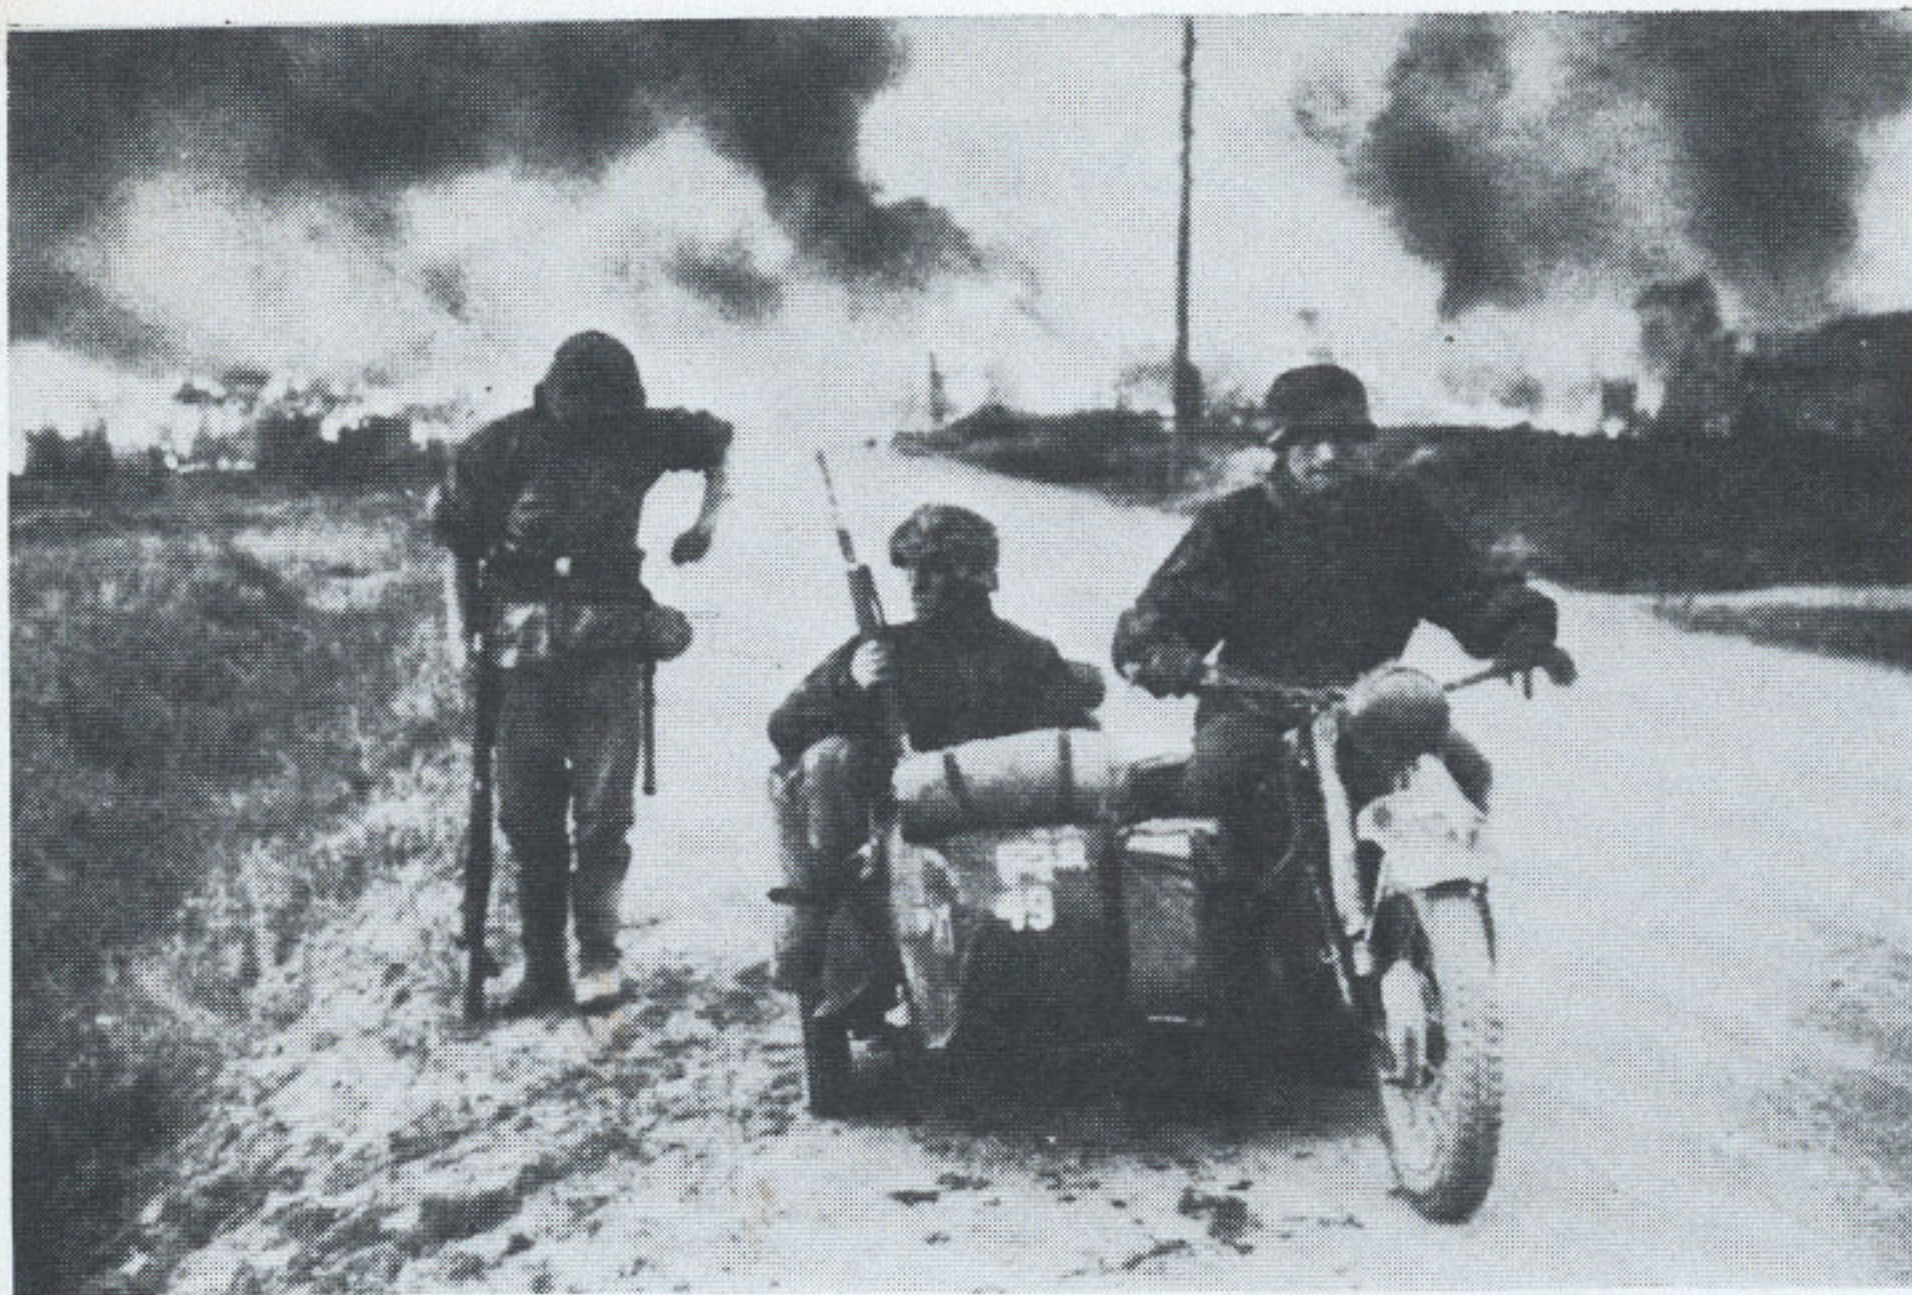
This grey finished, dust coated motorcycle combination sports tactical marks and numbers on its sidecar. The tactical markings indicate that this combination belonged to the HQ (stabs) company of a reconnaissance unit. The number 49 is the number of the combination. A sign which looks like the 2nd SS Panzer's barred 'N' device appears on the sidecar but this is not clear.

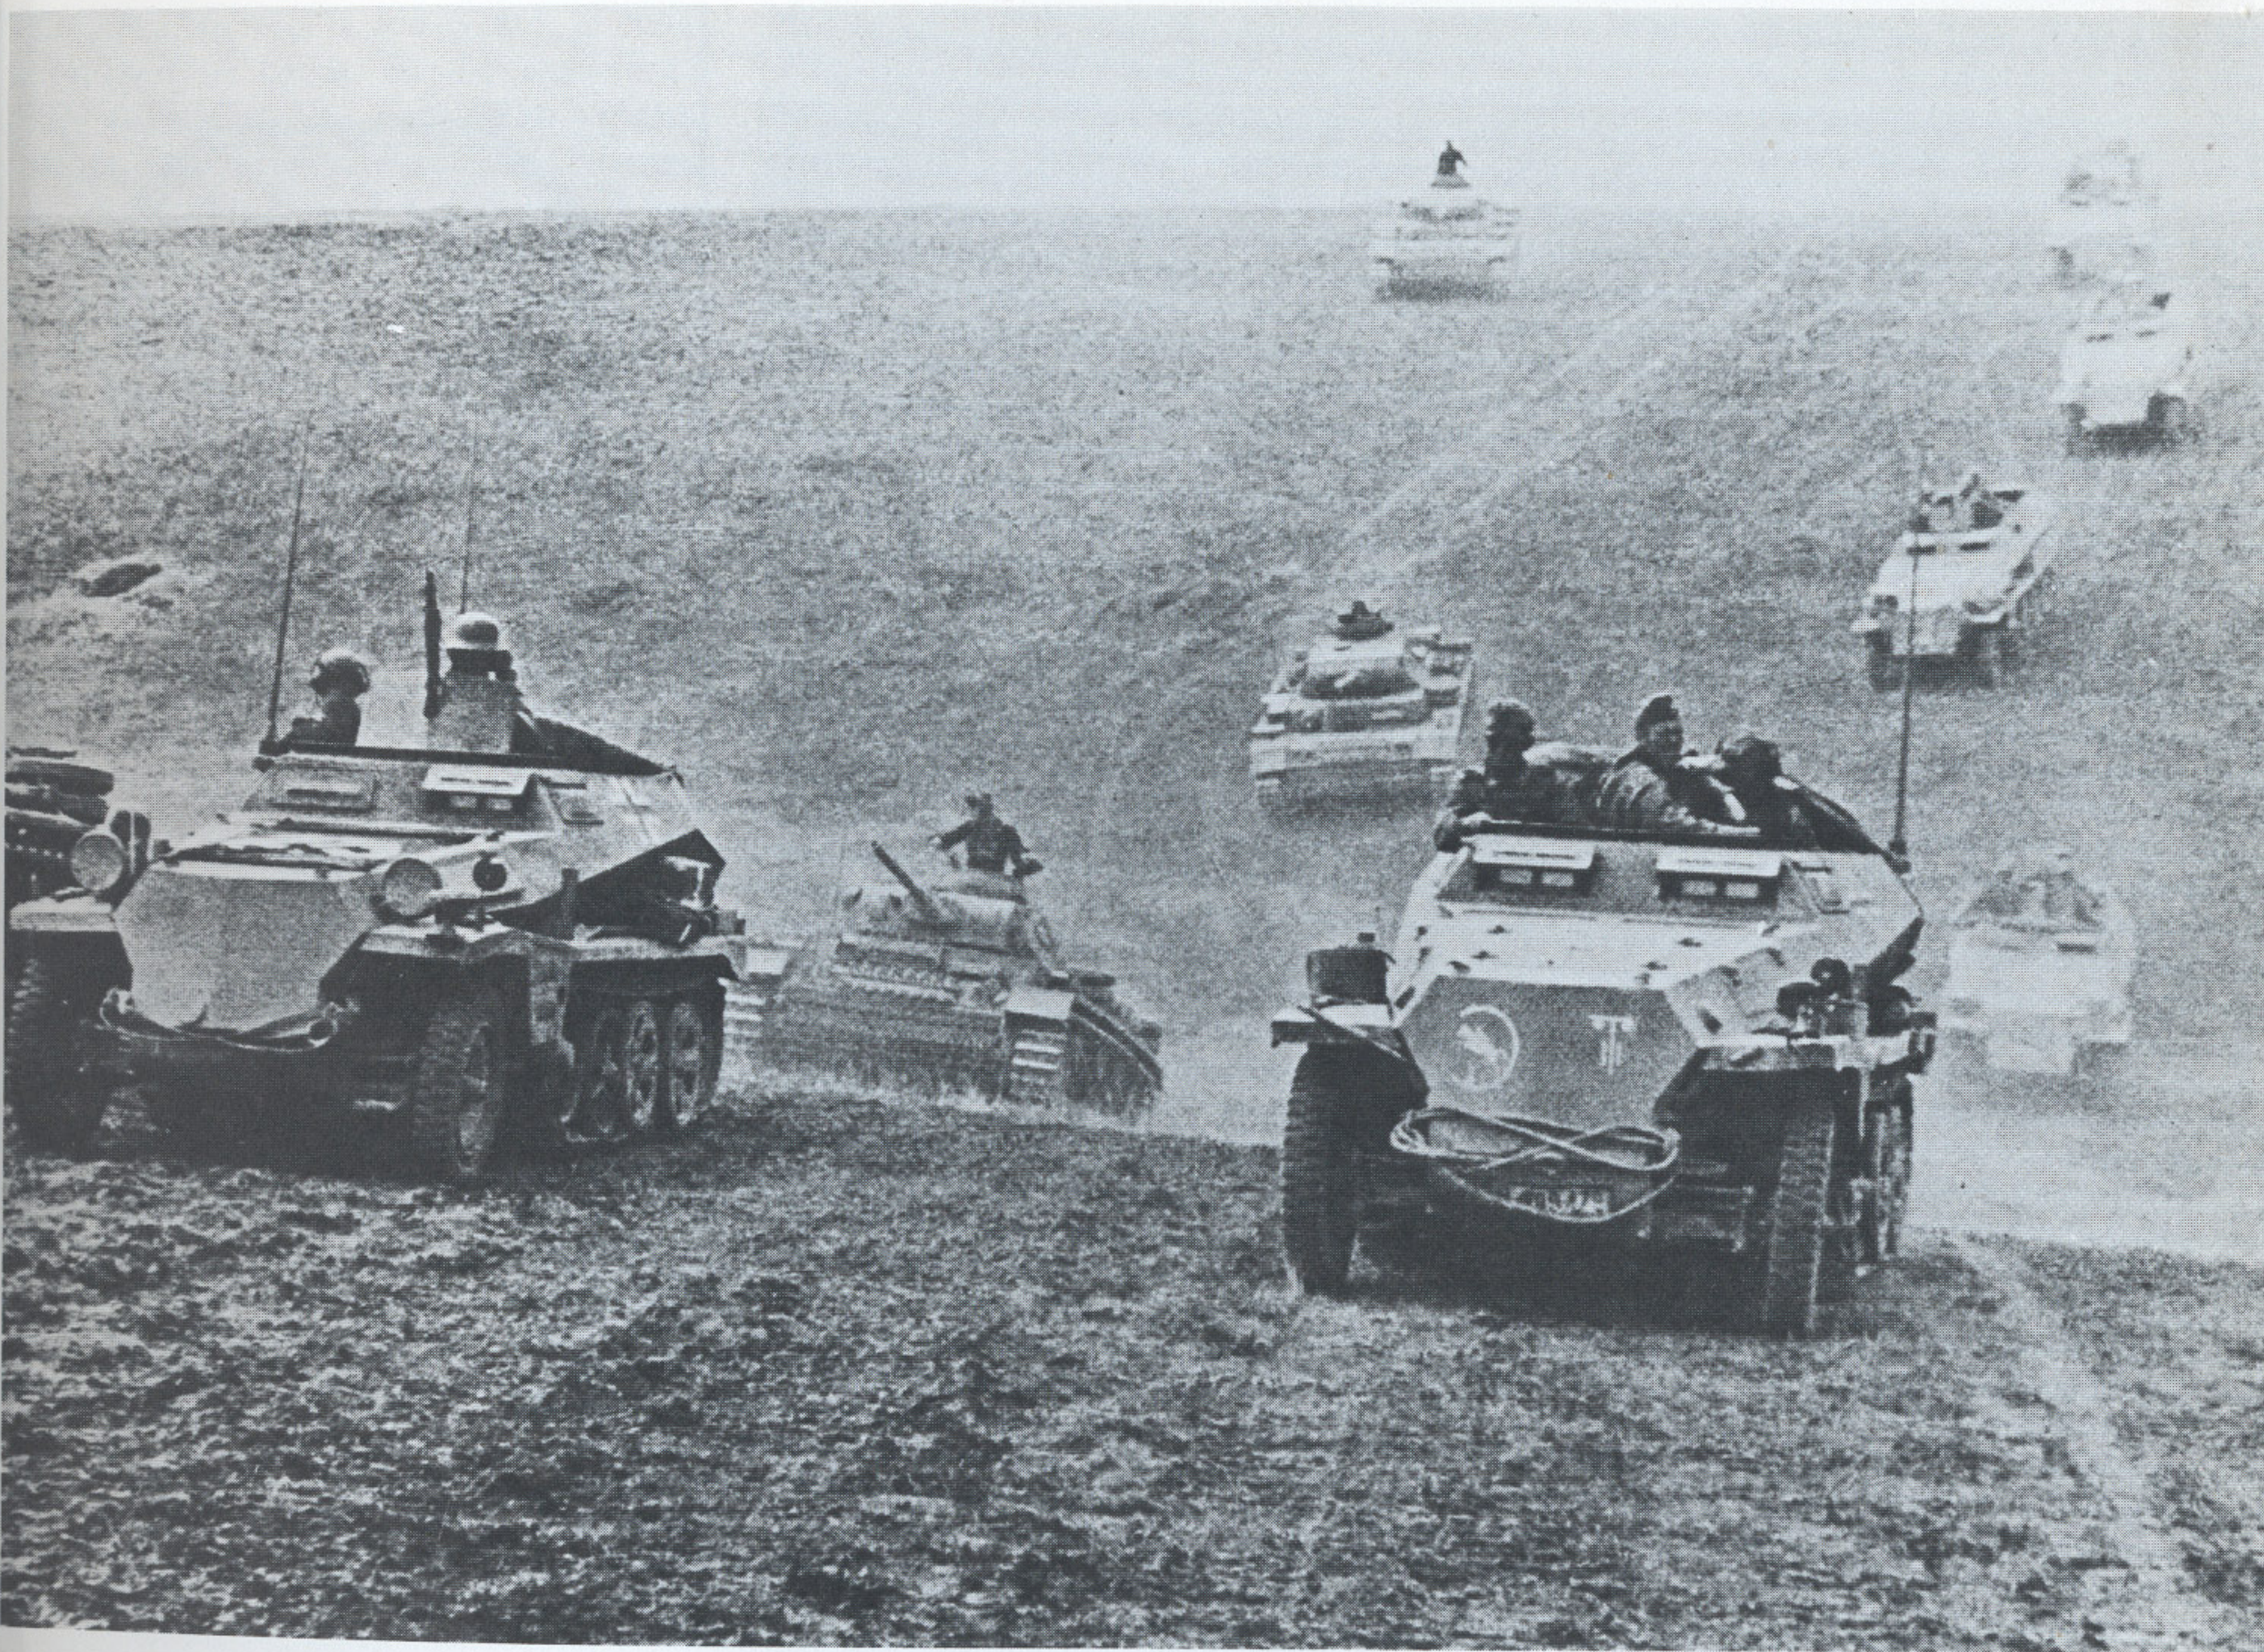
The 24th Panzer Division on the move; half-tracks, SdKfz 250's and 251's flanking PzKw III's. The two lead Sdkfz 250's show a good contrast in markings in that the left-hand vehicle carries only its national marking and a flag on its bonnet for aerial recognition, whereas the right hand-vehicle carries full divisional and tactical insignia. The divisional sign of the 24th Panzer is the leaping horse and rider. This should be painted yellow. The tactical marking denotes that this vehicle belongs to a fully motorized artillery unit within the 24th Panzer which was at the time Panzer Artillerieregiment 89. Note the dust thrown up by the vehicles and how the following tanks and half-tracks appear a shade lighter through it.

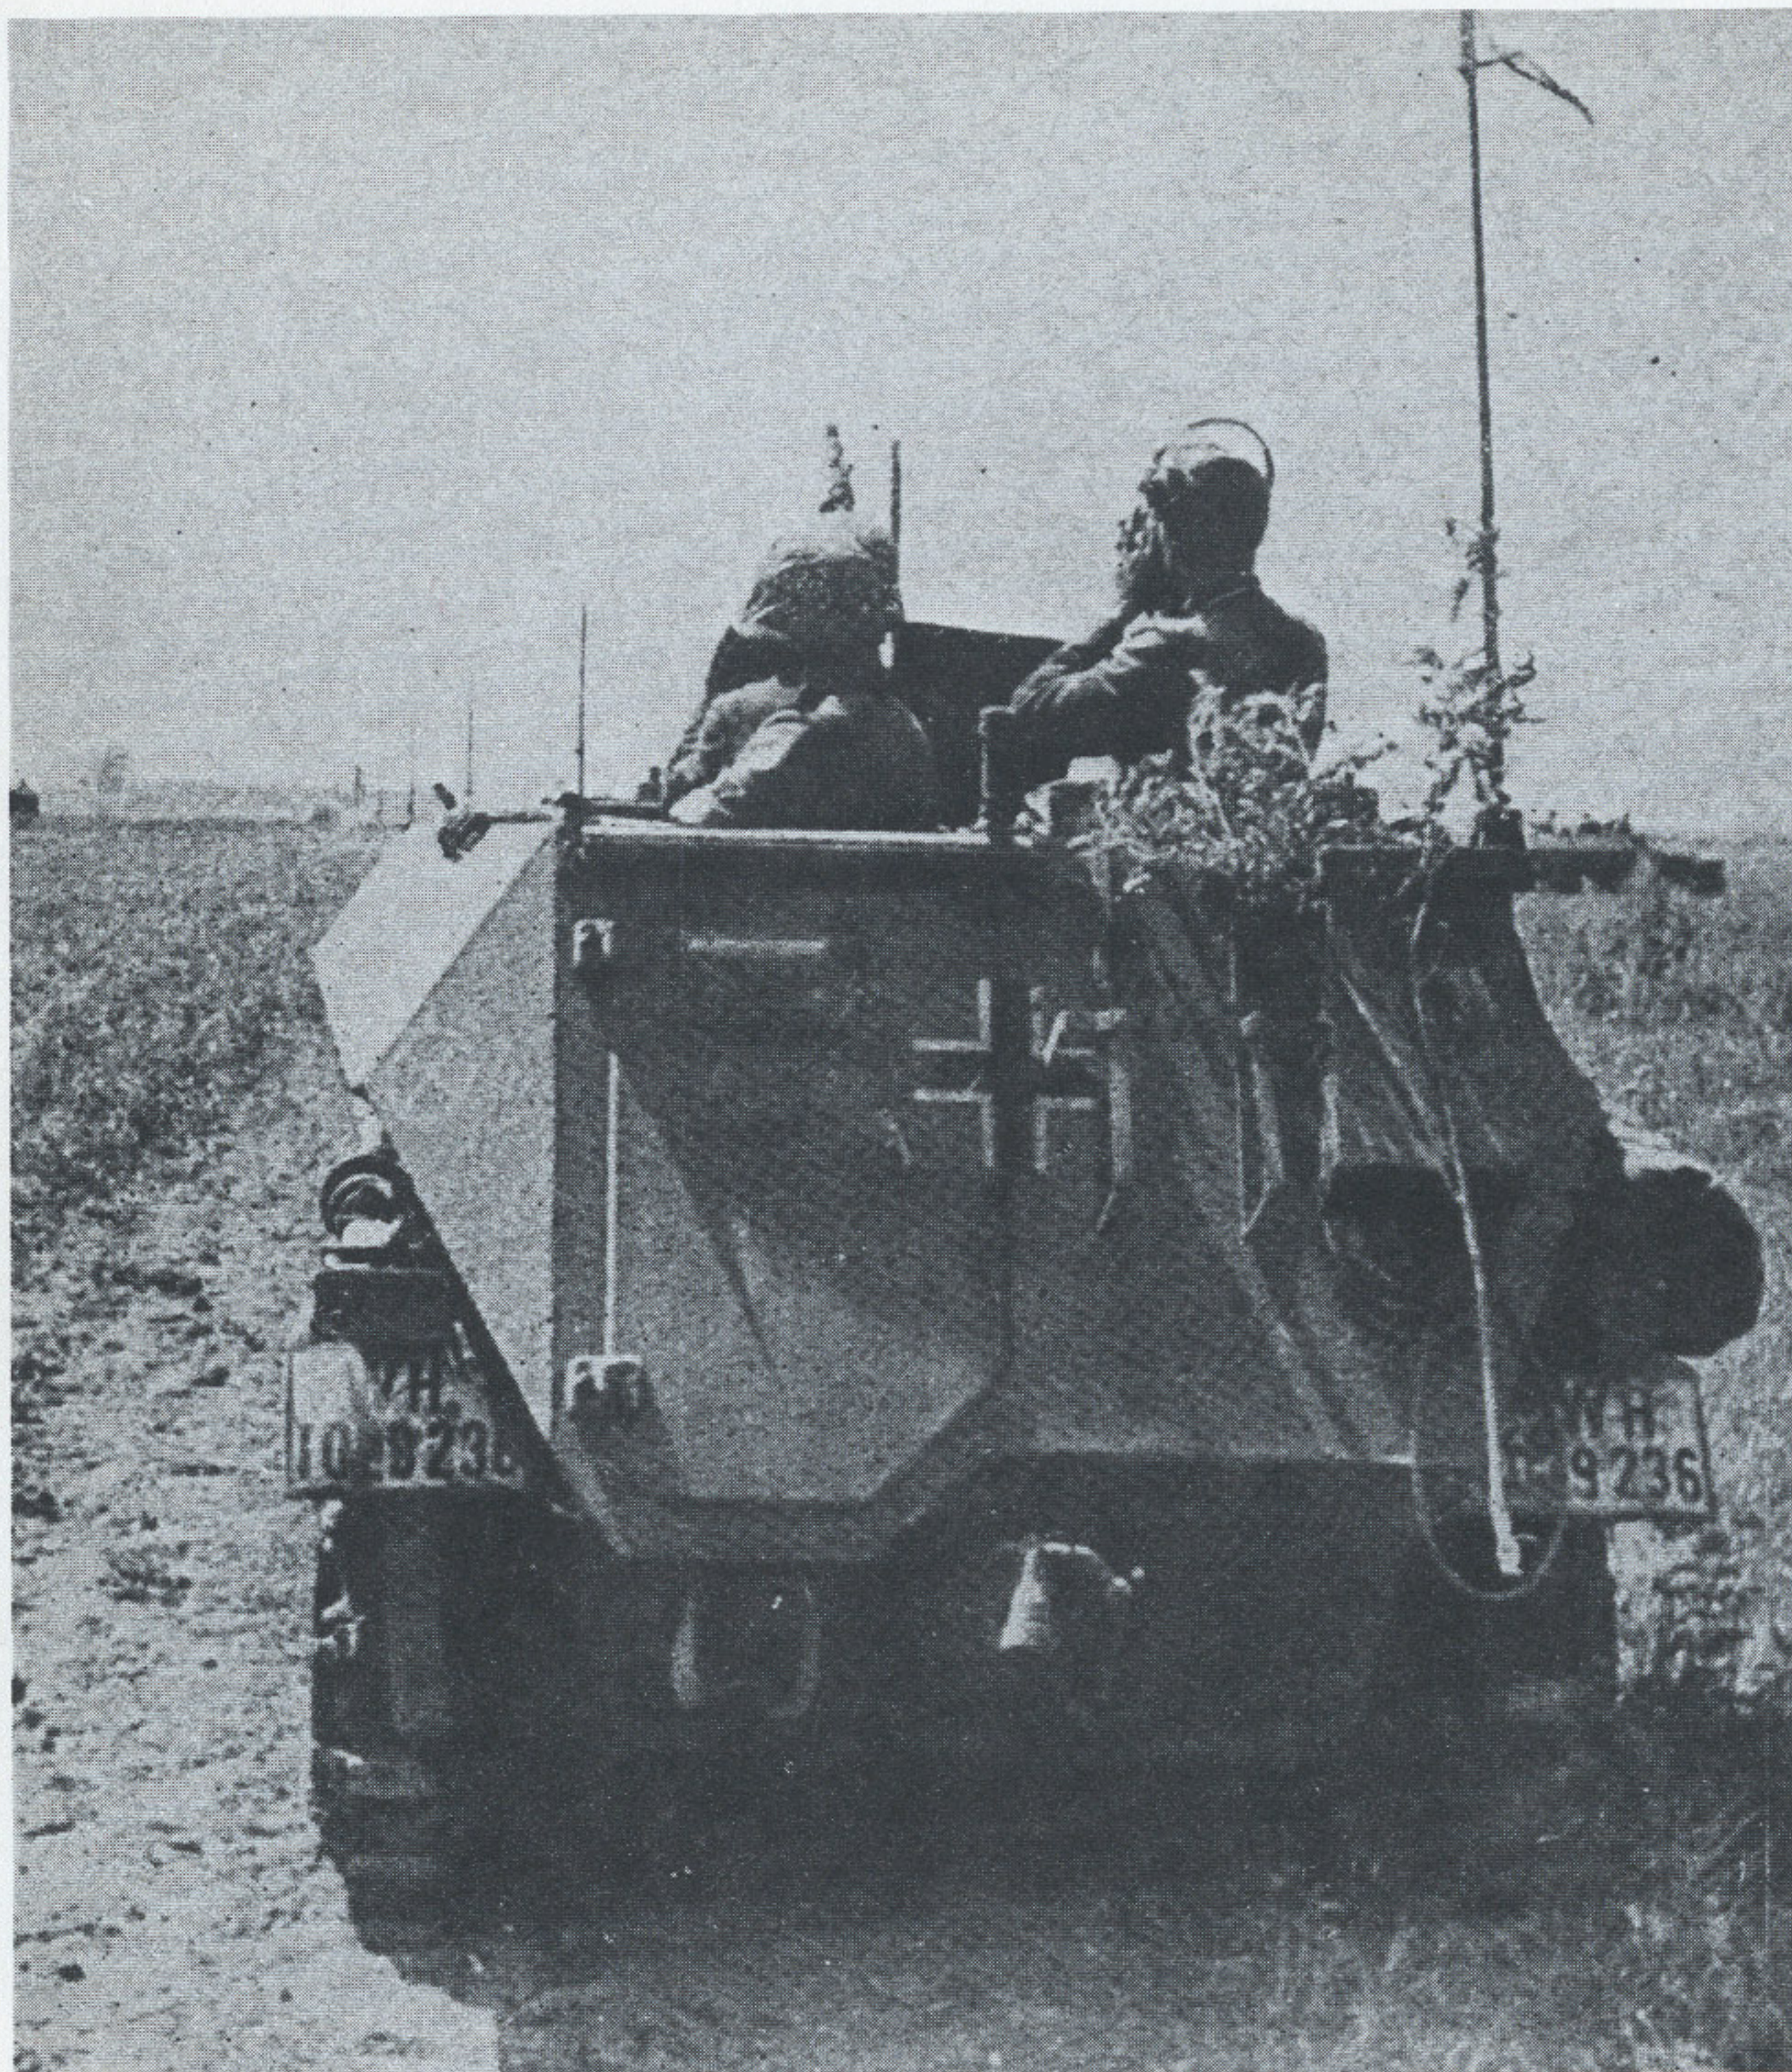
The rear view of this grey finished SdKfz 250 shows dual number plates and one variation of the national marking and its position, centrally, on the vehicle's rear plate. Note that the left arm and portion of the cross is on the rear entry door. The positioning of the cross was governed by the 'jerrycan' stowage racks on the right side. Faintly visible in this shot is the tactical sign of a motorcycle unit painted on the sloping facet of armour immediately above the rear 'Notek' light. No divisional signs are visible.

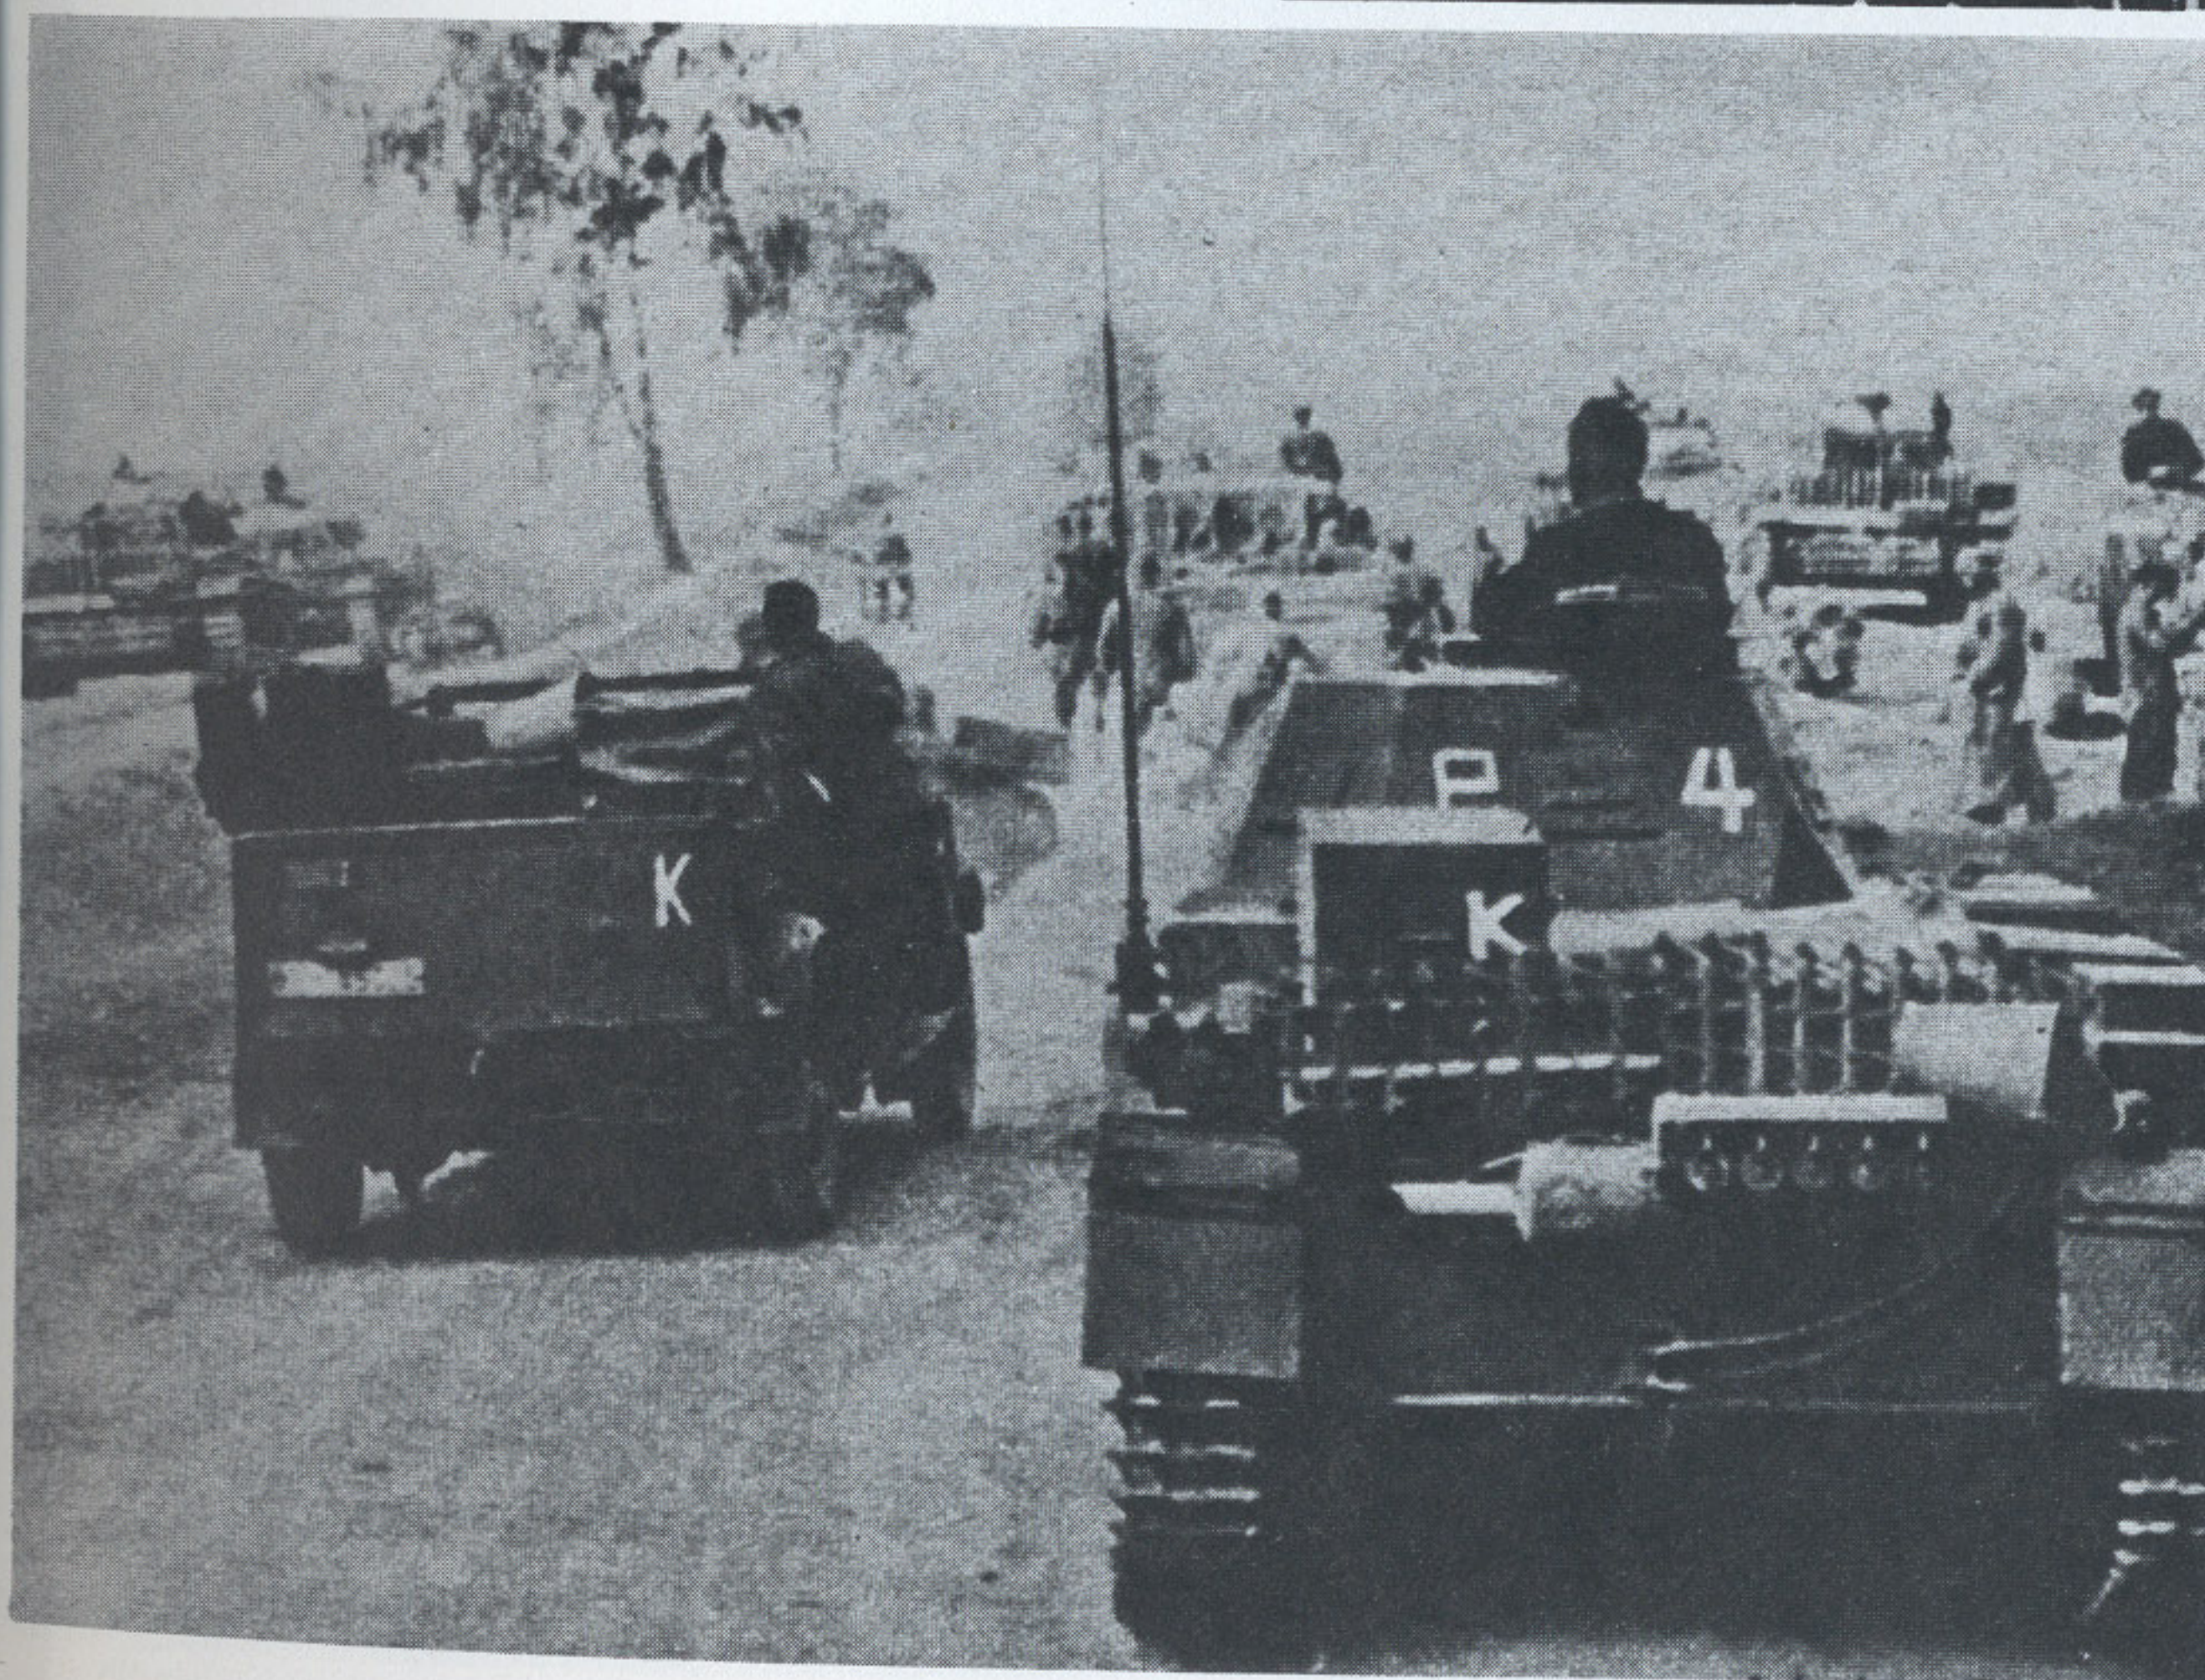
A column of vehicles from von Kleist's Panzergruppe, Army Group South, on a Russian road. The PzKw II and car are in overall dark grey with the large white letter 'K' to signify they belong to General Kleist's Panzergruppe. Vehicles are seen in photographs with the letter 'G' which signifies General Guderian's Panzergruppe. Without any other markings it is not certain to which unit these vehicles belonged.
