No.3 GERMAN

EASTERN FRONT

FOCUS ON
ARMOUR
CAMOUFLAGE
& MARKINGS

Kenneth M Jones

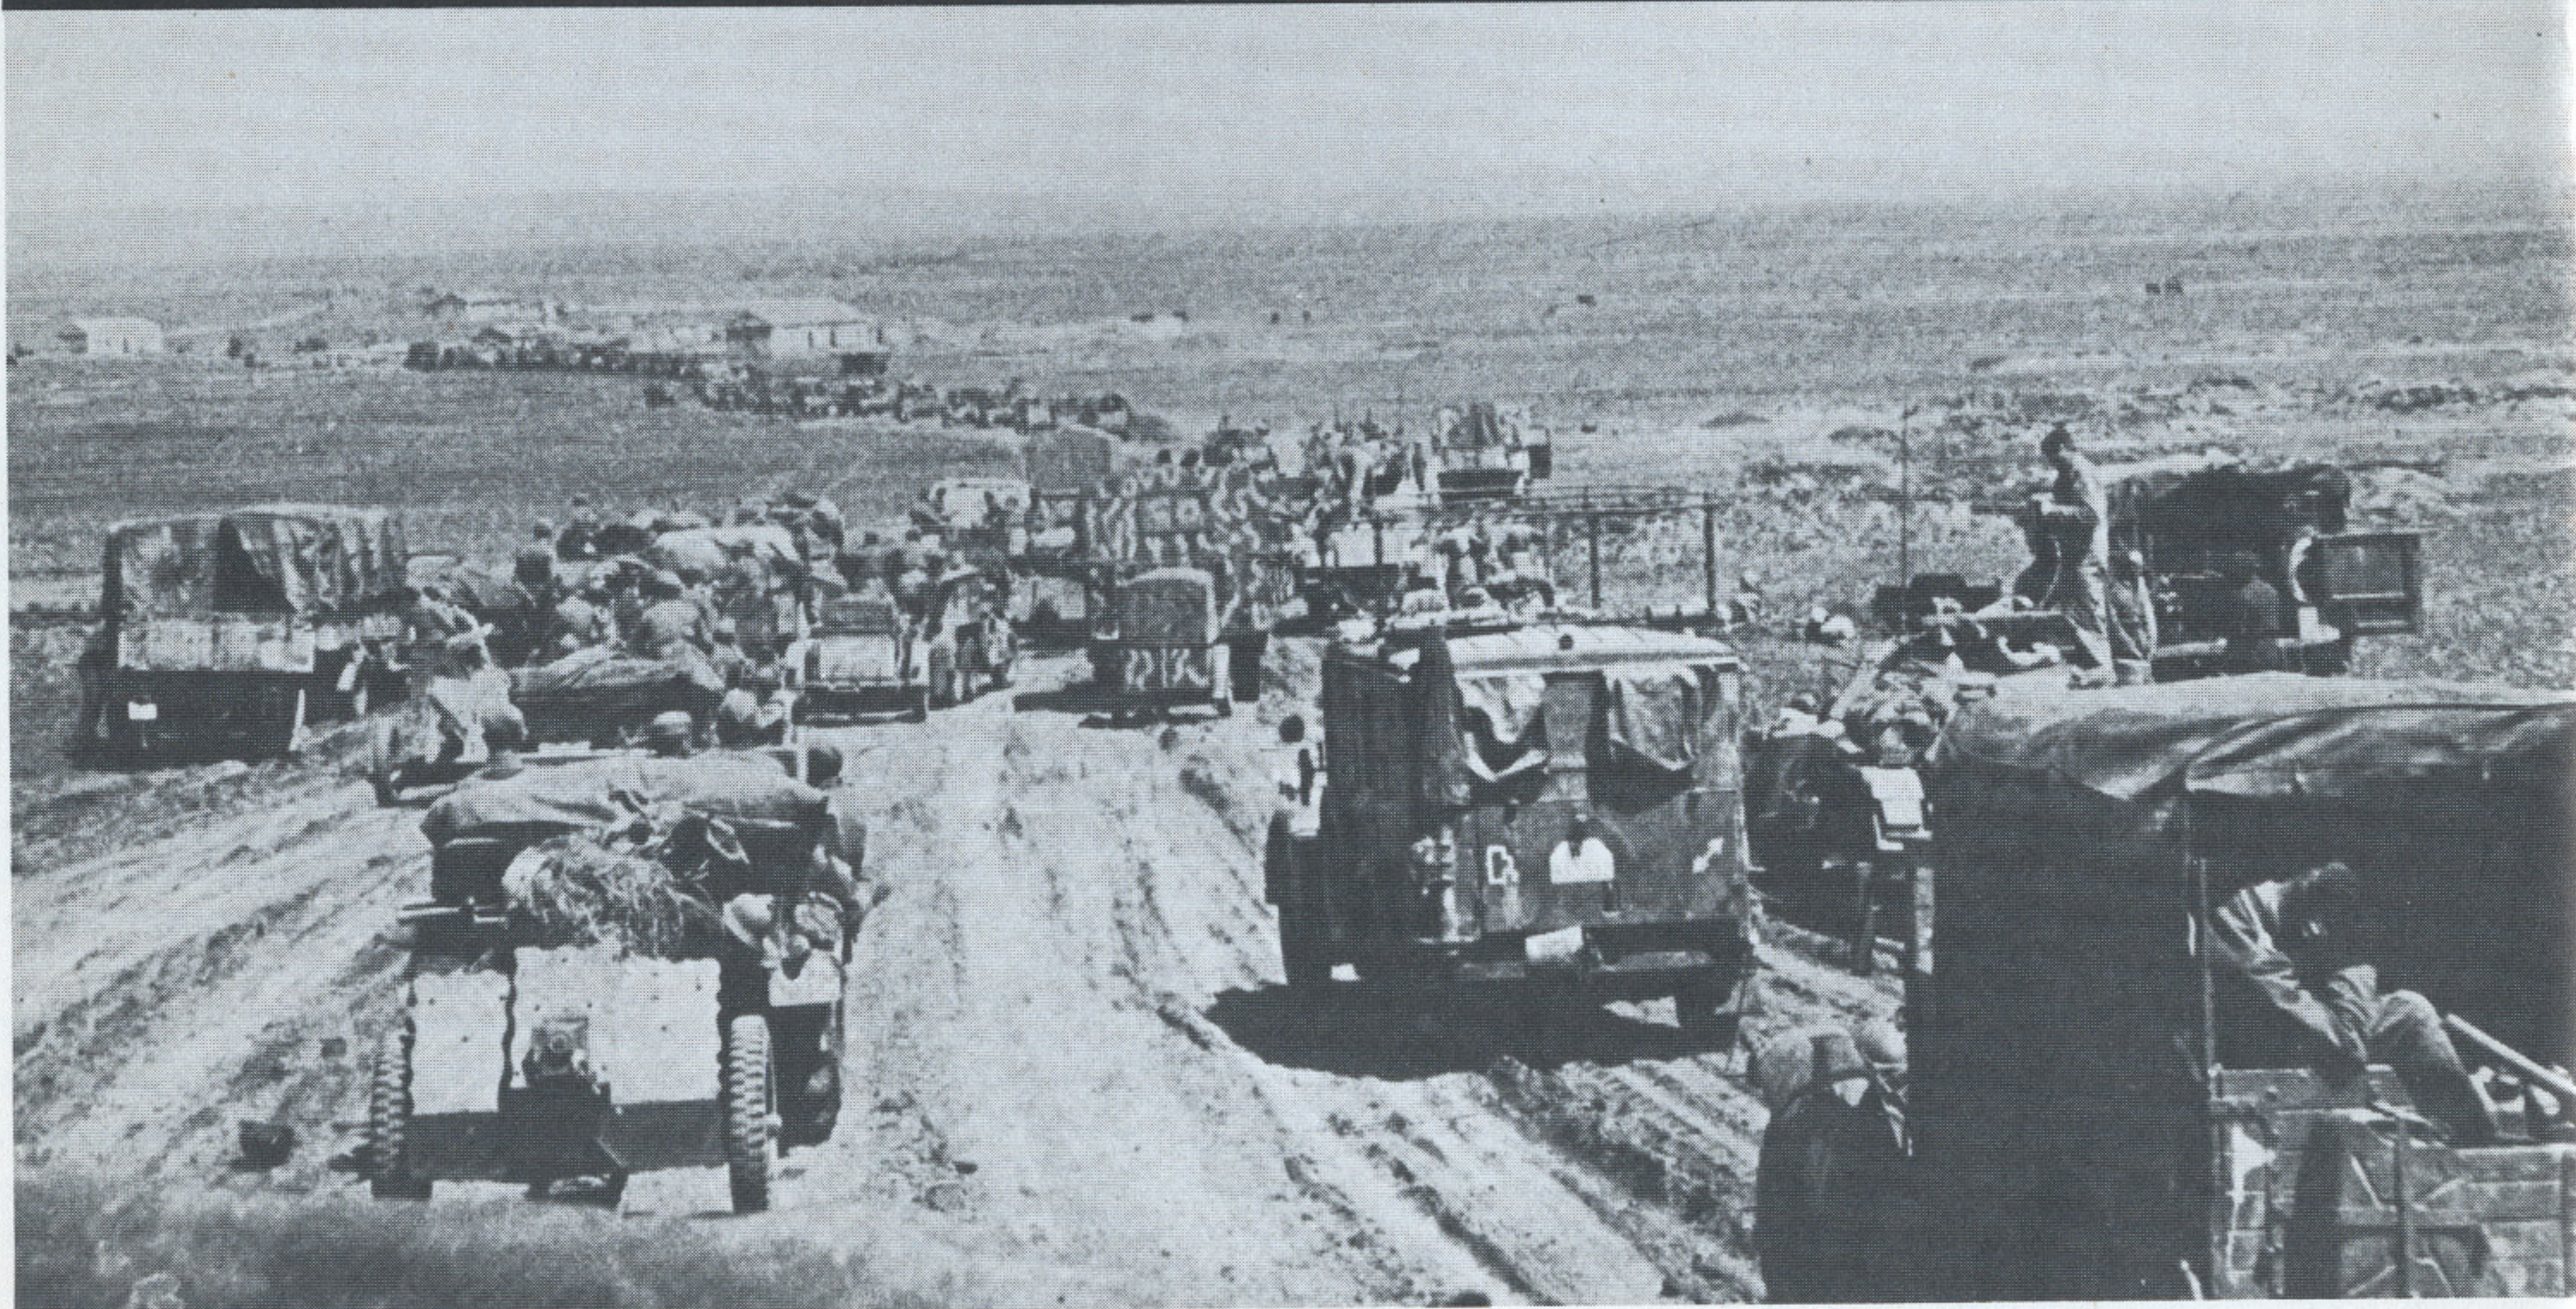
Many different types of vehicles are evident in this photograph of a column on the Russian plains. Note the heavily rutted Russian 'road'. The nearest light truck on the right has a battalion flag tactical marking on its tailboard, but no further subordination of this sign is evident. The Kfz 17 in front of this truck has a frame aerial erected and carries full tactical and divisional signs. The tactical sign is for the second signals company, and the divisional sign is that of the 22nd Panzer Division. It can be assumed that this radio truck, and the vehicle behind it with the battalion flag, belong to 140 Panzer Signal Battalion of 22nd Panzer Division, or one of its sub-units. The larger vehicle further down the road has had sand paint or dried mud painted on in wavy lines as a disruptive camouflage. The vehicles in the photograph are predominantly grey.

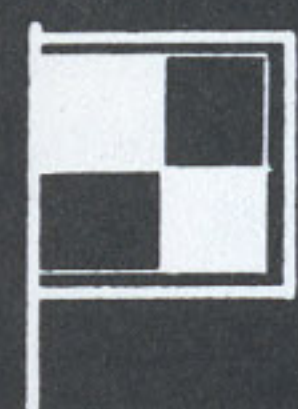
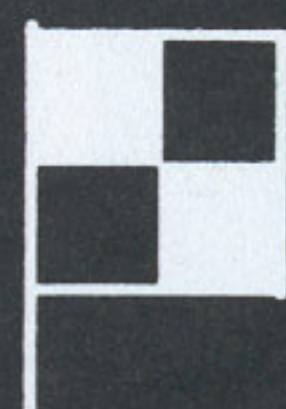
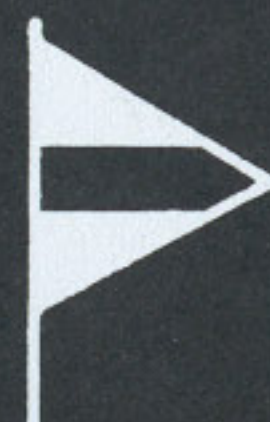
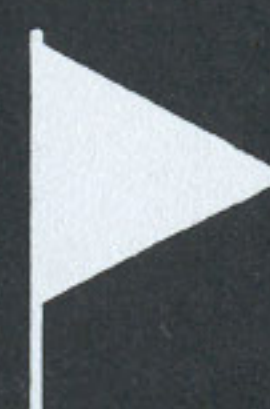
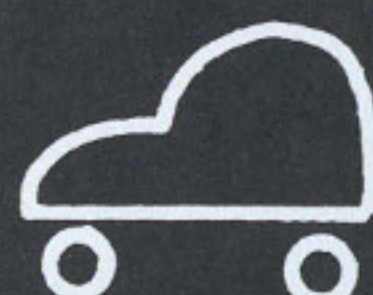
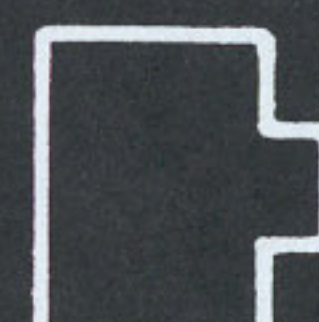
Basic Tactical Symbols

Command Flags. 1 Army. 2 Army Corps. 3 Division. 4 Regiment. 5 Battalion Units. 6 Machine gun. 7 Mortar. 8 Infantry howitzer. 9 Flame thrower. 10 Gun (field or anti-aircraft). 11 Howitzer. 12 Anti-tank. 13. Rocket/smoke. 14 Armoured. 15 Assault gun. 16 Armoured car. 17 Motorcycle. 18 Engineers. 19 Transport. 20 Signals. 21 Workshop/repair. 22 Medical. 23 Infantry/Grenadier. 24 Mountain. 25 Parachute. 26 Reconnaissance. 27 Searchlight. 28 Field post office. 29 Cavalry. Transport symbols. 30 Partly motorised. 31 Fully motorised. 32 Half-tracked. 33 Fully-tracked.

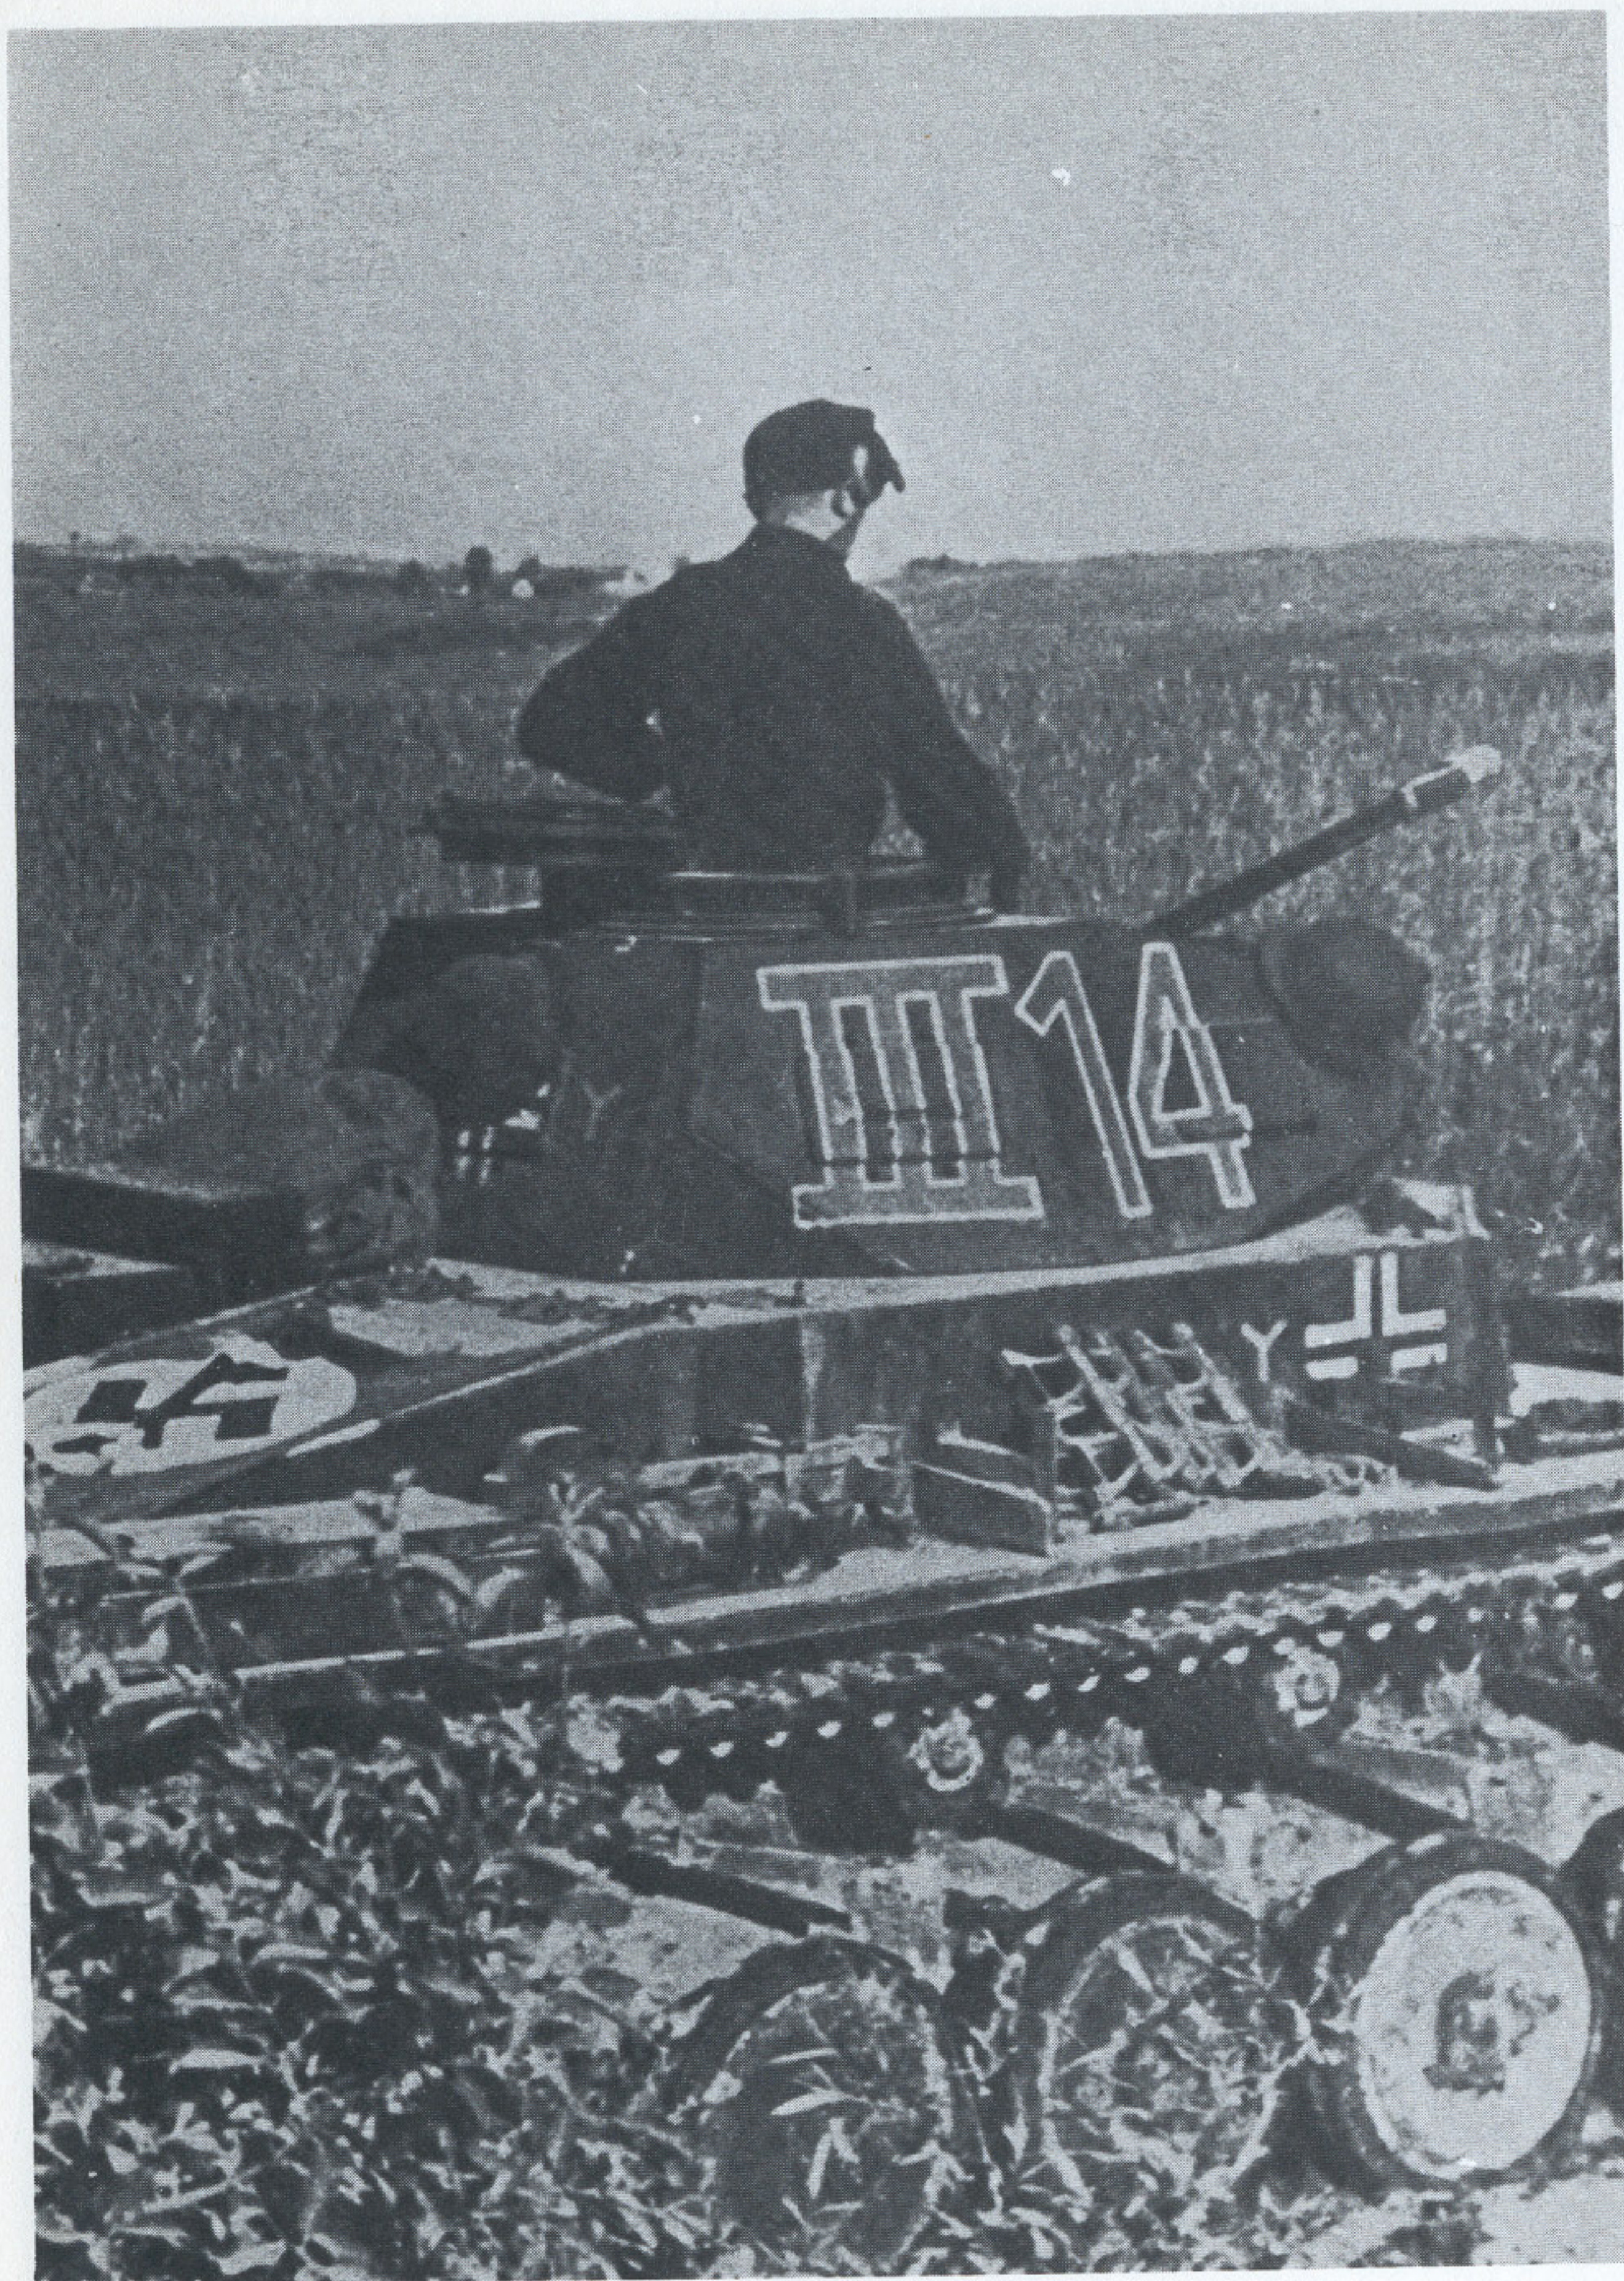
A PzKw II with the 'Y' divisional marking of the 7th Panzer Division on its turret rear plate and hull sides, which should be yellow. The large turret markings signify the third battalion, the dinome further subordinating the user of the vehicle within the 3rd Battalion. These markings are red, outlined white. Worthy of mention is the national marking repeated on the turret rear, just visible under the helmet slung there. This marking, as the hull side cross, is black with a white outline. Note the small national flag on the engine covers for aerial recognition.

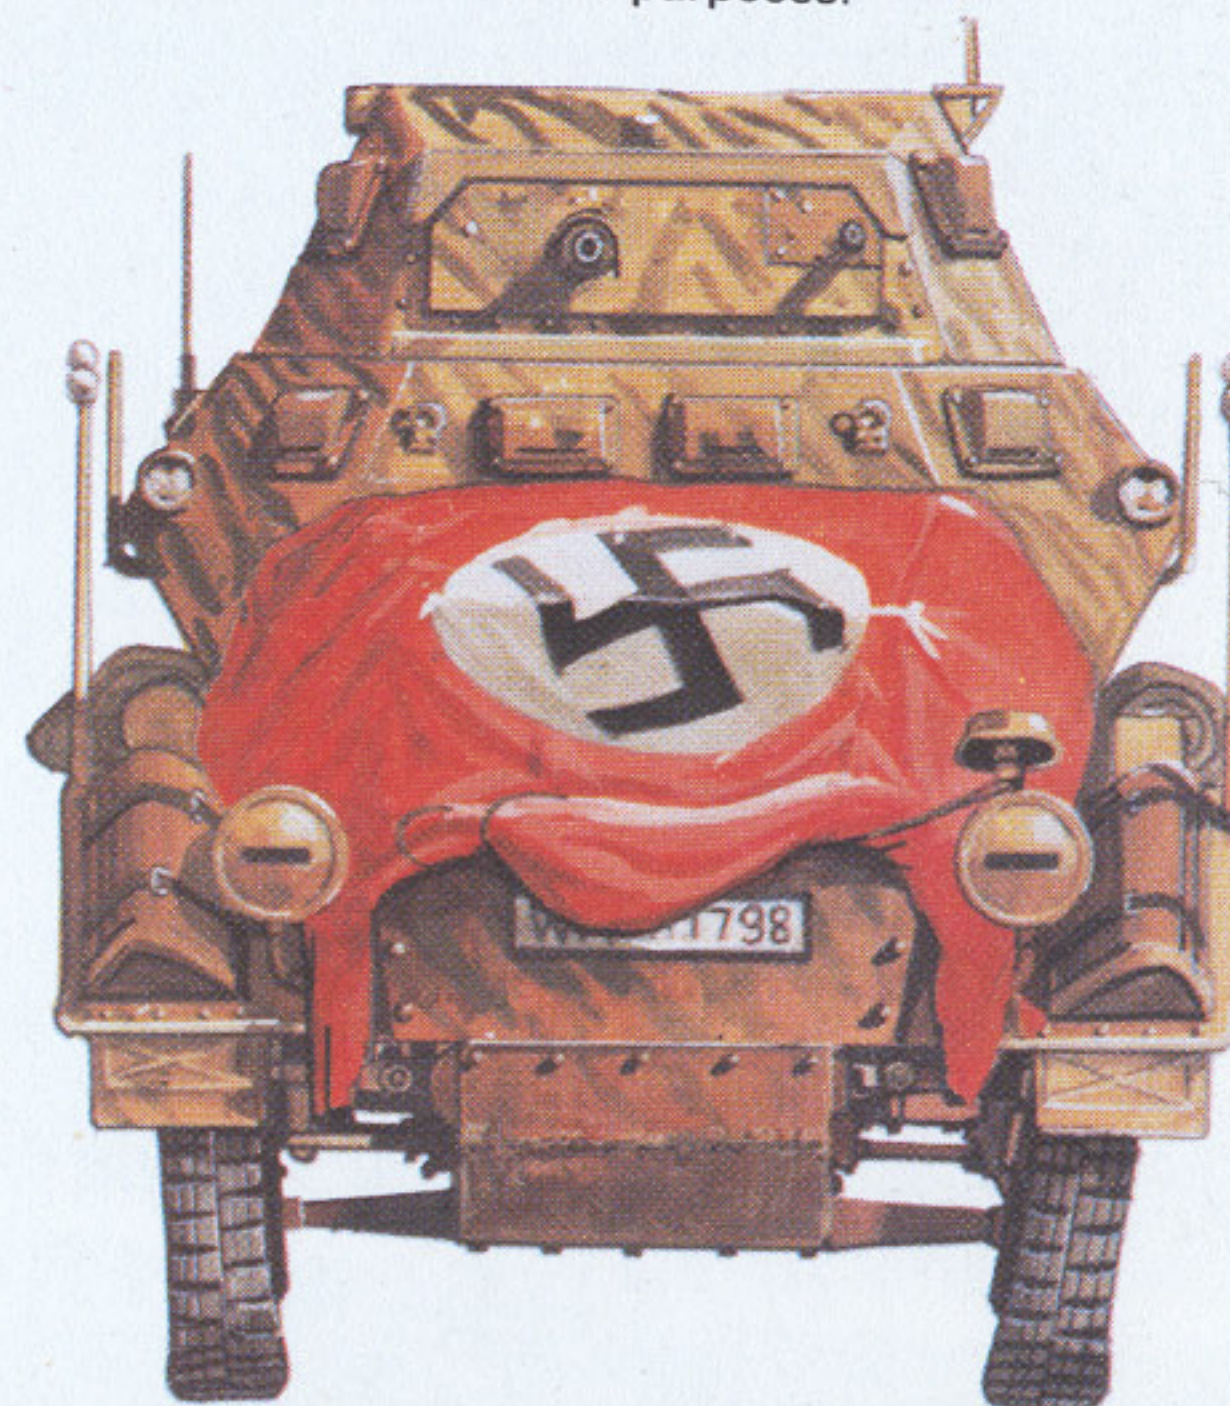
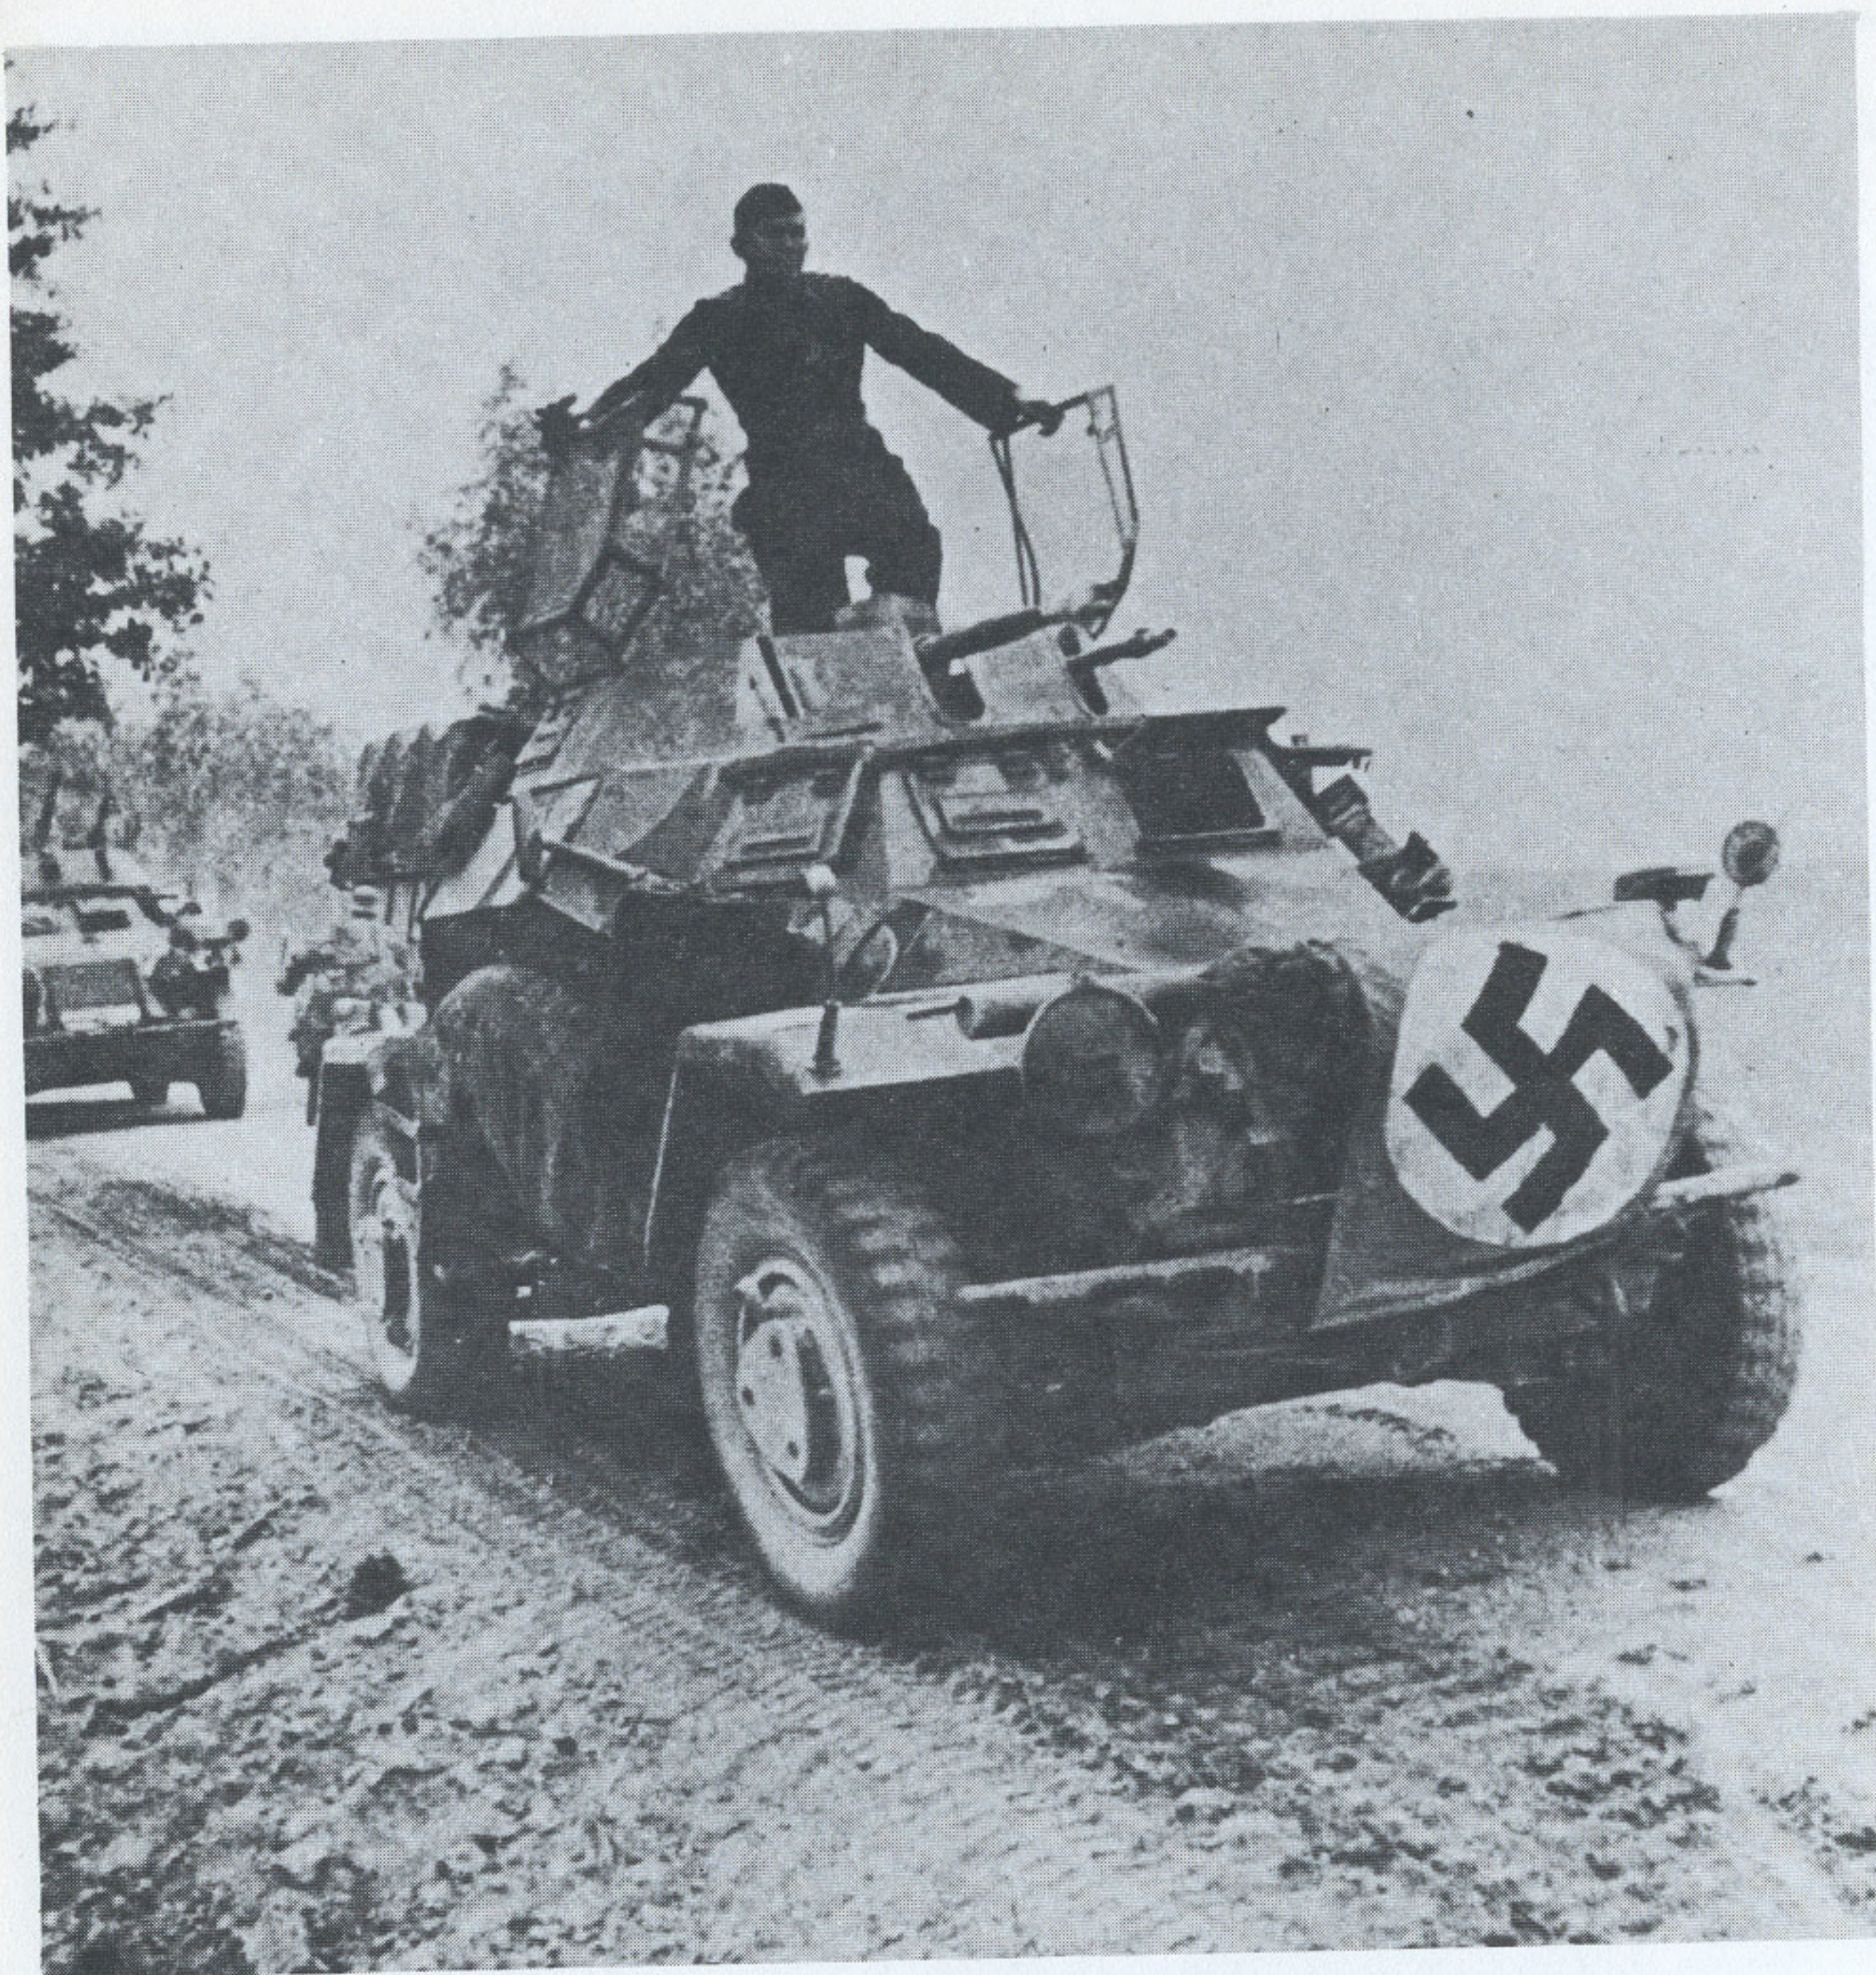
ABOVE: This scruffy SdKfz 222 shows how the national flag was often carried as extra recognition. In this case it cannot be assumed that the flag is mounted for aerial recognition but rather as an identifying marker to ground troops by virtue of its display on a vertical plane. This is a feature more commonly associated with captured equipment and it is quite plain that the flag in this position makes an excellent aiming point for an enemy anti-tank gunner, should this SdKfz 222 go into action with its flag in position. Noteworthy are the large canvas cover on the spare wheel and the folding turret screens, fitted to counteract missiles from being thrown into the open topped turret. Faint tyre pressure markings are just visible on the front wing edge.

RIGHT UPPER: A sand finished Raupen Schlepper Ost towing a similarly finished 10.5 cm Light Field Howitzer. The dark tarpaulin on the tractor contrasts well with the sand finish of the vehicle body. A weight data panel is stencilled in dark grey or black on the cab door. This panel gave type, weight and shipping classes for movements personnel. The circular device above this is a Steyr company badge, the builders of this particular tractor, which consisted of concentric rings broken by a cross on a dark background with a stylized 'Steyr' logo on the central disc. The dark objects in racks on the body side are track fittings for rough cross country operation.

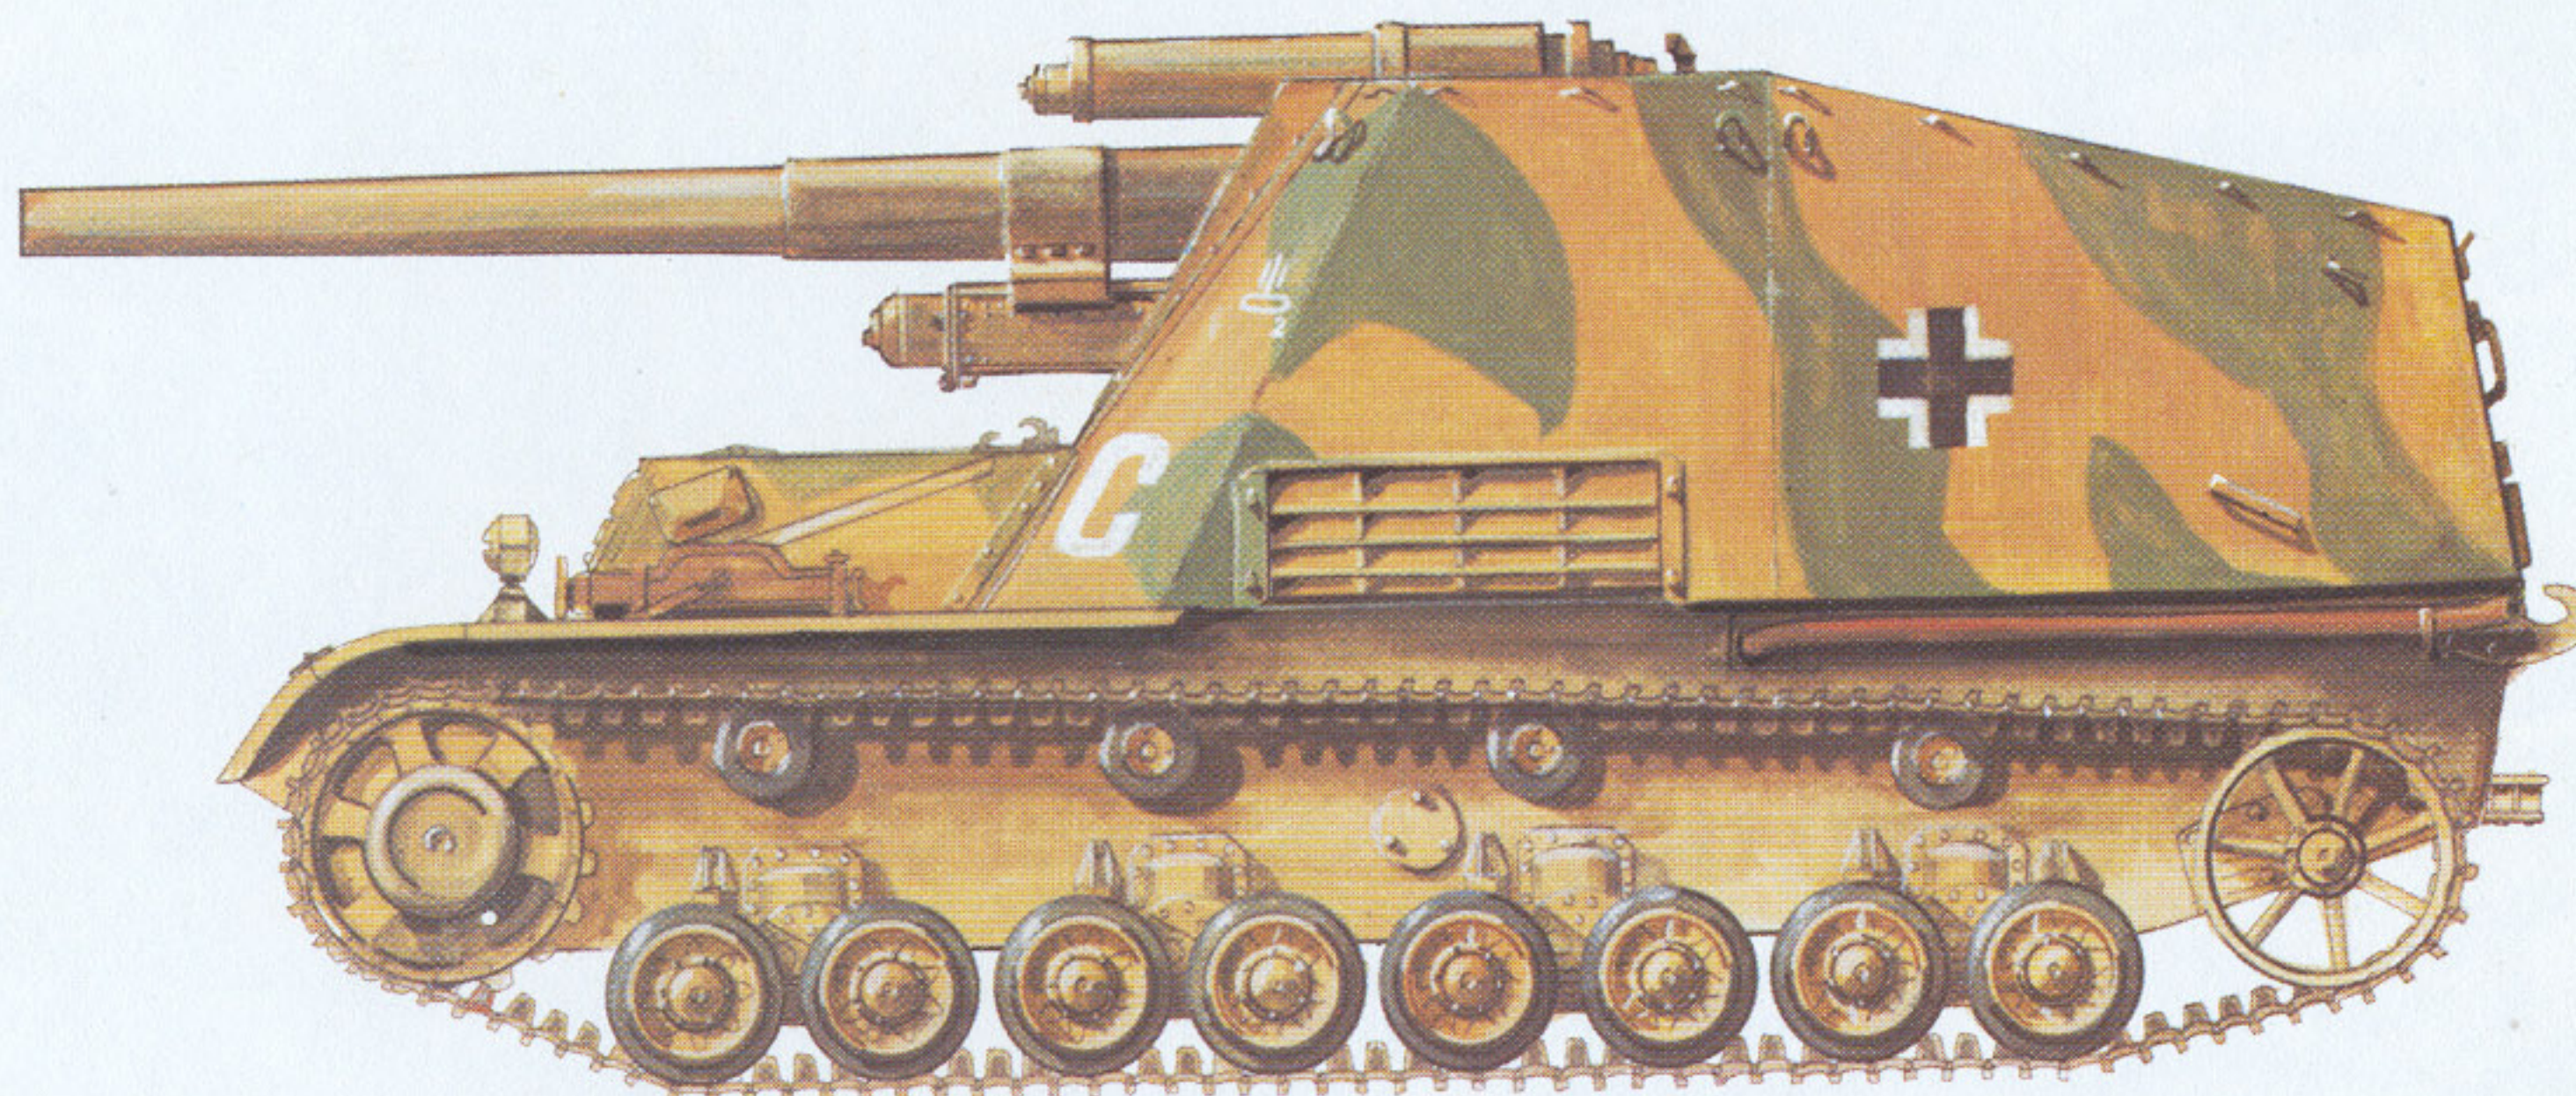
15cm. Panzerhaubitze 18 auf Sf IV 'Hummel', SdKfz 165.

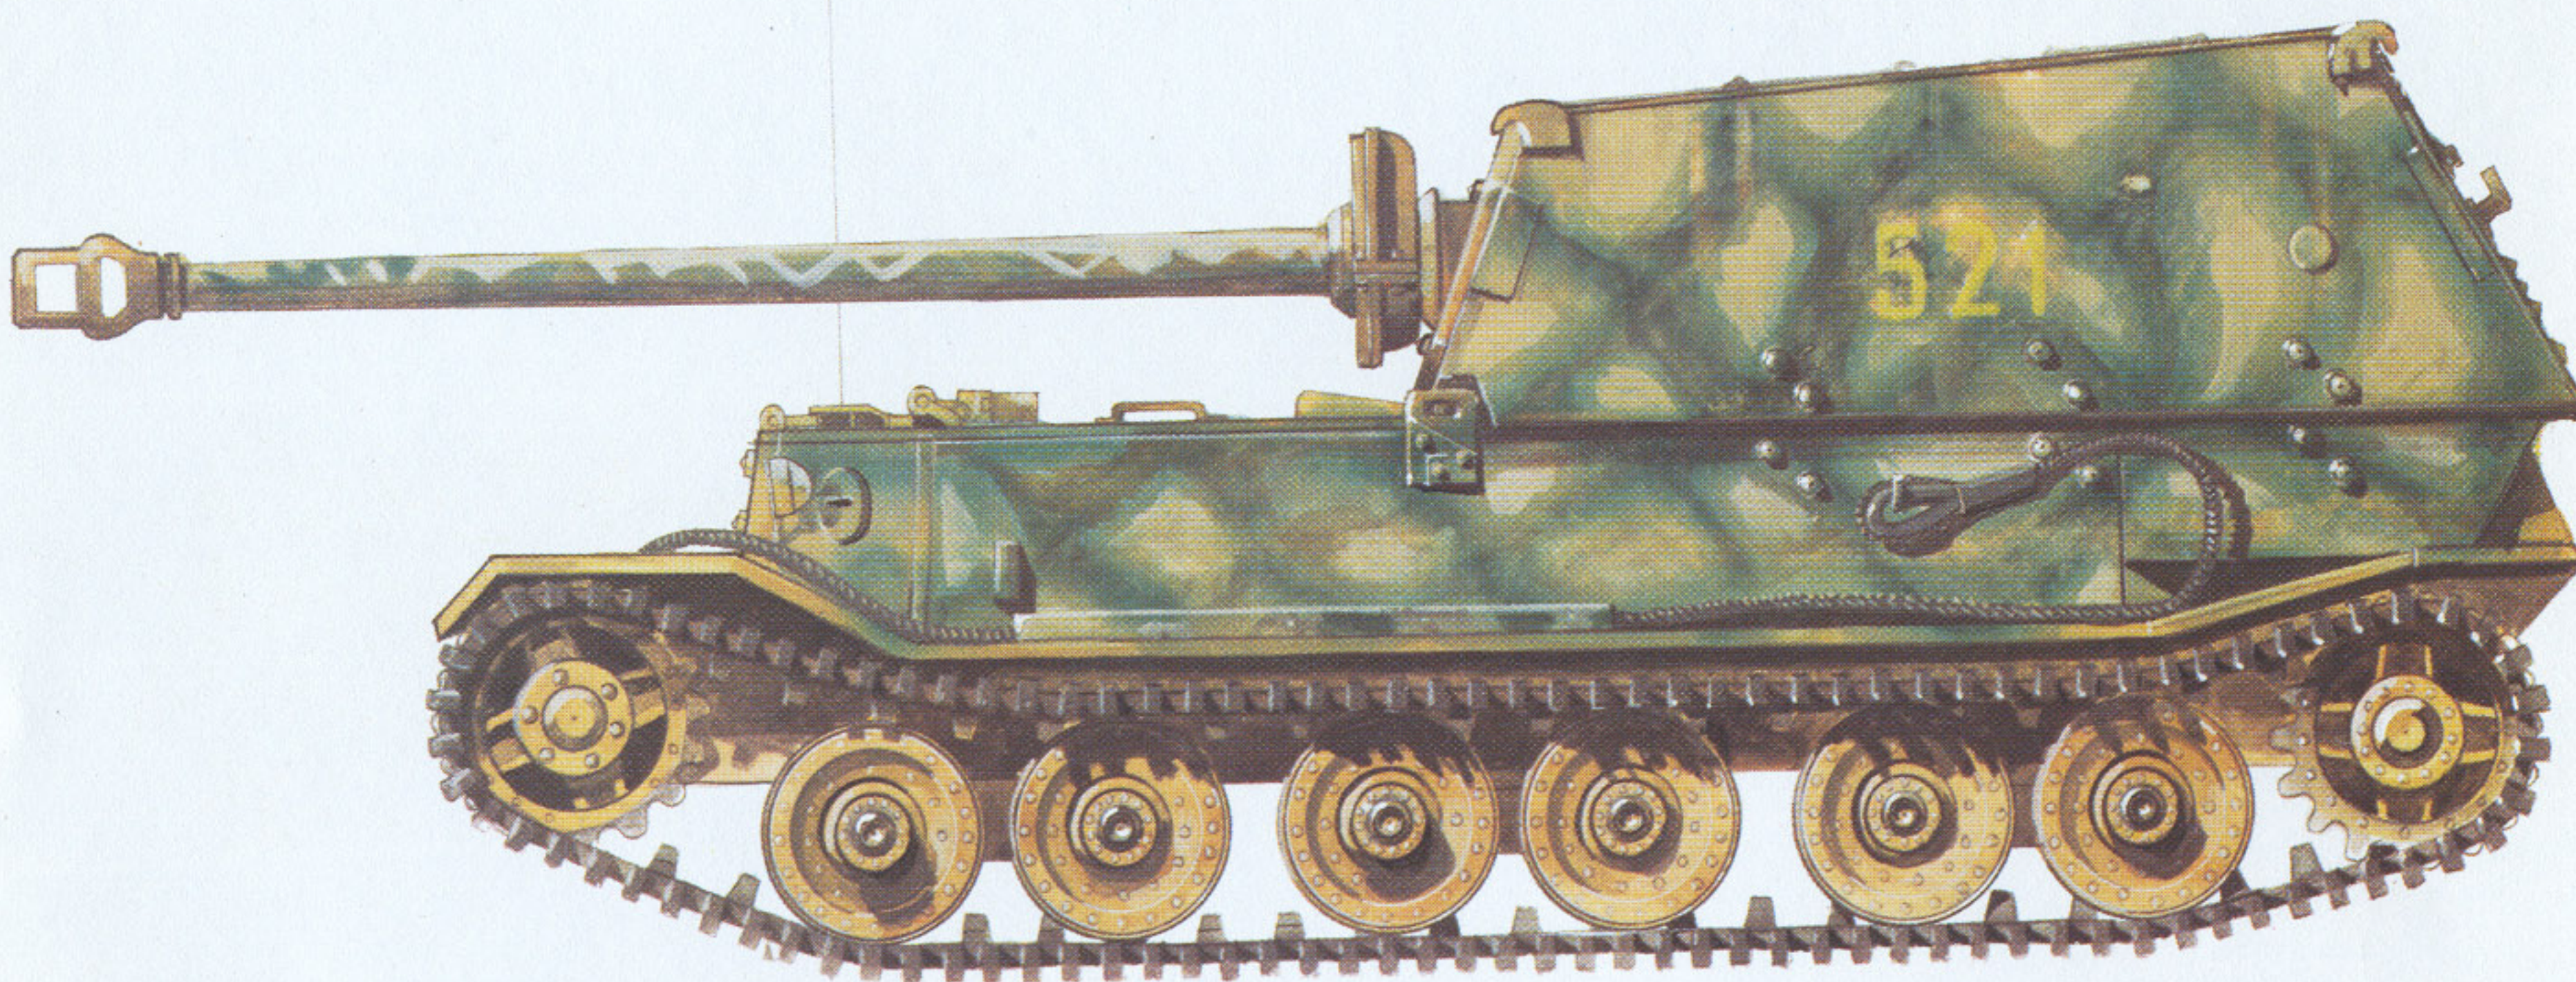
Jagdpanzer Tiger (P), 'Elefant' SdKfz 184.

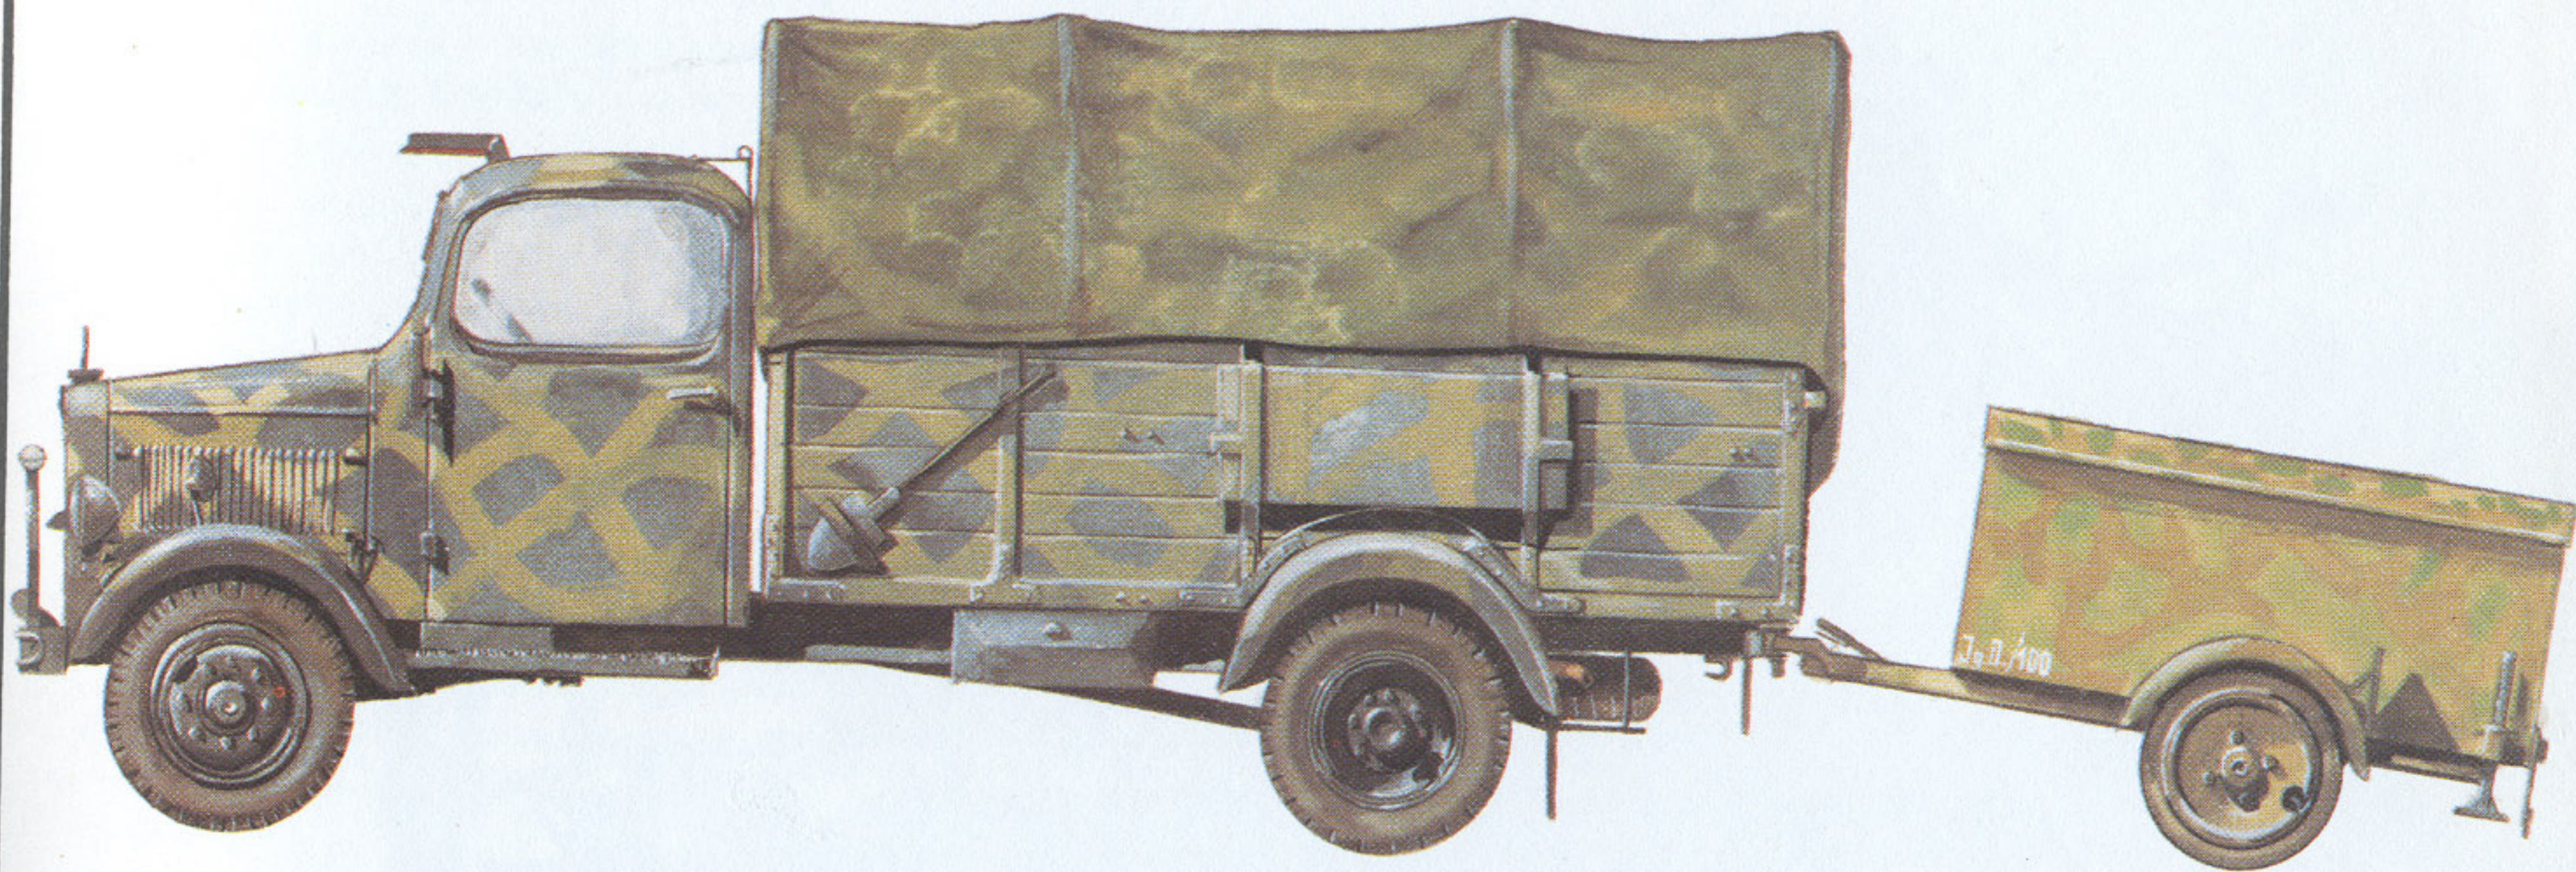
Daimler-Benz 'L-3000S', 4 × 2, 3 Ton Medium Truck, of 100 Jäger Division.
