No.3 GERMAN

EASTERN FRONT

FOCUS ON
ARMOUR
CAMOUFLAGE
& MARKINGS

Kenneth M Jones

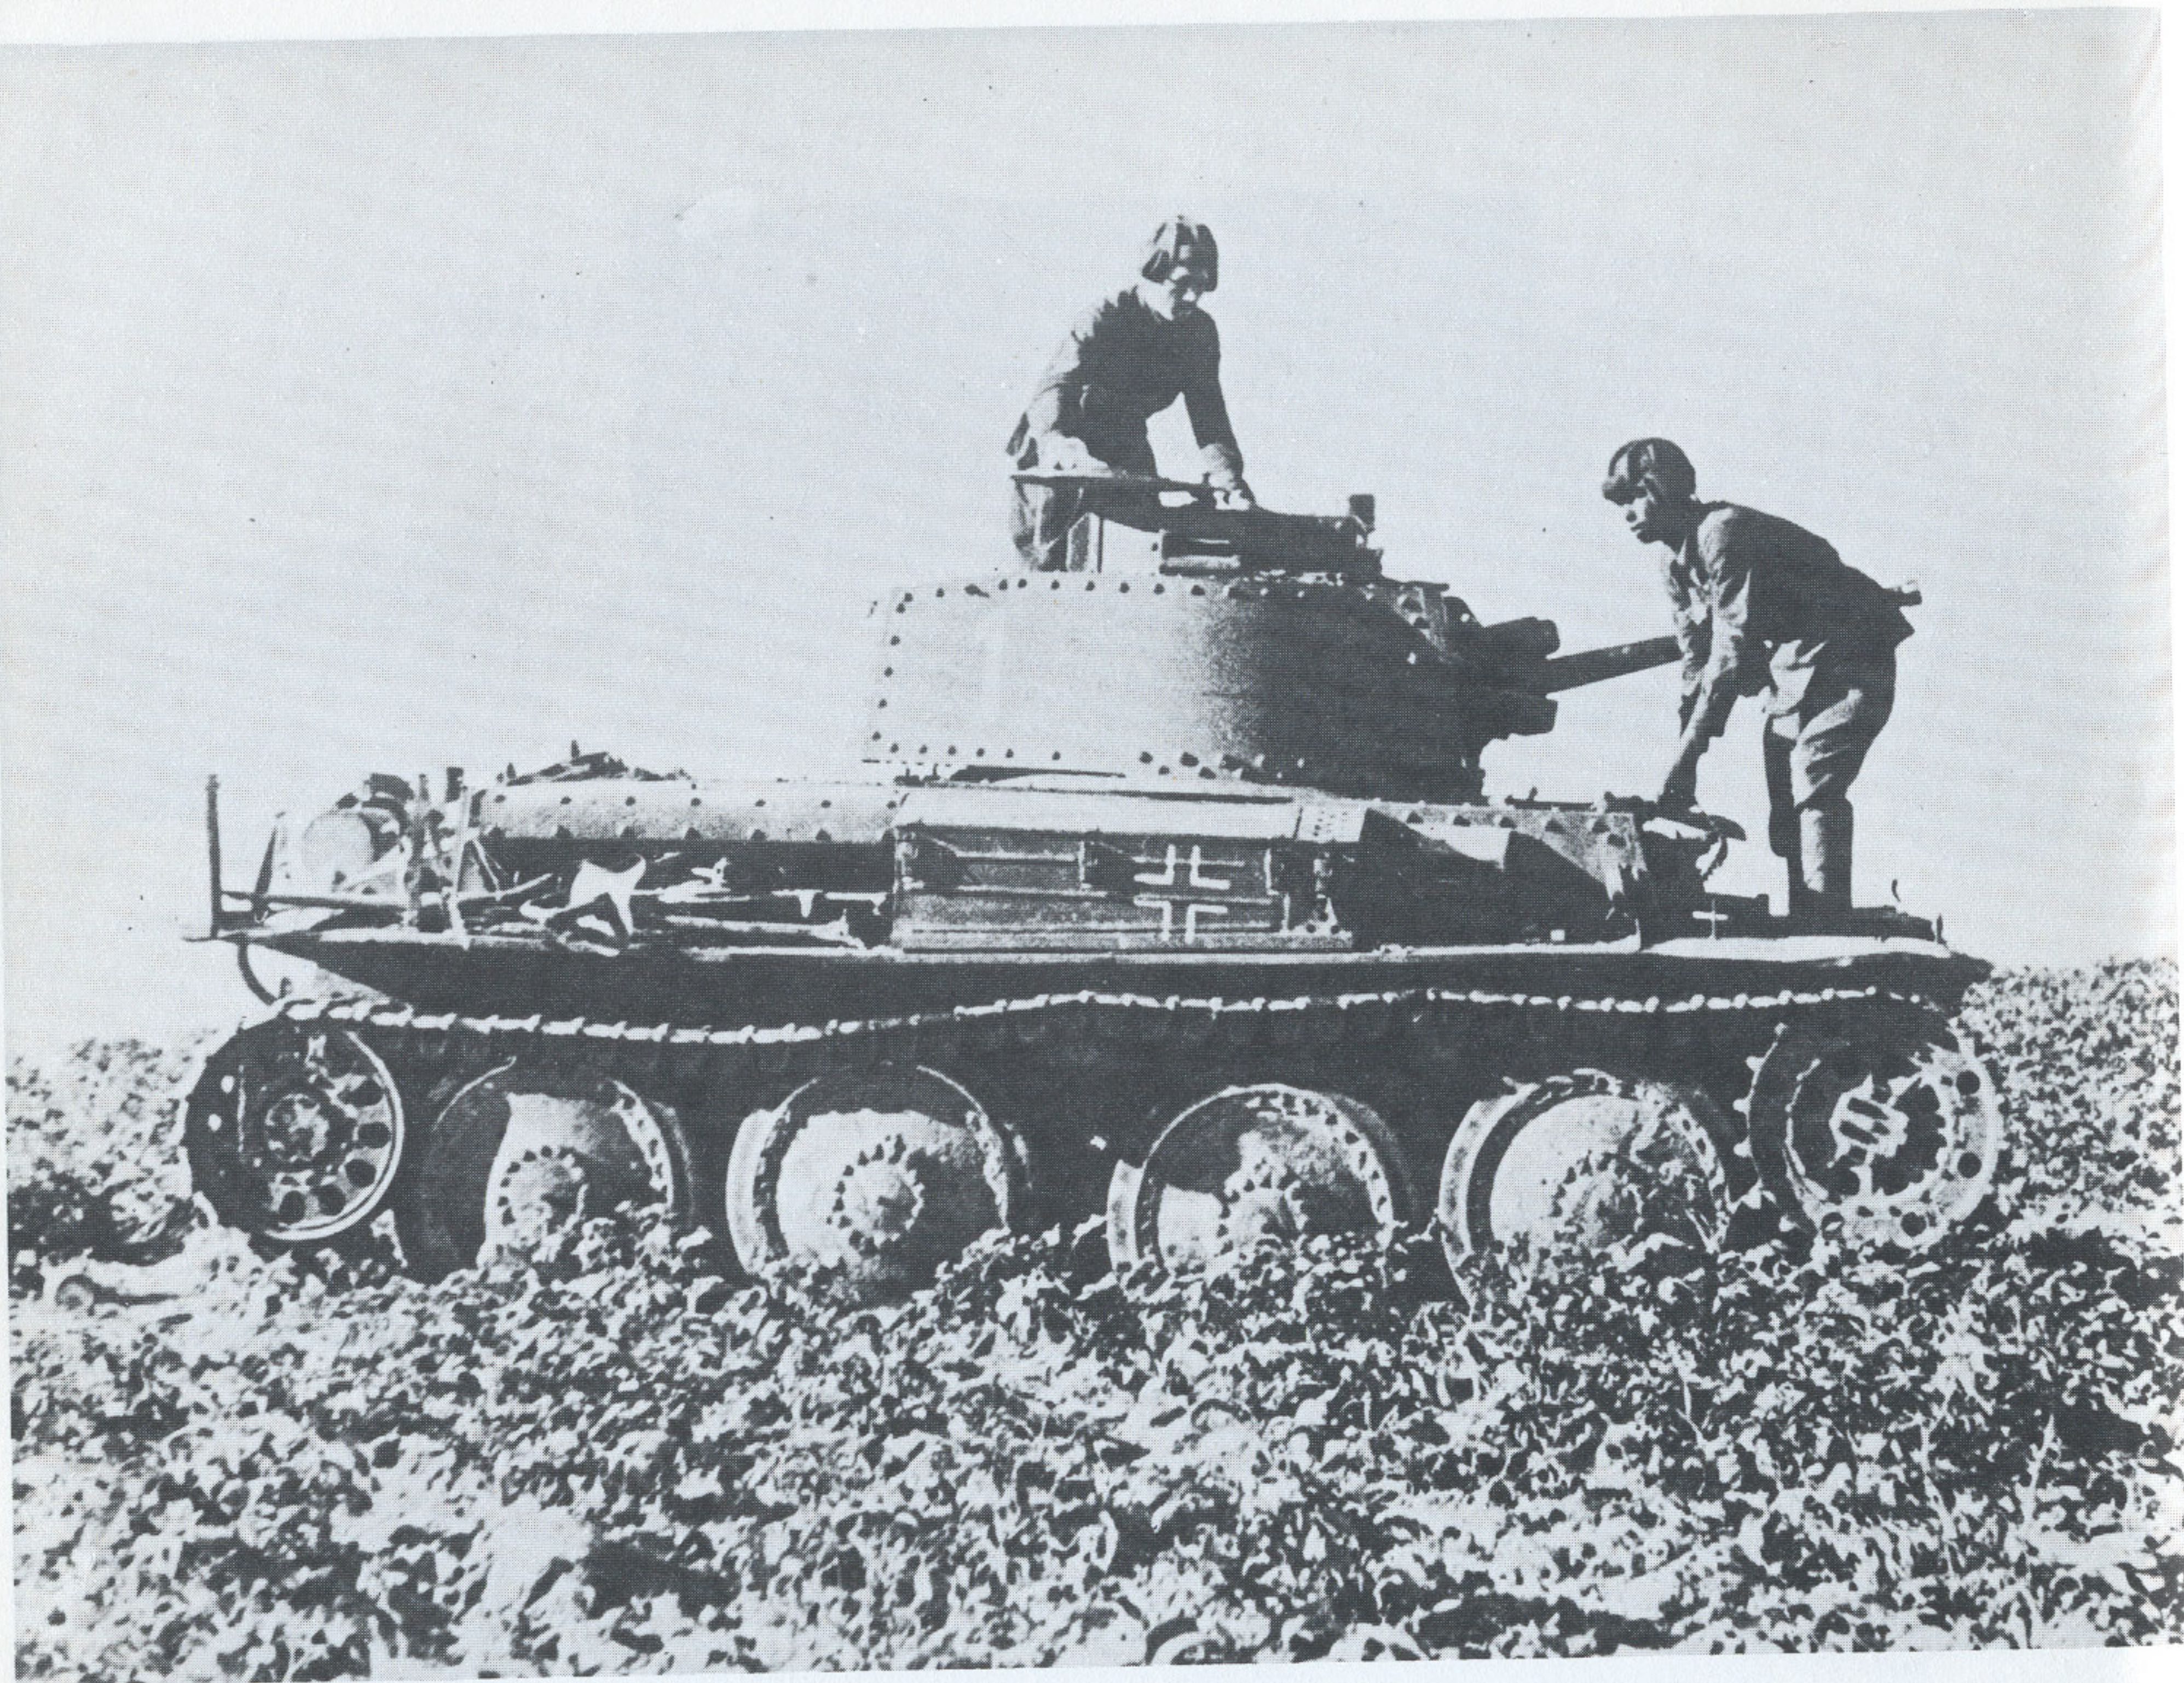
This interesting photograph from Soviet sources shows Russian tank men examining a knocked out Czech Model 38 tank, which in German service was known as the PzKw 38(t). This vehicle is finished grey with only two markings visible, an 'outline' type of national marking in white and a monomic tactical mark on the turret which does not appear to be white; although the photo is slightly blurred at this point. It could be yellow, but as always, this is not definite and it pays to be cautious in assuming what these colours are. PzKw 38(t)'s can be seen with large red turret numbers outlined white in photographs taken around the time of 'Operation Barbarossa' just as they were marked with plain white numbers, or as the version shown in this photograph. The Germans must have thought this tank was good in its class as they used them in large numbers in their Panzer Divisions.

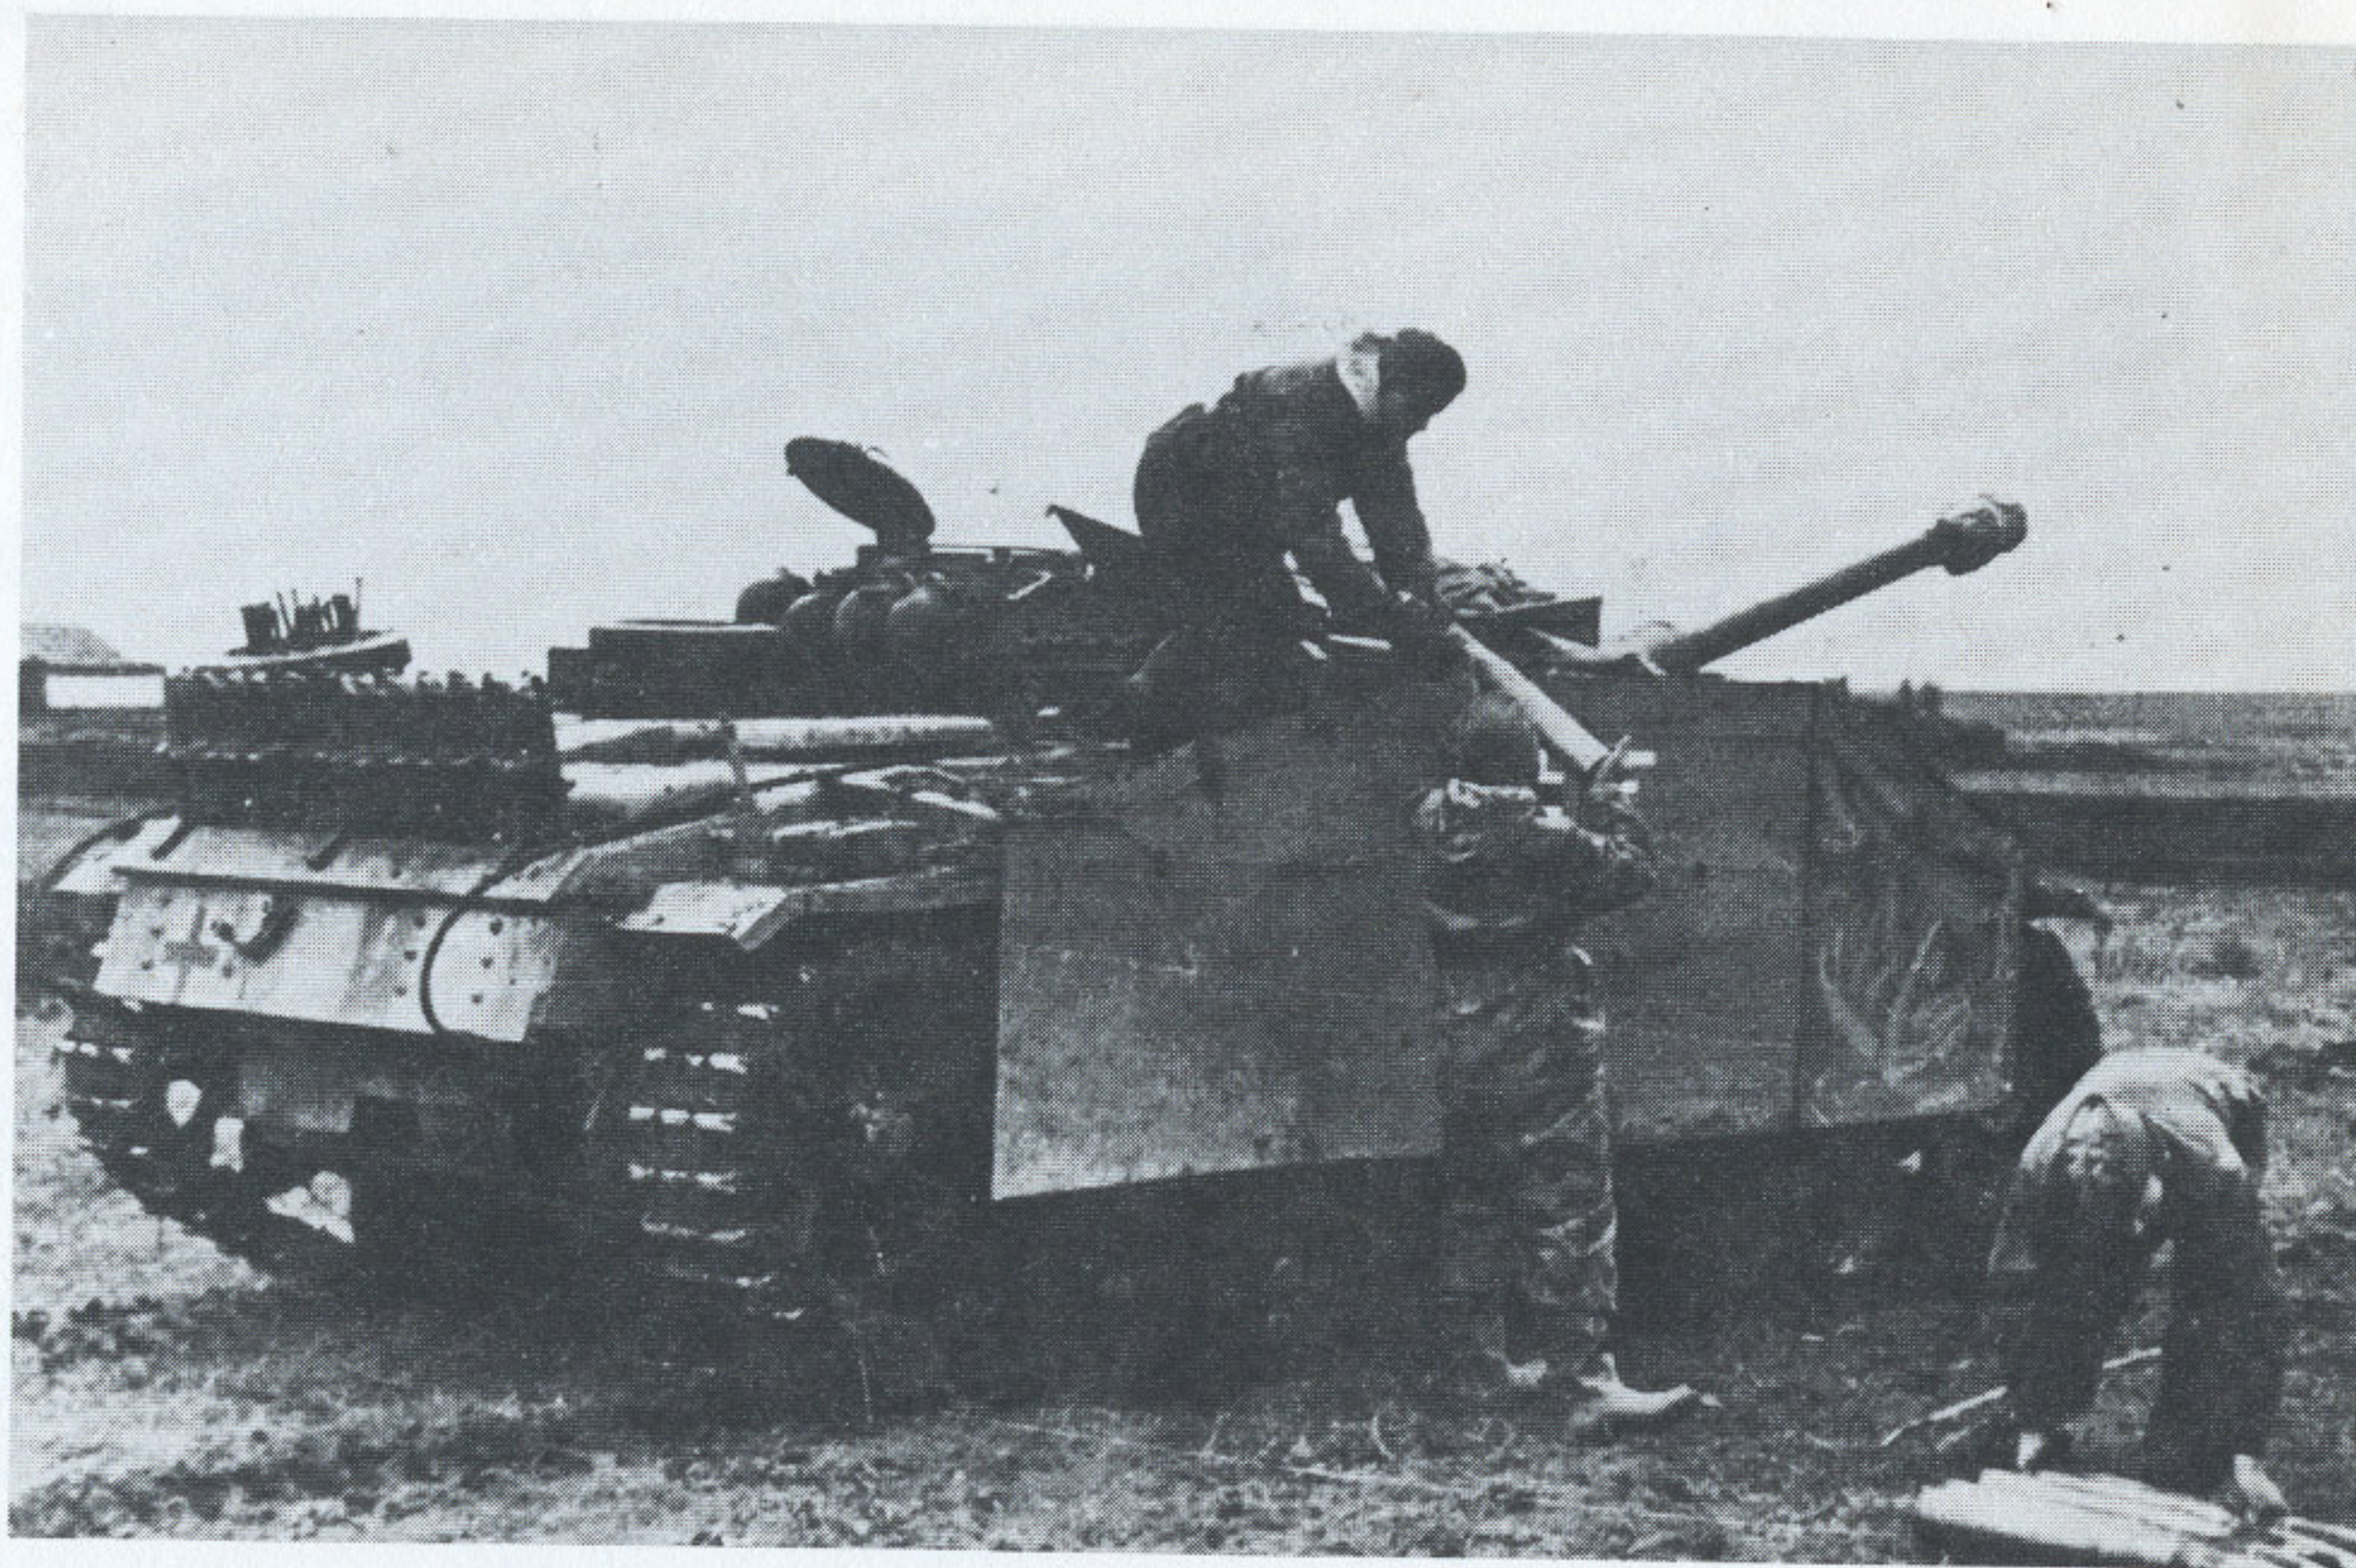
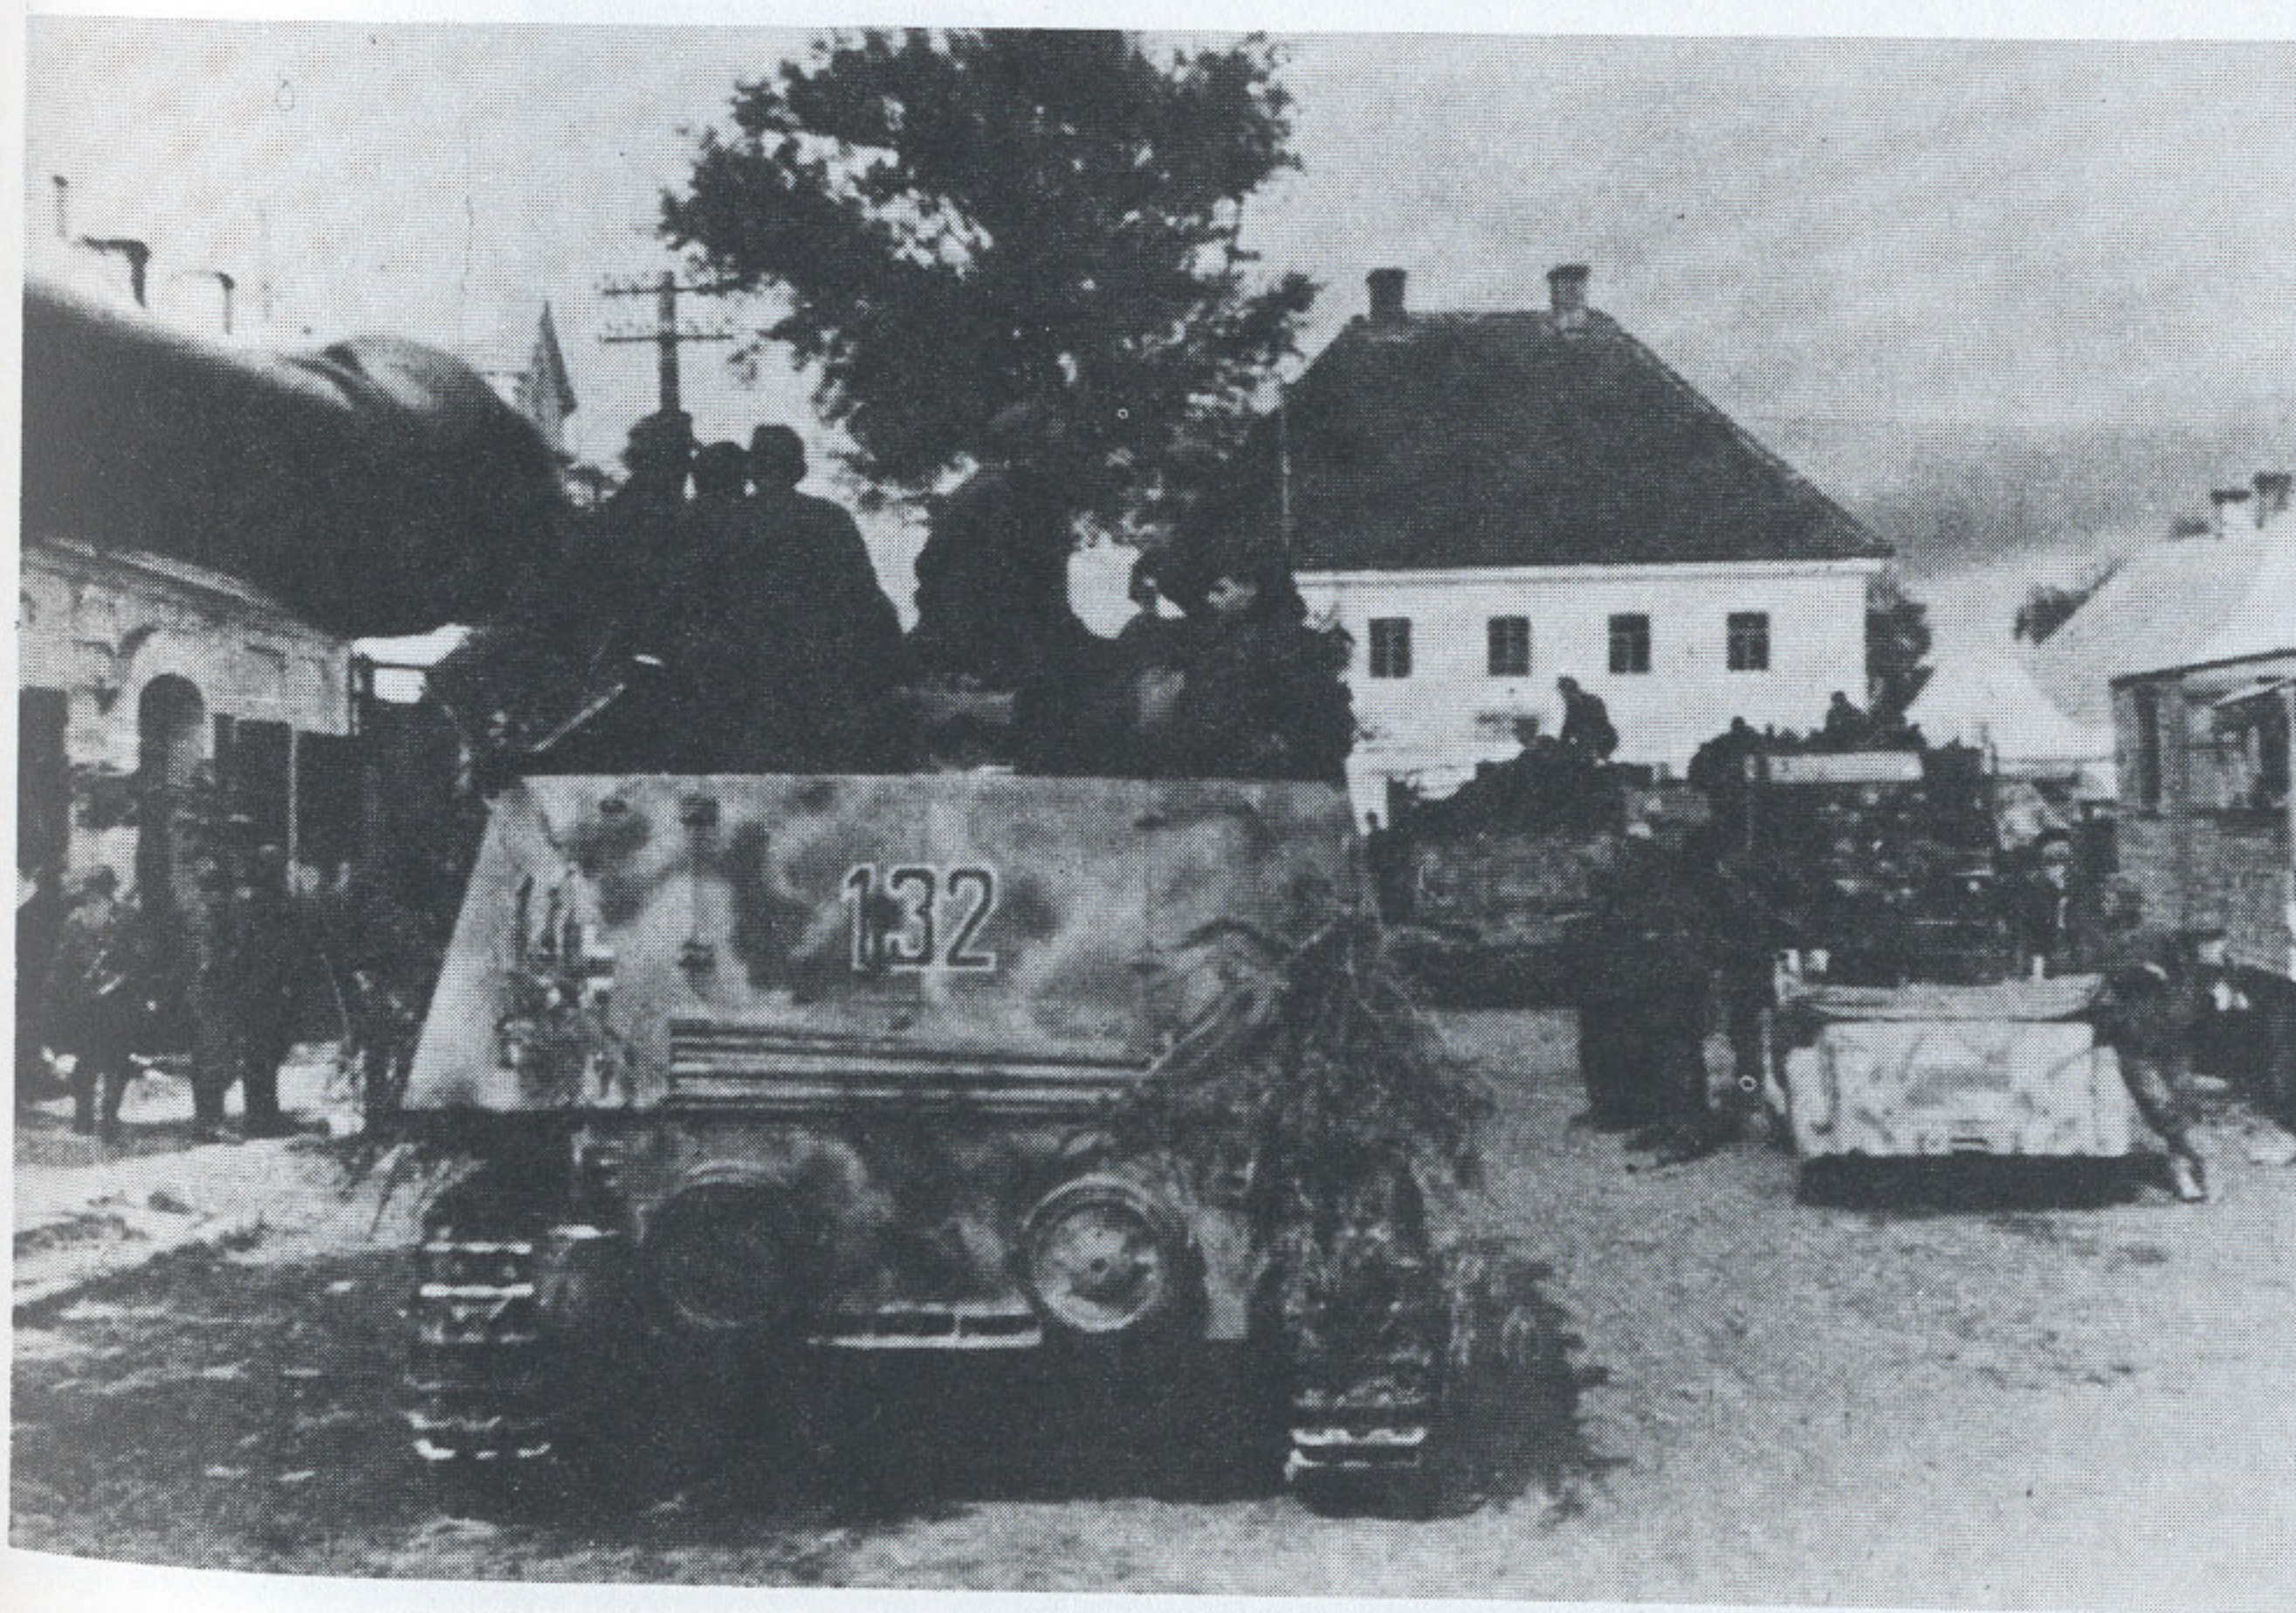
An interesting rear view of a 'Nashorn' (SdKfz 164, 8.8 cm Pak 43/1 L71 auf Sf IV) that has been camouflaged with either an overspray of green, or red brown mottle over a sand base colour. A tactical number has been applied by stencil as the numbers are very neatly painted. A cross with a white outline appears on the left side partially obscured by brushwood which has been deposited around the vehicle as extra camouflage. It appears that there is some sort of device under this cross which is also hidden and unidentifiable, probably a tactical marking. Note the car to the right of the 'Nashorn' which has a coat of very light sand paint with a faint mottle pattern.

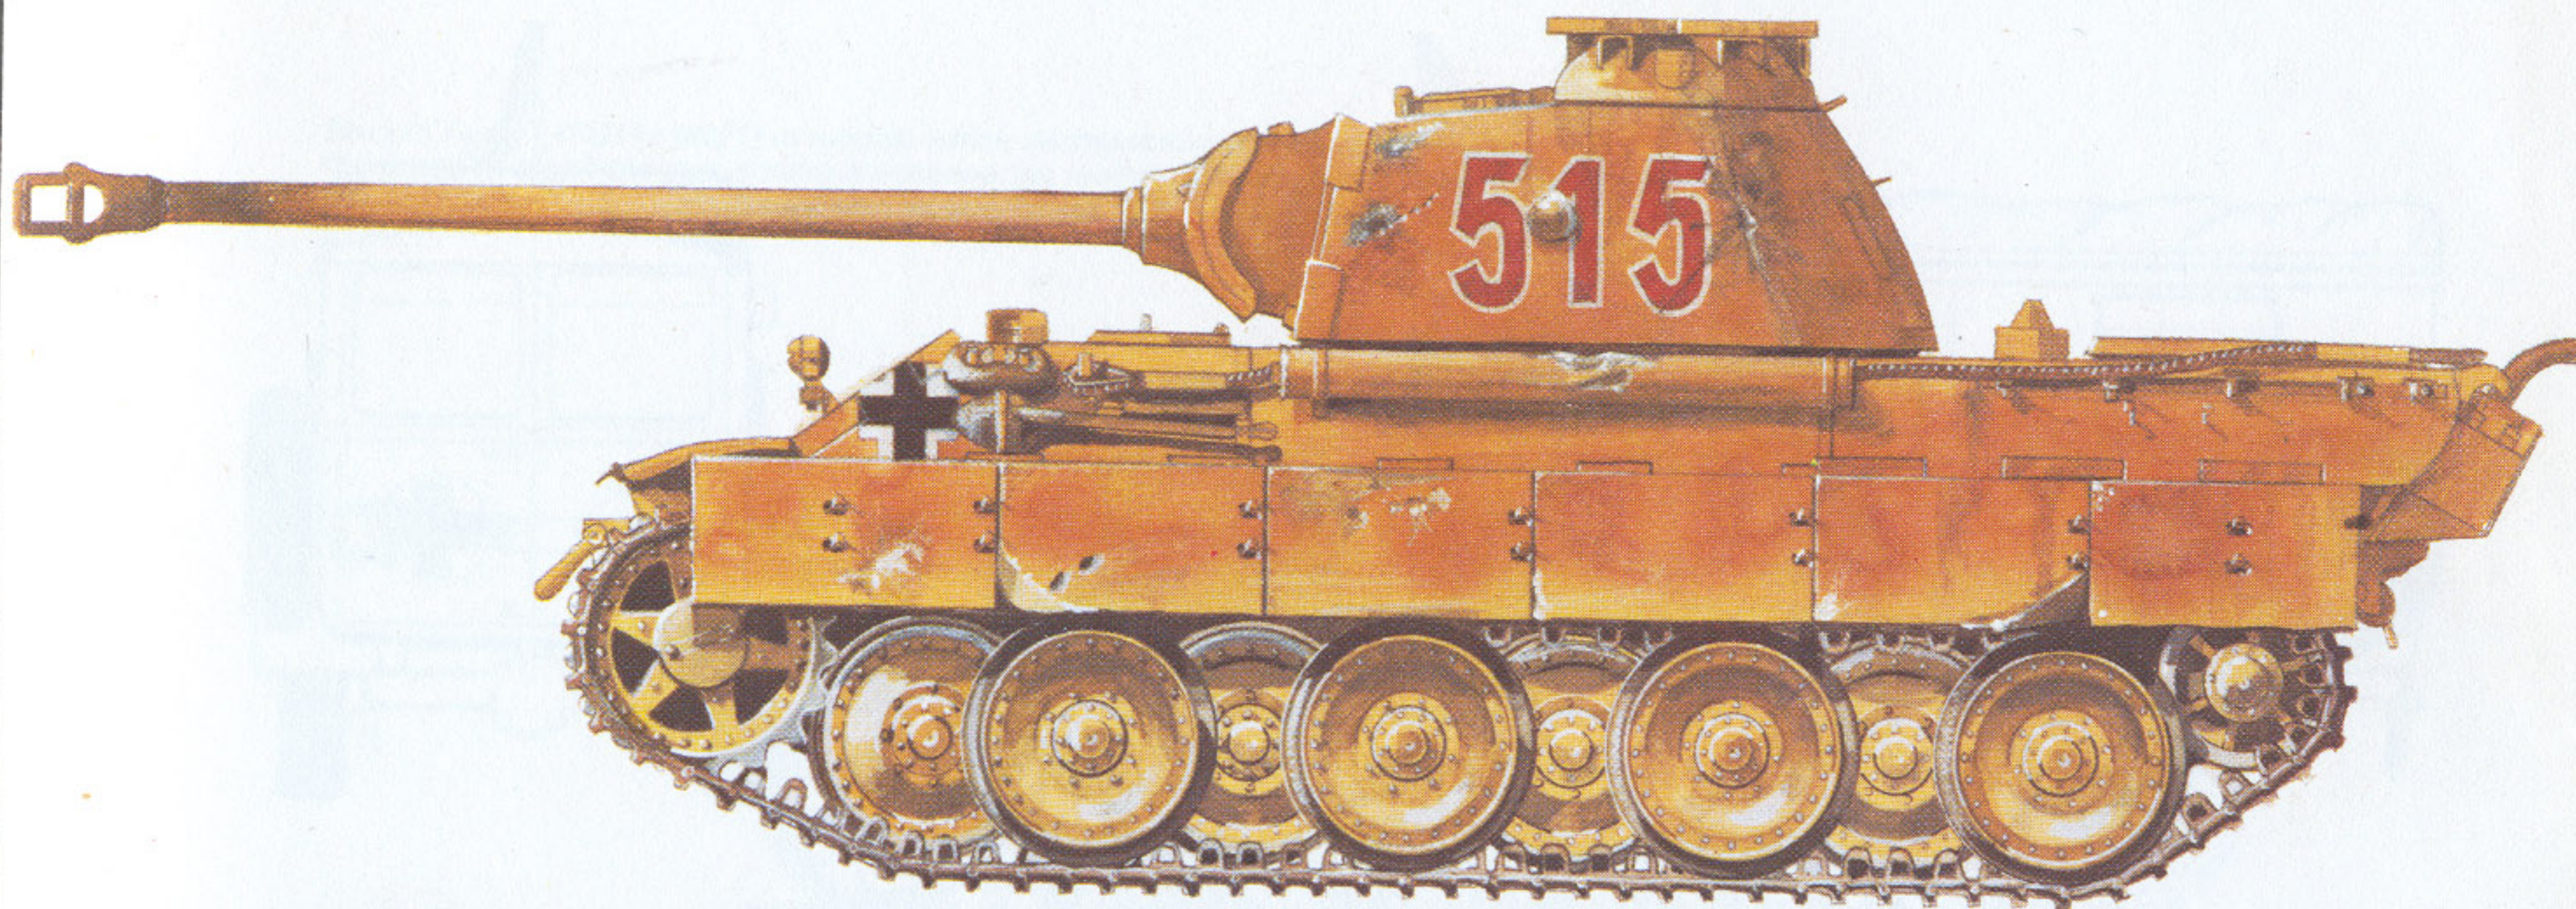
PzKw V, ausf. D 'Panther' (late production model) SdKfz 171.

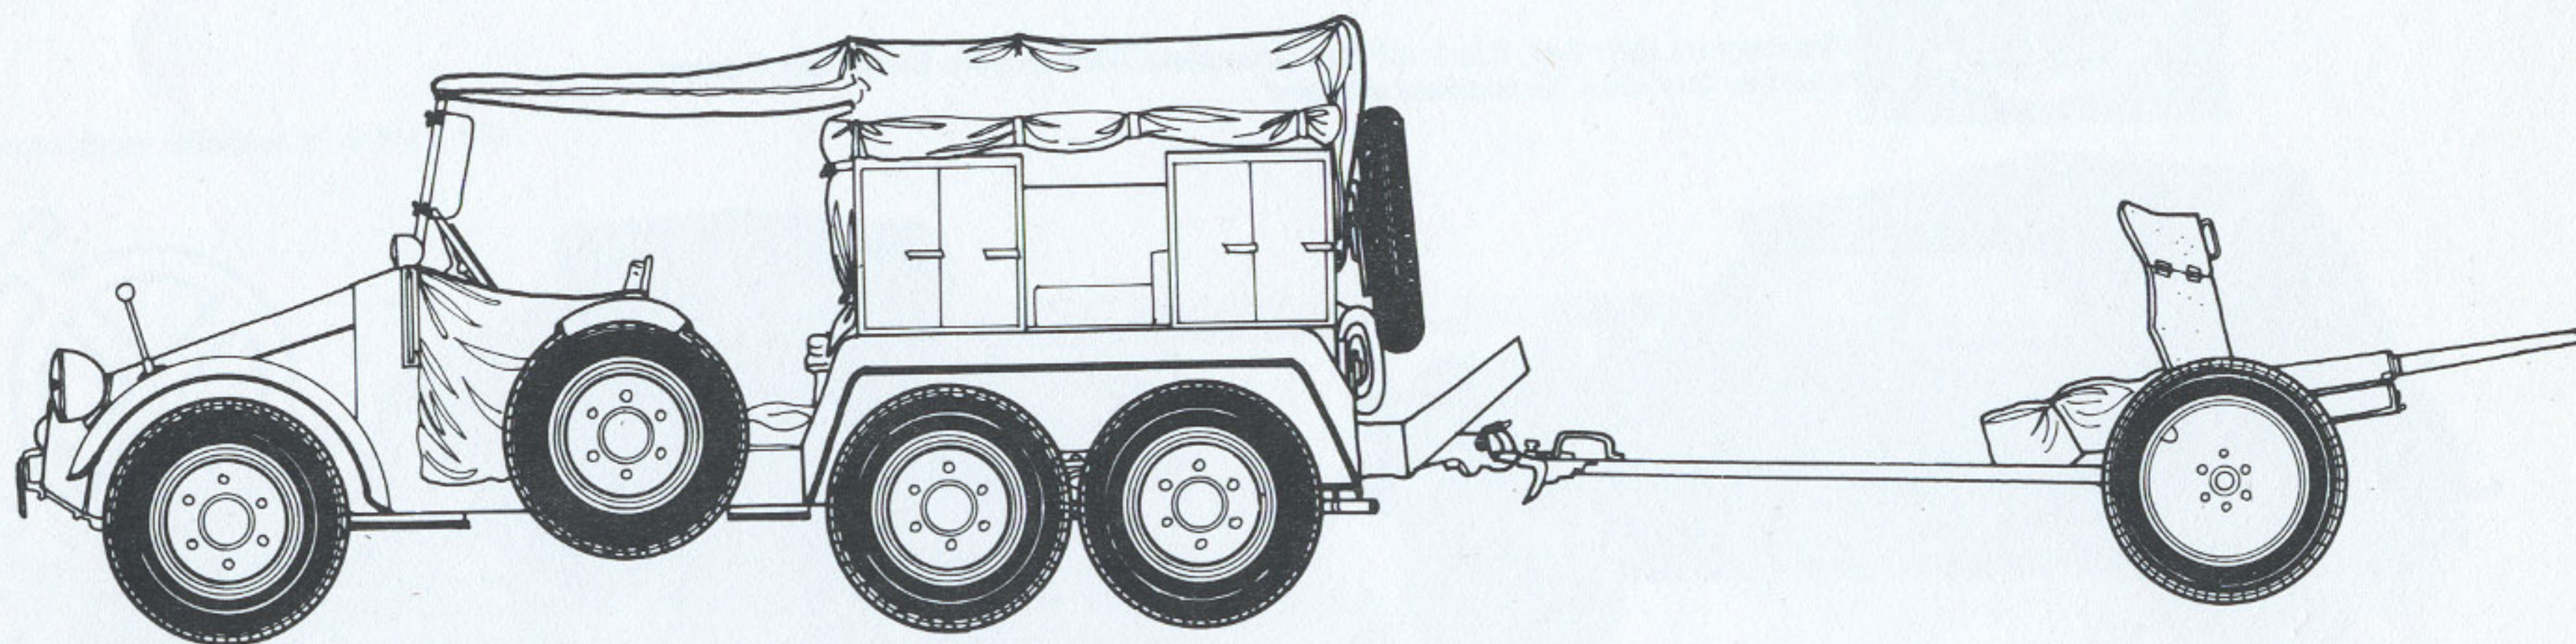
Kfz 69 Krupp light truck with a 37mm anti-tank gun. This vehicle was overall grey and carried a tactical marking for a Pak troop front and rear.

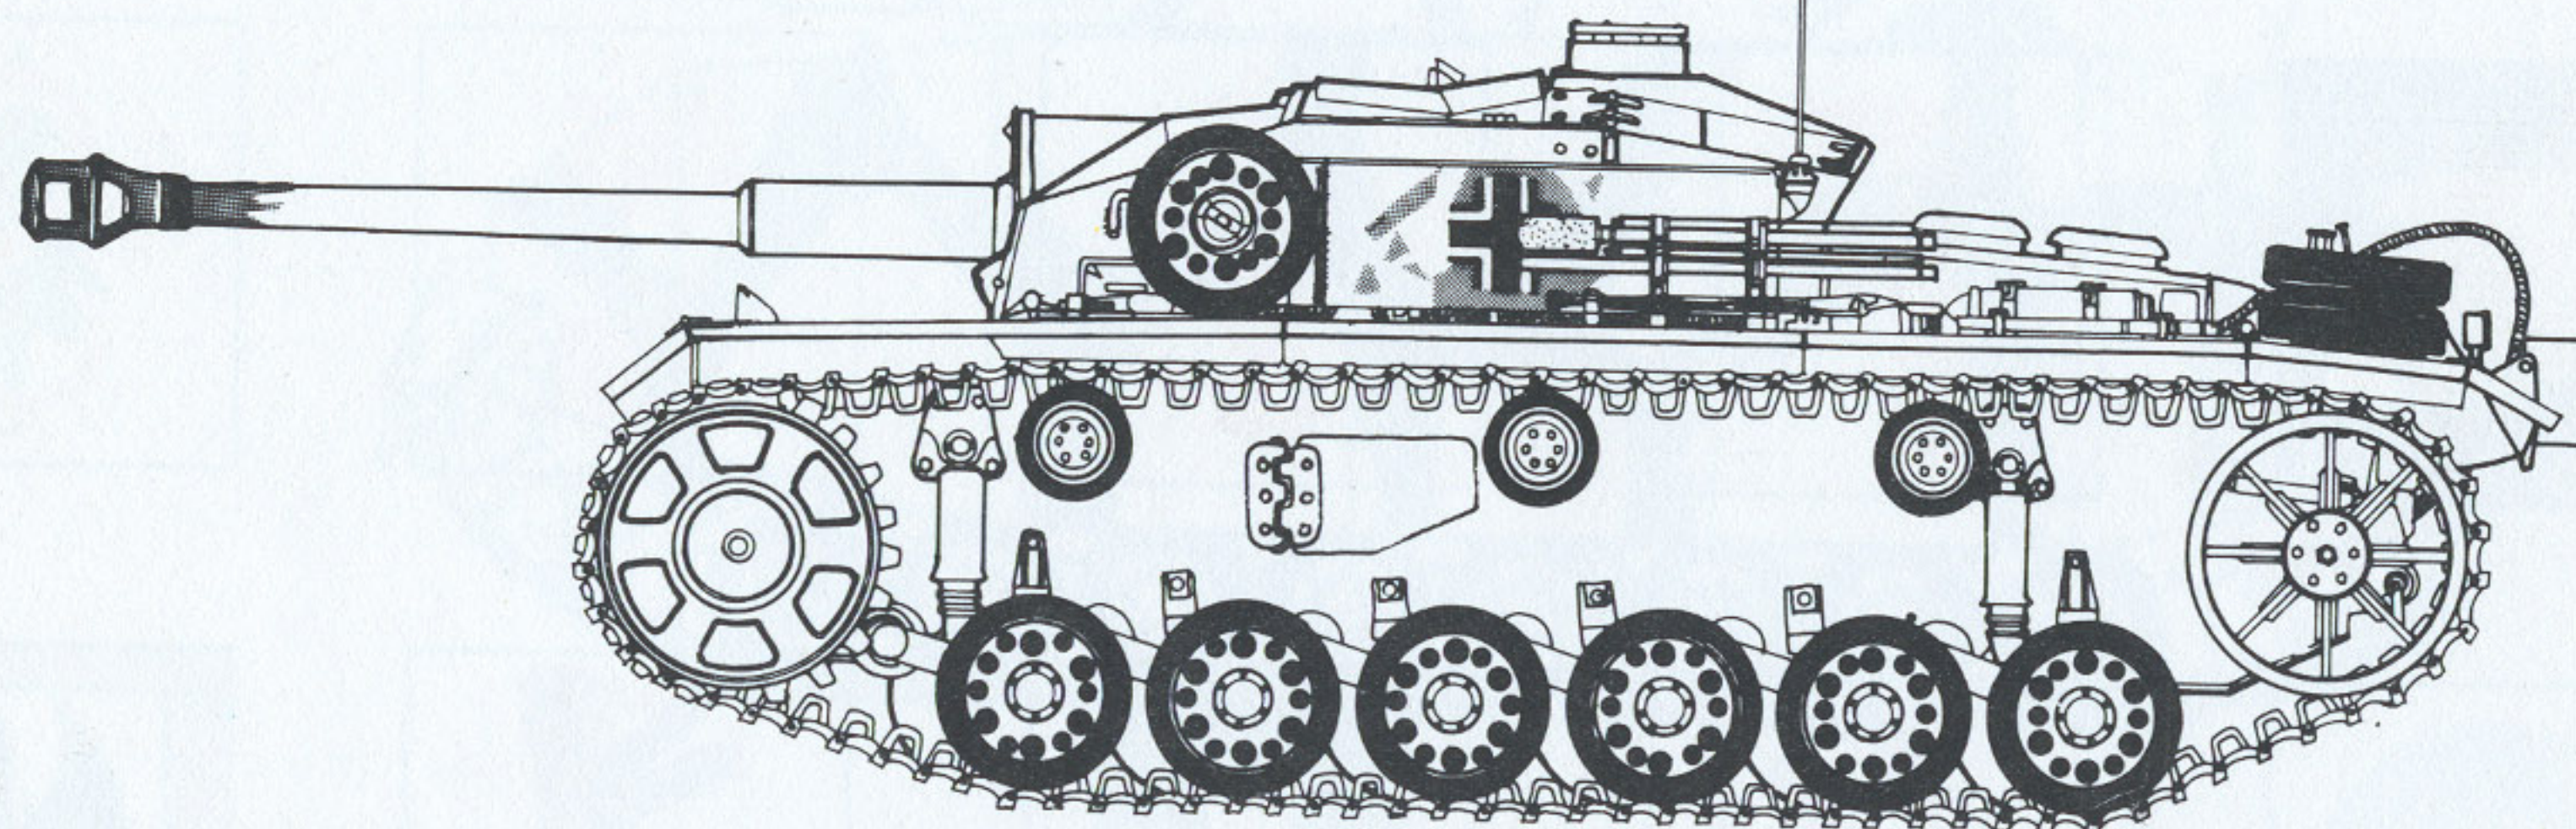
Marder III (SdKfz 139) in overall temporary white wash camouflage. The national flag is used as an aerial recognition sign.

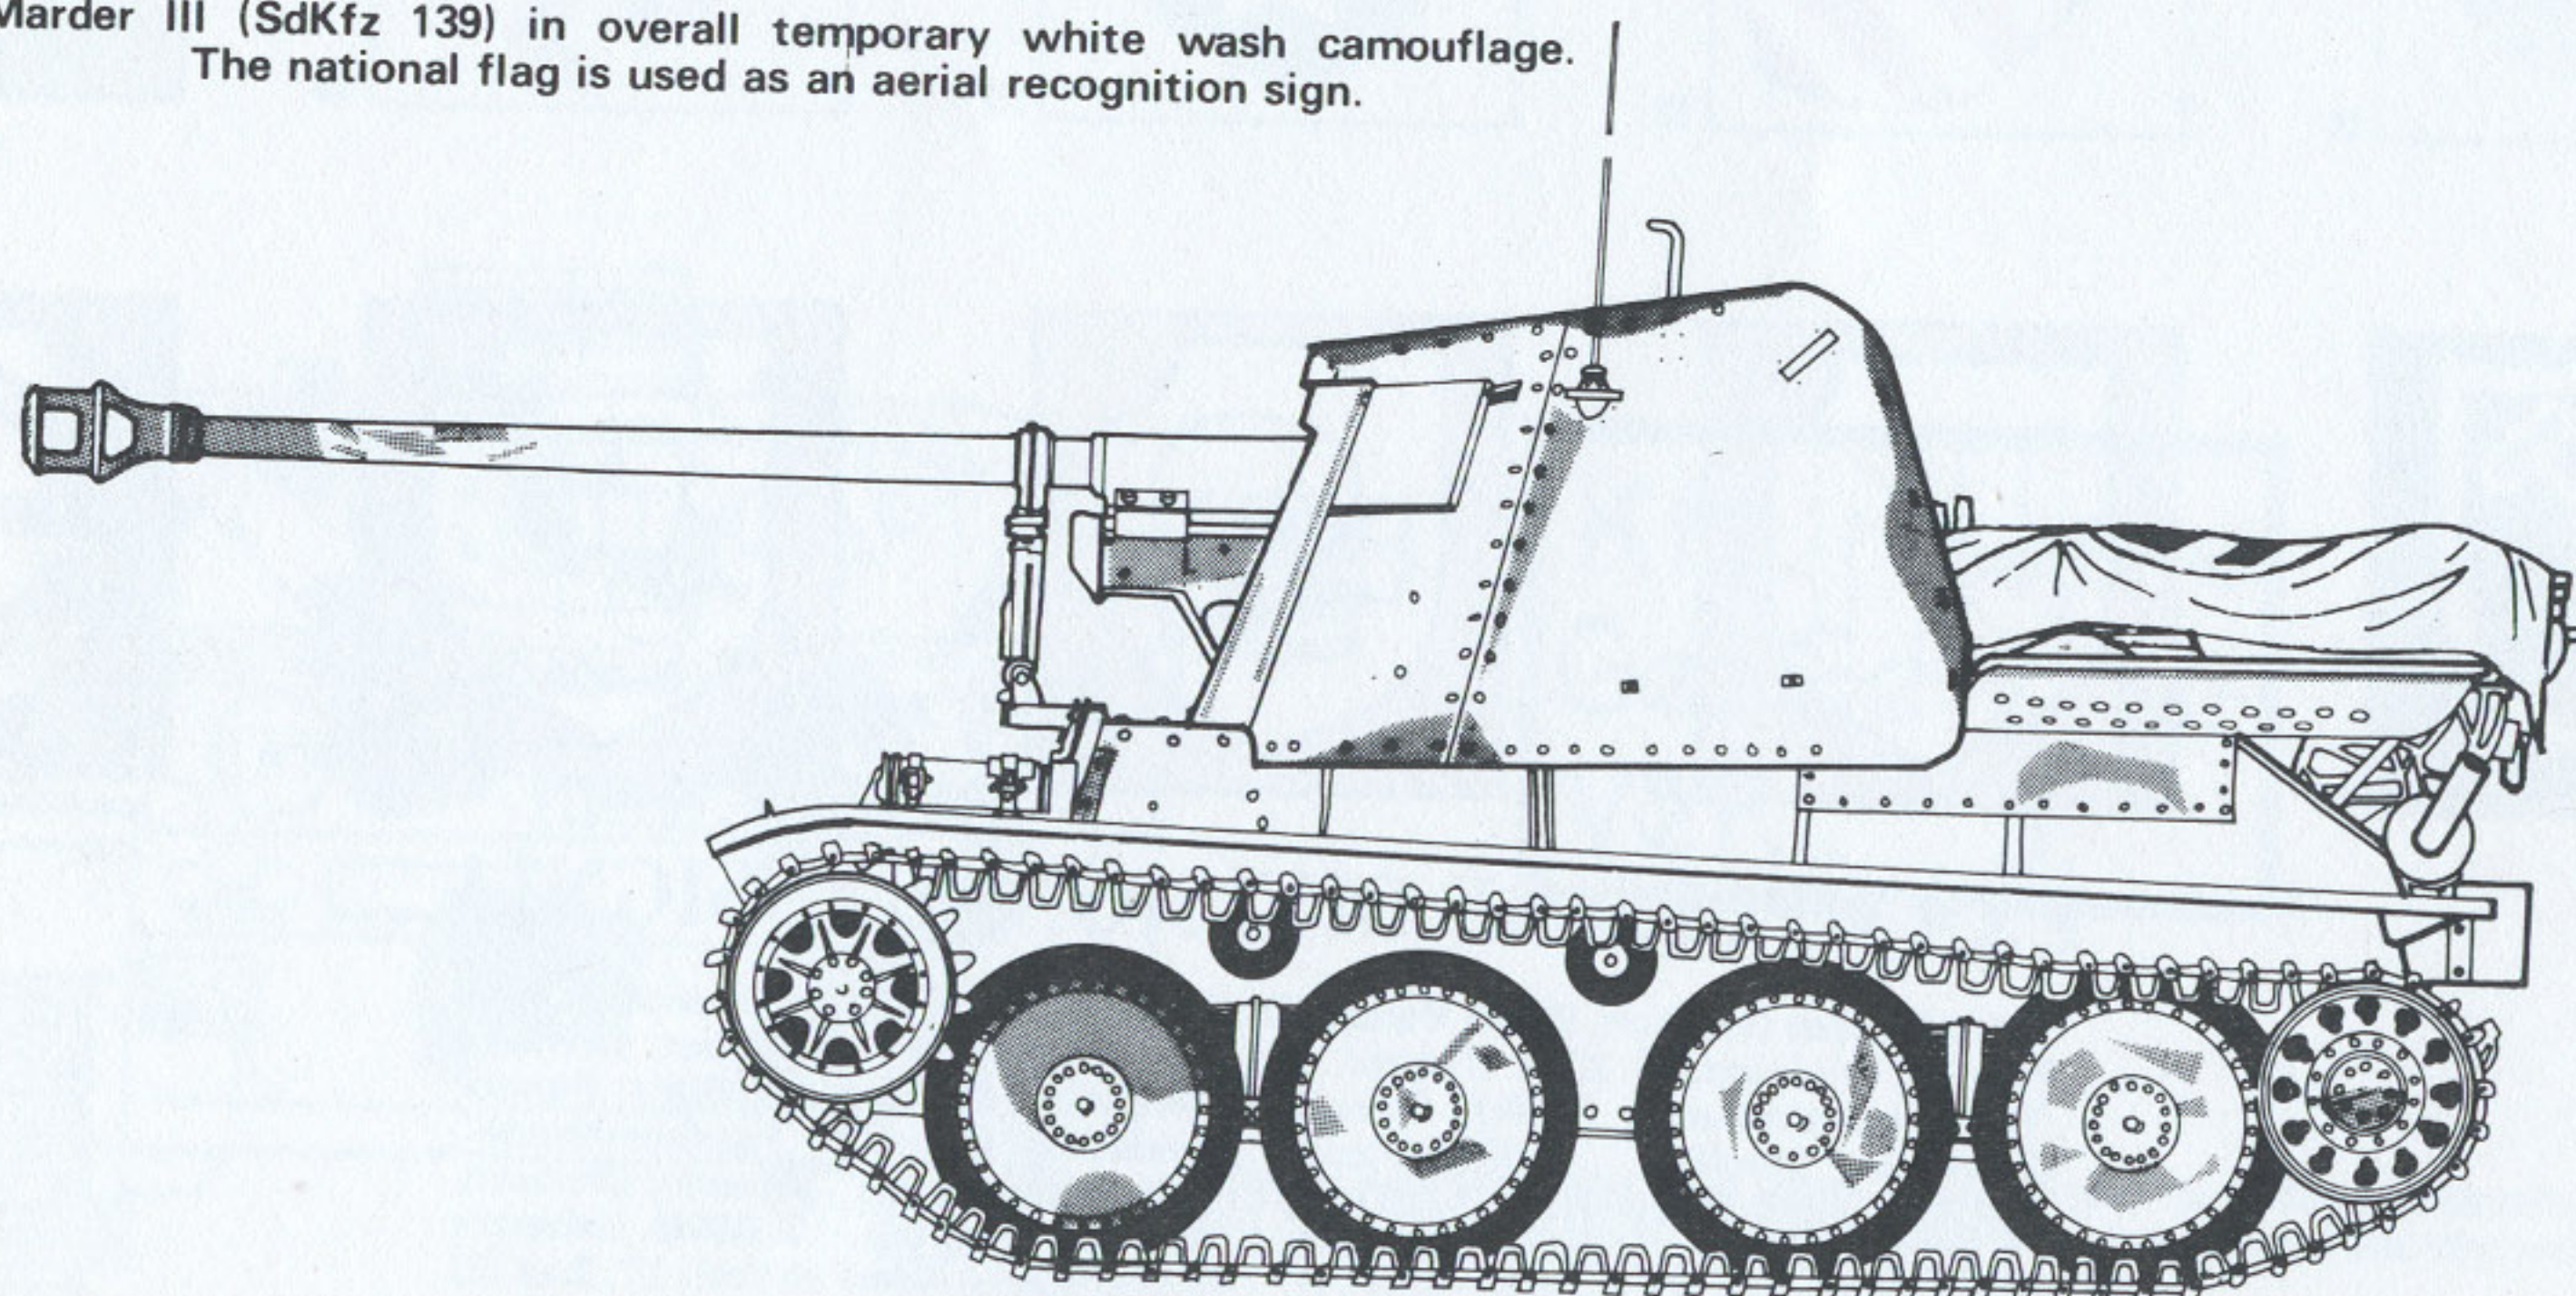
EXAMPLES OF DIVISIONAL INSIGNIA

1. 1st Panzer Division. 2. 8th Panzer Division. 3. 11th Panzer Division. 4. 16th Panzer Division. 5. 23rd Panzer Division. 6. Panzer Grenadier Division 'Grossdeutschland'. 7. 10th Panzer Grenadier Division. 8. 20th Panzer Grenadier Division. 9. 60th Panzer Grenadier Division 'Feldherrnhalle'. 10. 100th Jäger Division. 11. 11th Infantry Division. 12. 30th Infantry Division. 13. 168th Infantry Division. 14. 293rd Infantry Division. 15. 335th Infantry Division. 16. 1st SS Panzer Division, 'Leibstandarte Adolf Hitler'. 17. 2nd SS Panzer Division, 'Das Reich'. 18. 3rd SS Panzer Division, 'Totenkopf'. 19. 10th SS Panzer Division, 'Frundsberg'. 20. 11th SS Freiwilligen Panzer Grenadier Division, 'Nordland'.
