No.3 GERMAN

EASTERN FRONT

FOCUS ON
ARMOUR
CAMOUFLAGE
& MARKINGS

Kenneth M Jones

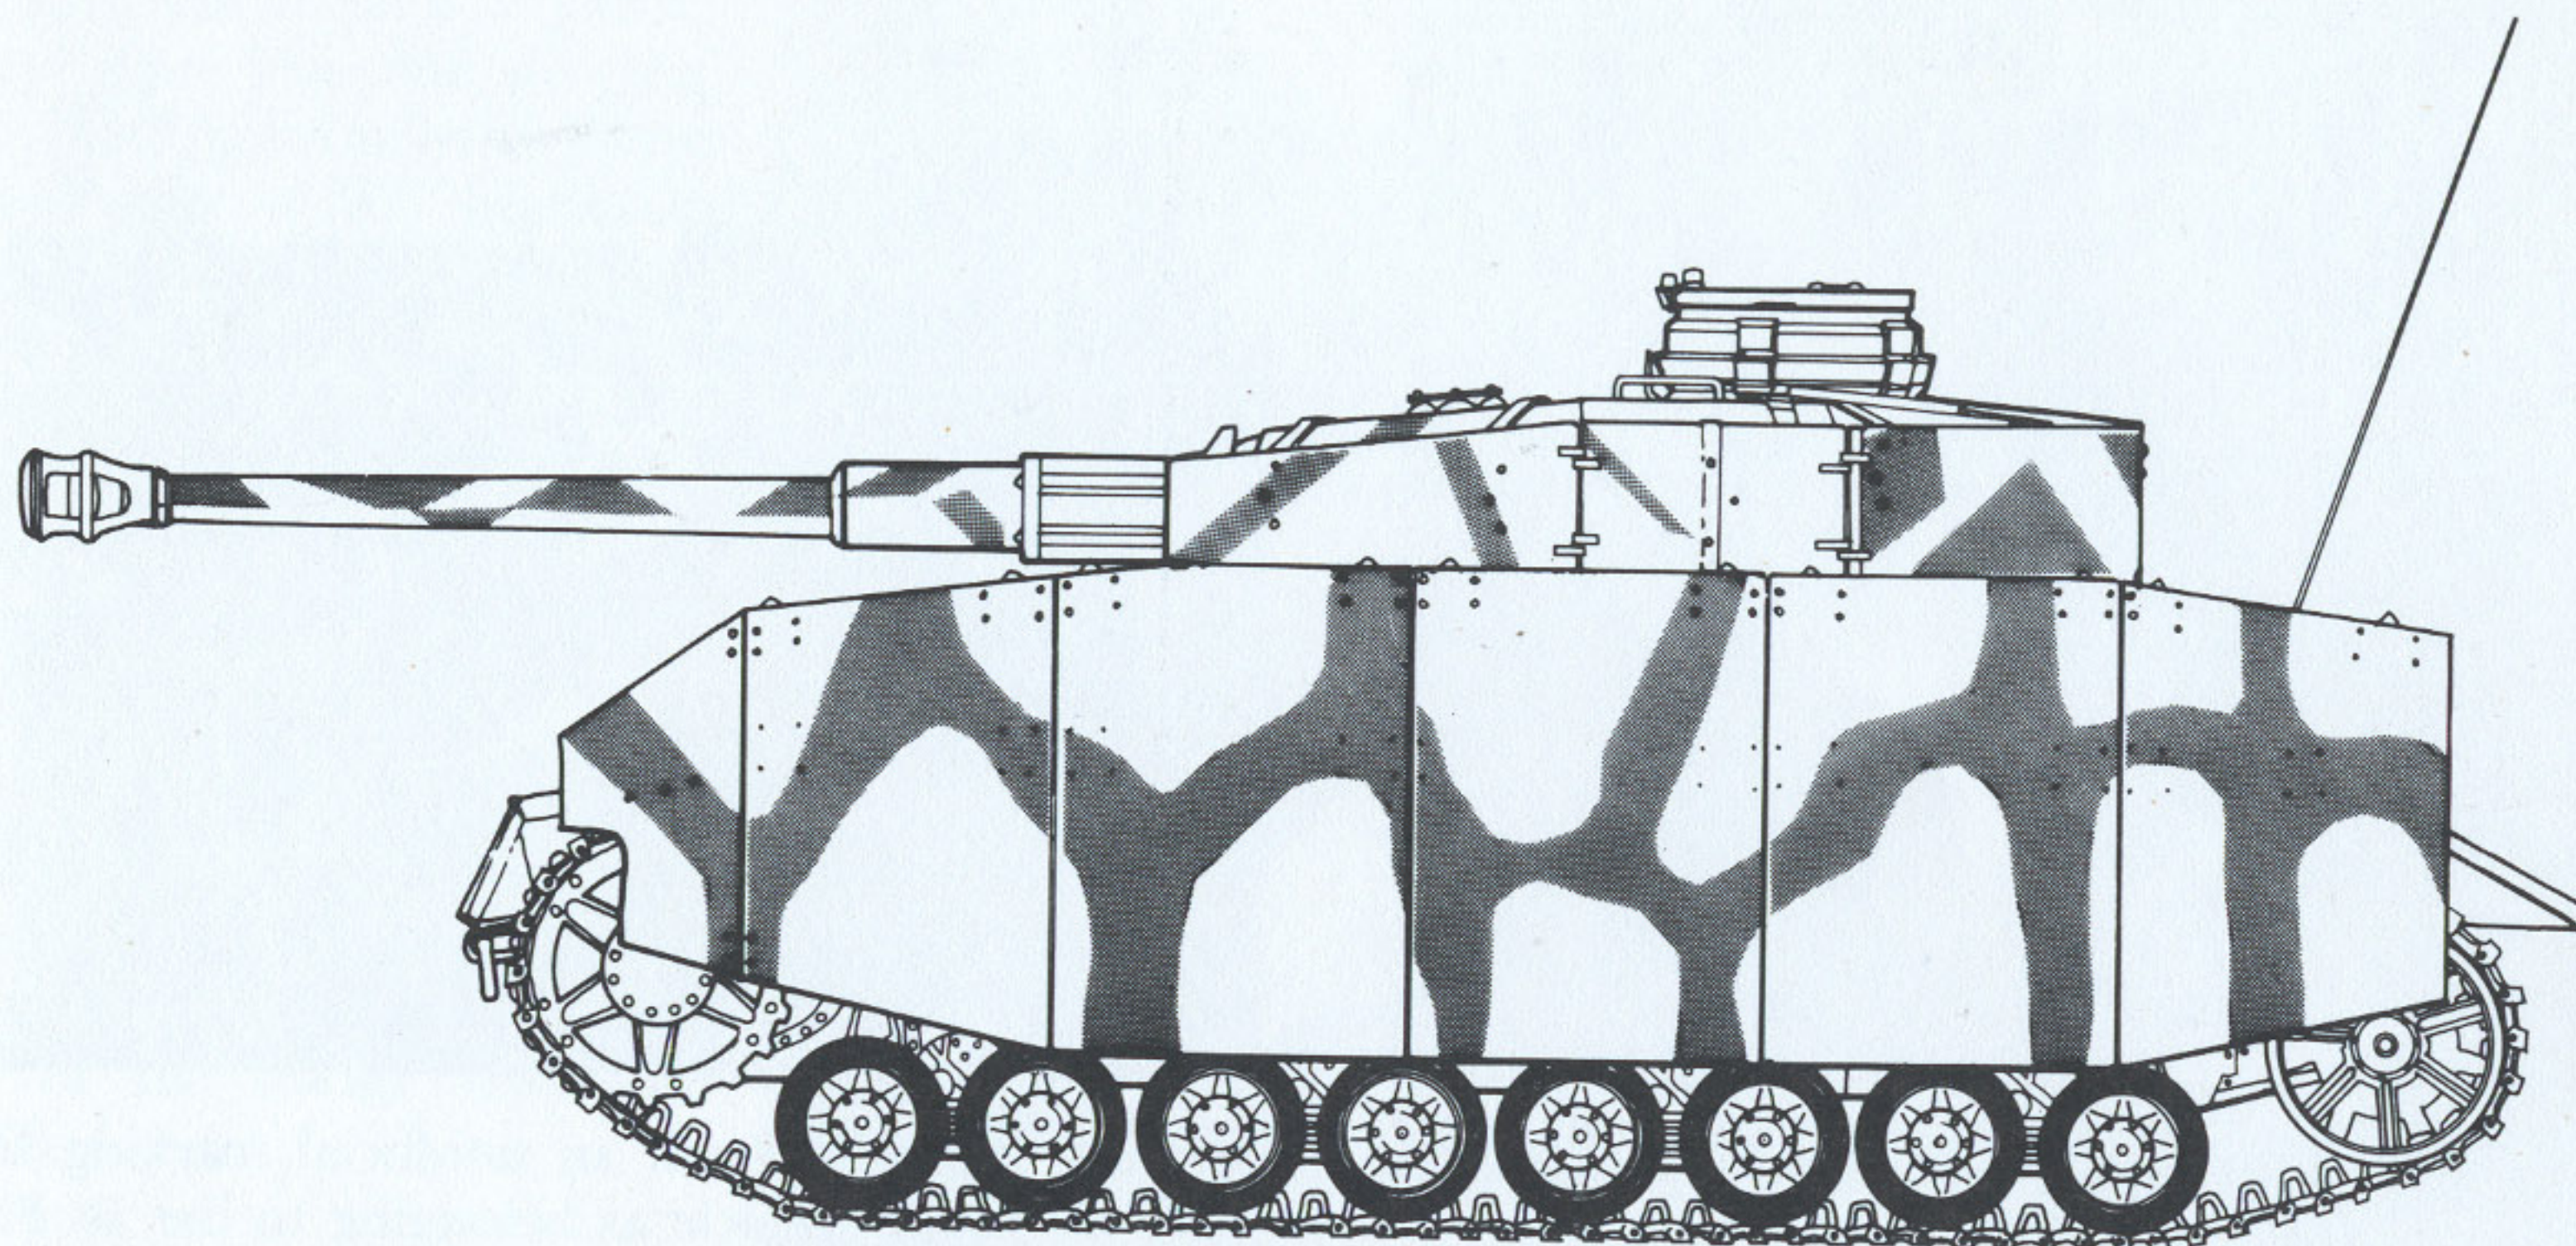
PzKw IV Ausf. J, in sand and green finish. This vehicle belonged to the 2nd Panzer Division.

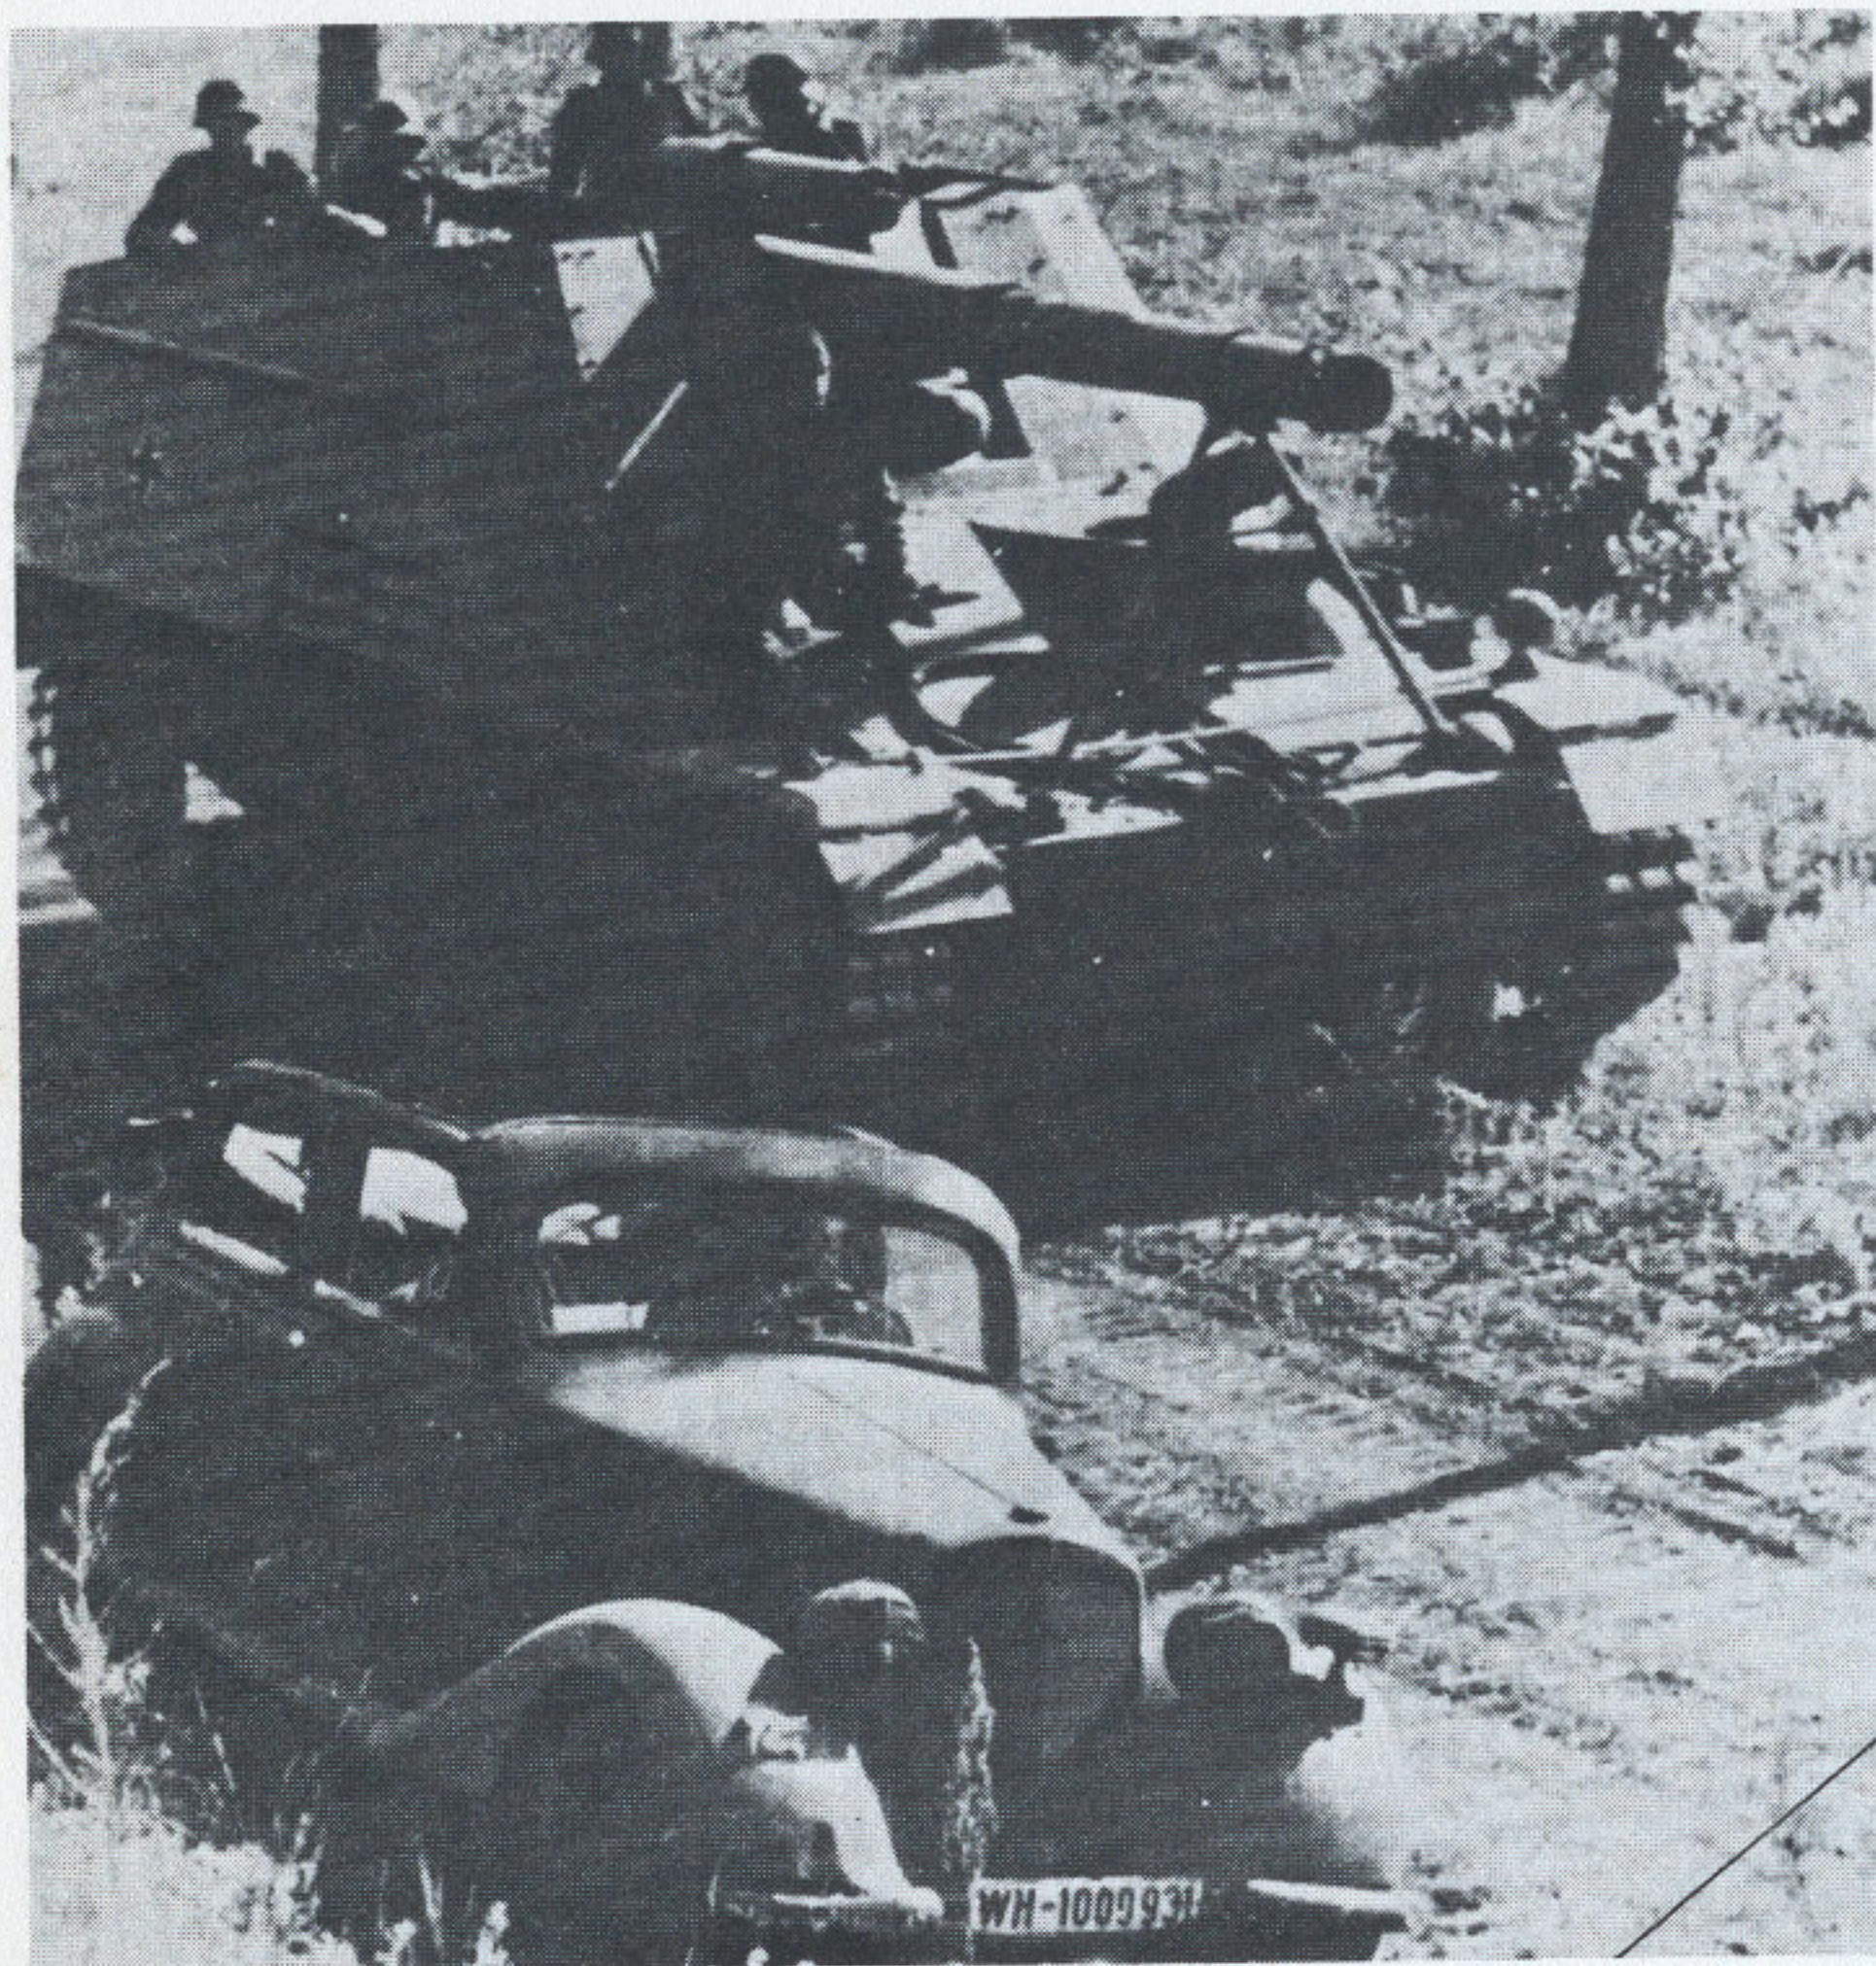
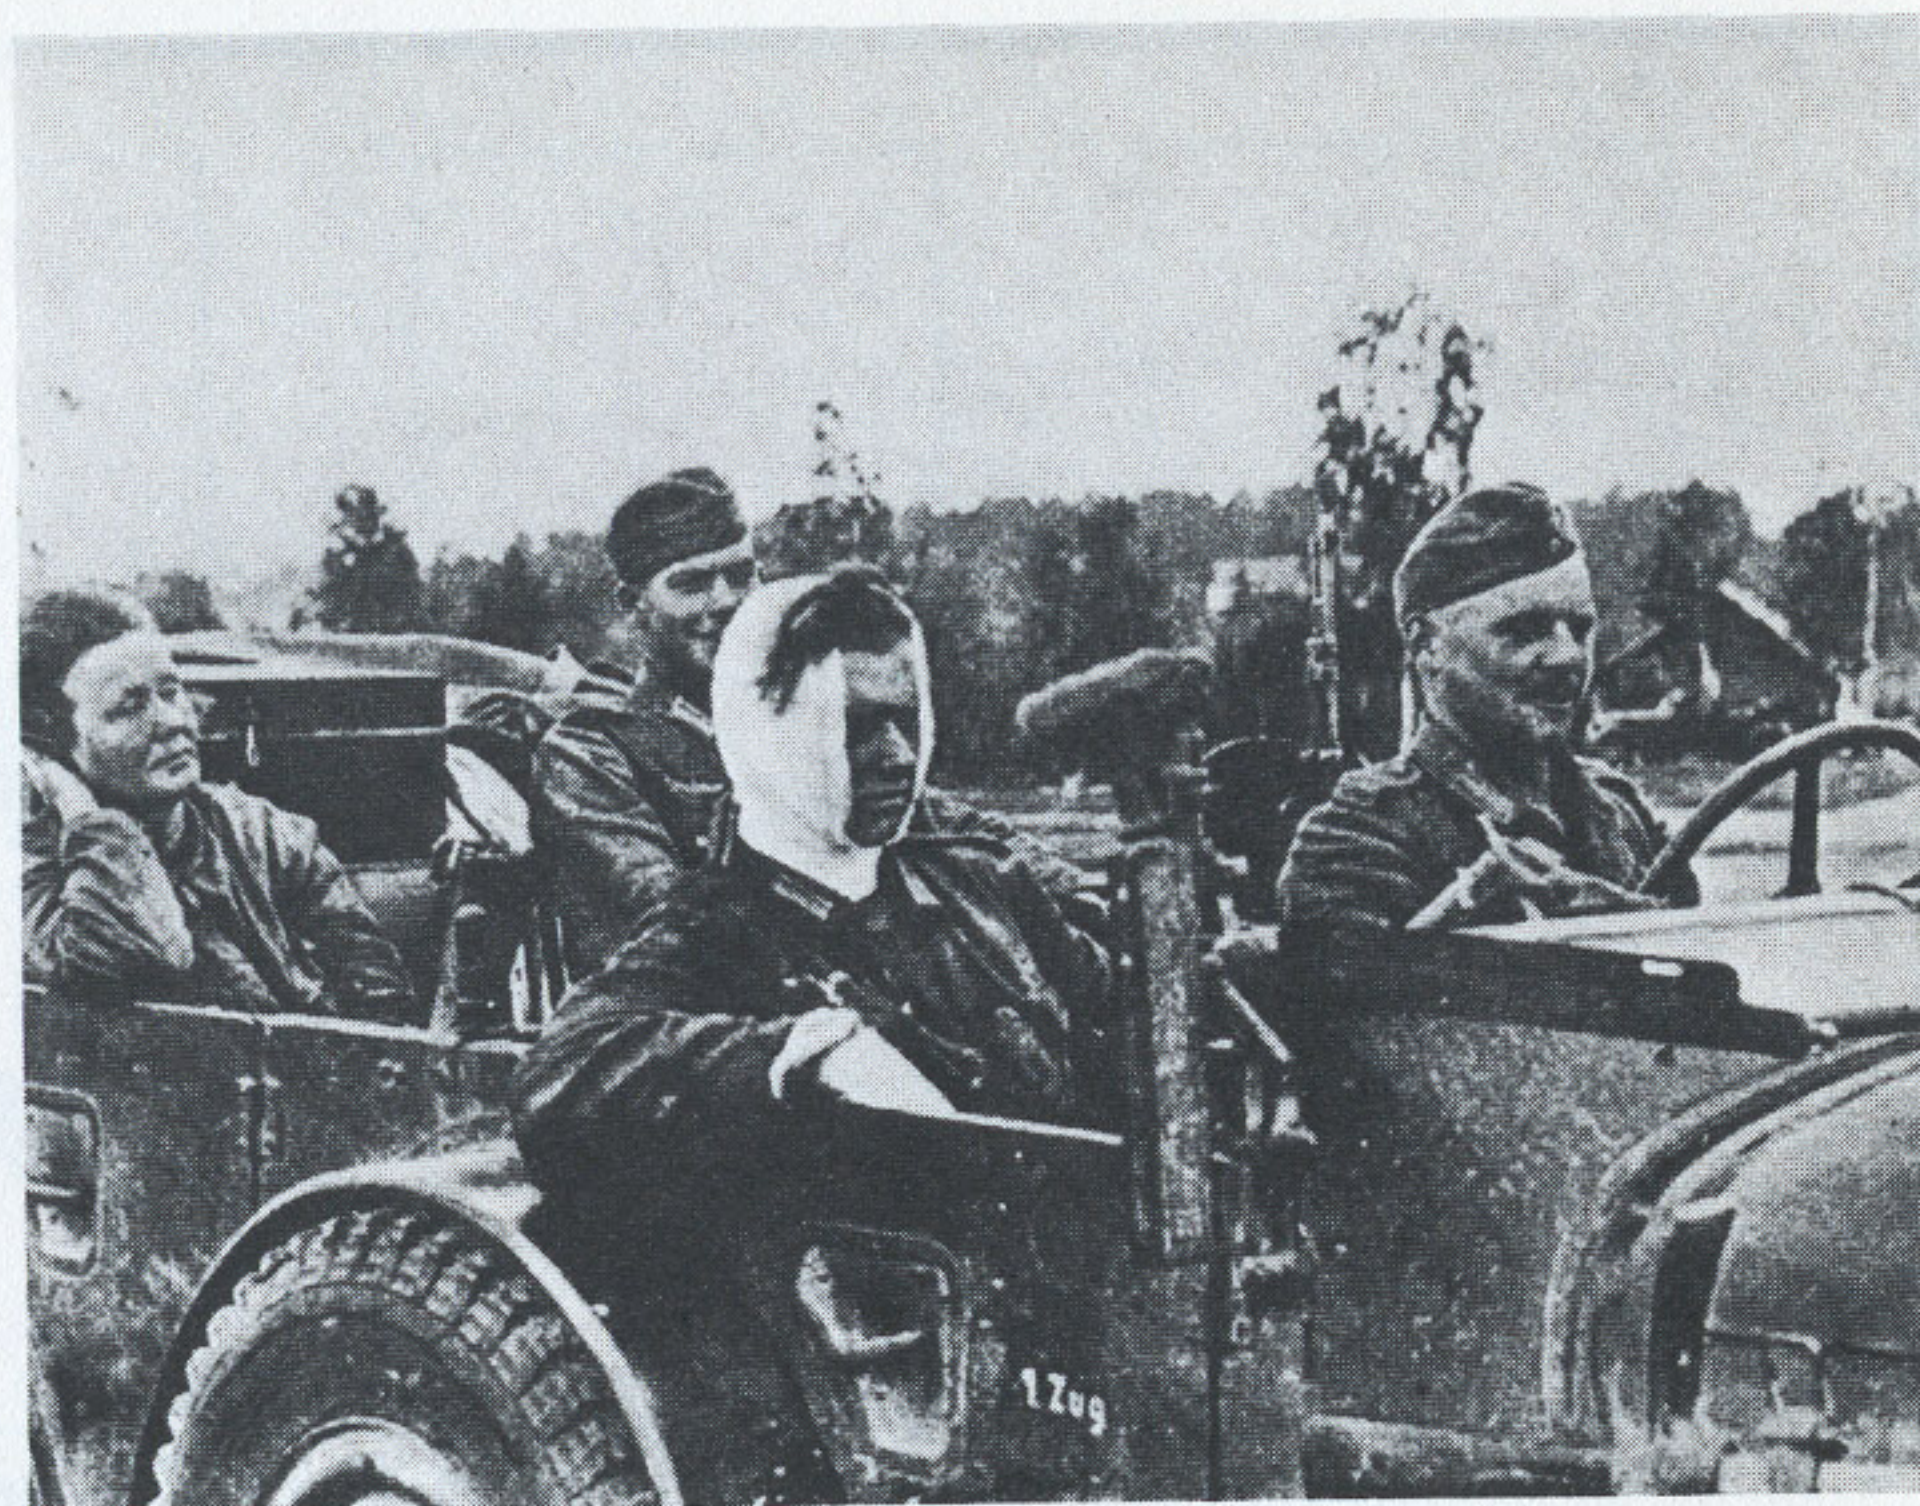
ABOVE: A Kfz 15 with an unofficial marking on the door, indentifying the vehicle as belonging to the 1st Platoon of an unidentified unit. This practice appeared to be fairly common on soft skin vehicles in service, going by photographic evidence that is.

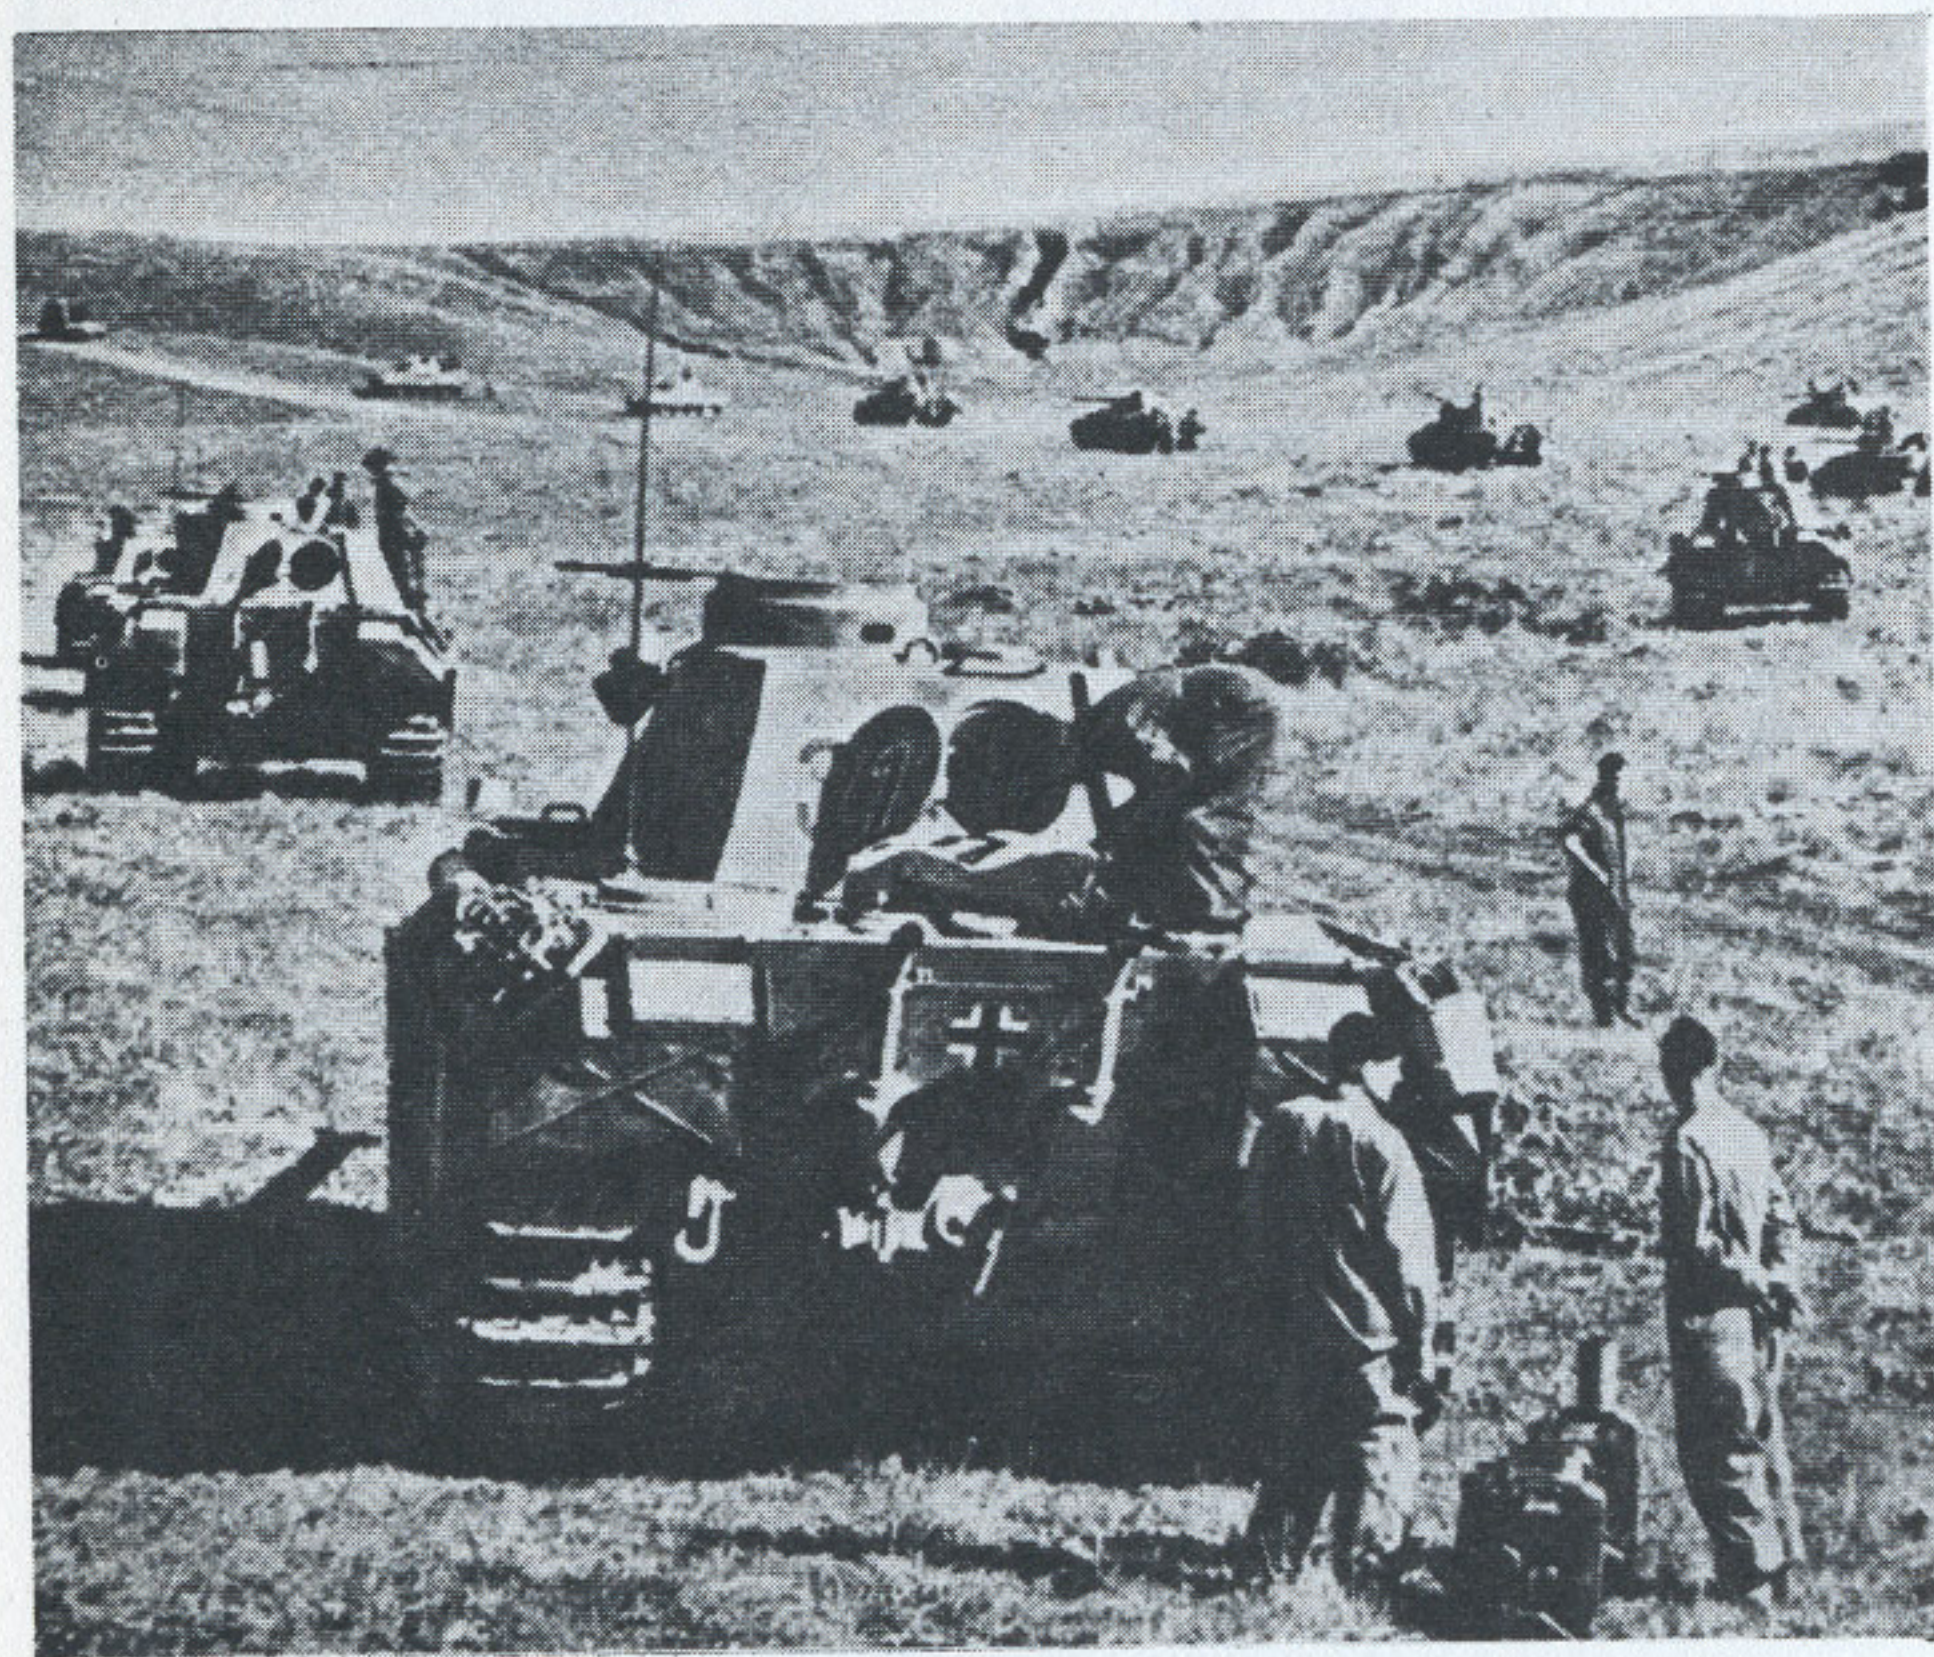
TOP LEFT: The Mercedes car in the foreground of this photo carries very interesting markings. Barely visible on the wing under the 'Notek' light is a tactical sign for a motorized unit with the letters 'PK' inside the square. These could equate to 'Propaganda Kompanie' if the device on the opposite wing is taken in conjunction with this. This shows the famous Baron Von Münchhausen riding a cannon ball, and the Baron was a well known tall-story teller from German folklaw! If this is not an official unit sign it could be the work of some German humorist.

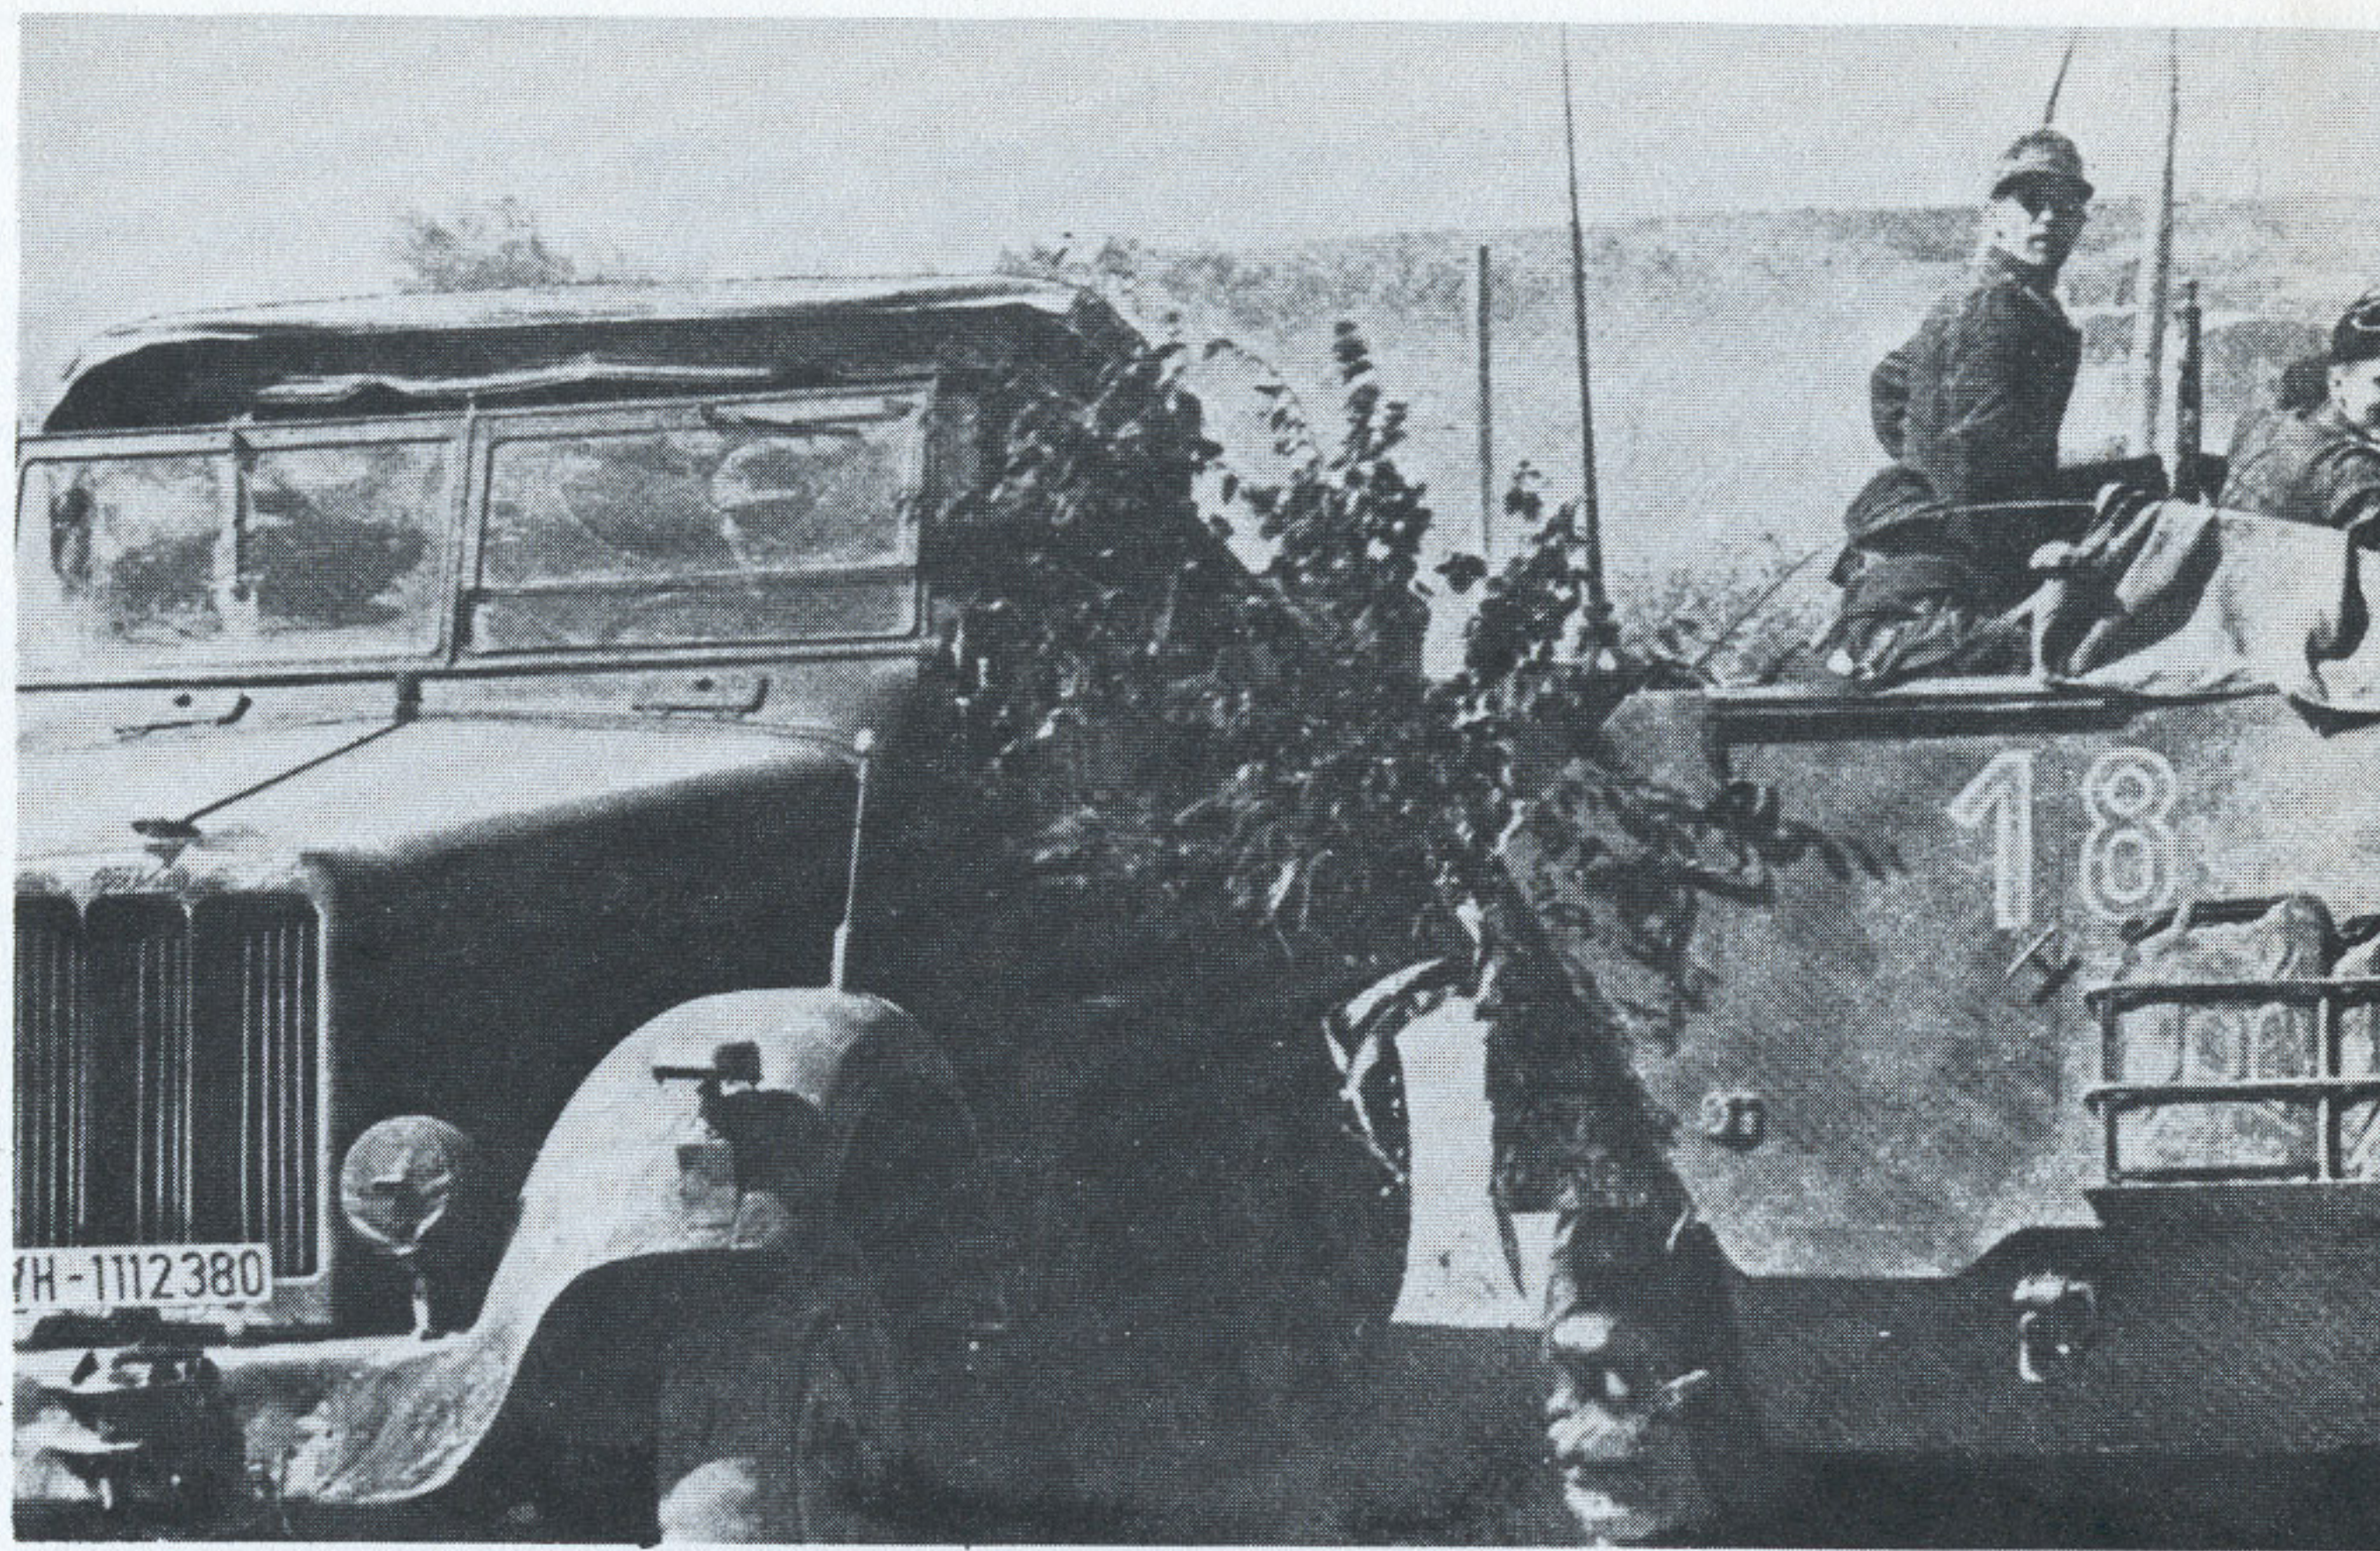
*MOTORIZED
WORKSHOPS
COMPANY*

A grey painted SdKfz 6 Praga built half-track passes a SdKfz 250 also in grey. The Praga 5 ton half-track shows a very clear front number plate but not so clear tactical markings on its front wing. These show it to belong to a fully motorized workshop company. Further identification above this on the wing, was unreadable on the original print, as is the rear body of the vehicle, hidden under foliage. Note the blackout headlamp covers on this vehicle, the 'Notek' light and width judging stanchion. The 250 carries no national markings on its rear plate, but a two figure tactical number in white outline only. Its numberplate is barely visible on the left trackguard, mainly obscured by the shadow of the foliage from the adjacent SdKfz 6.

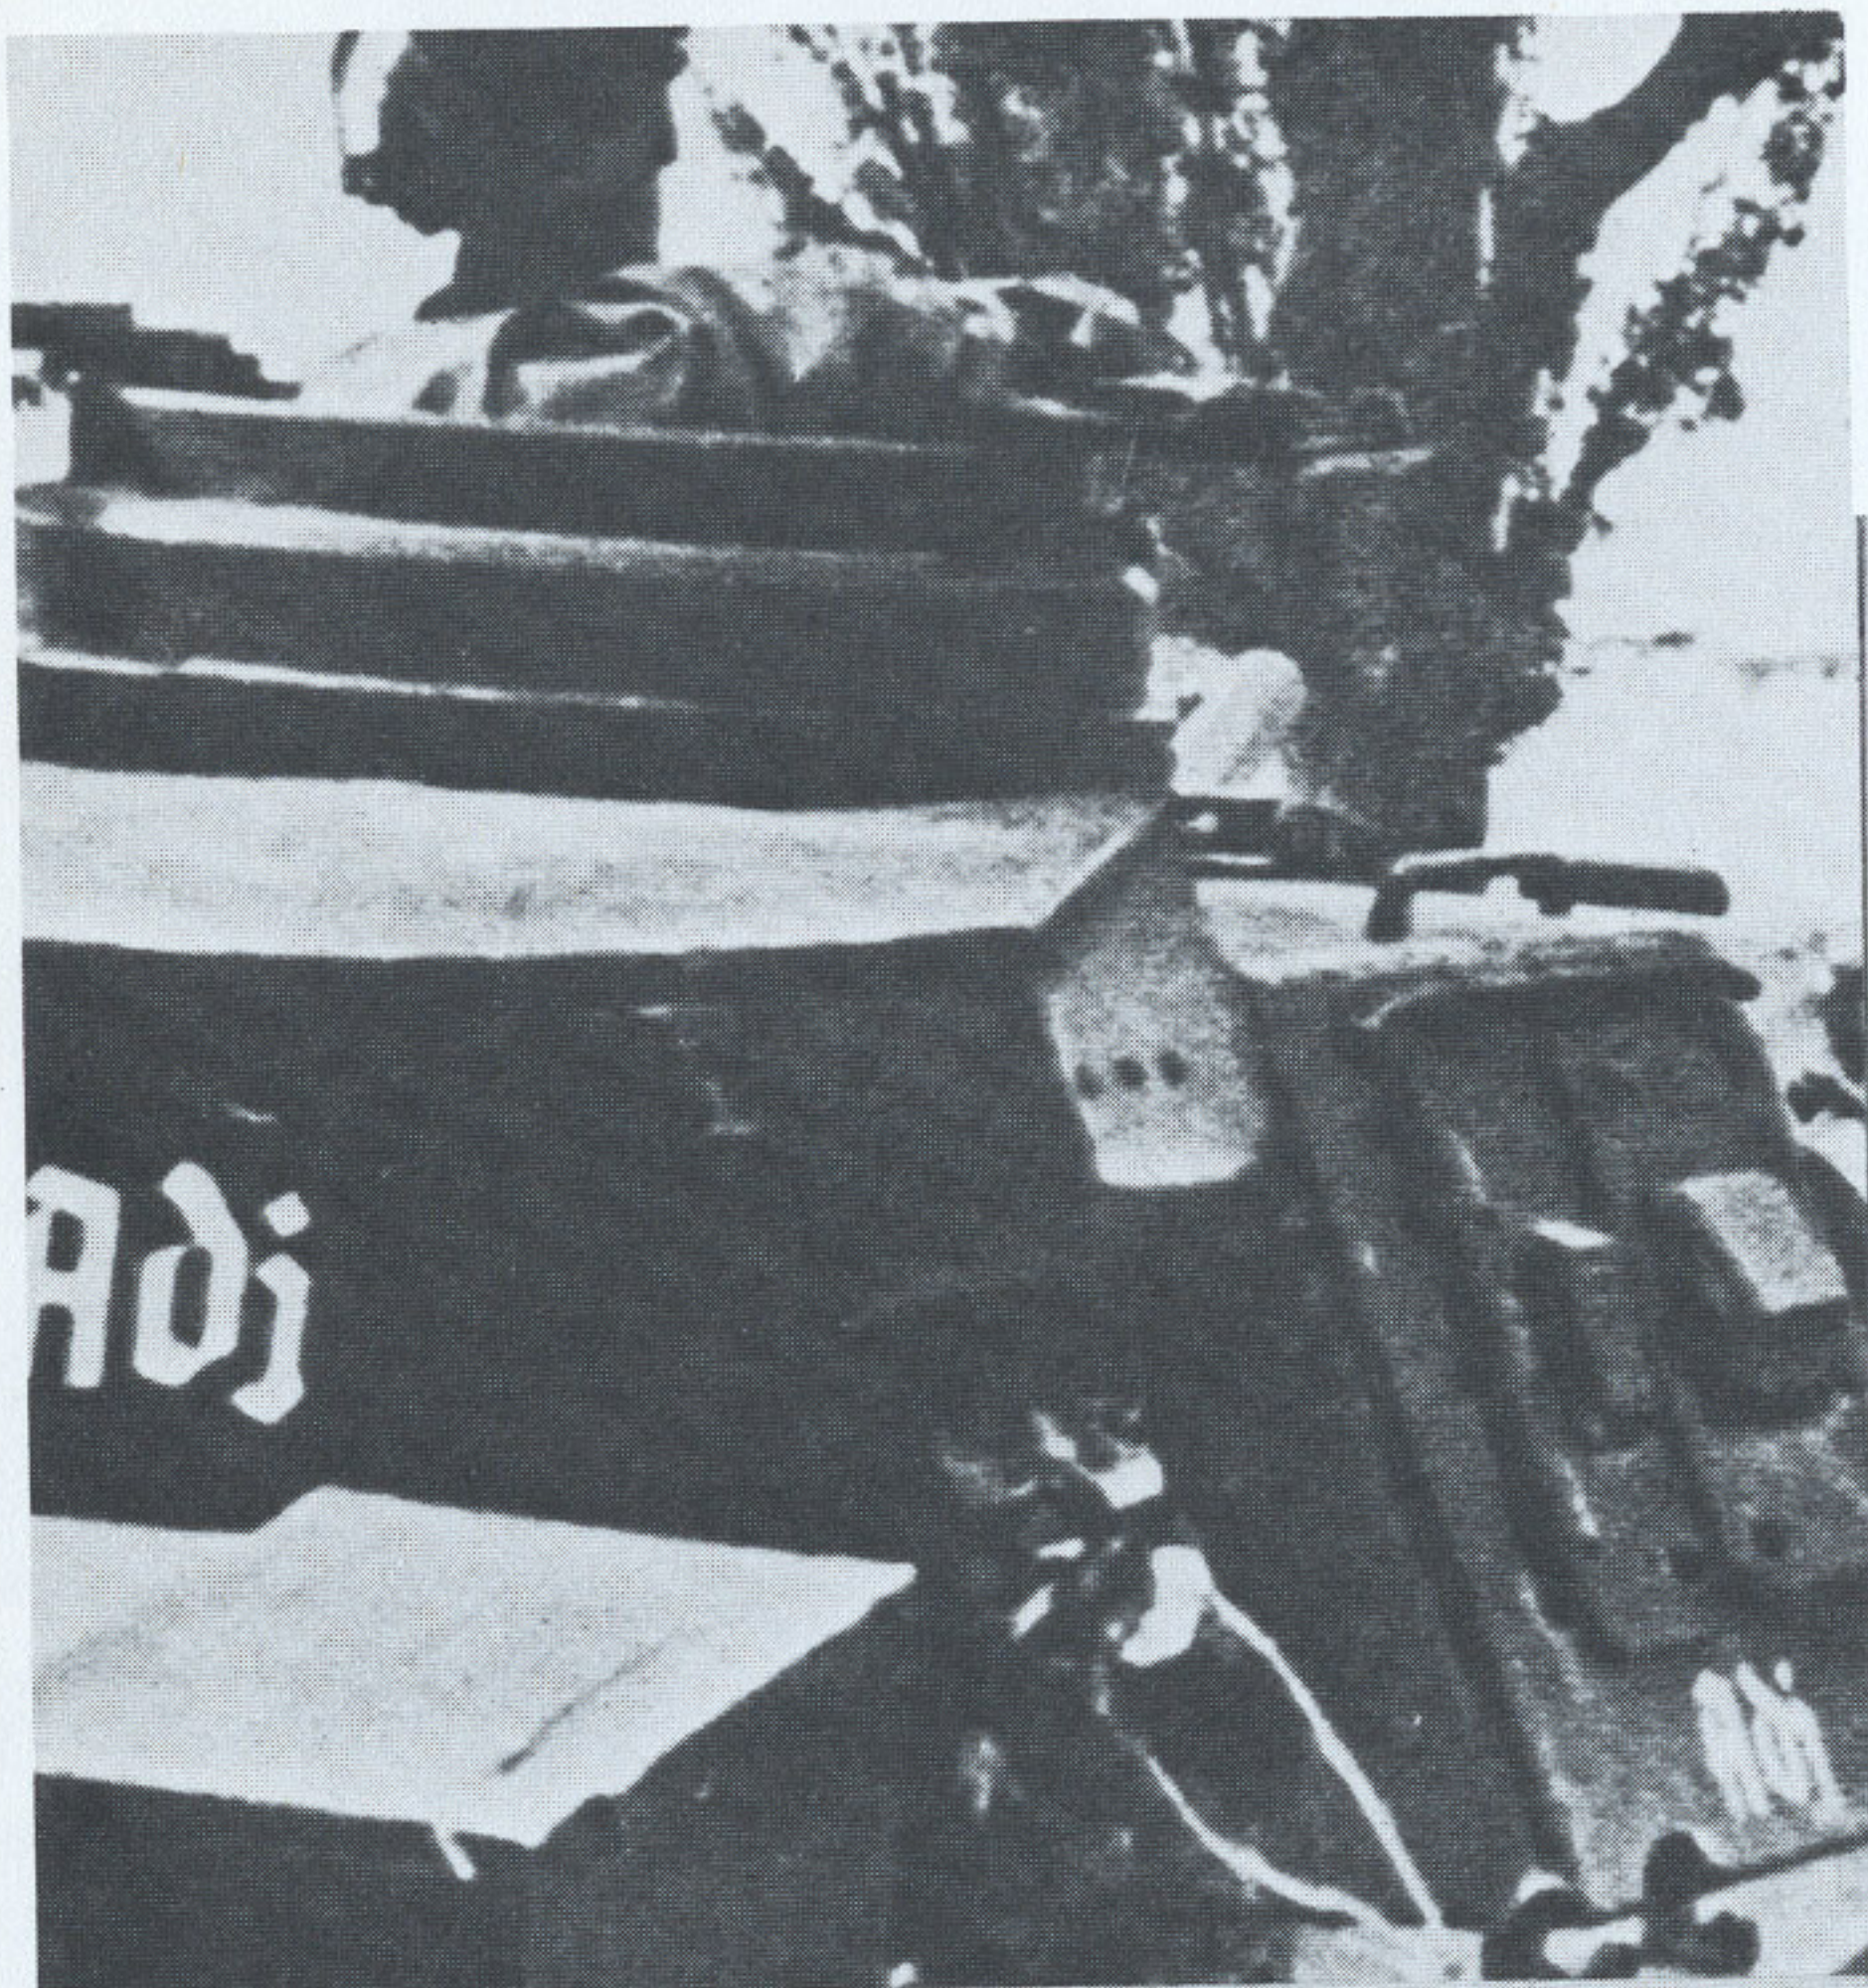
LEFT: Non-standard markings on a PzKw III signifying the unit adjutants tank within a Panzer unit, be it either regiment, battalion or company.
