No.3 GERMAN

EASTERN FRONT

FOCUS ON
ARMOUR
CAMOUFLAGE
& MARKINGS

Kenneth M Jones

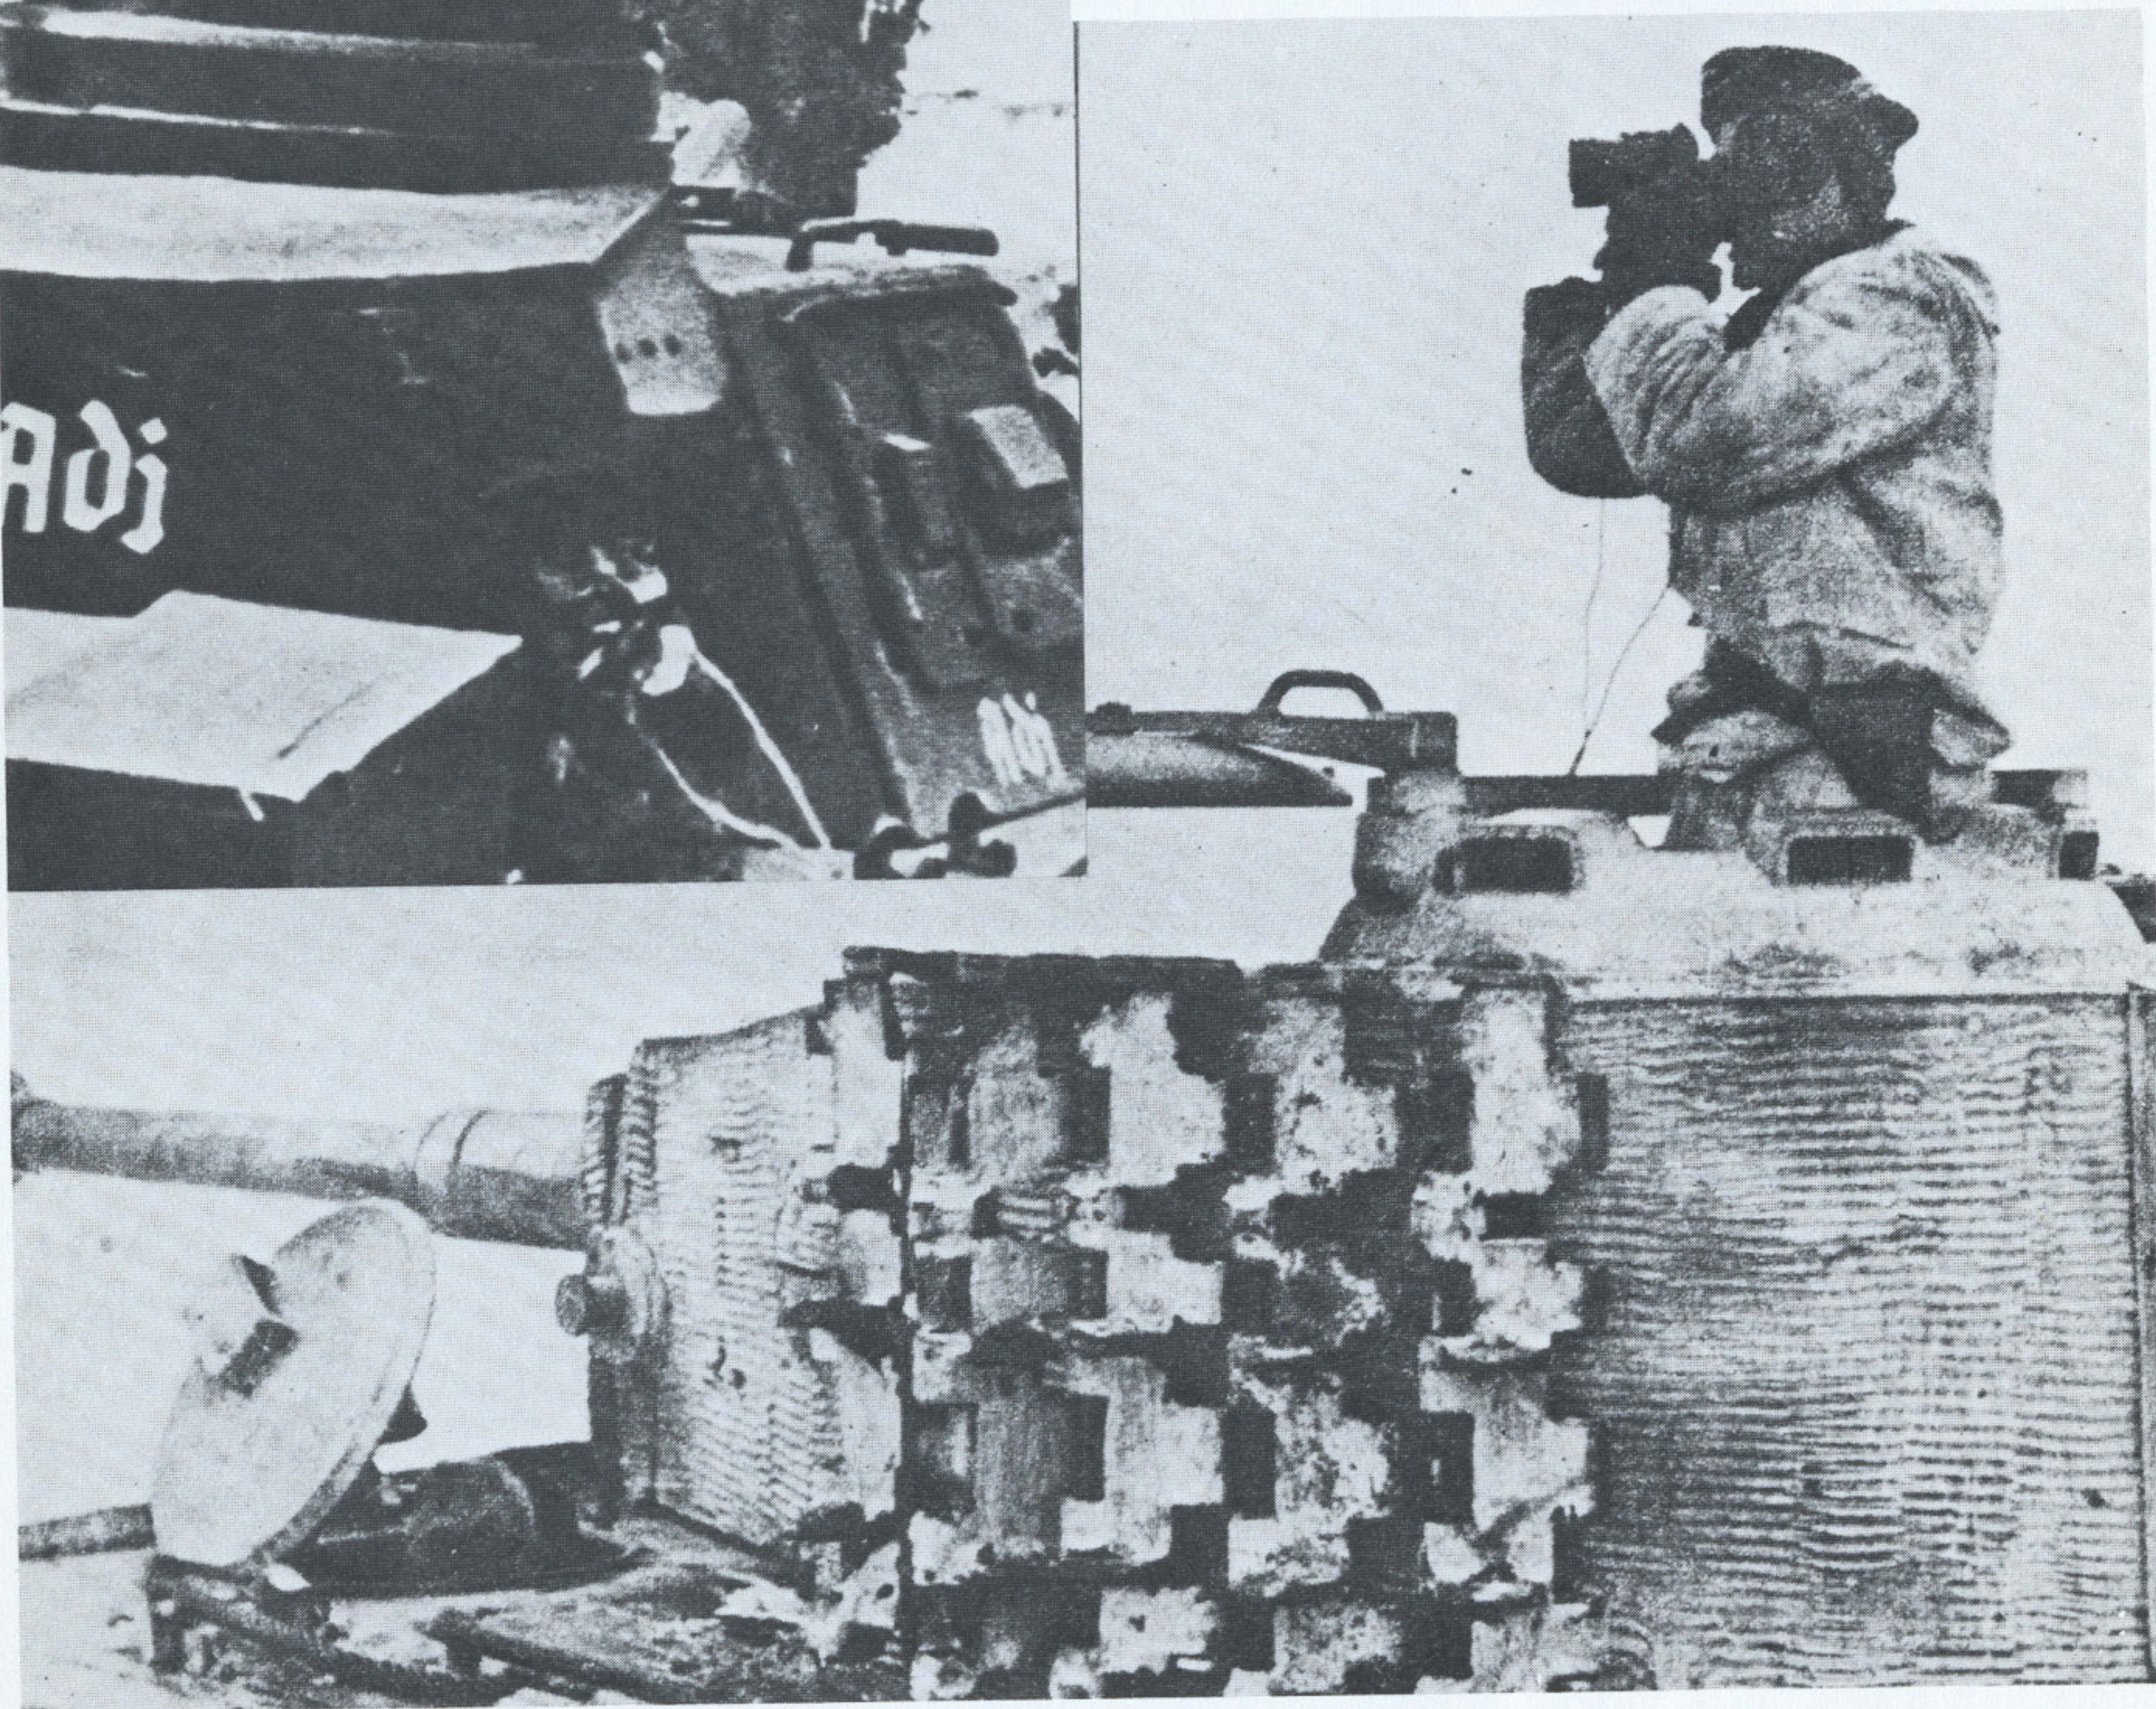
PzKw III Ausf. E commanders tank of the 13th Panzer Division. This vehicle is overall grey with white numbers and yellow divisional sign on the turret. This particular vehicle was the 1st Battalion Commanders vehicle.

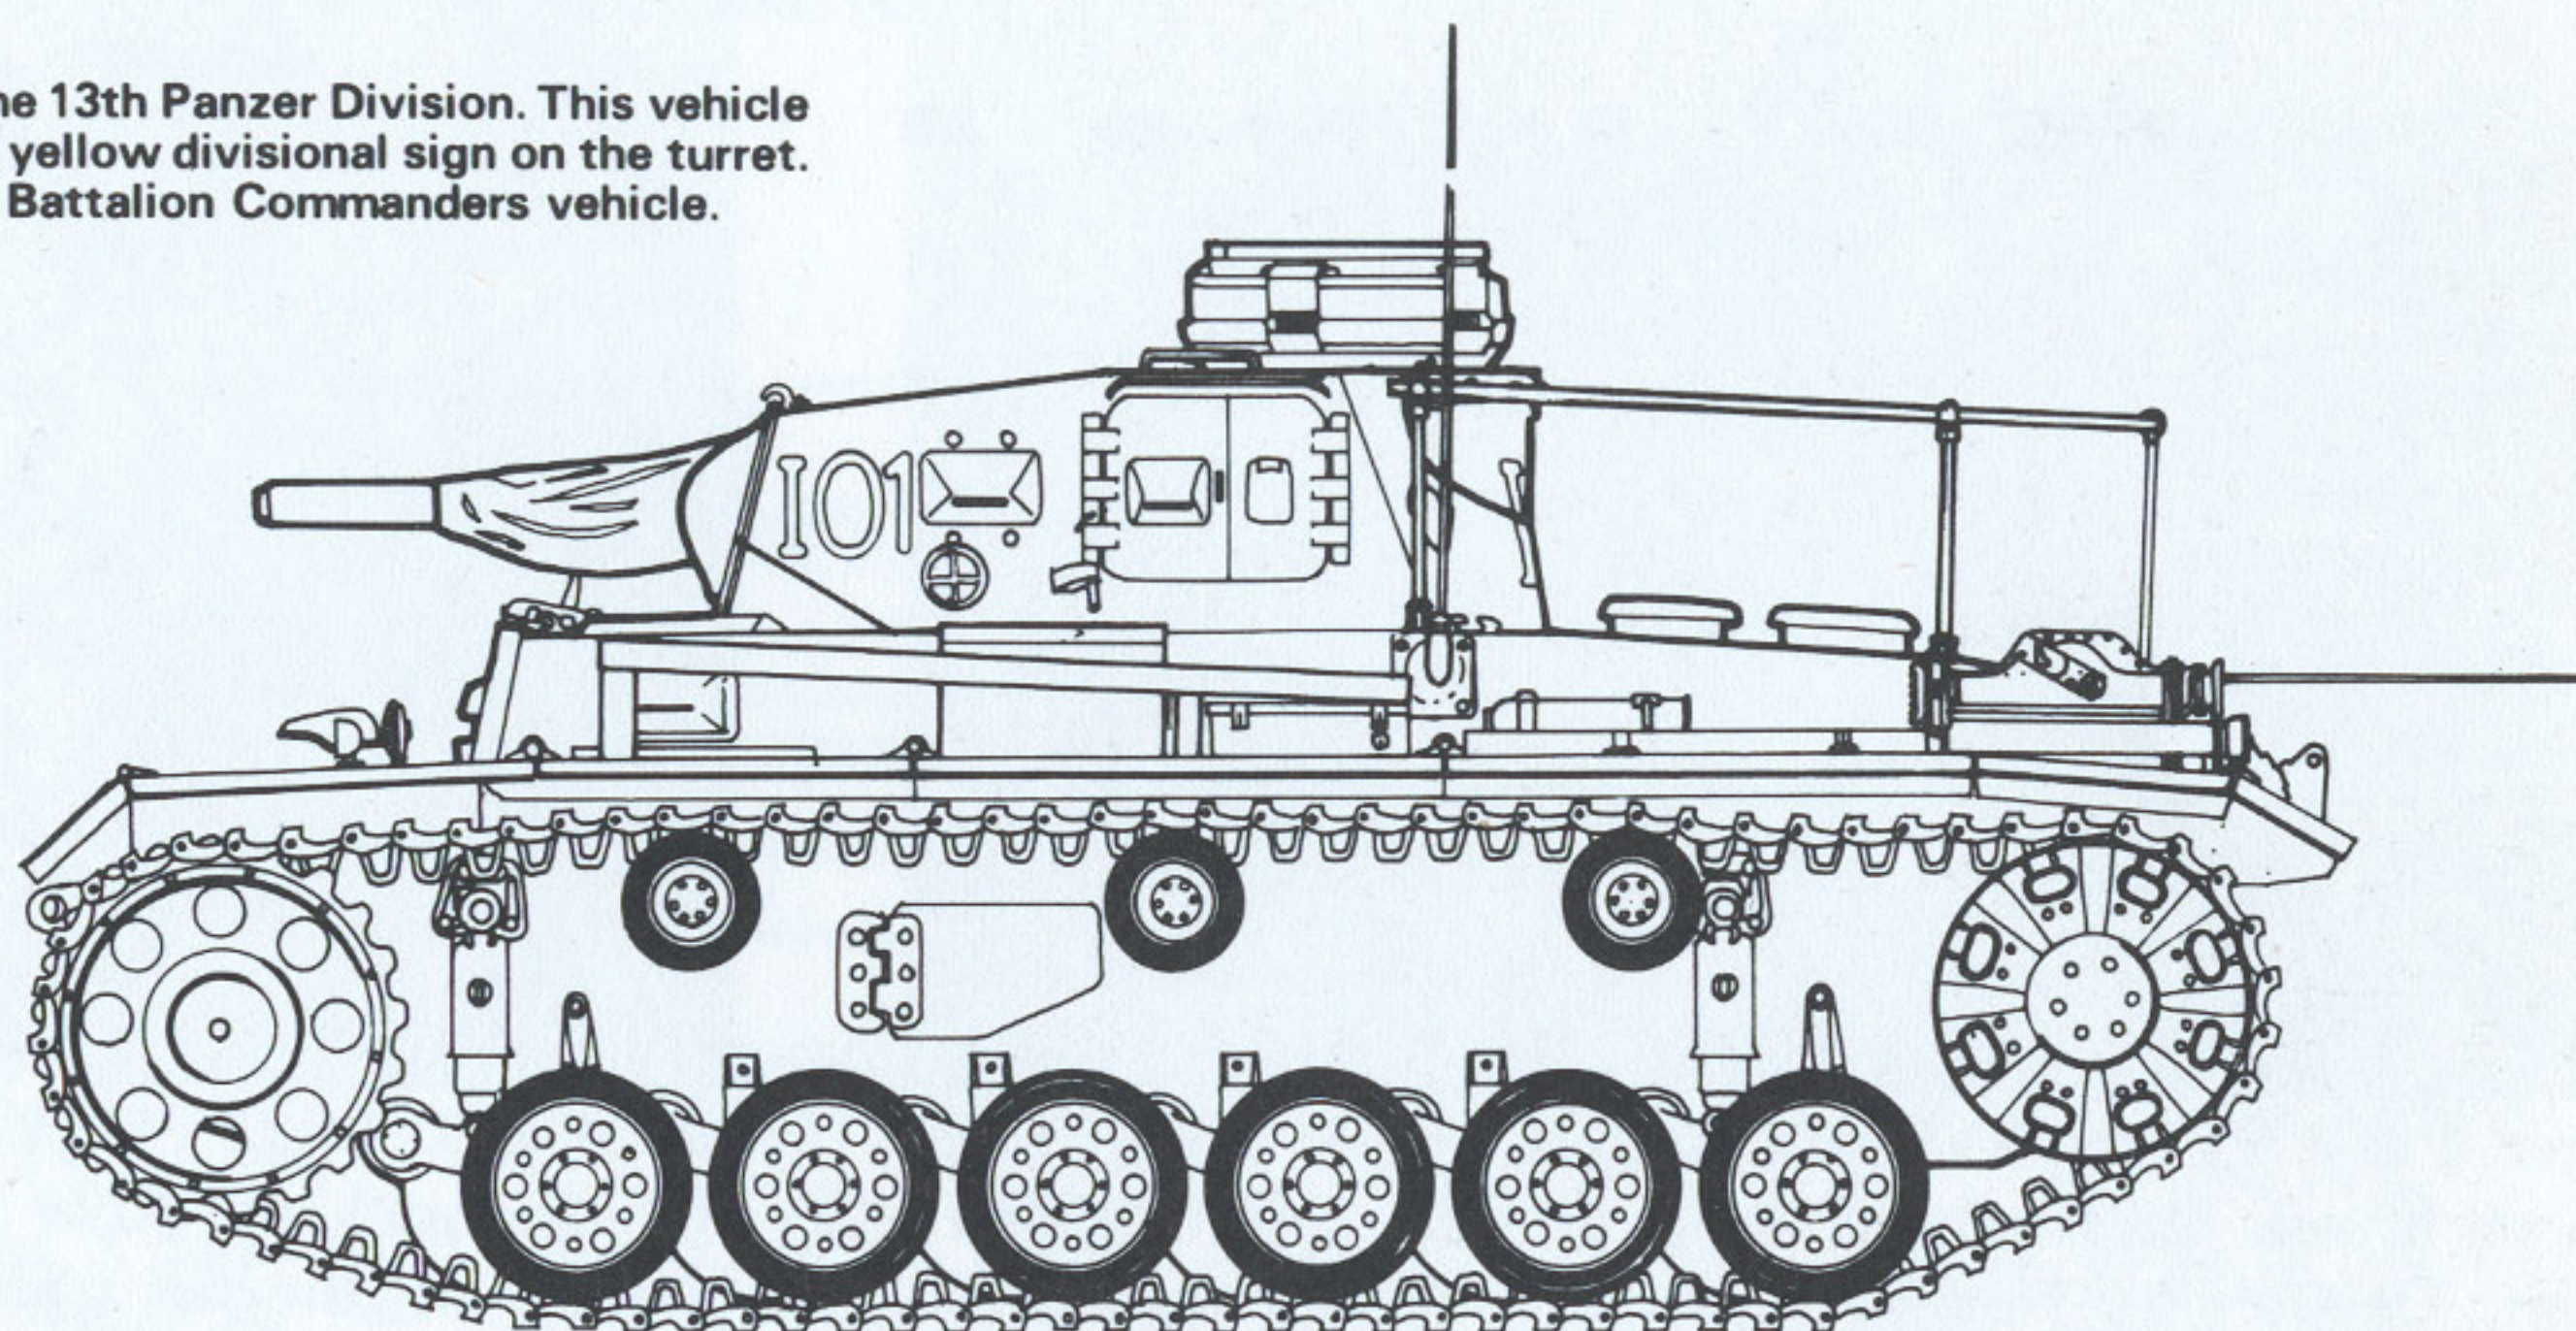
PzKw III Ausf. M in overall sand finish with plain black tactical numbers on the turret spaced armour.

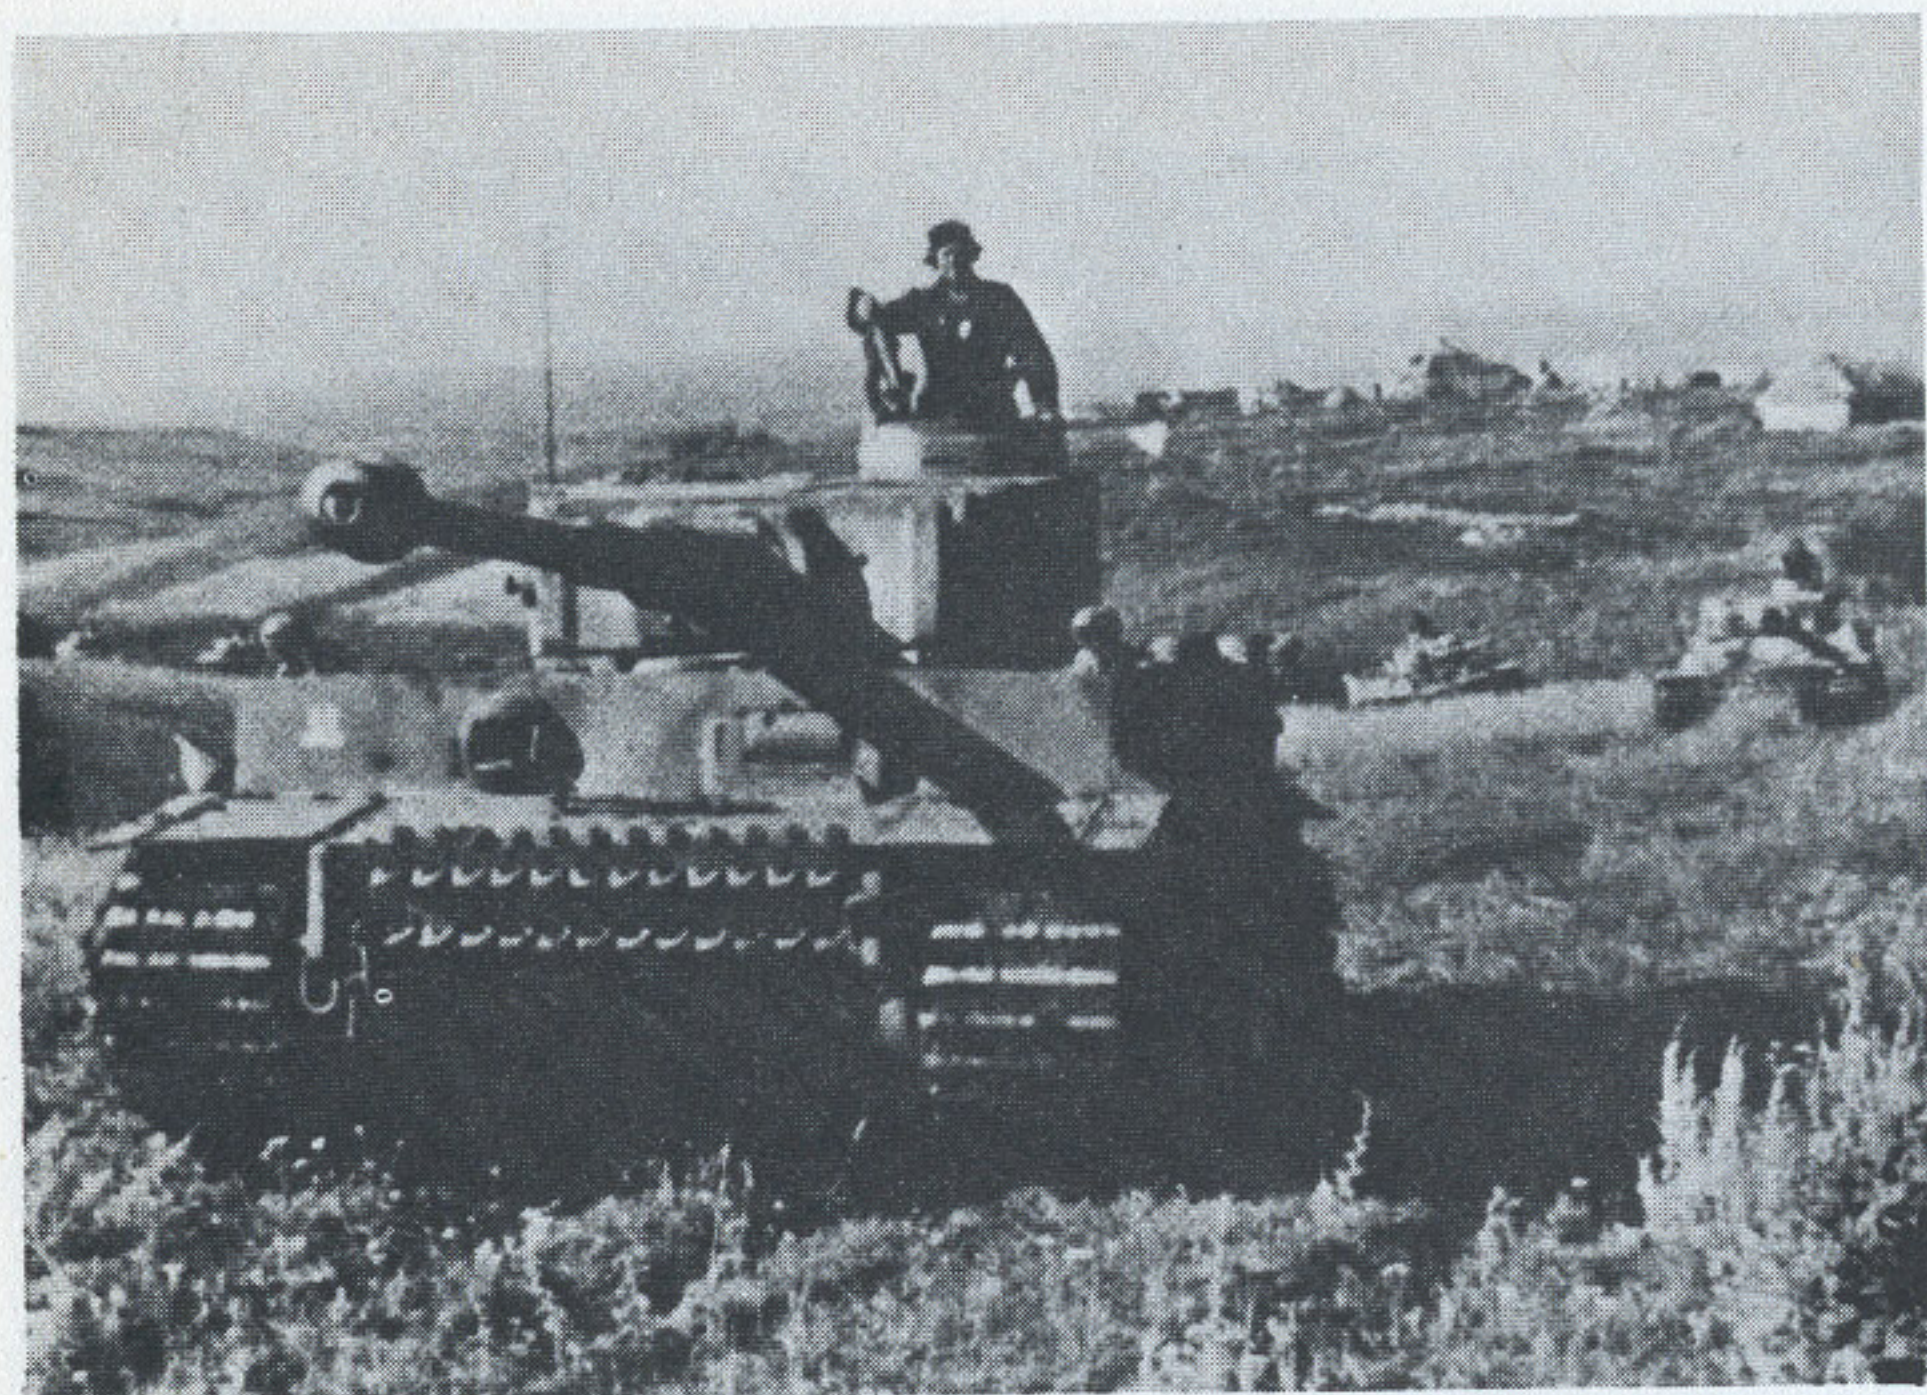
A Tiger (PzKw VI Ausf E) with a sprayed mottle finish, either green or brown on sand – or both – of the 2nd SS Panzer Division, 'Das Reich'. This photograph was taken during the Kursk battles and shows the insignia for 2nd Panzer on the bow plate. All other divisional emblems were removed and these 'operational markings' were used by the SS Panzer Korps at Kursk.

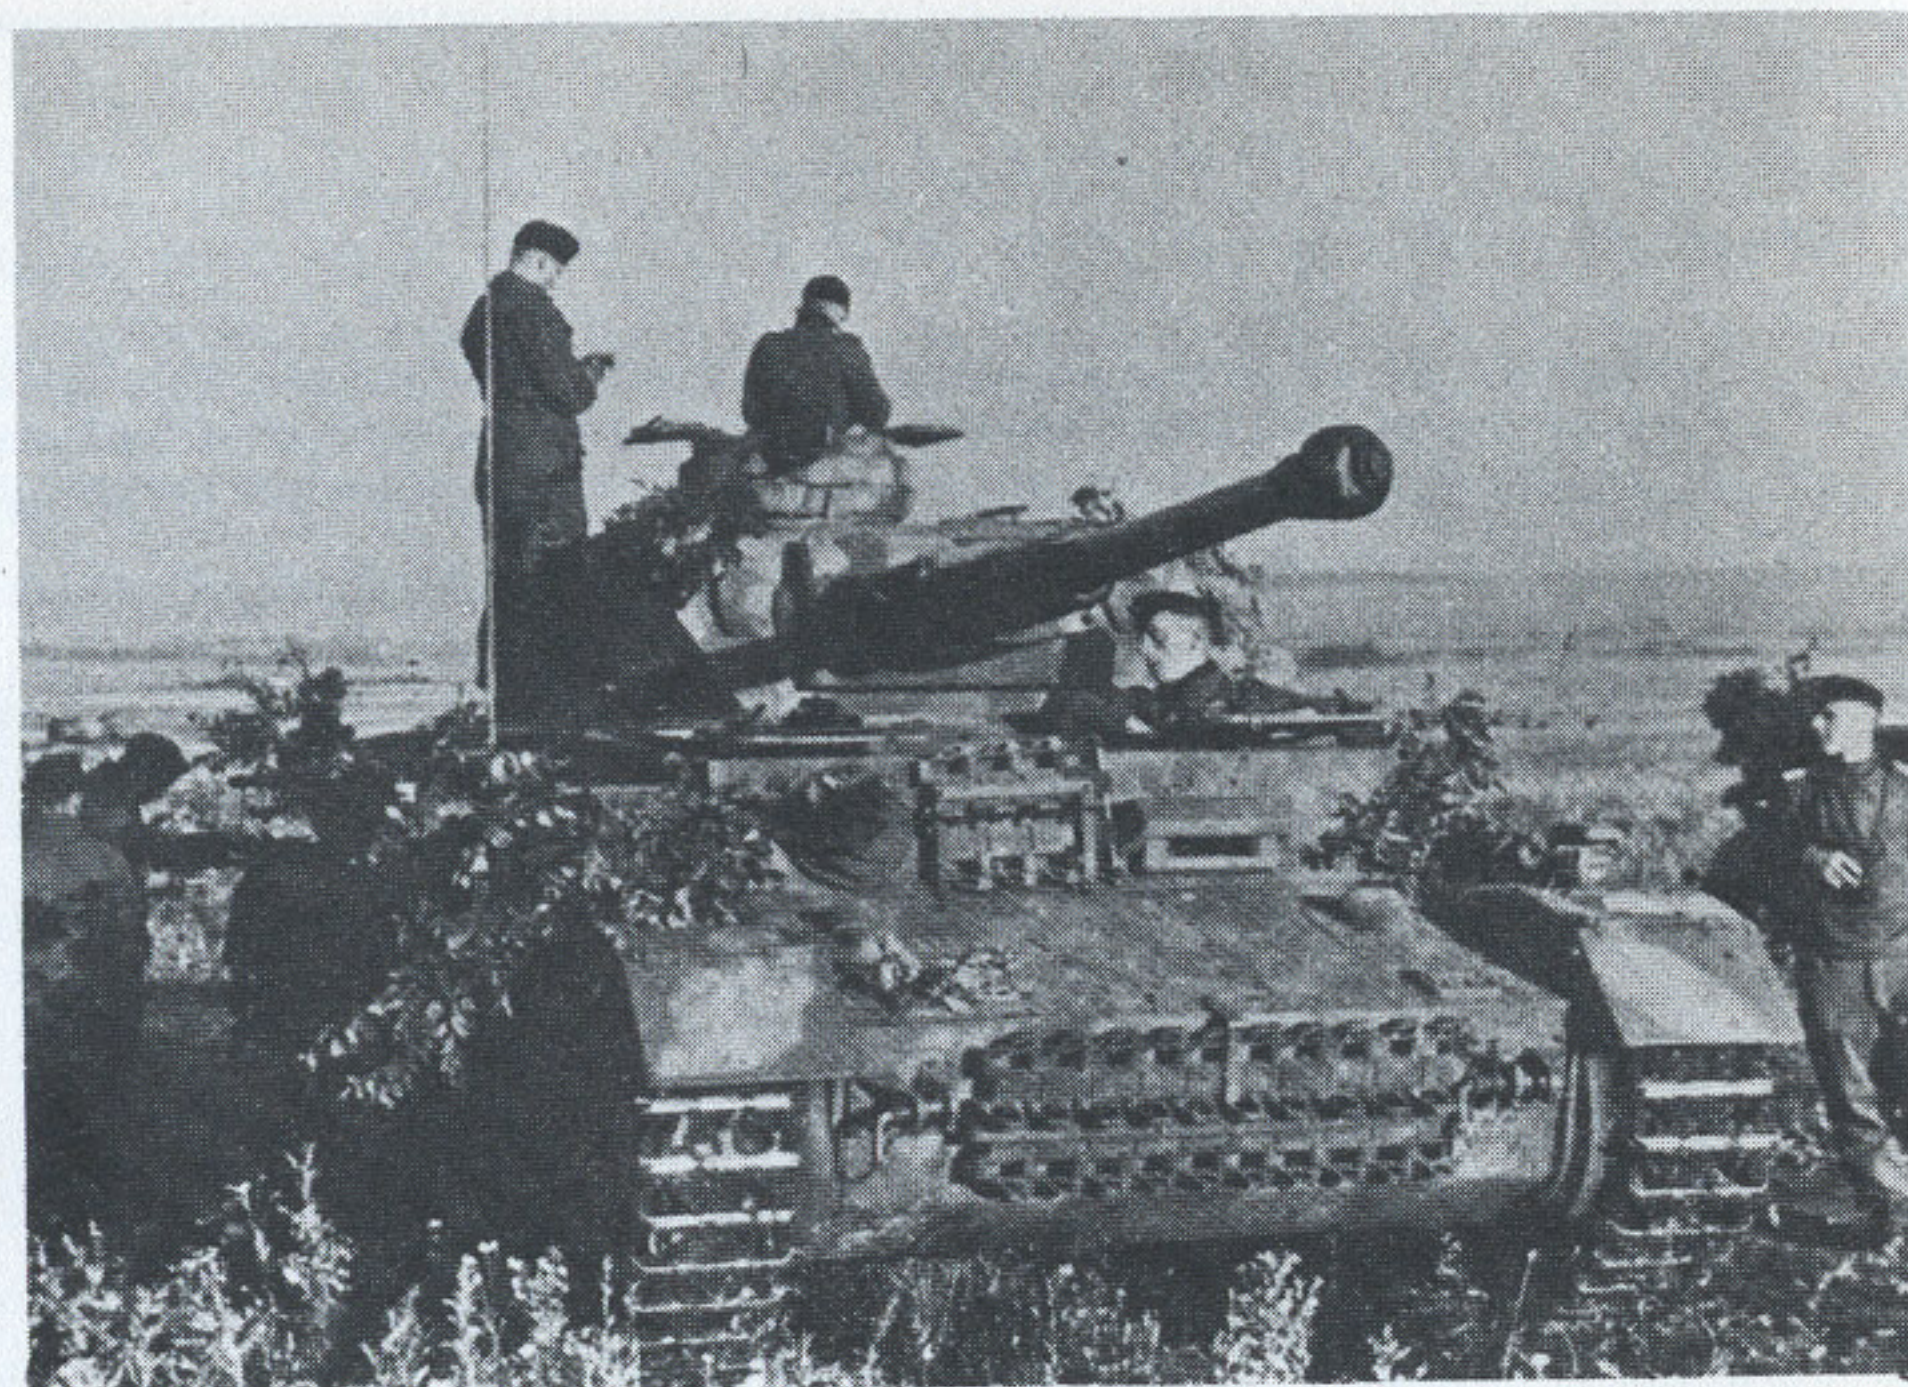
A PzKw IV Ausf F2 belonging to the Panzer Grenadier Division 'Grossdeutschland'. The famous helmet badge of the division appears on the far track-guard under the Notek light. The vehicle appears to have had sand paint painted on over the dark grey base colour. Foliage, once again, has been deposited about the vehicle in an attempt to break up the outline of the tank.

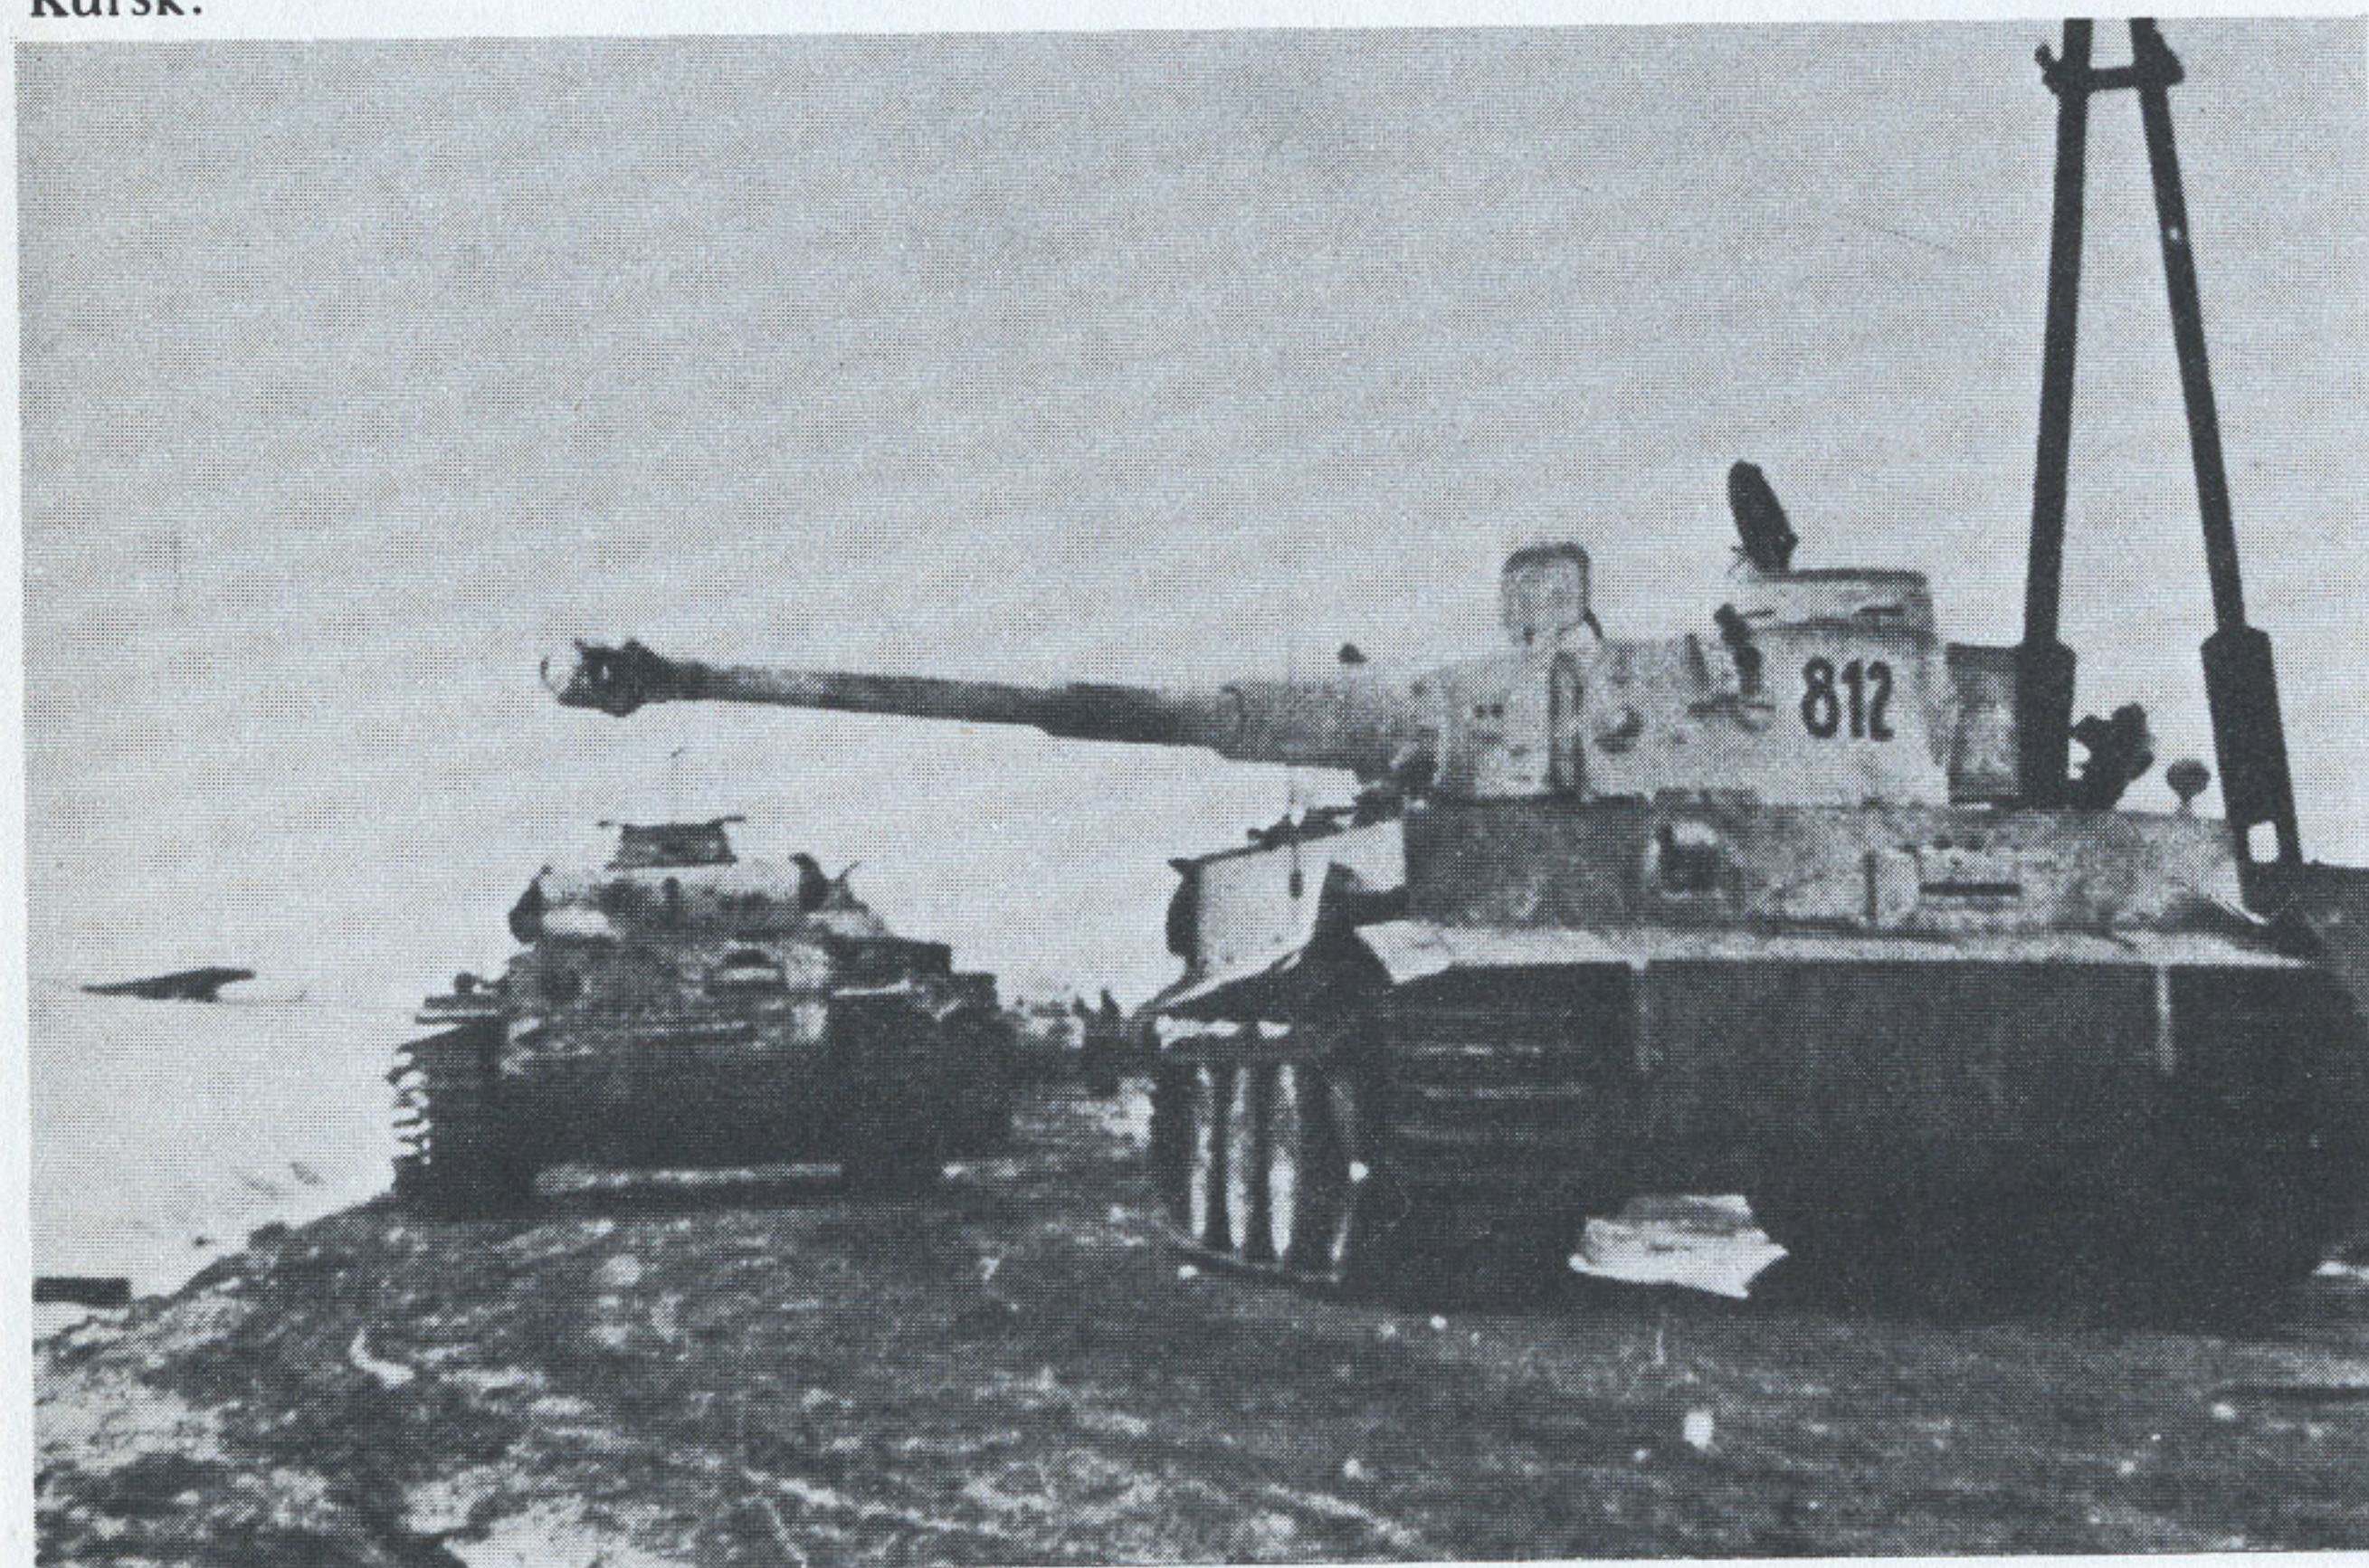
A Tiger I Ausf. E in scruffy whitewash finish, leads a line of PzKw III's. Noteworthy are the absence of the leading roadwheel on the Tiger which is fitted with battle tracks, and the PzKw III next in line fitted with 'Ostketten' links on its trackwork to improve its performance over softgoing. Note also the plain black tactical numbers on the Tiger's turret, the national marking on the sideplate, the smoke blackened gun barrel and muzzle brake. The whitewash finish on the tanks appears to be fading away.

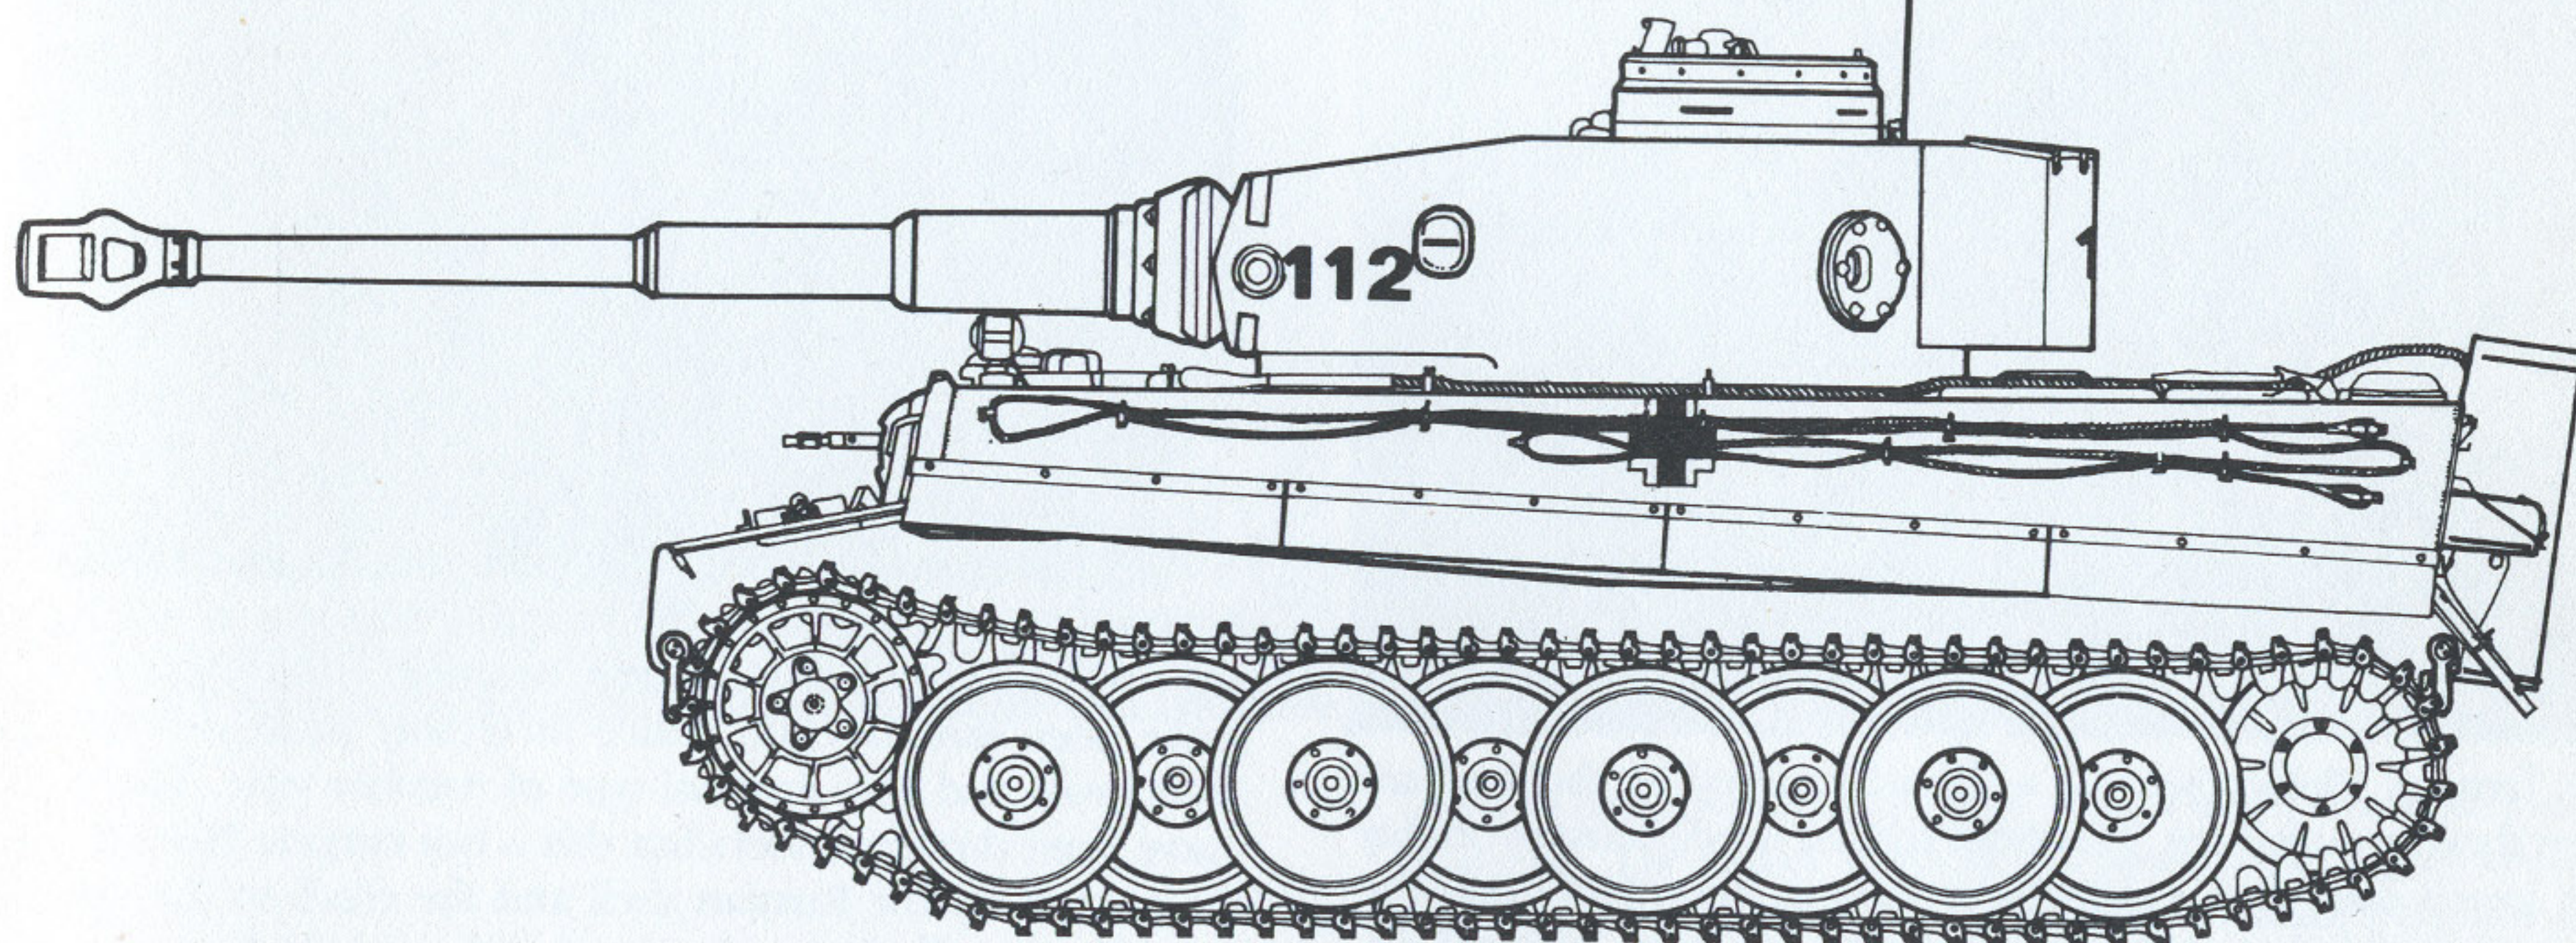
Tiger I Ausf. E of the 2nd SS Panzer Division 'Das Reich'. The bow marking was used by the SS Panzer Korps at Kursk and signifies the 2nd SS Panzer Division. No other markings were carried.

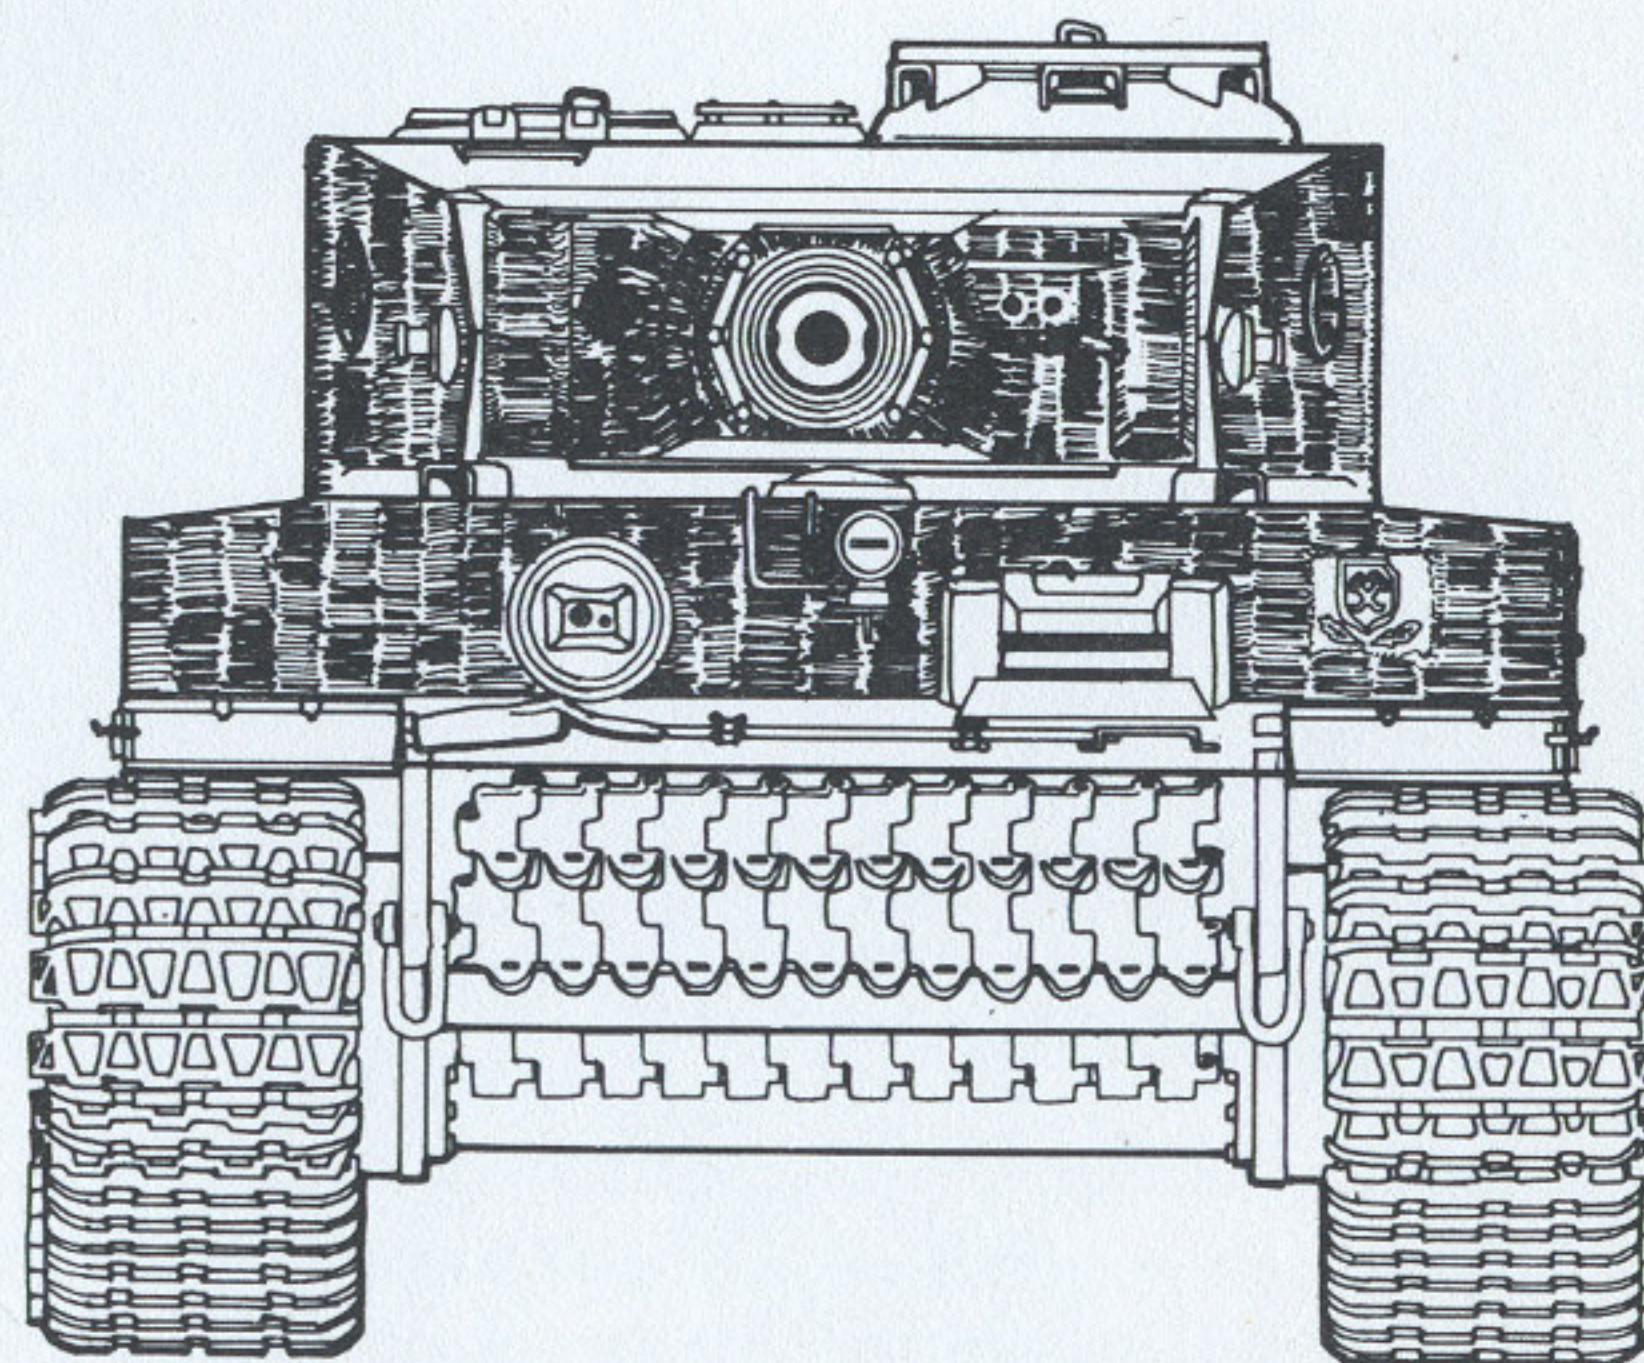
Tiger I late production model with zimmerit finish. Badge of the 1st SS Panzer Division, 'Leibstandarte Adolf Hitler' was left showing when the zimmerit was applied.
