No.3 GERMAN

EASTERN FRONT

FOCUS ON
ARMOUR
CAMOUFLAGE
& MARKINGS

Kenneth M Jones

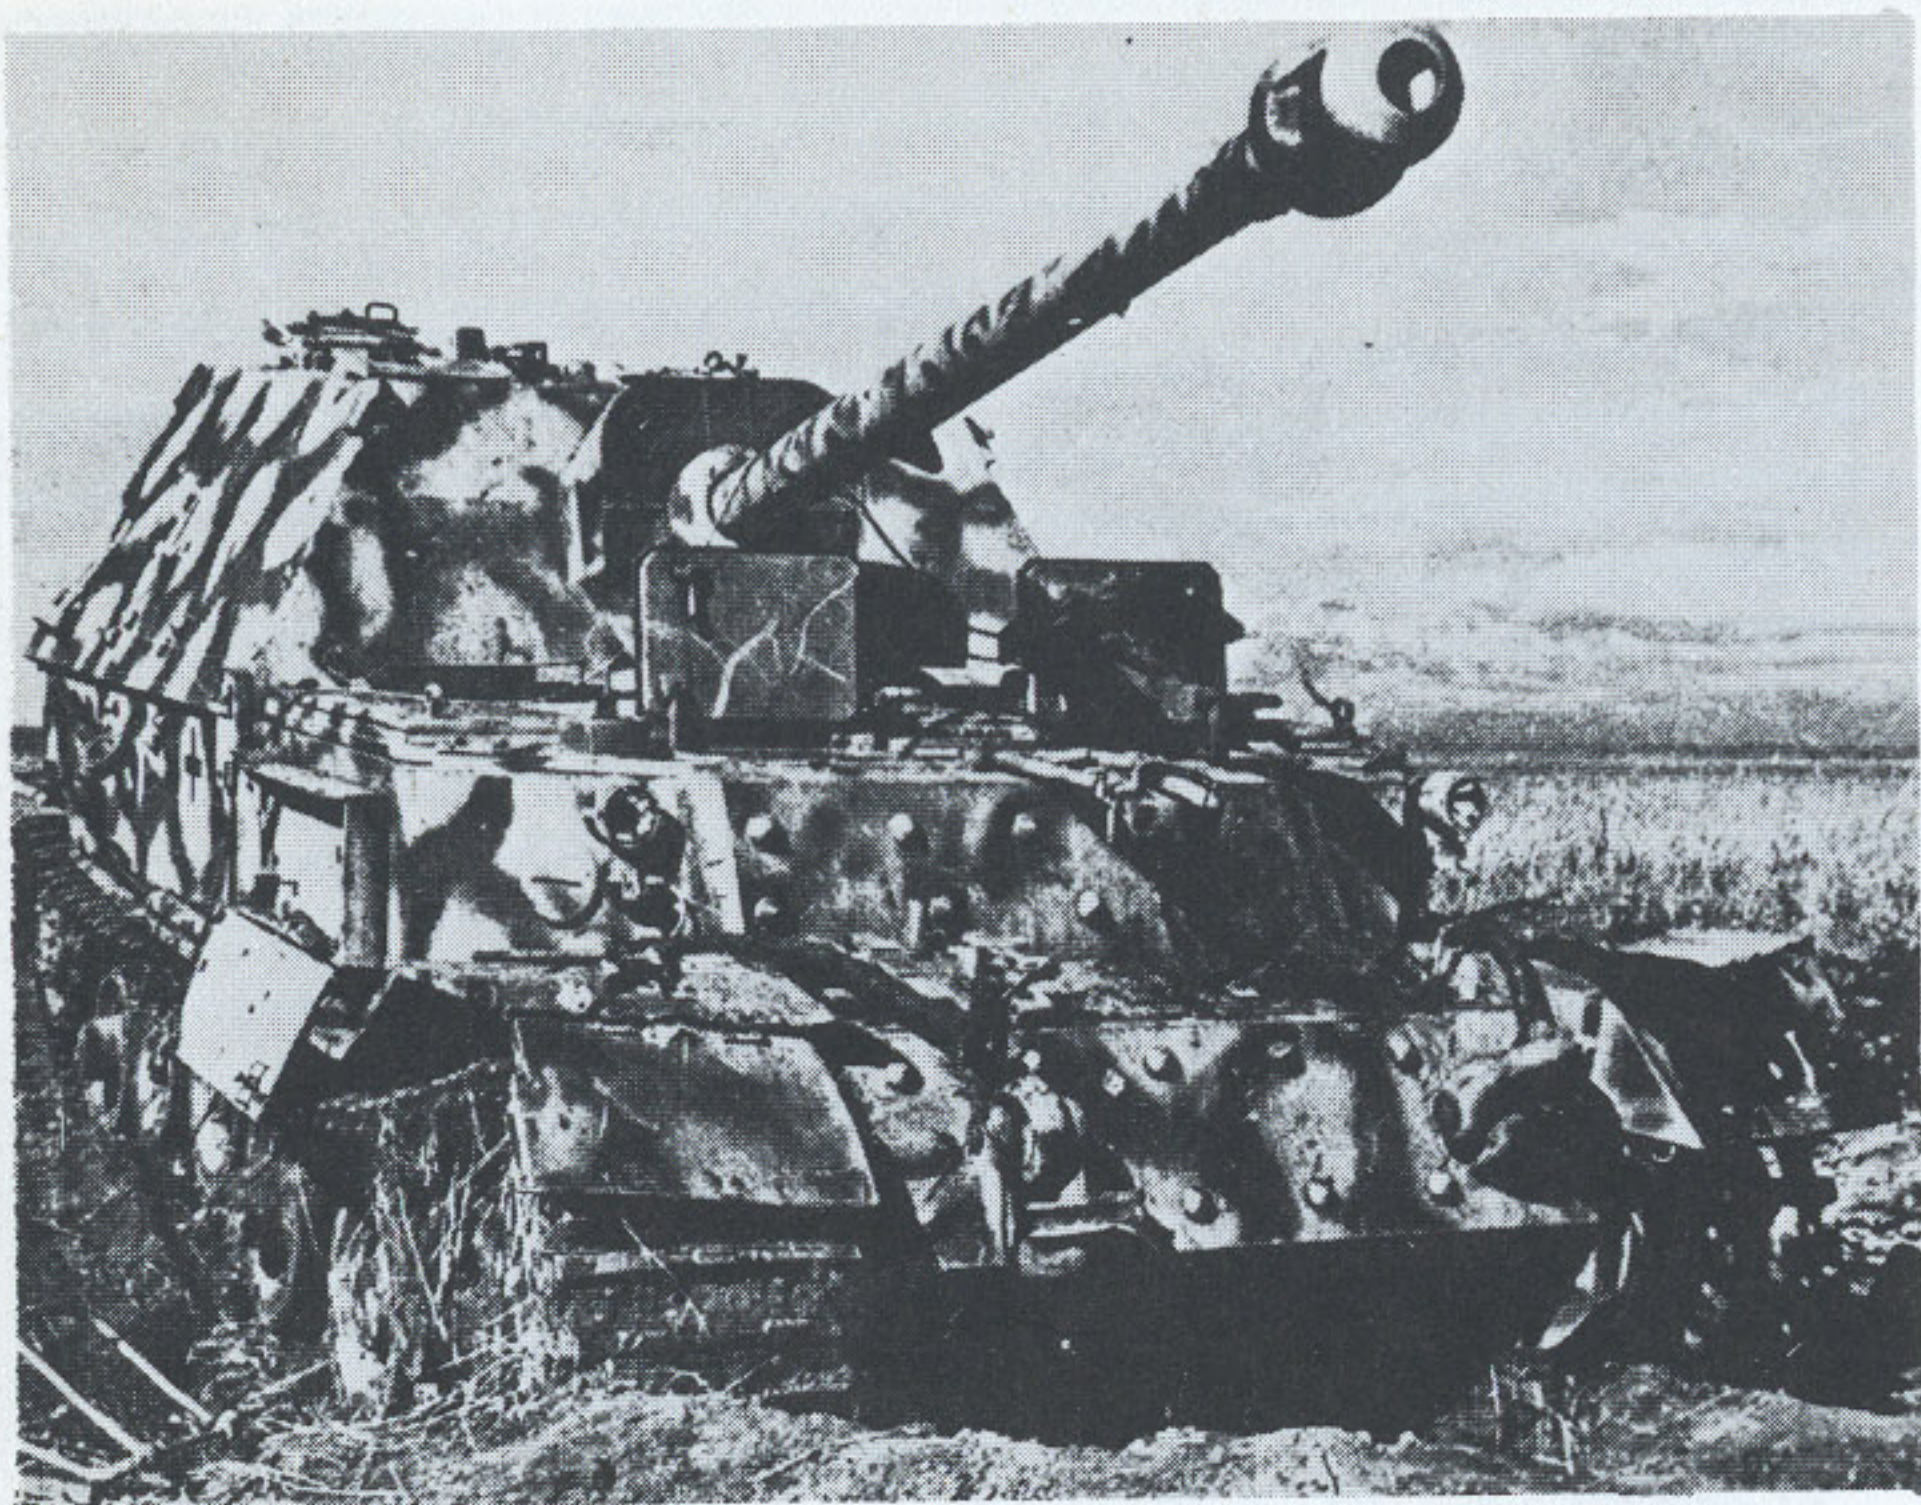
The 'famous' Elefant No. 501 as photographed by the Russians when they captured her. The bold striped finish, most probably dark green over dark sand is very evident here. Note that the left track is missing, and that the finish has been sprayed on. This photograph is from Soviet sources.

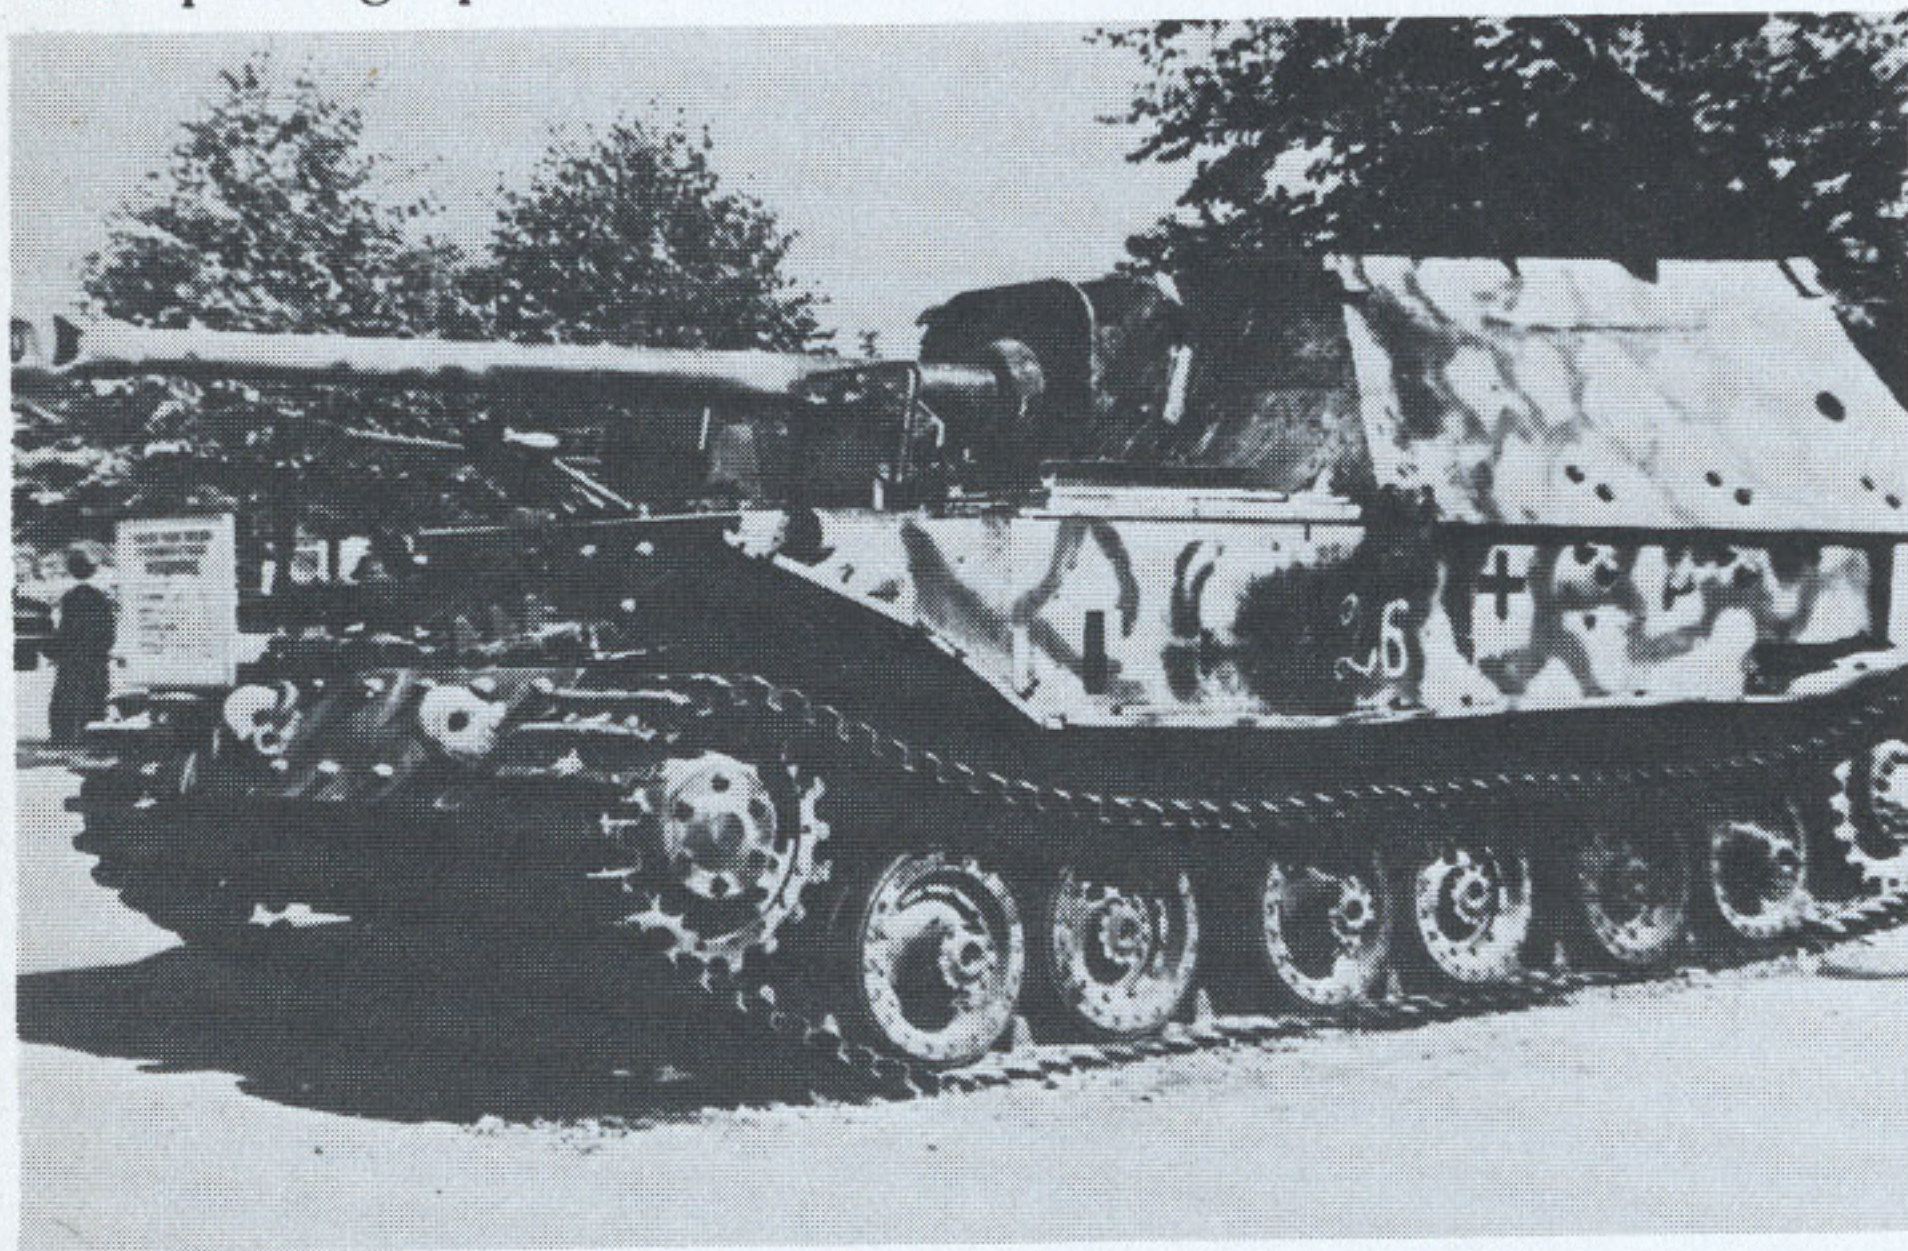
Another Soviet photograph of captured Elefant No. 624 (the numbers are very faint on the fighting compartment side) on display. The finish is very similar to No. 501 above. The large black patch is the flash made by an impacting armour piercing round which disabled 624. The numerals, 26, were most likely put there by the Soviets.

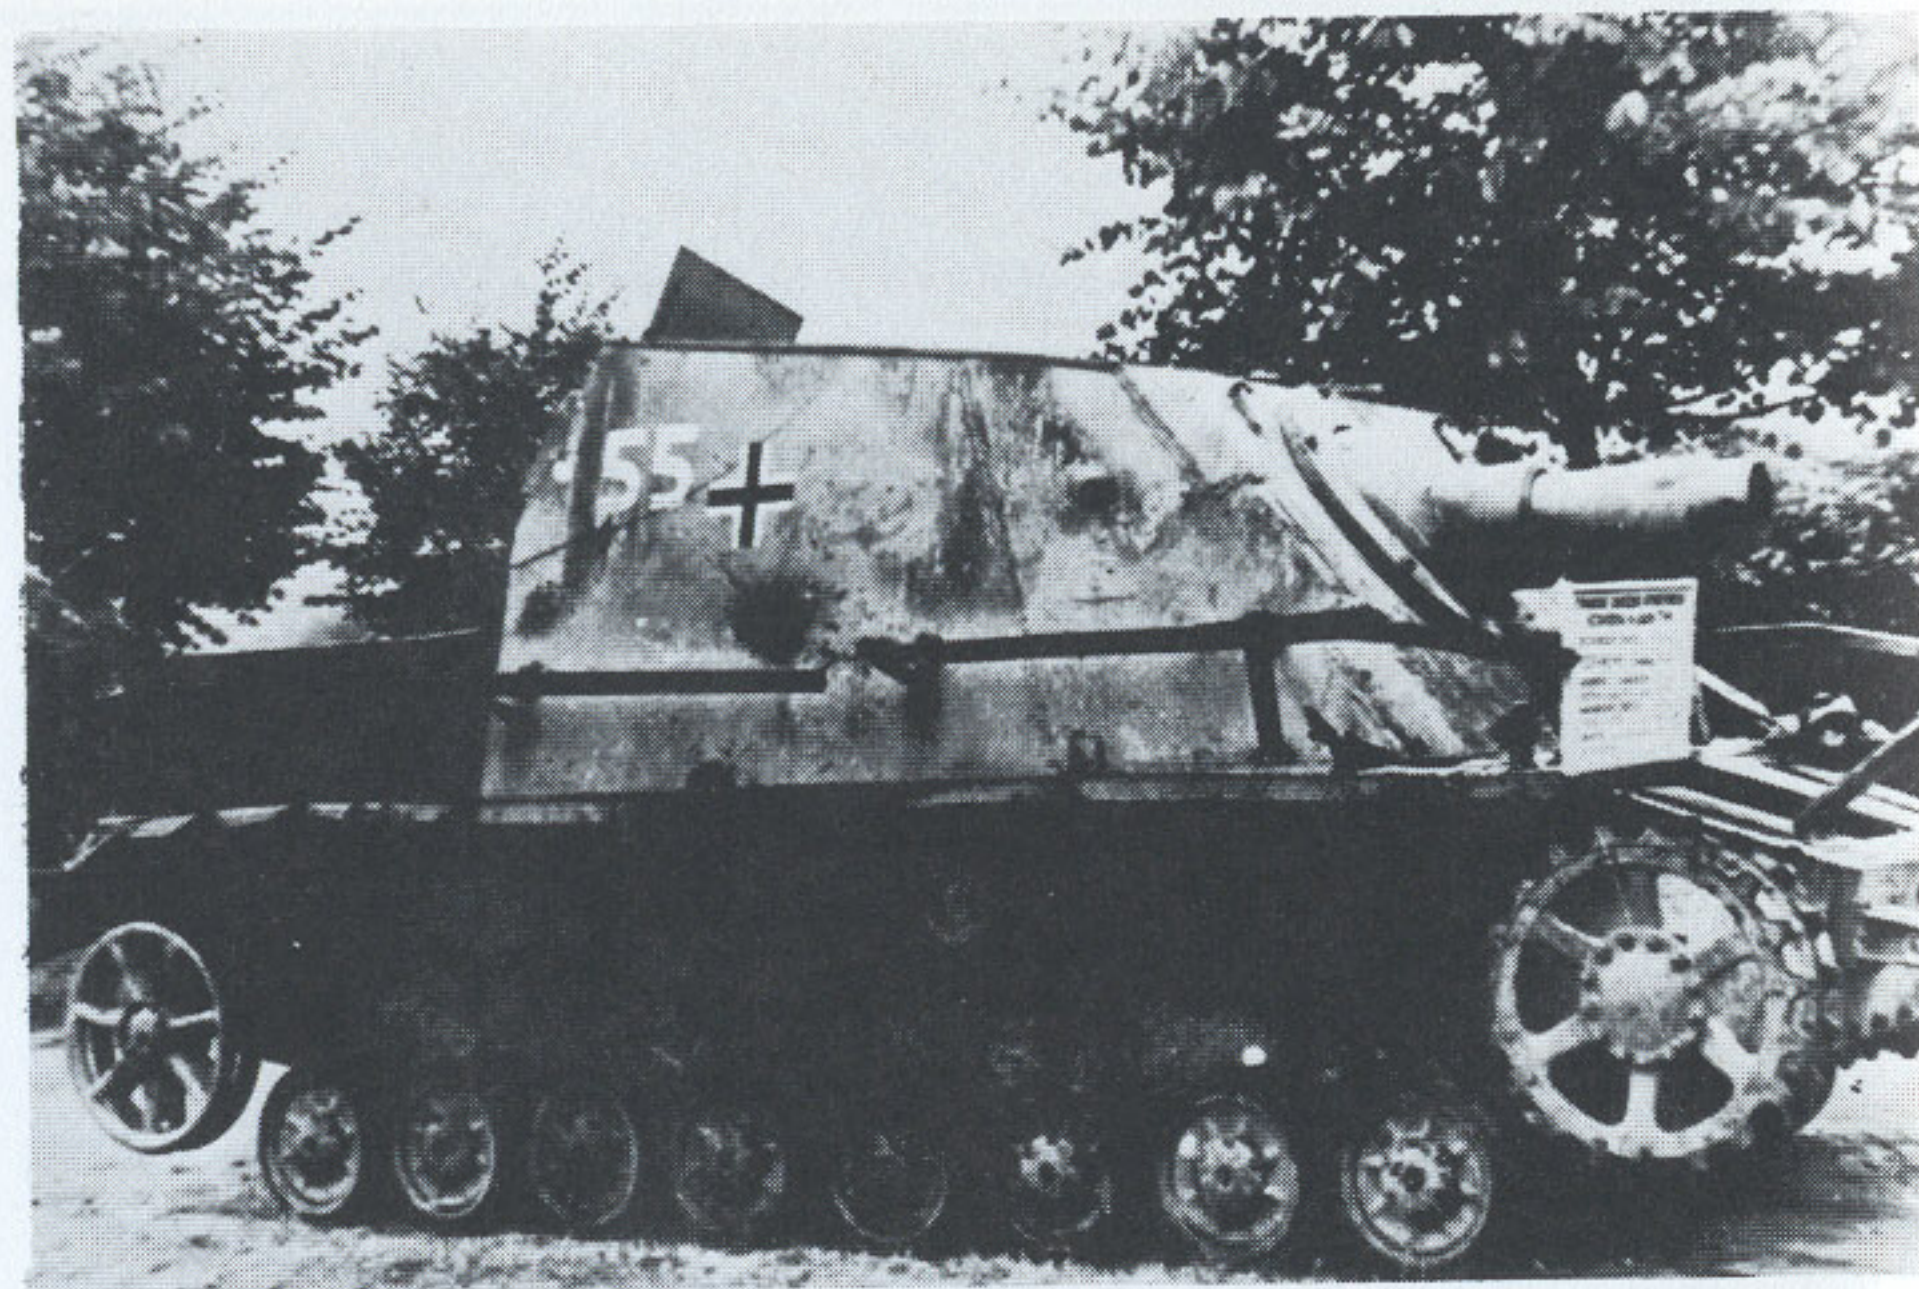
From the same display as the captured Elefants, is this Russian photograph of a badly mauled 'Brumbär'. This 'grizzly' could have been sand overall; notice its freshly painted markings, a neat cross and very unusual type of number style. There could have been three numbers but this is not certain. Note the huge hole made by the Russian shell and the crack in the side plate caused most likely by the ammunition exploding.

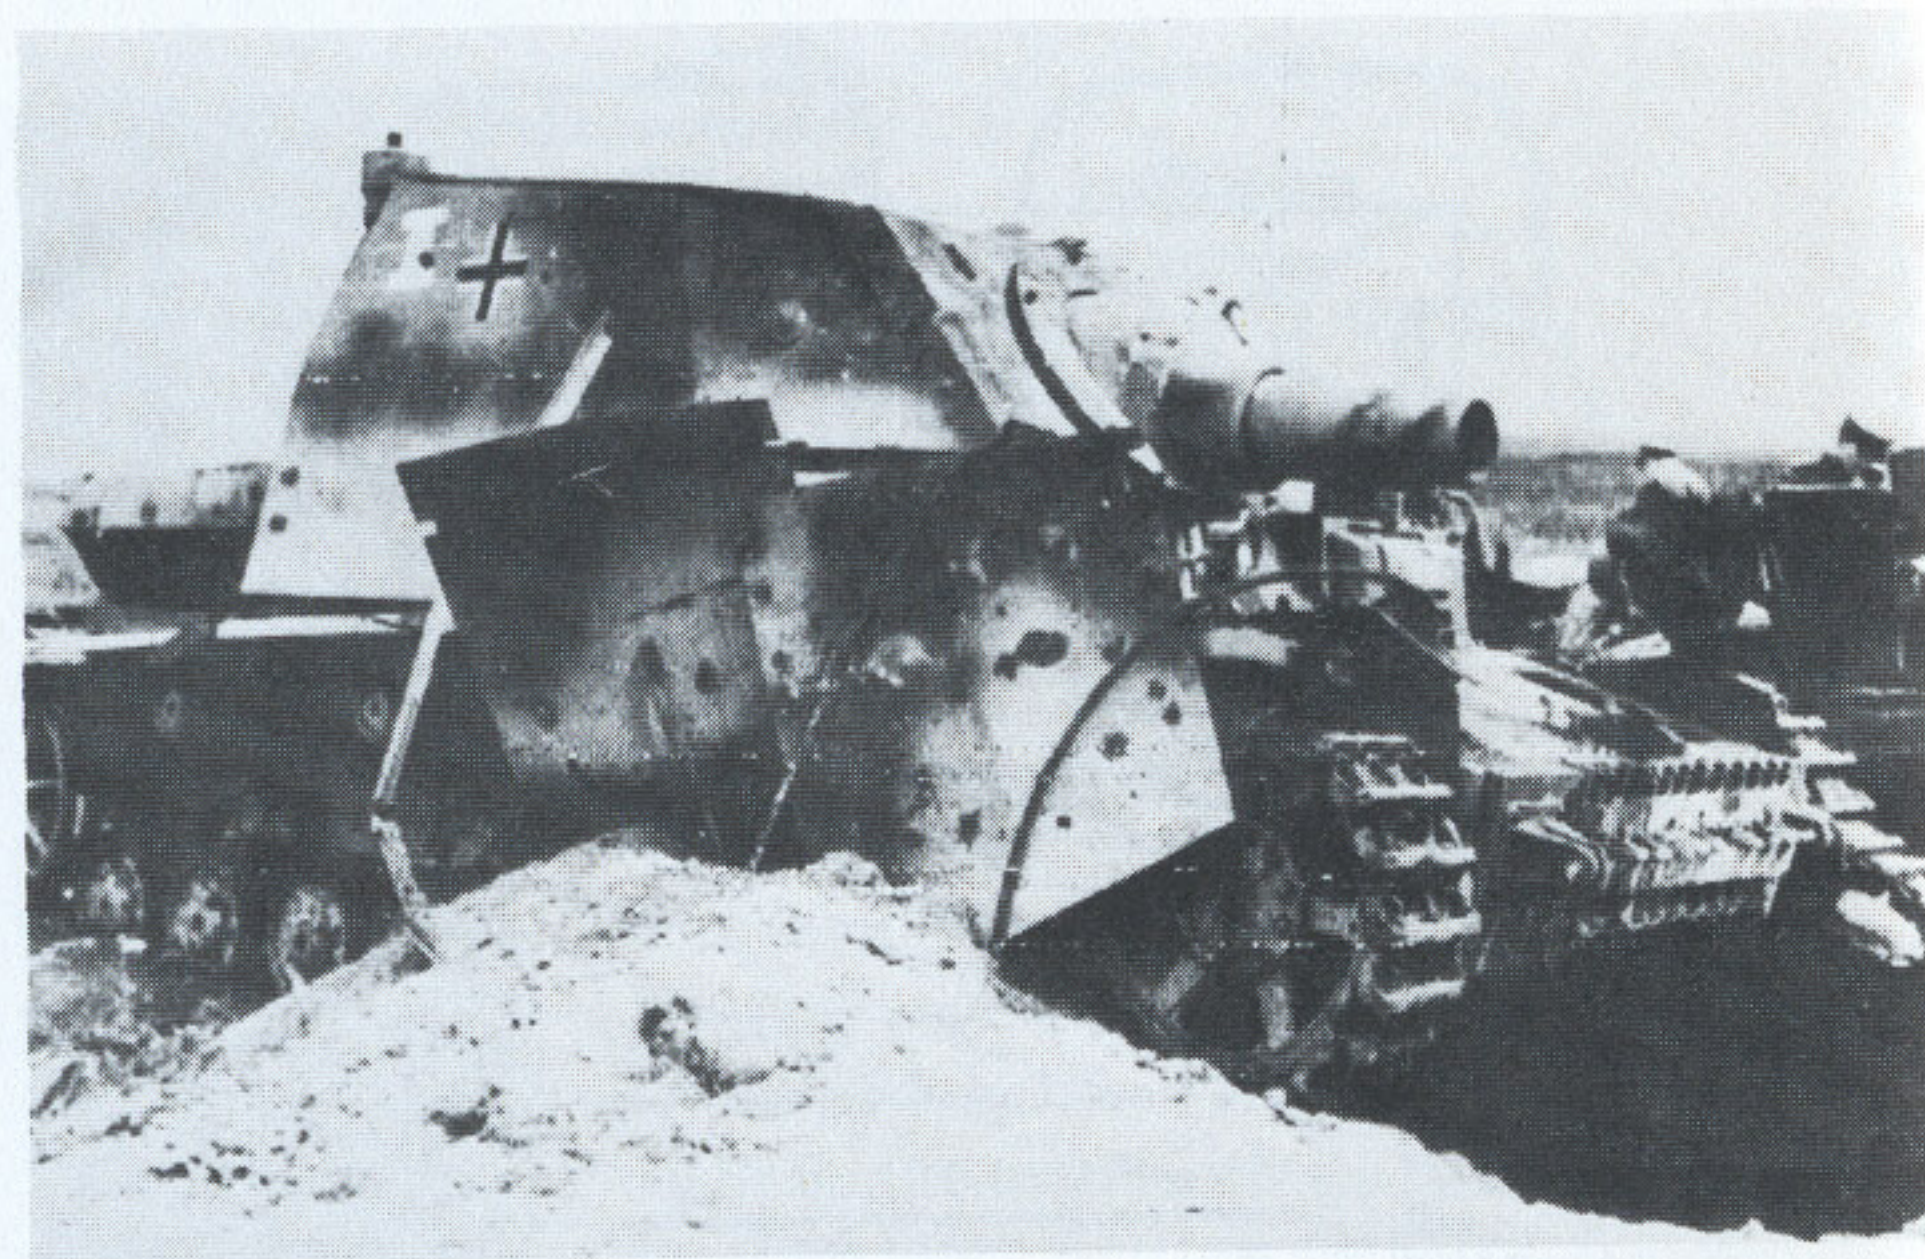
Another 'Brumbär' photographed by the Soviets shows the markings of a 2nd Battalion vehicle, though to which unit this 'grizzly' belonged is uncertain. From this photograph alone it is difficult to determine the finish, though as on the 'grizzly' in the photo above, no zimmerit is visible. The battalion sign appears red outlined white.

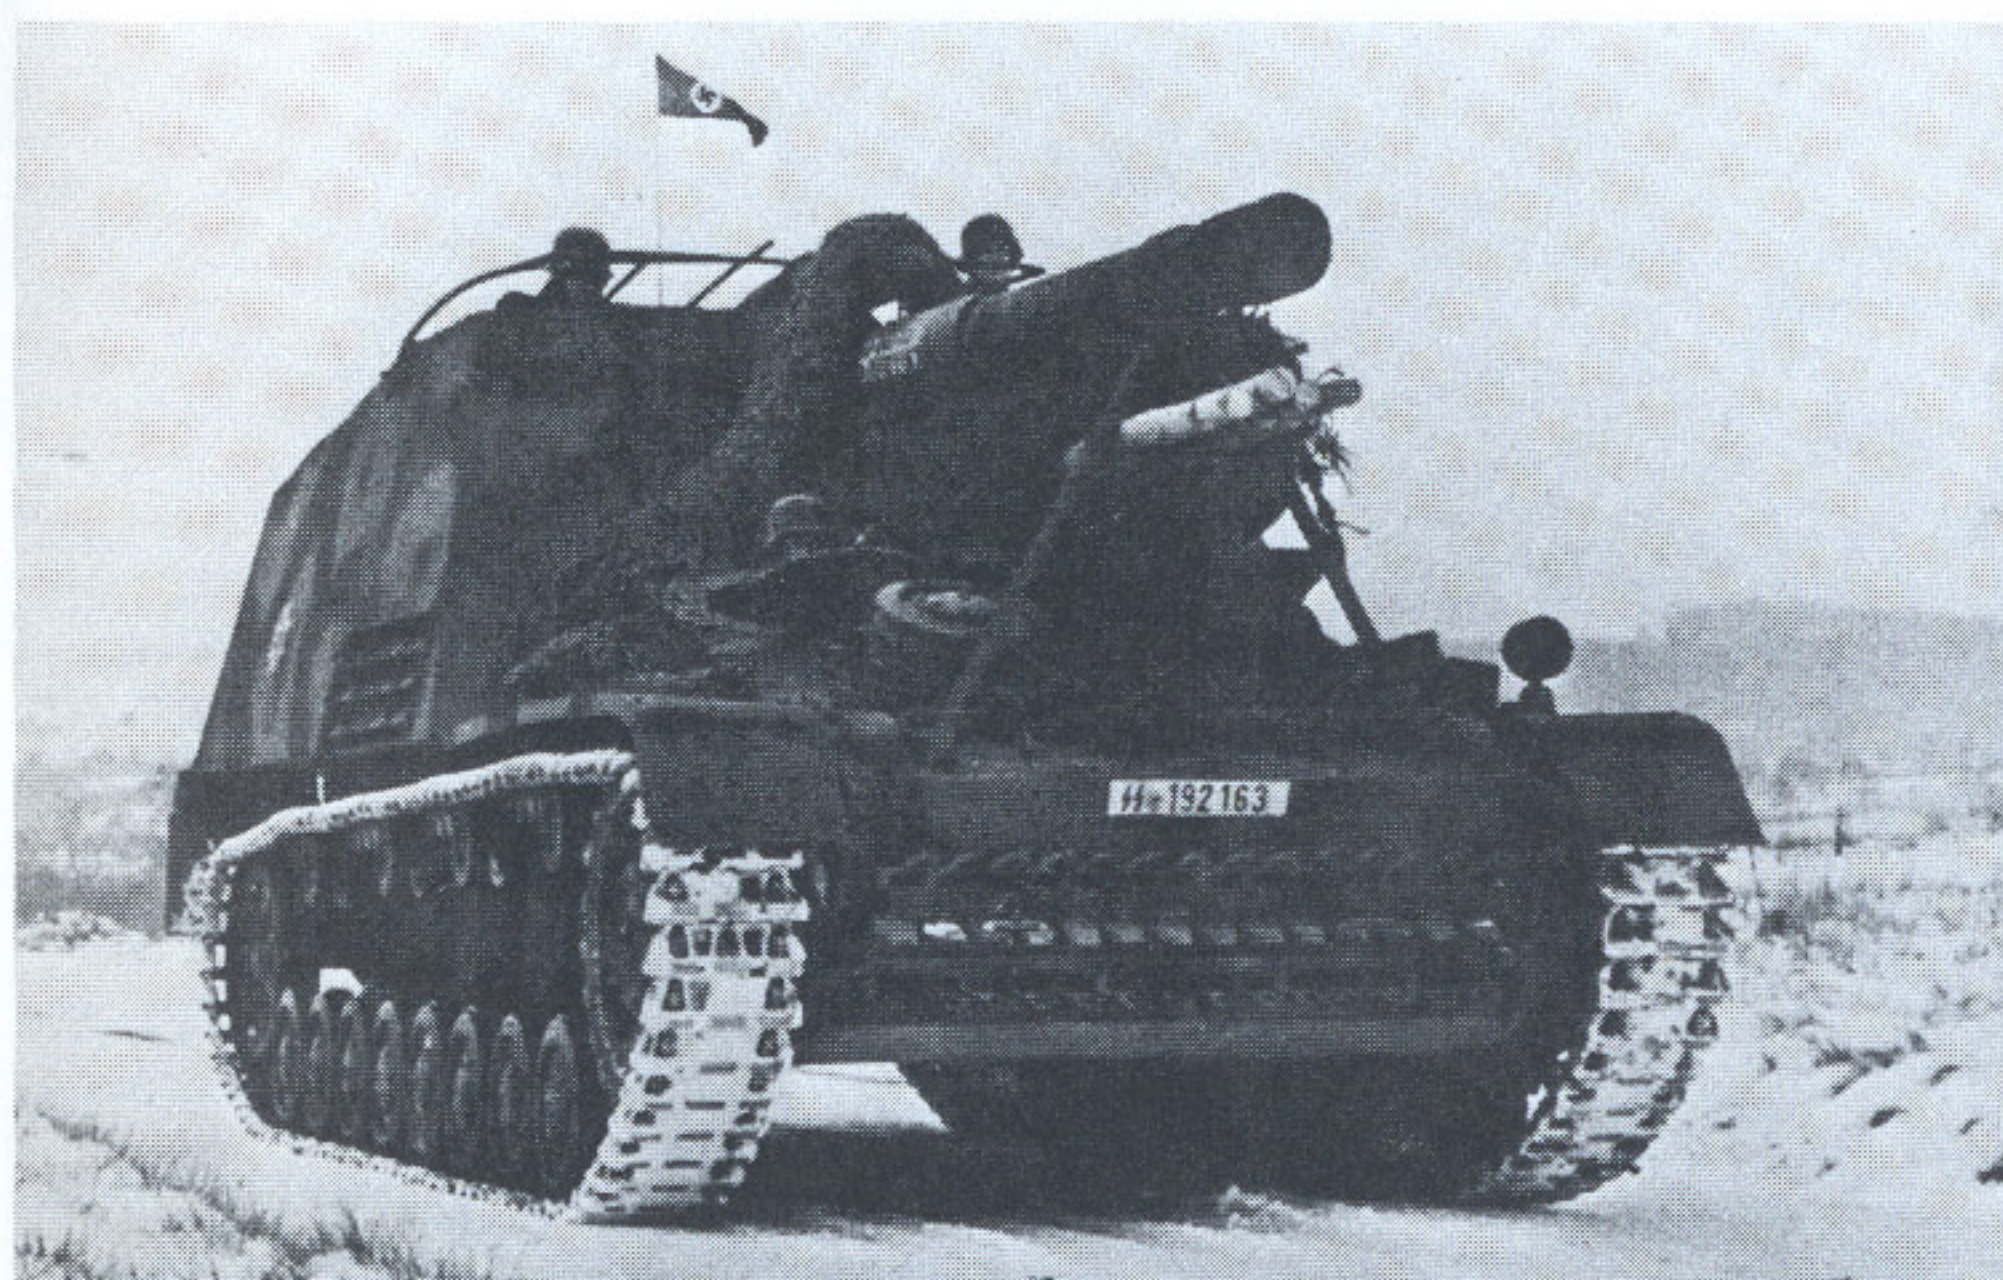
LEFT: These two photographs show a nicely finished 'Hummel' of the SS. The upper photograph shows a dark grey finish with random green stripes neatly applied. A small pennant on the radio aerial. Notice the red and white poles for lining up 'shoots' mounted on the hull rear. The lower photograph shows the unusual addition of a number plate on an AFV, even the Feldpost stamp is visible over the hyphen. The vehicle has been named 'Scharnhorst' and this is painted onto the gun barrel. The overall wire cage on top is unusual.

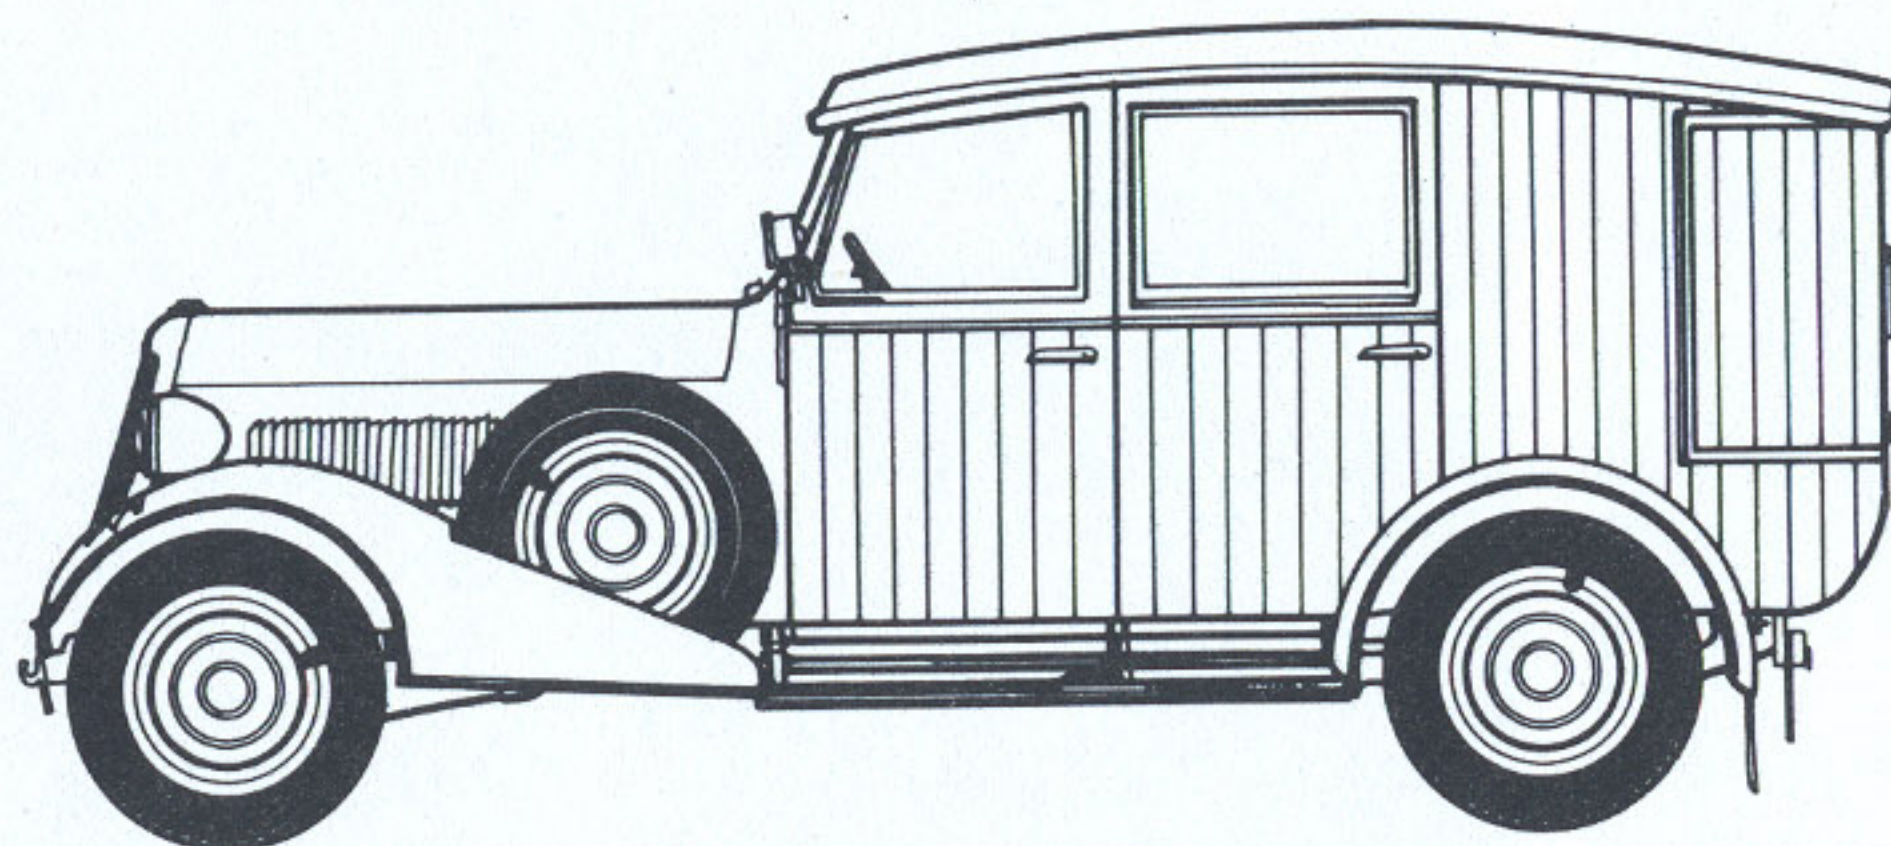
Kfz 17 Horch light radio car (*Kleinfunkwagen*) of Von Kleists 1st Panzergruppe, Army Group South. The tactical sign is for a signal battalion. Vehicle was overall grey with white markings.

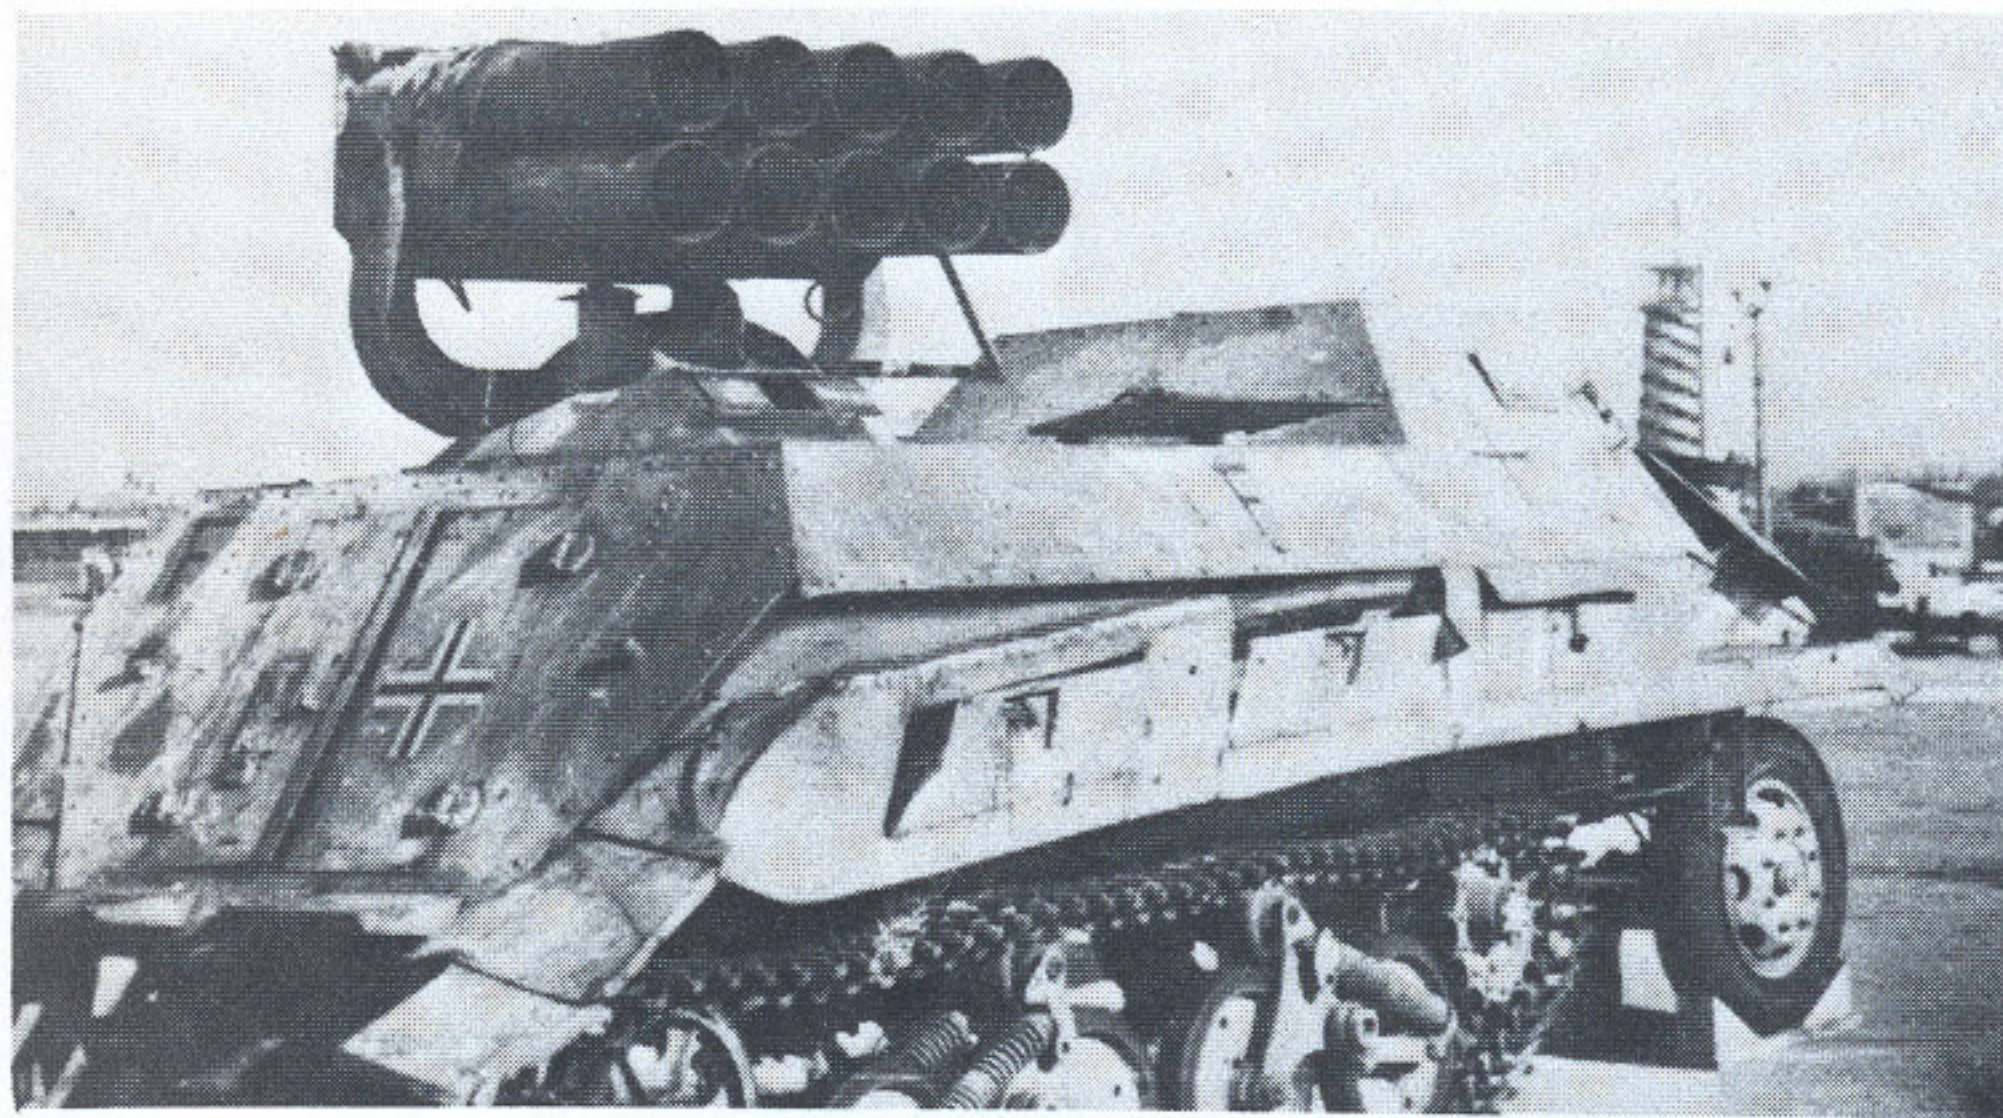
A 15 cm NbW 42 auf 2 ton 'Maultier' on display in Russia. This vehicle has a coat of whitewash over its sand base colour, note how the 'F' battery letter – also on the sideplate – was masked off when the whitewash was applied. Just visible below this is the tactical sign for a fully tracked NbW unit. The 'thin' type cross marking is neatly applied and appears to have been painted around with whitewash.

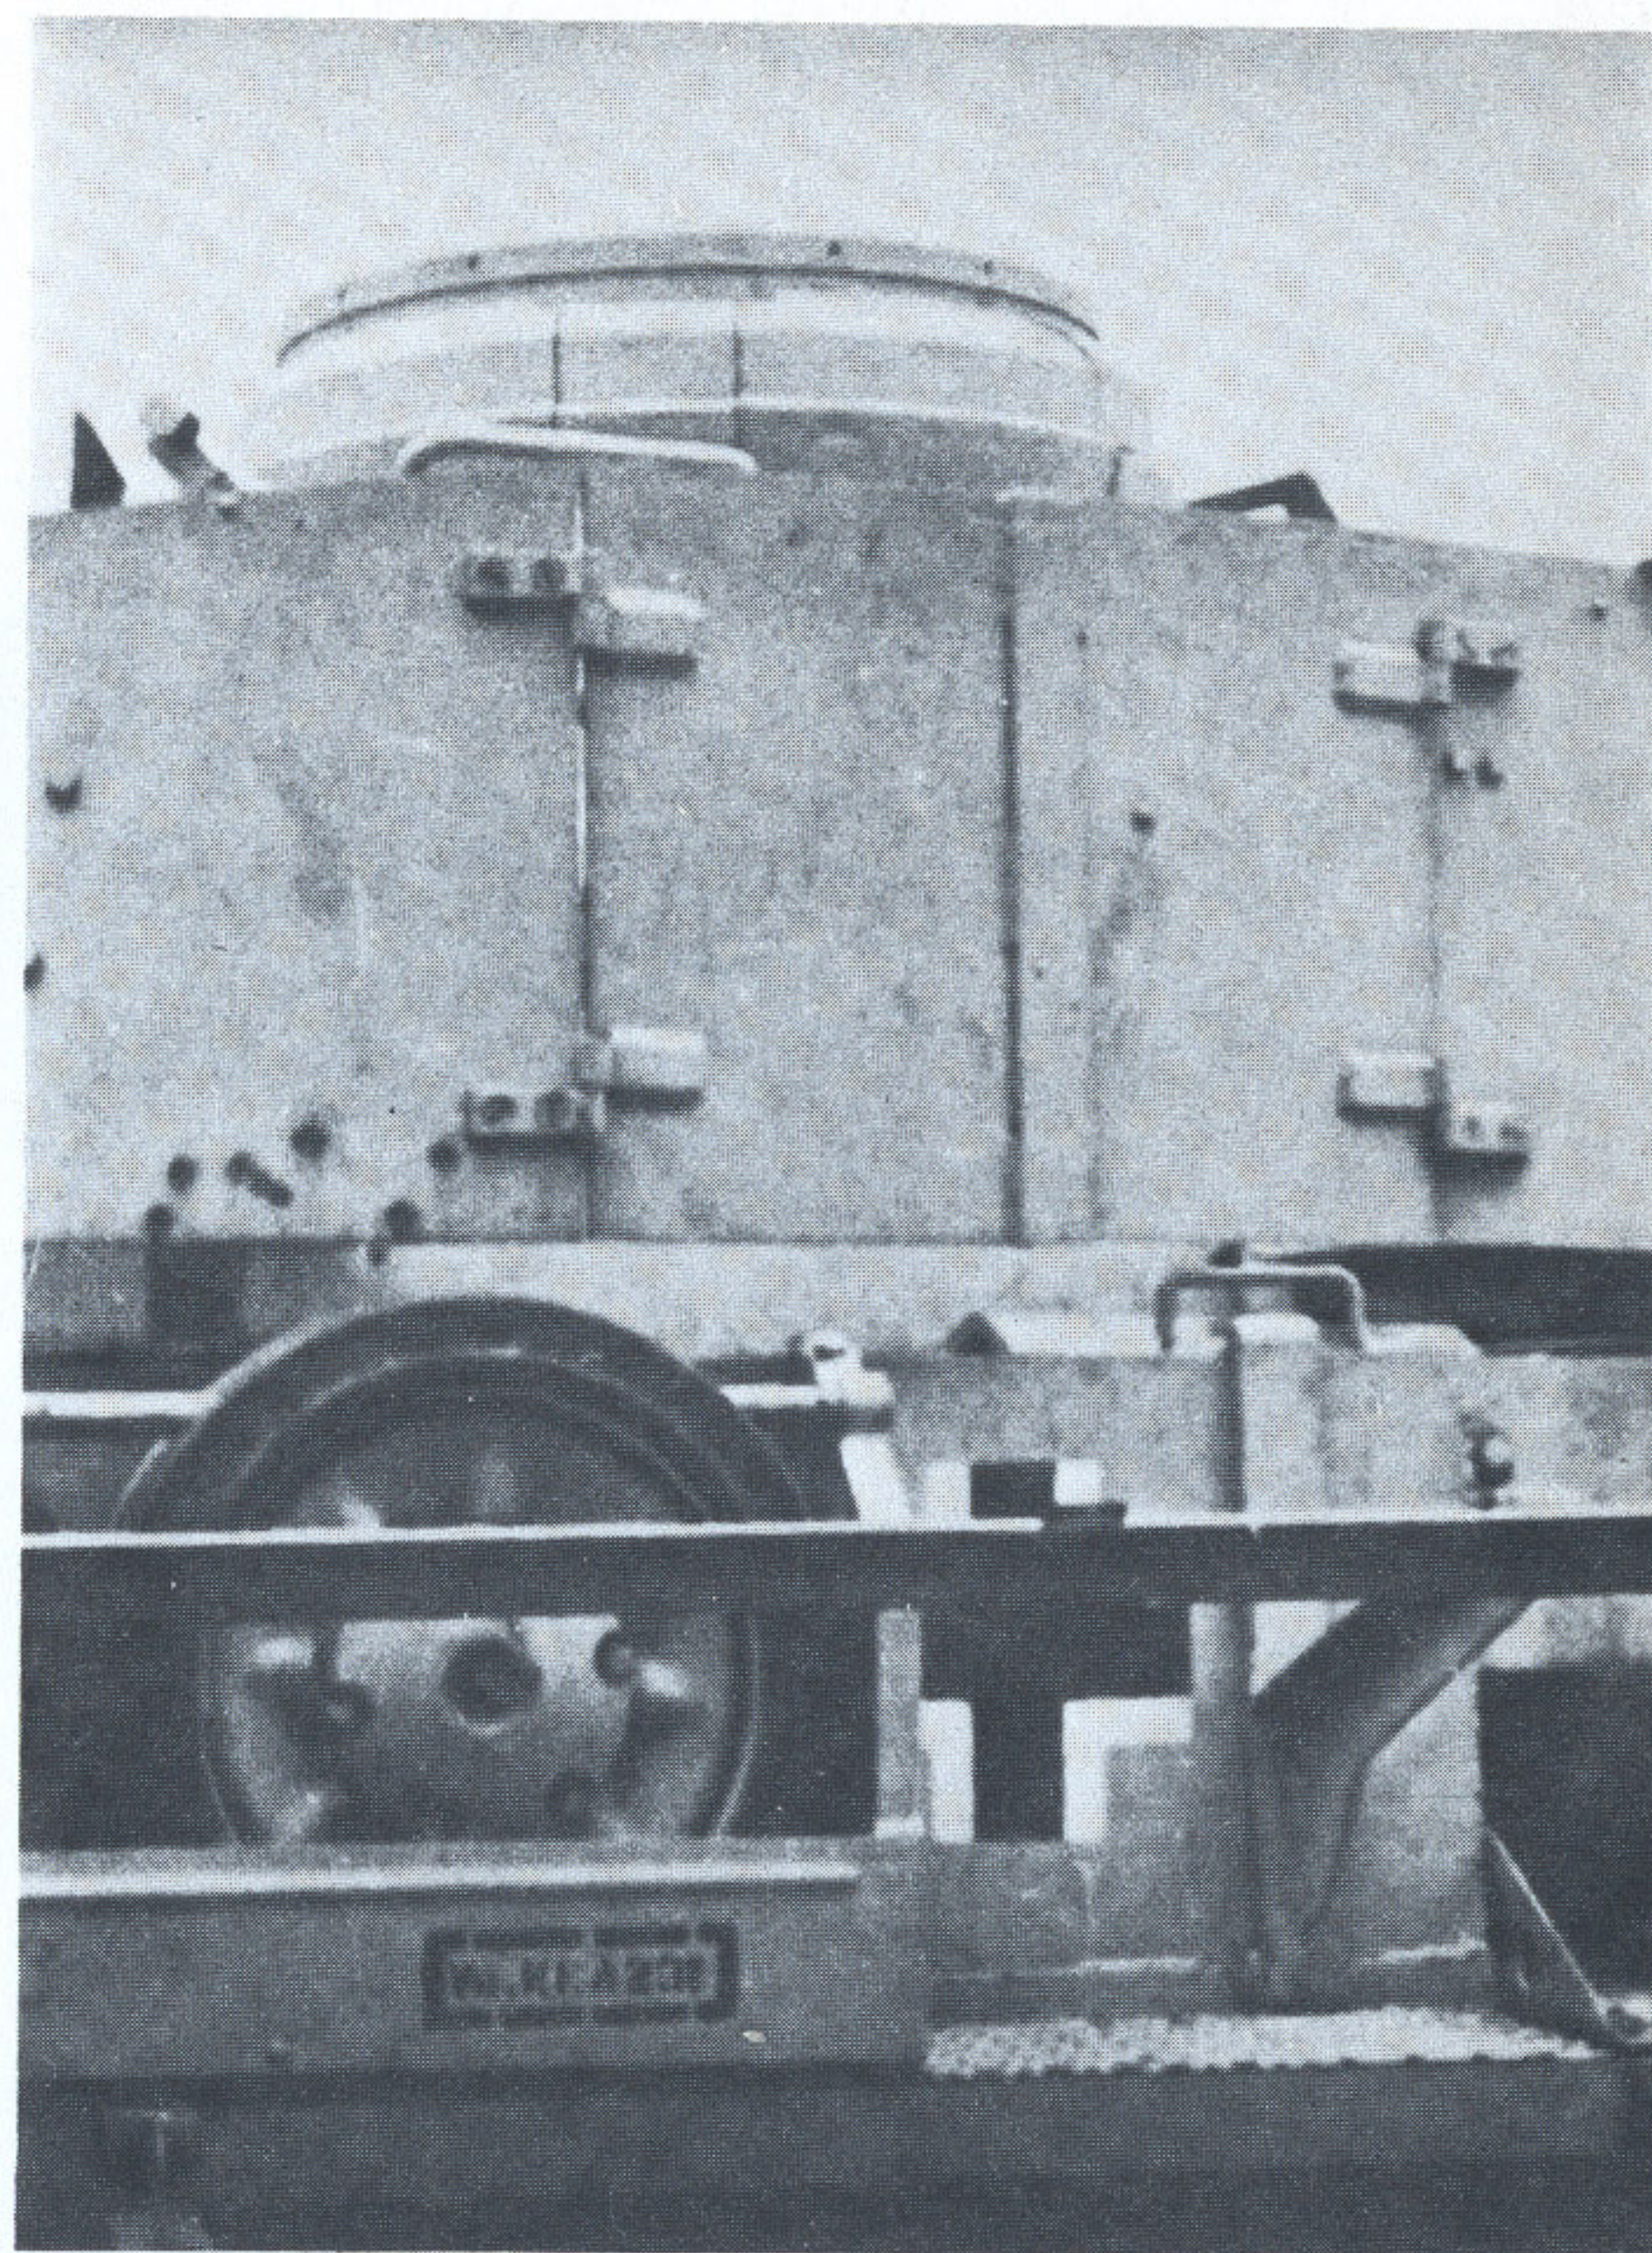
A close-up of a data panel on the side of a PzKw IV. This version shown was applied by stencil and gives information of the vehicle class for shipping and shows a weight of 23 tons (metric). Shipping data panels are usually more complex than the abbreviated example shown, giving type of vehicle, weight, shipping class and the like. Note the neatly applied cross on this sand finished panzer.
