No.3 GERMAN

EASTERN FRONT

FOCUS ON
ARMOUR
CAMOUFLAGE
& MARKINGS

Kenneth M Jones

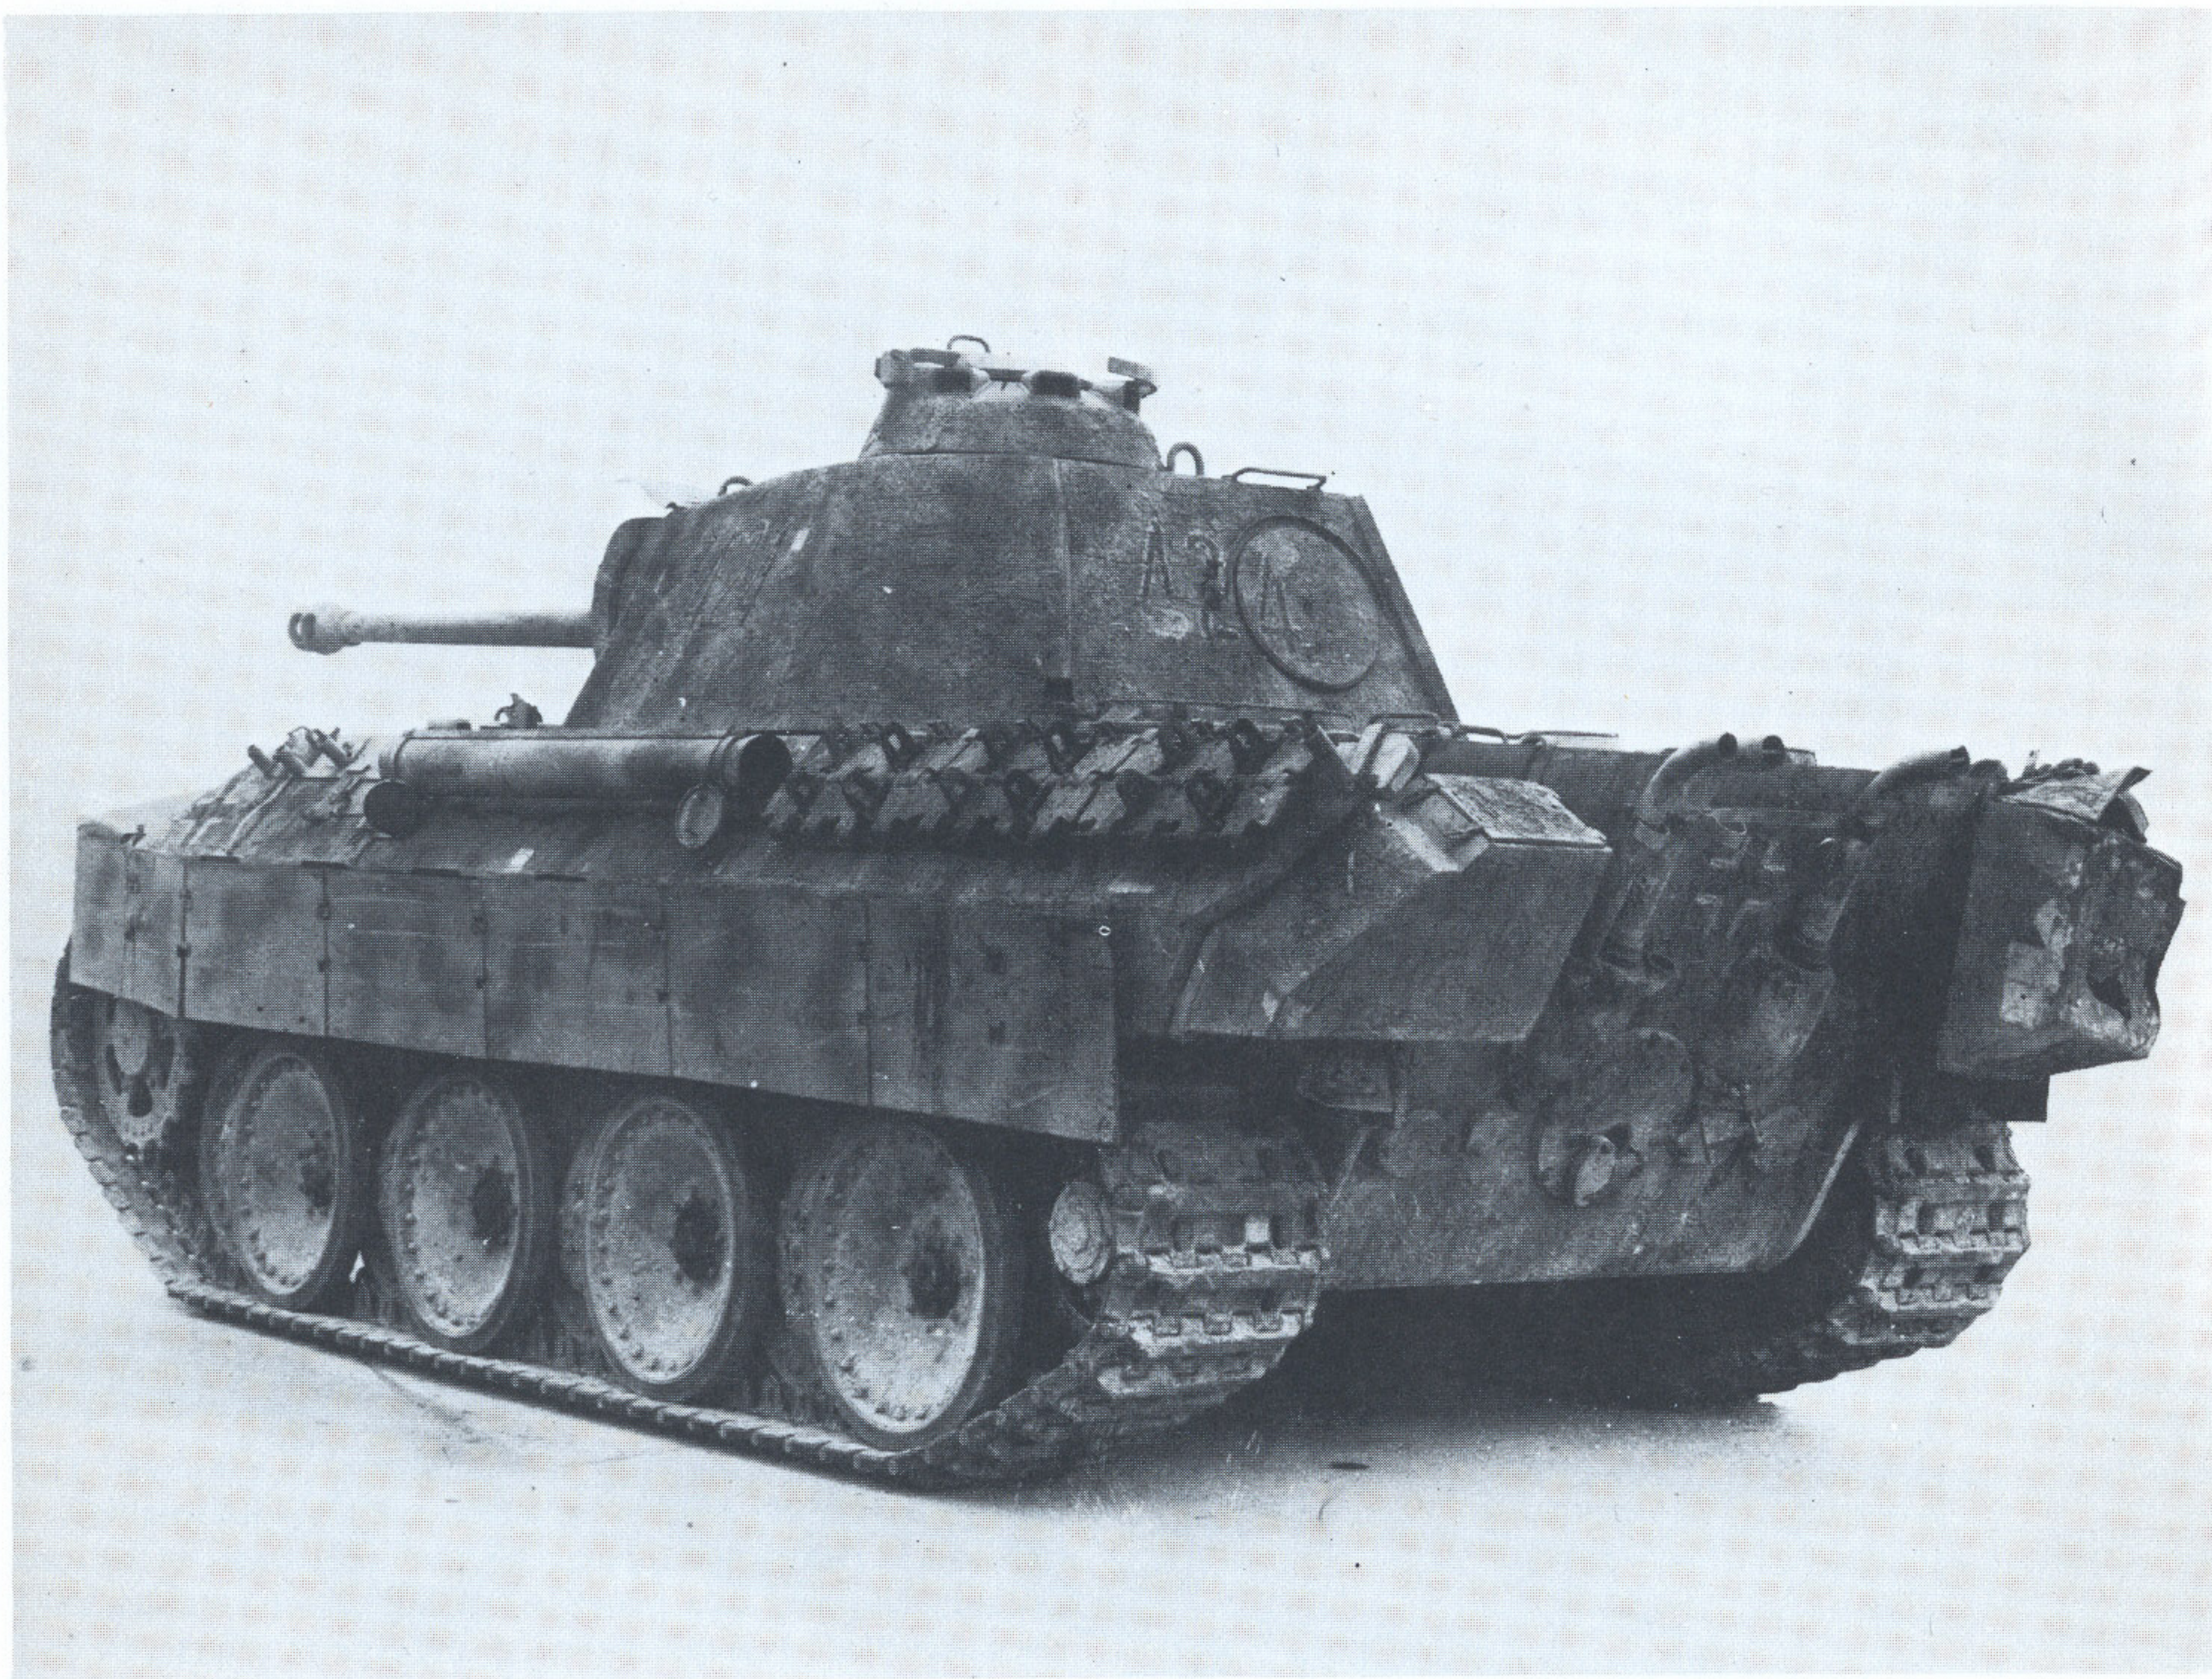
This Panther Ausf G has had an overall coat of zimmerit applied (even its cupola has been coated) which has been cross-hatched free hand. The Tactical numbers, 424, on the turret are black, outlined white, and have been painted over the zimmerit. A cross has been painted well forward – to clear hull side stores – on the sideplate and repeated on the rear plate between the exhaust stacks, of which the left cluster has a pipe missing. This Panther is in good condition, save for the battered right-hand stowage bin – its roadwheel tyres are hardly worn. Note the scratches on the sideplates and their 'attitude' when mounted on the vehicle's side.
