Panzer Colors

Camouflage of the German
Panzer Forces 1939-45

by Bruce Culver & Bill Murphy
illustrated by Don Greer

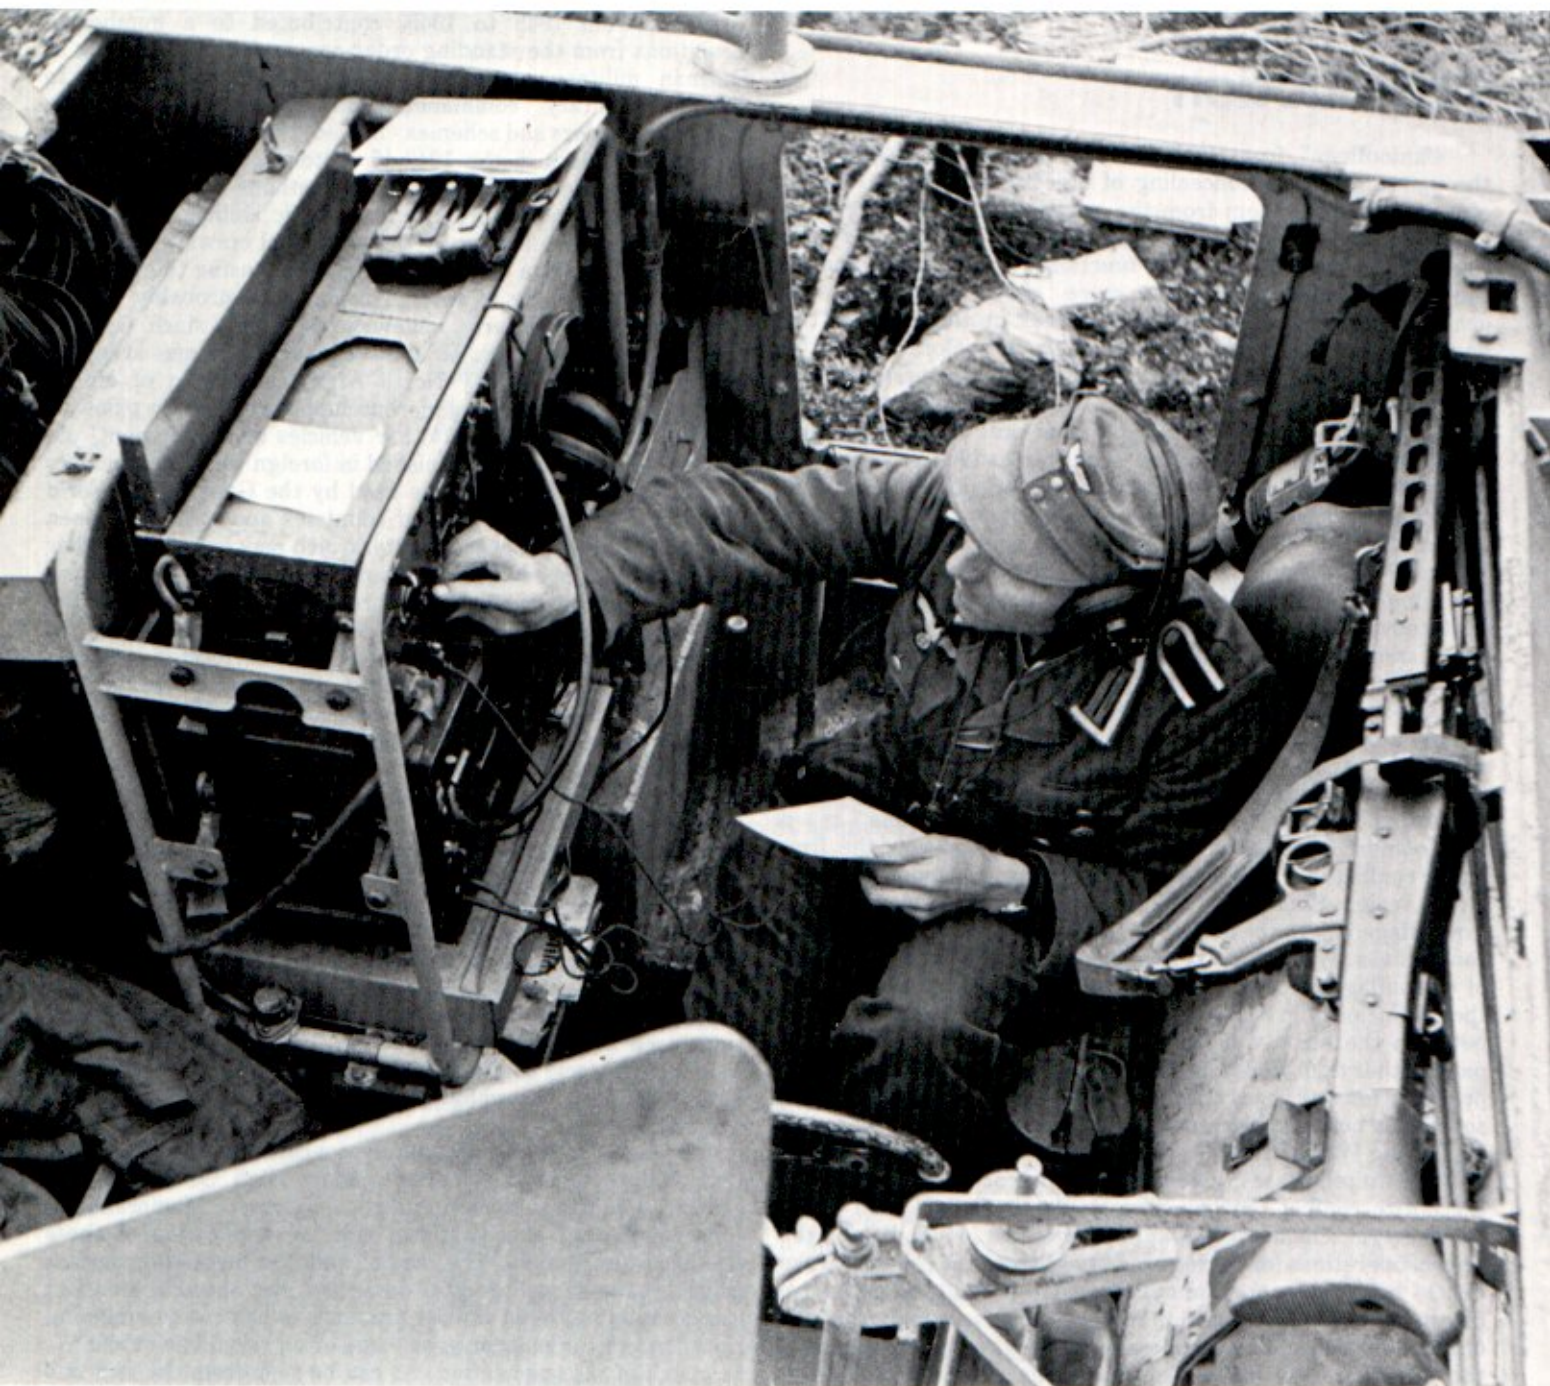
This late production SdKfz 250/3 radio halftrack shows the use of the dark yellow exterior color as the basic interior color. Most of the interior details and brackets are also painted in the base color. Stencilled labels are black. The radio sets and support racks are painted field gray and black. [Bundesarchiv]

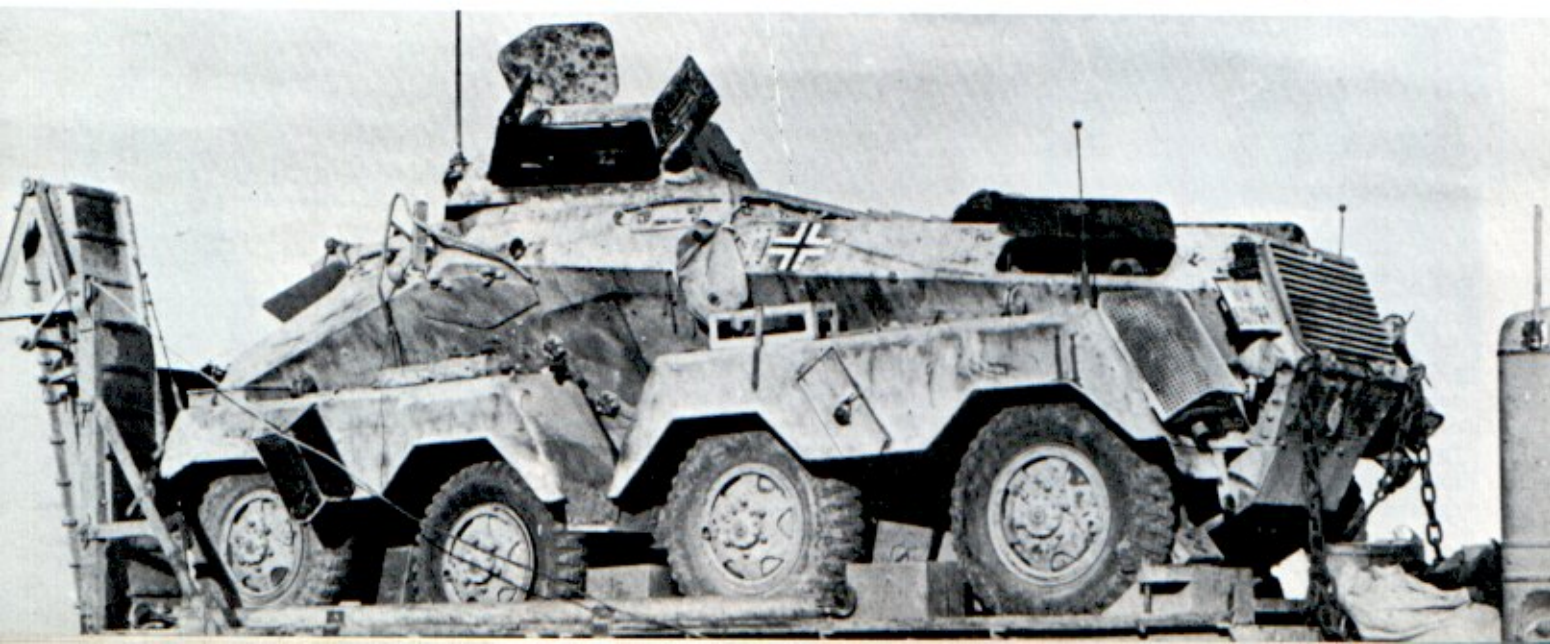
This captured SdKfz 231 [8 rad] armored car, although damaged by an internal fire, shows a badly deteriorated coat of camouflage paint. Note the stains from oil and grease, and the chalky appearance of the paint coating.

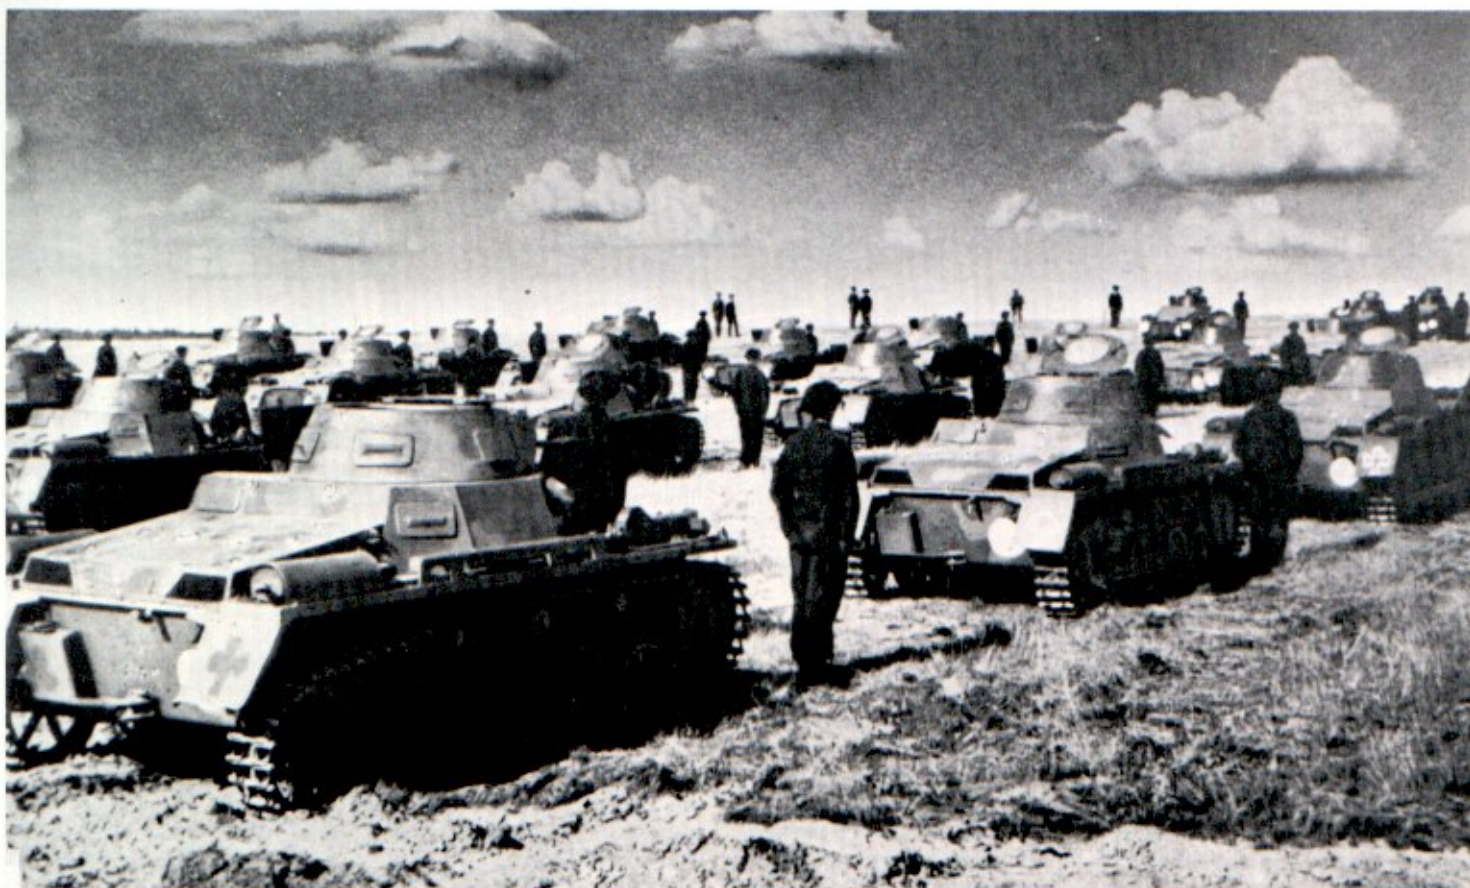
These PzKpfw I ausf A's seen during training exercises in 1934 display the Reichswehr color scheme of gray, green and brown. Note the use of playing card symbols and circles.

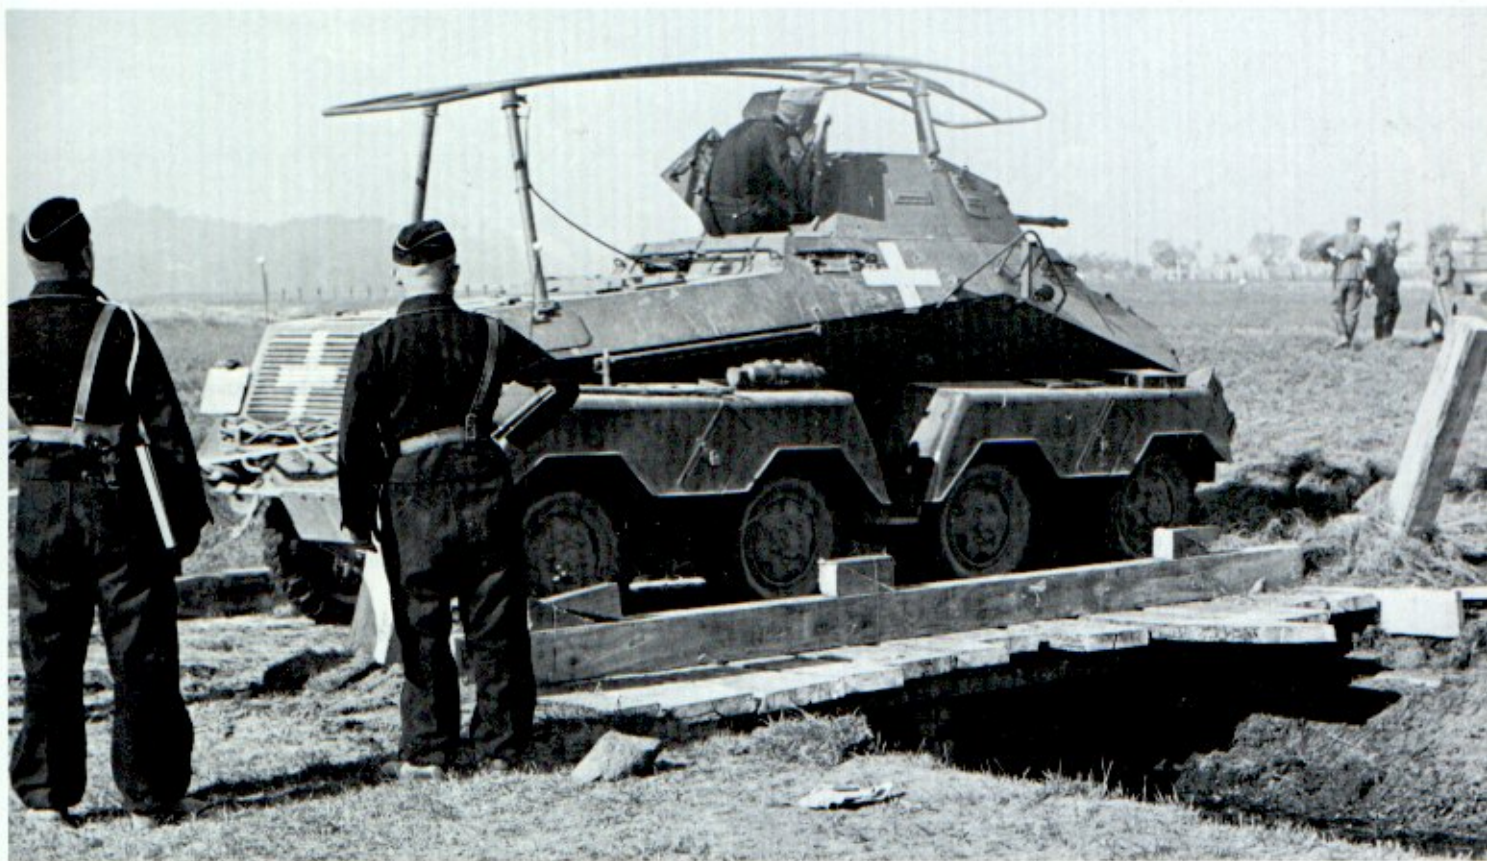
A SdKfz 232 [8 rad] radio armored car crosses a wooden bridge in Poland, 1939. Dust is noticeable on the upper surfaces. The large white crosses were the standard type of national marking during this period. The interiors of the open hatches are dark gray. [Bundesarchiv]

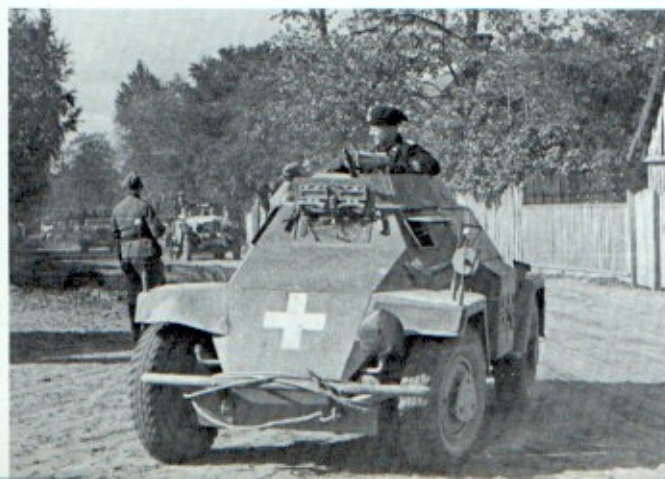
This SdKfz 221 armored car passing through a Polish village shows the effects of a light coat of dust over the dark gray paint. Note the driver's glass windshield. [Bundesarchiv]

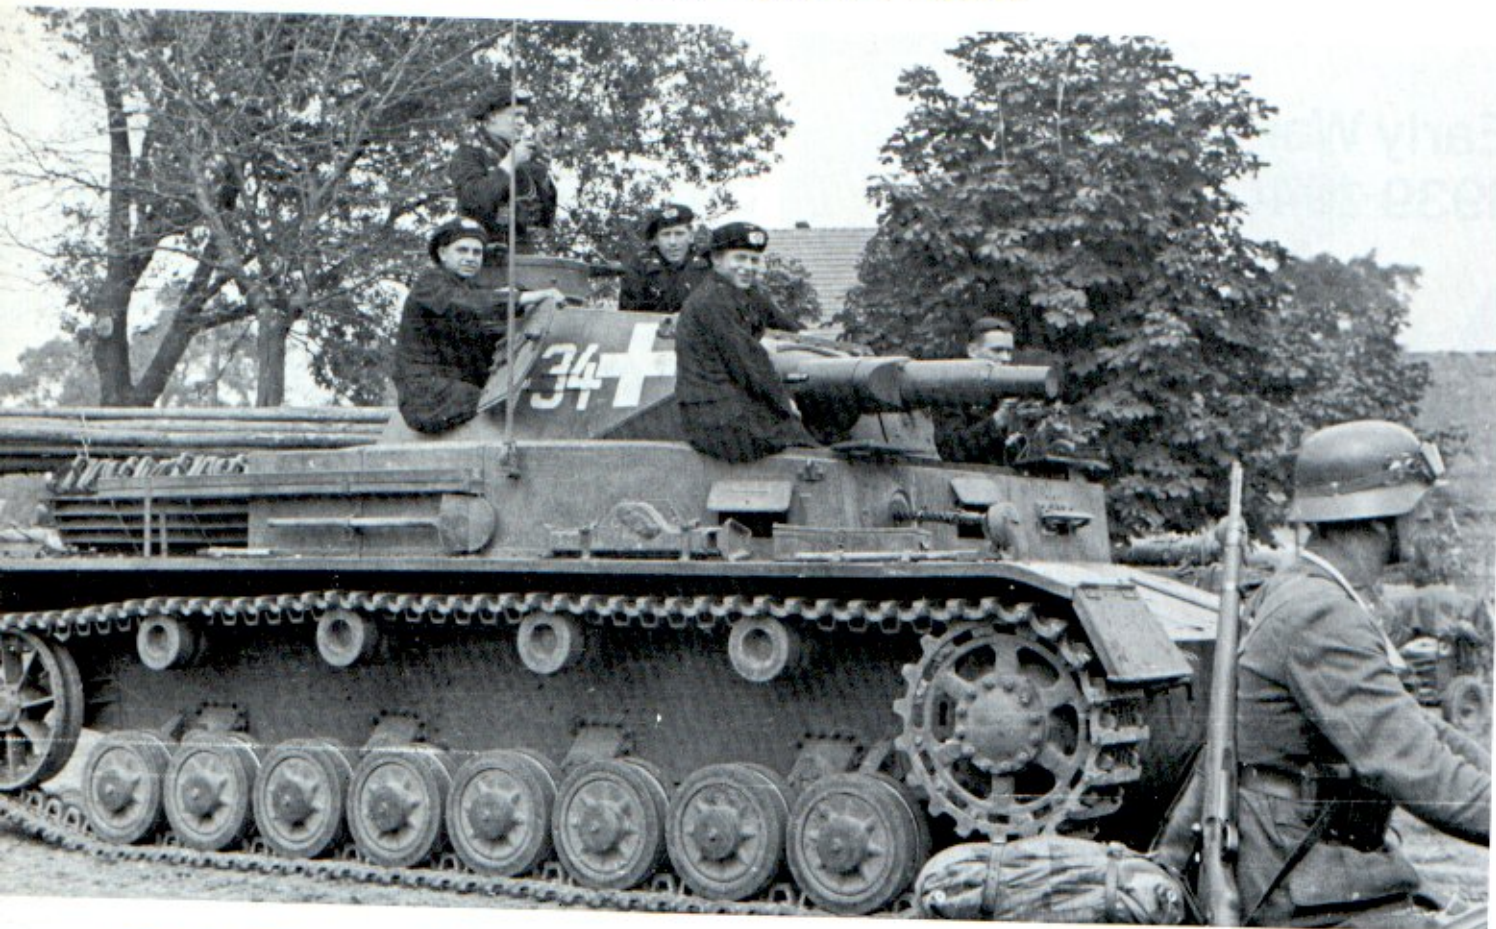
A PzKpfw IV ausf A, seen in Poland, displays the overall dark gray color scheme used by most German armored vehicles at this time. The turret numbers and solid cross are in white. Note the spare tracks above the antenna trough, and the saplings logs on the rear deck. [Bundesarchiv]

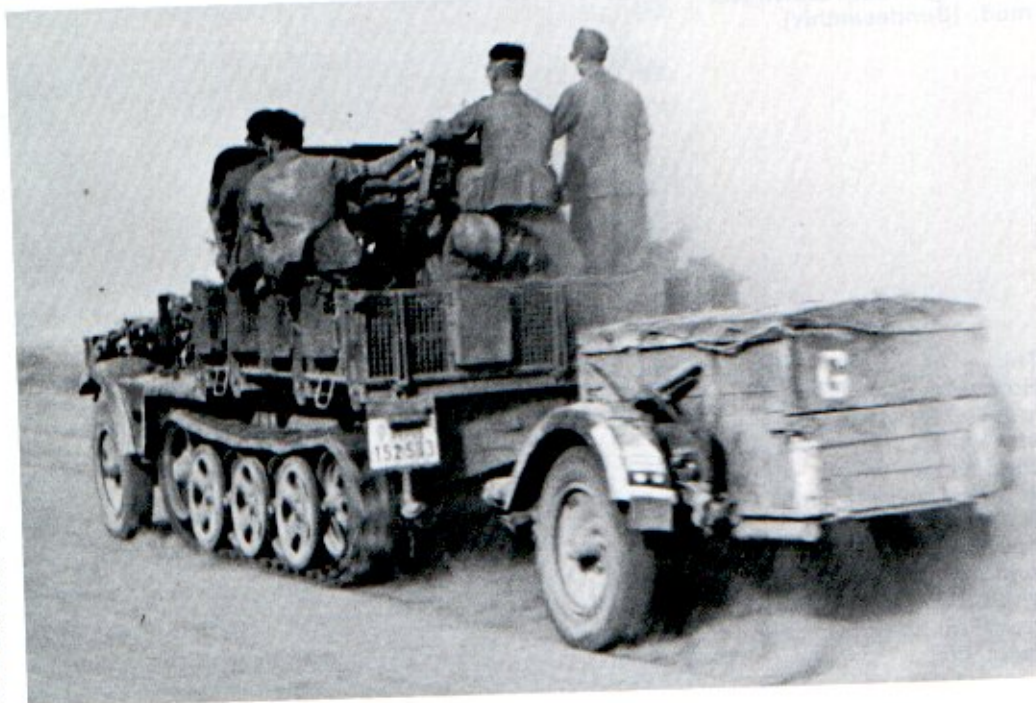
This SdKfz 10/5 halftrack during "Barbarossa", the invasion of Russia, is in an overall dark gray, with white edges on fenders for better visibility at night. The white "G" indicates the battle group commanded by Heinz Guderian. [Bundesarchiv]

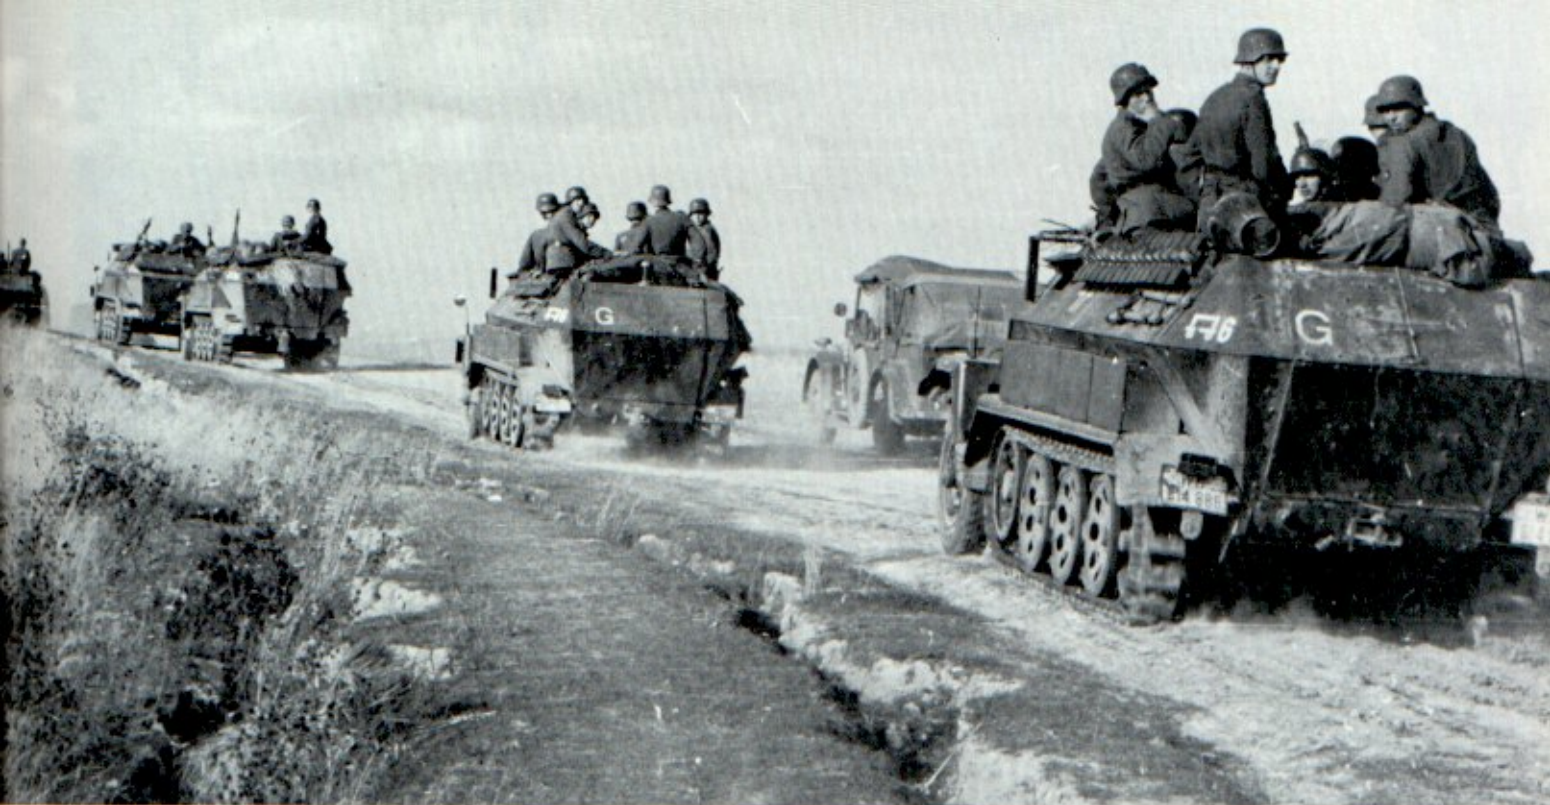
These SdKfz 251 Ausf C's of Guderian's force advance into Russia, 1941. The dark gray paint is covered with mud and dust directly behind the tracks. This shows the early stages of weathering by dust and mud. [Bundesarchiv]

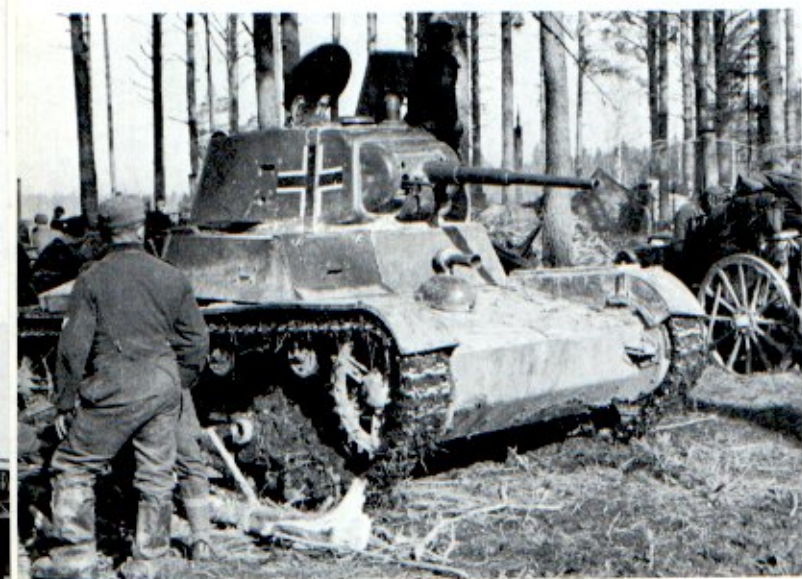
A Russian T-26 light tank captured by the Germans and later used by them. The vehicle has been repainted dark gray, and a large black and white cross is used to make identification easier - many gunners fire on a silhouette and captured equipment was usually marked with oversized insignia. [Bundesarchiv]

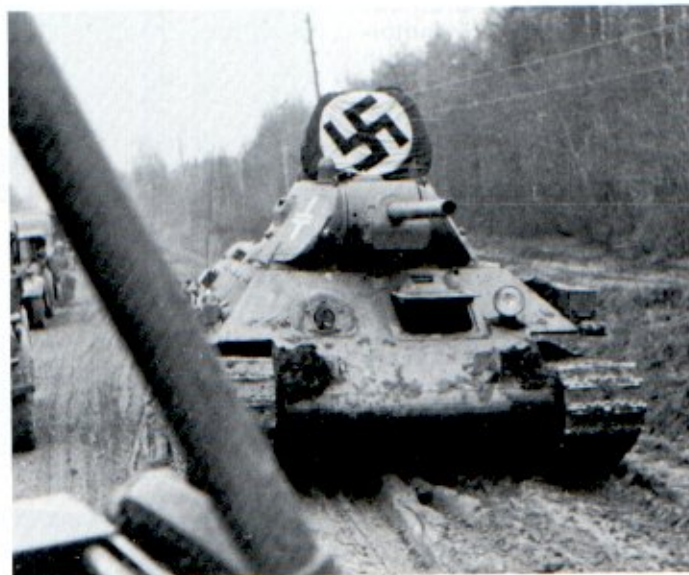
This T-34/76 has been painted dark gray and marked with fairly large white outline crosses. The German flag wrapped around the turret roof hatch is for proper identification by German pilots. This tank is quickly acquiring a heavy coat of mud in the fall rains. [Bundesarchiv]

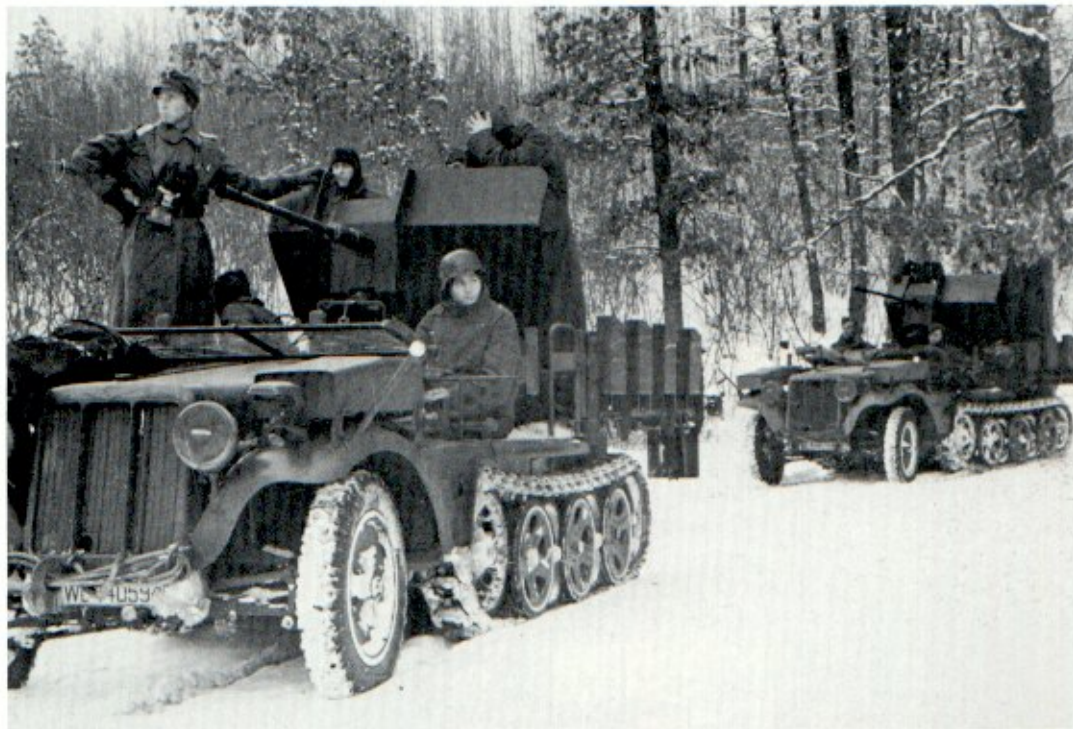
This SdKfz 7 8-ton tractor and 15 cm field gun again show the high contrast of the dark gray against snow. [Bundesarchiv]

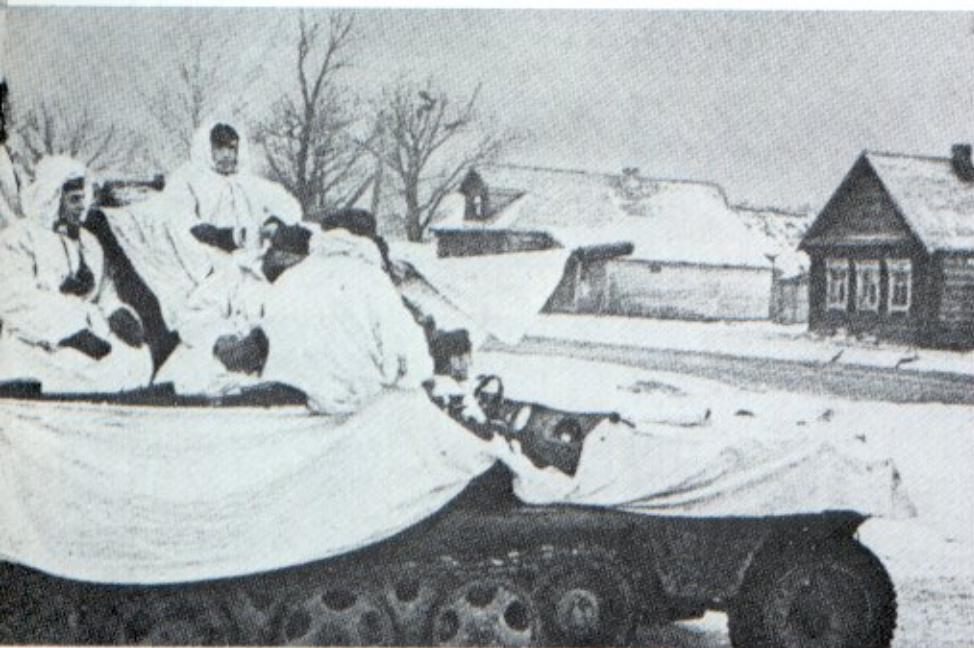
The crew of this SdKfz 10/4 was lucky enough to be issued white winter camouflage covers. Their vehicle, however, has been left with only bedsheets for white camouflage protection. In the first weeks of the 1941 snows, many vehicles did not get even this crude protection.

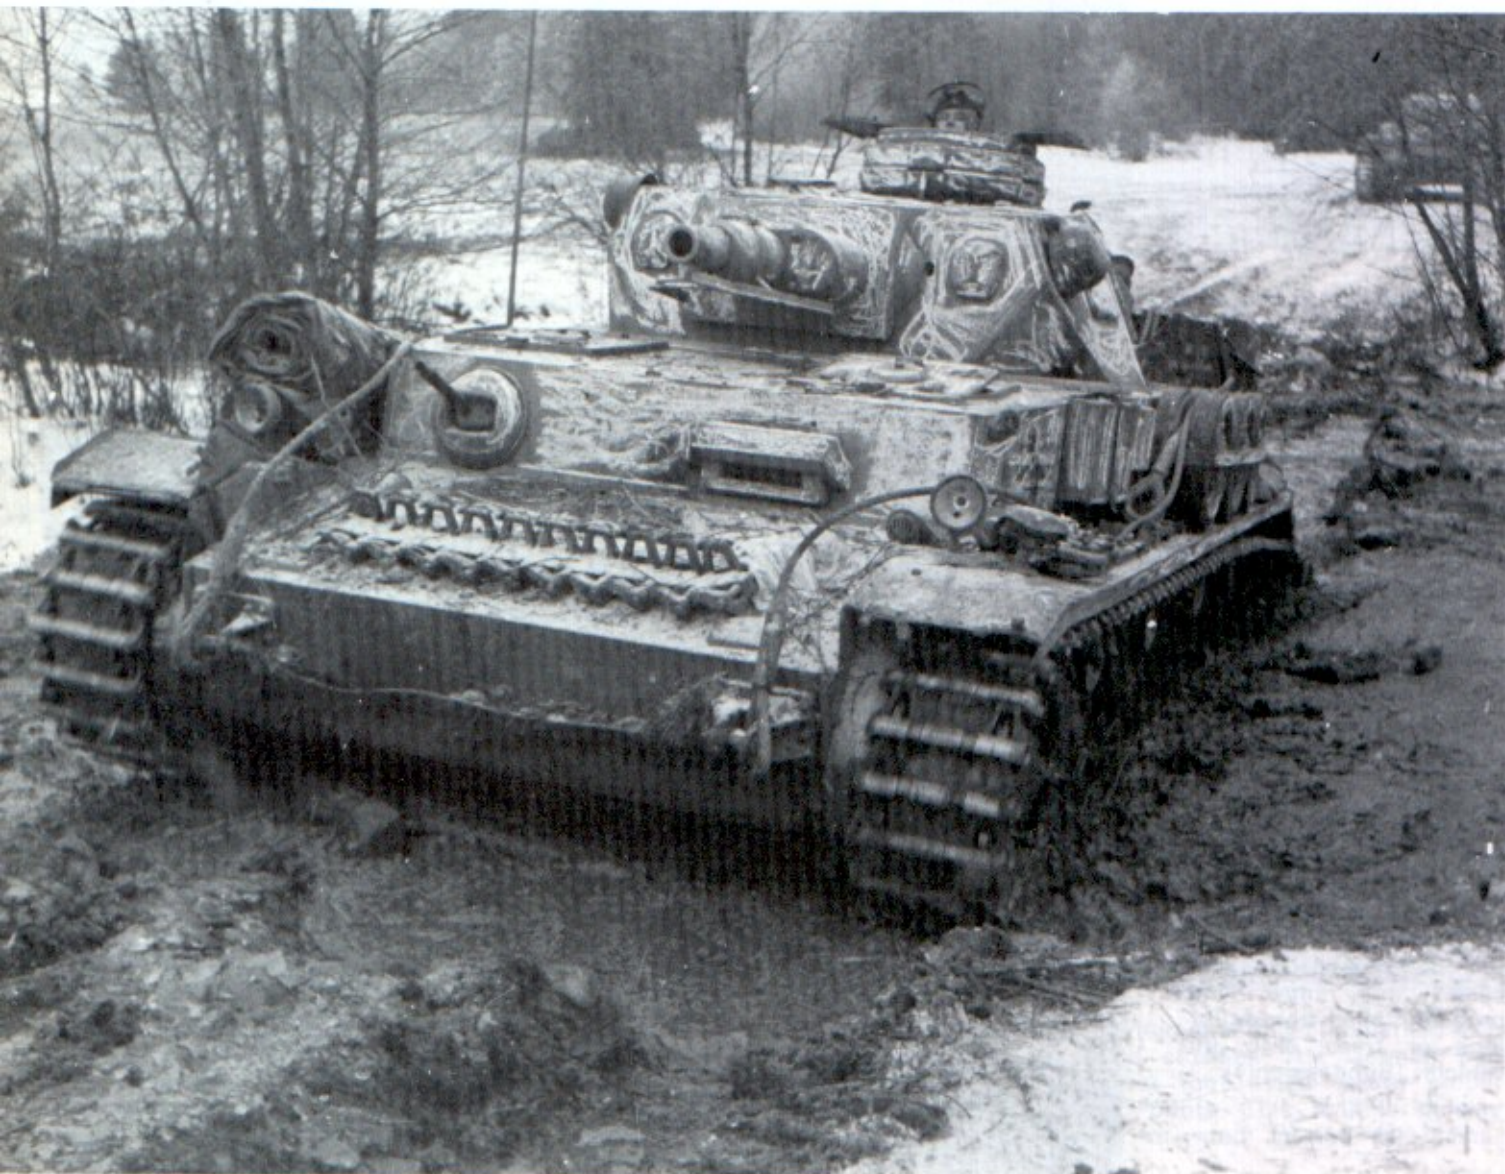
This PzKpfw IV ausf F1 shows perhaps best of all the last-ditch methods used to cover vehicles in the 1941 winter campaign. It is covered with scribbled lines in chalk! [Bundesarchiv]

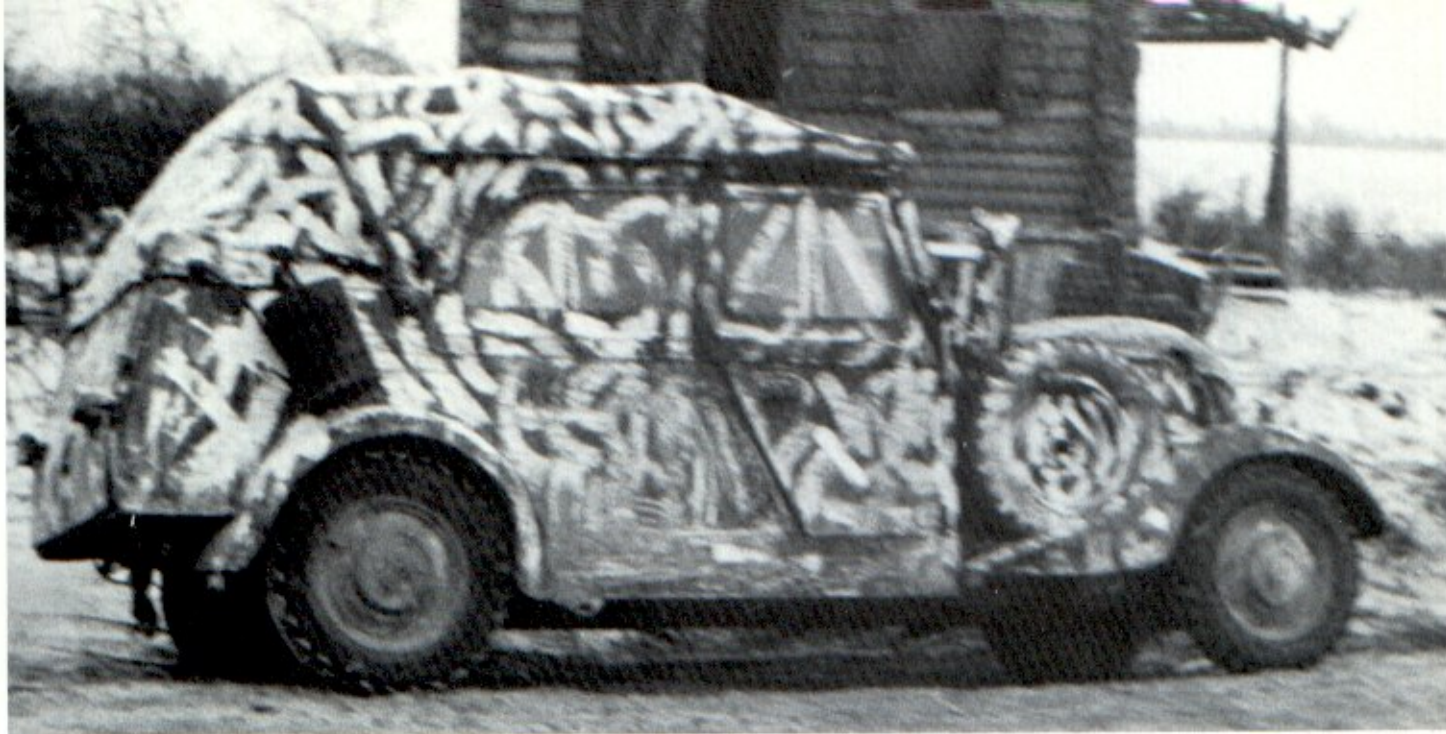
The supplies of white paint and even calcimine whitewash were often limited, and crews had to stretch the amount by painting only parts of the vehicles or by use of patterns of stripes or spots in white. [Bundesarchiv]

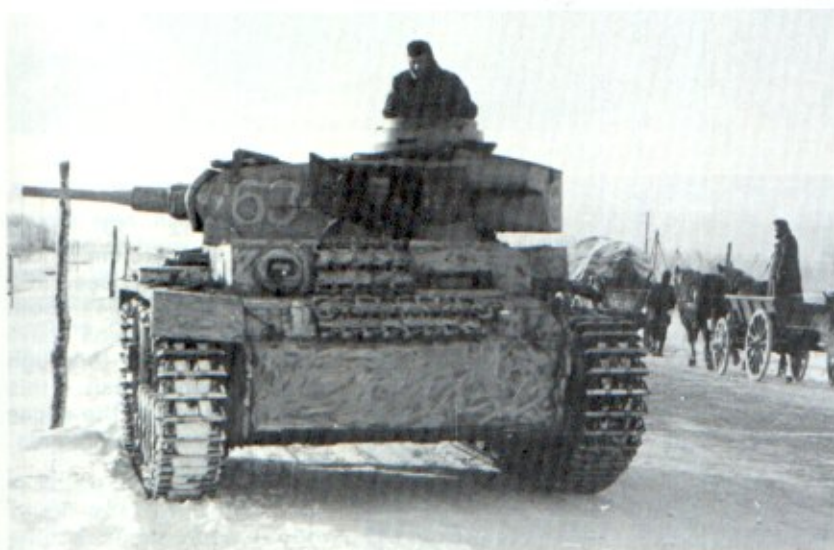
This PzKpfw III ausf G is a good example of the results of paint shortages. The paint has been applied in small strokes to only the front of the hull, and the front and forward sides of the turret. No white paint was applied to any of the rear turret or rear hull surfaces. [Bundesarchiv]

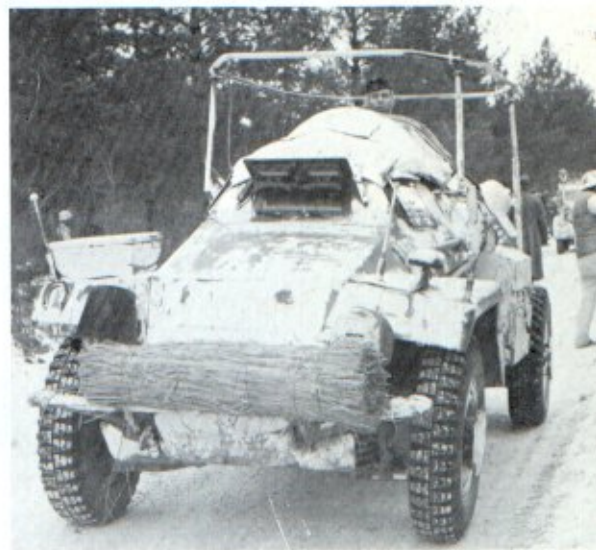
This SdKfz 261 armored car, whitewashed fairly well, is already showing the dark gray base through worn-away areas of the whitewash ruined by rain or water. [Bundesarchiv]

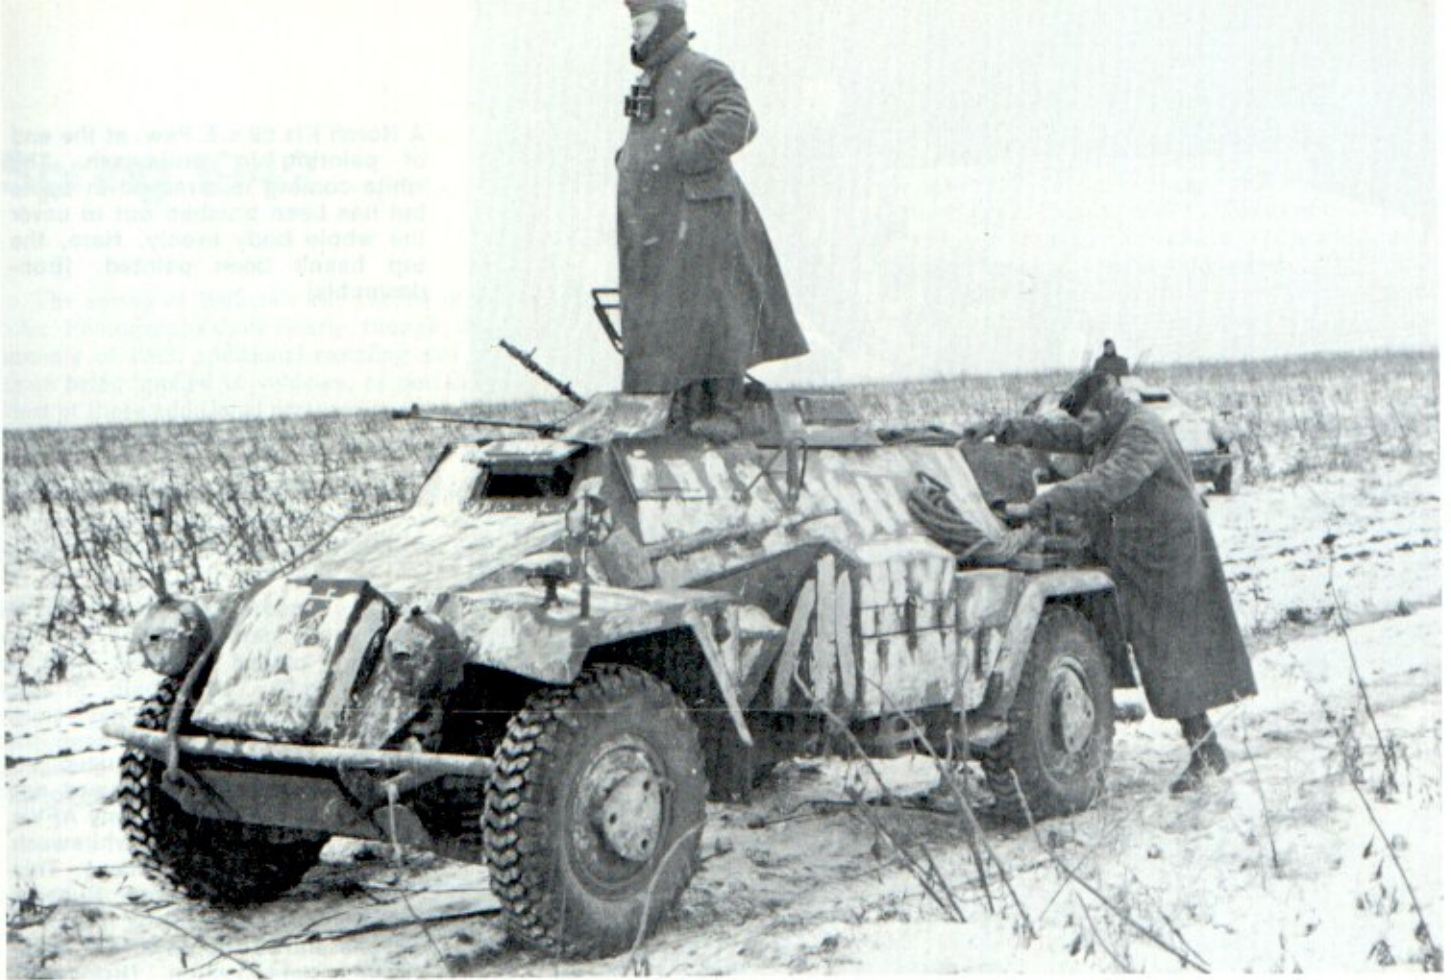
A case in which the shortage of paints was not serious. The white vertical stripes of this SdKfz 221 blend into the overgrown snow-covered fields better than a solid coating of whitewash. [Bundesarchiv]

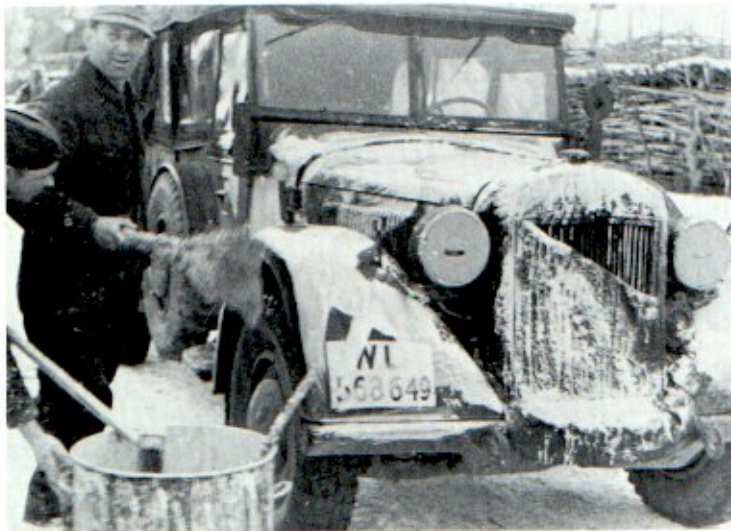
A Horch Kfz 15 m.E.Pkw receives a rough coat of whitewash, applied with a small push broom, and a straw broom used to splatter the whitewash all over the vehicle. The push broom was used to smooth out the splattered coating and give an overall white finish. [Bundesarchiv]

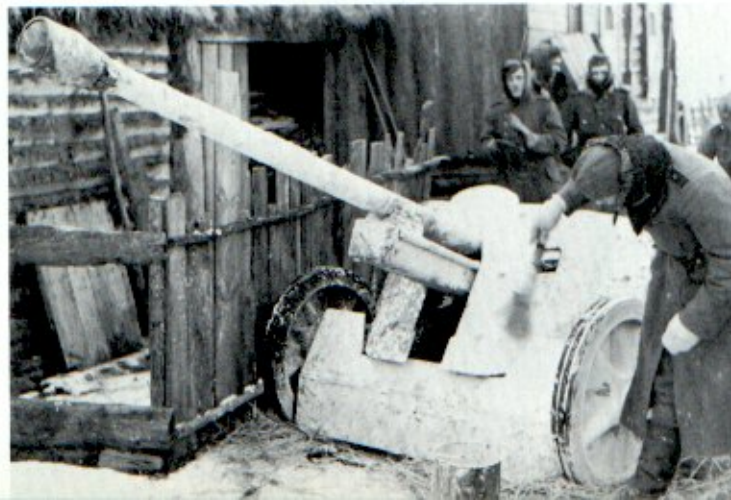
This 5 cm PAK 38 has been splattered all over to make an even coat of whitewash. The paint has built up in globs on the barrel and lower shield. Note the tire is largely covered also. [Bundesarchiv]

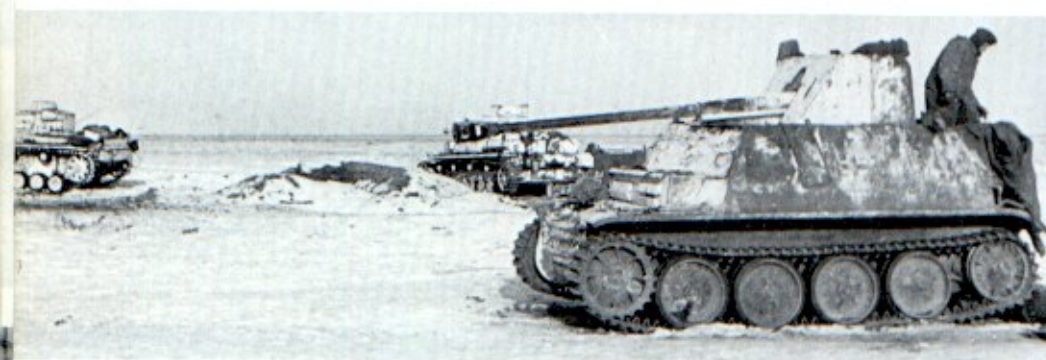
The whitewash coating used on many vehicles in Russia was not durable. In the spring, many AFV's lost much or all of their whitewash in the rain or spring thaws. This self-propelled 76.2 mm Russian PAK 36[r] on the PzKpfw II ausf D chassis shows the advanced stage of this deterioration. [Bundesarchiv]

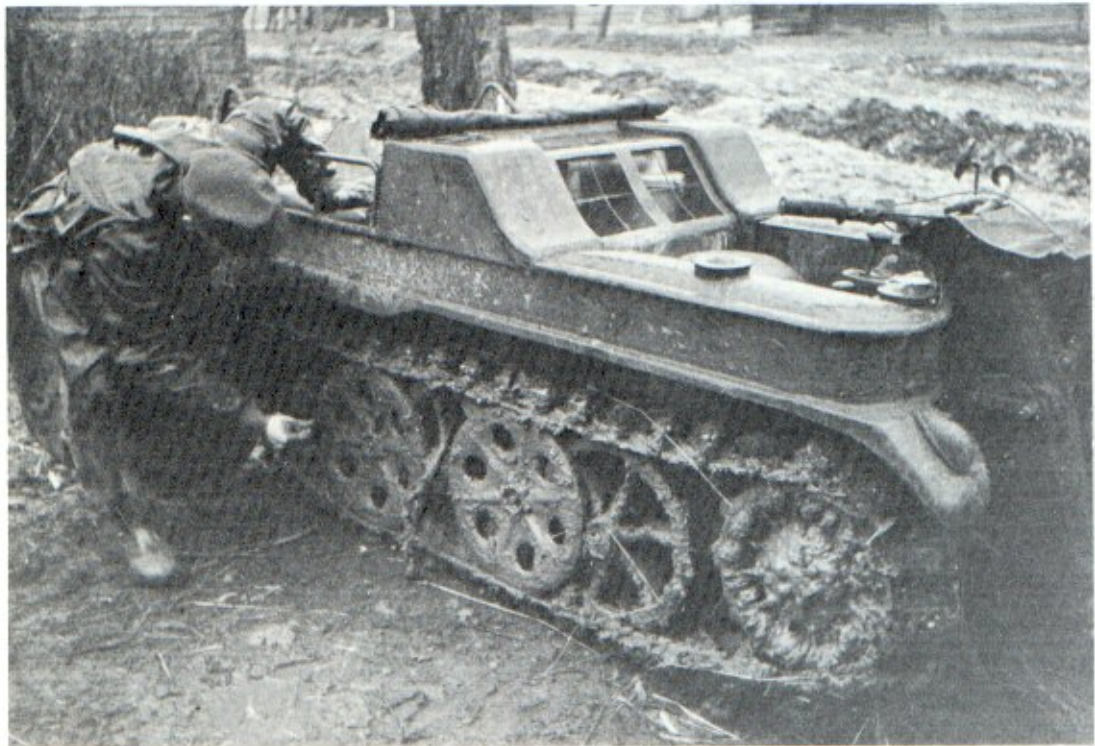
A SdKfz 10 negotiates a muddy road near Leningrad in early 1942. The dark gray paint is almost completely covered with splattered wet mud. When dry, the mud will match local earth in color. [Bundesarchiv]

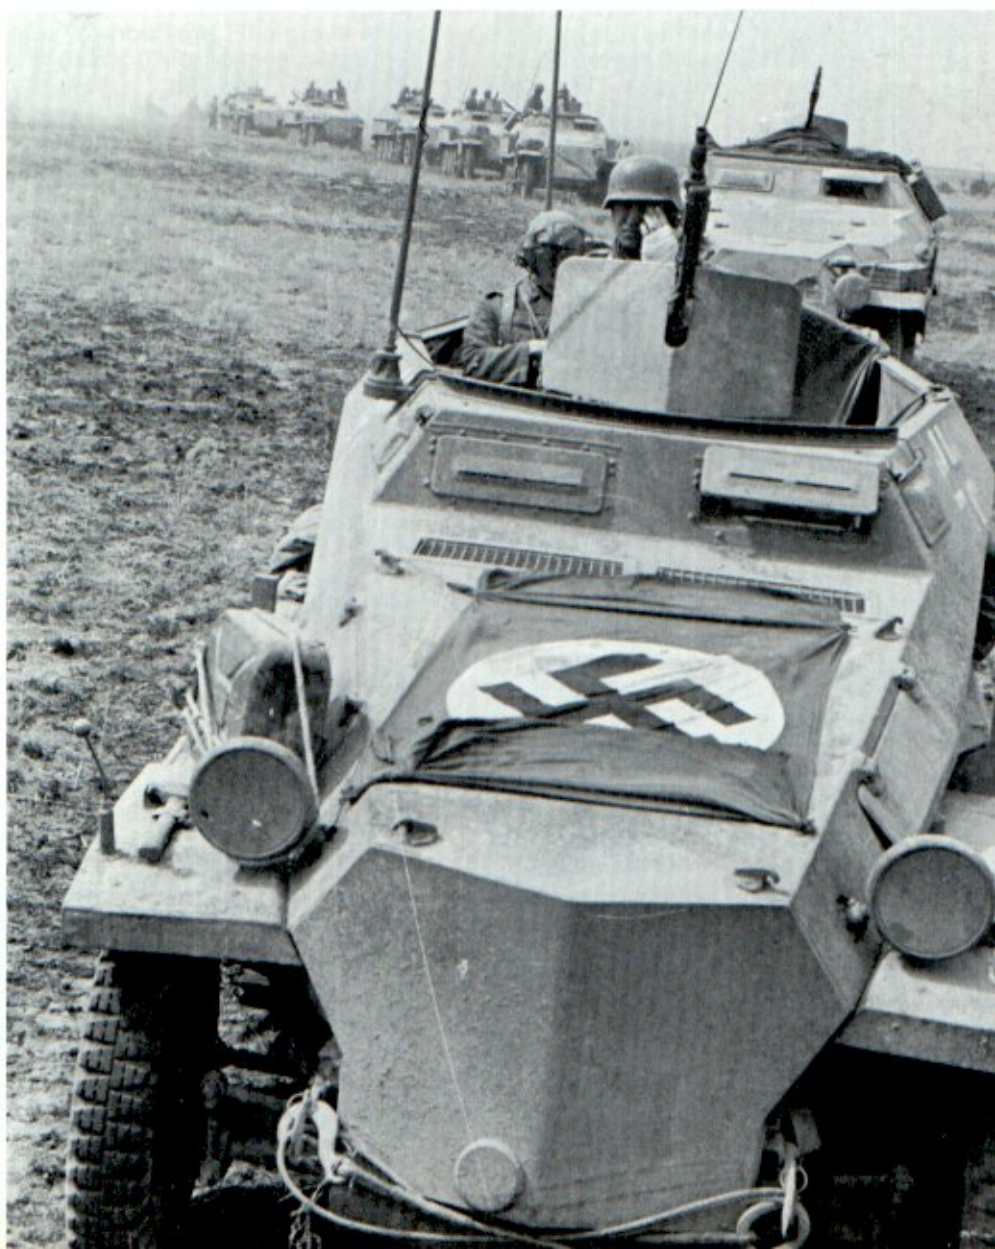
These halftracks, photographed in the summer of 1942, are in overall dark gray, but a heavy layer of sprayed and splattered mud and dust hides the gray almost completely. The lead vehicle is a SdKfz 250/3 radio vehicle. [Bundesarchiv]

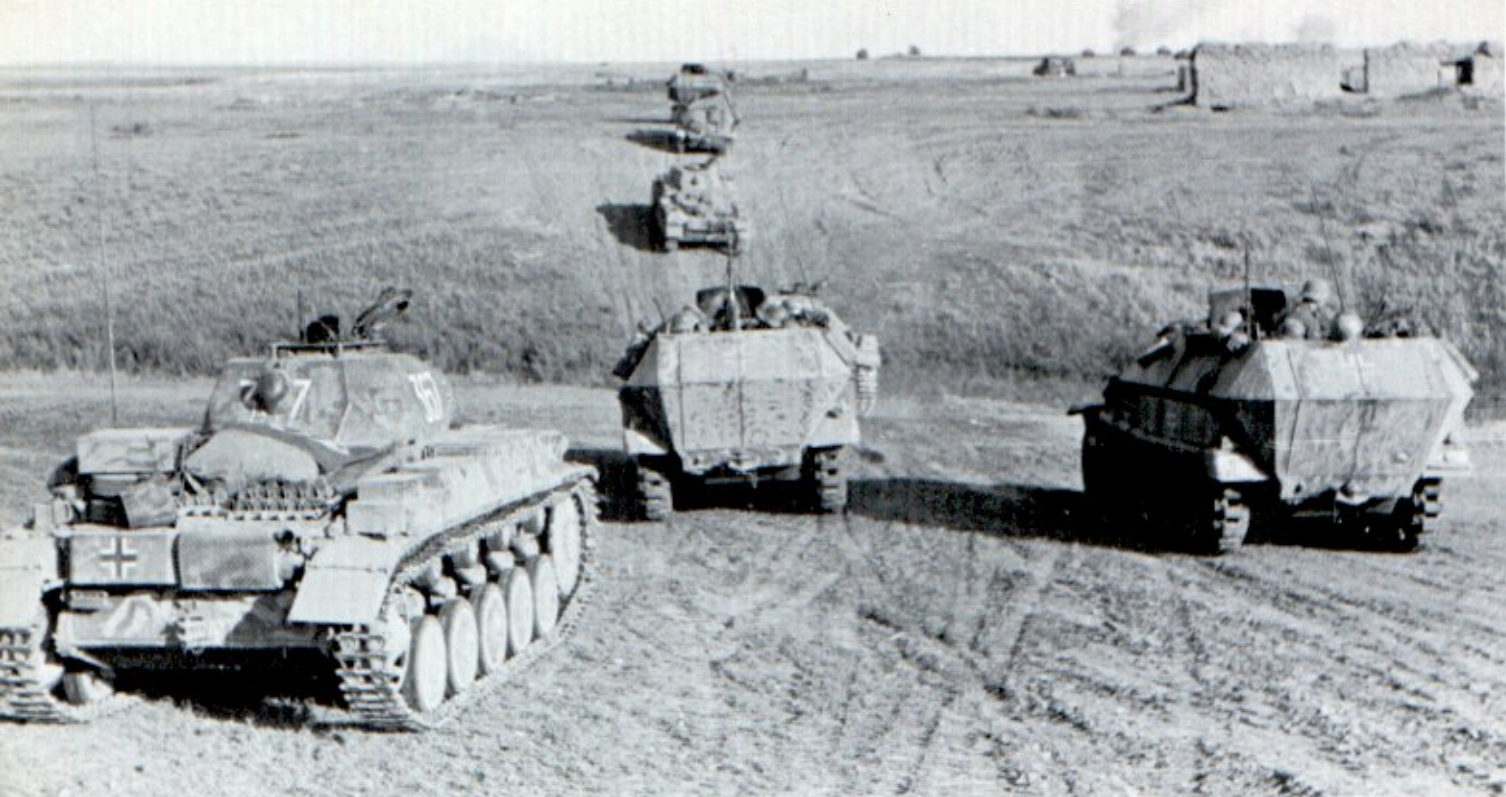
These vehicles show a hastily applied coating of mud, partly brushed and partly smeared in wavy stripes and patches. Dust covering the chassis components has blended with the applied mud and softened it in some areas. [Bundesarchiv]
