Panzer Colors

Camouflage of the German
Panzer Forces 1939-45

by Bruce Culver & Bill Murphy
illustrated by Don Greer

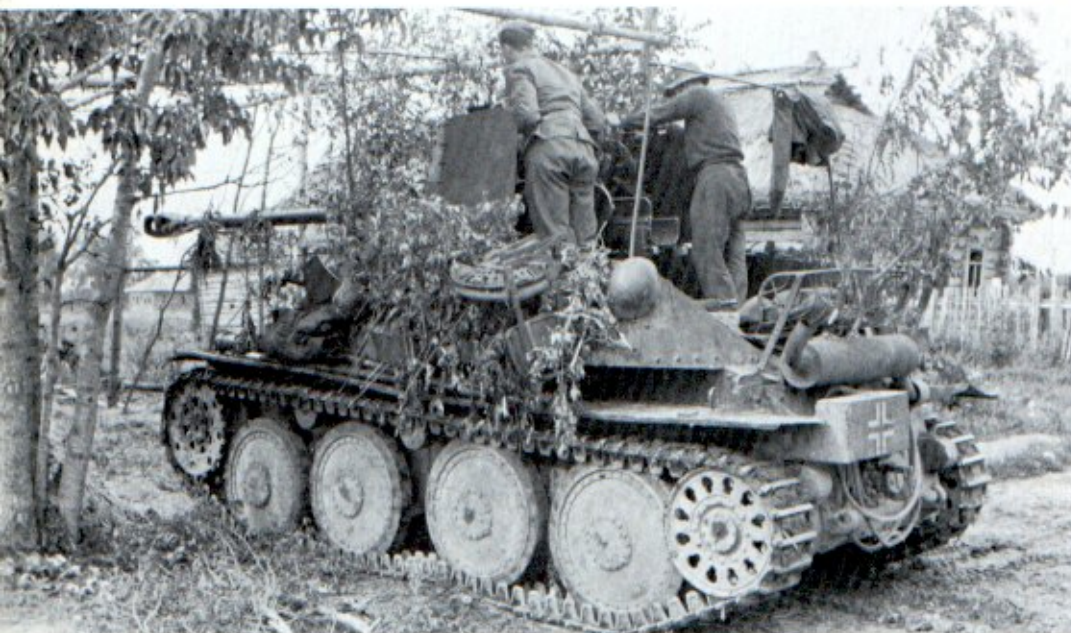
This Marder III [76.2 mm PAK 36 [r] on PzKpfw 38 [t] chassis] is dark gray with dried mud on the roadwheels. Foliage is used to break up the rather high shape and blend with the nearby trees. [Bundesarchiv]

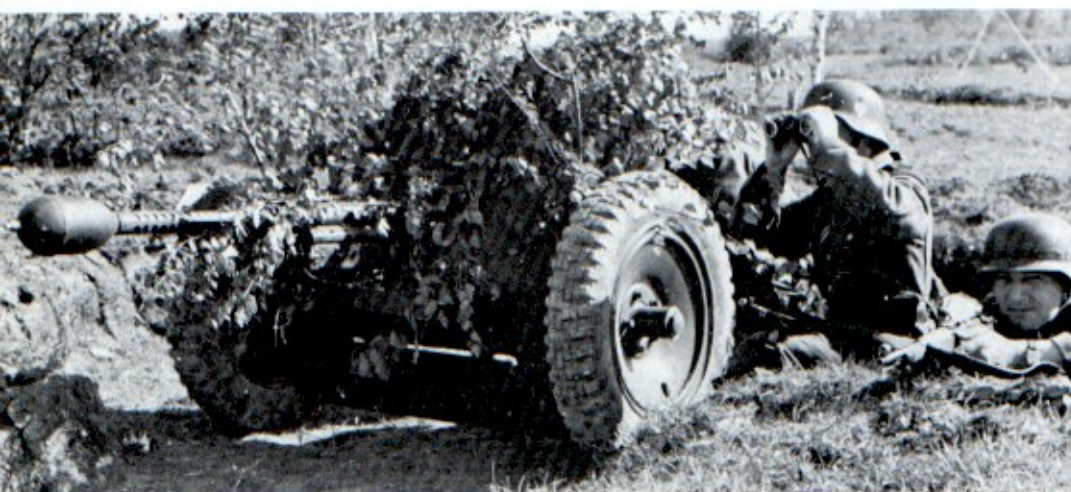
A 3.7 cm PAK 36 with a shaped-charge "Stielgranate" antitank grenade is in dark gray with foliage fastened to the gun and shield to conceal it better from the enemy. [Bundesarchiv]

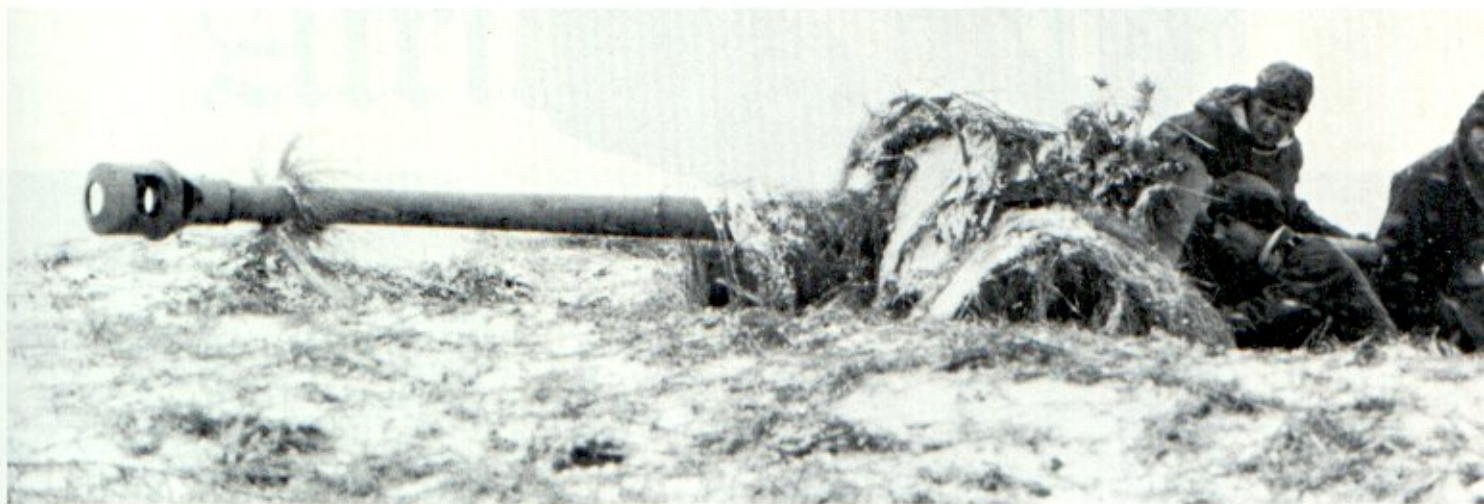
This 7.5 PAK 40 crew has used "natural" camouflage. The grass and straw piled on the gun has held new fallen snow, blending very well with the local fields. This weapon has been emplaced in a ditch to lower the silhouette as much as possible. [Bundesarchiv]

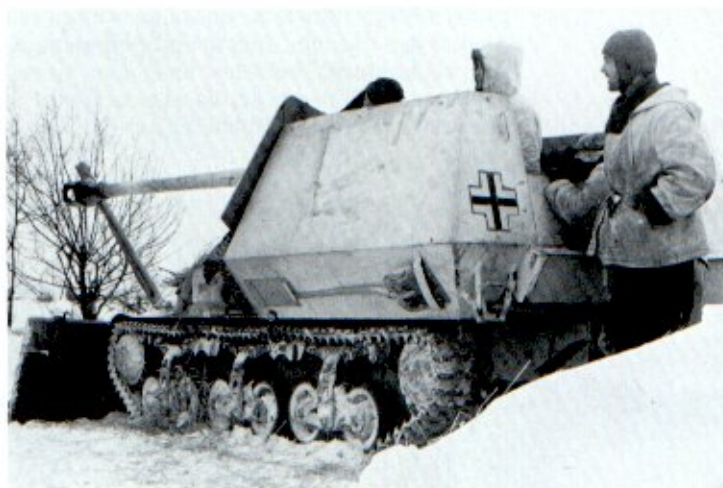
A Marder I [PAK 40 on the French "Lorraine" chassis] seen in a very even application of white paint. Packed snow provides additional camouflage on the wheels and tracks [Bundesarchiv]

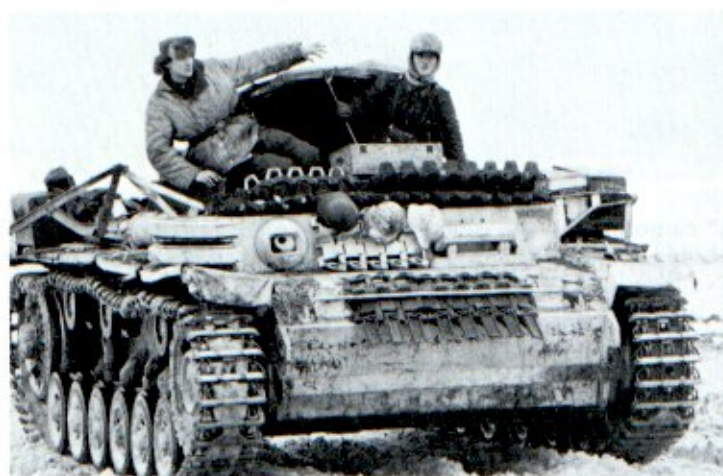
An old PzKpfw III, now used as an ammunition carrier, carries a scruffy but complete coat of white paint. The turret ring is covered by the round tarpaulin, and a great deal of extra tracks and fittings are stowed on the vehicle. The tracks on the bow are "ostketten", the wide tracks designed for use in the poor weather and rough terrain of the Russian front. [Bundesarchiv]

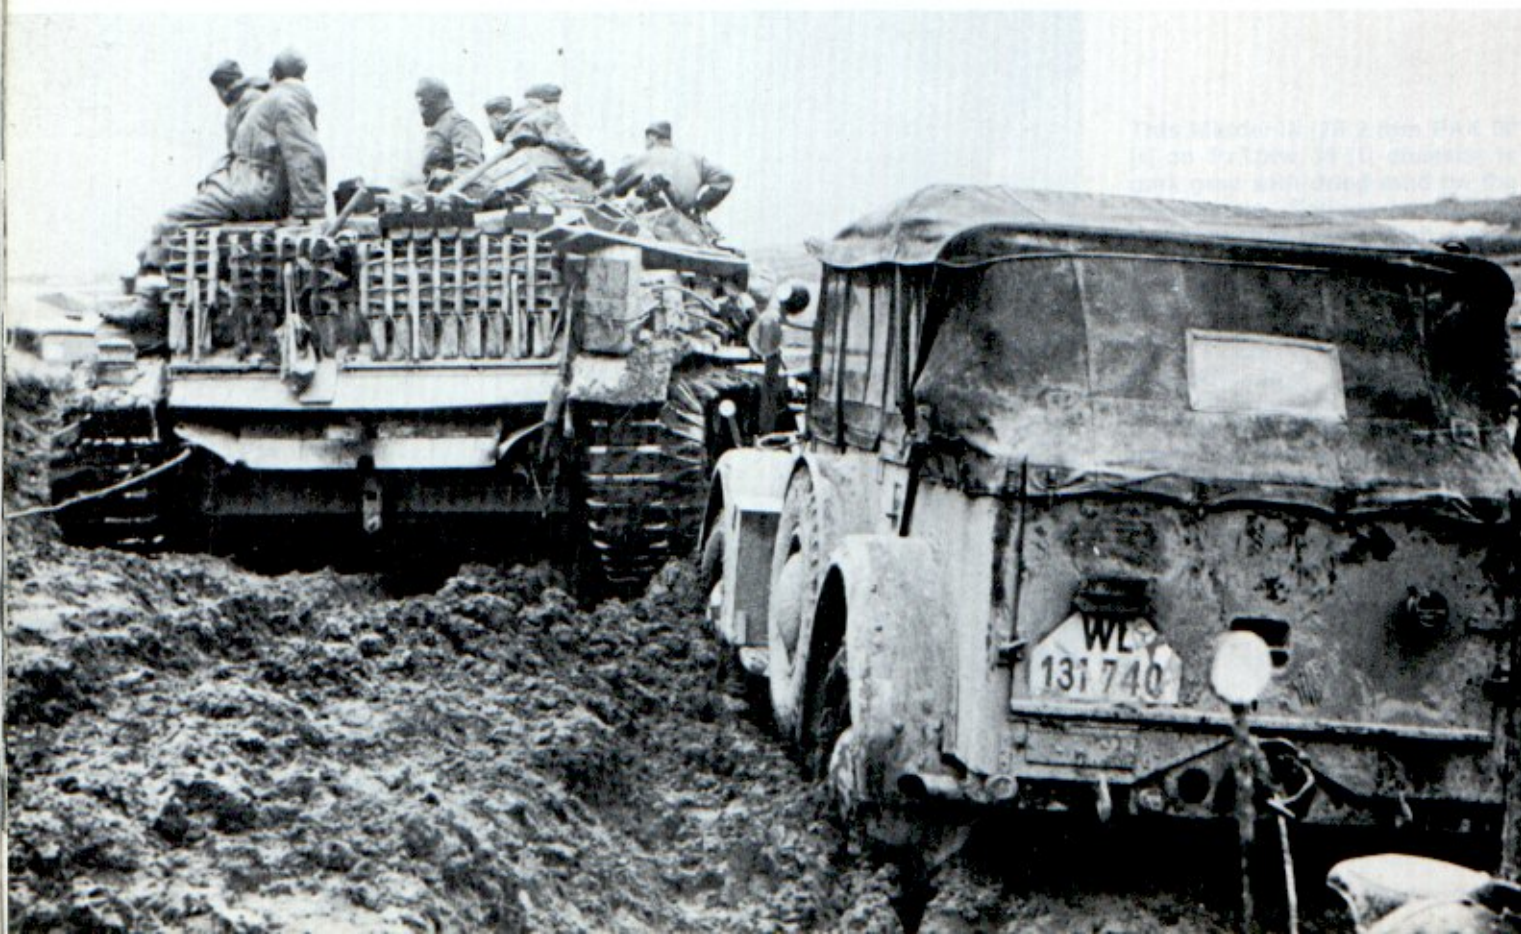
A StuG III ausf F and a Horch Kfz 15 plow through the mud of spring, 1943. The Horch is still overall dark gray, with an even layer of dust - further covered by freshly deposited mud. Note the "ostketten" in use on the StuG III and stowed on the rear.

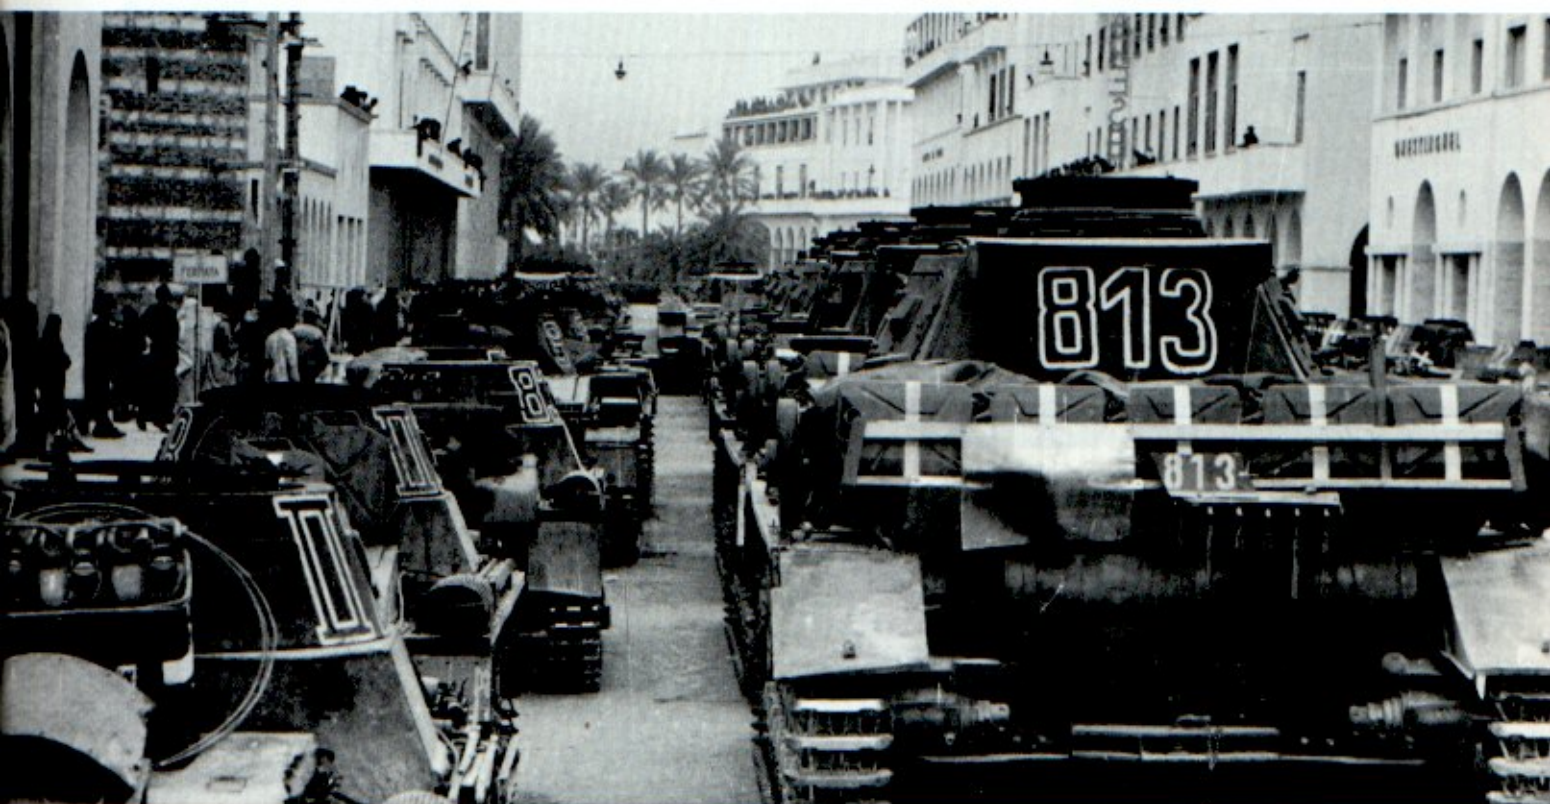
The first armored elements of the embryonic D.A.K. are seen in Tripoli, March 1941. All these vehicles, PzKpfw I's and II's on the left, PzKpfw IV's on the right, are in dark gray. The jerry cans were to be used only for carrying water. Note both large turret numbers in white and the older metal number plate on the rear of the nearest PzKpfw IV ausf D.

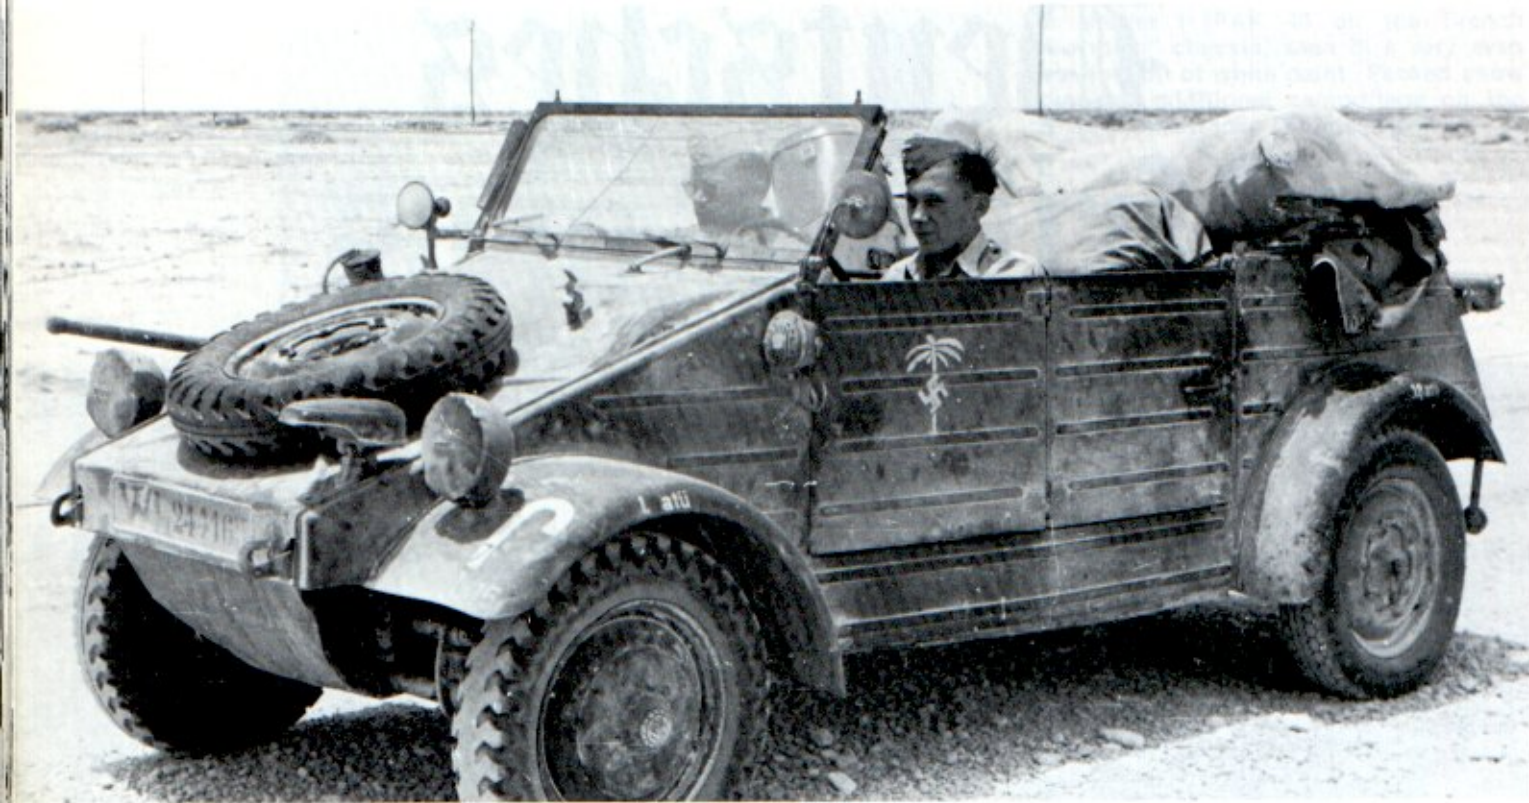
A dusty VW Kubelwagen sports an Afrika palm tree symbol, which was used on all vehicles under the control of the D.A.K. This is a Luftwaffe vehicle. [Bundesarchiv]

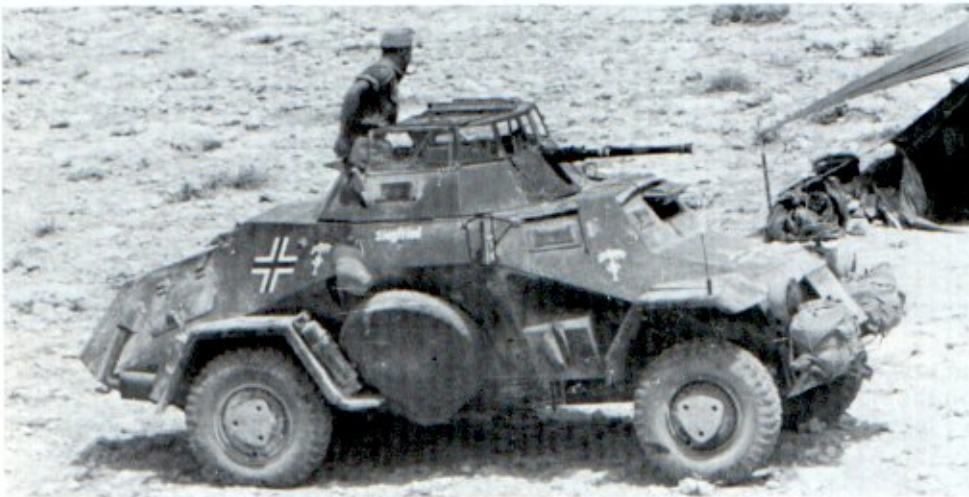
"Siegfried", a mid-production SdKfz 222 armored car, is in dark gray. Dust has been deposited on the front, and two Afrika palms are painted on the side. [Bundesarchiv]

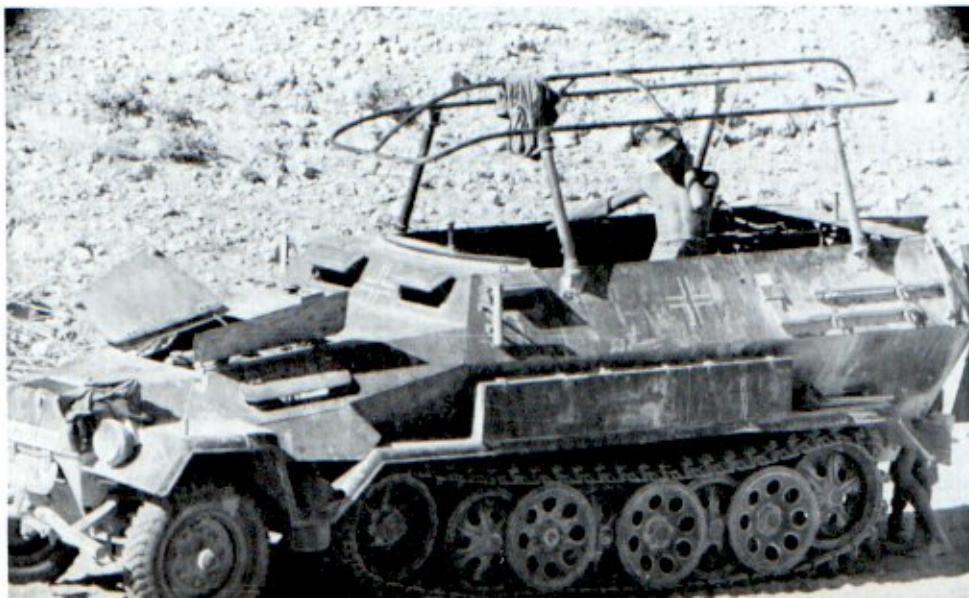
This SdKfz 251/3 ausf B in overall dark gray shows accumulations of dust on upper surfaces and the rear sides of the body. The engine hatches are all open for better ventilation. [Bundesarchiv]

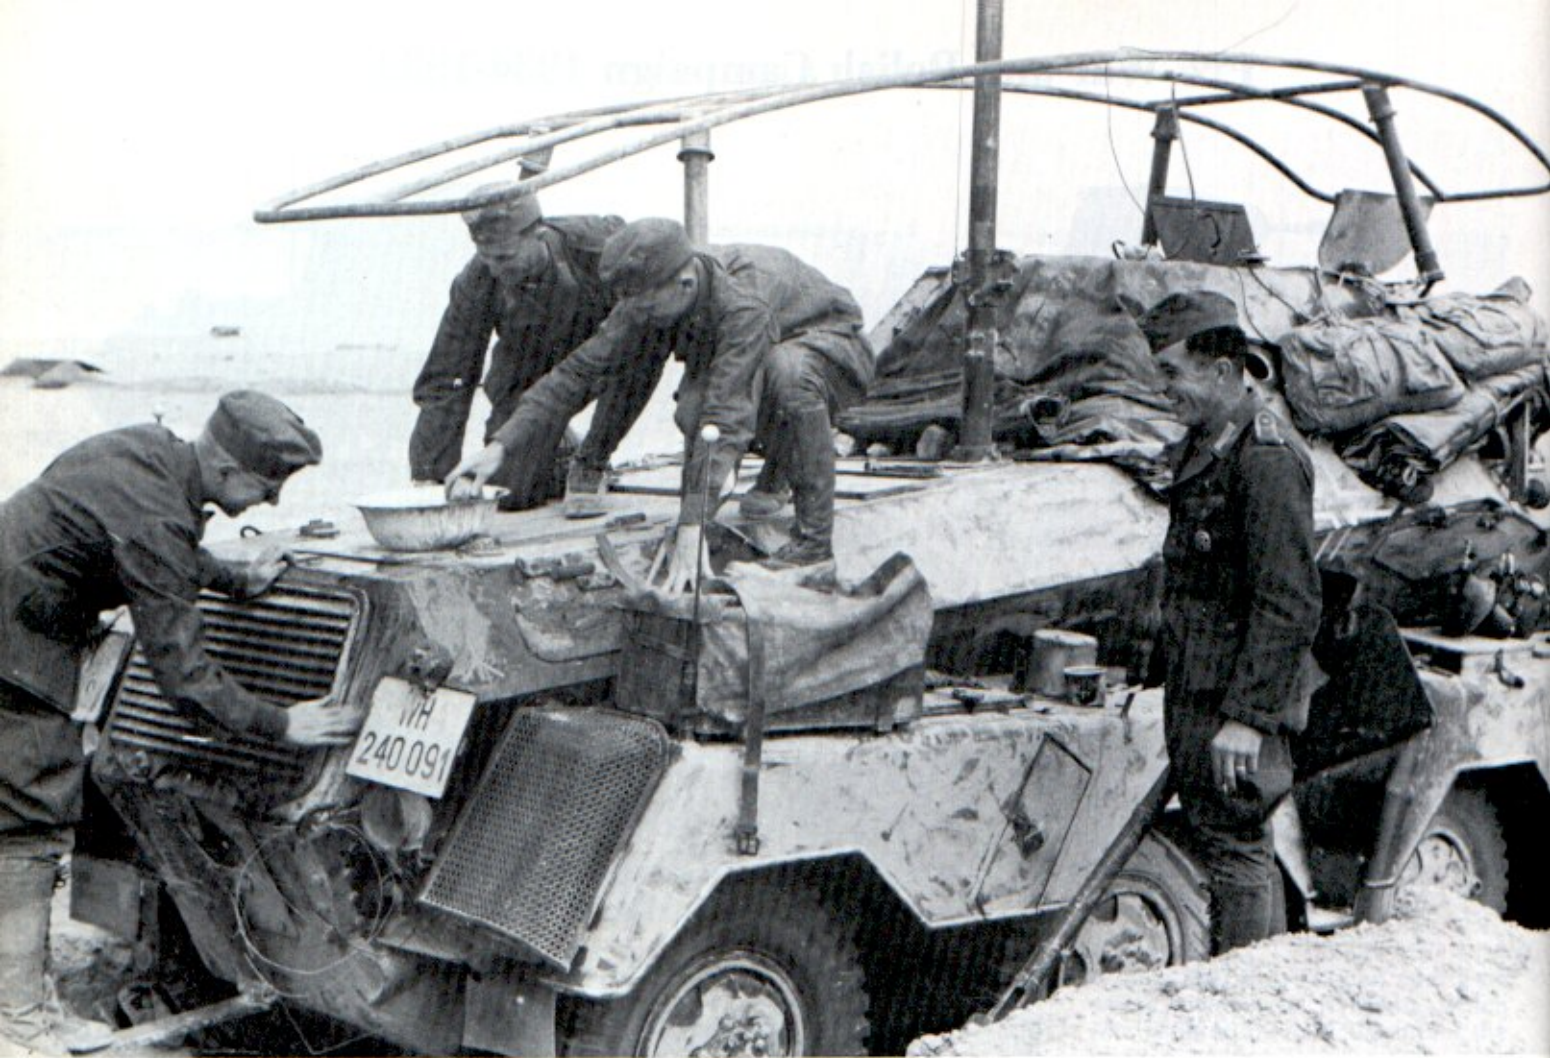
The crew of this SdKfz 263 armored car applies soupy mud to the rear deck and sides. When dry, the mud will match the rest of the vehicle, already covered with mud.

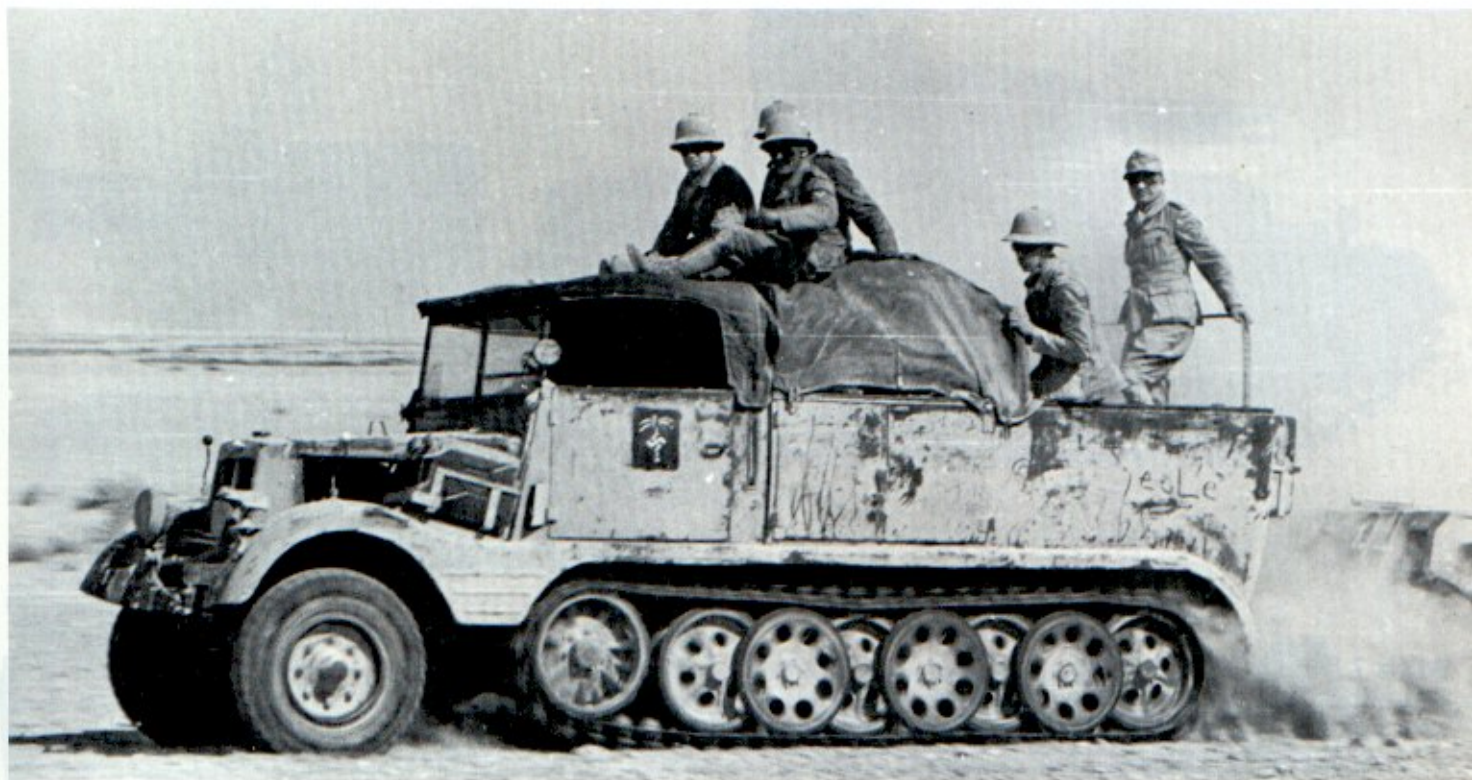
A SdKfz 11 3-ton tractor shows the effects of rubbing away some of the mud coating. Dark spots and streaks like these are a telltale sign that the vehicle has been daubed with mud, not paint.

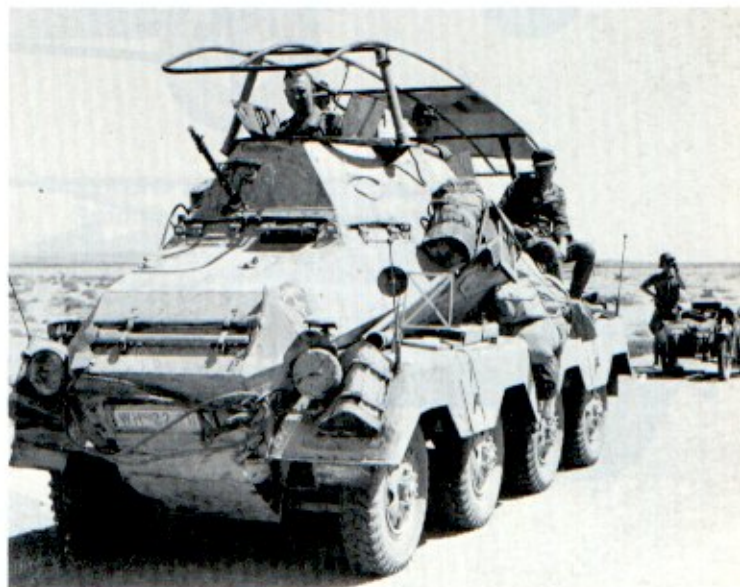
The SdKfz 263 radio car has a solid coat of mud. The Afrika palm has been left with a very narrow border of the dark gray base color. Like most vehicles in the desert, this example carries a great deal of extra stowage. A sunshade tarpaulin has been stretched over the radio antenna. [Bundesarchiv]

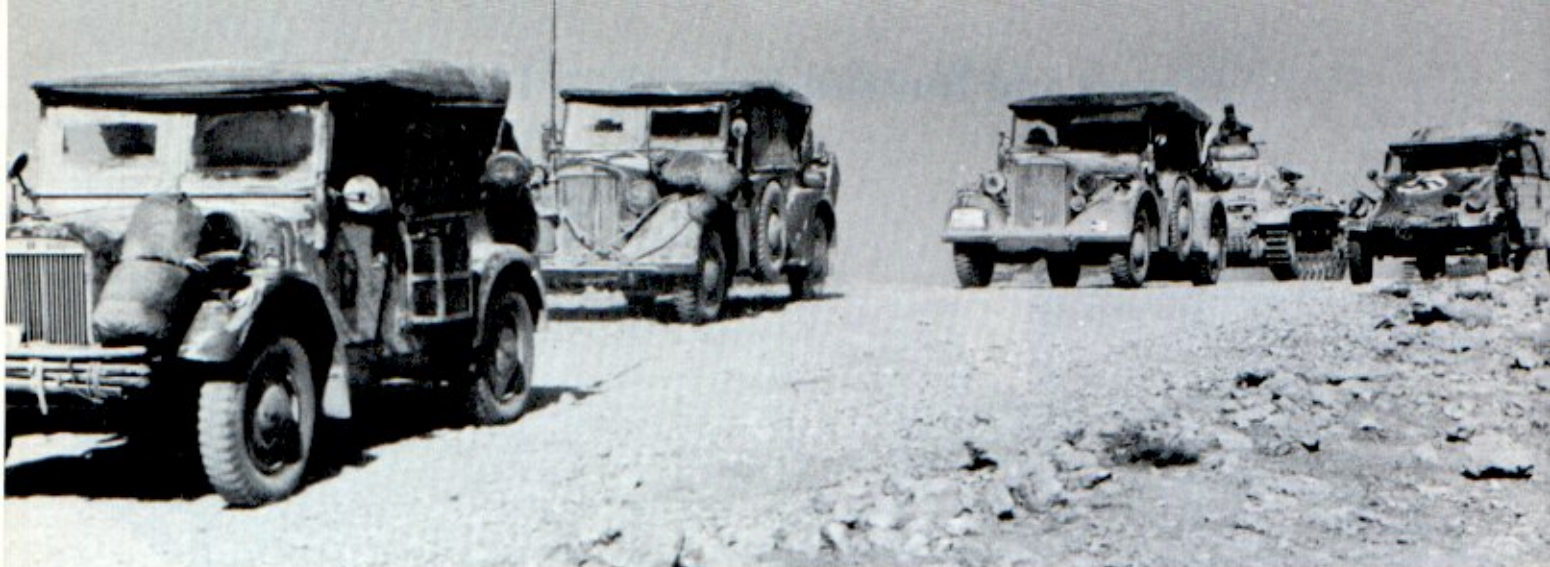
This column of passenger cars, a Kfz 4, 2 Kfz 15's and a Kfz 2 Kubelwagen, are all dark gray with a mud coat. The finish is wearing off the lead vehicle. The windshields of several of the vehicles have been painted with mud to reduce glare from the sun. Dust has settled on the canvas tops, which have not been coated. Mud didn't stay on canvas very long if the cloth folded or moved. Stretched canvas [tire covers, headlight slit covers] held mud coatings much longer, however.

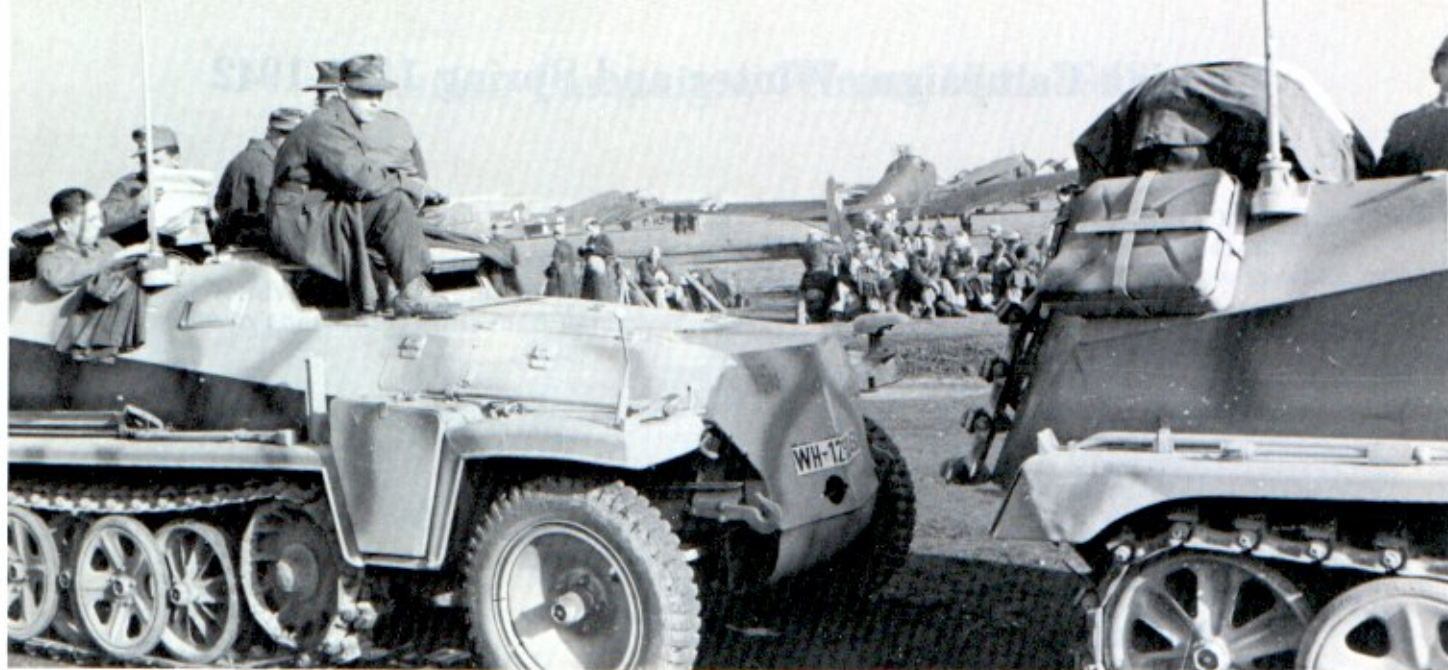
[Top] Two brand new SdKfz 250's, painted in yellow-brown with sprayed lines of gray green. This is a perfect example of careful "textbook" camouflage, done exactly as the orders intended. [Bundesarchiv]

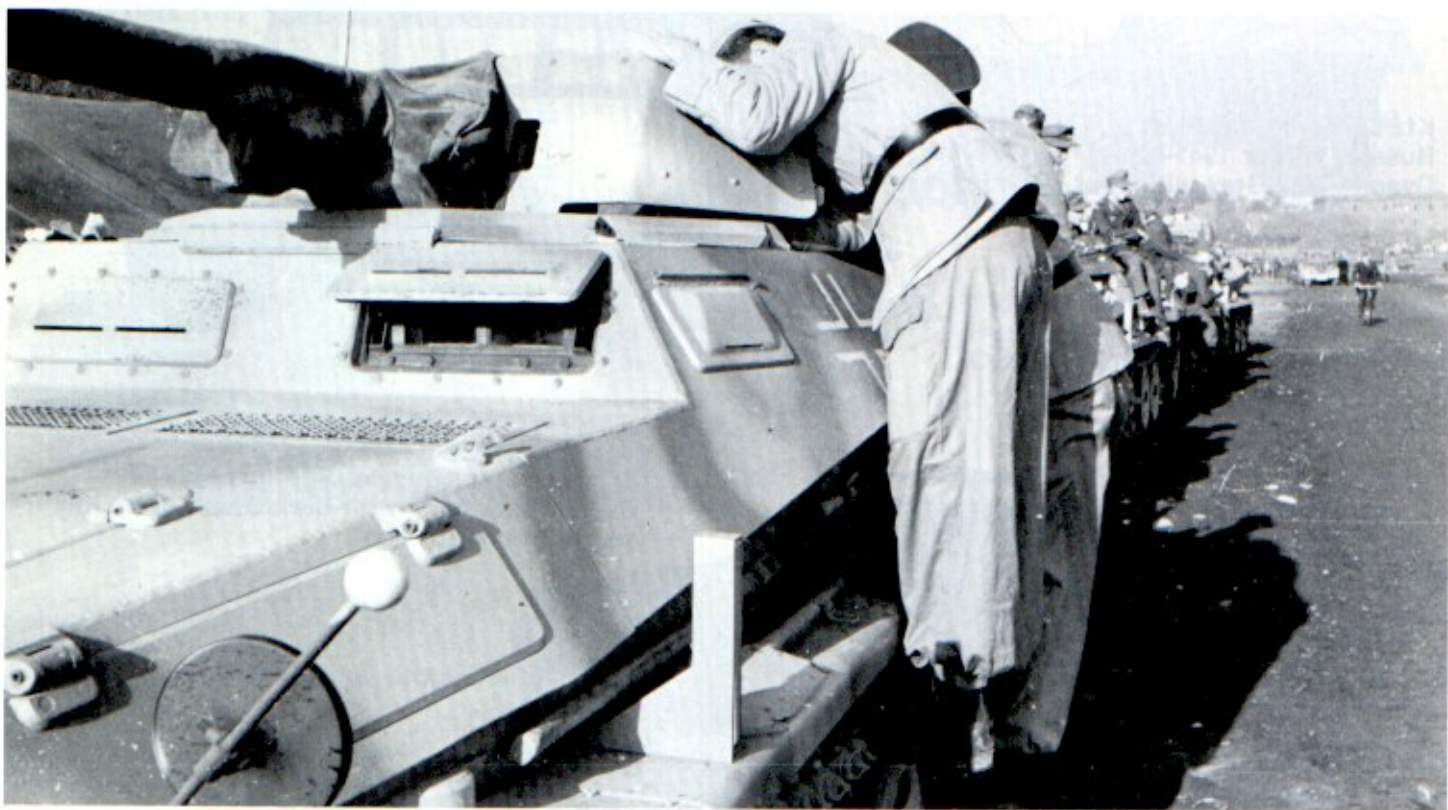
[Above] The other side of the same line of SdKfz 250's. The nearest vehicle, a 250/10, mounts a 3.7 cm PAK 36 with the later low armor shield. Note the old interior color on the drivers glass frame. The interior may not have been repainted. [Bundesarchiv]

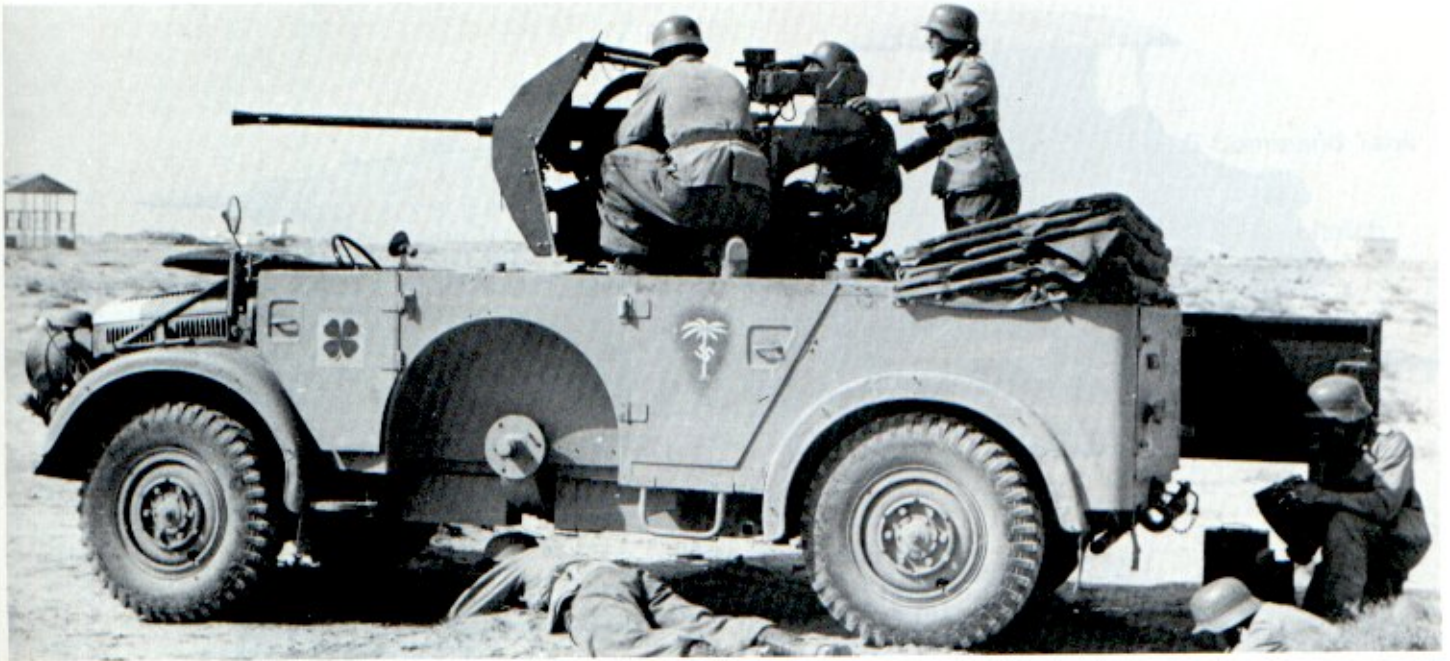
This Horch s.E. Pkw, Kfz 69, has been converted into a self-propelled mount for the 2 cm Flak 38. The yellow brown has been sprayed neatly over the entire vehicle, with a small area of original dark gray showing around the Afrika palm. The Flak 38 is still in dark gray. The four-leaf clover is green on a white square. [Bundesarchiv]

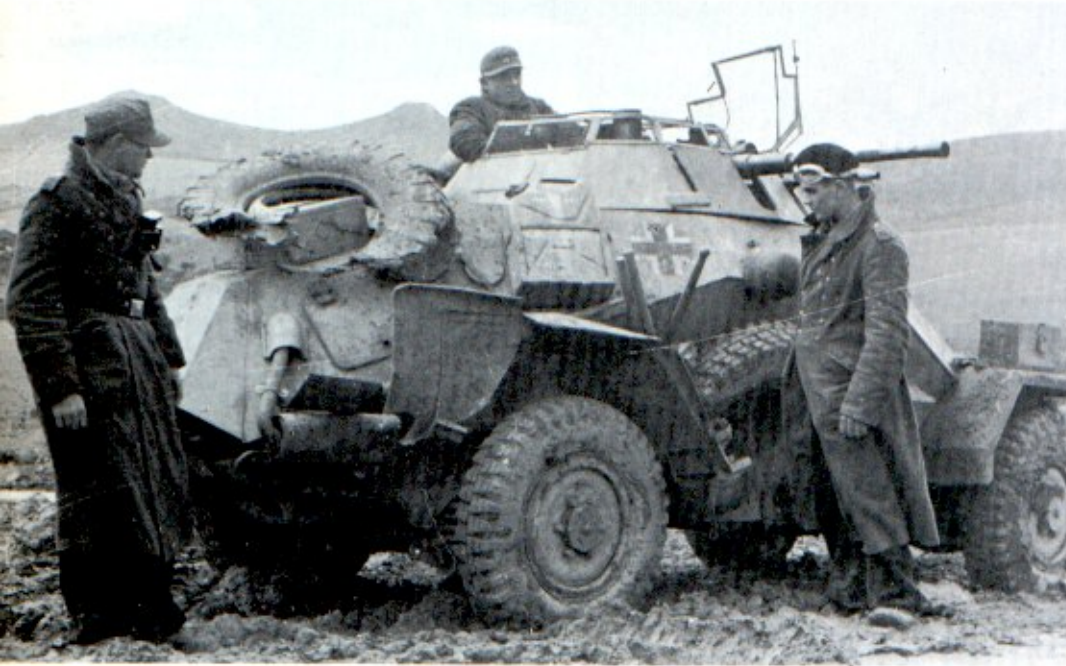
The crew of this SdKfz 222 has just finished replacing a tire destroyed by a mine. The vehicle is desert brown with a black and white cross. The crew wears long overcoats in the chill air often found in the northern coastal areas. The water can is also brown, rather than the more common black or dark gray. [Bundesarchiv]

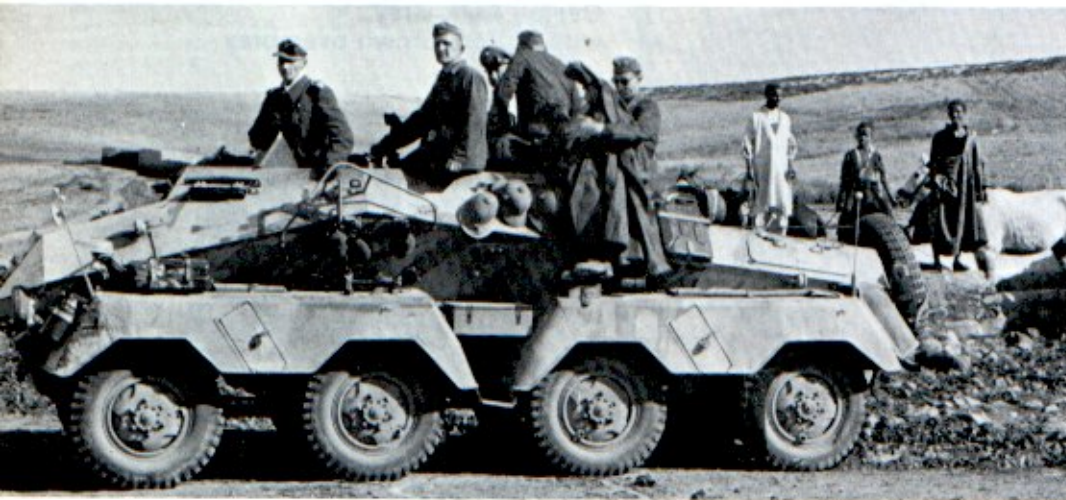
A SdKfz 233 self-propelled 7.5 cm howitzer, also seen in Tunisia. The desert brown paint is somewhat streaked and weathered. Note the old style pith helmets still carried. [Bundesarchiv]

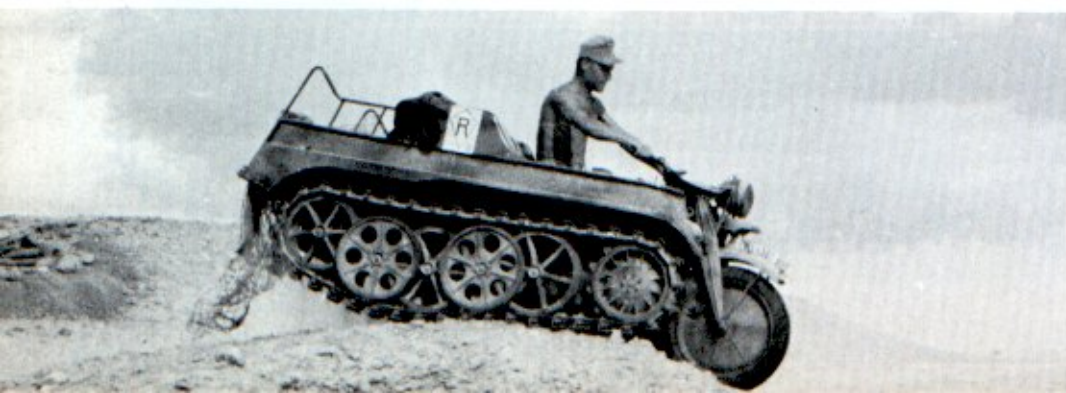
A NSU kleines Kettenrad, SdKfz 2, of the famous Ramcke's Fallschirmjäger brigade, in a scheme of brown oversprayed with the dark gray secondary color. Note the symbol for the Ramcke detachment, an "R" in a kite-shaped outline on a white background. [Bundesarchiv]

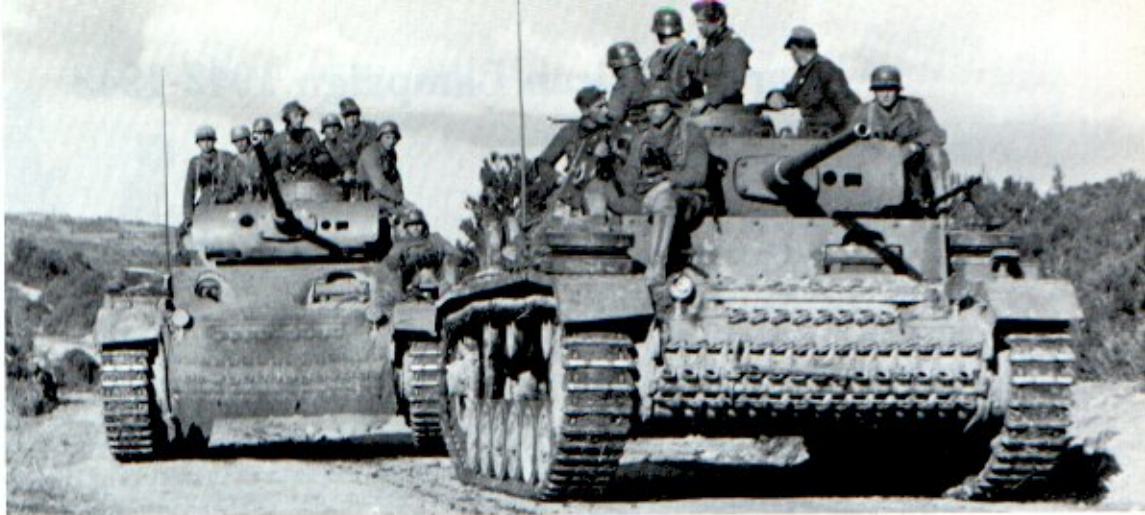
This desert brown Tiger I in Tunisia is covered with a layer of dust over most of the front. The turret numbers are black with white outlines, "124". [Bundesarchiv]

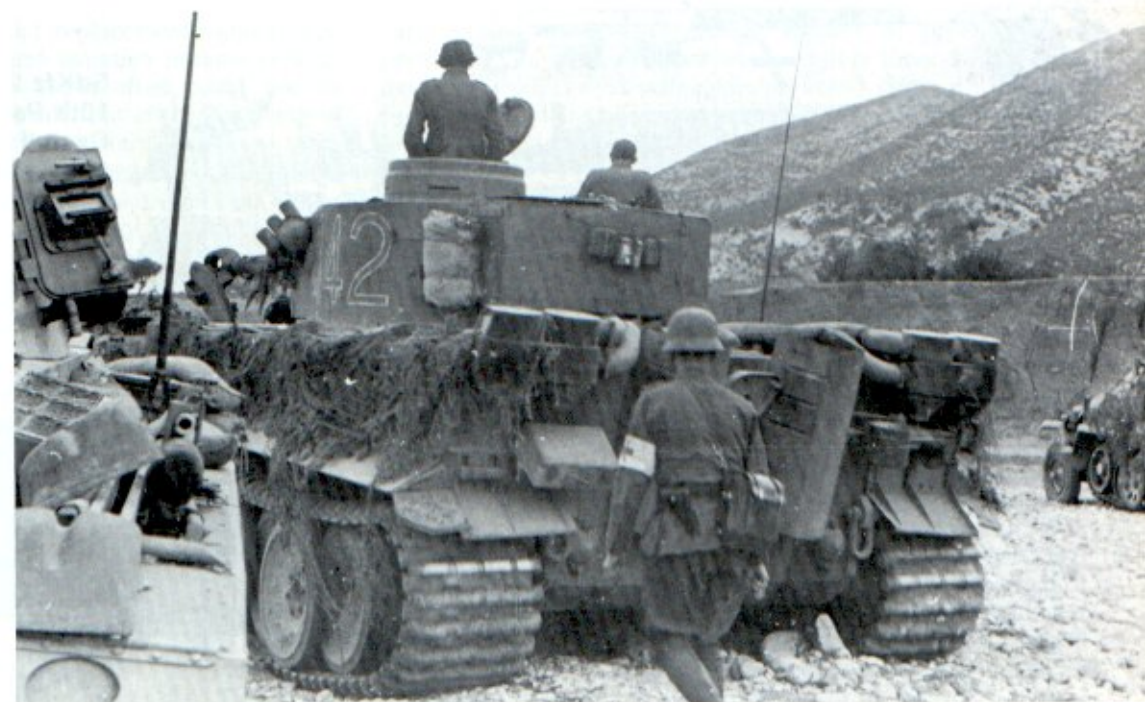
This Tiger I ausf E in Tunisia may be one of the olive green vehicles, though it is not possible to be sure. The tank is much darker than the brown tank in the foreground, and this indicates the color is olive green. The turret numbers are red with white boarders. [Bundesarchiv]

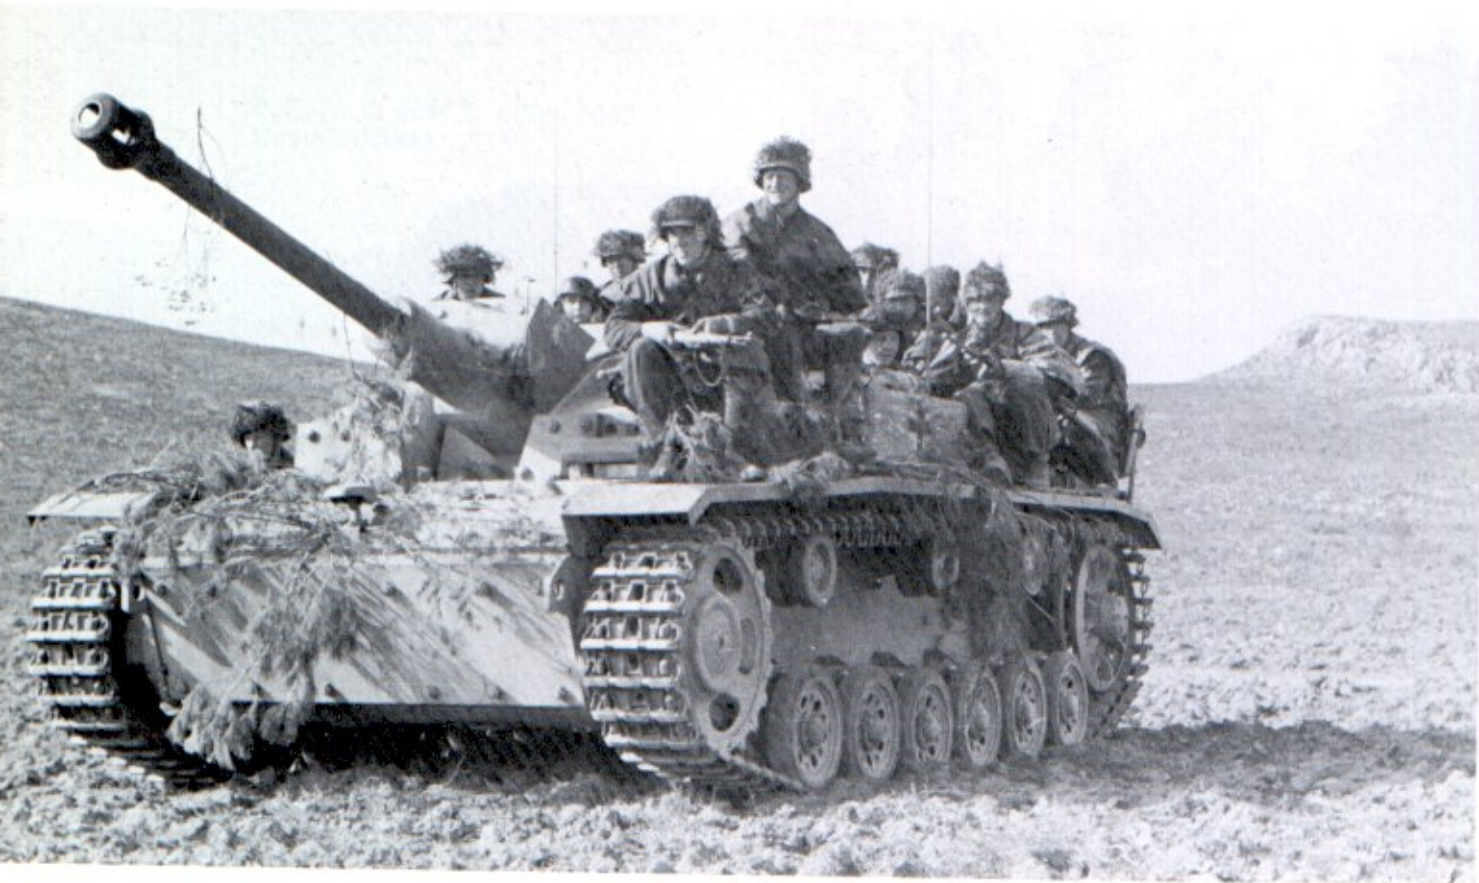
This StuG III ausf F was photographed in Tunisia,. Part of the last-ditch effort to reinforce Panzerarmee Afrika and the D.A.K., this vehicle was painted overall dark yellow. Foliage has been used to break up the corners of the superstructure front. Tunisia was much more temperate in climate than the Libyan desert, and many troops, as here, wore standard European uniforms. [Bundesarchiv]

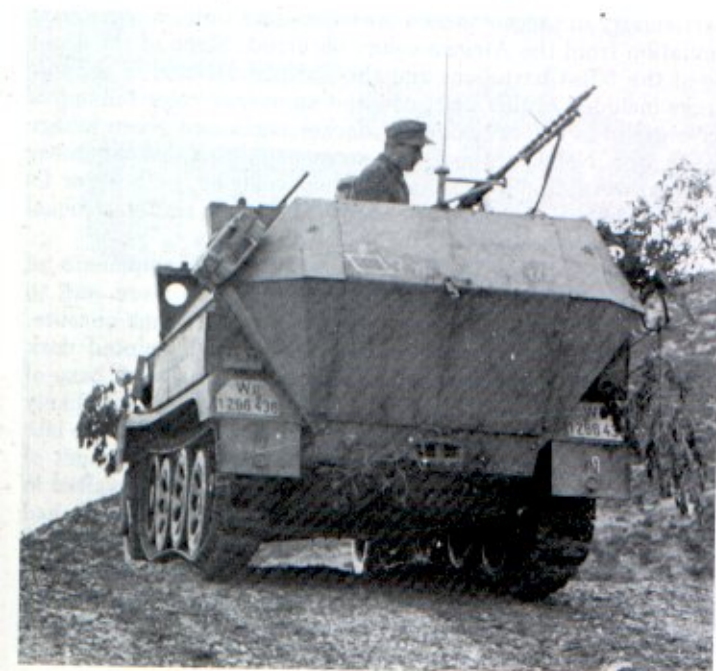
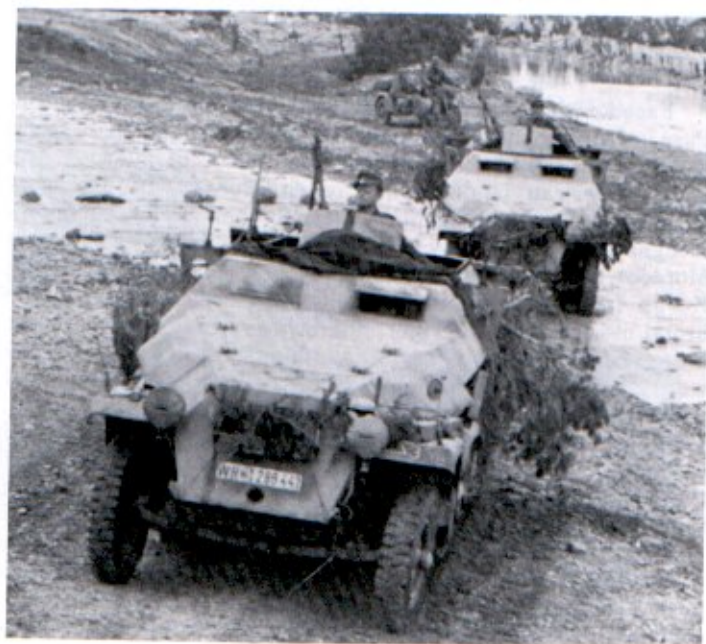
This SdKfz 251/7 engineers' vehicle again shows the application of dark yellow over the dark gray base. This was not confined to Africa but was done there first, as the vehicles were sent. [Bundesarchiv]

These two SdKfz 251's show different types of repainting. The rear vehicle is overall dark yellow, and may have been a new vehicle, but the front 251 is dark yellow sprayed over the dark gray, some of which shows through. [Bundesarchiv]

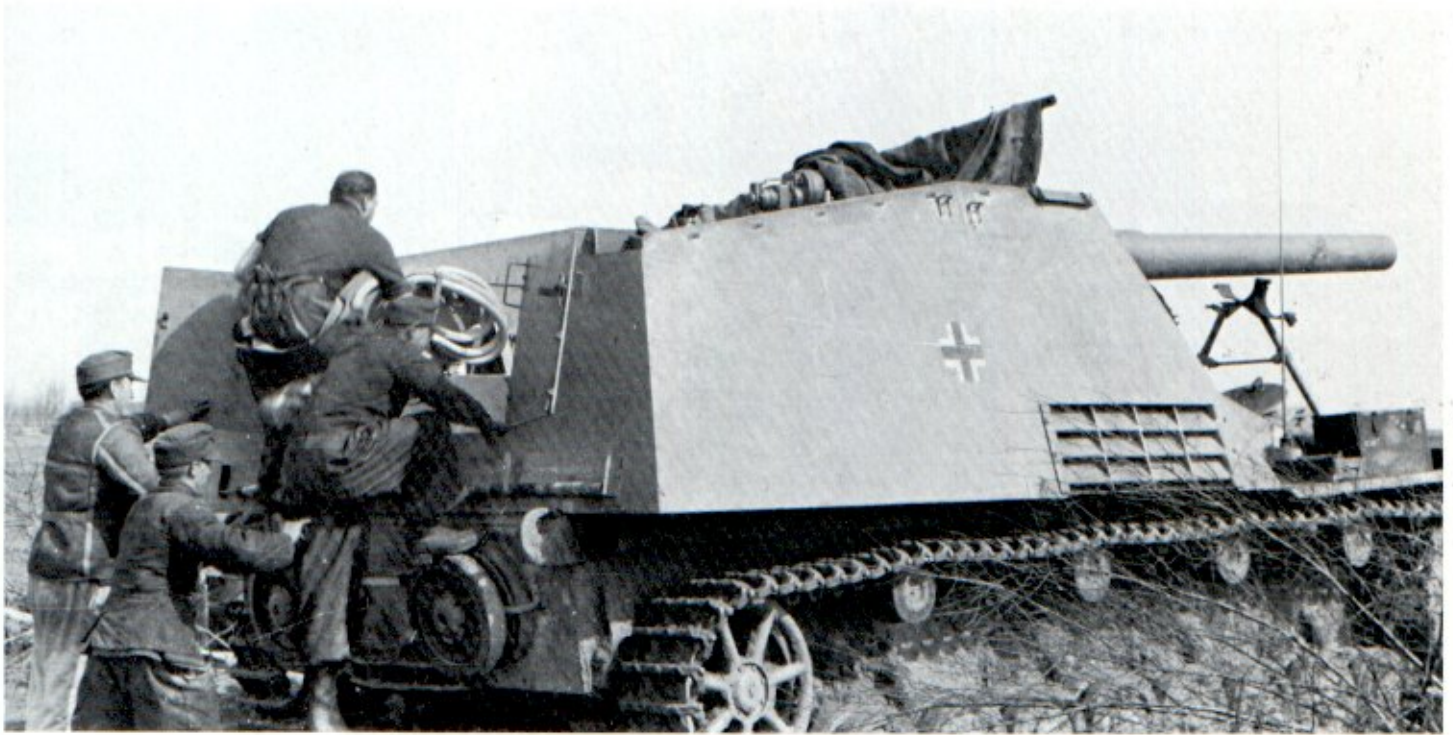
This "Hummel" self-propelled 15 cm gun has an overall covering of dark yellow. The high sides of this vehicle show why additional colors were desirable to break up large solid shapes and better conceal large equipment. [Bundesarchiv]
