Panzer Colors

Camouflage of the German
Panzer Forces 1939-45

by Bruce Culver & Bill Murphy
illustrated by Don Greer

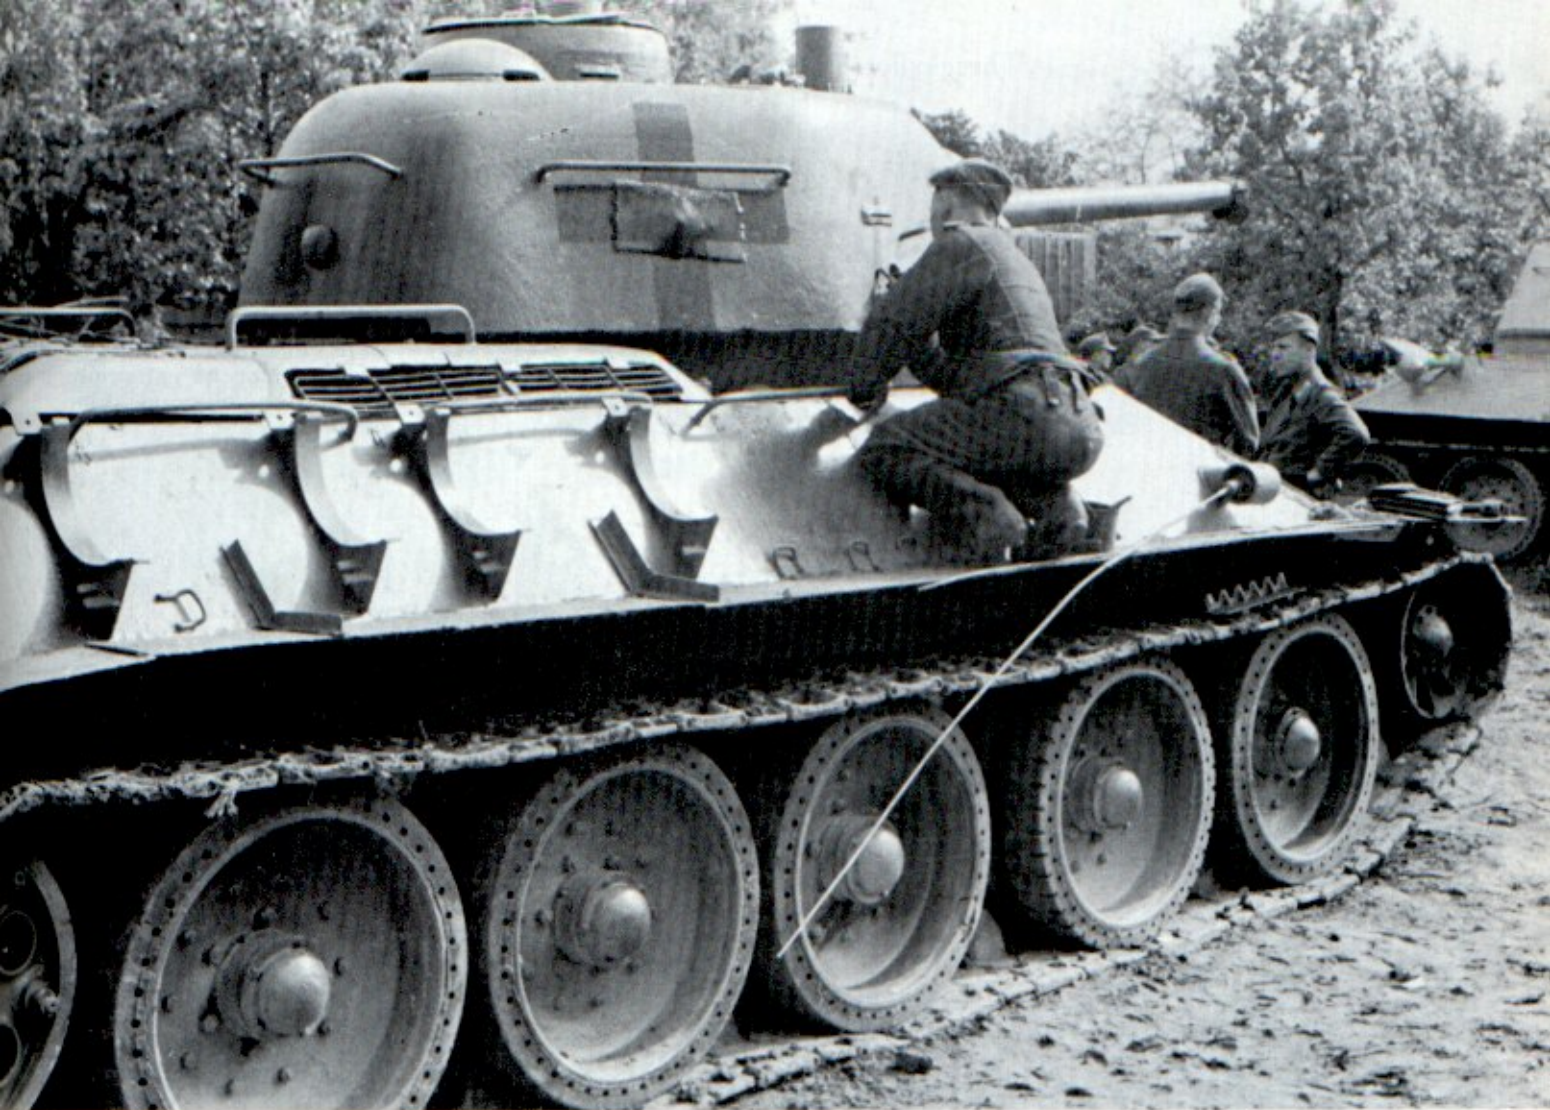
This T34/76 model 43 has been repainted in overall dark yellow, and the black background for the national cross insignia has been applied. The crosses on most captured equipment were oversized. The turret numbers were usually painted by hand, but stencils were used also.

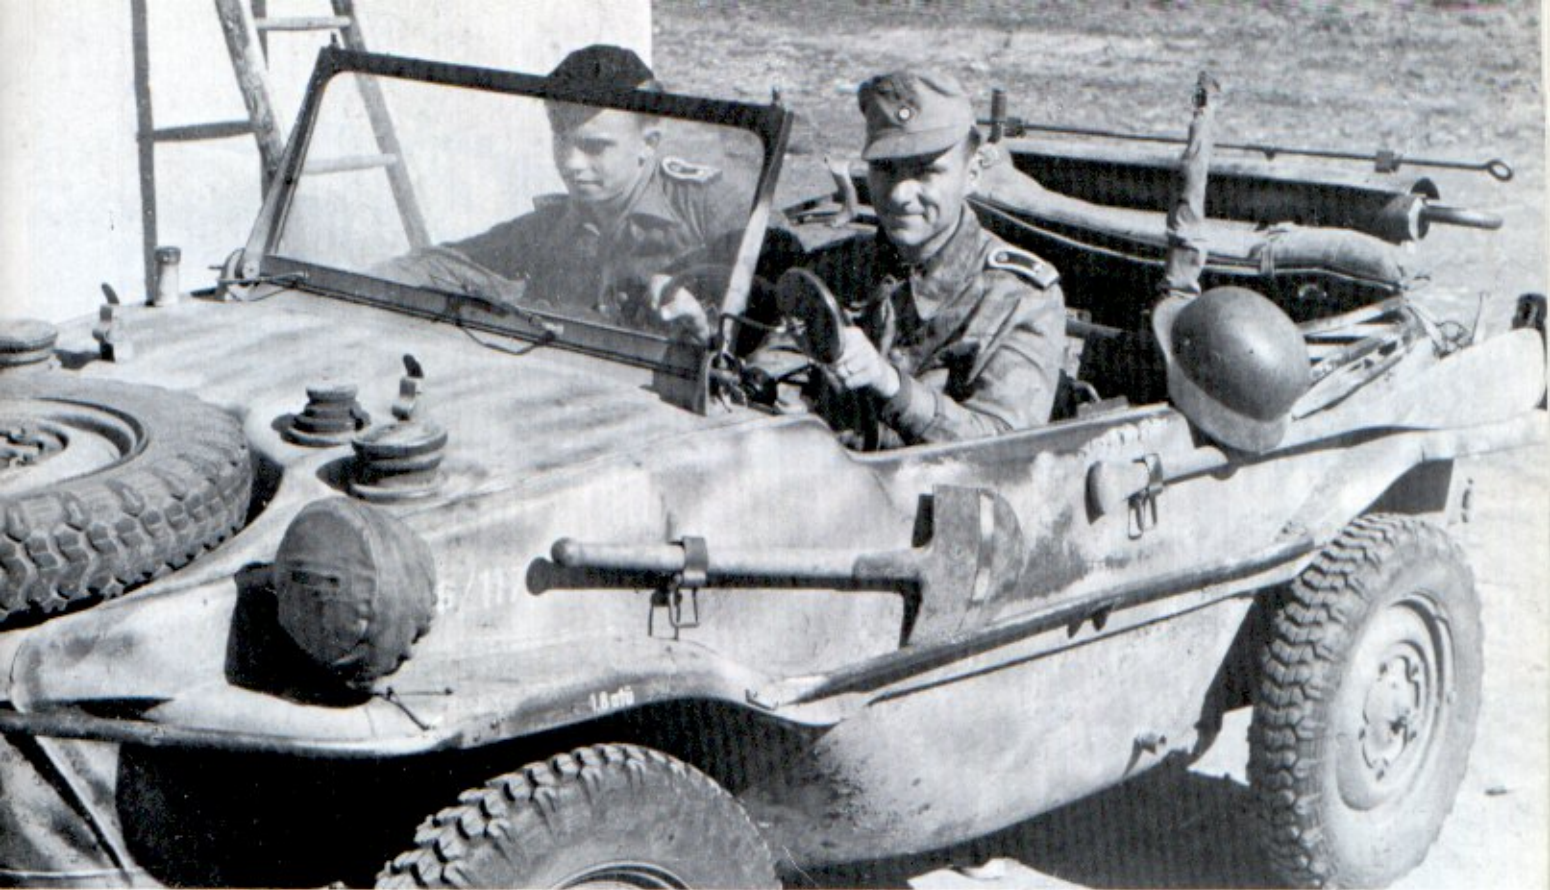
A Schwimmwagen in Russia, showing an extensive sprayed pattern of dark yellow over the dark gray. The yellow has been work away from the upper edges of the body. Paint was often rubbed off corners or protruding structures. [Bundesarchiv]

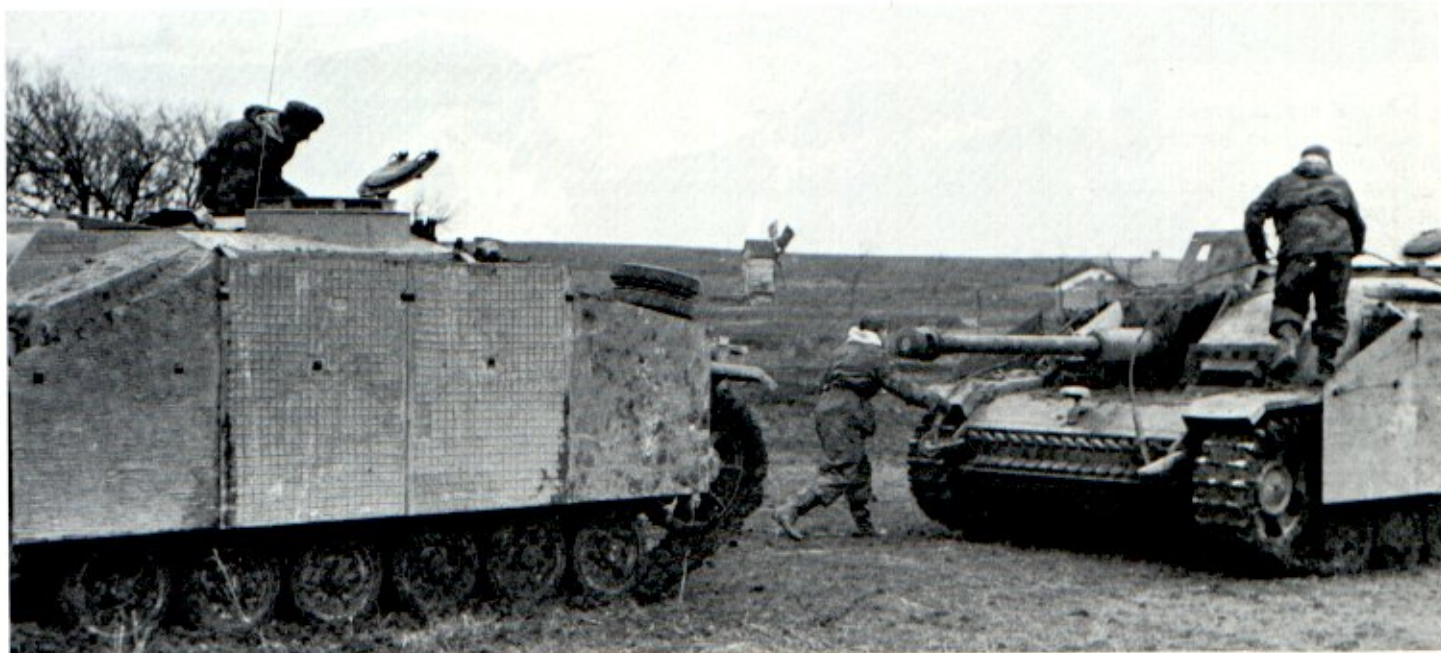
The left vehicle in this photo has a rough coat of zimmerit on the side skirts. Note the different patterns on the front and middle sections. The other vehicle has no zimmerit, but does have cement on the front of the superstructure for increased protection.

At the same time that the new dark yellow/olive green/red brown color system was coming into use, another material developed for use on vehicles appeared. This was "zimmerit", a rough cement plaster, which was intended to roughen the exterior surfaces of vehicles and prevent magnetic antitank charges used by the Russians from clinging to the metal.

Zimmerit was a light neutral gray color plaster, and was applied to the vehicles in the factories before painting. It was

applied to lower hull sides, front and rear plates, and usually on the sides of the upper superstructure and turret. Horizontal plates (roofs, engine decks, etc.) were not covered. On most vehicles, small rakes or patterned rollers were used to apply texture patterns to the zimmerit to make it more effective in repelling magnetic or sticky antitank charges. Since the zimmerit was painted over with the dark yellow base color, it did not affect the color directly except that the texture created small shadows which often made the color look darker and somewhat irregular. From early 1943, zimmerit was applied to most tanks and assault guns, but only rarely to armored S.P. guns, personnel carriers, or S.P. antitank guns. It was largely discontinued by early 1945.

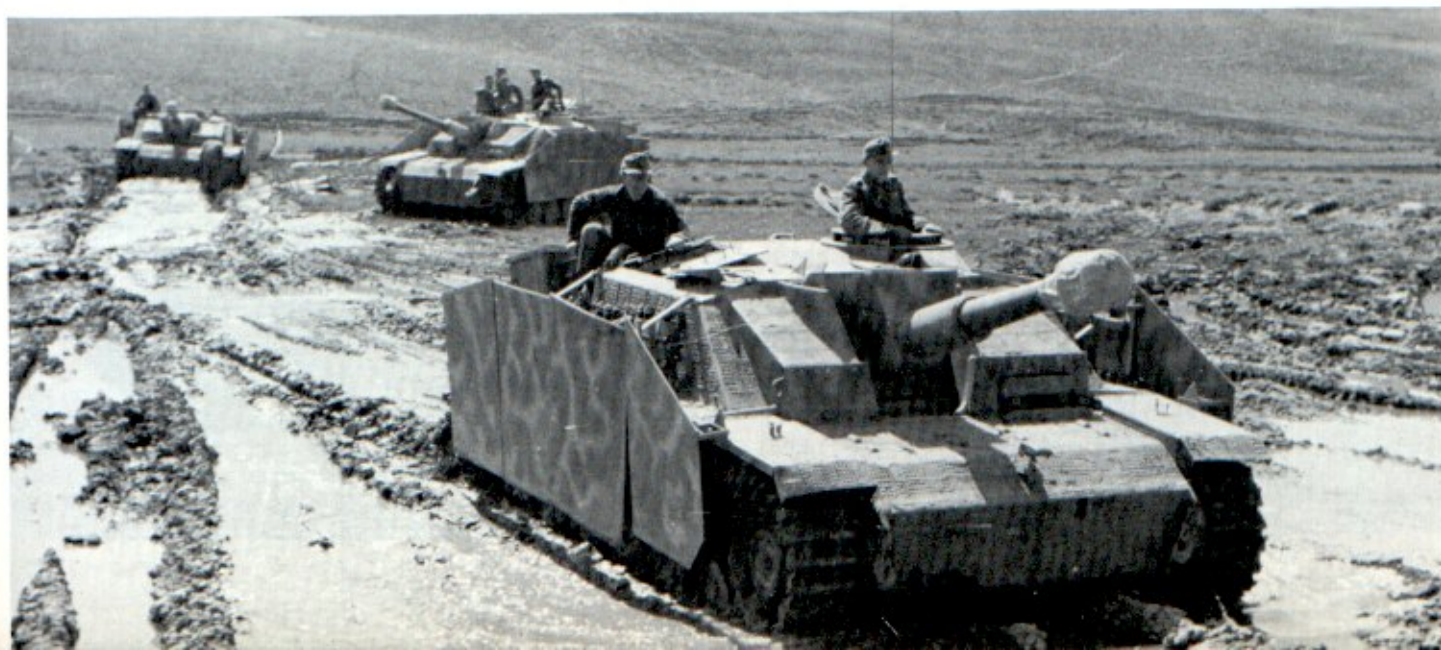
These vehicles in Southern Russia, a Stu H. 42 [10.5 cm howitzer] and a Stu G III G are painted in a scheme of dark green over dark yellow. The sunlight shows very clearly the patterns in the zimmerit coat on the Stu H. 42 in the foreground. Many Stu G vehicles had this "waffle plate" pattern. [Bundesarchiv]

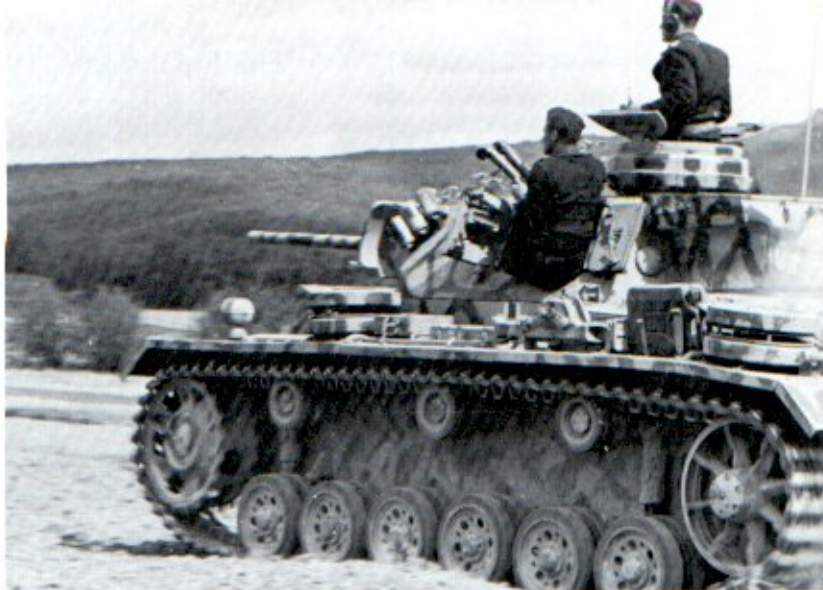
This PzKpfw III ausf M has a web of dark green brushed over the dark yellow base color. The color was usually darker when brushed than sprayed, but dilution of the pastes was as important as the method of application in determining the final colors.

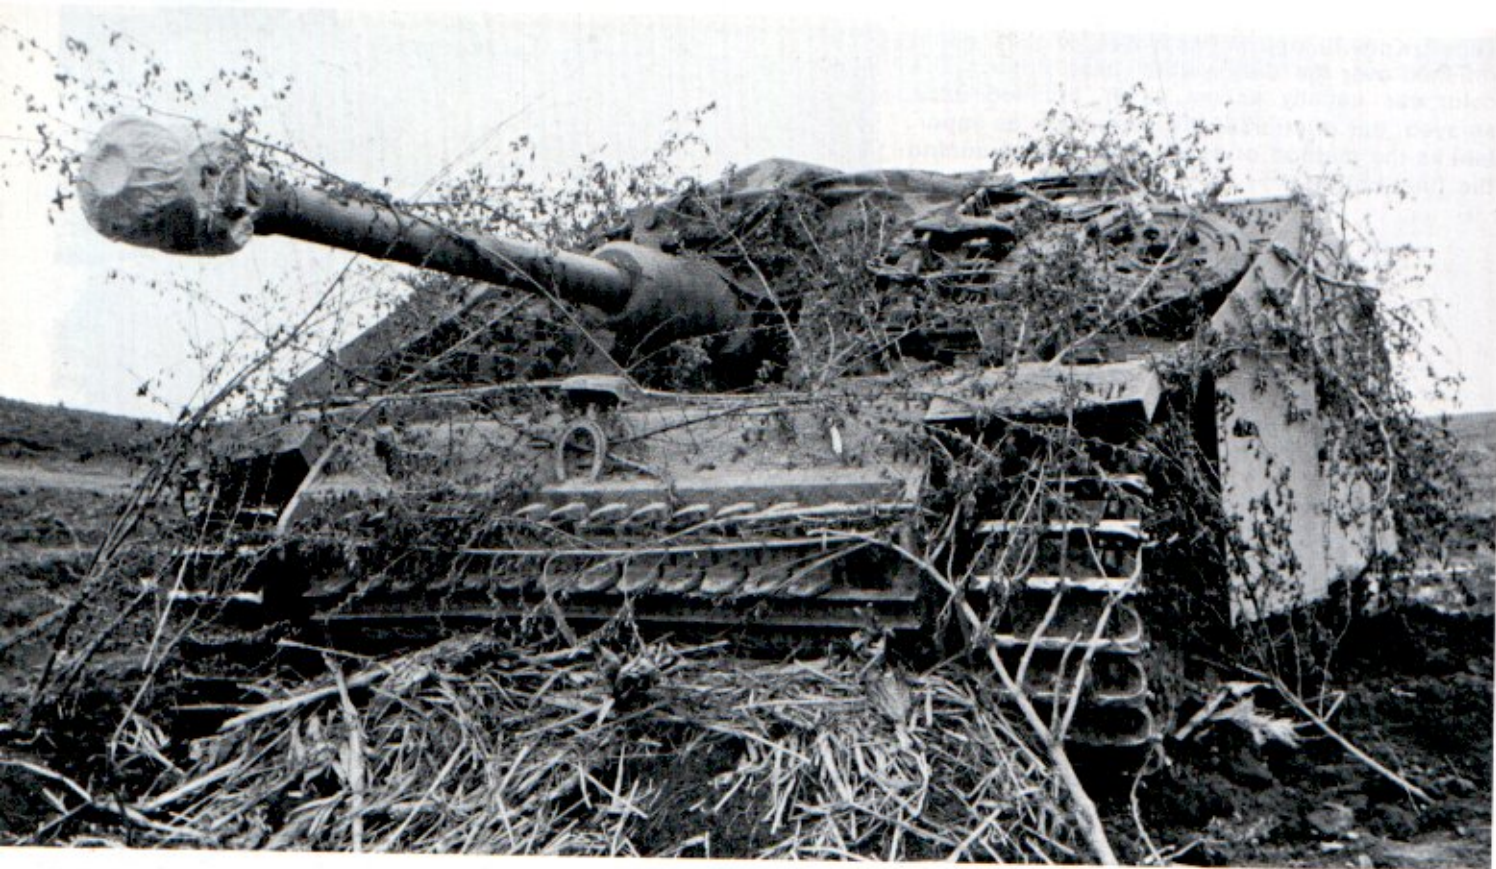
A StuG III ausf G in overall dark yellow, in Russia, 1943. There are no second colors applied, and the main camouflage is provided by the foliage piled around the vehicle. A camouflage tarpaulin is spread on the roof for more effective concealment.

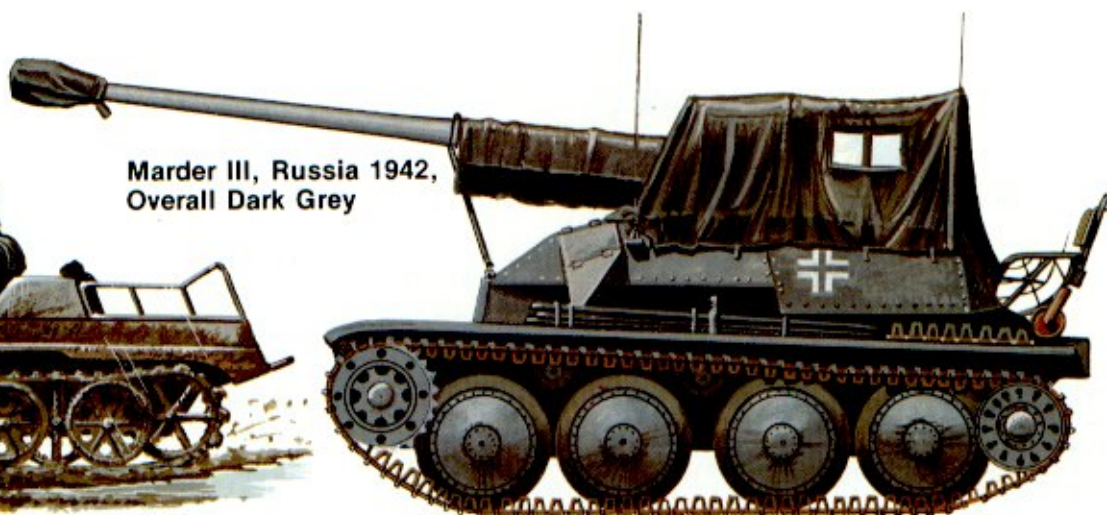
Marder III, Russia 1942,
Overall Dark Grey

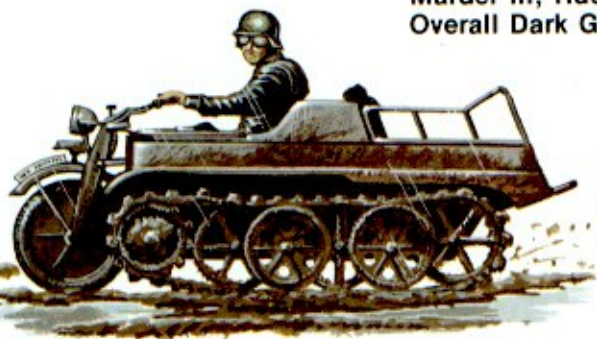
SdKfz 2 [NSU Hk101 Kettenrad],
Russia 1942
Overall Dark Grey
with heavy coat of wet mud

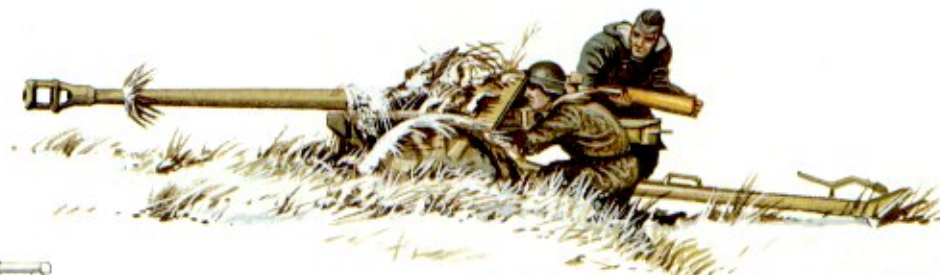
75mm Pak 40, Russia, Winter 1942-43
Overall Dark Yellow
with straw and foliage to hold snow

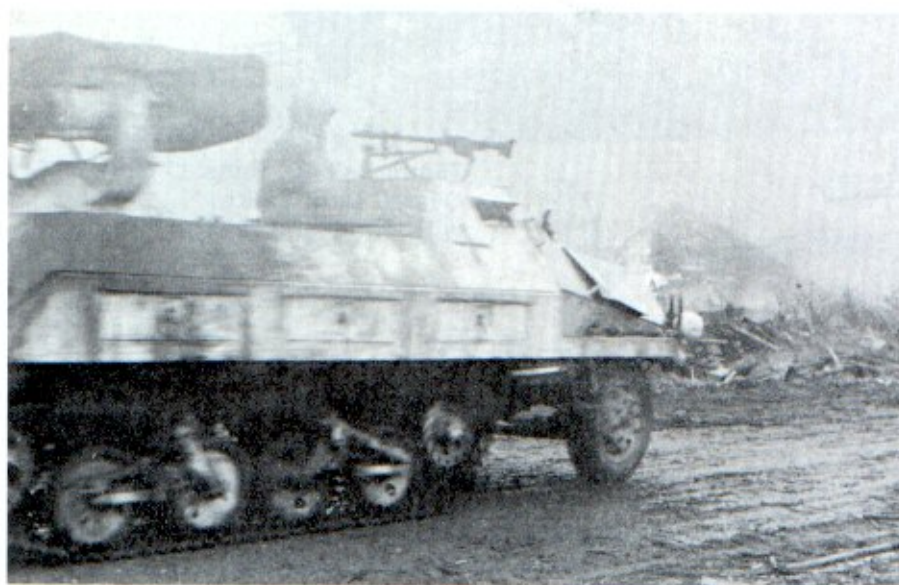
A snow-camouflaged Opel "Maultier" armored halftrack passes through a ruined Russian village. The white paint is badly worn away from the rear, probably by the effect of firing the 15 cm rocket projectiles. [Bundesarchiv]

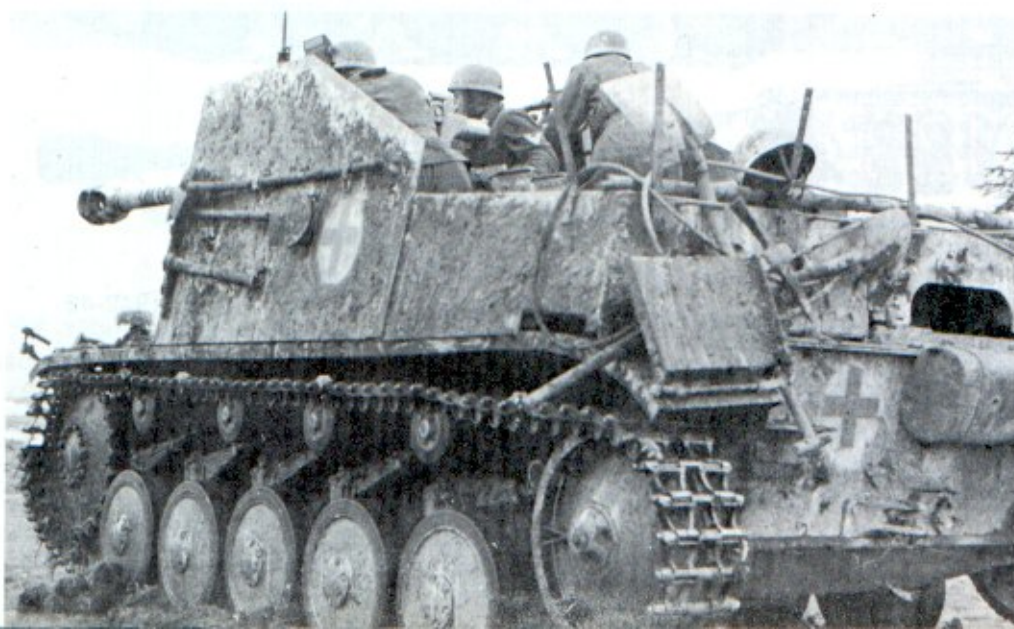
This Luftwaffe Marder II has been painted in snow camouflage over a dark yellow base. To hide the white paint, wet mud has been smeared over the whole vehicle. Note the insignia, left untouched by the white paint and the mud. [Bundesarchiv]

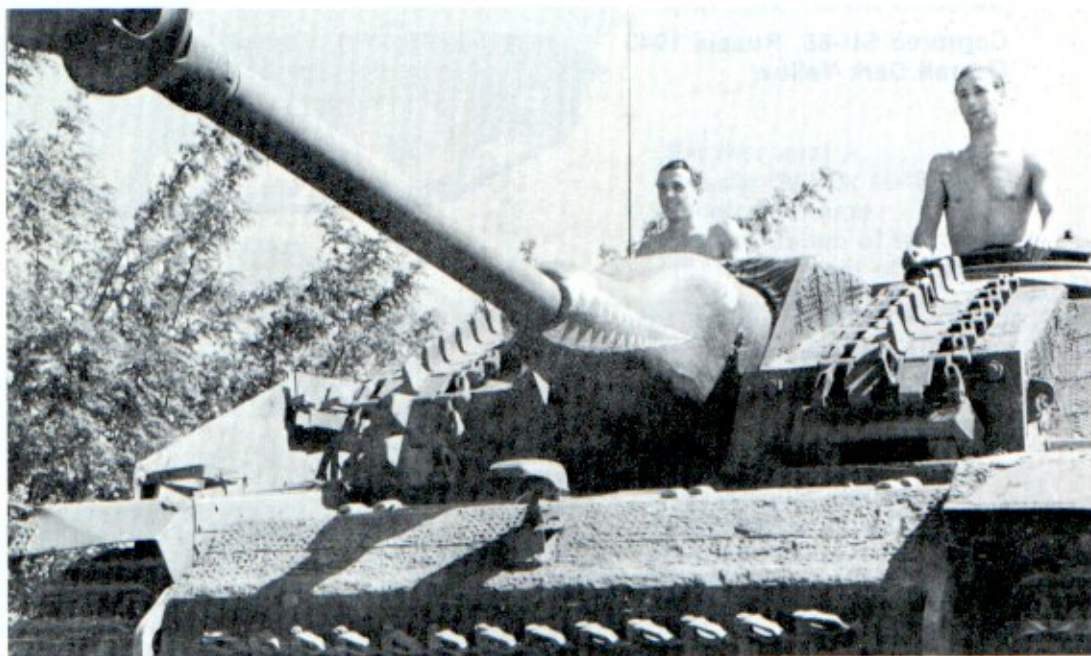
This StuG III ausf G is in overall dark yellow. The "Waffle plate" pattern in the zimmerit can be seen clearly. The mouth and eyes on the cast mantlet are in red and white.

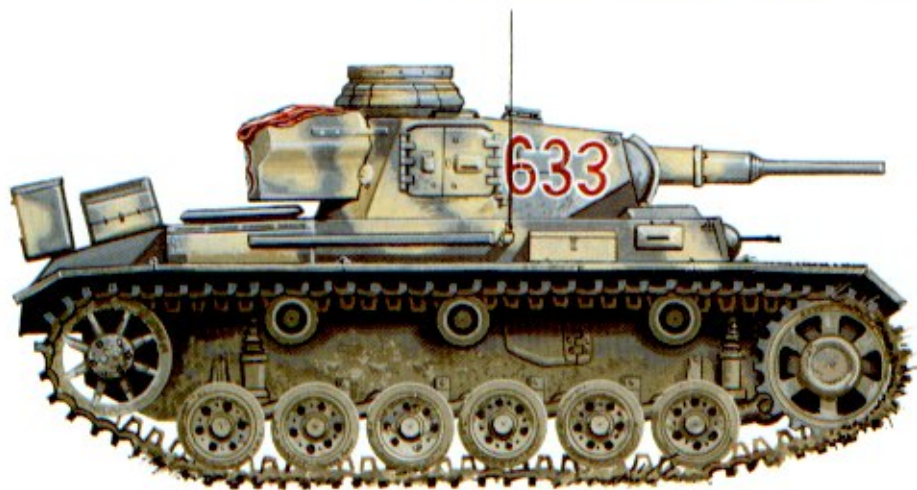
PzKpfw III ausf J,
Kursk, Russia 1943
Overall Dark Grey
with Dark Yellow overspray
and mud on chassis

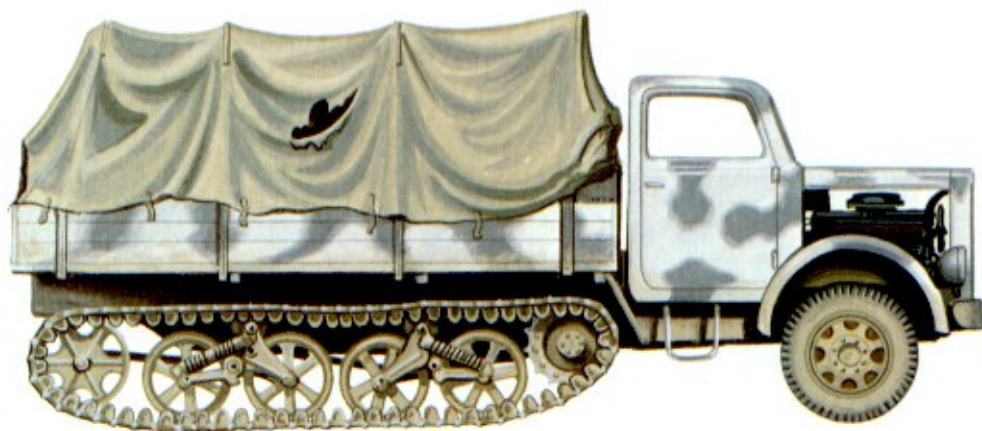
Magirus Maultier,
Russia 1943
Overall Dark Grey
with White winter overspray

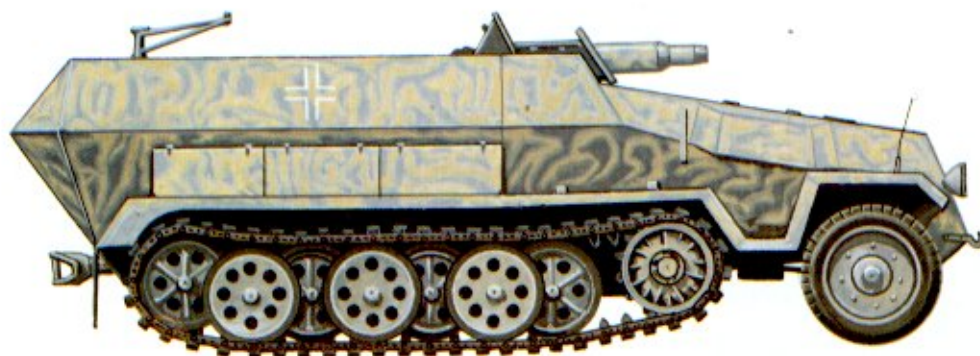
SdKfz 251/9c, Russia 1943
Overall Dark Grey
with Dark Yellow overspray

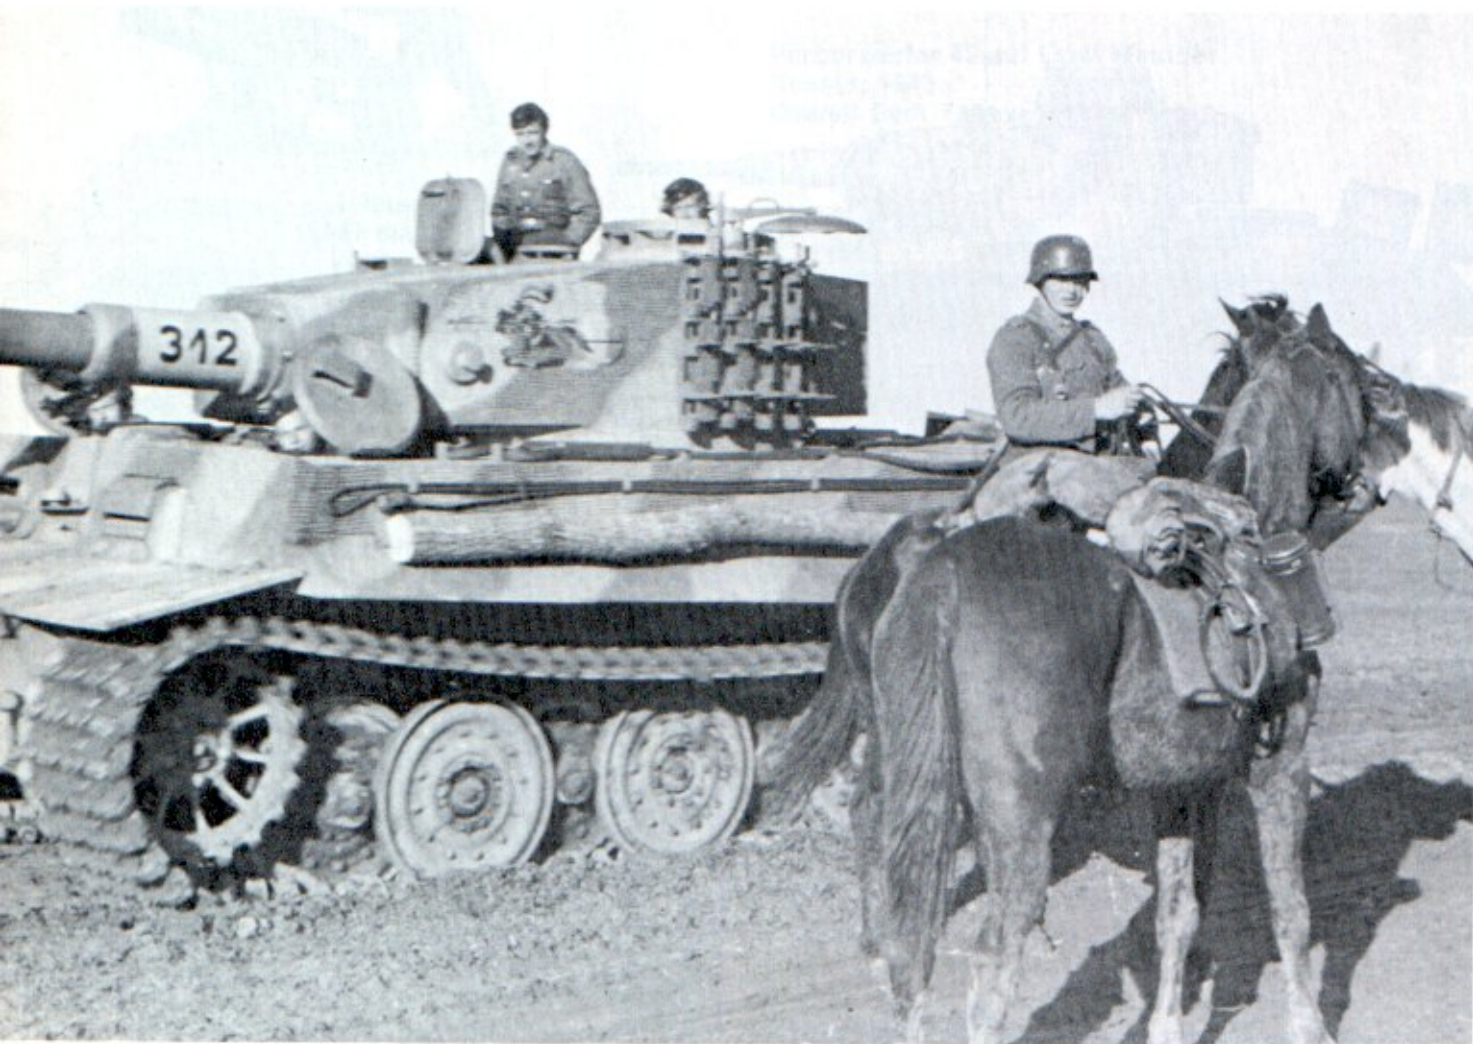
A late production Tiger I ausf E passes several cavalry horses, often used by rear area troops for police or partisan duties. The tank is dark yellow and red brown. The number on the gun is black. Note the neatly painted charging knight on the turret side. The horse is black, and the horse's long blanket is in red brown. Dark yellow is used as the background color. [Bundesarchiv]

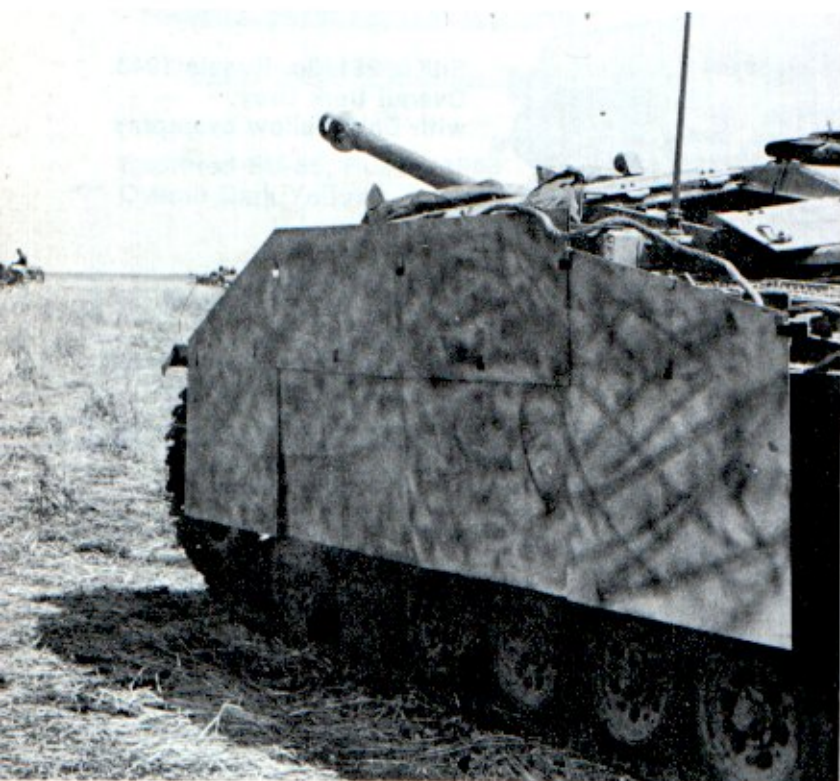
This StuG III ausf F in Russia is painted dark yellow. A very fast and rough pattern of sprayed strokes in olive green has been applied to the skirts. Very little time was allotted to this job. [Bundesarchiv]

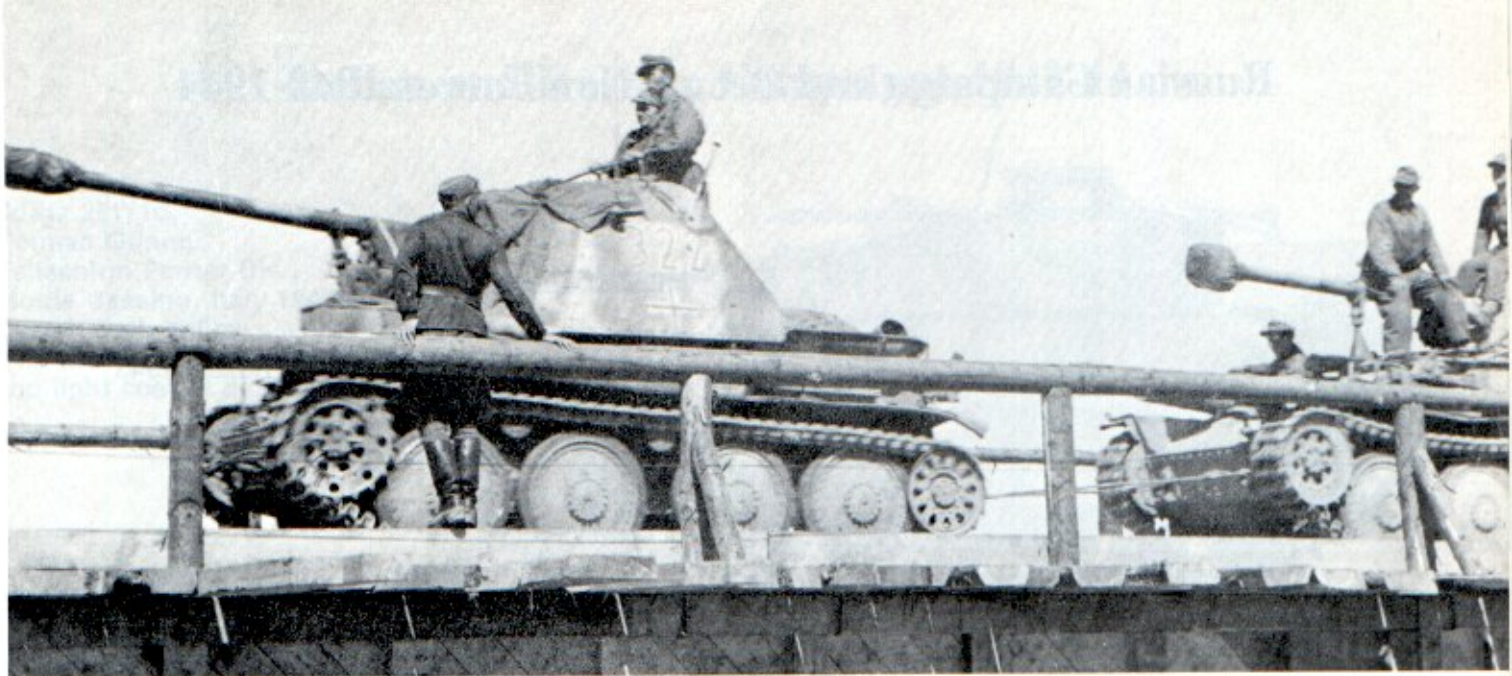
Two Marder III's move across a bridge in Russia. The lead vehicle, an ausf H, is in dark yellow with sprayed patches of olive green and red brown - a very clean application of the paste colors. [Bundesarchiv]

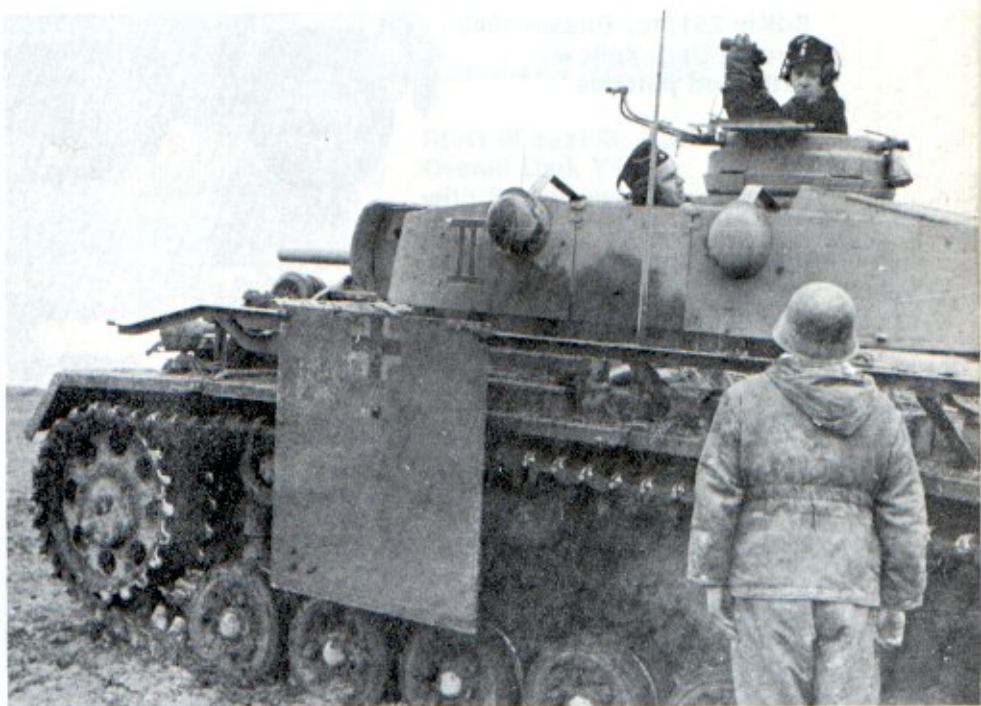
An upgraded early PzKpfw III, possibly an F or G, and used as a command tank, shows the effects of mud being thrown up on the vehicle. The dark areas are wet mud; the lighter areas are dust-covered dark yellow paint. The "II" is in red and white. [Bundesarchiv]

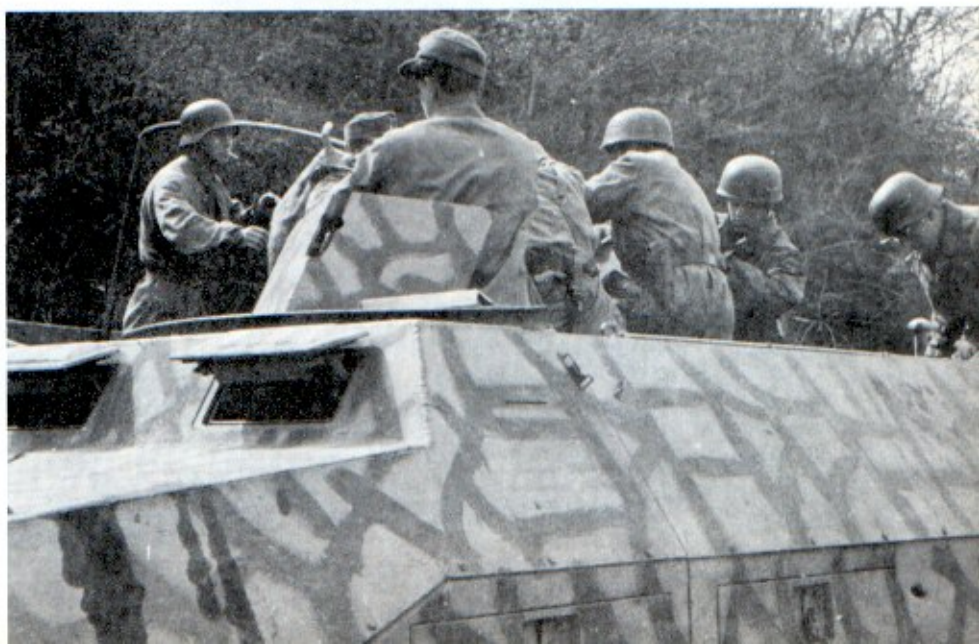
This SdKfz 251/1 ausf D, probably of "Hermann Göring" Panzer Division, is painted in dark yellow. A brushed on pattern of red brown stripes breaks up the flat sides, and blends in with the rocks and soil around Monte Cassino. [Bundesarchiv]

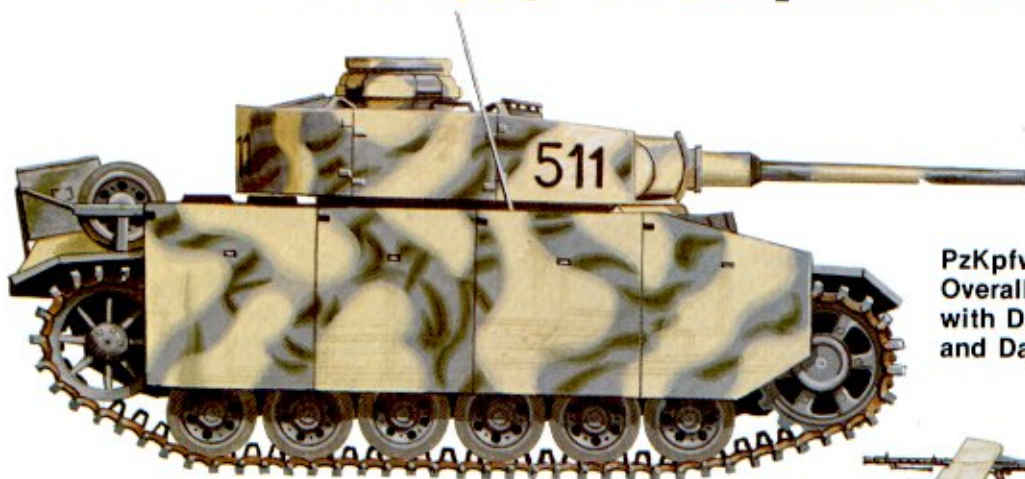
PzKpfw III ausf L, Russia 1943
Overall Dark Gray
with Dark Green stripes
and Dark Yellow overspray

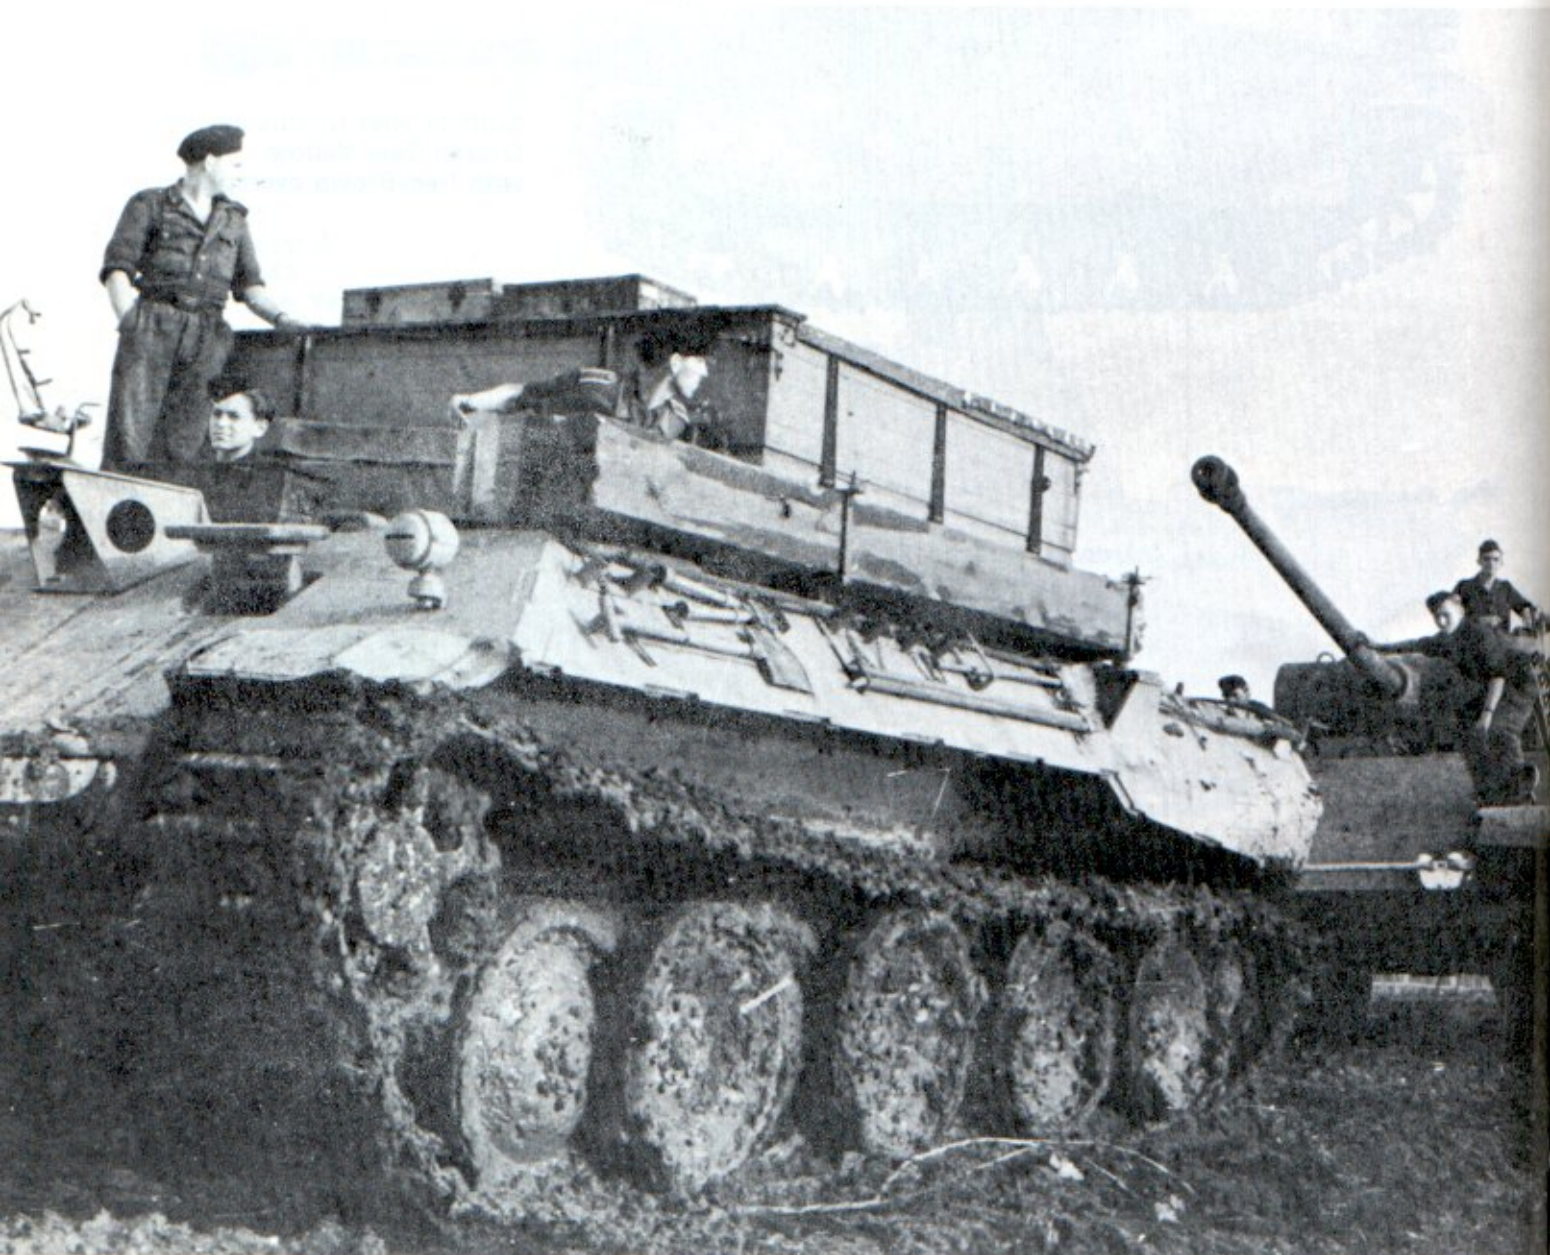
A Bergepanther recovery vehicle tows a disabled Panther ausf G. Both vehicles are dark yellow. Note the tow hook at the front of the Bergepanther - two vehicles are towing the Panther. An anti-aircraft MG mount has been attached to the base for the jib, on the glacis plate. [Bundesarchiv]

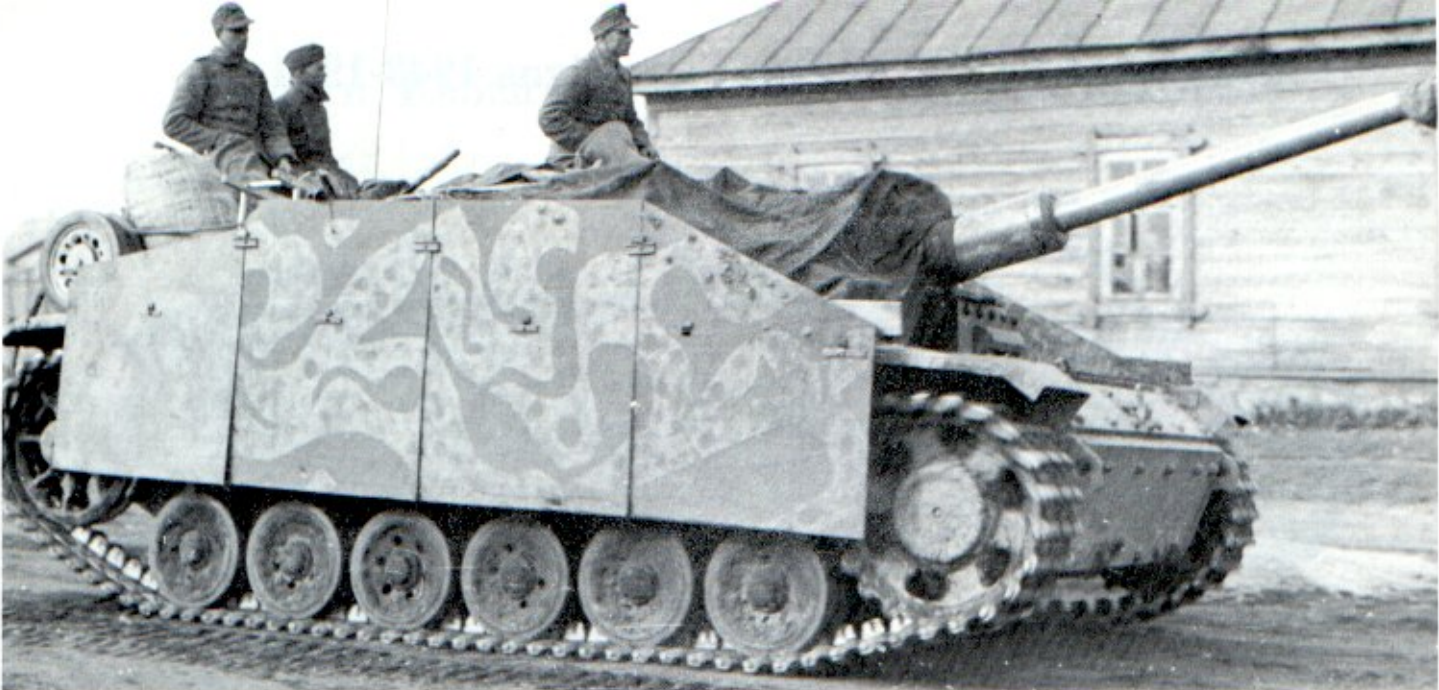
A superb example to prove that almost anything goes, this StuG III ausf G was photographed during the Kursk offensive. Picasso obviously had an admirer in this crew. The patterns are red brown and olive green over dark yellow, the red brown being lighter in this case. [Bundesarchiv]

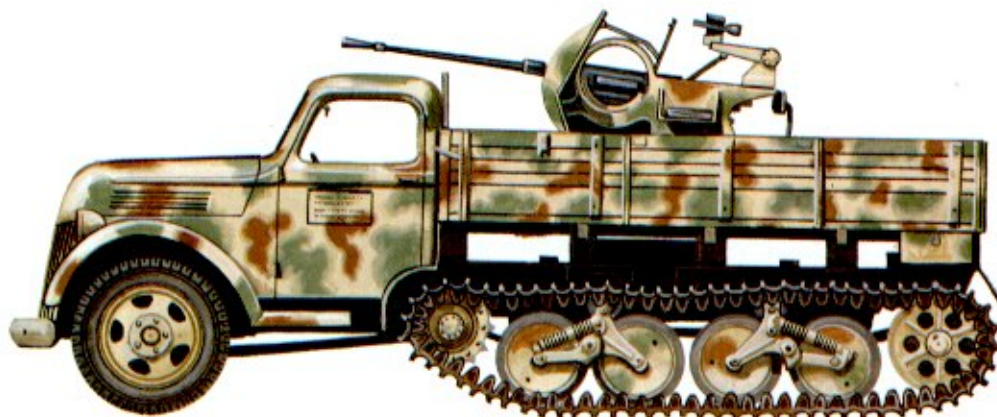
Ford Maultier
with 20mm Flak 38,
France 1944
3 Color scheme

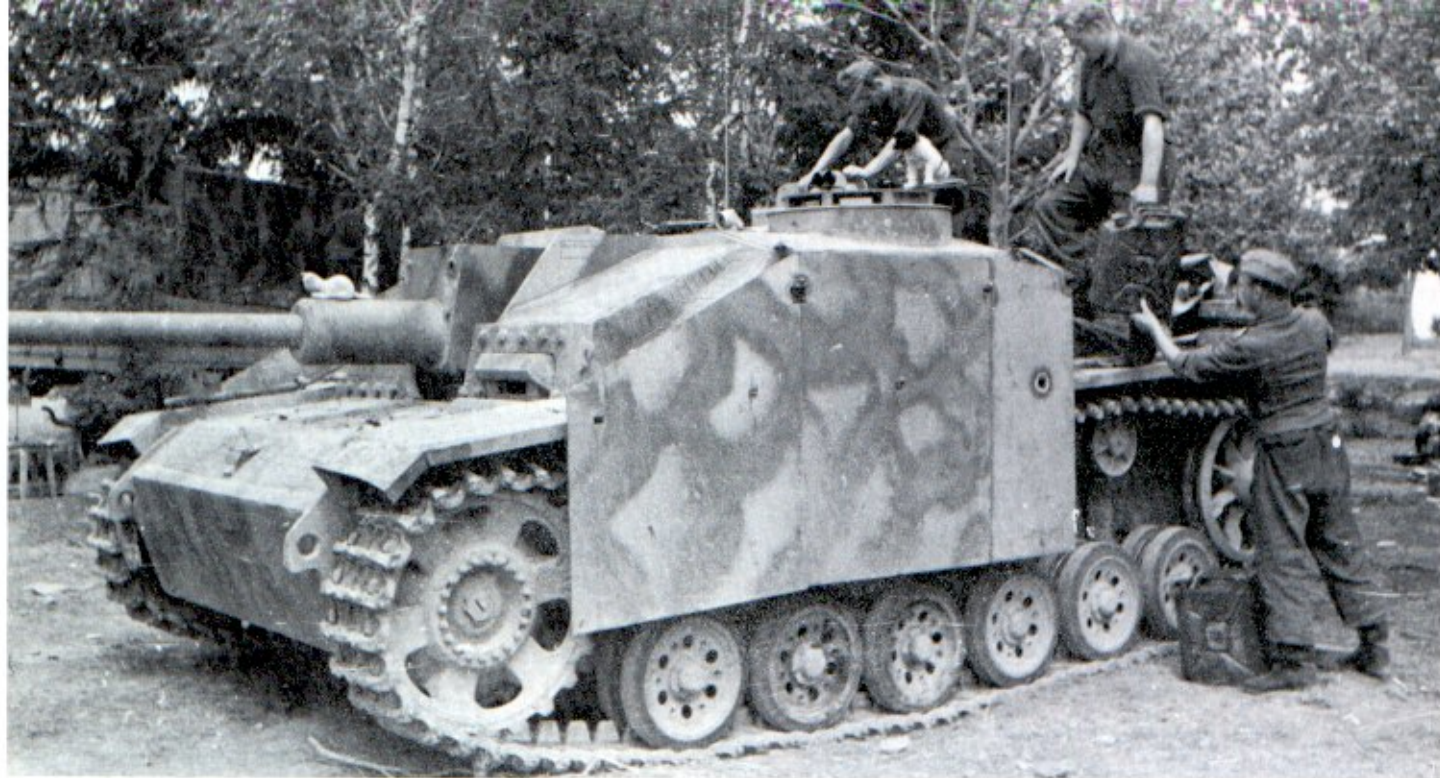
This StuG III ausf G has a scheme found often in southern Russia and Rumania. Base color is dark yellow. Red brown is sprayed in connected patches with olive green outlines. [Bundesarchiv]

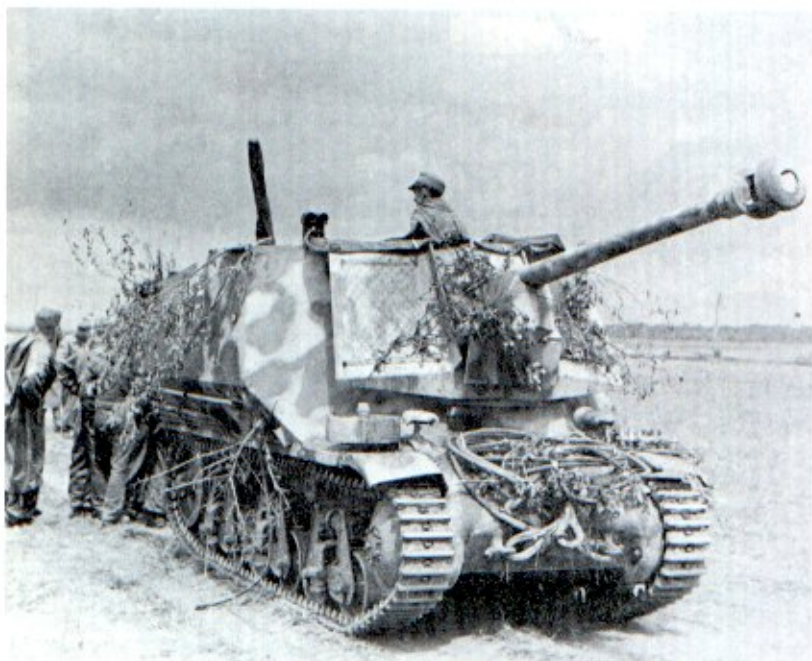
A "Marder I", built on a Hotchkiss H35 chassis, has red brown and dark olive green sprayed over dark yellow. Note the use of chain link fencing to attach extra foliage. [Bundesarchiv]
