Panzer Colors

Camouflage of the German
Panzer Forces 1939-45

by Bruce Culver & Bill Murphy
illustrated by Don Greer

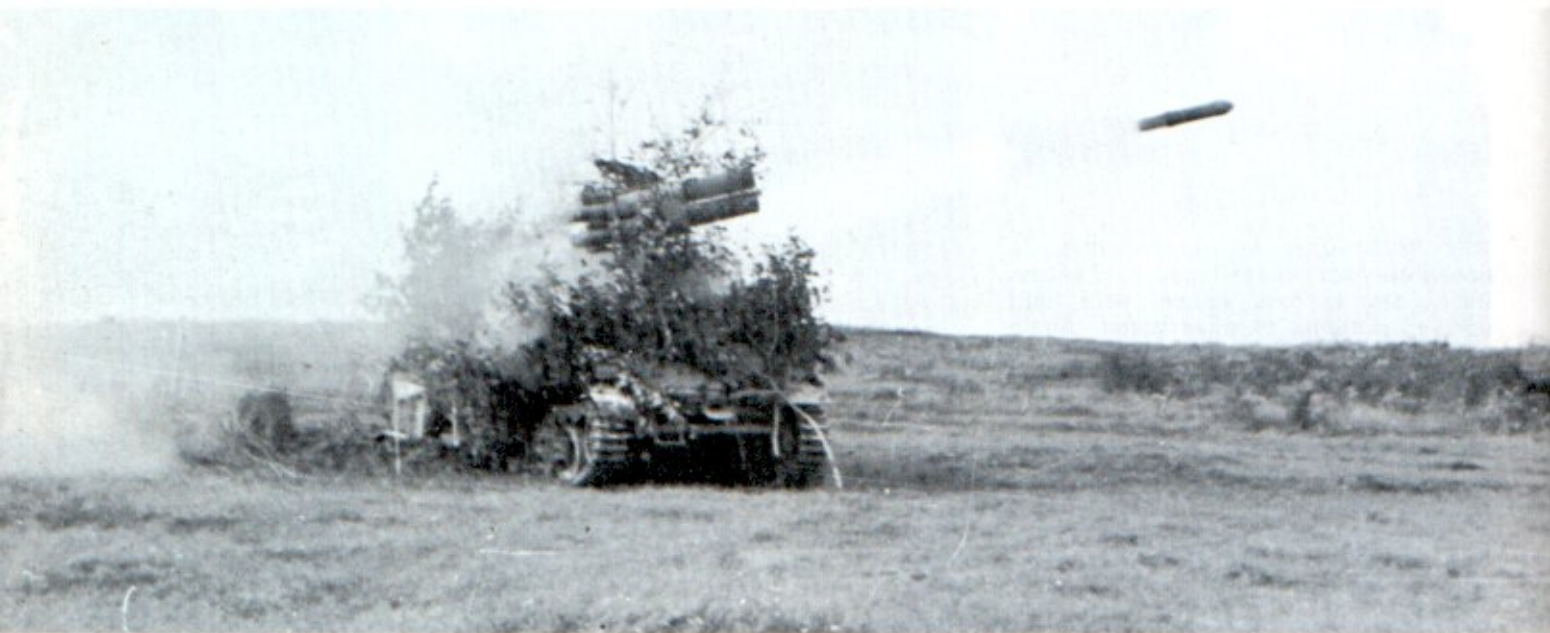
An Opel "Maultier" Panzerwerfer 42 at the moment of firing a 15 cm rocket. Very heavy foliage has been used on and around the vehicle to make it appear to be a small cluster of trees or bushes. The vehicle is dark yellow. [Bundesarchiv]

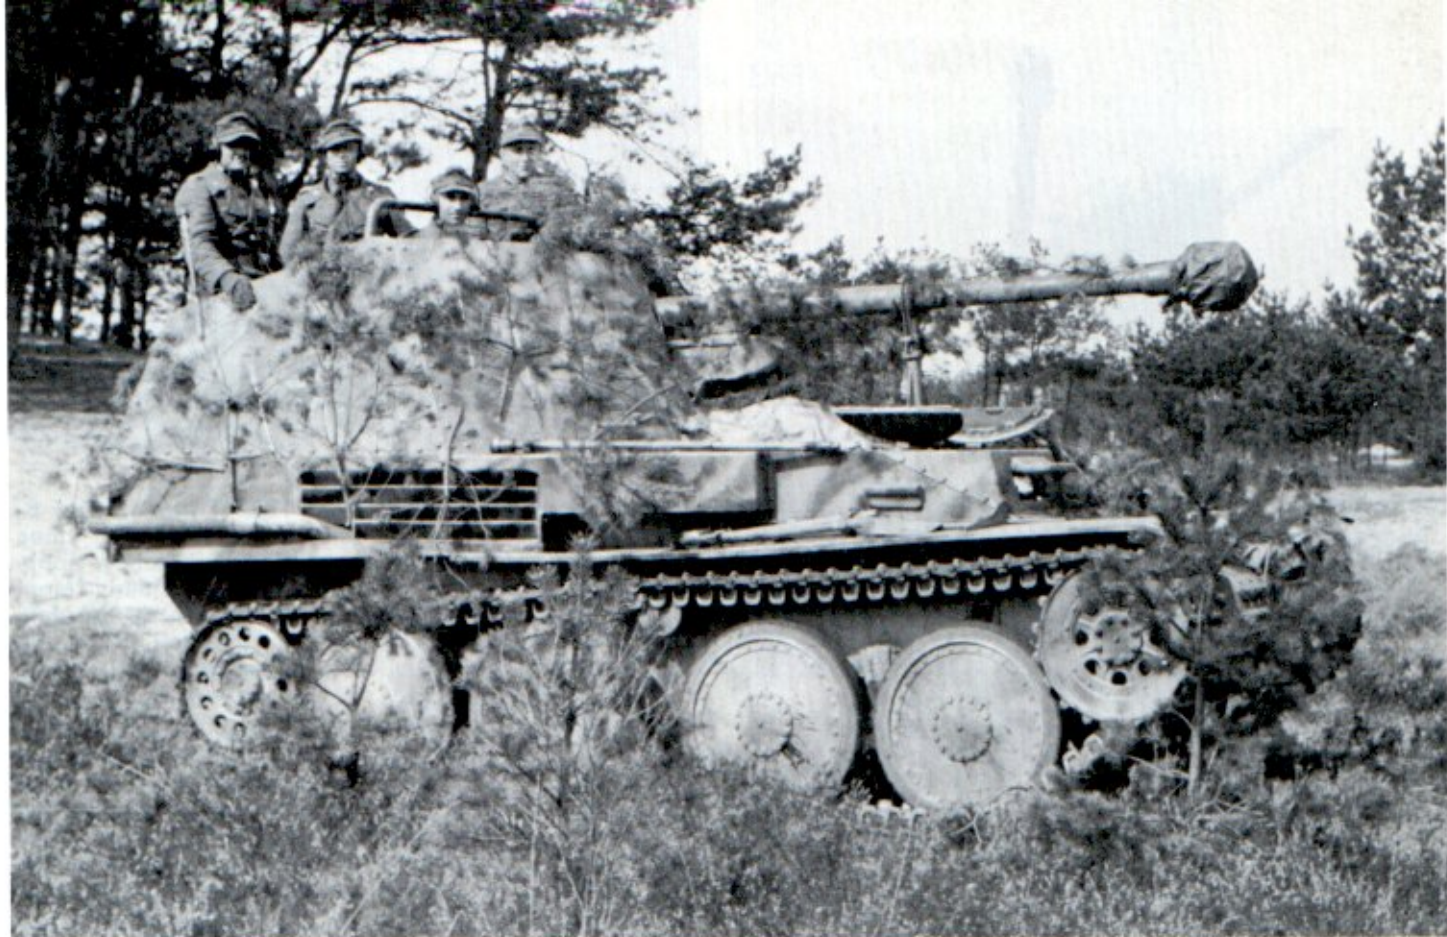
A "Marder III" ausf M with branches from pine trees for extra camouflage. Olive green has been sprayed over the dark yellow. [Bundesarchiv]

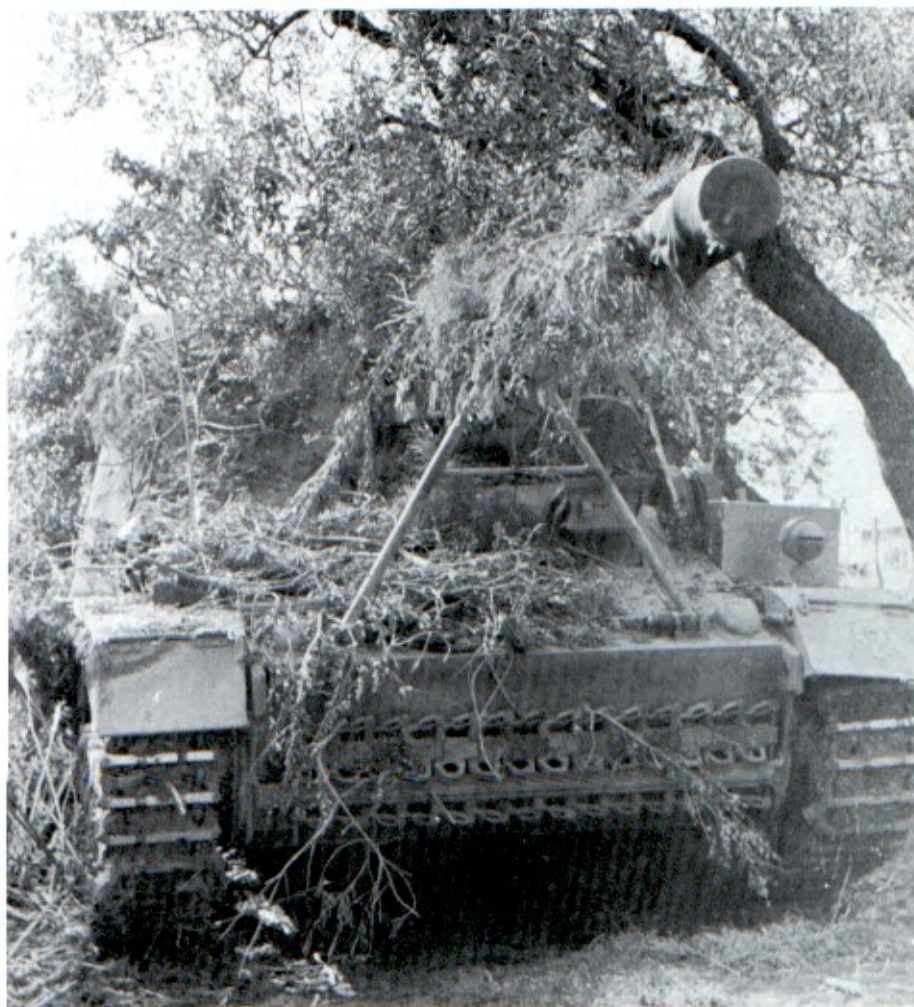
A "Hummel" parked in a roadside shelter. Foliage breaks up the vehicles shape and extra branches have been laid around the chassis to hide the wheels. Colors are dark yellow and light sprays of olive green. [Bundesarchiv]

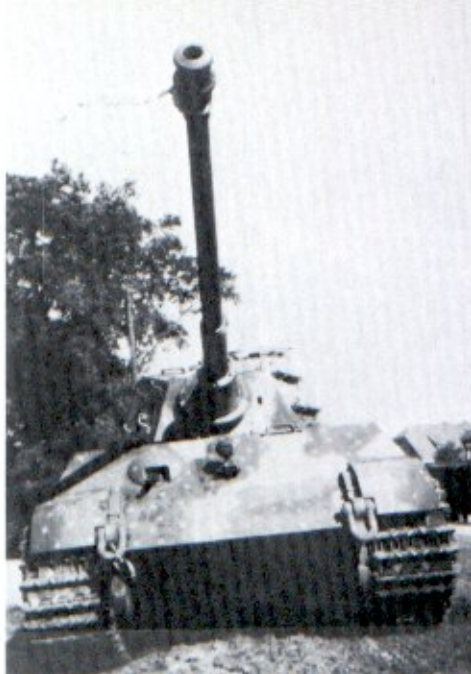
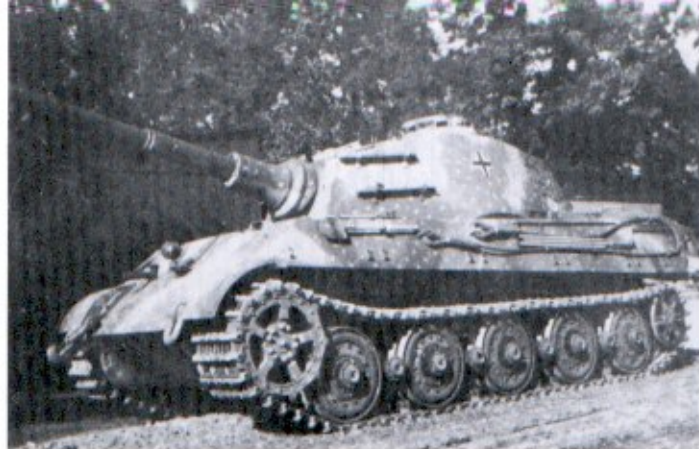
Two different views of a Royal Tiger [Tiger II ausf B] painted in the late war "ambush" scheme. All three colors are used, and the contrasting dark yellow spots on the olive green and red brown show up clearly. Most of the green and red brown spots that are on the dark yellow base have not photographed as well. Note this vehicle has narrow transportation tracks.

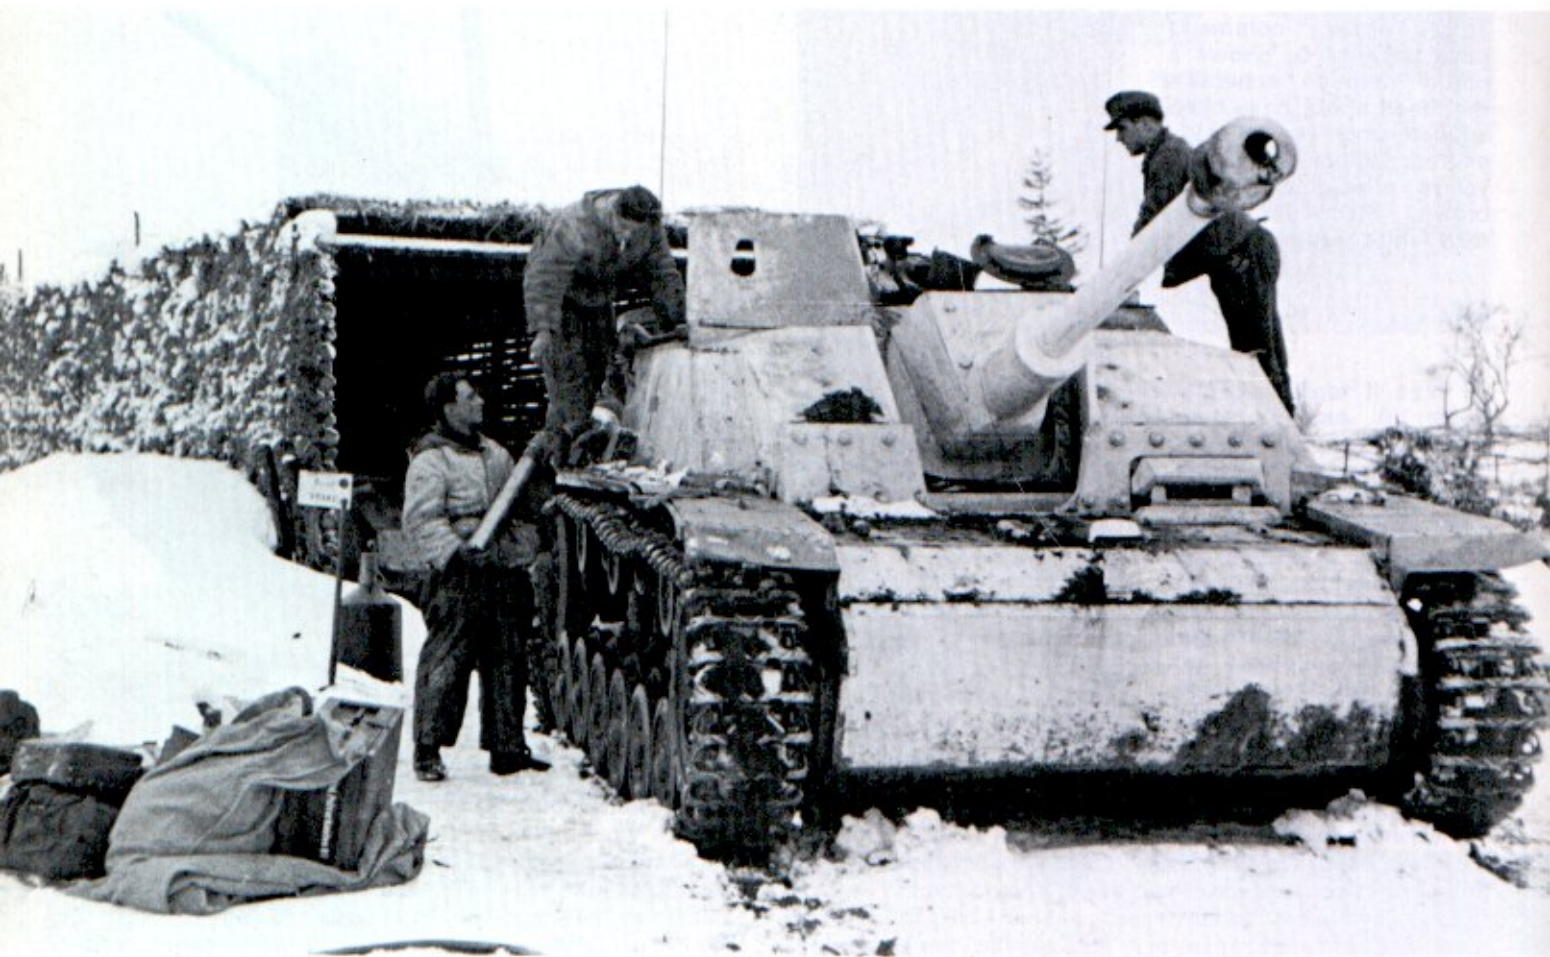
The white camouflage on the StuG III ausf G is badly deteriorated. In particular note the large camouflage "blind" behind the vehicle. The StuG III was normally parked in the "blind" for better concealment. [Bundesarchiv]

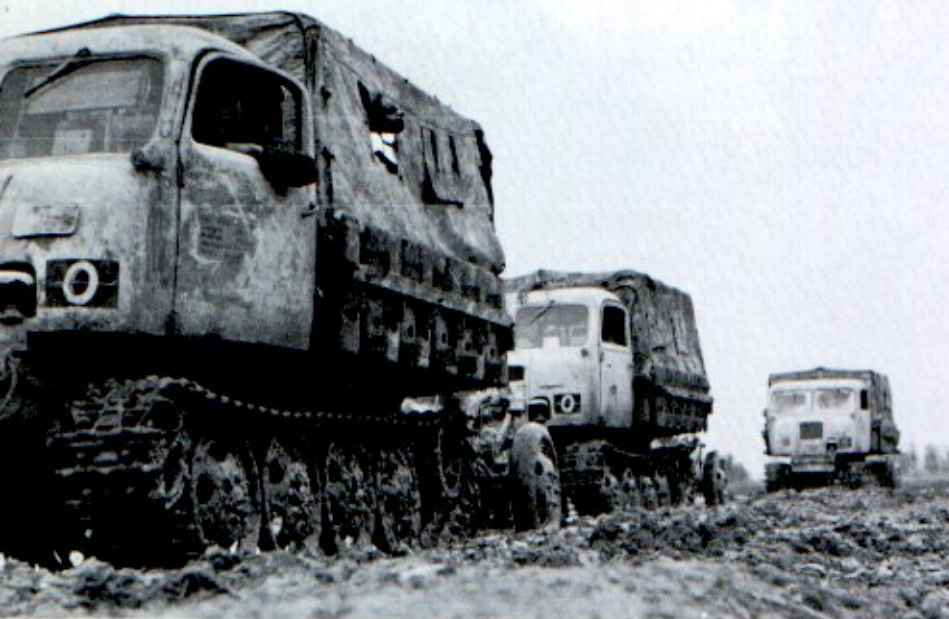
These Steyr Raupenschlepper Ost [RSO] trucks move through thick mud. Their white camouflage paint is wearing off. Many crews didn't remove the paint, but just stopped touching up the defects, and let it wear off gradually. [Bundesarchiv]

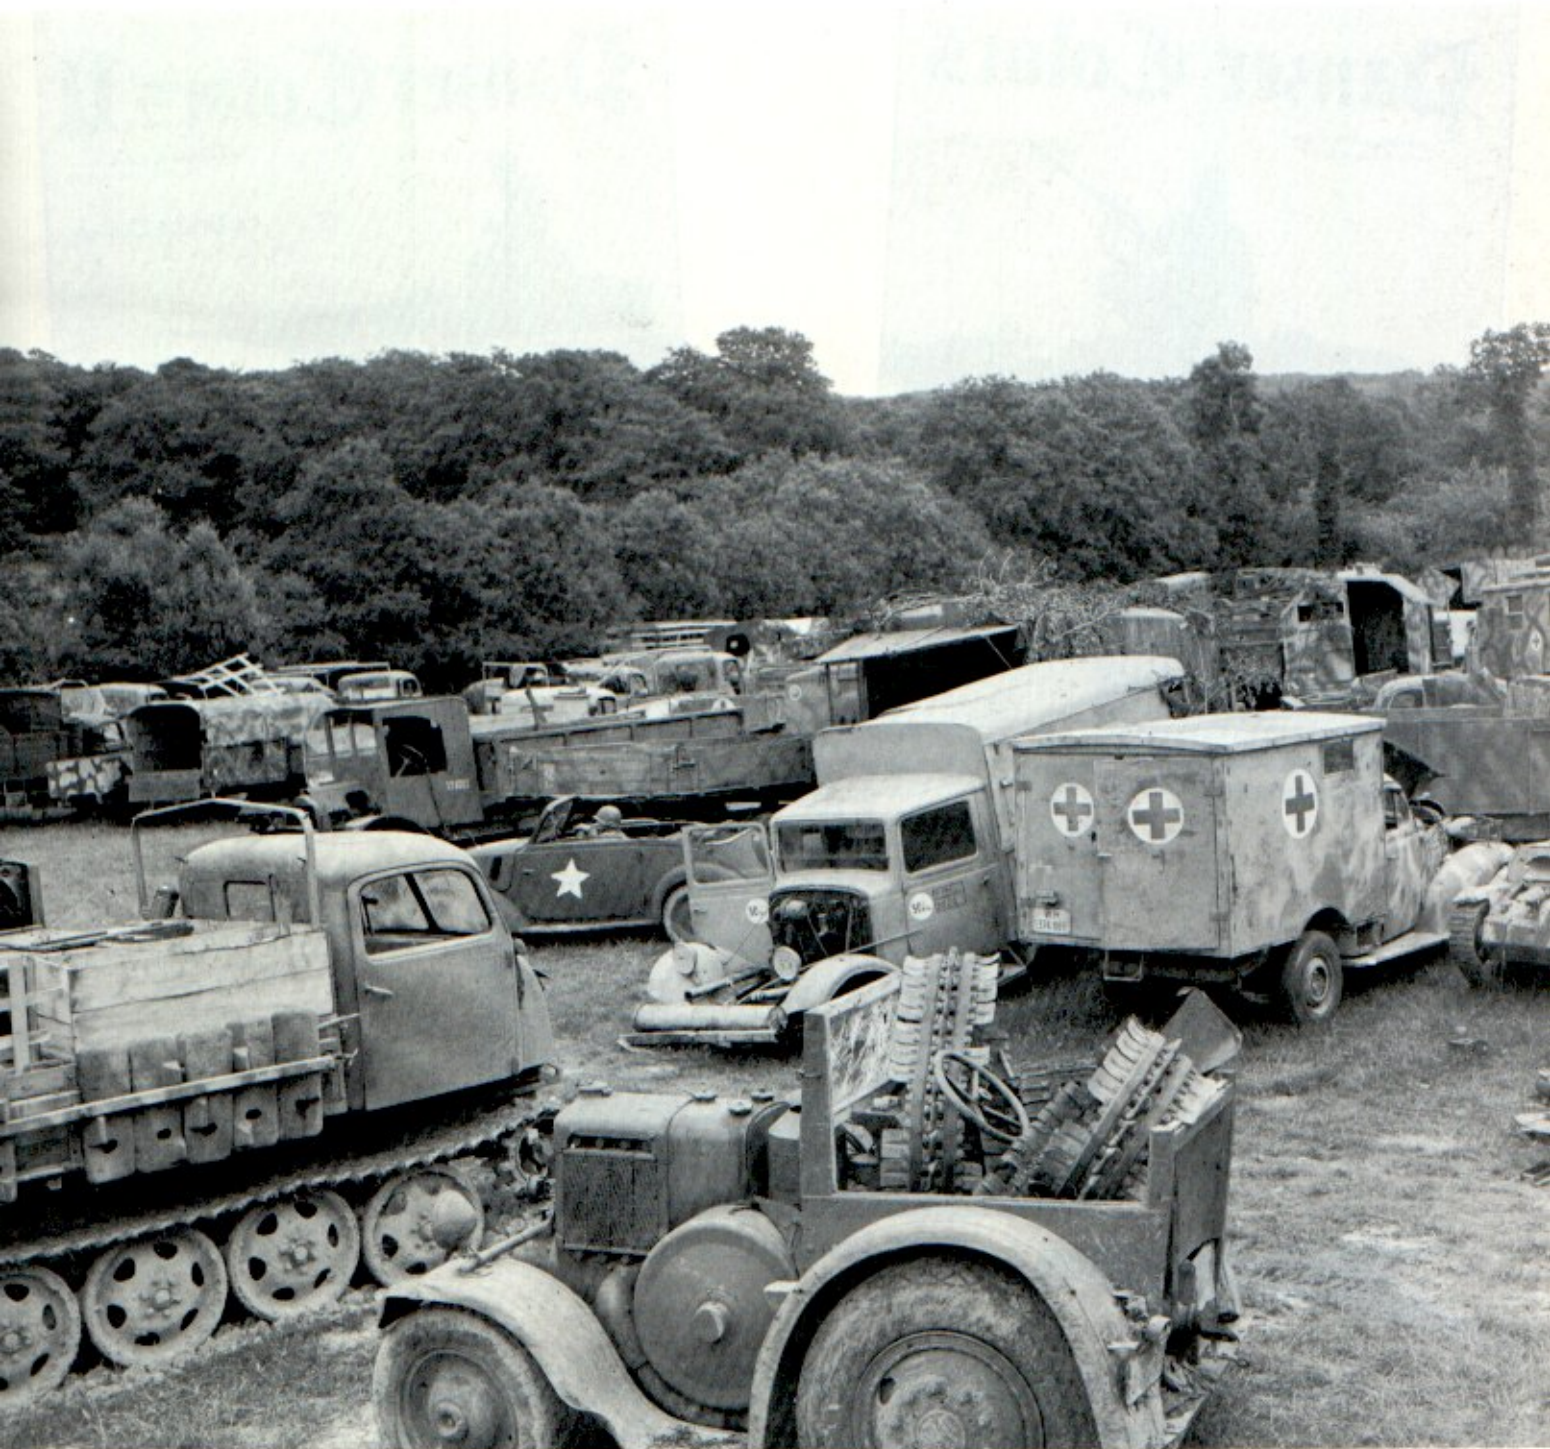
The vehicles in this abandoned German vehicle dump display considerable variety in patterns and colors. German, French and Italian-made vehicles are all found in this group. The ambulance in the right center of the picture has been converted by cutting off the rear body of an ordinary sedan and adding a box body for an ambulance. One small car, still running, has been marked with a very crude white U.S. star.
