Panzer-Division 1935-1945

(3) War on Two Fronts 1943-1945

Robert Michulec

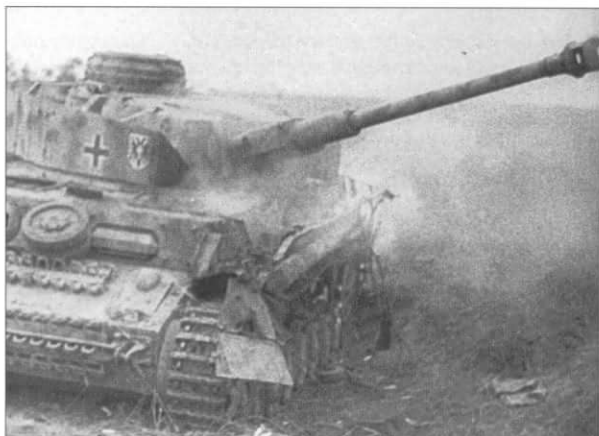
Most German tanks were lost in groups due to surprise fire from camouflaged batteries of enemy anti-tank guns. During the first days of the offensive many damaged German tanks were recovered and repaired because they held the newly captured ground. Later, after the Soviet counter-attack began, most damaged tanks were lost when the Germans were forced to give up the battlefield now littered with the remains of many damaged tanks. Here, a late Pz.Kpfw.IV Ausf.G or early Ausf.H from Pz.Rgt.3 of 2.Panzer-Division, still smolders after being hit in the left side. Note the additional 30mm armor plate bolted to the front of the superstructure. It is painted in dark sand with a camouflage pattern of green spots and carries the regimental emblem, a black two headed eagle in a white shield with a white cross on a small red shield on the eagle's breast, on the turret skirt armor along with the standard Balkenkreuz. Pz.Rgt.3 began Operation 'Citadel' with 118 tanks, including 60 Pz.Kpfw.IV, and fought in the Orel sector.

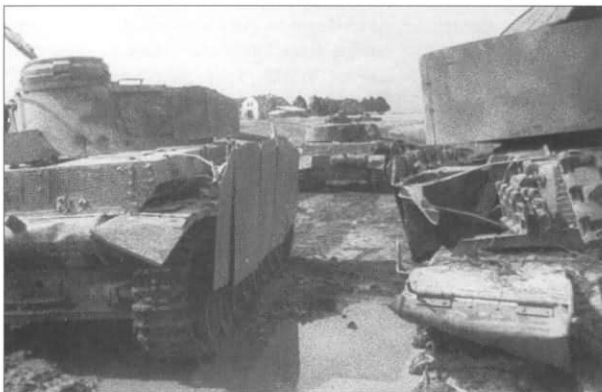
Three Pz.Kpfw.IV Ausf.H destroyed by Soviet anti-tank fire - note the two impacts on the rear of the turret of the tank on the left. They are covered with zimmerit, an anti-magnetic mine coating which began to be applied at the factory to most German tanks and assault guns beginning in September 1943. In addition to the standard extra track links placed by the crew in front of the superstructure for extra protection, two T-34 waffle pattern track links can also be seen along the side.

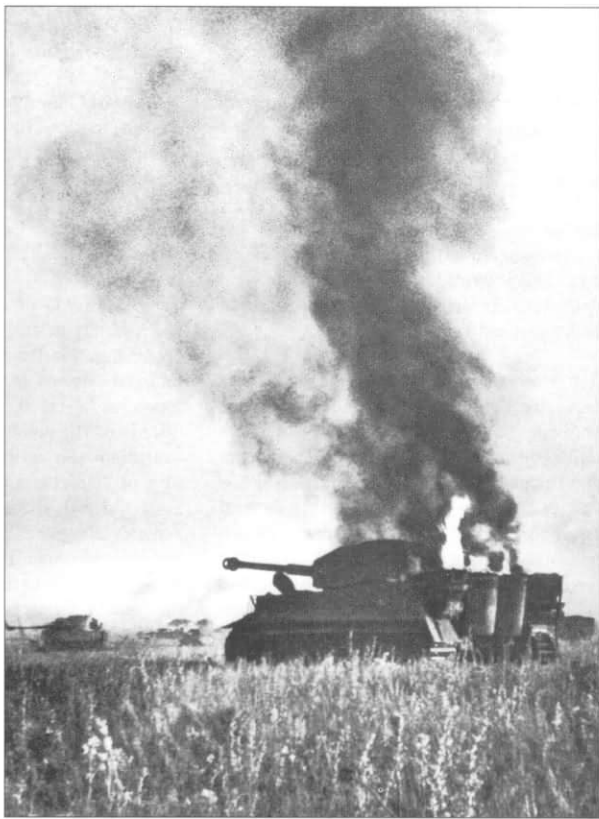
The invincibility of the Tiger I during Operation 'Citadel' is indicated by the number of losses during two months of heavy fighting, no less than 50 vehicles or almost one whole month's production. During the same period, another 16 were lost in Sicily. This Tiger has been set ablaze by the Soviets for propaganda photographs.

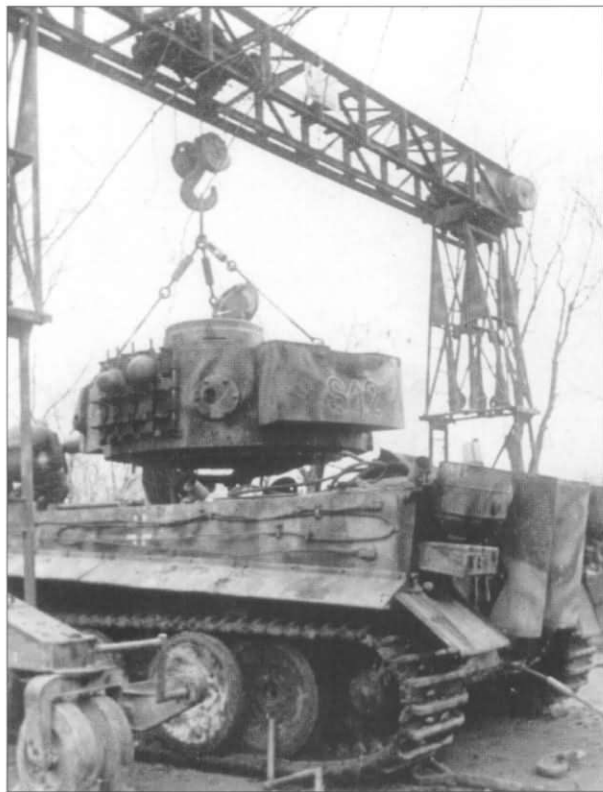
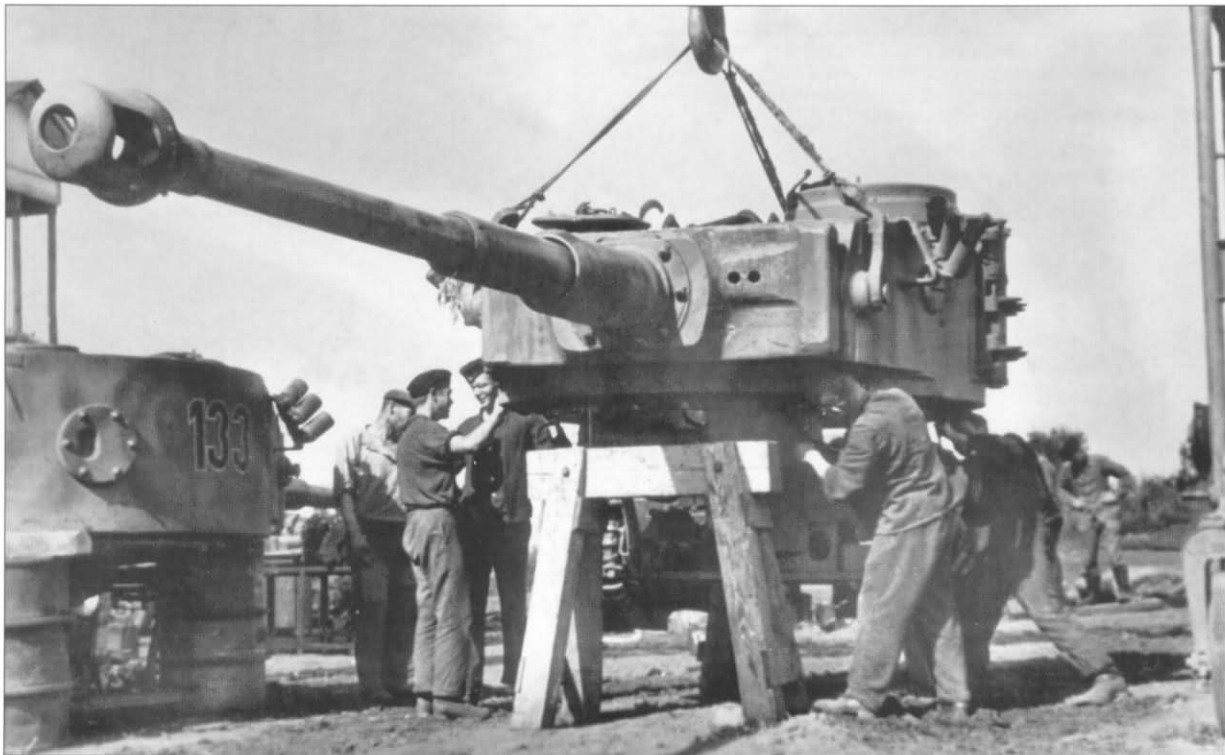
The independent Tiger battalions owed much of their success to their well equipped maintenance companies which kept the vehicles in fighting condition. Large portal cranes such as this were necessary to remove the heavy turret for repairs. The heavy armor of the Tiger made it more resistant to combat damage and after quick repairs, they could be returned to combat to inflict more damage to the enemy. Lighter tanks needed more time for repairs and often had to be transferred to specialized workshops located deep in the rear areas. Tiger 'S12' is from s.SS-Pz.Abt.101 seen in the autumn of 1943.

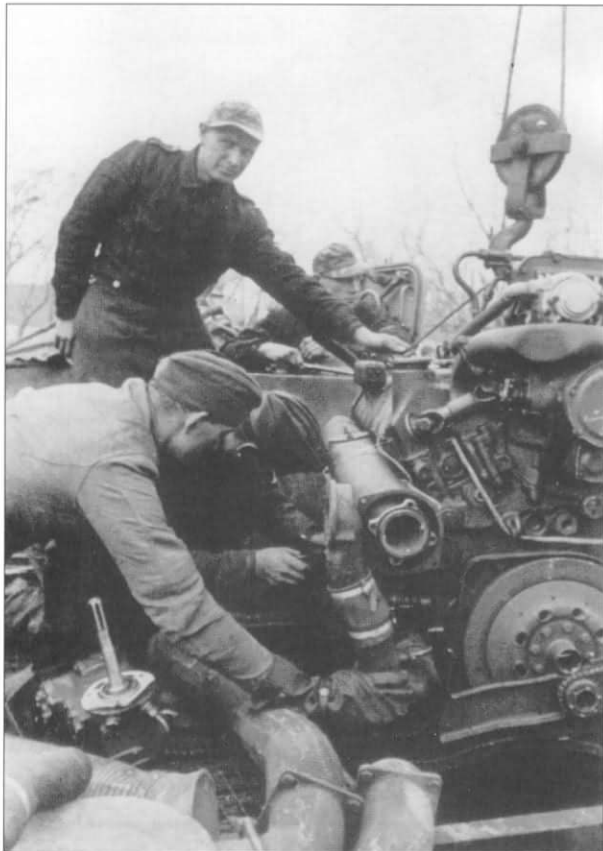
Mechanics work to replace the Maybach HL230 P45 V12 engine in a Tiger I. The 700 HP motor consumed almost 3 liters of fuel for each kilometer on the road and 5 liters over normal off-road terrain making it one of the less economical vehicles to run in the Panzerwaffe.

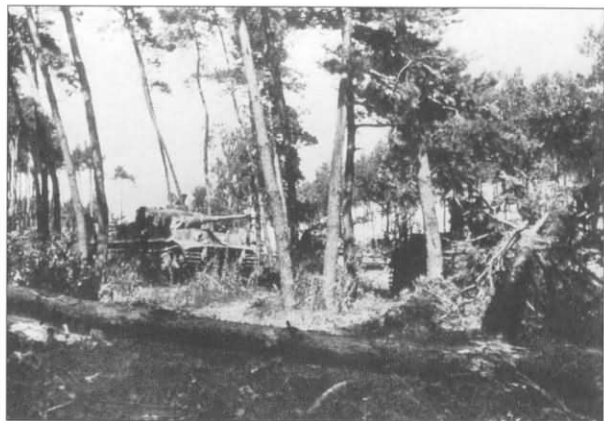
Tigers and Pz.Kpfw.III of Panzer-Regiment 'Großdeutschland' hidden in a wood in the Achtyrka sector of Russia, mid August 1943. After the Kursk battle, a new Tiger battalion was formed as III.Abt./Panzer-Regiment 'Großdeutschland' with three companies using the letters 'A', 'B' and 'C' as the first digit in their tactical number. 'B22' seen here, was formerly from 3./s.Pz.Abt.501 which was used to make up the new 10.Kompanie in the regiment.

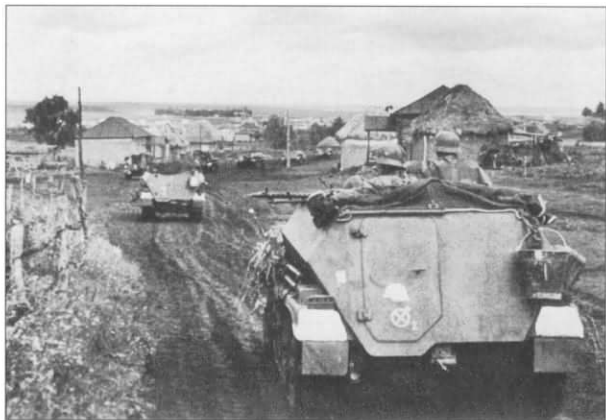
A column of Sd.Kfz.250 light armored personnel carriers advance through a Russian village in the southern sector of the Soviet Union during the autumn of 1943. The tactical markings indicate they are from the second company of a motorcycle reconnaissance battalion attached to Panzer-Division 'Großdeutschland'. To the left of the rear access door, a white number '18' indicates this is the 18th vehicle in the company. Unfortunately, the censor has overpainted the vehicle license plate number on this print though the same photo has appeared elsewhere unretouched.

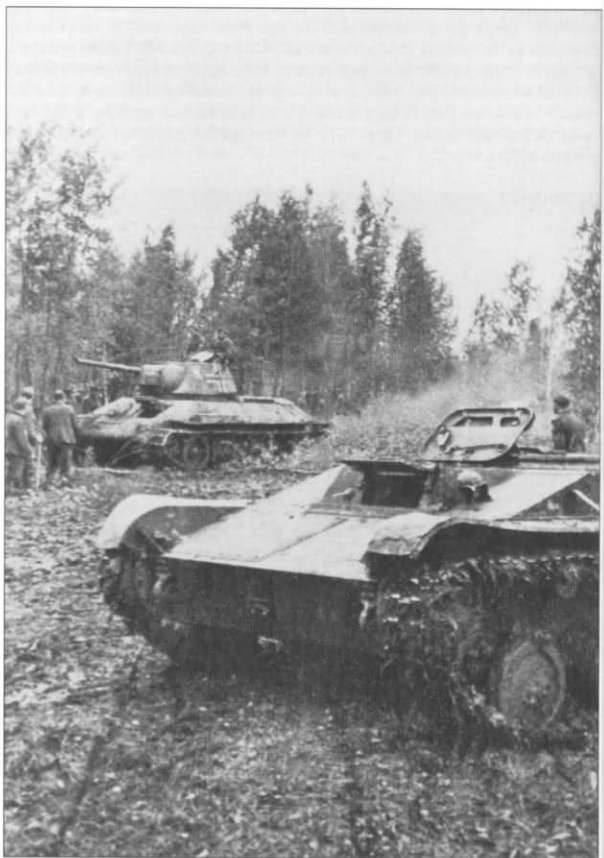
The Germans made extensive use of captured enemy equipment on all fronts during the war. The vehicle in the foreground is a Soviet T-60 light tank that has had its turret removed and is being used as an artillery tractor. In the background is a T34/76 Model 1943 which has a large white outline Balkenkreuz painted on the side of the turret along with a white outline Roman numeral 'II' in front of it. For obvious reasons, they were generally relegated to anti-partisan duties in rear areas.

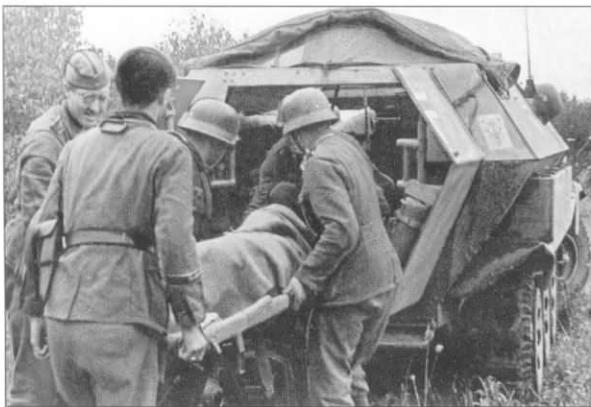
Soldiers from 'Großdeutschland' load a wounded comrade into an Sd.Kfz.251/1 Ausf.C being utilized temporarily as a Krankenpanzerwagen, or armored ambulance, in early October 1943. It has the standard white outlined Balkenkreuz on its side and an interesting emblem beside the rear door, a stag's head with a cross above it, both painted on a light colored rectangle, similar to the emblem of 521.Pz.Jg.Abt. which was destroyed at Stalingrad.

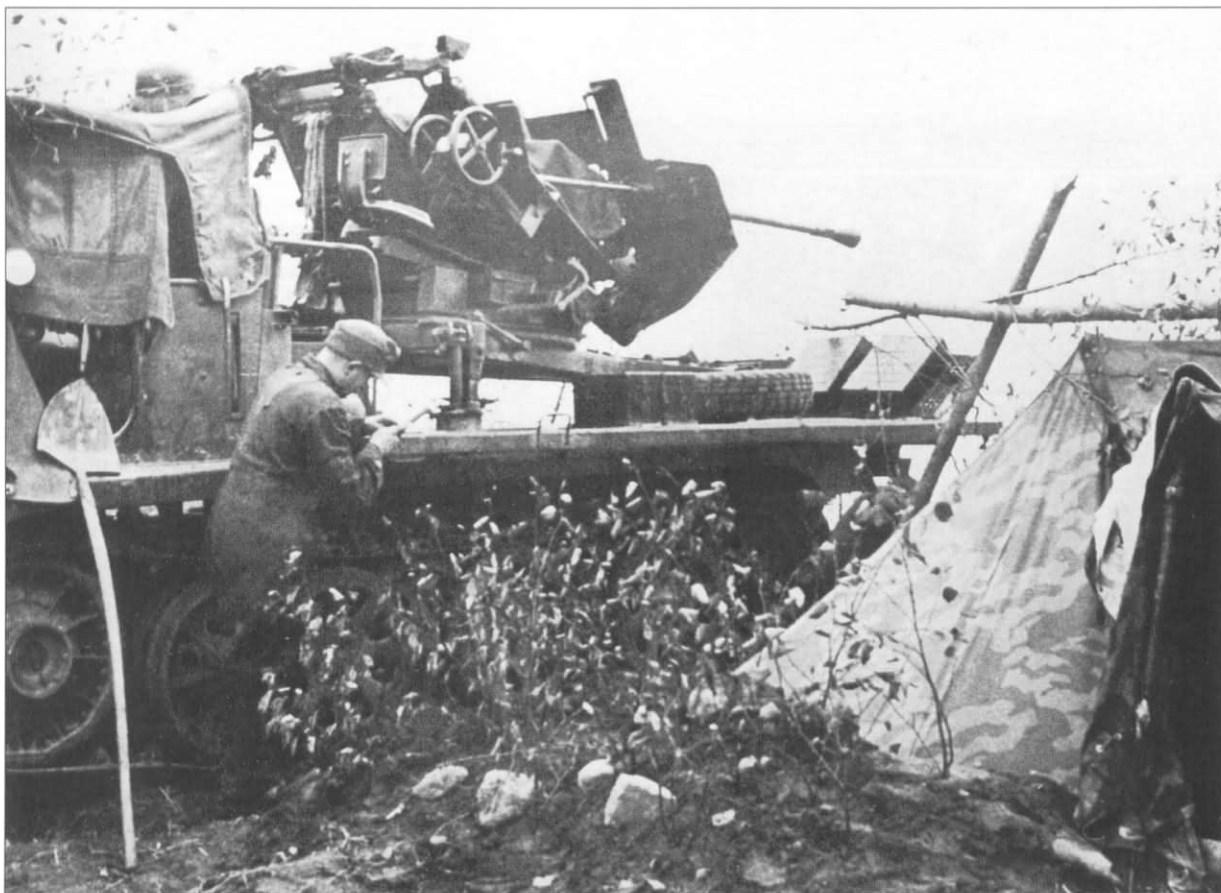
An Sd.Kfz.7/2 self-propelled anti-aircraft gun on station in October 1943. The mounting of the 3.7cm FlaK36 anti-aircraft gun is clearly shown. Judging from the tent made up of Army splinter pattern Zeltbahn shelter quarters, it is possibly attached to a Wehrmacht Heer unit, although Luftwaffe troops were also issued with the Zeltbahn as well.

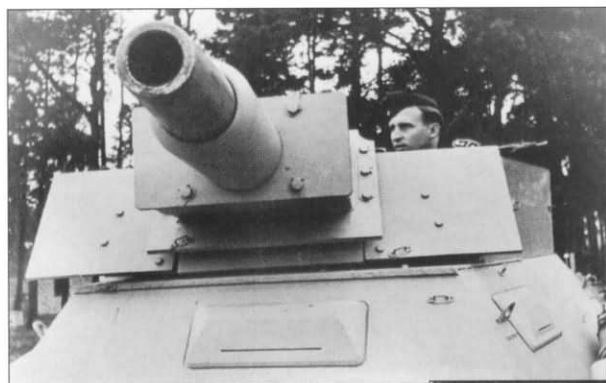
Two new vehicles in the Panzerwaffe in the autumn of 1943, were the Schwere Panzerspähwagen (5cm) (Sd.Kfz.234/2) mounting a 5cm KwK39/1, nicknamed the 'Puma', and the Schwere Panzerspähwagen (7.5cm KwK) (Sd.Kfz.234/3) mounting the 7.5cm KwK51 L/24. Here, they are being exhibited on the training ground at Arys in October 1943 along with other new models of reconnaissance vehicles. The original order for 1,500 Pumas was cut to 100 vehicles in January 1944 in favor of the Sd.Kfz.234/1, mounting the 2cm KwK38 L/55, and Sd.Kfz.234/3, with production terminating in September 1944 after 101 vehicles were produced. Actual production of the Sd.Kfz.234/3 started in June 1944 and continued until December at which time, production of the Sd.Kfz.234/4 mounting the 7.5cm PaK40 L/46 started and continued until the end of the war.

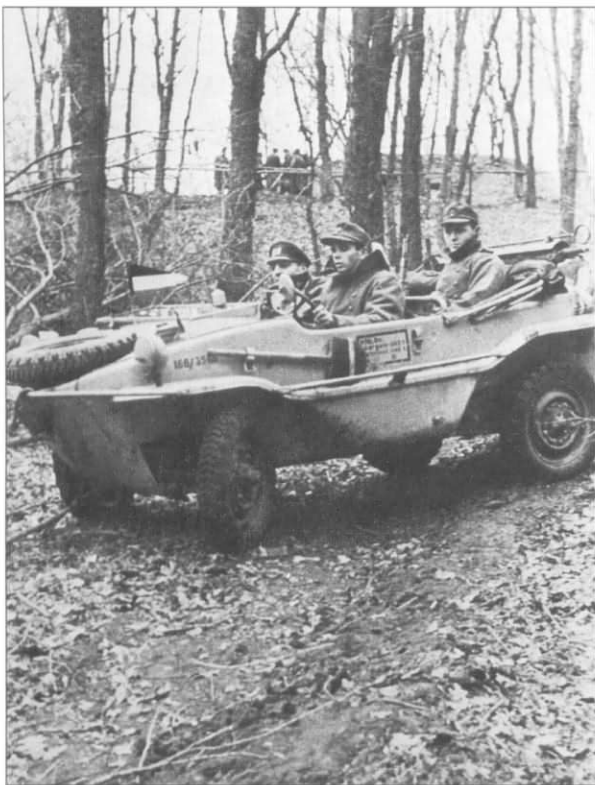
A new Schwimmwagen Typ 166 amphibious car of a Panzer-Division staff traveling through a Russian forest in the autumn of 1943. The black over white over red metal command pennant for a Panzer-Division commander can be seen on the right mudguard. The vehicle is painted in overall dark sand and has a shipping stencil prominently displayed on the side giving the Kfz. number, empty weight, payload weight and vehicle class. The numbers on the side behind the headlight indicate the vehicle type '166' although the significance of the number following is unclear.

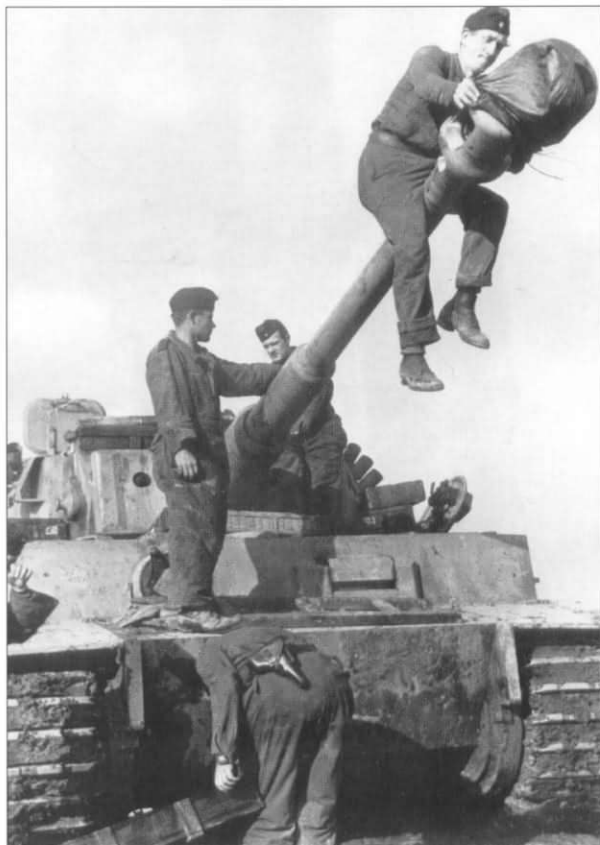
A Tiger crewman from s.Pz.Abt.502 pulls on the protective cover over the muzzle brake of his tank during a lull in the action in late 1943. The unit's emblem, a black outline mammoth, can be seen on the front plate next to the machine gun ball mount. Its shape was changed in the spring of 1943 from the earlier version seen in white on the original dark gray vehicles.

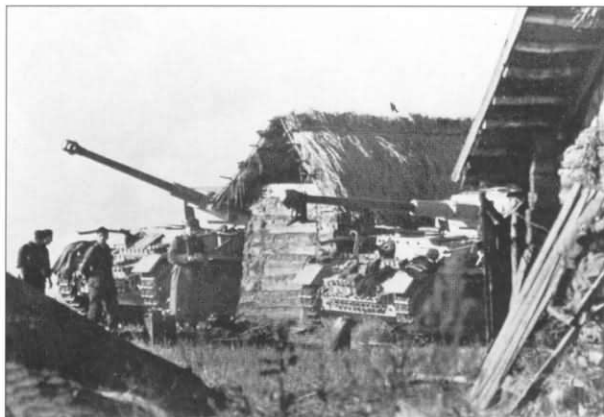
A pair of Pz.Kpfw.IV Ausf.H hidden in a Russian village close to Veliky Luki in autumn 1943. There is no battle damage evident which would indicate they are probably new vehicles. The nearest one is a very early Ausf.H and is still fitted with the additional 30mm armor plates bolted to the front of the upper and lower hull that were introduced on the Ausf.G, while having the newer drive sprocket. Both have turret skirts and support brackets for the side skirts which are not yet installed but often were carried on the vehicle during transport to avoid losing them. Neither has had any camouflage paint applied over the dark sand base, however, the nearest one appears to have a different colored gun barrel.

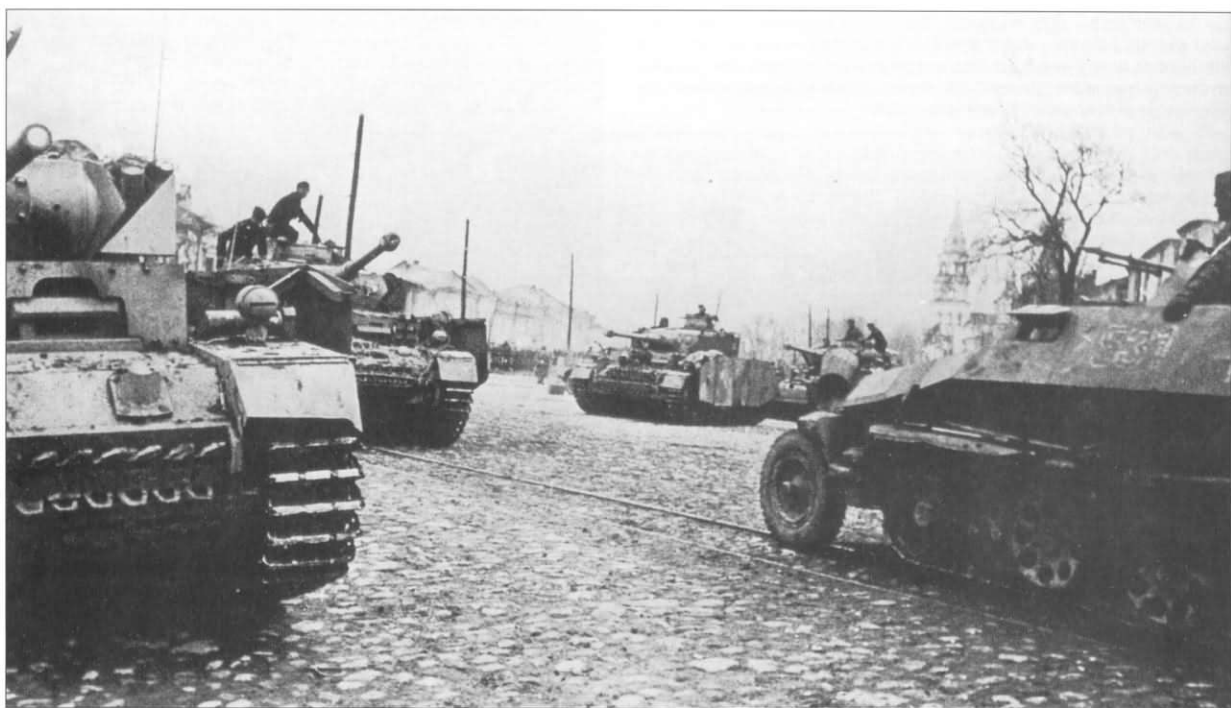
A Panzerbefehlswagen III Ausf.K, an Sd.Kfz.251/1 Ausf.C and several Pz.Kpfw.IV Ausf.G in Zhitomir after XXXVIII.Pz.Kp. with 1., 7., 19., 25. and 2.SS-Panzer-Division, recaptured the city in late November 1943. The Befehlspanzer is unusual in that the turret skirts are those of a Pz.Kpfw.IV and not those from a Pz.Kpfw.III as normally used. The battered looking half-track has the tactical number '531' in red with a white outline painted on the side and is missing the shield for the MG34 machine gun.

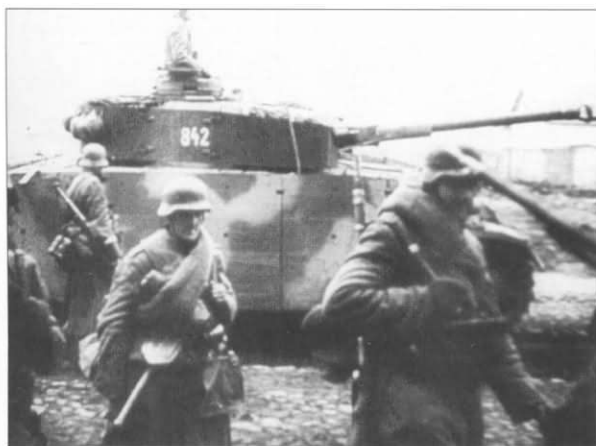
A new Pz.Kpfw.IV Ausf.G and troops from 1.Panzer-Division occupy Zhitomir in December 1943. The tactical number '842' indicates that this is the second tank in the fourth platoon of the eighth company in the second battalion. It is still painted in its summer camouflage scheme of brown and green over the dark sand base although there does not appear to be much of the base color showing on the turret. In November, the division reported a strength of 95 Pz.Kpfw.IV.

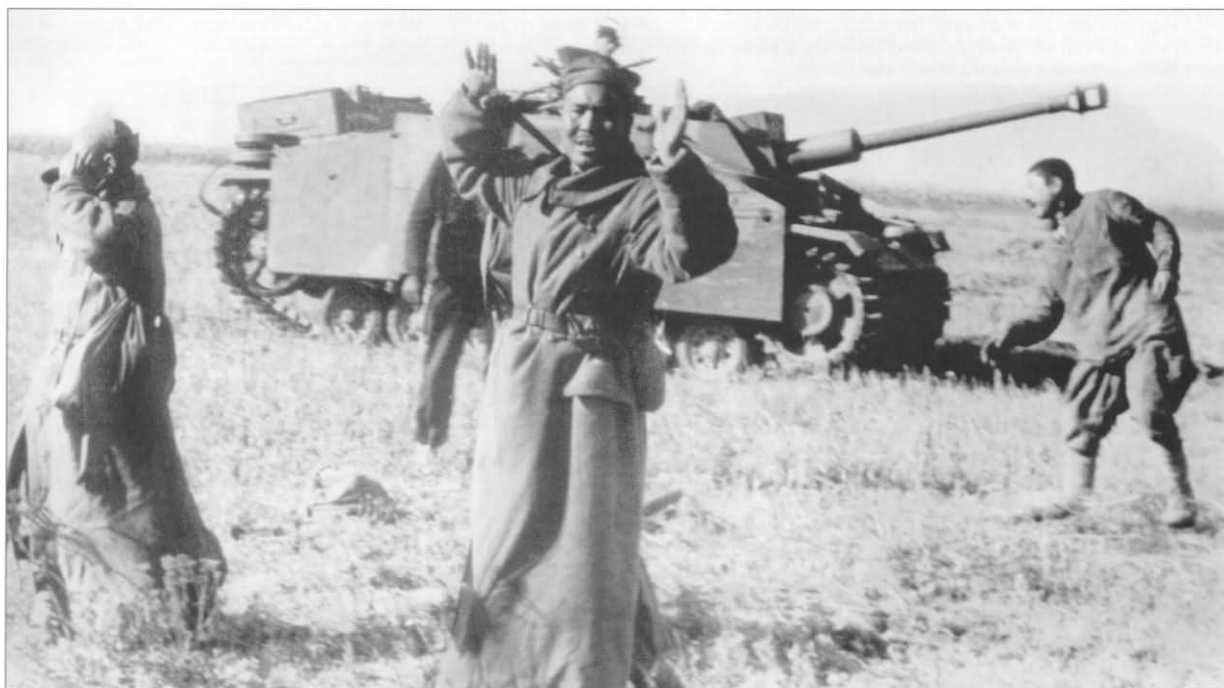
Surrendering Soviet troops are taken into captivity by German infantry supported by a StuG.III Ausf.G. It could be from one of the independent Sturmgeschütz Abteilungen or possibly one of the Panzer-Divisions which started to be equipped with these vehicles in their newly created III.Abteilung starting in April 1943. A camouflage scheme of large brown patches has been sprayed over the dark sand base which was common for the early spring and autumn seasons.

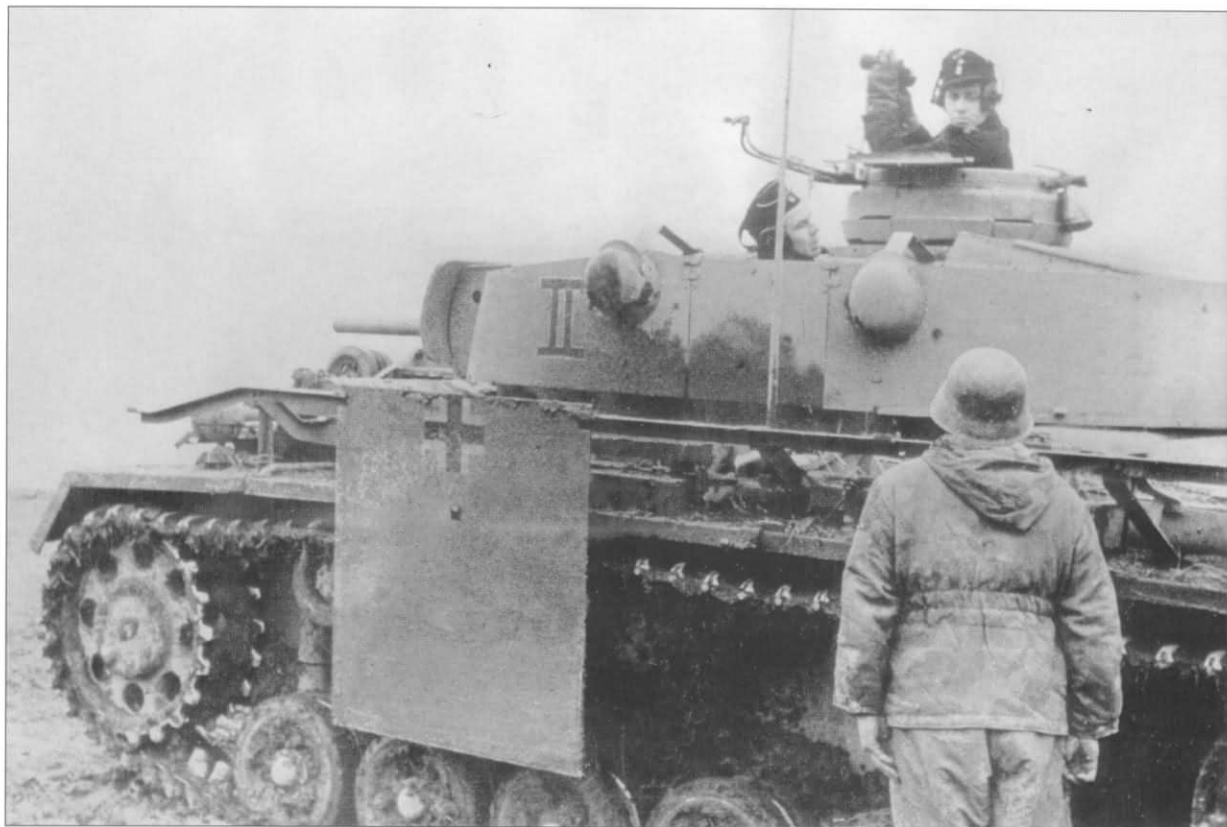
The commander of a Pz.Bef.Wg.III Ausf.J receives a communication from a courier in late 1943. 81 vehicles were produced from August to November 1942 with another 104 converted from Pz.Kpfw.III from March to September 1943. This one has been fitted with the early 8 hole drive sprockets with a spacer ring to accommodate the 40cm track. Not visible in the photo is the armored pot mount on the rear of the engine deck for the star antenna. It is finished in a scruffy coat of winter whitewash paint and, unusually, is equipped with the anti-aircraft mount for the MG34. The Roman numeral 'II', painted in black with a white outline, signifies a second battalion staff vehicle.

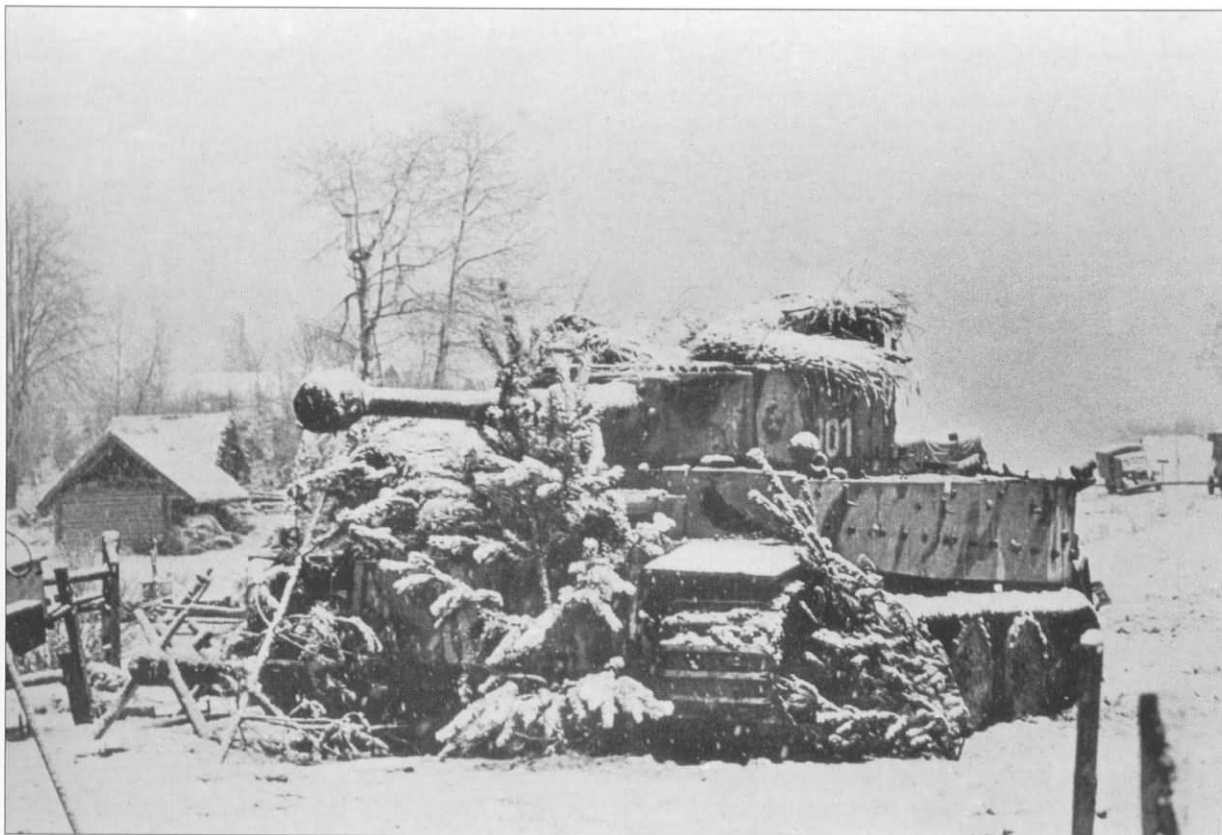
The German defenses in the Nevel area in late 1943 were bolstered with about 30 Tigers of s.Pz.Abt.502. Here, one of them, heavily camouflaged with snow covered spruce boughs, guards a road in early January 1944. It is an early vehicle equipped with S-mine dischargers on the hull, an early cupola and lacks zimmerit. The tank has an interesting camouflage pattern of brown patches applied over the dark sand base and a white tactical number '101' painted on the turret, indicating it is a first company command vehicle.

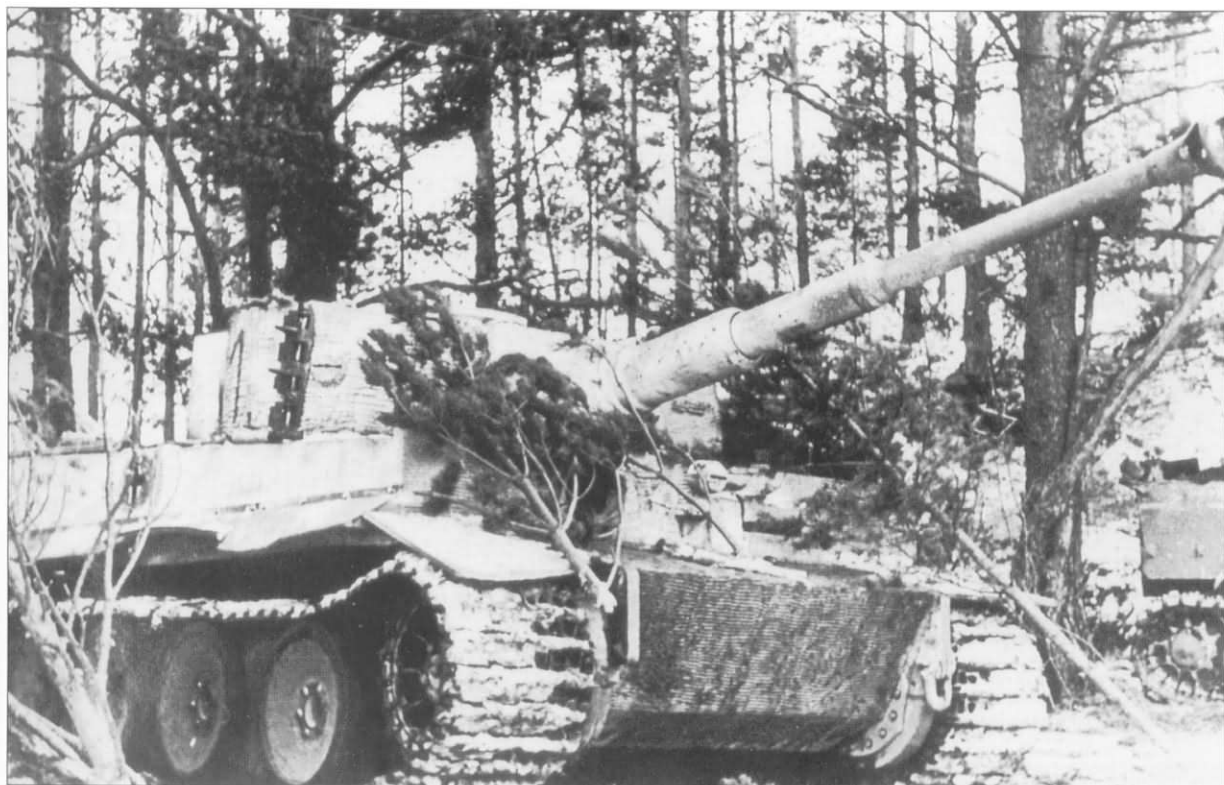
A mid production Tiger I hidden at the edge of a Russian forest in January/February 1944. It probably belonged to s.Pz.Abt.506 which marked their tanks with large one and two digit tactical markings, although they were usually on the front half of the turret, not on the rear as this '1' is. The Tiger carries zimmerit which has been covered with white winter camouflage paint along with a small Balkenkreuz on the side of the hull in a patch of the dark sand base color.

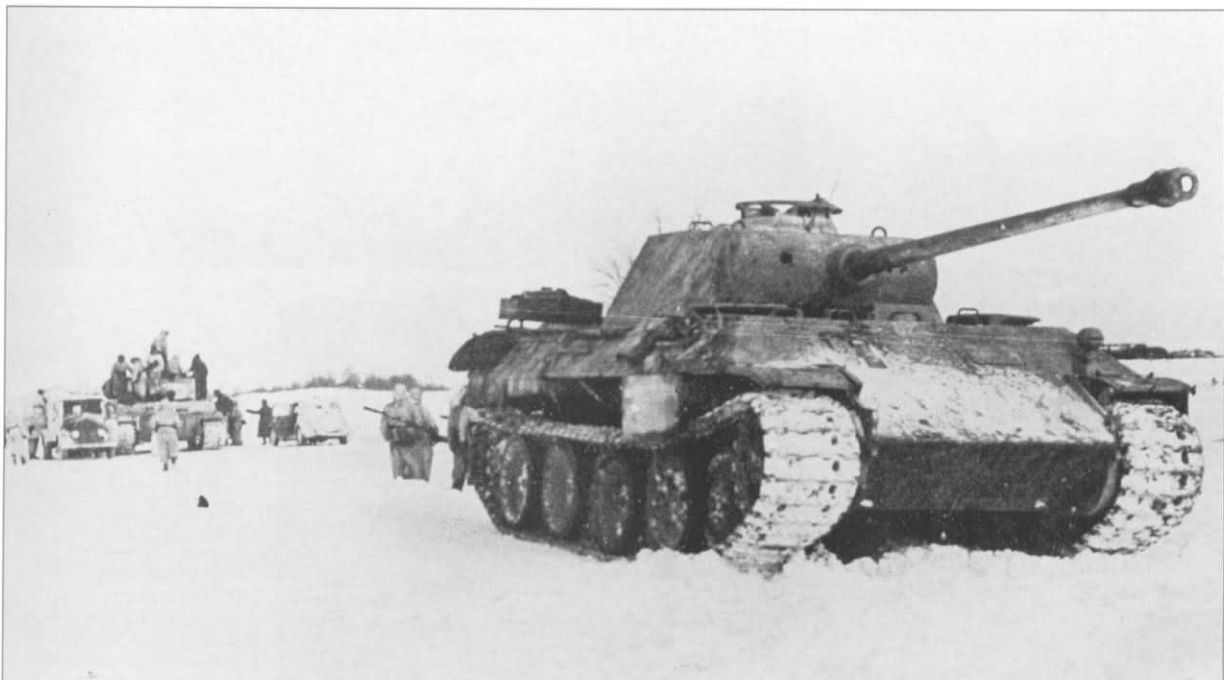
In late January 1944, Oberstleutnant Dr. Franz Bake, commander of Pz.Rgt.11 of 6.Panzer-Division, was given the task of spearheading the attack attempting to relieve the Korsun-Cherkassy Pocket, where about 56,000 German troops were trapped. In addition to his regiment, he was placed in command of s.Pz.Abt.503 with 34 Tigers and II./Pz.Rgt.23 with 47 Pz.Kpfw.V Panther. The new unit was to be named s.Pz.Rgt. Bake. Here we see one of the Tigers and an early Pz.Kpfw.V Panther Ausf.A as the unit makes ready for battle.

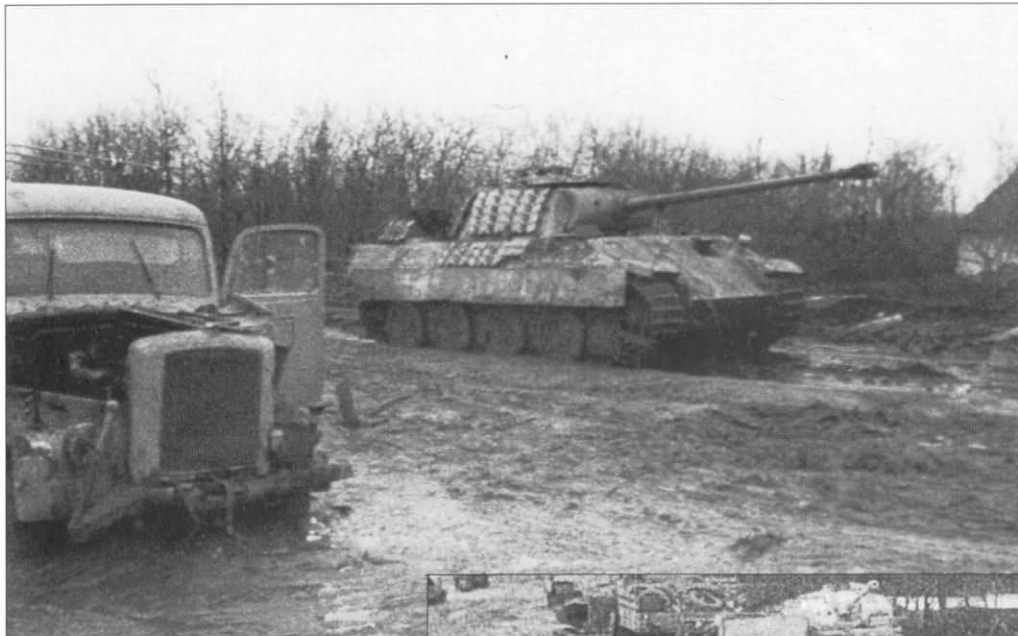
Two photographs of vehicles abandoned by 1. Panzer-Armee on the road leading out of the Korsun-Cherkassy Pocket after the breakout attempt. The two early Pz.Kpfw.V Panther Ausf.A, a few Maultiers and a StuG.III Ausf.G of 5.SS-Panzer-Division 'Wiking' are shown here in March 1944. It appears that these vehicles were destroyed by their crews after running out of fuel as evidenced by the internal explosion that blew off the turret roof of the Panther. The still connected tow cables indicate it had been immobilized.

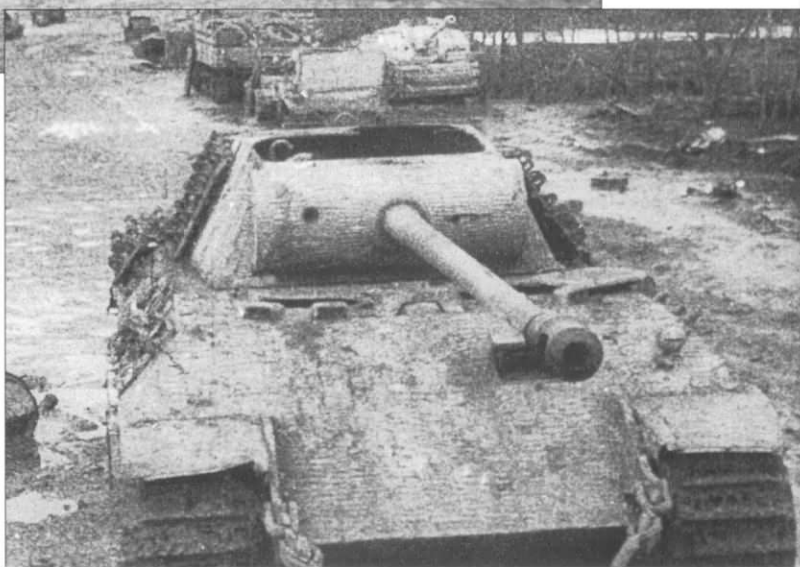
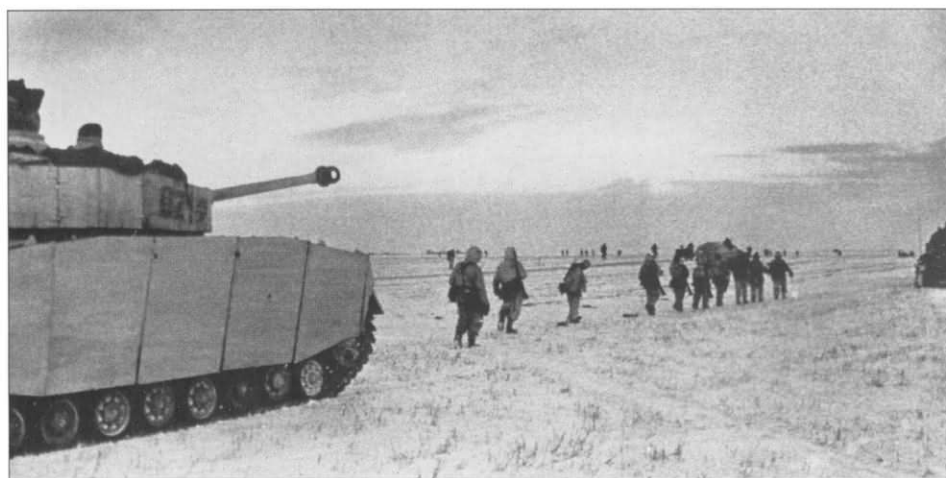
Two Pz.Kpfw.IV Ausf.H and an Sd.Kfz.251 half-track accompanied by infantry make their way across the frozen wasteland of the Eastern Front in the winter of 1943-44. The tank appears to be new as all of its schürzen are intact and there is no apparent damage. It has a uniform coat of white winter camouflage paint and a three digit tactical number '821' February in a black stencil outline with a lower Balkenkreuz in front of it.

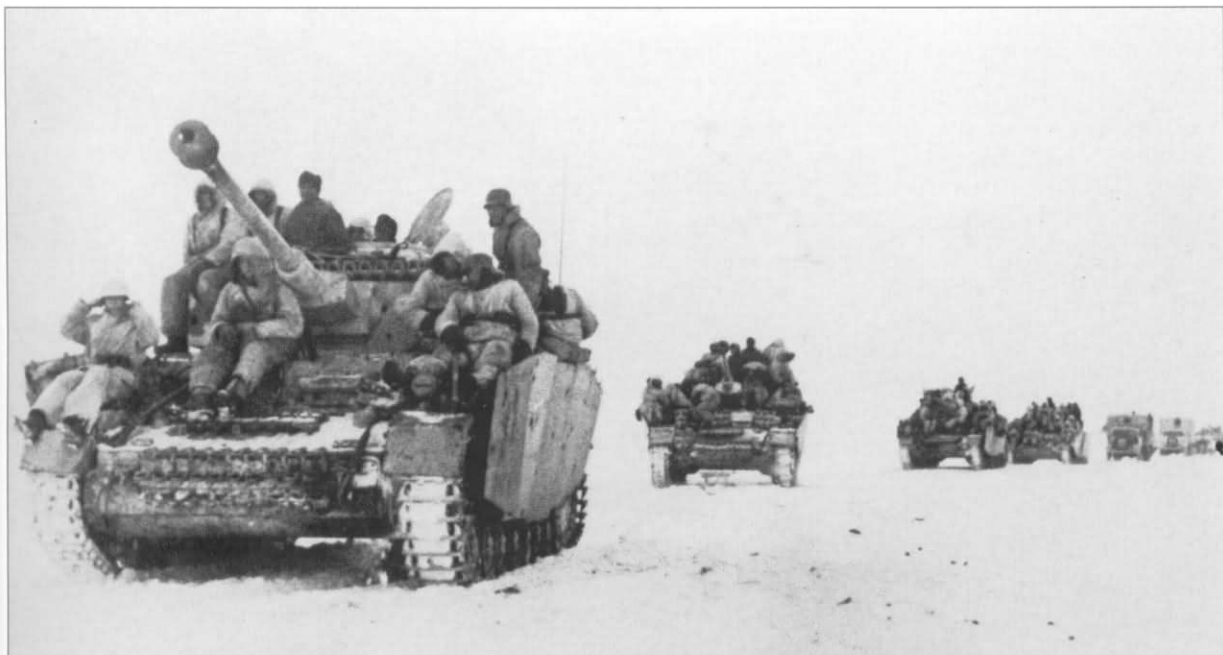
A column of infantry laden Pz.Kpfw.IV Ausf.H, possibly from II./Pz.Rgt.11 of s.Pz.Rgt.Bake, near the village of Pogrebishtche in February 1944. In order to maintain their speed, the accompanying infantry were carried on the tanks and trucks into the battle. When they ran into stiff opposition, they would dismount to protect themselves from heavy losses. Though the tanks have white winter camouflage paint applied, most has been worn off, thereby limiting its effectiveness.

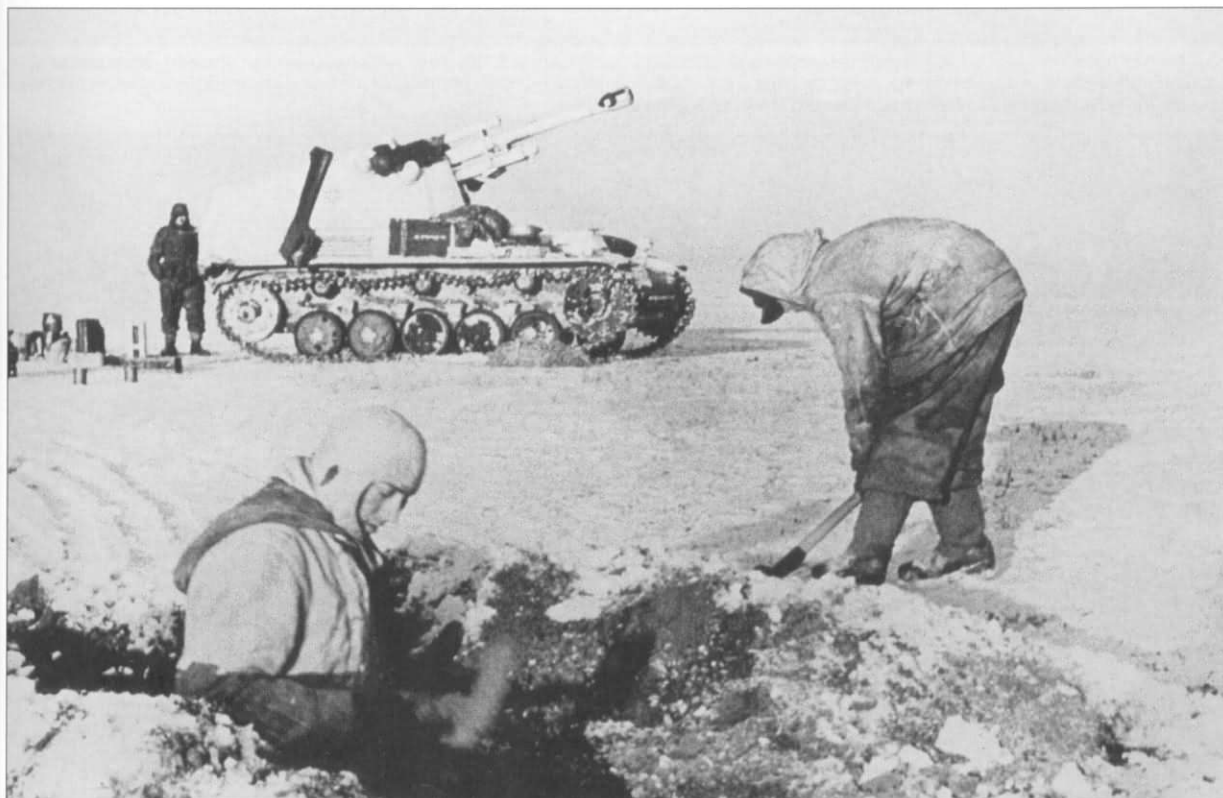
A 'Wespe' self-propelled gun armed with a 10.5cm IFH18M howitzer sits in firing position on the Eastern Front near the village of Pogrebishtche in February 1944 while the crew prepare foxholes for themselves. The upper hull has been painted in a uniform coat of white winter camouflage paint while the lower hull is covered with snow buildup, some of which has fallen off revealing the dark gray base coat. The only visible marking is a black outline Balkenkreuz on the side of the fighting compartment.

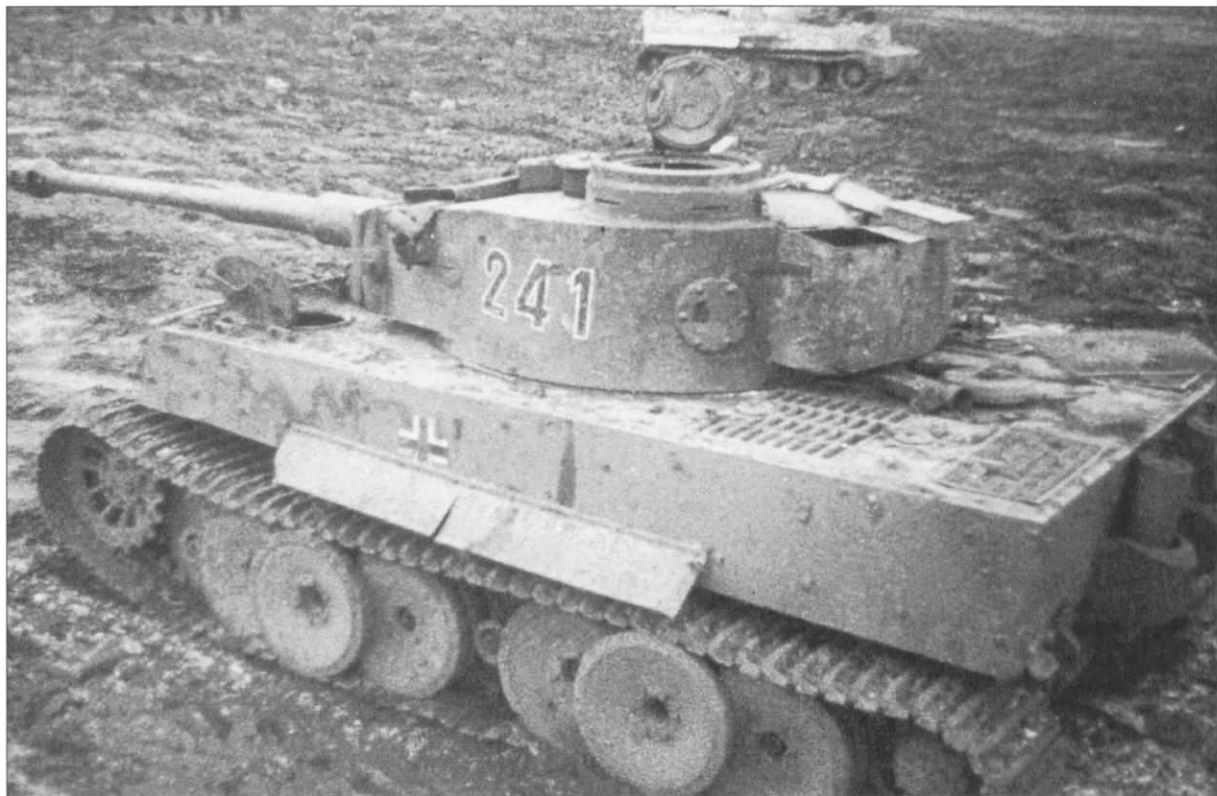
A trio of Tigers from s.Pz.Abt.503 abandoned somewhere in Russia, probably late 1943. This particular vehicle has been previously photographed while fitted with a Pz.Kpfw.III stowage bin on the rear of the turret and is readily identifiable by the slightly crooked manner in which the turret numbers have been applied. The tactical number and Balkenkreuz are both black with a white outline.

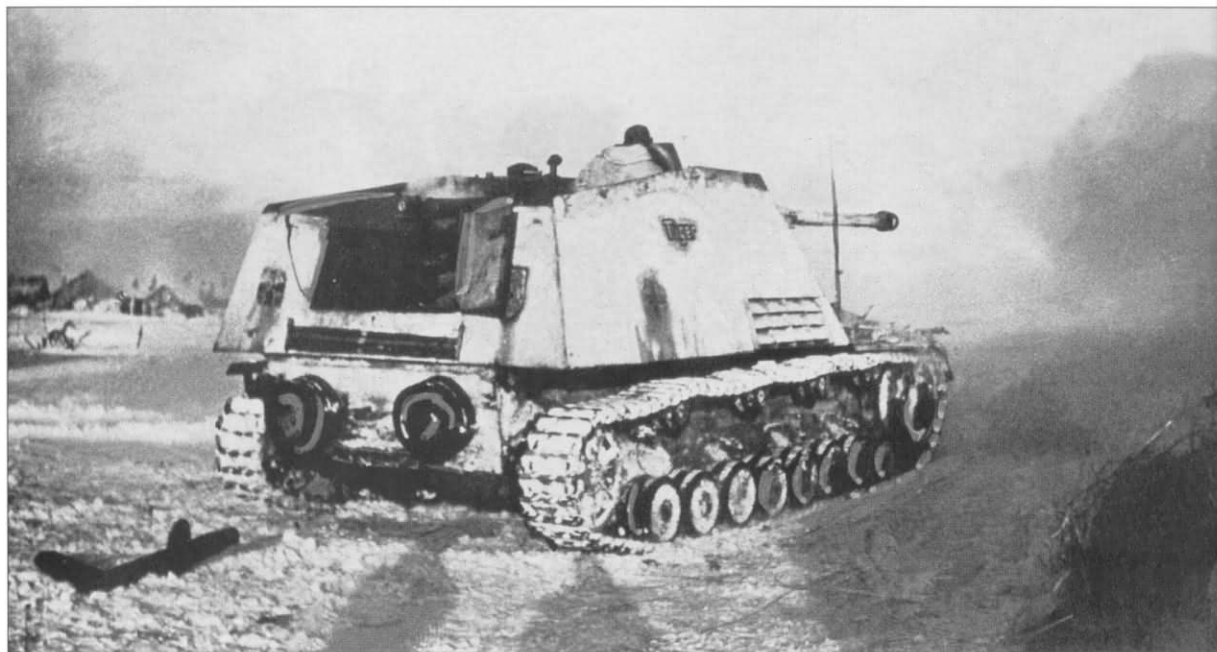
A 'Nashorn' self-propelled anti-tank gun, mounting the deadly 8.8cm PaK43/1 L/71, fires at an enemy target during one of the Eastern Front battles in the winter of 1943-44. In addition to its white winter camouflage paint, the vehicle carries the name 'Tiger' on the side along with a white outlined Balkenkreuz, also repeated on the left rear. A large unit emblem in the shape of a shield can be seen just behind the open right rear access door but, unfortunately, is not clear enough to be identified. The 'Nashorn' was introduced in time for the battle at Kursk in July 1943 and proved to be a highly effective tank killer unit in the East. It was replaced in 1944 by the Jagdpanzer IV and Jagdpanther.

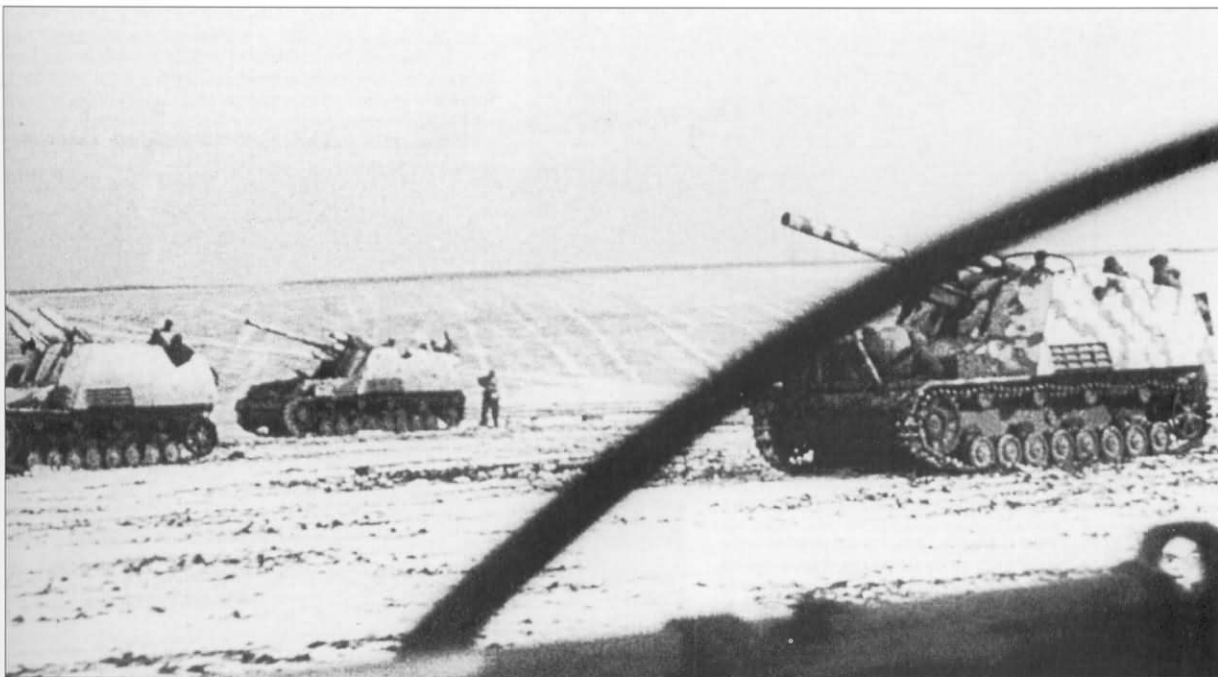
A battery of 'Hummel' self-propelled guns mounting the 15cm sFH18 howitzer prepare to fire at enemy targets in February-March 1944. The chassis of the 'Hummel' was identical to that used for the 'Nashorn'. White winter camouflage paint has been applied uniformly to one of the vehicles while the other two have an irregular pattern leaving some of their base color showing through. As usual, the only markings visible are the white outline black national crosses on the sides.

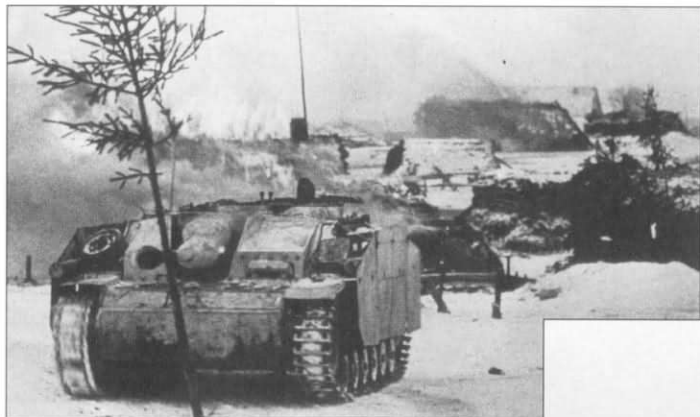
A late StuG.III Ausf.G advances through a burning village near Vitebsk in March 1944. It is fitted with the 'topfblende' cast gun mantlet and shot deflector in front of the cupola that were installed on Sturmgeschütz produced starting in the fall of 1943. Since the spring of 1943, Sturmgeschütz were used to create a new III.Abteilung in some of the Panzer-Divisions to increase their operational strength due to low production rates for the more expensive standard gun tanks.
