Panzer-Division 1935-1945

(3) War on Two Fronts 1943-1945

Robert Michulec

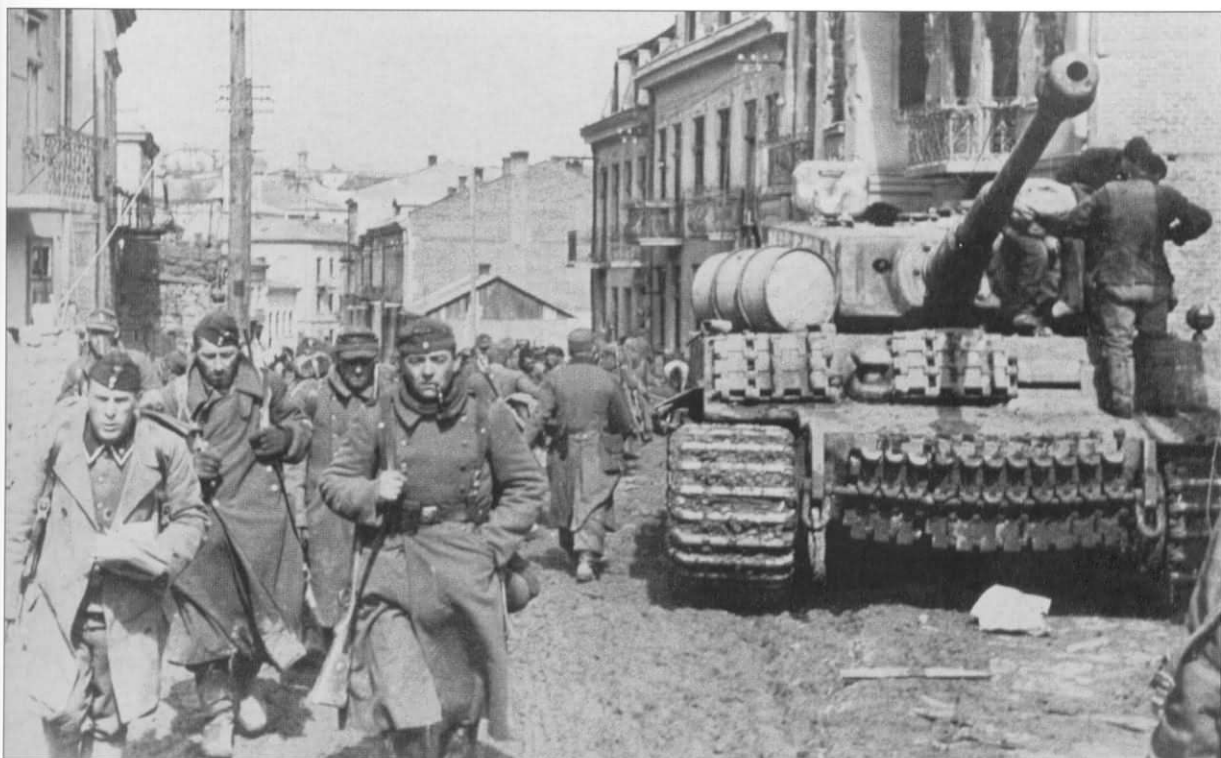
A Tiger I of s.Pz.Abt.507 near Tarnopol after the relief of the city in mid April 1944. They were supported in the attempt by elements of 9.SS-Panzer-Division 'Hohenstauffen' and a small battlegroup formed from various other units, advancing to within seven miles of the city and allowing a small contingent to break out.

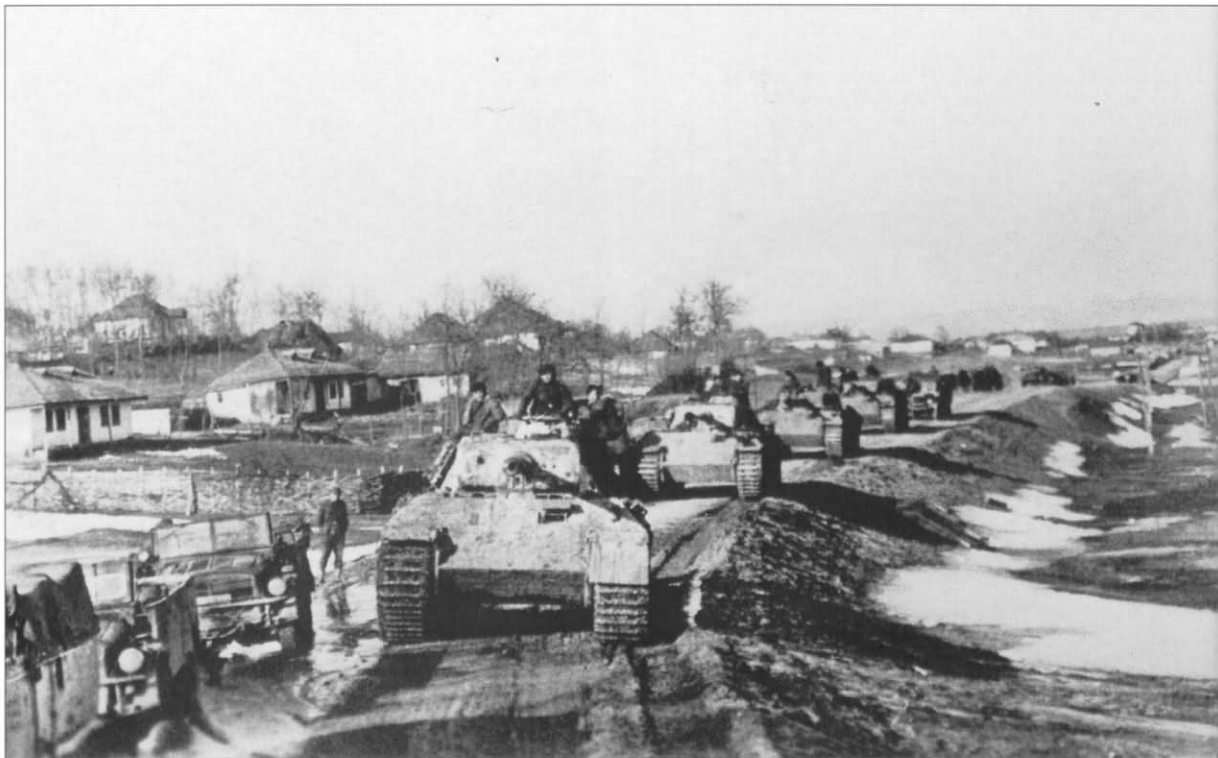
A column of Pz.Kpfw.V Panther Ausf.A from Panzer-Regiment 'Großdeutschland' and other divisional soft-skin vehicles on a road near Jassy, Romania in early April 1944. Most of the snow has disappeared but the ground is still firmly frozen as can be seen by the condition of the dirt road these vehicles are traveling on. These are early production Ausf.A fitted with the new cast cupola but still retaining the MG flap in the glacis.

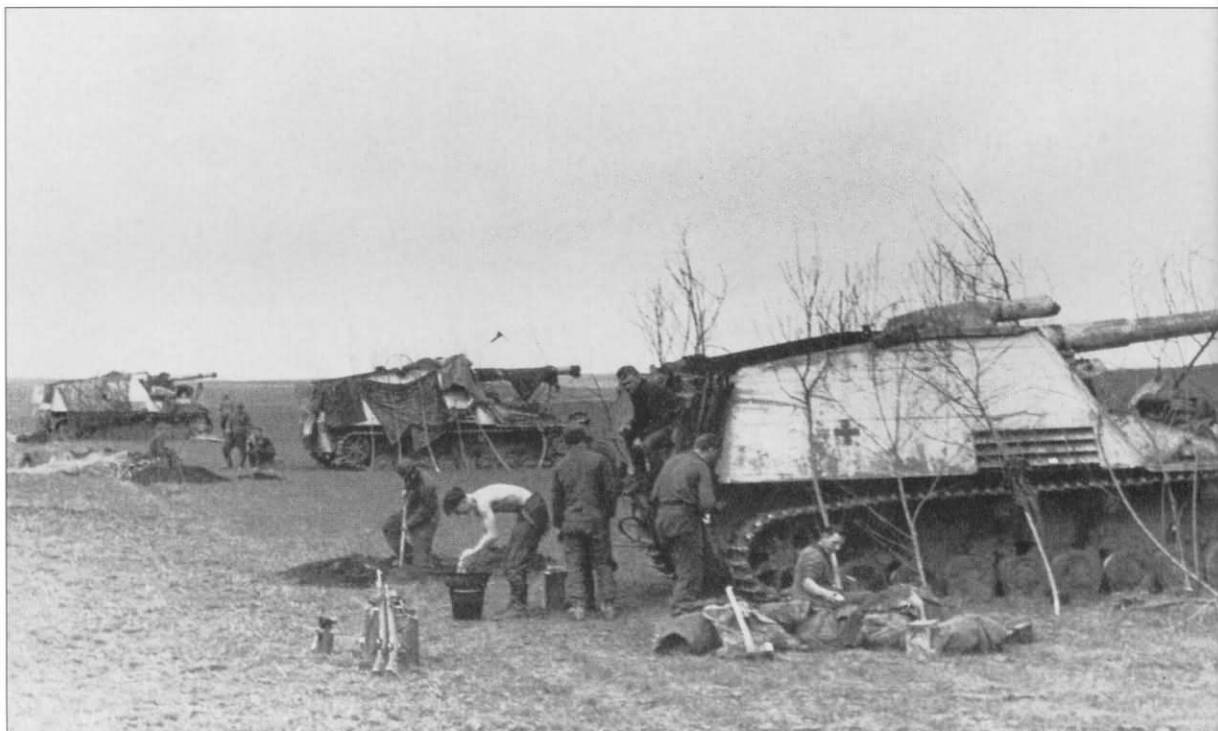
A battery of 'Hummel' self-propelled guns sit in position somewhere in Romania in early May 1944. An attempt has been made to camouflage the vehicles with branches so their winter camouflage schemes will not be so noticeable on the spring landscape. The paint was usually thinned with water which made it easy to wash off when it was no longer necessary.

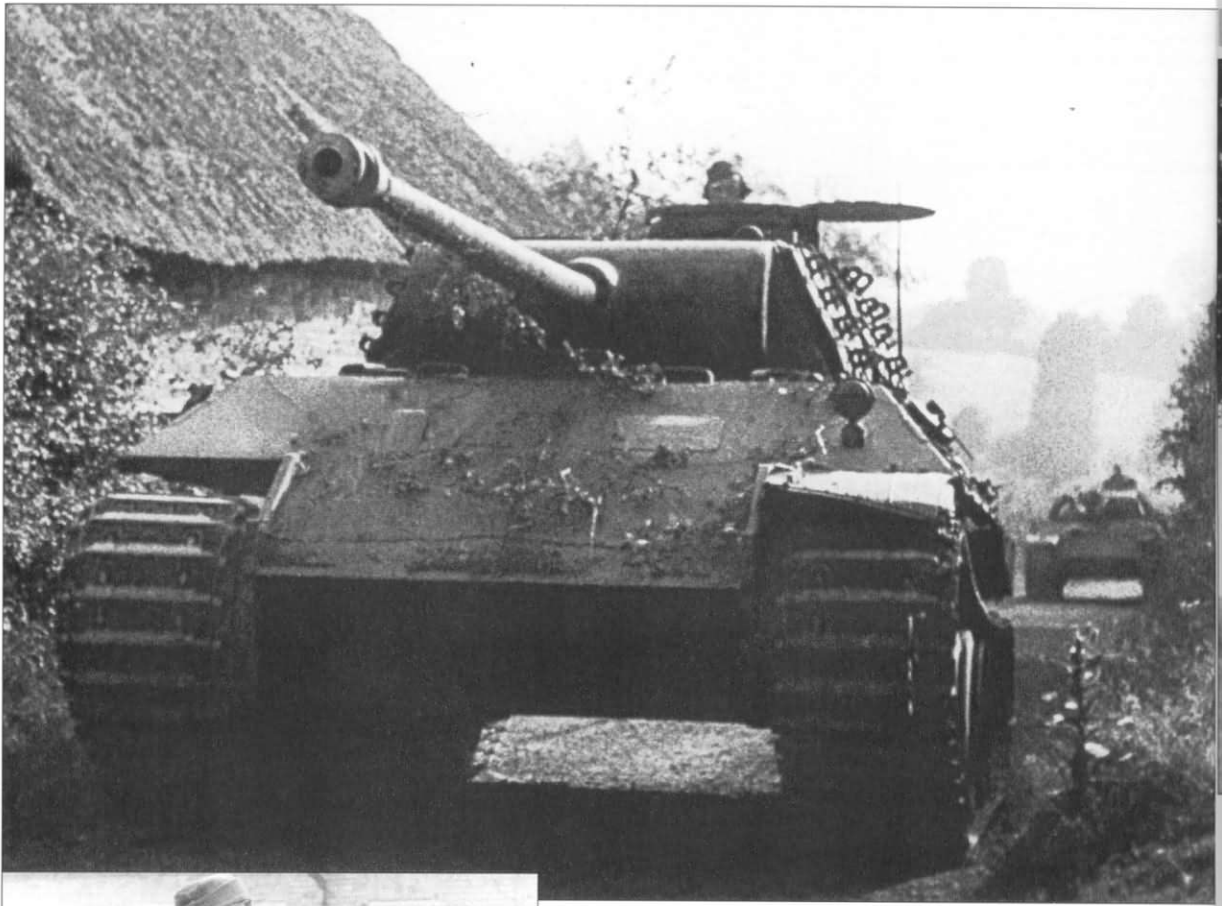
An old Pz.Kpfw.V Panther Ausf.D still in service on the Eastern Front in the late spring of 1944. The last of the Ausf.D production were built in August 1943 at which time the new Ausf.A made its appearance. The first Ausf.A, while fitted with the new commander's cupola, still retained the MG flap on the glacis.

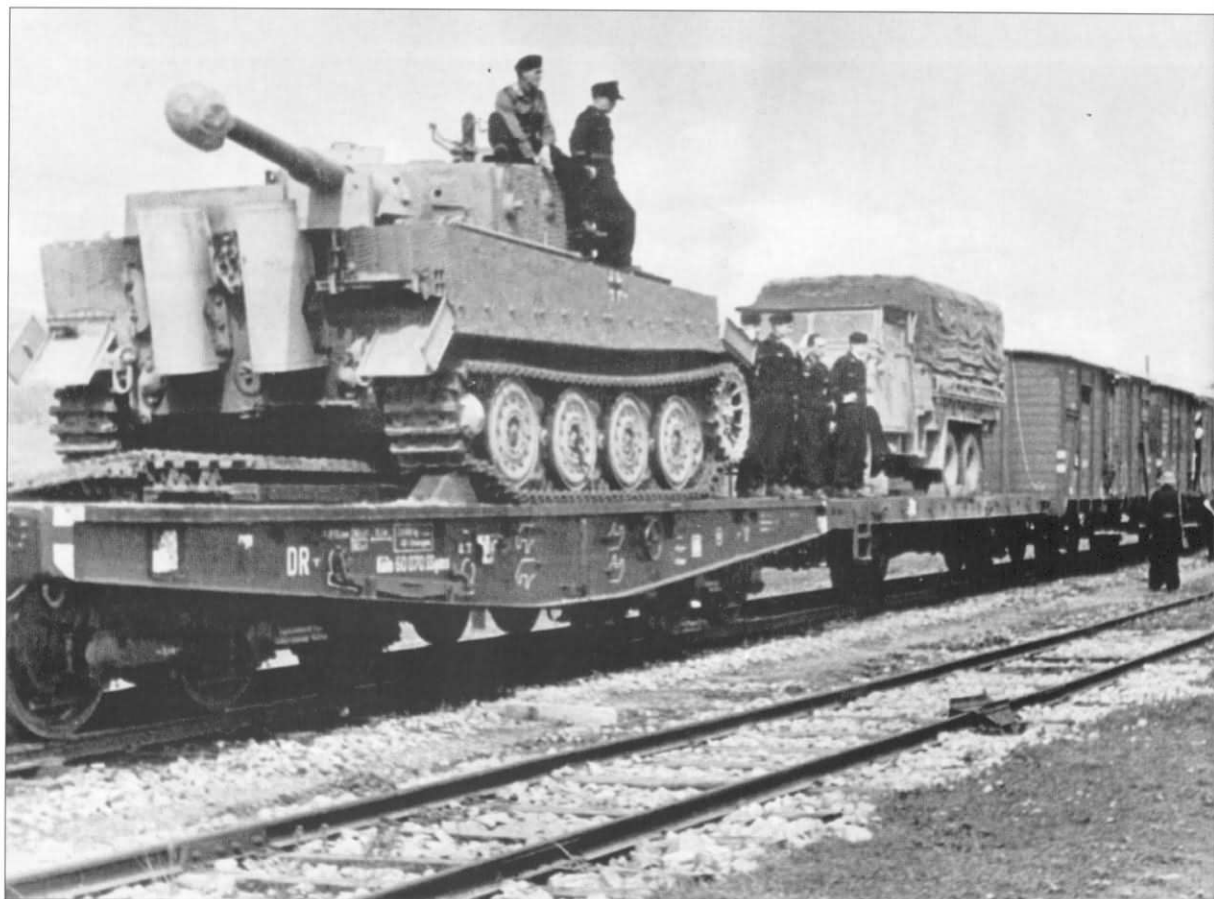
A new Tiger I sits on a railway flatcar on its way to Panzer-Division 'Großdeutschland' in May 1944. There are no visible markings but the distinctive cuffband of the division can be seen on some of the crew uniforms. The vehicle has been prepared for rail transport following standard procedures with the narrow transport tracks installed, the side mudguards removed and the turret traversed to the rear with the gun barrel securely blocked with a wooden cradle. The wide battle tracks can be seen stowed underneath the vehicle.

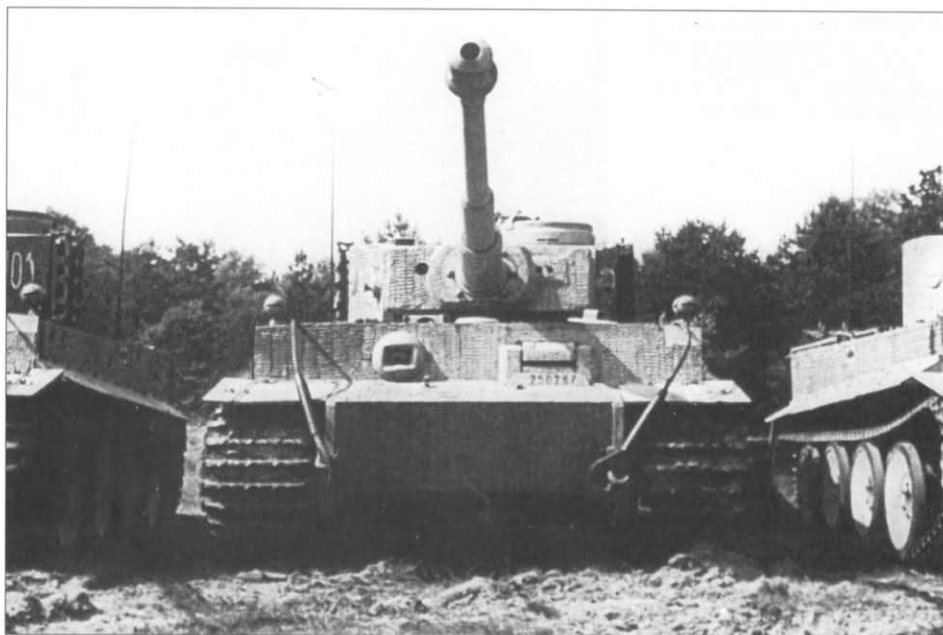
An interesting photograph of three rare Tigers on the Eastern Front during the summer of 1944. The Tiger in the middle has the chassis number '250287' stenciled on the front which indicates it is one of 60 produced in June 1943 but it is covered with zimmerit which was not applied until starting in September 1943. The vehicle on the left is a Panzerbefehlswagen Tiger, identifiable by the antenna mounted on the left side of the engine deck, also fitted with the early cupola and having zimmerit. On the right is an even earlier production vehicle which does not have the spare track link brackets on the turret that were introduced in April 1943. It is also covered with zimmerit as well. All three have white tactical numbers on the turrets outlined with black. In August 1943, s.Pz.Abt.506 reported receiving 45 new Tigers, all with zimmerit, three of which still had the early cupola. This may well be those three vehicles.

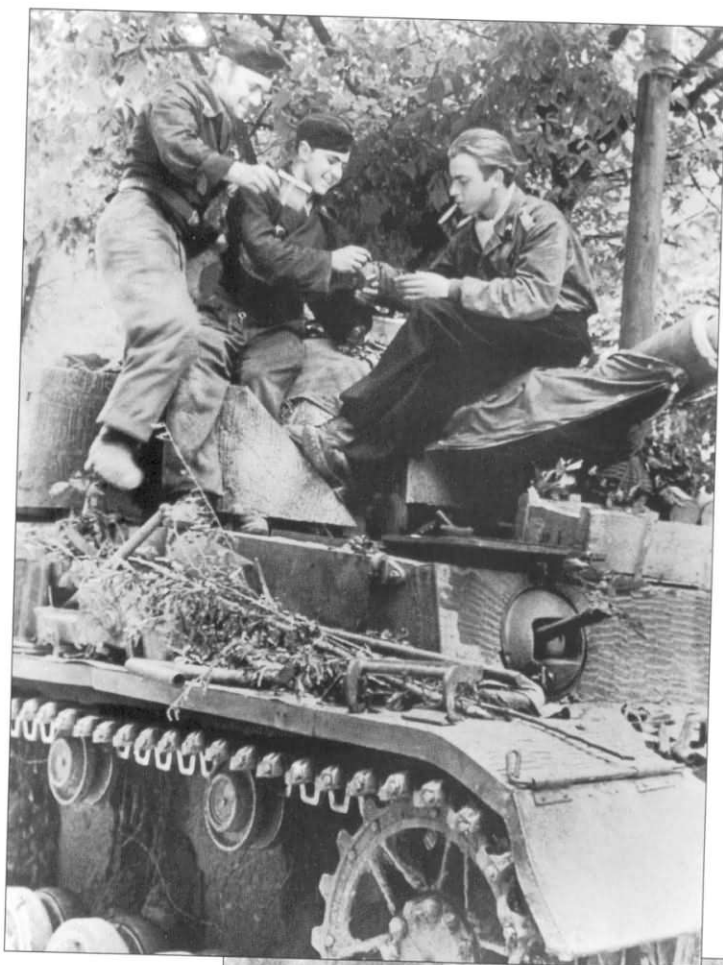
The crew of this Pz.Kpfw.IV Ausf.H enjoy a cigarette break in France during the summer of 1944. The vehicle is fitted with the newer drive sprocket and all steel return rollers which were introduced in the previous year along with a single 80mm front plate and zimmerit anti-magnetic mine coating.

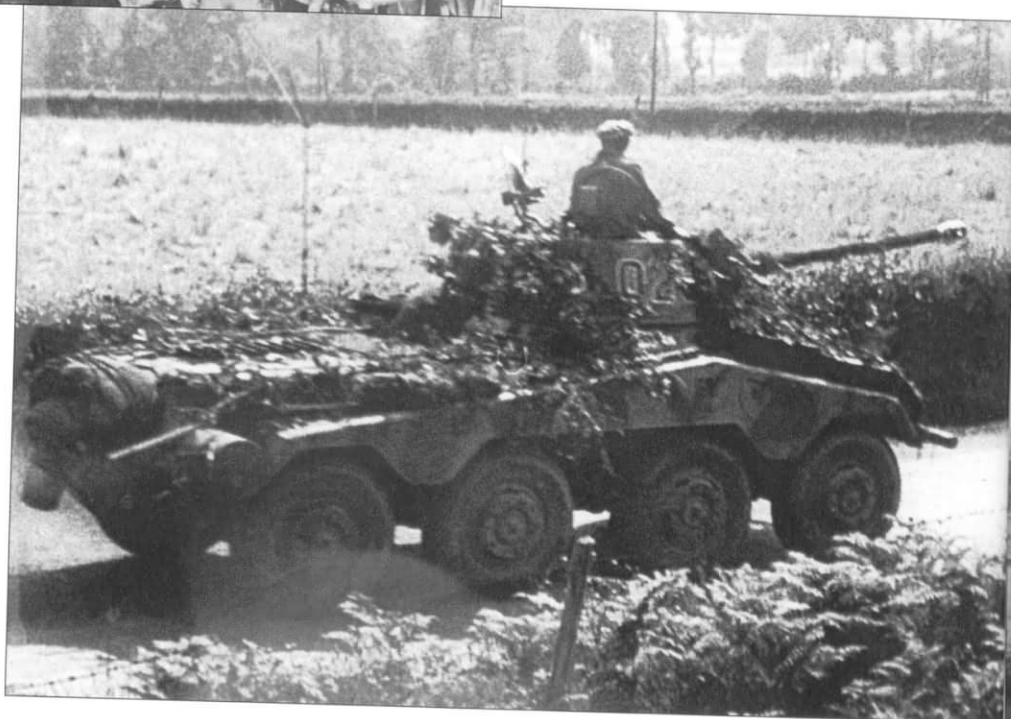
Command version of the Sd.Kfz.234/2 Puma equipped with additional radios and a star antenna mounted on the engine deck, most likely in France during the summer of 1944. The vehicle is painted in a three color camouflage scheme of green and brown over the dark sand base and has heavy foliage cover as well. On the turret, a tactical number, '023' or '025', is painted in black with a white outline. Of special interest is the very light color of the muzzle brake on the 5cm main armament.

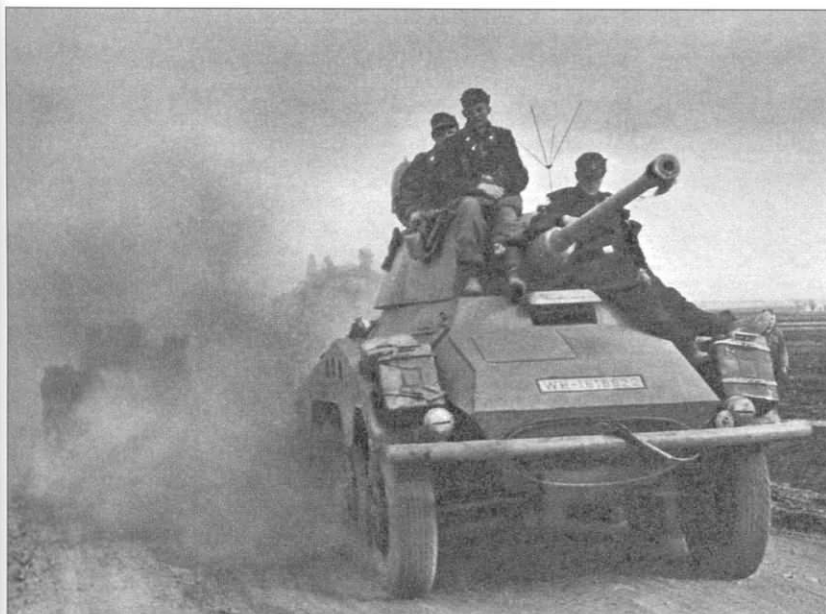
Another photo of a command Puma racing down a road on the Eastern Front in June 1944. It is finished in dark sand without any camouflage paint and has no markings other than the vehicle license number 'WH-1618820'. With only 101 manufactured, it was a rarely photographed vehicle.

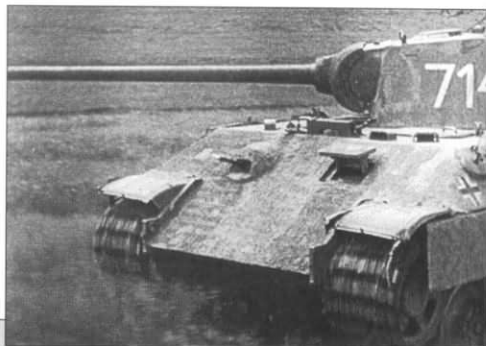
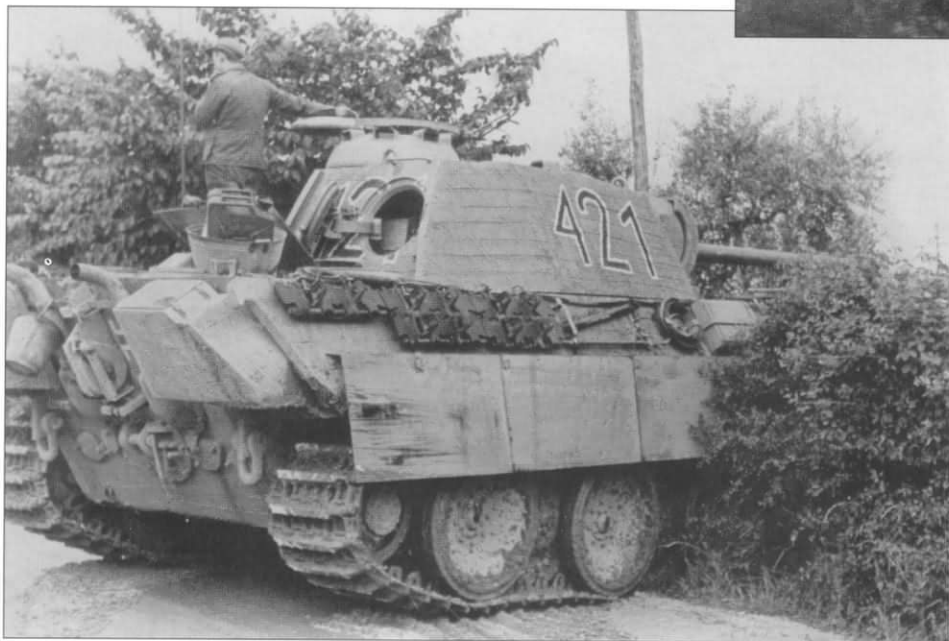
A Pz.Kpfw.V Panther Ausf.G swings off the road and through a hedgerow in France June 1944. Unusually, the vehicle has no camouflage paint applied over its dark sand base. The rather large tactical number '421' appears to be newly painted in black with a white outline. As well, a white outline Balkenkreuz can also be seen on the rear of the hull between the exhaust pipes, partially obscured by the jack.

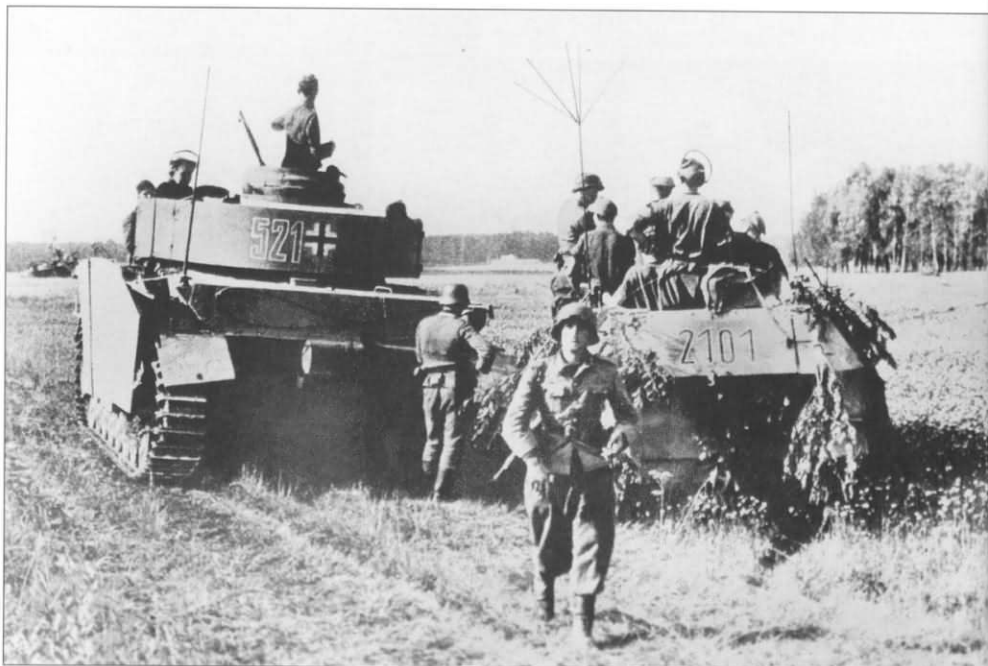
The commander of a Pz.Kpfw.IV Ausf.J receives orders from an Sd.Kfz.251/3 Ausf.C command half-track somewhere on the Eastern Front in early autumn 1944. An identifying feature of the Ausf.J is the lack of a muffler for the auxiliary turret traverse motor beside the engine muffler and the square cover on the engine deck over the radiator filler caps. Additionally, the vehicle does not have the zimmerit coating that was eliminated beginning in September 1944. The tactical number '521' is painted in red with a white outline beside a white outlined Balkenkreuz. The tactical number '2101' on the half-track is painted in black with a white outline.

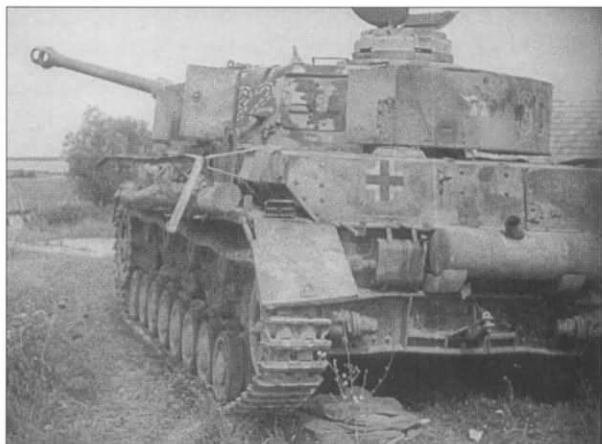
The summer of 1944 was a bitter struggle for the German Panzertruppe on the Eastern Front which resulted in severe losses in all the units involved. Among them was this Pz.Kpfw.IV Ausf.G with a white stenciled outline tactical number '332' appearing on the side of the turret which would indicate the tank was refitted with the schürzen armor on the turret and hull in a field workshop. The white elephant emblem on the rear of the turret schürzen beside the tactical number is that of s.Pz.Abt.502. This is one of at least two Pz.Kpfw.IV Ausf.G used by the battalion, though none appear on any known strength reports.

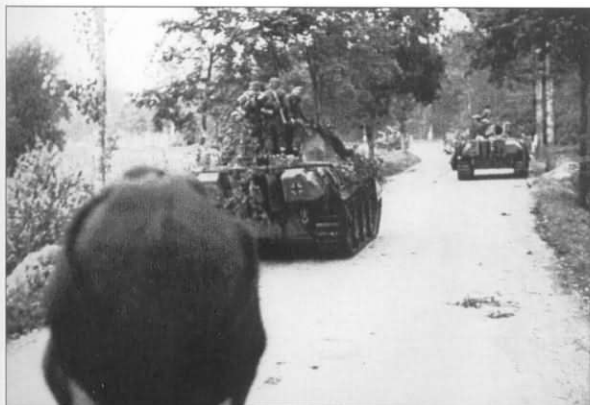
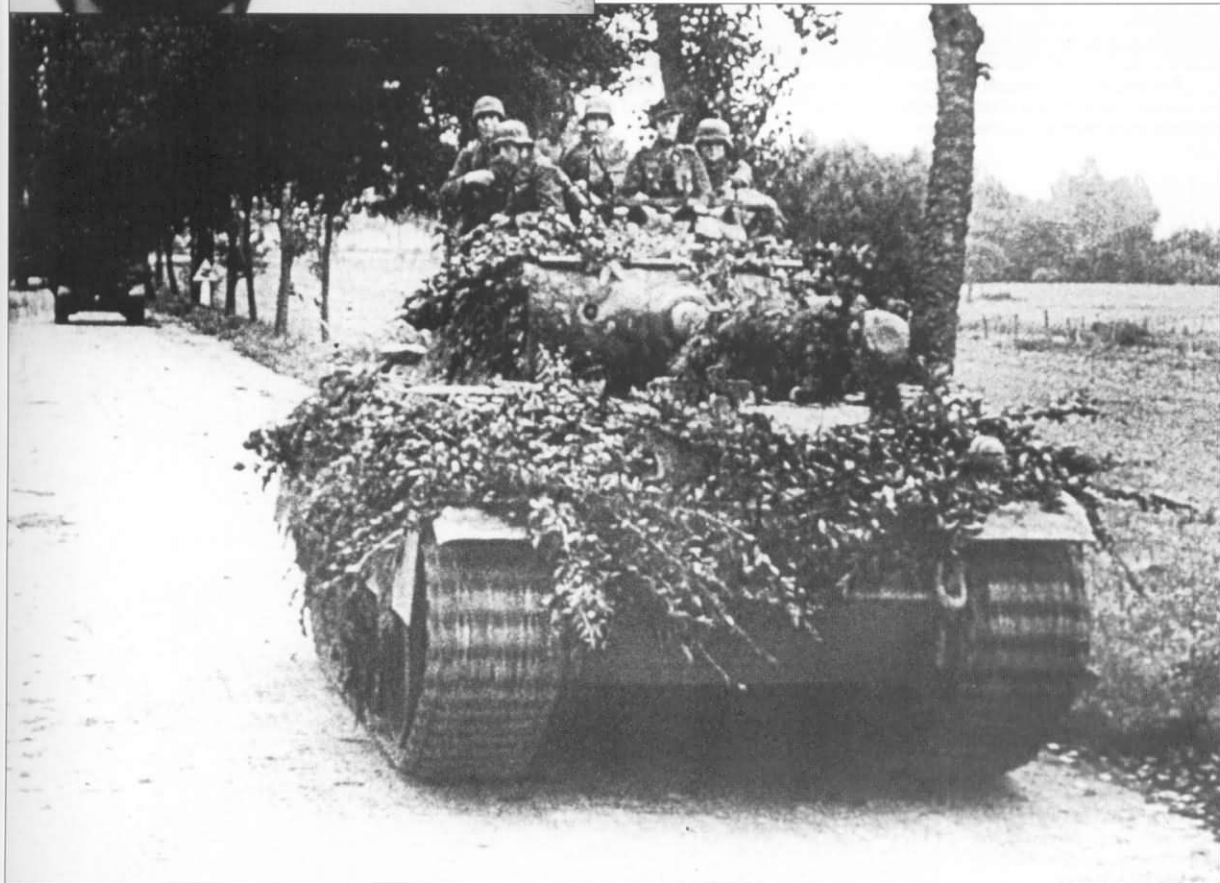
A column of Pz.Kpfw.V Panther Ausf.G, carrying infantry, on the march in France, late summer 1944. They are camouflaged with branches and hug the sides of the road to avoid detection from Allied fighters. The first two Ausf.G were built by M.A.N. in March 1944 and they began to be distributed to the Panzer-Divisions in April when a total of 105 were completed. Production of the Ausf.A continued at the MNH plant until July when they converted over to Ausf.G.

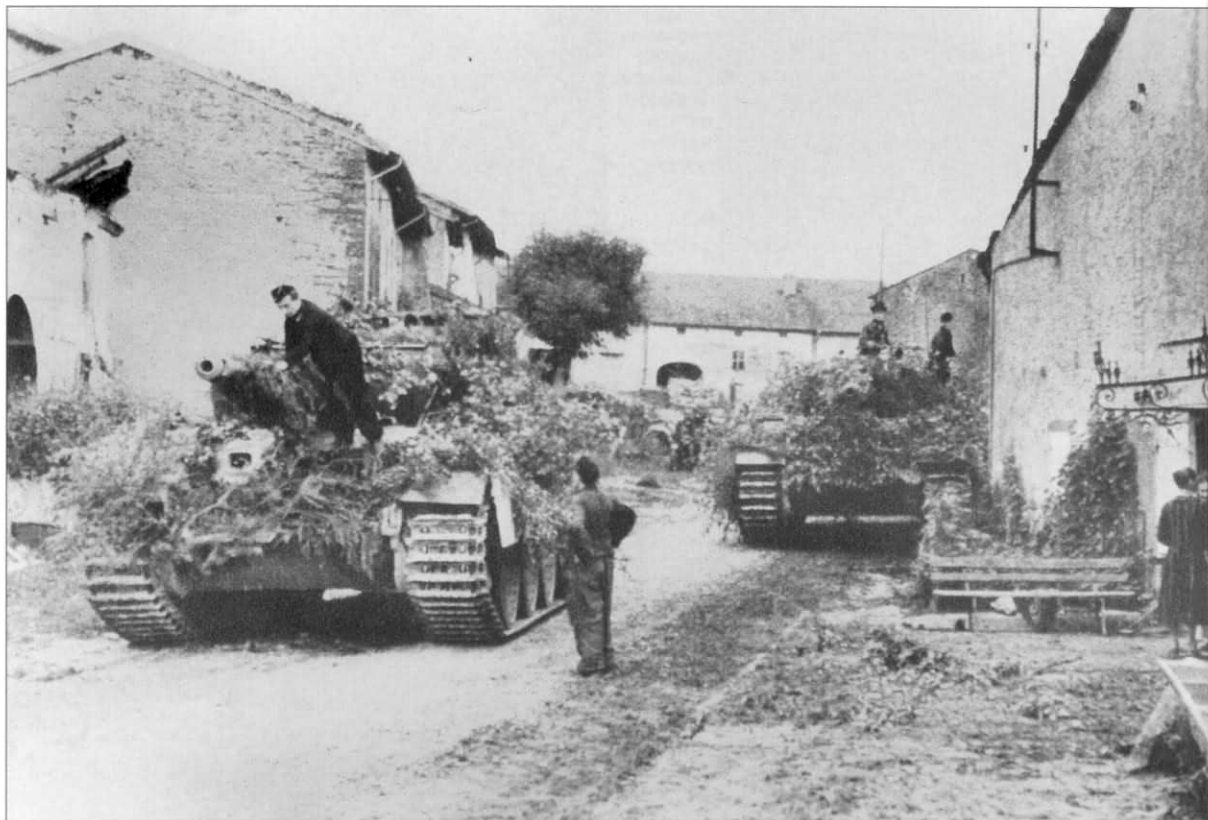
Two heavily camouflaged Pz.Kpfw.V Panther Ausf.G in a Norman village in July 1944. They are possibly from Panzer-Lehr-Division which was in the Normandy area when the invasion began. On June 10, 1944, they reported a strength of 98 Pz.Kpfw.IV and 88 Panthers. By July 8, 41 Pz.Kpfw.IV and 8 Panthers were reported as total losses.

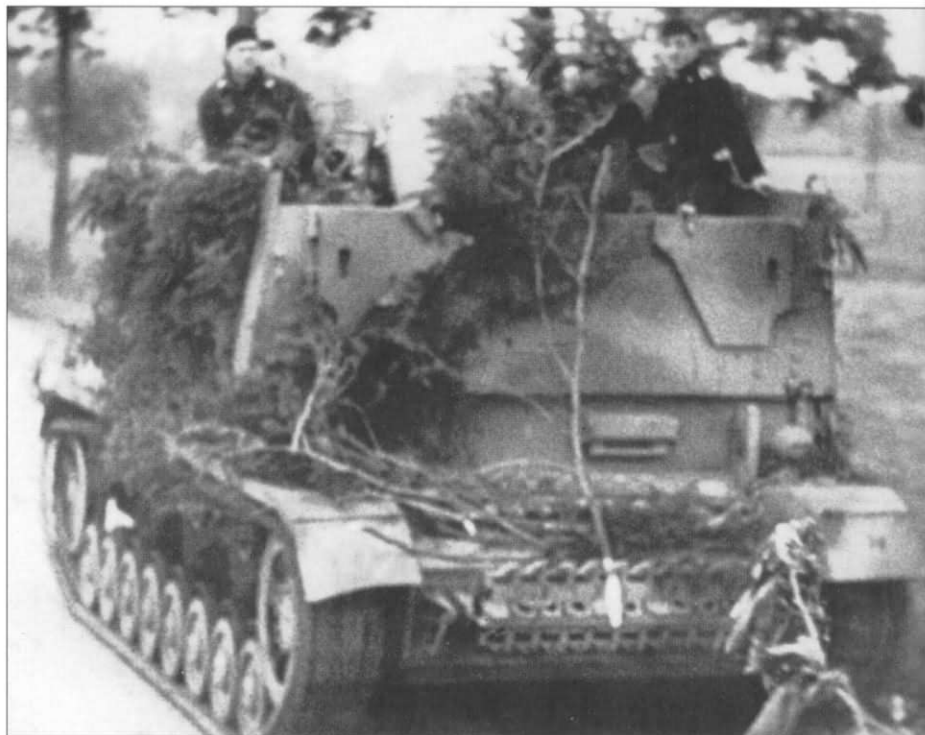
A Flakpanzerkampfwagen IV (3.7cm FlaK43) (Sd.Kfz.161/3) self-propelled anti-aircraft gun, known as the 'Möbelwagen', from the same unit. The first 20 'Möbelwagen' were completed by the end of March 1944 and began to be issued to the Panzer-Divisions on June 15, 1944, with eight going to each of the 9., 11., and 116. Panzer-Divisions in Normandy. A further sixteen were issued to 6. and 19. Panzer-Division on the Eastern Front. Four each were issued to Panzer-Brigade 105, 106, 107 and 108 on the Western Front and another four to each of the other six Panzer-Brigades on the Eastern Front. Starting in September 1944, Panzer-Regiments and Abteilungen as well as Panzer-Jäger-Abteilung began to be issued with four 'Möbelwagen' and four 'Wirbelwind'.

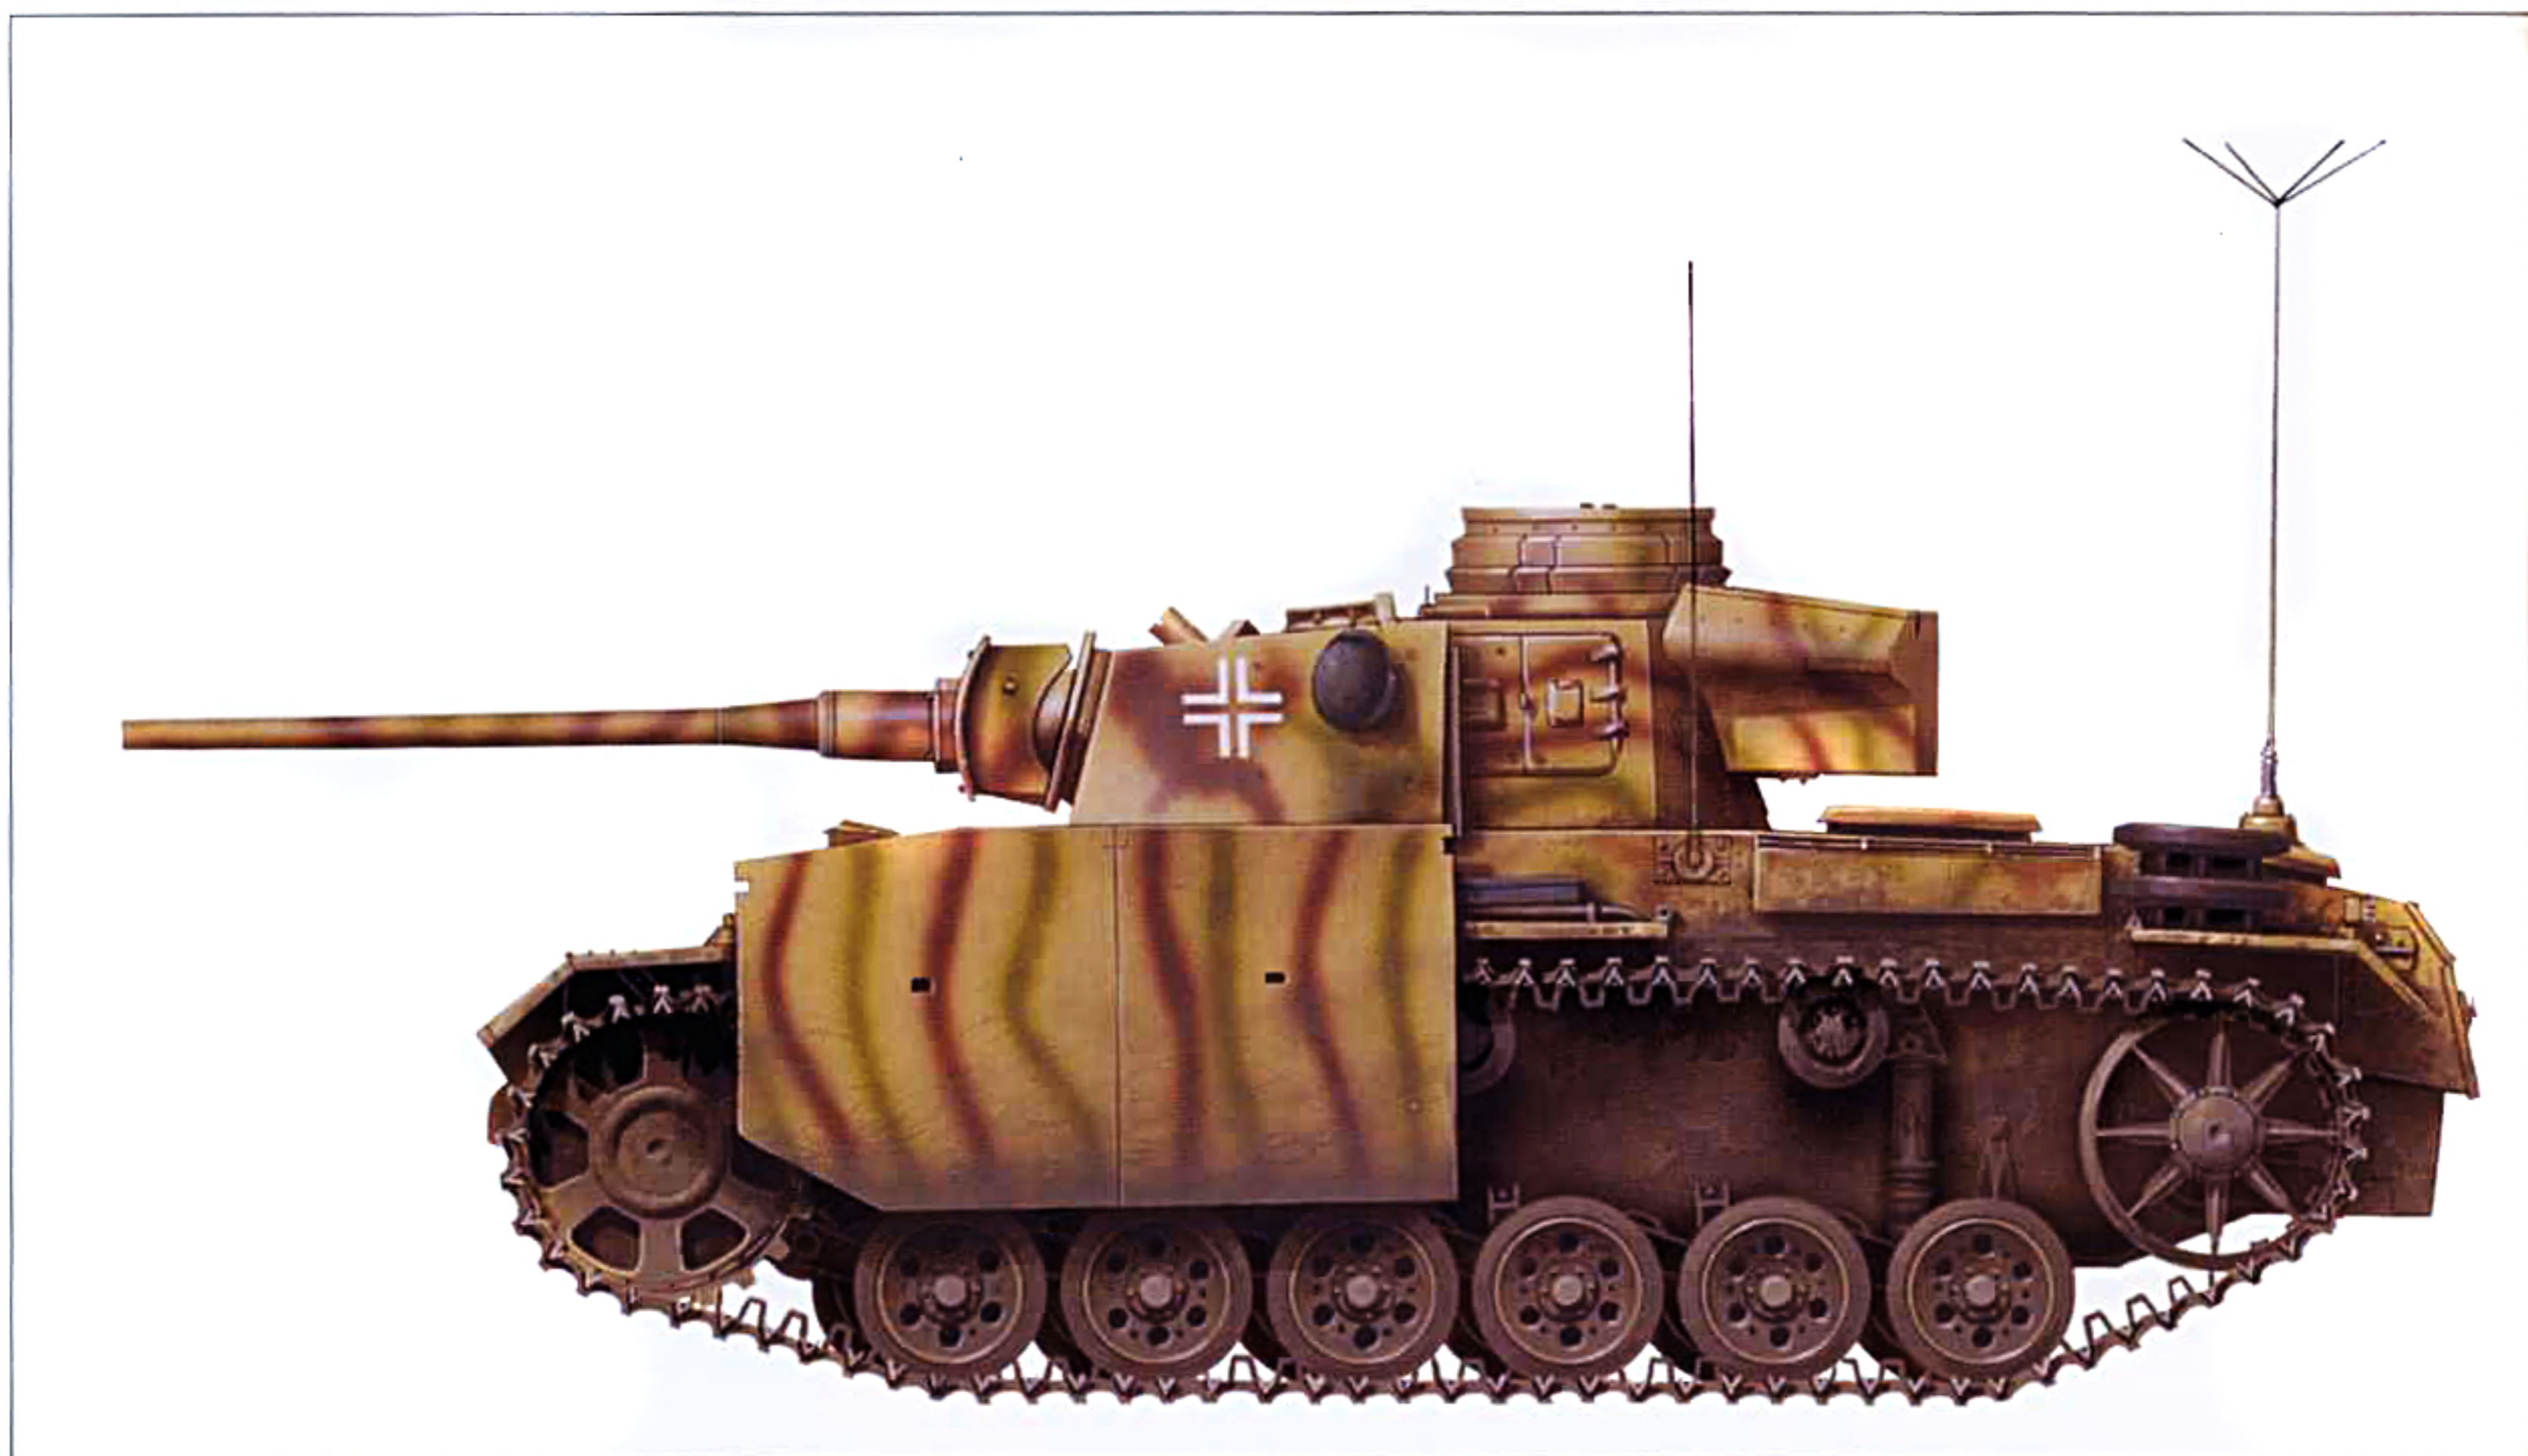
Pz.Bef.Wg.III Ausf.J, unknown Panzer-Division, Russia, summer 1944

This Pz.Bef.Wg.III Ausf.J is identifiable by the antenna pot on the rear of the engine deck and additional antenna swivel mount on the hull side, just in front of the air intake housing. It is painted in overall dark sand and has a camouflage scheme of thin green and brown wavy lines. Markings appear to be limited to the white outline Balkenkreuz on the side of the turret schürzen, although there may have been other markings on the missing rear part of the skirt armor. This vehicle was also fitted with the wide winterketten tracks.

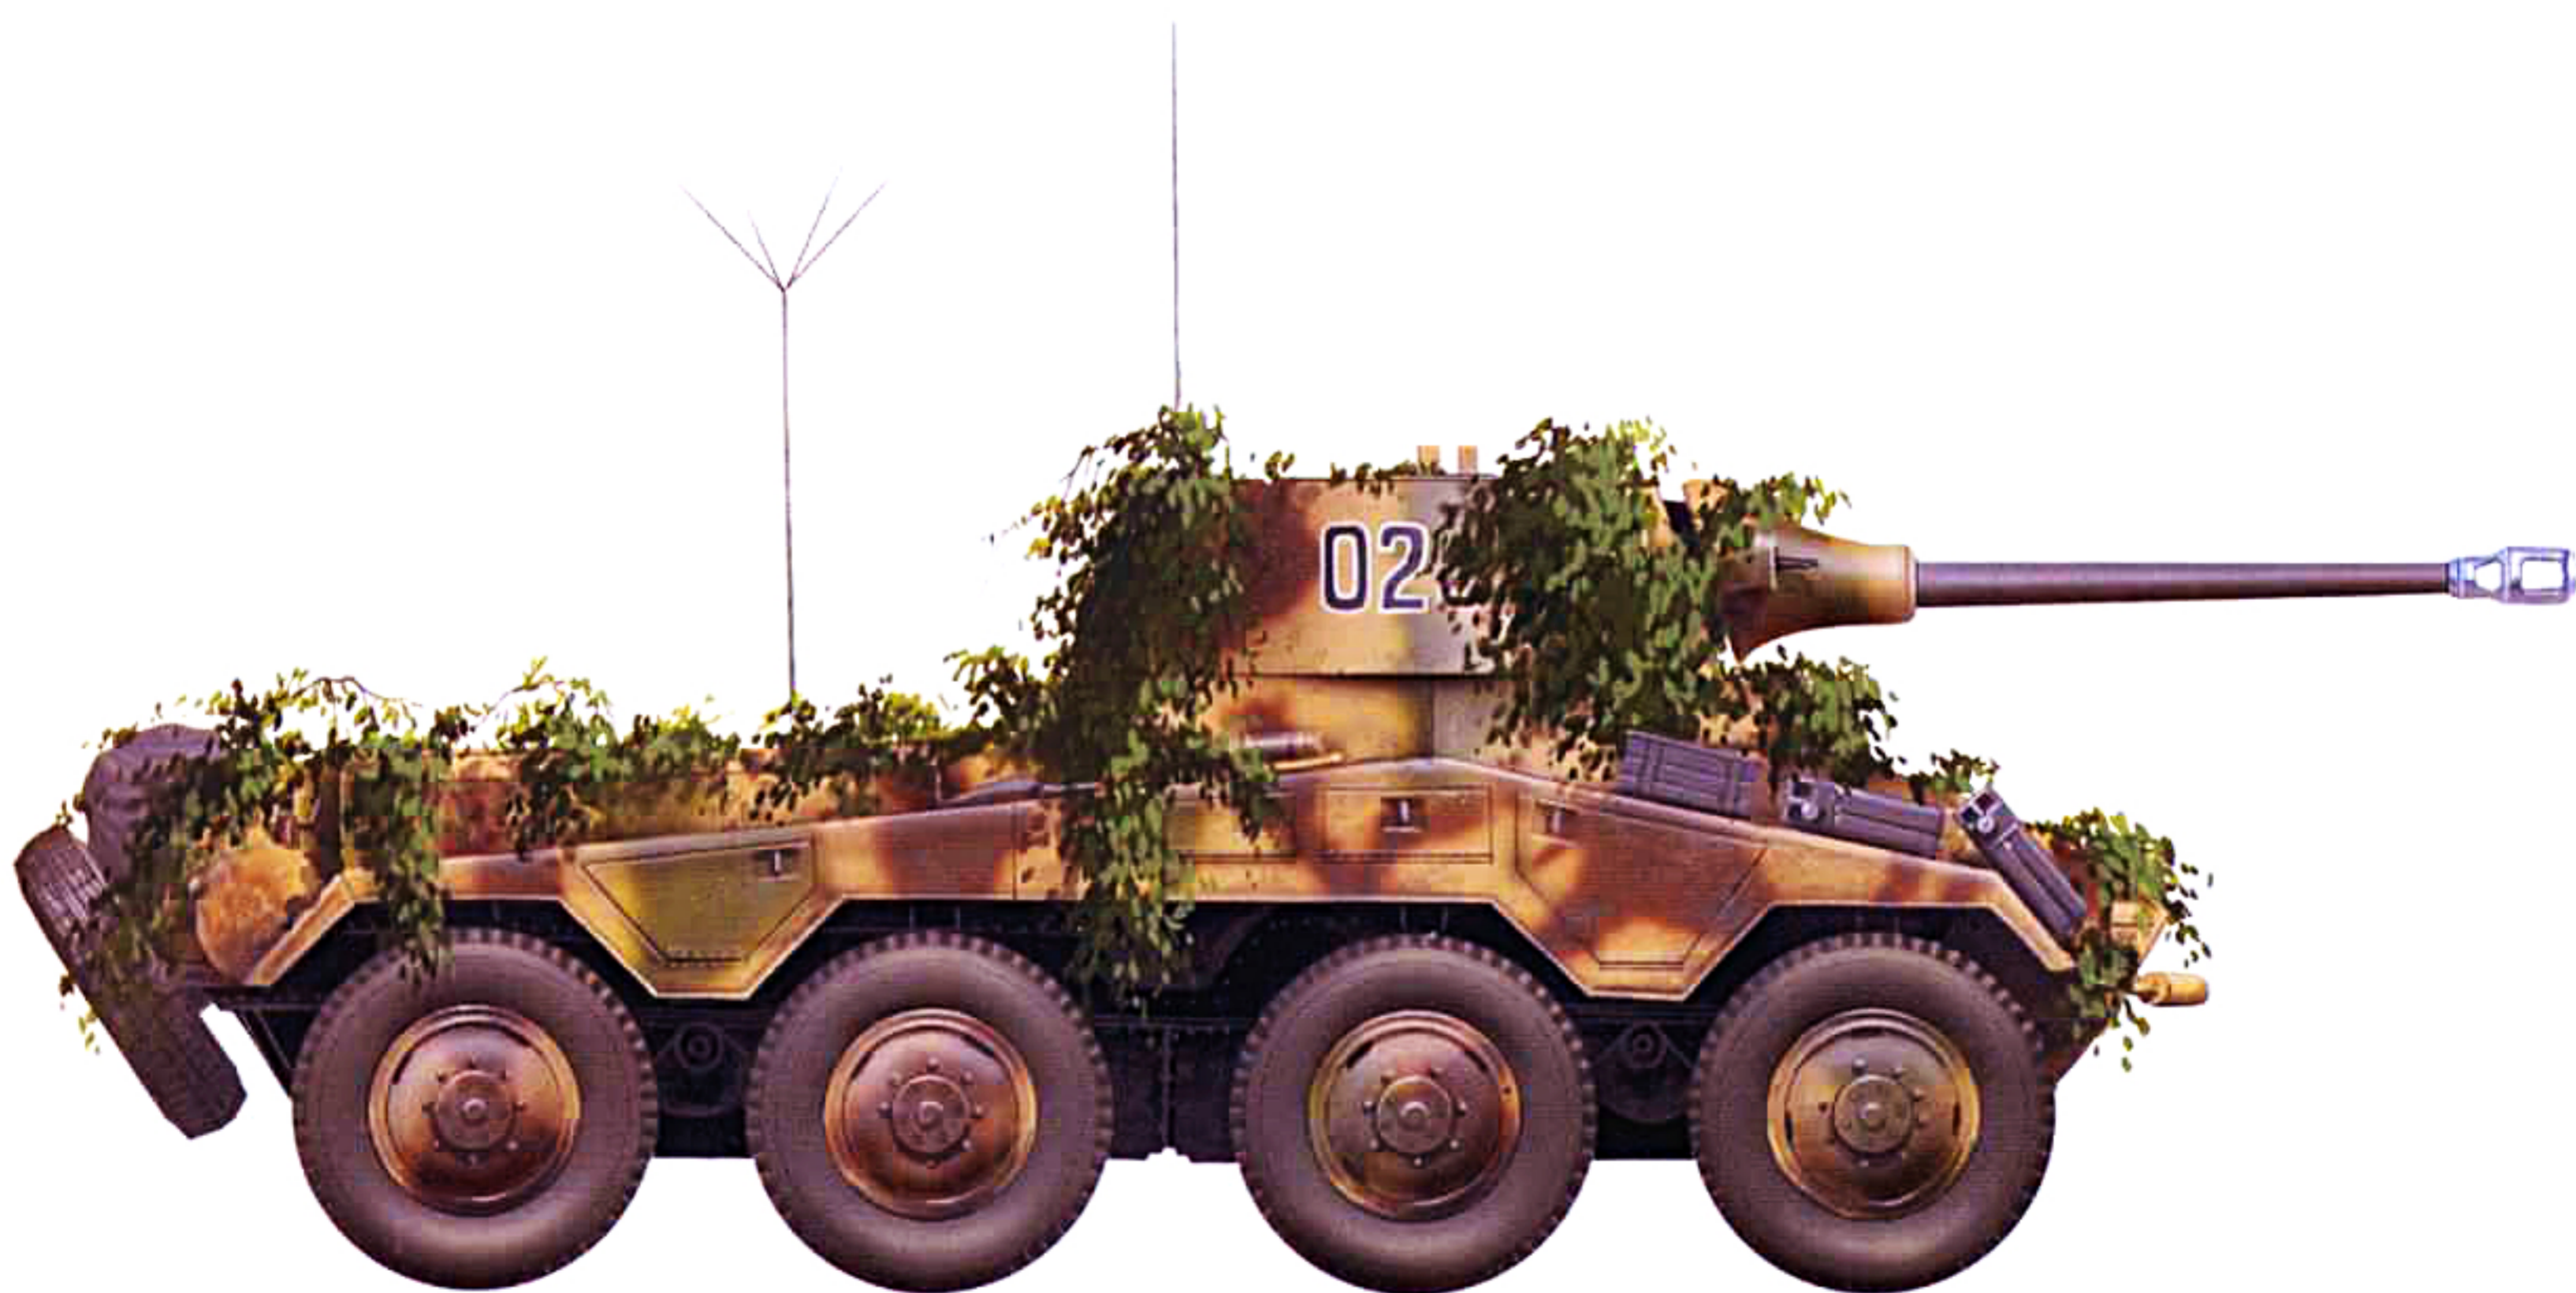
Pz.Kpfw. Tiger Ausf.B, 3./s.Pz.Abt.503, Mailly-le-Camp, France, July 1944

3./s.Pz.Abt.503 was equipped with 14 new Tiger II with the early turret, some of which still had the monobloc 8.8cm KwK43 L/71 gun barrel. This Tiger II has a camouflage scheme of large patches of green and brown, leaving little of the dark sand base color showing. The tactical number, '334', is painted in red with a white outline and the Balkenkreuz has a small circle of the dark sand color surrounding it.
